**Re: Chiquita Canyon, LLC Analysis of October 1, 2024 FLIR Survey in
Response to the December 24, 2024 LEA Letter Regarding
Milestone 2B Compliance, Chiquita Canyon Landfill**

Waste Connections Chiquita Canyon
Project: 2024 10 Thermal Study
Job: Thermal Study
Report Submitted Oct 2, 2024
Report Modified Feb 6, 2024

Emission Study Thermal Report

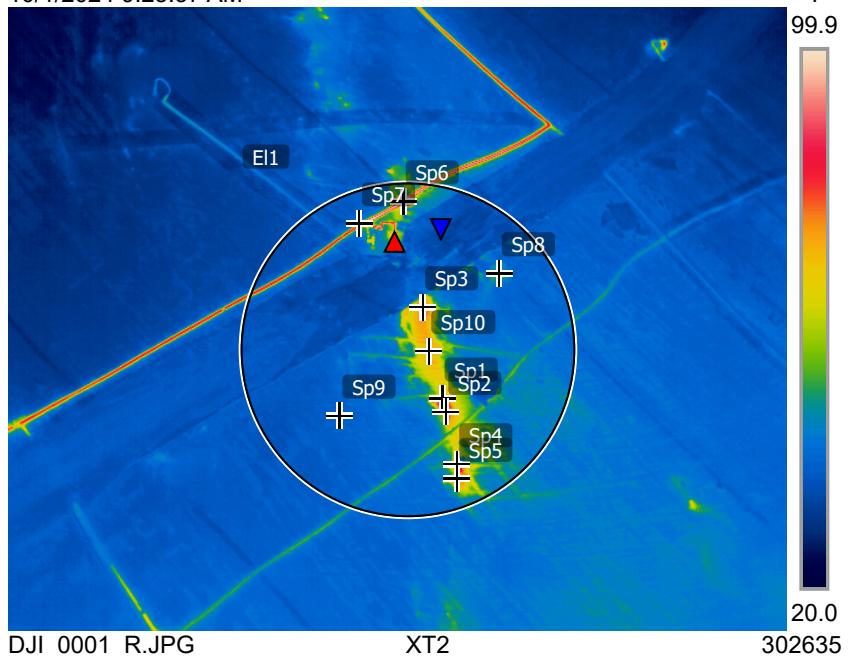
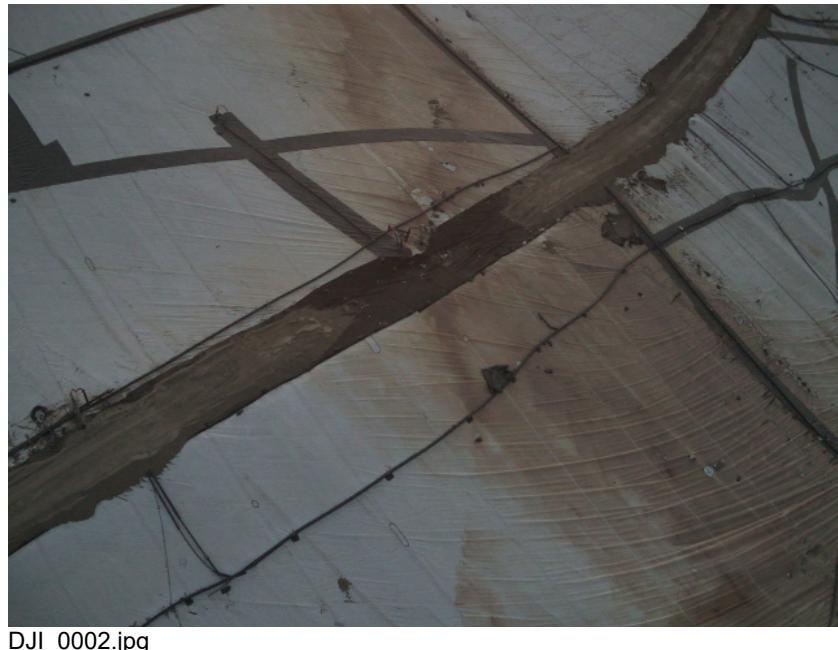
Reference #: 0001

The area designated by the LEA as "Area D" appears to be in grid 181. The Sniffer data reference point within Area D is point 0001. The horizontal collector for the GCCS discussed above in Area C also runs through Area D. Chiquita installed the horizontal collector for the GCCS system in this area and the nearby Area C in order to collect additional hot gas for conveyance to the flares and thereby further address elevated temperatures in this area.

El1	Max	117.9 °F
	Min	32.8 °F
	Average	45.4 °F
Sp1		100.4 °F
Sp2		102.2 °F
Sp3		80.1 °F
Sp4		91.5 °F
Sp5		93.8 °F
Sp6		101.0 °F
Sp7		100.5 °F
Sp8		64.5 °F
Sp9		42.5 °F
Sp10		70.7 °F

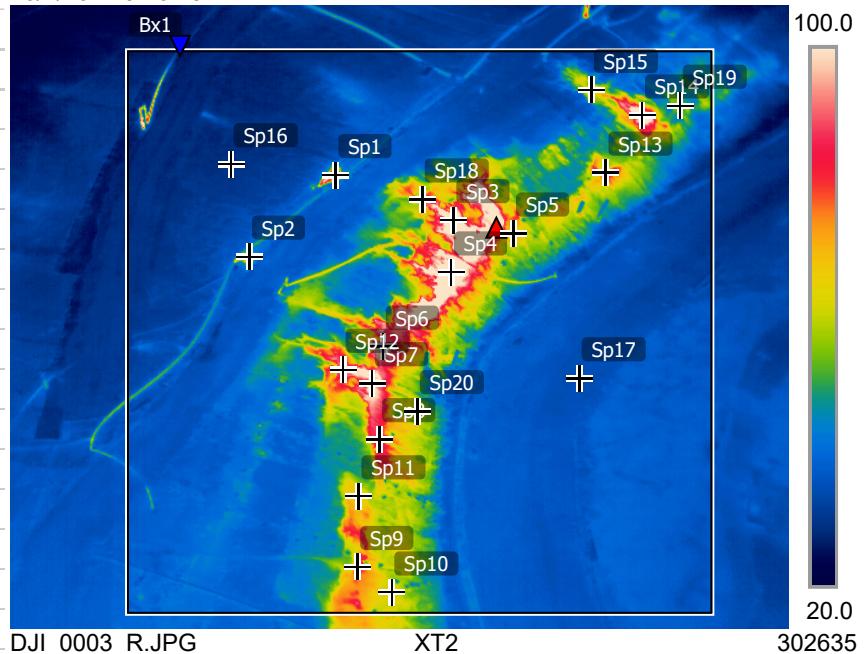
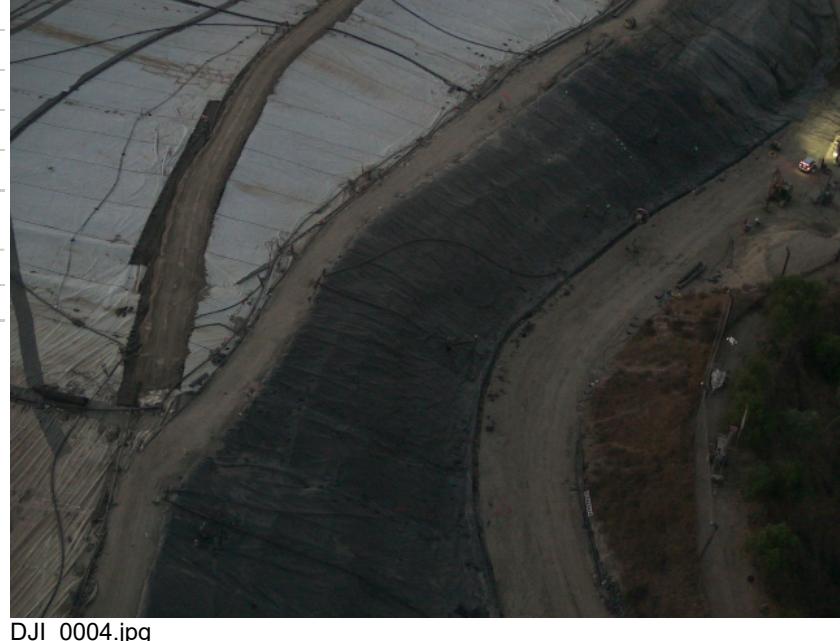
Reference #: 0003

Bx1	Max	141.1 °F
	Min	24.1 °F
	Average	45.8 °F
Sp1		103.1 °F
Sp2		83.1 °F
Sp3		113.8 °F
Sp4		113.2 °F
Sp5		75.5 °F
Sp6		102.0 °F
Sp7		99.4 °F
Sp8		89.4 °F
Sp9		88.2 °F
Sp10		68.6 °F
Sp11		70.9 °F
Sp12		97.9 °F
Sp13		85.1 °F
Sp14		102.9 °F
Sp15		68.1 °F
Sp16		29.7 °F
Sp17		37.6 °F
Sp18		85.0 °F
Sp19		62.5 °F
Sp20		63.1 °F

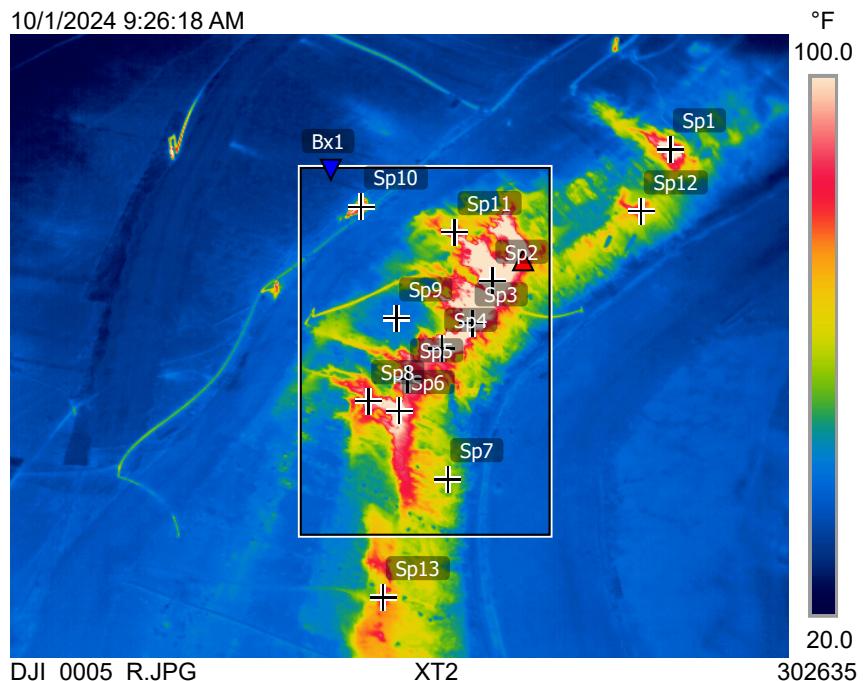
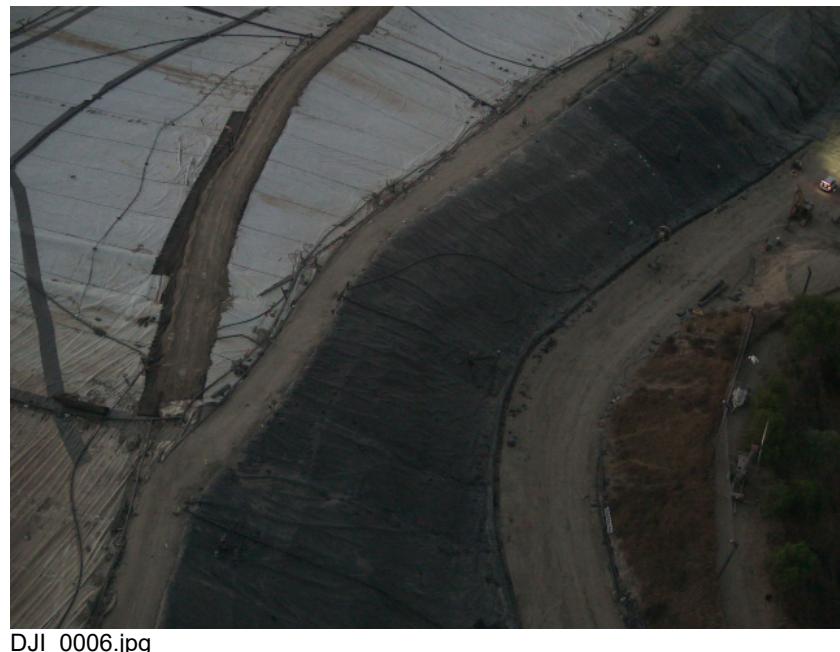
Reference #: 0005

Bx1	Max	140.6 °F
	Min	30.1 °F
	Average	57.4 °F
Sp1		103.6 °F
Sp2		127.0 °F
Sp3		108.8 °F
Sp4		101.4 °F
Sp5		102.3 °F
Sp6		100.8 °F
Sp7		62.6 °F
Sp8		98.6 °F
Sp9		45.2 °F
Sp10		104.1 °F
Sp11		84.9 °F
Sp12		78.1 °F
Sp13		89.5 °F

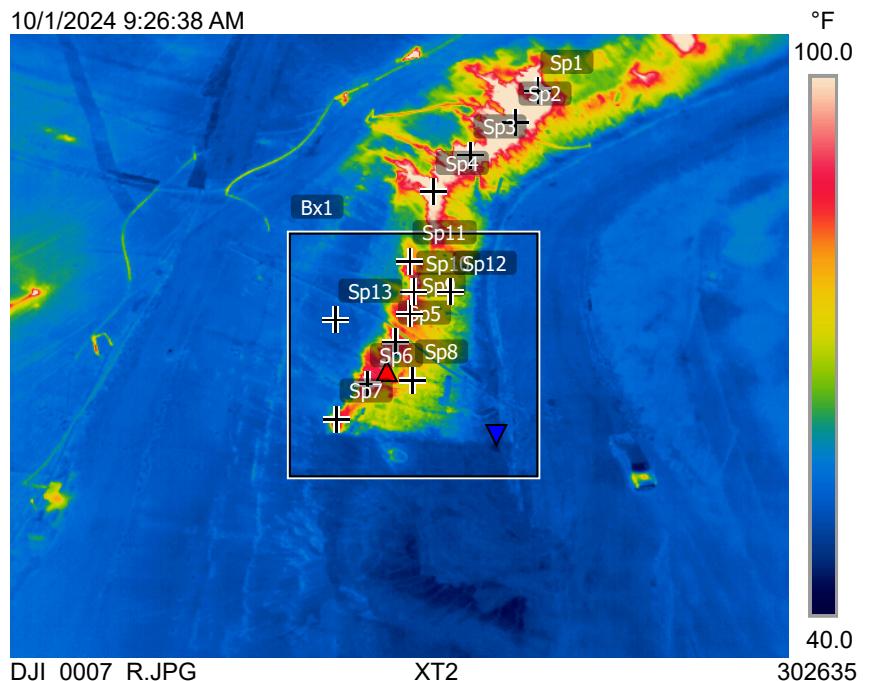
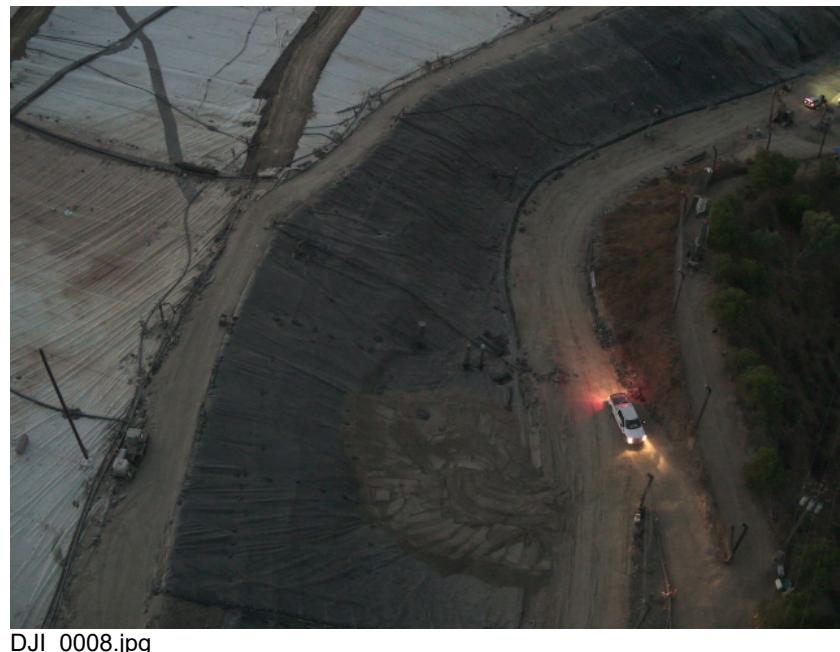
Reference #: 0007

The area designated by the LEA as "Area C" appears to be in grid 181. There are no specific data reference points included in the October 1, 2024 Sniffer data for this area, though point 0007 is nearby. This area is along the western portion of the Landfill, where the reaction is closer to the surface relative to the rest of the reaction area, meaning elevated temperatures are closer to the surface and therefore more readily detected by the radiometric thermal camera. At the time of the October 1,

Bx1	Max	108.2 °F
	Min	44.5 °F
	Average	60.4 °F
Sp1		120.8 °F
Sp2		120.1 °F
Sp3		111.0 °F
Sp4		110.4 °F
Sp5		99.2 °F
Sp6		99.8 °F
Sp7		99.9 °F
Sp8		79.0 °F
Sp9		100.0 °F
Sp10		97.5 °F
Sp11		87.3 °F
Sp12		75.9 °F
Sp13		53.9 °F

2024 survey, work along the western portion of the Landfill to complete the western toe drain installation project was being performed in order to install a new toe drain, secondary drain, and ancillary piping to facilitate leachate drainage into the Landfill's leachate collection system and to improve gas collection by replacing the temporary plastic cover with a continuous geosynthetic cover over the area, to further mitigate the elevated temperatures. That work is now complete. In addition, in late April to early May 2024, Chiquita installed a horizontal collector for the GCCS system in this area and the nearby Area D in order to collect additional hot gas for conveyance to the flares and thereby further address elevated temperatures in this area.

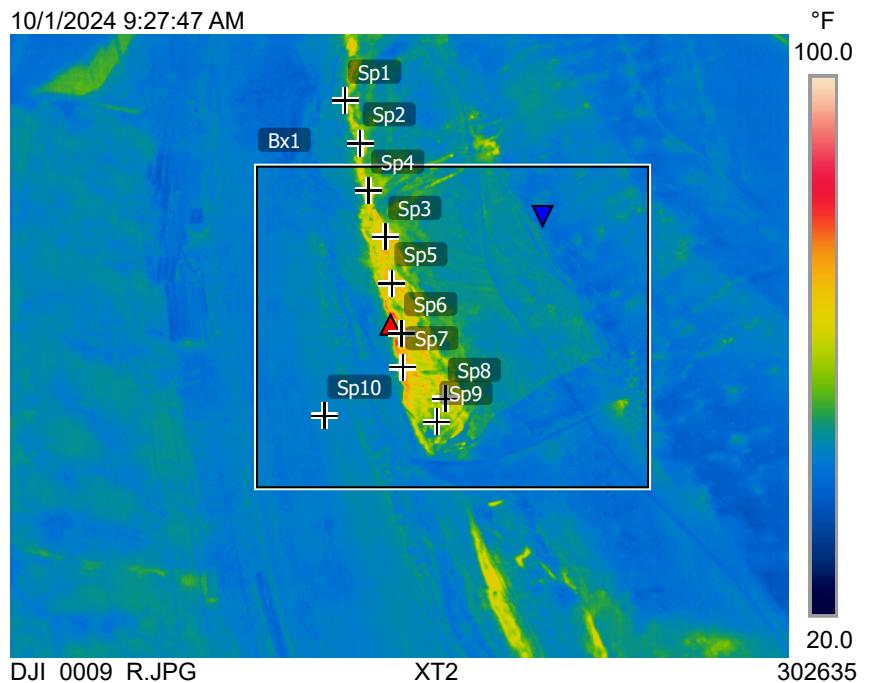
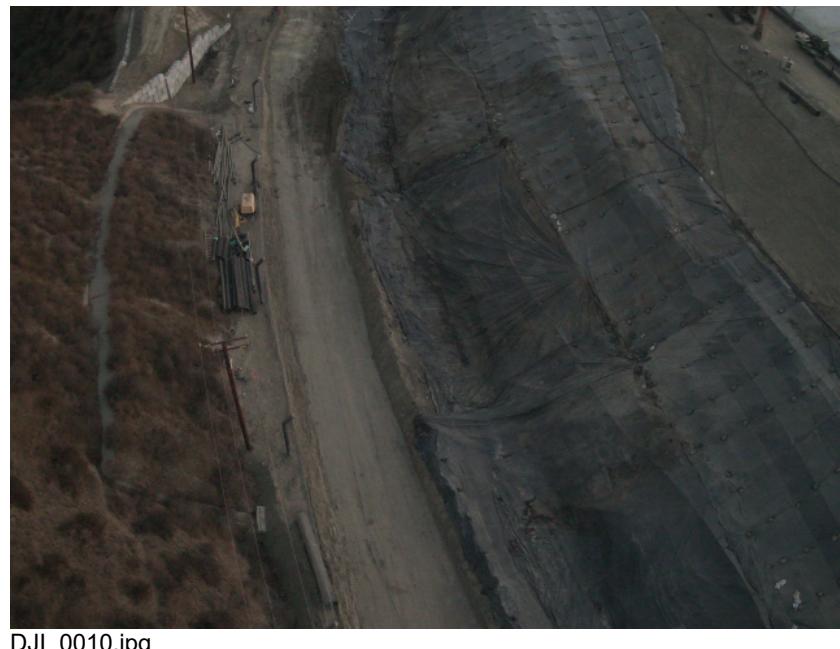
Reference #: 0009

Measurements		
Bx1	Max	83.0 °F
	Min	40.6 °F
	Average	49.8 °F
Sp1		75.8 °F
Sp2		74.9 °F
Sp3		76.6 °F
Sp4		68.6 °F
Sp5		76.5 °F
Sp6		79.6 °F
Sp7		75.6 °F
Sp8		73.4 °F
Sp9		54.4 °F
Sp10		48.2 °F

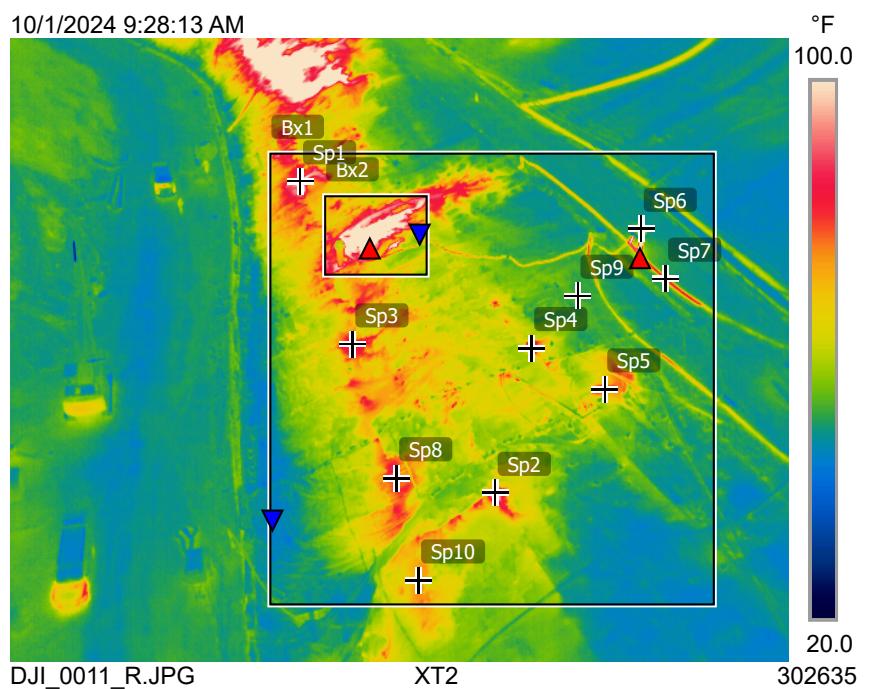
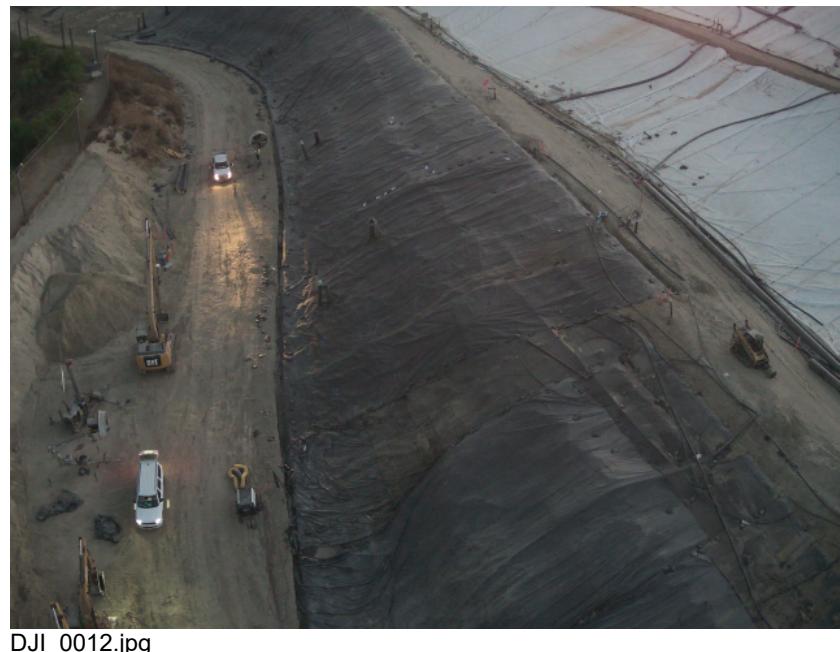
Reference #: 0011

Bx1	Max	137.3 °F
	Min	45.3 °F
	Average	61.8 °F
Bx2	Max	133.5 °F
	Min	57.6 °F
	Average	81.7 °F
Sp1		102.7 °F
Sp2		104.1 °F
Sp3		91.2 °F
Sp4		106.7 °F
Sp5		81.0 °F
Sp6		119.2 °F
Sp7		83.5 °F
Sp8		78.4 °F
Sp9		55.2 °F
Sp10		76.2 °F

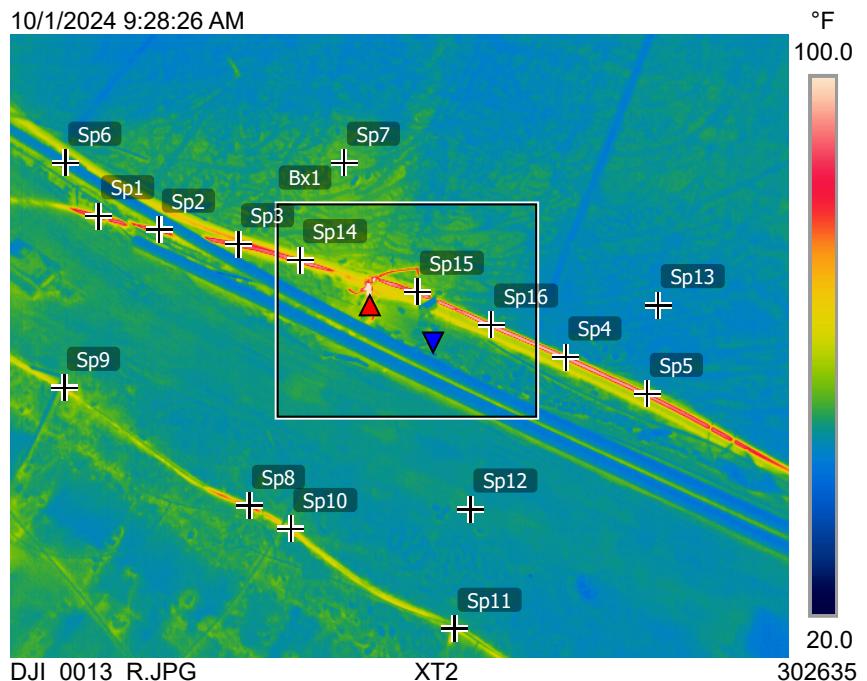
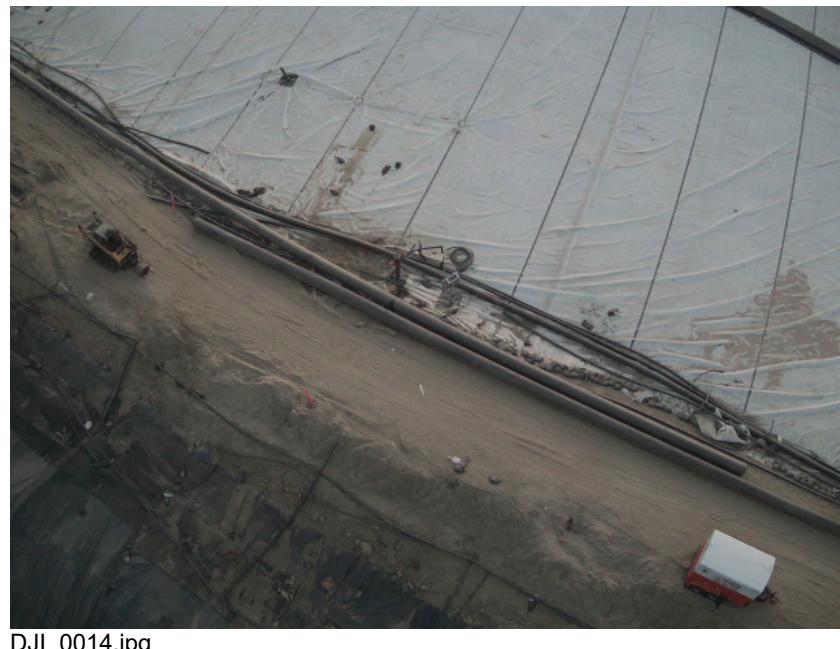
Reference #: 0013

Bx1	Max	117.6 °F
	Min	39.2 °F
	Average	54.8 °F
Sp1		91.7 °F
Sp2		90.5 °F
Sp3		91.3 °F
Sp4		96.6 °F
Sp5		96.0 °F
Sp6		47.5 °F
Sp7		56.0 °F
Sp8		83.4 °F
Sp9		75.0 °F
Sp10		81.4 °F
Sp11		72.8 °F
Sp12		51.8 °F
Sp13		48.2 °F
Sp14		95.7 °F
Sp15		90.3 °F
Sp16		96.9 °F

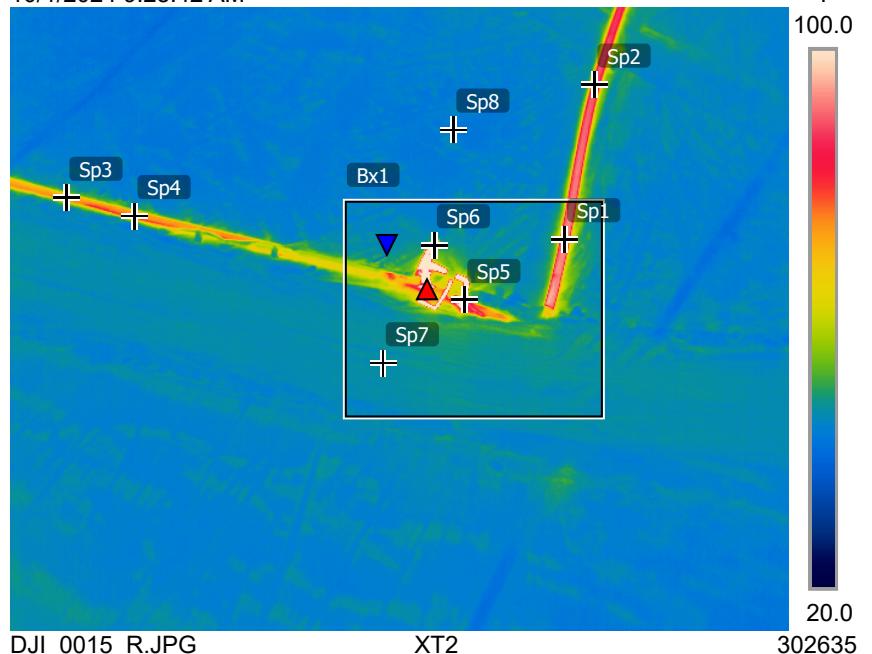
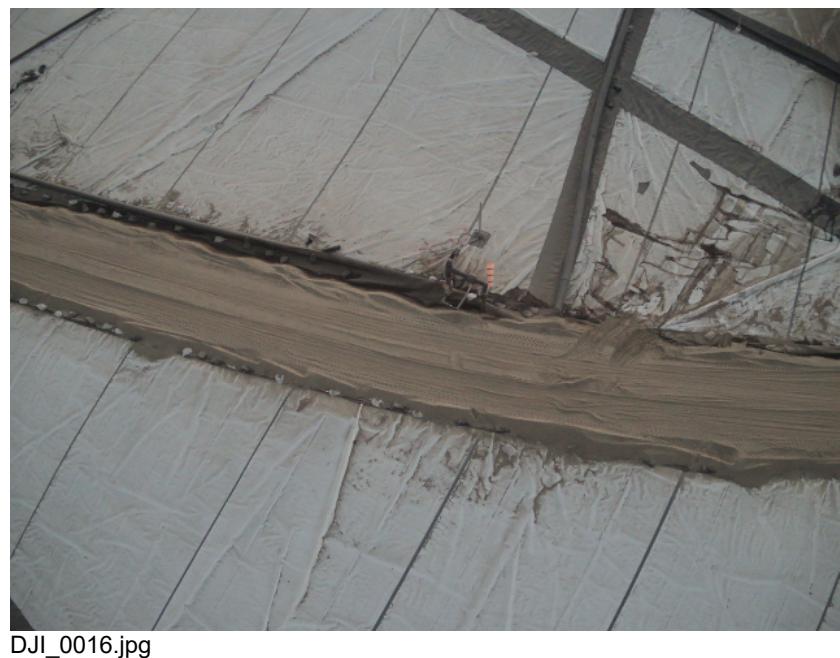
Reference #: 0015

Bx1	Max	171.5 °F
	Min	43.2 °F
	Average	54.5 °F
Sp1		94.0 °F
Sp2		91.1 °F
Sp3		76.8 °F
Sp4		80.2 °F
Sp5		116.2 °F
Sp6		111.5 °F
Sp7		49.7 °F
Sp8		46.2 °F

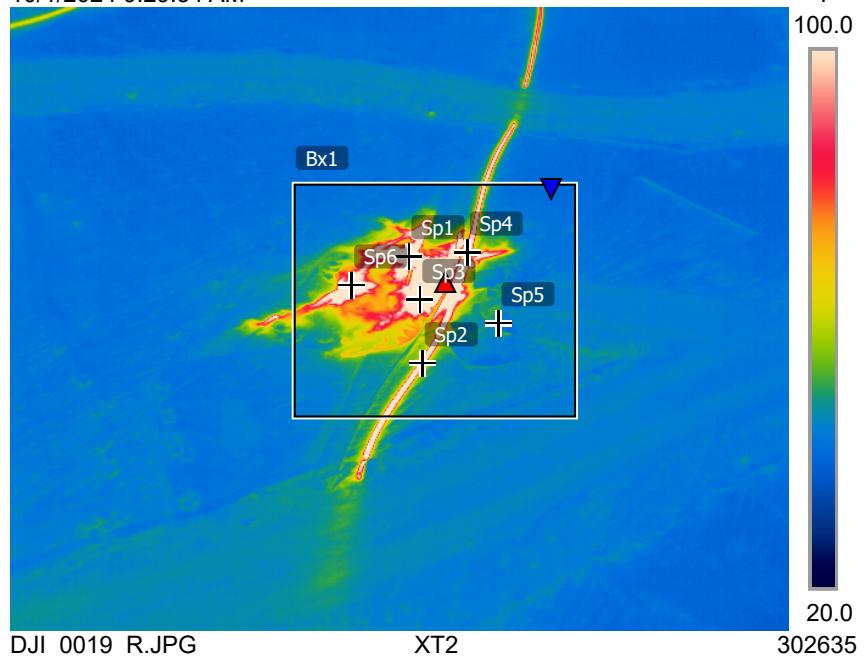
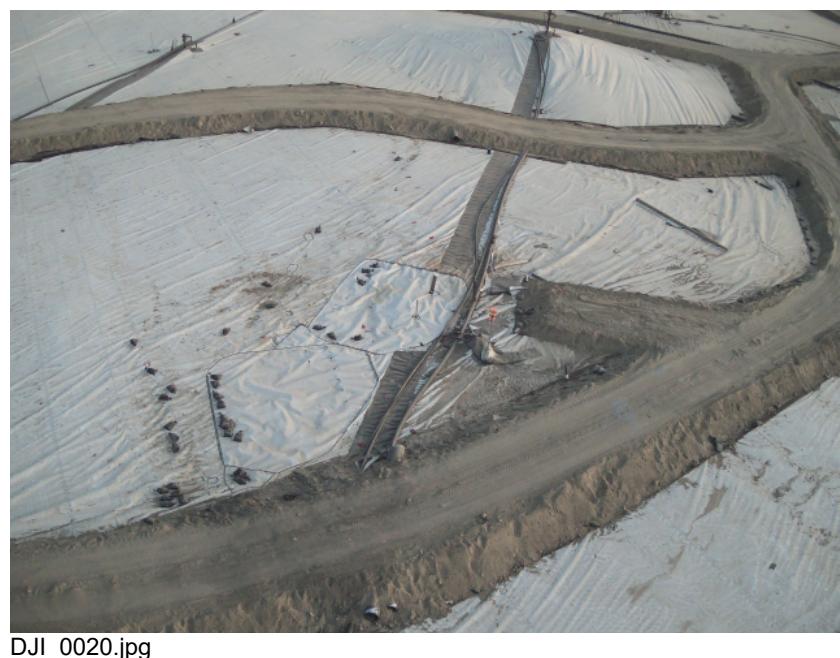
Reference #: 0019

The area designated by the LEA as "Area E" appears to be in grid 177. The Sniffer data reference points within Area E are points 0019 and 0021. An abandoned gas well, well CV-2302, exists within Area E and is photographed on page 10 of Attachment A. Additional gas wells and dewatering pumps were installed in the area to replace CV-2302. However, the abandoned borehole for CV-2302 may be continuing to emit heat to the surface, which may explain the elevated temperatures detected in the area. The other gas wells and pumps installed in the area continue to remove hot gas and liquids from the Landfill.

Bx1	Max	159.1 °F
	Min	42.6 °F
	Average	59.8 °F
Sp1		139.0 °F
Sp2		120.1 °F
Sp3		112.1 °F
Sp4		114.0 °F
Sp5		50.9 °F
Sp6		117.4 °F

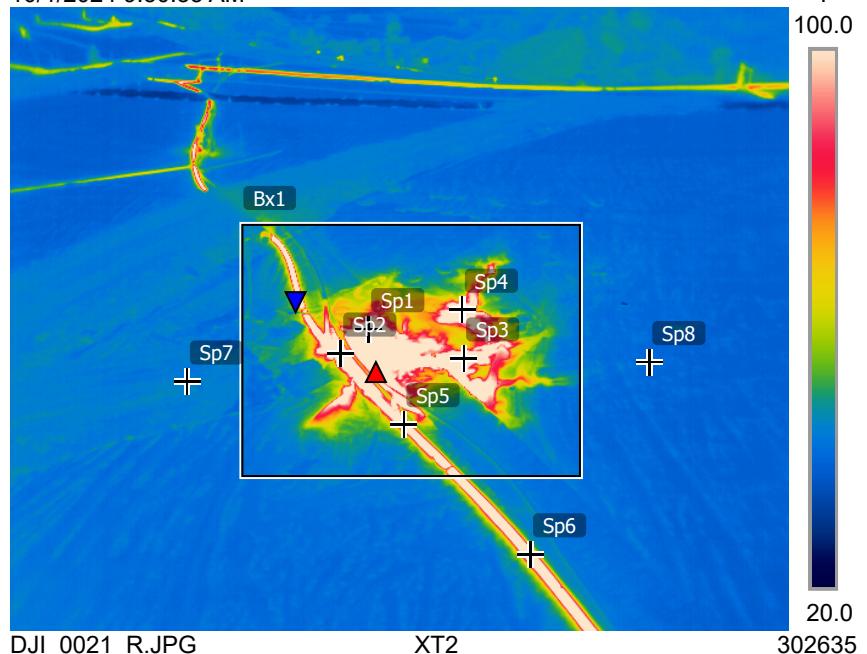
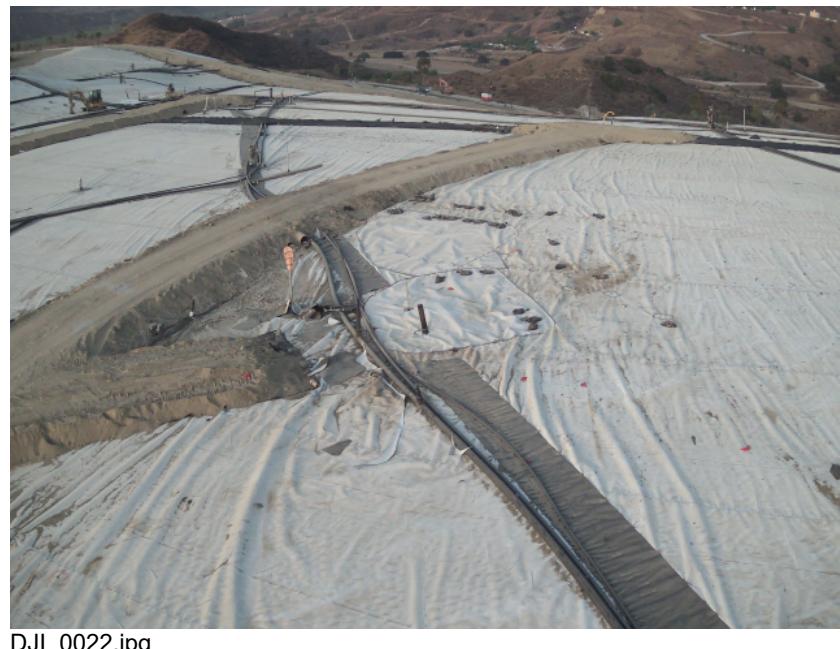
Reference #: 0021

Bx1	Max	161.1 °F
	Min	41.0 °F
	Average	61.8 °F
Sp1		111.4 °F
Sp2		130.9 °F
Sp3		128.5 °F
Sp4		114.6 °F
Sp5		113.5 °F
Sp6		112.3 °F
Sp7		48.0 °F
Sp8		43.0 °F

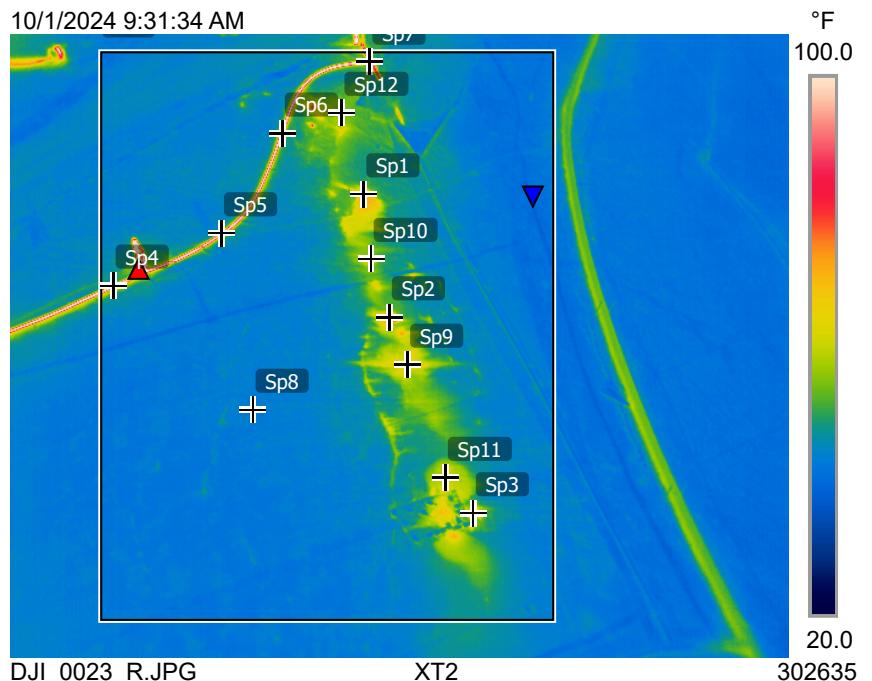
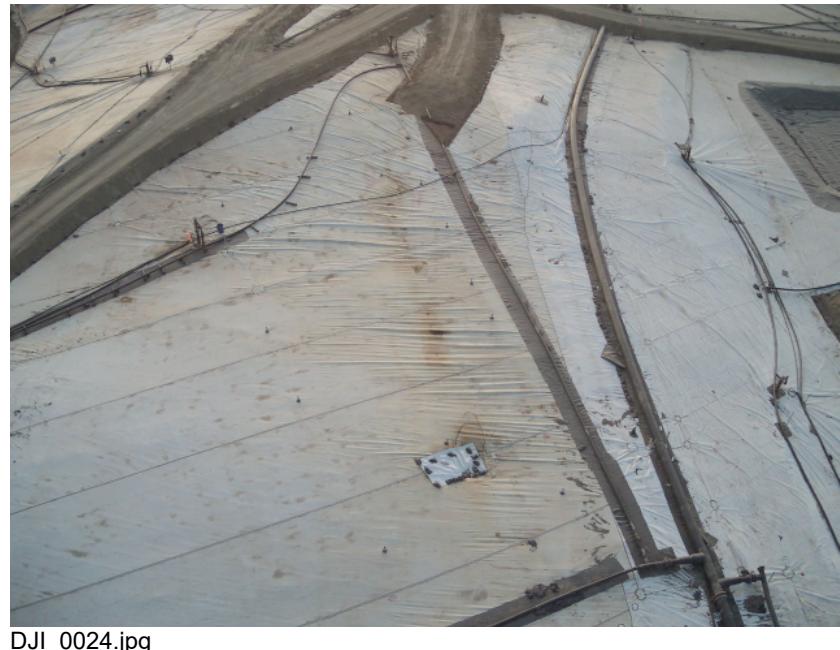
Reference #: 0023

The area designated by the LEA as "Area B" appears to be in grid 185. The Sniffer data reference points in Area B are points 0023 and 0025. As with the nearby Area A, GCCS infrastructure is highly concentrated in this area. As the GCCS system is designed to convey the landfill gas from the north slope to the flares, we would expect to see elevated temperatures here, particularly given the higher concentration of GCCS infrastructure. This area was also subject to elevated temperatures where the integrity of the dirt cover was compromised. Chiquita repaired the geomembrane cover and performed related work during the fourth quarter of 2024 to address this issue.

Bx1	Max	152.6 °F
	Min	41.0 °F
	Average	49.5 °F
Sp1		77.2 °F
Sp2		81.6 °F
Sp3		80.6 °F
Sp4		100.6 °F
Sp5		97.6 °F
Sp6		105.5 °F
Sp7		111.5 °F
Sp8		46.5 °F
Sp9		76.0 °F
Sp10		83.4 °F
Sp11		63.8 °F
Sp12		59.9 °F

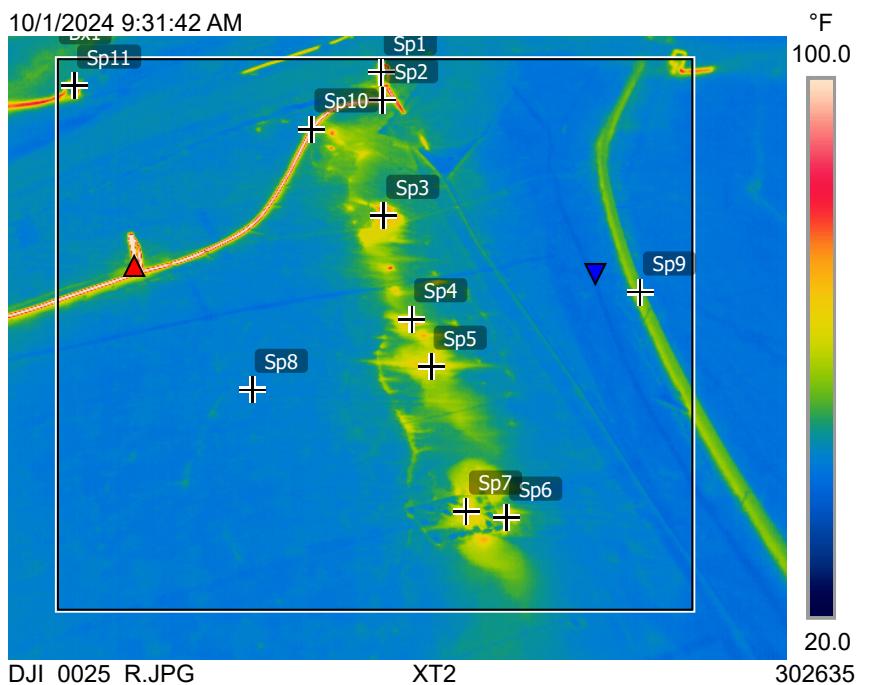
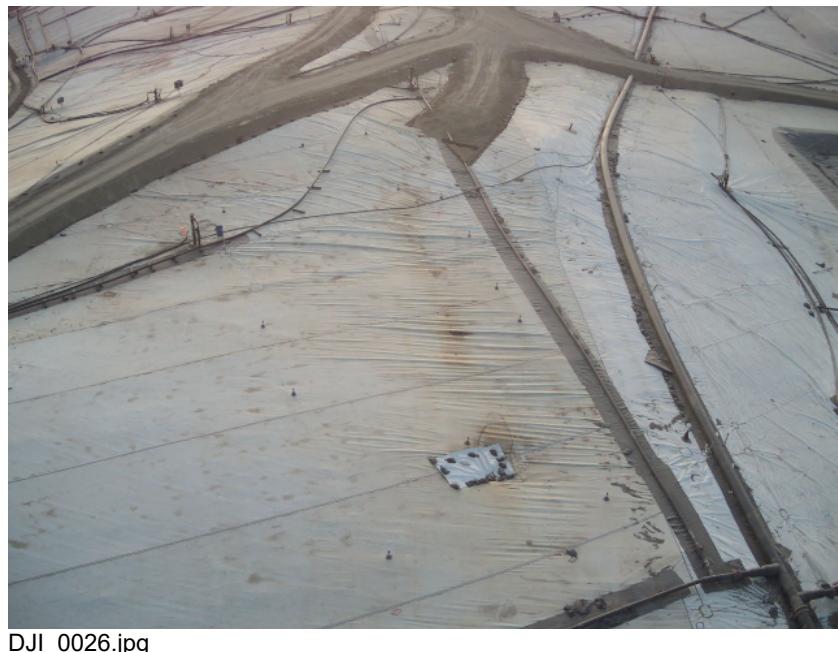
Reference #: 0025

Bx1	Max	154.7 °F
	Min	40.7 °F
	Average	49.4 °F
Sp1		132.6 °F
Sp2		107.8 °F
Sp3		72.1 °F
Sp4		81.8 °F
Sp5		76.1 °F
Sp6		74.7 °F
Sp7		72.8 °F
Sp8		46.4 °F
Sp9		56.9 °F
Sp10		105.9 °F
Sp11		108.6 °F
