**Re: Chiquita Canyon, LLC Analysis of February 4, 2025 FLIR Survey in
Response to the December 24, 2024 LEA Letter Regarding
Milestone 2B Compliance, Chiquita Canyon Landfill**

Waste Connections Chiquita Canyon
Project: 2025 02 Thermal Study
Job: Thermal Study
Report Issued Mar 4, 2025

Emission Study Thermal Report

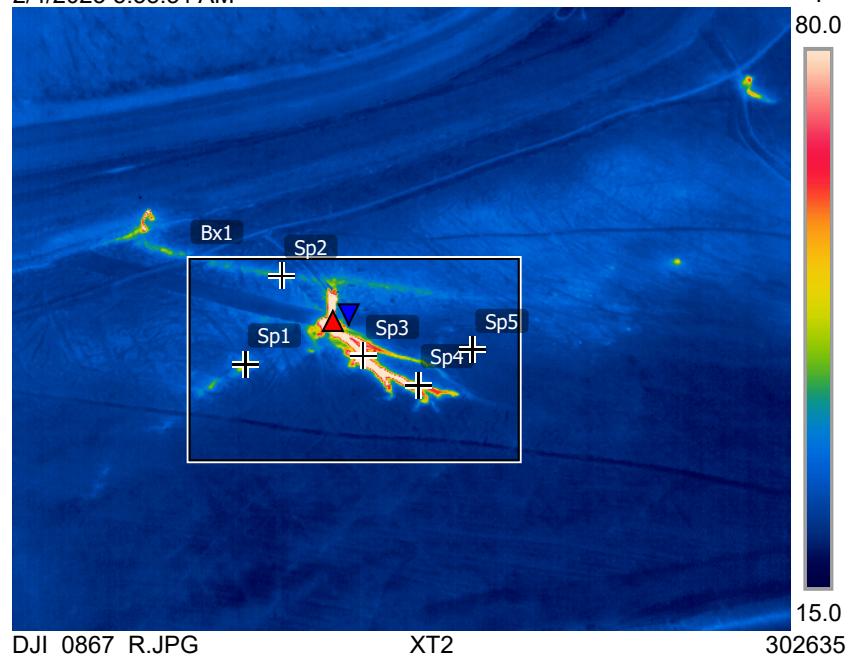
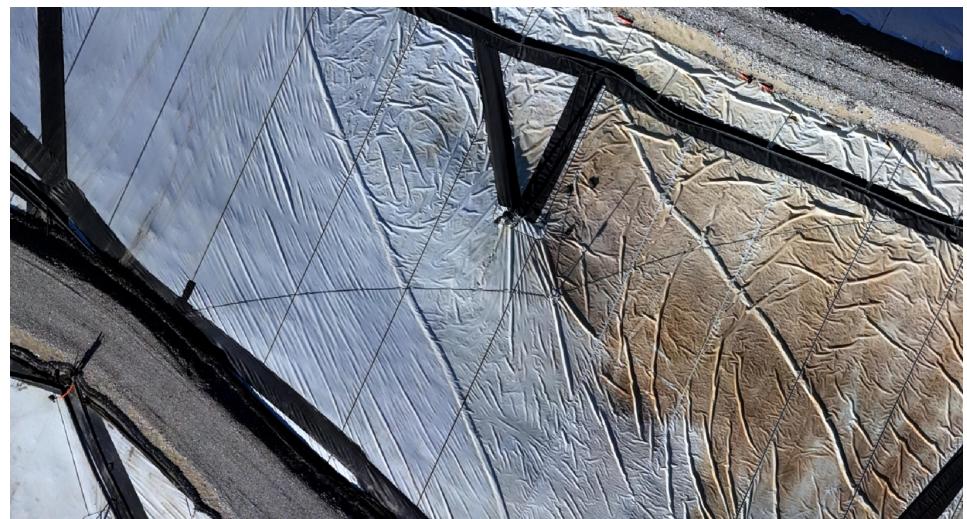
Reference # 02

The area designated by the LEA as "Area A" appears to be in grid 150. The Sniffer data reference points in Area A are points 02 and 07. As discussed in Chiquita's February 28, 2025 analysis of Sniffer's October 1, 2024 FLIR survey, there is active gas collection occurring in this area. Chiquita's Gas Collection and Control System ("GCCS") conveys warm gas to the Landfill's flares, as designed. There is a high concentration of GCCS piping in this area relative to the rest of the Landfill, including multiple vertical paths (landfill gas wellheads), horizontal paths (landfill gas header lines), and conveyance lines that remove hot gases and liquids from the north slope of the Landfill. It is expected that the GCCS system will have higher temperatures in this area, particularly given the higher concentration of GCCS infrastructure.

Bx1	Max	139.7 °F
	Min	22.0 °F
	Average	36.1 °F
Sp1		122.1 °F
Sp2		103.3 °F
Sp3		119.8 °F
Sp4		93.7 °F
Sp5		121.6 °F
Sp6		103.8 °F
Sp7		84.0 °F
Sp8		96.9 °F
Sp9		84.9 °F
Sp10		63.5 °F

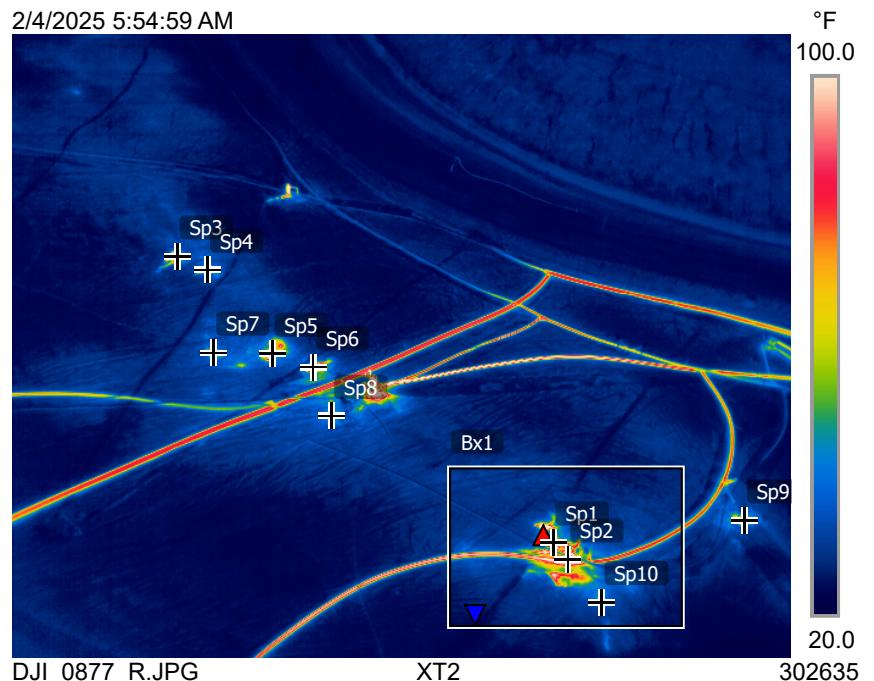
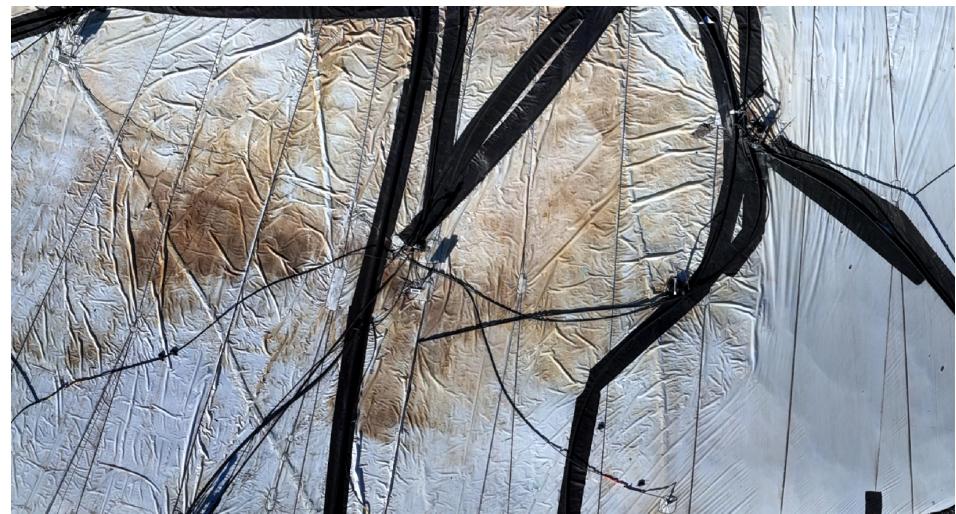
Reference # 03

On the whole, the February survey noted fewer areas of the Landfill with elevated temperatures. As acknowledged by CalRecycle in its November 25, 2024 letter, FLIR surveys can detect heat sources that may or may not be significant. This is the case with reference points 03 and 04 in the February 2025 survey. Reference point 03 was likely detected because it is in an area where the liner is black as opposed to the surrounding white liner, which we would expect to absorb more heat; and reference point 04 is the location of a condensate collection sump, which collects liquids that form in the landfill gas conveyance lines of the GCCS, and also includes a large infrastructure of black HDPE pipes on top of surrounding white liner. In addition, fluctuations in surface temperature detected by FLIR may be influenced by operational changes, including changes to the landfill gas or leachate capture and conveyance

Bx1	Max	45.2 °F
	Min	23.5 °F
	Average	27.3 °F
Sp1		35.6 °F
Sp2		31.6 °F
Sp3		36.5 °F

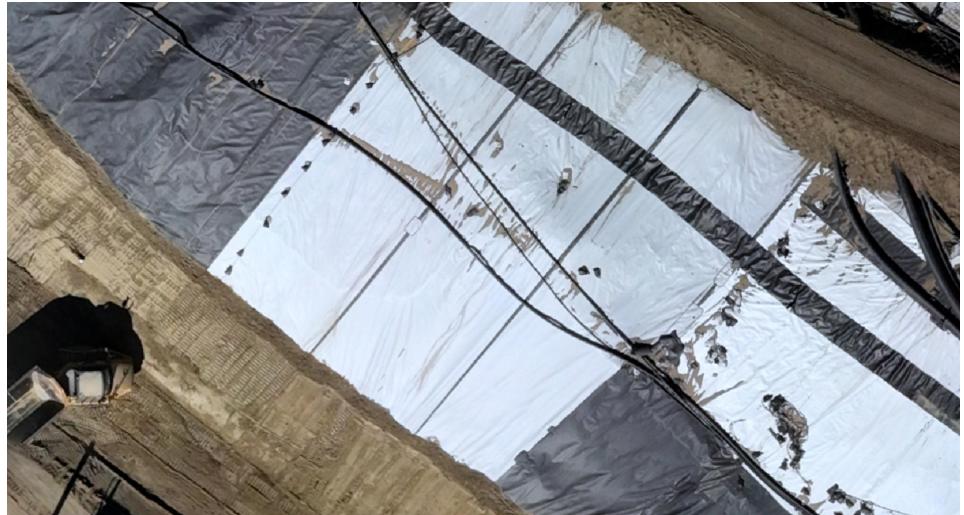
Reference # 04

Bx1	Max	149.6 °F
	Min	66.2 °F
	Average	80.0 °F
Sp1		134.1 °F
Sp2		123.5 °F
Sp3		125.0 °F
Sp4		77.0 °F

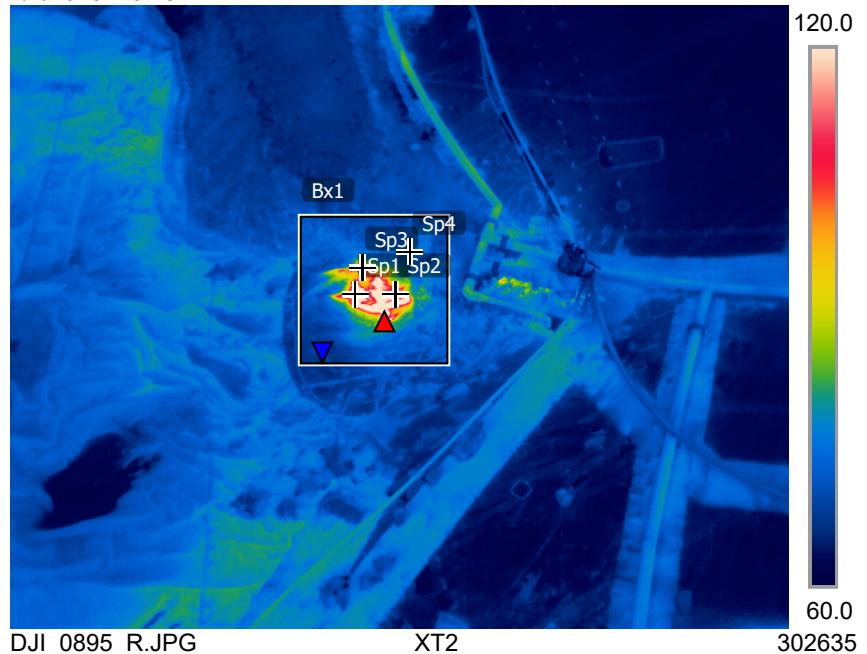
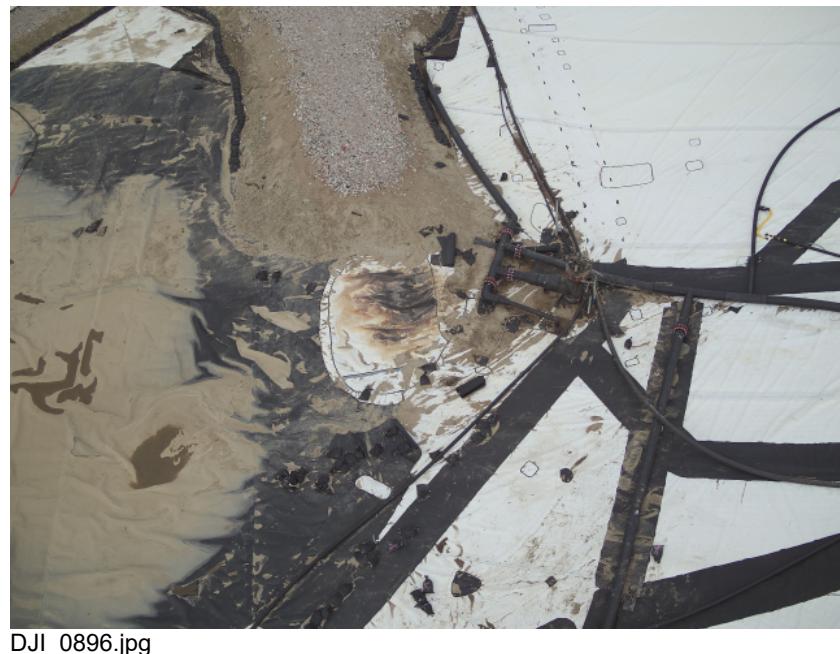
Reference # 05

The area designated by the LEA as "Area E" appears to be in grid 177. The Sniffer data reference point within Area E is point 05. An abandoned gas well, well CV-2302, exists within Area E and is photographed on PDF page 7 of Attachment A under "Reference # 05." Additional gas wells and dewatering pumps were installed in the area to replace CV-2302. However, as discussed in Chiquita's February 28, 2025 analysis of Sniffer's October 1, 2024 FLIR survey, the abandoned borehole for CV-2302 may be continuing to emit heat to the surface, which may explain the elevated temperatures detected in the area. The other gas wells and pumps installed in the area continue to remove hot gas and liquids from the Landfill.

Nevertheless, the maximum temperatures detected in the thermal images for this area (reference points 0019 and 0021 in the October 2024 survey and reference point 05 in the February 2025 survey) are within approximately 2.4 degrees of each other.

Bx1	Max	158.7 °F
	Min	55.1 °F
	Average	69.4 °F
Sp1		120.5 °F
Sp2		134.4 °F
Sp3		145.1 °F
Sp4		126.6 °F
Sp5		73.6 °F

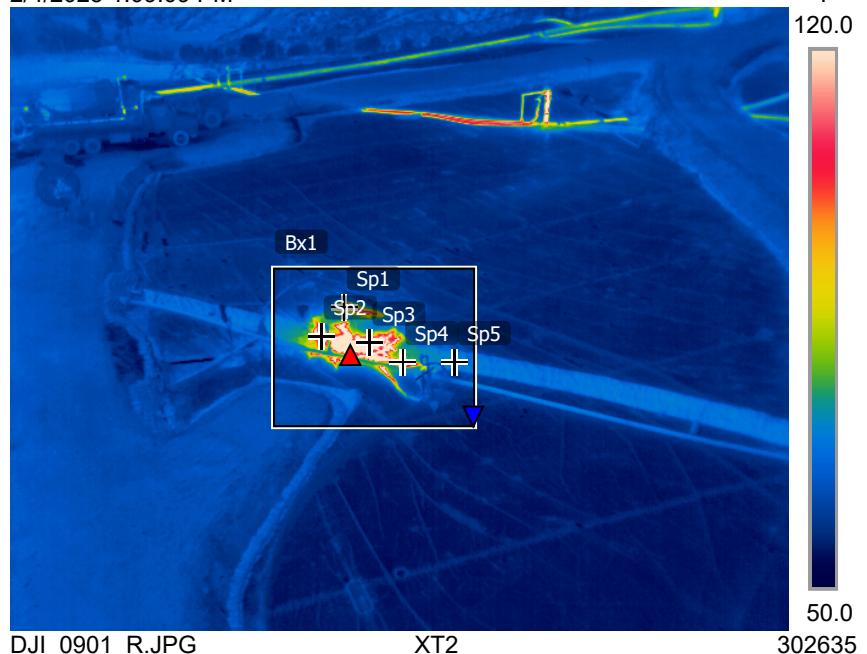
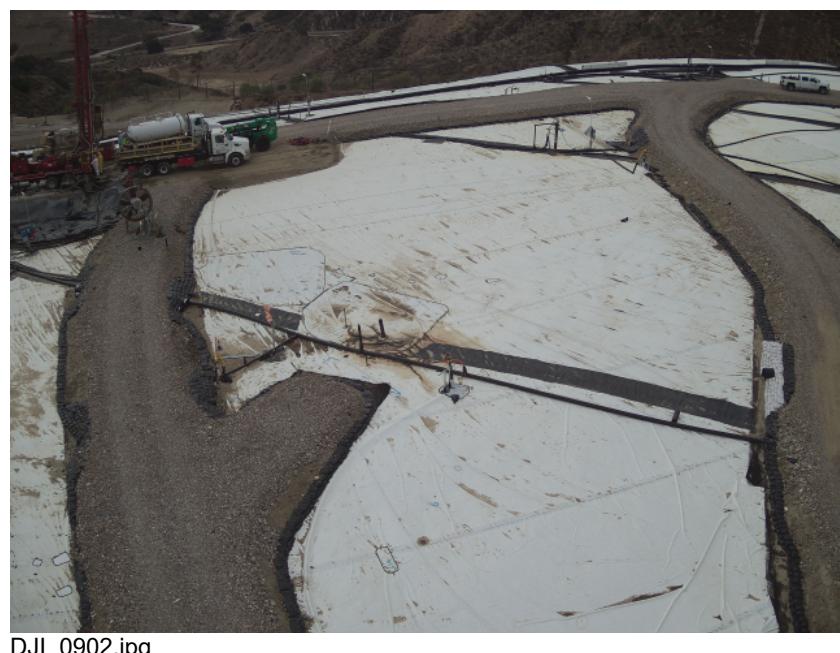
Reference # 06

The area designated by the LEA as "Area C" appears to be in grid 181. The Sniffer data reference point in Area C is point 06. As discussed in Chiquita's February 28, 2025 analysis of Sniffer's October 1, 2024 FLIR survey, this area is along the western portion of the Landfill, where the reaction is closer to the surface relative to the rest of the reaction area, meaning elevated temperatures are closer to the surface and therefore more readily detected by the radiometric thermal camera. At the time of the October 1, 2024 survey, work along the western portion of the Landfill to complete the western toe drain installation project was being performed in order to install a new toe drain, secondary drain, and ancillary piping to facilitate leachate drainage into the Landfill's leachate collection system and to improve gas collection by replacing the temporary plastic cover with a continuous geosynthetic cover over the area, to further mitigate the elevated temperatures. That work is now complete. In addition, in late April to early May 2024, Chiquita installed a horizontal collector for the GCCS system in this area and the nearby Area D in order to collect additional hot gas for conveyance to the flares and thereby further address elevated temperatures in this area.

An overall decrease in temperatures in Area C is evidenced by the thermal camera's detection of only slightly elevated temperatures in this area as compared to the October 2024 survey. The hues in the October 2024 survey were bright green as compared to the largely purple hues in the February 2025 survey.

Bx1	Max	121.5 °F
	Min	56.0 °F
	Average	69.8 °F
Sp1		103.8 °F
Sp2		75.1 °F
Sp3		74.5 °F
Sp4		76.6 °F

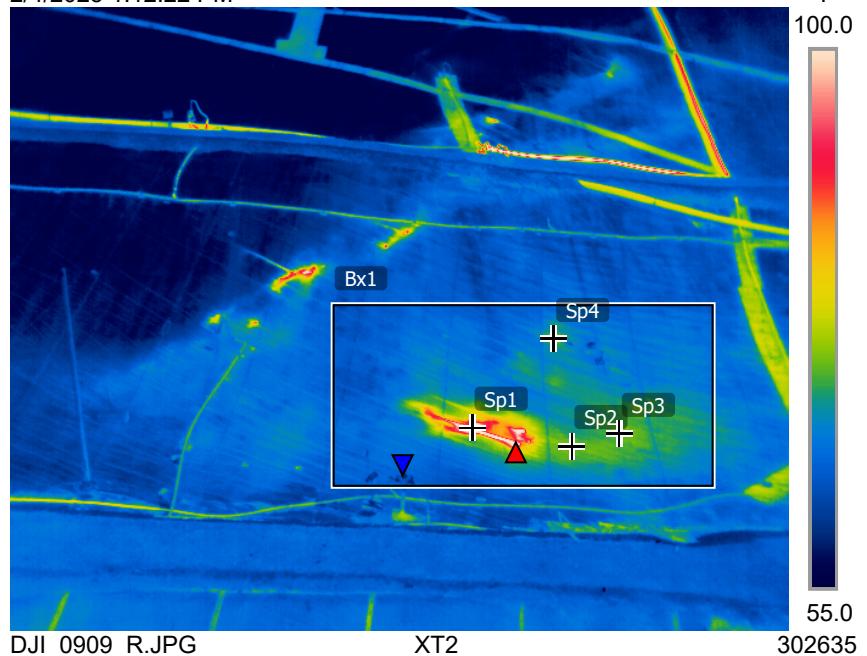
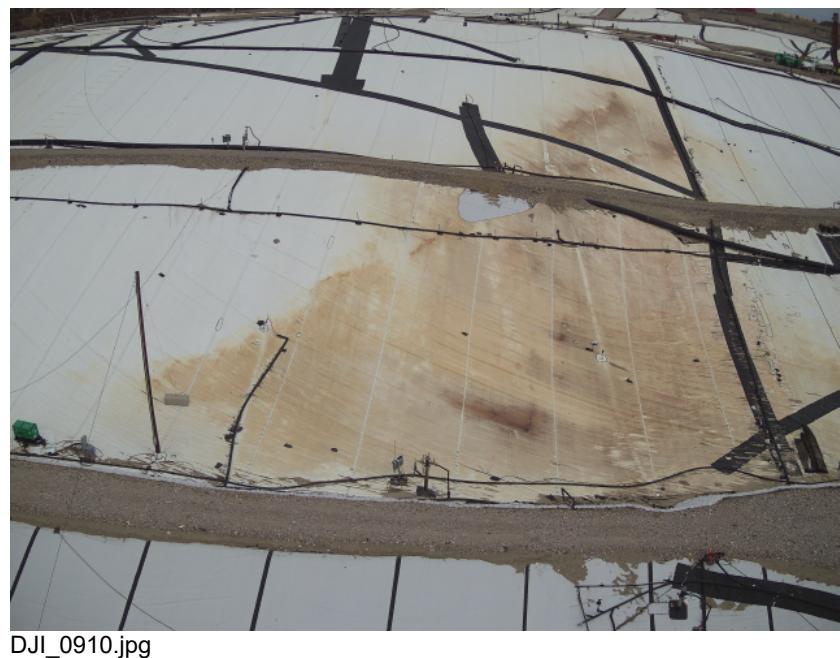
Reference # 07

As indicated in the thermal inspection image labeled Reference # 07, background temperatures are low (represented by blue hues), with somewhat higher temperatures throughout the GCCS system (represented by green/yellow hues), which as described above, is to be expected. Comparison of the October 2024 and February 2025 surveys indicates an overall decrease in temperature in Area A (compare green hues to largely purple hues).

Bx1	Max	152.4 °F
	Min	58.0 °F
	Average	68.7 °F
Sp1		126.4 °F
Sp2		111.5 °F
Sp3		116.4 °F
Sp4		118.2 °F
Sp5		105.8 °F
Sp6		99.7 °F

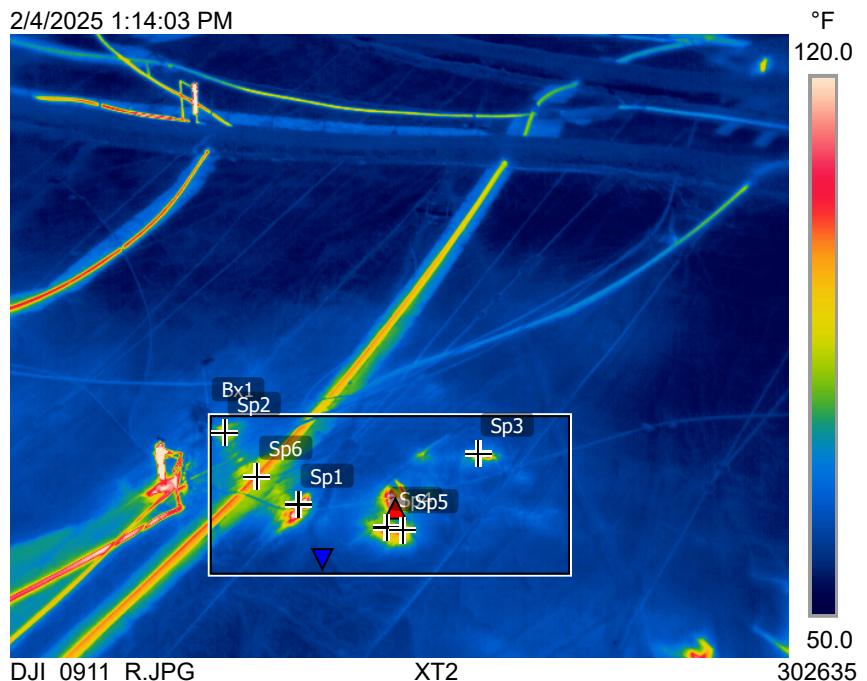
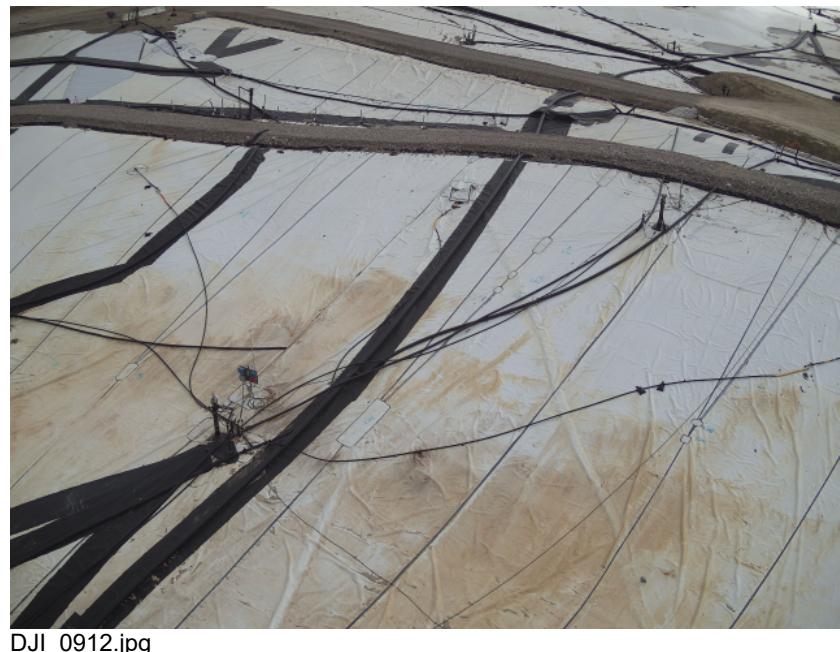
Reference # 08

A comparison of the October 2024 and February 2025 thermal images in Area B indicates an overall decrease in temperature in that area. While the precise geolocations vary slightly between the surveys, the average temperatures decreased by about eleven degrees (compare data reference points 0023 and 0025 in the October 2024 thermal images report and data reference point 08 in the February 2025 report).

Bx1	Max	91.6 °F
	Min	29.3 °F
	Average	38.4 °F
Sp1		44.1 °F
Sp2		39.7 °F
Sp3		74.7 °F
Sp4		93.2 °F
Sp5		45.2 °F

data reference point in Area B is point 08. As with the nearby Area A, GCCS infrastructure is highly concentrated in this area. As discussed in Chiquita's February 28, 2025 analysis of Sniffer's October 1, 2024 FLIR survey, because the GCCS system is designed to convey the landfill gas from the north slope to the flares, we would expect to see elevated temperatures here, particularly given the higher concentration of GCCS infrastructure. This area was also subject to elevated temperatures where the integrity of the dirt cover was compromised. Chiquita repaired the geomembrane cover and performed related work during the fourth quarter of 2024 to address this issue.

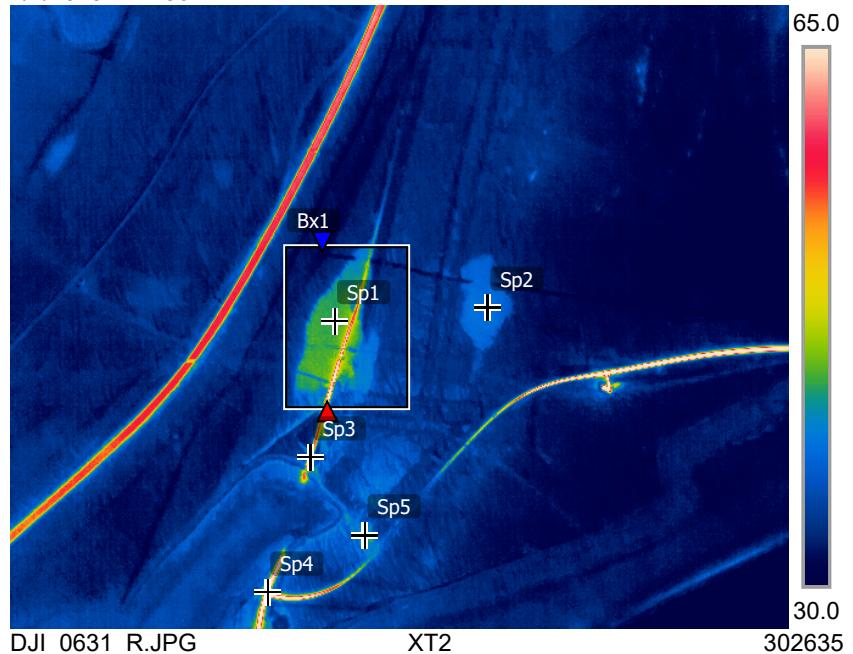
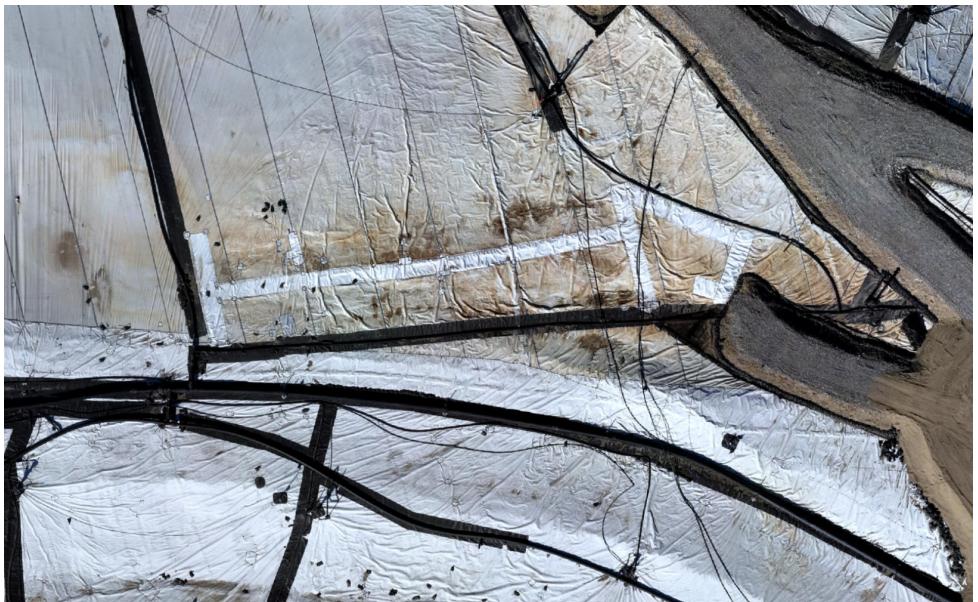
Reference # 09

An overall decrease in temperatures in Area D is evidenced by the thermal camera's detection of only slightly elevated temperatures in this area as compared to the October 2024 survey. The survey indicates only slightly elevated temperatures (represented by blue hues) along the GCCS piping network. In comparing thermal images of point 0001 in the October 2024 report with point 09 in the February 2025 report, average temperatures in this area dropped approximately seven degrees Fahrenheit, representing an overall decrease in temperature over time.

Bx1	Max	70.2 °F
	Min	27.1 °F
	Average	33.6 °F
Sp1		55.4 °F
Sp2		63.2 °F
Sp3		51.7 °F
Sp4		54.2 °F
Sp5		44.0 °F
Sp6		56.1 °F
Sp7		50.6 °F
Sp8		45.1 °F

discussed above in Area C also runs through Area D. As discussed in Chiquita's February 28, 2025 analysis of Sniffer's October 1, 2024 FLIR survey, Chiquita installed the horizontal collector for the GCCS system in this area and the nearby Area C in order to collect additional hot gas for conveyance to the flares and thereby further address elevated temperatures in this area.
