April 21, 2025  
File No. 01204123.42, Task 10

Subject: March 2025 Monthly Report for Modified Stipulated Order for Abatement (Case No. 6177-4), Chiquita Canyon Landfill (Facility ID 119219), Castaic, California

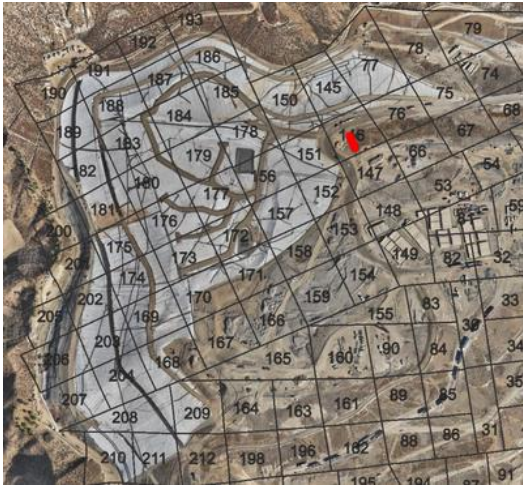
146

Using the attached image, annotate all areas where inspectors identified a fissure or tension crack.

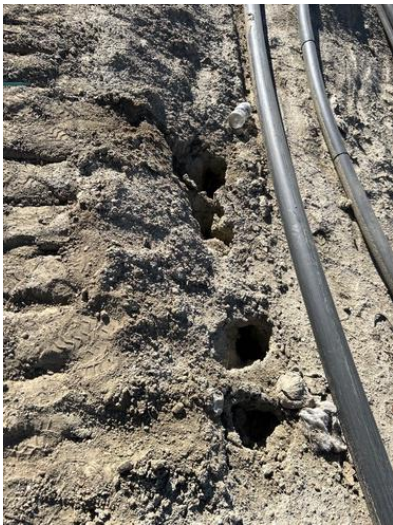
Photo 1

**Length of crack (ft) or area containing multiple cracks (ft x ft)** 1ft x 4ft

**Was Fissure or Crack fixed? If yes, add photo and description of repairs performed** Yes

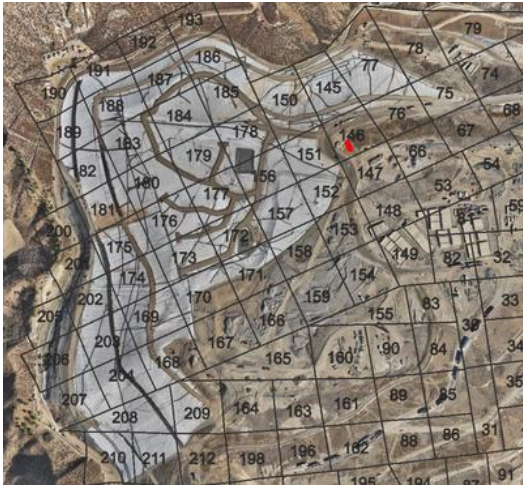
146

Using the attached image, annotate all areas where inspectors identified a fissure or tension crack.

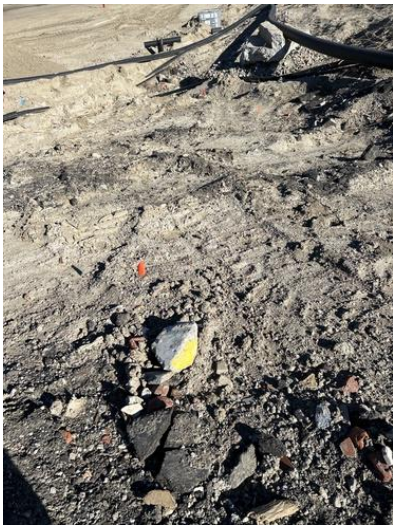
Photo 1

Using the Media link below, attach the before photo of the fissure or tension crack.

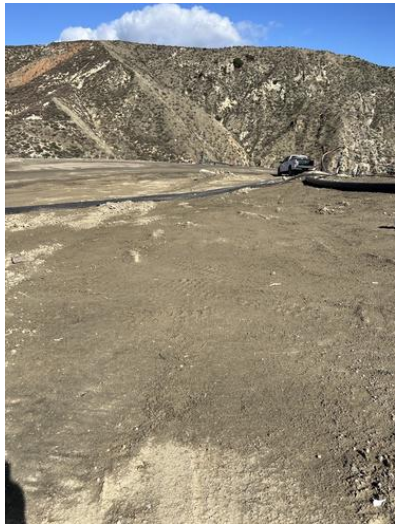
Photo 1

Fissure or Tension Crack Found?

No

Grid 146

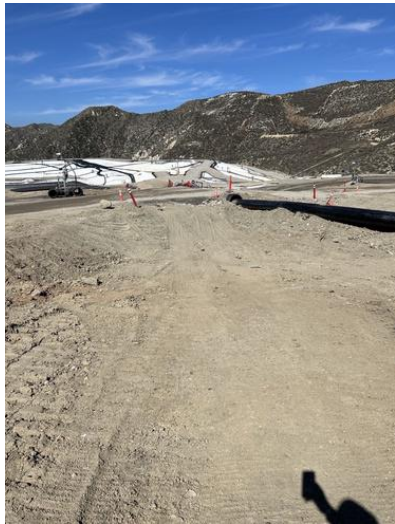
Photo 1

Fissure or Tension Crack Found?

No

Grid 147

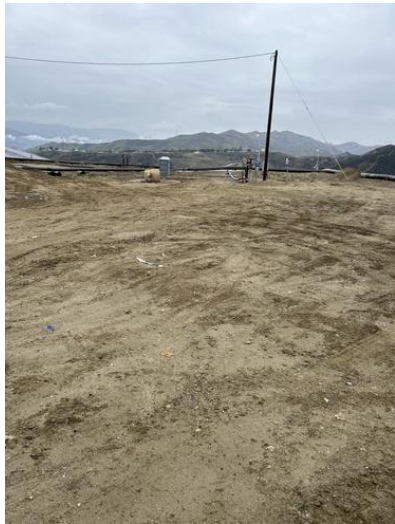
Photo 1

**Fissure or Tension Crack Found?**

No

Grid 170

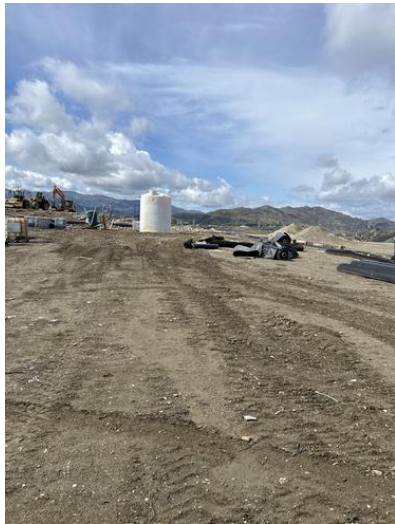
Photo 1

Fissure or Tension Crack Found?

No

Grid 154

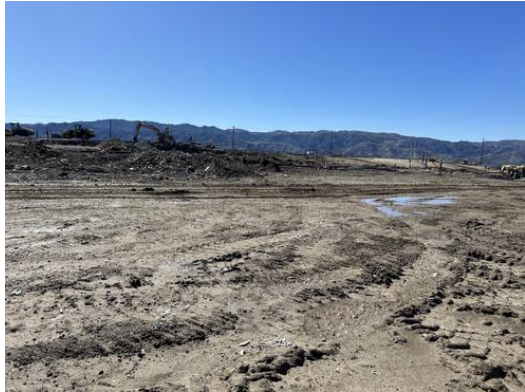
Photo 1

**Fissure or Tension Crack Found?**

No

Grid 153

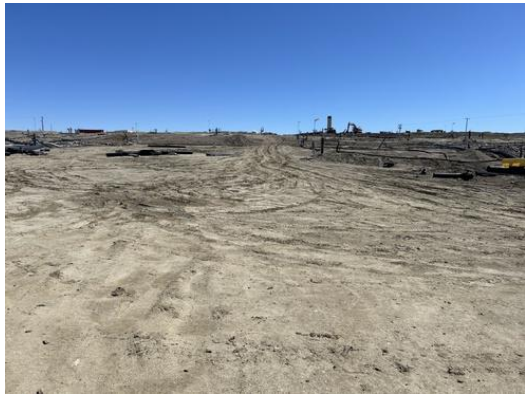
Photo 1

**Fissure or Tension Crack Found?**

No

Grid 170

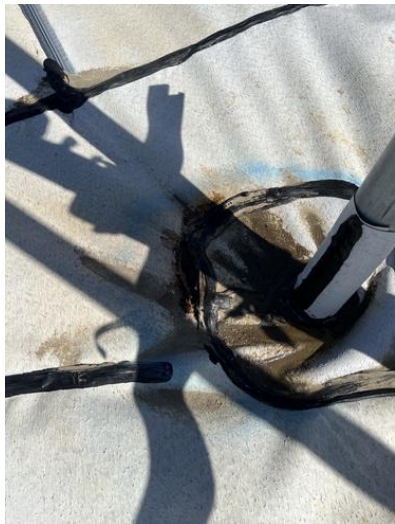
Photo 1

Yes

Take photo of identified issues

4 inch tear in liner in grid 185.  
Needs to be patched and  
extrusion welded.

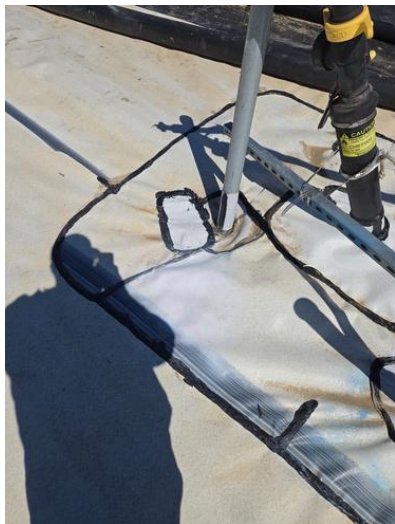
Photo 3

Take photo of repair

Description of repair work

Date and time of repair (within 2 hours)

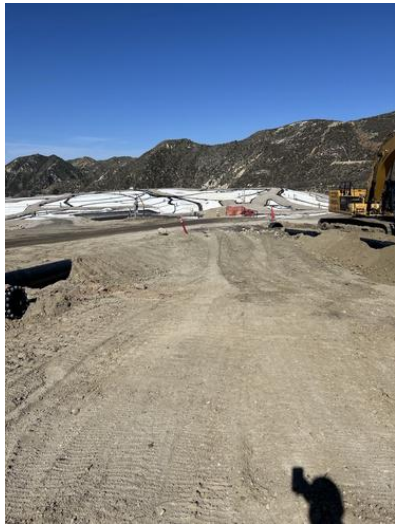
Photo 1

Fissure or Tension Crack Found?

No

Grid 147

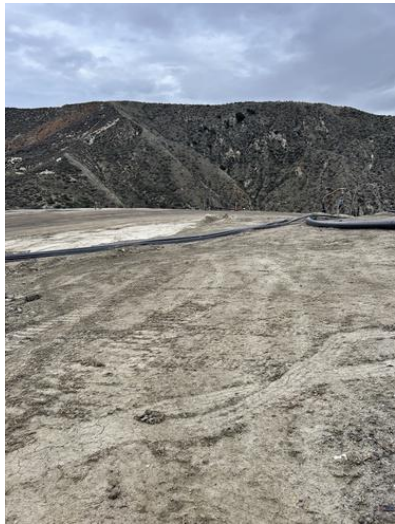
Photo 1

Fissure or Tension Crack Found?

No

Grid 146

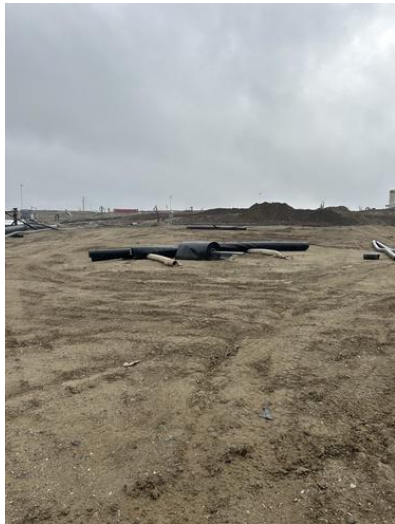
Photo 1

Fissure or Tension Crack Found?

No

Grid 170/171

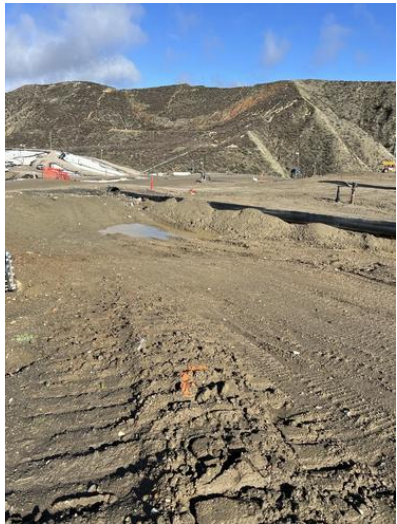
Photo 1

**Fissure or Tension Crack Found?**

No

Grid 147

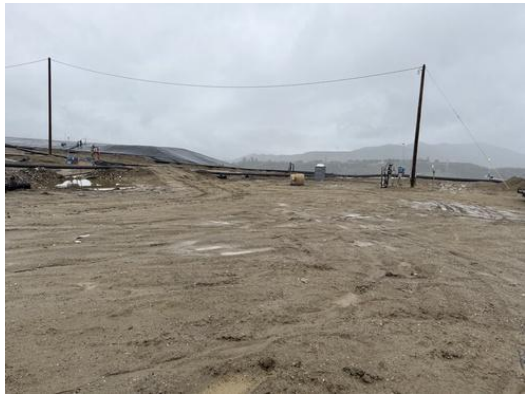
Photo 1

**Fissure or Tension Crack Found?**

No

Grid 170

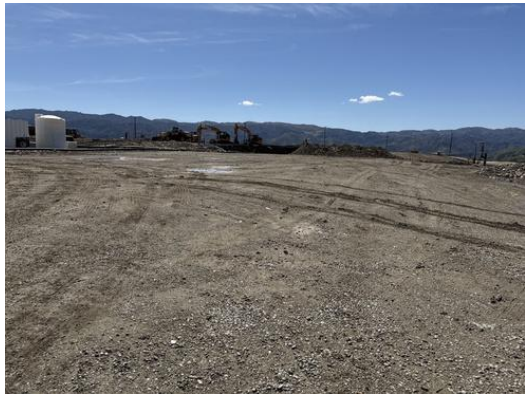
Photo 1

**Fissure or Tension Crack Found?**

No

Grid 153

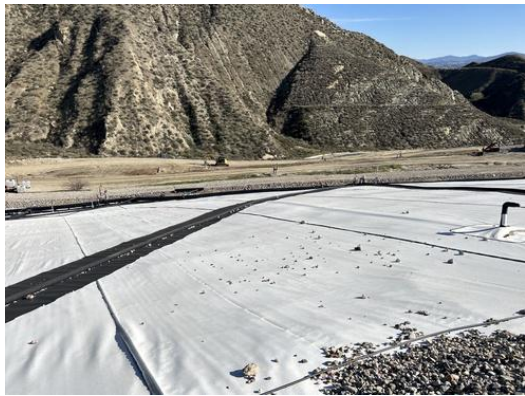
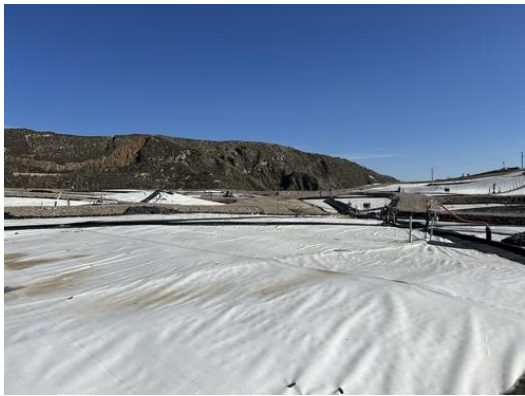
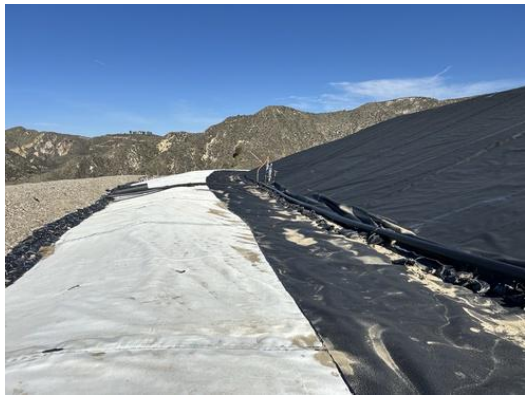
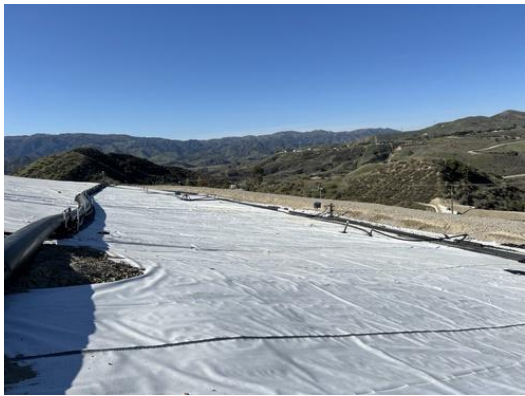
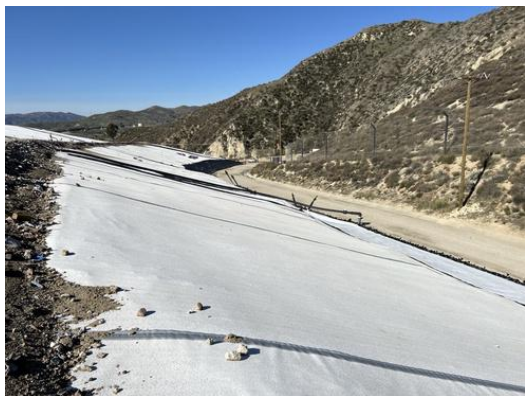
Are there any issues with the geosynthetic cover?

No

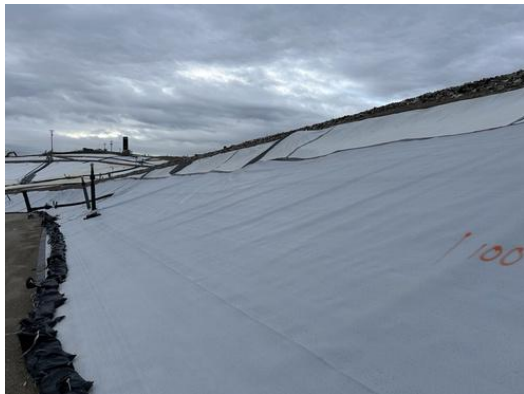
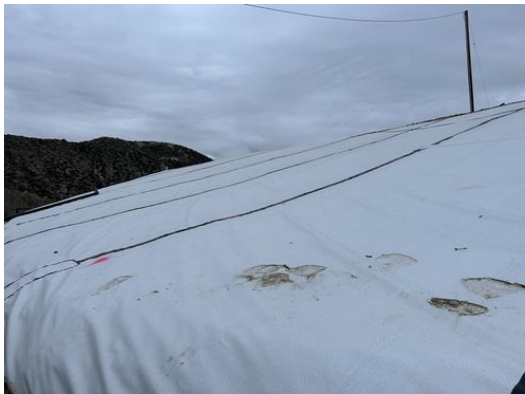
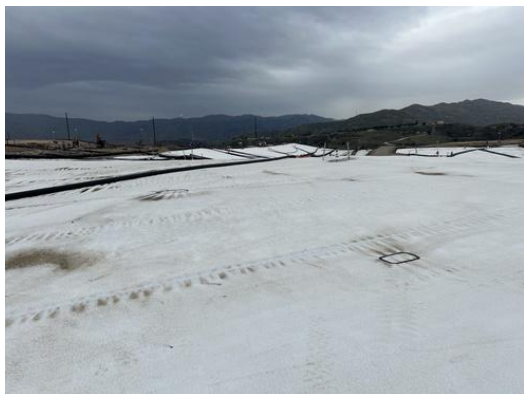
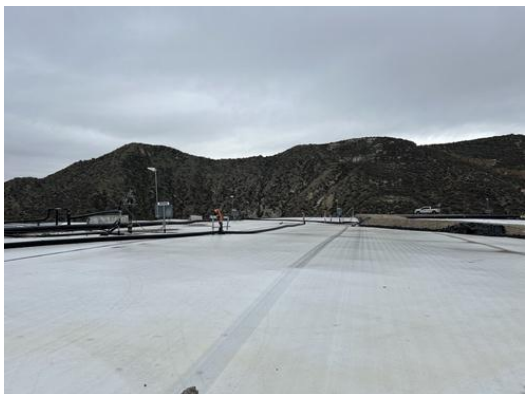
Are there any issues with the geosynthetic cover?

No

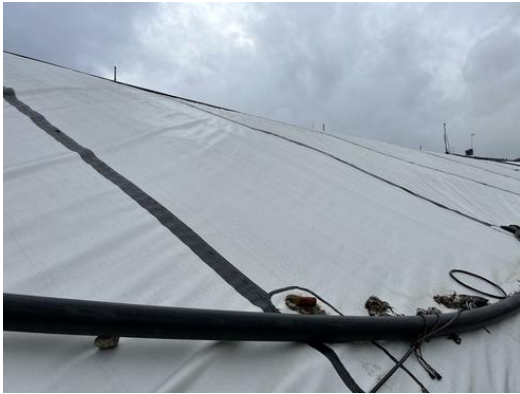
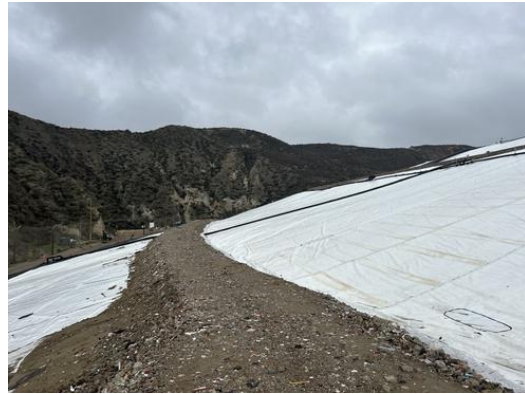
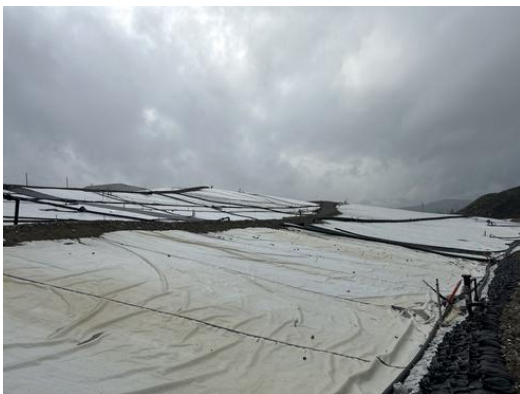
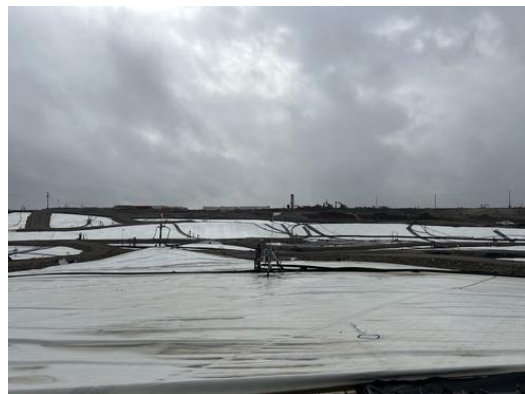
Are there any issues with the geosynthetic cover?

No

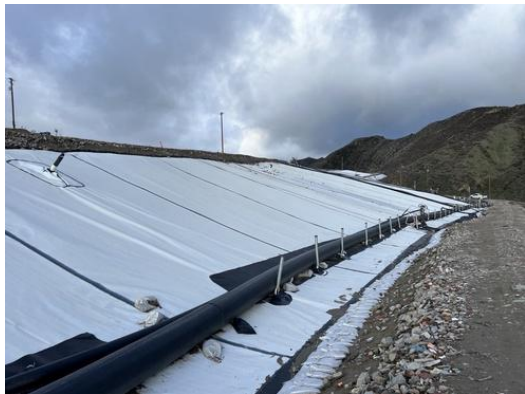
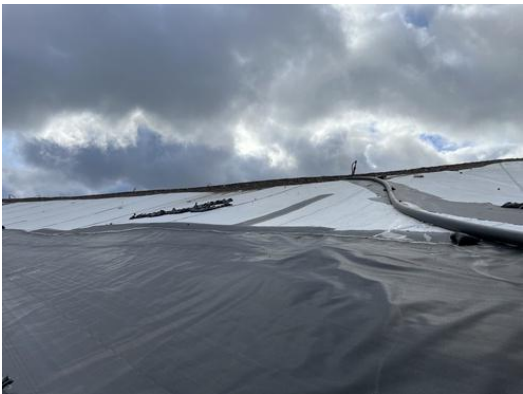
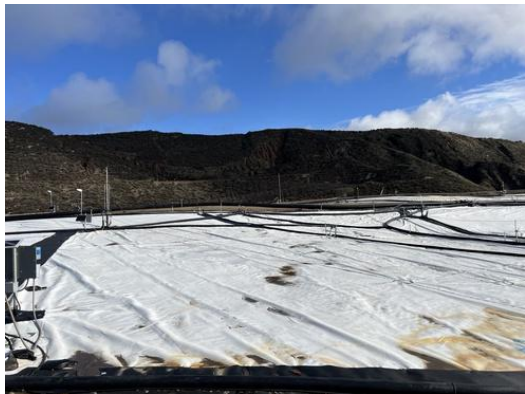
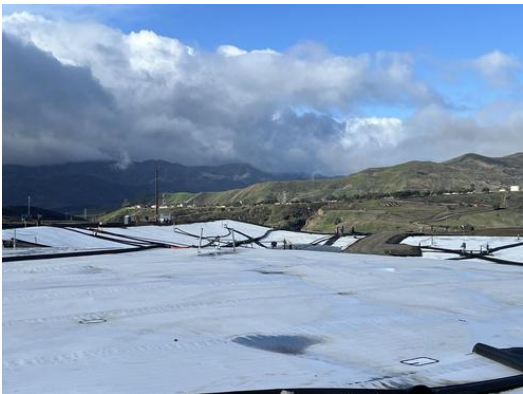
Are there any issues with the geosynthetic cover?

No

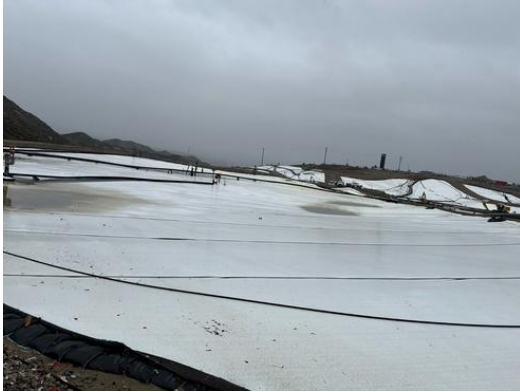
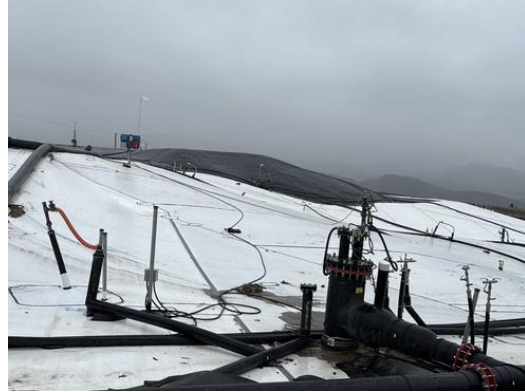
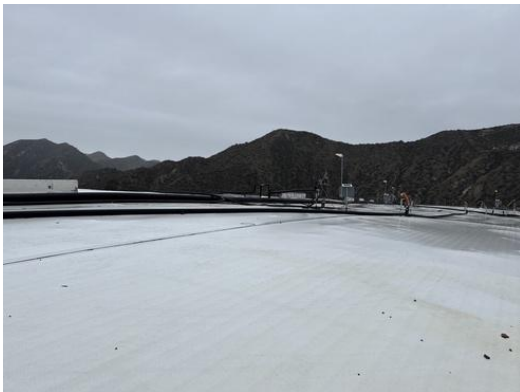
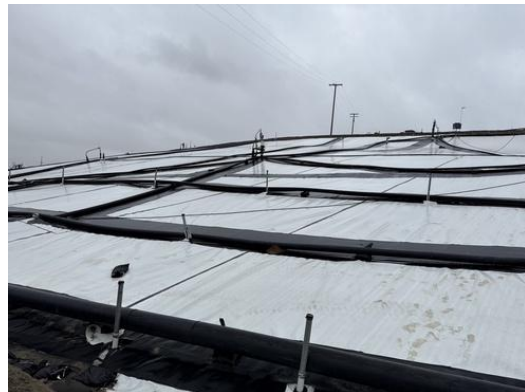
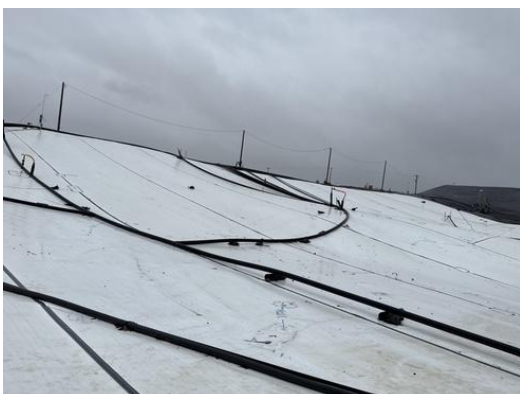
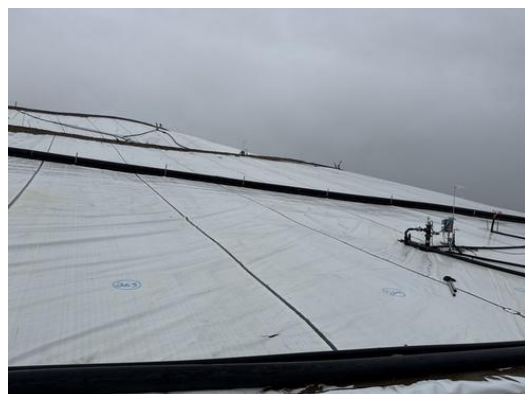
**Are there any issues with the geosynthetic cover?**

No

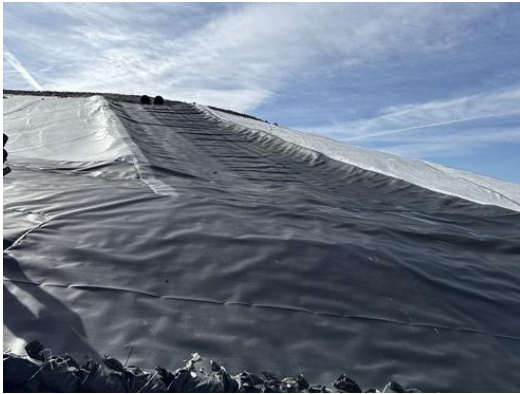
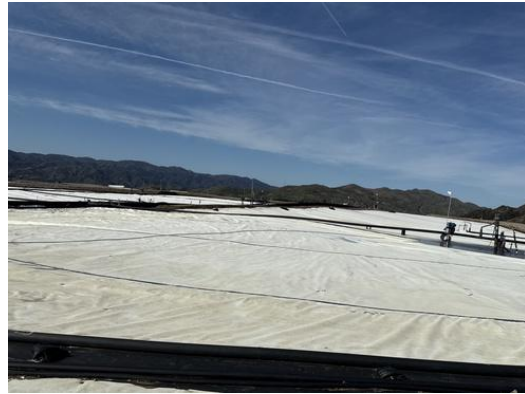
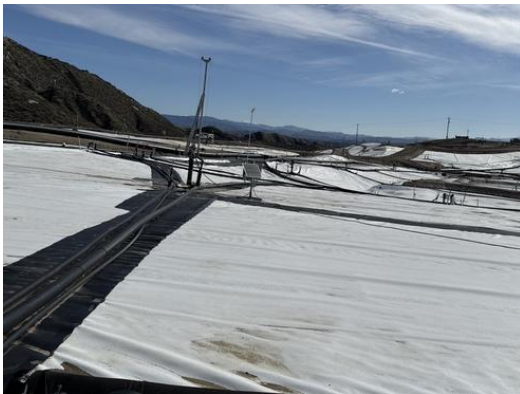
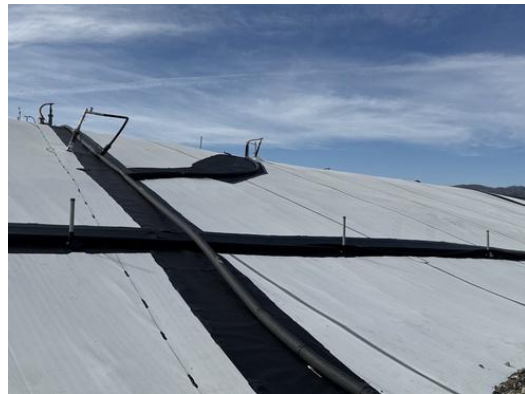
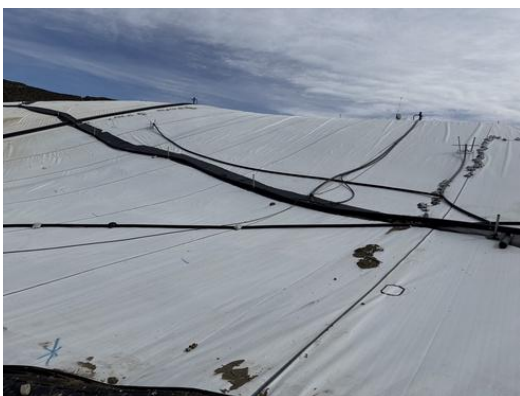
Are there any issues with the geosynthetic cover?

No

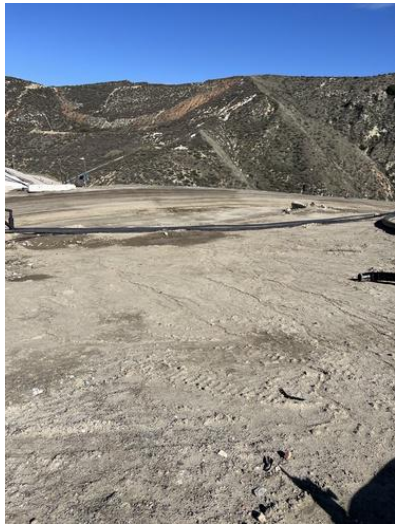
Photo 1

Fissure or Tension Crack Found?

No

Grid 146

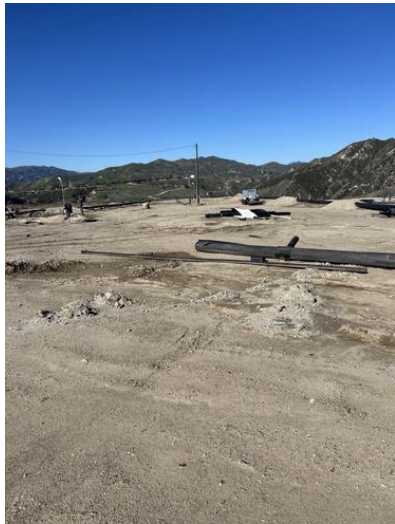
Photo 1

**Fissure or Tension Crack Found?**

No

Grid 171/170

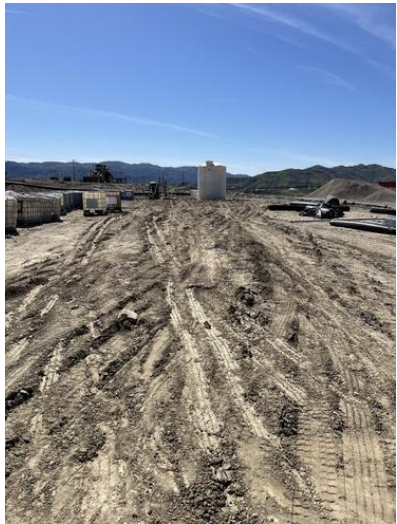
Photo 1

No

Grid 154.

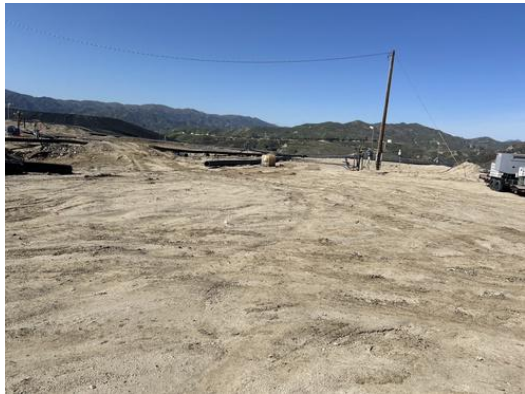
Photo 1

No

Grid 170

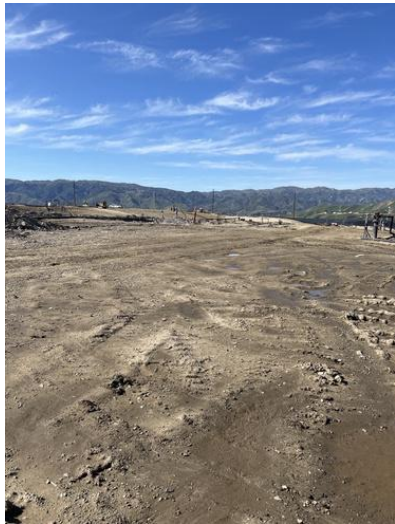
Photo 1

No

Grid 153

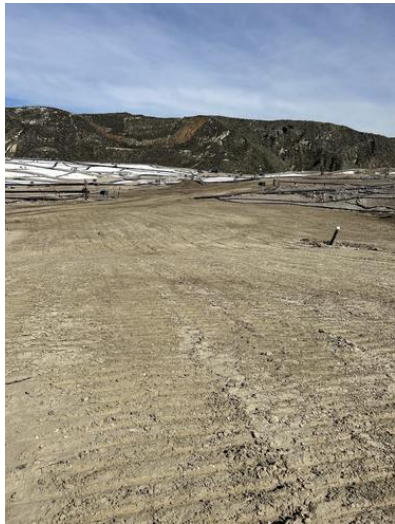
Photo 1

No

Grid 165

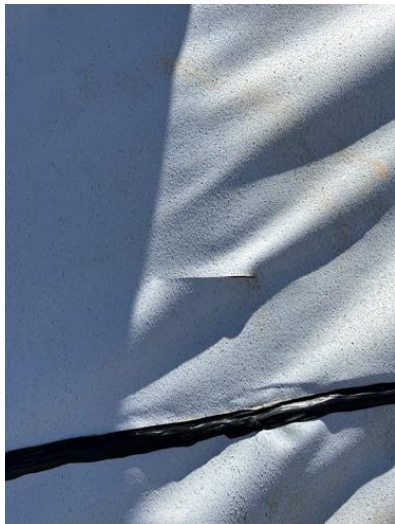
Photo 1

4 inch cut in the liner in grid 205.  
Needs to be patched and  
extrusion welded.

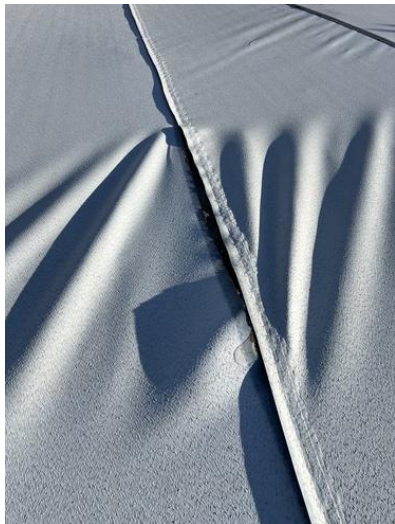
Photo 1

4 ft separation at a seam in grid 145, needs to be patched and extrusion welded

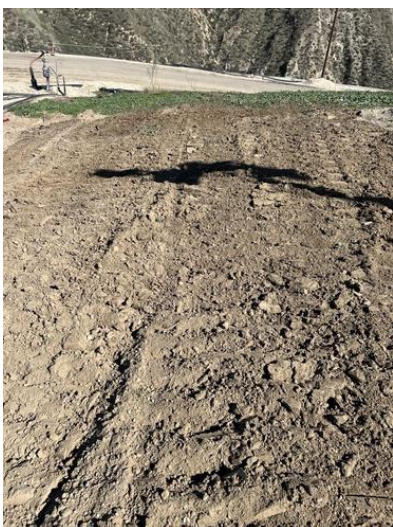
Photo 5

**Was Fissure or Crack fixed? If yes, add photo and description of repairs performed**

Cracks were track walked.

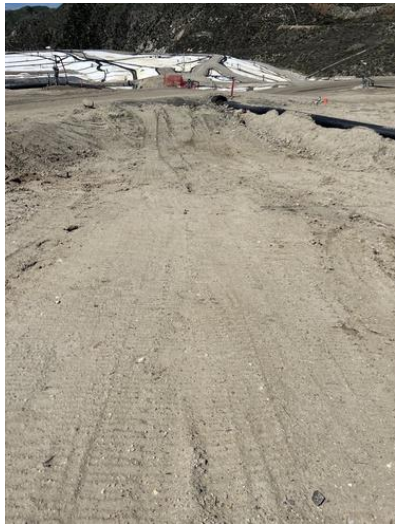
Photo 1

No

Grid 147

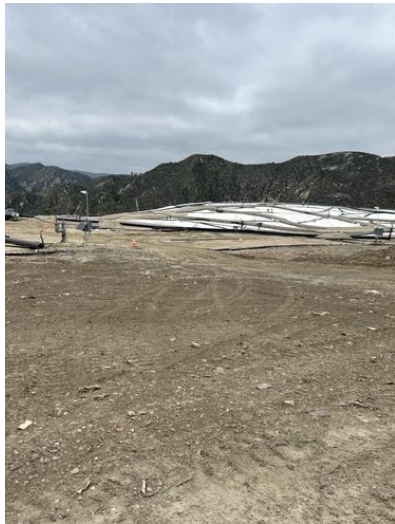
Photo 1

No

Grid 159/171

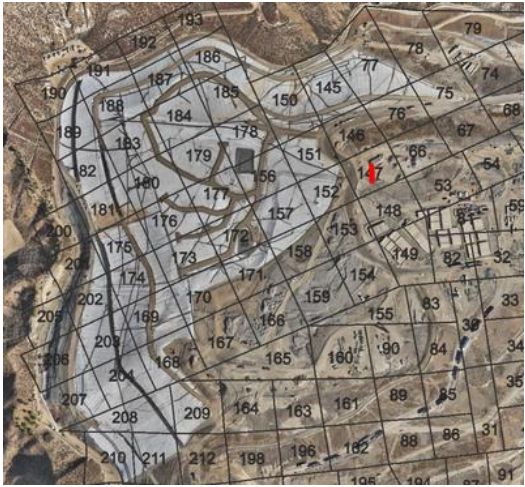
Grid Location

Using the attached image, annotate all areas where inspectors identified a fissure or tension crack.

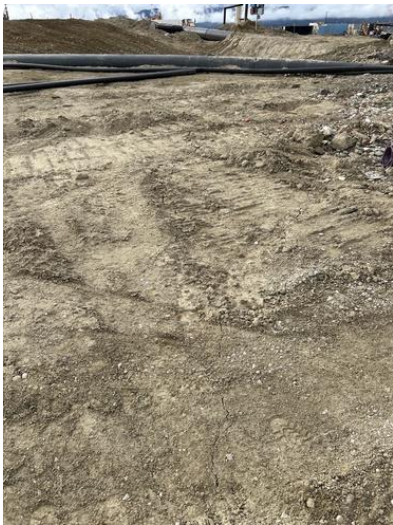
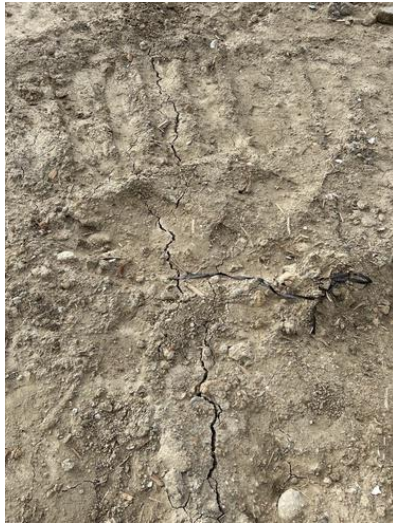
Photo 1

147

**Length of crack (ft) or area containing multiple cracks (ft x ft)** 6ft x 35ft

**Was Fissure or Crack fixed? If yes, add photo and description of repairs performed** Yes

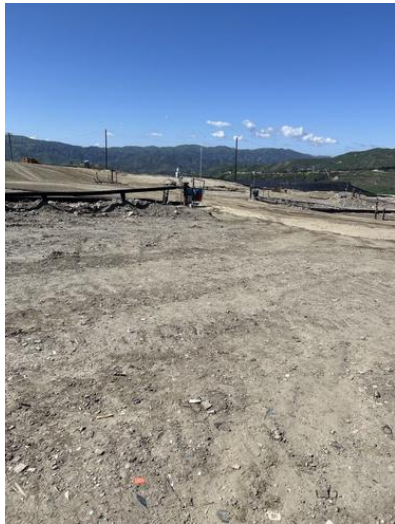
Photo 1

No

Grid 166

Instability

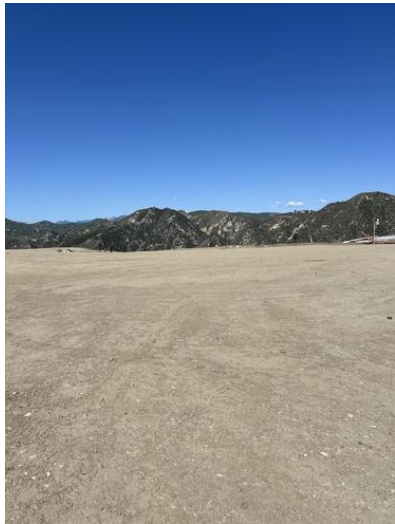
Photo 1

No

Grid 164

Instability

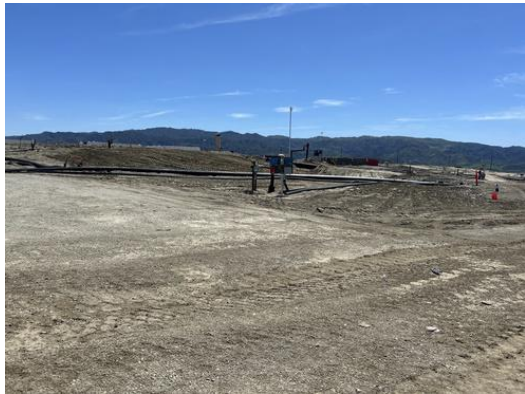
Photo 1

No

Grid 147

Instability

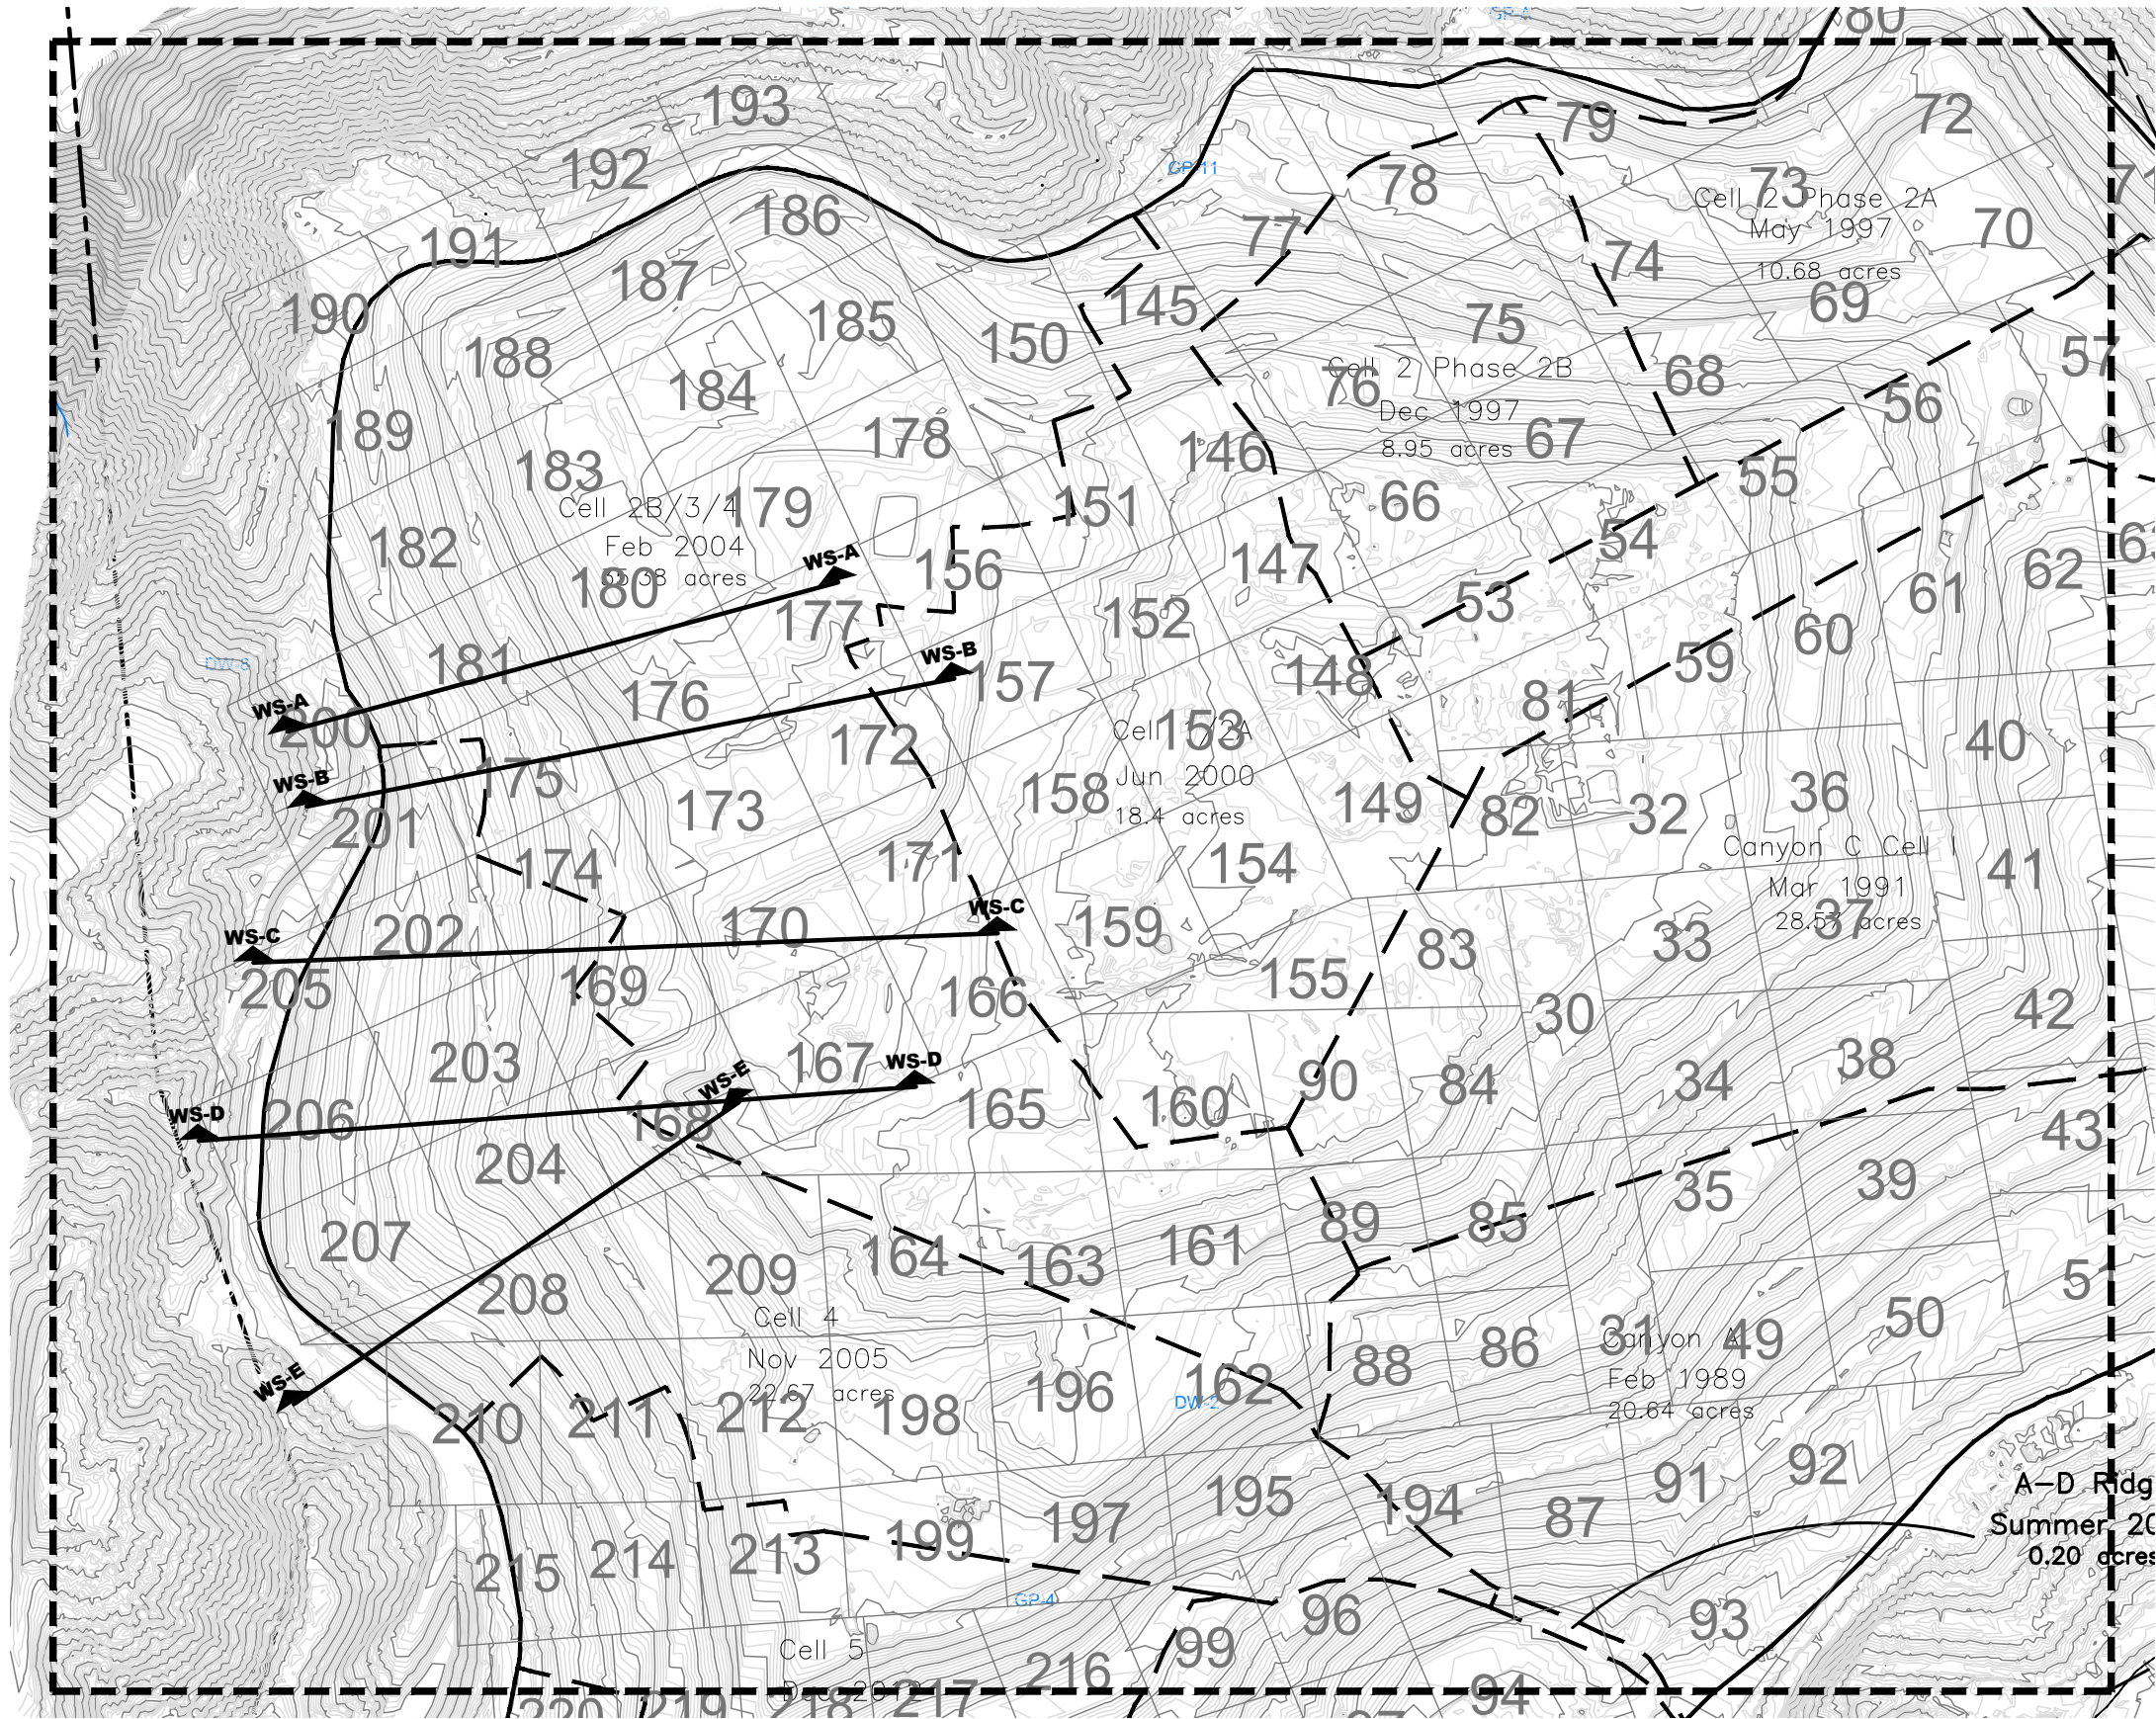
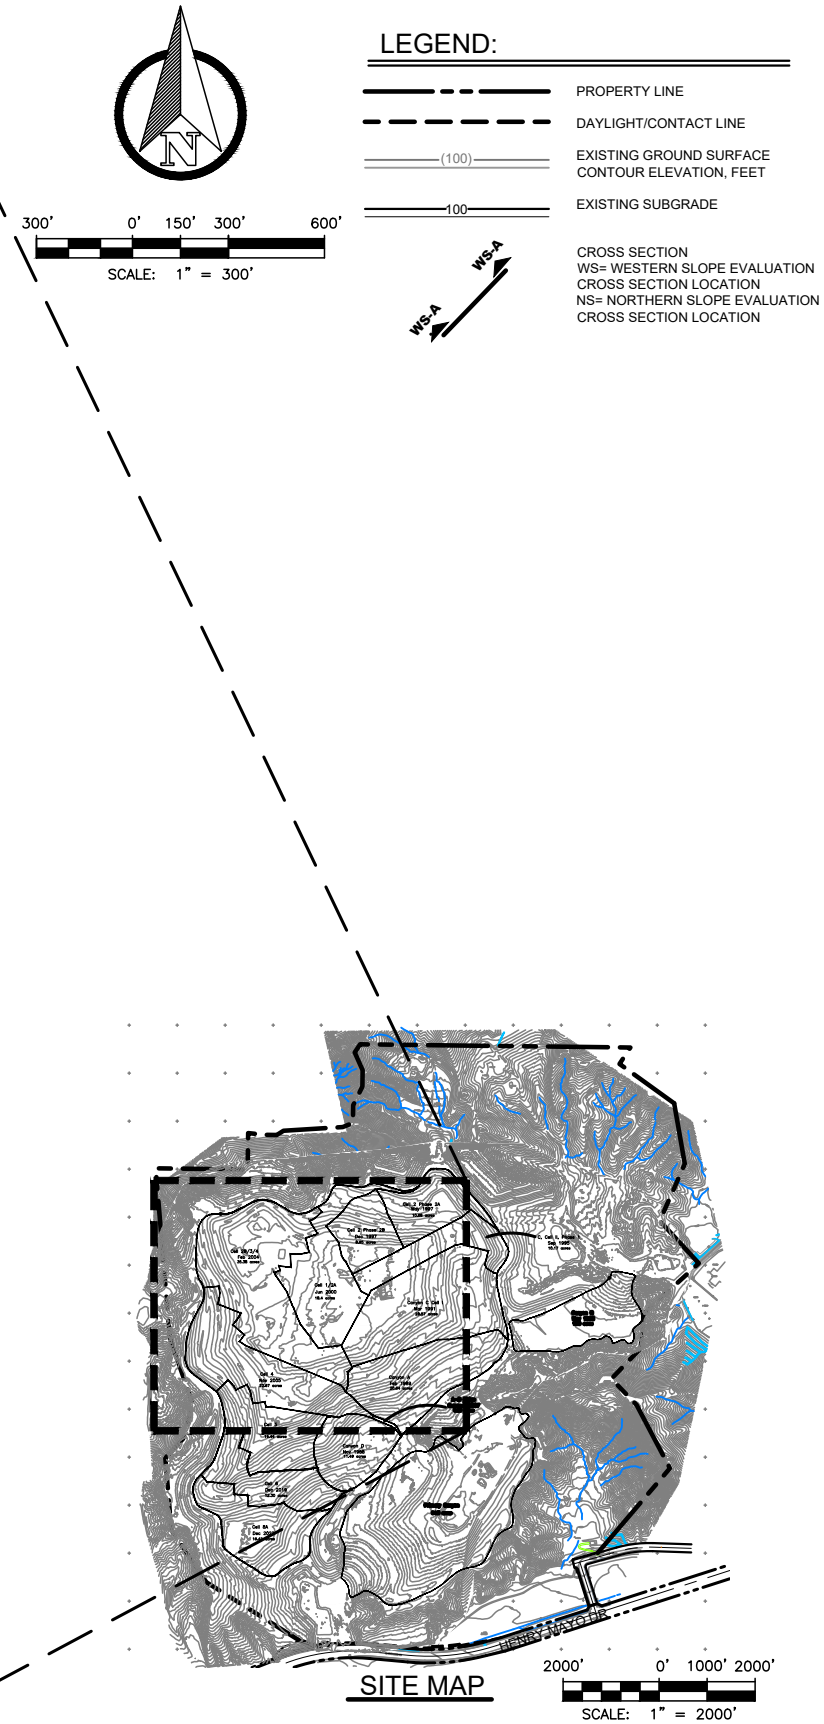
FIG NO.  
**01**  
PROJECT NO.  
RM22.1077

fissures with “medium” or “large” horizontal offset were observed in March. The locations of the grids are shown in Figure 1. This figure does not show any cracks or fissures because no cracks meeting the definition of “significant” or having a “medium” or “large” horizontal offset were observed in March.

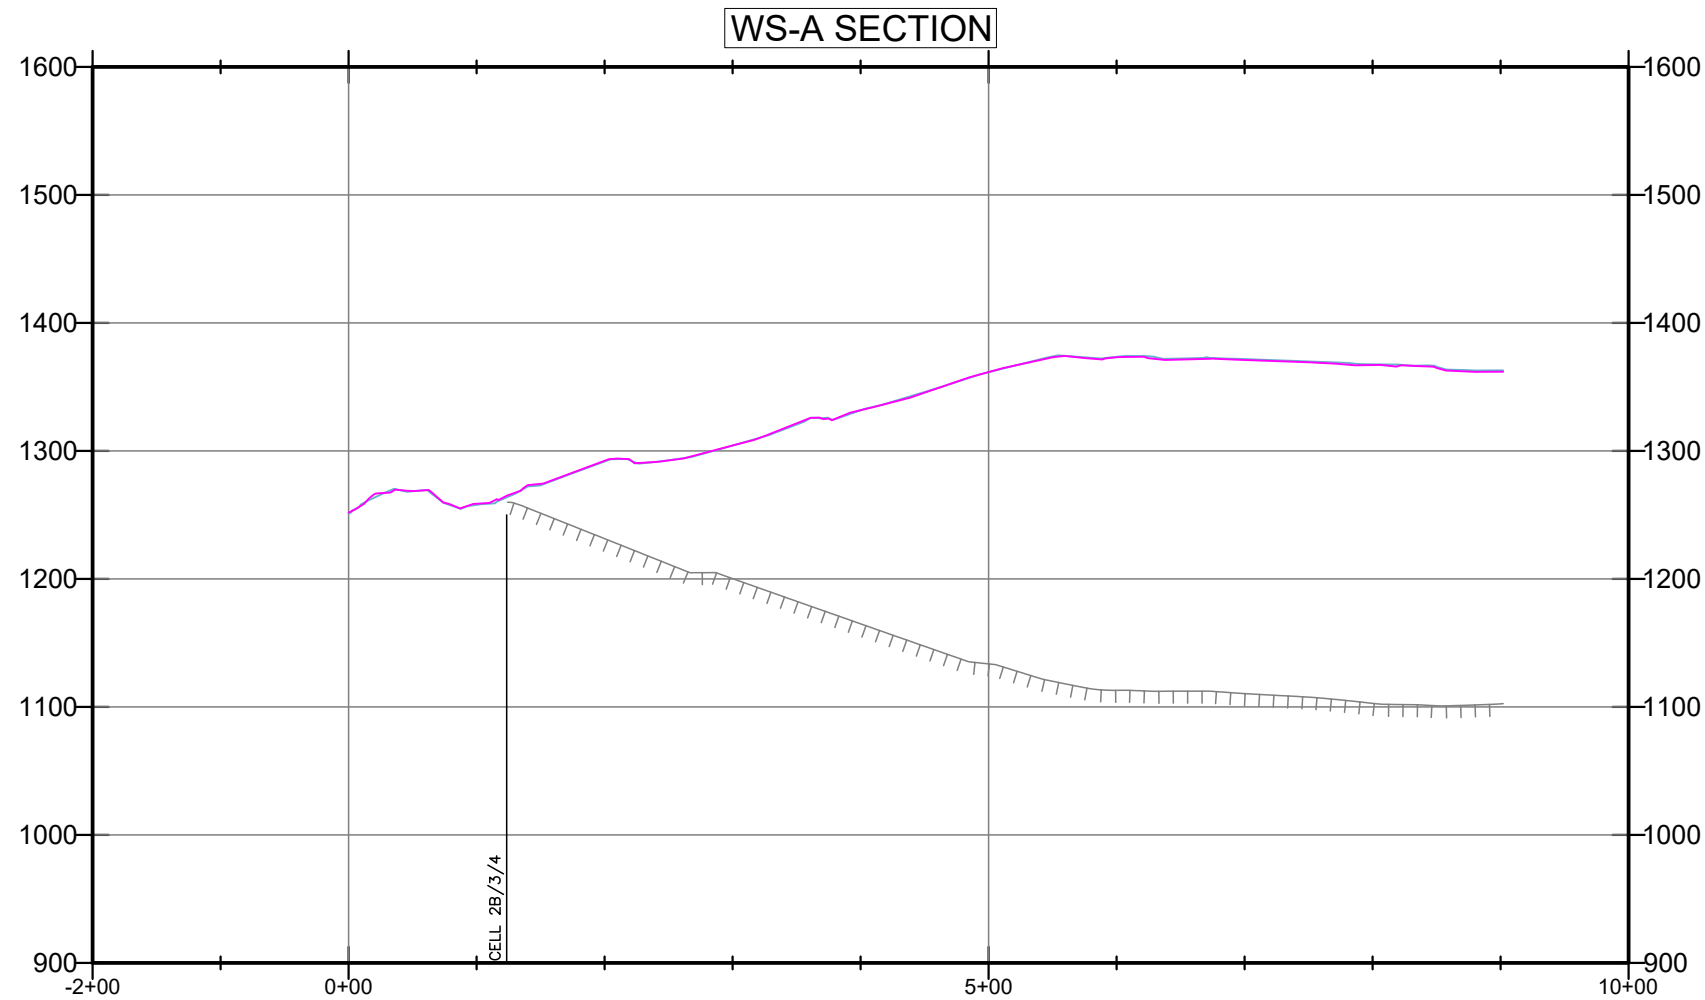
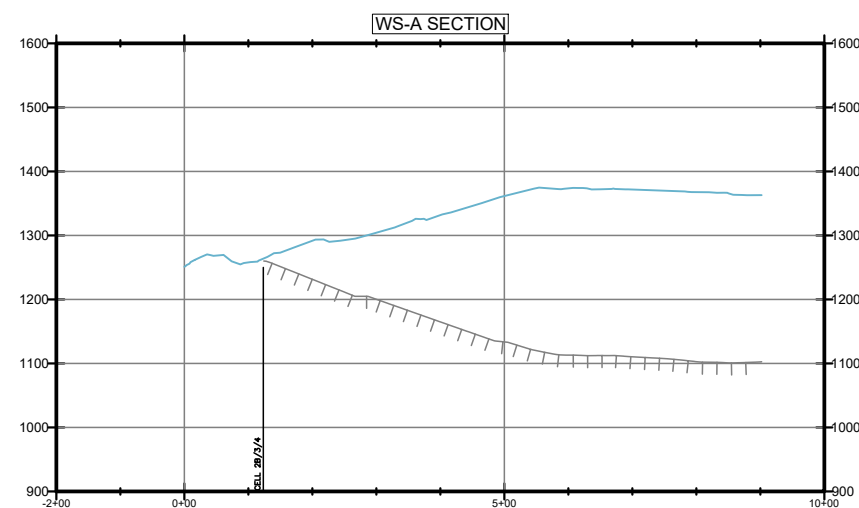
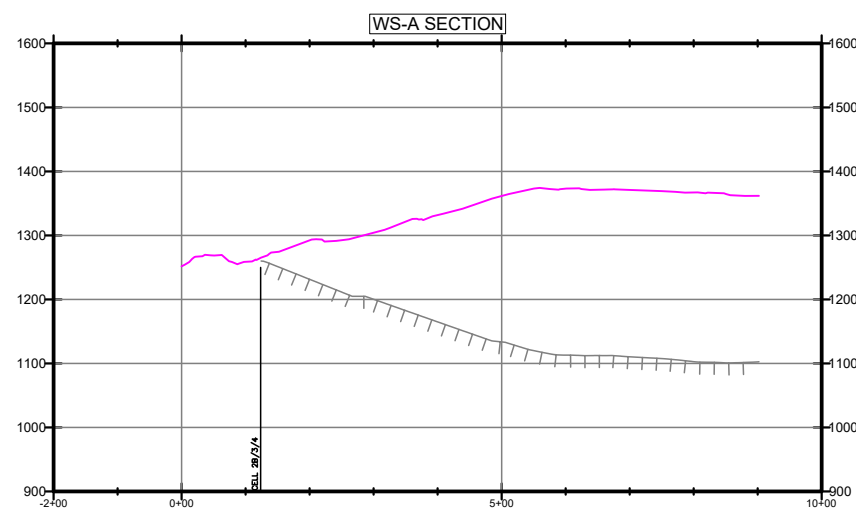
FIGURE 2A

WESTERN SLOPE CROSS SECTION A  
MARCH 2025 MONITORING SUMMARY  
CHIQUITA CANYON LANDFILL  
COUNTY OF LOS ANGELES, CA

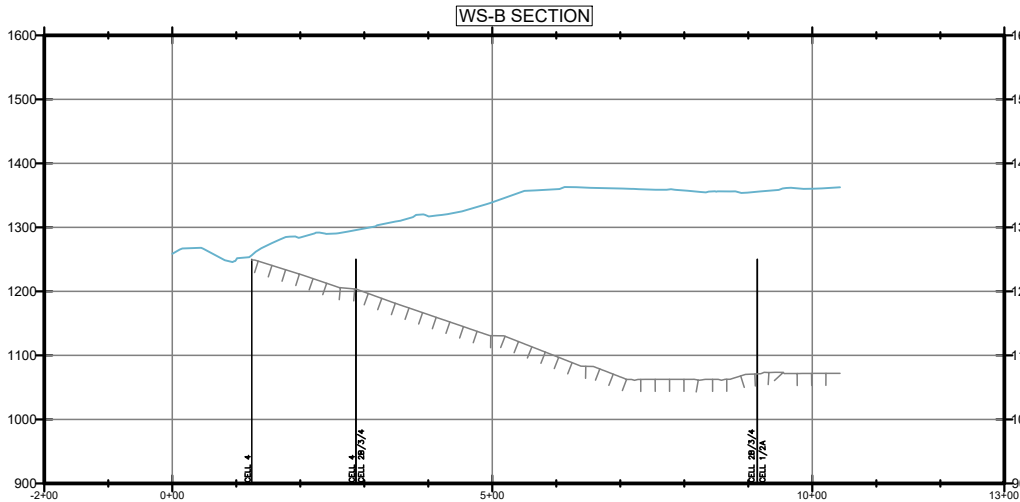
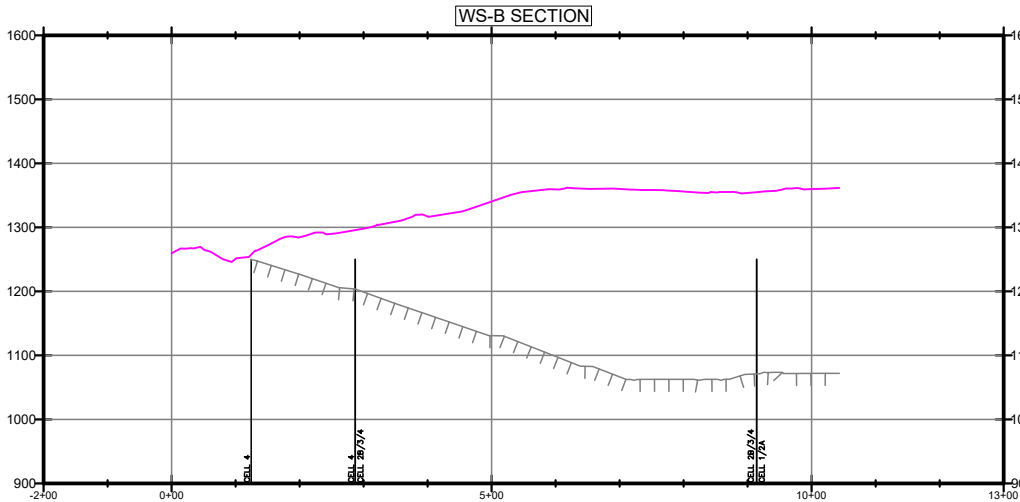
FIGURE 2B

WESTERN SLOPE CROSS SECTION B  
MARCH 2025 MONITORING SUMMARY  
CHIQUITA CANYON LANDFILL  
COUNTY OF LOS ANGELES, CA
