April 21, 2025  
File No. 01204123.42, Task 10

Subject: March 2025 Monthly Report for Modified Stipulated Order for Abatement (Case No. 6177-4), Chiquita Canyon Landfill (Facility ID 119219), Castaic, California

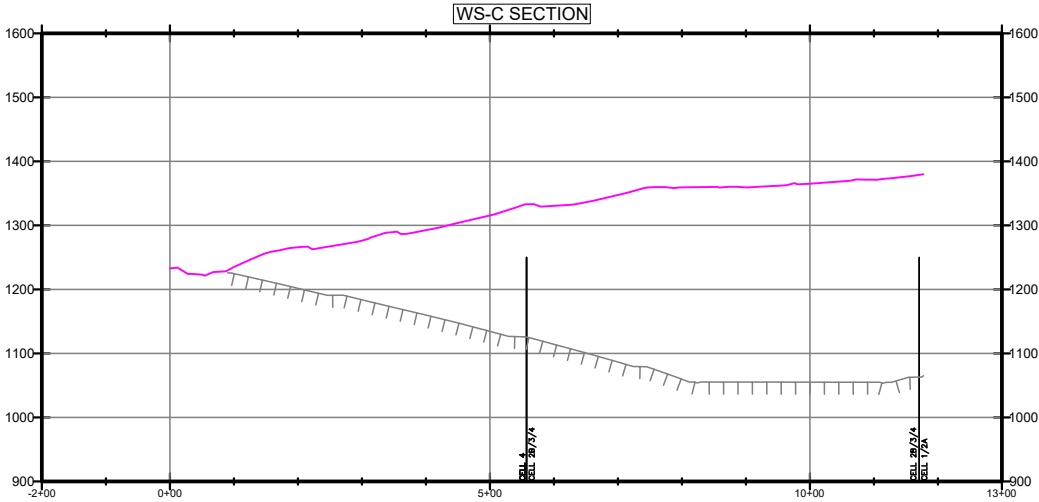
FIGURE 2C

WESTERN SLOPE CROSS SECTION C  
MARCH 2025 MONITORING SUMMARY  
CHIQUITA CANYON LANDFILL  
COUNTY OF LOS ANGELES, CA

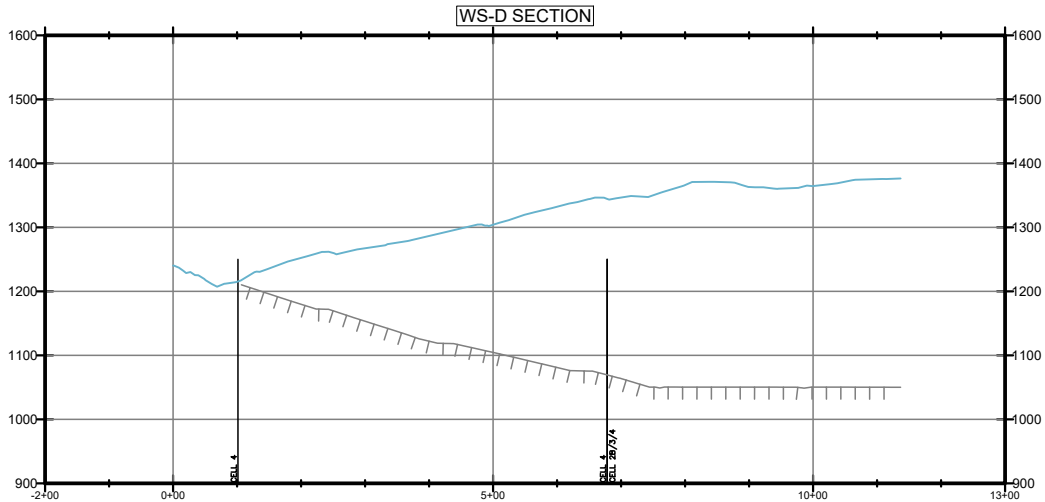
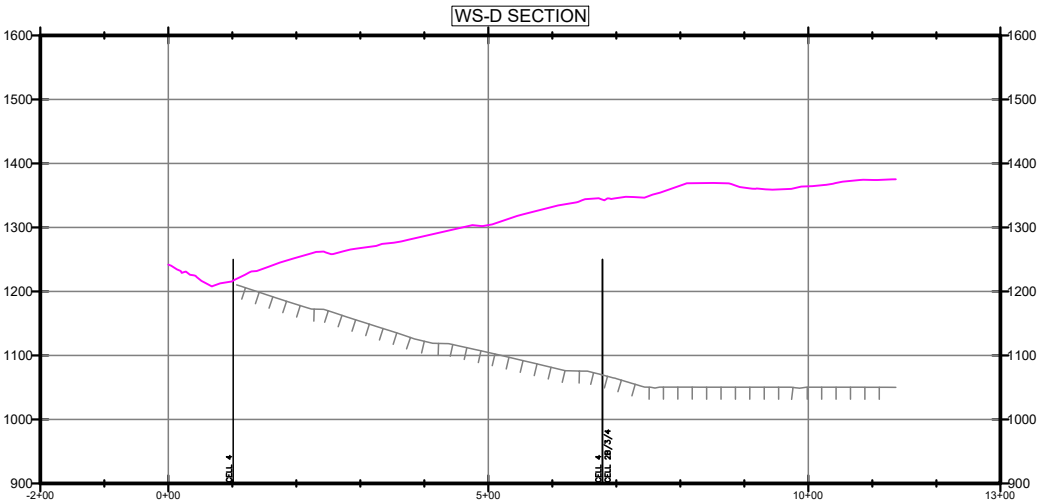
FIGURE 2D

WESTERN SLOPE CROSS SECTION D  
MARCH 2025 MONITORING SUMMARY  
CHIQUITA CANYON LANDFILL  
COUNTY OF LOS ANGELES, CA

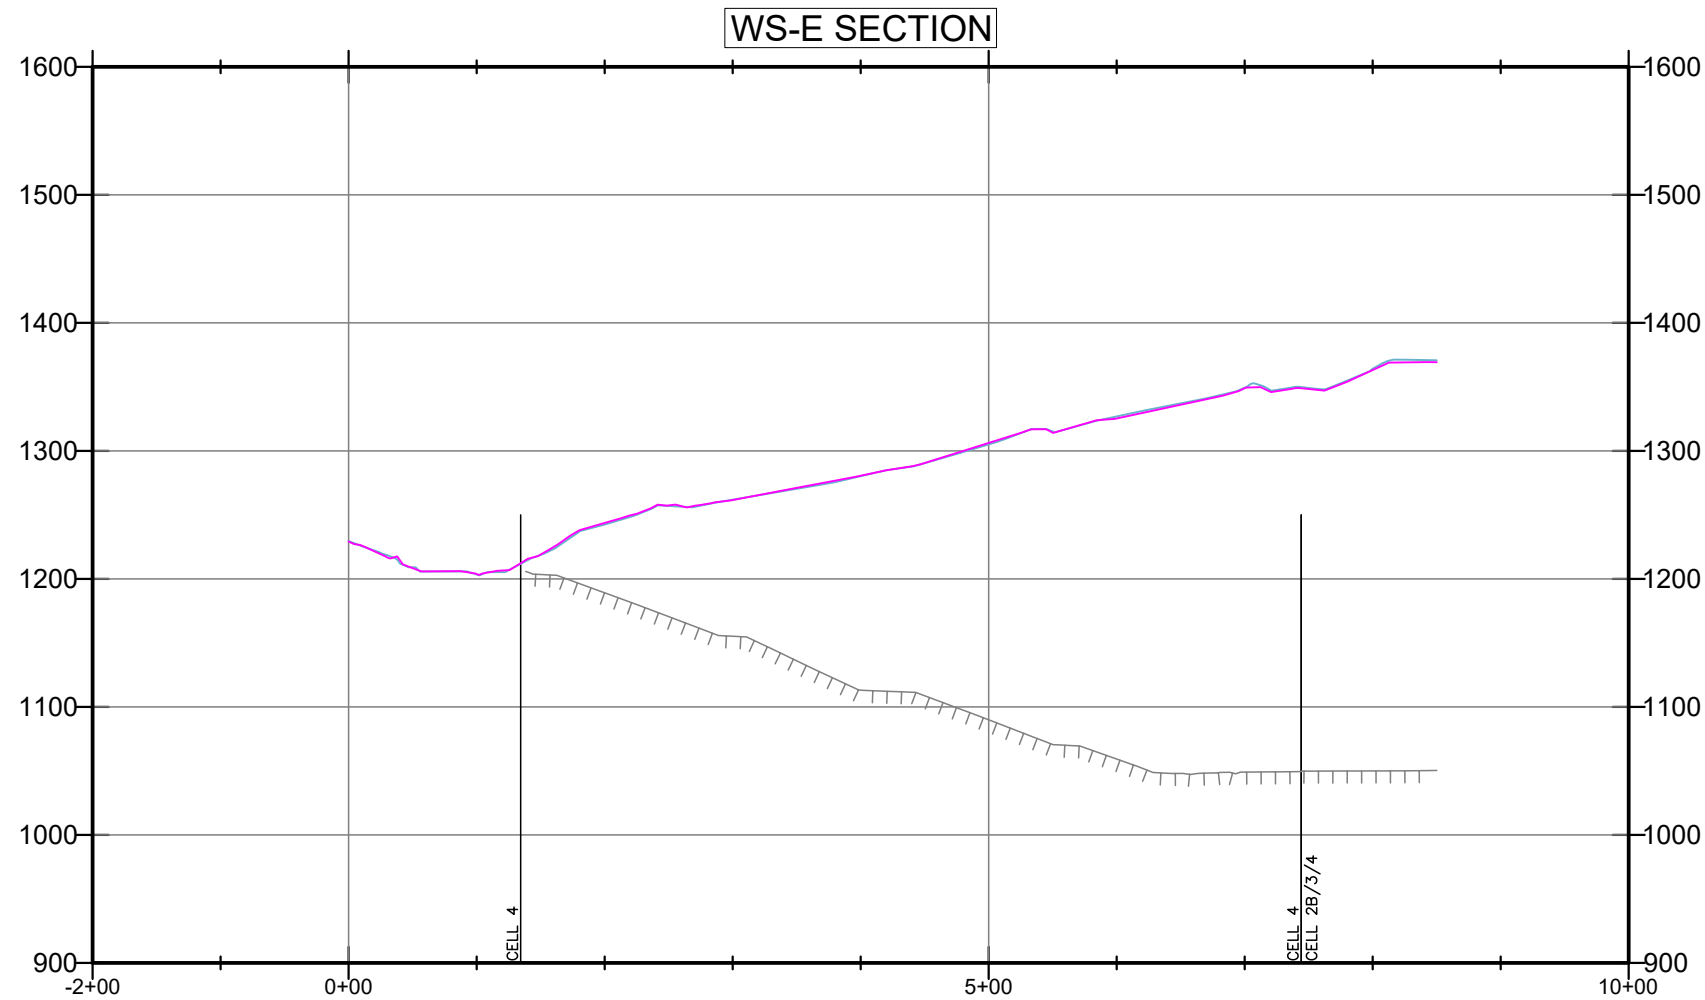
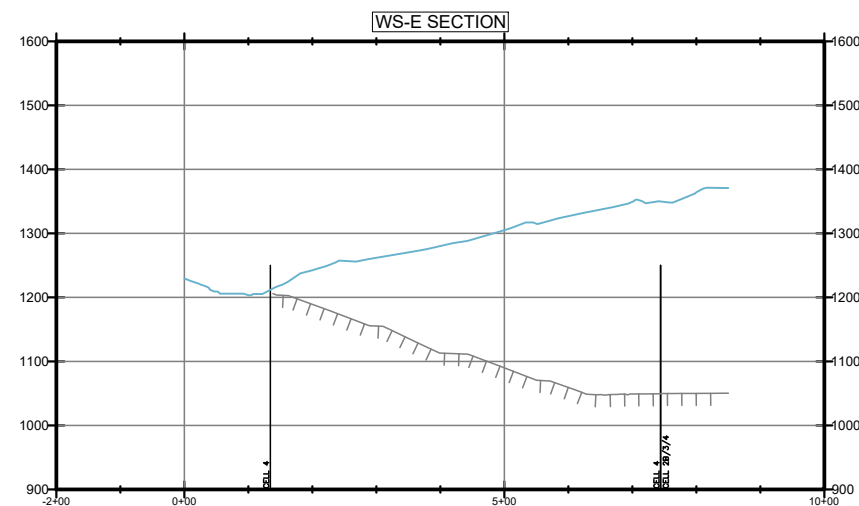
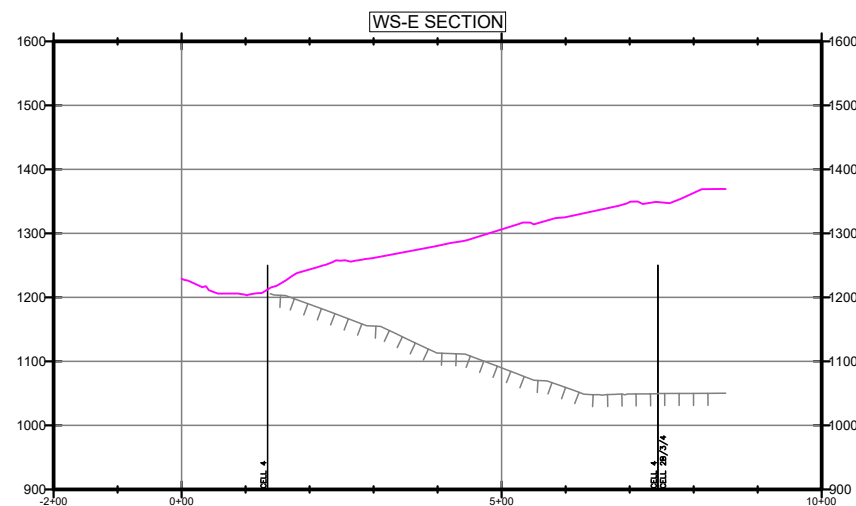
FIGURE 2E

WESTERN SLOPE CROSS SECTION E  
MARCH 2025 MONITORING SUMMARY  
CHIQUITA CANYON LANDFILL  
COUNTY OF LOS ANGELES, CA

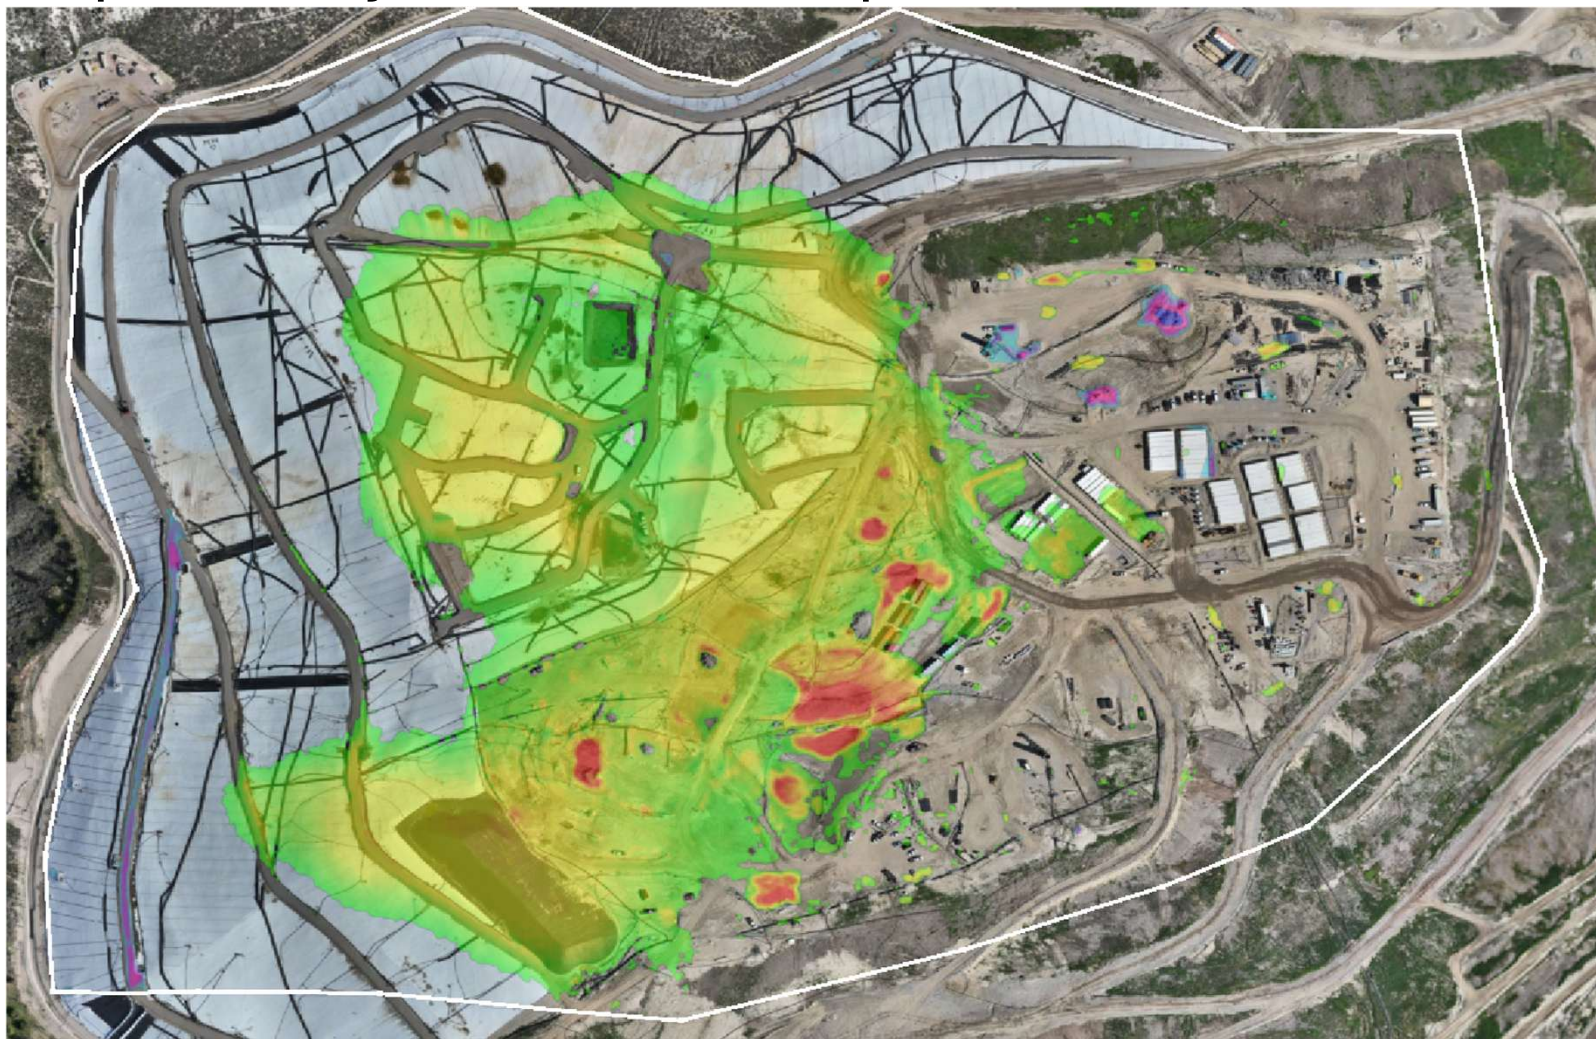
# Chiquita Canyon Landfill - Isopach

April 2, 2025 Survey Image. January 3, 2025 vs April 2, 2025

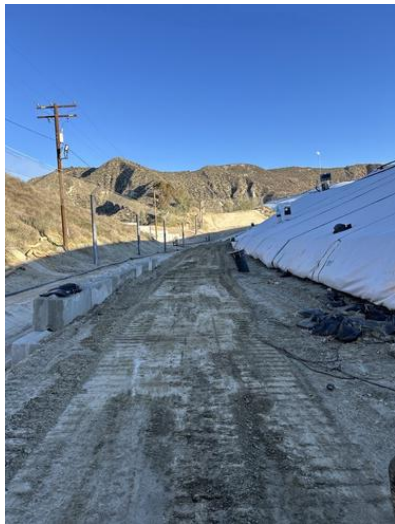
Photo 1

**Has a leachate seep/pooling been located?**

No

**Description of area in photo where there is no leachate seepage or pooling.**

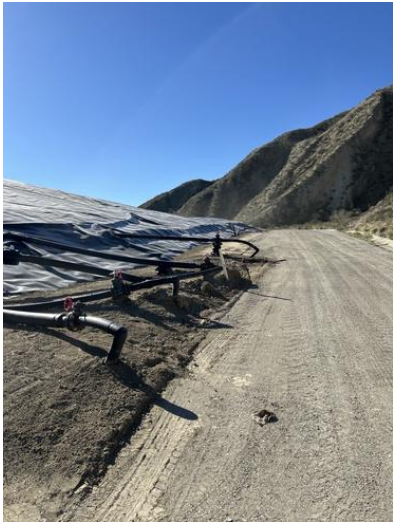
Photo 1

**Has a leachate seep/pooling been located?**

No

**Description of area in photo where there is no leachate seepage or pooling.**

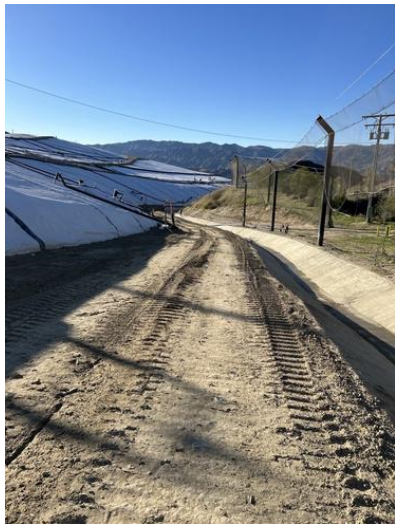
Photo 1

**Has a leachate seep/pooling been located?**

No

**Description of area in photo where there is no leachate seepage or pooling.**

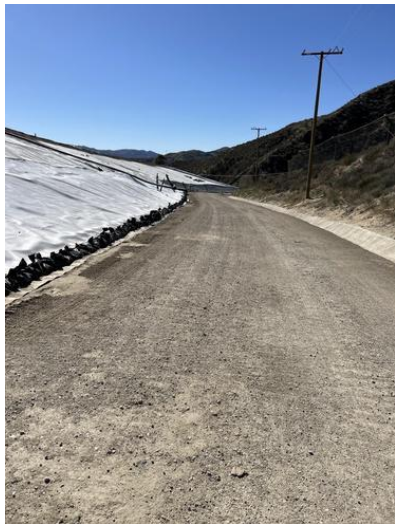
Photo 1

**Has a leachate seep/pooling been located?**

No

**Description of area in photo where there is no leachate seepage or pooling.**

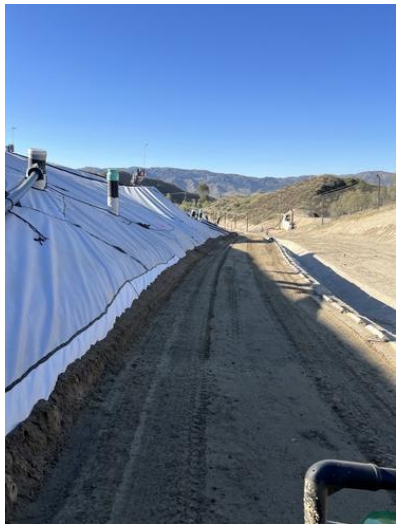
Photo 1

**Has a leachate seep/pooling been located?**

No

**Description of area in photo where there is no leachate seepage or pooling.**

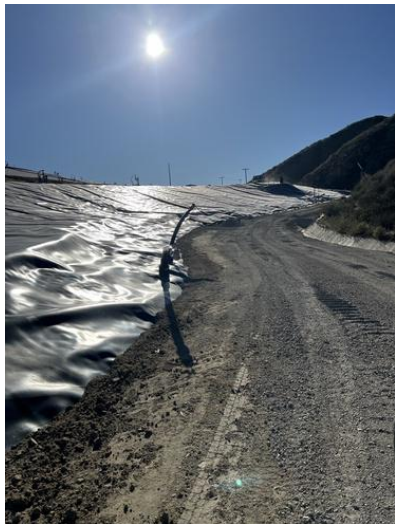
Photo 1

**Has a leachate seep/pooling been located?**

No

**Description of area in photo where there is no leachate seepage or pooling.**

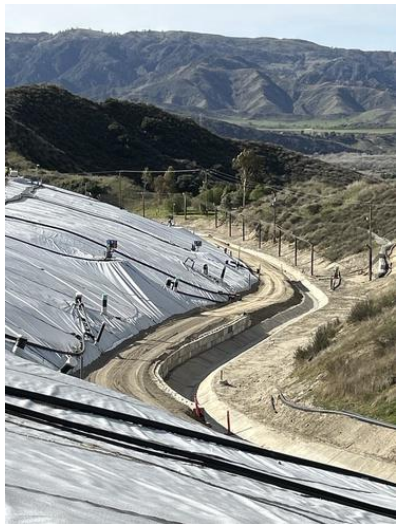
Photo 1

**Has a leachate seep/pooling been located?**

No

**Description of area in photo where there is no leachate seepage or pooling.**

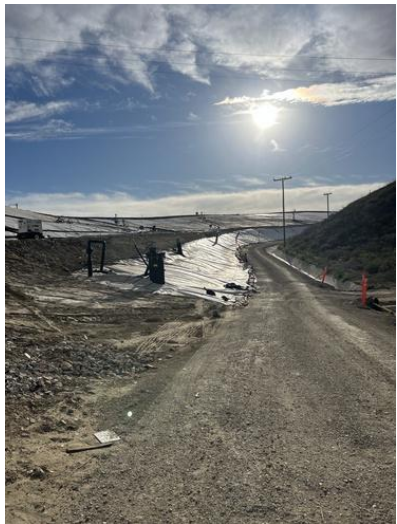
Photo 1

**Has a leachate seep/pooling been located?**

No

**Description of area in photo where there is no leachate seepage or pooling.**

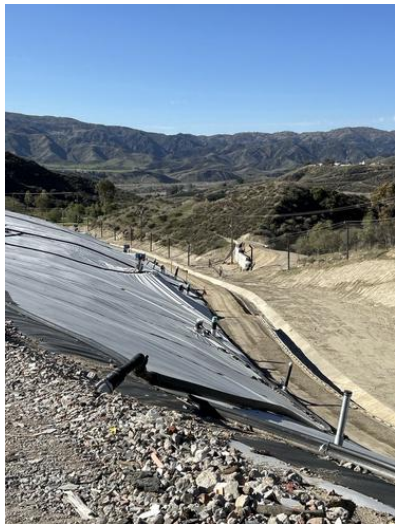
Photo 1

**Has a leachate seep/pooling been located?**

No

**Description of area in photo where there is no leachate seepage or pooling.**

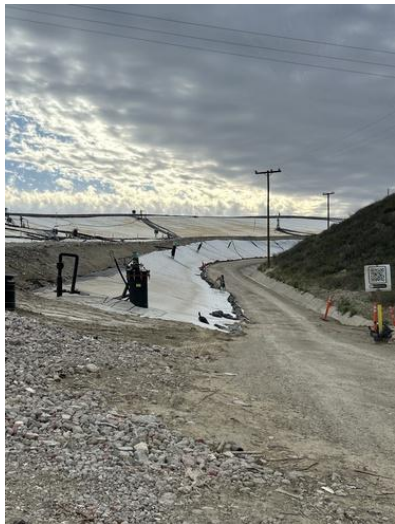
Photo 1

**Has a leachate seep/pooling been located?**

No

**Description of area in photo where there is no leachate seepage or pooling.**

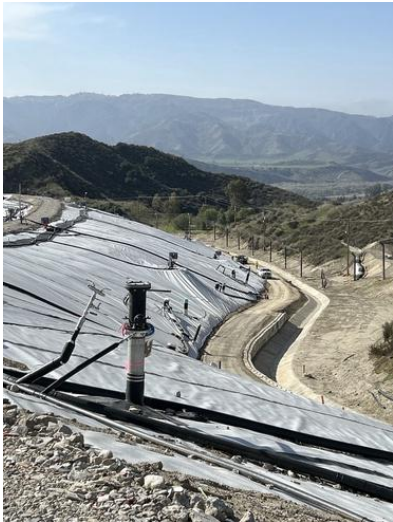
Photo 1

**Has a leachate seep/pooling been located?**

No

**Description of area in photo where there is no leachate seepage or pooling.**

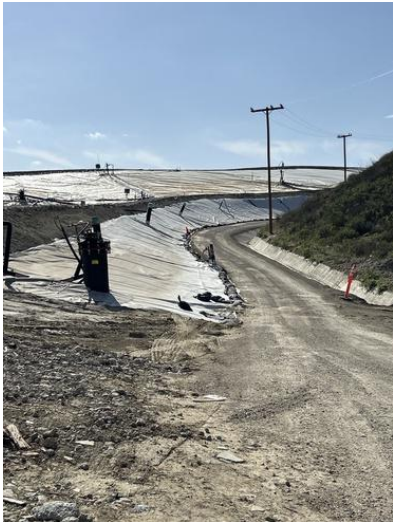
Photo 1

**Has a leachate seep/pooling been located?**

No

**Description of area in photo where there is no leachate seepage or pooling.**

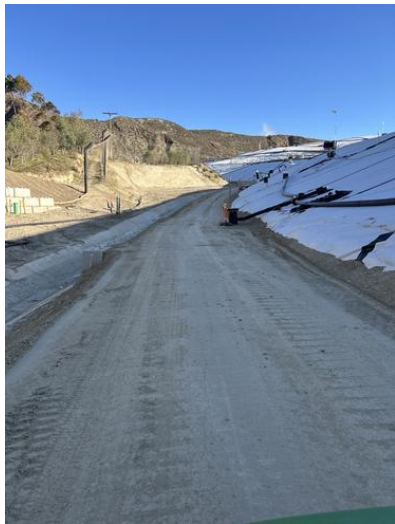
Photo 1

**Has a leachate seep/pooling been located?**

No

**Description of area in photo where there is no leachate seepage or pooling.**

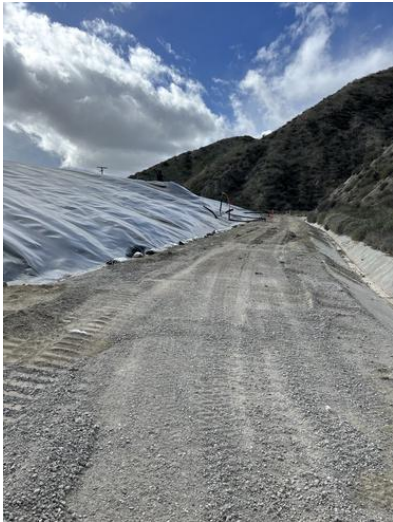
Photo 1

**Has a leachate seep/pooling been located?**

No

**Description of area in photo where there is no leachate seepage or pooling.**

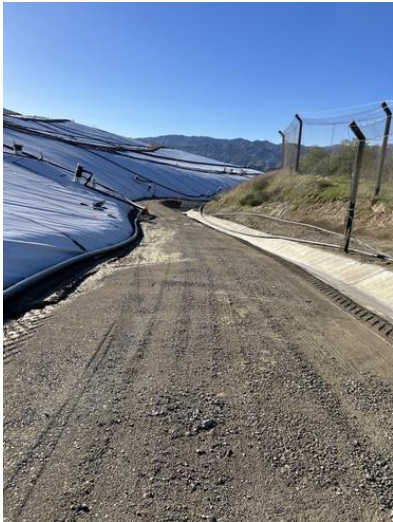
Photo 1

**Has a leachate seep/pooling been located?**

No

**Description of area in photo where there is no leachate seepage or pooling.**

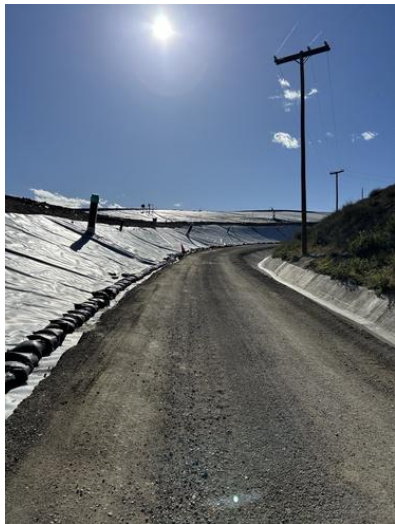
Photo 1

**Has a leachate seep/pooling been located?**

No

**Description of area in photo where there is no leachate seepage or pooling.**

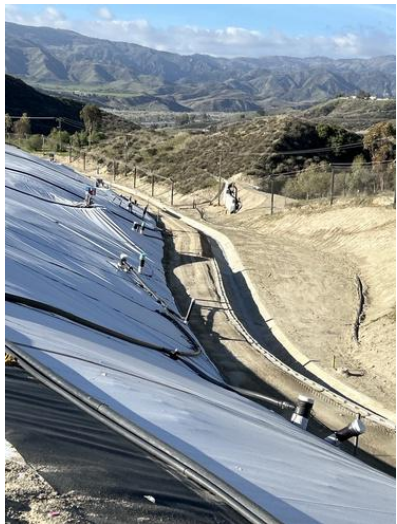
Photo 1

Has a leachate seep/pooling been located?

No

Description of area in photo where there is no leachate seepage or pooling.

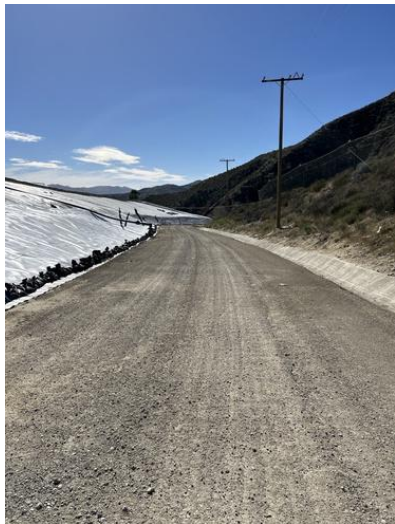
Photo 1

**Has a leachate seep/pooling been located?**

No

**Description of area in photo where there is no leachate seepage or pooling.**

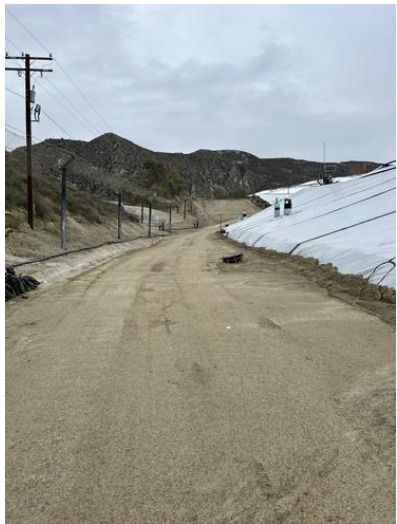
Photo 1

**Has a leachate seep/pooling been located?**

No

**Description of area in photo where there is no leachate seepage or pooling.**

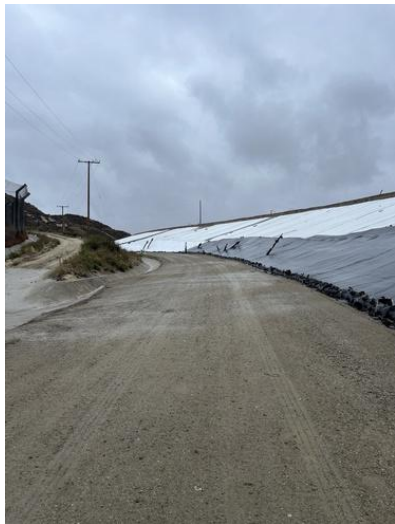
Photo 1

**Has a leachate seep/pooling been located?**

No

**Description of area in photo where there is no leachate seepage or pooling.**

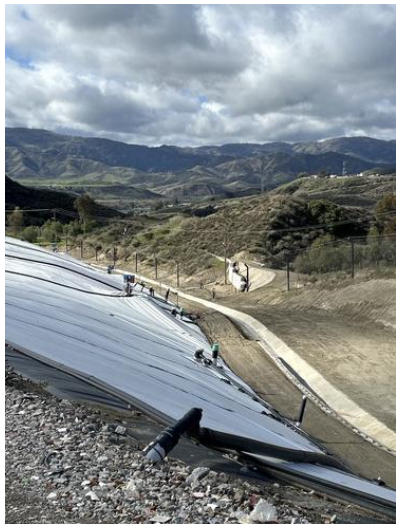
Photo 1

**Has a leachate seep/pooling been located?**

No

**Description of area in photo where there is no leachate seepage or pooling.**

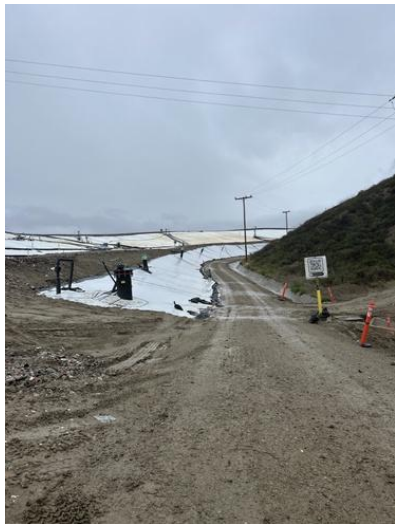
Photo 1

**Has a leachate seep/pooling been located?**

No

**Description of area in photo where there is no leachate seepage or pooling.**

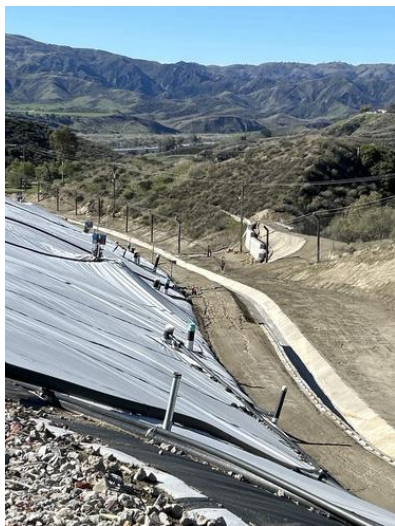
Photo 1

**Has a leachate seep/pooling been located?**

No

**Description of area in photo where there is no leachate seepage or pooling.**

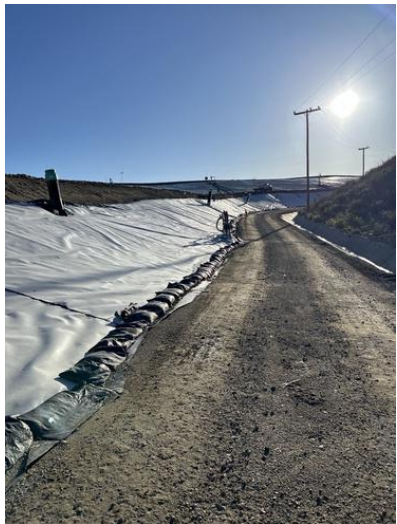
Photo 1

**Has a leachate seep/pooling been located?**

No

**Description of area in photo where there is no leachate seepage or pooling.**

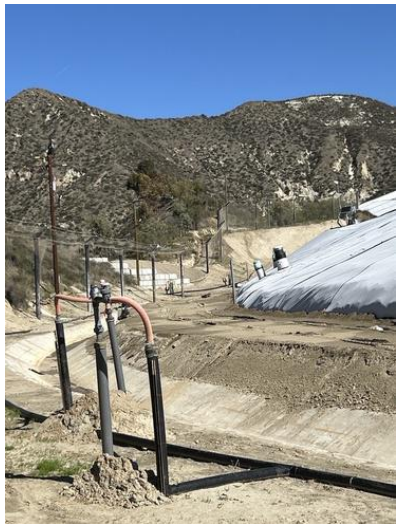
Photo 1

**Has a leachate seep/pooling been located?**

No

**Description of area in photo where there is no leachate seepage or pooling.**

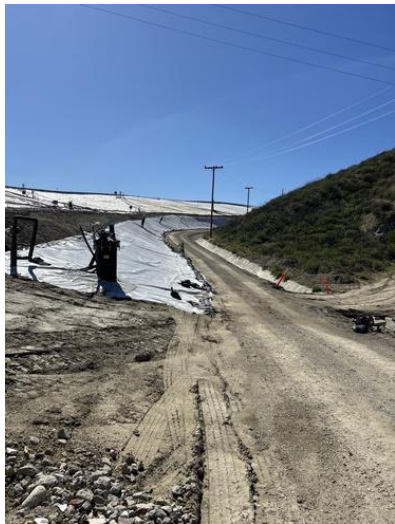
Photo 1

**Has a leachate seep/pooling been located?**

No

**Description of area in photo where there is no leachate seepage or pooling.**

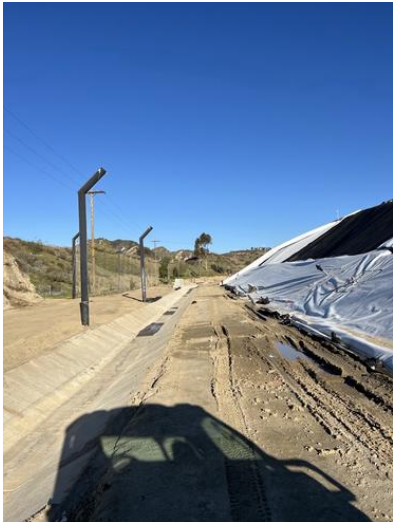
Photo 1

**Has a leachate seep/pooling been located?**

No

**Description of area in photo where there is no leachate seepage or pooling.**

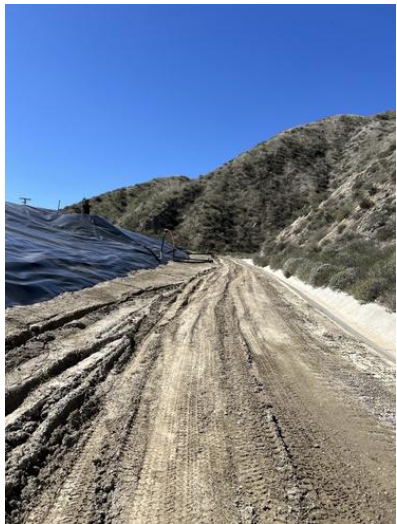
Photo 1

**Has a leachate seep/pooling been located?**

No

**Description of area in photo where there is no leachate seepage or pooling.**

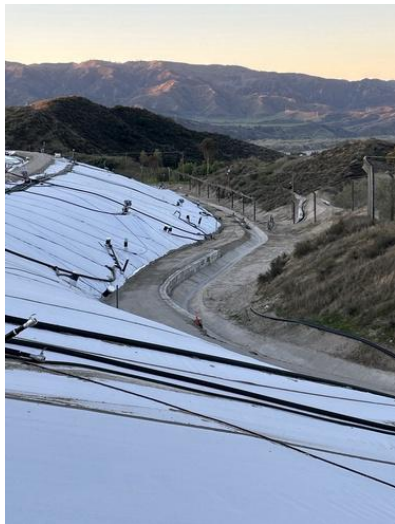
Photo 1

**Has a leachate seep/pooling been located?**

No

**Description of area in photo where there is no leachate seepage or pooling.**

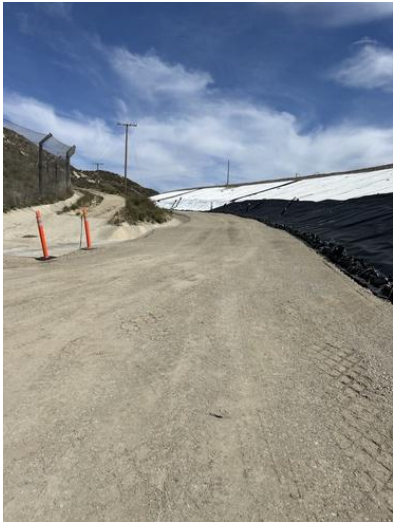
Photo 1

**Has a leachate seep/pooling been located?**

No

**Description of area in photo where there is no leachate seepage or pooling.**

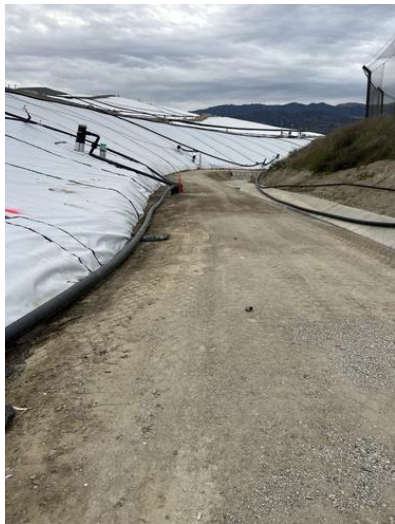
Photo 1

**Has a leachate seep/pooling been located?**

No

**Description of area in photo where there is no leachate seepage or pooling.**

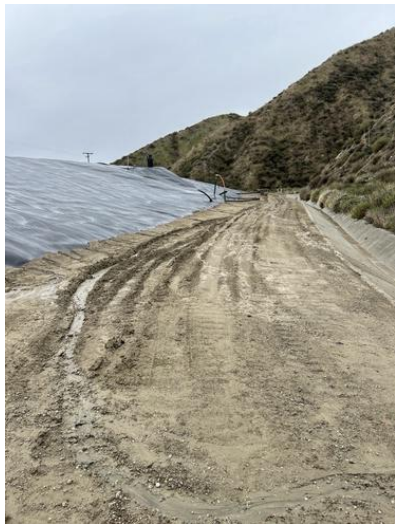
Photo 1

**Has a leachate seep/pooling been located?**

No

**Description of area in photo where there is no leachate seepage or pooling.**

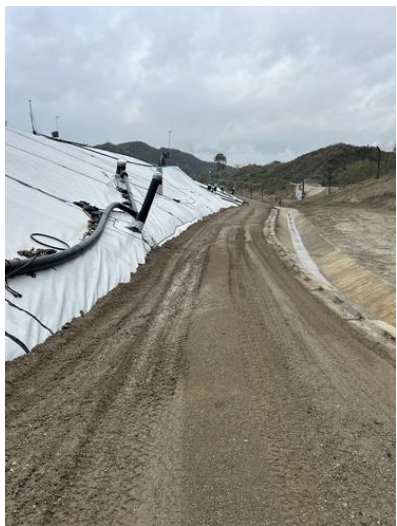
Photo 1

**Has a leachate seep/pooling been located?**

No

**Description of area in photo where there is no leachate seepage or pooling.**

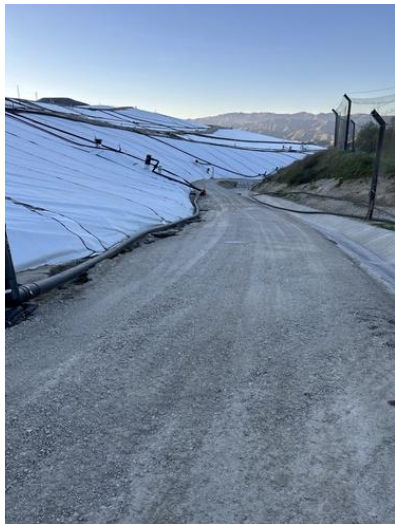
Photo 1

No

Westside perimeter road.

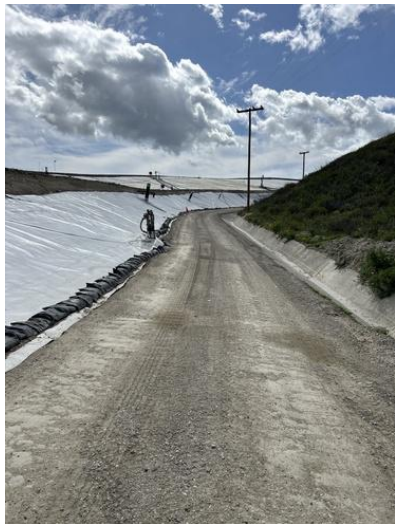
Photo 1

**Has a leachate seep/pooling been located?**

No

**Description of area in photo where there is no leachate seepage or pooling.**

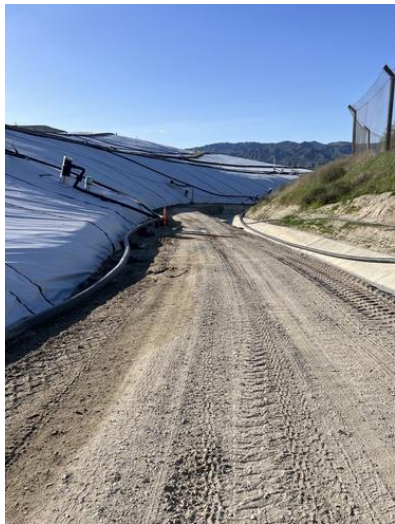
Photo 1

**Has a leachate seep/pooling been located?**

No

**Description of area in photo where there is no leachate seepage or pooling.**

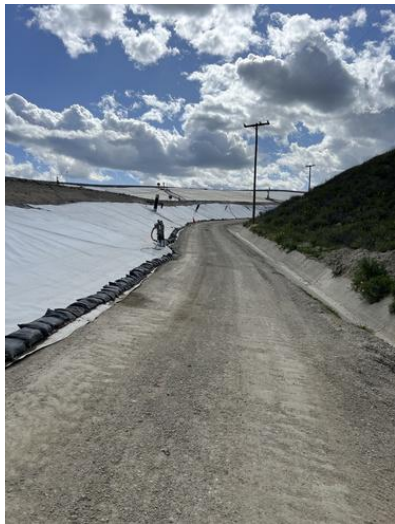
Photo 1

**Has a leachate seep/pooling been located?**

No

**Description of area in photo where there is no leachate seepage or pooling.**

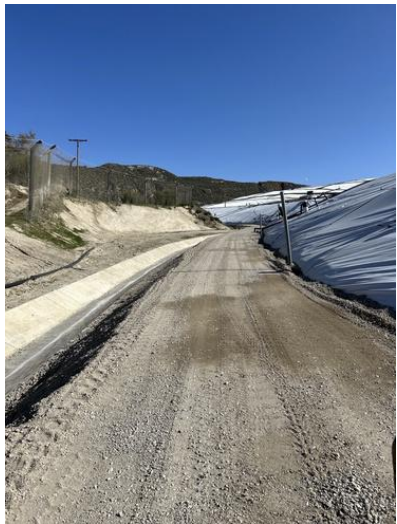
Photo 1

**Has a leachate seep/pooling been located?**

No

**Description of area in photo where there is no leachate seepage or pooling.**

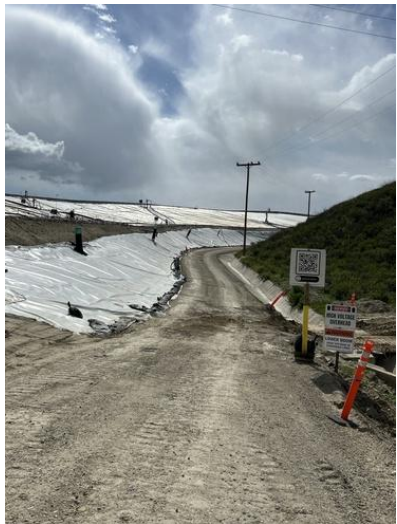
Photo 1

**Has a leachate seep/pooling been located?**

No

**Description of area in photo where there is no leachate seepage or pooling.**

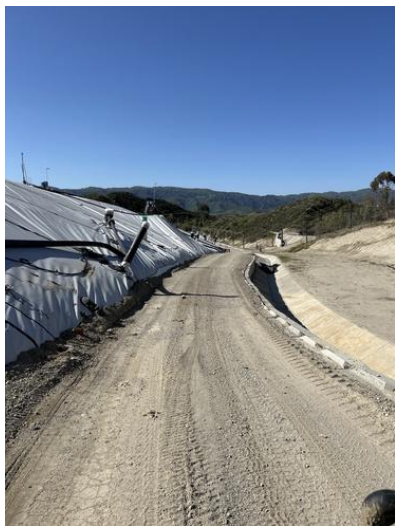
Photo 1

**Has a leachate seep/pooling been located?**

No

**Description of area in photo where there is no leachate seepage or pooling.**

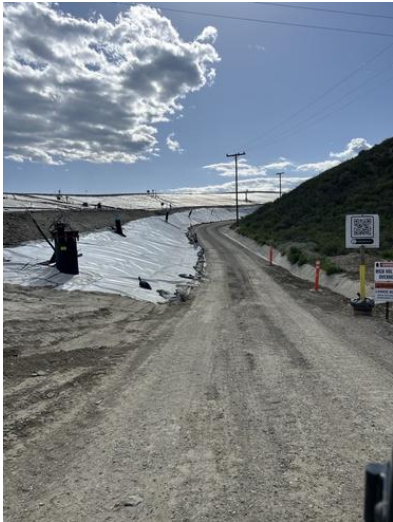
Photo 1

**Has a leachate seep/pooling been located?**

No

**Description of area in photo where there is no leachate seepage or pooling.**

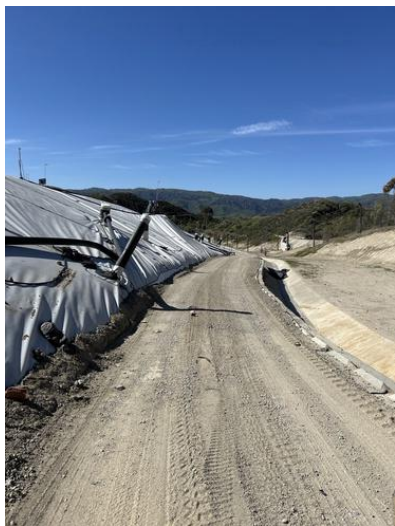
Photo 1

**Has a leachate seep/pooling been located?**

No

**Description of area in photo where there is no leachate seepage or pooling.**

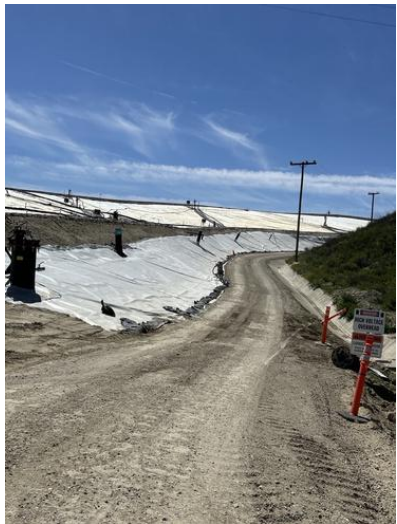
Photo 1

**Has a leachate seep/pooling been located?**

No

**Description of area in photo where there is no leachate seepage or pooling.**

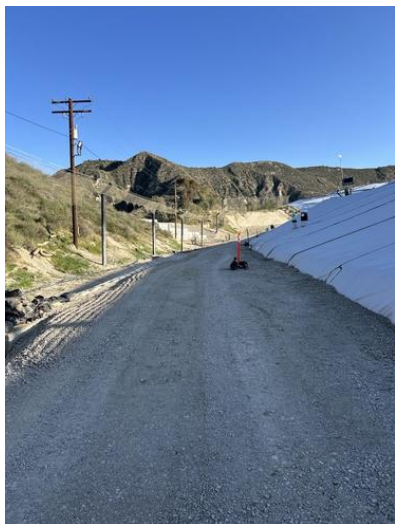
Photo 1

**Has a leachate seep/pooling been located?**

No

**Description of area in photo where there is no leachate seepage or pooling.**

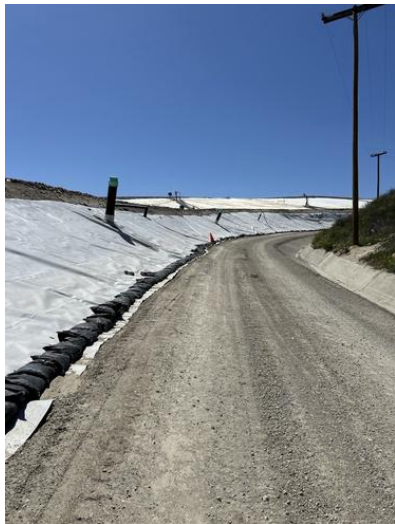
Photo 1

**Has a leachate seep/pooling been located?**

No

**Description of area in photo where there is no leachate seepage or pooling.**
