**Re: Chiquita Canyon, LLC Analysis of April 2, 2025 FLIR Survey in
Response to the December 24, 2024 LEA Letter Regarding
Milestone 2B Compliance, Chiquita Canyon Landfill**

Waste Connections Chiquita Canyon
Project: 2025 04 Thermal Study
Job: Thermal Study
Report Submitted Apr 11, 2025

Emission Study Thermal Report

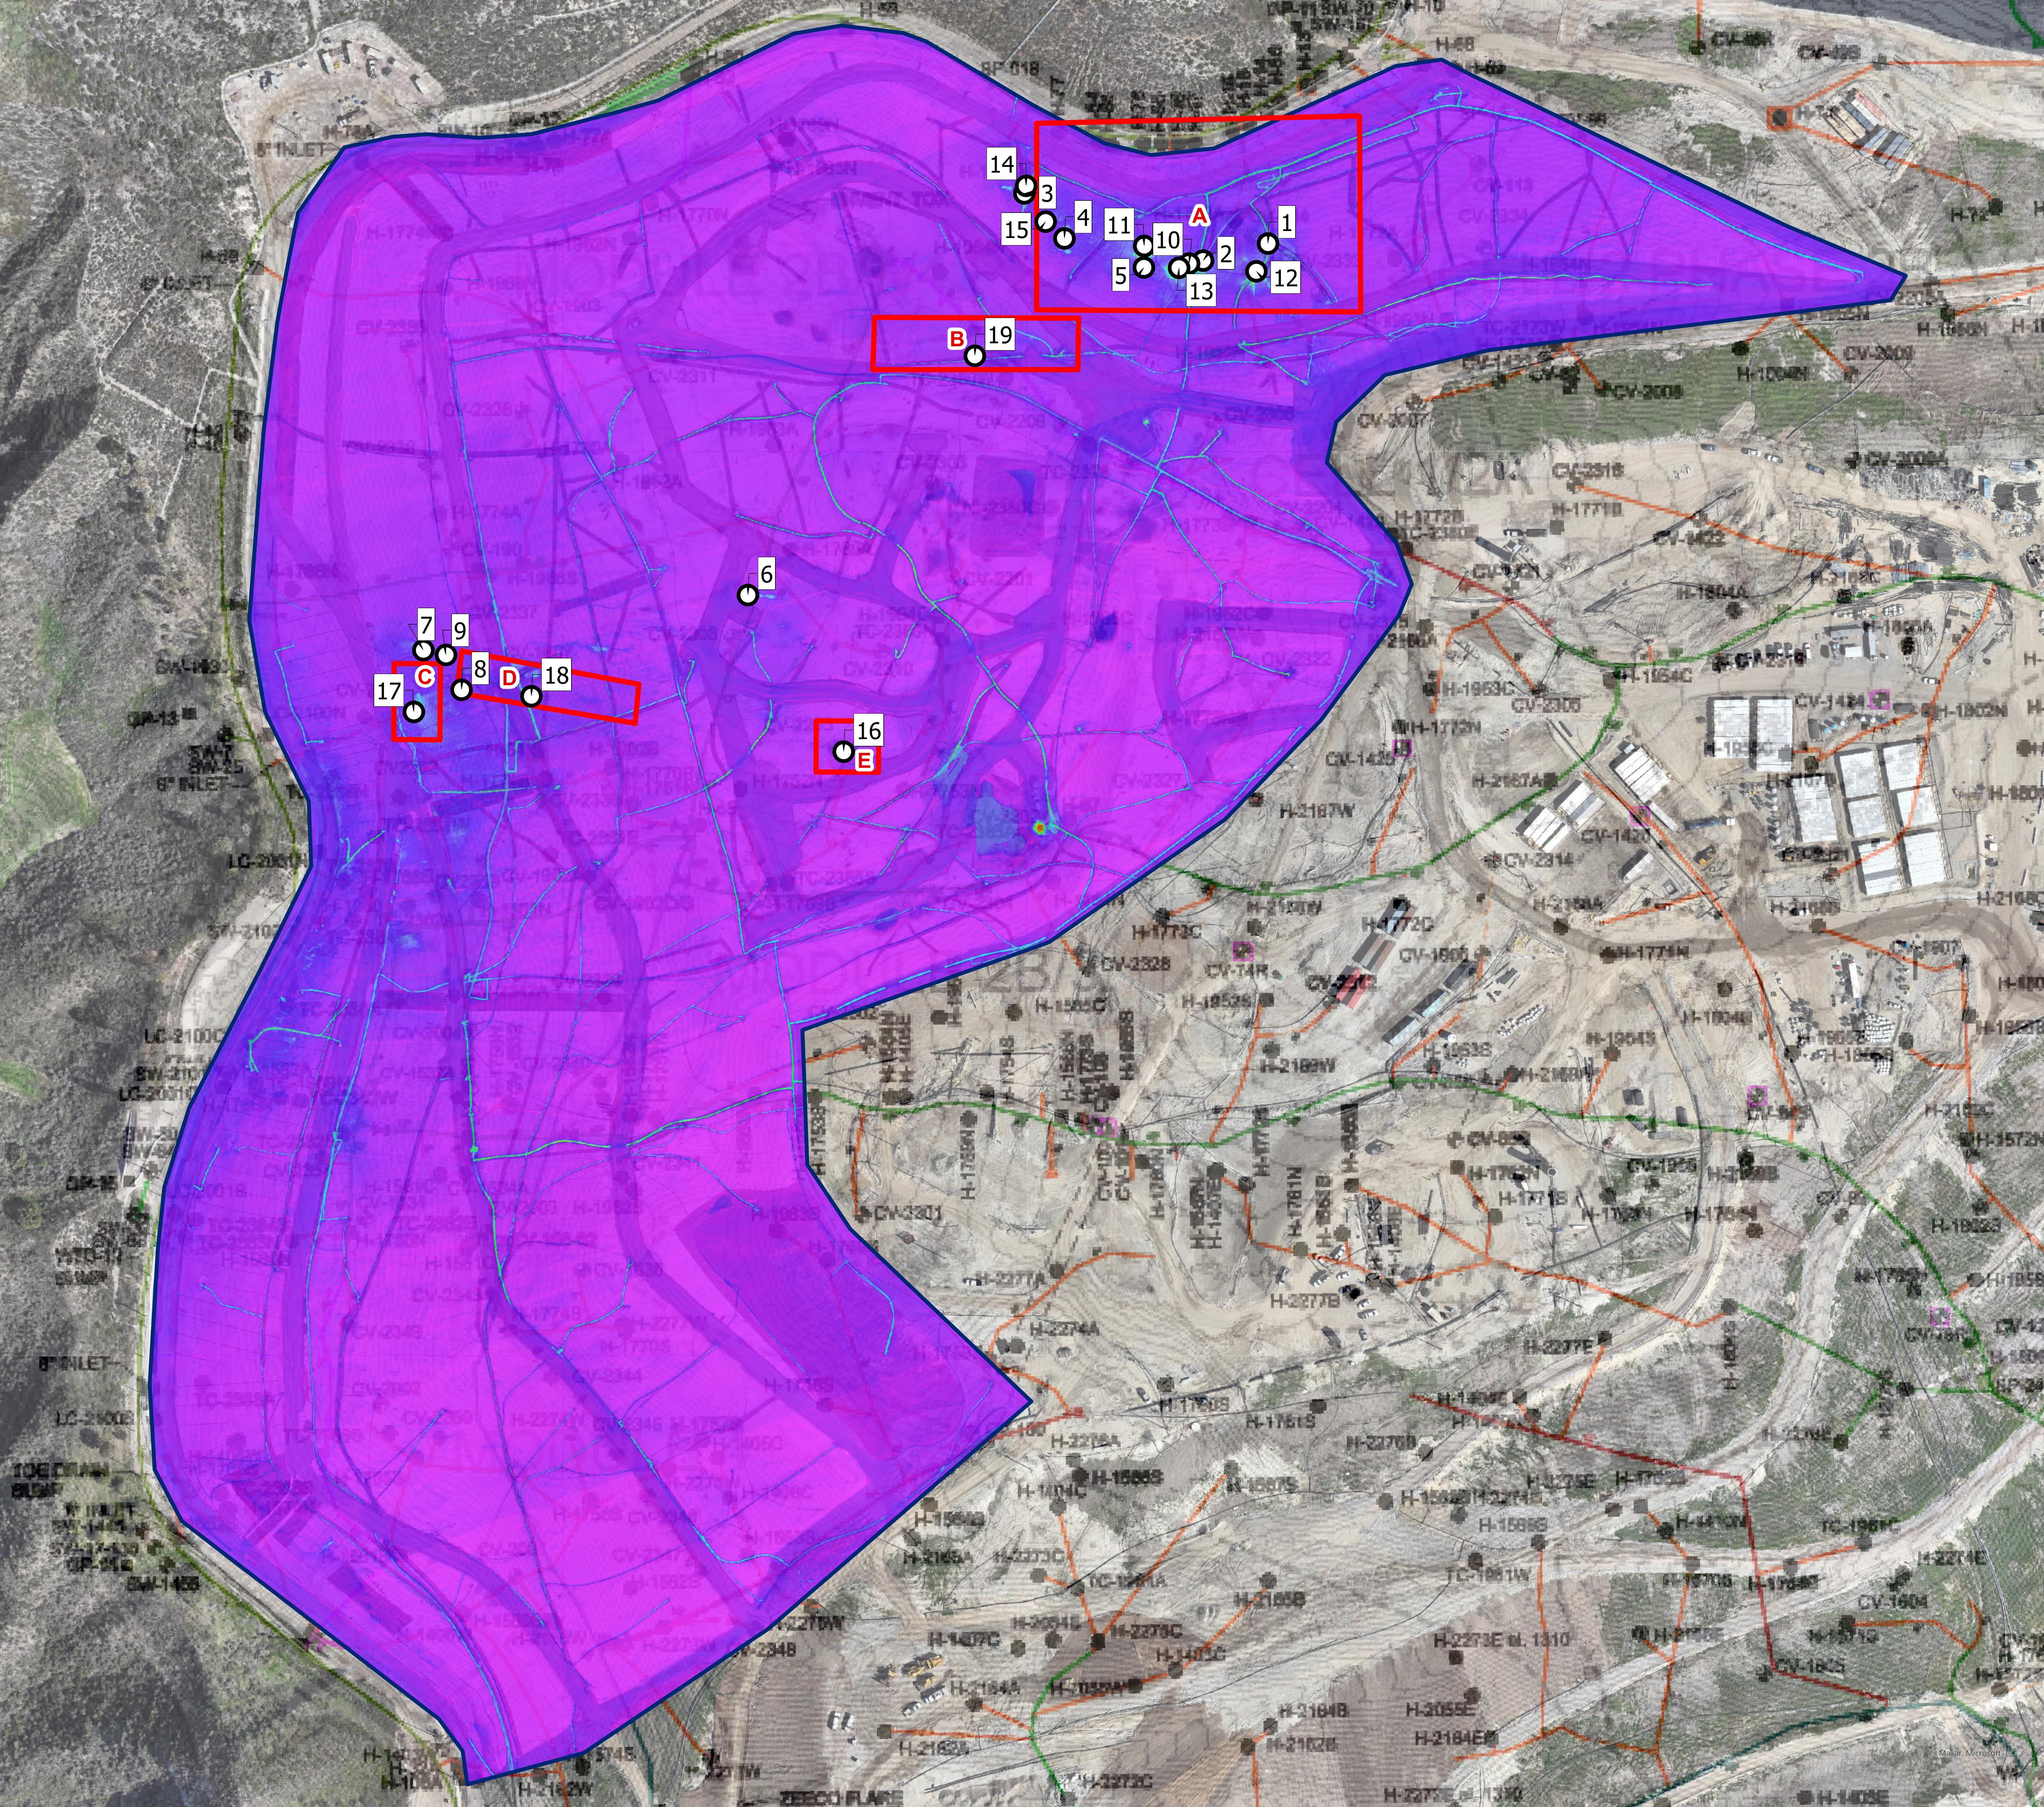
Chiquita Canyon Discrete Thermal Image Locations over Thermal Reflectance, as Recorded by the SnifferDRONE™

This report provides details of peak temperature locations as determined by the photos taken from the SnifferDRONE™ and processed. Report details include: coordinates of image locations, date and time of data collection, measured maximum temperatures (Fahrenheit), additional notes, map(s) displaying image locations, and thermal photographic documentation.

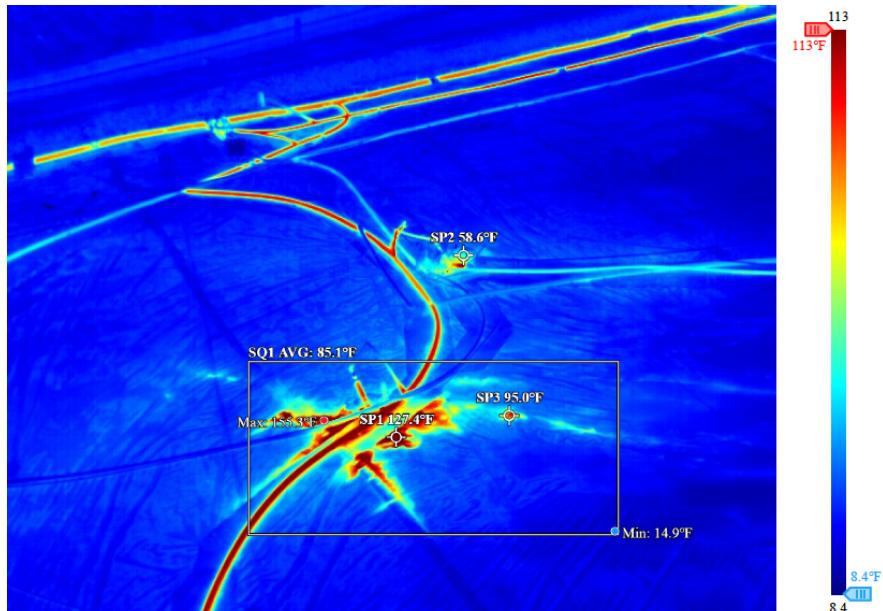
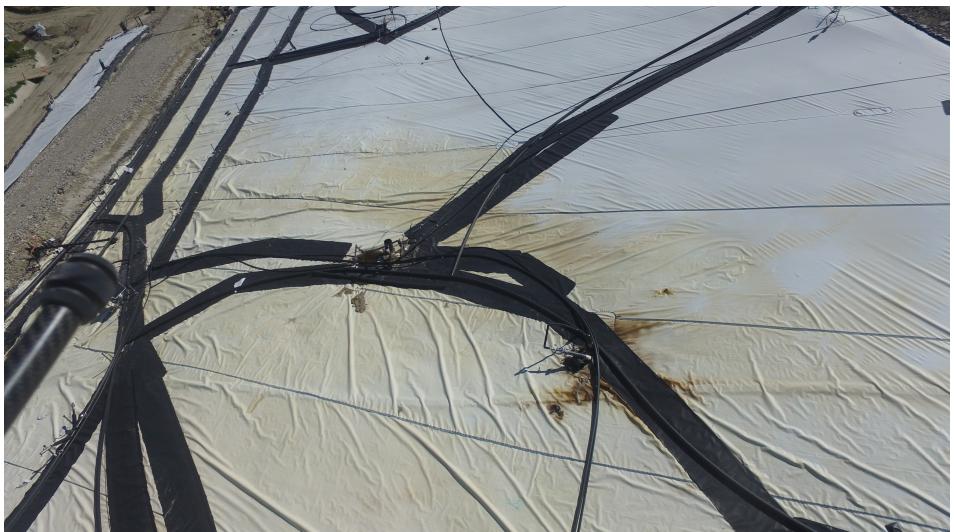
Reference # 01

The area designated by the LEA as "Area A" appears to be in grid 150. The Sniffer data reference points in Area A for the April 2, 2025 survey are points 01–05, and 10–15.¹ As discussed in Chiquita's previous submittals for past surveys, there is active gas collection occurring in this area. Chiquita's Gas Collection and Control System ("GCCS") conveys warm gas to the Landfill's flares, as designed. There is a high concentration of GCCS piping in this area relative to the rest of the Landfill, including multiple vertical paths (landfill gas wellheads), horizontal paths (landfill gas header lines), and conveyance lines that remove hot gases and liquids from the north slope of the Landfill. It is expected that the GCCS system will have higher temperatures in this area, particularly given the higher concentration of GCCS infrastructure. In addition, at the time the April 2, 2025 survey was conducted, the landfill gas wells in this area were in the process of being descaled. The higher saturation prior to the descaling may have resulted in short-term temperature elevations captured on April 2, 2025, which have since been resolved.

SQ1	Max	155.3 °F
	Min	14.9 °F
	Average	85.1 °F
Sp1		127.4 °F
Sp2		58.6 °F
Sp3		95.0 °F

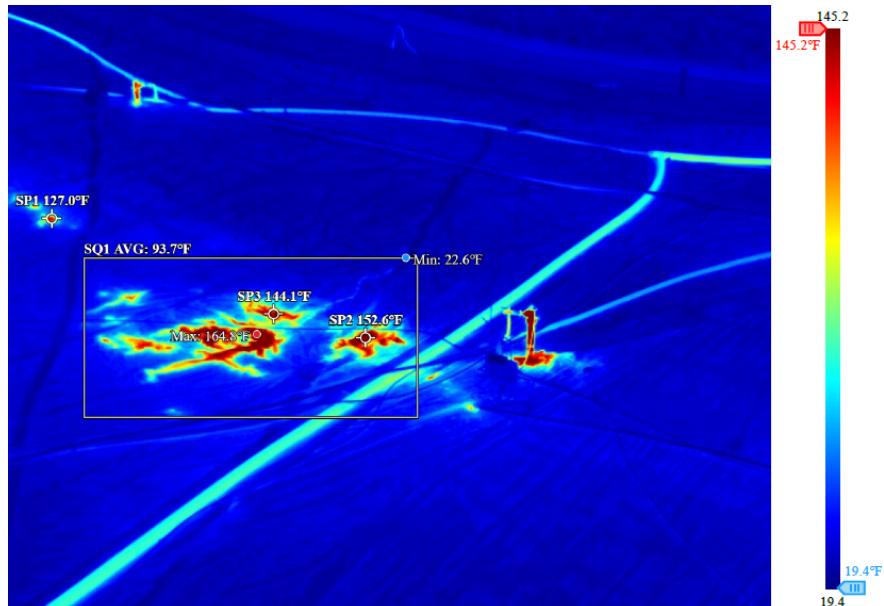
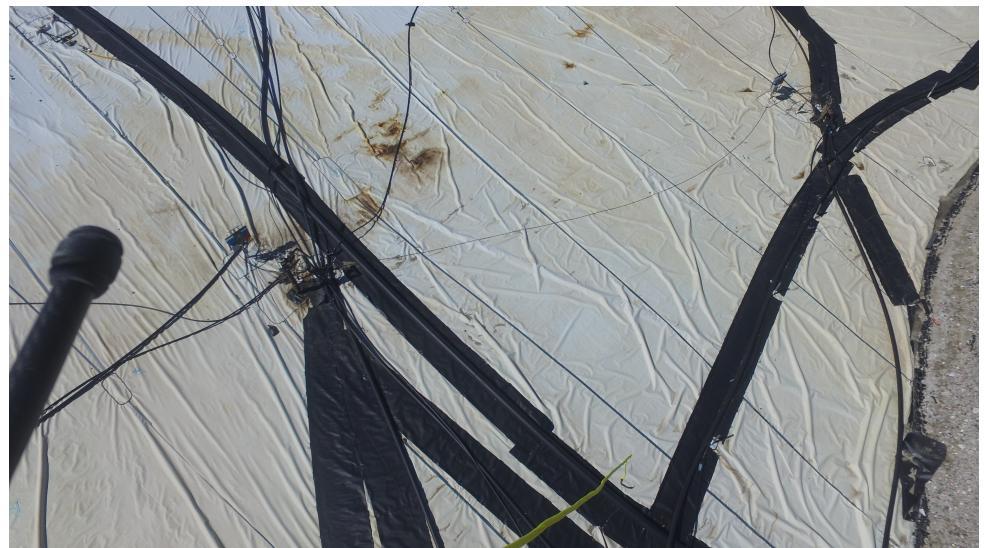
Reference # 02

SQ1	Max	164.8 °F
	Min	22.6 °F
	Average	93.7 °F
Sp1		127.0°F
Sp2		152.6 °F
Sp3		144.1 °F

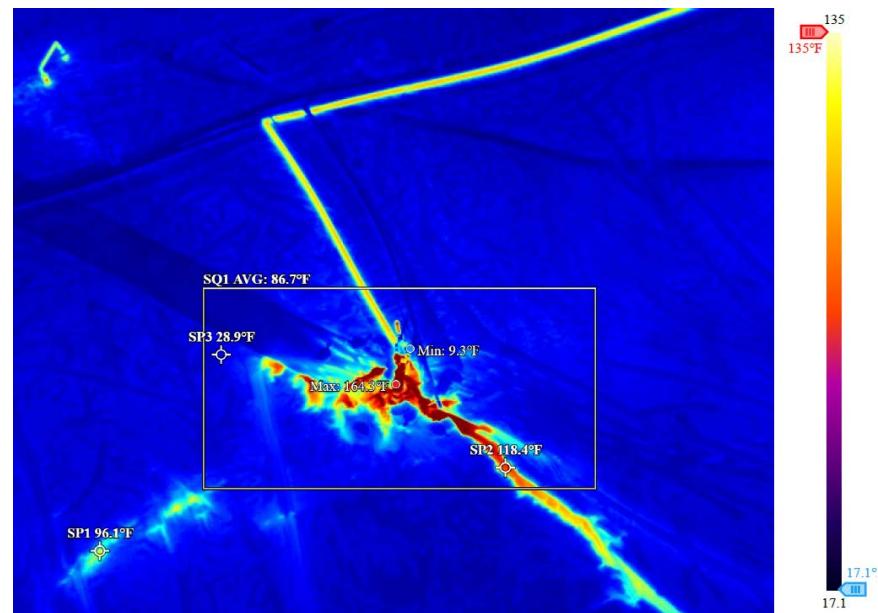
Reference # 03

SQ1	Max	164.3 °F
	Min	9.3 °F
	Average	86.7 °F
Sp1		96.1°F
Sp2		118.4 °F
Sp3		28.9 °F

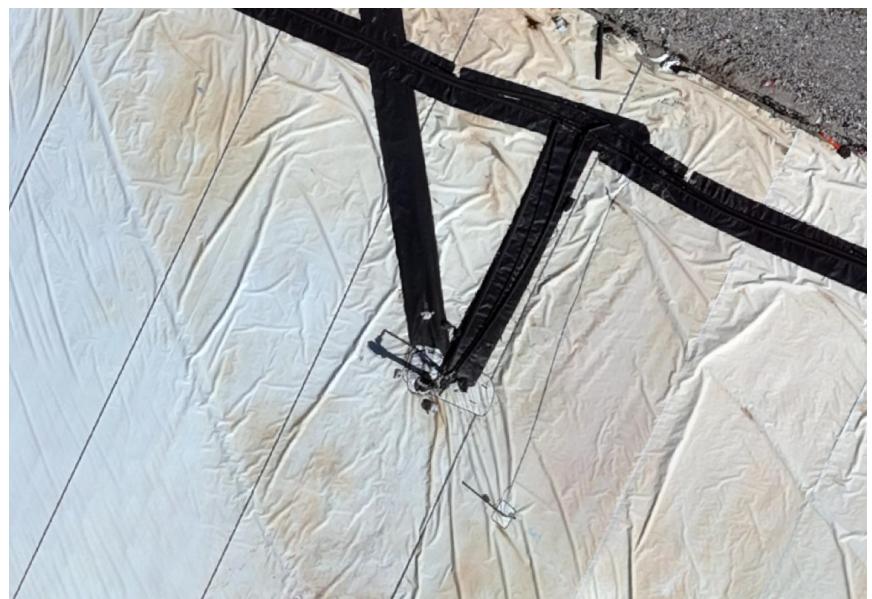
Reference # 04

SQ1	Max	124.7 °F
	Min	15.4 °F
	Average	70.0 °F

Sp1	121.3 °F
Sp2	115.9 °F
Sp3	100.8 °F
Sp4	46.8 °F
Sp5	43.9 °F

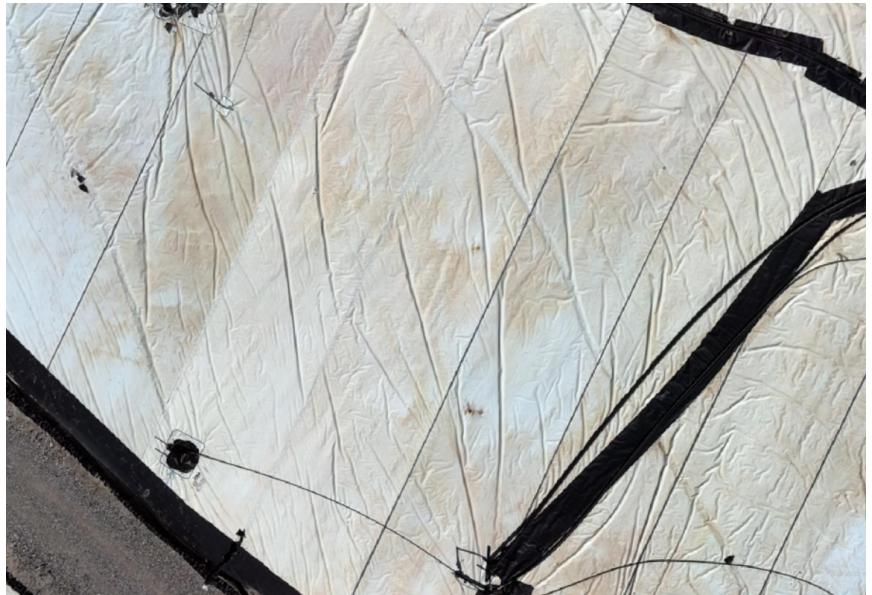
Reference # 05

SQ1	Max	159.4 °F
	Min	22.6 °F
	Average	91.0 °F
Sp1		124.0 °F
Sp2		150.1 °F
Sp3		86.9 °F
Sp4		143.1 °F

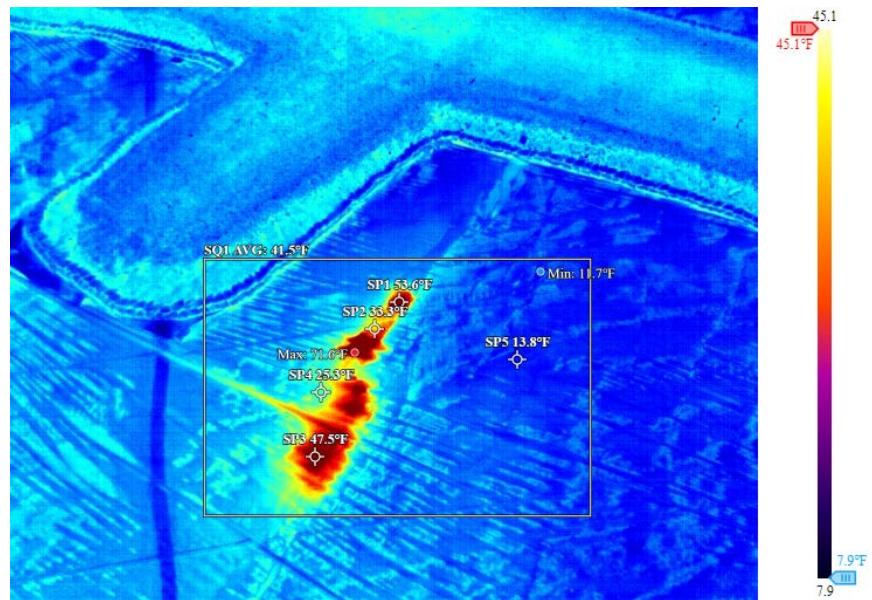
Reference # 06

³ During the April 2, 2025 survey, Sniffer’s thermal camera detected one area with elevated temperatures outside of Areas A through E. That area, point 06, is located in an area where there is a horizontal collector under the geosynthetic cover, and showed a maximum temperature reading of 71.6°F.

SQ1	Max	71.6 °F
	Min	11.7 °F
	Average	71.6 °F
Sp1		53.6 °F
Sp2		33.3 °F
Sp3		47.5 °F
Sp4		25.3 °F
Sp5		13.8 °F

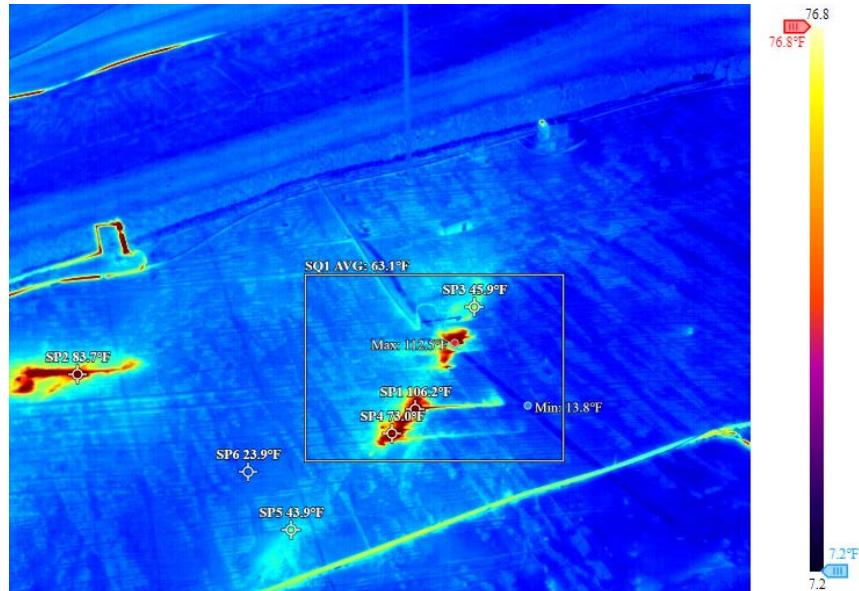
Reference # 07

The area designated by the LEA as “Area C” appears to be in grid 181. The Sniffer data reference points in Area C for the April 2, 2025 survey are points 07, 09, and 17.² As discussed in Chiquita’s previous submittals for past surveys, this area is along the western portion of the Landfill, where the reaction is closer to the surface relative to the rest of the reaction area, meaning elevated temperatures are closer to the surface and therefore more readily detected by the radiometric thermal camera. In late April to early May 2024, Chiquita installed a horizontal collector for the GCCS system in this area and the nearby Area D in order to collect additional hot gas for conveyance to the flares and thereby further mitigate elevated temperatures in this area. For all three of these reference points (07, 09, and 17), the thermal inspection images show concentrations of light blue and red shading running along these horizontal collection pipes, which are functioning as designed, carrying the hot liquids and gas through the GCCS system.

SQ1	Max	112.5 °F
	Min	13.8 °F
	Average	63.1 °F
Sp1		106.2 °F
Sp2		83.7 °F
Sp3		45.9 °F
Sp4		73.0 °F
Sp5		43.9 °F
Sp6		23.9 °F

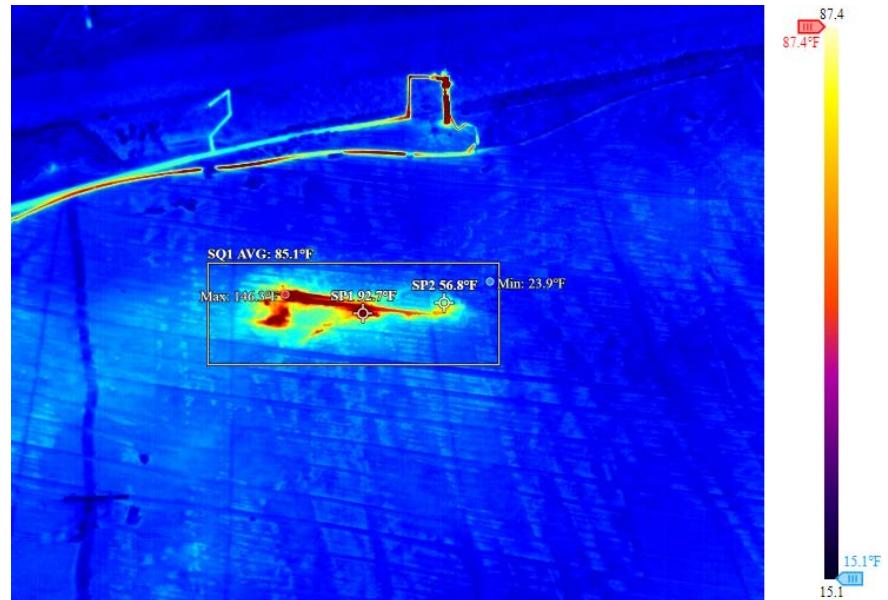
Reference # 08

The area designated by the LEA as “Area D” appears to be in grid 181. The Sniffer data reference points within Area D for the April 2, 2025 survey are 08 and 18. The horizontal collector for the GCCS discussed above in Area C also runs through Area D. As discussed in Chiquita’s previous submittals for past surveys, Chiquita installed the horizontal collector for the GCCS system in this area and the nearby Area C in order to collect additional hot gas for conveyance to the flares and thereby further address elevated temperatures in this area.

While there are elevated temperatures being seen in this area, they are concentrated and limited to small areas or only where the lateral line and vertical gas

well are located. As previously discussed, the lateral line and vertical gas well are part of the overall GCCS system which is designed to convey the hot liquid and gas. A high temperature of 109 in the area not associated with the well or lateral line may indicate slightly elevated temperatures beneath the geomembrane cap from heat being emitted to the surface.

SQ1	Max	146.3 °F
	Min	23.9 °F
	Average	85.1 °F
Sp1		92.7 °F
Sp2		56.8 °F

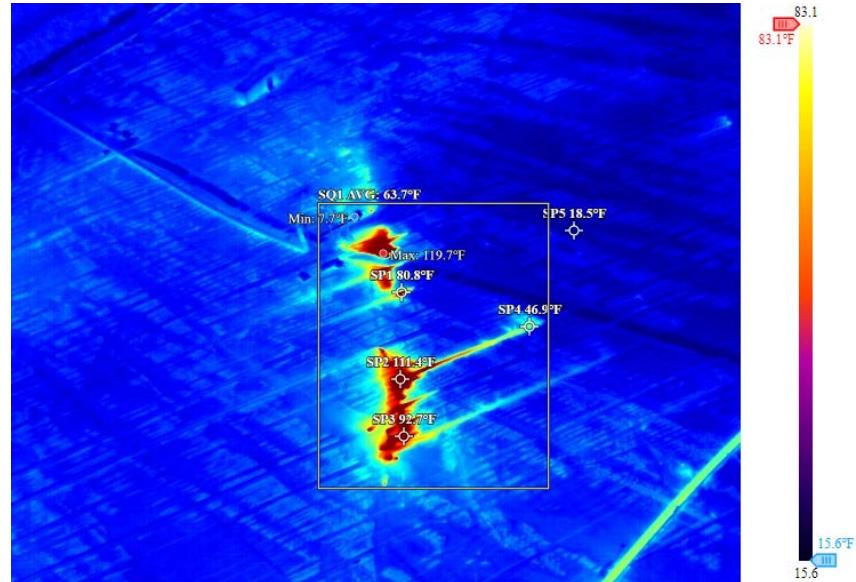
Reference # 09

SQ1	Max	119.7 °F
	Min	7.7 °F
	Average	63.7 °F
Sp1		80.8 °F
Sp2		111.4 °F
Sp3		92.7 °F
Sp4		46.9 °F
Sp5		18.5 °F

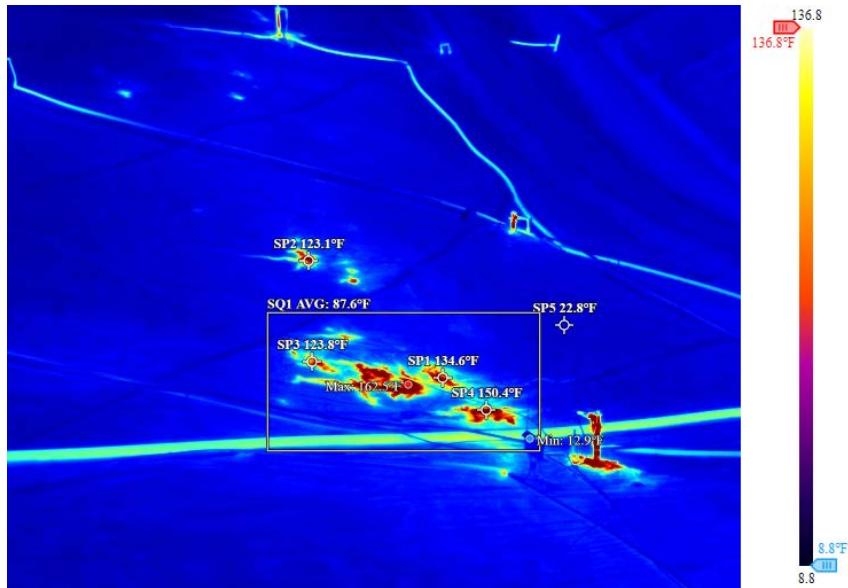
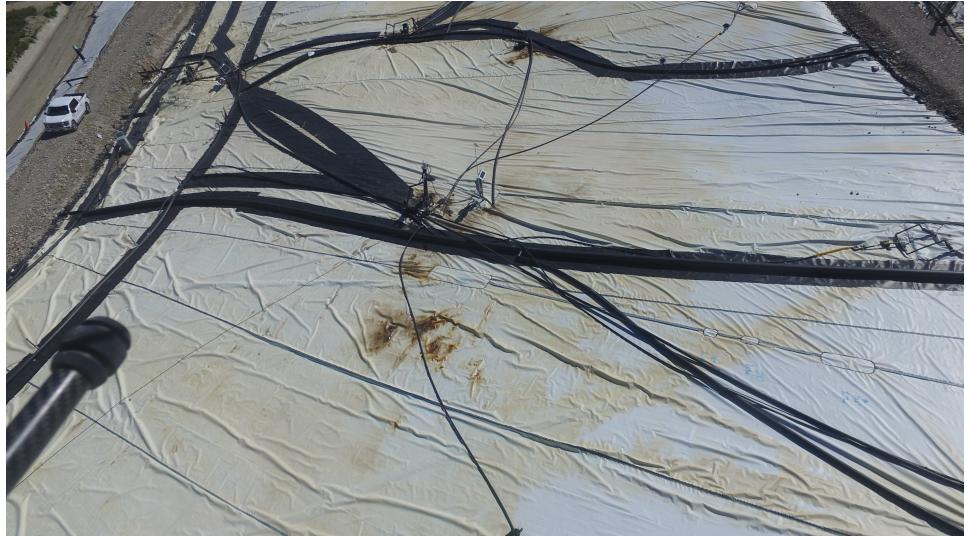
Reference # 10

SQ1	Max	162.5 °F
	Min	12.9 °F
	Average	87.6 °F
Sp1		134.6 °F
Sp2		123.1 °F
Sp3		123.8 °F
Sp4		150.4 °F
Sp5		22.8 °F

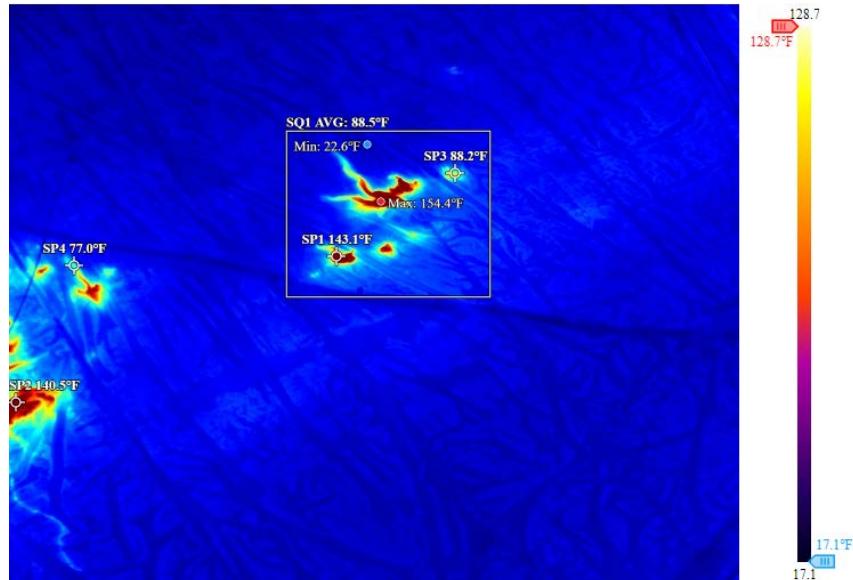
Reference # 11

SQ1	Max	154.4 °F
	Min	22.6 °F
	Average	88.5 °F
Sp1		148.6 °F
Sp2		140.5 °F
Sp3		88.2 °F
Sp4		77.0 °F

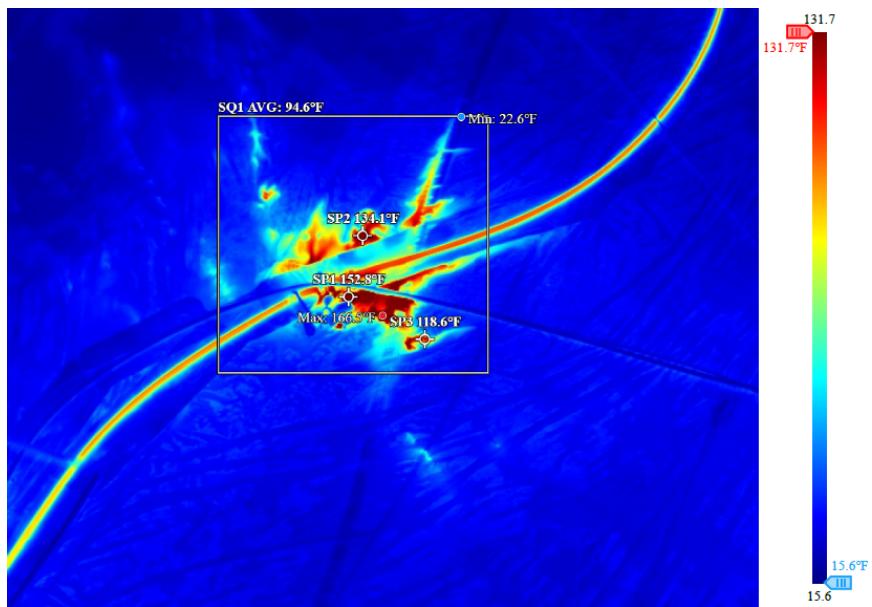
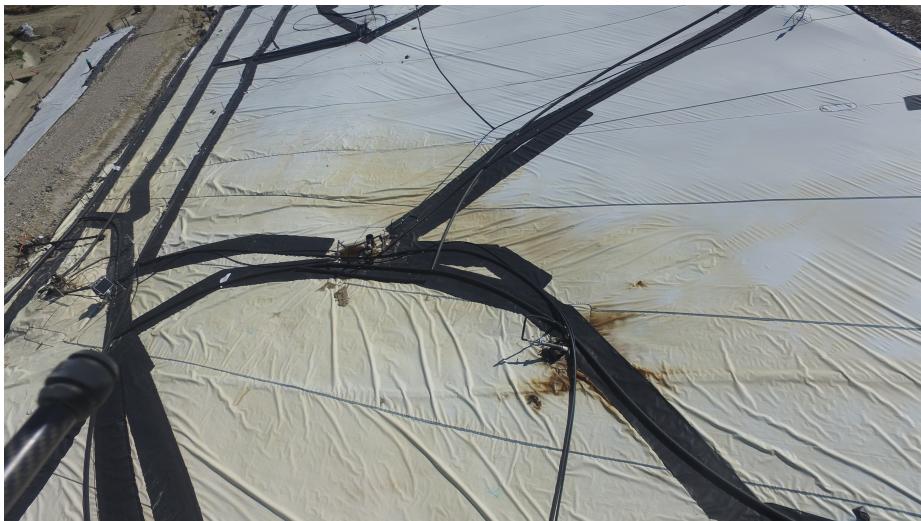
Reference # 12

SQ1	Max	166.5 °F
	Min	22.6 °F
	Average	94.6 °F
Sp1		152.8 °F
Sp2		134.1 °F
Sp3		118.6 °F

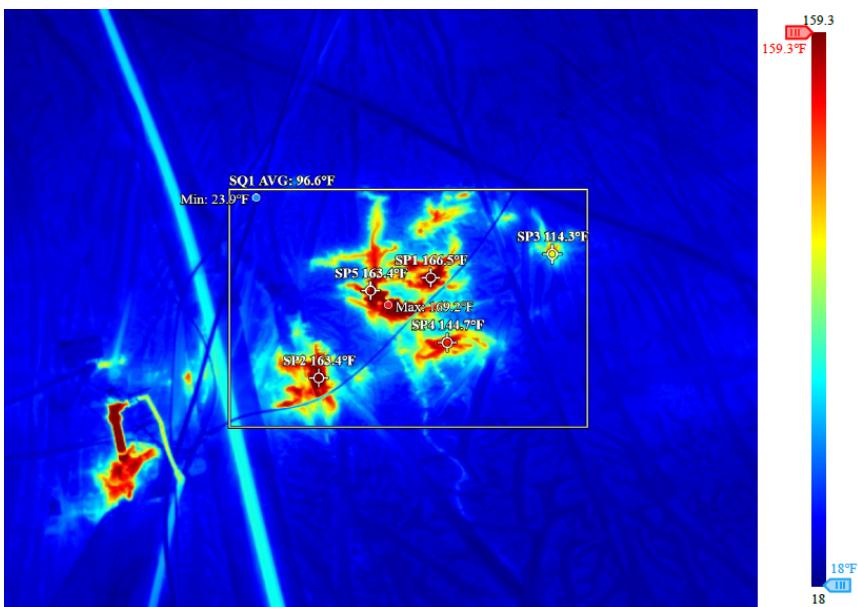
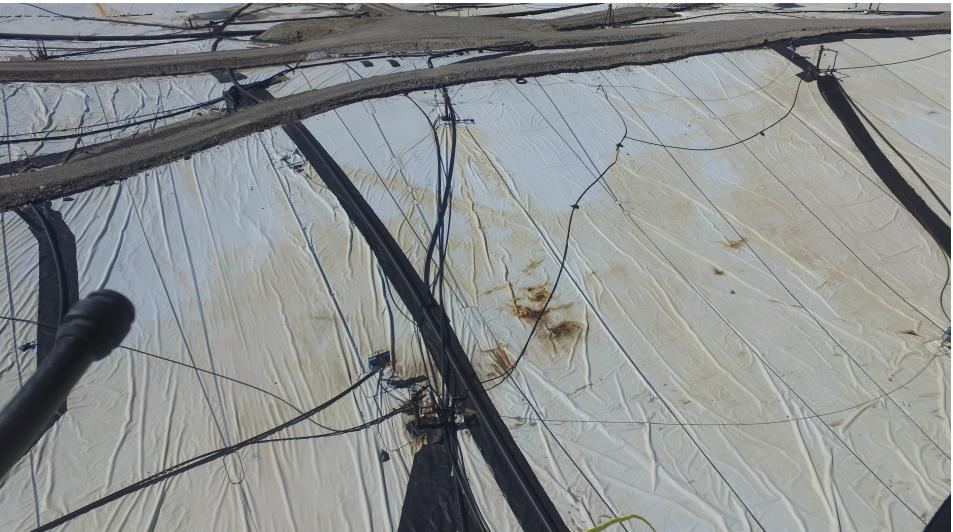
Reference # 13

SQ1	Max	169.2 °F
	Min	23.9°F
	Average	96.6 °F
Sp1		166.5 °F
Sp2		163.4 °F
Sp3		114.3 °F
Sp4		144.7 °F
Sp5		163.4 °F

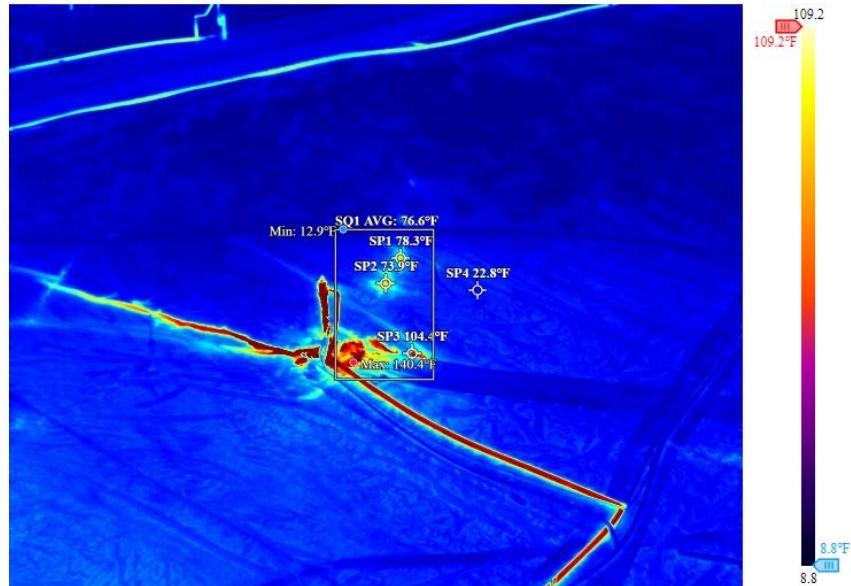
Reference # 14

SQ1	Max	140.4 °F
	Min	12.9°F
	Average	76.6 °F
Sp1		78.3 °F
Sp2		73.9 °F
Sp3		104.4 °F
Sp4		22.8 °F

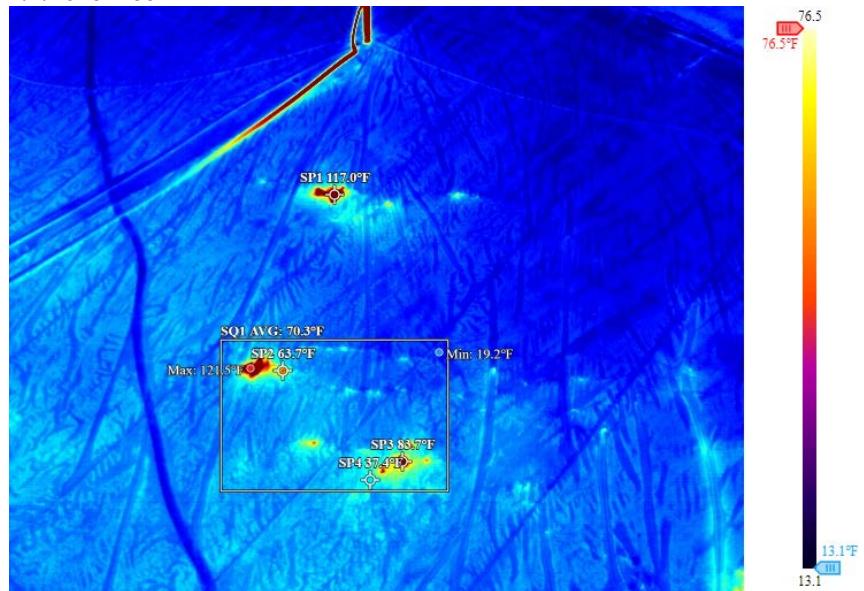
Reference # 15

SQ1	Max	121.5 °F
	Min	19.2°F
	Average	70.3 °F
Sp1	117.0 °F	
Sp2	63.7 °F	
Sp3	83.7 °F	
Sp4	37.4 °F

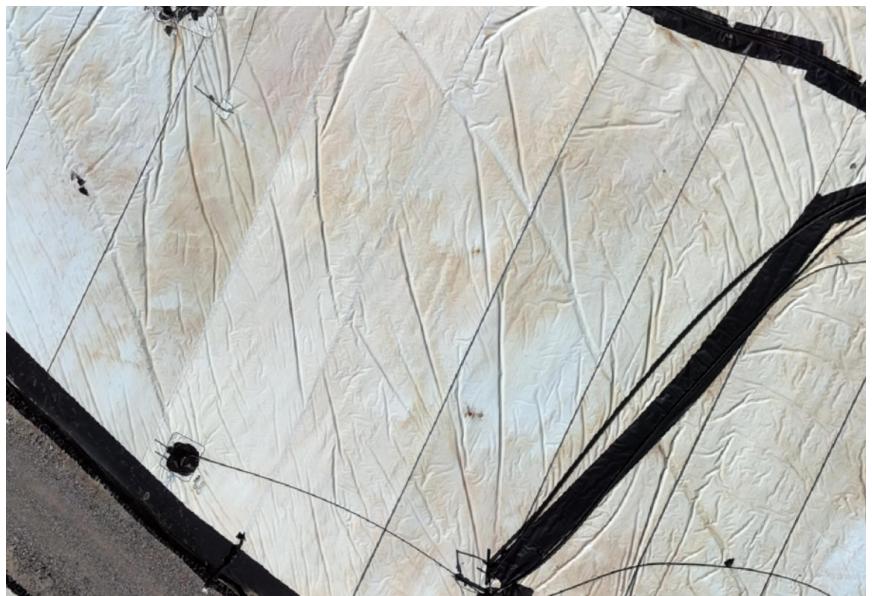
Reference # 16

The area designated by the LEA as “Area E” appears to be in grid 177. The Sniffer data reference point within Area E for the April 2, 2025 survey is point 16. An abandoned gas well, well CV-2302, exists within Area E and is photographed on PDF page 19 of Attachment A under “Reference # 16.” Additional gas wells and dewatering pumps were installed in the area to replace CV-2302. However, as discussed in previous survey analyses, the abandoned borehole for CV-2302 may be continuing to emit heat to the surface, which may explain the elevated temperatures detected in the area. The other gas wells and pumps installed in the area continue to remove hot gas and liquids from the Landfill.

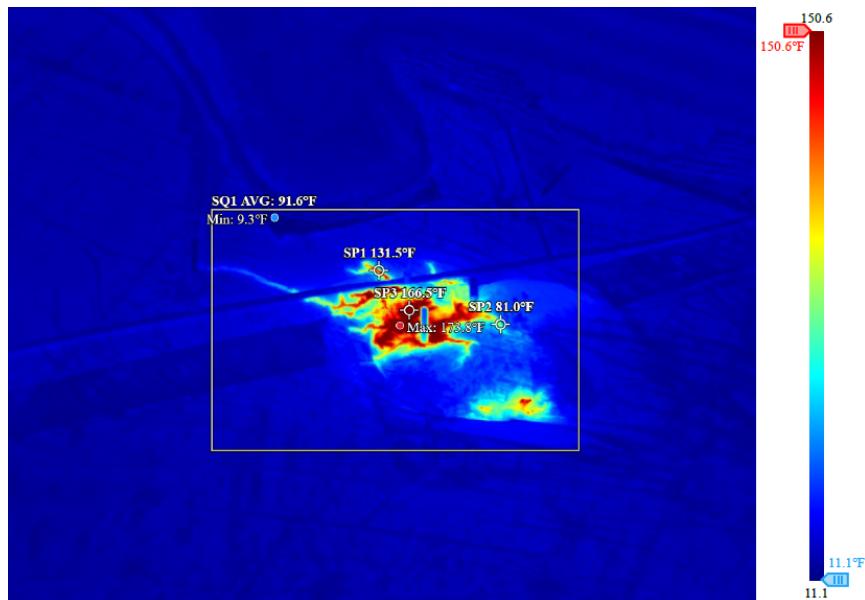
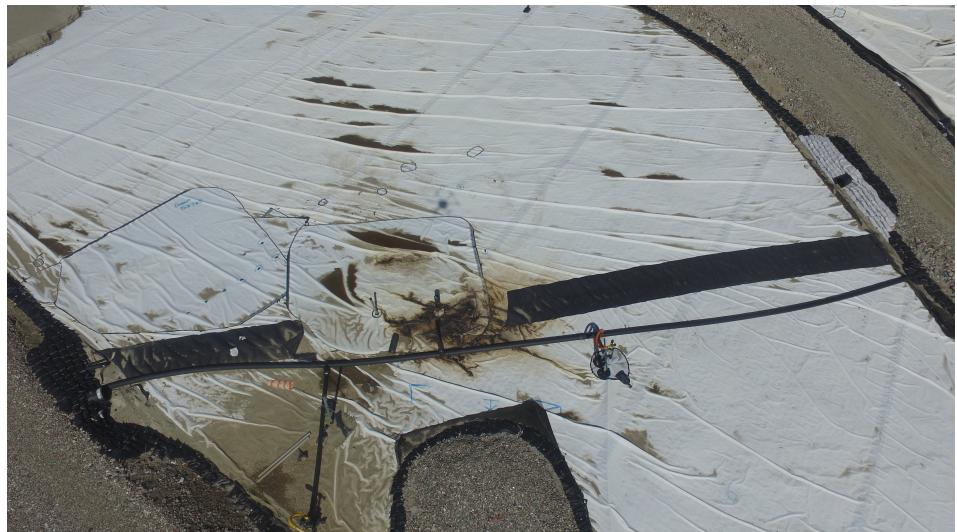
Nevertheless, the maximum temperature detected in the thermal images for this area (see reference point 16 in the April survey) is below 180 degrees.³

SQ1	Max	173.8 °F
	Min	9.3 °F
	Average	91.6 °F
Sp1		131.5 °F
Sp2		81.0 °F
Sp3		166.5 °F

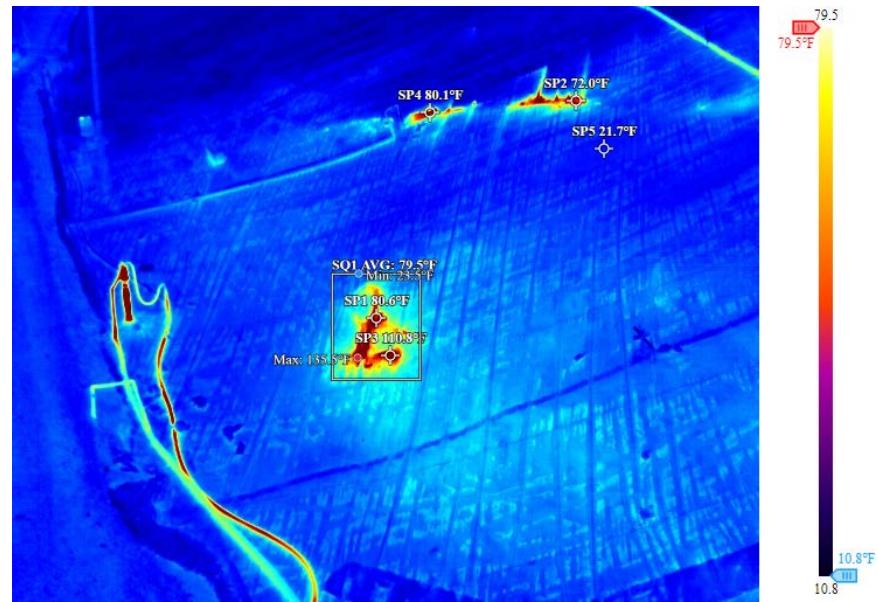
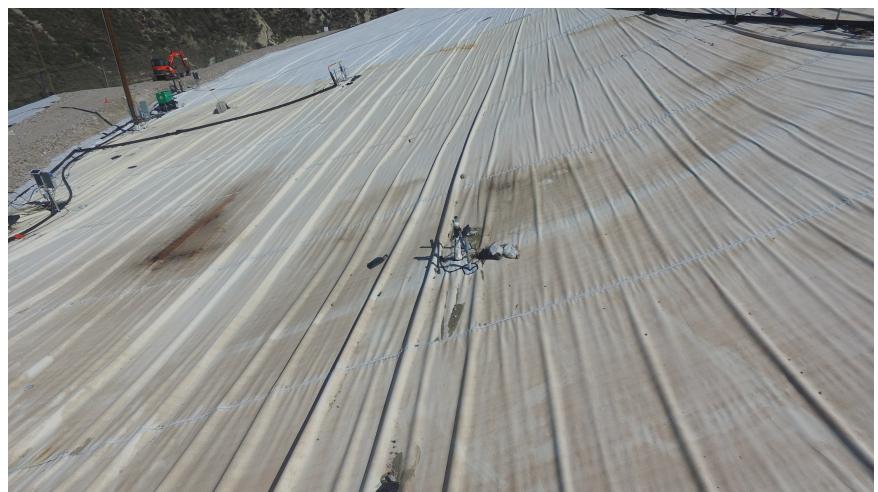
Reference # 17

A comparison of the February 2025 and April 2025 thermal images in Area C indicates a decrease of about eleven (11) degrees in average temperature in that area (compare reference point 06 in the February thermal images report to reference point 17 in the April survey).

SQ1	Max	135.5 °F
	Min	23.5 °F
	Average	79.5 °F
Sp1		80.6 °F
Sp2		72.0 °F
Sp3		110.8 °F
Sp4		80.1 °F
Sp5		21.7 °F

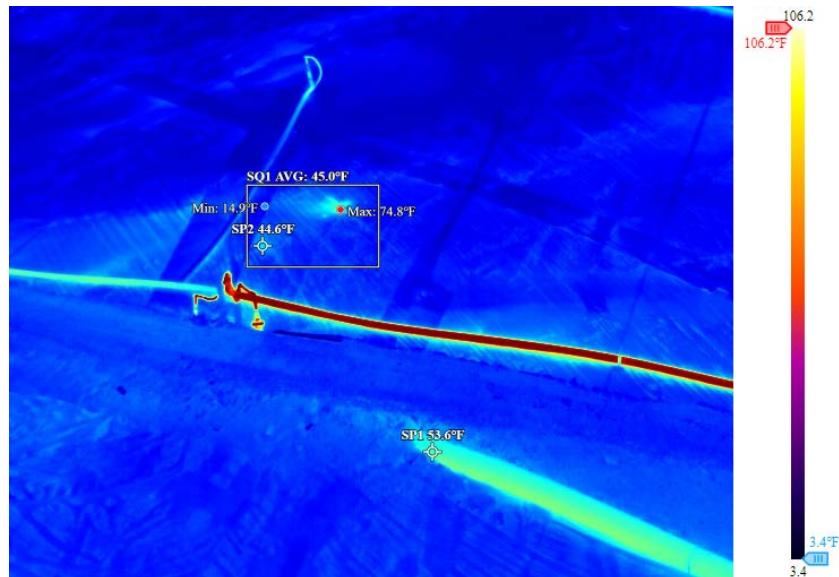
Reference # 18

SQ1	Max	74.8 °F
	Min	14.9 °F
	Average	45.0 °F
Sp1		53.6 °F
Sp2		44.6 °F

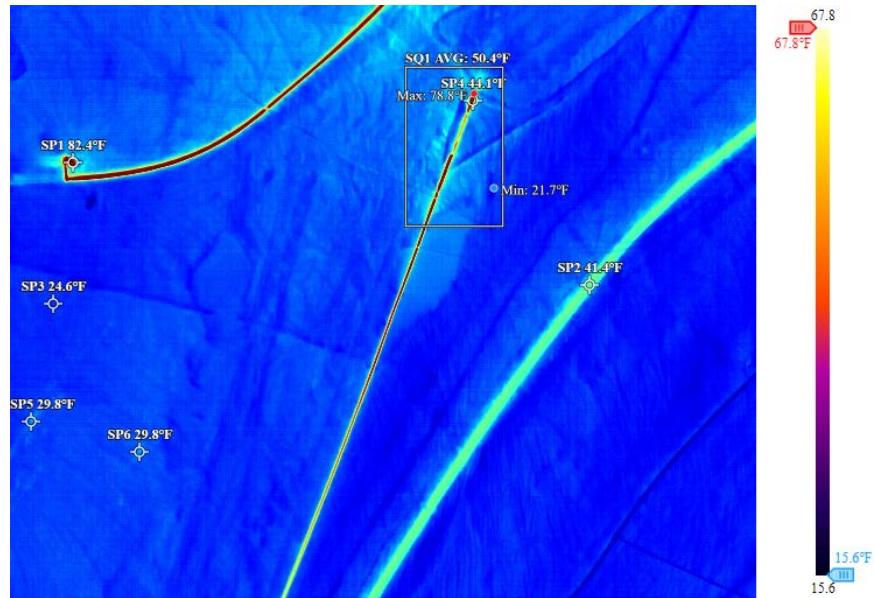
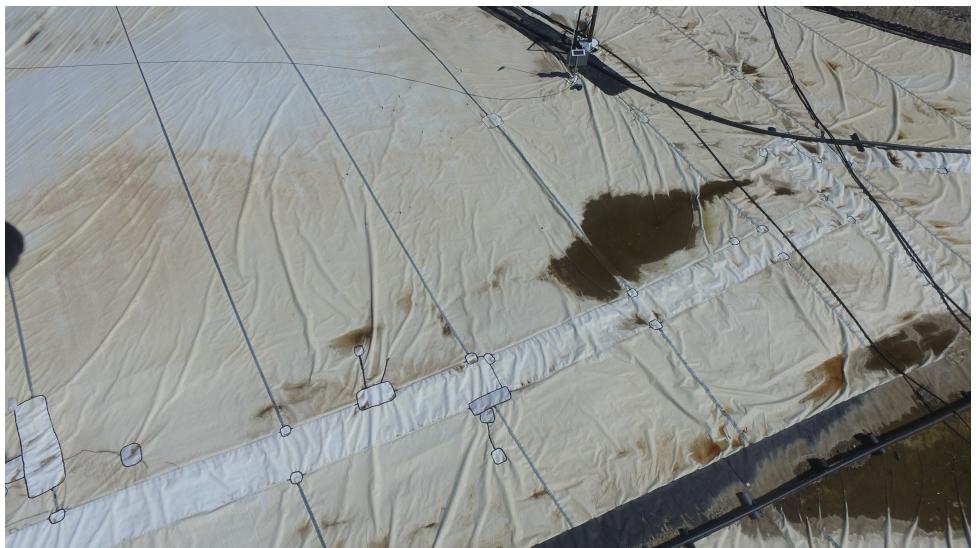
Reference # 19

The area designated by the LEA as "Area B" appears to be in grid 185. The Sniffer data reference point in Area B for the April 2, 2025 survey is point 19. Please note that during the April 2, 2025 survey, Sniffer's thermal camera did not detect any elevated temperatures in Area B, one of the areas of interest previously identified in the LEA's and CalRecycle's letters. Nevertheless, Sniffer included point 19 and thermal images, photographs, and GPS coordinates in accordance with the LEA's directive to track trends in Area B over time. As with the nearby Area A, GCCS infrastructure is highly concentrated in this area. As discussed in Chiquita's previous submittals for past surveys, because the GCCS system is designed to convey the landfill gas from the north slope to the flares, we would expect to see elevated temperatures here, particularly given the higher concentration of GCCS infrastructure. As discussed in Chiquita's previous submittal, this area was also subject to elevated temperatures

A comparison of the February 2025 and April 2025 thermal images in Area B indicates an overall decrease in temperature in that area, with the maximum temperature detected decreasing about nine (9) degrees (compare reference point 08 in the February thermal images report to reference point 19 in the April thermal images report).

SQ1	Max	78.8 °F
	Min	21.7 °F
	Average	50.4 °F
Sp1		82.4 °F
Sp2		41.4 °F
Sp3		24.6 °F
Sp4		44.1 °F
Sp5		29.8 °F
Sp6		29.8 °F

where the integrity of the dirt cover was previously compromised. Chiquita repaired the dirt cover, reinstalled the geomembrane cover, and performed related work during the fourth quarter of 2024 to address this issue.
