**Re: Chiquita Canyon, LLC Analysis of June 10, 2025 FLIR Survey in
Response to the December 24, 2024 LEA Letter Regarding
Milestone 2B Compliance, Chiquita Canyon Landfill**

Waste Connections Chiquita Canyon
Project: 2025 06 Emission Study
Job: Emission Study
Report Submitted June 17, 2025

Emission Study Thermal Report

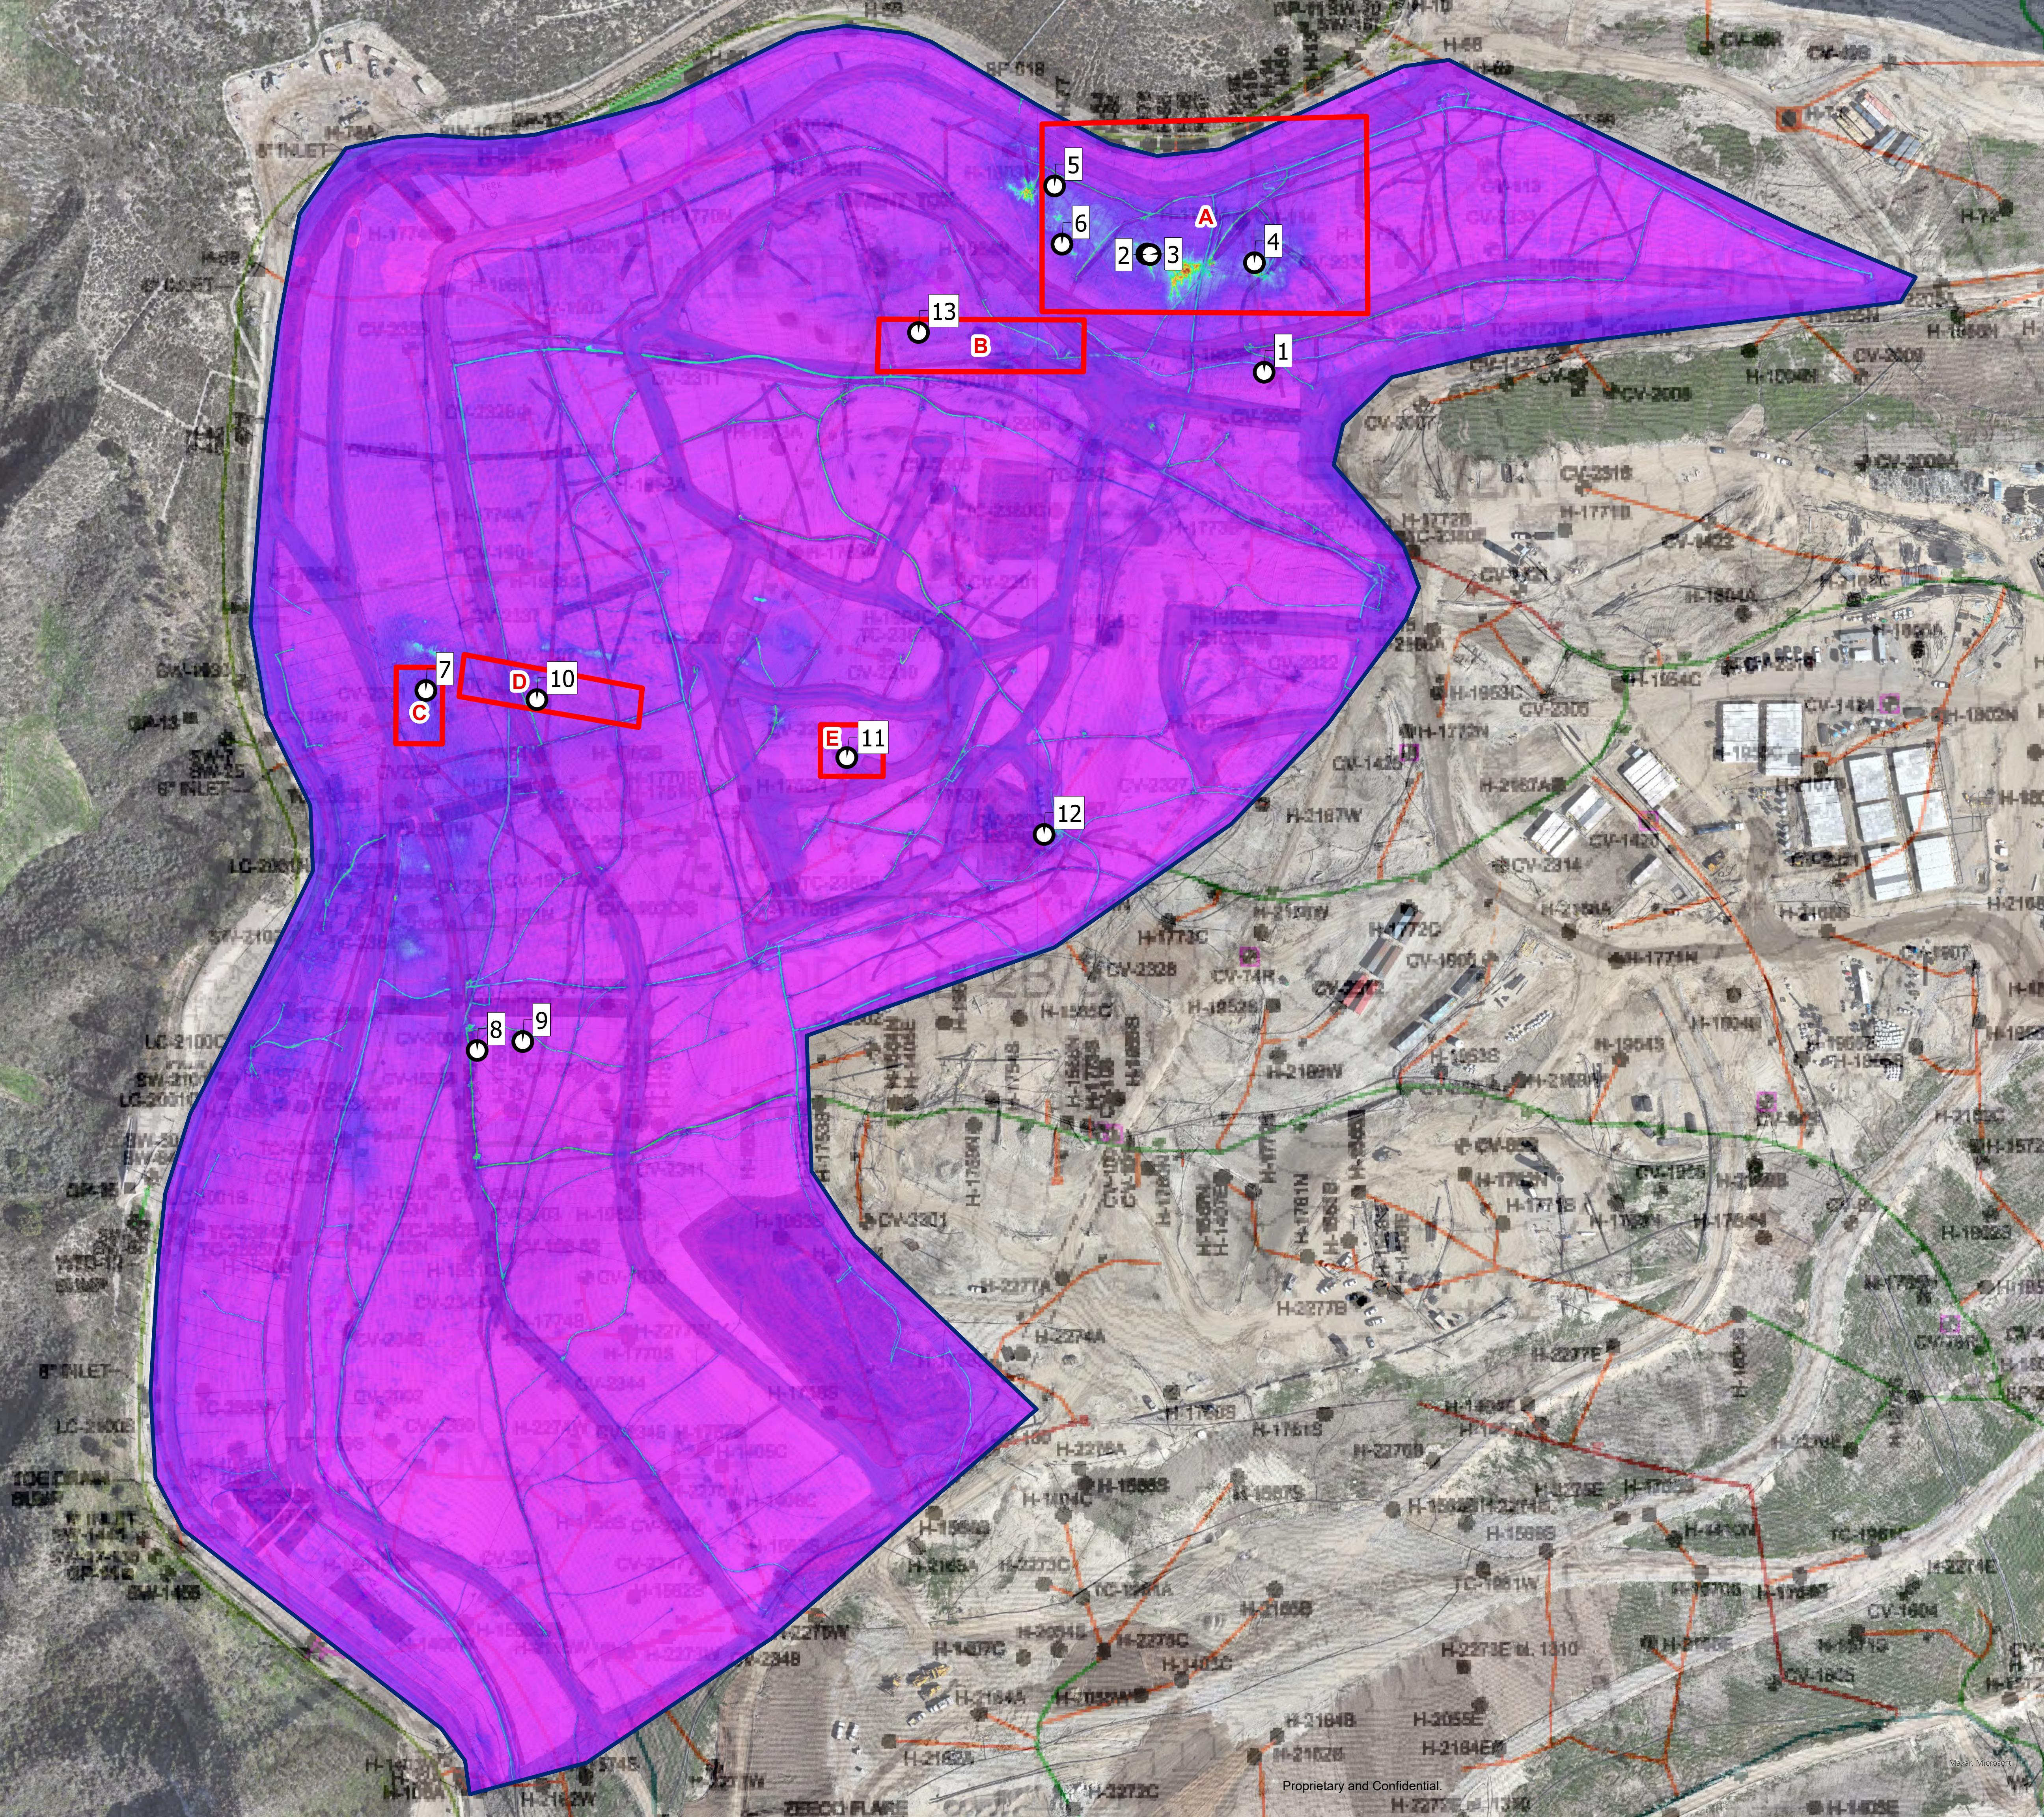
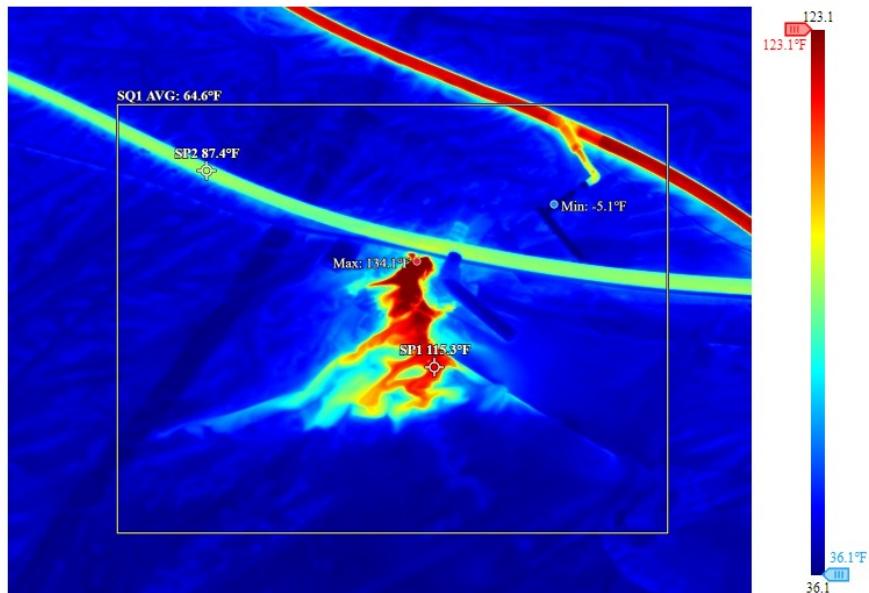
Reference # 01

SQ1	Max	134.1 °F
	Min	-5.1°F
	Average	64.6 °F
Sp1		115.3 °F
Sp2		87.4°F

The area designated by the LEA as "Area A" appears to be in grid 150. The Sniffer data reference points in Area A for the June 10, 2025 survey are points 01–06.¹ As discussed in Chiquita's previous submittals for past surveys, there is active gas collection occurring in this area. Chiquita's Gas Collection and Control System ("GCCS") conveys warm gas to the Landfill's flares, as designed. There is a high concentration of GCCS piping in this area relative to the rest of the Landfill, including multiple vertical paths (landfill gas wellheads), horizontal paths (landfill gas header lines), and conveyance lines that remove hot gases and liquids from the north slope of the Landfill. It is expected that the GCCS system will have higher temperatures in this area, particularly given the higher concentration of GCCS infrastructure. The June 2025 survey shows that the area is improving—there are only six (6) reference points within the Area A boundary in this survey as compared to ten (10) in the April 2025 survey, showing that at the time of the survey, the Landfill's GCCS infrastructure was concentrating hot gas and liquids through the piping as needed.

¹ Reference point 01 is adjacent to the LEA's designated Area A. A gas extraction well is located here which, as described above, would be expected to exhibit higher temperatures.

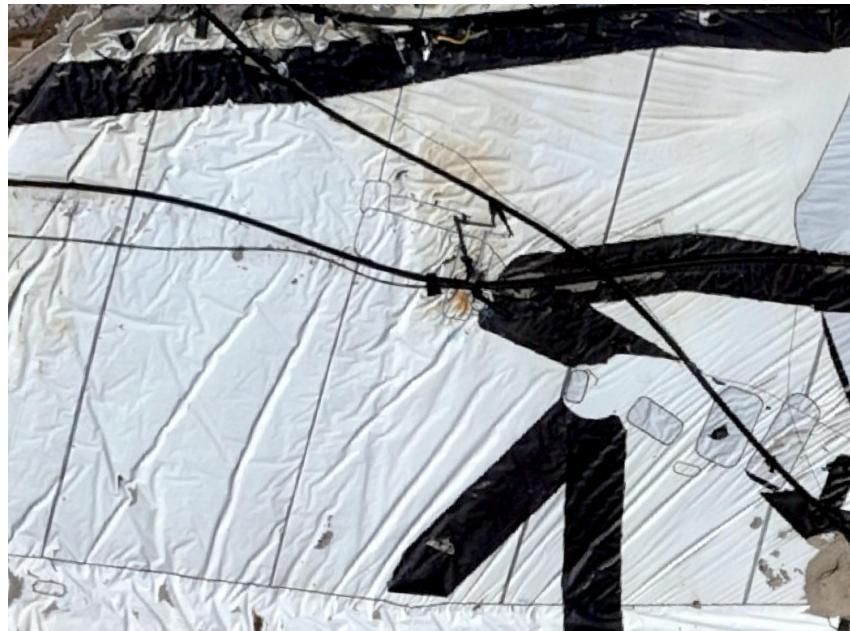
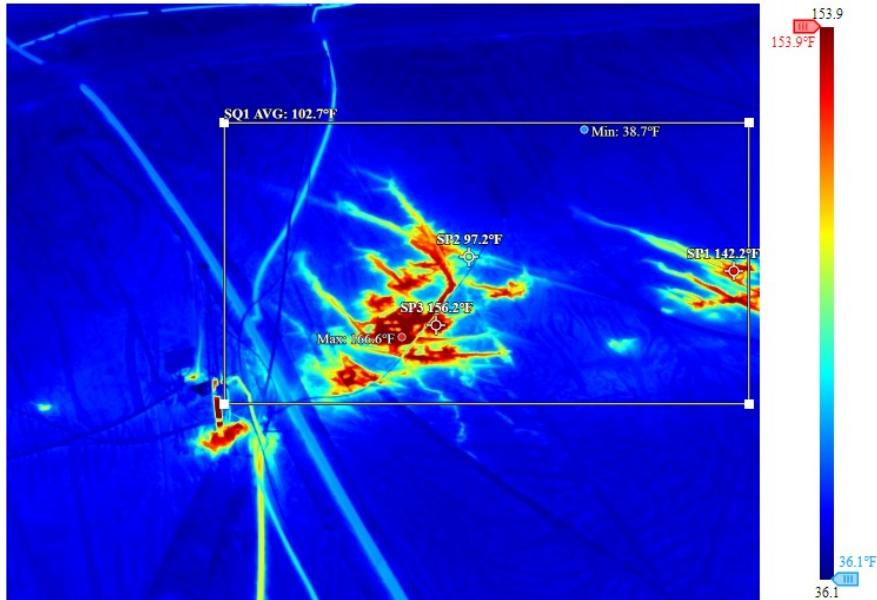
Reference # 02

SQ1	Max	166.6 °F
	Min	38.7 °F
	Average	102.7 °F
Sp1		142.2°F
Sp2		97.2 °F
Sp3		156.2 °F

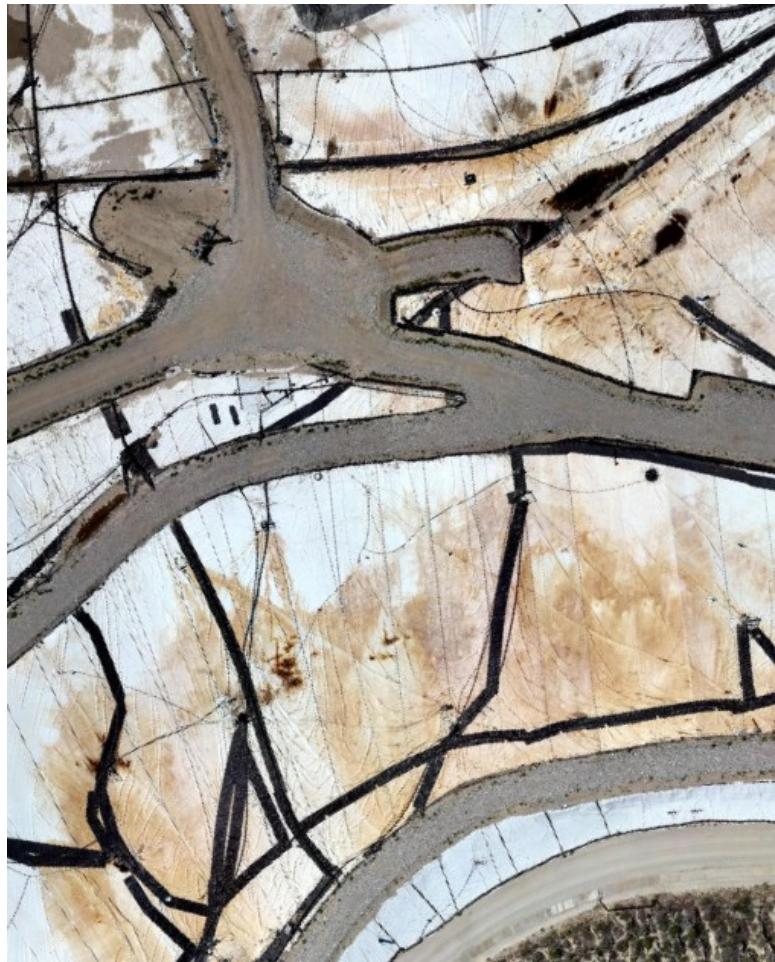
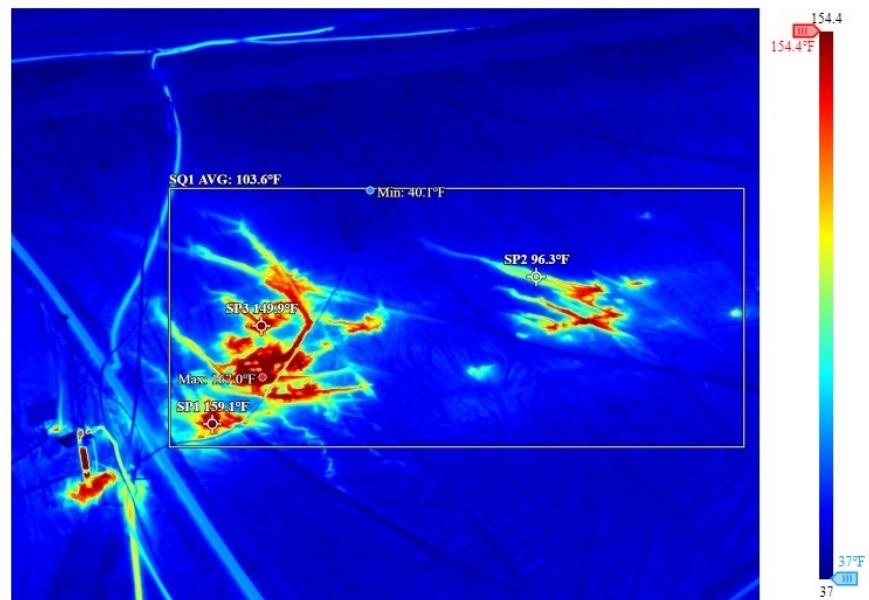
Reference # 03

SQ1	Max	167.0 °F
Sp1		159.1°F
Sp2		96.3 °F
Sp3		149.9 °F

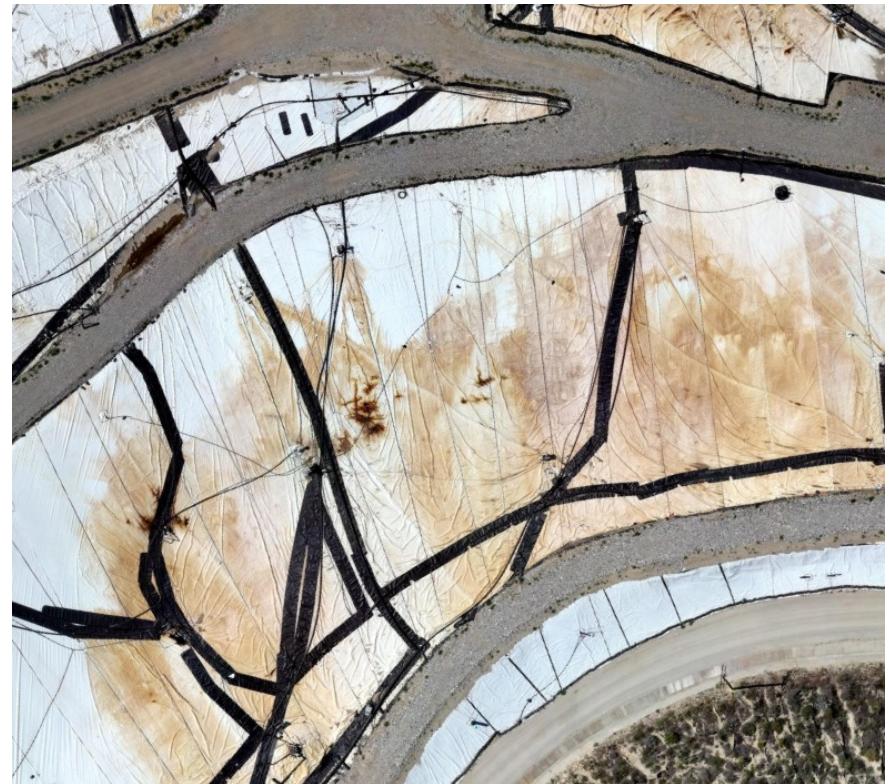
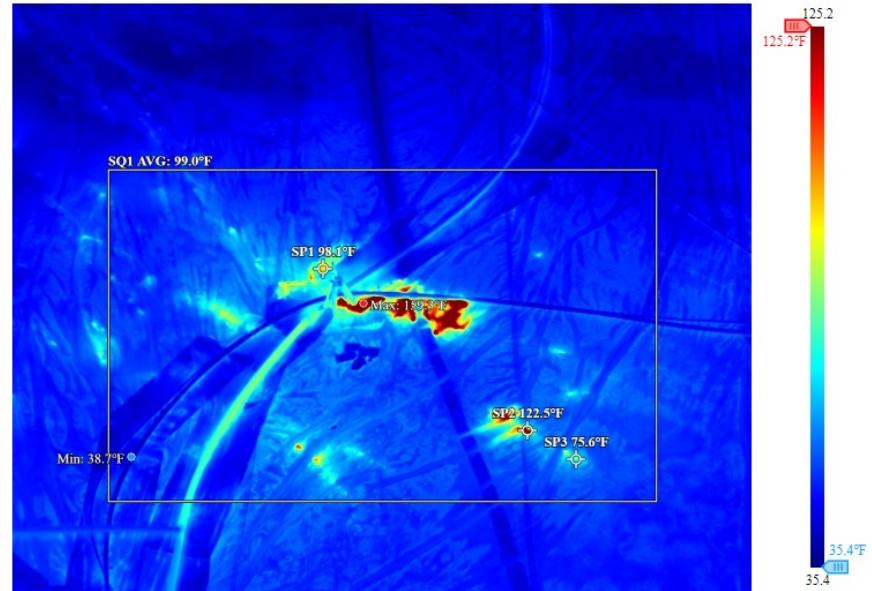
Reference # 04

SQ1	Max	159.3 °F
Sp1		98.1 °F
Sp2		122.5 °F
Sp3		75.6 °F

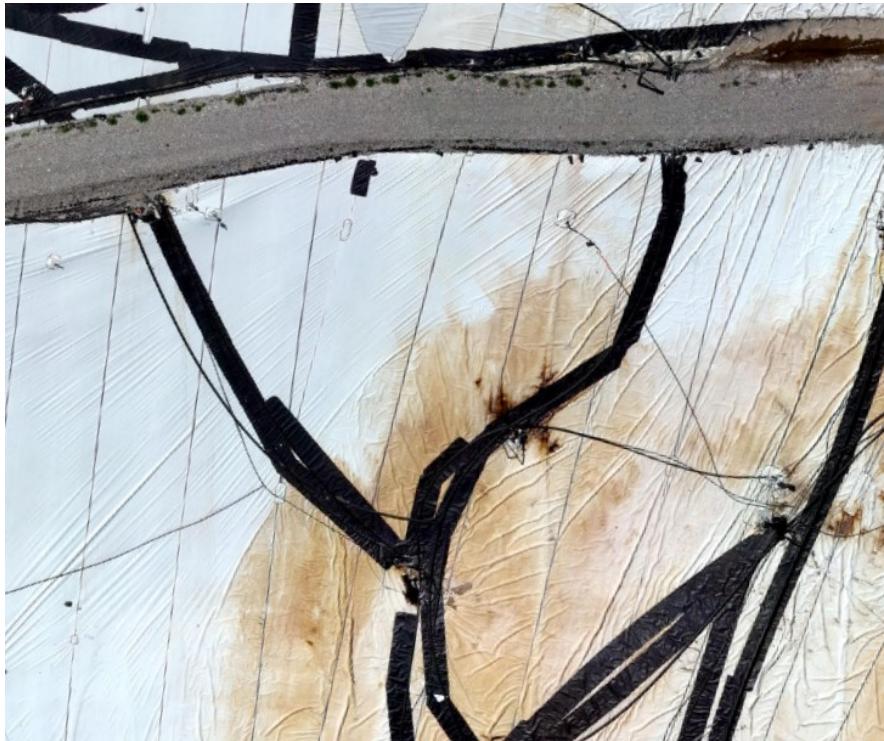
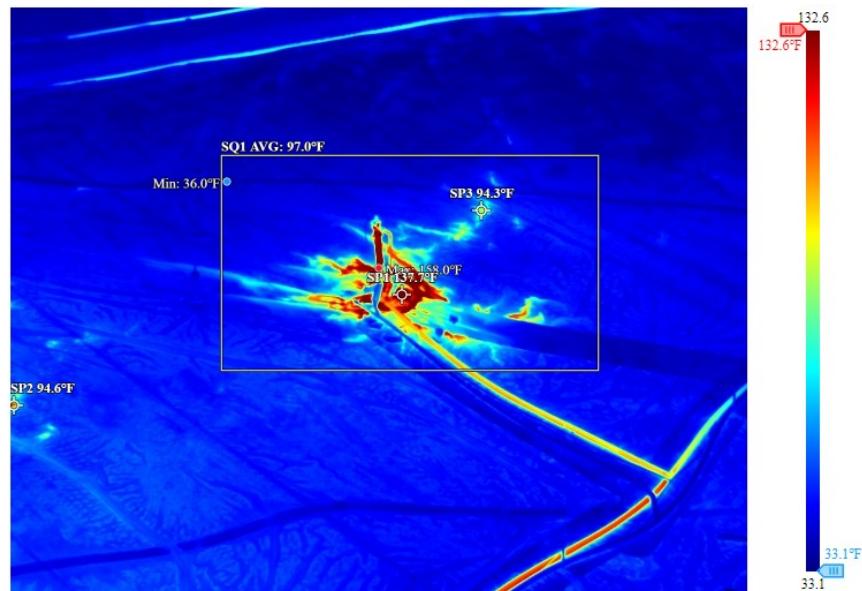
Reference # 05

SQ1	Max	158.0 °F
	Min	36.0 °F
	Average	97.0 °F
Sp1		137.7 °F
Sp2		94.6 °F
Sp3		94.3 °F

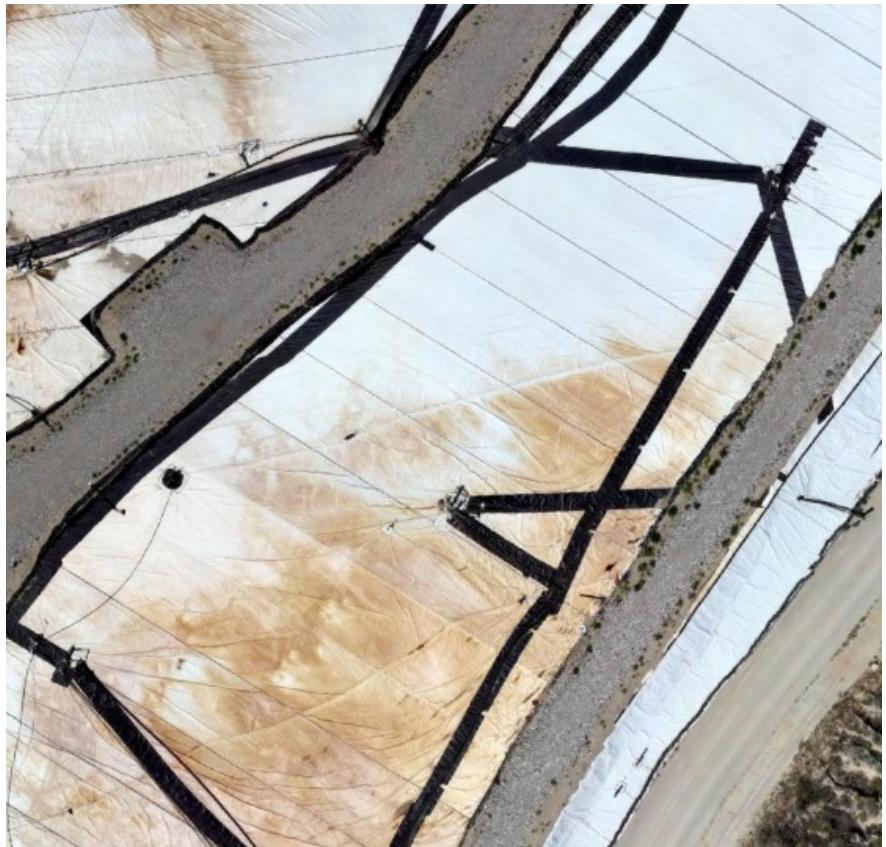
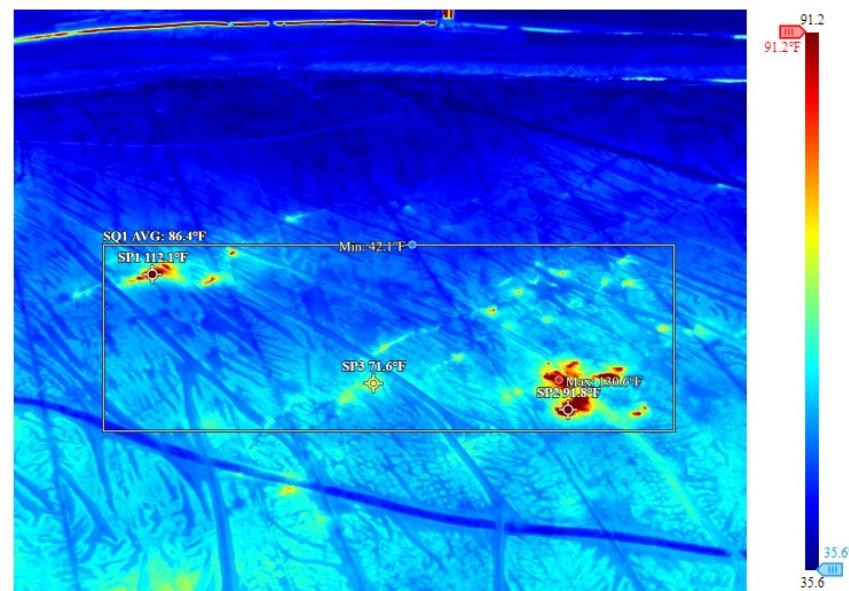
Reference # 06

SQ1	Max	130.6 °F
Sp1	Max	112.1 °F
Sp2	Max	91.8 °F
Sp3	Max	71.6 °F

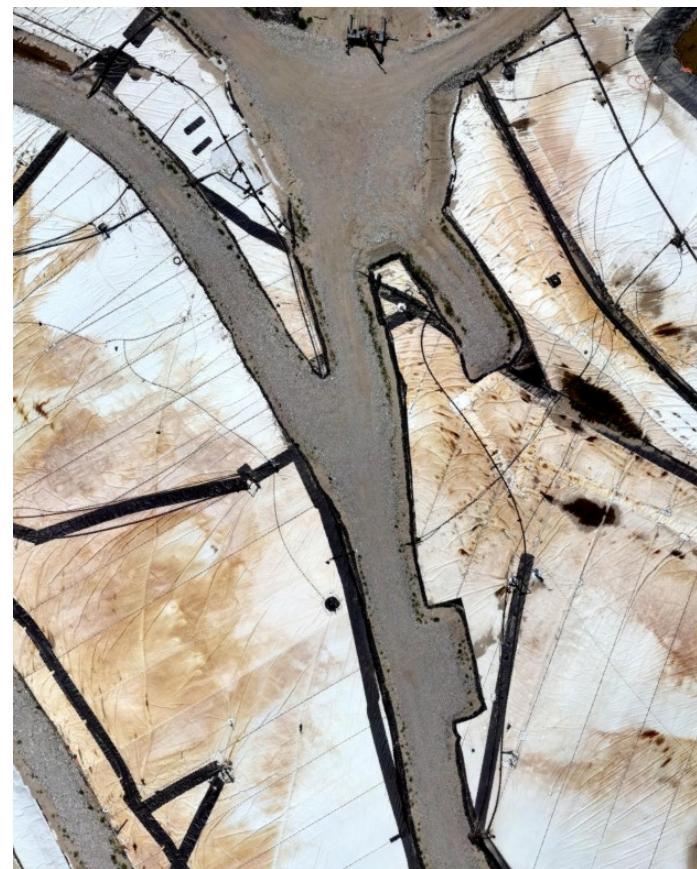
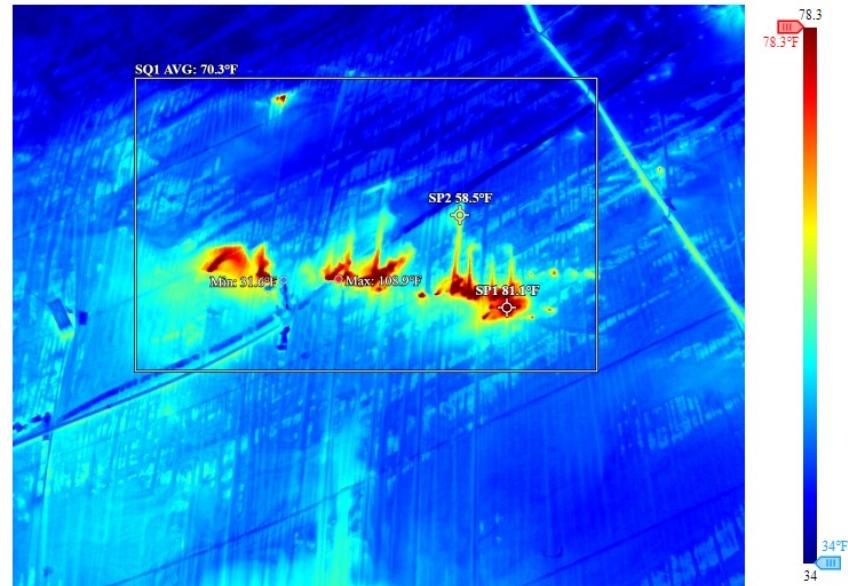
Reference # 07

SQ1	Max	108.9 °F
	Min	31.6 °F
	Average	70.3 °F
Sp1		81.1 °F
Sp2		58.5 °F

The area designated by the LEA as "Area C" appears to be in grid 181. The Sniffer data reference point in Area C for the June 10, 2025 survey is point 07. As discussed in Chiquita's previous submittals for past surveys, this area is along the western portion of the Landfill, where the reaction is closer to the surface relative to the rest of the reaction area, meaning elevated temperatures are closer to the surface and therefore more readily detected by the radiometric thermal camera. In late April to early May 2024, Chiquita installed a horizontal collector for the GCCS system in this area and the nearby Area D in order to collect additional hot gas for conveyance to the flares and thereby further mitigate elevated temperatures in this area.

A comparison of the April 2025 and June 2025 thermal images in Area C indicates a decrease of about nine (9) degrees in average temperature in that area and maximum detected temperature decreasing almost twenty-seven (27) degrees (compare reference point 17 in the April 2025 thermal images report to reference point 07 in the June 2025 thermal images report).

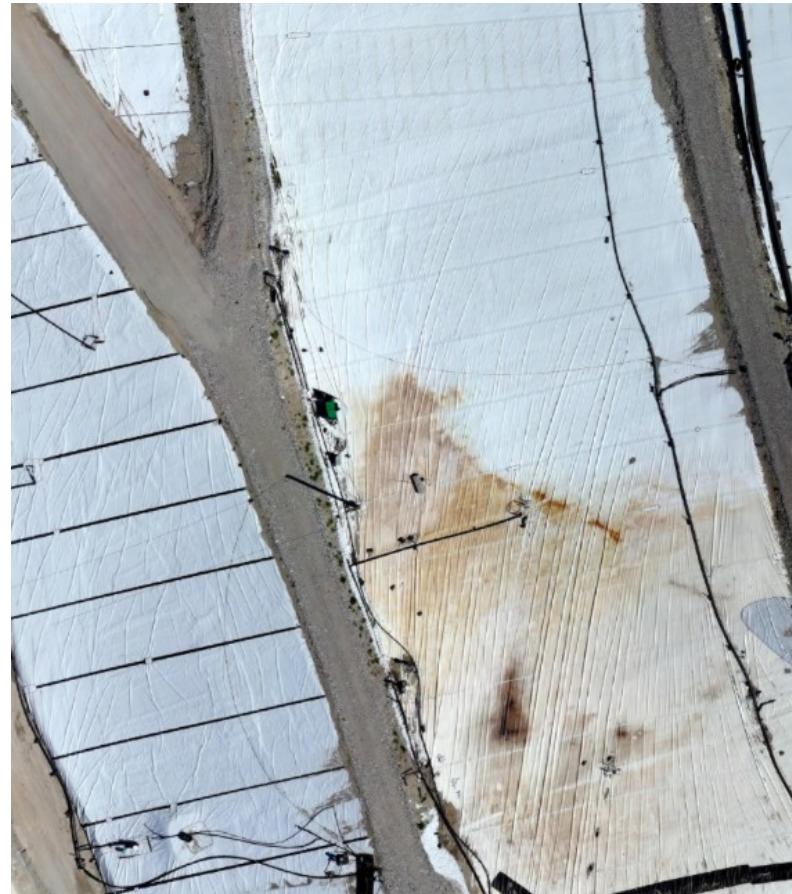
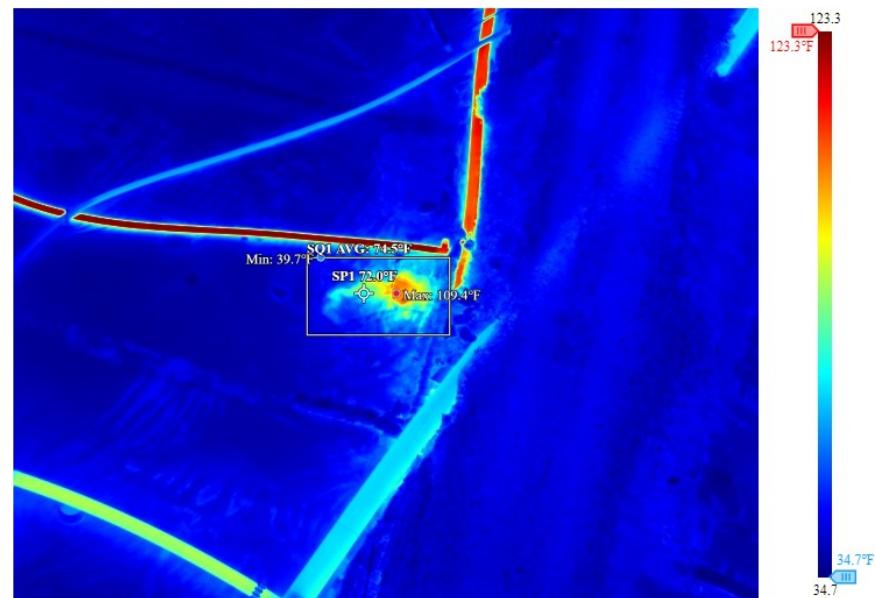
Reference # 08

SQ1	Max	109.4 °F
	Min	39.7 °F
	Average	74.5 °F
Sp1		72.0 °F

On the whole, the June 2025 survey detected fewer heat signatures than the April 2025 survey (eleven total detections in June compared to eighteen total in April). Reference points 08, 09, and 12 were detected outside of Areas A–E. As acknowledged by CalRecycle in its November 25, 2024 letter, FLIR surveys can detect heat sources that may or may not be significant. Similarly, Chiquita believes that these three (3) reference points detected during the June 2025 survey indicate heat sources that are not significant. Reference points 08 and 09 were likely detected because they are in an area densely populated with gas collection wells and pipes. The elevated temperatures detected in reference point 08 are in close proximity or directly over landfill gas piping, which collects and distributes hot landfill gases (see thermal image labeled "Reference # 08" in the June 2025 thermal inspection report). Similarly, reference point 09 depicts a small area directly over a shallow landfill gas collector and vacuum line (see thermal image labeled "Reference # 09" in the June 2025 thermal inspection report). Reference point 12 is in the location of a condensate collection sump, which collects liquids that form in the landfill gas conveyance lines of the

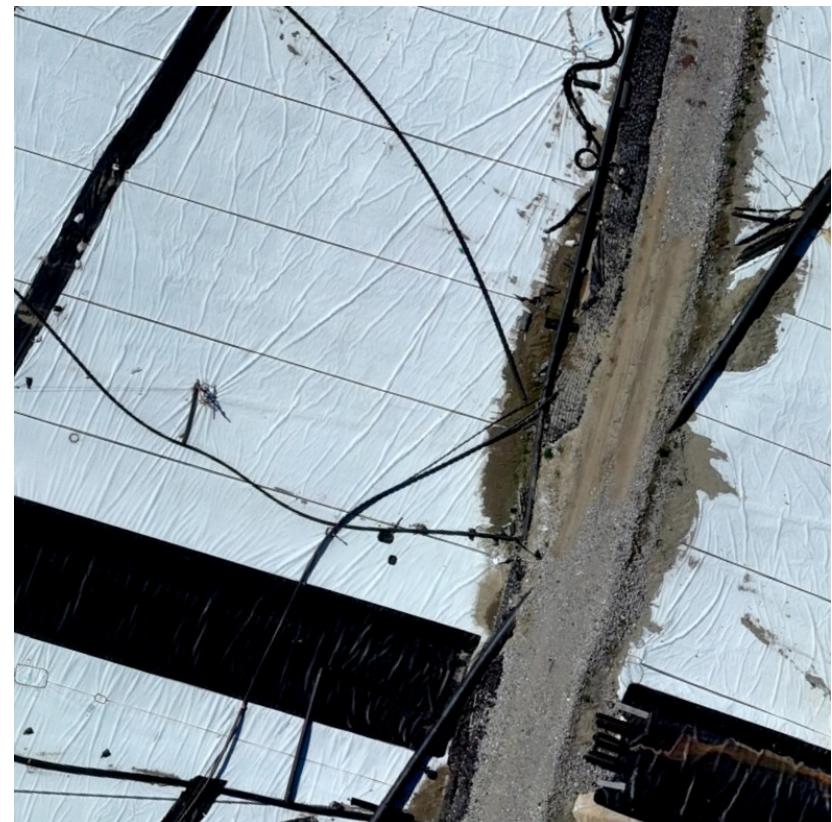
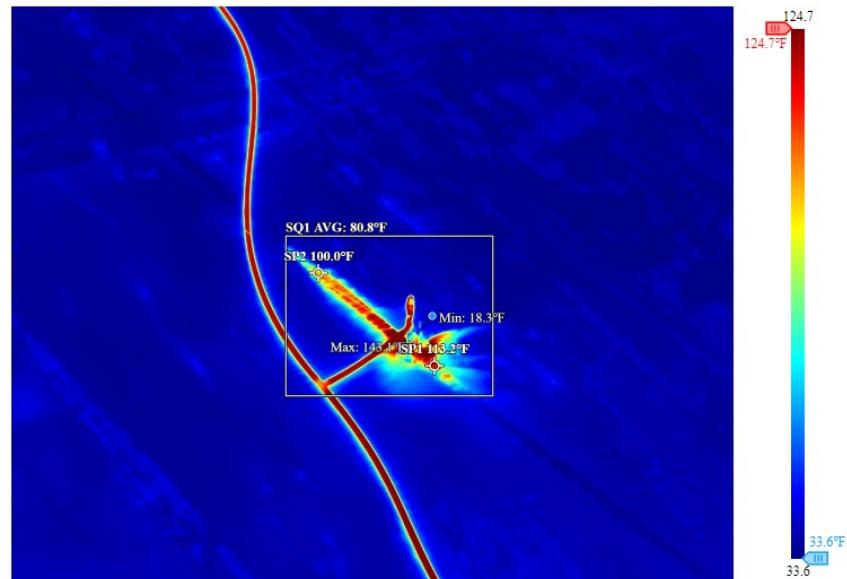
Reference # 09

SQ1	Max	143.1 °F
	Min	18.3 °F
	Average	80.8 °F
Sp1		113.2 °F
Sp2		100.0 °F

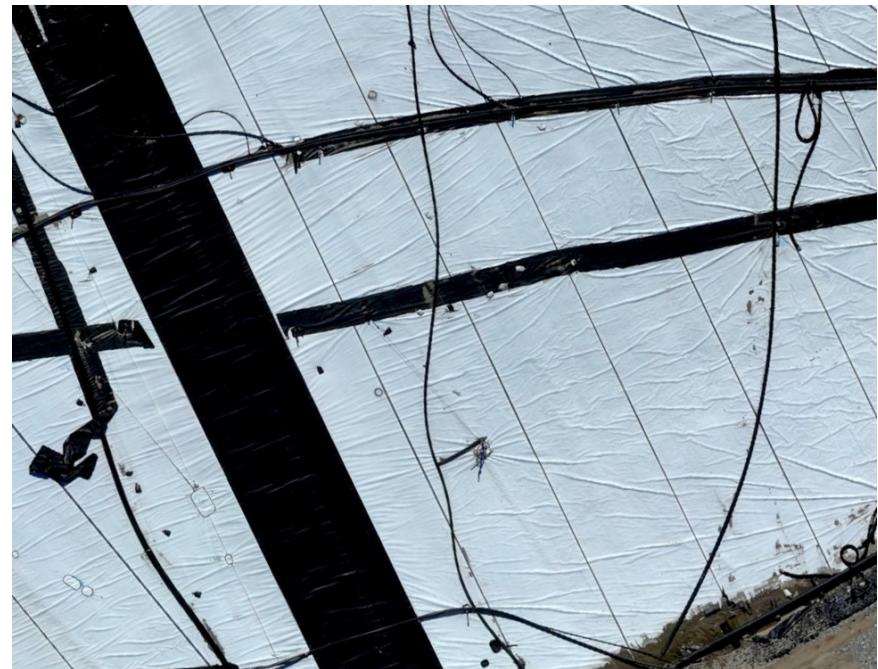
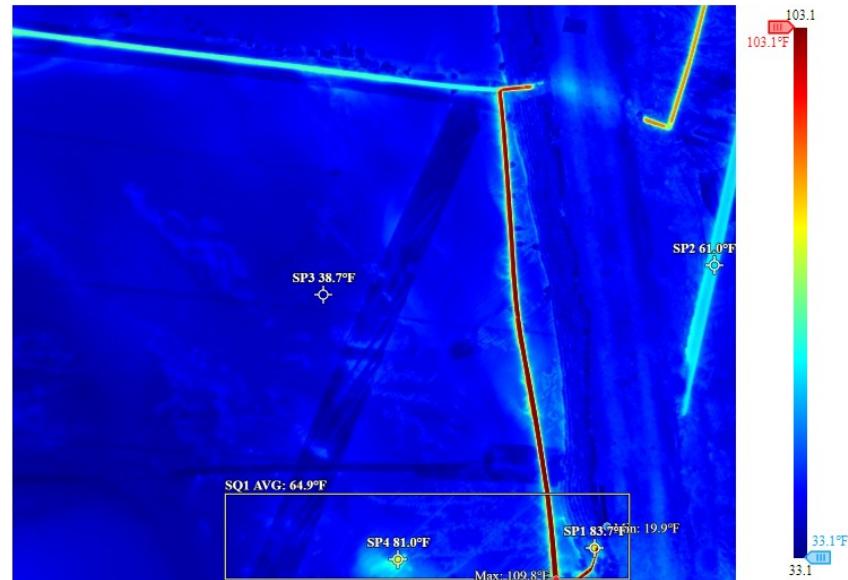
Reference # 10

SQ1	Max	109.8°F
	Min	19.9 °F
	Average	64.9 °F
Sp1		83.7 °F
Sp2		61.0 °F
Sp3		38.7 °F
Sp4		81.0 °F

The area designated by the LEA as "Area D" appears to be in grid 181. The Sniffer data reference point within Area D for the June 10, 2025 survey is 10. Please note that Sniffer's thermal camera did not detect any elevated temperatures in Area D, one of the areas of interest previously identified in the LEA's and CalRecycle's letters. Nevertheless, Sniffer included reference point 10 and thermal images, photographs, and GPS coordinates in accordance with the LEA's directive to track trends in Area D

The FLIR technology captured a smaller overall area in the June 2025 survey as compared to the April 2025 survey. The maximum temperature noted in that area was 109.8°F, and the elevated temperatures were concentrated to only the conveyance line of the GCCS system.

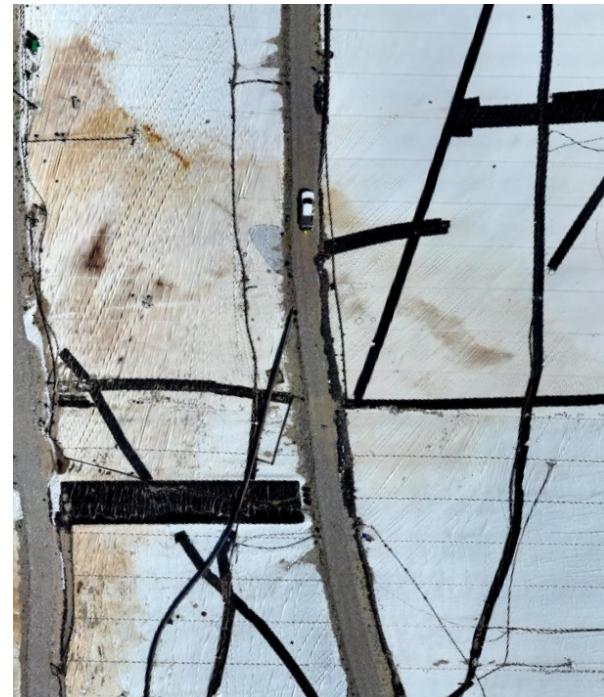
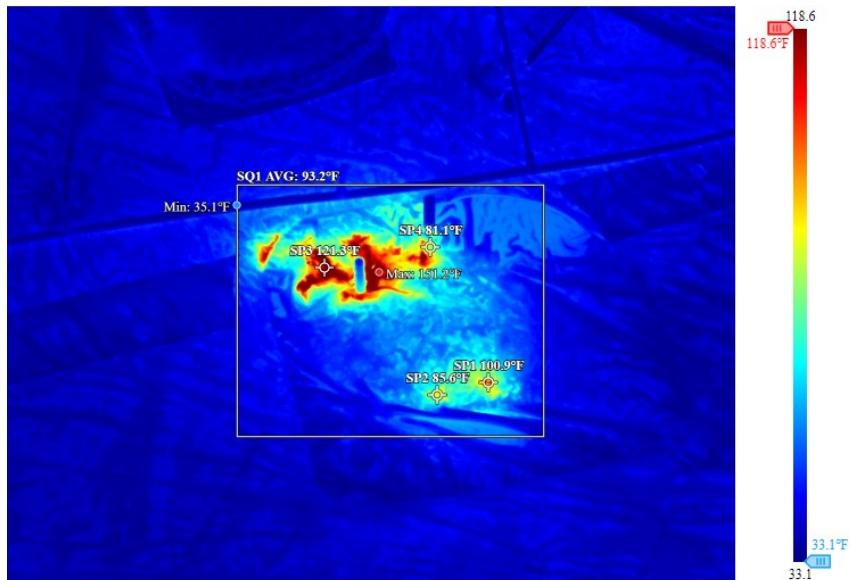
Reference # 11

SQ1	Max	151.2 °F
	Min	35.1 °F
	Average	93.2 °F
Sp1		100.9 °F
Sp2		85.6 °F
Sp3		121.3 °F
Sp4		81.1 °F

The area designated by the LEA as "Area E" appears to be in grid 177. The Sniffer data reference point within Area E for the June 10, 2025 survey is 11. An abandoned gas well, well CV-2302, exists within Area E and is photographed on PDF page 14 of Attachment A under "Reference # 11." Additional gas wells and dewatering pumps were installed in the area to replace CV-2302. However, as discussed in previous survey analyses, the abandoned borehole for CV-2302 may be continuing to emit heat to the surface, which may explain the elevated temperatures detected in the area. The other gas wells and pumps installed in the area continue to remove hot gas and liquids from the Landfill.

Nevertheless, the maximum temperature detected in the thermal images for this area decreased over twenty-two (22) degrees since the April 2025 survey (compare reference point 16 in the April 2025 thermal images report to reference point 11 in the June 2025 thermal images report).

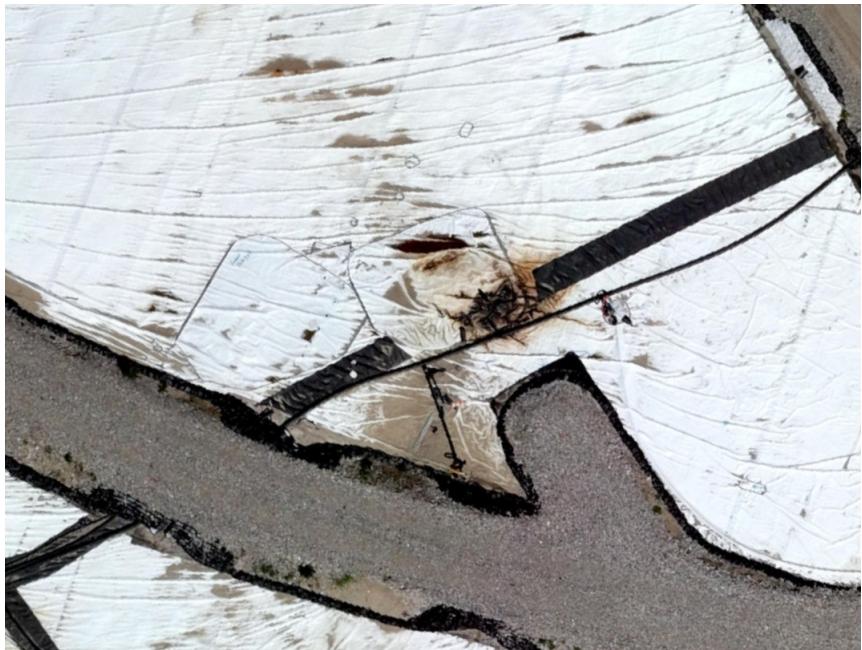
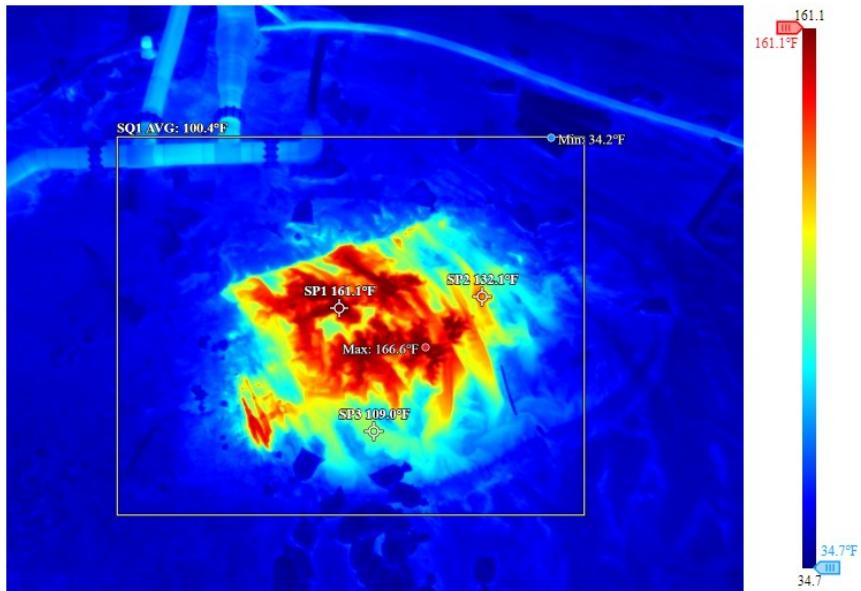
Reference # 12

SQ1	Max	166.6 °F
	Min	34.2 °F
	Average	100.4 °F
Sp1		161.1 °F
Sp2		132.1 °F
Sp3		109.0 °F

GCCS, and includes a large infrastructure of black HDPE pipes on top of surrounding white liner.² In addition, fluctuations in the surface temperatures as detected by FLIR may be influenced by operational changes, including changes to the landfill gas or leachate capture and conveyance.

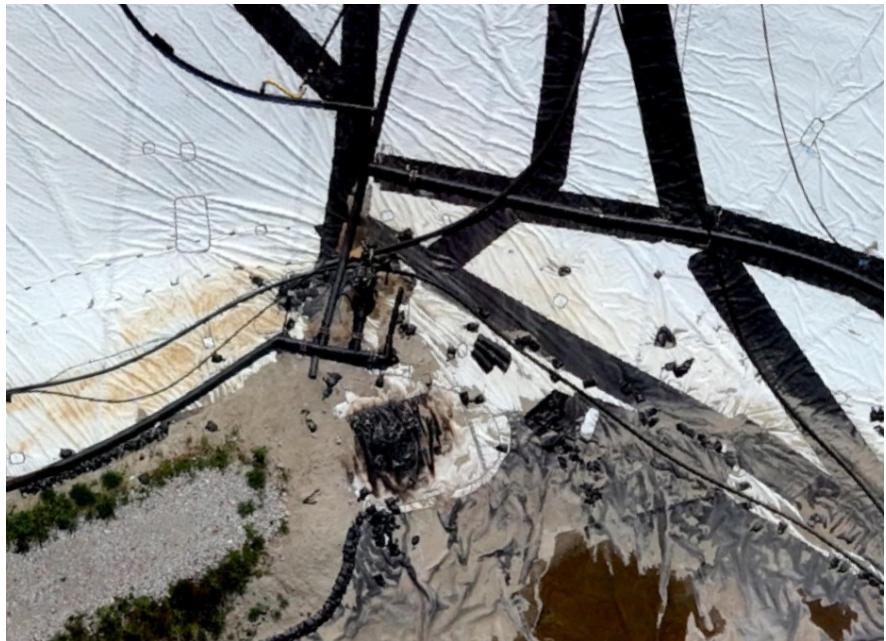
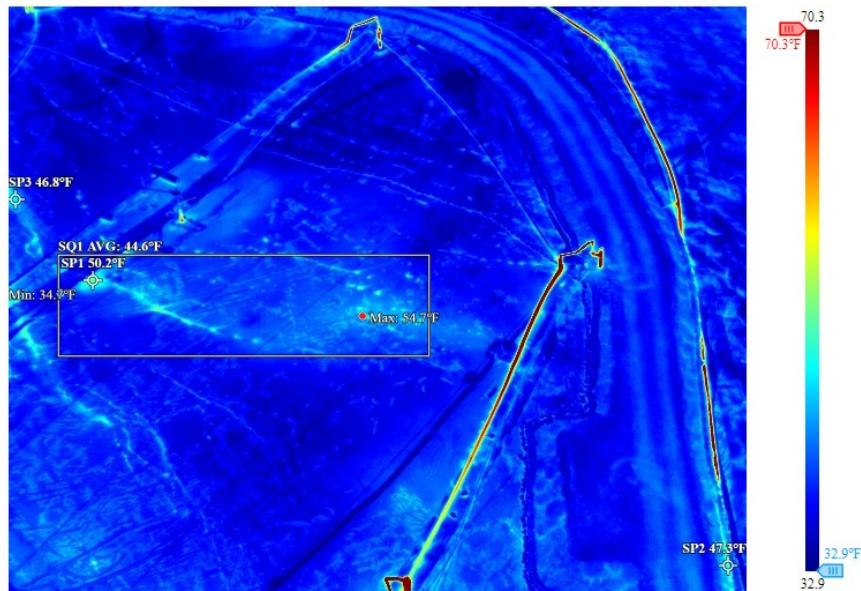
Reference # 13

SQ1	Max	54.7 °F
	Min	34.7°F
	Average	44.6 °F
Sp1		50.2 °F
Sp2		47.3 °F
Sp3		46.8 °F

The area designated by the LEA as "Area B" appears to be in grid 185. The Sniffer data reference point in Area B for the June 10, 2025 survey is point 13. Please note that, as with the April 2025 survey, Sniffer's thermal camera did not detect any elevated temperatures in Area B, one of the areas of interest previously identified in the LEA's and CalRecycle's letters. Nevertheless, Sniffer included reference point 13 and thermal images, photographs, and GPS coordinates in accordance with the LEA's directive to track trends in Area B over time. As with the nearby Area A, GCCS infrastructure is highly concentrated in this area. As discussed in Chiquita's previous submittals for past surveys, because the GCCS system is designed to convey the landfill gas from the north slope to the flares, we may expect to see elevated

Since October 2024, the maximum temperatures noted in this area have decreased dramatically from between 152–154 degrees down to about 55 degrees (compare reference points 23 and 25 in the October 2024 thermal images report to reference point 13 in the June 2025 thermal images report). The last two surveys did not result in heat signatures in this area, and a comparison of the April 2025 and June 2025 thermal images in Area B indicates further decrease in temperature in Area B, with the average detected temperature decreasing about six (6) degrees and the maximum detected temperature decreasing about twenty-four (24) degrees (compare reference point 19 in the April 2025 thermal images report to reference point 13 in the June 2025 thermal images report).
