Assessment of the Viability and Functionality of Landfill Gas Wellfield Flow and Gas Composition Automated Remote Monitoring System

Chiquita Canyon Landfill
Castaic, California
SCAQMD Facility No. 119219

SCS ENGINEERS

01204123.21-13 | April 8, 2026

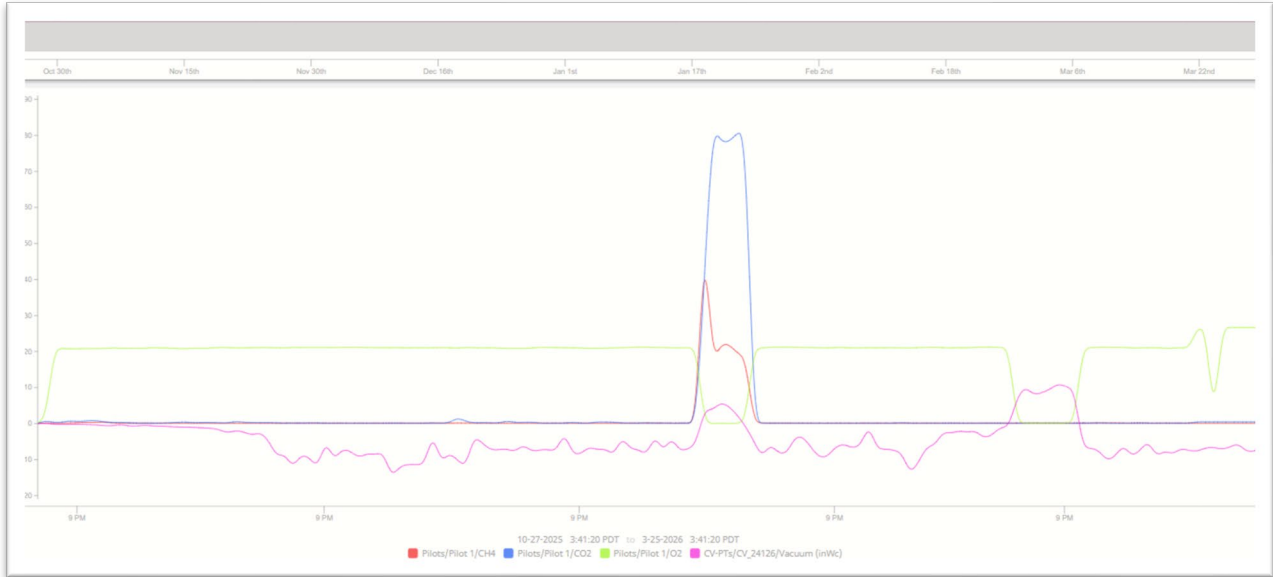
Exhibit 1. PILOT 1 GAS COMPOSITION VS. VACUUM TREND

- **Oxygen** – Pilot 1 did not have many O2 sensor errors; however, the recorded measurements exhibited values that were likely influenced by ambient air intrusion around the sensor flange during much of the study. There was an inverse relationship between O2 and measured well vacuum observed during two events, shown on Appendix B – Exhibit 1, where the well pressure went positive and the O2 value declined. This may be indicative of air intrusion on the sampling assembly, or a limited flow or restricted flow path to the sample assembly under vacuum conditions.

- **Methane / Carbon Dioxide** – Pilot 1 had the least amount of CH4/CO2 sensor errors compared to the other pilot wells. Similar to the O2 sensor, these sensors appeared to respond to one of the positive pressure events shown on Appendix B – Exhibit 1. There were errors on the CH4/CO2 sensors during the second noted positive pressure event, and the concentrations did not change.

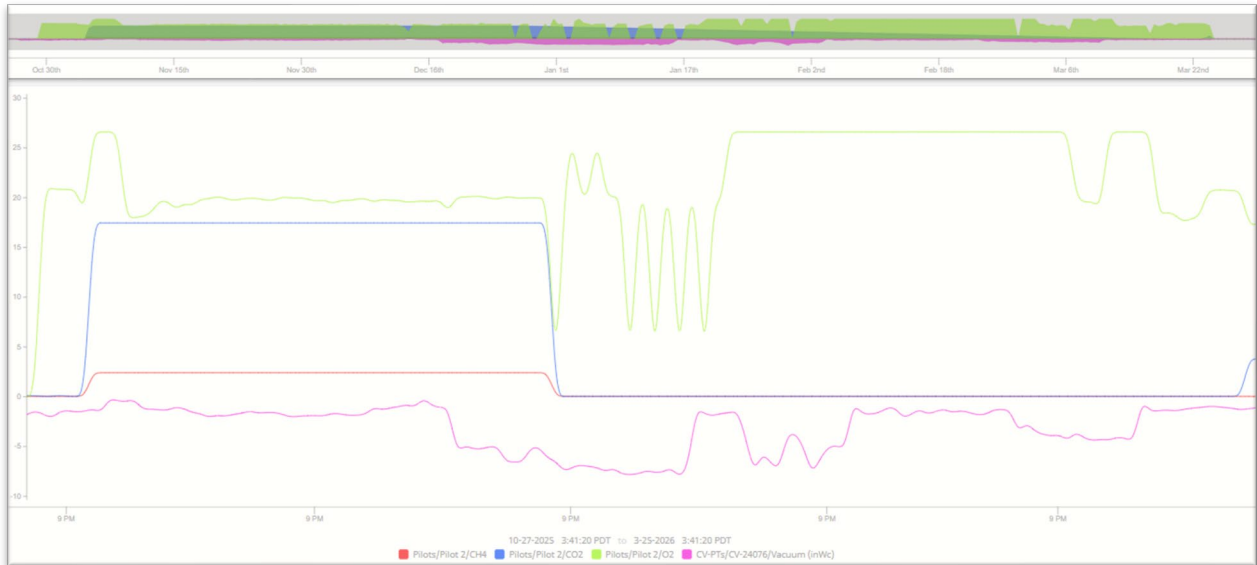
Exhibit 2. PILOT 2 GAS COMPOSITION VS. VACUUM TREND

- **Oxygen** – The O2 sensor on Pilot 2 recorded an error 33% of the time and exhibited elevated concentrations from 16 to 20% when no errors were present on the sensor. The GEM data consistently showed lower O2 concentration values from 0 to 3% over the same time periods. There were no positive pressure events observed during the test period to evaluate if the concentration changed under positive pressure conditions based on data shown in Appendix B – Exhibit 2. The O2 sensor did go into alarm around January 5, 2026, and the alarm cleared following servicing of the unit on March 19, 2026. The sensor went back into an error state on March 25, 2026, only six (6) days after being serviced. This sensor was

observed to be severely impacted by the LFG with discoloration, solids buildup, and liquids present when inspected. This is an elevated temperature well.

- Pilot 2 was inspected and a leak was found on the HDPE flange mount for the O2 sensor. The flange was repaired and the O2 value dropped to expected values.
- Pilot 2 v-cone flow element was removed to inspect for buildup or impact by the LFG. This well was selected because it is an elevated temperature well that had demonstrated the most degradation on the exposed analyzer components when inspected and serviced. SCS did not remove the v-cone flow elements from the other locations as it requires significant effort to mechanically remove and reinstall.
- Pilot 2 sample assembly was modified to add a 2" tee and sample port so that a sample could be obtained with the GEM in the upper assembly to measure the actual gas to which the analyzer sensor was being exposed. Prior to this, the analyzer measurements were compared to the values obtained from the wellhead port.

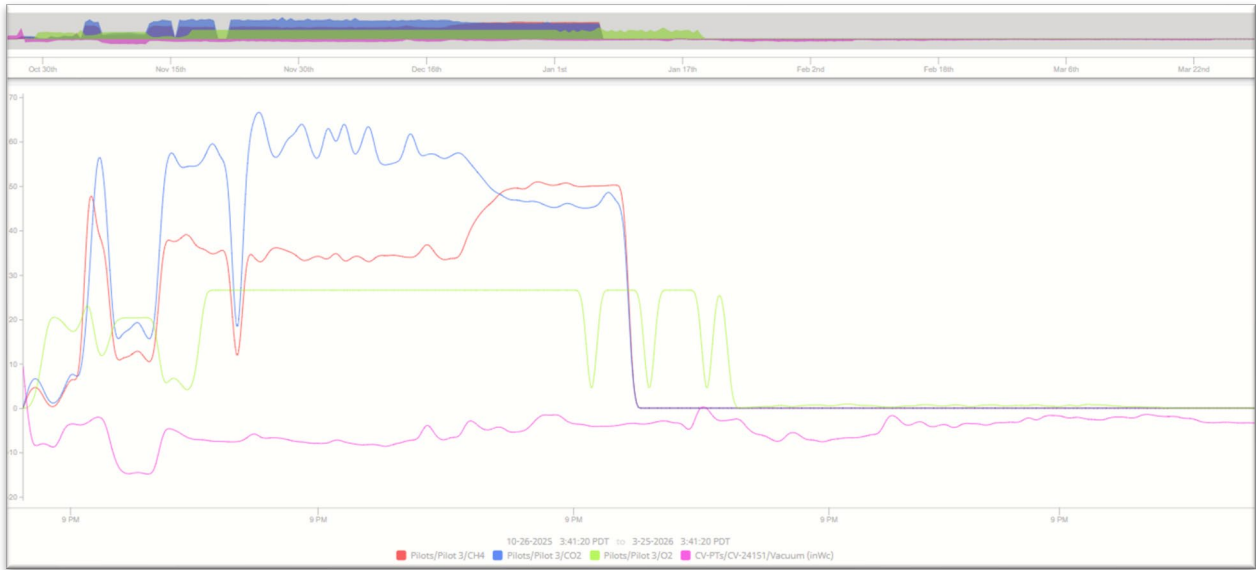
Exhibit 3. PILOT 3 GAS COMPOSITION VS. VACUUM TREND

- **Methane / Carbon Dioxide** – Pilot 3 had CH₄/CO₂ sensor errors 47% of the time during the study. The sensor appeared to function correctly without errors and with reasonable concentrations during 5 of the comparison GEM readings between November 13, 2025 and January 6, 2026. On or about January 6, 2026, the sensor did not record a measured value (other than “0.0”) and entered a “sensor failure” error state. While the sensor failure error was resolved after servicing on February 6, 2026, the sensor did not record a measured value (other than “0.0”), indicating that it remained non-functional. During the period of February 6 through March 13, 2026, the sensor intermittently triggered the sensor failure error state but continued to record the default measured concentration value of “0.0” for both constituents. On March 13, 2026, the IIoT device failed and the measured concentration value and error status were no longer recorded.

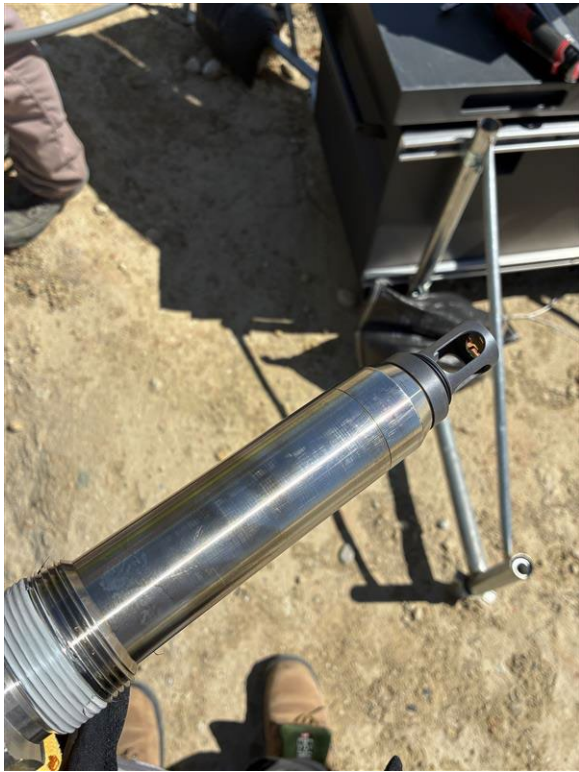
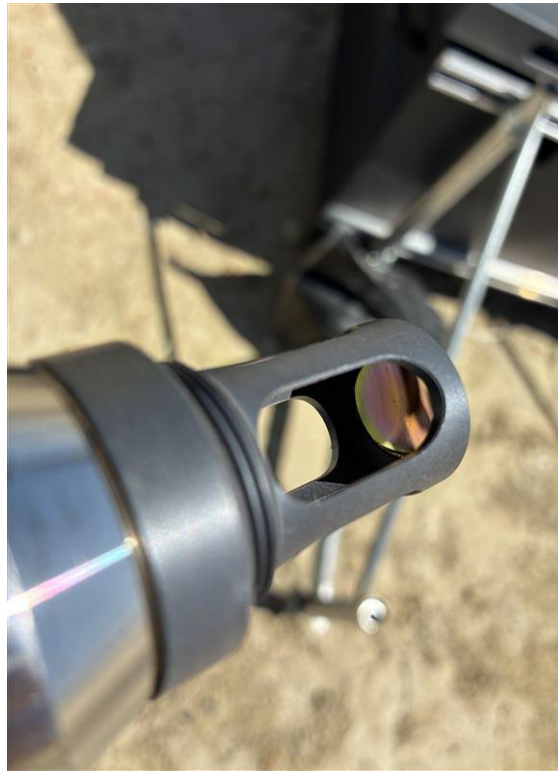
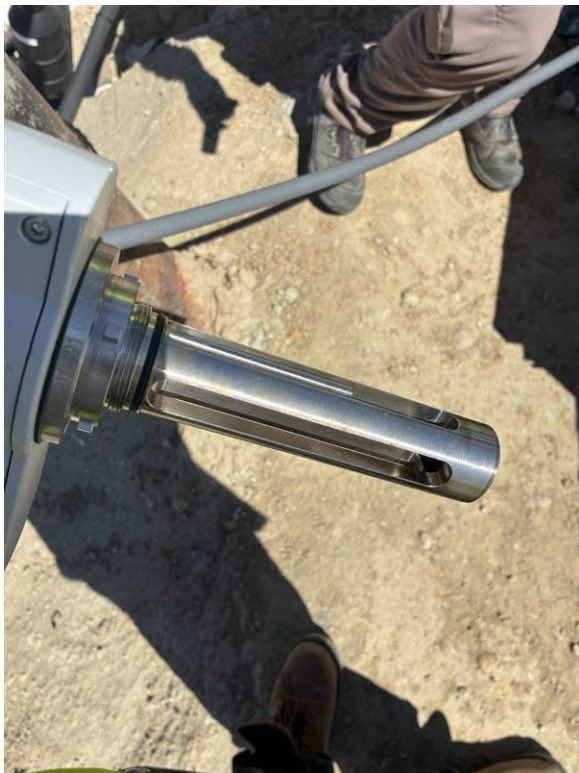
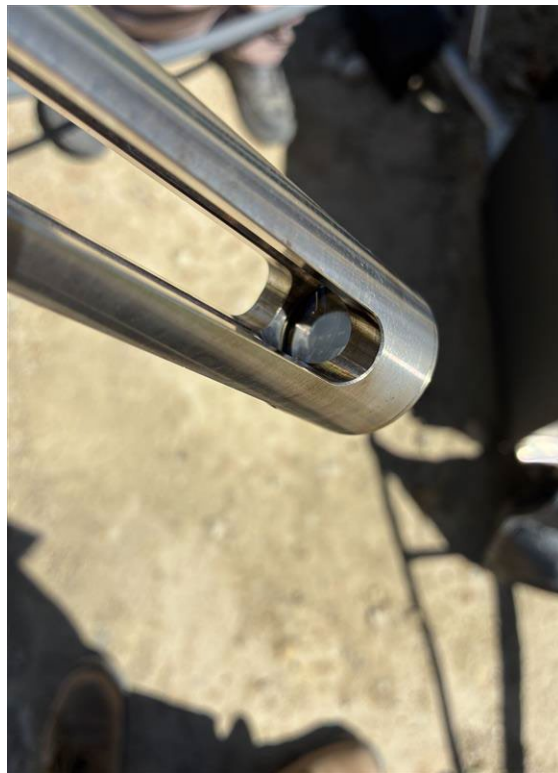
- CH₄/CO₂ Sensor – showed significant discoloring that stained the stainless steel housing and PTFE filter; optic was discolored
- O₂ Sensor – showed significant discoloring that stained the stainless steel filter and PTFE filter; solids were observed on the stainless filter as well; optic was discolored

Pilot 1 – CH4/CO2 Probe

Pilot 1 – CH4/CO2 Probe Optic

Pilot 1 – O2 Probe with Filters Removed

Pilot 1 – O2 Probe Optic

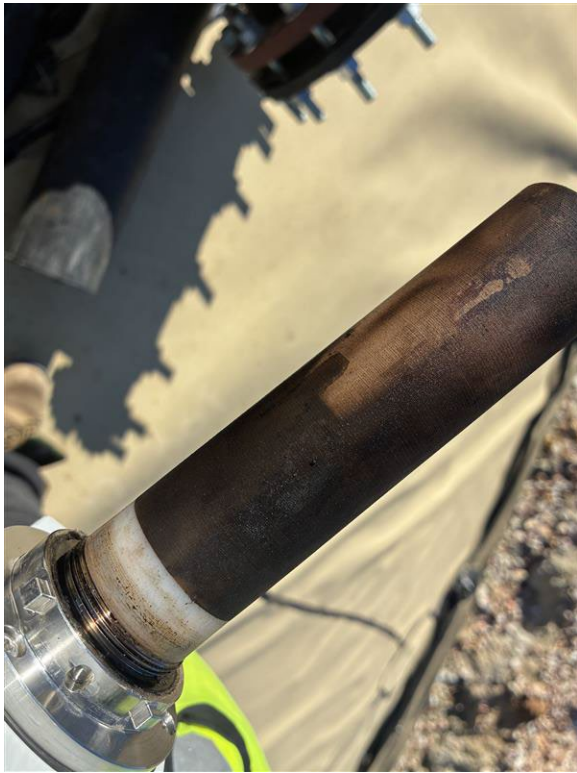
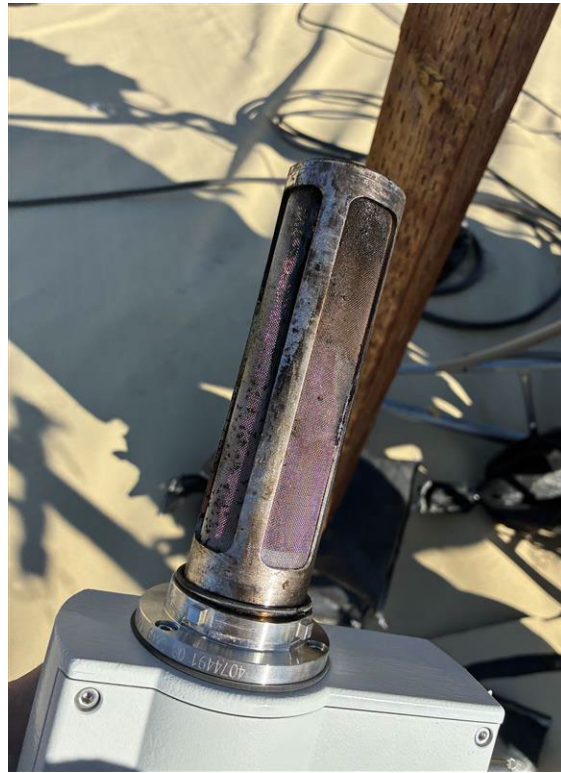
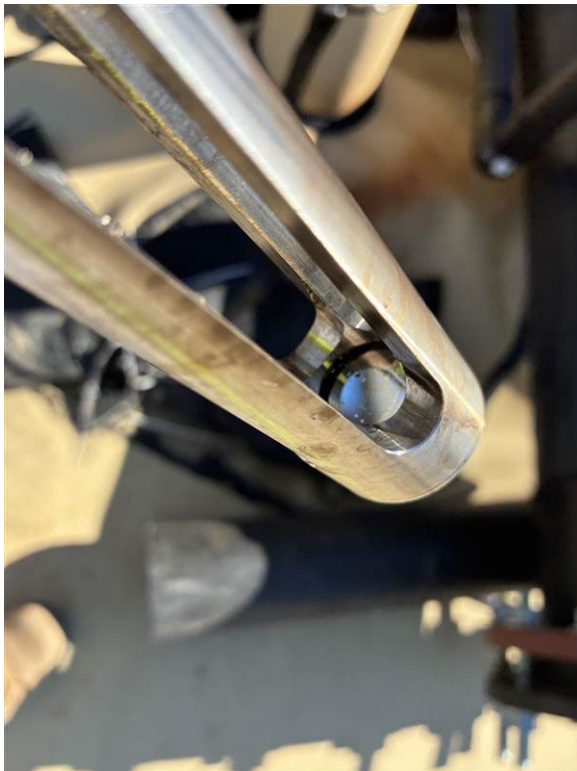
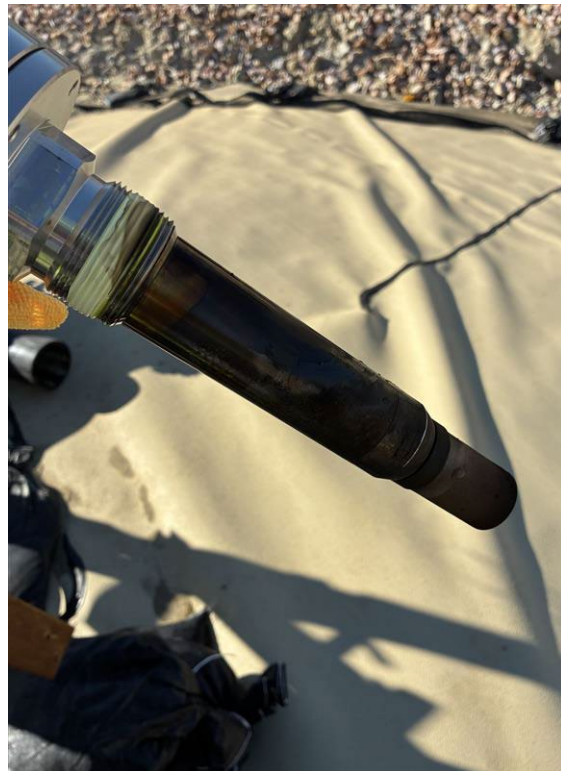
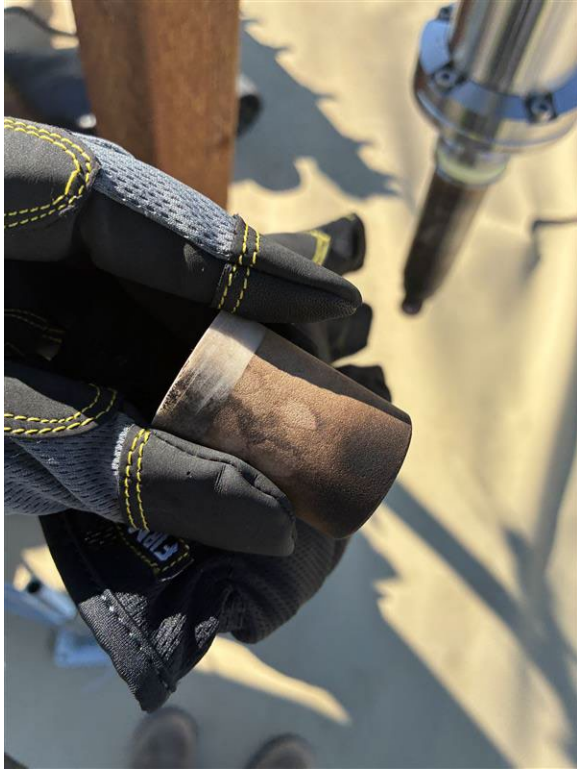
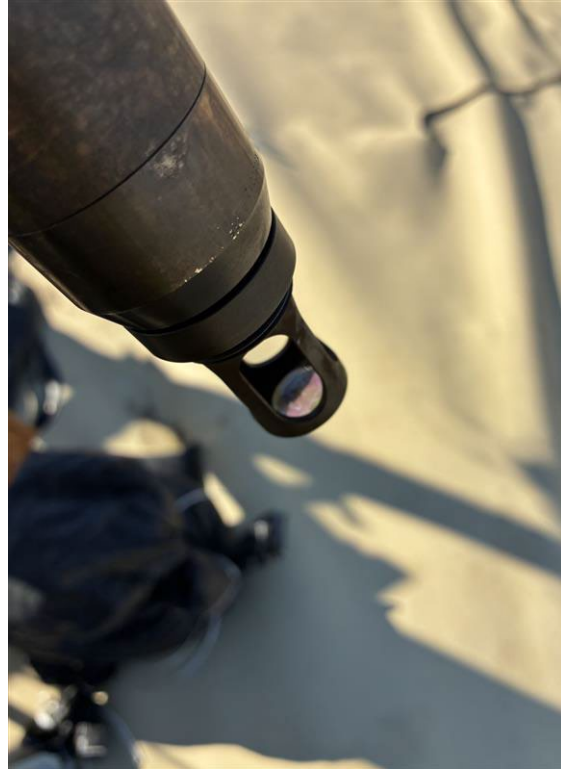
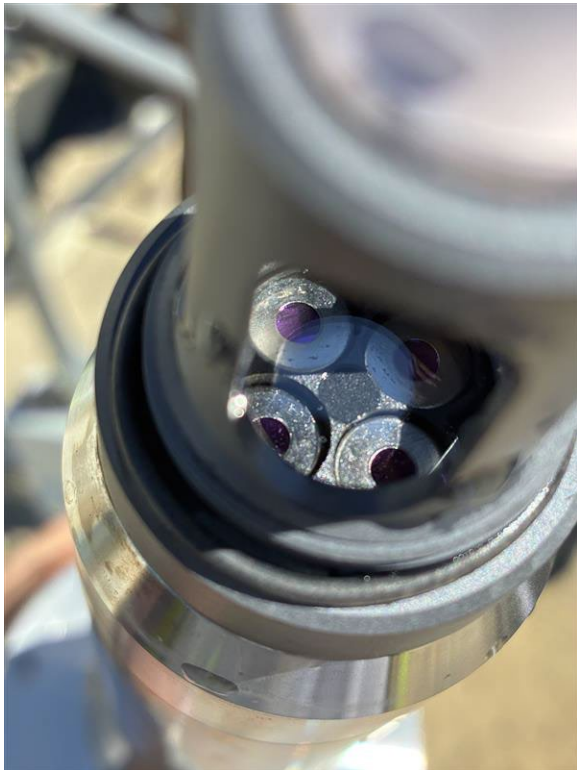
- CH₄/CO₂ Sensor – please note that the PTFE filter was not installed on this sensor while in operation, there was some minor debris on the sensor tip noted around the optic, optic was slightly discolored
- O₂ Sensor – no debris or scaling observed on the PTFE filter; no scaling was observed on the stainless filter; optic was not discolored

Pilot 2 - O2 Probe with PTFE Filter

Pilot 2 - O2 Probe with SS Filter

Pilot 2 - O2 Probe Optic

Pilot 2 - CH4/CO2 Probe with PTFE Filter

Pilot 2 - CH4/CO2 Probe PTFE Filter Cap

Pilot 2 - CH4/CO2 Probe Optic

Pilot 2 - CH4/CO2 Probe Sensors

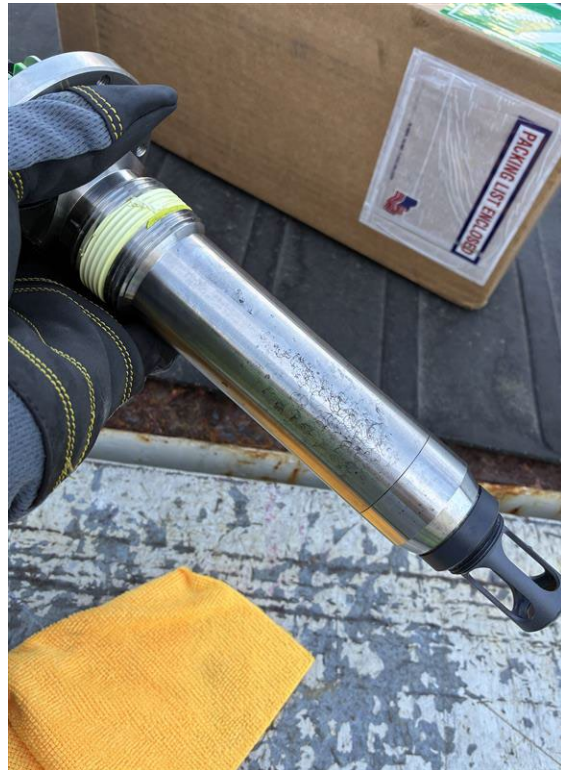
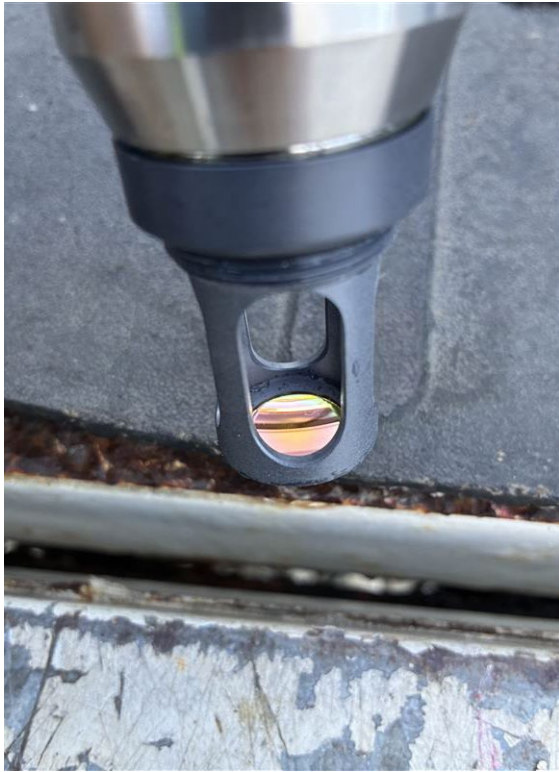
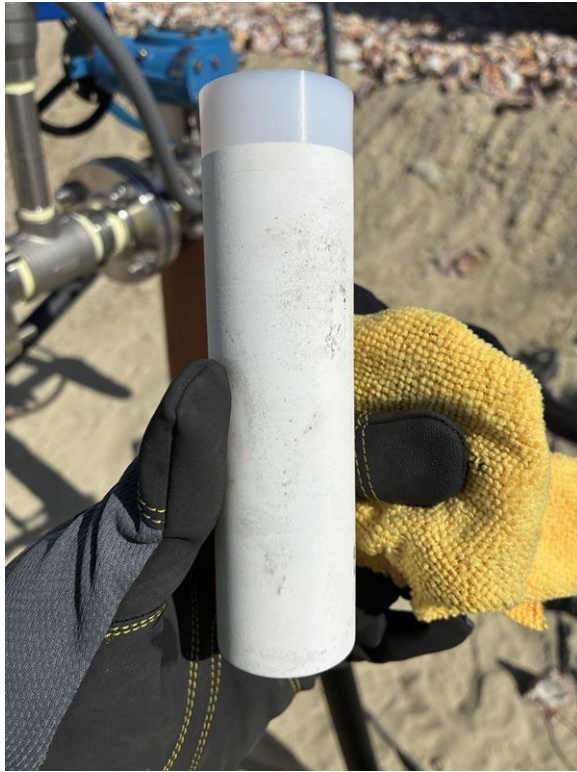
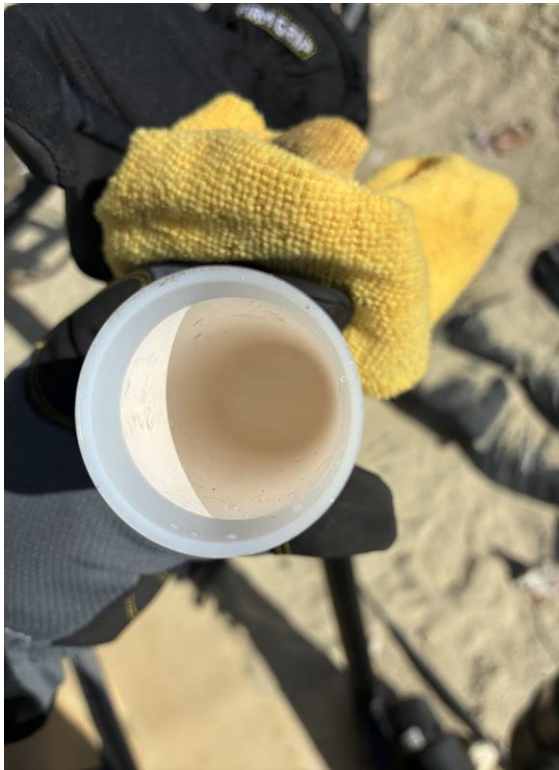
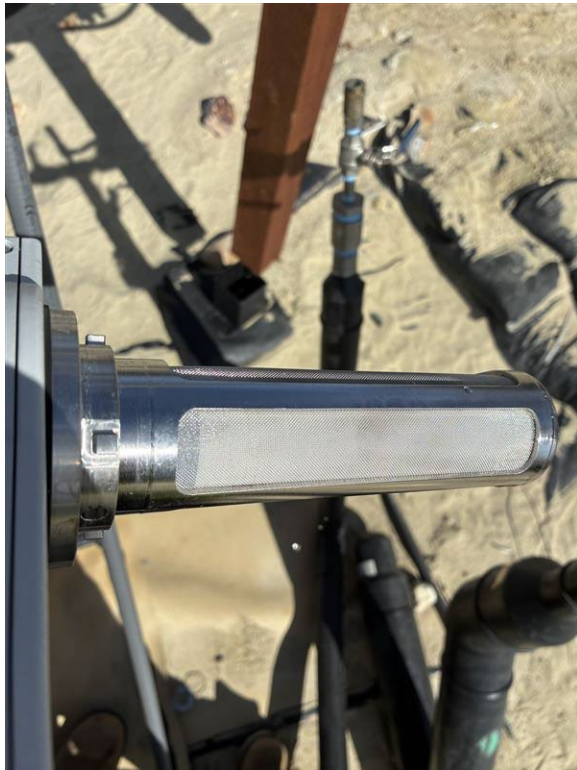
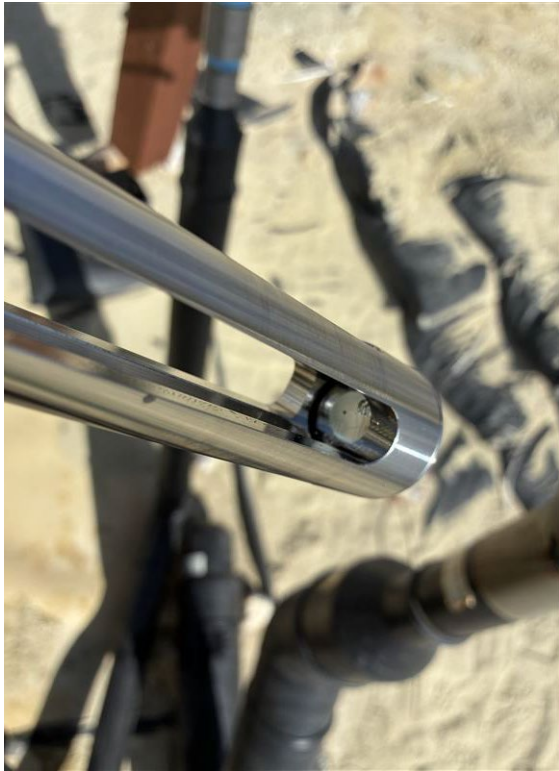
- CH₄/CO₂ Sensor – the PTFE filter had a significant white/yellow scaling on inside and outside of the filter element; some discoloration and film noted on the optic
- O₂ Sensor – the PTFE filter had yellow scaling on the outside of the filter element with some slight black discoloration; slight black discoloration noted on the stainless filter and sensor housing, some discoloration on the optic

- there was notable water drop stains on CH₄/CO₂ sensor housing; liquid droplets were observed on the inside of the O₂ PTFE filter, on the stainless filter, and on the optic

Pilot 3 - CH4/CO2 Probe missing Cover

Pilot 3 - CH4/CO2 Probe Optic

Pilot 3 - O2 Probe PTFE Filter

Pilot 3 - O2 Probe with SS Filter

Pilot 3 - O2 Probe Optic

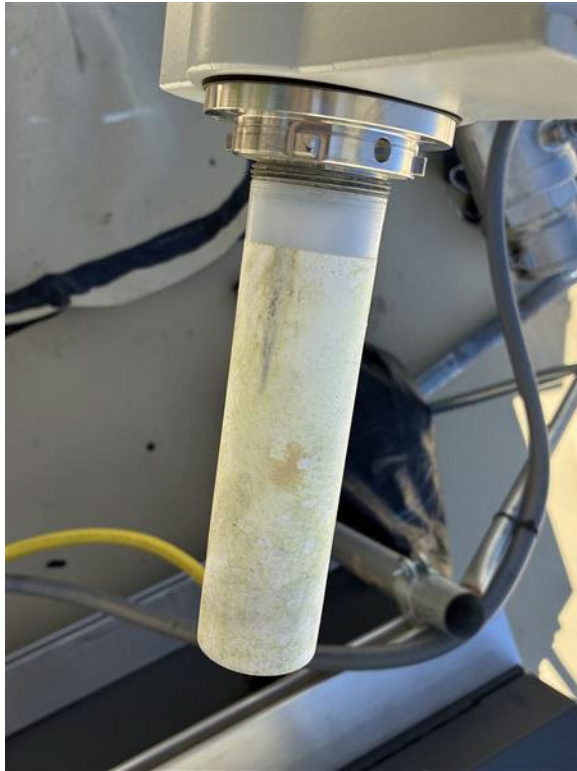
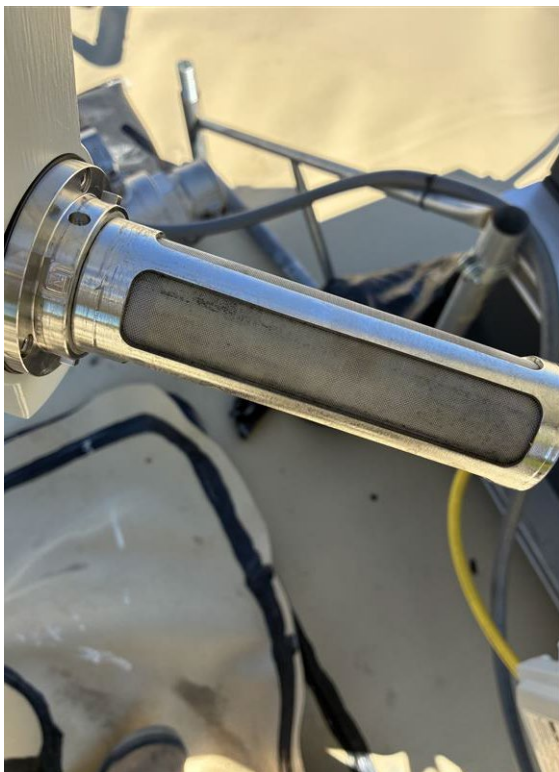
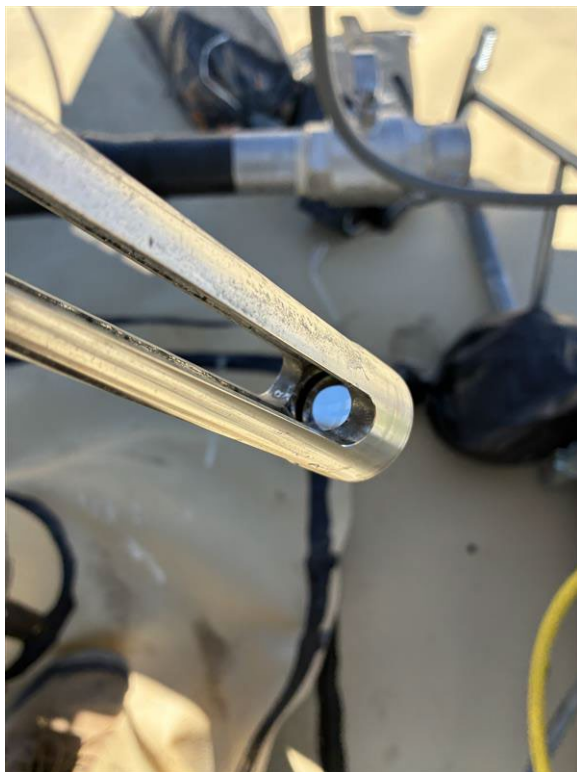
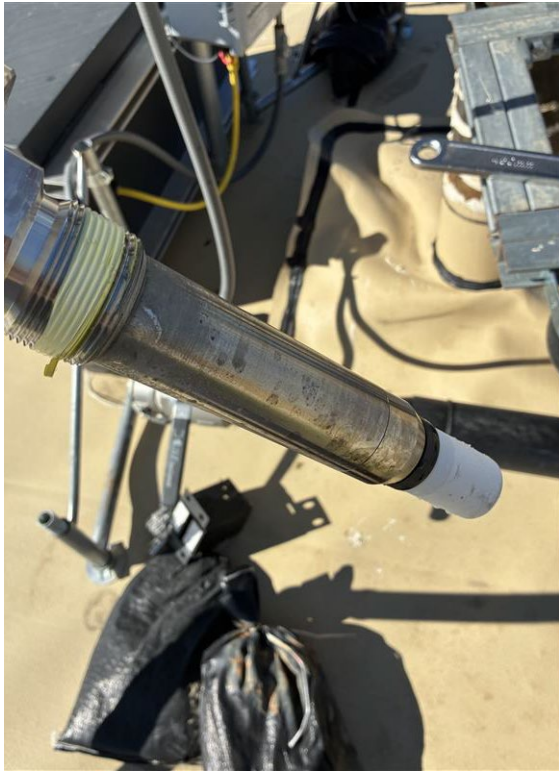
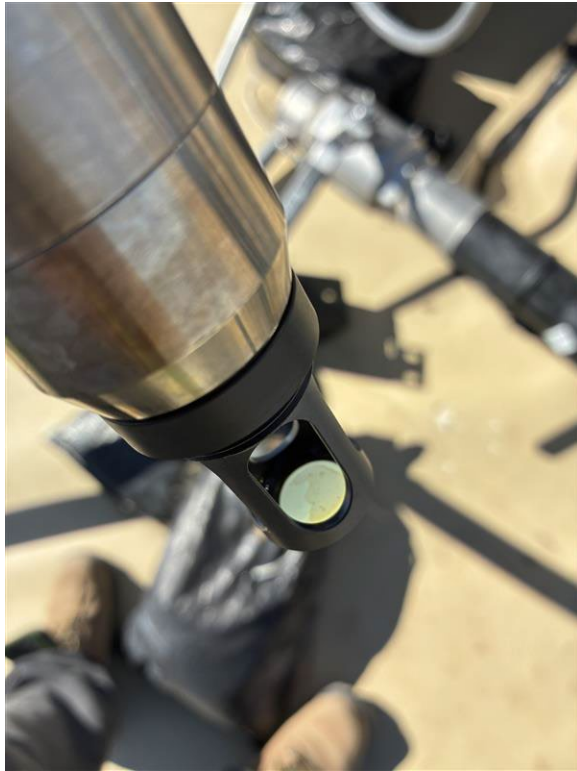
- CH₄/CO₂ Sensor – the PTFE filter had a significant white scaling on the outside of the filter element; no debris or scaling noted on the stainless housing;
- O₂ Sensor – the PTFE filter had a significant white scaling on the outside of the filter element; no debris or scaling noted on the stainless housing; optic had some particulate noted

Pilot 4 - O2 Probe with PTFE Filter

Pilot 4 - O2 Probe with SS Filter

Pilot 4 - O2 Probe Optic

Pilot 4 - CH4/CO2 Probe with PTFE Filter

Pilot 4 - CH4/CO2 Probe Optic

- Pilot 4 gaskets were replaced and the manifold was modified with 45-degree elbow to allow the O2 sensor to drain liquid away from the optics. This was only completed on Pilot 4 to assess the effectiveness before modifying the other locations.
- Pilot 4 O2 sensor error cleared and was functional for a longer period of time, approximately 1/21 to 3/18 without elevated or erroneous readings.

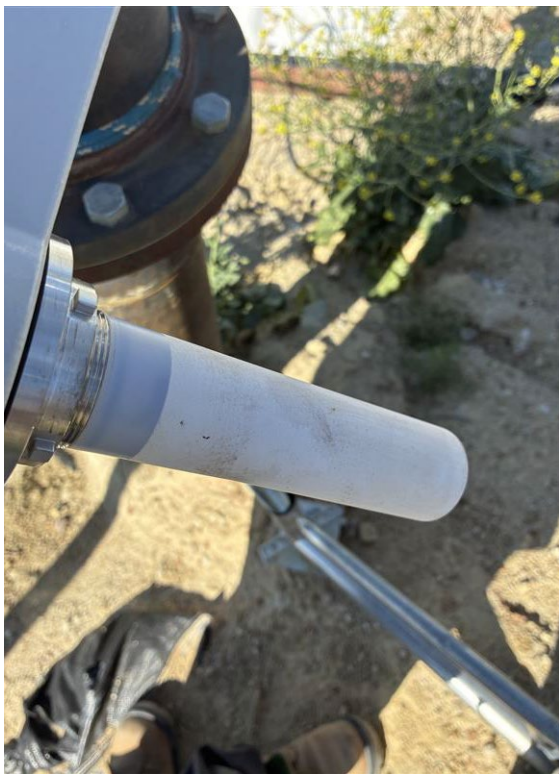
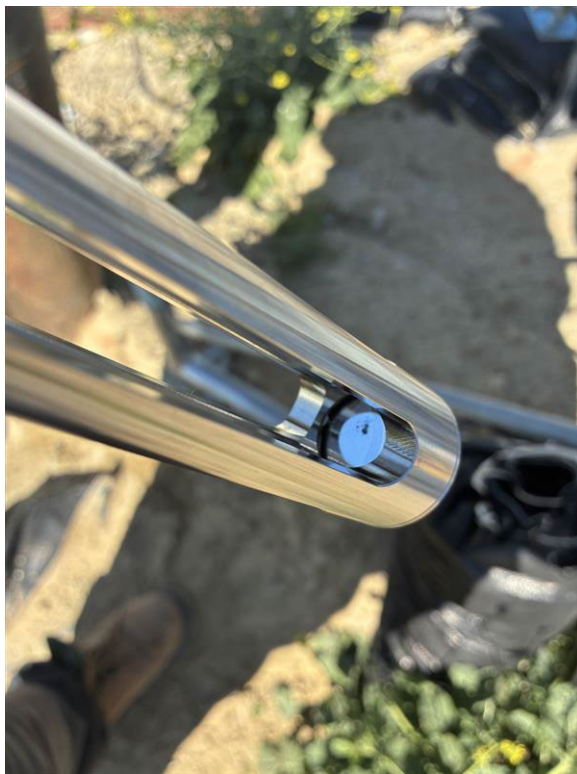
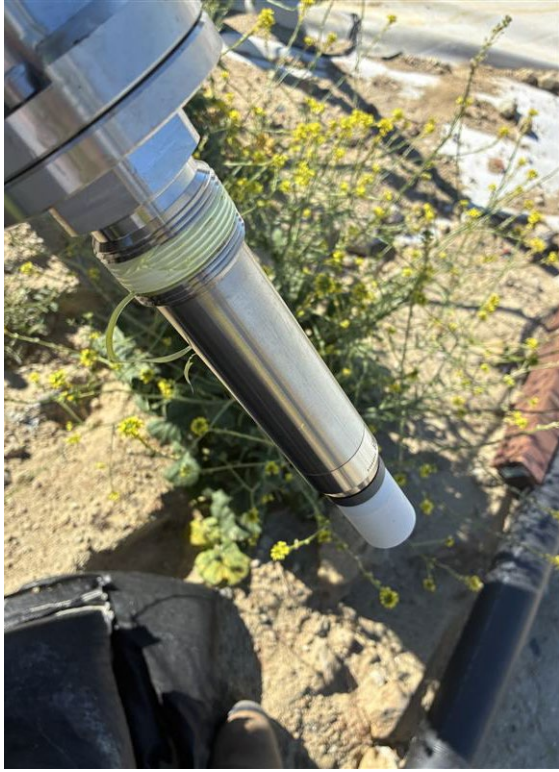
Pilot 5 - O2 Probe with PTFE Filter

Pilot 5 - O2 Probe Optic

Pilot 5 - CH₄/CO₂ Probe with PTFE Filter

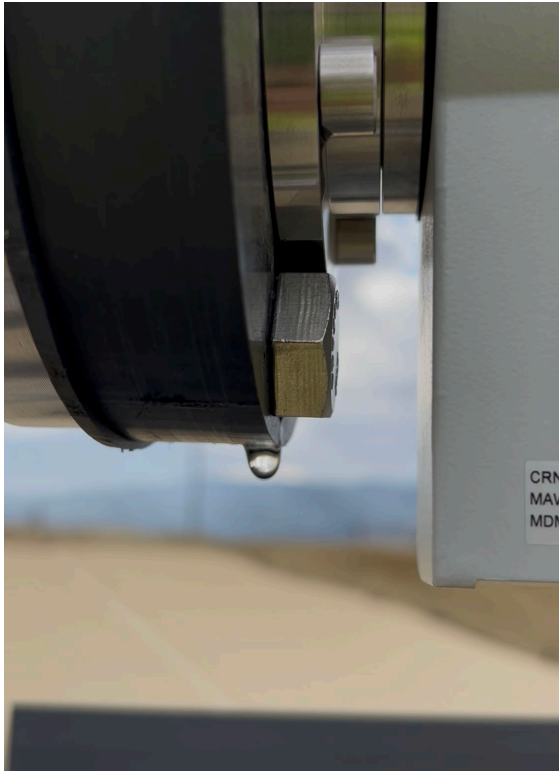
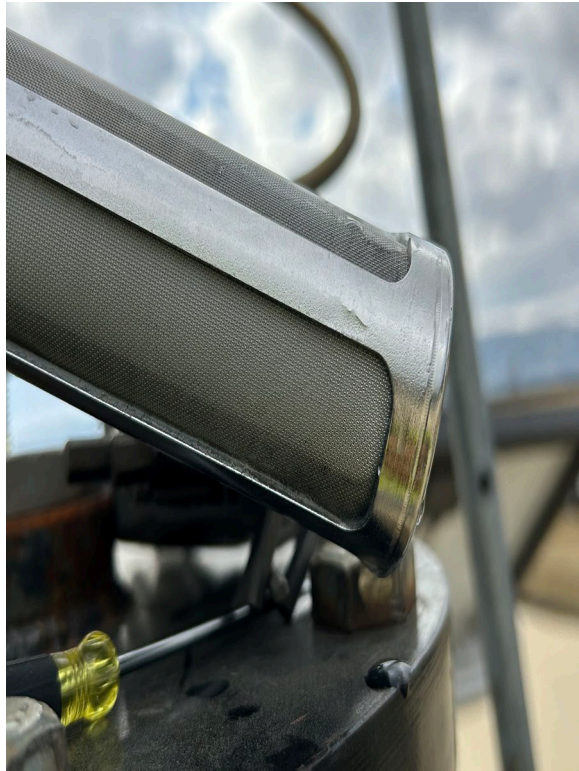
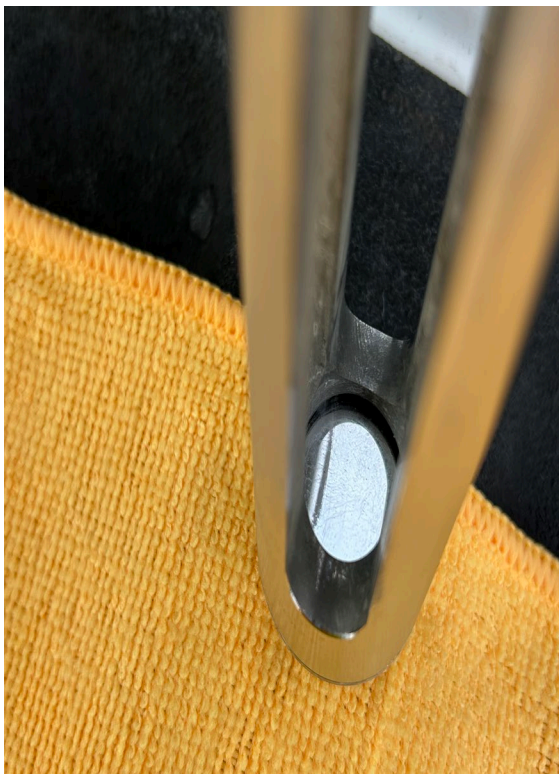
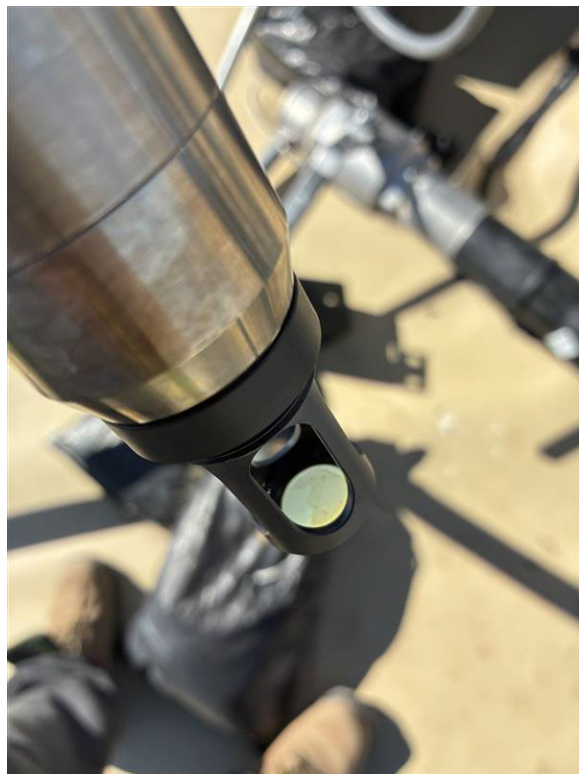
- there were notable liquids on both the CH₄/CO₂ and O₂ sensor filters and optics; liquid was noted to be dripping from the O₂ mounting flange and the O₂ optic appeared to be partially submerged in liquid; the O₂ sensor mount was modified to help mitigate liquid accumulation on the sensor as a test. The O₂ sensor appeared to function better following this modification as described in the data validation section below and shown in Appendix A.

Pilot 4 - Liquid dripping from O2 flange

Pilot 4 - Liquid dripping from O2 sensor

Pilot 4 - Water line on O2 Sensor Optic

Pilot 4 - CH4/CO2 Probe Optic

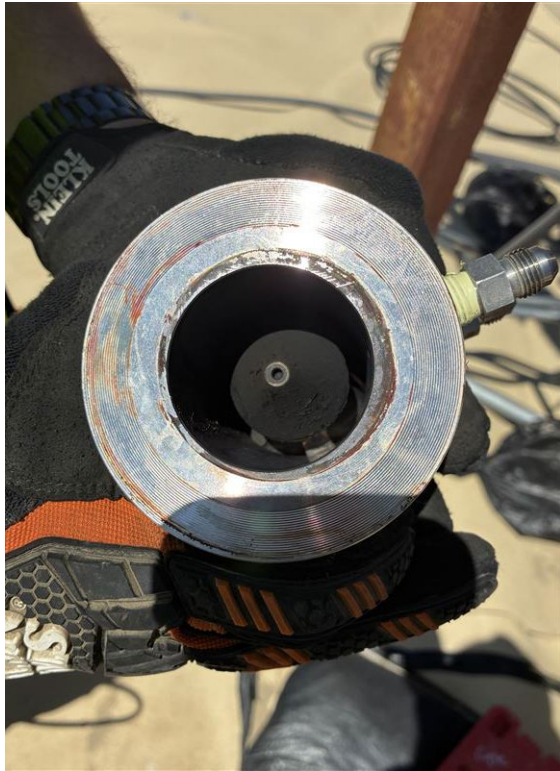
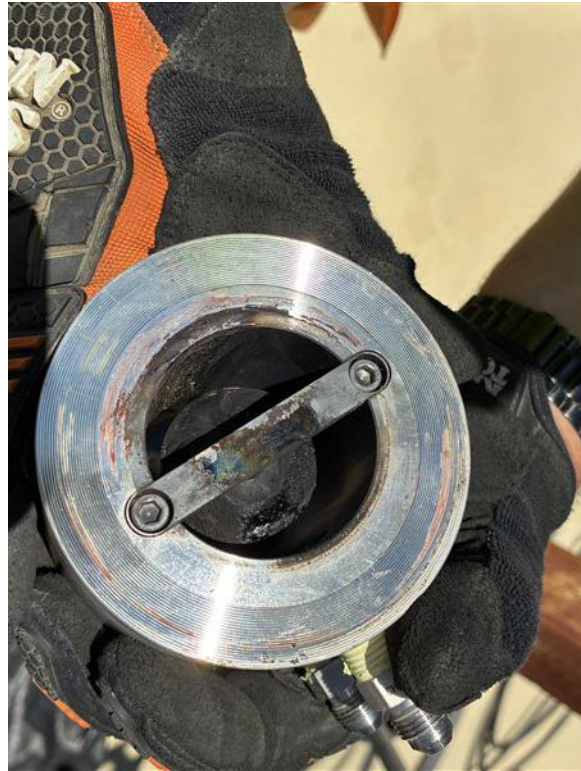
As noted above, only the flow element for Pilot 2 was removed for inspection and evaluation. Photos of the removed meter showing the flow tube and mounted v-cone element are shown in Appendix D. There was a notable thin black dry residue coating the internal surfaces. There was no significant thickness to the residue, and the annular space was not obstructed by it.

As noted above, only the flow element for Pilot 2 was removed for inspection and evaluation. There was a very small section on the back side of the flow element that appeared to be liquid combining with the black residue observed that thickened into a resin as shown in photographs presented in Appendix D. This small patch of resin observed during this limited time period did not appear to restrict the annular space in the flow meter and likely had a negligible effect on flow measurements.

As noted above, only the flow element for Pilot 2 was removed for inspection and evaluation. There did not appear to be any adverse effects related to chemical compatibility in the form of

pitting, corrosion, or deterioration of the internal 316 stainless steel surfaces, during this time period.

Pilot 2 - V-Cone Front View 3/25

Pilot 2 - V-Cone Back View 3/25

Overall, the flow meter appeared to perform as intended in this environment, for this limited time period. The larger unrestricted annular space between the flow tube and element minimized fouling and build up. The residue coating that was observed will likely increase in thickness over time and will likely require routine scheduled maintenance.

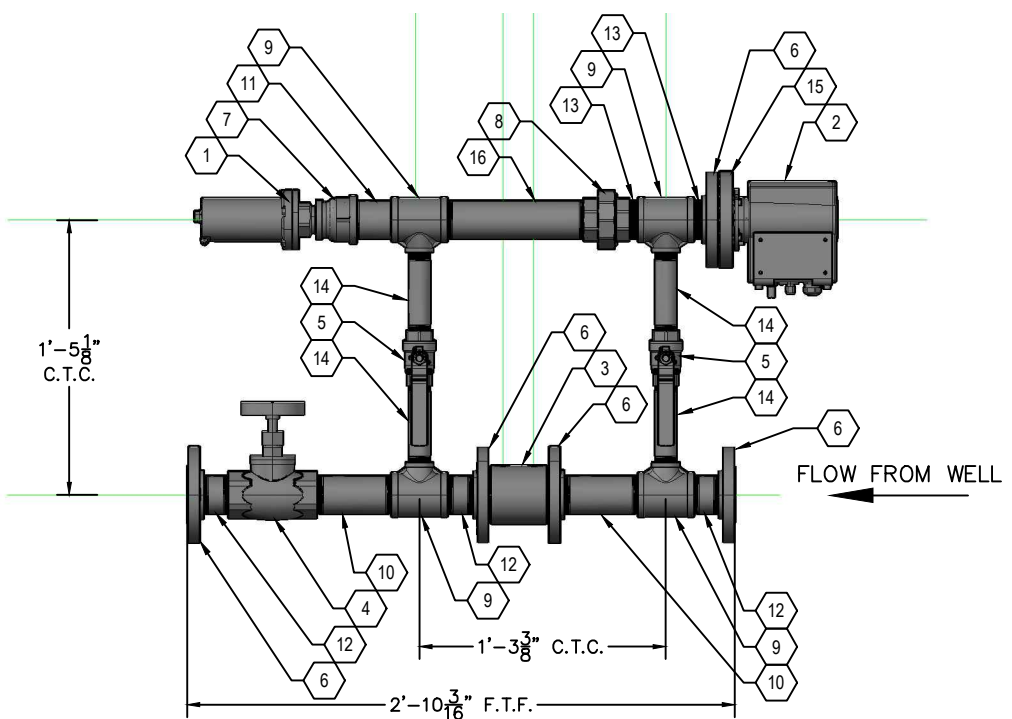
The flow elements were incorporated into a fabricated pilot system assembly that was mounted directly to existing flanges on the steel-cased well risers. The flow device is a wafer style mounted between flanges and was placed in a section that maintained their specified minimum upstream (3 pipe diameters) and downstream (1 pipe diameter) offset requirements. The pressure transmitter was mounted on the upper sampling portion of the assembly with stainless steel tubing connected to the flow element. The tubing was installed with positive drainage back to the flow element to prevent accumulation of moisture that could impact the delta-pressure measurement.

The CH₄/CO₂ and O₂ sensors were installed in the pilot system assembly on a parallel sample train, as shown in Appendix E, to minimize the impact of liquids and higher temperatures on these sensors. Mounting the O₂ sensor to the sample train assembly proved to be more difficult than expected as the sensor has a custom flange that does not easily adapt to a standard pipe flange. The connection that was configured in the field to this custom flange supplied by the sensor manufacturer has resulted in air intrusion issues. For any future installation of these sensors, a custom fabricated stainless steel flange will need to be manufactured by ISCO or another pipe supplier to adequately seal these devices and restrict air intrusion. During the pilot feasibility study, alternative gaskets, o-rings, and mounting hardware were procured and installed to seek to improve the integrity of this connection and reduce the potential for air intrusion.

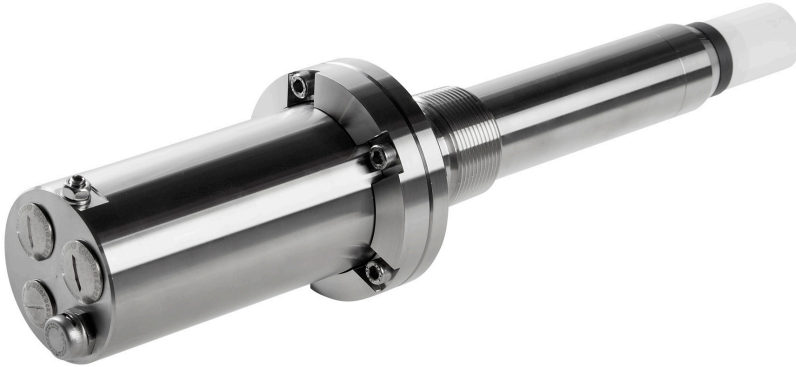
For methane, carbon dioxide, and humidity measurement

Vaisala CARBOCAP® MGP261 Multigas Probe for Methane, Carbon Dioxide, and Humidity Measurement is designed for in situ measurements in demanding biogas processing conditions where repeatable, stable, and accurate measurement is essential. MGP261 is Ex-certified for use in Ex Zone 0 (parts inserted into process) and Ex Zone 1 (parts outside the process). The probe belongs to the Vaisala MGP260 series product family.

MGP261 measures the main components of biogas and landfill gas: methane (CH₄), carbon dioxide (CO₂), and humidity. These gases make up the bulk of biogas, and measuring all three parameters gives you a 100 % picture of the process. MGP261 measures CH₄, CO₂, and humidity in vol-% units, or alternatively dewpoint temperature (T_d) in degrees Celsius.

MGP261 measures gases directly in the process pipeline without a need for moisture removal. This simplifies the measurement both in situ and as part of an extractive system with optional flow through cell accessory. The heated

optical elements provide reliable measurements even in most demanding process conditions with condensate in the process gas.

MGP261 is Ex-certified for use in Ex Zone 0 (parts inserted into process) and Ex Zone 1 (parts outside the process). The electronics and optics of the IP66-rated instrument are protected by encapsulation in a potting compound to ensure maximum resistance to weather, dust, and ingress of process gases in the probe. Materials exposed to process gas are carefully selected for good chemical resistance against hydrogen sulfide: they include stainless 316L steel and polytetrafluoroethylene (PTFE).

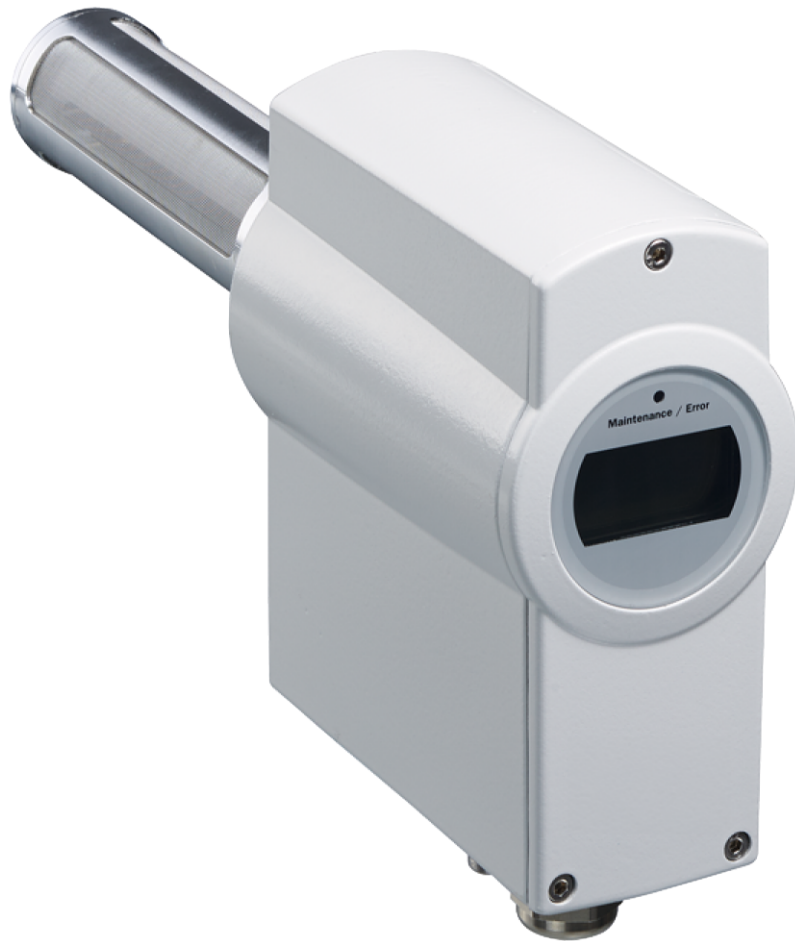
Laser Oxygen Transmitter

Dimensions	TRANSIC121LP transmitter
Transmitter dimensions (H × W × D)	306 × 184 × 74 mm ³ (12.05 × 7.24 × 2.91 inch ³)
Weight	2.2 kg (4.85 lbs)
Enclosure material	G-AlSi10Mg (DIN 1725)
Enclosure classification	IP66
Flange	Can be attached to DIN/ANSI standard flanges. Minimum flange sizes: <ul style="list-style-type: none"> • DIN EN 1092 DN50: Fitted with M16 DIN 933 or similar • ANSI ASME B16.5 (150) 2.5": Fitted with UNC 3/4"-10 or similar
Cable bushing	<ul style="list-style-type: none"> • Cable gland M20×1.5 • Conduit screw fitting 1/2" NPT
Filter	<ul style="list-style-type: none"> • Stainless steel mesh, holes 0.31 mm, wire thickness 0.2 mm • Hydrophobic PTFE filter, average pore size 8 μm
Materials with sample gas contact	<ul style="list-style-type: none"> • AISI 316 L(1.4404) • FKM or Kalrez® Spectrum 6375 • PTFE, SiN, MgF₂, quartz • Polymer coating
