REPORT
ON
FLOODS OF DECEMBER 1955
AND JANUARY 1956
IN
NORTHERN CALIFORNIA COASTAL STREAMS

Prepared by
San Francisco District
Corps of Engineers, U.S. Army

June 1956

Prepared in the
Office of the District Engineer
San Francisco District
Corps of Engineers
U. S. Army
June 1956

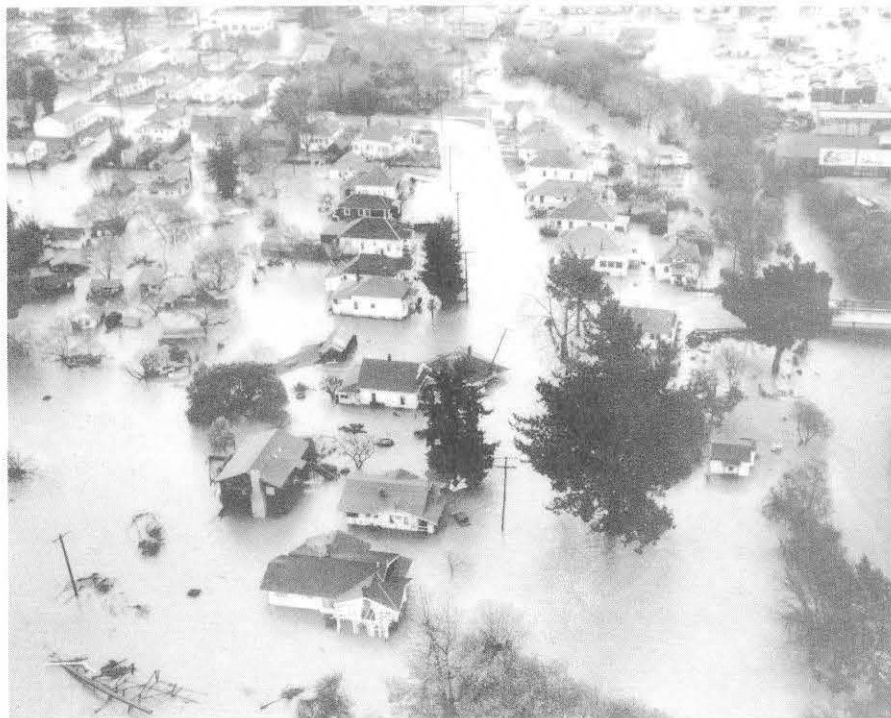
San Lorenzo River, City of Santa Cruz. Inundation and Destruction of Property on Left Bank of River near Branciforte Creek.

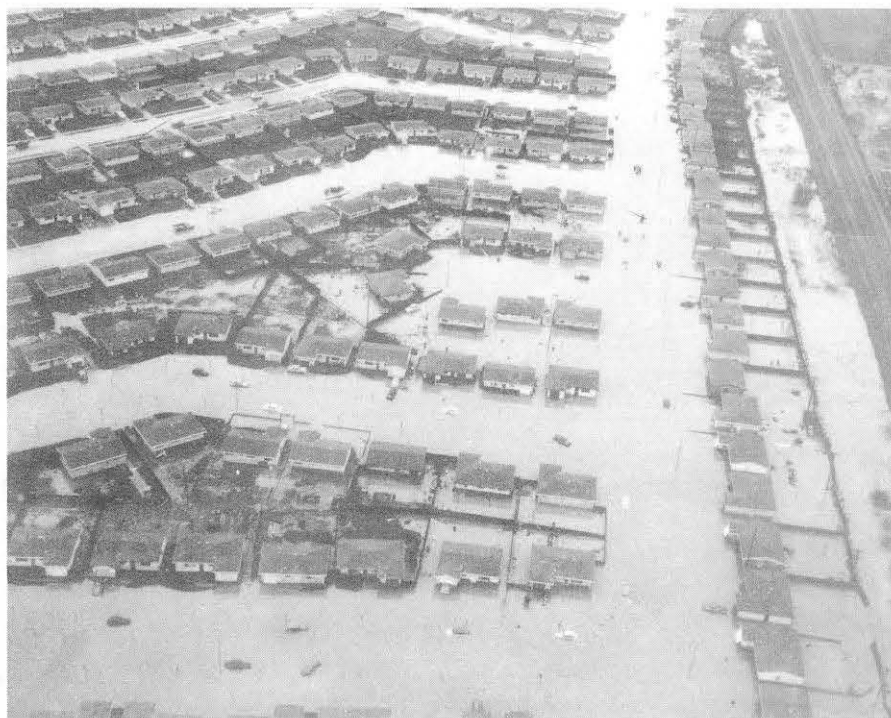
San Tomas Aquinas Creek, Santa Clara County. Inundation of Greenville Subdivision near Sunnyvale.

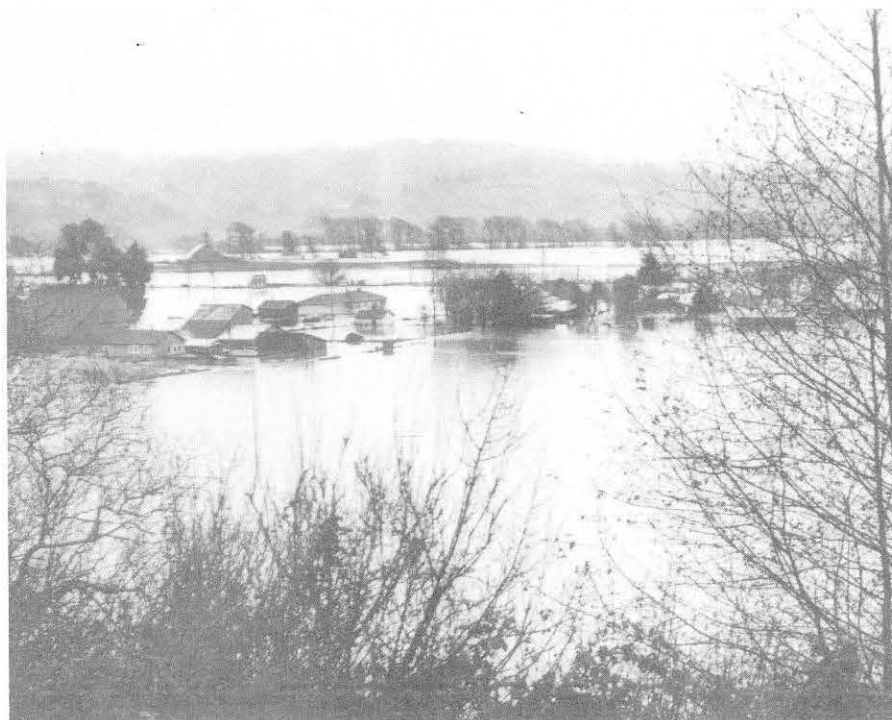
Eel River near Alton. Inundation of Small Community near Junction of Van Duzen River.

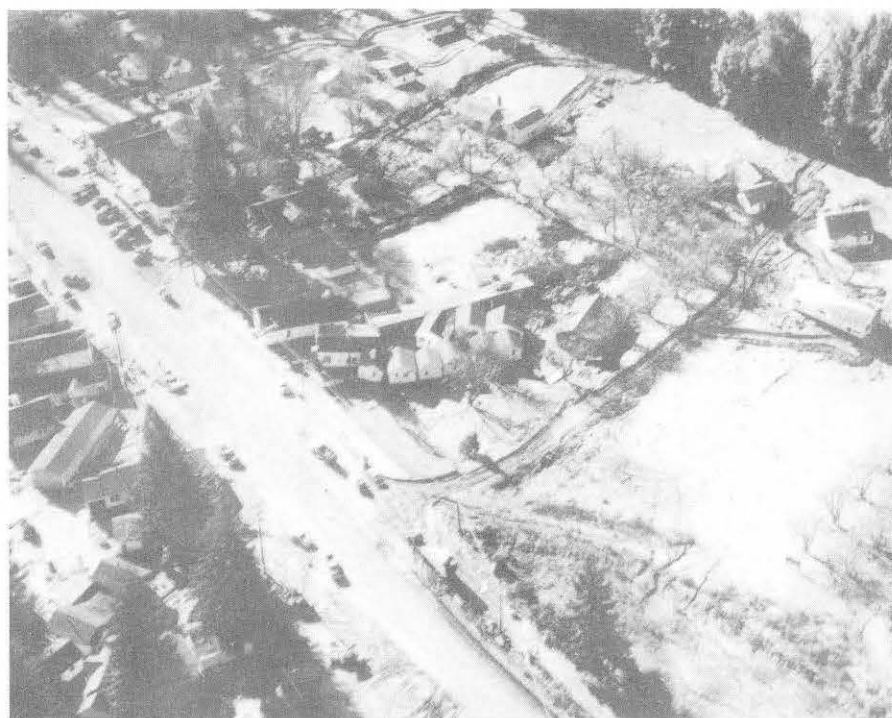
Eel River. Town of Pepperwood, One Week after Flood of 22 December 1955, Showing Heavy Deposit of Silt and Mud Extensive Building Damage

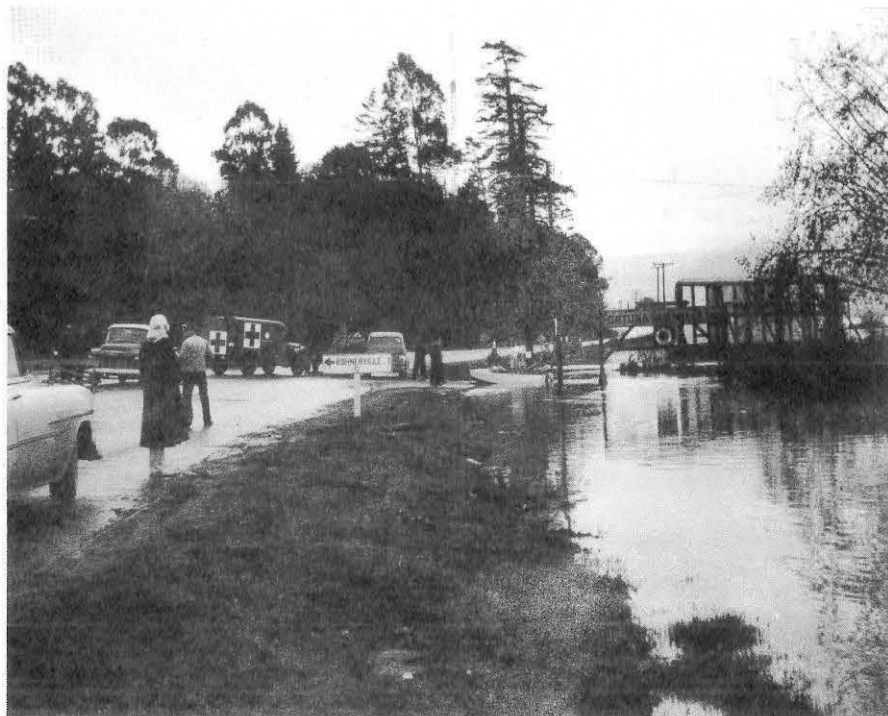
Eel River near Fortuna. California National Guard and Local Rescue Teams

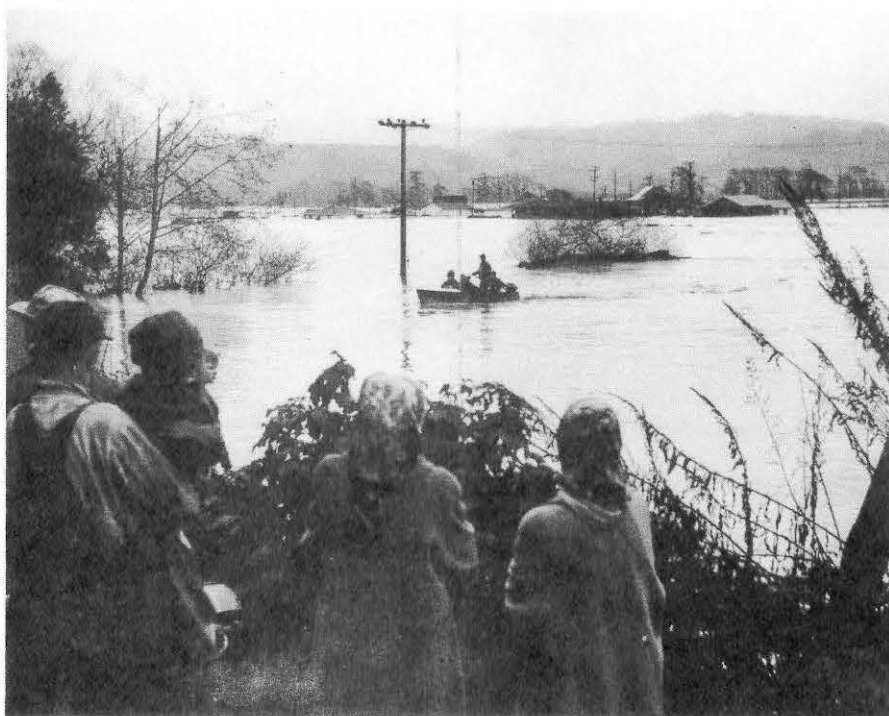
Eel River near Alton. Evacuation of Local Residents by boat.

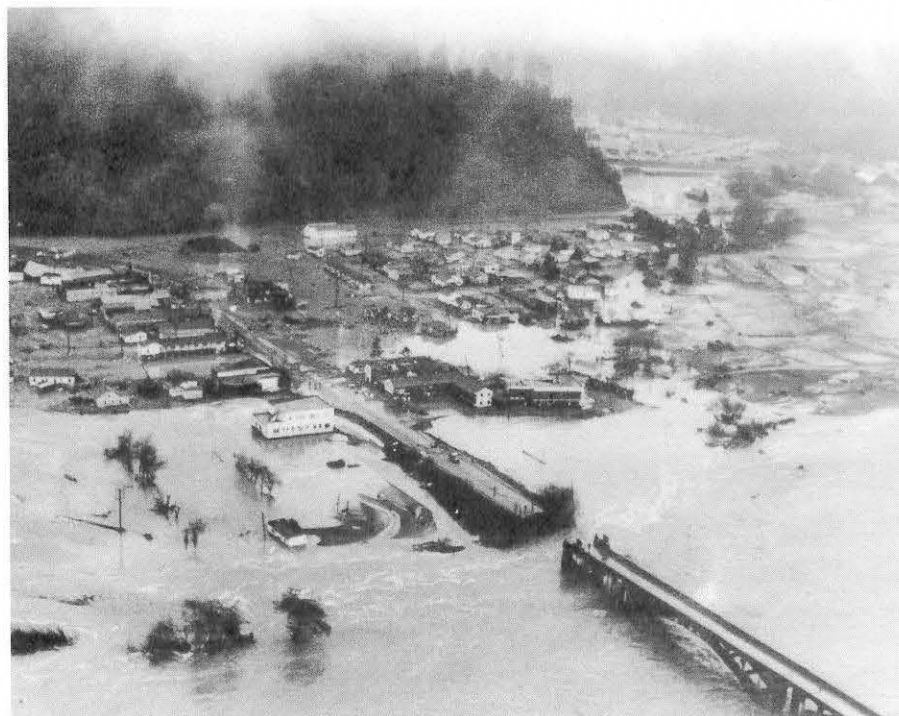
North end of Douglas Memorial Bridge on U.S. Highway 101, Klamath River at Klamath

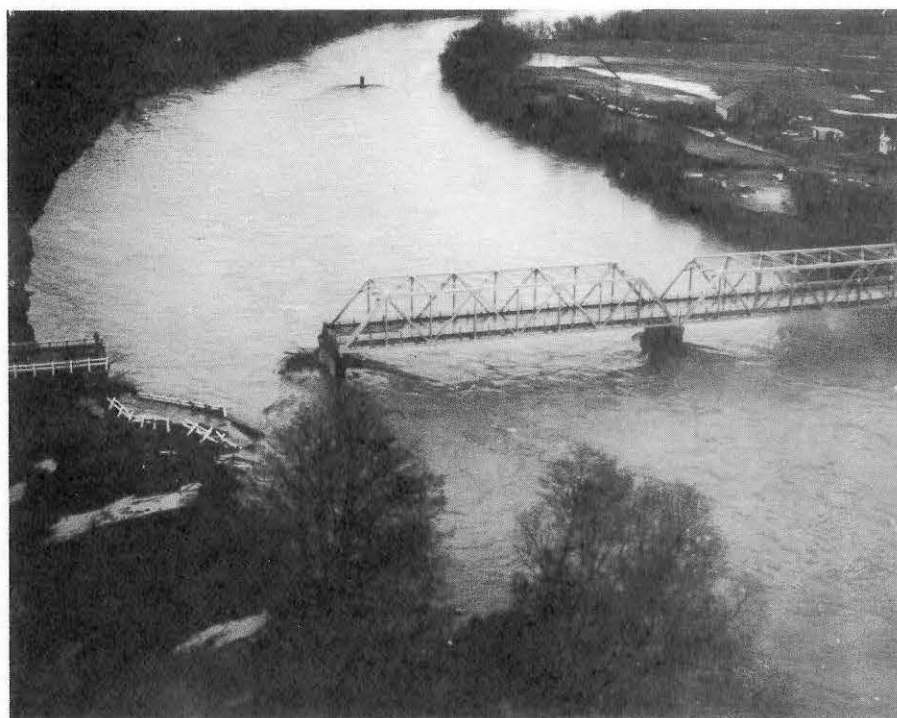
North end of U.S. Highway 101 Bridge over Mad River at Arcata.

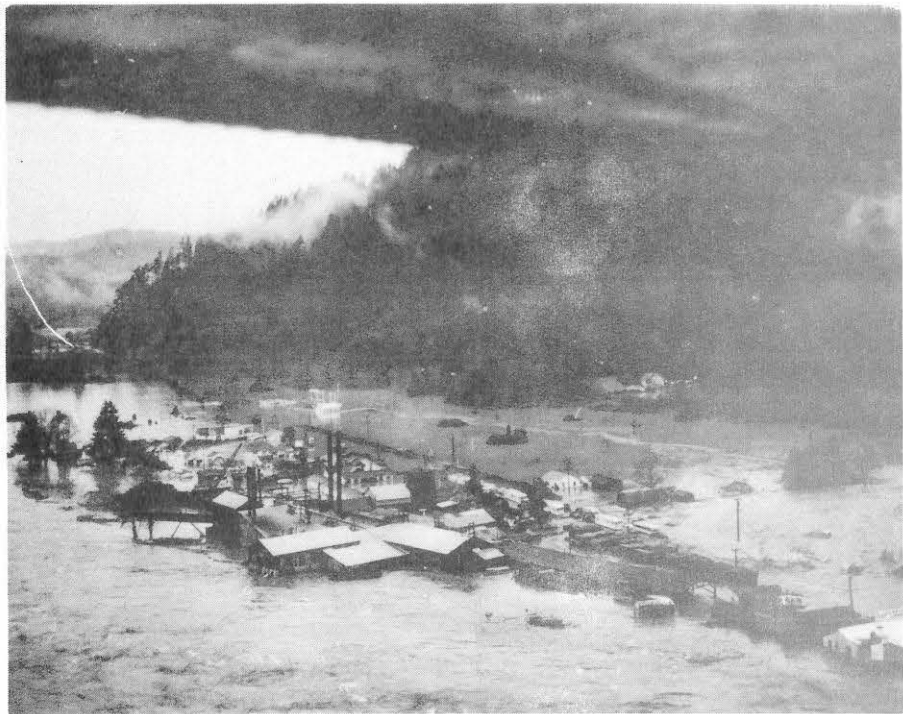
PLATE V

Klamath River at Klamath. Inundation and Destruction of Property of Lumber Mill on Right Bank.

TYPICAL INDUSTRIAL DAMAGE
Both photos, Klamath River at Klamath.

14. Damage to commercial establishments such as sawmills, wood products manufacturers, and food and dairy processing plants reached record proportions. Because of the unprecedented discharges and velocities of the various streams, in some cases whole communities were partially destroyed, particularly in the narrow river gorges of the Eel, Klamath, and San Lorenzo River basins. Typical damage to sawmills is shown on Plates V and VI.

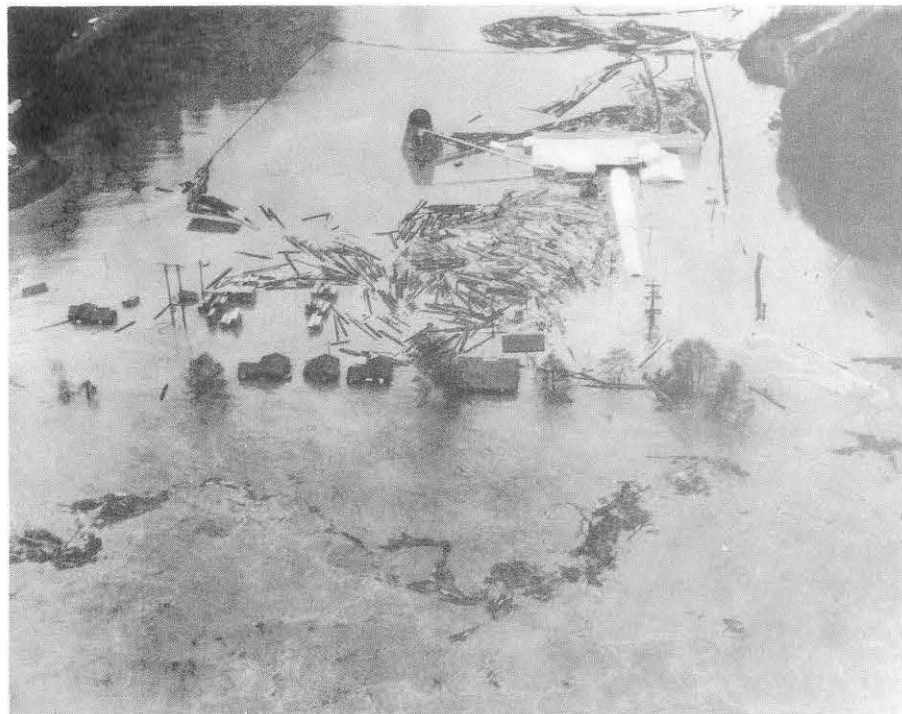
Klamath River at Klamath. Inundation and Loss of Logs and Lumber at Mill on Left Bank.

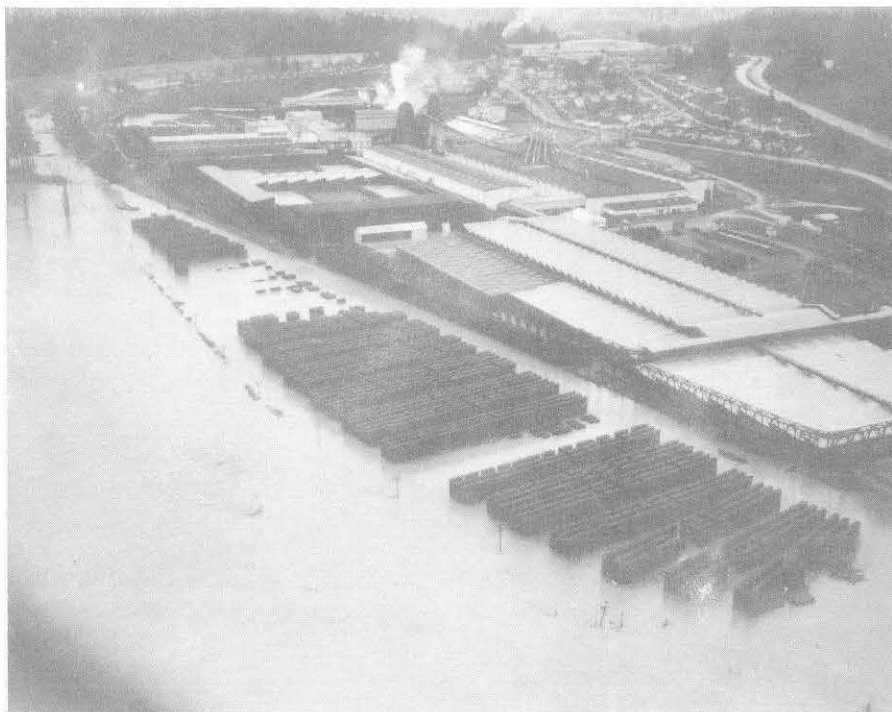
Eel River at Scotia. Inundation of Large Redwood Products Mill.

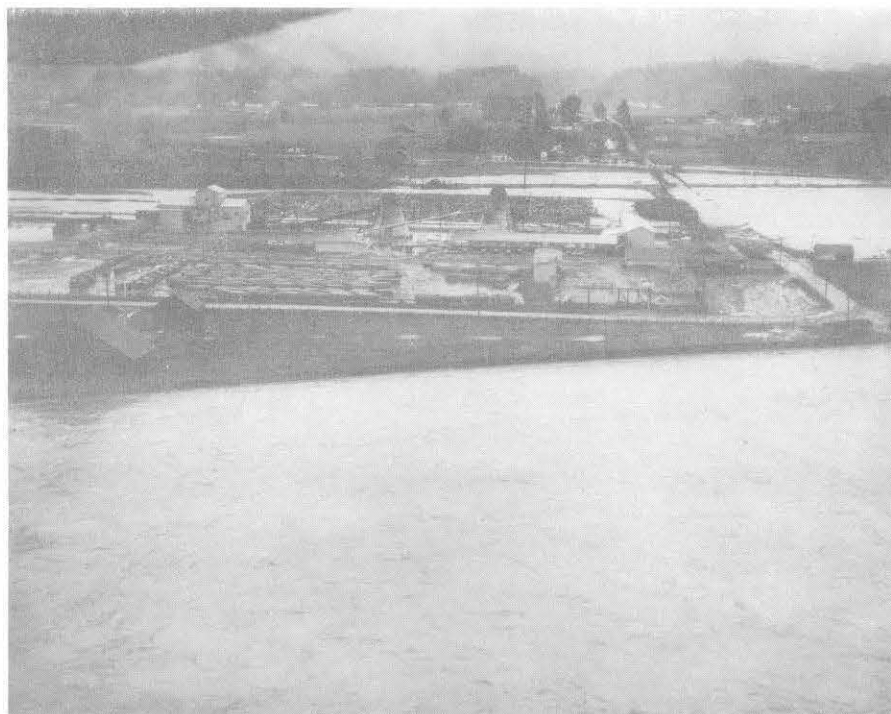
Eel River at Sandy Prairie near Fortuna. Inundation of Lumber Mill and Bank Cutting of Nearby Properties.

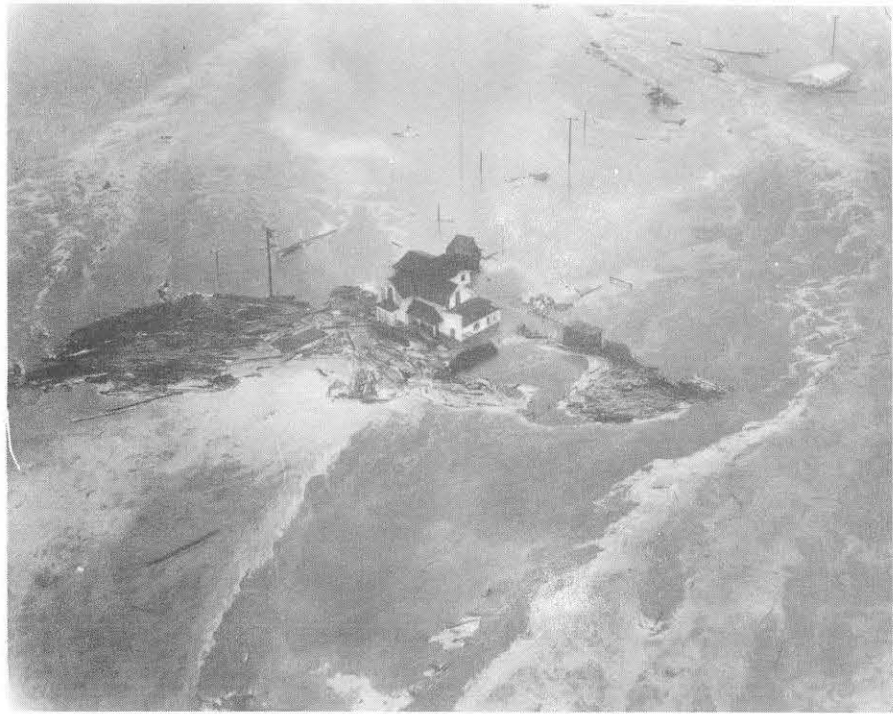
PLATE VII

Eel River near Mouth. Inundation and Debris Damage.

TYPICAL AGRICULTURAL DAMAGE
Both photos Eel River near mouth.

17. The principal damages to agriculture were loss of land due to bank cutting and river meandering, deposition of sand and gravel over cultivated areas, topsoil erosion, and deposition of debris from trees, houses, and barns on cultivated lands. Local protection works such as levees and bank stabilization works were partially destroyed or failed completely. Over 2,500 animals, including approximately 1,300 cattle, and 1,200 head of sheep were drowned in the delta area of the Eel Basin. Damage to farm buildings, farm equipment, fences, and farm machinery was extensive. Because of the frequency at which minor flooding occurs in the delta regions, farmers have learned to cope with minor flooding by moving equipment and farm animals to raised barns for safety. Due to the magnitude of the December floods, however, these precautionary measures were inadequate as the barns and buildings were washed away with resulting loss of equipment and animals. Typical agricultural damage and animal loss are shown on Plates VII and VIII.

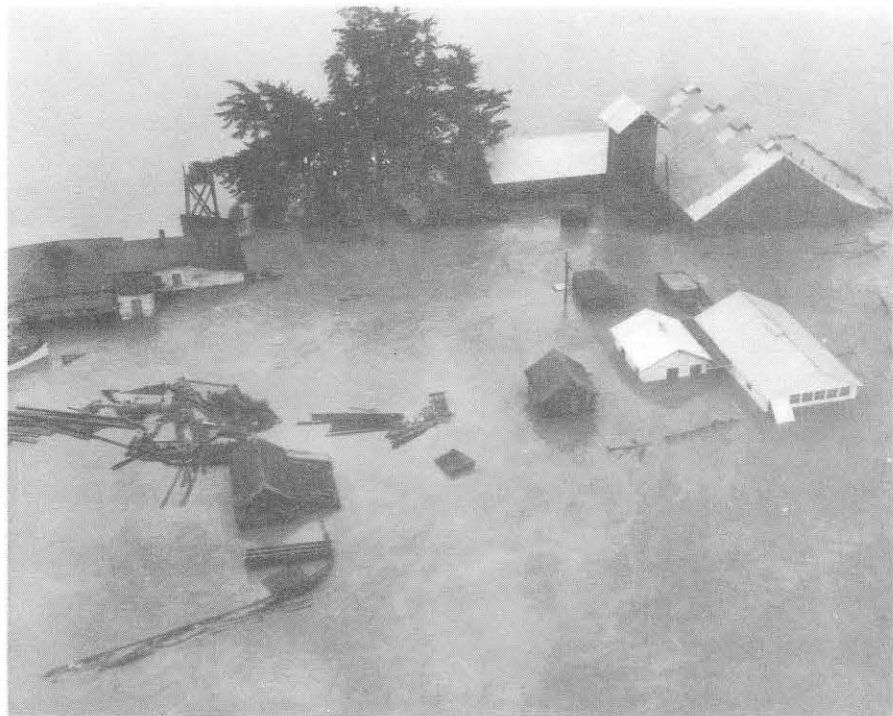
Eel River near Mouth. Closeup, Inundation of Farm Buildings.

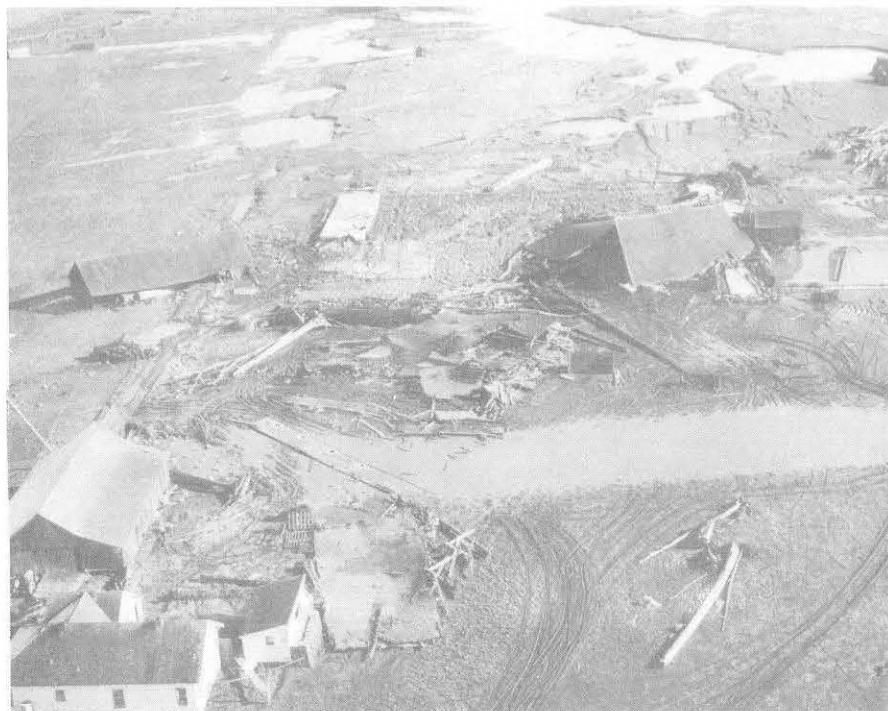
Eel River near Mouth. Building, Debris, and Sheet Erosion Damage

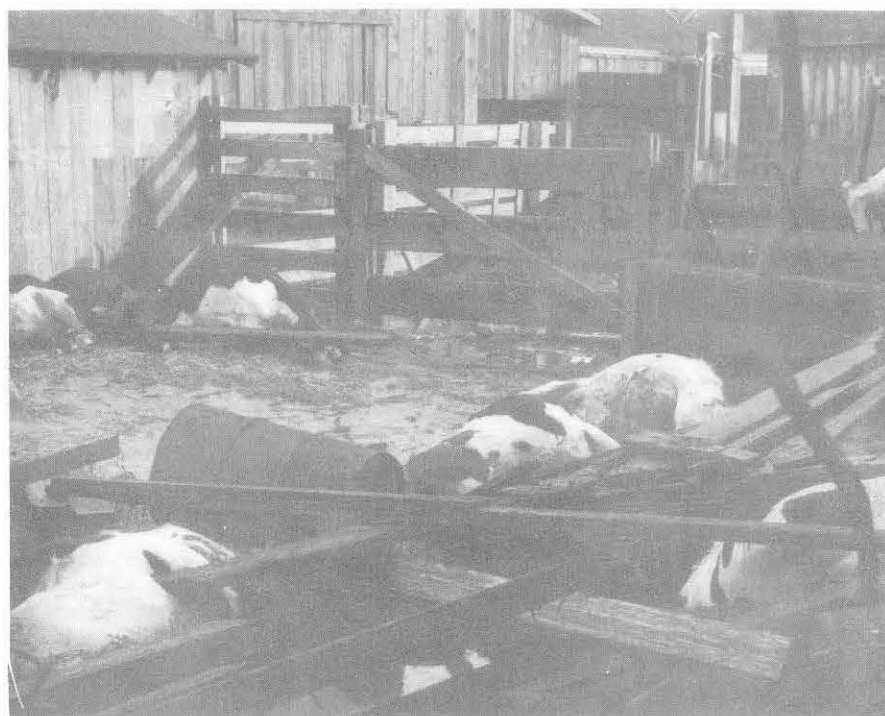
Eel River near Mouth. Losses to Dairy Herds

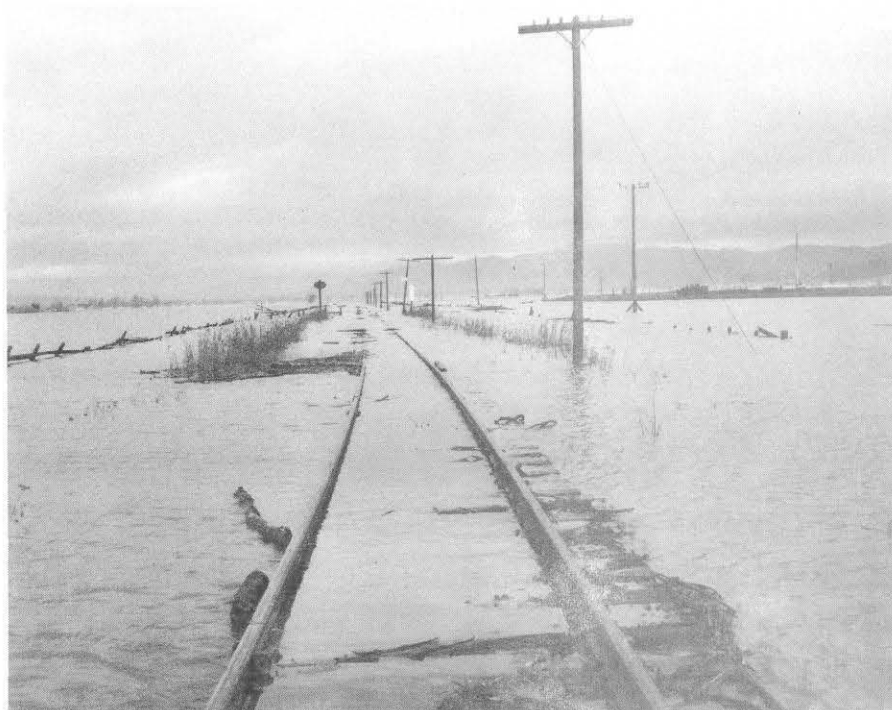
Sonoma Creek near Wingo, Sonoma County, showing inundation of track and right of way.

18. The Northwestern Pacific Railroad suffered numerous slides, washouts, and roadbed inundation damage from Healdsburg north to Eureka. Traffic was interrupted from the early stages of the flood until 6 February 1956 when operations were carried on during the daylight hours only. Full operation, except for passenger service, was restored on 15 March. This railroad is the principal means of transporting lumber products out of the area, and in addition to the physical damages, considerable indirect damage, both to the railroad and to the industries it serves, was caused by the inability of the railroad to operate. Typical railroad damage is shown on Plate IX.

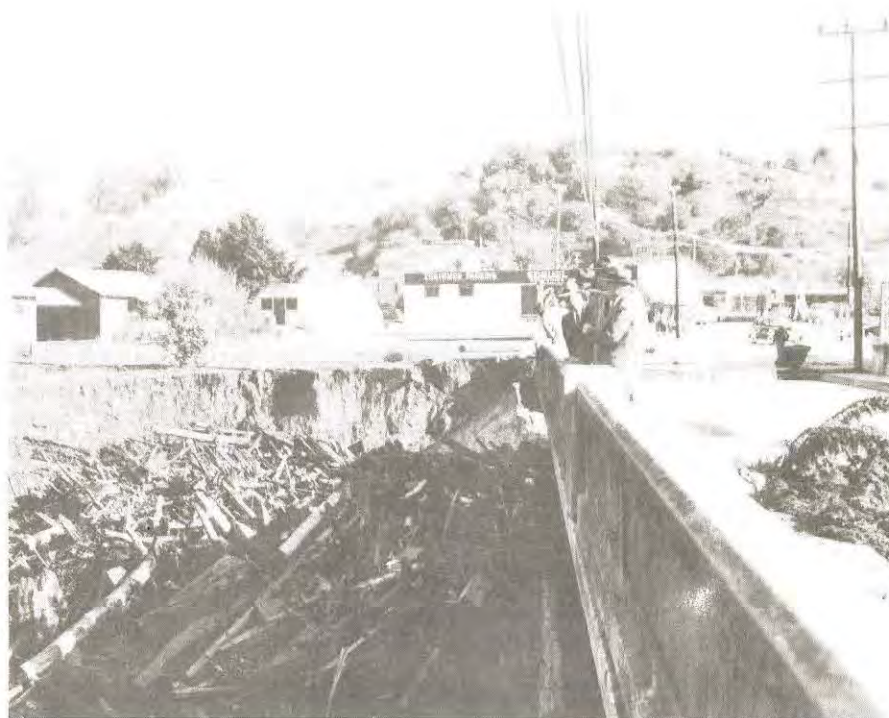
Soquel Creek at Soquel. Large Debris Jam Which
Caused Failure of Bridge.

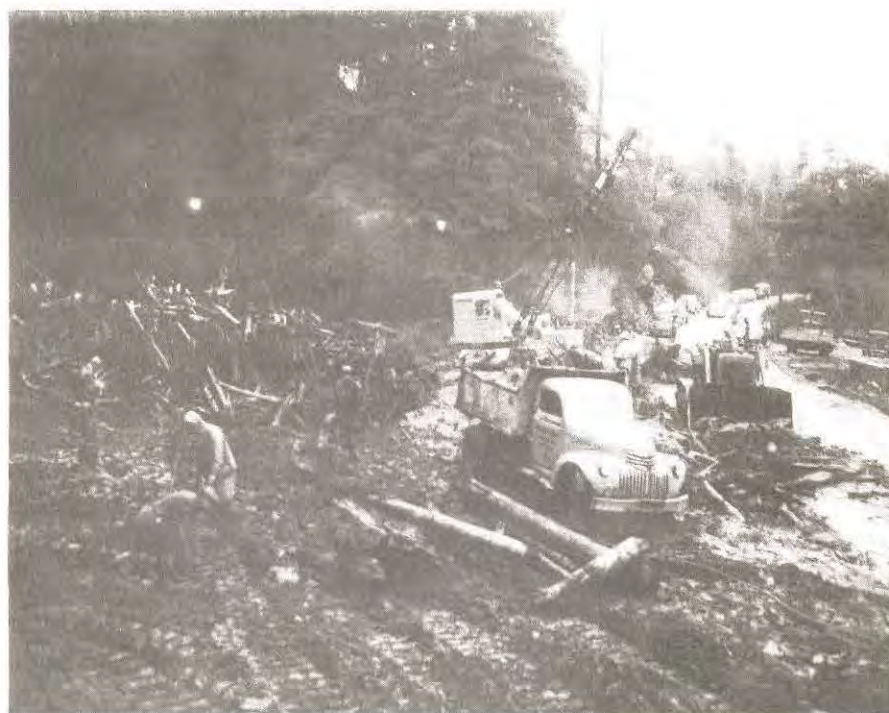
Little Creek, Santa Cruz County. Heavy Debris Deposits
on Highway.

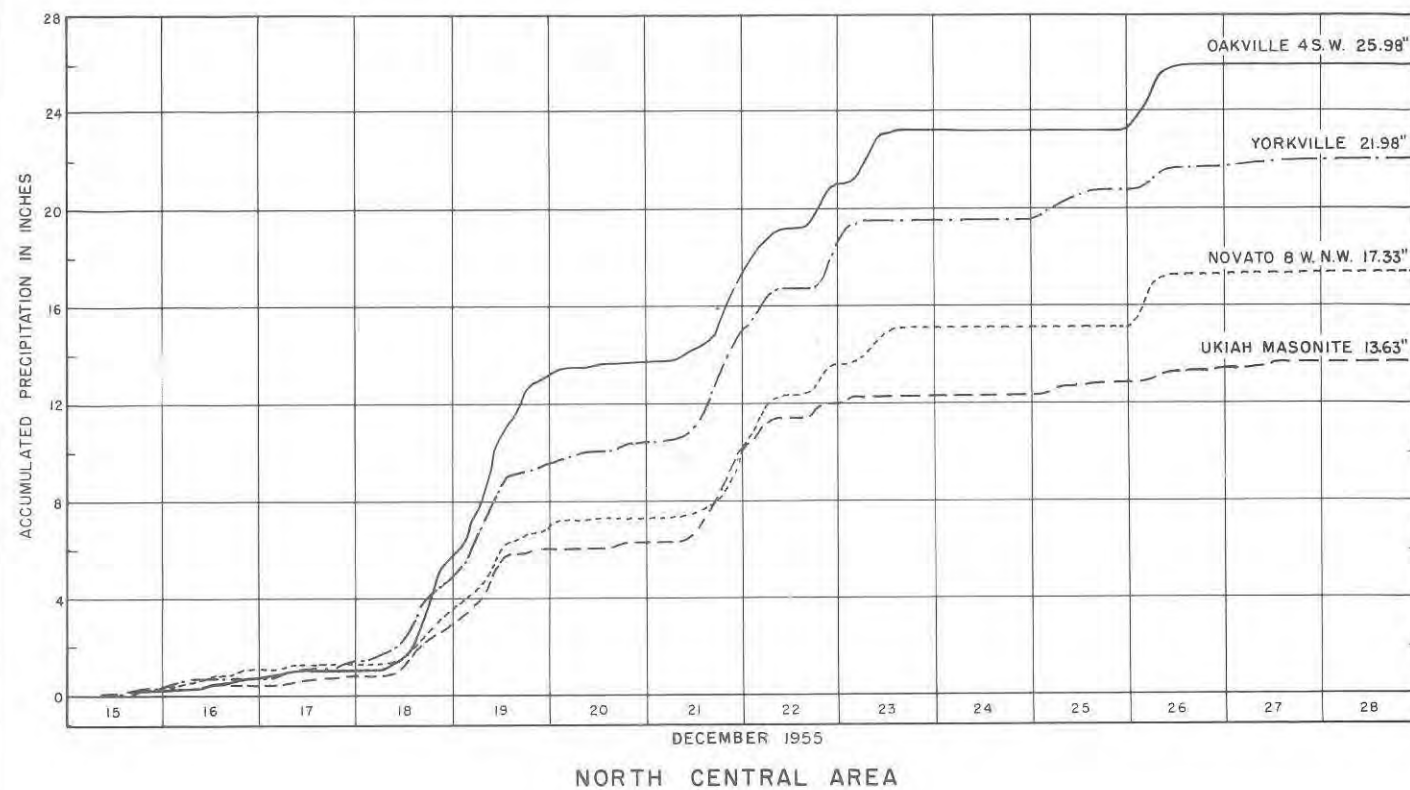
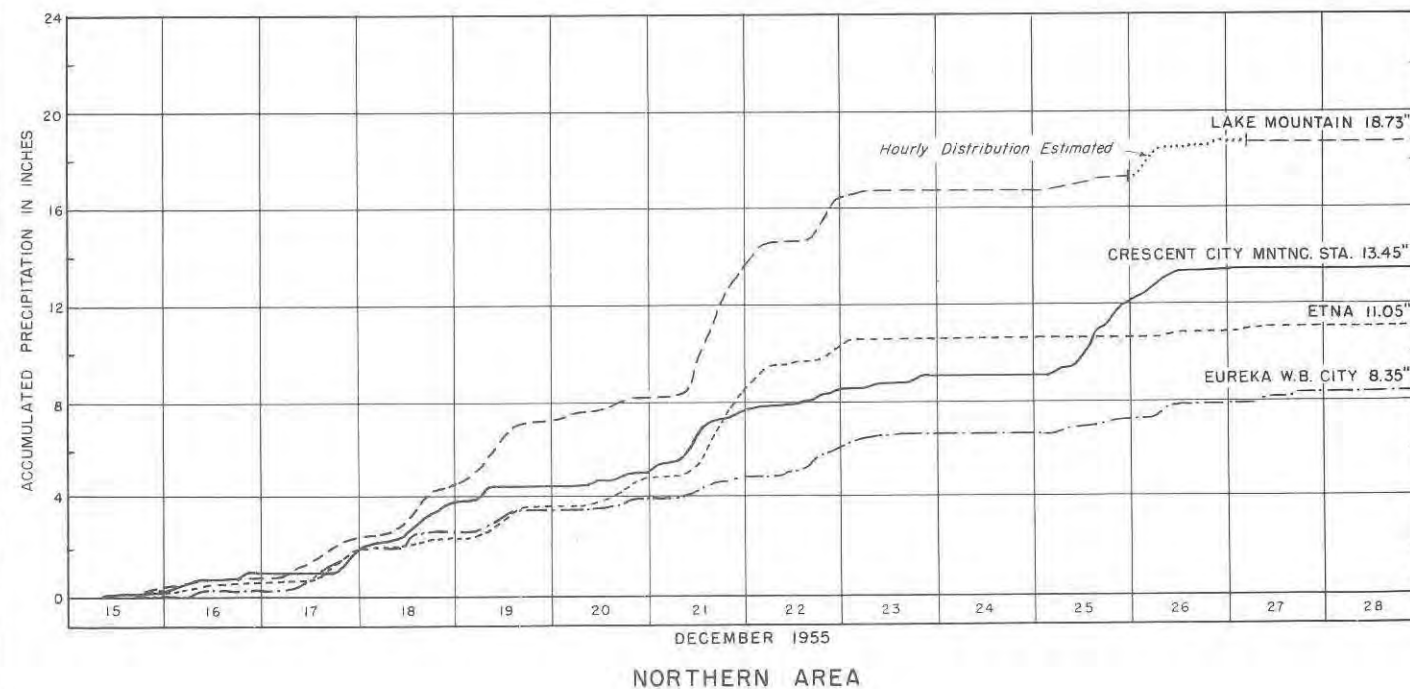
REPORT ON
FLOODS OF DECEMBER 1955
AND JANUARY 1956 IN THE
SAN FRANCISCO DISTRICT
MASS RAINFALL CURVES
STORMS OF 15-28 DEC. 1955

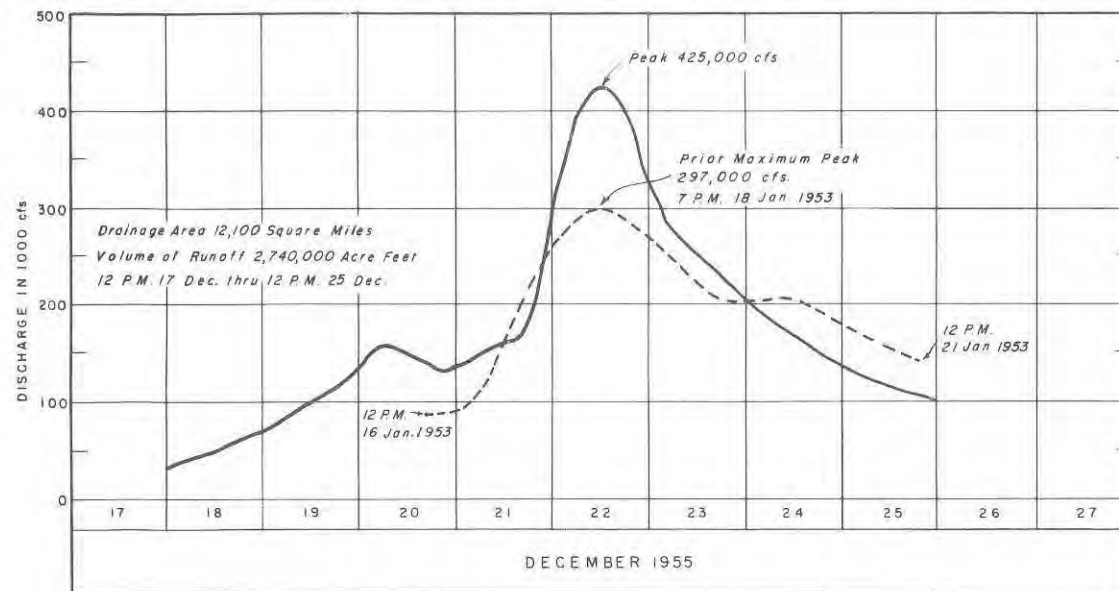
KLAMATH RIVER NEAR KLAMATH

REPORT ON
FLOODS OF DECEMBER 1955
AND JANUARY 1956 IN THE
SAN FRANCISCO DISTRICT
HYDROGRAPHS
FOR SELECTED STREAMS
