Appendix A California Emissions Estimator Model Data

Palo Alto Flood Basin Tide Gate Replacement Project - Santa Clara County, Annual

Figure 1-1 Overview of study area in South San Francisco Bay near Palo Alto.

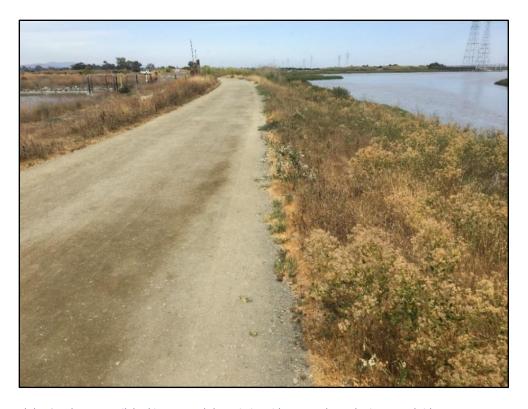
Photo 1. Adobe Creek Loop Trail, looking toward the existing tide gate, where the improved tide gate structure would be installed (July 2018).

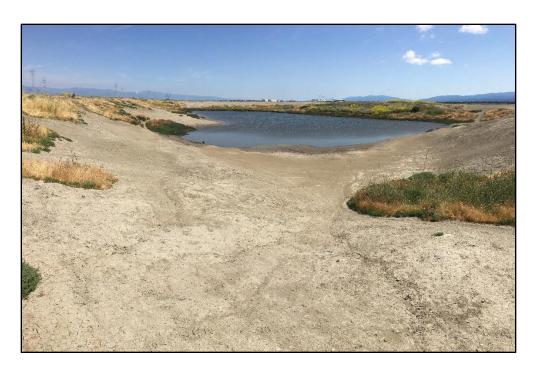
Photo 4. Borrow ditch at the center of the levee road circling Staging Area 2 (May 2019).

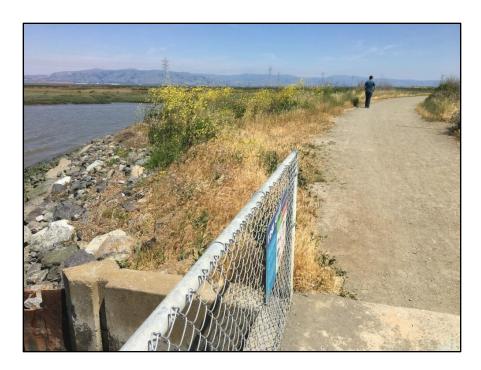
Photo 10. Part of the rip-rap apron lining the Bay side of the levee is visible on the left-hand side of this photo.

Hardscape: is limited to the existing concrete tide gate structure, which also serves as a trail along the top of the levee. Rip-rap aprons (Photo 10) are present underwater along the tide gate but were categorized as aquatic habitats for the purposes of this analysis.

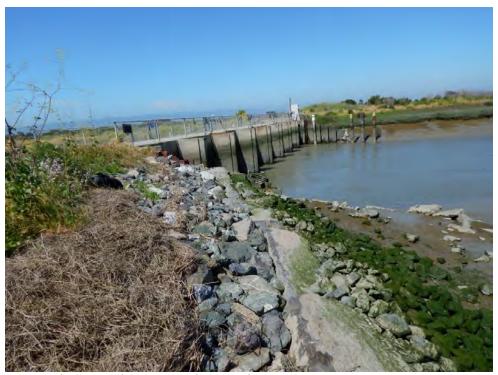
PP-4 Looking at tide gates and HTL indicators.

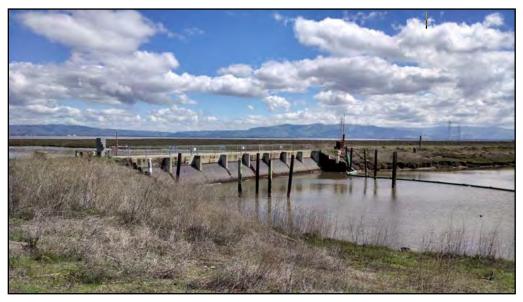
Figure 1. Existing Palo Alto Tide Gate Structure

The Palo Alto Flood Basin and tide gate structure were constructed in 1957 to control water discharged into San Francisco Bay from Matadero, Adobe, and Barron Creeks through Mayfield and Charleston Sloughs. Valley Water is proposing to replace the existing tide gate primarily because it is operating beyond its designed 50-year lifespan and the tide gate is subject to future loss of function due to sea-level rise. Figure 1 shows the existing tide gate and levee.

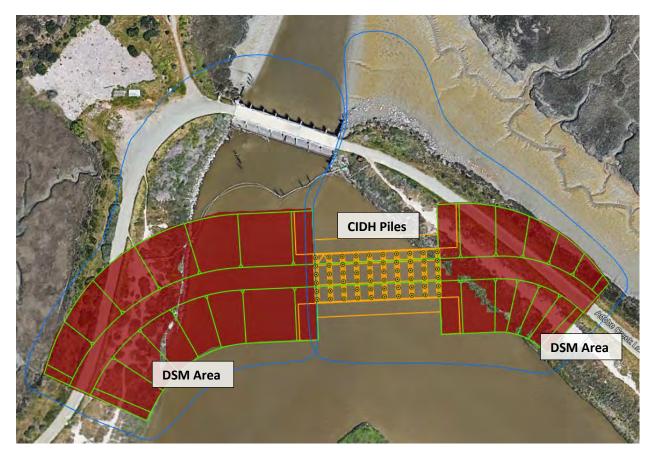
Figure 3. CIDH Pile and DSM Locations

Figure 3 shows where the CIDH piles will be installed for the new tide gate and where DSM will occur under the new levee.

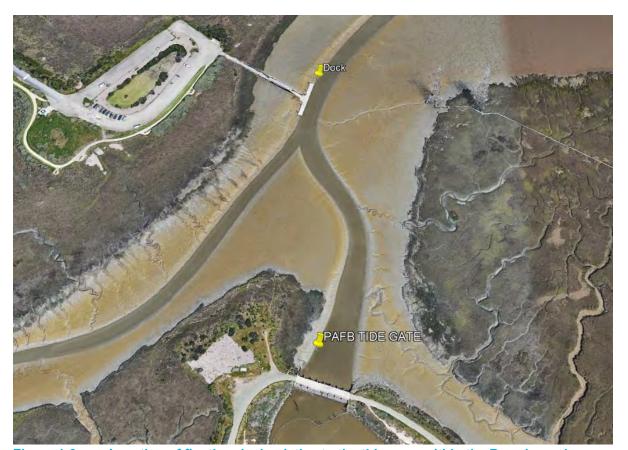
Location of floating dock relative to the tide gage within the Bay channel Figure 1-3

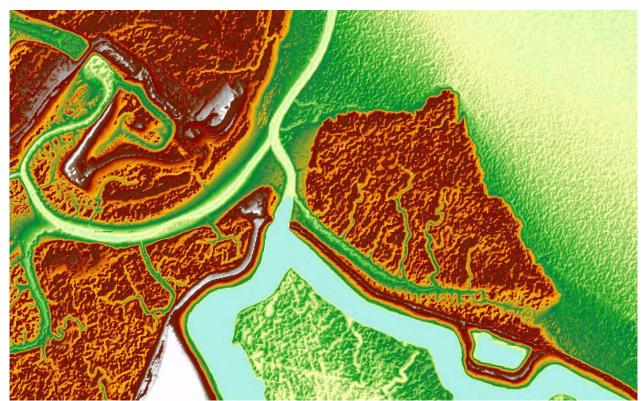
Figure 2-1 Screen shot of USGS 2m seamless DEM covering the model area.

Based on the metadata file that can also be obtained from the above link, the DEM is a combination of many topographic (LiDAR) and bathymetric surveys performed over various periods of time and depends on the region of the bay considered. LiDAR data is typically from the period between 2010 to 2012. Bathymetry survey data varies, and LiDAR is used to the low tide level. Most of this area was collected in 2004 by USGS. The DEM is used to represent model mesh bed elevations as-is without performing any field validation. There are some concerns that the DEM may be underestimating water depths in some areas. For example, at the gates the DEM reports a depth of -1.71 feet (NAVD88), while the bottom of the existing gate is minimally at -2.2 feet (NAVD88). We would expect the ground level to be level or below the bottom of the gate flaps. Also, the bed level of the channel downstream of the gate rapidly rises to a level of about +0.3 feet (NAVD88), which is likely also somewhat higher than reality since these channels don't typically completely dry out at low tide. If future phases of this project are carried out, requiring more detailed analysis, then it is recommended to perform field bathymetric surveys for the channel areas. Considering that the model bathymetry in the channels may be higher than exists in the field, the study places more emphasis on qualitative comparisons between model simulations of alternatives versus quantitative comparisons. Also, more weight is placed on comparison of flow velocities versus bed shear stresses, as the bed shear stresses are also sensitive to uncertainties of the bottom bathymetry levels in the channels and comparing to typical soil shear strengths is not practical at this stage of the investigation. Note that no data was available to perform a calibration/validation of the model, thus model inputs were based on best available data and engineering judgement from previous studies performed in the Bay. The regional San Francisco Bay model used for providing boundary conditions into this model was thoroughly calibrated for the FEMA studies.

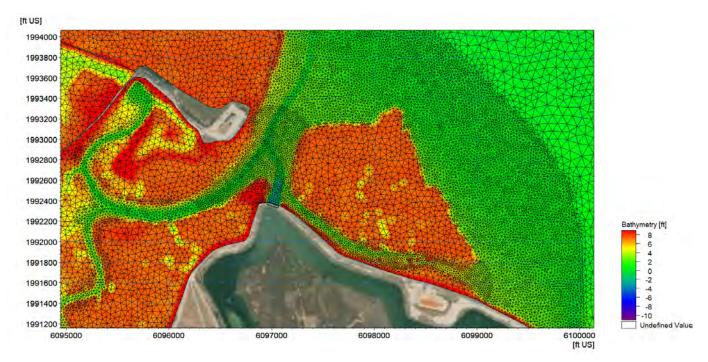
Figure 2-3 Existing Gate MIKE 21 model mesh zoomed in around gate area.

Figure 2-3 and Figure 2-4 show the model meshes zoomed in around the area of interest for the existing gate and proposed gate scenarios, respectively.

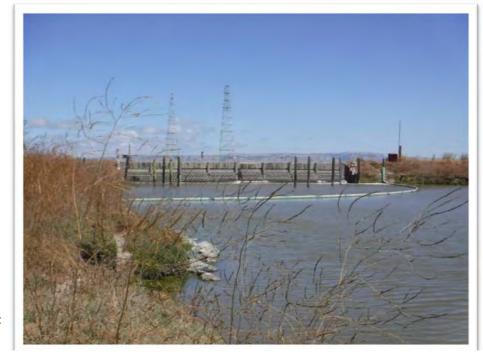
(IMG-2494) View of the Palo Alto Levee and Tide Gate with a pedestrian on the Adobe Creek Loop Trail as it crosses the tide gate.

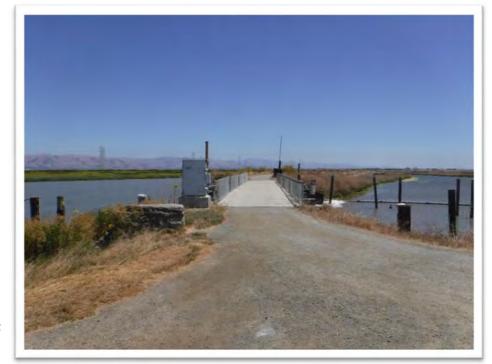
(IMG-2500) View of the top of the tide gate from the first Project staging area.

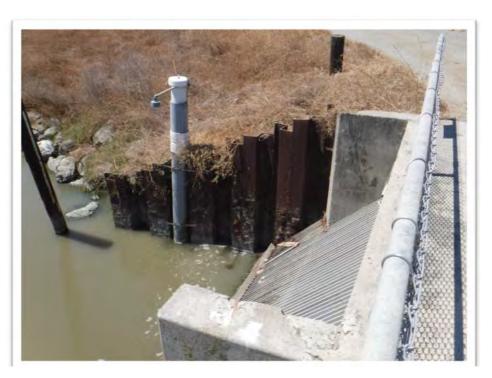
Photograph No. 6 **Direction:** Northwest **Date:** 08/01/18

(IMG-2503) Close-up view of the tide gate and metal piers as they retain the western segment of the levee.

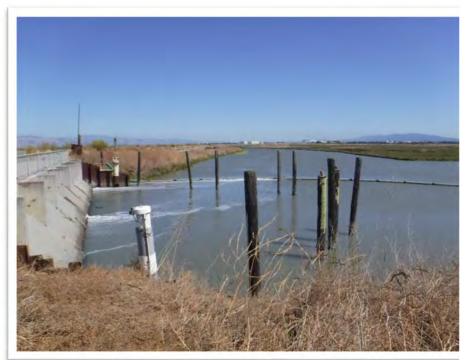
(IMG-2572) View of the tide gate with its current 16-cell configuration looking towards the eastern levee segment where the new 32-cell tide gate will be constructed.

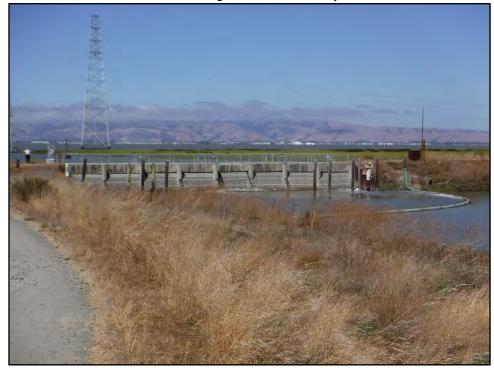
P5b. Description of Photo: (August 1, 2019, IMG-2493) A view of the historic period levee and tidal gate looking northnortheast with the Adobe Creek Trail in the left foreground.

*P3b. Resource Attributes: HP39 (Other): Levee and tide gate structure

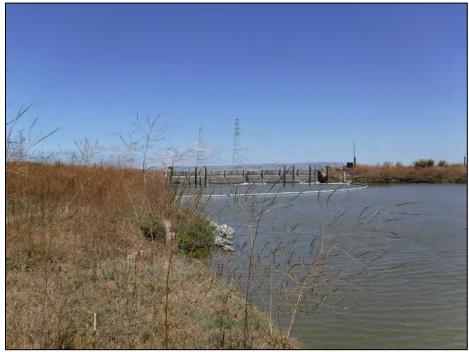
(IMG-2492) A view of the historic period levee and tide gate looking north-northeast.

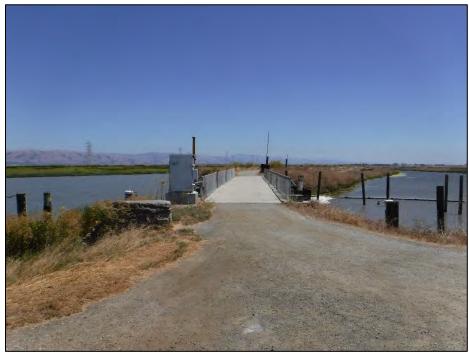
(IMG-2500) A view of the tide gate looking east with the San Francisco Bay to the left (north) and Palo Alto Flood Basin to the right (south).

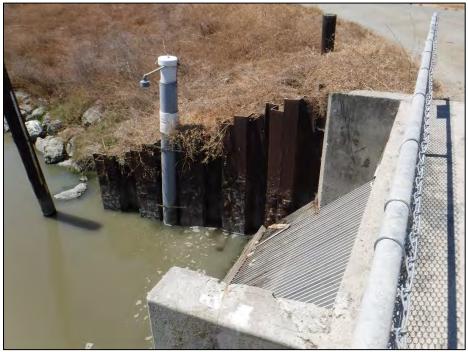
(IMG-2503) A close-up view (looking west) of the tide gate and the metal pilings that support the edge of the levee west of the gate.

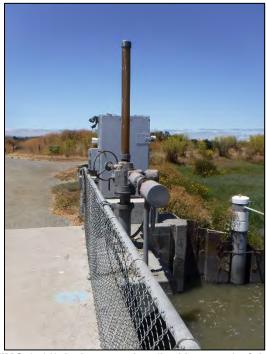
(IMG-2506) A close-up view (looking west) of the bay side of the tide gate and the gate control.

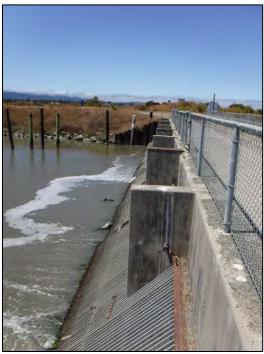
(IMG-25011 A view (looking west) of the tide gate and the Adobe Creek Loop Trail as it continues west.
