School-Focused Road Safety Assessment

VANDORA SPRINGS ELEMENTARY SCHOOL

Pilot Project Report

November 19, 2021

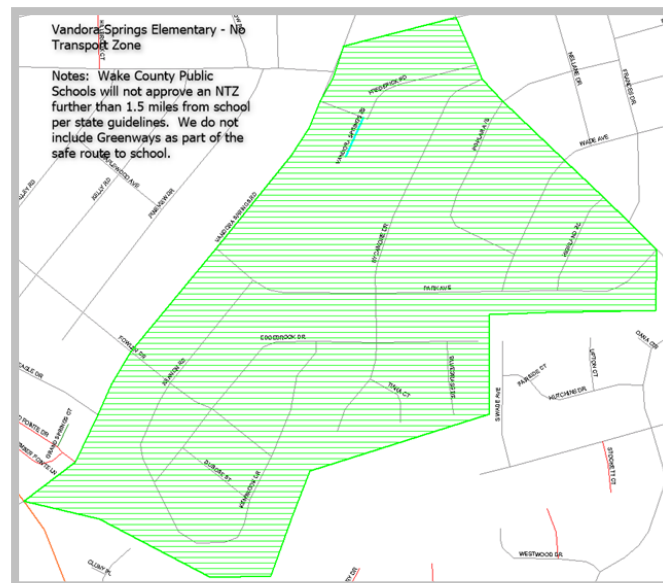
Figure 1: Vandora Springs Elementary School Transport (NTZ)

NTZ (No Transport Zone) was revised going into the 2021-2022 school year. Neighborhoods on the west side of Vandora Springs Road were removed from the NTZ due to a lack of infrastructure, such as sidewalks, crosswalks, stop lights, and crossing guards. The current boundaries of the NTZ are shown in the image below.

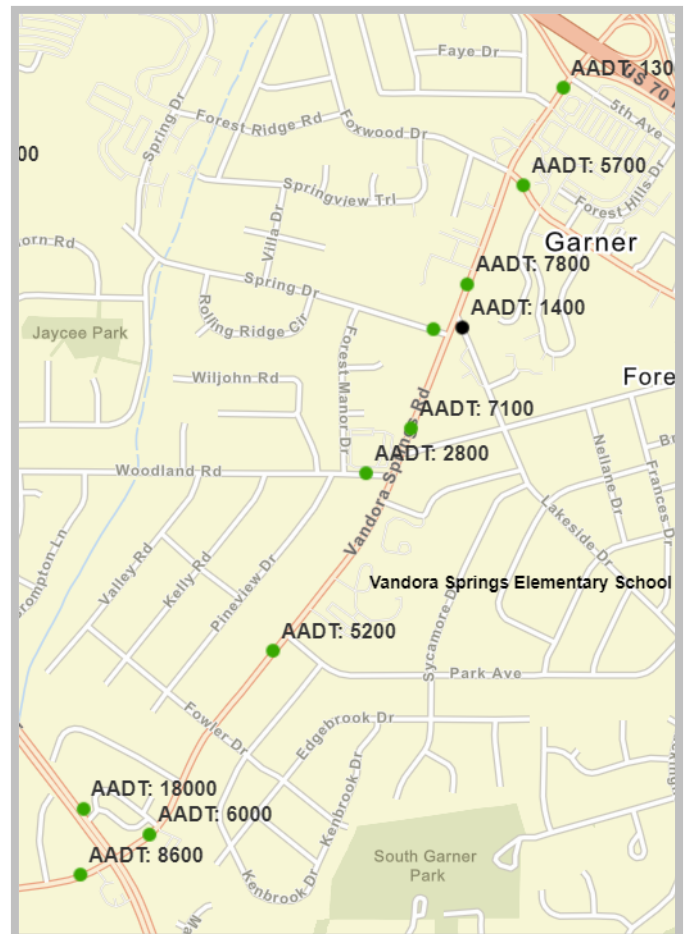
Figure 2: Annual Average Daily Traffic (AADT)

The most current Annual Average Daily Traffic (AADT) volume data from 2019 shows that Vandora Springs Road carries between 5,000 and 7,000 vehicles per day in the section of interest. Woodland Road carries 2,800 vehicles per day near its intersection with Vandora Springs.

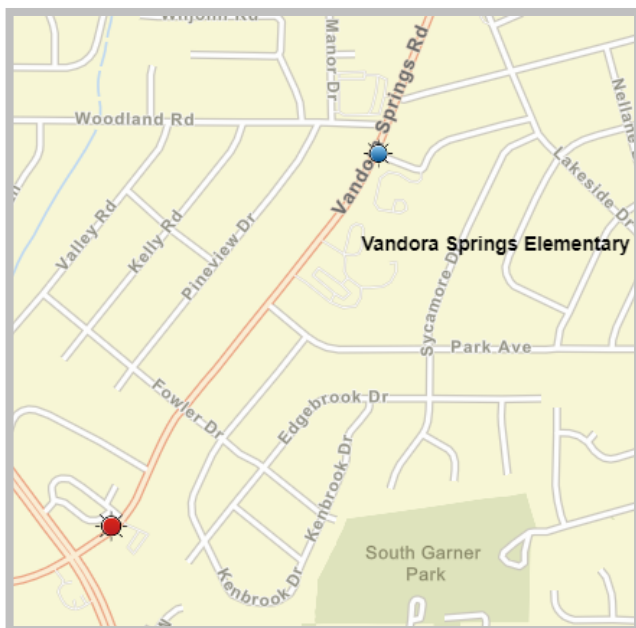
Figure 3: Bicycle Crashes, 2007-2020

Pedestrian and bicycle crash data from 2007 to 2020 show that there has been one pedestrian crash and one bicycle crash near the school in that time period. The bicycle crash involved a motorist failing to yield and striking an adult bicyclist at the intersection of Vandora Springs and Frederick. The pedestrian crash was farther south, near the intersection with Timber Drive, and involved a person struck while dealing with a disabled vehicle. A full crash report is included in the appendix of this report.

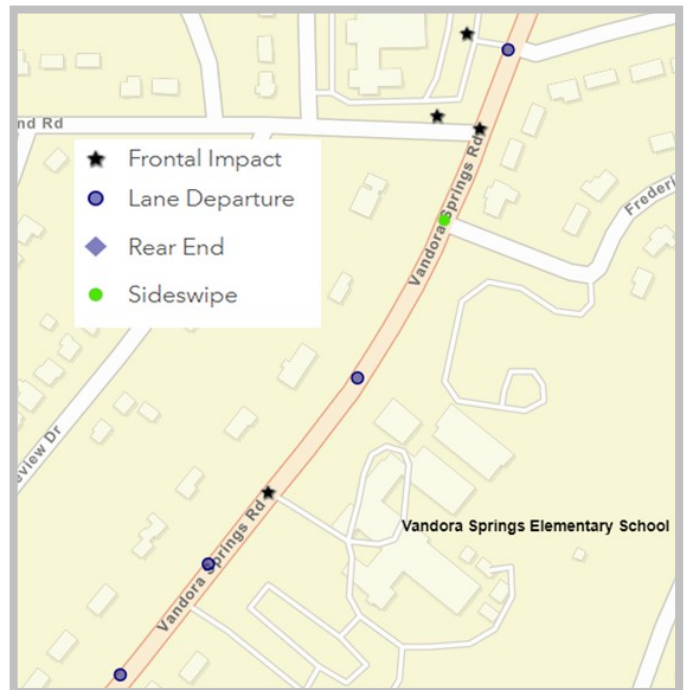
Figure 4: Total Crash Data, 2016-2020

Total crash data (involving any parties, not just pedestrian or bicyclists) from 2016 to 2020 show that there have been nine crashes near the school as shown in the map in the next column.

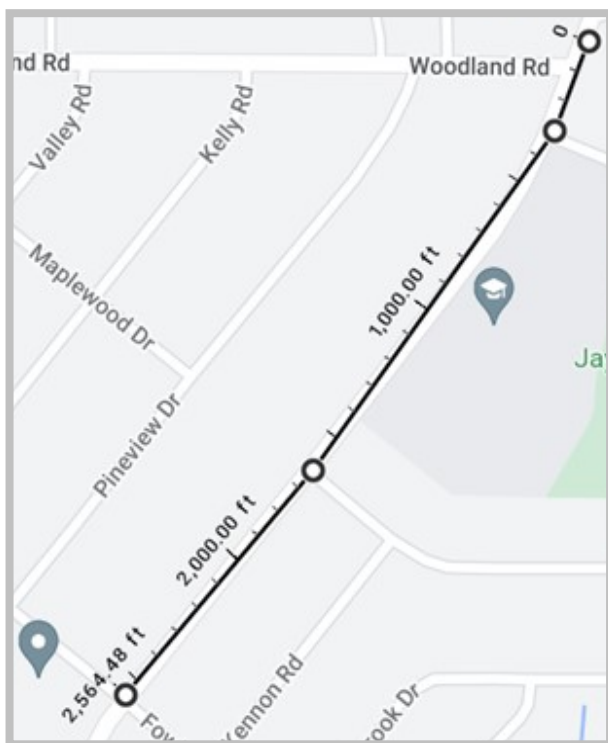
Figure 5: Map of Field Review Route

The RSA team walked from Garner Town Hall down Vandora Springs Rd to Vandora Springs Elementary School at 11am on the day of the RSA workshop. The team focused attention on the intersections immediately adjacent to the school on Vandora Springs Rd, as well as the stretch of Vandora Springs Rd between Woodland Rd and Park Ave.

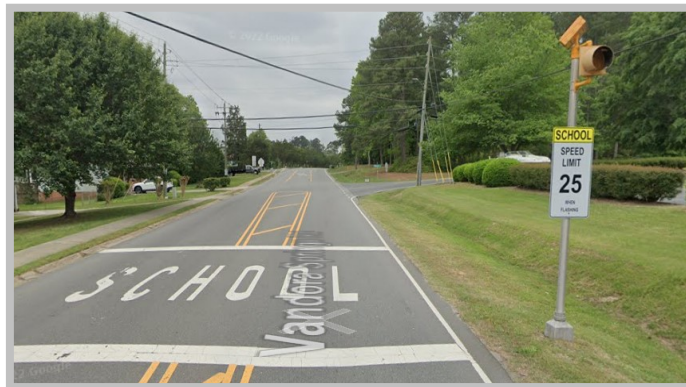
School zone speed limit is 25mph and there are flashing solar-powered speed signs on each side of the school zone, as well as school zone striping on the pavement. Sight distance is good in all but one direction (looking south from Woodland as the road rises).

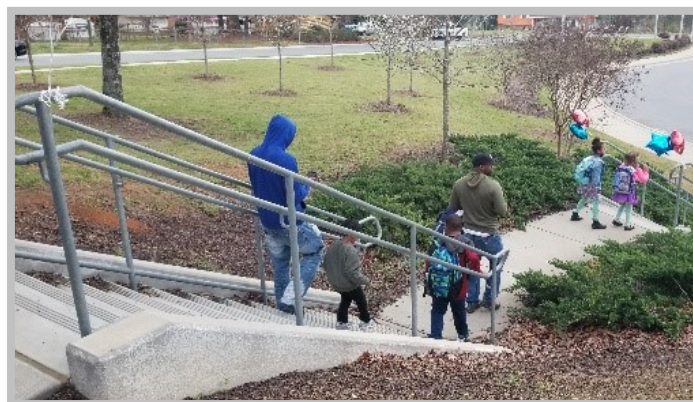
There is continuous sidewalk on the eastside of Vandora Springs Road which connects to a path on the school campus leading to the front entrance, separate from vehicular traffic.

Photo of stairwell connecting Vandora Springs Rd sidewalk to campus sidewalk taken by Jennifer Delcourt

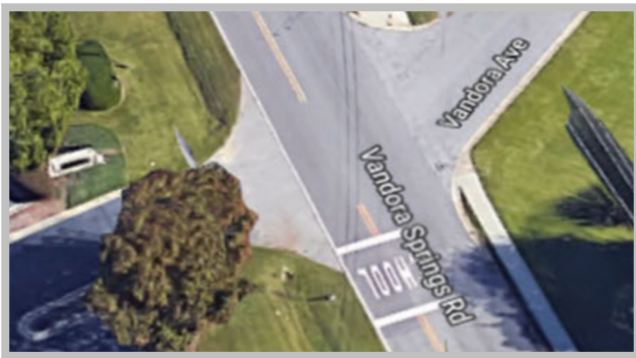
- A portion of the northbound lane on Vandora Springs Rd is approximately 18' wide with curb and gutter, beginning at Vandora Ave until a striped center lane emerges just before Lakeside Drive. The southbound lane is 9' with shoulder striping and ditch. Several team members have observed vehicles speeding to pass each other in the single northbound lane.
- Sidewalk is present on the east side of the road only.

Screenshot taken from Google maps, showing Vandora Springs Road where northbound lane becomes wider.

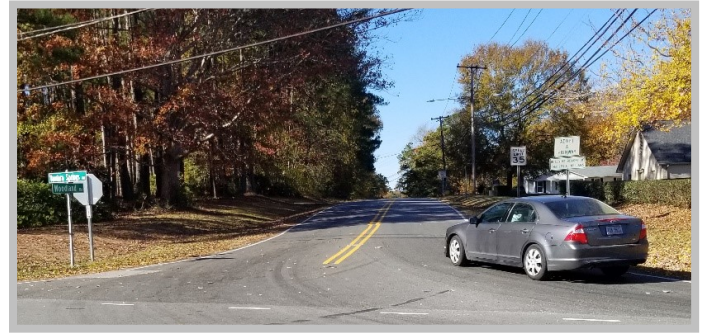
- There is no marked crossing of Vandora Springs Rd north of the school. A marked crossing was removed from the intersection of Vandora Springs Rd at Woodland Rd in 2017.
- There are no sidewalks along Woodland Rd; the shoulders are narrow, and worn paths are visible in some places on both sides of the roadway.
- There is poor sight distance at the intersection of Vandora Springs Rd & Woodland Ave looking south due to the crest and curve in the road in front of the school.

- The geometry of the Vandora Springs Road and Woodland Drive intersection is widest at the northwest corner, making it an easy turn that allows vehicles to maintain speed (see photo).
- There is a new high-visibility pedestrian warning sign on the north side of the Vandora Springs & Woodland Drive intersection, but there are no crossing facilities.

Photo of intersection of Woodland Drive and Vandora Springs Road taken by Jennifer Delcourt

Woodland Rd	Pedestrians walking along shoulder on Woodland Rd	Add sidewalks along Woodland Rd	Mid-term (2-5 years)	TBD	Town of Garner
Vandora Springs Rd to Park Ave	Existing unenhanced crossing	Evaluate crosswalk location at Park Ave to determine if it should be removed, relocated, or enhanced.	Short-term (less than 2 years)	Low	Town of Garner & NCDOT

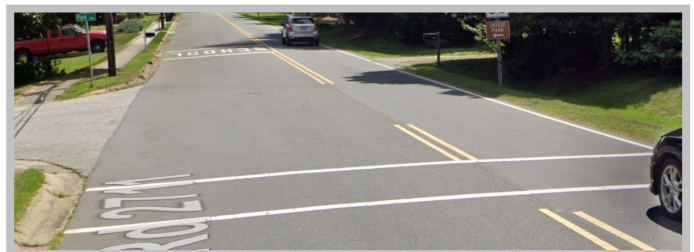
- There is a crosswalk on Vandora Springs Rd south of the school at Park Ave. It has no curb ramps and connects to sidewalk only on the east side of Vandora Springs Rd. (See photo)

Photo of crosswalk on Vandora Springs Road at Park Ave, screenshot taken from Google Maps

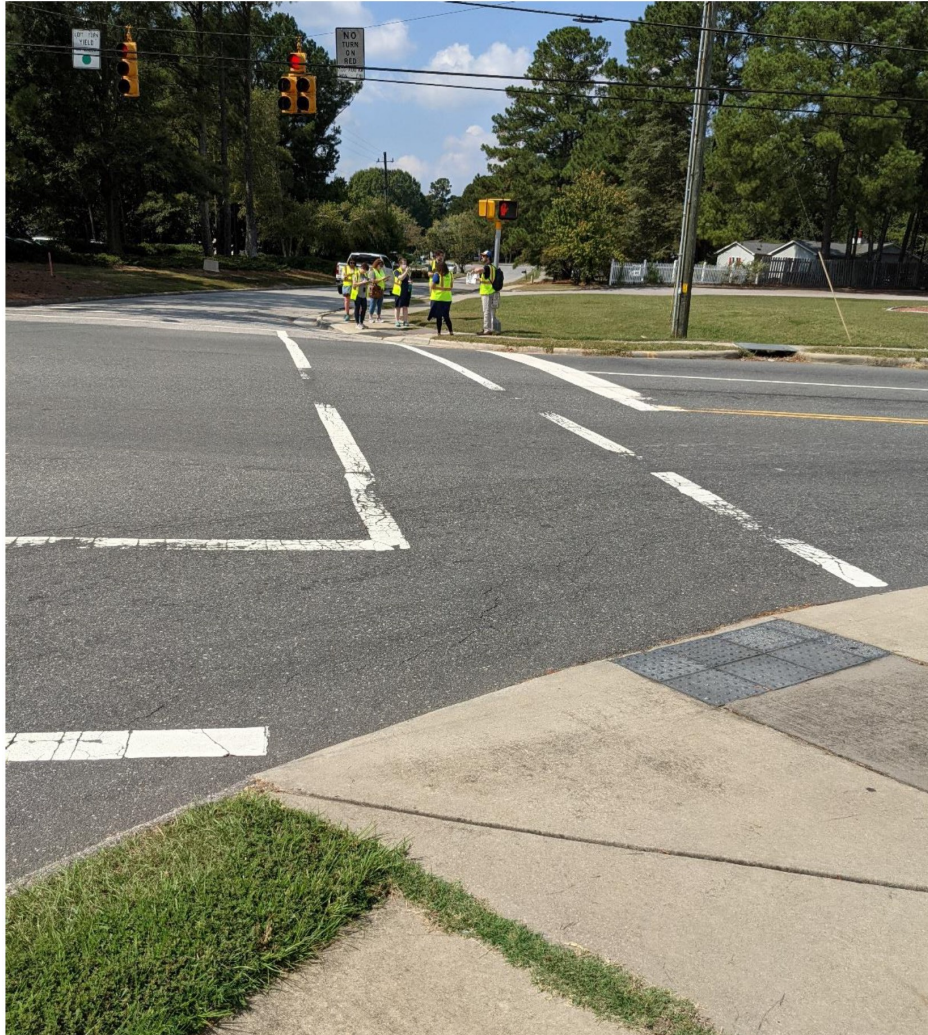
1 - Vandora Springs Rd at 7th Ave/Foxwood Dr., facing west

- Standard crosswalk striping, beginning to fade
- Curb ramps with truncated dome, but only one truncated dome to cross west; missing one facing crosswalk to go south
- Pedestrian crossing signal

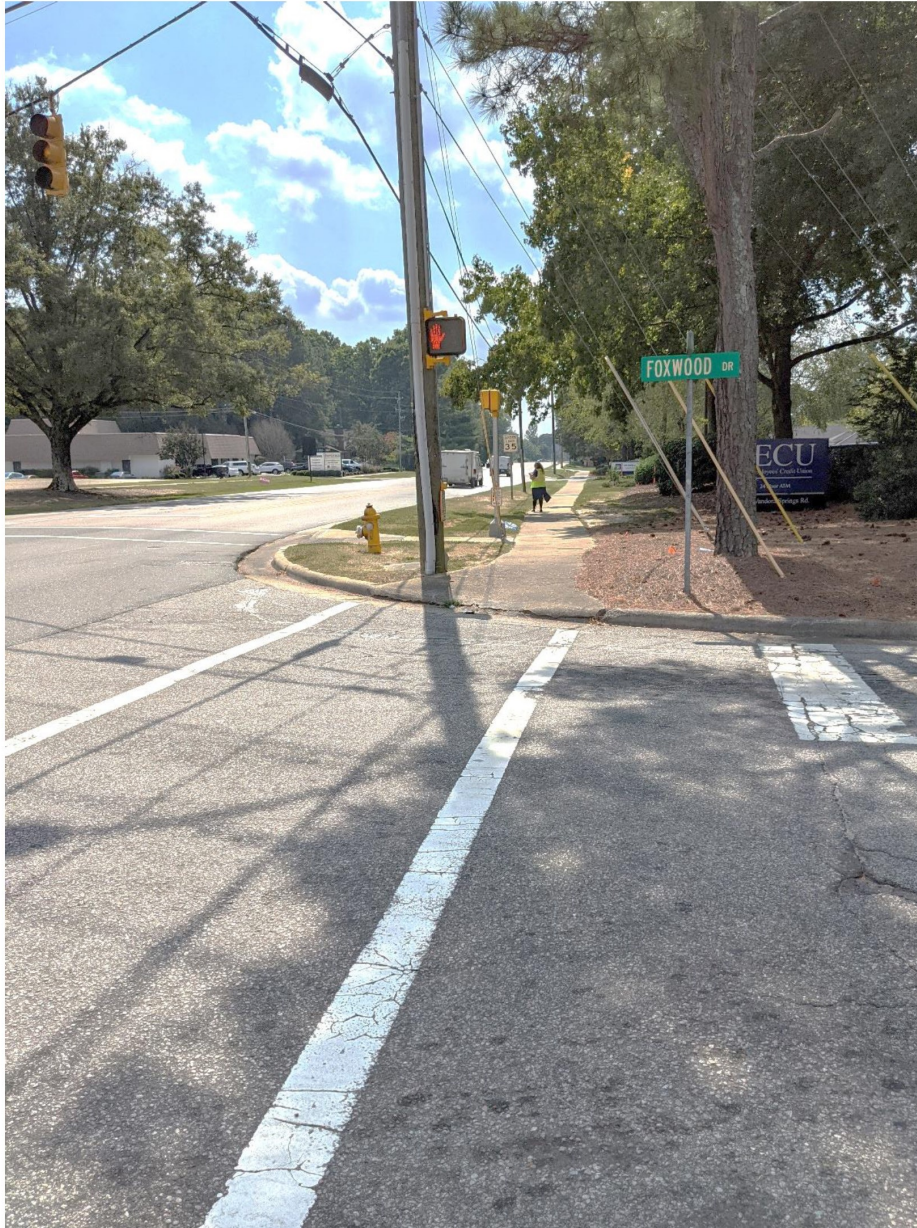
2 - Vandora Springs Rd at 7th Ave/Foxwood Dr., facing south

- Standard striping crosswalk present
- Pedestrian operated crossing signal
- Curb ramp missing truncated dome and in need of maintenance to repair cracked pavement

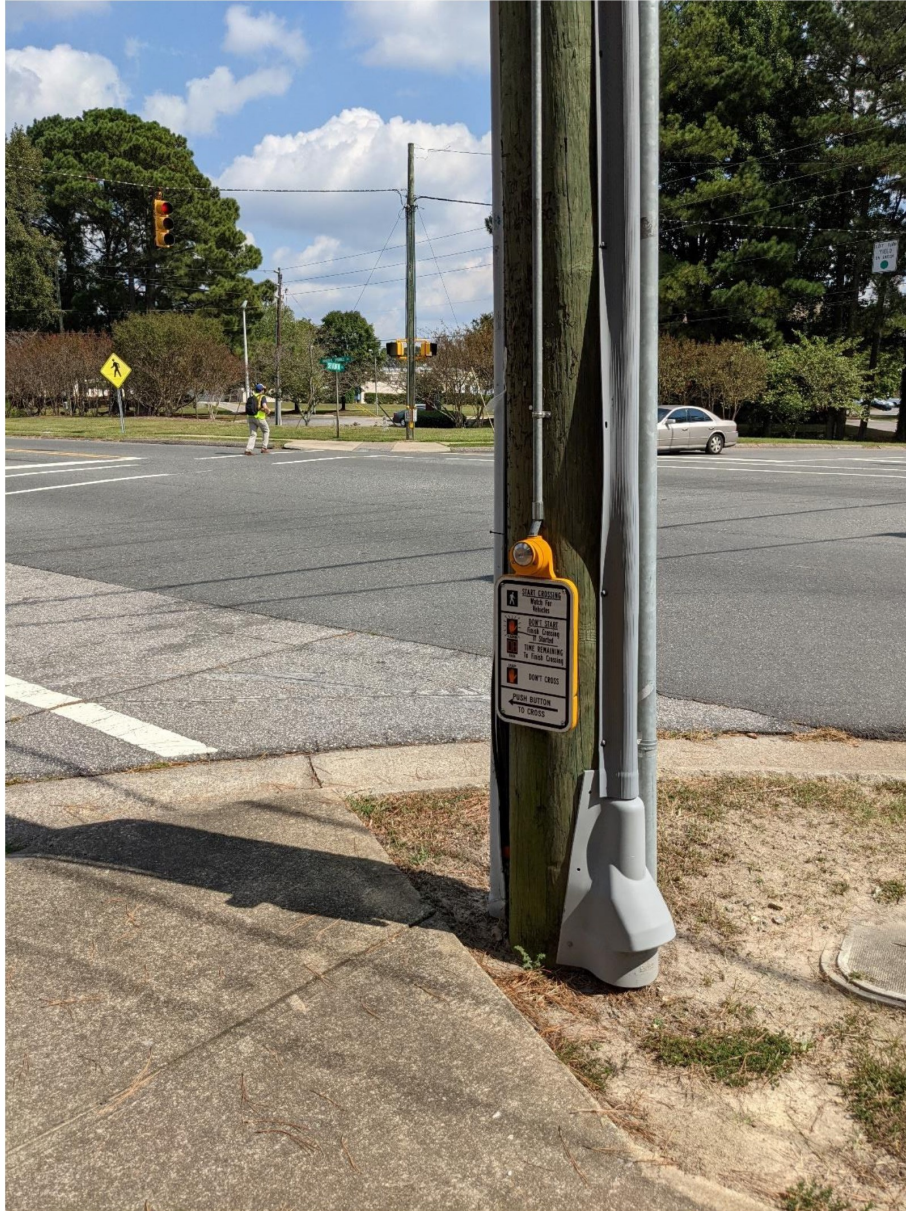
3 – Vandora Springs Rd at 7th Ave/Foxwood Dr.

- Good example of a pedestrian push-button
- Pedestrian push-button is installed at appropriate height and spot for someone in wheelchair

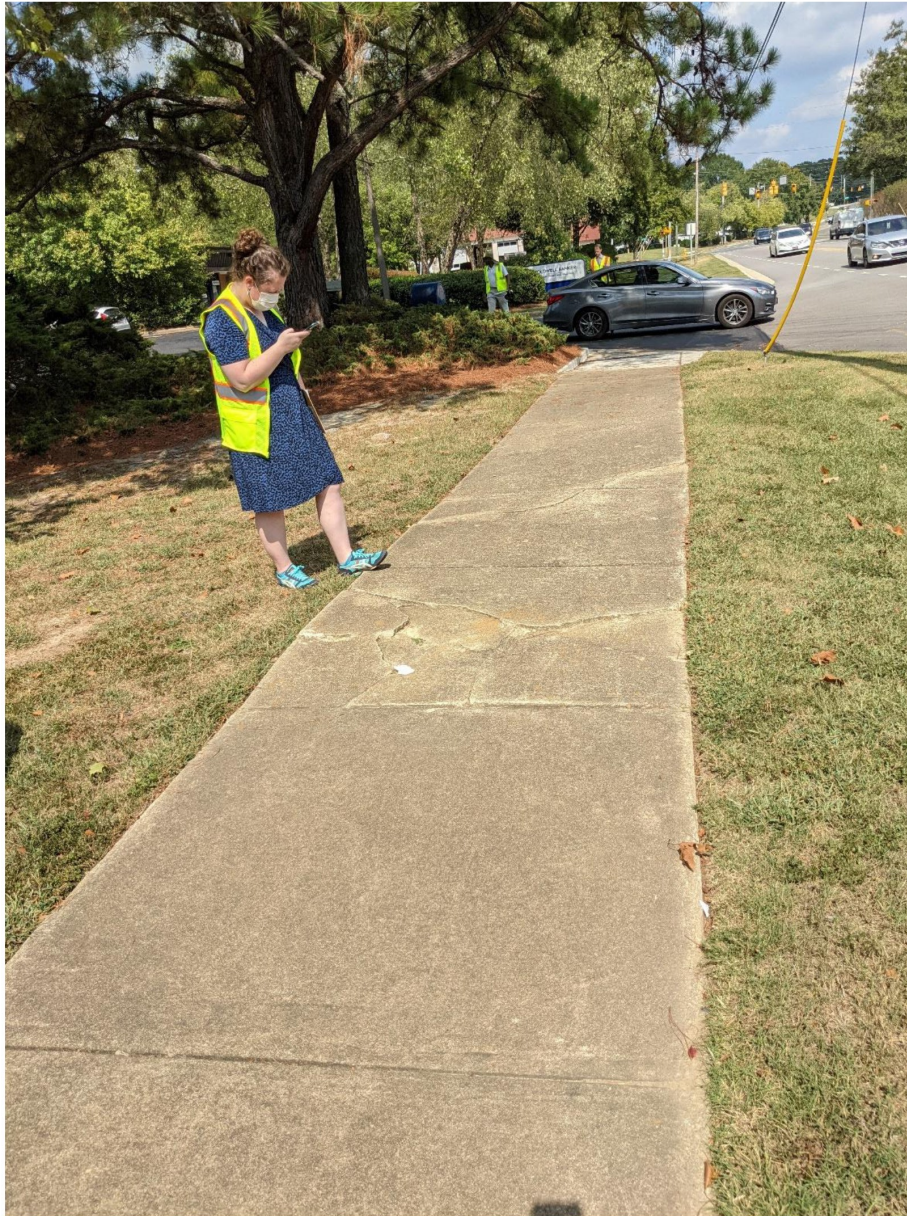
4 – Vandora Springs Rd at Business Driveway, facing north

- Cracked sidewalk
- Car blocking pedestrian crossing
- Grass strip provides good buffer between pedestrians and vehicular traffic

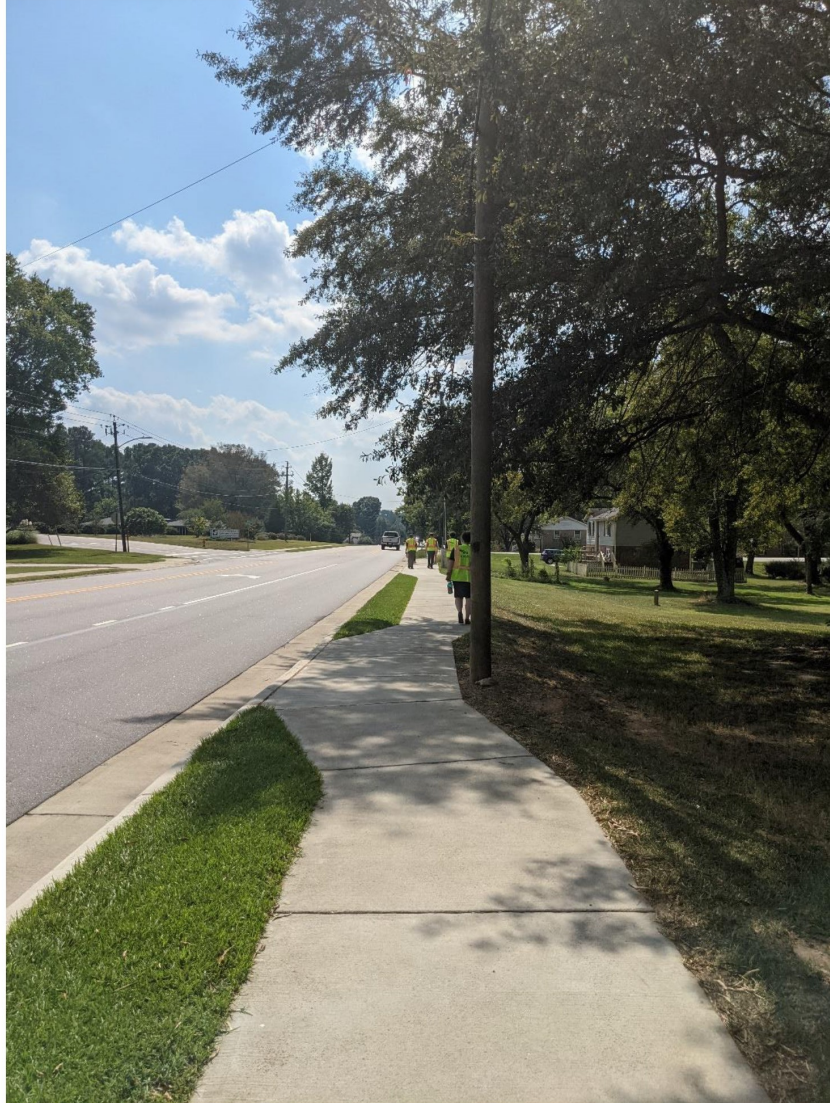
5 – Vandora Spring Rd, facing south

- Sidewalk path diverts around utility pole

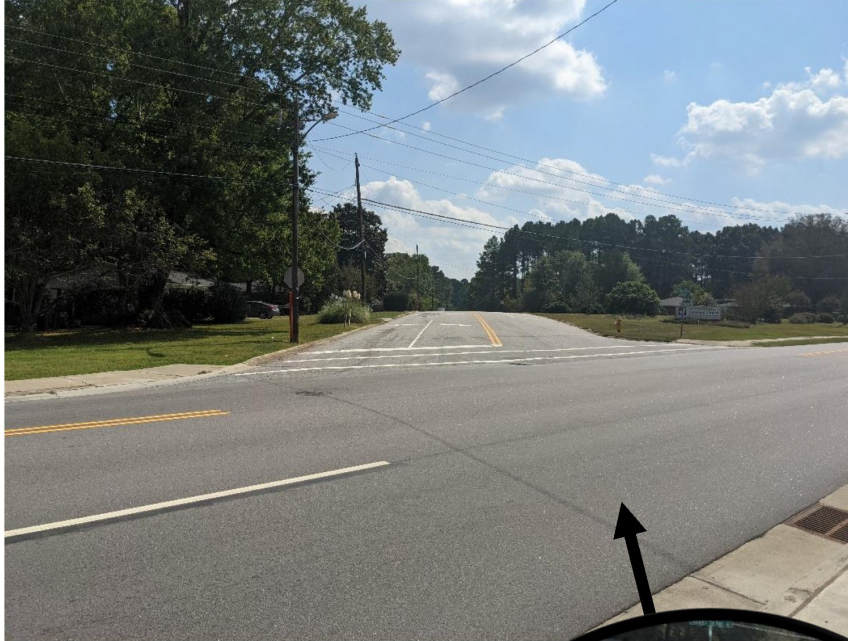
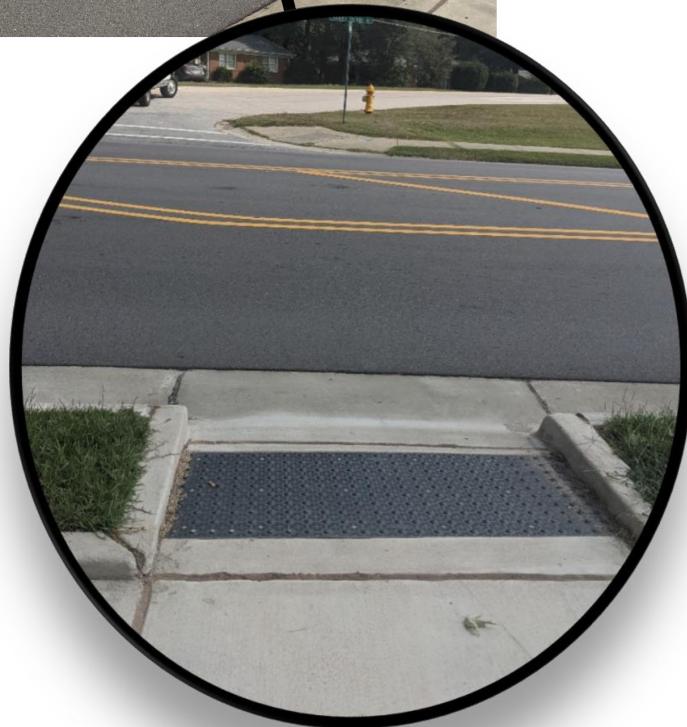
6 –Vandora Springs Rd at Lakeside Dr, facing east

- Standard crosswalk striping along Vandora Springs Rd, to cross Lakeside Dr
- Curb ramp missing truncated domes and does not line up with the crosswalk
- Image to the right shows ADA-accessible curb ramp, the crossing is not appropriately marked for pedestrians to walk across Vandora

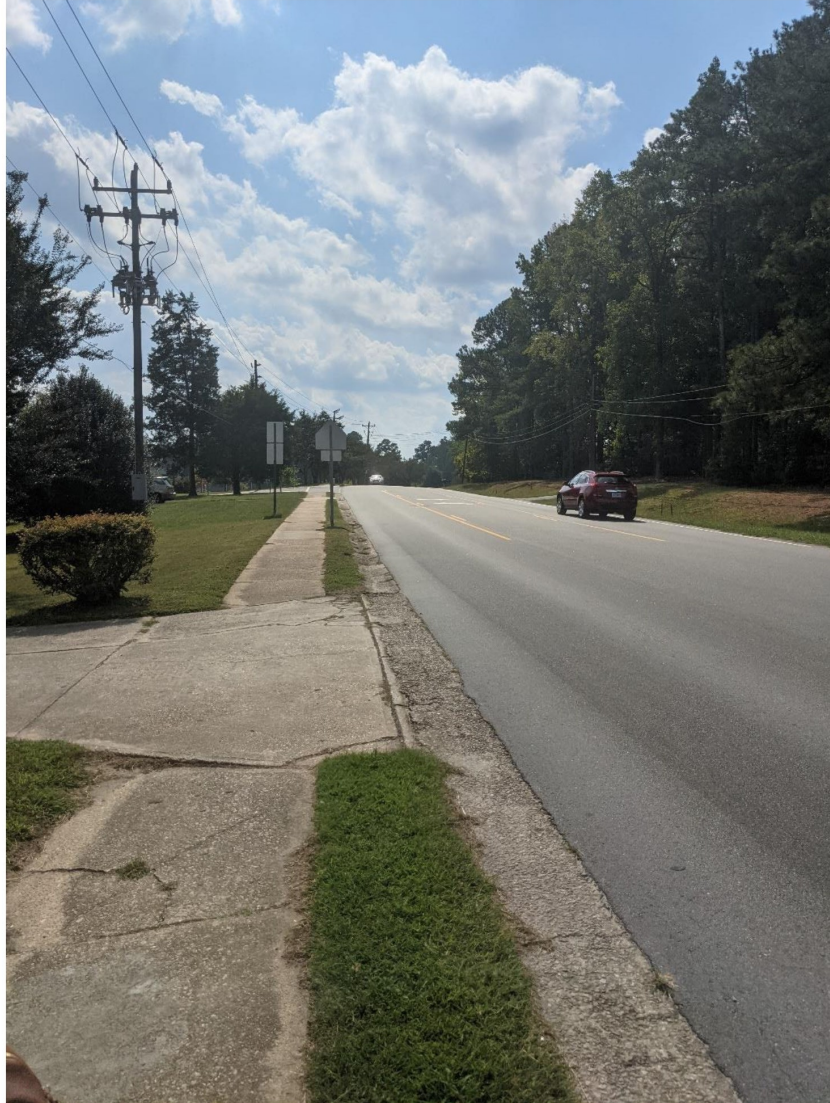
7 – Vandora Springs Rd, facing south

- On this section of Vandora Springs sidewalk is not installed on east side, it is only available on the west
- Sidewalk pavement in need of repair

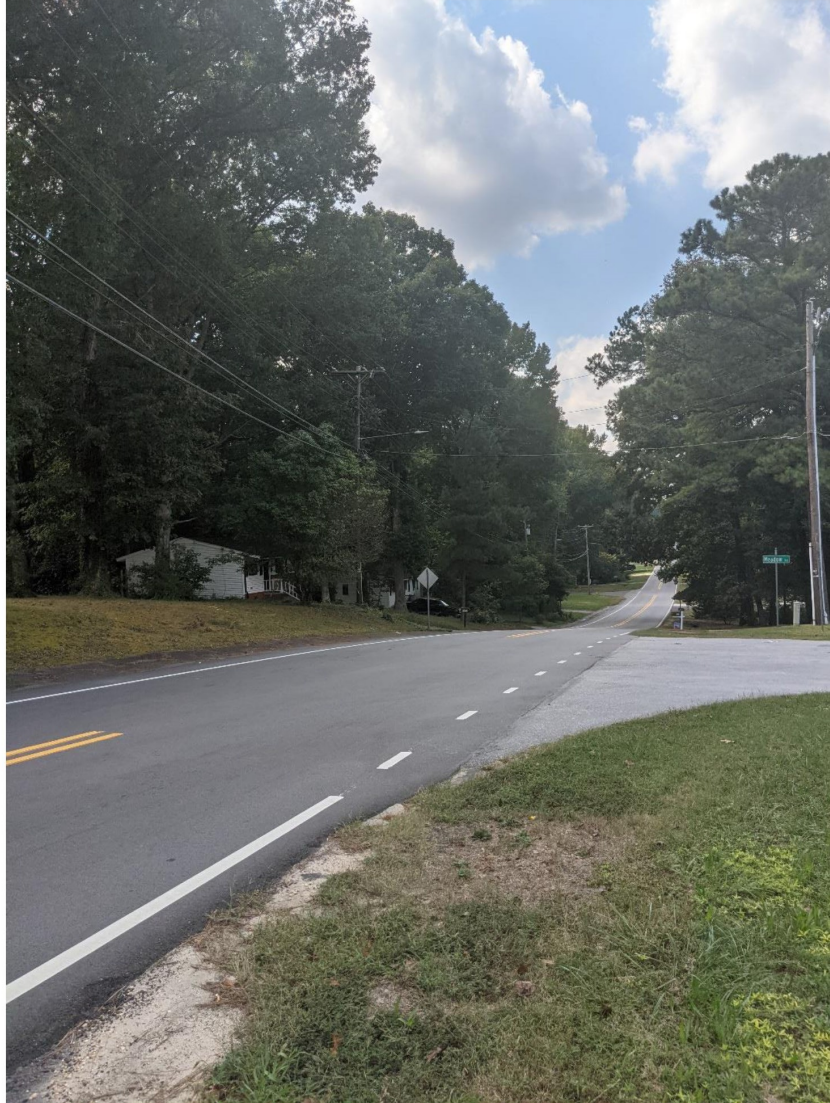
8 – Woodland Rd at Meadow Rd, facing west

- No sidewalk or shoulder along Woodland Rd
- Road is hilly which creates visibility challenges in certain areas
