20 de febrero de 2025
Archivo No. 01204123.25, Tarea 10

Asunto: Informe Mensual de enero de 2025 de la Orden de Depuración Estipulada Modificada (Caso No. 6177-4), Vertedero de Chiquita Canyon (Código de Instalación 119219), Castaic,

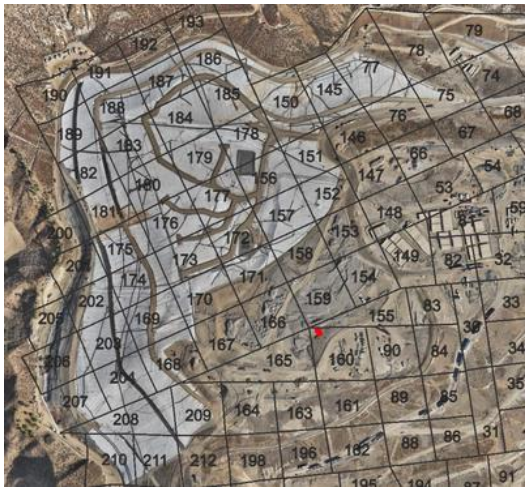
Chiquita Reaction Area Tracking of Fissures and Tension Cracks
2

Fissure or Tension Crack Found?	Yes

Grid Location	160
Using the Media link below, attach the before photo of the fissure of tension crack.	28 Jan 2025 12:00 PM PST

Length of crack (ft) or area containing multiple cracks (ft x ft)	30ft X 20ft
Horizontal Offset (width)	Medium 2-4" in width
Vertical Offset (height)	Extra small <0.5" in height
Orientation (direction)	NE to SW
Location	Castaic CA 91384 United States (34.43376262530023, -118.64779732402356)
Was Fissure or Crack fixed? If yes, add photo and description	Yes

Date and time of repairs	28 Jan 2025 1:51 PM PST
Description of repairs	Cracks were track walked.
Instability	
Are there any indications of slope stability concerns?	No

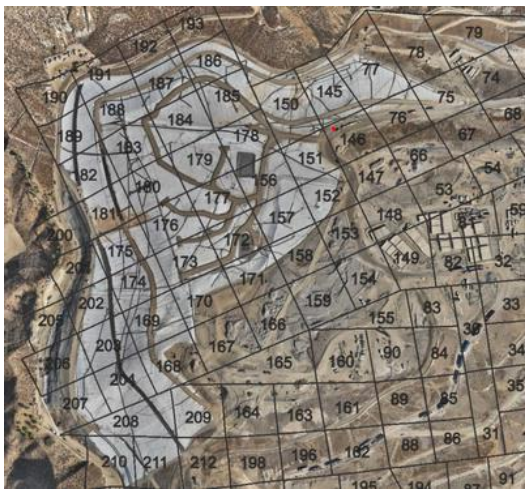
Chiquita Reaction Area Tracking of Fissures and Tension Cracks	
Chiquita Reaction Area Tracking of Fissures and Tension Cracks	
Chiquita Reaction Area Tracking of Fissures and Tension Cracks 1	
Fissure or Tension Crack Found?	Yes

Grid Location	146
Using the Media link below, attach the before photo of the fissure of tension crack.	21 Jan 2025 10:41 AM PST

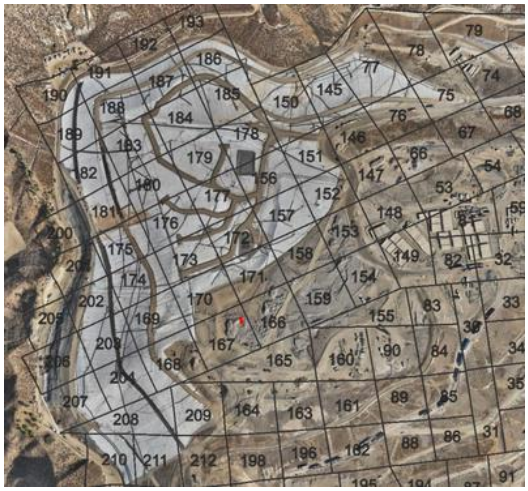
Fissure or Tension Crack Found?	Yes

Grid Location	167

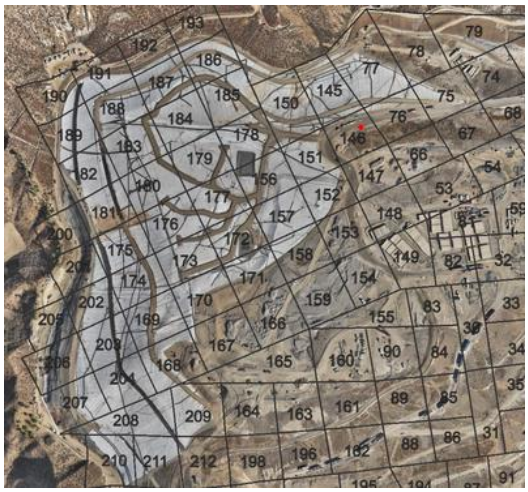
Photo 1

Chiquita Reaction Area Tracking of Fissures and Tension Cracks	
Chiquita Reaction Area Tracking of Fissures and Tension Cracks	
Chiquita Reaction Area Tracking of Fissures and Tension Cracks 1	
Fissure or Tension Crack Found?	Yes

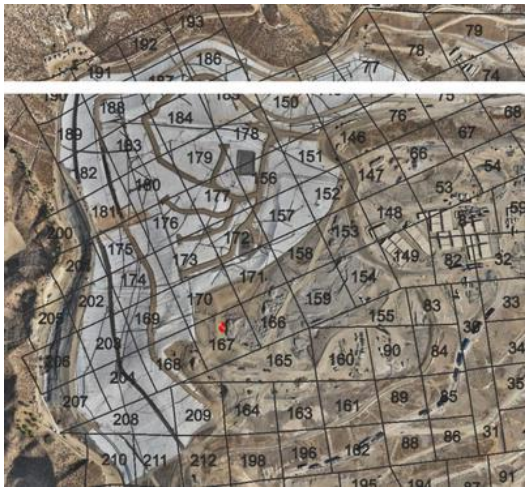
Photo 1

Fissure or Tension Crack Found? Yes

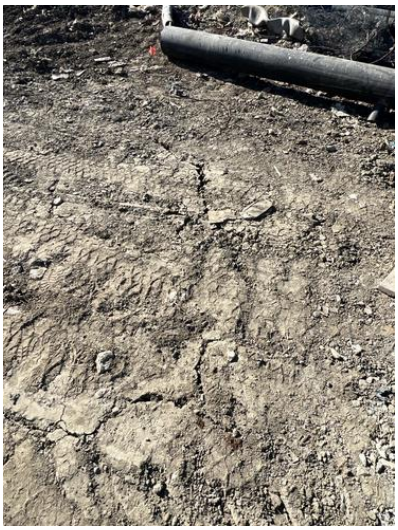
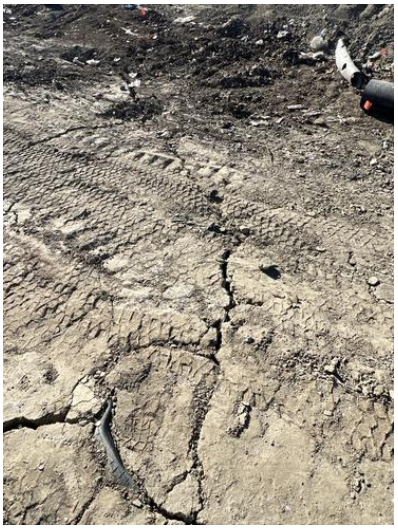
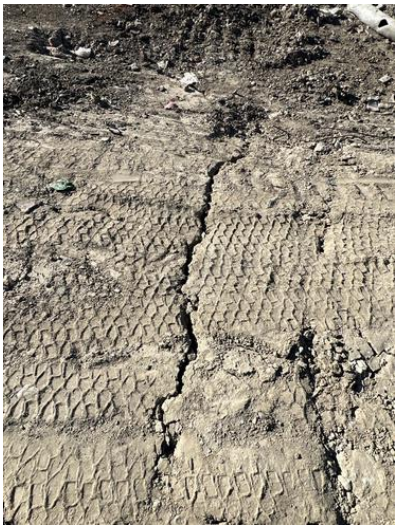
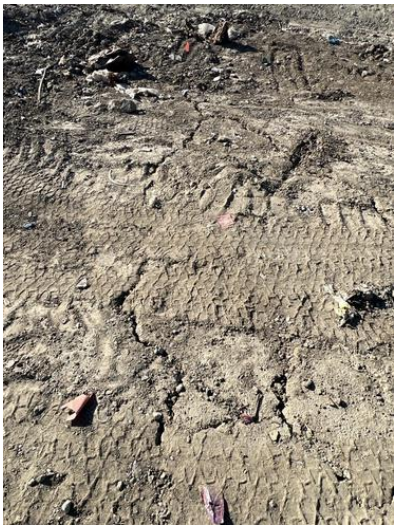
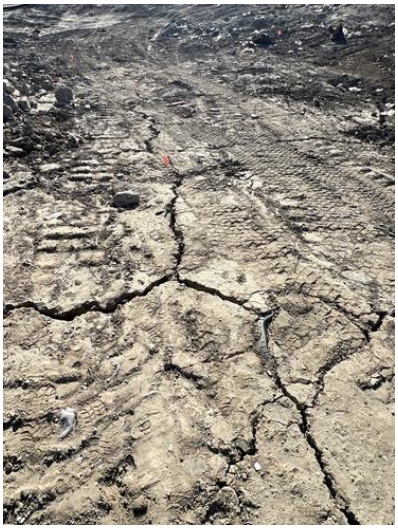
Length of crack (ft) or area containing multiple cracks (ft x ft)	10ft x 20ft
Horizontal Offset (width)	Medium 2-4" in width
Vertical Offset (height)	Extra small <0.5" in height
Orientation (direction)	NW to SE
Location	Castaic CA 91384 United States (34.43341323207699, -118.64787477767729)
Was Fissure or Crack fixed? If yes, add photo and description of repairs performed	Yes

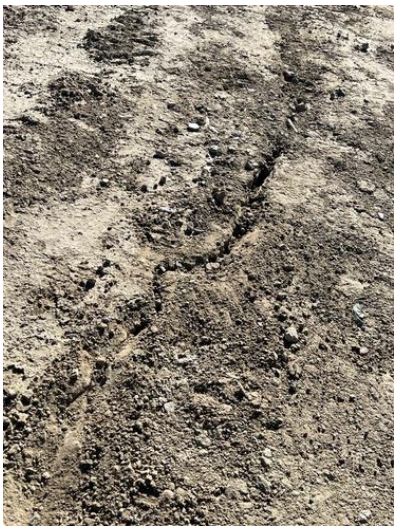
Photo 1

Grid Location	147

Using the Media link below, attach the before photo of the fissure of tension crack.	6 Jan 2025 11:06 AM PST

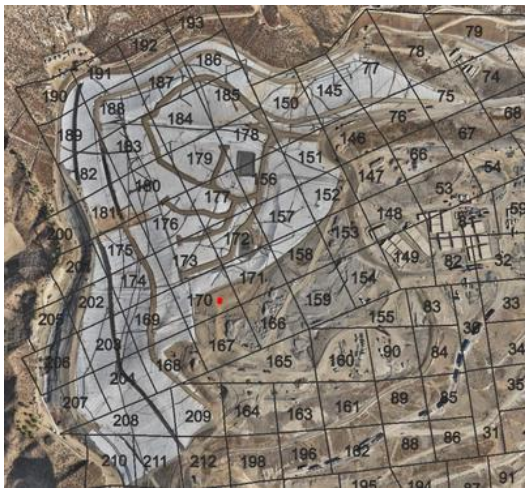
Fissure or Tension Crack Found?	Yes

Grid Location	170
Using the Media link below, attach the before photo of the fissure of tension crack.	6 Jan 2025 1:09 PM PST

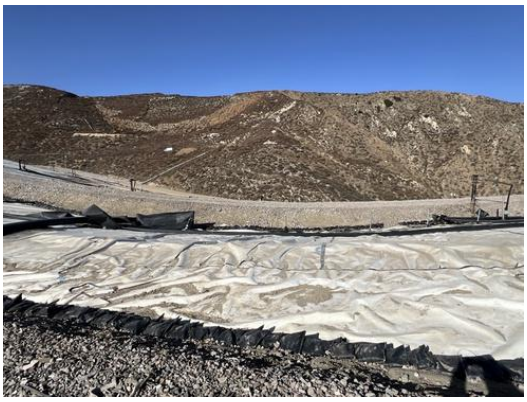
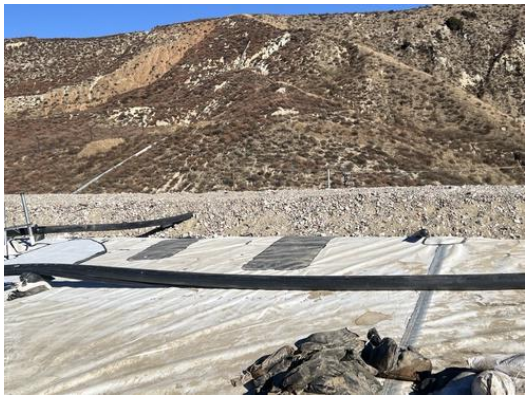
Take photo of identified issues

Description of repair work	Pieces of liner were used to patch the cover
Date and time of repair (within 2 hours)	9 Jan 2025 5:00 PM PST

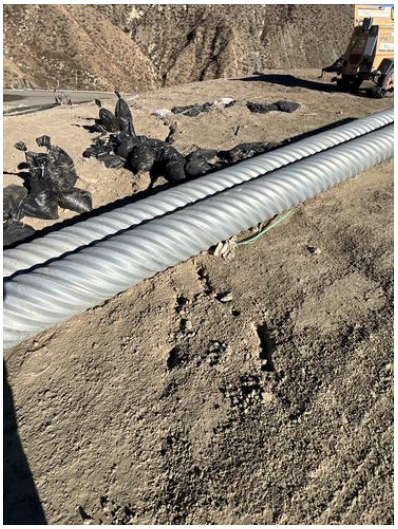
Photo 2

Length of crack (ft) or area containing multiple cracks (ft x ft)	15ft
Horizontal Offset (width)	Medium 2-4" in width
Vertical Offset (height)	Extra small <0.5" in height
Orientation (direction)	N to S
Location	Castaic CA 91384 United States (34.43595679473625, -118.64686711294573)
Was Fissure or Crack fixed? If yes, add photo and description of repairs performed	Yes

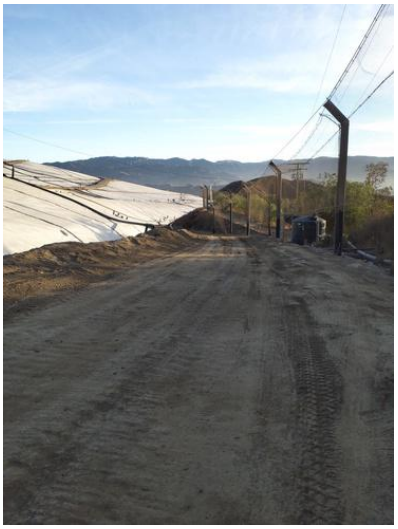
Photo 1

Has a leachate seep/pooling been located?	No

Description of area in photo where there is no leachate seepage or pooling.	West side perimeter road

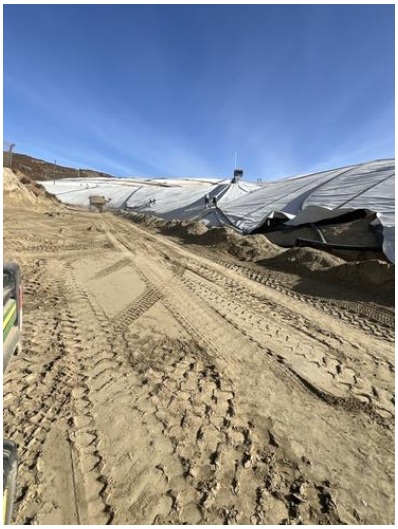
Photo 2

Has a leachate seep/pooling been located?	No

Description of area in photo where there is no leachate seepage or pooling.	West side perimeter road

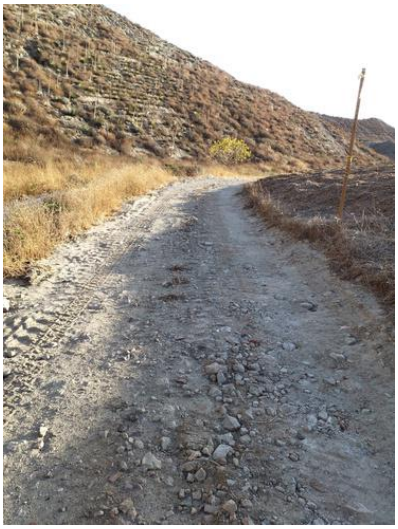
Photo 2

Has a leachate seep/pooling been located?	No

Description of area in photo where there is no leachate seepage or pooling.	North Side perimeter road

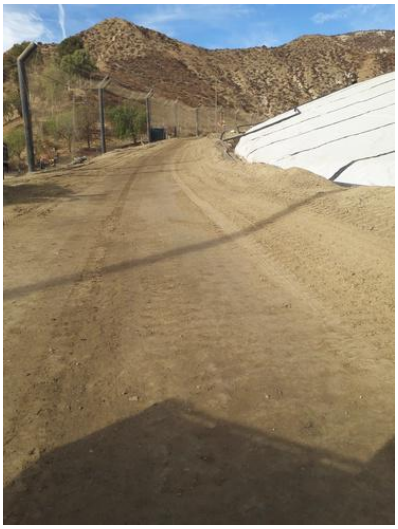
Photo 2

Has a leachate seep/pooling been located?	No

Description of area in photo where there is no leachate seepage or pooling.	West side perimeter road

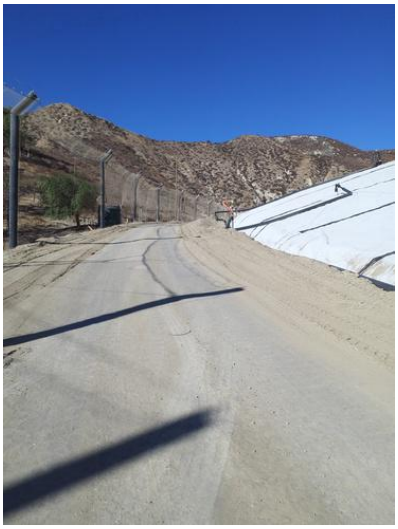
Photo 2

Has a leachate seep/pooling been located?	No

Description of area in photo where there is no leachate seepage or pooling.	West side perimeter road

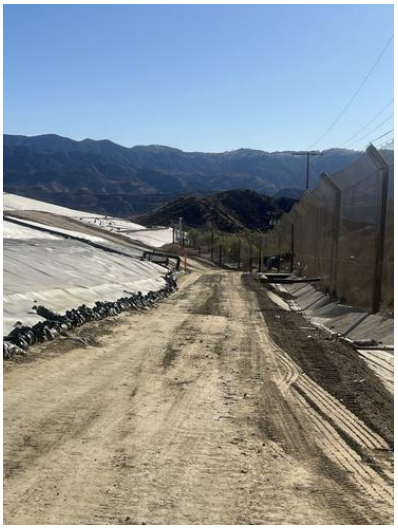
Photo 1

Has a leachate seep/pooling been located?	No

Description of area in photo where there is no leachate seepage or pooling.	West side perimeter road

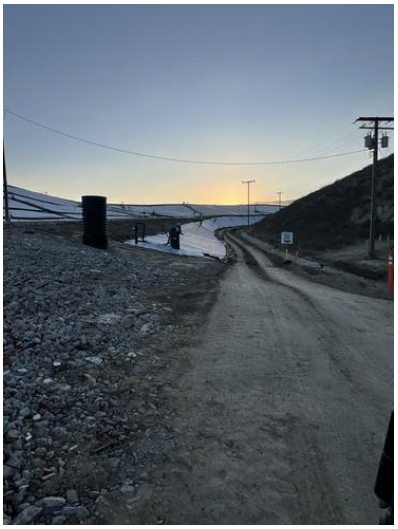
Photo 1

Has a leachate seep/pooling been located?	No

Description of area in photo where there is no leachate seepage or pooling.	North side perimeter road

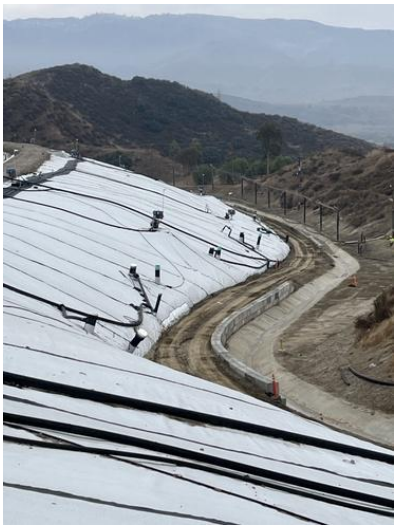
Photo 1

Has a leachate seep/pooling been located?	No

Description of area in photo where there is no leachate seepage or pooling.	West side perimeter road

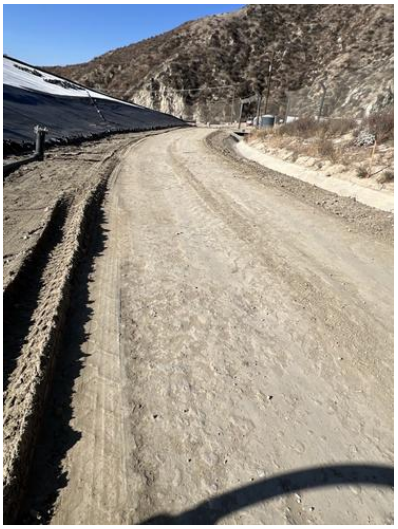
Photo 1

Has a leachate seep/pooling been located?	No

Description of area in photo where there is no leachate seepage or pooling.	North side perimeter road
