May 20, 2025
File No. 01204123.42, Task 10

Subject: April 2025 Monthly Report for Modified Stipulated Order for Abatement (Case No. 6177-4), Chiquita Canyon Landfill (Facility ID 119219), Castaic, California

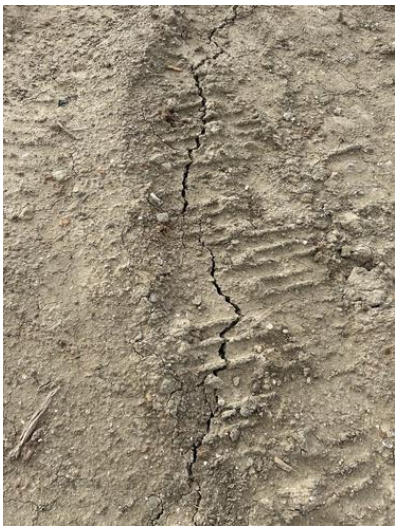
Photo 1

Using the Media link below, attach the before photo of the fissure of tension crack. 31 Mar 2025 9:12 AM PDT

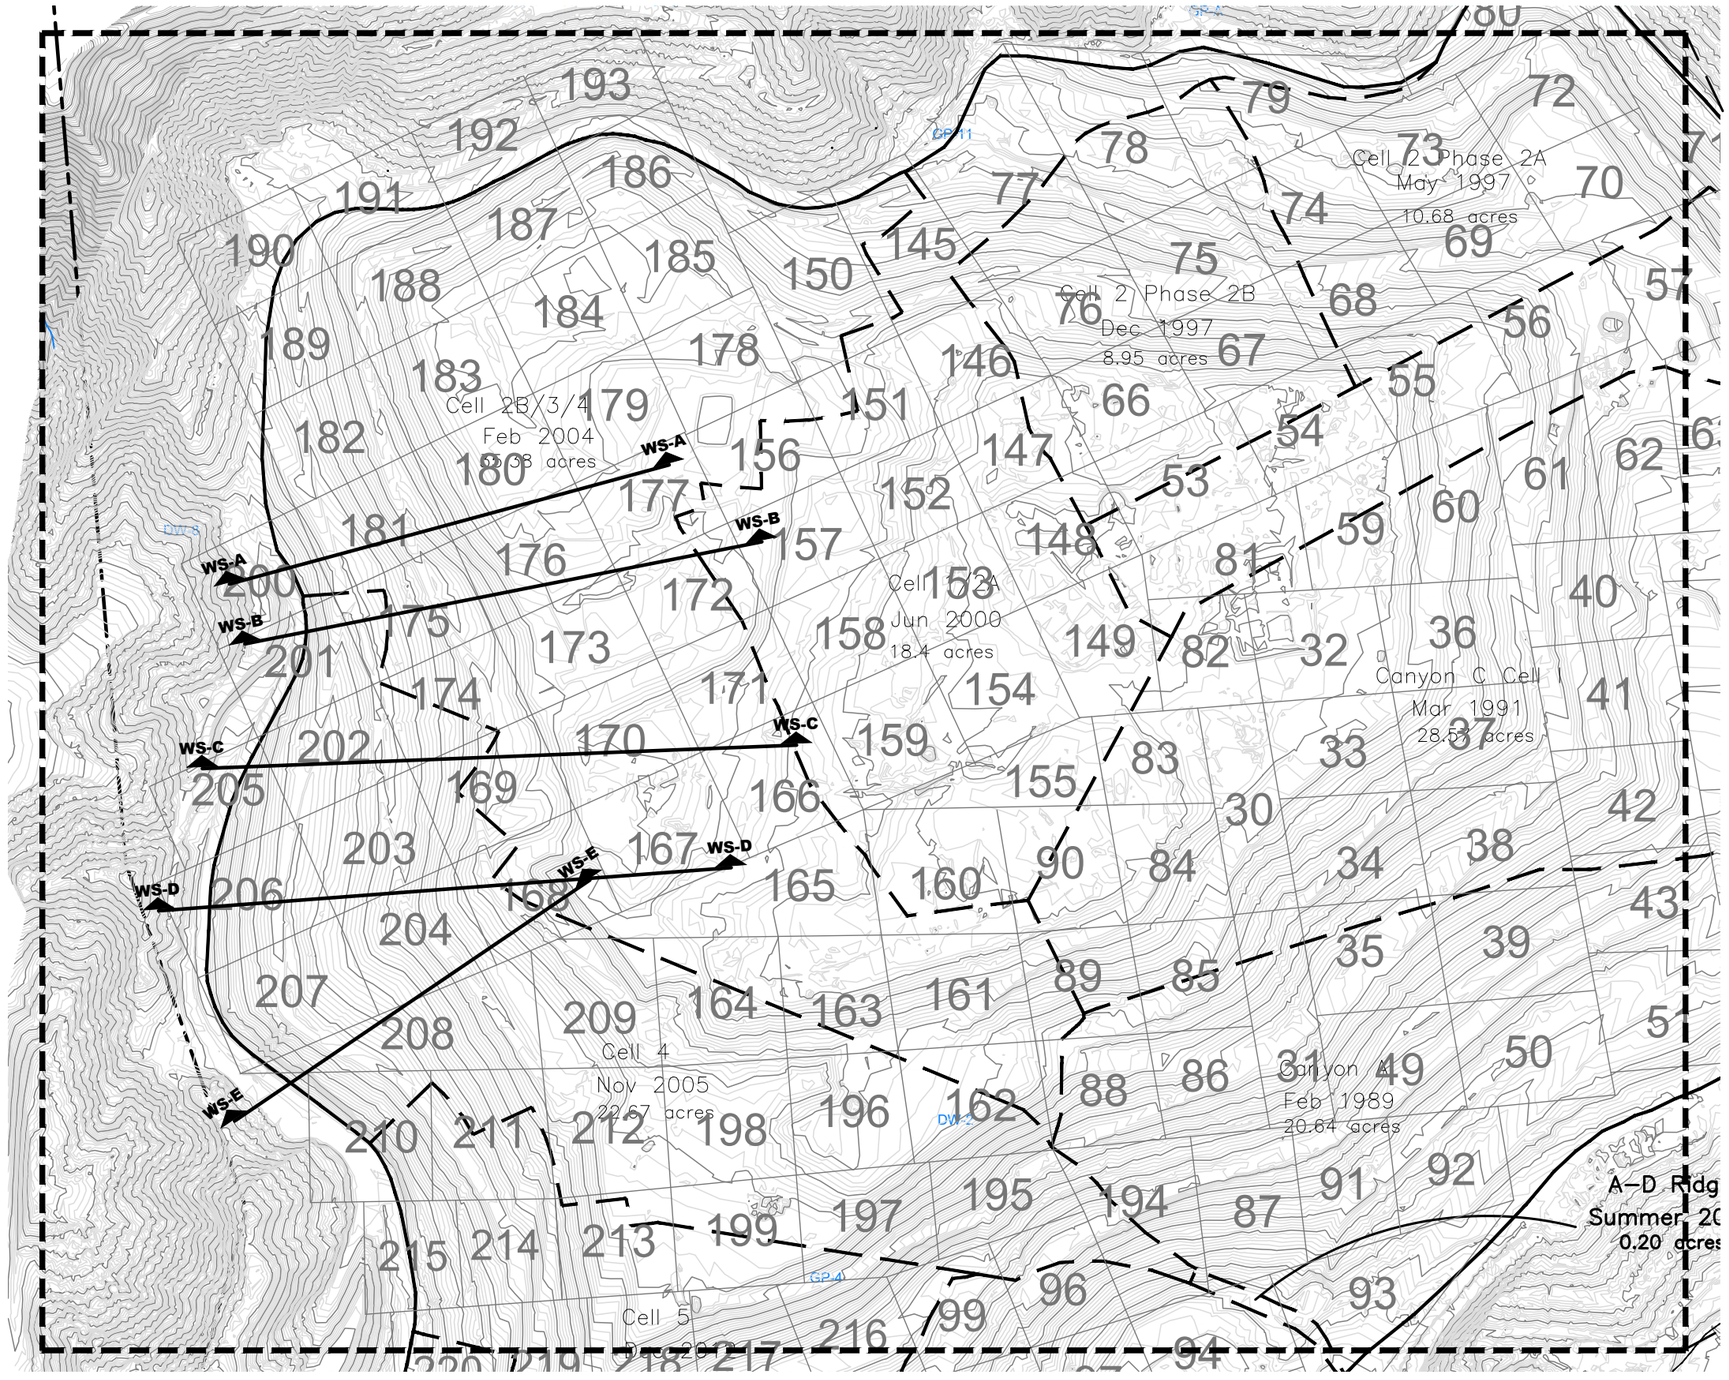
fissures with "medium" or "large" horizontal offset were observed in March. The locations of the grids are shown in Figure 1. This figure does not show any cracks or fissures because no cracks meeting the definition of "significant" or having a "medium" or "large" horizontal offset were observed in March.

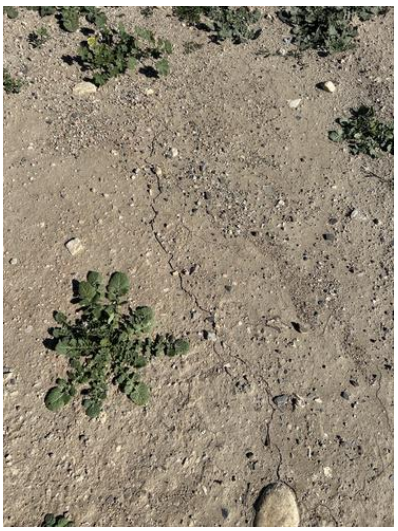
Photo 4

Length of crack (ft) or area containing multiple cracks (ft x ft)	15ft x 30ft
Horizontal Offset (width)	Extra Small <0.5 in width
Vertical Offset (height)	Extra small <0.5" in height
Orientation (direction)	NW to SE
Location	Castaic CA 91384 United States (34.43538049520011, -118.64519091926218)
Was Fissure or Crack fixed? If yes, add photo and description of repairs performed	Yes

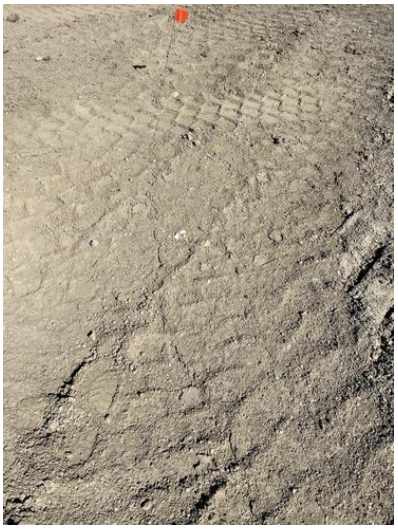
Photo 2

Length of crack (ft) or area containing multiple cracks (ft x ft)	15 ft
Horizontal Offset (width)	Extra Small <0.5 in width
Vertical Offset (height)	Extra small <0.5" in height
Orientation (direction)	NW to SE
Location	Castaic CA 91384 United States (34.43585811063539, -118.64702988834738)
Was Fissure or Crack fixed? If yes, add photo and description of repairs performed	Yes

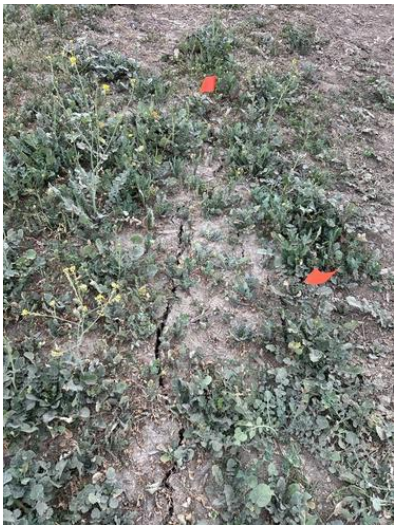
Photo 2

Length of crack (ft) or area containing multiple cracks (ft x ft)	25ft
Horizontal Offset (width)	Medium 2-4" in width
Vertical Offset (height)	Extra small <0.5" in height
Orientation (direction)	NW to SE
Location	Castaic CA 91384 United States (34.43617240227281, -118.64688934755694)
Was Fissure or Crack fixed? If yes, add photo and description of repairs performed	Yes

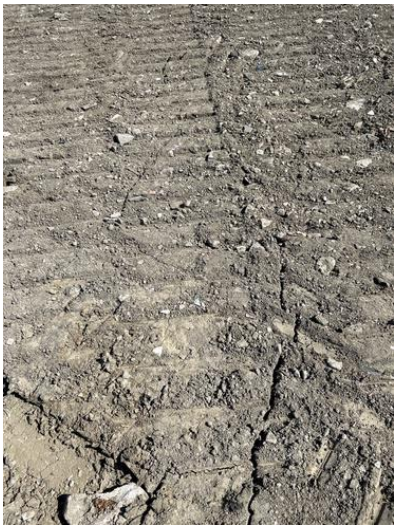
Photo 4

Length of crack (ft) or area containing multiple cracks (ft x ft)	20 ft x 60 ft
Horizontal Offset (width)	Small 0.5-2" in width
Vertical Offset (height)	Extra small <0.5" in height
Orientation (direction)	N to S
Location	Castaic CA 91384 United States (34.43362391557026, -118.64778164785228)
Was Fissure or Crack fixed? If yes, add photo and description of repairs performed	Yes

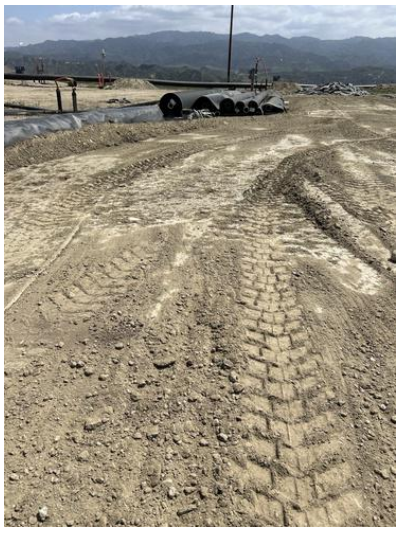
Photo 9

Length of crack (ft) or area containing multiple cracks (ft x ft)	20ft x20ft area
Horizontal Offset (width)	Extra Small <0.5 in width
Vertical Offset (height)	Extra small <0.5" in height
Orientation (direction)	N to S
Location	Castaic CA 91384 United States (34.43345149434266, -118.64694404750318)
Was Fissure or Crack fixed? If yes, add photo and description of repairs performed	Yes

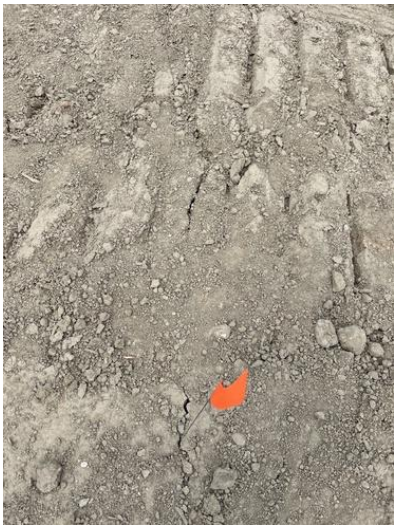
Photo 8

Length of crack (ft) or area containing multiple cracks (ft x ft)	6ft
Horizontal Offset (width)	Extra Small <0.5 in width
Vertical Offset (height)	Extra small <0.5" in height
Orientation (direction)	NW to SE
Location	Castaic CA 91384 United States (34.43361685566815, -118.64675436298374)
Was Fissure or Crack fixed? If yes, add photo and description of repairs performed	Yes

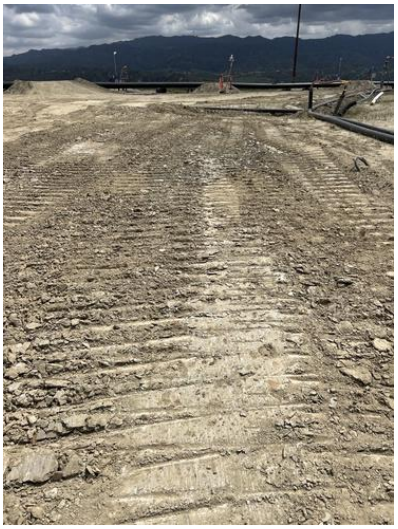
Photo 16

Length of crack (ft) or area containing multiple cracks (ft x ft)	7ft x 25ft area
Horizontal Offset (width)	Extra Small <0.5 in width
Vertical Offset (height)	Extra small <0.5" in height
Orientation (direction)	N to S
Location	Castaic CA 91384 United States (34.433539970809996, -118.646829463652)
Was Fissure or Crack fixed? If yes, add photo and description of repairs performed	Yes

Date and time of repairs	25 Apr 2025 12:45 PM PDT
Description of repairs	Cracks were track walked.
Chiquita Reaction Area Tracking of Fissures and Tension Cracks 4	
Fissure or Tension Crack Found?	Yes

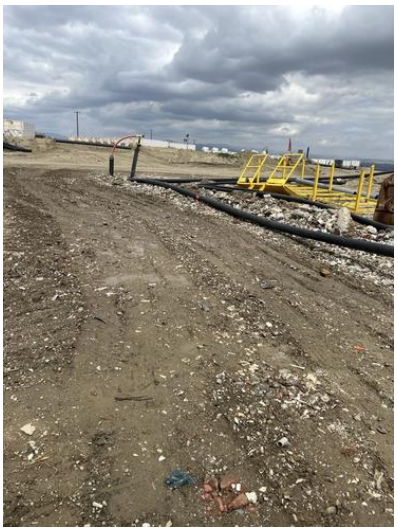
Photo 19

Length of crack (ft) or area containing multiple cracks (ft x ft)	25ft
Horizontal Offset (width)	Small 0.5-2" in width
Vertical Offset (height)	Extra small <0.5" in height
Orientation (direction)	NE to SW
Location	Castaic CA 91384 United States (34.434158345716575, -118.6466875580313)
Was Fissure or Crack fixed? If yes, add photo and description of repairs performed	Yes

Date and time of repairs	25 Apr 2025 12:54 PM PDT
Description of repairs	Cracks were track walked.

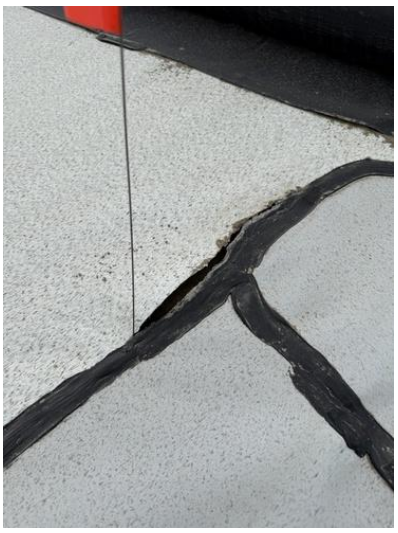
Grid 145

Notate what the issue is and what needs to be repaired	Liner separated at seam. Patch needed

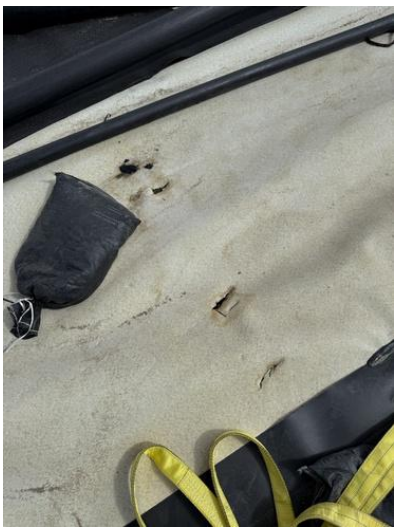
Grid 150

Notate what the issue is and what needs to be repaired	Punctures through liner. Liner needs to be patched

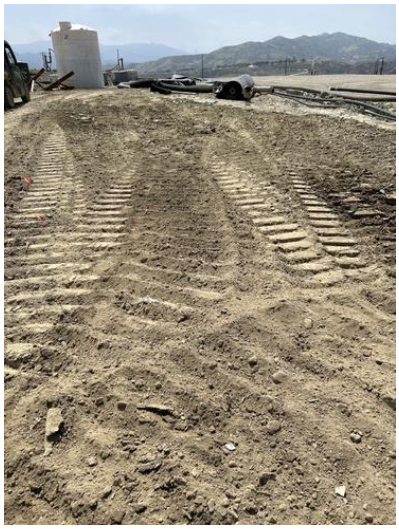
Photo 7

Length of crack (ft) or area containing multiple cracks (ft x ft)	20ft x 10ft area
Horizontal Offset (width)	Extra Small <0.5 in width
Vertical Offset (height)	Extra small <0.5" in height
Orientation (direction)	NE to SW
Location	Castaic CA 91384 United States (34.43402067921757, -118.64662937848354)
Was Fissure or Crack fixed? If yes, add photo and description of repairs performed	Yes

Date and time of repairs	1 May 2025 12:01 PM PDT
Description of repairs	Cracks were track walked.
Chiquita Reaction Area Tracking of Fissures and Tension Cracks 2	
Fissure or Tension Crack Found?	Yes

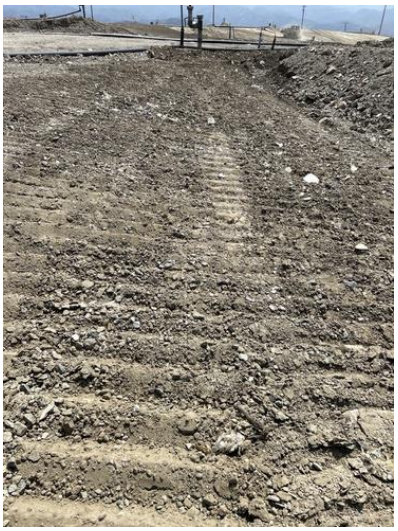
Photo 12

Length of crack (ft) or area containing multiple cracks (ft x ft)	8ft
Horizontal Offset (width)	Small 0.5-2" in width
Vertical Offset (height)	Extra small <0.5" in height
Orientation (direction)	N to S

Location	Castaic CA 91384 United States (34.43443633153516, -118.64735928375147)
Was Fissure or Crack fixed? If yes, add photo and description of repairs performed	Yes

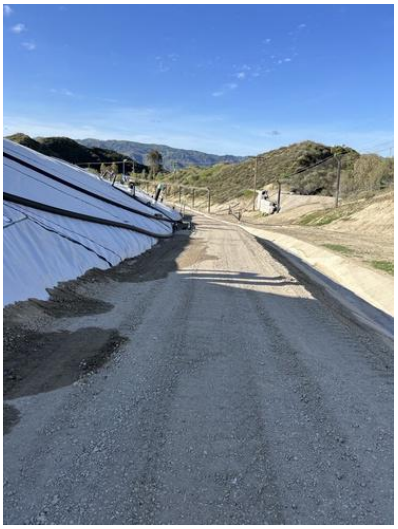
Photo 1

Has a leachate seep/pooling been located?	No

Description of area in photo where there is no leachate seepage or pooling.	Westside perimeter road.

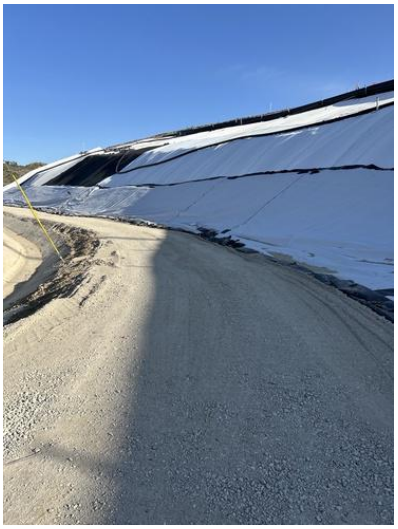
Photo 1

Has a leachate seep/pooling been located?	No

Description of area in photo where there is no leachate seepage or pooling.	Westside perimeter road.

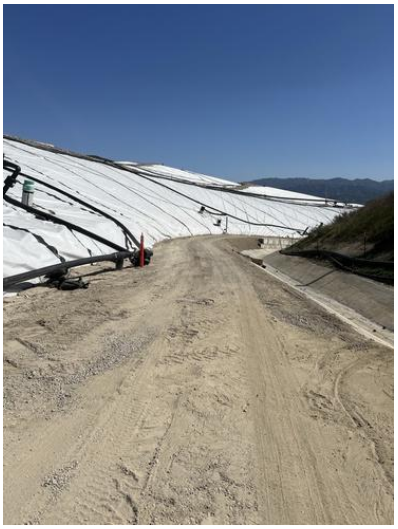
Photo 1

Has a leachate seep/pooling been located?	No

Description of area in photo where there is no leachate seepage or pooling.	Westside perimeter road.

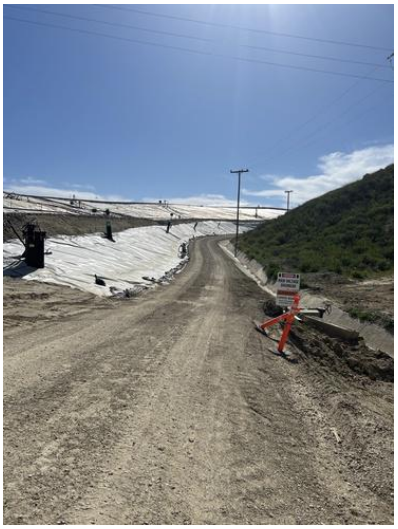
Photo 1

Has a leachate seep/pooling been located?	No

Description of area in photo where there is no leachate seepage or pooling.	North side perimeter road

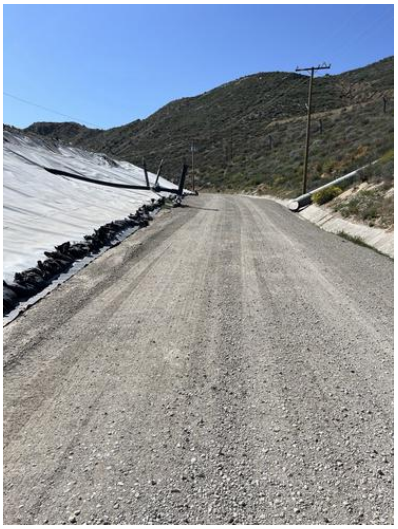
Photo 1

Has a leachate seep/pooling been located?	No

Description of area in photo where there is no leachate seepage or pooling.	North perimeter road.

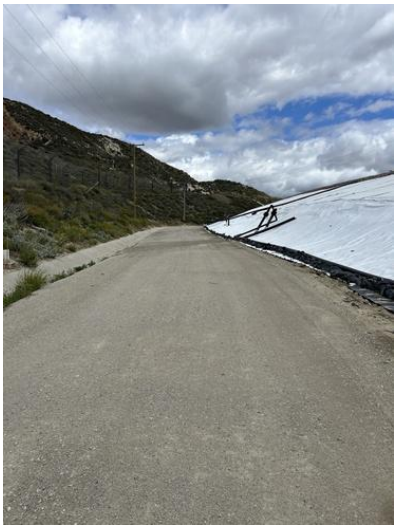
Photo 1

Has a leachate seep/pooling been located?	No

Description of area in photo where there is no leachate seepage or pooling.	North perimeter road.

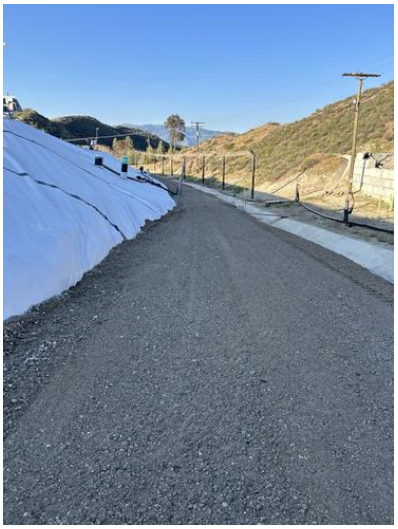
Photo 1

Has a leachate seep/pooling been located?	No

Description of area in photo where there is no leachate seepage or pooling.	Westside perimeter road.

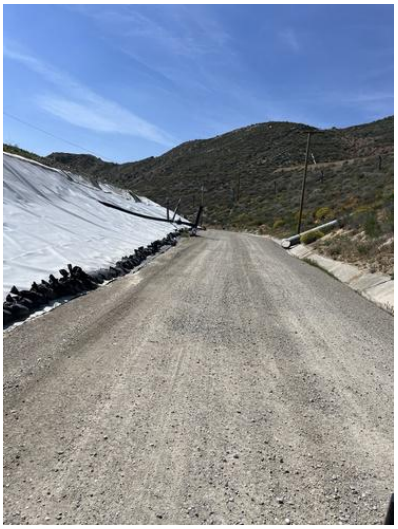
Photo 1

Has a leachate seep/pooling been located?	No

Description of area in photo where there is no leachate seepage or pooling.	North perimeter road.
