20 de agosto de 2025
Archivo No. 01204123.42, Tarea 10

Asunto: Informe Mensual de julio de 2025 de la Orden de Depuración Estipulada Modificada (Caso No. 6177-4), Vertedero de Chiquita Canyon (Código de Instalación 119219), Castaic, California

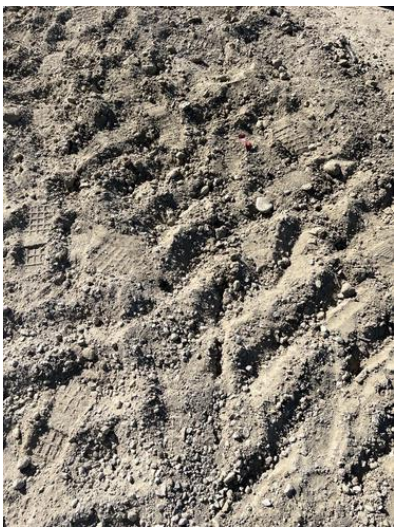
Photo 4

Length of crack (ft) or area containing multiple cracks (ft x ft)	60ft x 20ft
Horizontal Offset (width)	Small 0.5-2" in width
Vertical Offset (height)	Small 0.5-2" in height
Orientation (direction)	NW to SE
Location	Castaic CA 91384 United States (34.43566592883262, -118.64662677666595)
Was Fissure or Crack fixed? If yes, add photo and description of repairs performed	Yes

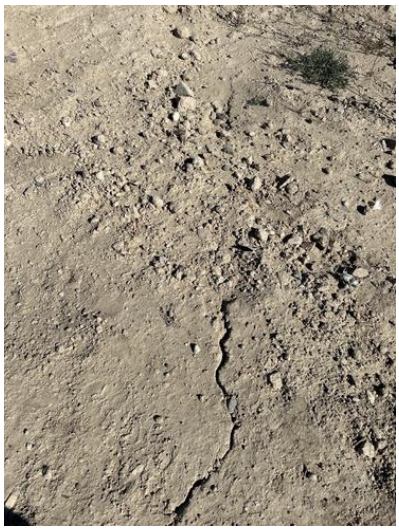
Photo 1

Length of crack (ft) or area containing multiple cracks (ft x ft)	15ft x 90 ft
Horizontal Offset (width)	Small 0.5-2" in width
Vertical Offset (height)	Extra small <0.5" in height
Orientation (direction)	NW to SE
Location	Castaic CA 91384 United States (34.435312952878355, -118.64629503350578)
Was Fissure or Crack fixed? If yes, add photo and description of repairs performed	Yes

Date and time of repairs	8 Jul 2025 10:17 AM PDT
Description of repairs	Cracks were track walked.
Chiquita Reaction Area Tracking of Fissures and Tension Cracks 2	
Fissure or Tension Crack Found?	Yes

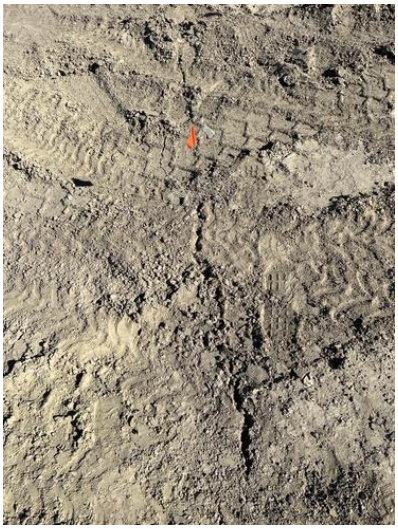
Photo 9

Grid Location	146.147
Date and Time Found	8 Jul 2025 9:26 AM PDT

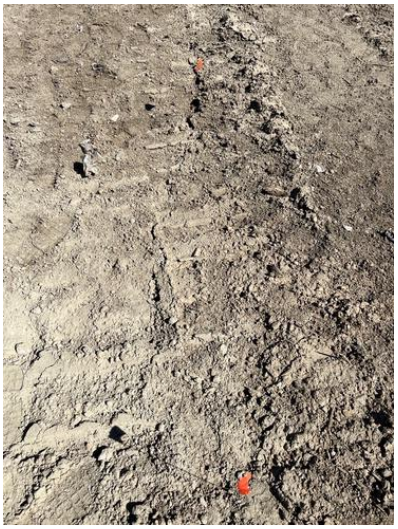
Photo 2

Length of crack (ft) or area containing multiple cracks (ft x ft)	30 ft
Horizontal Offset (width)	Small 0.5-2" in width
Vertical Offset (height)	Extra small <0.5" in height
Orientation (direction)	NW to SE
Location	Castaic CA 91384 United States (34.4359872128271, -118.64678428729033)
Was Fissure or Crack fixed? If yes, add photo and description of repairs performed	Yes

Date and time of repairs	9 Jul 2025 12:19 PM PDT
Description of repairs	Cracks were track walked.

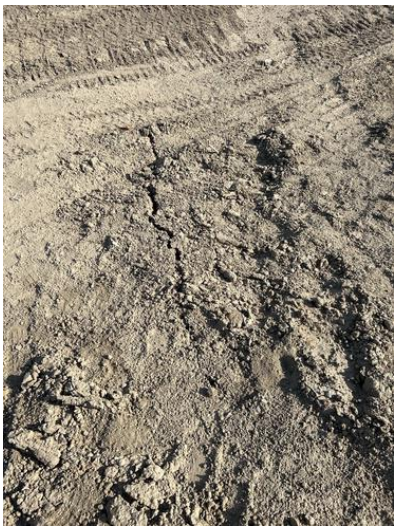
Photo 1

Grid Location	146
Date and Time Found	14 Jul 2025 8:45 AM PDT

Length of crack (ft) or area containing multiple cracks (ft x ft)	8 ft

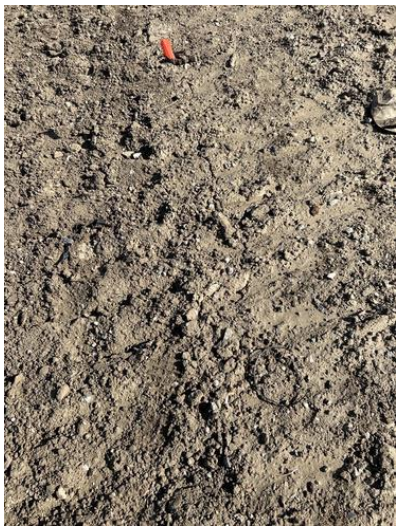
Photo 1

Length of crack (ft) or area containing multiple cracks (ft x ft)	25ft
Horizontal Offset (width)	Small 0.5-2" in width
Vertical Offset (height)	Extra small <0.5" in height
Orientation (direction)	NW to SE
Location	Castaic CA 91384 United States (34.43590170935845, -118.64709566421057)
Was Fissure or Crack fixed? If yes, add photo and description of repairs performed	Yes

Date and time of repairs	15 Jul 2025 9:46 AM PDT
Description of repairs	Cracks were track walked.

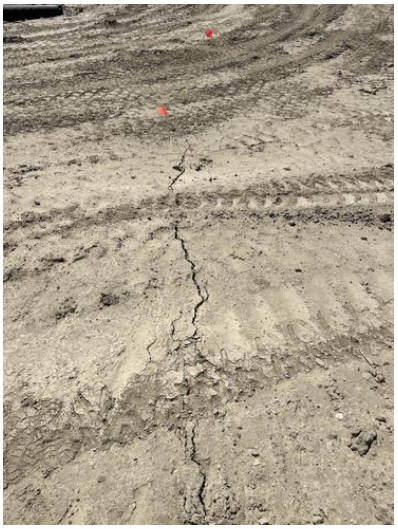
Length of crack (ft) or area containing multiple cracks (ft x ft)	20ft x 20ft area
Horizontal Offset (width)	Small 0.5-2" in width

Vertical Offset (height)	Extra small <0.5" in height
Orientation (direction)	N to S
Location	Castaic CA 91384 United States (34.43624500334951, -118.64579652585817)
Was Fissure or Crack fixed? If yes, add photo and description of repairs performed	Yes

Date and time of repairs	17 Jul 2025 12:12 PM PDT
Description of repairs	Cracks were track walked.

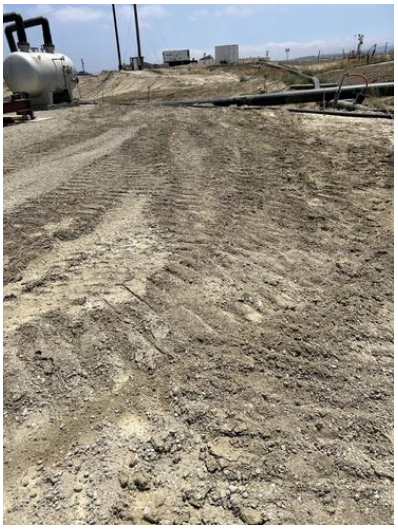
Length of crack (ft) or area containing multiple cracks (ft x ft)	25ft x 40ft
Horizontal Offset (width)	Medium 2-4" in width
Vertical Offset (height)	Small 0.5-2" in height
Orientation (direction)	NW to SE
Location	Castaic CA 91384 United States (34.43572370804336, -118.64672703679524)
Was Fissure or Crack fixed? If yes, add photo and description of repairs performed	Yes

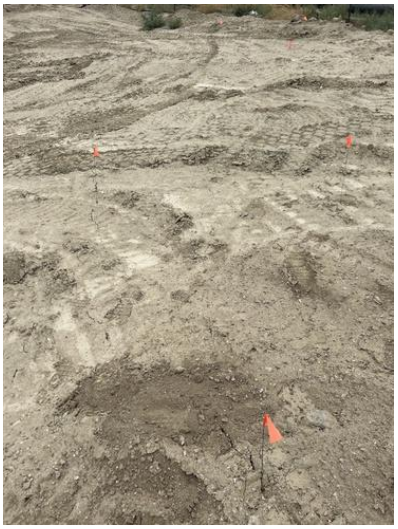
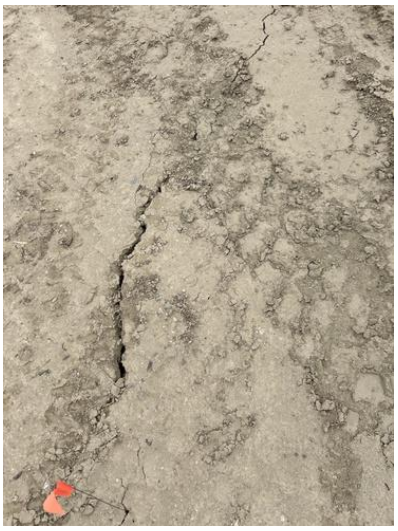
Grid Location	148
Date and Time Found	21 Jul 2025 9:21 AM PDT

Length of crack (ft) or area containing multiple cracks (ft x ft)	40ft x 10ft
Horizontal Offset (width)	Small 0.5-2" in width

Vertical Offset (height)	Extra small <0.5" in height
Orientation (direction)	NW to SE
Location	Castaic CA 91384 United States (34.435416665305205, -118.64633611529703)
Was Fissure or Crack fixed? If yes, add photo and description of repairs performed	Yes

Date and time of repairs	21 Jul 2025 9:54 AM PDT
Description of repairs	Cracks were track walked.

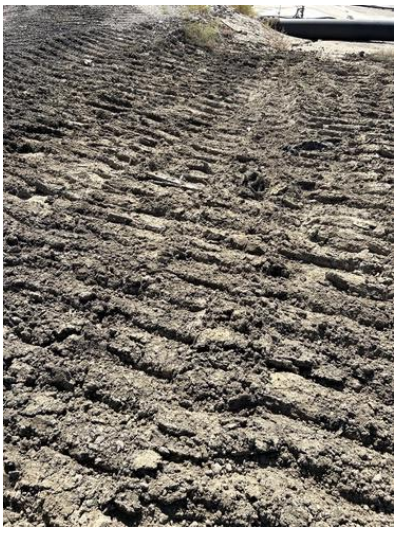
Length of crack (ft) or area containing multiple cracks (ft x ft)	10 ft x 5 ft
Horizontal Offset (width)	Medium 2-4" in width
Vertical Offset (height)	Extra small <0.5" in height
Orientation (direction)	NW to SE
Location	Castaic CA 91384 United States (34.43559382699576, -118.64725017796698)
Was Fissure or Crack fixed? If yes, add photo and description of repairs performed	Yes

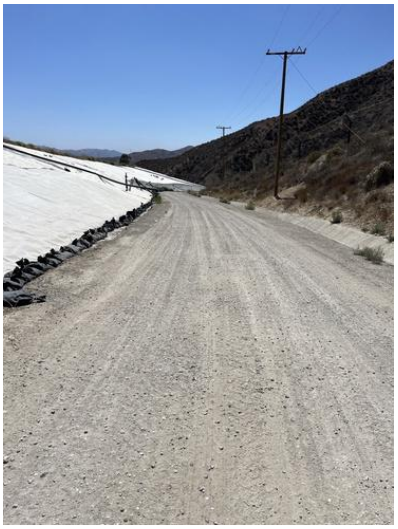
Photo 1

Has a leachate seep/pooling been located?	No

Description of area in photo where there is no leachate seepage or pooling.	North perimeter road.

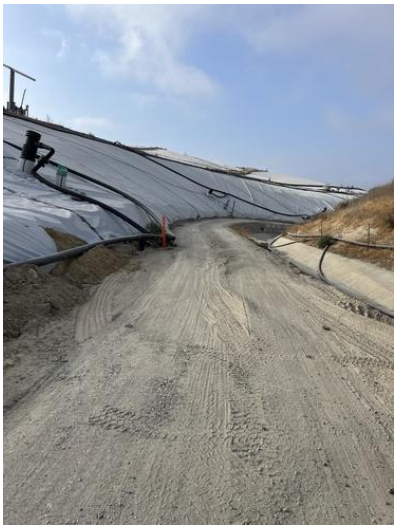
Photo 1

Has a leachate seep/pooling been located?	No

Description of area in photo where there is no leachate seepage or pooling.	Westside perimeter road.

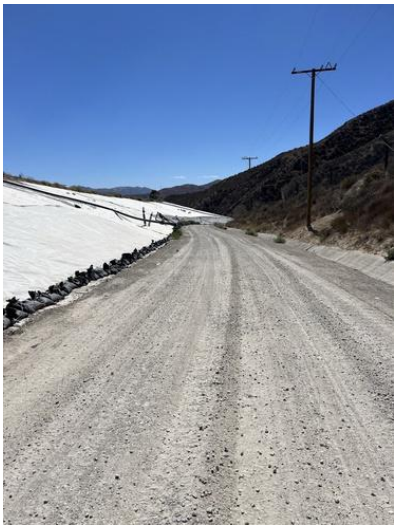
Photo 1

Has a leachate seep/pooling been located?	No

Description of area in photo where there is no leachate seepage or pooling.	North perimeter road.

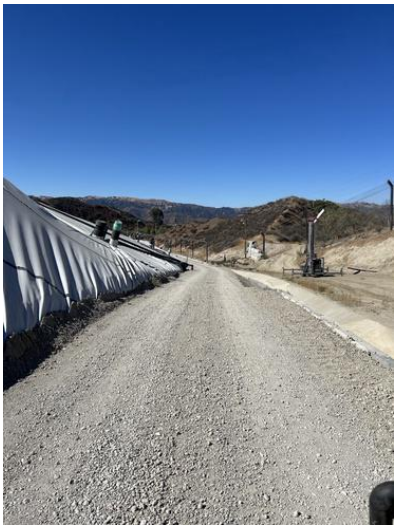
Photo 1

Has a leachate seep/pooling been located?	No

Description of area in photo where there is no leachate seepage or pooling.	West side perimeter road

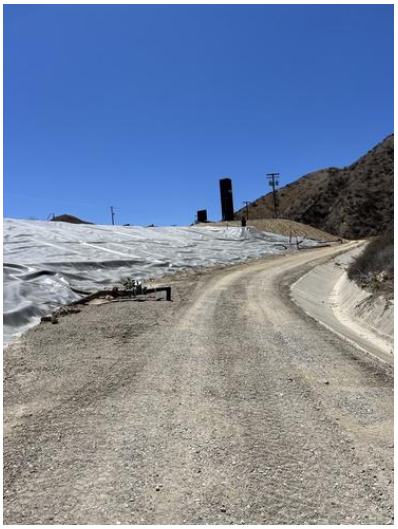
Photo 1

Has a leachate seep/pooling been located?	No

Description of area in photo where there is no leachate seepage or pooling.	North perimeter road.

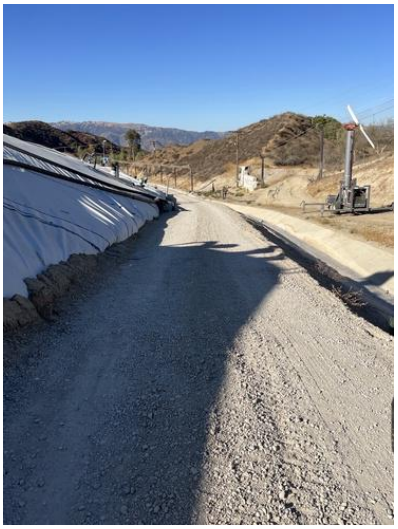
Photo 1

Has a leachate seep/pooling been located?	No

Description of area in photo where there is no leachate seepage or pooling.	Westside perimeter road.

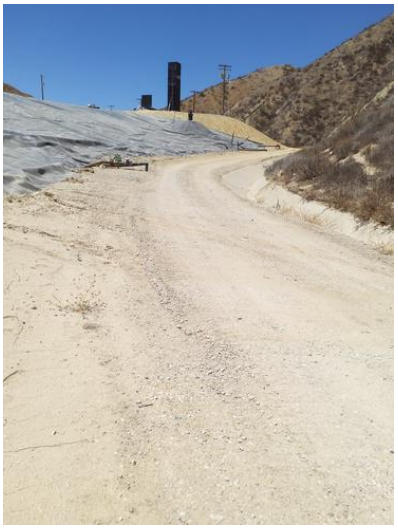
Photo 1

Has a leachate seep/pooling been located?	No

Description of area in photo where there is no leachate seepage or pooling.	North perimeter road

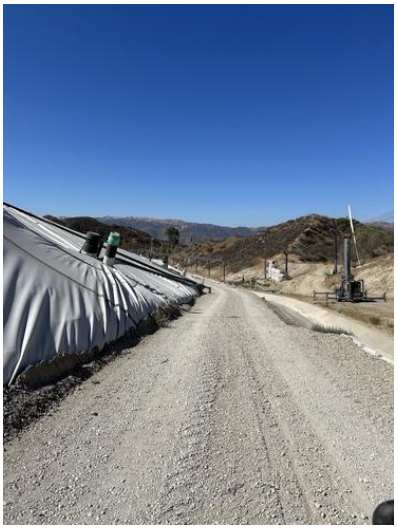
Photo 1

Has a leachate seep/pooling been located?	No

Description of area in photo where there is no leachate seepage or pooling.	West side perimeter road

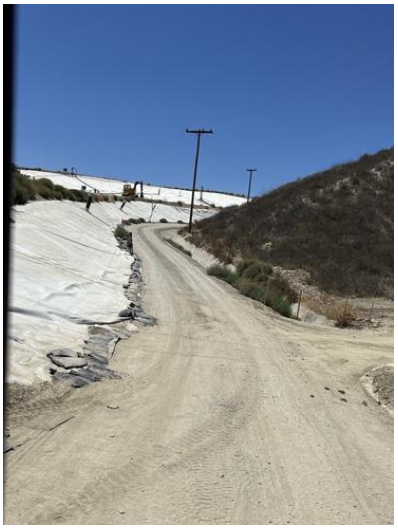
Photo 1

Has a leachate seep/pooling been located?	No

Description of area in photo where there is no leachate seepage or pooling.	North side perimeter road
