22 de septiembre de 2025
Archivo No. 01204123.42, Tarea 10

Asunto: Informe Mensual de agosto de 2025 de la Orden de Depuración Estipulada Modificada (Caso No. 6177-4), Vertedero de Chiquita Canyon (Código de Instalación 119219), Castaic, California

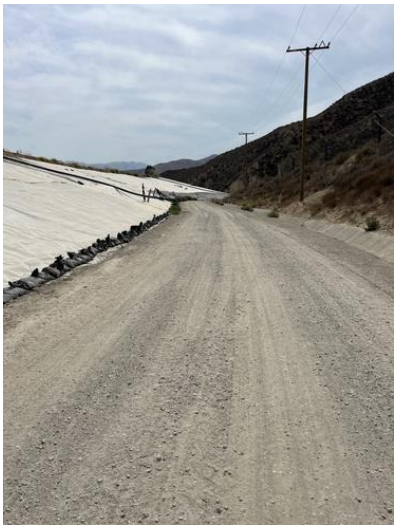
Photo 1

Description of area in photo where there is no leachate seepage or pooling.	North perimeter road.

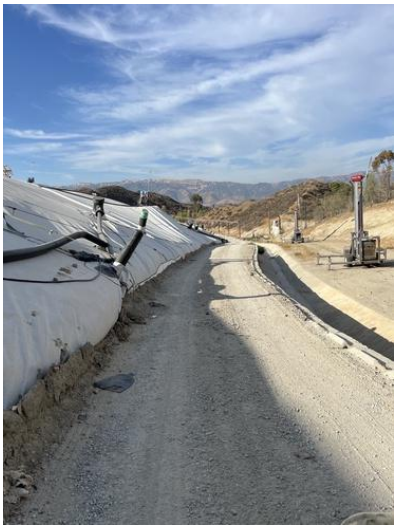
Photo 1

Description of area in photo where there is no leachate seepage or pooling.	Westside perimeter road.

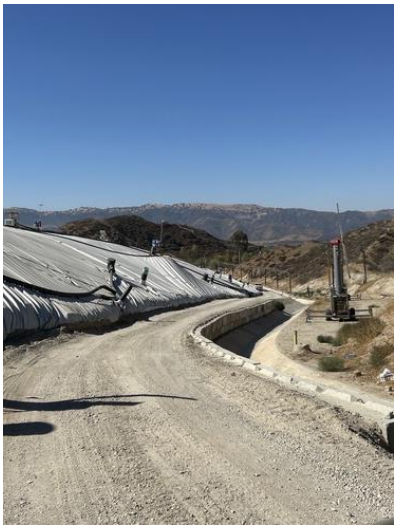
Photo 1

Description of area in photo where there is no leachate seepage or pooling.	West side perimeter road

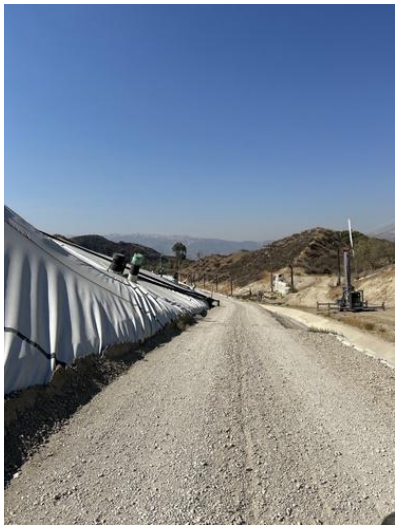
Photo 1

Description of area in photo where there is no leachate seepage or pooling.	West side perimeter road

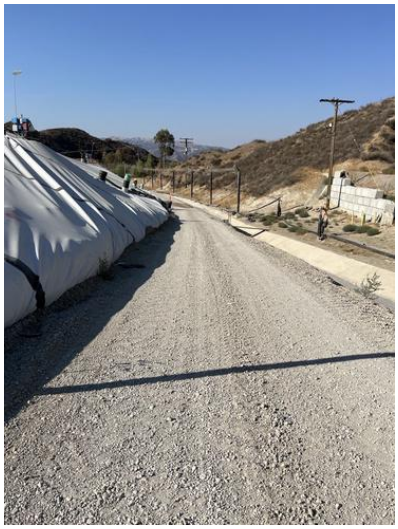
Photo 1

Description of area in photo where there is no leachate seepage or pooling.	Westside perimeter road.

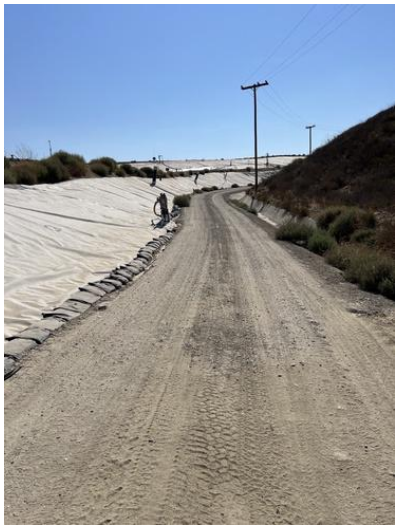
Photo 1

Description of area in photo where there is no leachate seepage or pooling.	North perimeter road.

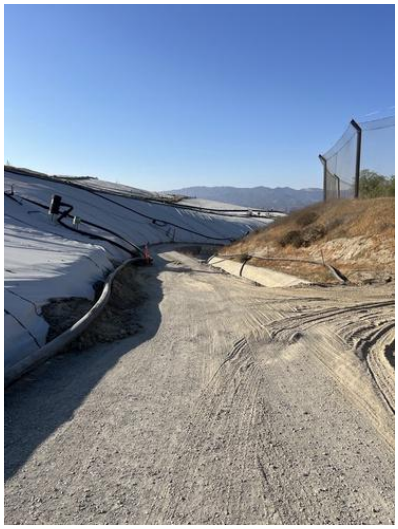
Photo 1

Description of area in photo where there is no leachate seepage or pooling.	Westside perimeter road.

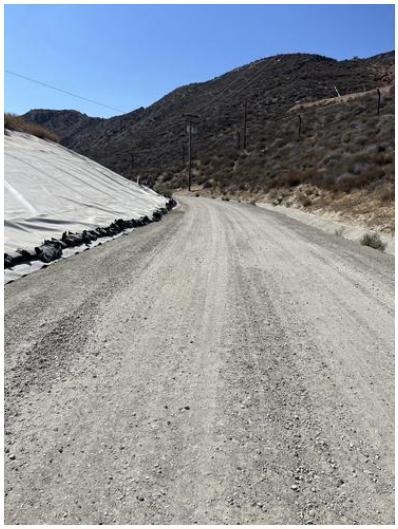
Photo 1

Description of area in photo where there is no leachate seepage or pooling.	North perimeter road.

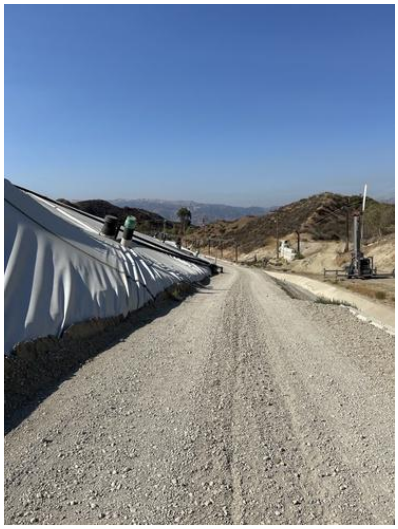
Photo 1

Description of area in photo where there is no leachate seepage or pooling.	West side perimeter road

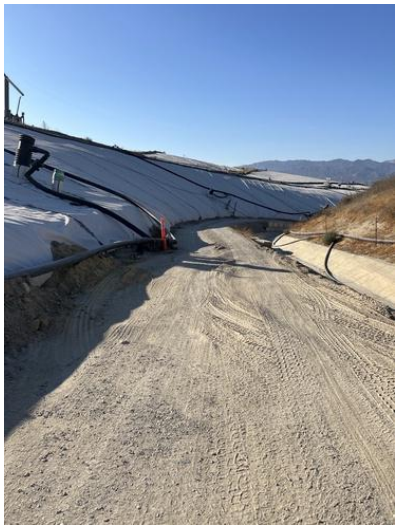
Photo 1

Description of area in photo where there is no leachate seepage or pooling.	Westside perimeter road.

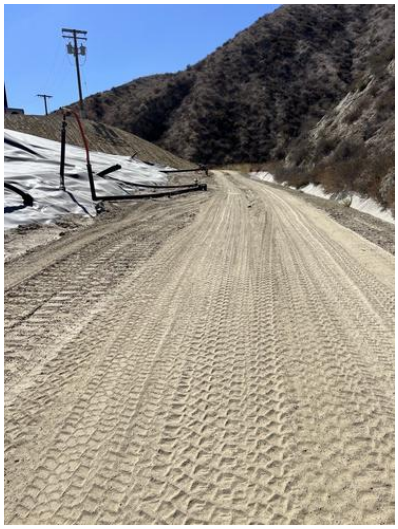
Photo 1

Description of area in photo where there is no leachate seepage or pooling.	North perimeter road.

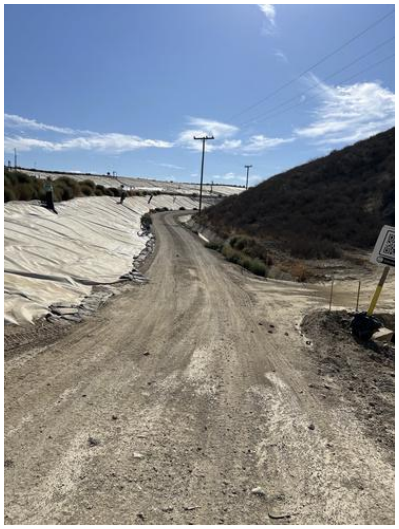
Photo 1

Has a leachate seep/pooling been located?	No

Description of area in photo where there is no leachate seepage or pooling.	North side perimeter road

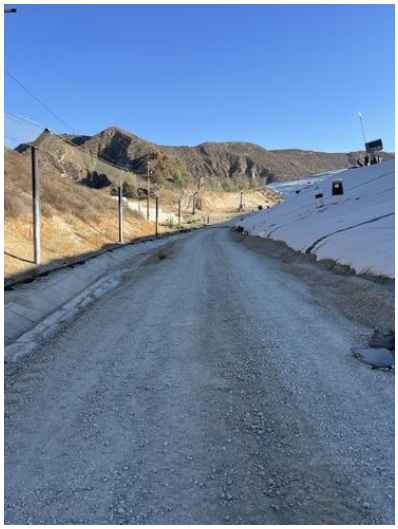
Photo 1

Has a leachate seep/pooling been located?	No

Description of area in photo where there is no leachate seepage or pooling.	Westside perimeter road.

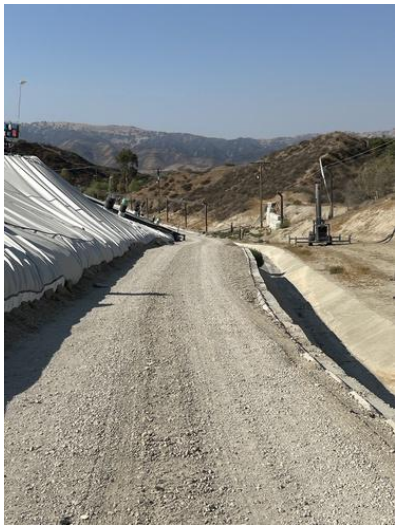
Photo 1

Has a leachate seep/pooling been located?	No

Description of area in photo where there is no leachate seepage or pooling.	West side perimeter road

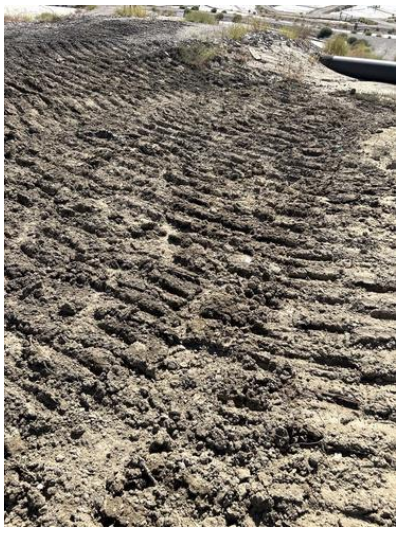
Photo 5

Fissure or Tension Crack Found?	Yes

Grid Location	152
Date and Time Found	30 Jul 2025 12:59 PM PDT

Length of crack (ft) or area containing multiple cracks (ft x ft)	10 ft x 5 ft
Horizontal Offset (width)	Medium 2-4" in width
Vertical Offset (height)	Extra small <0.5" in height
Orientation (direction)	NW to SE
Location	Castaic CA 91384 United States (34.43559382699576, -118.64725017796698)
Was Fissure or Crack fixed? If yes, add photo and description of repairs performed	Yes

Date and time of repairs	30 Jul 2025 2:55 PM PDT
Description of repairs	Cracks were track walked.

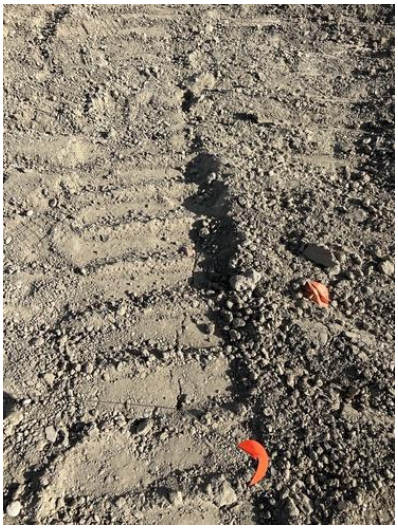
Photo 4

Length of crack (ft) or area containing multiple cracks (ft x ft)	8ft x 12ft
Horizontal Offset (width)	Small 0.5-2" in width
Vertical Offset (height)	Extra small <0.5" in height
Orientation (direction)	N to S
Location	Castaic CA 91384 United States (34.43603735229077, -118.64698830045313)
Was Fissure or Crack fixed? If yes, add photo and description of repairs performed	Yes

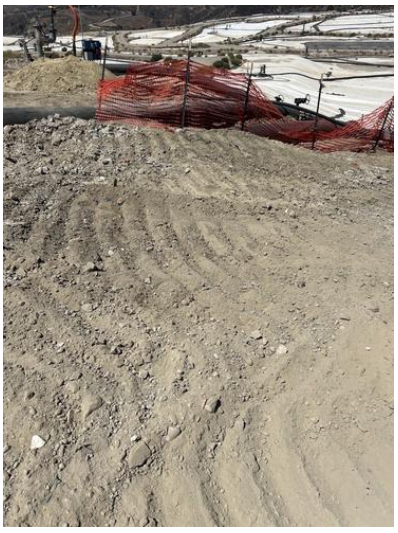
Photo 4

Length of crack (ft) or area containing multiple cracks (ft x ft)	2ft x 9ft area
Horizontal Offset (width)	Small 0.5-2" in width
Vertical Offset (height)	Extra small <0.5" in height
Orientation (direction)	E to W
Location	Castaic CA 91384 United States (34.435538889062784, -118.64687933782933)
Was Fissure or Crack fixed? If yes, add photo and description of repairs performed	Yes

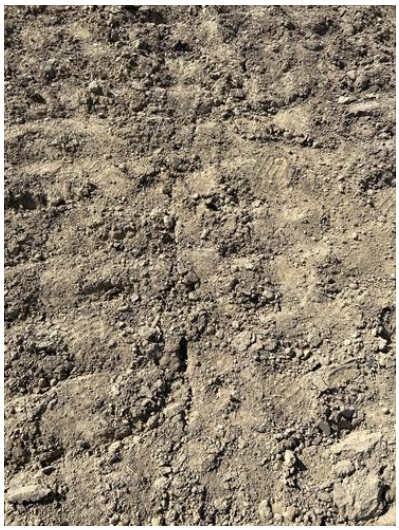
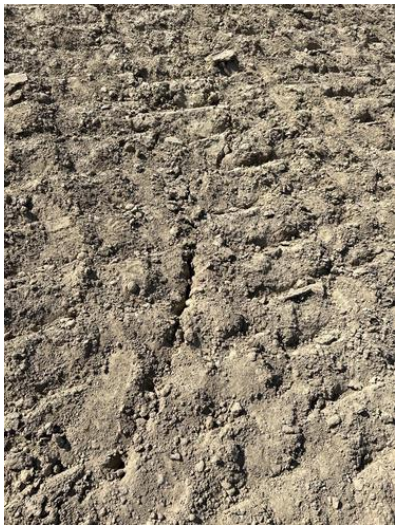
Length of crack (ft) or area containing multiple cracks (ft x ft)	30ft
Horizontal Offset (width)	Small 0.5-2" in width
Vertical Offset (height)	Extra small <0.5" in height
Orientation (direction)	N to S
Location	Castaic CA 91384 United States (34.43591219815509, -118.64679143338822)
Was Fissure or Crack fixed? If yes, add photo and description of repairs performed	Yes

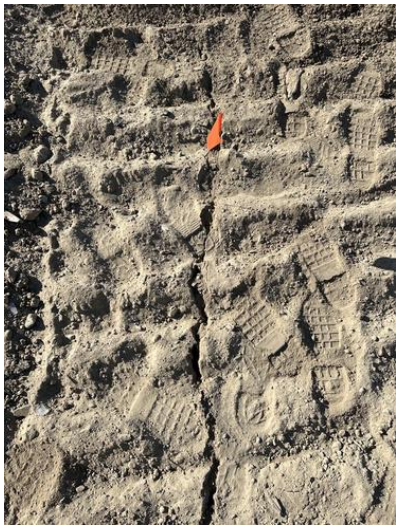
Length of crack (ft) or area containing multiple cracks (ft x ft)	10ft x 25ft
Horizontal Offset (width)	Small 0.5-2" in width
Vertical Offset (height)	Extra small <0.5" in height
Orientation (direction)	NW to SE
Location	Castaic CA 91384 United States (34.435933401453305, -118.64700663105296)
Was Fissure or Crack fixed? If yes, add photo and description of repairs performed	Yes

Date and time of repairs	12 Aug 2025 9:41 AM PDT
Description of repairs	Cracks were track walked.

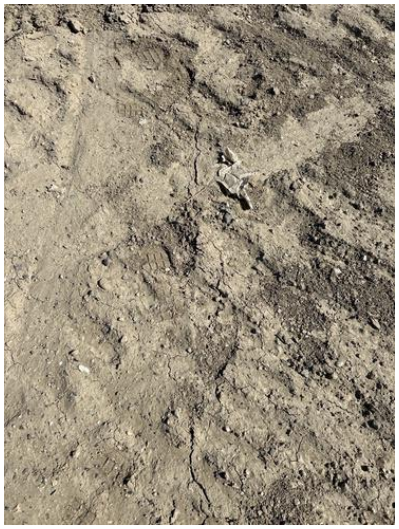
Length of crack (ft) or area containing multiple cracks (ft x ft)	17ft x 10ft
Horizontal Offset (width)	Extra Small <0.5 in width
Vertical Offset (height)	Extra small <0.5" in height
Orientation (direction)	N to S
Location	Castaic CA 91384 United States (34.43537468705416, -118.6465316770216)
Was Fissure or Crack fixed? If yes, add photo and description of repairs performed	Yes

Date and time of repairs	12 Aug 2025 10:04 AM PDT
Description of repairs	Cracks were track walked.

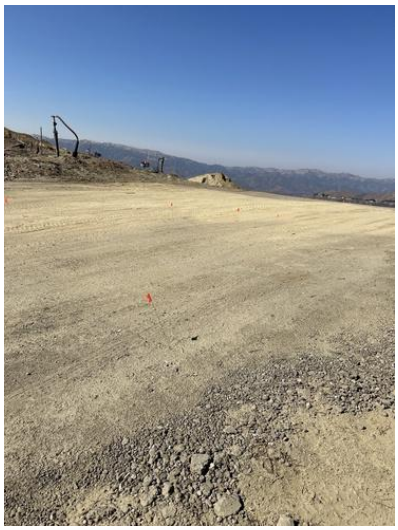
Grid Location	146
Date and Time Found	13 Aug 2025 9:31 AM PDT

Length of crack (ft) or area containing multiple cracks (ft x ft)	45ft x 35ft
Horizontal Offset (width)	Small 0.5-2" in width
Vertical Offset (height)	Extra small <0.5" in height
Orientation (direction)	NW to SE
Location	Castaic CA 91384 United States (34.436363959717035, -118.64682652998589)
Was Fissure or Crack fixed? If yes, add photo and description of repairs performed	Yes

Date and time of repairs	13 Aug 2025 11:18 PM PDT
Description of repairs	Other (please describe)

Cracks were covered over with dirt and compacted.

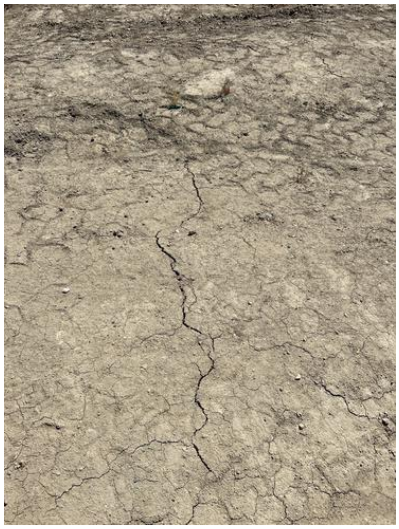
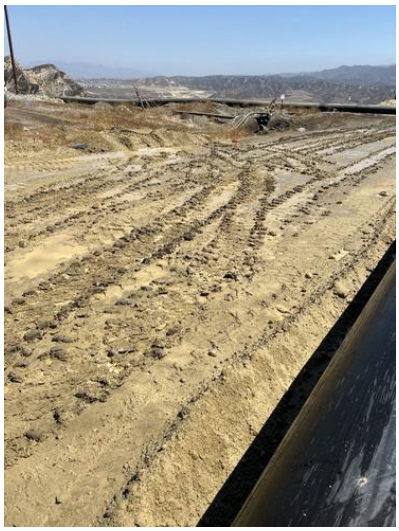
Grid Location	90
Date and Time Found	14 Aug 2025 10:31 AM PDT

Length of crack (ft) or area containing multiple cracks (ft x ft)	20x 30ft area
Horizontal Offset (width)	Small 0.5-2" in width
Vertical Offset (height)	Small 0.5-2" in height
Orientation (direction)	NE to SW
Location	Castaic CA 91384 United States (34.43520765961595, -118.6449109314678)
Was Fissure or Crack fixed? If yes, add photo and description of repairs performed	Yes

Date and time of repairs	14 Aug 2025 12:23 PM PDT
Description of repairs	Cracks were track walked.

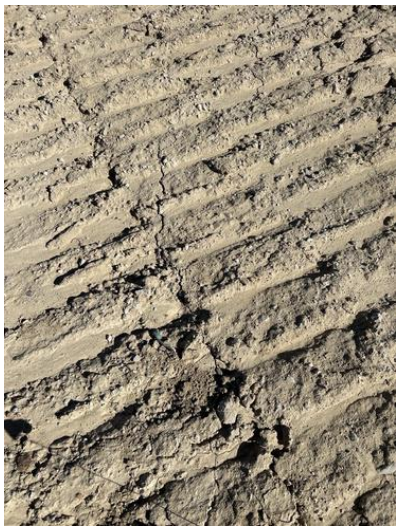
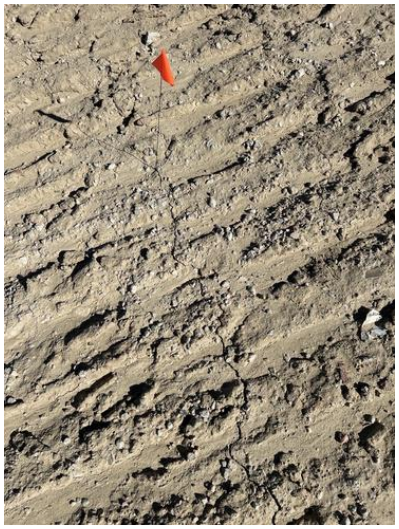
Grid Location	147
Date and Time Found	18 Aug 2025 10:42 AM PDT

Length of crack (ft) or area containing multiple cracks (ft x ft)	75ft x 5ft

No individual crack was over 50ft

Horizontal Offset (width)	Extra Small <0.5 in width
Vertical Offset (height)	Extra small <0.5" in height
Orientation (direction)	NW to SE
Location	Castaic CA 91384 United States (34.43572257648635, -118.64703490409873)
Was Fissure or Crack fixed? If yes, add photo and description of repairs performed	Yes

Date and time of repairs	18 Aug 2025 12:22 PM PDT
Description of repairs	Cracks were track walked.
Instability	
Are there any indications of slope stability concerns?	No

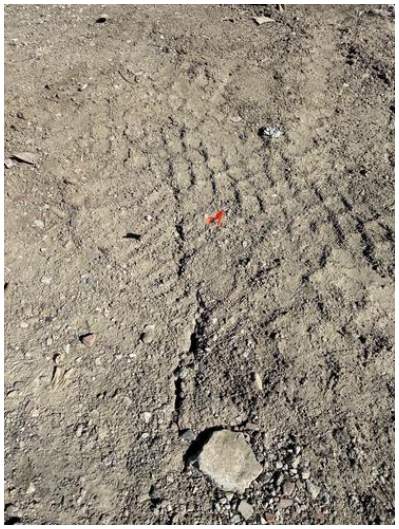
Grid Location	159
Date and Time Found	19 Aug 2025 9:50 AM PDT

Length of crack (ft) or area containing multiple cracks (ft x ft)	55ft x 20ft

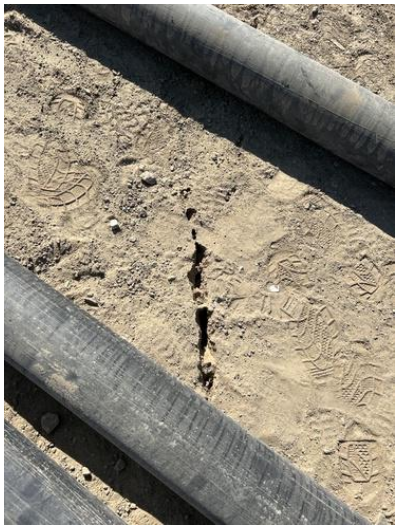
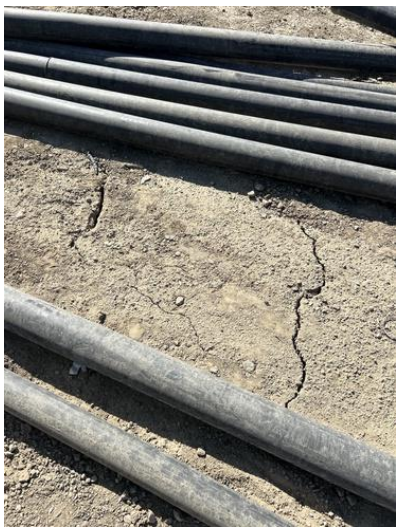
Length of crack (ft) or area containing multiple cracks (ft x ft)	6ft x 20ft area
Horizontal Offset (width)	Medium 2-4" in width
Vertical Offset (height)	Small 0.5-2" in height
Orientation (direction)	NW to SE
Location	Castaic CA 91384 United States (34.4358110820343, -118.64625080459615)
Was Fissure or Crack fixed? If yes, add photo and description of repairs performed	Yes

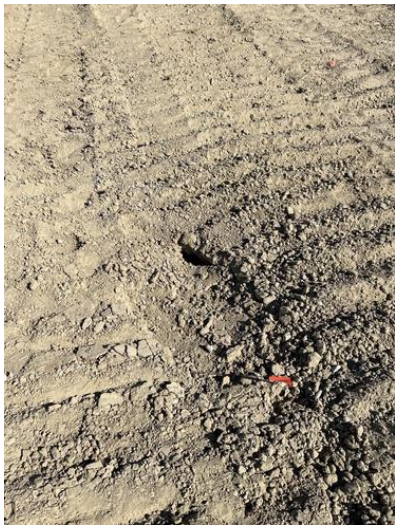
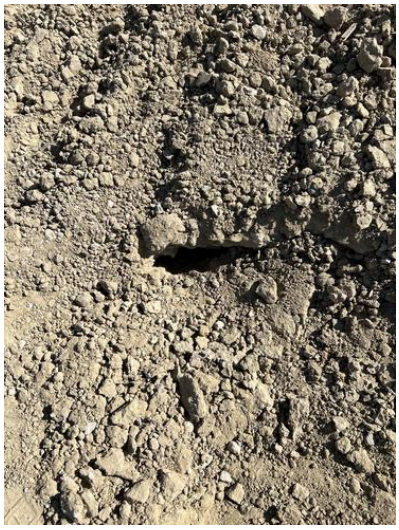
Grid Location	147
Date and Time Found	26 Aug 2025 10:16 AM PDT

Length of crack (ft) or area containing multiple cracks (ft x ft)	1ft
Horizontal Offset (width)	Medium 2-4" in width

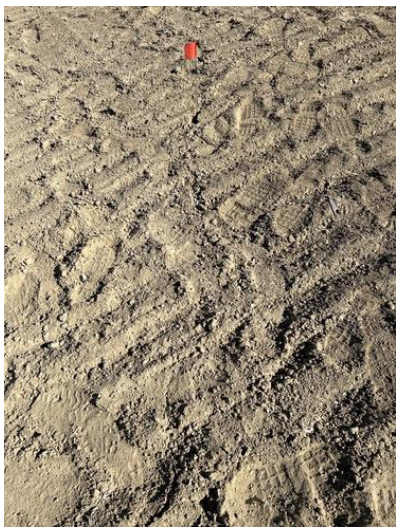
Length of crack (ft) or area containing multiple cracks (ft x ft)	30 ft
Horizontal Offset (width)	Small 0.5-2" in width
Vertical Offset (height)	Extra small <0.5" in height
Orientation (direction)	N to S
Location	Castaic CA 91384 United States (34.43563255723377, -118.64717205056597)
Was Fissure or Crack fixed? If yes, add photo and description	Yes

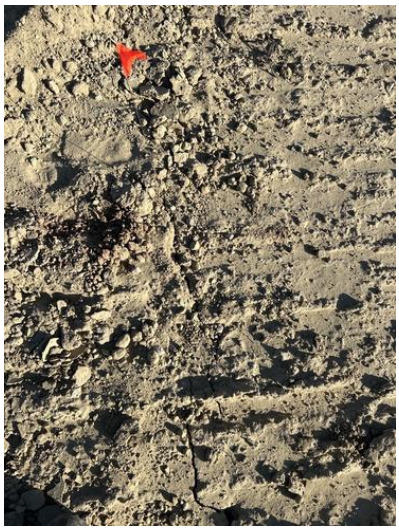
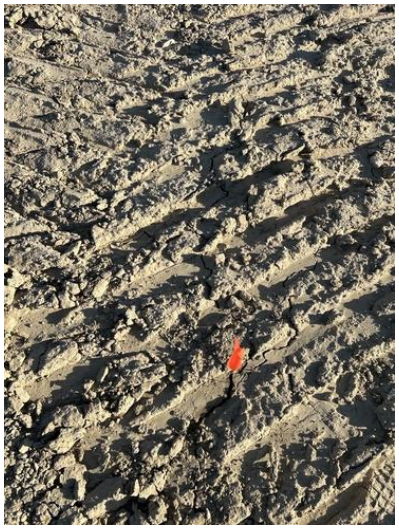
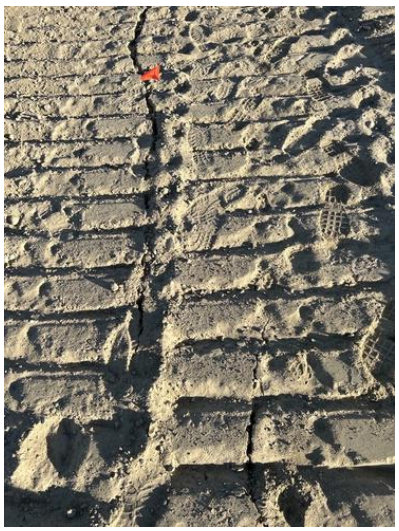
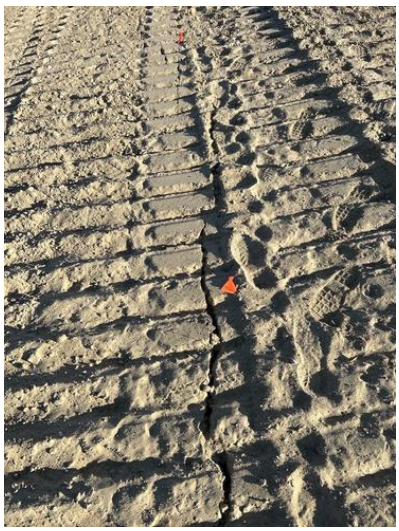
Length of crack (ft) or area containing multiple cracks (ft x ft)	155ft x 5ft

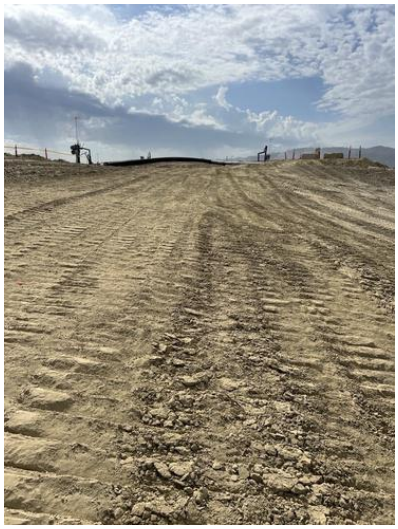
Photo 7

Horizontal Offset (width)	Small 0.5-2" in width
Vertical Offset (height)	Small 0.5-2" in height
Orientation (direction)	NW to SE
Location	Castaic CA 91384 United States (34.43585040656491, -118.64698804473485)
Was Fissure or Crack fixed? If yes, add photo and description of repairs performed	Yes

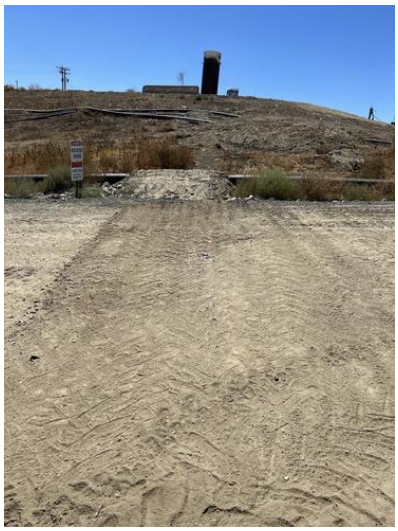
Photo 3

Horizontal Offset (width)	Extra Small <0.5 in width
Vertical Offset (height)	Extra small <0.5" in height
Orientation (direction)	N to S
Location	Castaic CA 91384 United States (34.43624834541708, -118.64696033177474)
Was Fissure or Crack fixed? If yes, add photo and description of repairs performed	Yes
