20 de noviembre de 2025
Archivo No. 01204123.42, Tarea 10

Asunto: Informe Mensual de octubre de 2025 de la Orden de Depuración Estipulada Modificada (Caso No. 6177-4), Vertedero de Chiquita Canyon (Código de Instalación 119219), Castaic,

SCS Engineers (SCS), en nombre de Chiquita Canyon, LLC (Chiquita), mediante el presente le proporciona al Distrito de Gestión de la Calidad del Aire de la Costa Sur (SCAQMD) un informe mensual según la Orden de Depuración Estipulada Modificada (SOFA) (Caso No. 6177-4). La SOFA se aprobó inicialmente el 6 de septiembre de 2023 y se modificó posteriormente el 17 de enero de 2024, el 21 de marzo de 2024, el 24 de abril de 2024, el 27 de agosto de 2024, el 13 de noviembre de 2024, el 16 de abril de 2025 y el 24 de junio de 2025.

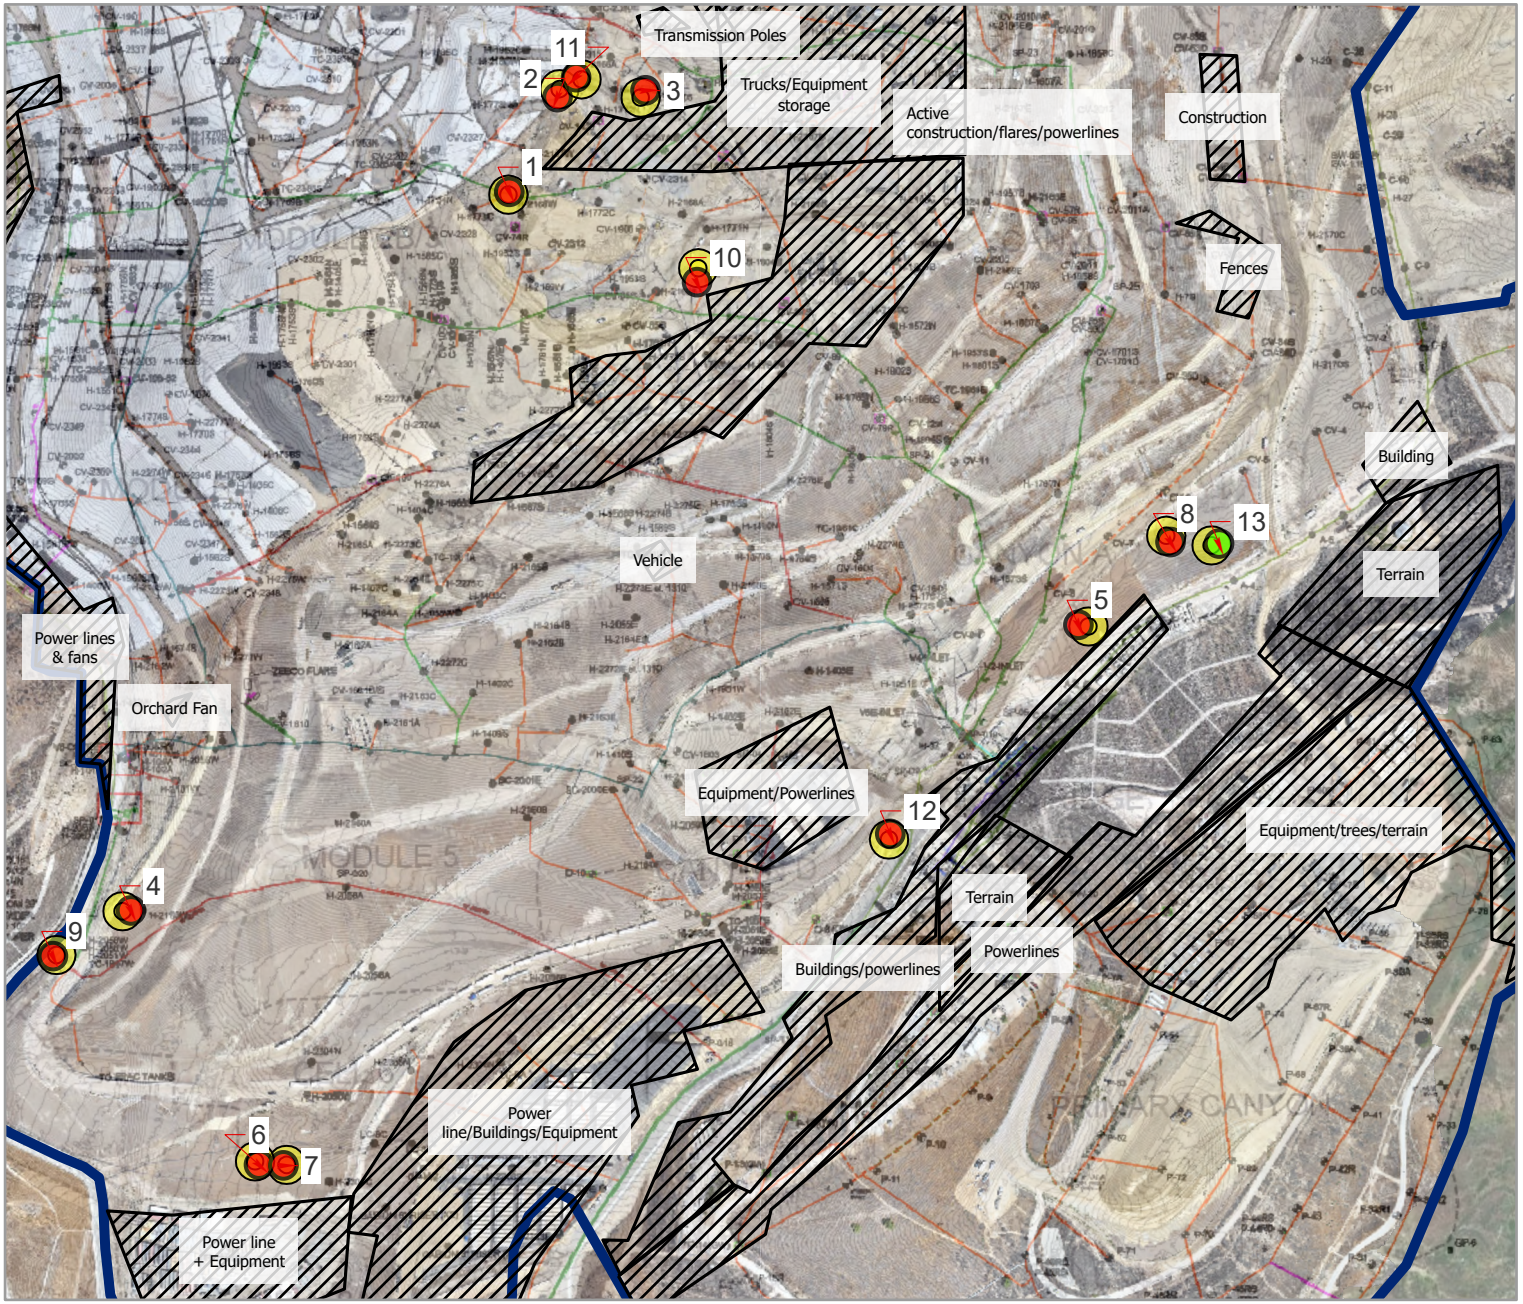
Chiquita Canyon Landfill Peak Verification Map

1. SnifferDRONE Verification

2. SnifferDRONE Verification

3. SnifferDRONE Verification

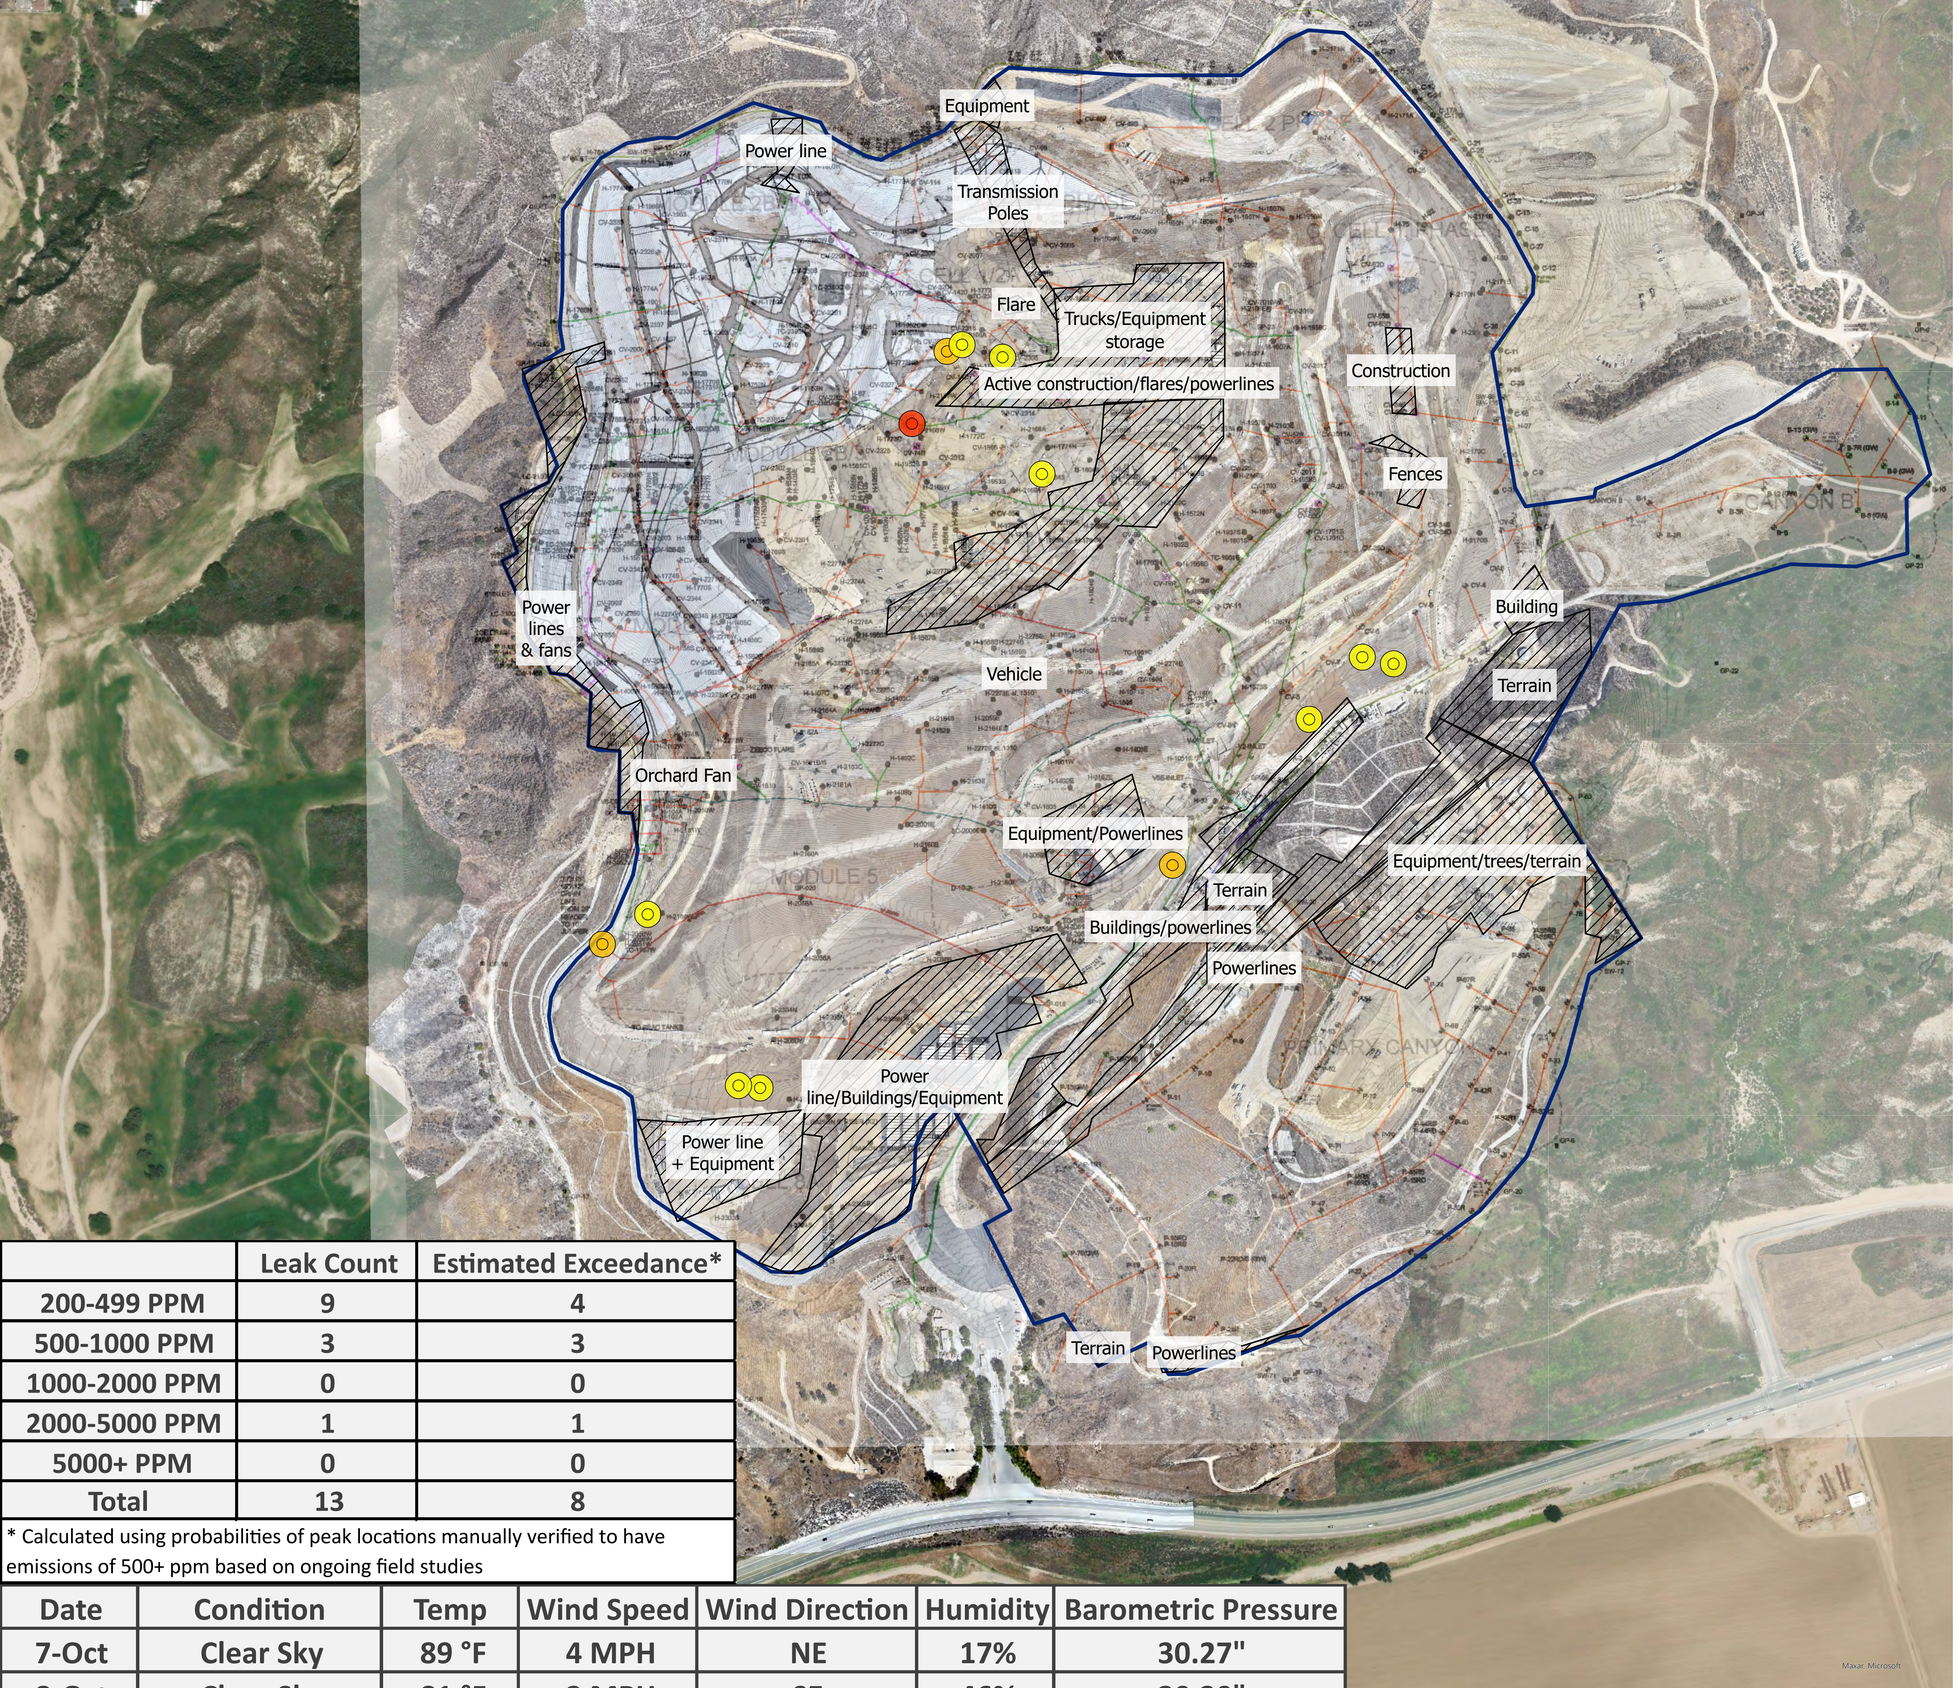
Leak Count	Estimated Exceedance*
200-499 PPM	9	4
500-1000 PPM	3	3
1000-2000 PPM	0	0
2000-5000 PPM	1	1
5000+ PPM	0	0
Total	13	8

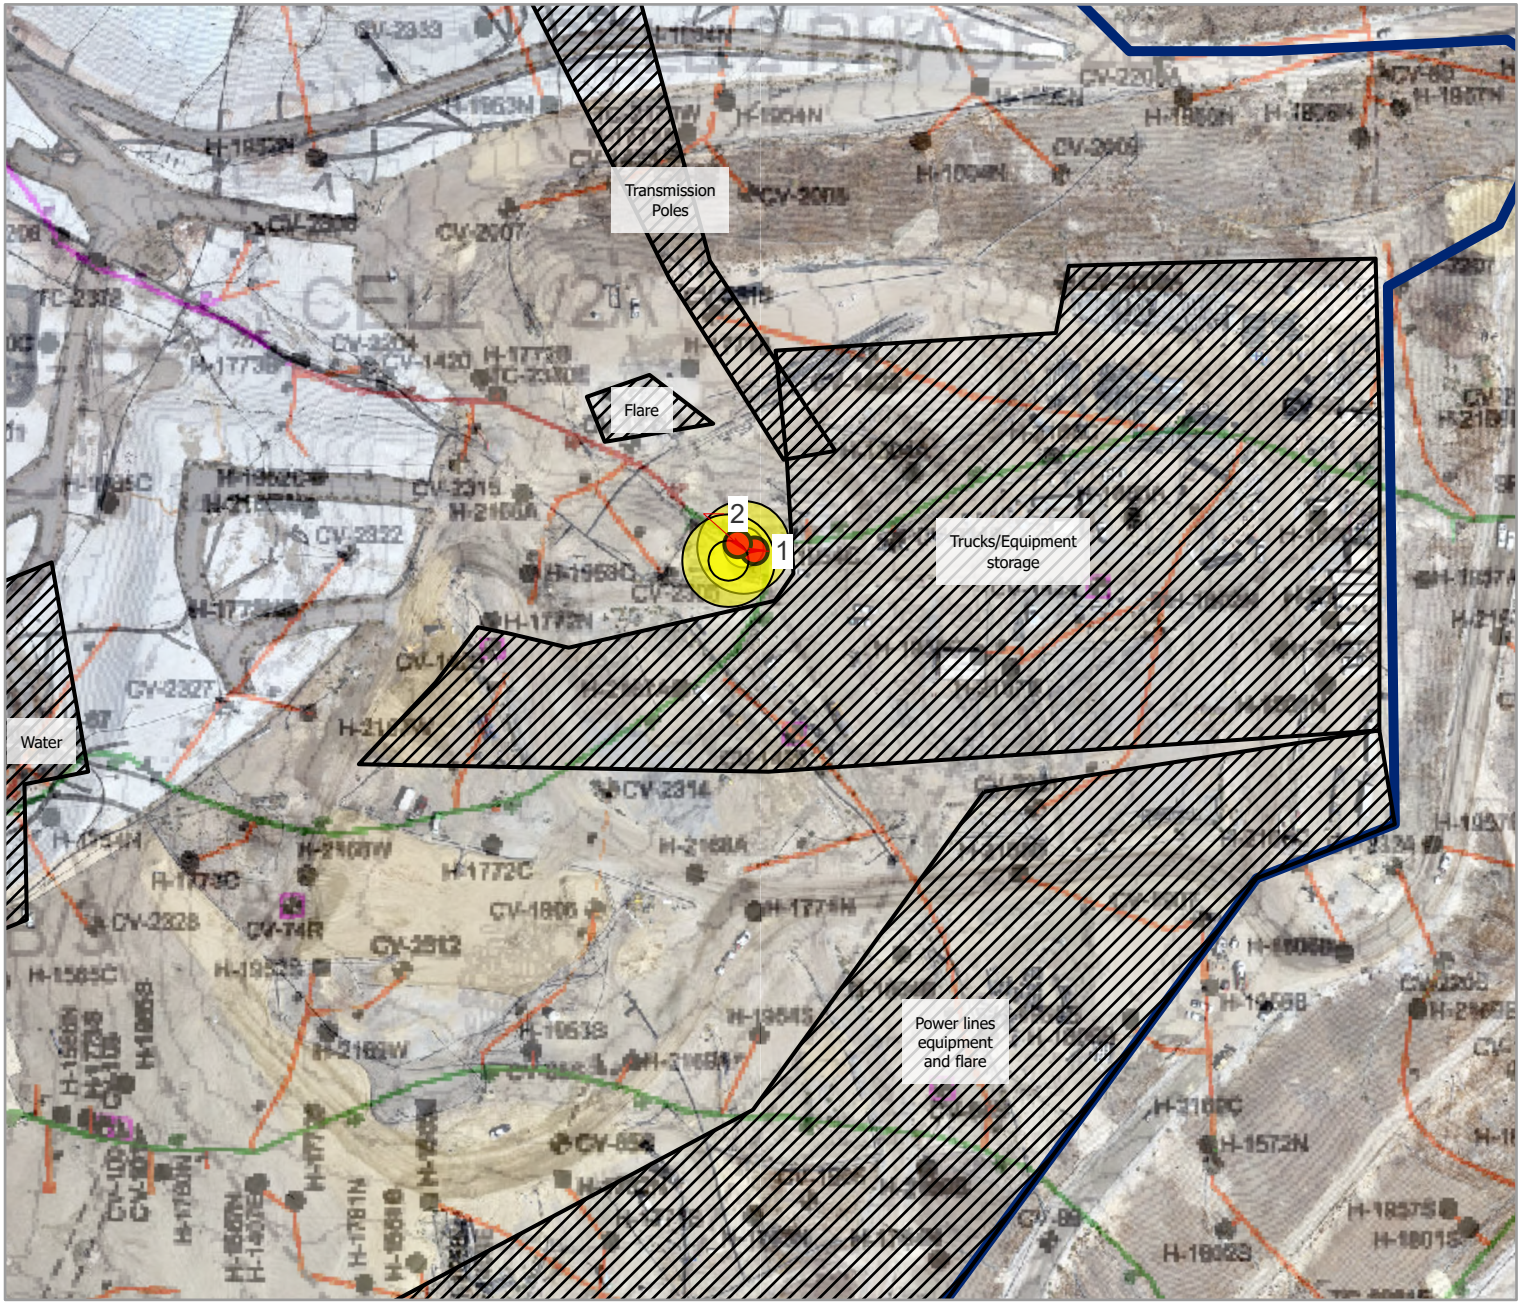
Chiquita Canyon Landfill Peak Verification Map

LOCATION DETAILS						**INSPECTION RESULTS**						
Ref	**SnifferDRONE Lat**	**SnifferDRONE Long**	**Verified Lat**	**Verified Long**	**Location Description**	**SnifferDRONE Date (UTC)**	**SnifferDRONE Time (UTC)**	**SnifferDRONE PPM**	**Verified Date (UTC)**	**Verified Time (UTC)**	**Verified PPM**	**Notes**
1	34.43531	-118.64623	34.43530553	-118.64620		10/14/2025	21:20	282	10/14/2025	21:41	***51,000***	
2	34.43528	-118.64628	34.43532321	-118.64625		10/14/2025	21:21	221	10/14/2025	21:40	***1,000***

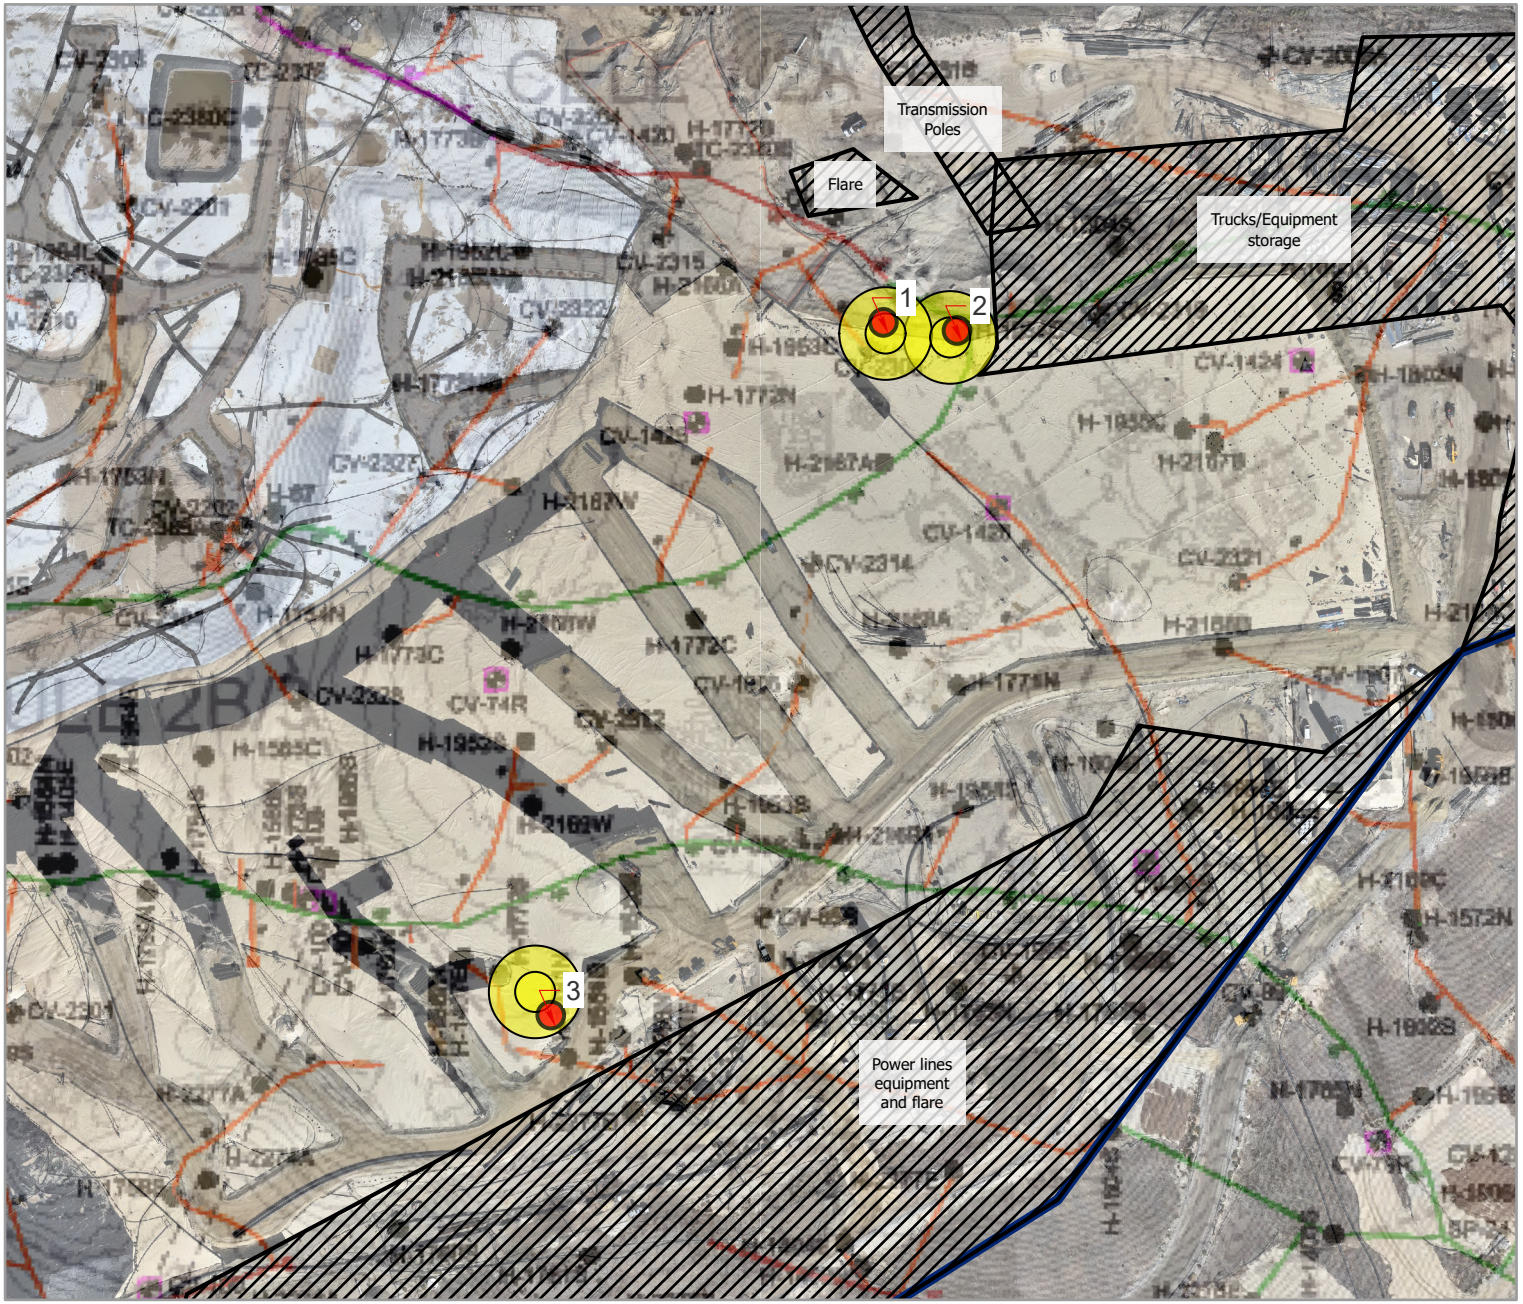
Chiquita Canyon Landfill Peak Verification Map

LOCATION DETAILS						INSPECTION RESULTS						
Ref	SnifferDRONE Lat	SnifferDRONE Long	Verified Lat	Verified Long	Location Description	SnifferDRONE Date (UTC)	SnifferDRONE Time (UTC)	SnifferDRONE PPM	Verified Date (UTC)	Verified Time (UTC)	Verified PPM	Notes
1	34.43528	-118.64643	34.43530912	-118.64644		10/29/2025	18:51	203	10/29/2025	19:48	***83,000***	
2	34.43527	-118.64623	34.43529088	-118.64620		10/29/2025	18:51	1,304	10/29/2025	19:50	***77,000***	
3	34.43353	-118.64751	34.43346449	-118.64746		10/29/2025	19:27	212	10/29/2025	21:11	***2,000***

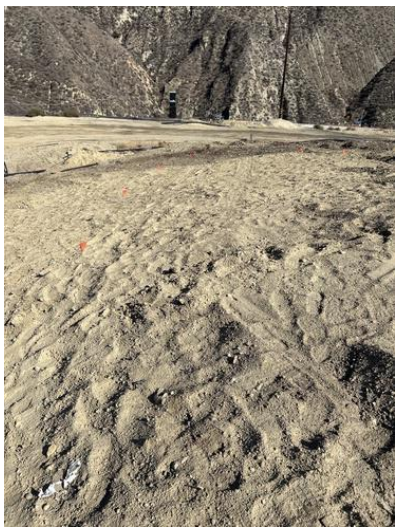
Photo 5

Image of Fissure/Tension Crack

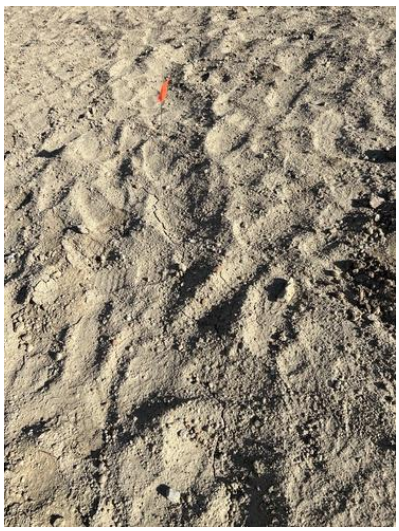
Photo 6

Fissure or Tension Crack Found?	Yes

Grid Location	146
Date and Time Found	30 Sep 2025 10:04 AM PDT

Length of crack (ft) or area containing multiple cracks (ft x ft)	40ft x 20ft
Horizontal Offset (width)	Small 0.5-2" in width
Vertical Offset (height)	Extra small <0.5" in height
Orientation (direction)	N to S
Location	Castaic CA 91384 United States (34.436114334321026, -118.64689422654669)
Was Fissure or Crack fixed? If yes, add photo and description of repairs performed	Yes

Date and time of repairs	30 Sep 2025 10:41 AM PDT
Description of repairs	Cracks were track walked.
Instability	
Are there any indications of slope stability concerns?	No

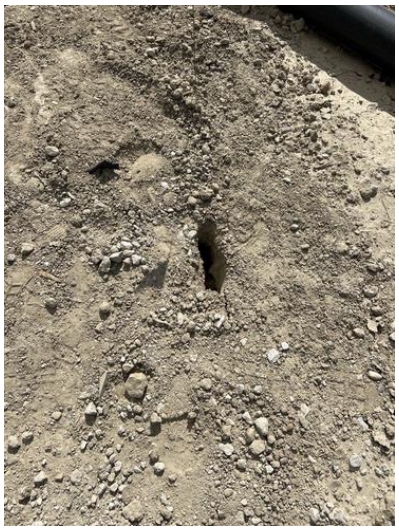
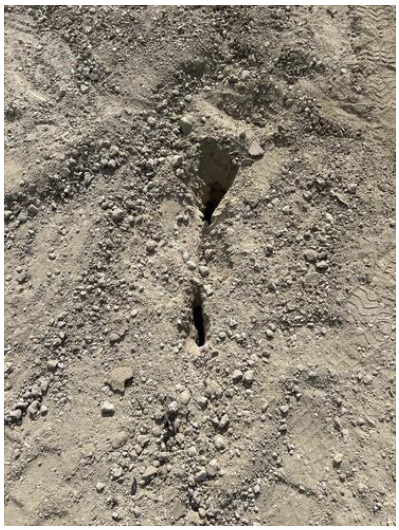
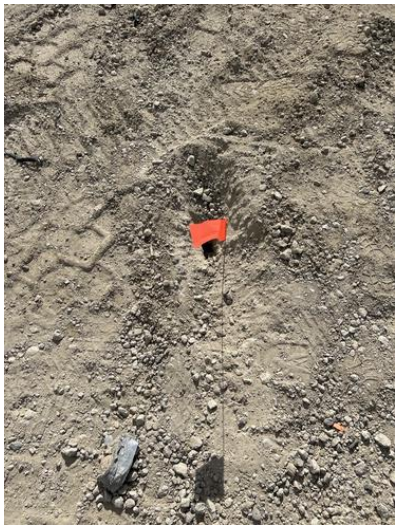
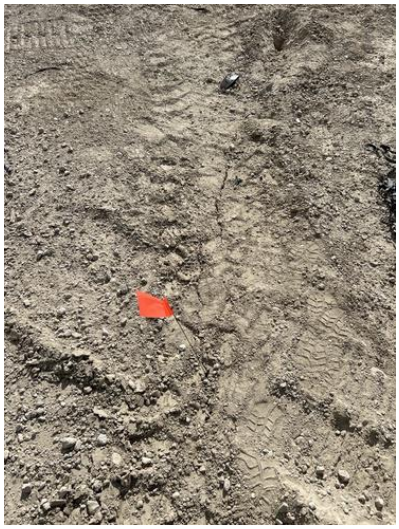
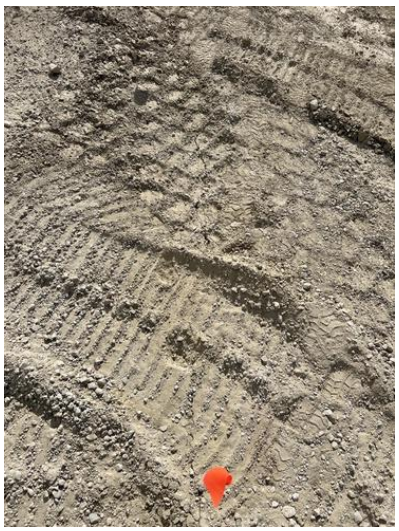
Fissure or Tension Crack Found?	Yes

Grid Location	147
Date and Time Found	3 Oct 2025 10:41 AM PDT

Length of crack (ft) or area containing multiple cracks (ft x ft)	30ft
Crack is 30ft long in total with soil creating a bridge over parts of crack	
Horizontal Offset (width)	Medium 2-4" in width
Vertical Offset (height)	Extra small <0.5" in height
Orientation (direction)	NW to SE
Location	Castaic CA 91384 United States (34.44113922231614, -118.63985214402598)
Was Fissure or Crack fixed? If yes, add photo and description of repairs performed	Yes

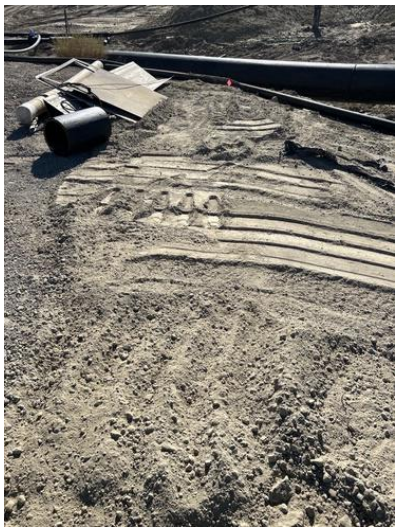
Photo 3

Horizontal Offset (width)	Medium 2-4" in width
Vertical Offset (height)	Extra small <0.5" in height
Orientation (direction)	NW to SE
Location	Valencia CA 91355 United States (34.429749773441145, -118.64428420507733)
Was Fissure or Crack fixed? If yes, add photo and description of repairs performed	Yes

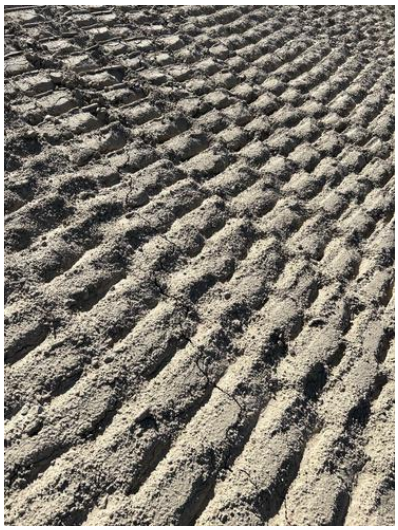
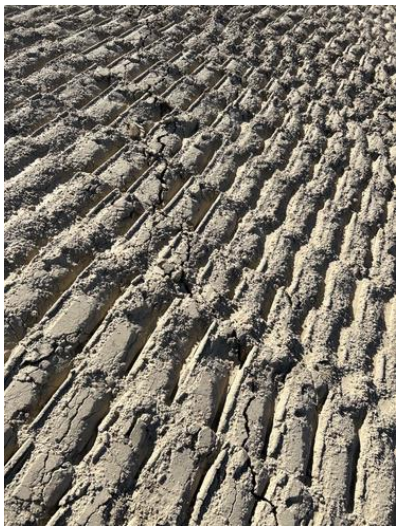
Grid Location	147
Date and Time Found	6 Oct 2025 9:50 AM PDT

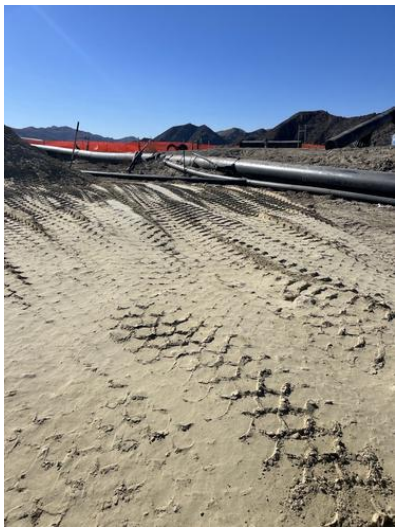
Photo 3

Horizontal Offset (width)	Small 0.5-2" in width
Vertical Offset (height)	Extra small <0.5" in height
Orientation (direction)	NW to SE
Location	Castaic CA 91384 United States (34.435639026319144, -118.64639745945652)
Was Fissure or Crack fixed? If yes, add photo and description of repairs performed	Yes

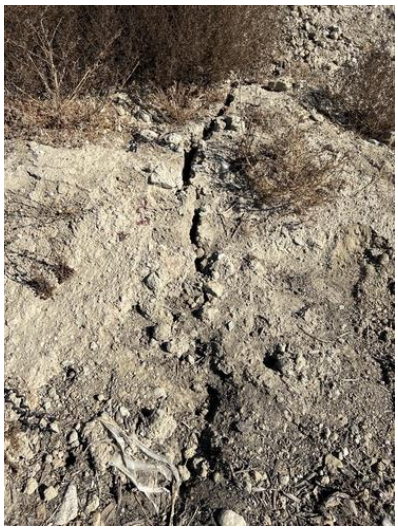
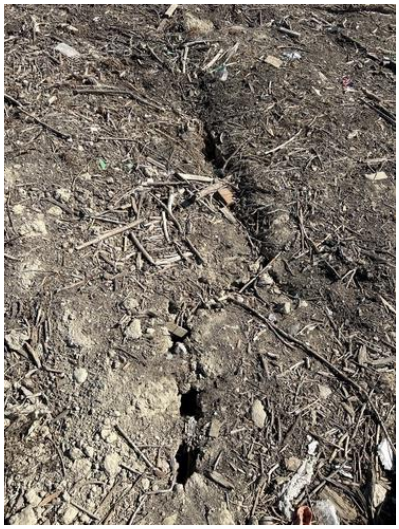
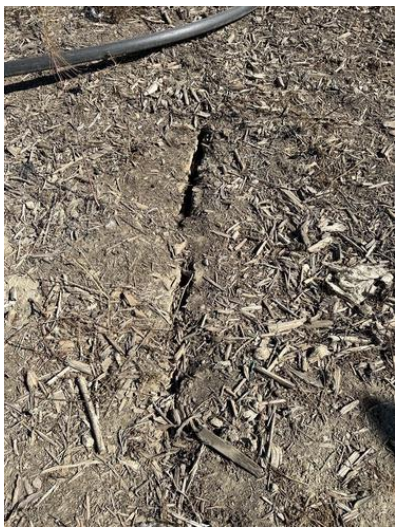
Grid Location	163
Date and Time Found	10 Oct 2025 9:56 AM PDT

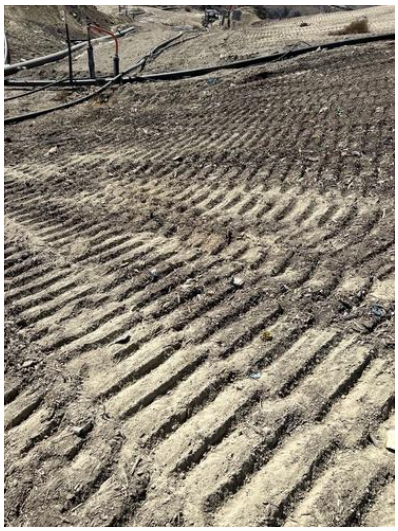
Photo 14

Horizontal Offset (width)	Large >4" in width
Vertical Offset (height)	Extra small <0.5" in height
Orientation (direction)	NE to SW
Location	Castaic CA 91384 United States (34.43468202173708, -118.64759519450548)
Was Fissure or Crack fixed? If yes, add photo and description of repairs performed	Yes

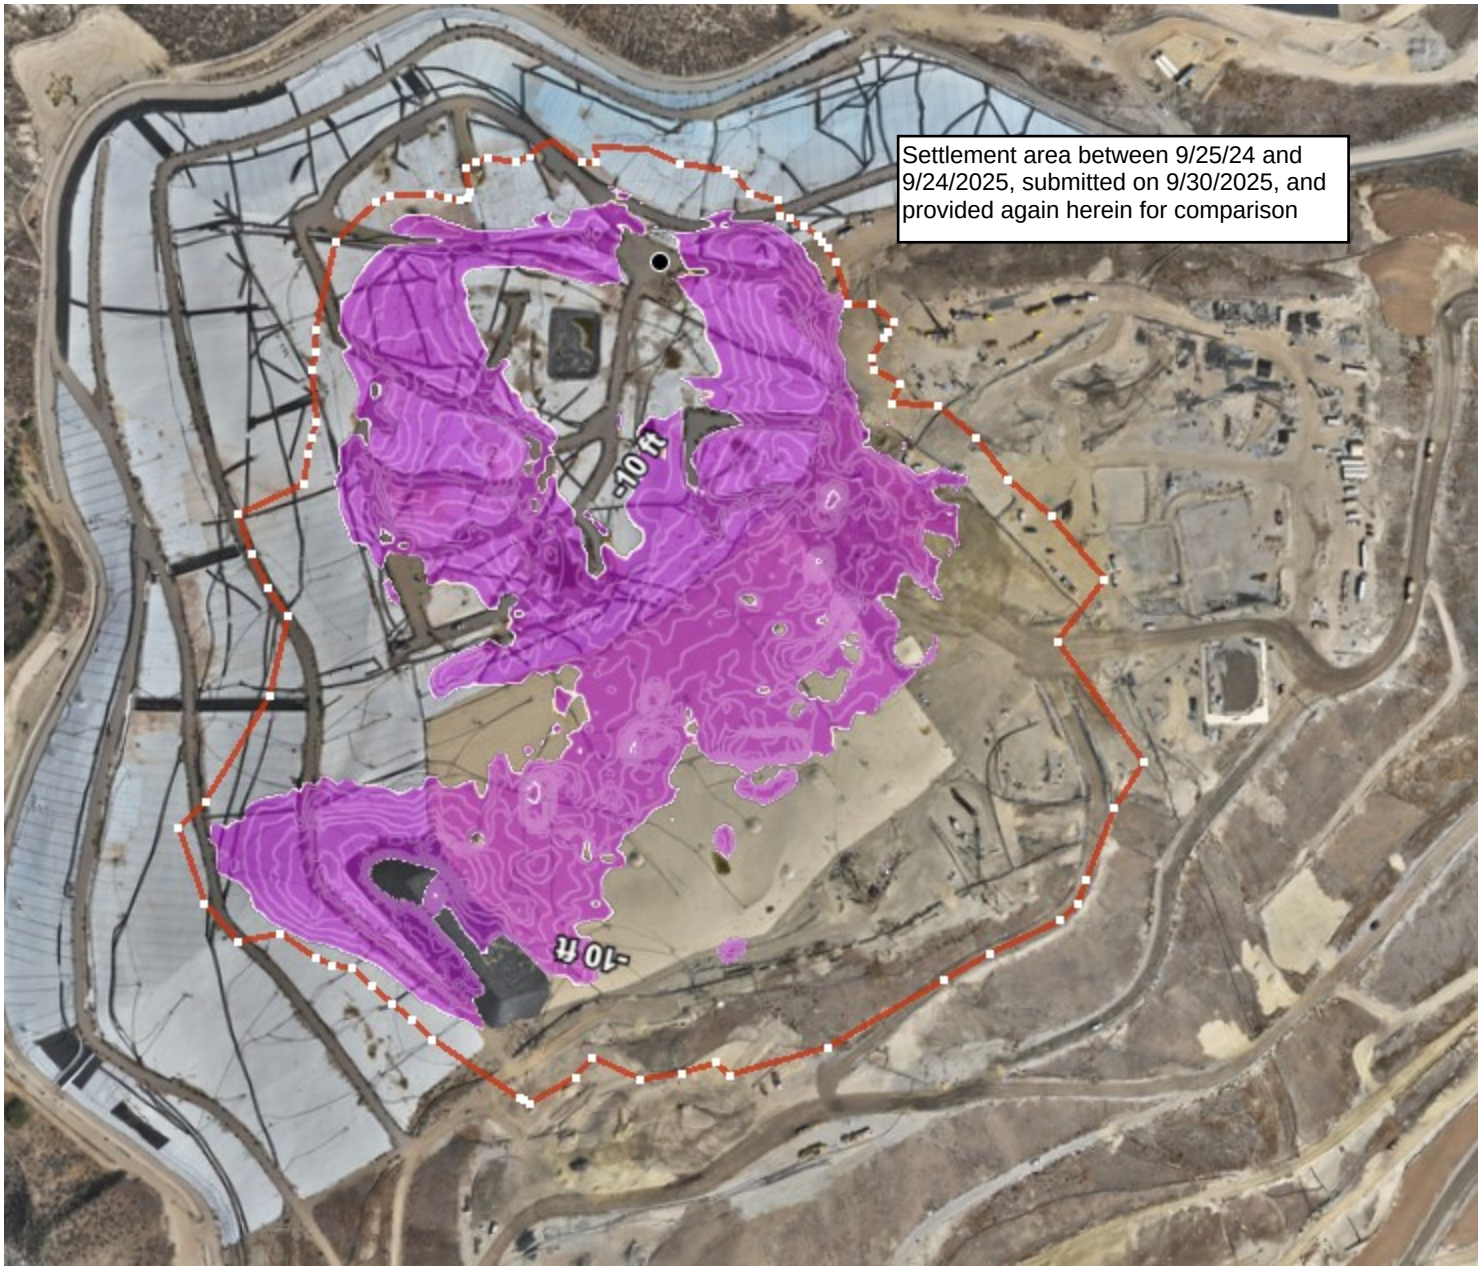
Settlement area between 9/25/24 and 9/24/2025, submitted on 9/30/2025, and provided again herein for comparison
-10 ft
-10 ft

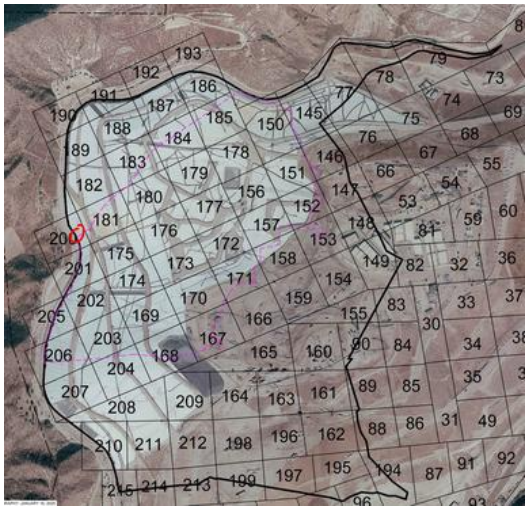
Identification of Issues	
Identified Issue	
Identified Issue 1	
Are there any issues with the geosynthetic cover?	Yes
Date and Time Issue Found	6 Oct 2025 8:03 AM PDT

Notate what the issue is and what needs to be repaired	Tear in liner needs to be patched/extrusion welded.

Description of repair work	Tear taped upon discovery, permanent repair completed on the same day at 12:45pm.
Date and time of repair (within 2 hours)	6 Oct 2025 8:05 AM PDT
Are further permanent repairs required?	No
Instability under the cover	
Are there any anomalous (unusual or unexpected) areas of cover damage or deformation that may indicate underlying instability?	No
Are there any signs of a downslope tension crack at the top of the slope or bulging at or near the toe of the slope?	No
Is there any movement of the equipment that vertically penetrates the cover (e.g., tilting)?	No

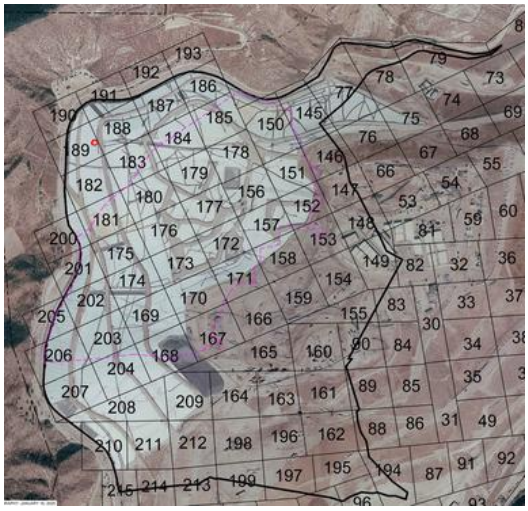
Grid 189

Identification of Issues	
Identified Issue	
Identified Issue 1	
Are there any issues with the geosynthetic cover?	Yes
Date and Time Issue Found	9 Oct 2025 12:10 PM PDT

Notate what the issue is and what needs to be repaired	Small tear in liner. Needs to be patched and extrusion welded

Description of repair work	Flex tape placed over tear to temporarily seal it
Date and time of repair (within 2 hours)	9 Oct 2025 12:12 PM PDT
Are further permanent repairs required?	Yes

Permanent repair was conducted on 10/10/25. Liner was patched and extrusion welded.

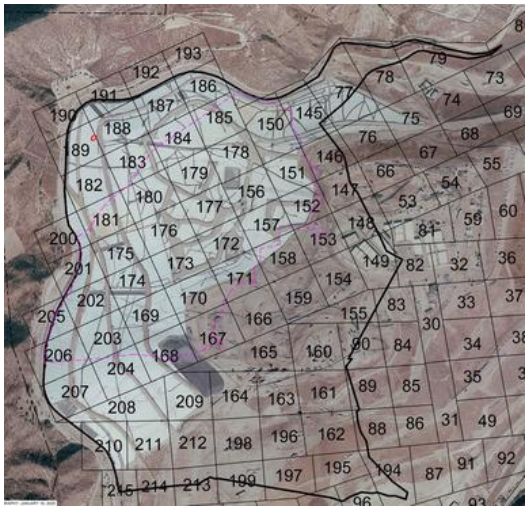
Grid 189

Are there any issues with the geosynthetic cover?	Yes
Date and Time Issue Found	9 Oct 2025 12:13 PM PDT
Grid Location

Description of repair work	Flex tape placed over tear to temporarily seal it
Date and time of repair (within 2 hours)	9 Oct 2025 12:16 PM PDT
Are further permanent repairs required?	Yes

Permanent repair was conducted on 10/10/25. Liner was patched and extrusion welded.

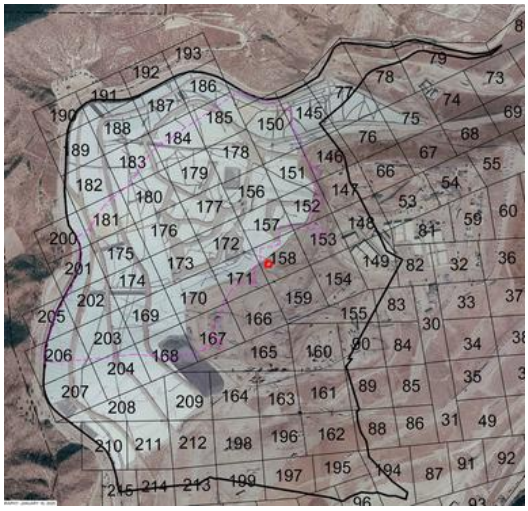
Grid 158

Identification of Issues	
Identified Issue	
Identified Issue 1	
Are there any issues with the geosynthetic cover?	Yes
Date and Time Issue Found	10 Oct 2025 10:52 AM PDT

Notate what the issue is and what needs to be repaired	Tear in liner. Needs to be patched and extrusion welded

Description of repair work	Flex tape placed over tear upon discovery. Tear was patched and extrusion welded on 10/13/25.
Date and time of repair (within 2 hours)	10 Oct 2025 11:02 AM PDT
Are further permanent repairs required?	No
Instability under the cover	
Are there any anomalous (unusual or unexpected) areas of cover damage or deformation that may indicate underlying instability?	No
Are there any signs of a downslope tension crack at the top of the slope or bulging at or near the toe of the slope?	No
Is there any movement of the equipment that vertically penetrates the cover (e.g., tilting)?	No

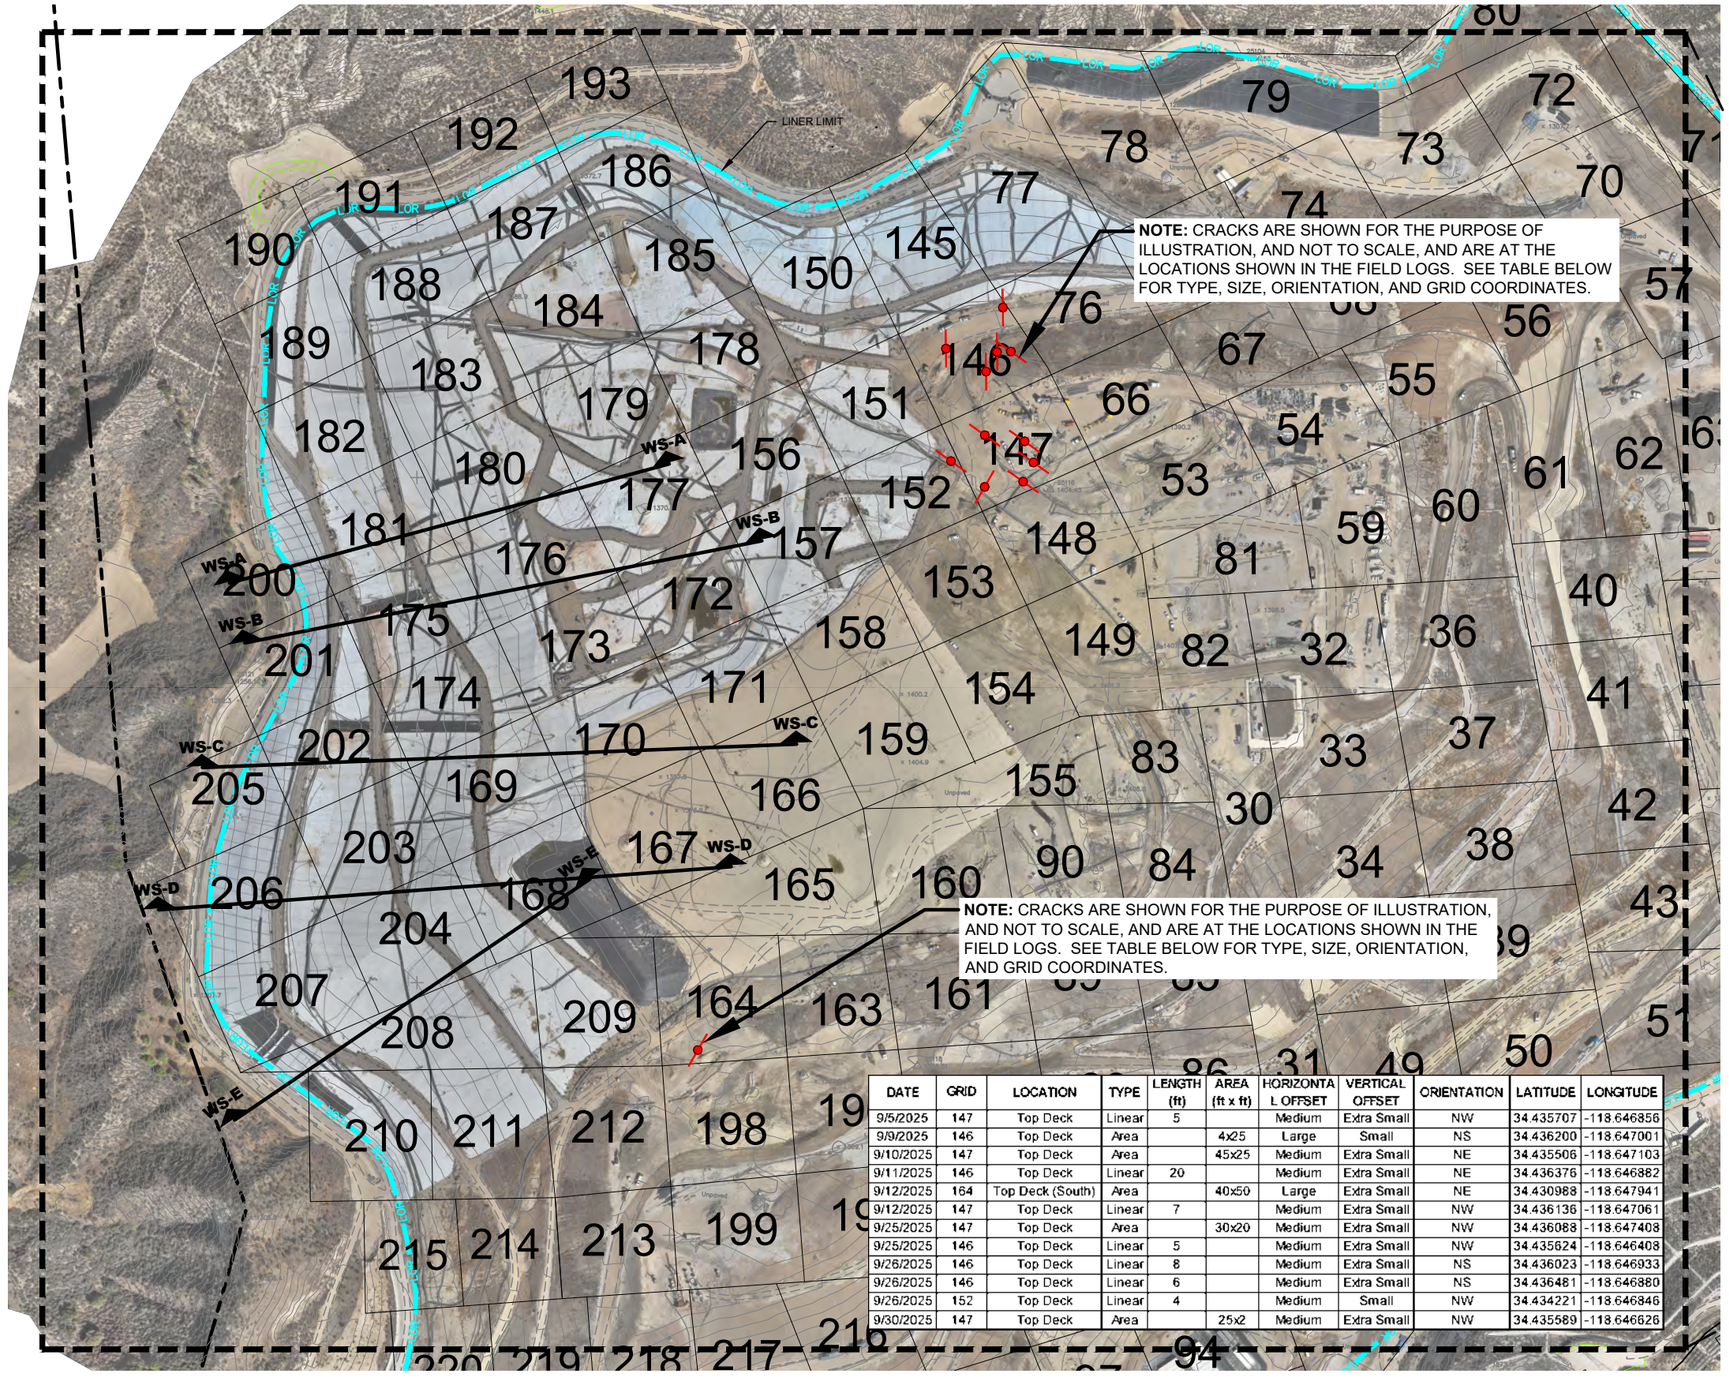
September Notes:

1. Small tear in liner. Tear was taped on September 4. Permanent repair was completed on 9/5/2025.
2. Liner torn. Tear was taped on September 5. Permanent patch was placed on 9/8/2025.
3. Cut in liner. Tear was patched and extrusion welded on 9/15/2025.
4. Tear at seam in liner. Covered with new liner and sand bagged. Permanent repair was completed on 10/2/2025.

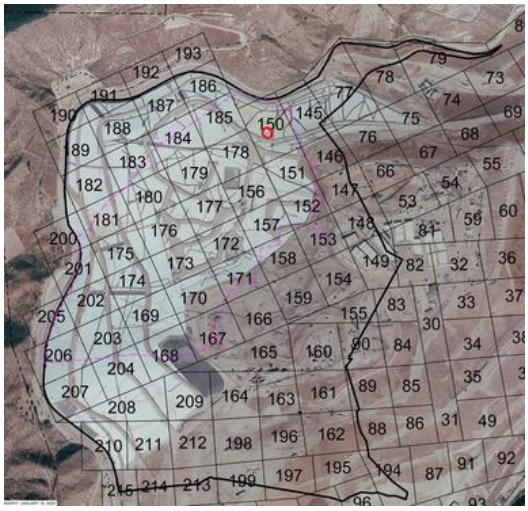
Identification of Issues	
Identified Issue	
Identified Issue 1	
Are there any issues with the geosynthetic cover?	Yes
Date and Time Issue Found	20 Oct 2025 9:56 AM PDT

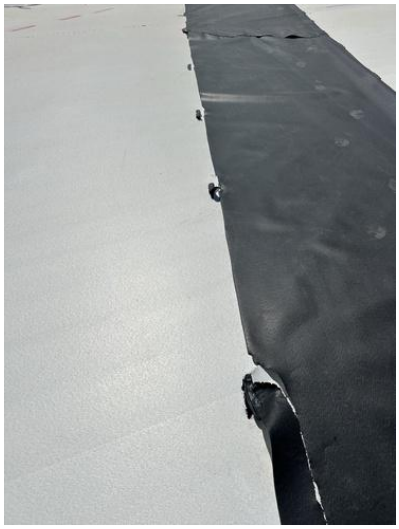
Photo 1

Notate what the issue is and what needs to be repaired	A few tears in liner need to be patched/extrusion welded.

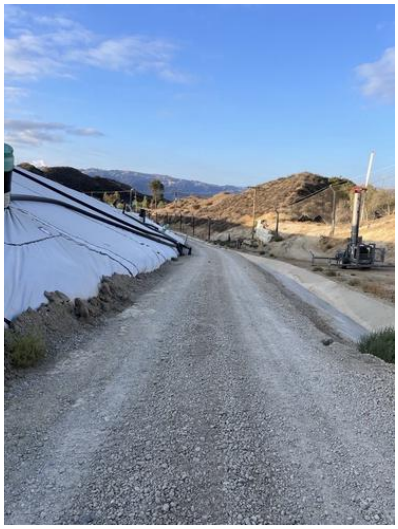
Photo 1

Description of area in photo where there is no leachate seepage or pooling.	Westside perimeter road.

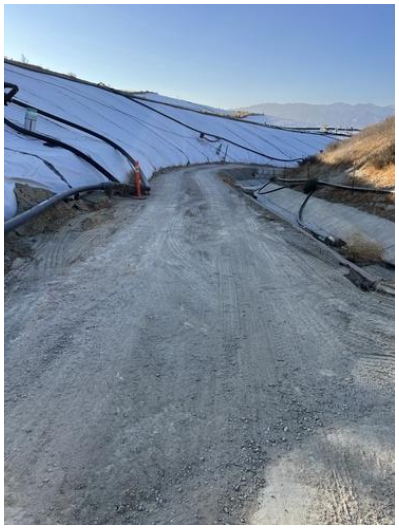
Photo 1

Description of area in photo where there is no leachate seepage or pooling.	Westside perimeter road.

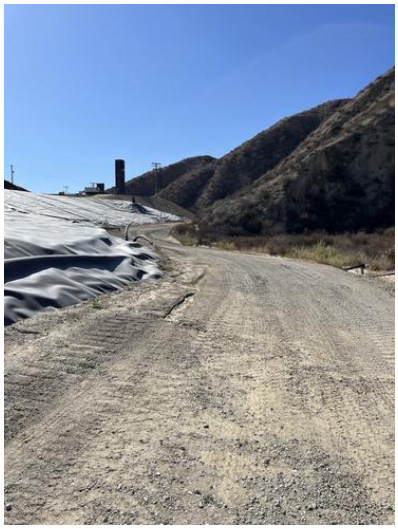
Photo 1

Description of area in photo where there is no leachate seepage or pooling.	North perimeter road.

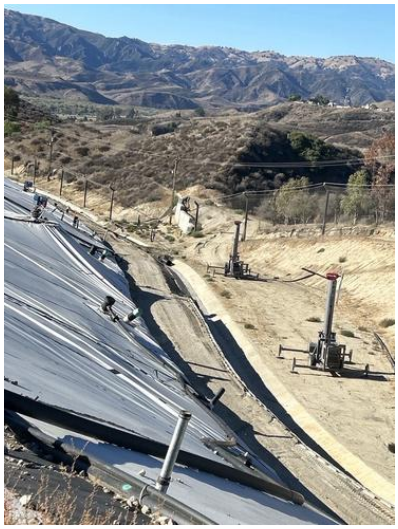
Photo 1

Description of area in photo where there is no leachate seepage or pooling.	West side perimeter road

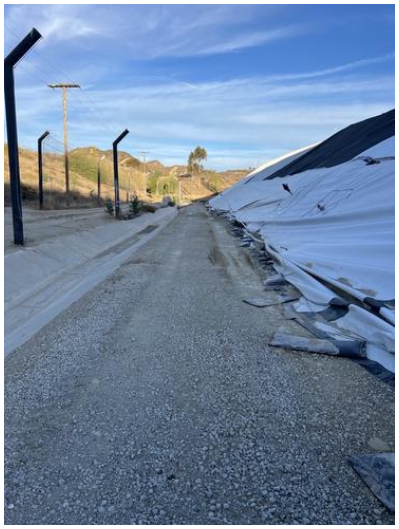
Photo 1

Description of area in photo where there is no leachate seepage or pooling.	Westside perimeter road.

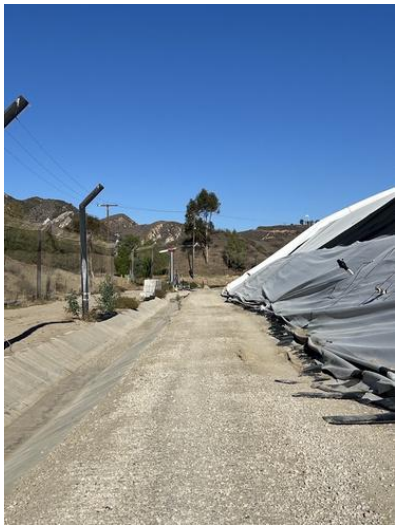
Photo 1

Description of area in photo where there is no leachate seepage or pooling.	Westside perimeter road.

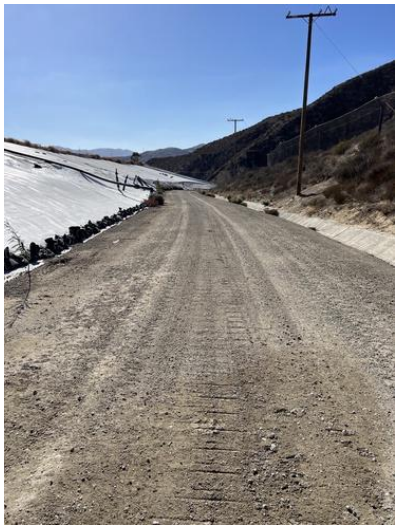
Photo 1

Has a leachate seep/pooling been located?	No

Description of area in photo where there is no leachate seepage or pooling.	North perimeter road.

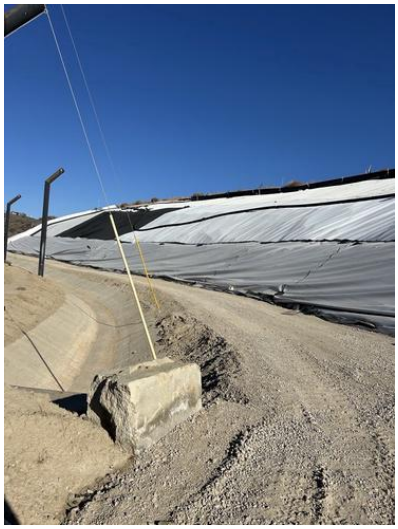
Photo 1

Has a leachate seep/pooling been located?	No

Description of area in photo where there is no leachate seepage or pooling.	West side perimeter road
