22 de diciembre de 2025
Archivo No. 01204123.42, Tarea 10

Asunto: **Informe Mensual de noviembre de 2025 de la Orden de Depuración Estipulada Modificada (Caso No. 6177-4), Vertedero de Chiquita Canyon (Código de Centro 119219), Castaic, California**

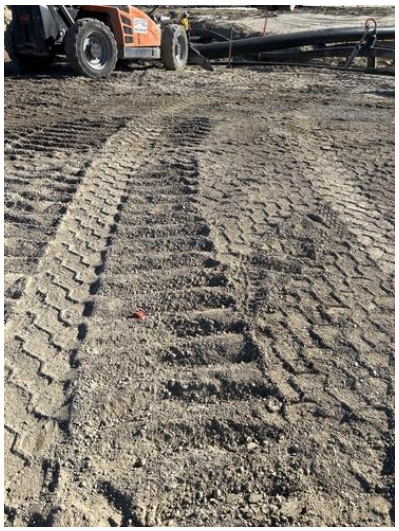
Photo 5

Length of crack (ft) or area containing multiple cracks (ft x ft)	22ft
Horizontal Offset (width)	Small 0.5-2" in width
Vertical Offset (height)	Extra small <0.5" in height
Orientation (direction)	NW to SE
Location	Castaic CA 91384 United States (34.43524325212597, -118.6459991595963)
Was Fissure or Crack fixed? If yes, add photo and description of repairs performed	Yes

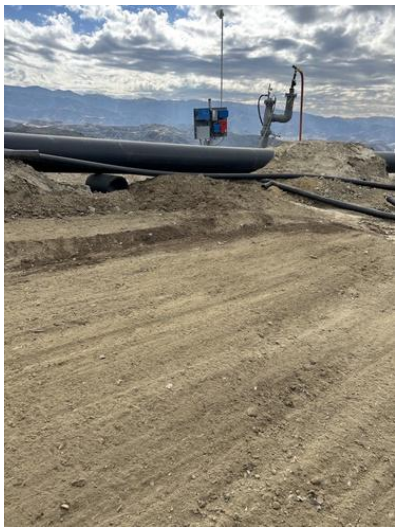
Photo 5

Length of crack (ft) or area containing multiple cracks (ft x ft)	25ftx4ft area
Horizontal Offset (width)	Small 0.5-2" in width
Vertical Offset (height)	Extra small <0.5" in height
Orientation (direction)	NE to SW
Location	Castaic CA 91384 United States (34.43305905430511, -118.64750840127373)
Was Fissure or Crack fixed? If yes, add photo and description of repairs performed	Yes

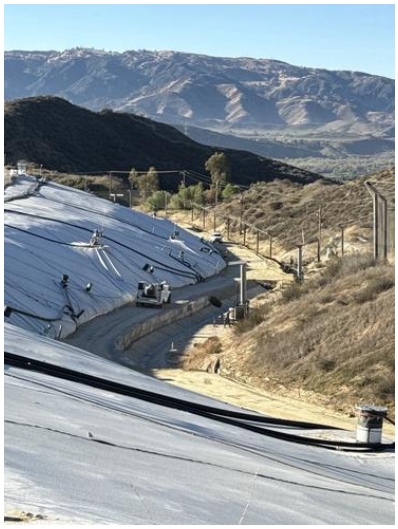
Photo 1

Description of area in photo where there is no leachate seepage or pooling.	West side perimeter road

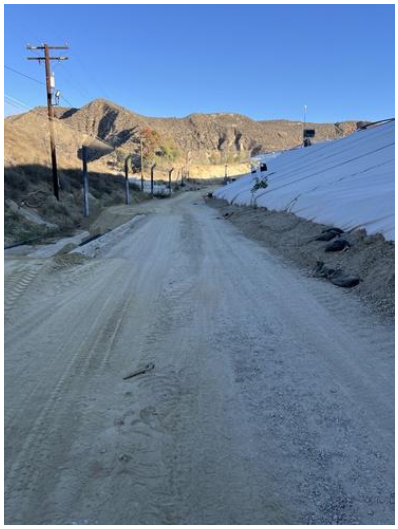
Photo 1

Description of area in photo where there is no leachate seepage or pooling.	Westside perimeter road.

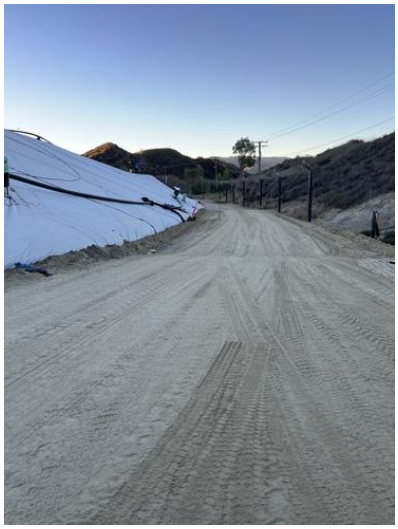
Photo 1

Description of area in photo where there is no leachate seepage or pooling.	Westside perimeter road.

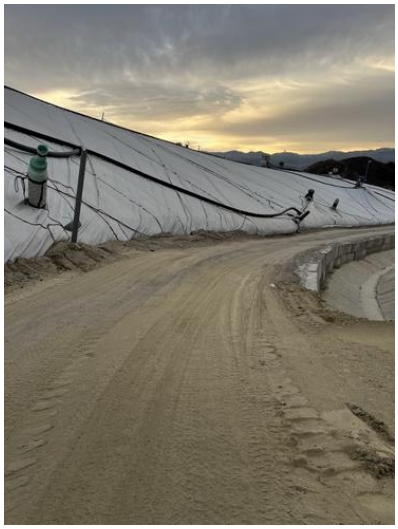
Photo 1

Description of area in photo where there is no leachate seepage or pooling.	Westside perimeter road.

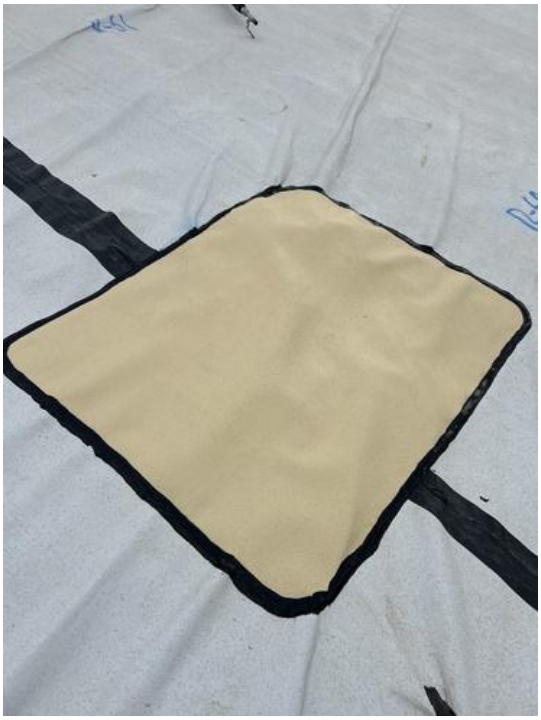
Notate what the issue is and what needs to be repaired	Two boots separated from liner in close proximity to each other. Newd to be patched and extrusion welded

Description of repair work	One poll was removed, liner was patched and extrusion welded in both locations
Date and time of repair	12 Nov 2025 4:54 PM PST
Are further permanent repairs required?	No
