February 20, 2026
File No. 01204123.42, Task 10

Subject: January 2026 Monthly Report for Modified Stipulated Order for Abatement (Case No. 6177-4), Chiquita Canyon Landfill (Facility ID 119219), Castaic, California

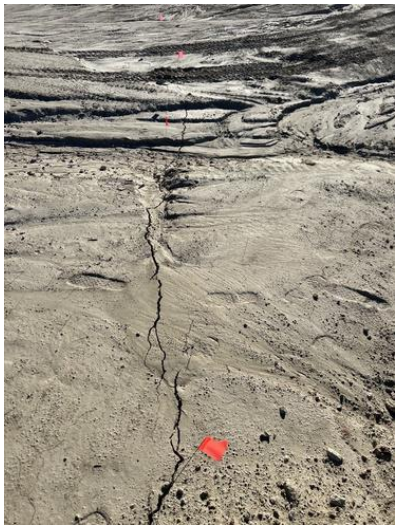
Fissure or Tension Crack Found?	Yes

Grid Location	148
Date and Time Found	13 Jan 2026 9:25 AM PST

Length of crack (ft) or area containing multiple cracks (ft x ft)	130ft x 8ft

Horizontal Offset (width)	Small 0.5-2" in width
Vertical Offset (height)	Extra small <0.5" in height
Orientation (direction)	NW to SE
Location	Castaic CA 91384 United States (34.435553848775605, -118.64634415145836)
Was Fissure or Crack fixed? If yes, add photo and description of repairs performed	Yes

Description of repairs	Cracks were track walked.
Instability	
Are there any indications of slope stability concerns?	No

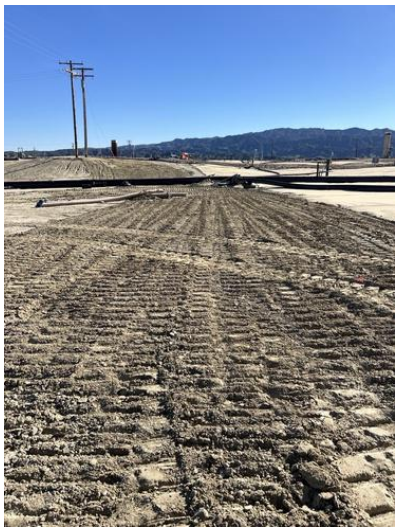
Photo 5

Length of crack (ft) or area containing multiple cracks (ft x ft)	20ft x 35ft
Horizontal Offset (width)	Small 0.5-2" in width
Vertical Offset (height)	Extra small <0.5" in height
Orientation (direction)	NW to SE
Location	Castaic CA 91384 United States (34.43567367802216, -118.64639309158599)
Was Fissure or Crack fixed? If yes, add photo and description of repairs performed	Yes

Date and time of repairs	19 Jan 2026 11:15 AM PST
Description of repairs	Cracks were track walked.

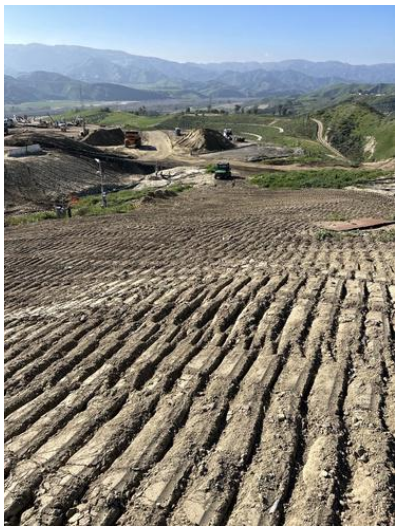
Grid 164

Fissure or Tension Crack Found?	No

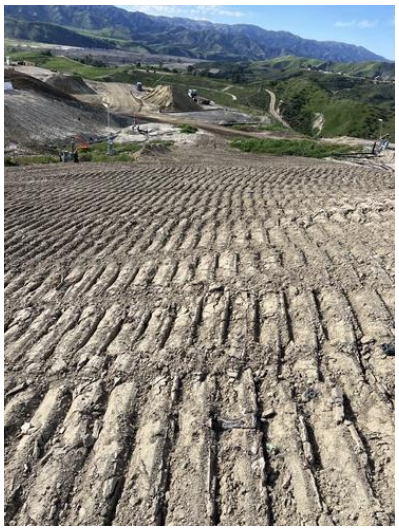
Grid 164

Fissure or Tension Crack Found?	No

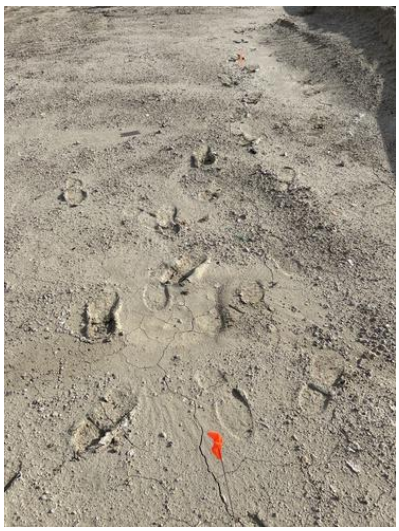
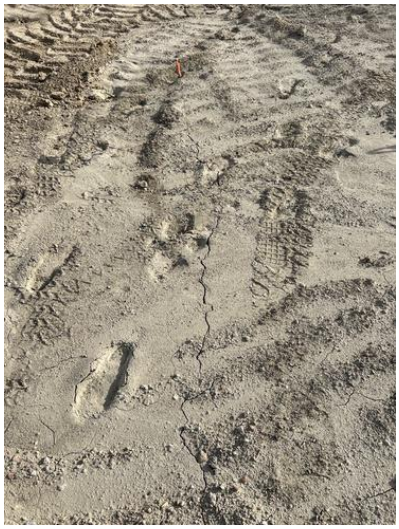
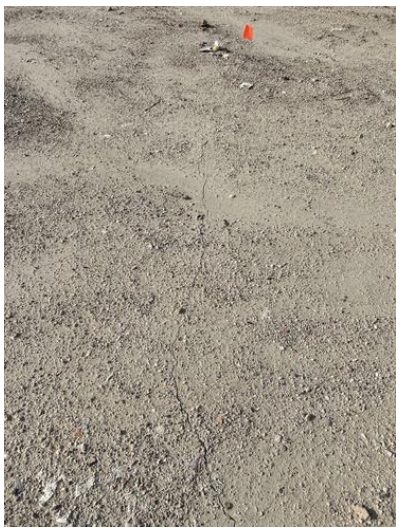
Fissure or Tension Crack Found?	Yes

Grid Location	155
Date and Time Found	28 Jan 2026 9:44 AM PST

Length of crack (ft) or area containing multiple cracks (ft x ft)	70ft x 35ft
No individual crack over 50ft	
Horizontal Offset (width)	Small 0.5-2" in width
Vertical Offset (height)	Extra small <0.5" in height
Orientation (direction)	NE to SW
Location	Castaic CA 91384 United States (34.434004873069405, -118.64619989890478)
Was Fissure or Crack fixed? If yes, add photo and description of repairs performed	Yes

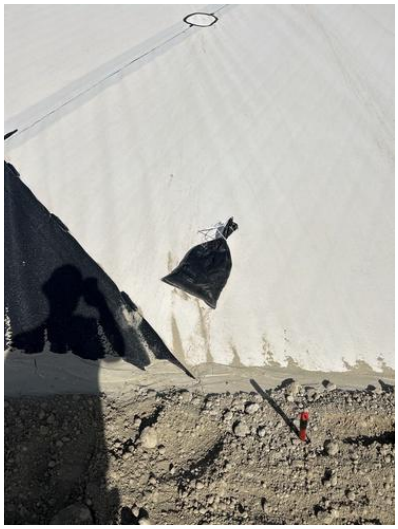
Grid Number	175

Identification of Issues	
Identified Issue	
Identified Issue 1	
Are there any issues with the geosynthetic cover?	Yes
Date and Time Issue Found	28 Jan 2026 1:54 PM PST

Notate what the issue is and what needs to be repaired	Two small tears side by side need to be patched/extrusion welded.

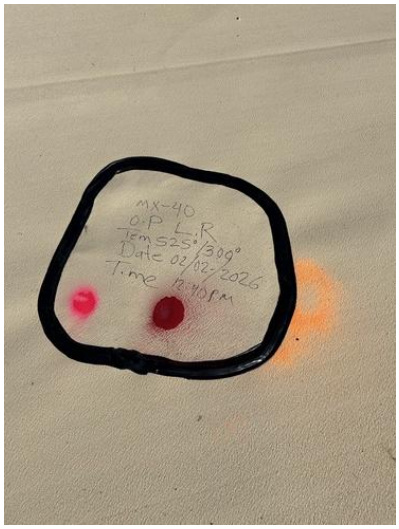
Grid Number	155

Identification of Issues	
Identified Issue	
Identified Issue 1	
Are there any issues with the geosynthetic cover?	Yes
Date and Time Issue Found	29 Jan 2026 10:41 AM PST

Description of repair work	Flex tape added to seal hole until permanent repairs can be conducted. Hole was later patched and extrusion welded.
Date and time of repair (within 2 hours)	29 Jan 2026 10:48 AM PST
Are further permanent repairs required?	No
Date and Time of final repair (if necessary)	2 Feb 2026 12:40 PM PST

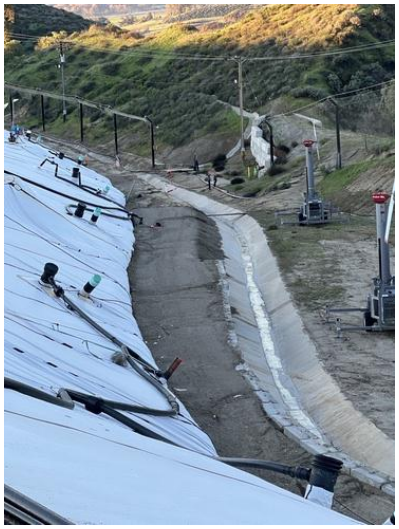
Photo 1

Description of area in photo where there is no leachate seepage or pooling.	Westside perimeter road.

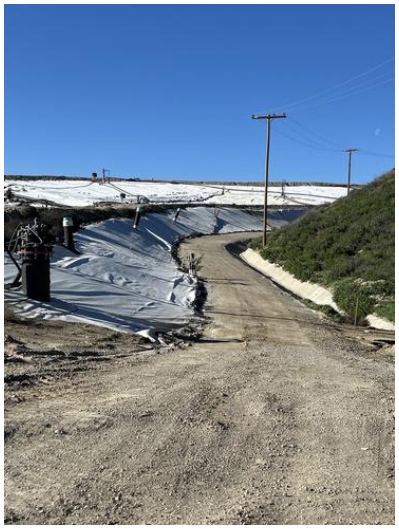
Photo 1

Description of area in photo where there is no leachate seepage or pooling.	North side perimeter road

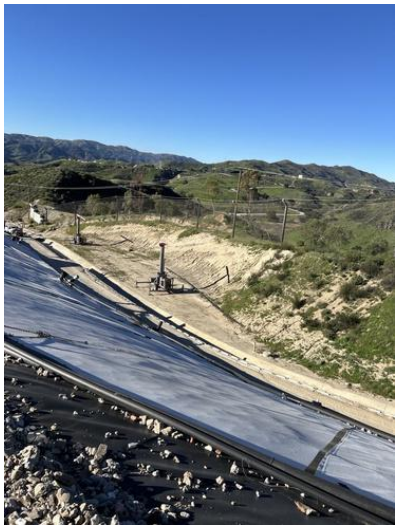
Photo 1

Description of area in photo where there is no leachate seepage or pooling.	West side perimeter road

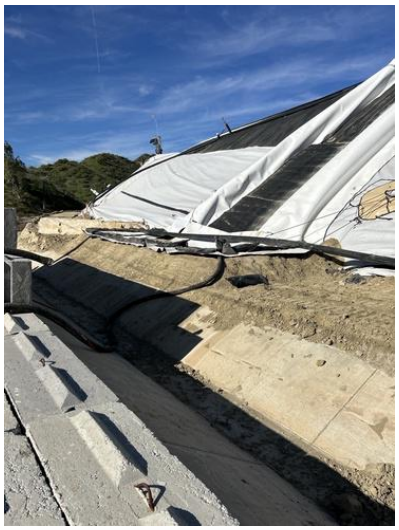
Photo 2

Actions taken to contain seep/pooling?

Berm constructed around effected area, liner placed and sandbagged overtop to contain atmospheric exposure, vacuum hose inserted to collect any liquids should any pooling accumulate inside containment area

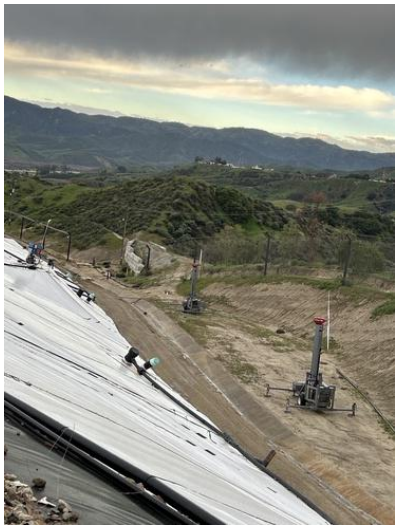
Photo 1

Description of area in photo where there is no leachate seepage or pooling.	West side perimeter road
