March 20, 2026
File No. 01204123.42, Task 10

Subject: February 2026 Monthly Report for Modified Stipulated Order for Abatement (Case No. 6177-4), Chiquita Canyon Landfill (Facility ID 119219), Castaic, California

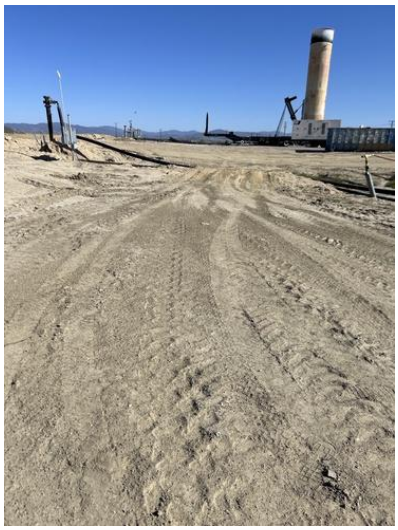
Photo 1

Fissure or Tension Crack Found?	No

Grid 160

Instability

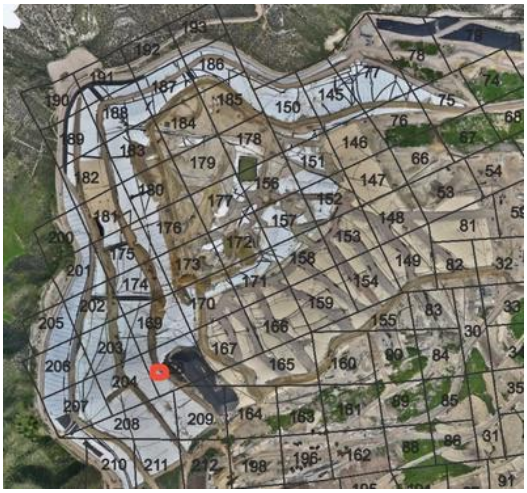
Grid Number	168

Identification of Issues	
Identified Issue	
Identified Issue 1	
Are there any issues with the geosynthetic cover?	Yes
Date and Time Issue Found	3 Feb 2026 2:16 PM PST

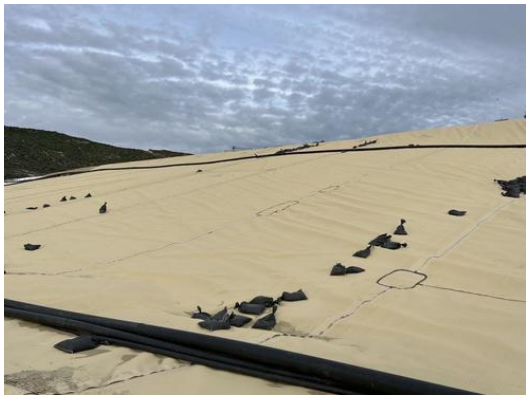
Photo 4

Instability under the cover	
Are there any anomalous (unusual or unexpected) areas of cover damage or deformation that may indicate underlying instability?	No
Are there any signs of a downslope tension crack at the top of the slope or bulging at or near the toe of the slope?	No
Is there any movement of the equipment that vertically penetrates the cover (e.g., tilting)?	No

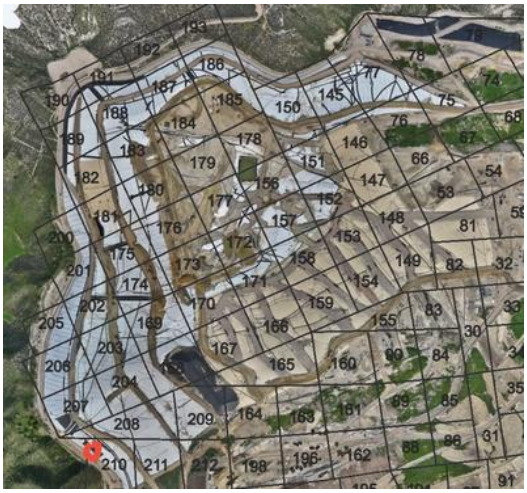
Leachate Seep Inspection	
Leachate seep/pooling Inspection	
Leachate seep/pooling Inspection 1	
Has a leachate seep/pooling been located?	Yes
Which grid is the leachate seep/pooling located?	Adjacent to 210

Drop Pin to record lat/long of seep/pooling location.	(34.43170688212353, -118.65096071220283)
Time seep/pooling was discovered	23 Feb 2026 3:15 AM PST
Estimated duration of presence of leachate at such location	6 hours
Estimated quantity of leachate	>150 gallons
Extent of area impacted (approximate sq ft impacted)	20 sq ft at location of seep and approximately 3,000 ft of stormwater channel.
Odor type	Leachate
Odor intensity	4 - Strong Odor
Surrounding soil saturation level	Standing free liquid

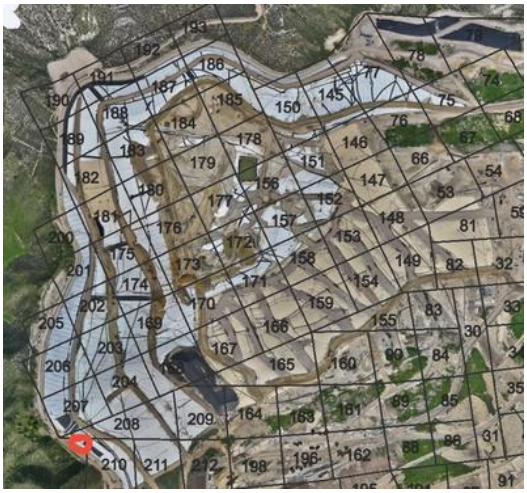
Leachate Seep Inspection	
Leachate seep/pooling Inspection	
Leachate seep/pooling Inspection 1	
Has a leachate seep/pooling been located?	Yes
Which grid is the leachate seep/pooling located?	Adjacent to 210

Drop Pin to record lat/long of seep/pooling location.	(34.43209505578834, -118.65137177761433)
Time seep/pooling was discovered	23 Feb 2026 2:00 PM PST
Estimated duration of presence of leachate at such location	11 hours
Estimated quantity of leachate	>150 gallons
Extent of area impacted (approximate sq ft impacted)	20 sq ft
Odor type	Leachate
Odor intensity	3 - Moderate Odor
Surrounding soil saturation level	Standing free liquid

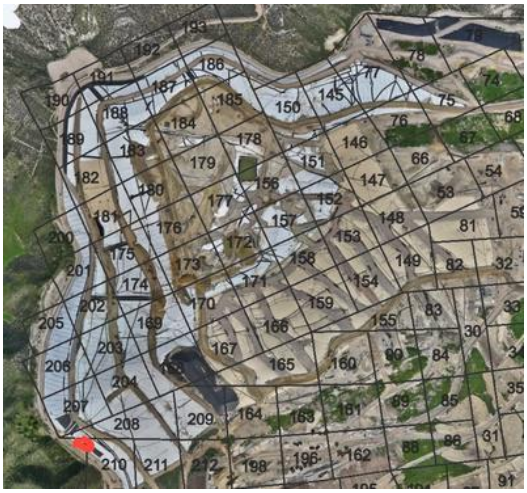
Leachate Seep Inspection	
Leachate seep/pooling Inspection	
Leachate seep/pooling Inspection 1	
Has a leachate seep/pooling been located?	Yes
Which grid is the leachate seep/pooling located?	Adjacent to 210

Drop Pin to record lat/long of seep/pooling location.	(34.43215542066448, -118.65154696884296)
Time seep/pooling was discovered	24 Feb 2026 9:47 AM PST
Estimated duration of presence of leachate at such location	31 hours
Estimated quantity of leachate	>150 gallons
Extent of area impacted (approximate sq ft impacted)	20 sq ft
Odor type	Leachate
Odor intensity	2 - Light Odor Detected
Surrounding soil saturation level	Saturated

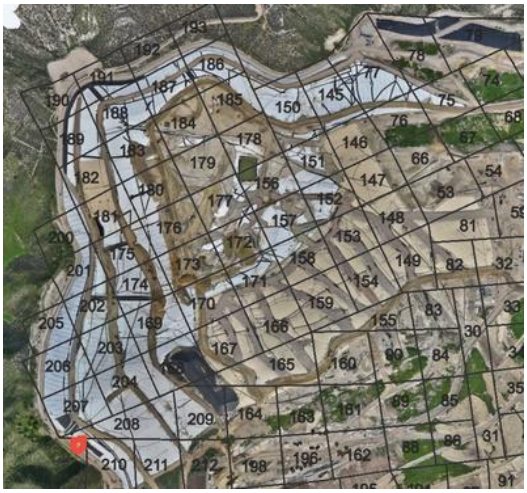
Leachate Seep Inspection	
Leachate seep/pooling Inspection	
Leachate seep/pooling Inspection 1	
Has a leachate seep/pooling been located?	Yes
Which grid is the leachate seep/pooling located?	Adjacent to 210

Drop Pin to record lat/long of seep/pooling location.	(34.43166455291356, -118.65101317790655)
Time seep/pooling was discovered	24 Feb 2026 3:21 PM PST
Estimated duration of presence of leachate at such location	35 hours
Estimated quantity of leachate	>150 gallons
Extent of area impacted (approximate sq ft impacted)	20 sq ft
Odor type	Leachate
Odor intensity	2 - Light Odor Detected
Surrounding soil saturation level	Saturated

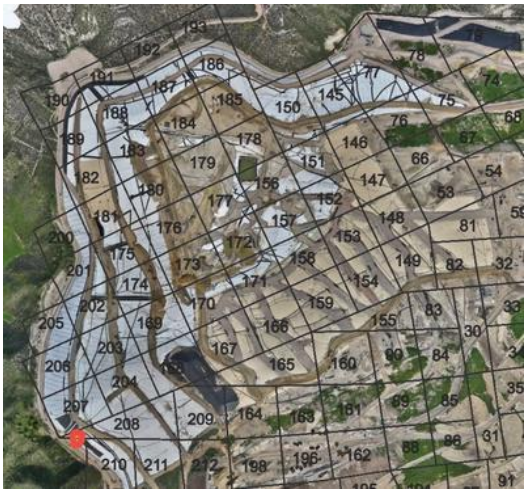
Leachate Seep Inspection	
Leachate seep/pooling Inspection	
Leachate seep/pooling Inspection 1	
Has a leachate seep/pooling been located?	Yes
Which grid is the leachate seep/pooling located?	Adjacent to 210

Drop Pin to record lat/long of seep/pooling location.	(34.43166455291356, -118.65101317790655)
Time seep/pooling was discovered	25 Feb 2026 7:11 AM PST
Estimated duration of presence of leachate at such location	51 hours
Estimated quantity of leachate	21-50 gallons
Extent of area impacted (approximate sq ft impacted)	20sq ft
Odor type	Leachate
Odor intensity	1 - Very Light Odor Detected
Surrounding soil saturation level	Semi-dry

Berm was constructed to contain seep.
Construction work to repair the seep is ongoing.
