20 de marzo de 2026
Archivo No. 01204123.42, Tarea 10

Asunto: Informe Mensual de Febrero de 2026 de la Orden de Depuración Estipulada Modificada (Caso No. 6177-4), Vertedero de Chiquita Canyon (Código de Centro 119219), Castaic, California

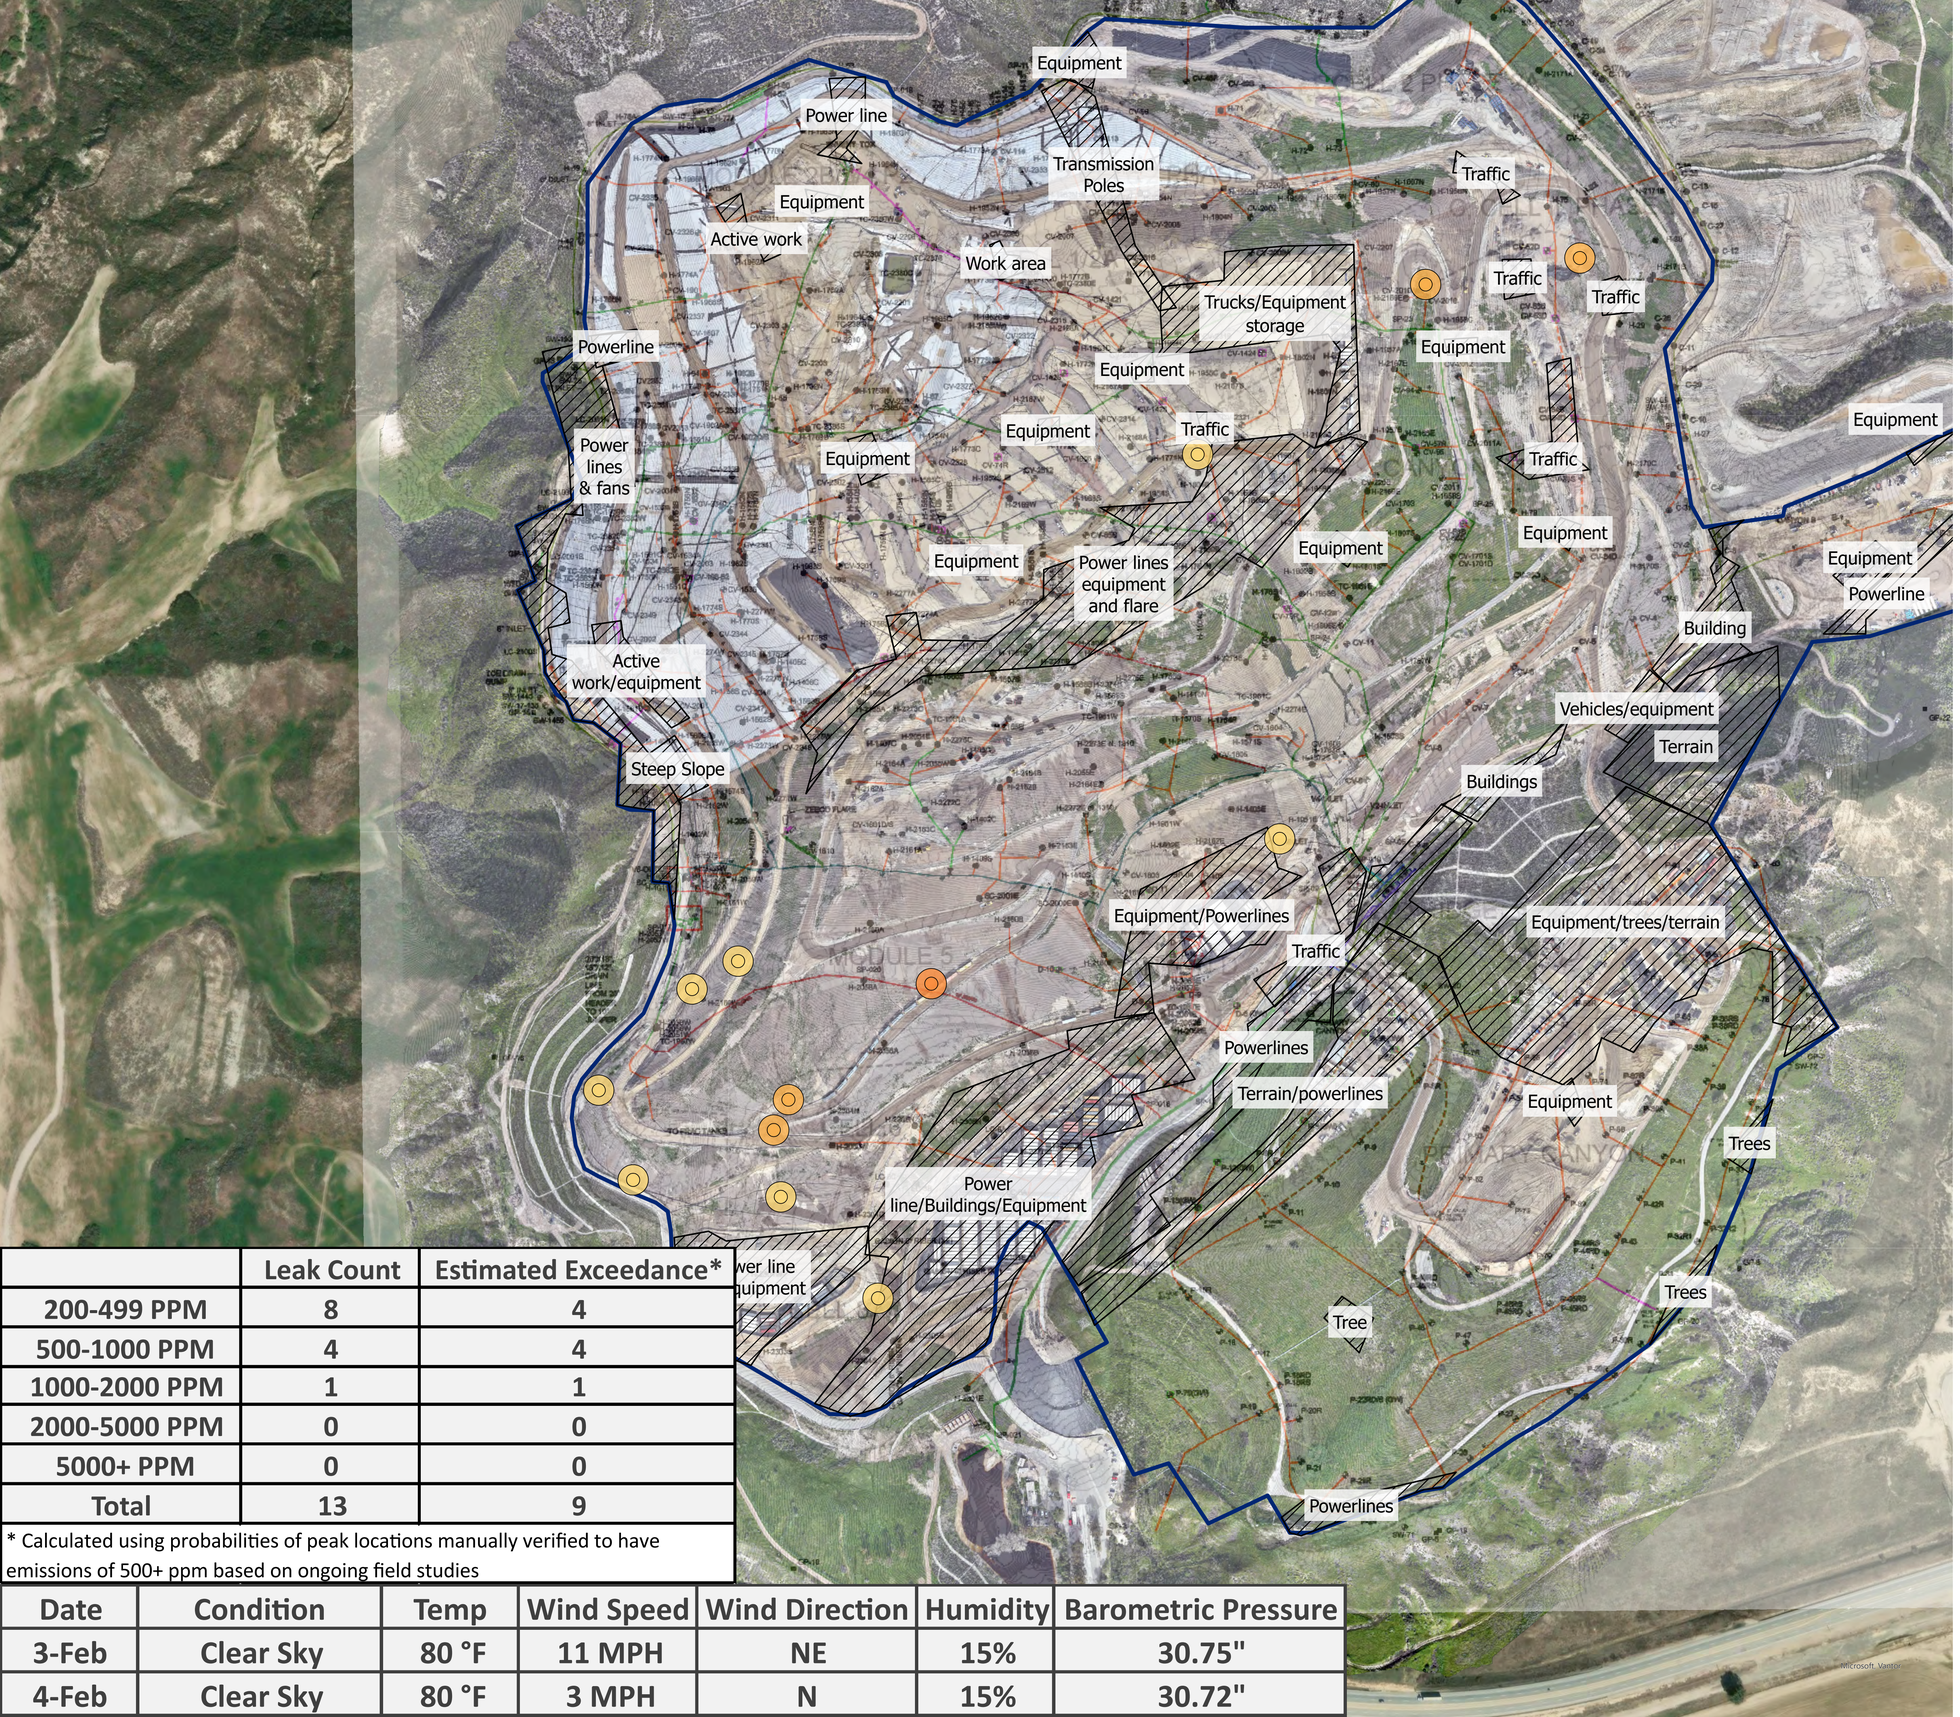
Leak Count	Estimated Exceedance*
200-499 PPM	8	4
500-1000 PPM	4	4
1000-2000 PPM	1	1
2000-5000 PPM	0	0
5000+ PPM	0	0
Total	13	9

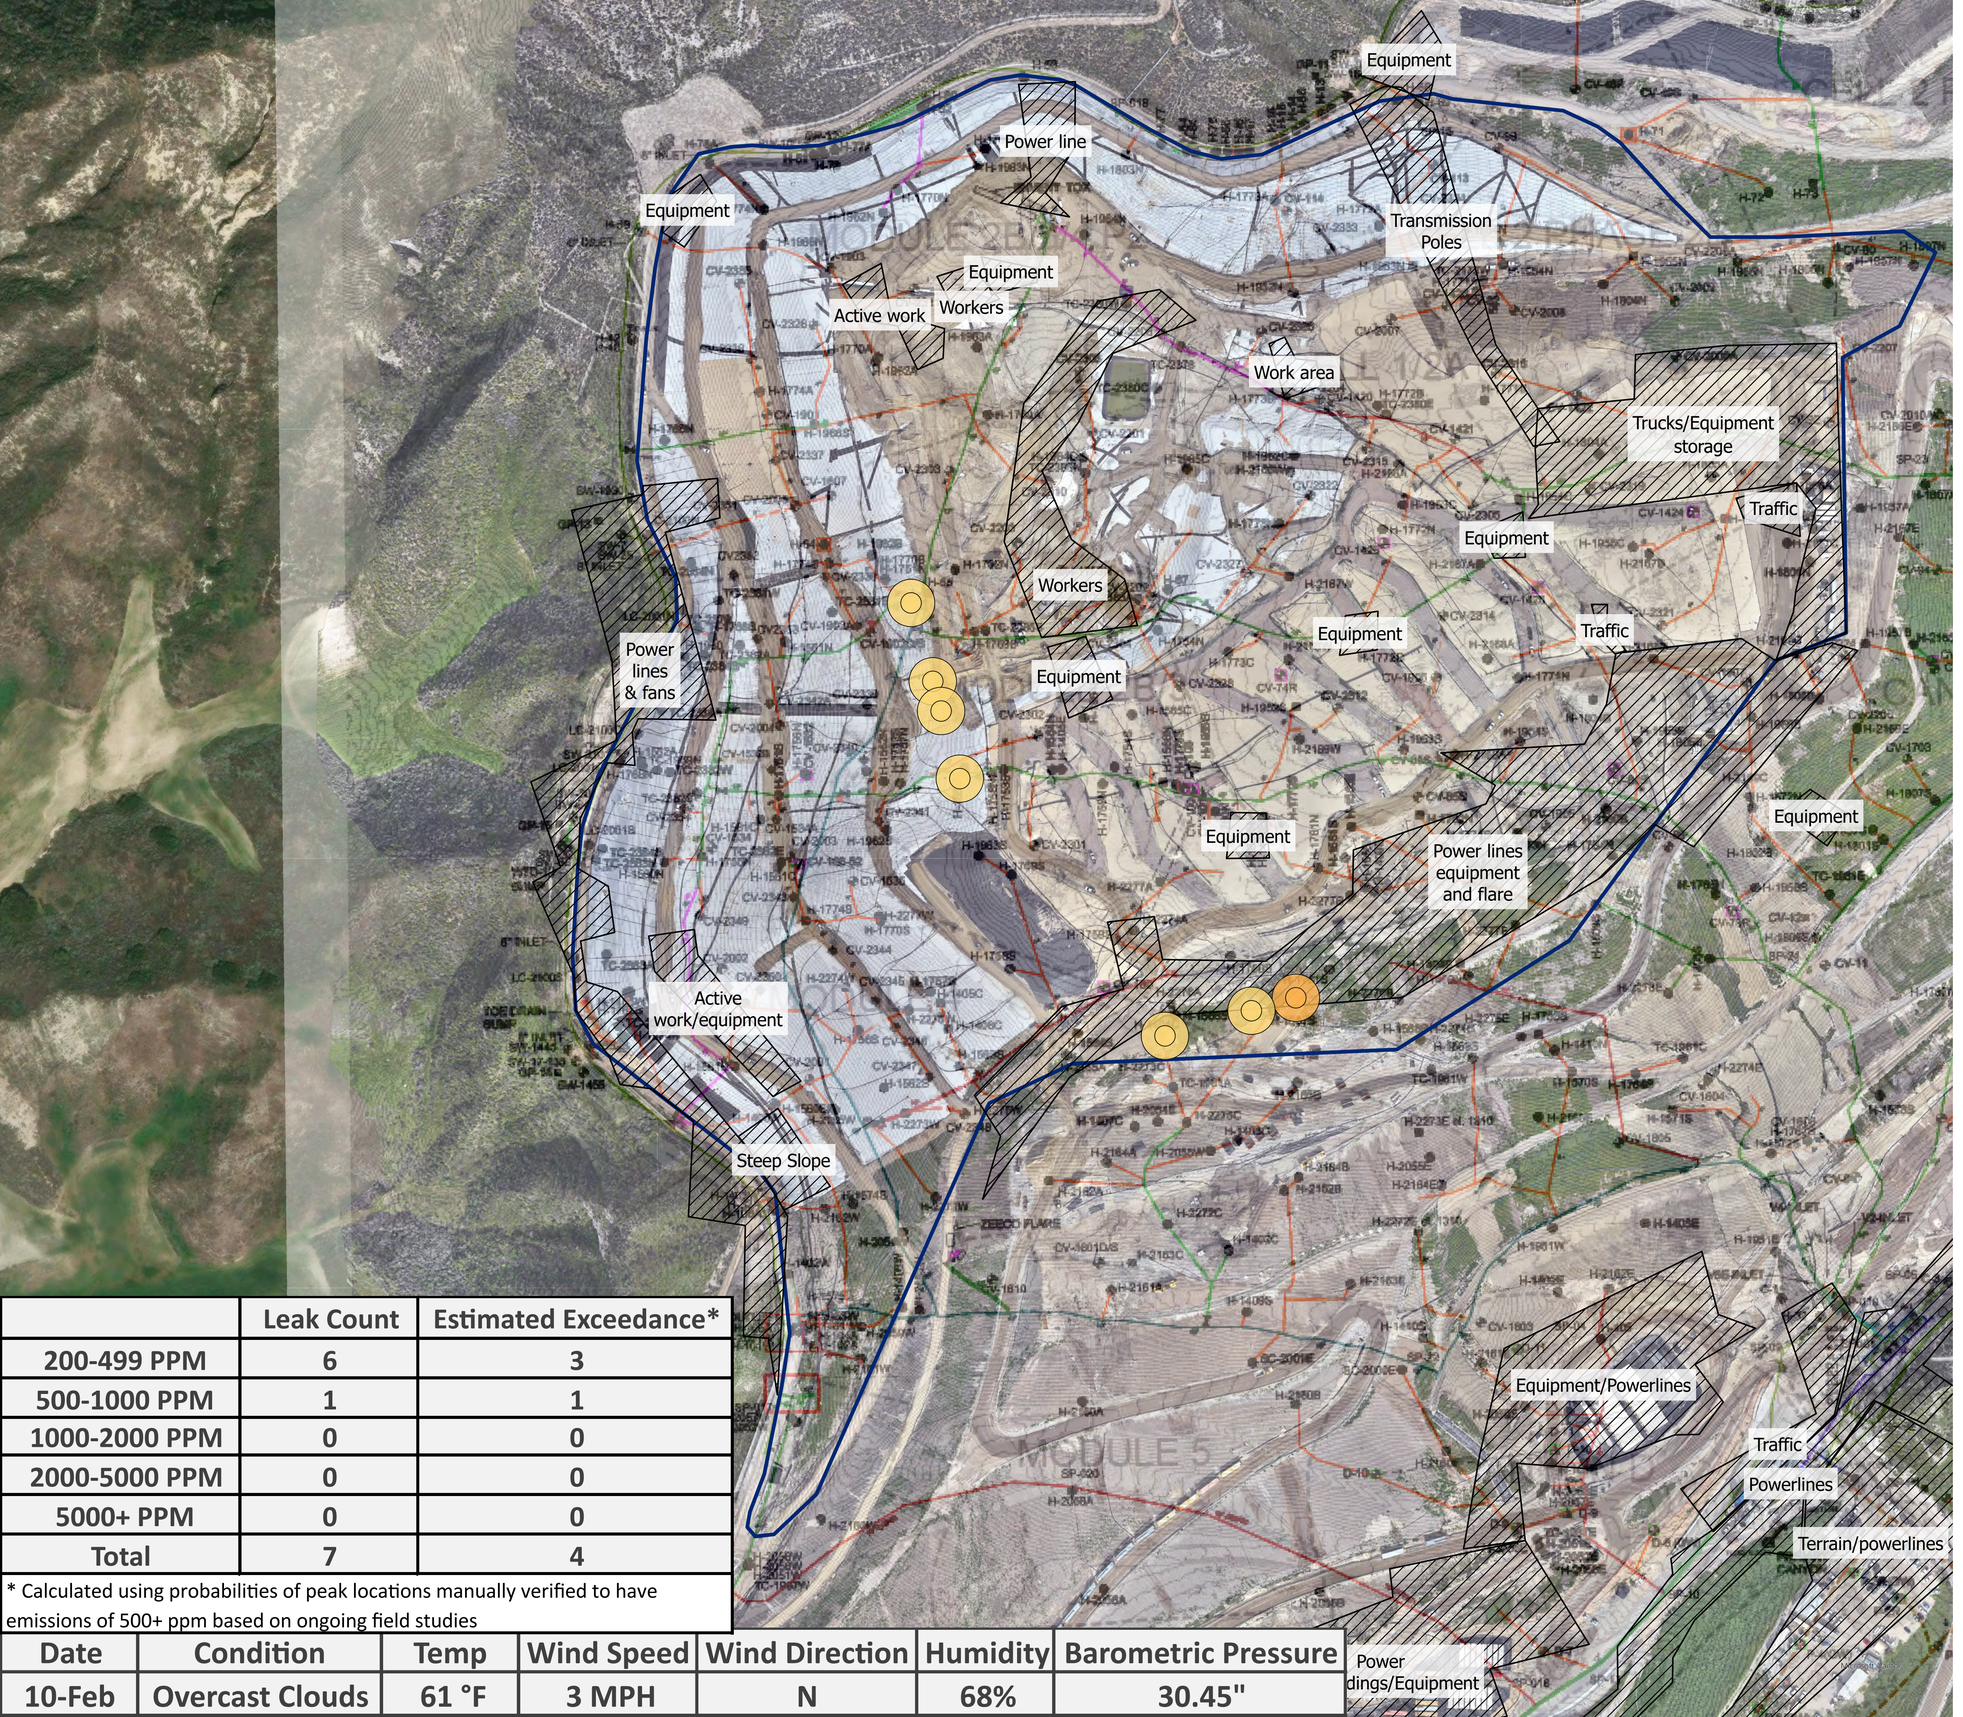
Leak Count	Estimated Exceedance*
200-499 PPM	6	3
500-1000 PPM	1	1
1000-2000 PPM	0	0
2000-5000 PPM	0	0
5000+ PPM	0	0
Total	7	4

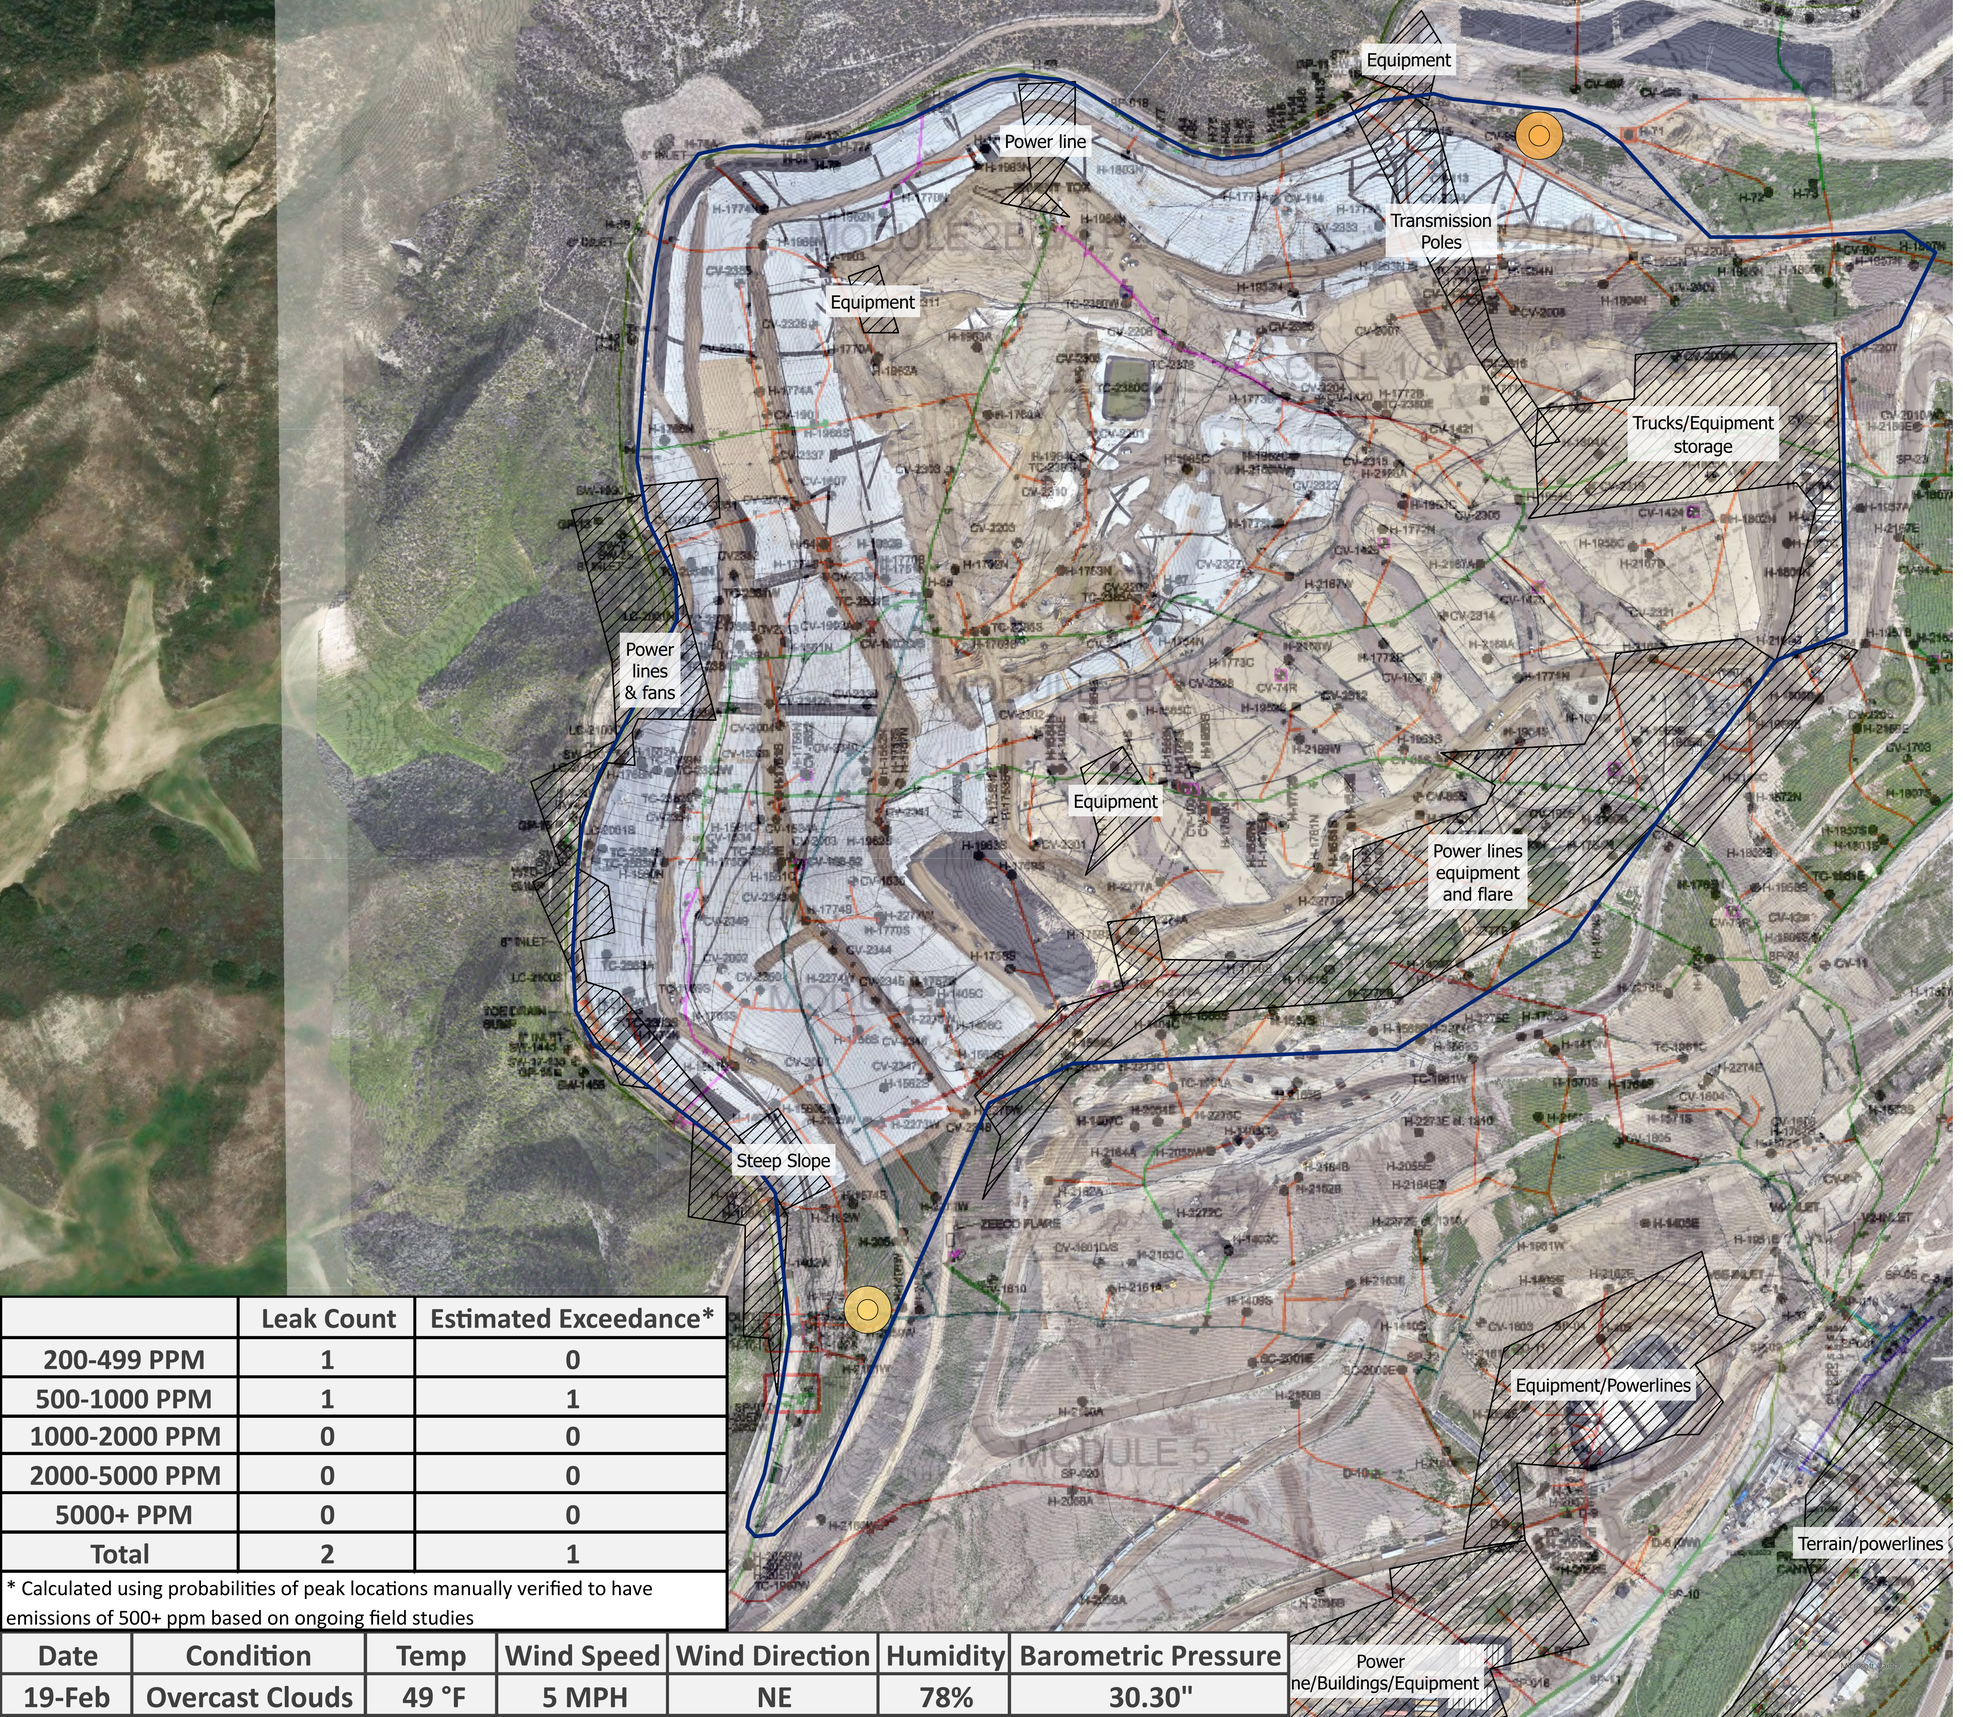
Leak Count	Estimated Exceedance*
200-499 PPM	1	0
500-1000 PPM	1	1
1000-2000 PPM	0	0
2000-5000 PPM	0	0
5000+ PPM	0	0
Total	2	1

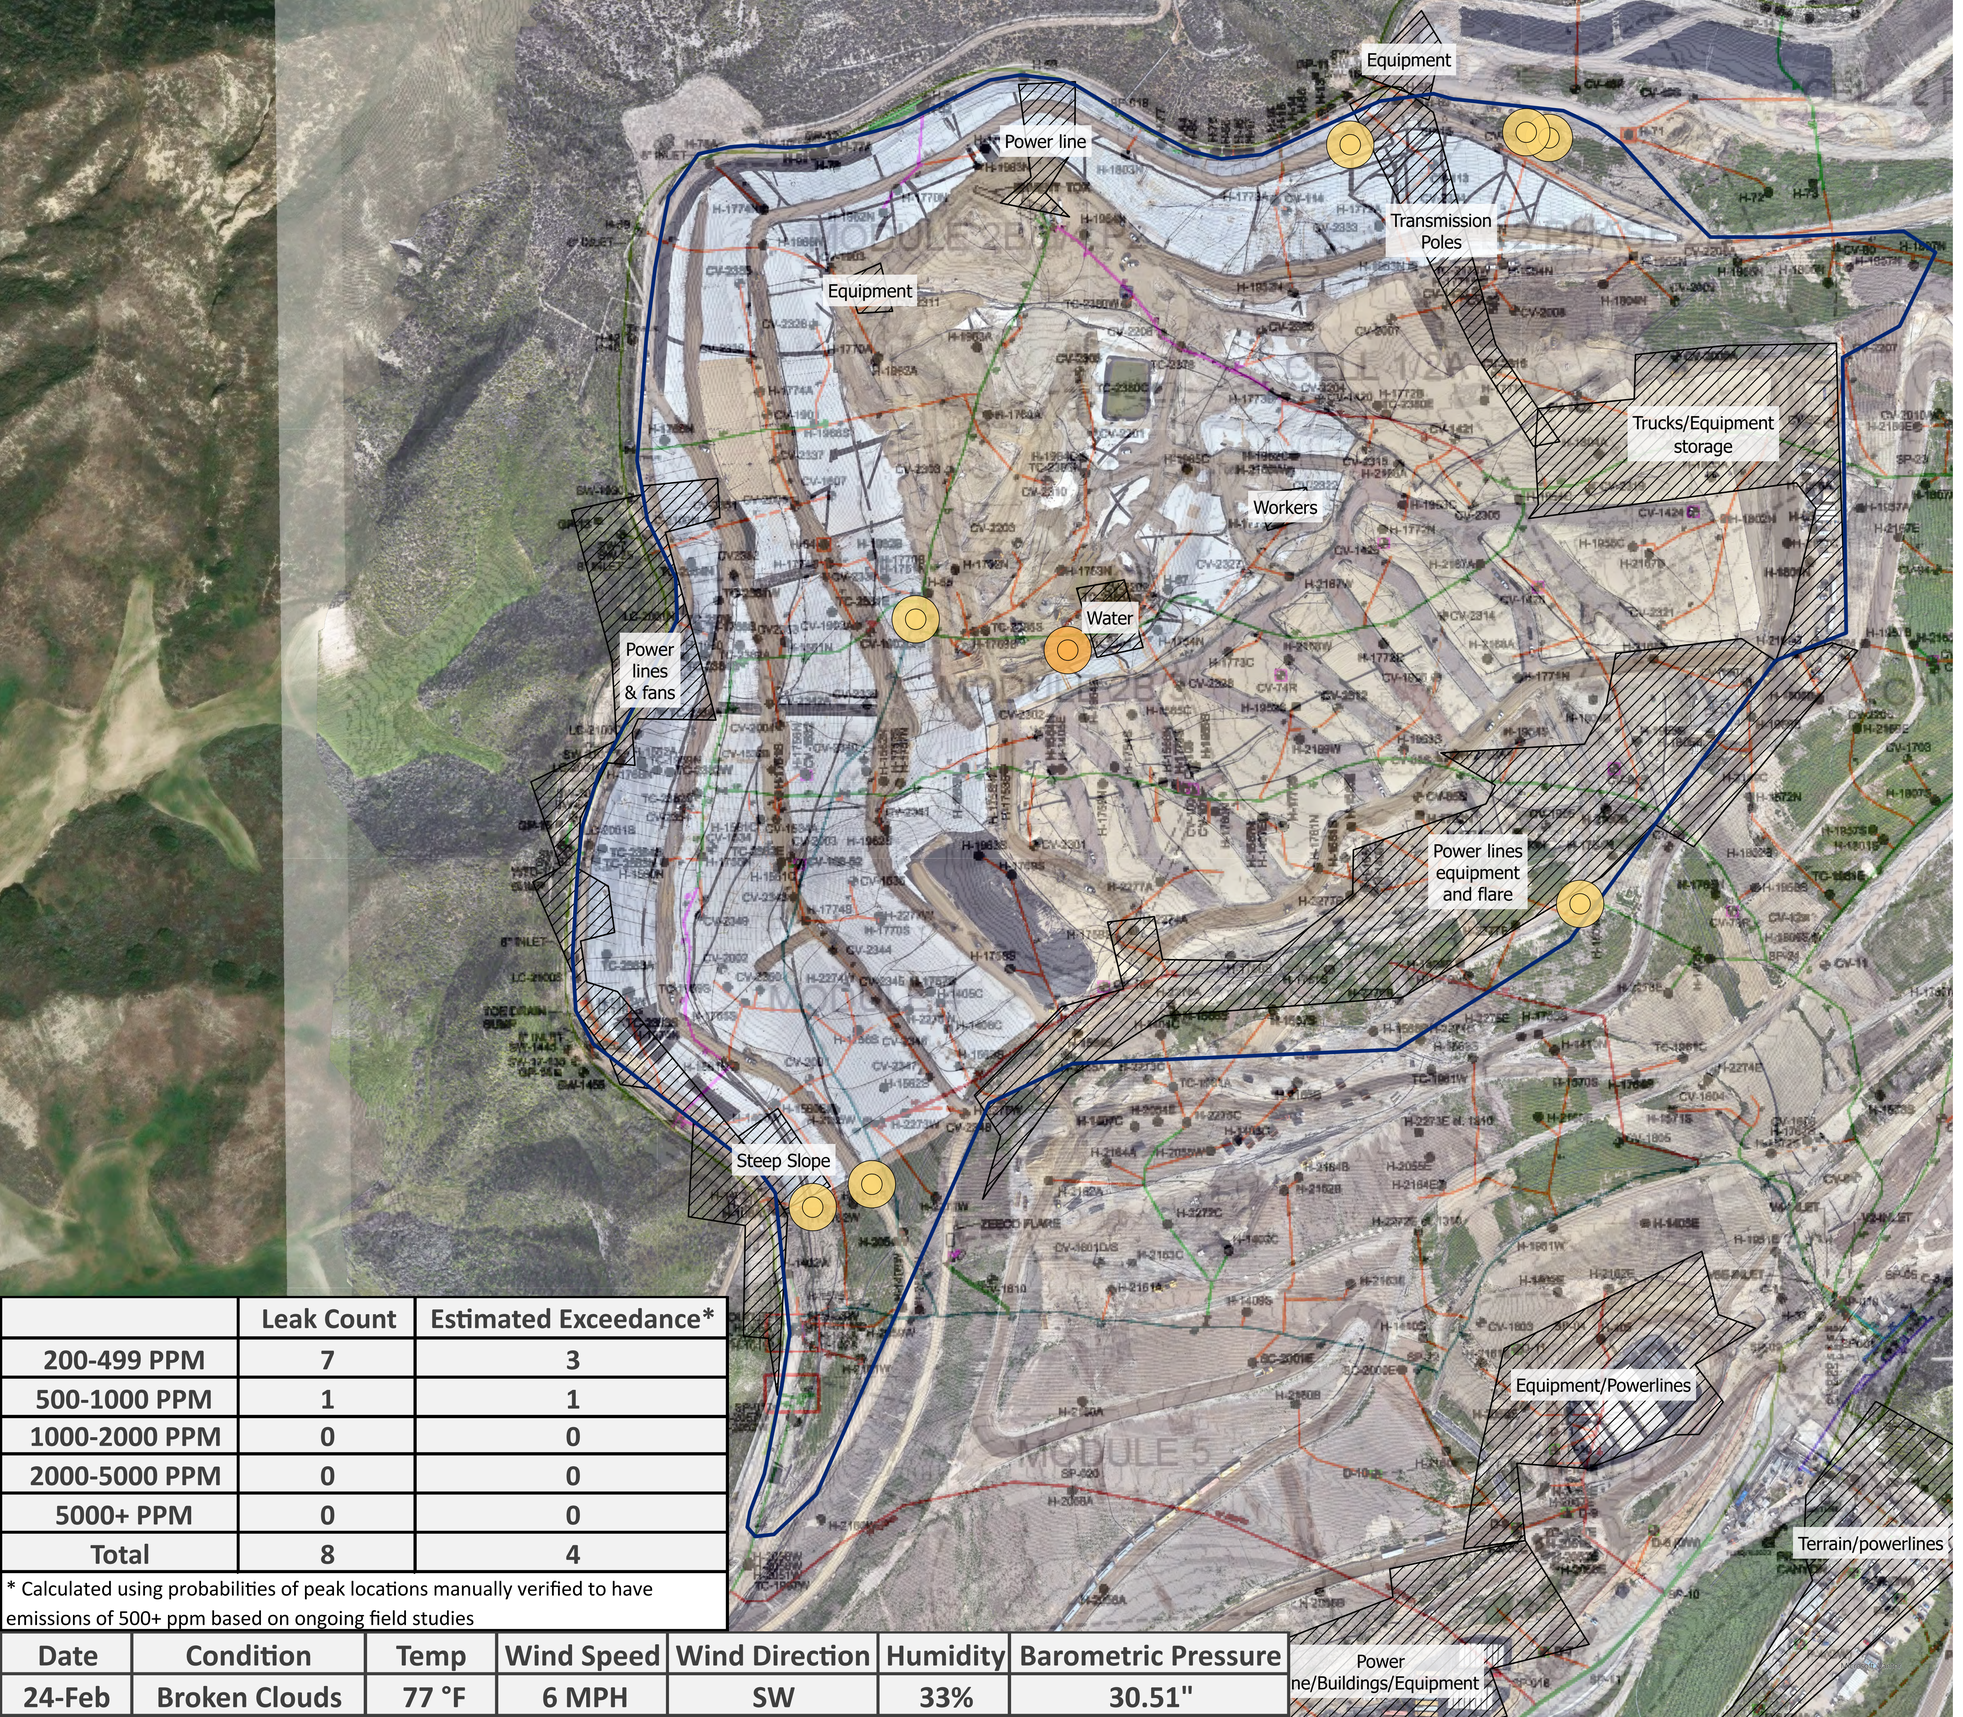
Leak Count	Estimated Exceedance*
200-499 PPM	7	3
500-1000 PPM	1	1
1000-2000 PPM	0	0
2000-5000 PPM	0	0
5000+ PPM	0	0
Total	8	4

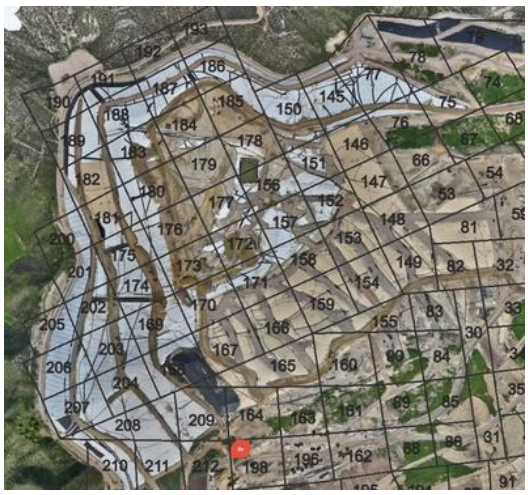
Grid Location	198
Date and Time Found	5 Feb 2026 10:20 AM PST

Image of Fissure/Tension Crack

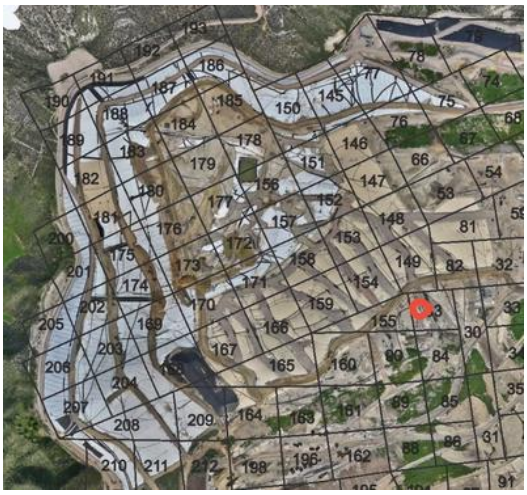
Grid Location	83
Date and Time Found	5 Feb 2026 11:38 AM PST

Image of Fissure/Tension Crack

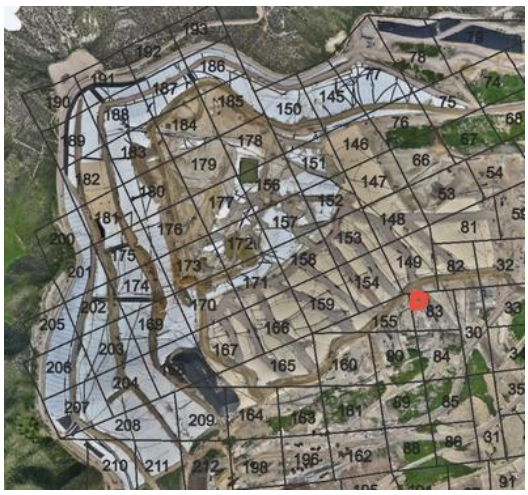
Grid Location	83
Date and Time Found	6 Feb 2026 10:27 AM PST

Image of Fissure/Tension Crack

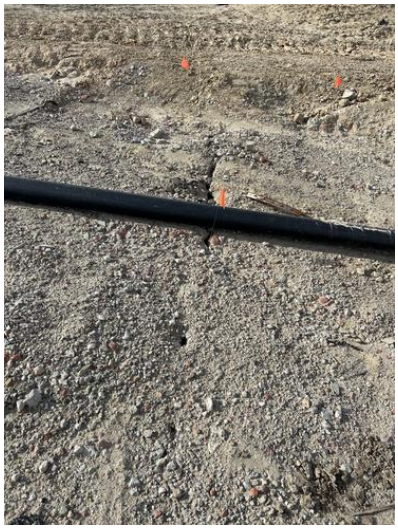
Photo 1

Length of crack (ft) or area containing multiple cracks (ft x ft)	Multiple cracks in a 11ft x 16ft area
Horizontal Offset (width)	Small 0.5-2" in width
Vertical Offset (height)	Extra small <0.5" in height
Orientation (direction)	E to W
Location	Castaic CA 91384 United States (34.434193771180176, -118.64603794500265)
Was Fissure or Crack fixed? If yes, add photo and description of repairs performed	Yes

Date and time of repairs	6 Feb 2026 11:45 AM PST
Description of repairs	Cracks were track walked.

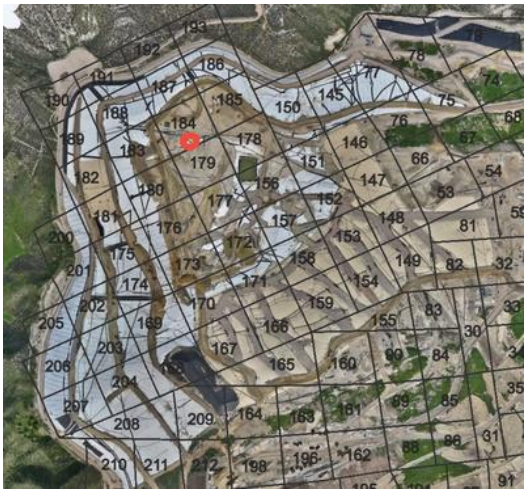
Grid Number	184

Identification of Issues	
Identified Issue	
Identified Issue 1	
Are there any issues with the geosynthetic cover?	Yes
Date and Time Issue Found	2 Feb 2026 9:47 AM PST

Notate what the issue is and what needs to be repaired	Hole where a pole was removed needs to be patched and extrusion welded.

Description of repair work	Hole was taped and sandbagged upon discovery. As part of ongoing construction the area was covered with dirt and will eventually be lined with EVOH.
Date and time of repair (within 2 hours)	2 Feb 2026 9:52 AM PST
Are further permanent repairs required?	No
Date and Time of final repair (if necessary)

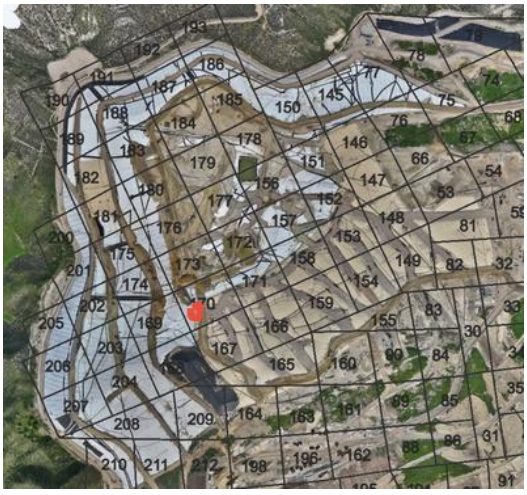
Grid Number	170

Are there any issues with the geosynthetic cover?	Yes
Date and Time Issue Found	2 Feb 2026 10:02 AM PST

Notate what the issue is and what needs to be repaired	Hole in liner needs to be patched/extrusion welded.

Description of repair work	Hole taped and sandbagged upon discovery and later patched and extrusion welded.
Date and time of repair (within 2 hours)	2 Feb 2026 12:40 PM PST
Are further permanent repairs required?	No
Date and Time of final repair (if necessary)	2 Feb 2026 1:06 PM PST
Identified Issue 3	
Are there any issues with the geosynthetic cover?	Yes

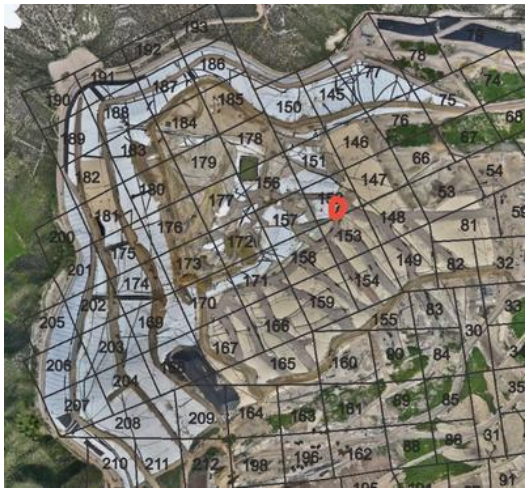
Grid Number 152

Date and Time Issue Found 2 Feb 2026 12:58 PM PST

Notate what the issue is and what needs to be repaired Tear in liner needs to be patched/extrusion welded.

Description of repair work	Tear was taped and sandbagged upon discovery and later extrusion welded.
Date and time of repair (within 2 hours)	2 Feb 2026 1:00 PM PST
Are further permanent repairs required?	No
Date and Time of final repair (if necessary)	4 Feb 2026 7:53 AM PST

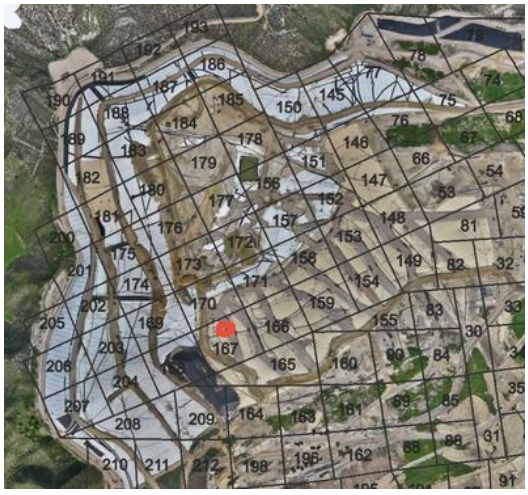
Grid Number	167

Are there any issues with the geosynthetic cover?	Yes
Date and Time Issue Found	2 Feb 2026 1:11 PM PST

Notate what the issue is and what needs to be repaired	Hole in liner needs to be patched and extrusion welded.

Description of repair work	Tear taped and sandbagged upon discovery and later extrusion welded.
Date and time of repair (within 2 hours)	2 Feb 2026 1:13 PM PST
Are further permanent repairs required?	No
Date and Time of final repair (if necessary)	4 Feb 2026 12:47 PM PST
Identified Issue 5	
Are there any issues with the geosynthetic cover?	Yes
Date and Time Issue Found	2 Feb 2026 1:16 PM PST

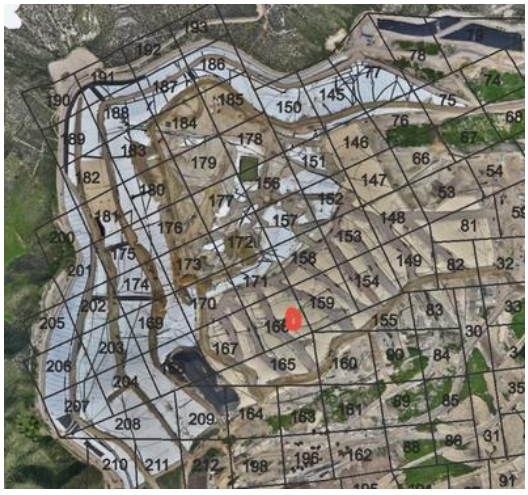
Grid Number	166

Are there any issues with the geosynthetic cover?	Yes
Date and Time Issue Found	2 Feb 2026 1:47 PM PST

Two small tears in liner near each other need to be extrusion welded.

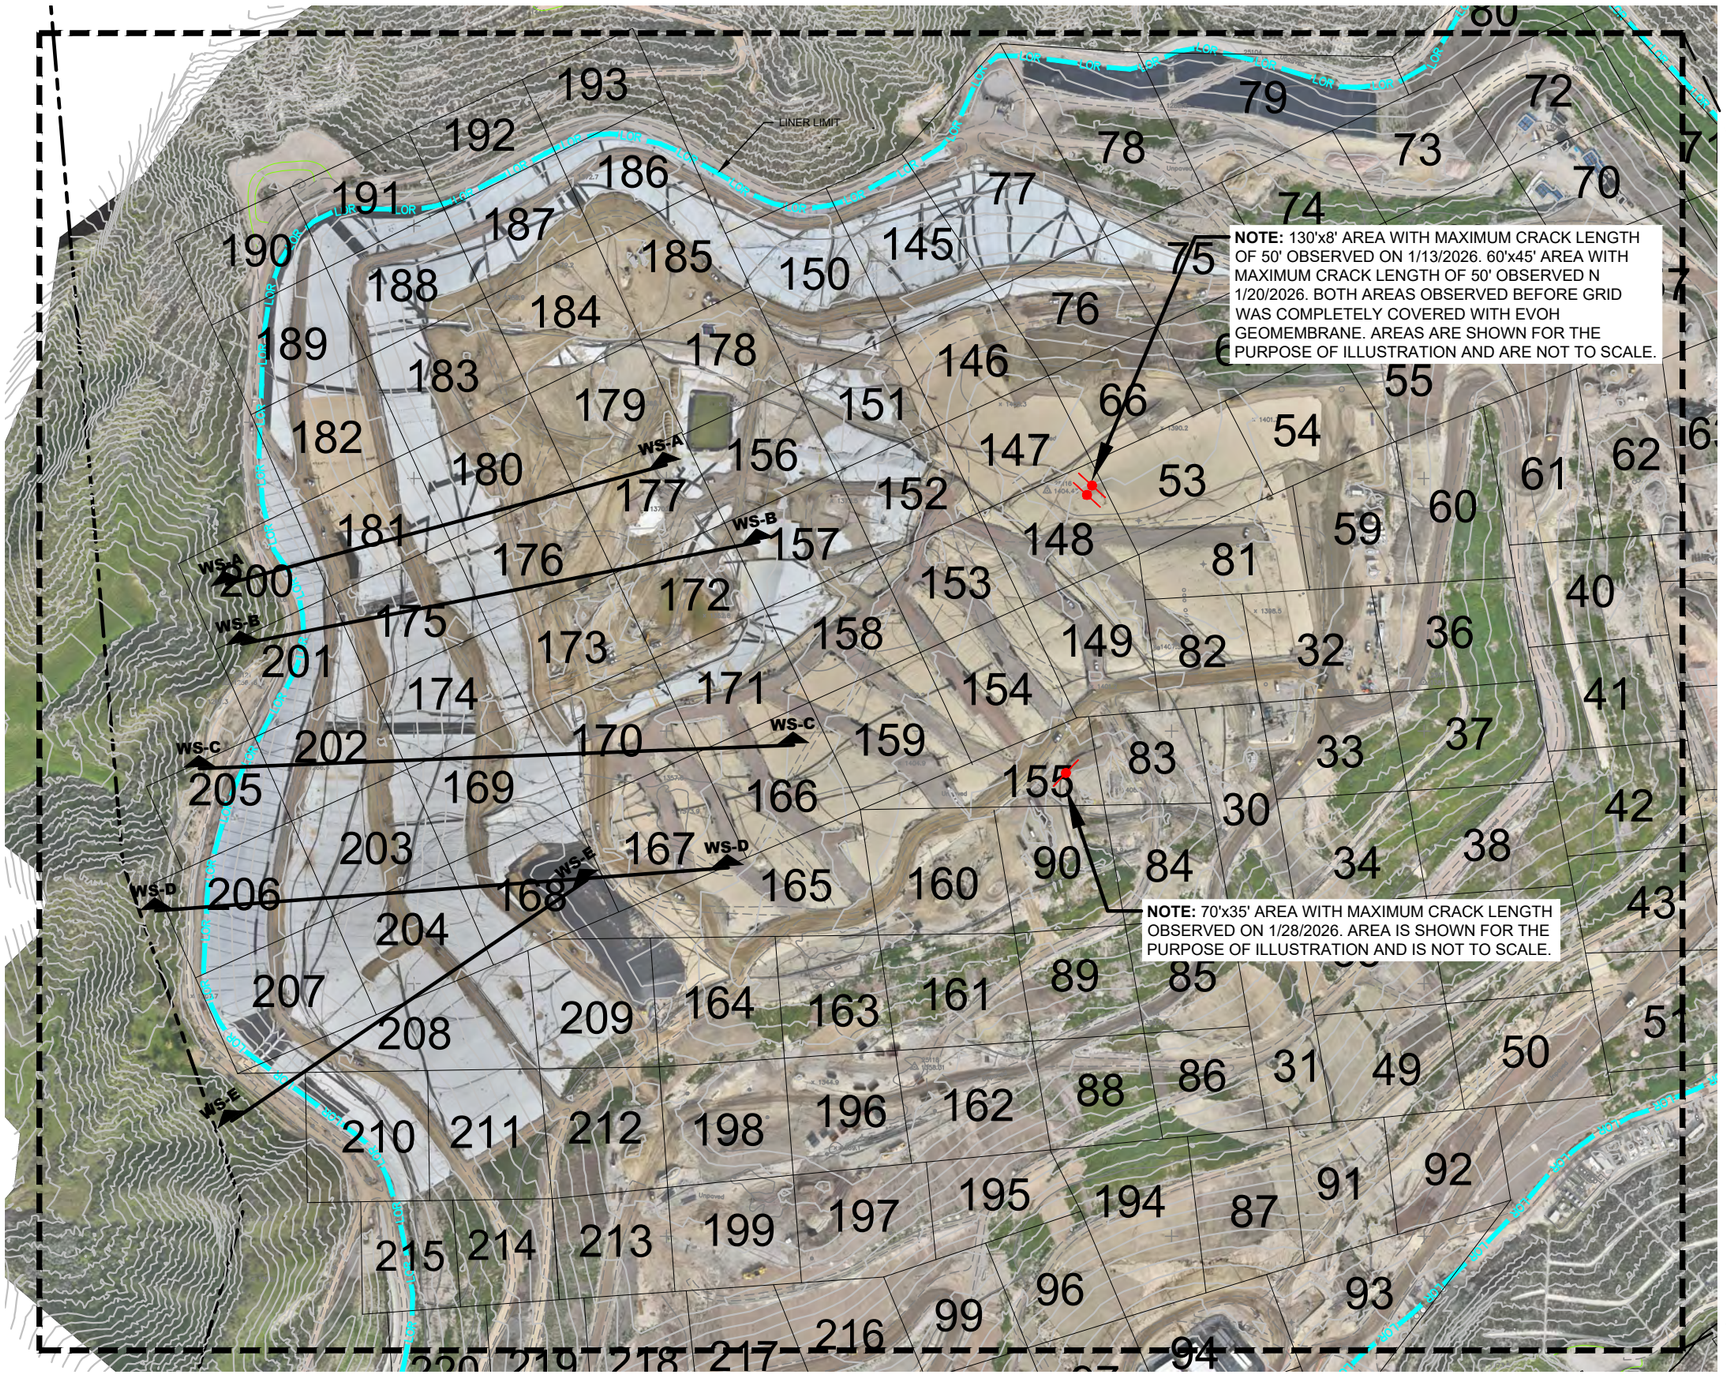
19. Liner torm in Grid 188. Liner sealed with flex tape. Tear was later patched and extrusion welded. Final repairs completed on 2/2/2026.

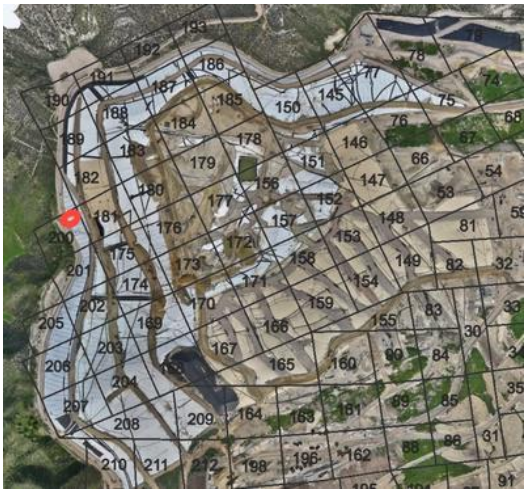
Identification of Issues	
Identified Issue	
Identified Issue 1	
Are there any issues with the geosynthetic cover?	Yes
Date and Time Issue Found	9 Feb 2026 12:29 PM PST

Notate what the issue is and what needs to be repaired	Tear in liner needs to be patched and extrusion welded.

Description of repair work	Tear was patched and extrusion welded.
Date and time of repair (within 2 hours)	10 Feb 2026 1:09 PM PST
Are further permanent repairs required?	No
Date and Time of final repair (if necessary)

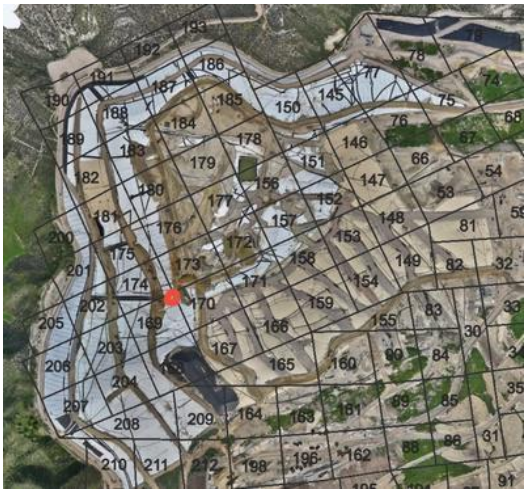
Grid Number	169

Identification of Issues	
Identified Issue	
Identified Issue 1	
Are there any issues with the geosynthetic cover?	Yes
Date and Time Issue Found	11 Feb 2026 11:50 AM PST

Notate what the issue is and what needs to be repaired	Small tear in liner. Needs to be patched and extrusion welded

Description of repair work	Taped and sandbagged upon discovery. Permanent repairs were conducted and tear was patched and extrusion welded
Date and time of repair (within 2 hours)	11 Feb 2026 11:52 AM PST
Are further permanent repairs required?	No
Date and Time of final repair (if necessary)	12 Feb 2026 9:10 AM PST
Instability under the cover	
Are there any anomalous (unusual or unexpected) areas of cover damage or deformation that may indicate underlying instability?	No
Are there any signs of a downslope tension crack at the top of the slope or bulging at or near the toe of the slope?	No

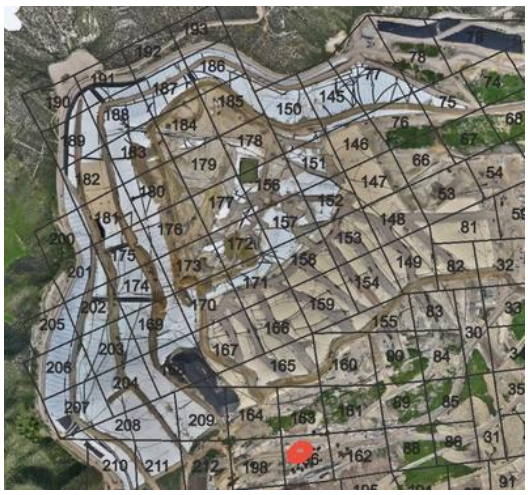
Grid Location	196
Date and Time Found	24 Feb 2026 11:08 AM PST

Fissure or Tension Crack Found?	Yes

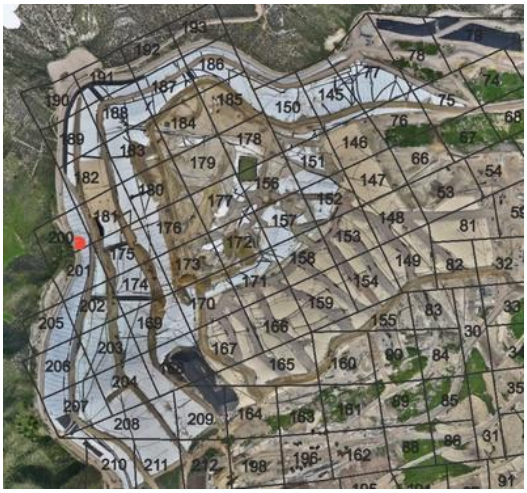
Grid Number	200

Identification of Issues	
Identified Issue	
Identified Issue 1	
Are there any issues with the geosynthetic cover?	Yes
Date and Time Issue Found	23 Feb 2026 1:55 PM PST

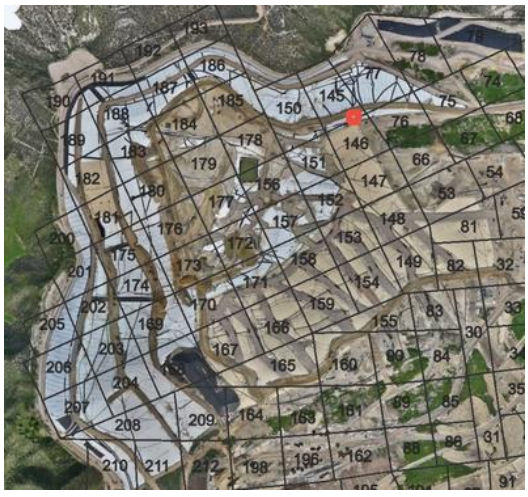
Grid Number	145

Are there any issues with the geosynthetic cover?	Yes
Date and Time Issue Found	23 Feb 2026 10:58 AM PST

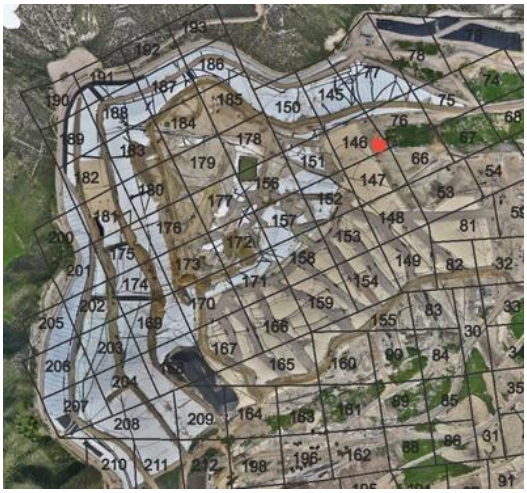
Grid Number	146

Identification of Issues	
Identified Issue	
Identified Issue 1	
Are there any issues with the geosynthetic cover?	Yes
Date and Time Issue Found	24 Feb 2026 12:33 PM PST

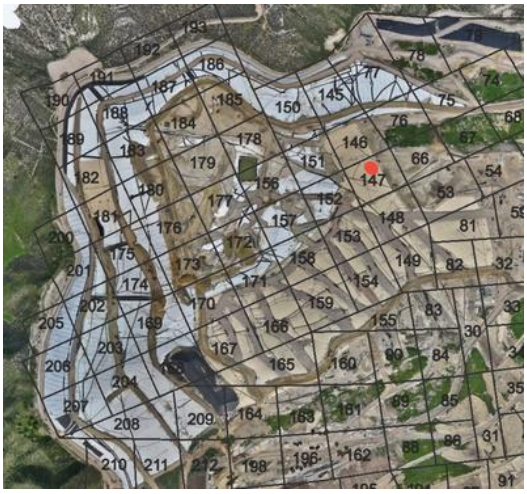
Grid Number	147

Are there any issues with the geosynthetic cover?	Yes
Date and Time Issue Found	24 Feb 2026 12:36 PM PST

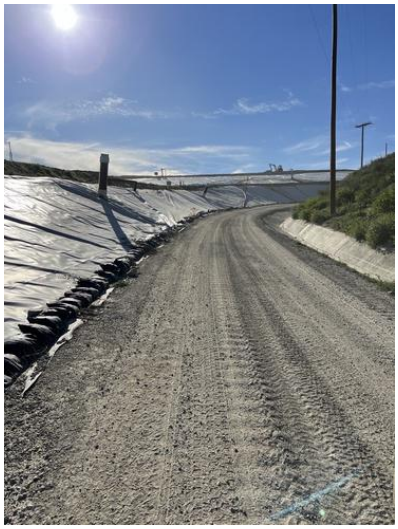
Photo 1

Description of area in photo where there is no leachate seepage or pooling.	North perimeter road.

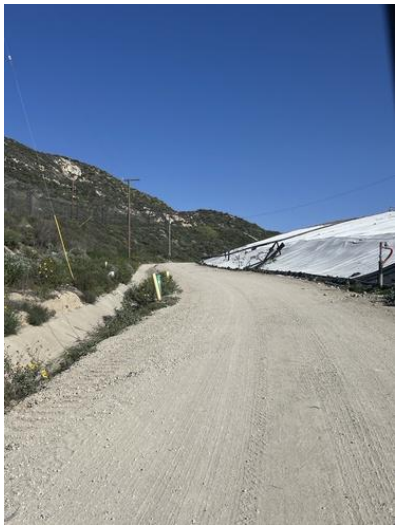
Photo 1

Description of area in photo where there is no leachate seepage or pooling.	North side perimeter road

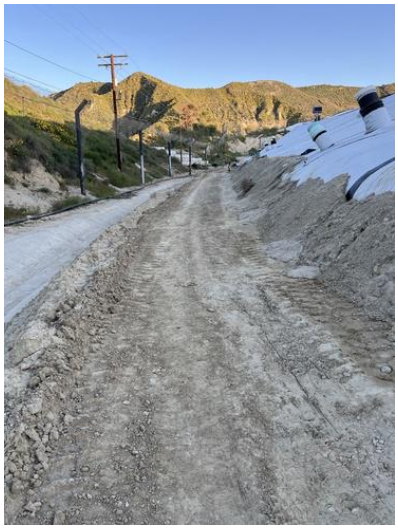
Photo 1

Description of area in photo where there is no leachate seepage or pooling.	Westside perimeter road.

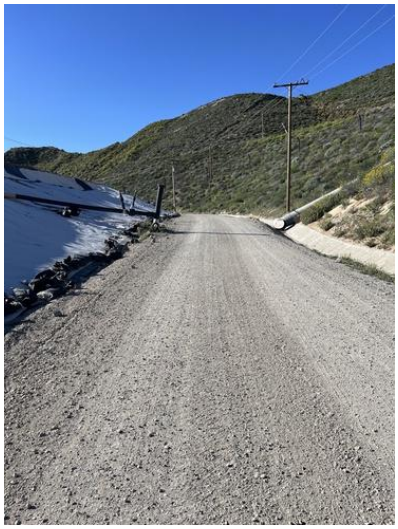
Photo 1

Description of area in photo where there is no leachate seepage or pooling.	North perimeter road.

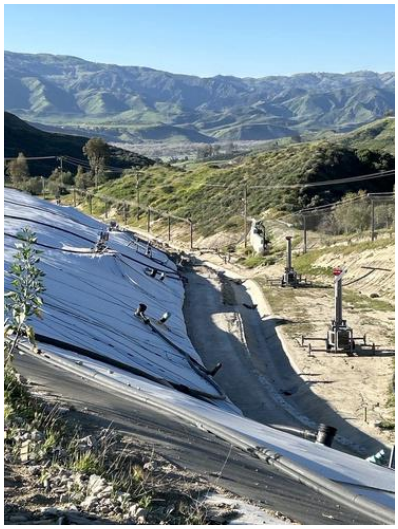
Photo 1

Description of area in photo where there is no leachate seepage or pooling.	West side perimeter road

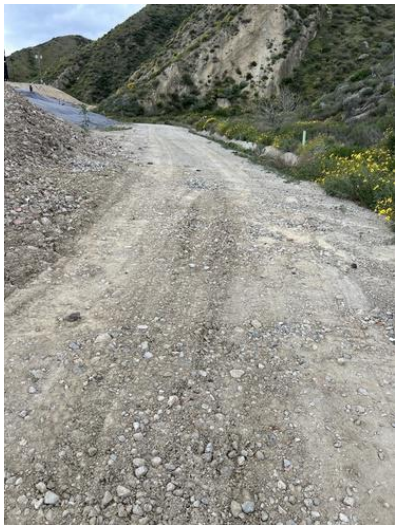
Photo 1

Description of area in photo where there is no leachate seepage or pooling.	North side perimeter road
