20 de marzo de 2026
Archivo No. 01204123.42, Tarea 10

Asunto: Informe Mensual de Febrero de 2026 de la Orden de Depuración Estipulada Modificada (Caso No. 6177-4), Vertedero de Chiquita Canyon (Código de Centro 119219), Castaic, California

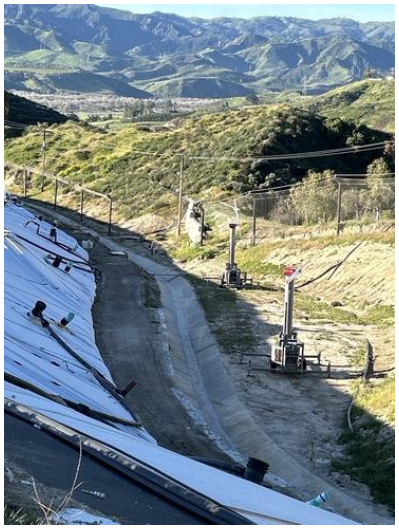
Photo 1

Description of area in photo where there is no leachate seepage or pooling.	West side perimeter road

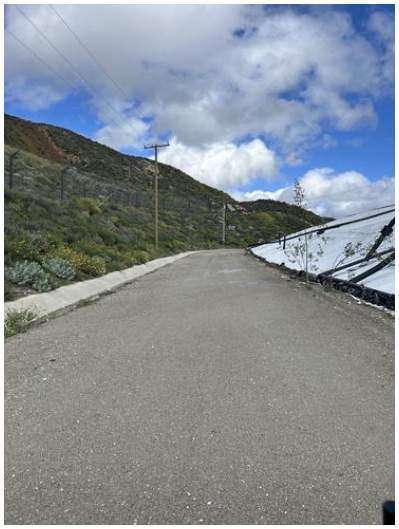
Photo 1

The seep from the morning inspection was not observed at this time

Description of area in photo where there is no leachate seepage or pooling.	North side perimeter road

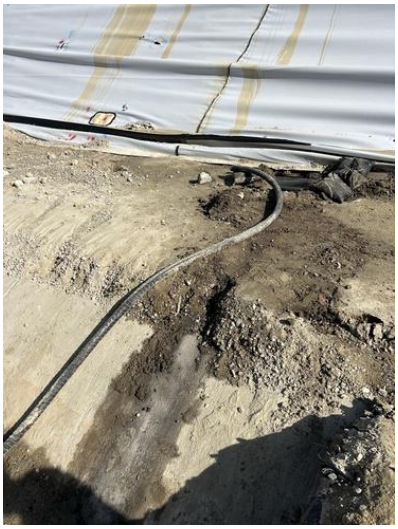
Photo 2

Drop Pin to record lat/long of seep/pooling location.	(34.43170688212353, -118.65096071220283)
Time seep/pooling was discovered	23 Feb 2026 3:15 AM PST
Estimated duration of presence of leachate at such location	6 hours
Estimated quantity of leachate	>150 gallons
Extent of area impacted (approximate sq ft impacted)	20 sq ft at location of seep and approximately 3,000 ft of stormwater channel.
Odor type	Leachate
Odor intensity	4 - Strong Odor
Surrounding soil saturation level	Standing free liquid

Did the seep/pooling travel into the stormwater channel? Yes

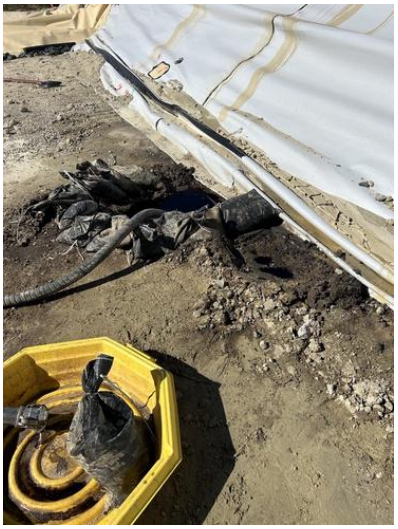
Photo 1

Drop Pin to record lat/long of seep/pooling location.	(34.43209505578834, -118.65137177761433)
Time seep/pooling was discovered	23 Feb 2026 2:00 PM PST
Estimated duration of presence of leachate at such location	11 hours
Estimated quantity of leachate	>150 gallons
Extent of area impacted (approximate sq ft impacted)	20 sq ft
Odor type	Leachate
Odor intensity	3 - Moderate Odor
Surrounding soil saturation level	Standing free liquid

Did the seep/pooling travel into the stormwater channel?	No

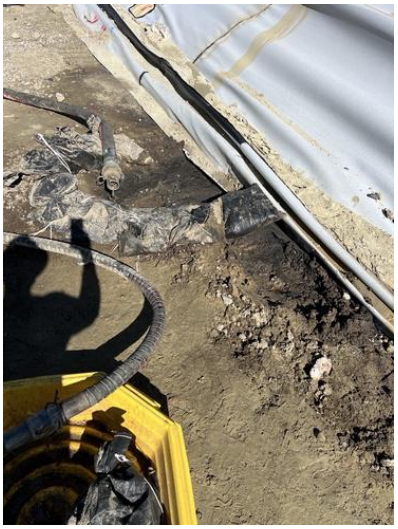
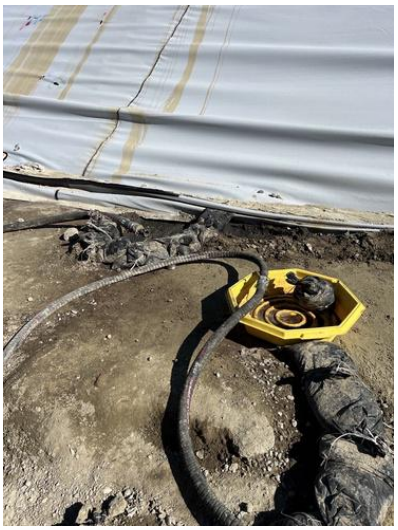
Drop Pin to record lat/long of seep/pooling location.	(34.43215542066448, -118.65154696884296)
Time seep/pooling was discovered	24 Feb 2026 9:47 AM PST
Estimated duration of presence of leachate at such location	31 hours
Estimated quantity of leachate	>150 gallons
Extent of area impacted (approximate sq ft impacted)	20 sq ft
Odor type	Leachate
Odor intensity	2 - Light Odor Detected
Surrounding soil saturation level	Saturated

Did the seep/pooling travel into the stormwater channel?	No

Berm placed around seep. Leachate being vacuumed out throughout day to minimize pooling. Stormwater channel pressure washed and liquid vacuumed out. Check dams put in place in stormwater channel.

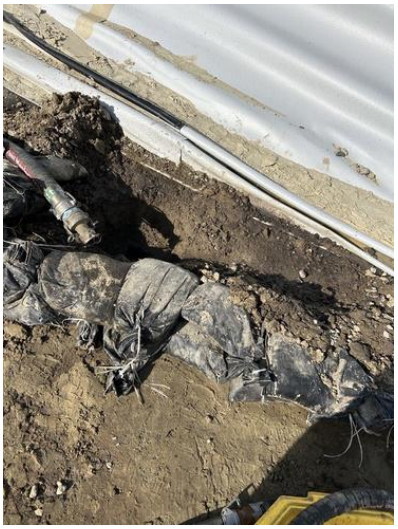
Photo 1

Drop Pin to record lat/long of seep/pooling location.	(34.43166455291356, -118.65101317790655)
Time seep/pooling was discovered	24 Feb 2026 3:21 PM PST
Estimated duration of presence of leachate at such location	35 hours
Estimated quantity of leachate	>150 gallons
Extent of area impacted (approximate sq ft impacted)	20 sq ft
Odor type	Leachate
Odor intensity	2 - Light Odor Detected
Surrounding soil saturation level	Saturated

Did the seep/pooling travel into the stormwater channel?	No

Berm placed around seep. Leachate being vacuumed out throughout day to minimize pooling. Stormwater channel pressure washed and liquid vacuumed out. Check dams put in place in stormwater channel. Work to repair seep schedule to begin 2/25/26.
