April 20, 2026
File No. 01204123.42, Task 10

Subject: March 2026 Monthly Report for Modified Stipulated Order for Abatement (Case No. 6177-4), Chiquita Canyon Landfill (Facility ID 119219), Castaic, California

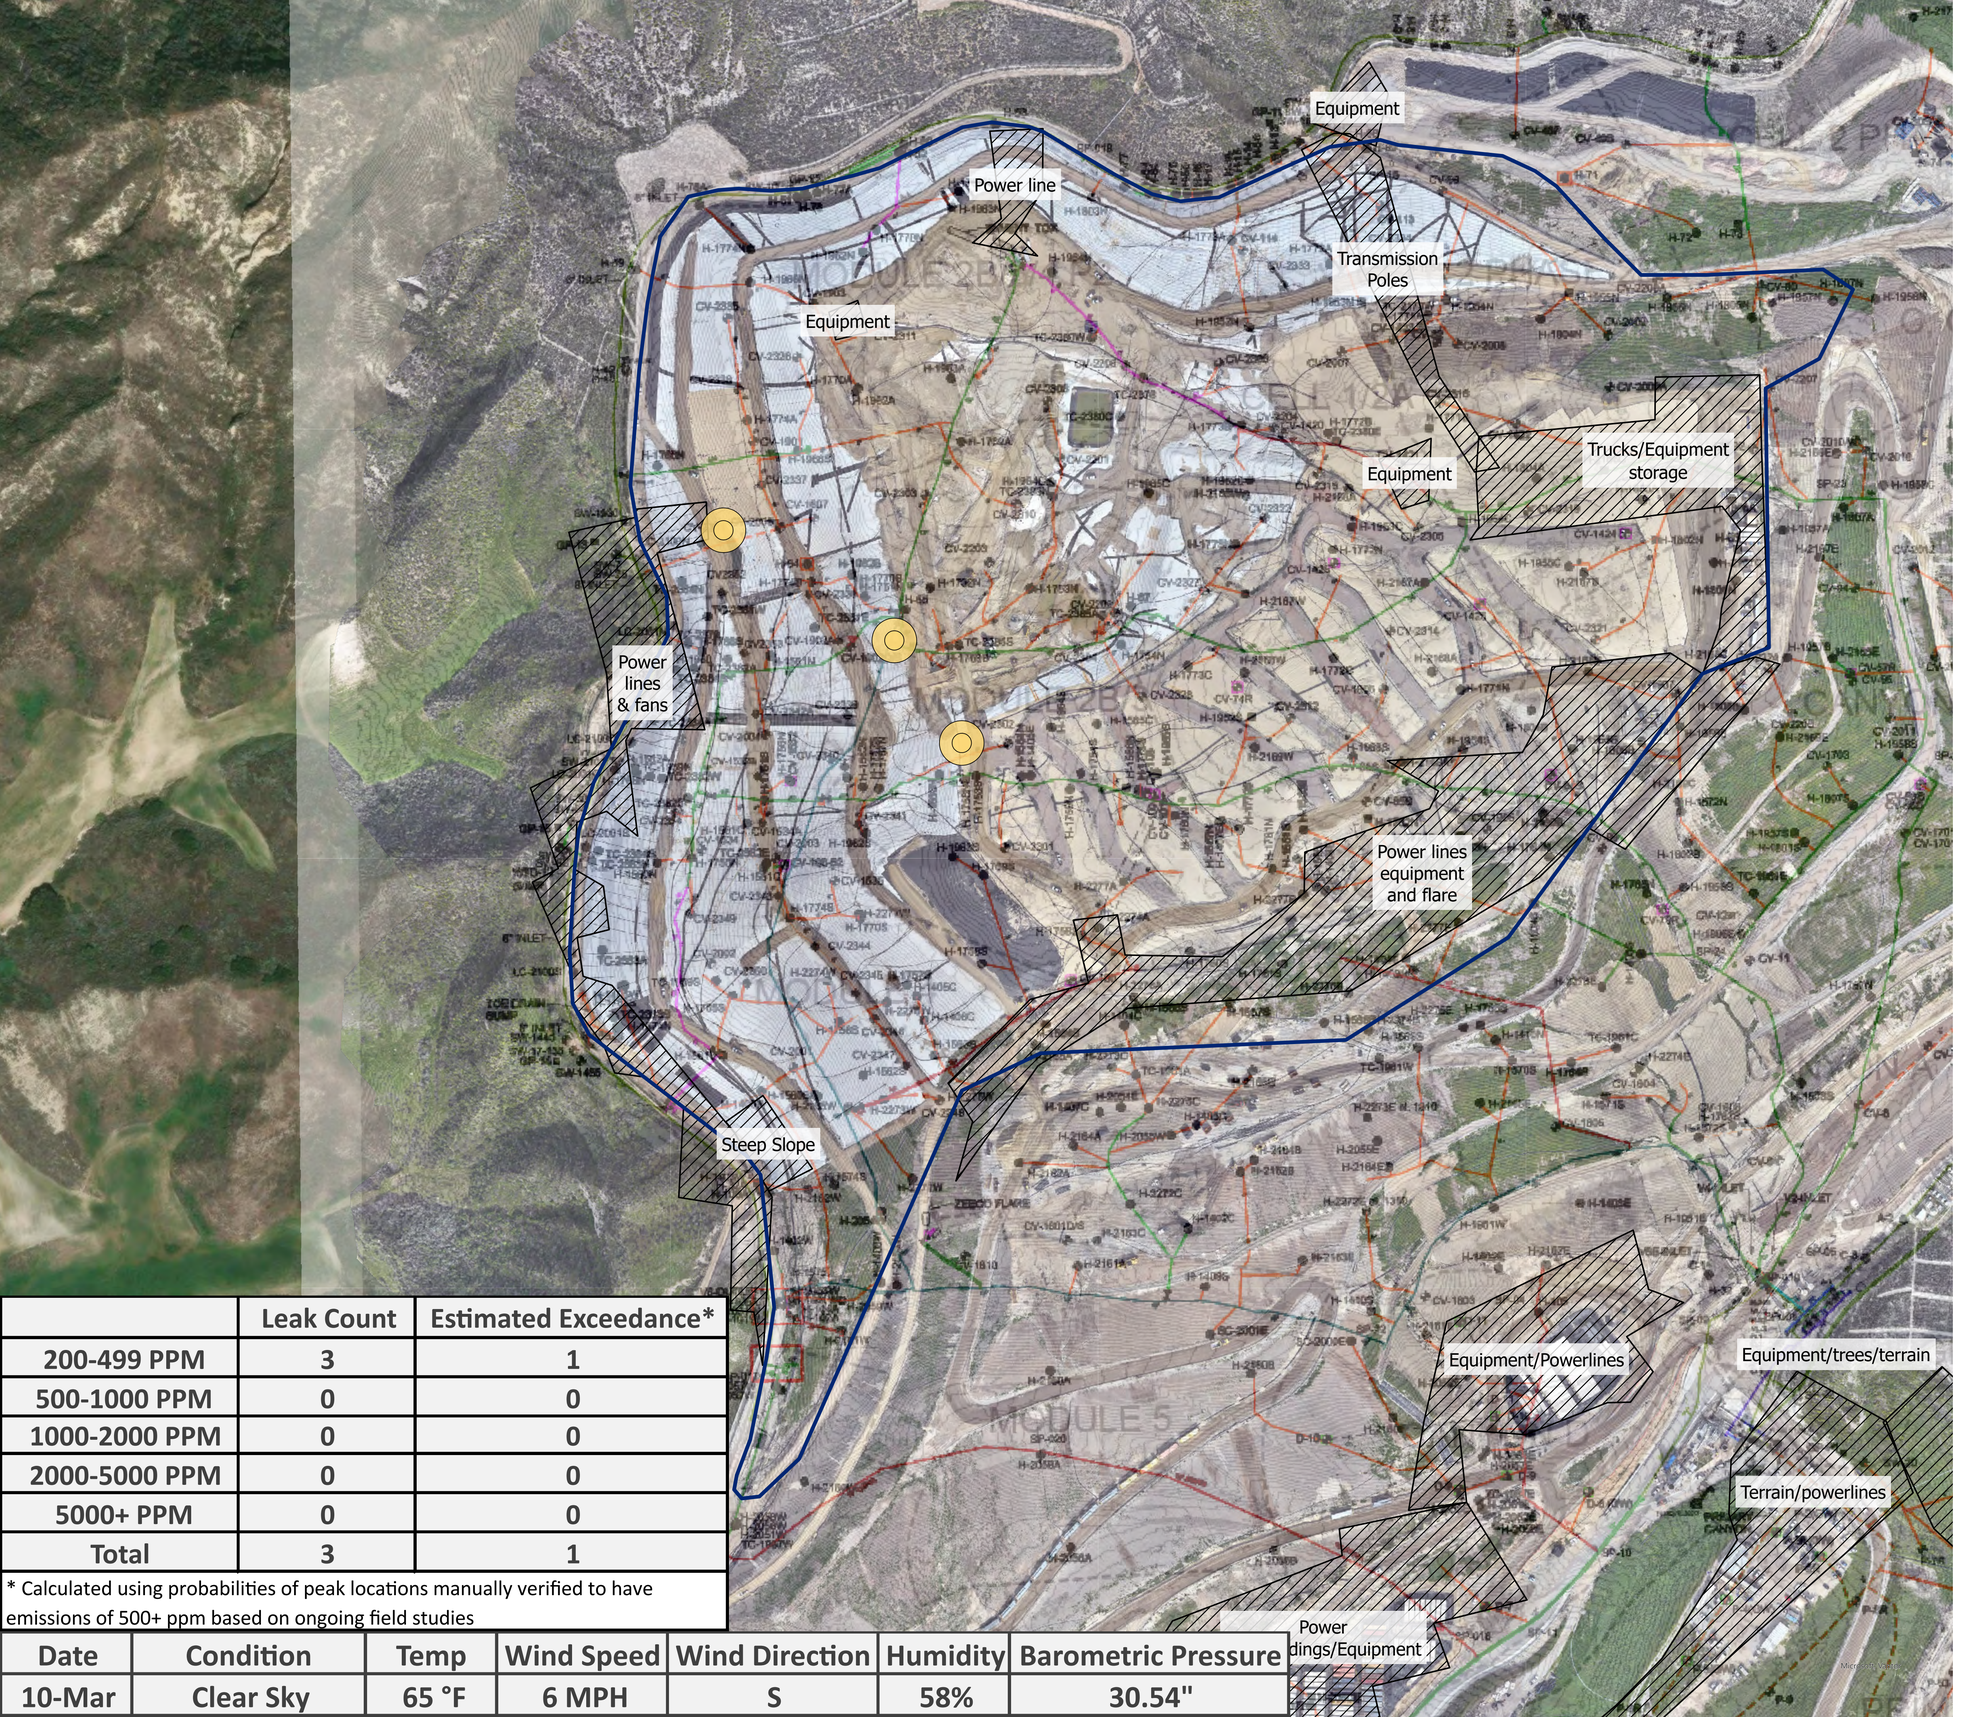
Leak Count	Estimated Exceedance*
200-499 PPM	3	1
500-1000 PPM	0	0
1000-2000 PPM	0	0
2000-5000 PPM	0	0
5000+ PPM	0	0
Total	3	1

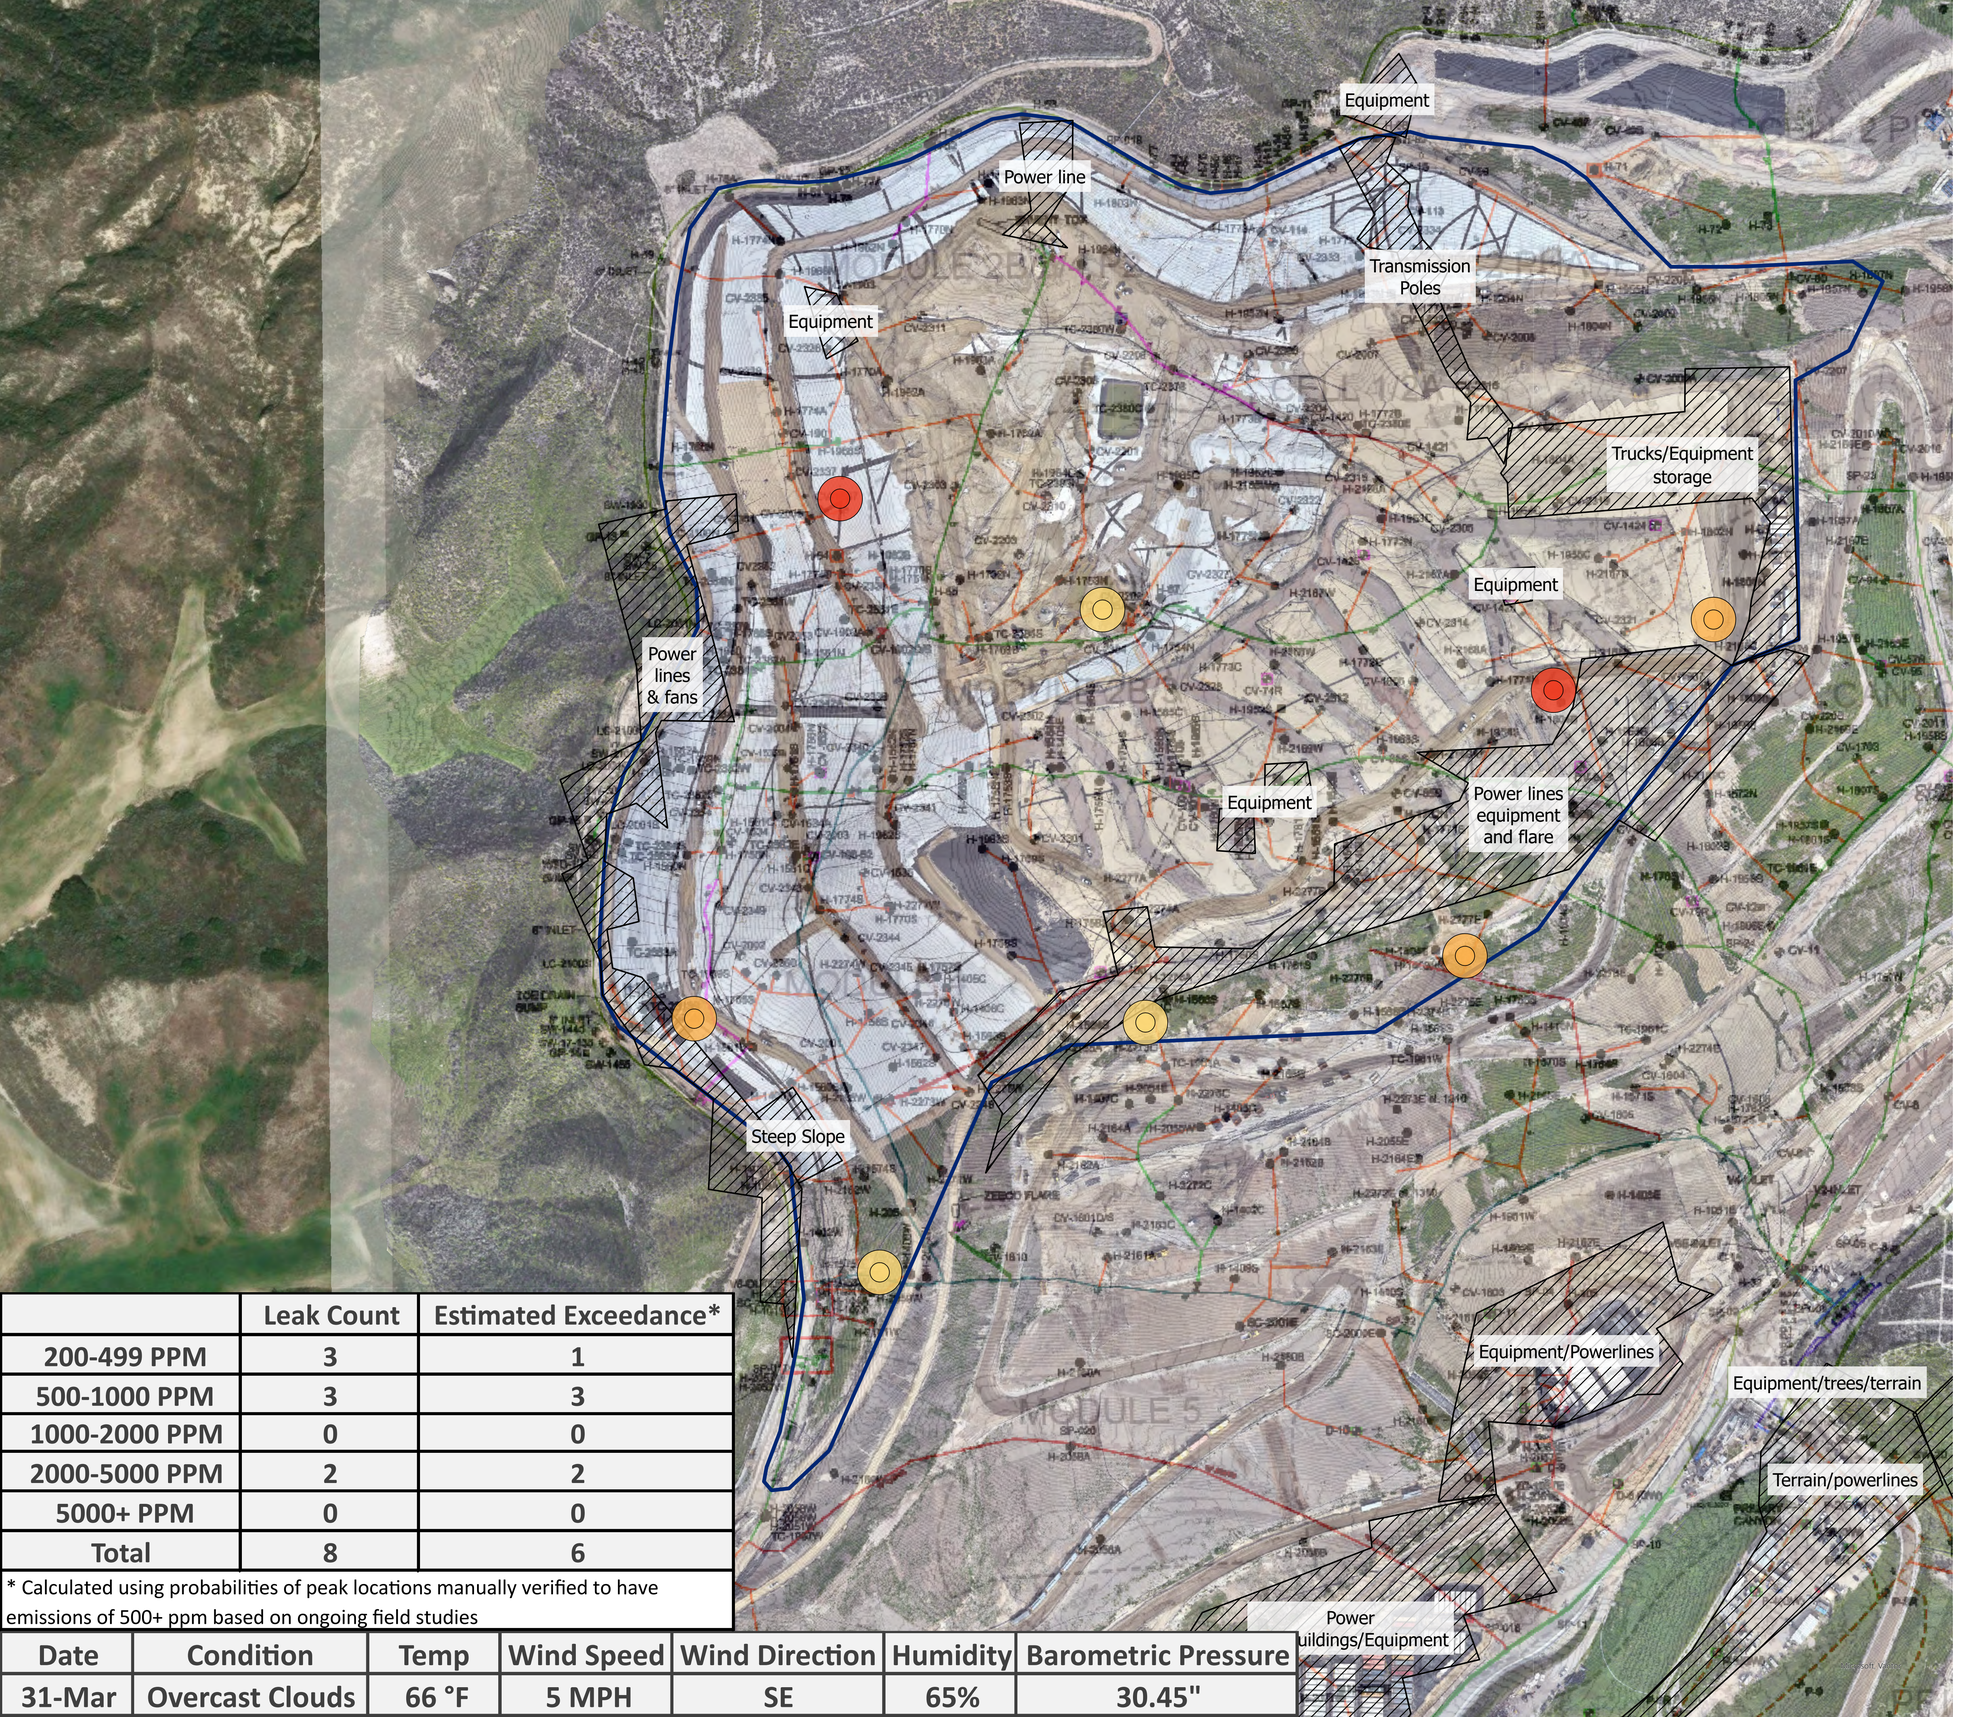
Photo 2

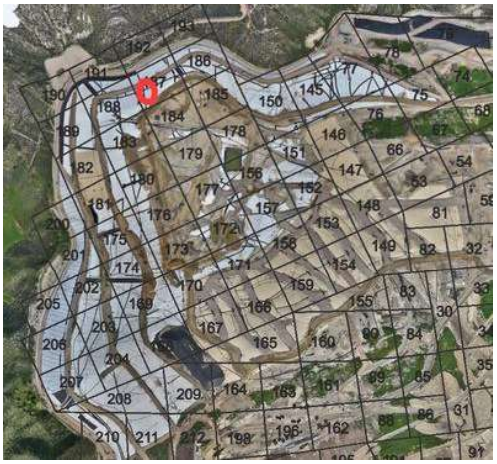
Grid Number	187

Identification of Issues	
Identified Issue	
Identified Issue 1	
Are there any issues with the geosynthetic cover?	Yes
Date and Time Issue Found	3 Mar 2026 11:16 AM PST

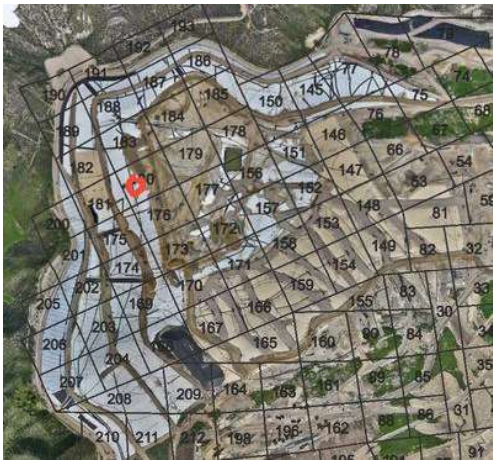
Grid Number	180

Are there any issues with the geosynthetic cover?	Yes
Date and Time Issue Found	5 Mar 2026 12:22 PM PST

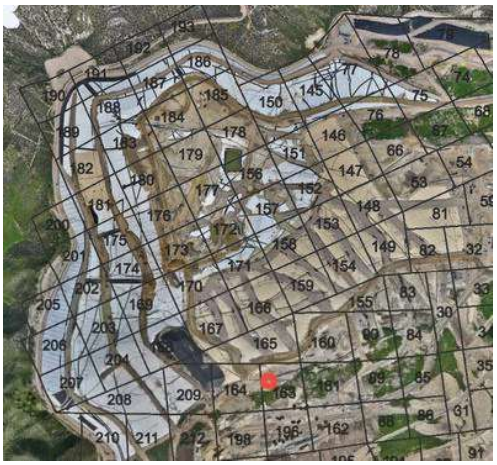
Grid Location	168
Date and Time Found	19 Mar 2026 10:07 AM PDT

Using the attached image, annotate all areas where inspectors identified a fissure or tension crack.

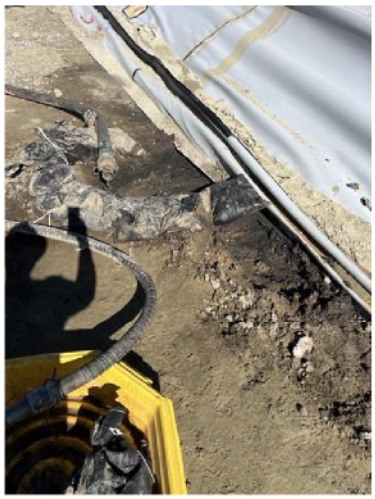
Routine landfill cover and geosynthetic cover inspections and repairs, as needed, were performed and logged throughout the month of March 2026. Results of the daily inspection and the repair logs are provided in **Attachment H**.

> *Any subsequent additions to the well-field shall be documented in the monthly reports pursuant to Condition 8. In installing any additional wells, Respondent shall ensure it complies with all conditions in Respondent's currently operative landfill gas collection system permit. In installing any additional wells pursuant to this Condition, Respondent shall additionally take the following measures: (…)*

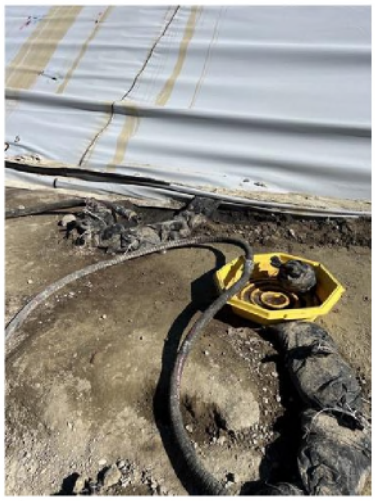
Photo 2

Berm placed around seep. Leachate being vacuumed out throughout day to minimize pooling. Stormwater channel pressure washed and liquid vacuumed out. Check dams put in place in stormwater channel.

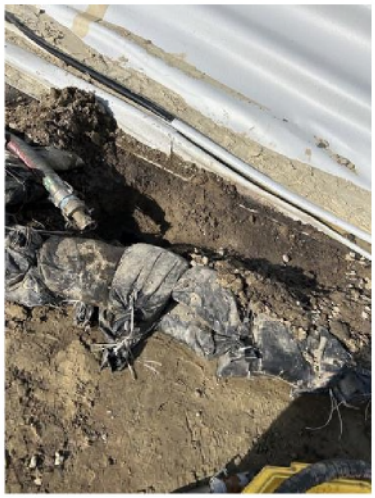
Section O – Updates of the Geosynthetic Cover

Additionally, as of April 3, 2026, Chiquita had installed approximately 1,584,301 square feet of tan 60-mil EVOH/HDPE geomembrane cover. Of the 1,584,301 square feet deployed, approximately 212,001 square feet was deployed on the west slope and in the area known as "the bowl"—currently covered with the 30-mil HDPE geomembrane cover. Chiquita also continued to perform repairs of the existing 30-mil HDPE geomembrane cover using the 60-mil EVOH/HDPE geomembrane.

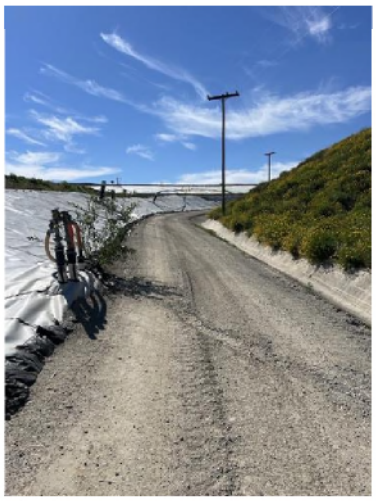
Photo 1

Description of area in photo where there is no leachate seepage or pooling.	North perimeter road.

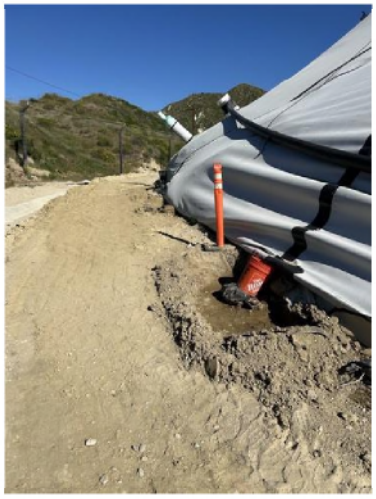
Photo 2

Berms created around seep point. Area is being monitored and liquid vacuumed out if needed to prevent pooling
No leachate was observed coming from the ground points during this inspection

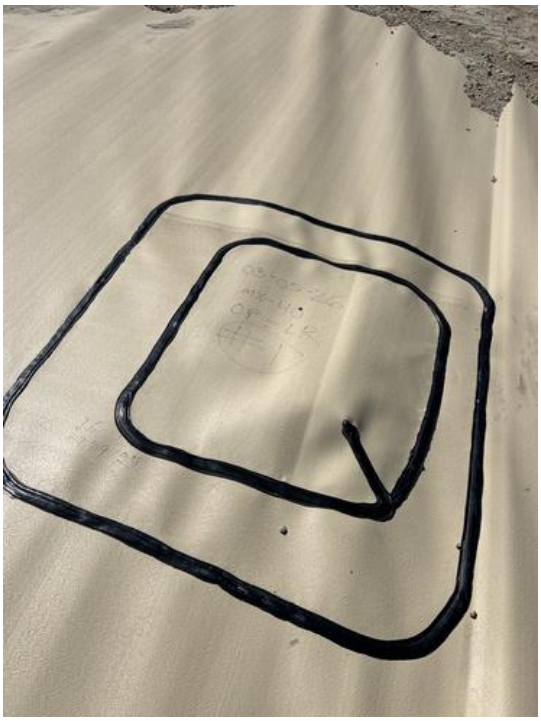
Photo 3

Notate what the issue is and what needs to be repaired	Tear at boot needs to be patched/extrusion welded.

Description of repair work	Boot and pole removed, area patched and extrusion welded
Date and time of repair	5 Mar 2026 6:40 AM PST
Are further permanent repairs required?	No
