May 20, 2026
File No. 01204123.42, Task 10

Subject: April 2026 Monthly Report for Modified Stipulated Order for Abatement (Case No. 6177-4), Chiquita Canyon Landfill (Facility ID 119219), Castaic, California

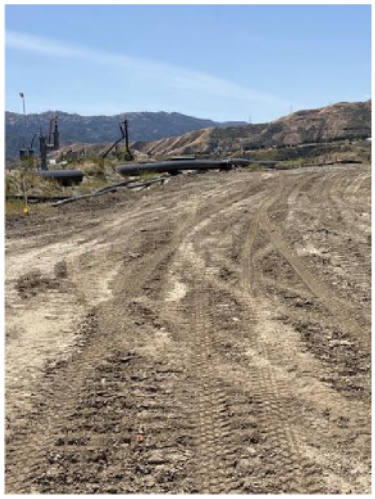
Grid 160

Fissure or Tension Crack Found?	No

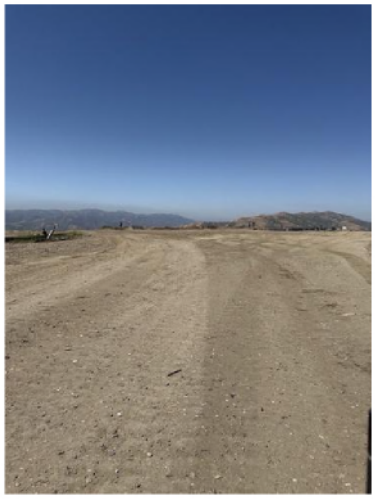
Grid 196

Fissure or Tension Crack Found?	No
