SCS ENGINEERS

June 15, 2026

**Subject:** **May 2026 Monthly Report Pursuant to Milestones 1A-3 and 5 of the LEA June 6, 2024 Compliance Order and July 30, 2024 Letter, Chiquita Canyon Landfill, Castaic, California**

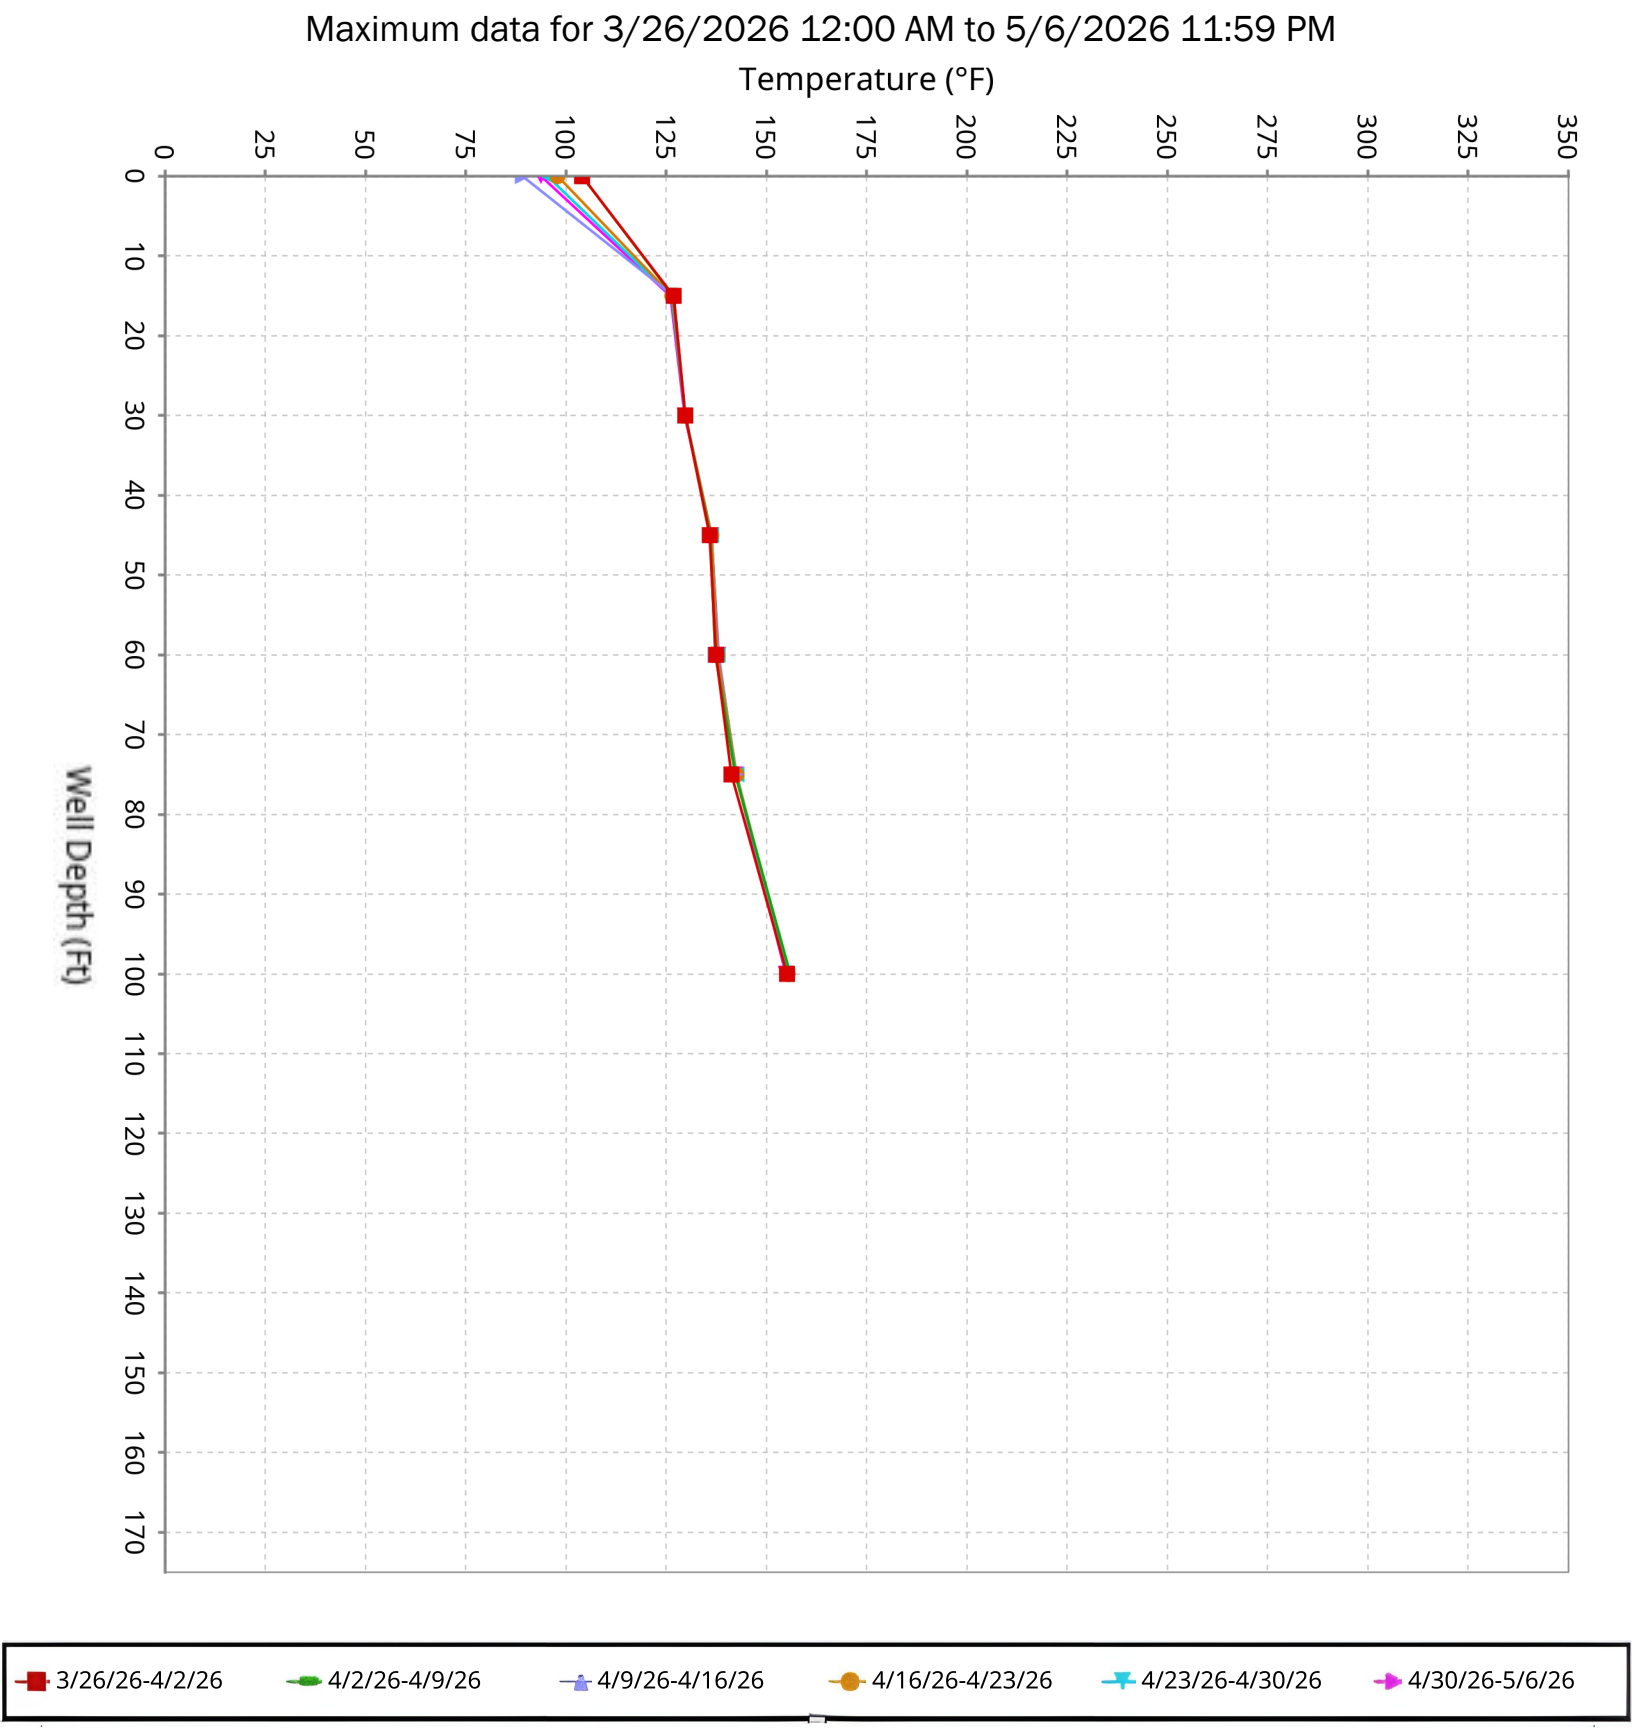
# Vertical Temperature Profiles from Temperature Probes at Chiquita Landfill for TP-8

- TP-08
  - The 125-foot thermocouple went offline on March 3rd and TP-8 was offline between March 6th and March 9th for evaluation and maintenance. Upon removing the thermocouples, the casing for TP-08 was found to be damaged due to differential settlement beyond 45-feet, thus preventing the installation of the 100-foot, 125-foot, and 150-foot thermocouples. The 15-foot, 30-foot, and 45-foot thermocouples are active and reporting data.
  - The 30-foot thermocouple showed an increase in maximum temperature of 14°F from 159°F to 173°F from April 30th to May 6th.
  - The 45-foot thermocouple showed an increase in maximum temperature of 12°F from 166°F to 178°F from April 30th to May 6th.

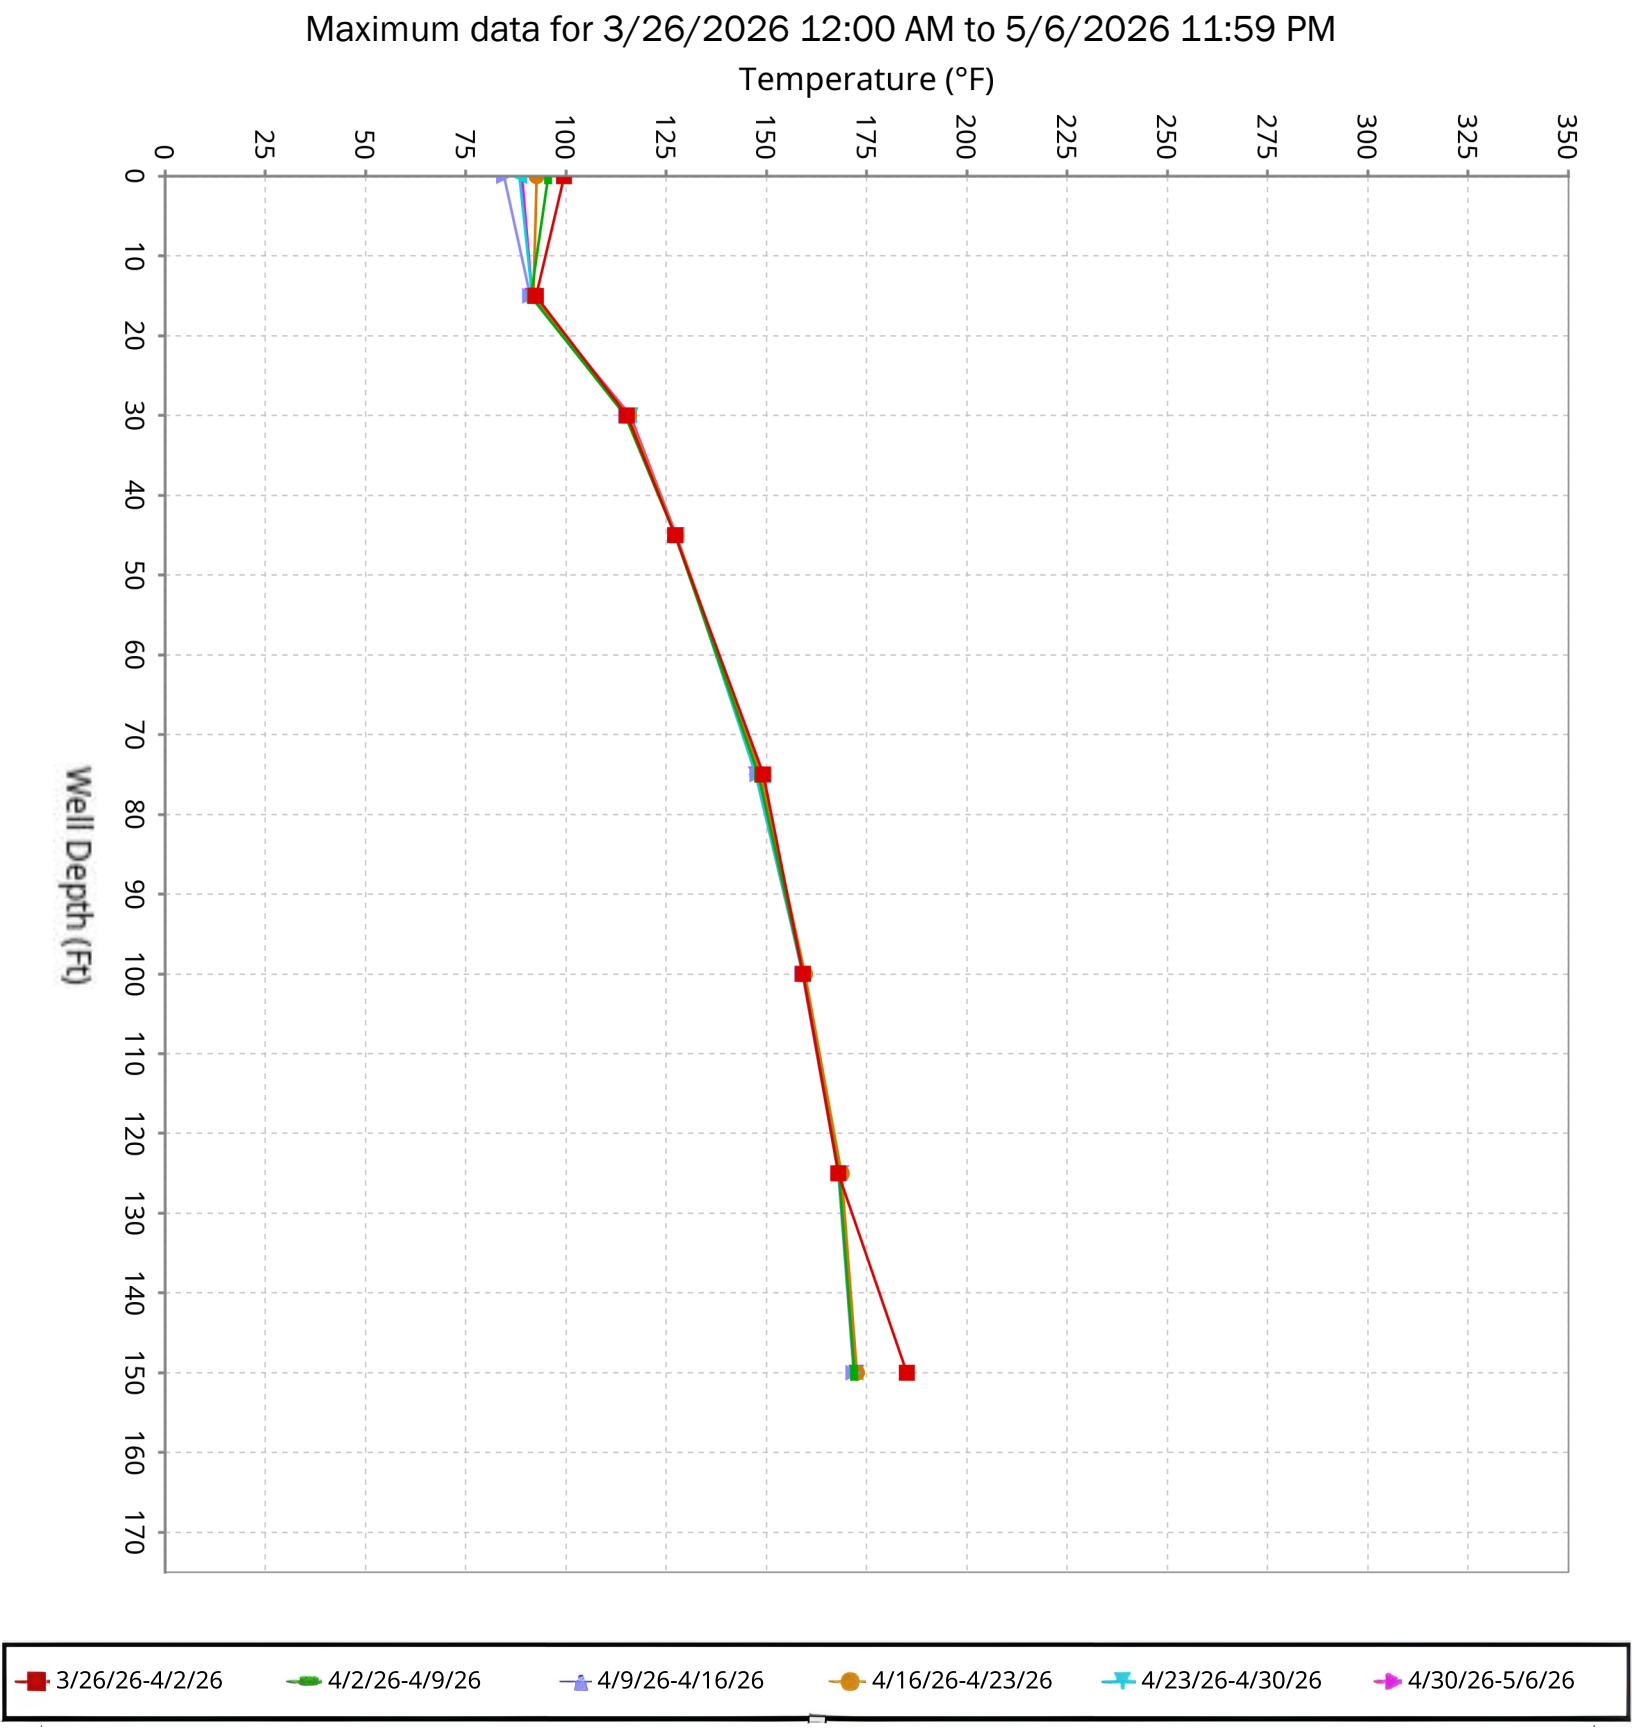
# Vertical Temperature Profiles from Temperature Probes at Chiquita Landfill for TP-14

**TP-14- The 150 foot thermocouple reported a maximum temperature of 2305 o May 10th, which was anomalous and likely associated with a potential thermocouple malfunction. As a result the report temperatures from May 11 to 15th are considered anomalous also. The 150 foot thermocouple was replaced on May 16thand temperature were consistent with previously recorded values.**

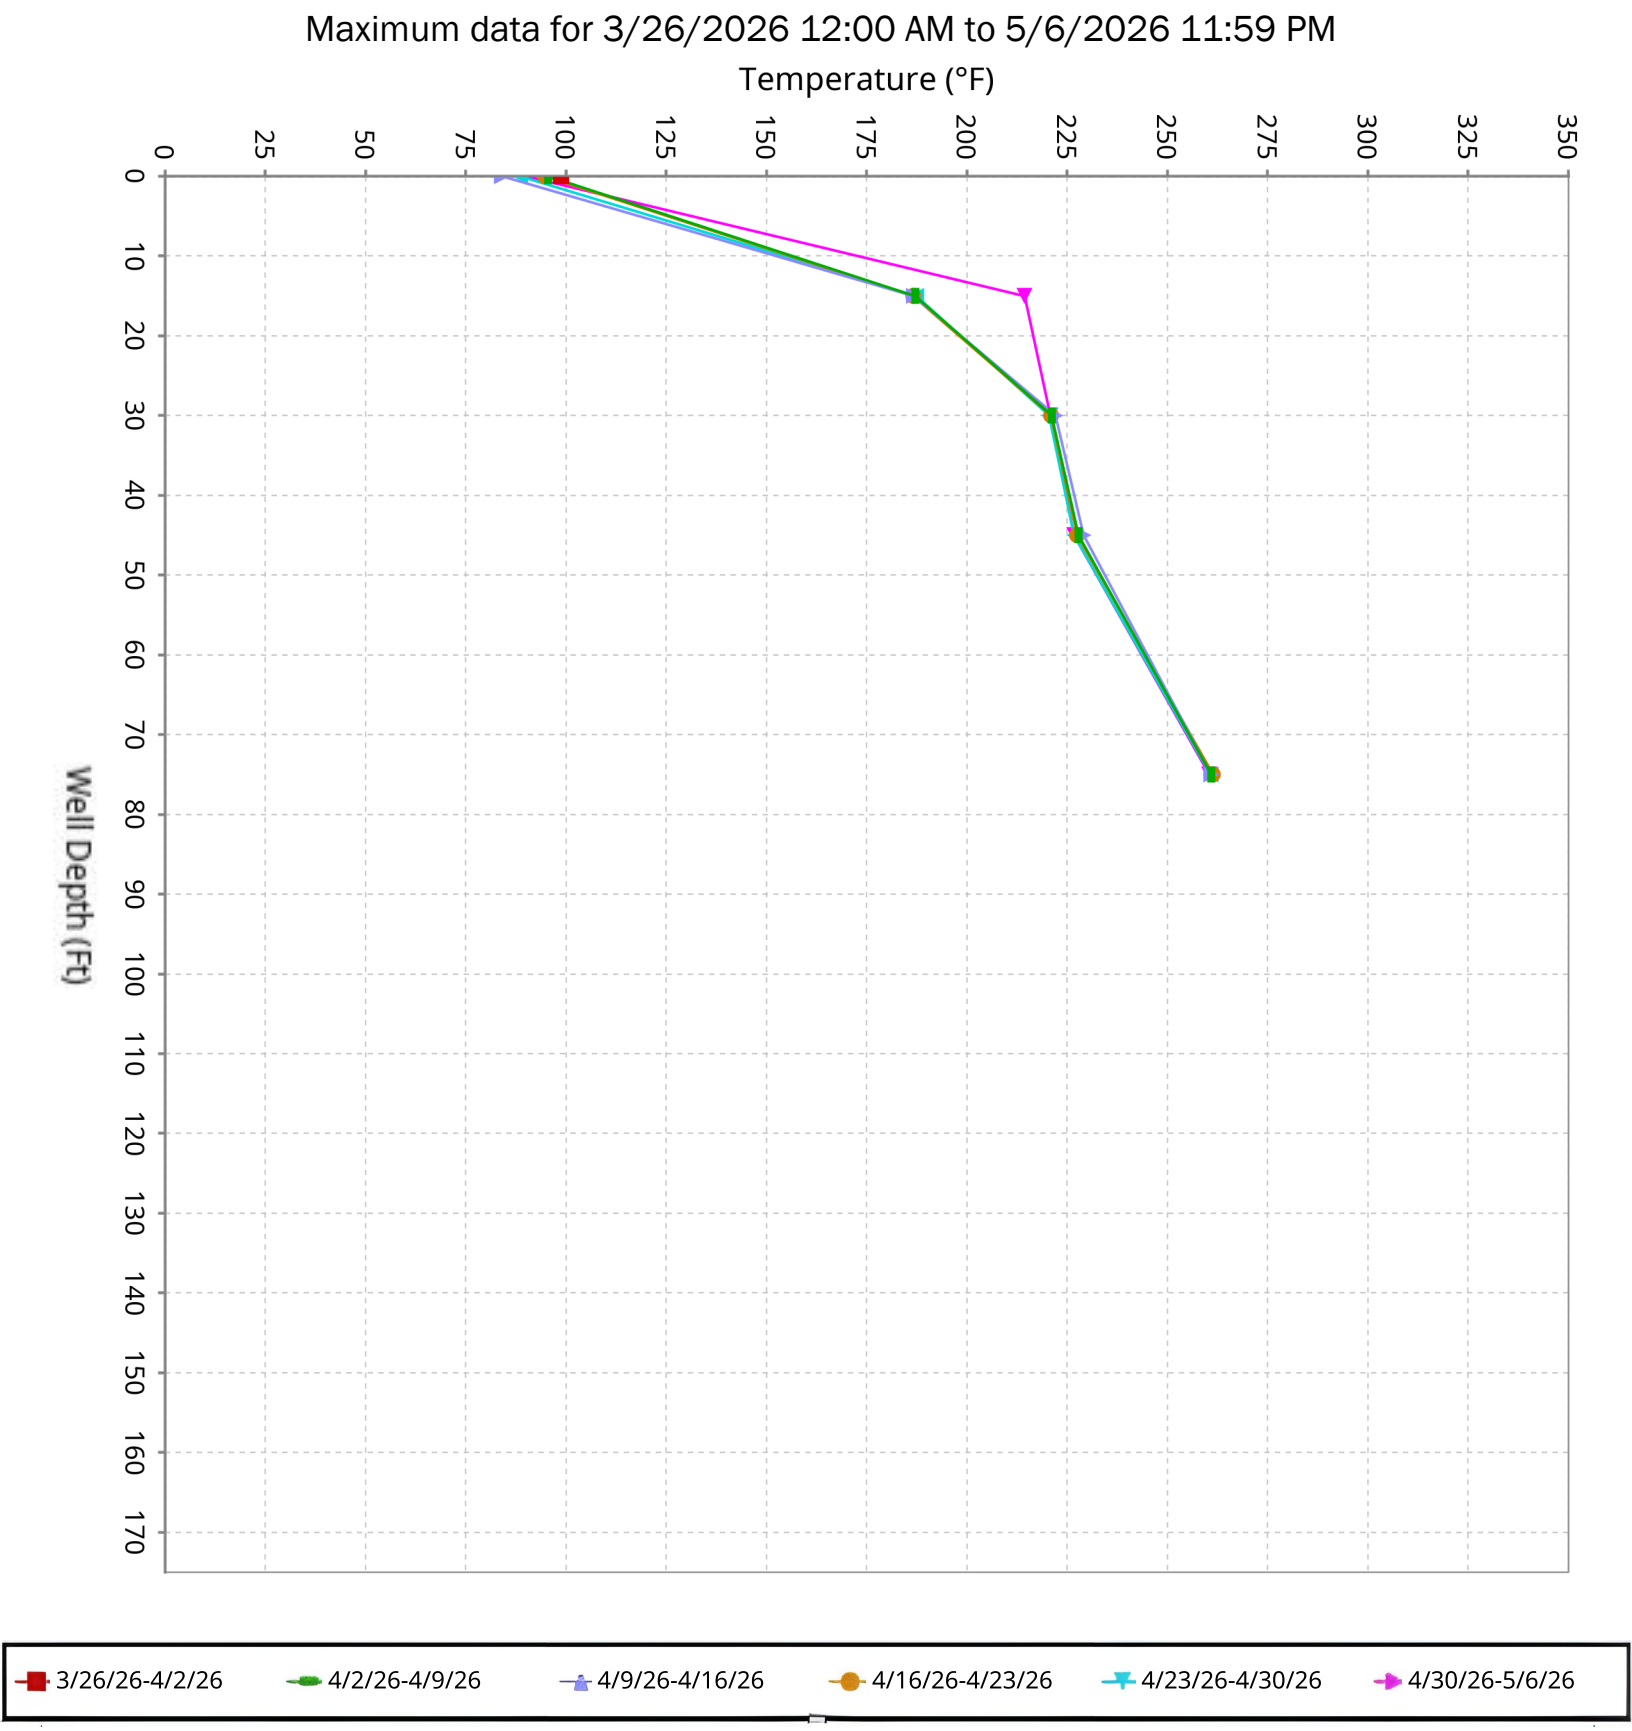
# Vertical Temperature Profiles from Temperature Probes at Chiquita Landfill for TP-23

- TP-23
  - The 15-foot thermocouple remained consistent with previous recorded temperatures.
  - The reported maximum temperature reading of 2508°F is considered anomalous and is believed to be associated with a potential thermocouple sensor malfunction. The sensor remains under evaluation and investigation.
- TP-36
  - The 250-foot thermocouple was evaluated due to low temperatures on April 6th and wiring that had come loose was corrected. After fixing the wiring issues, temperatures returned to 136°F as previously recorded prior to March 21st.

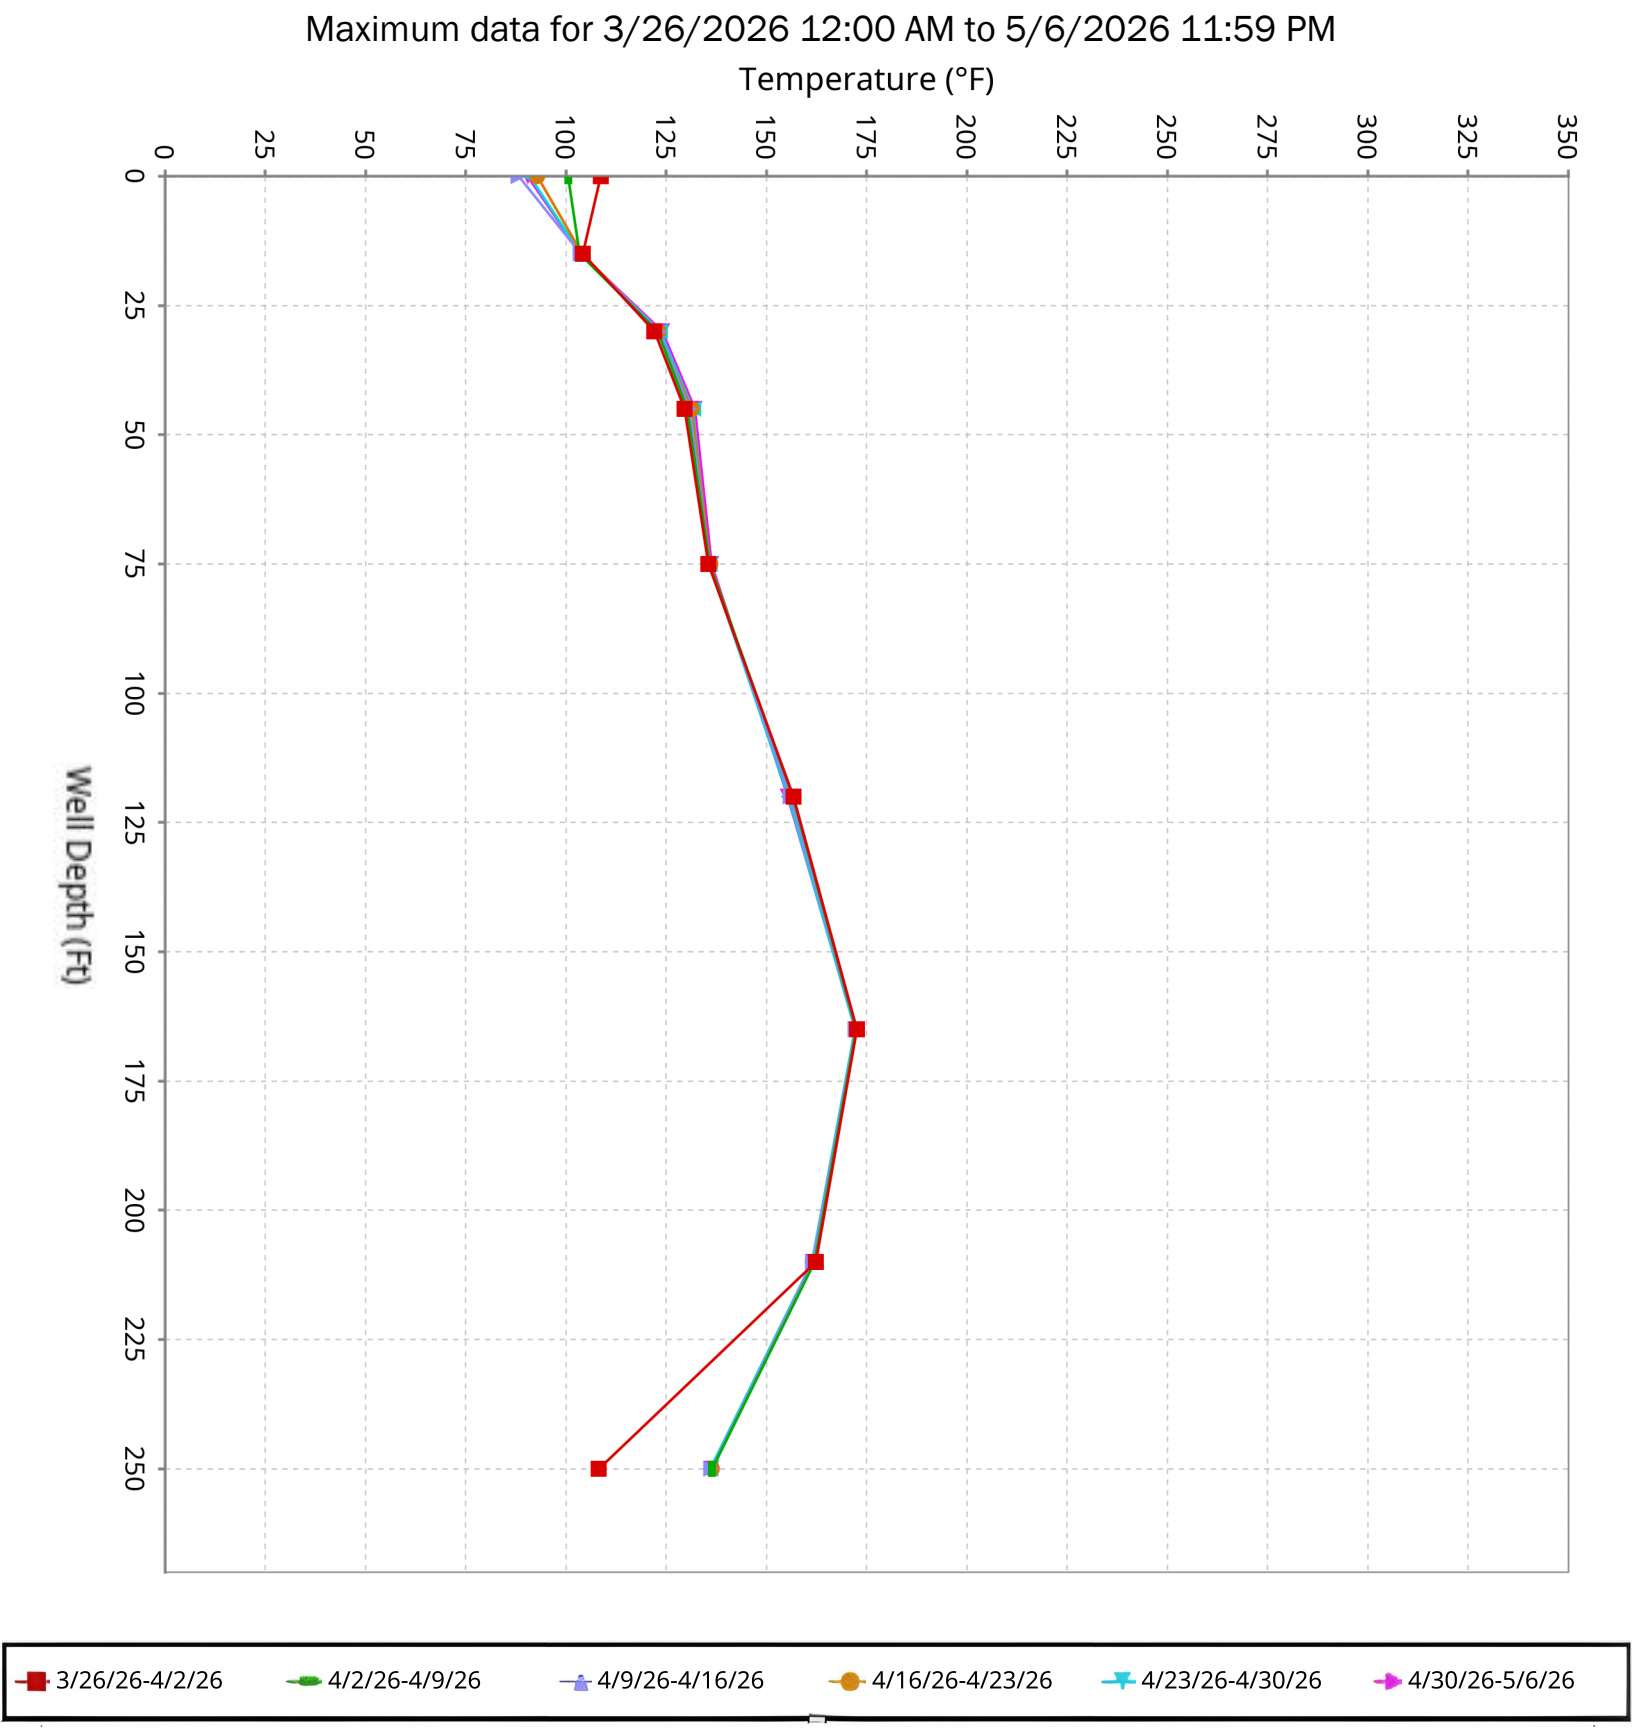
# Vertical Temperature Profiles from Temperature Probes at Chiquita Landfill for TP-36

- TP-36
  - The 250-foot thermocouple was evaluated due to low temperatures on April 6th and wiring that had come loose was corrected. After fixing the wiring issues temperatures returned to 136°F as previously recorded prior to March 21st.

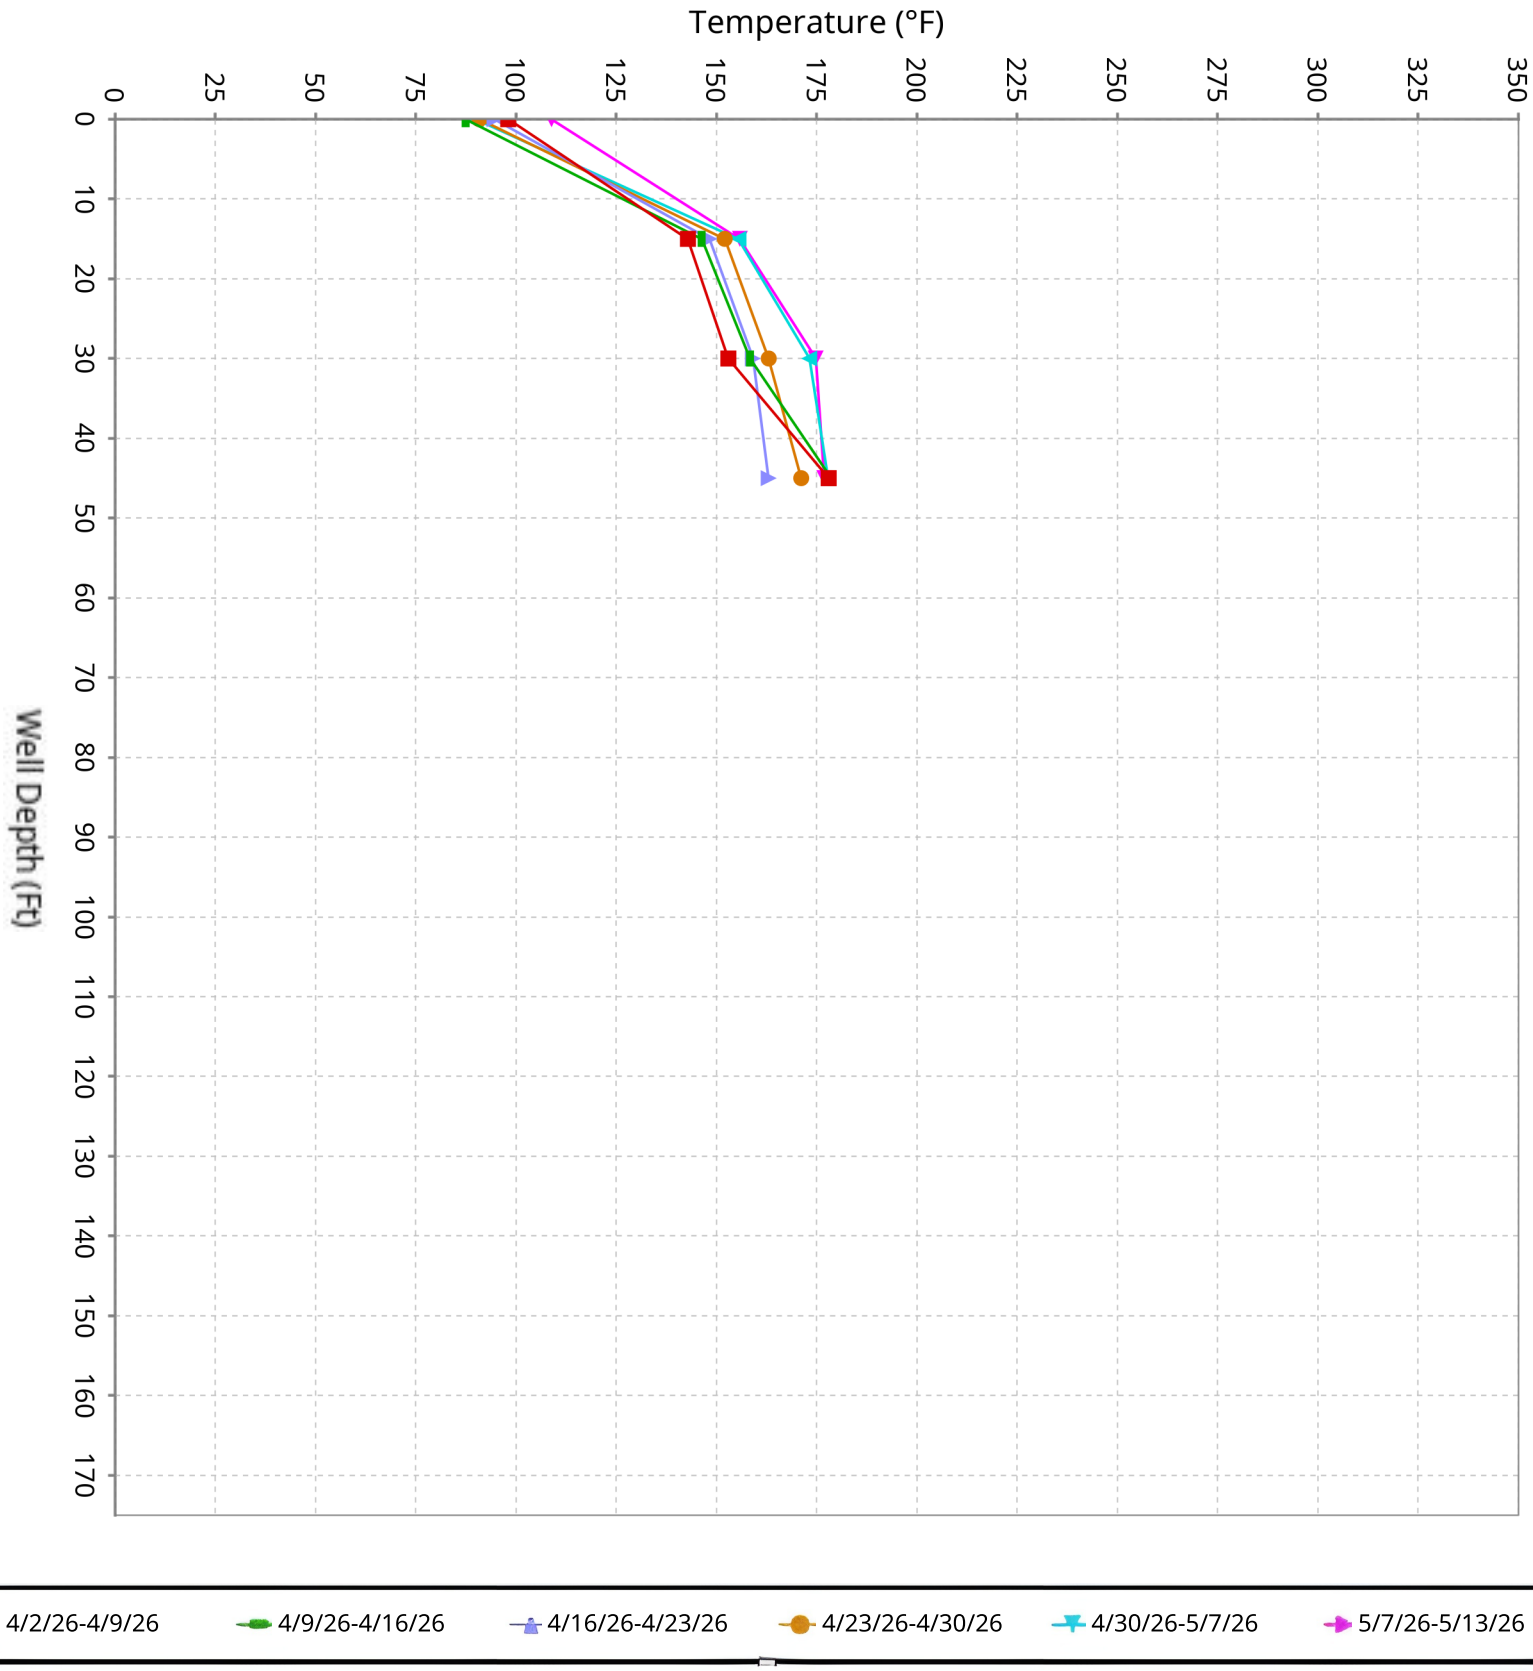
# Vertical Temperature Profiles from Temperature Probes at Chiquita Landfill for TP-8

- TP-08
  - The 125-foot thermocouple went offline on March 3rd and TP-8 was offline between March 6th and March 9th for evaluation and maintenance. Upon removing the thermocouples, the casing for TP-08 was found to be damaged due to differential settlement beyond 45-feet, thus preventing the installation of the 100-foot, 125-foot, and 150-foot thermocouples. The 15-foot, 30-foot, and 45-foot thermocouples are active and reporting data.
  - The 15-foot thermocouple showed a decrease in maximum temperature of 19°F from 156°F to 137°F from May 7th to May 13th.
  - The 30-foot thermocouple showed a decrease in maximum temperature of 35°F from 175°F to 140°F from May 7th to May 13th.
  - The 45-foot thermocouple showed a decrease in maximum temperature of 36°F from 177°F to 141°F from May 7th to May 13th.

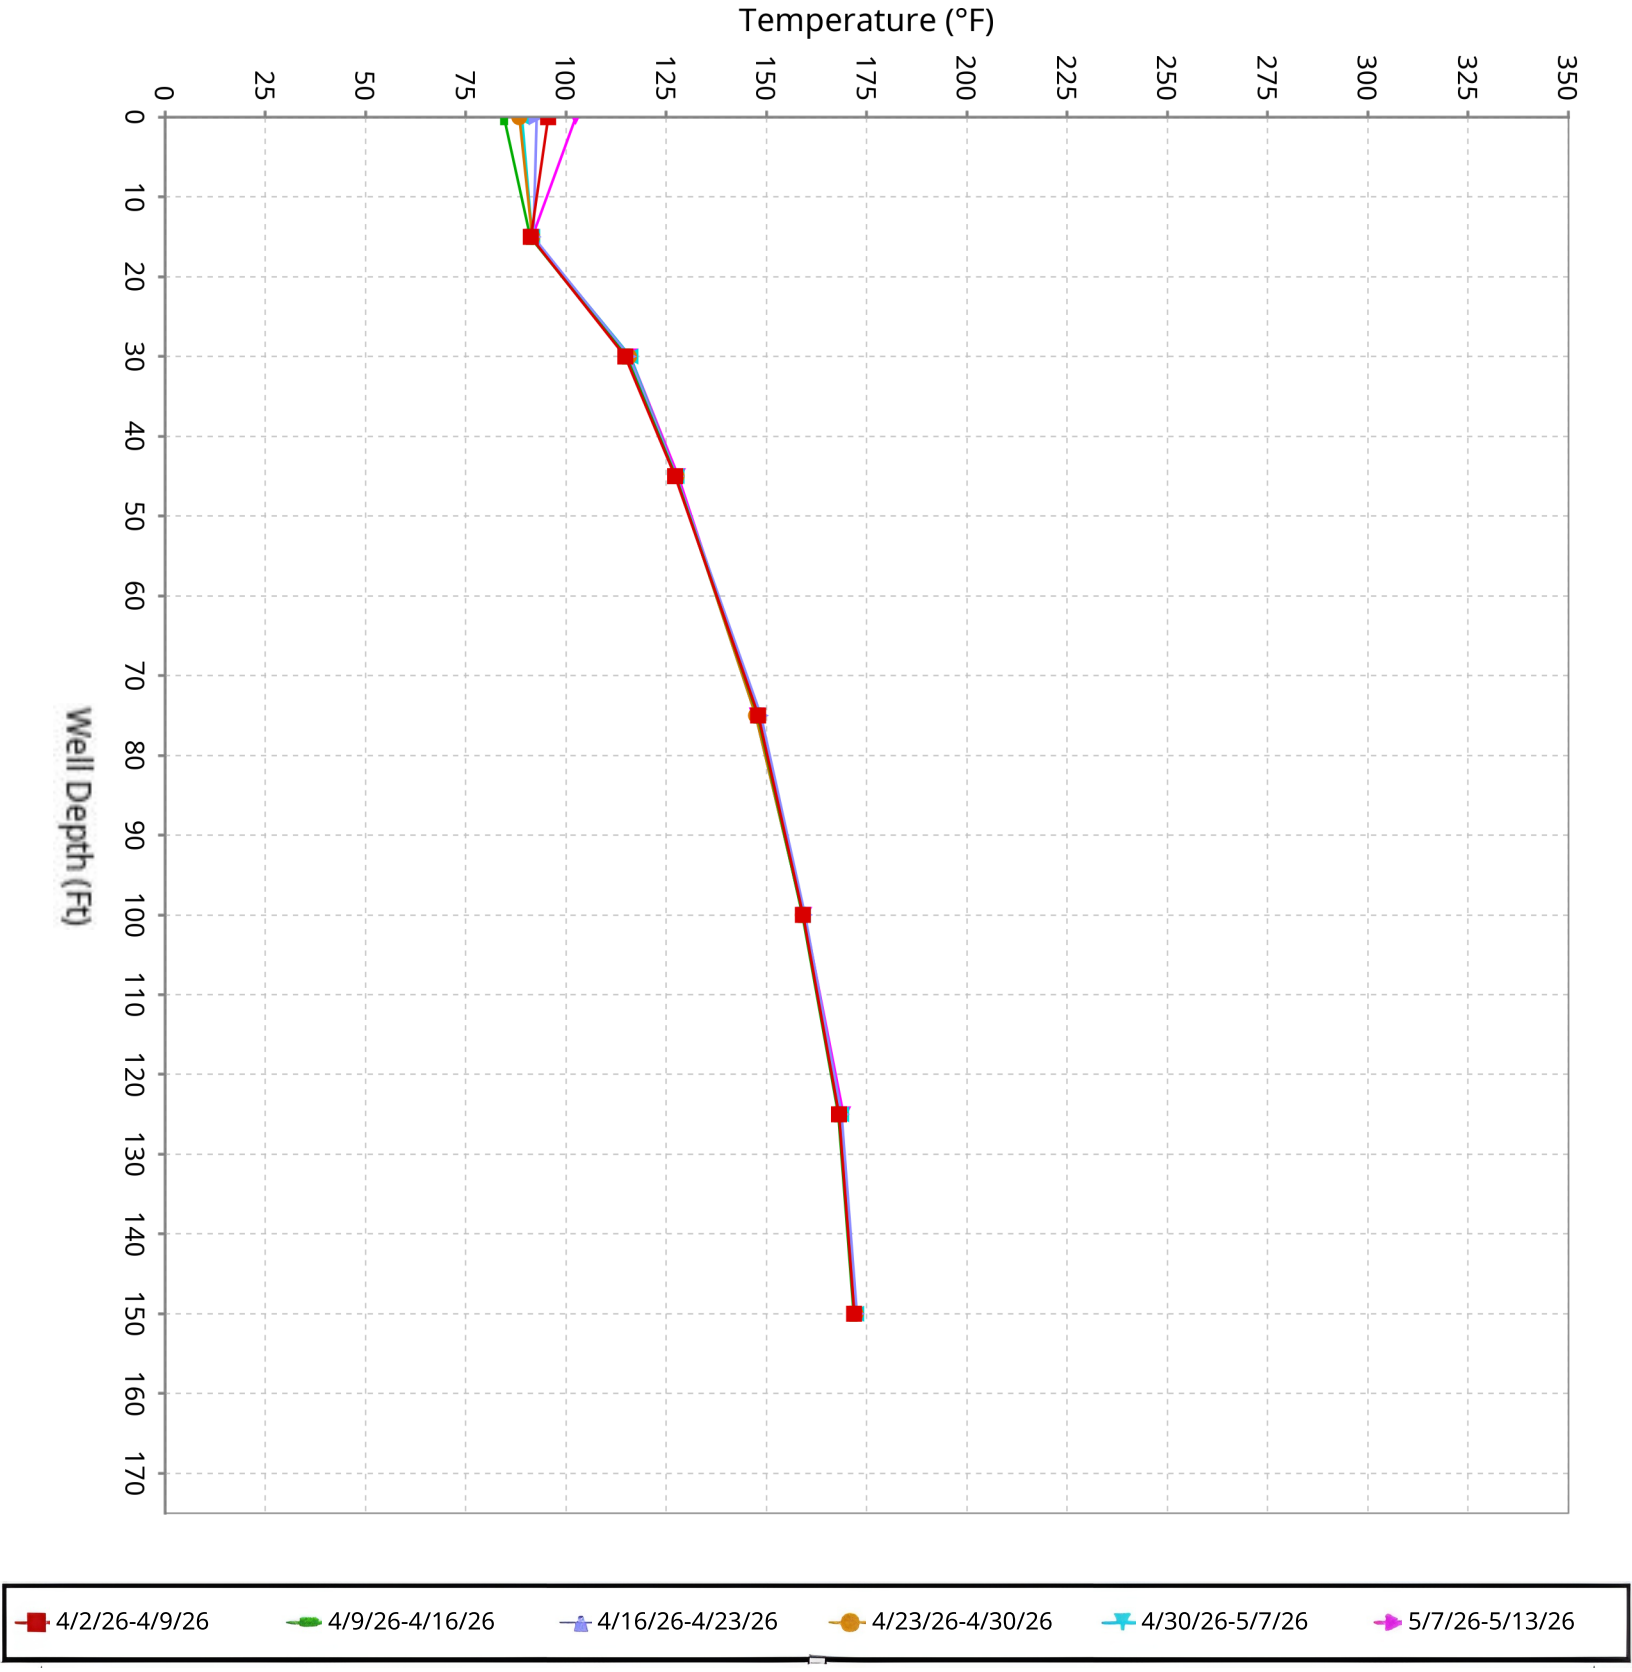
# Vertical Temperature Profiles from Temperature Probes at Chiquita Landfill for TP-14

- TP-14
  - The 150-foot thermocouple showed a single hour anomalous temperature increase on May 10th.
  - The reported maximum temperature reading of 2508°F is considered anomalous and is believed to be associated with a potential thermocouple sensor malfunction. The sensor remains under evaluation and investigation.

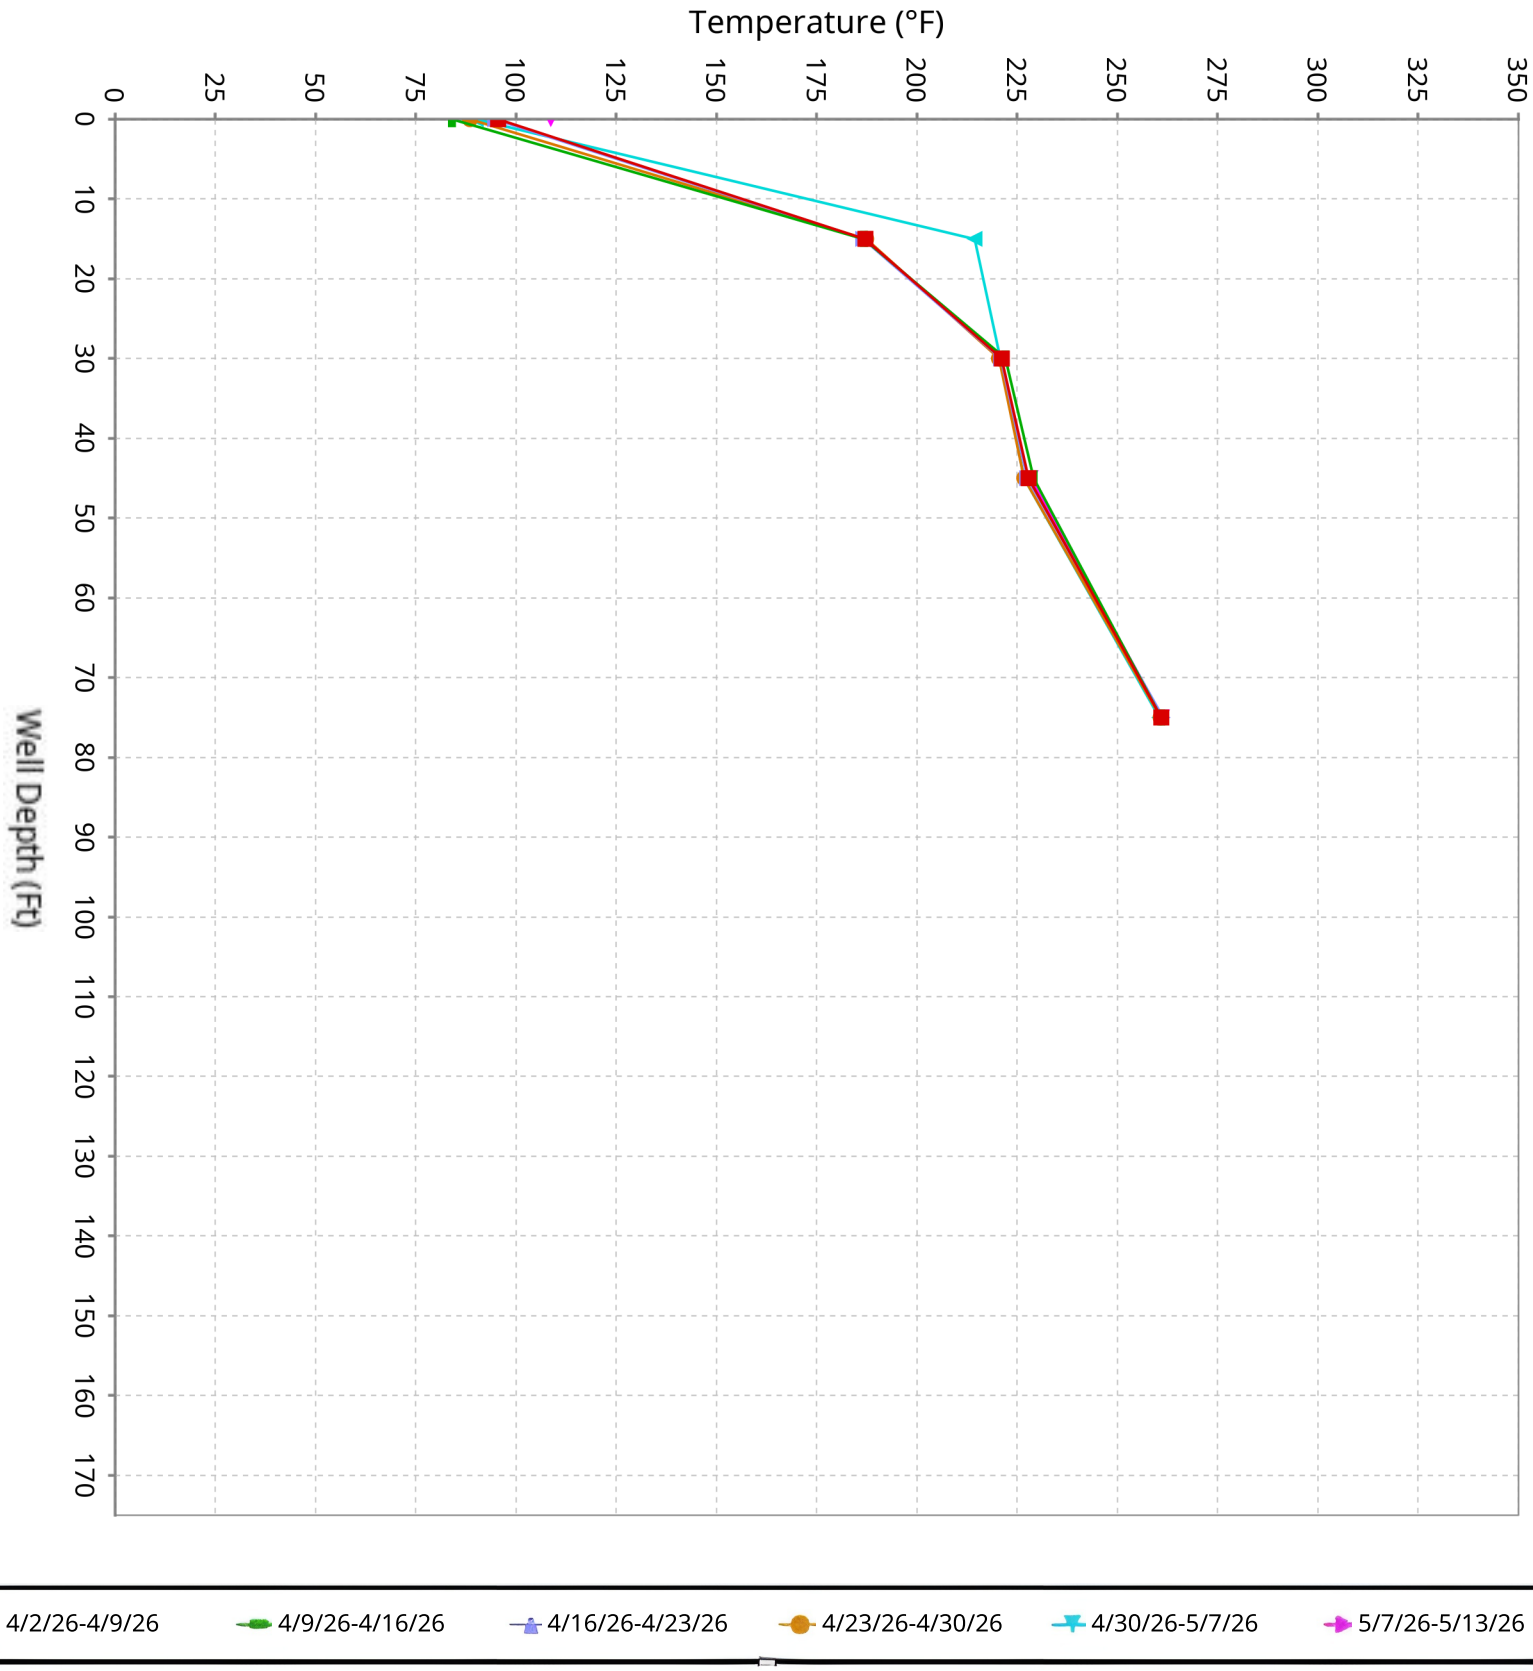
# Vertical Temperature Profiles from Temperature Probes at Chiquita Landfill for TP-23

- TP-23
  - The 15-foot thermocouple reported temperatures of 0°F from May 13th to May 18th, which were anomalous and likely associated with a potential thermocouple sensor malfunction. On May 19th, a temperature of 189°F was reported, with temperatures remaining consistent with previous recorded values through May 20th with the thermocouple functioning as normal.
  - The 30-foot thermocouple reported temperatures of 0°F from May 13th to May 18th, which were anomalous and likely associated with a potential thermocouple sensor malfunction. On May 19th, a

temperature of 221°F was reported, with temperatures remaining consistent with previous recorded values through May 20th with the thermocouple under evaluation and investigation.
