SCS ENGINEERS

June 15, 2026

**Subject:** **May 2026 Monthly Report Pursuant to Milestones 1A-3 and 5 of the LEA June 6, 2024 Compliance Order and July 30, 2024 Letter, Chiquita Canyon Landfill, Castaic, California**

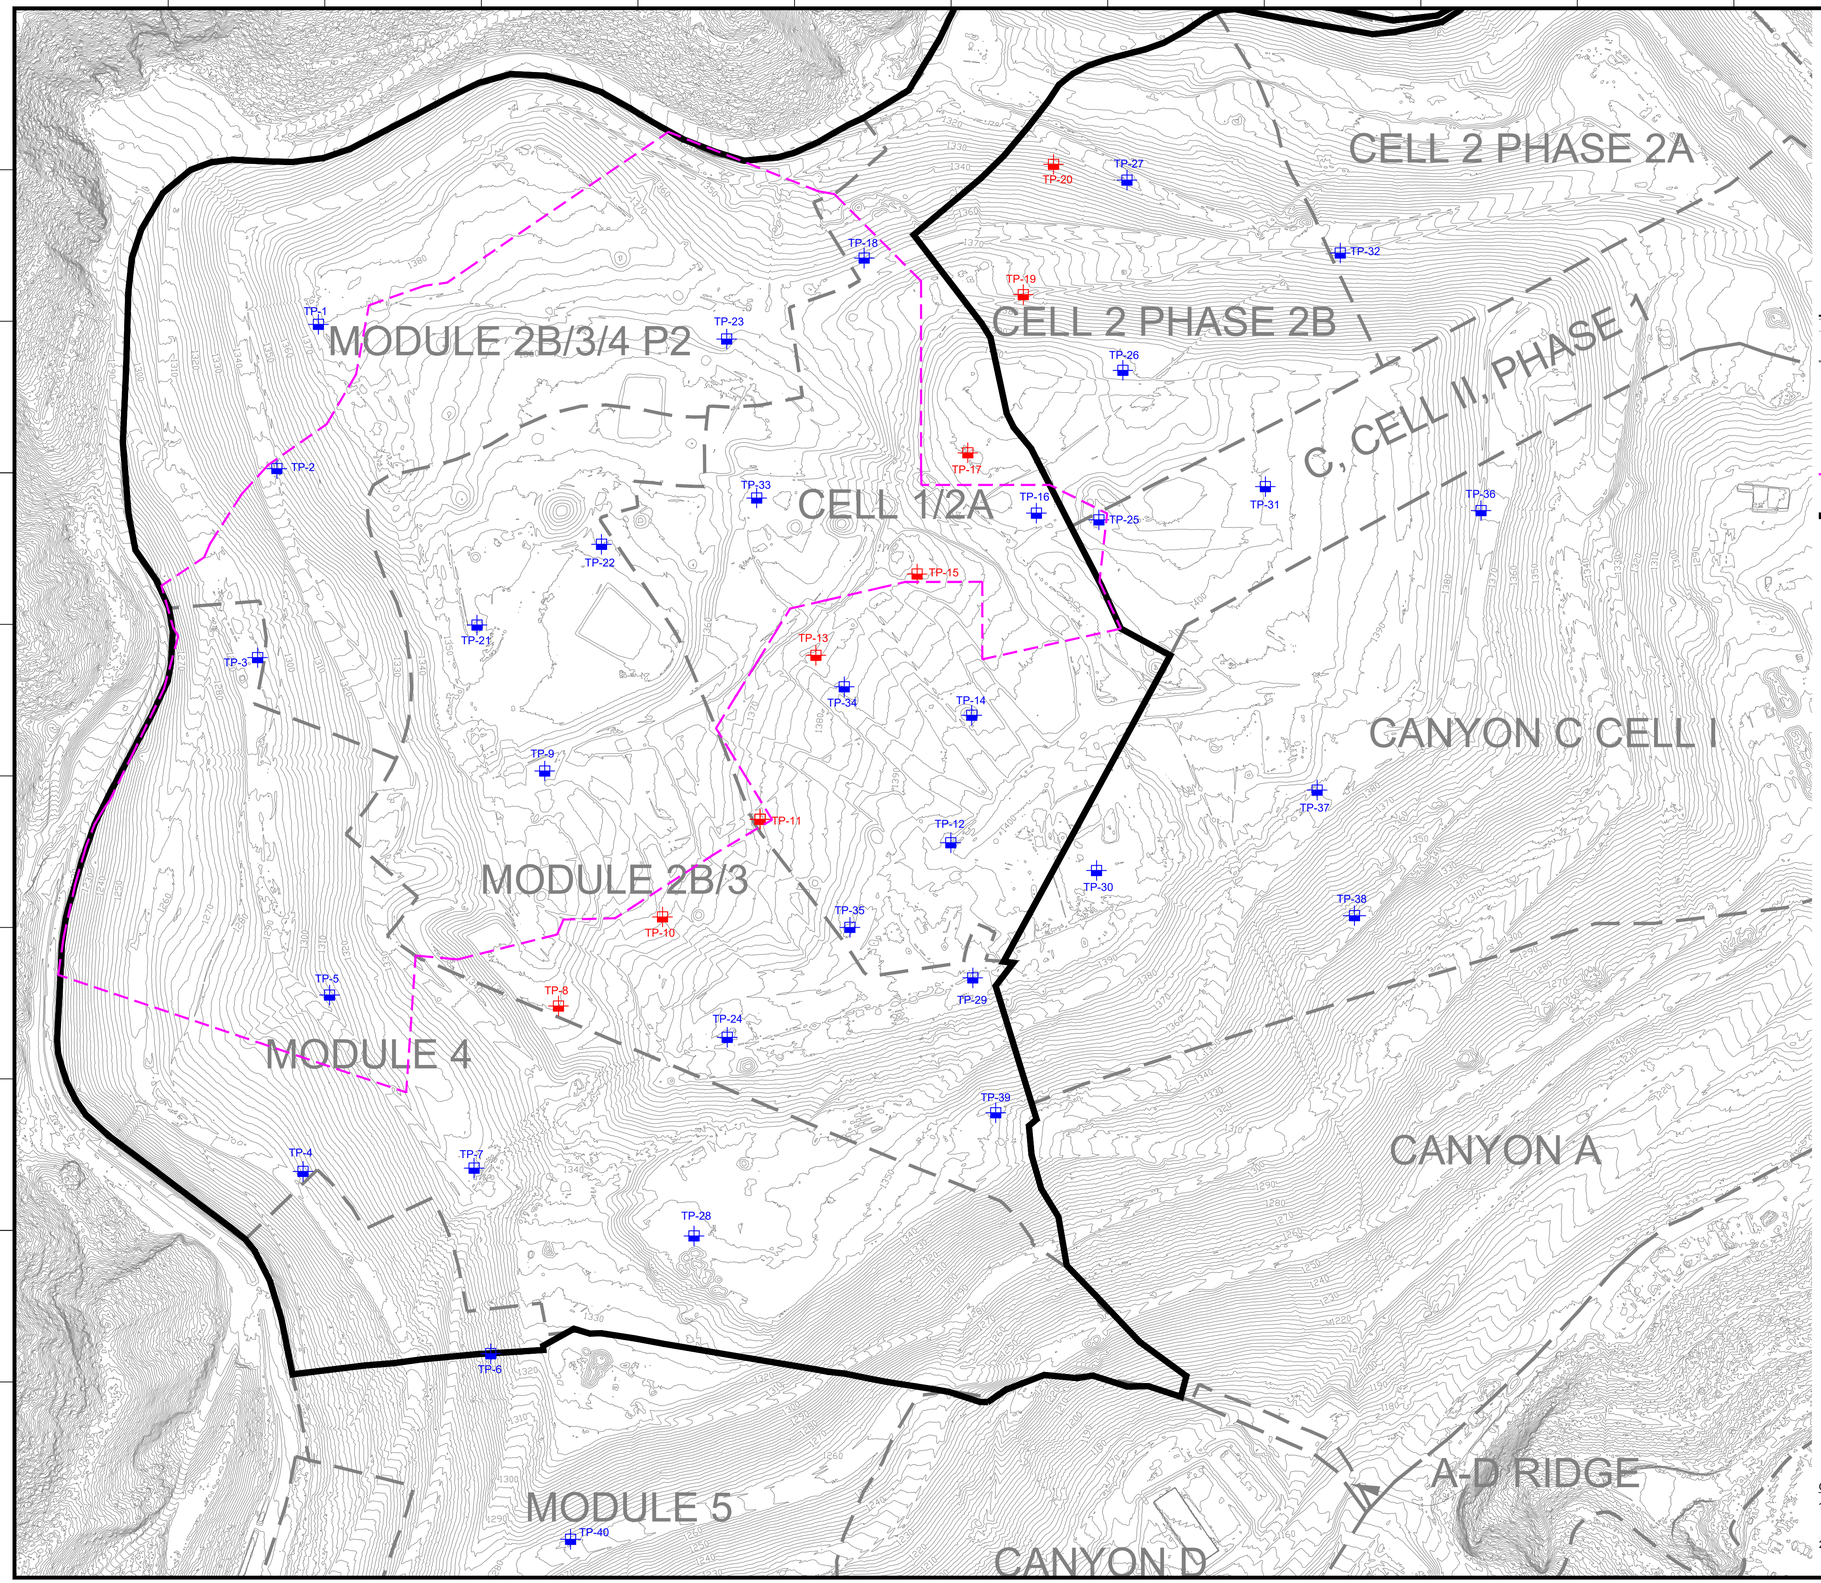
*The reported maximum temperature reading of 2508°F for TP-14 and TP-23 is considered anomalous and is believed to be associated with a potential thermocouple sensor malfunction. The sensors remain under evaluation and investigation.

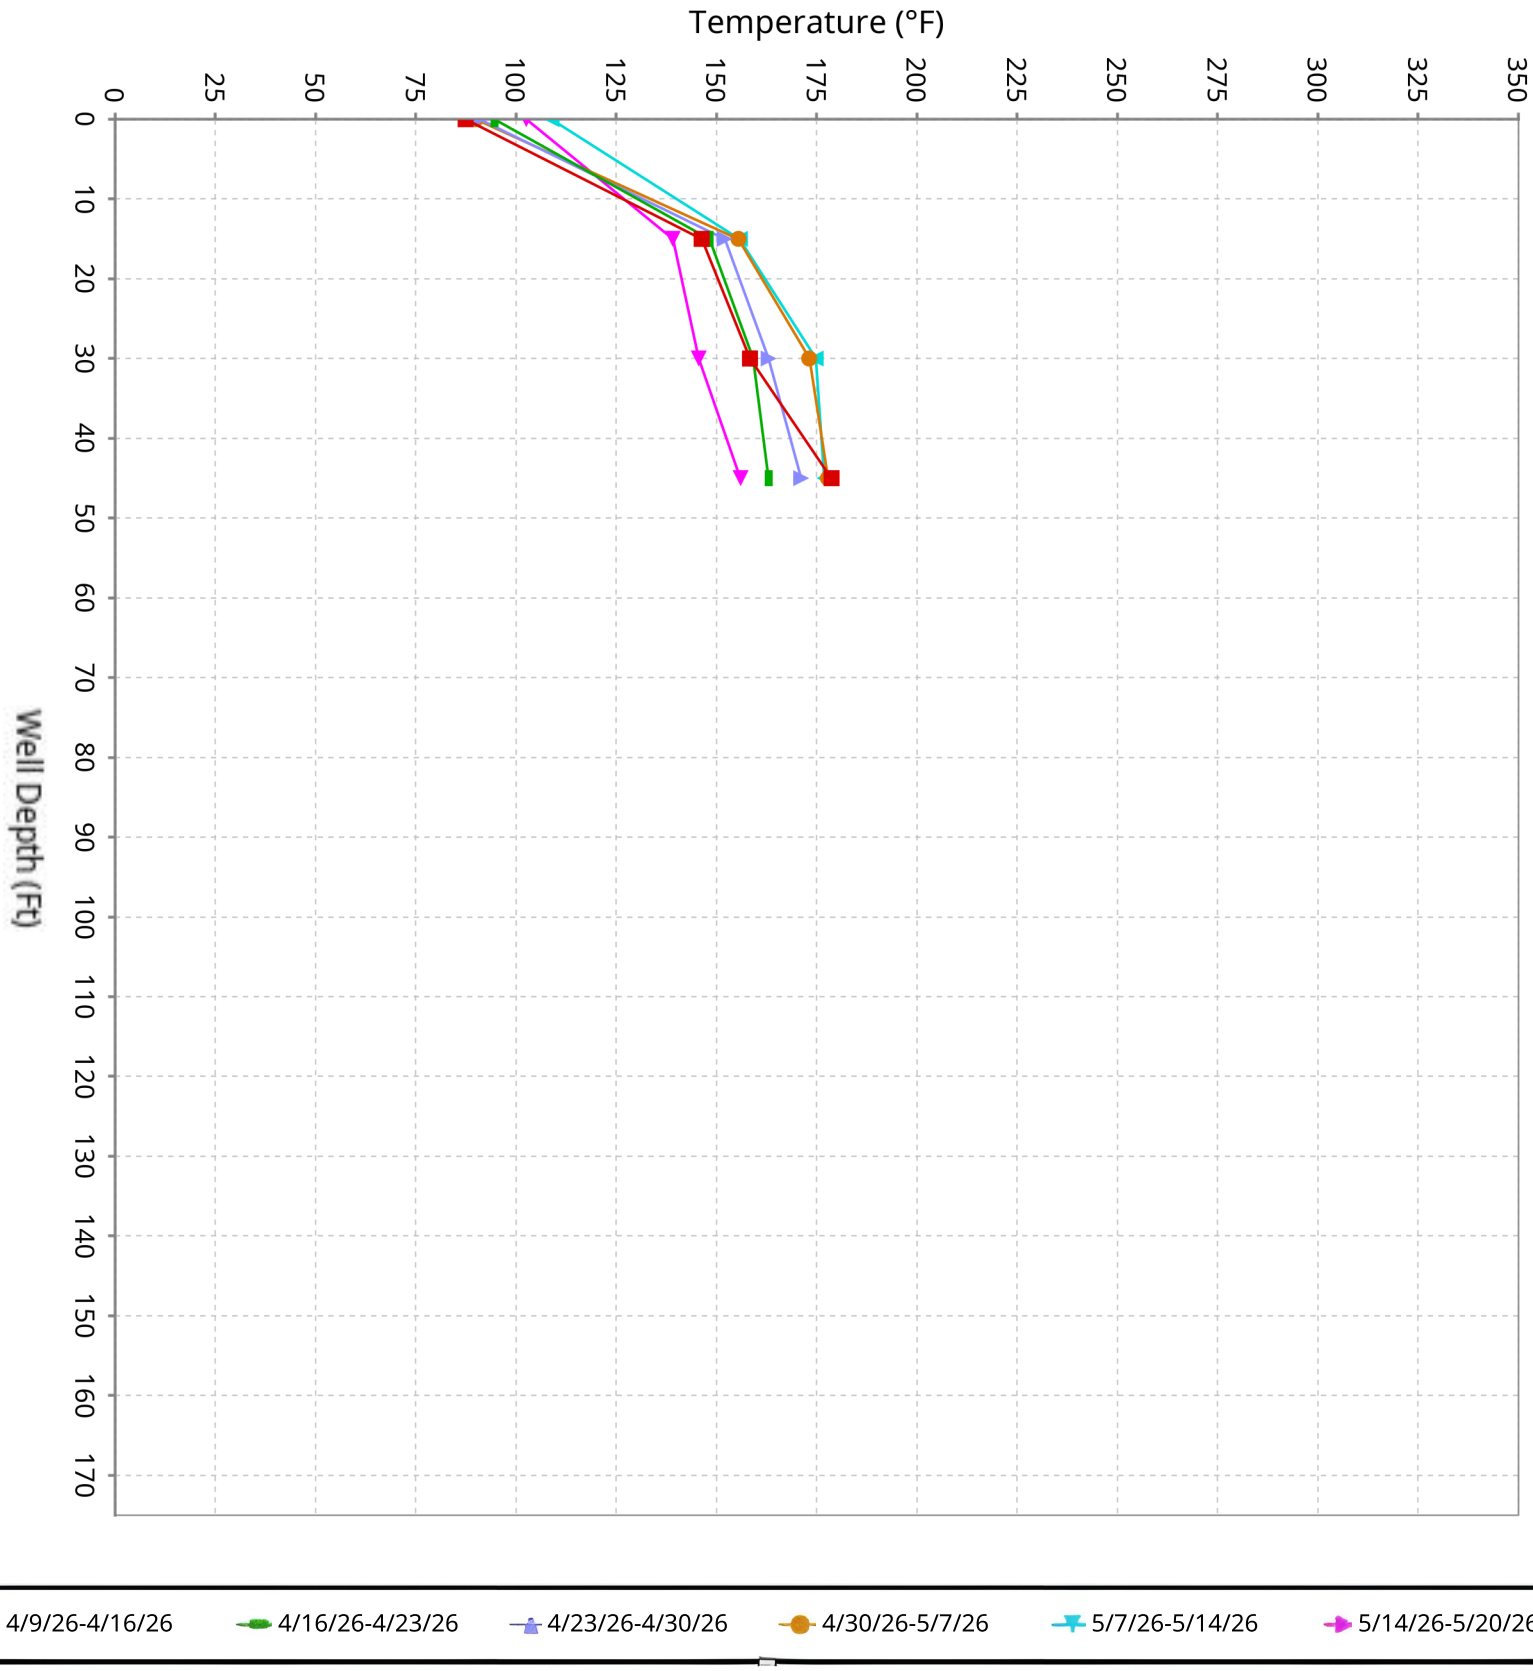
# Vertical Temperature Profiles from Temperature Probes at Chiquita Landfill for TP-8

- TP-08
  - The 125-foot thermocouple went offline on March 3rd and TP-8 was offline between March 6th and March 9th for evaluation and maintenance. Upon removing the thermocouples, the casing for TP-08 was found to be damaged due to differential settlement beyond 45-feet, thus preventing the installation of the 100-foot, 125-foot, and 150-foot thermocouples. The 15-foot, 30-foot, and 45-foot thermocouples are active and reporting data.

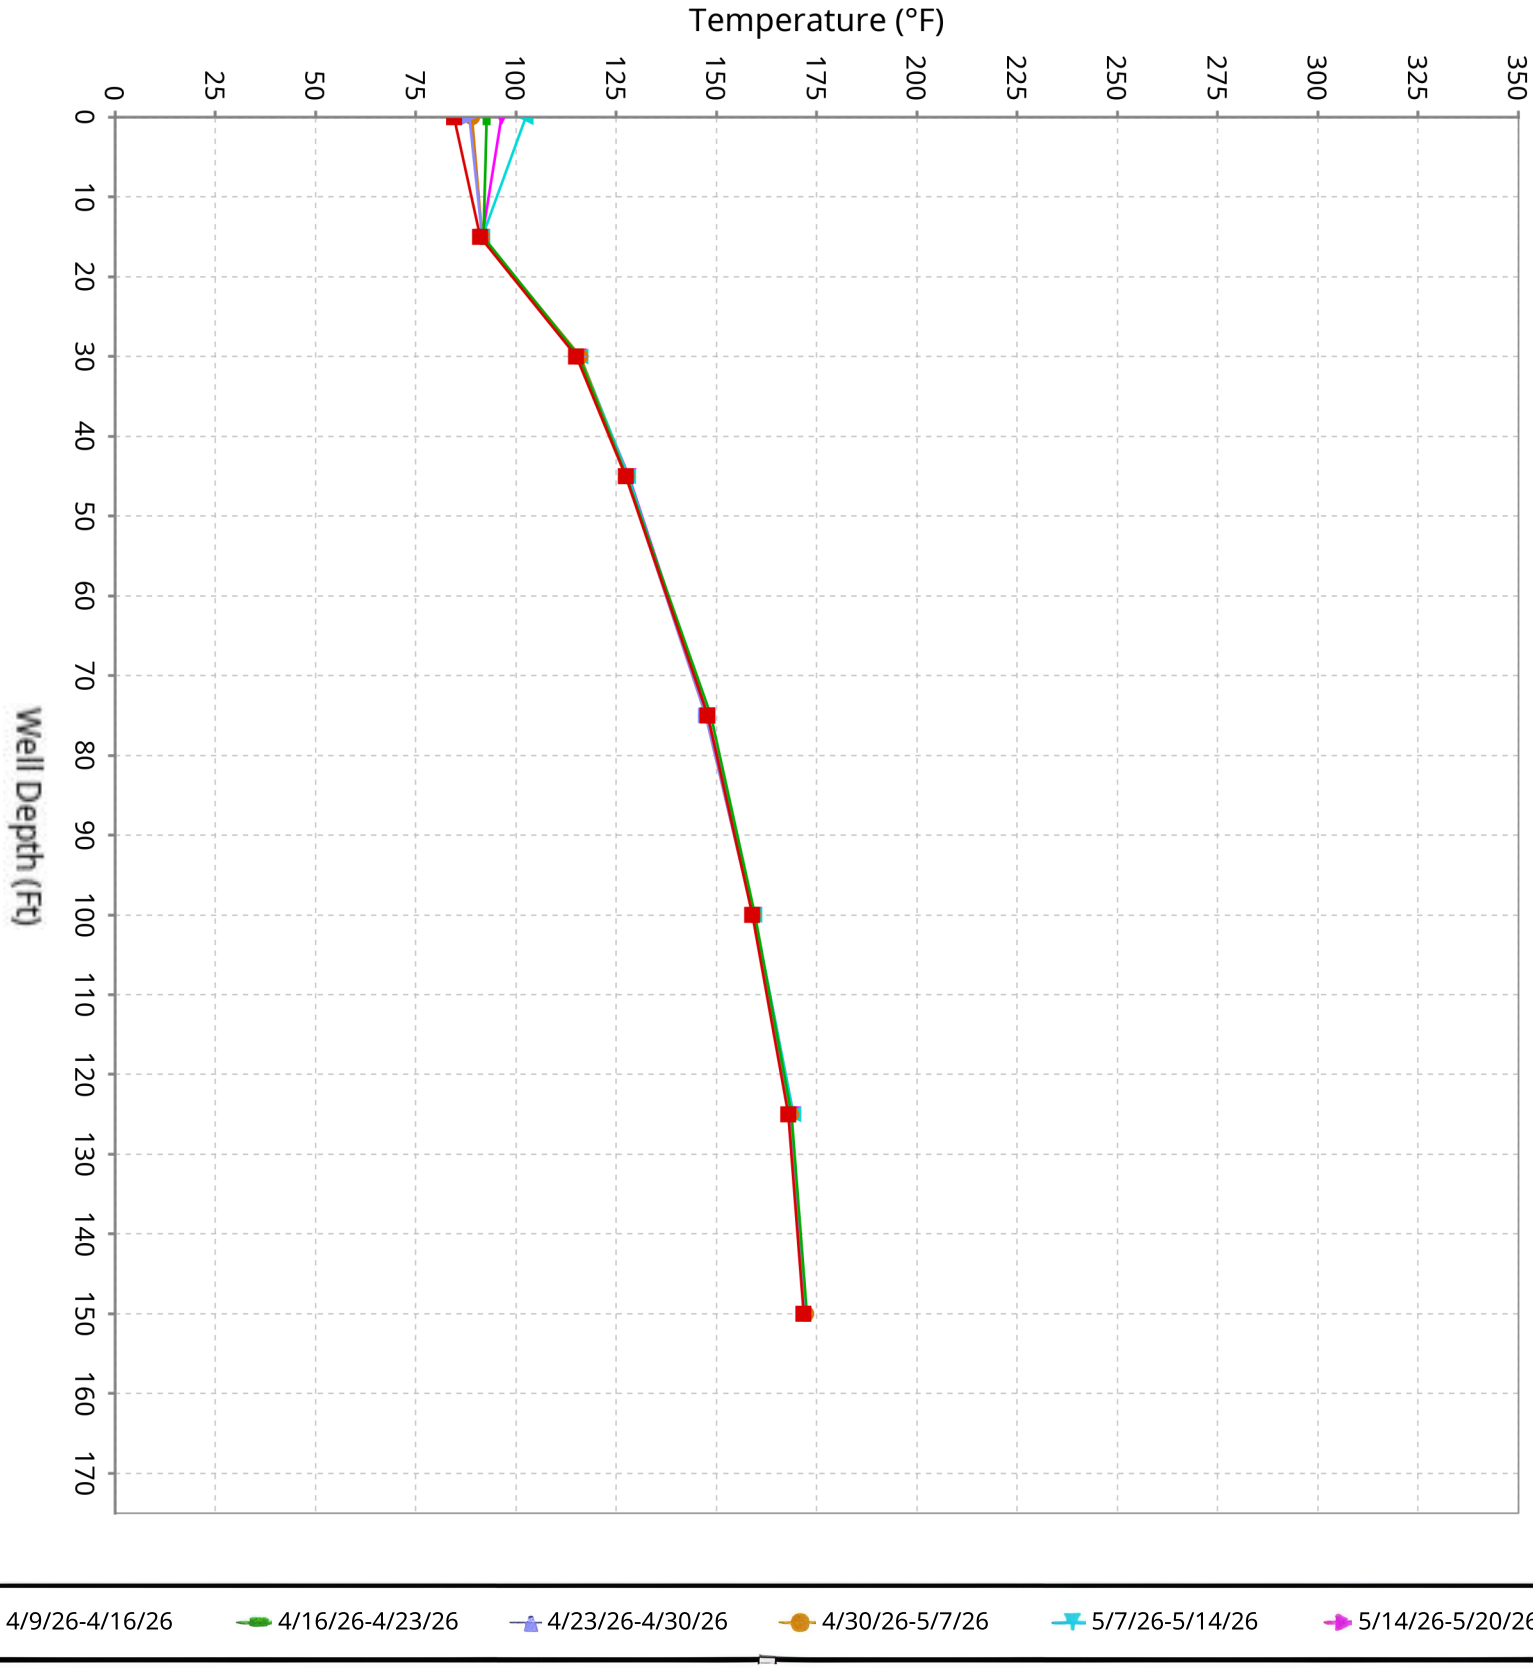
# Vertical Temperature Profiles from Temperature Probes at Chiquita Landfill for TP-14

**TP-14- The 150 foot thermocouple reported a maximum temperature of 2305 o May 10th, which was anomalous and likely associated with a potential thermocouple malfunction. As a result the report temperatures from May 11 to 15th are considered anomalous also. The 150 foot thermocouple was replaced on May 16thand temperature were consistent with previously recorded values.**

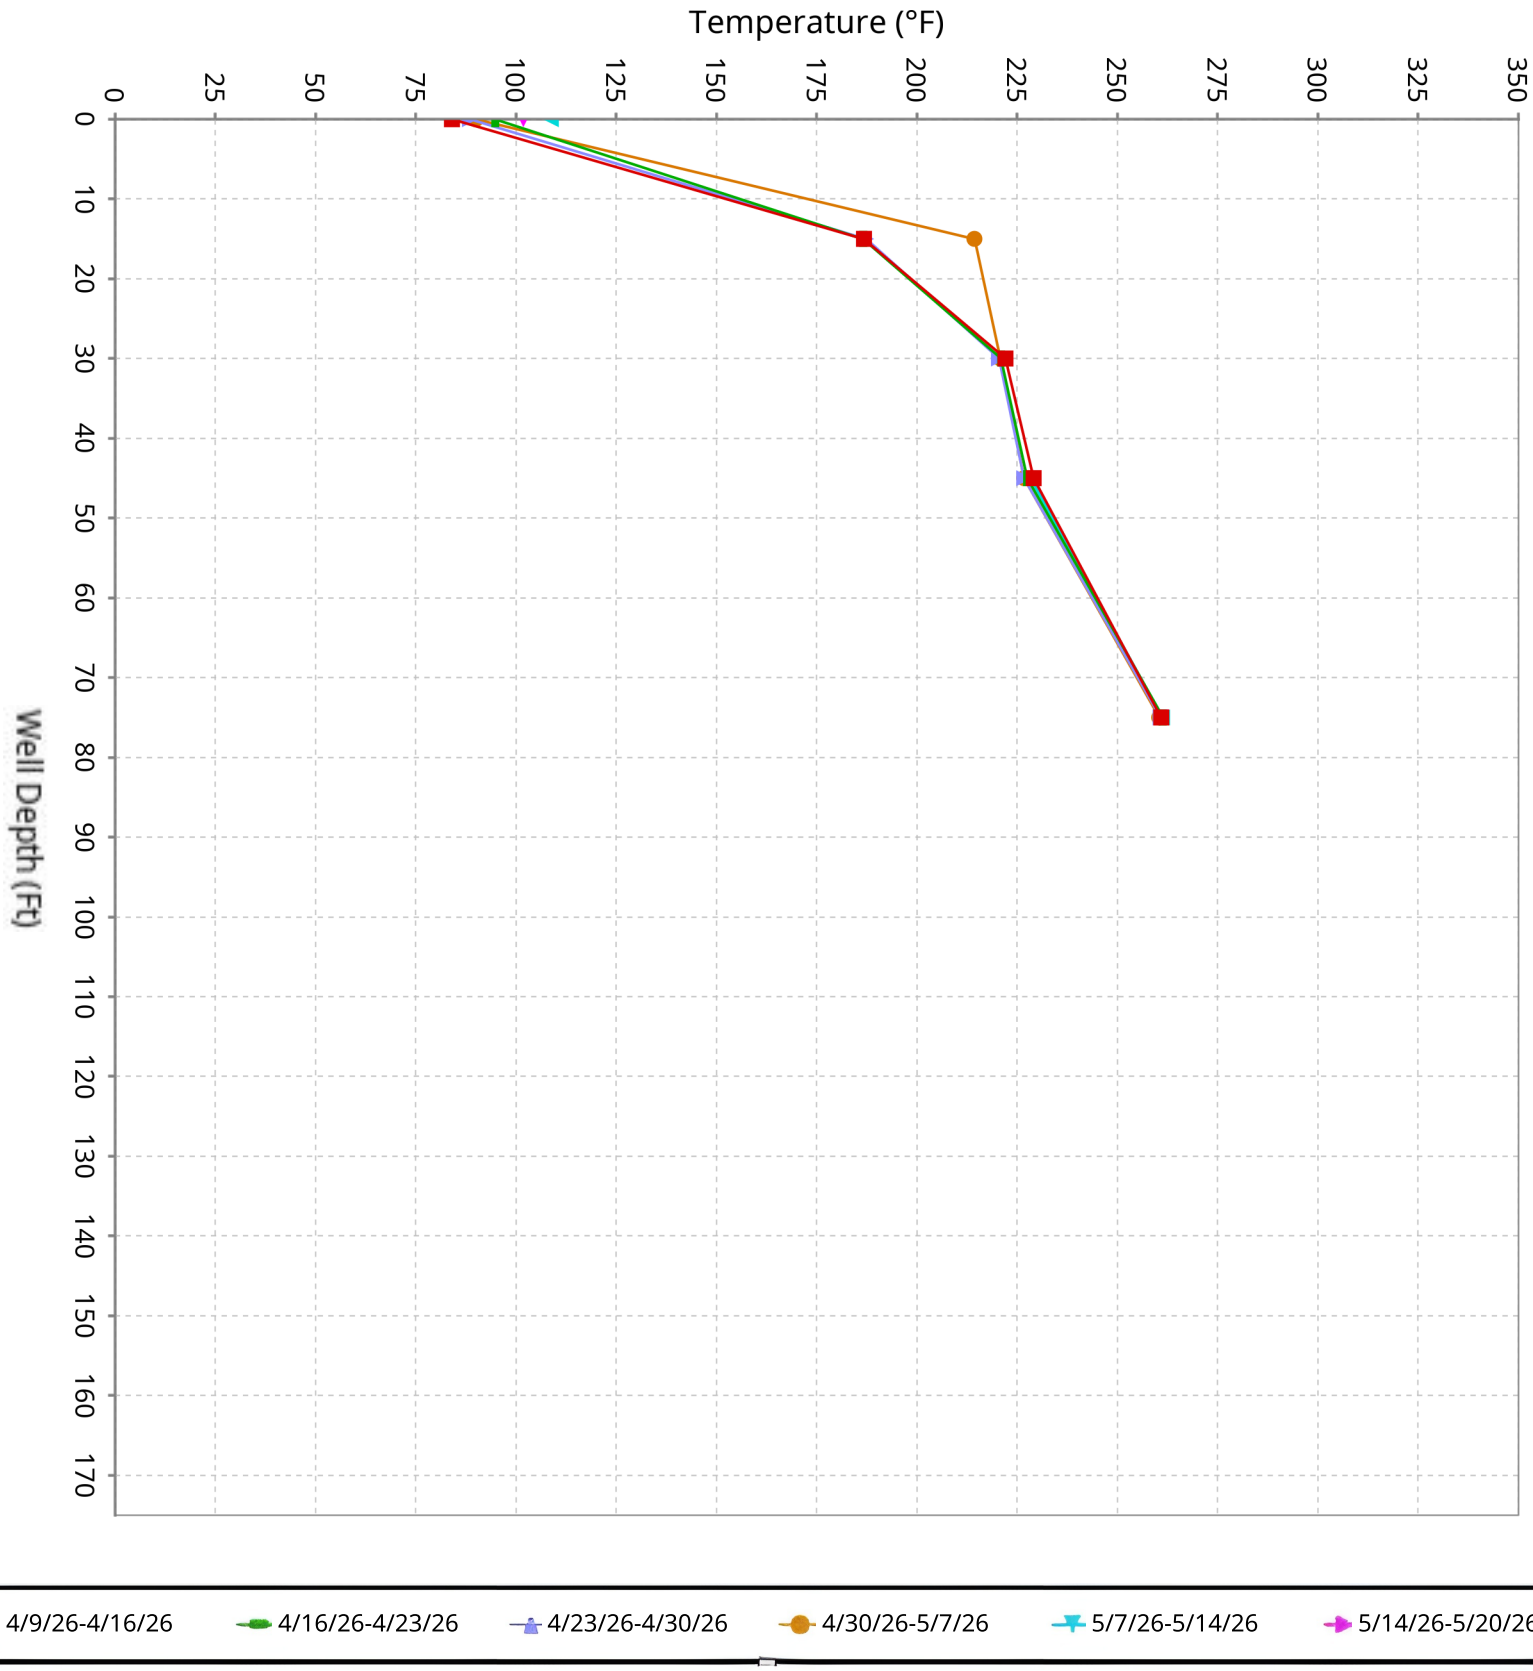
# Vertical Temperature Profiles from Temperature Probes at Chiquita Landfill for TP-23

- TP-23
  - The 15-foot thermocouple remained consistent with previous recorded temperatures.
  - The reported maximum temperature reading of 2508°F is considered anomalous and is believed to be associated with a potential thermocouple sensor malfunction. The sensor remains under evaluation and investigation.
- TP-36
  - The 250-foot thermocouple was evaluated due to low temperatures on April 6th and wiring that had come loose was corrected. After fixing the wiring issues, temperatures returned to 136°F as previously recorded prior to March 21st.

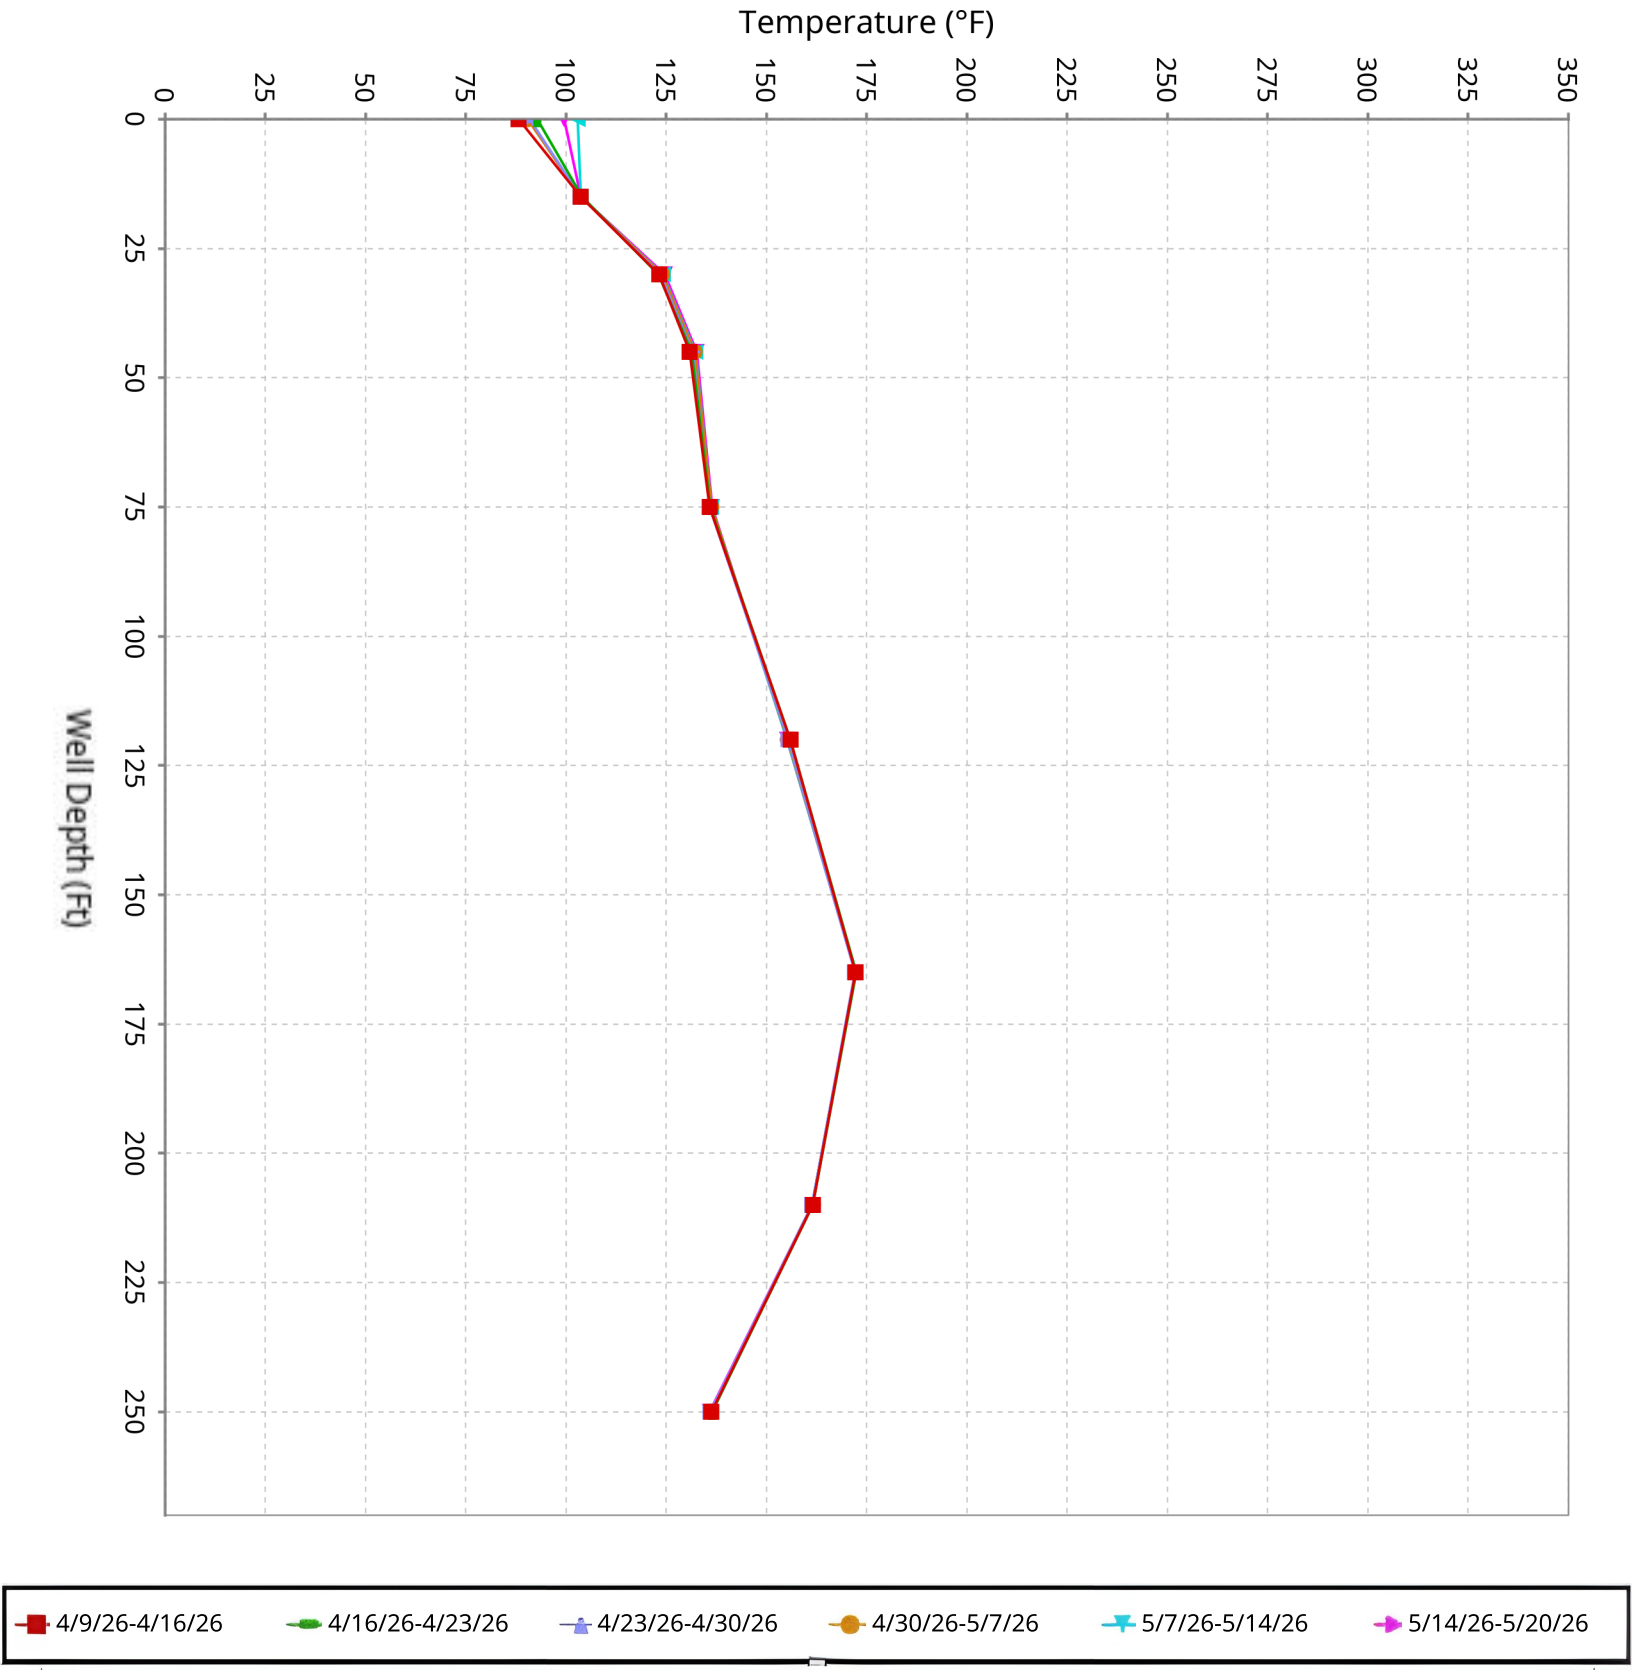
# Vertical Temperature Profiles from Temperature Probes at Chiquita Landfill for TP-36

- TP-36
  - The 250-foot thermocouple was evaluated due to low temperatures on April 6th and wiring that had come loose was corrected. After fixing the wiring issues temperatures returned to 136°F as previously recorded prior to March 21st.

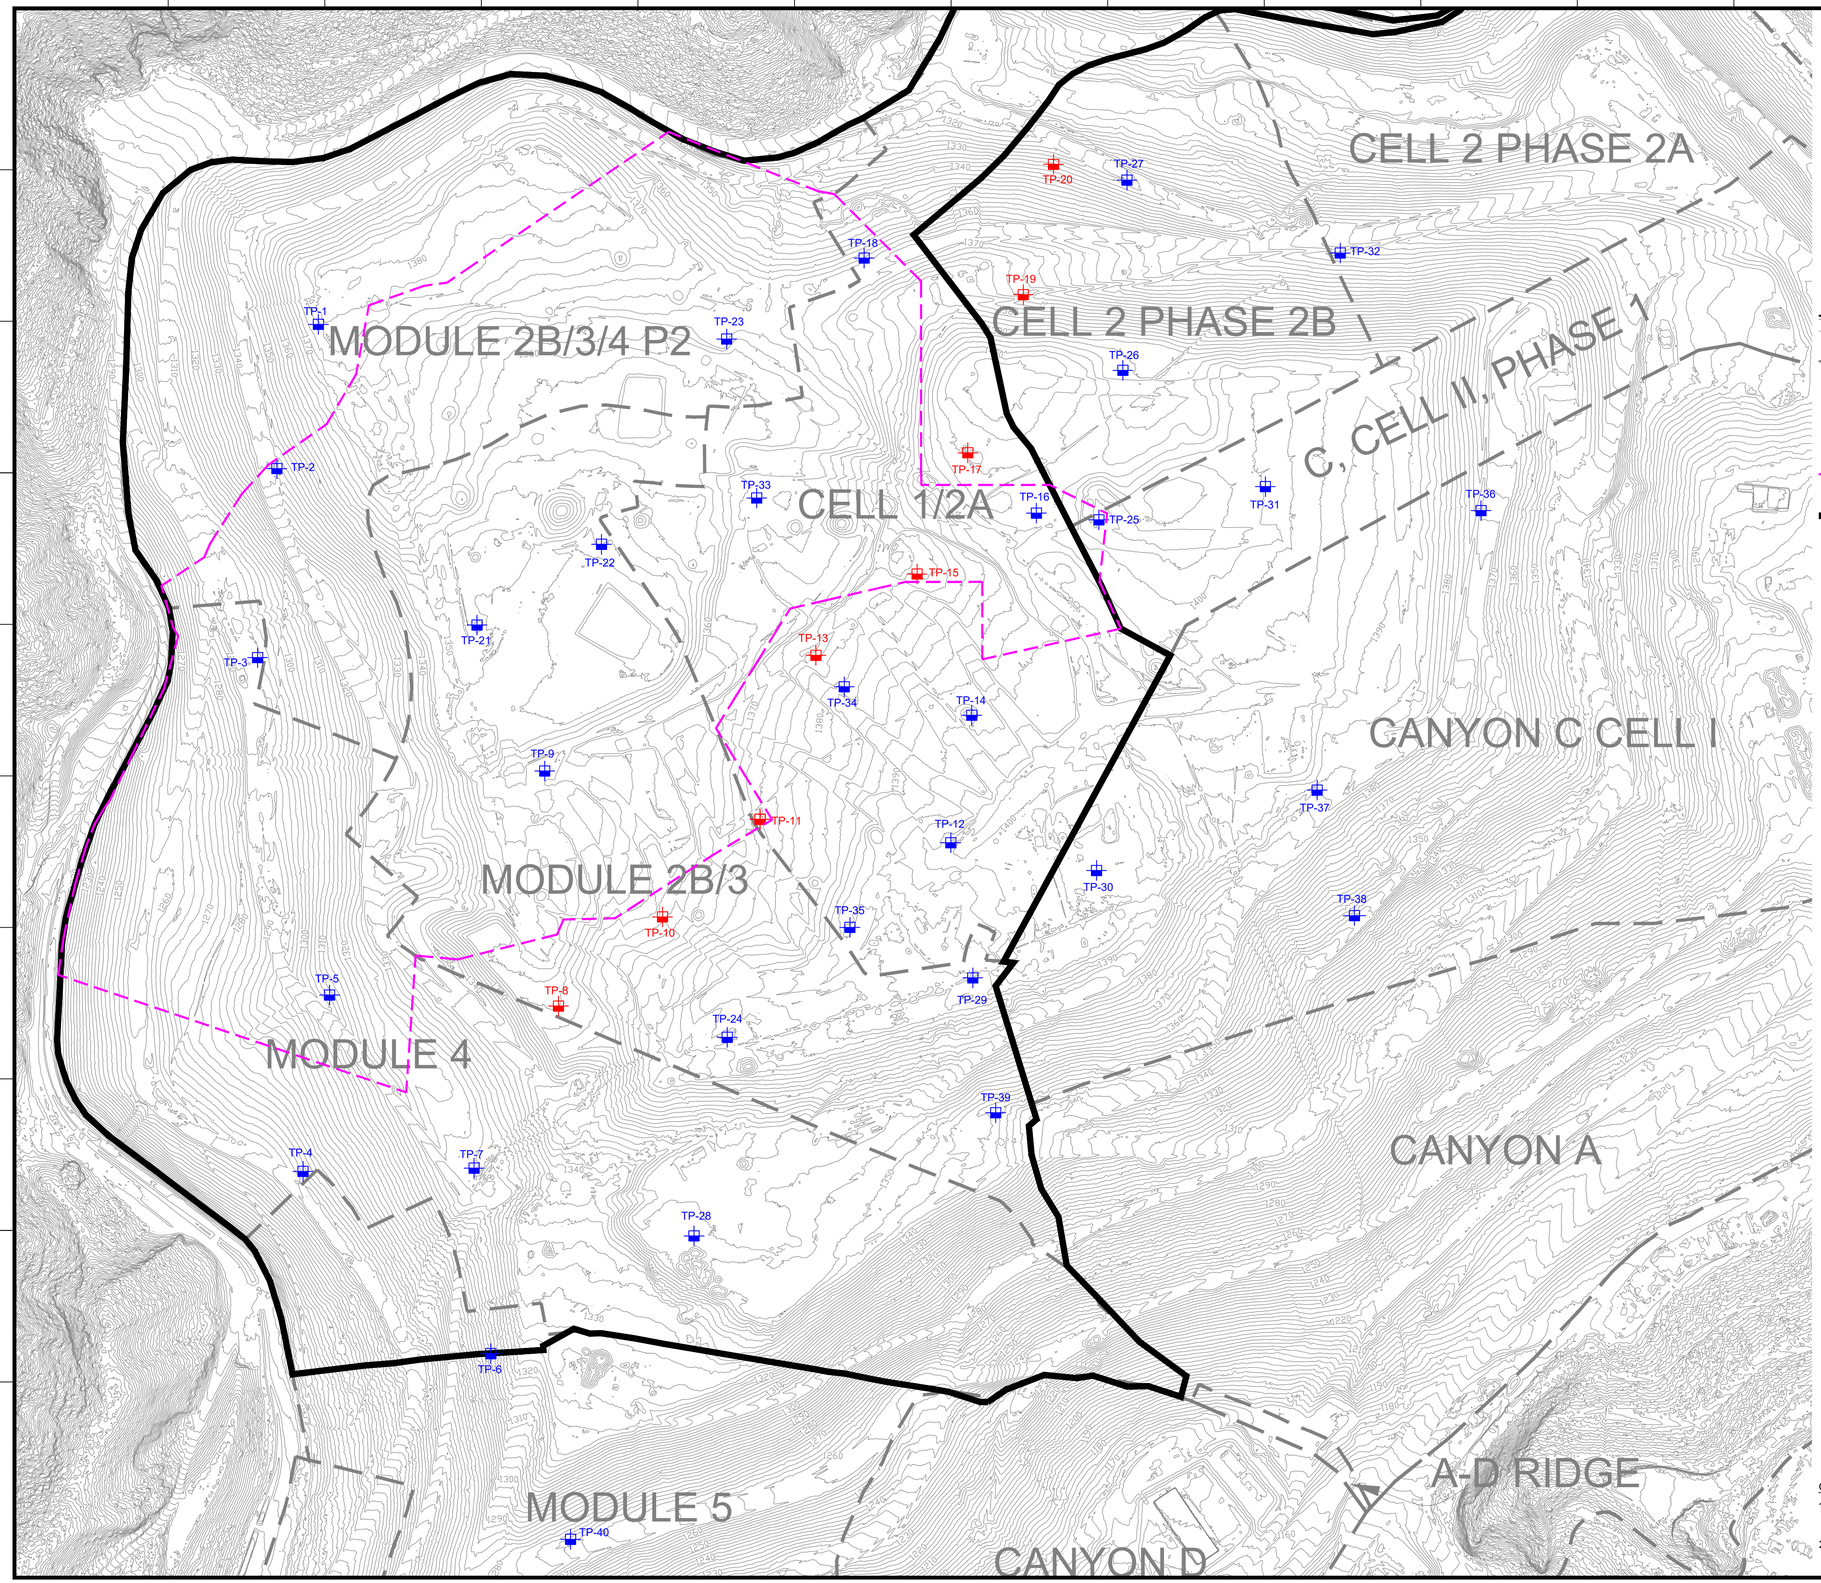
*The reported maximum temperature readings of 2508°F for TP-14 and TP-23 are considered anomalous and are believed to be associated with potential thermocouple sensor malfunctions. The sensors remain under evaluation and investigation.

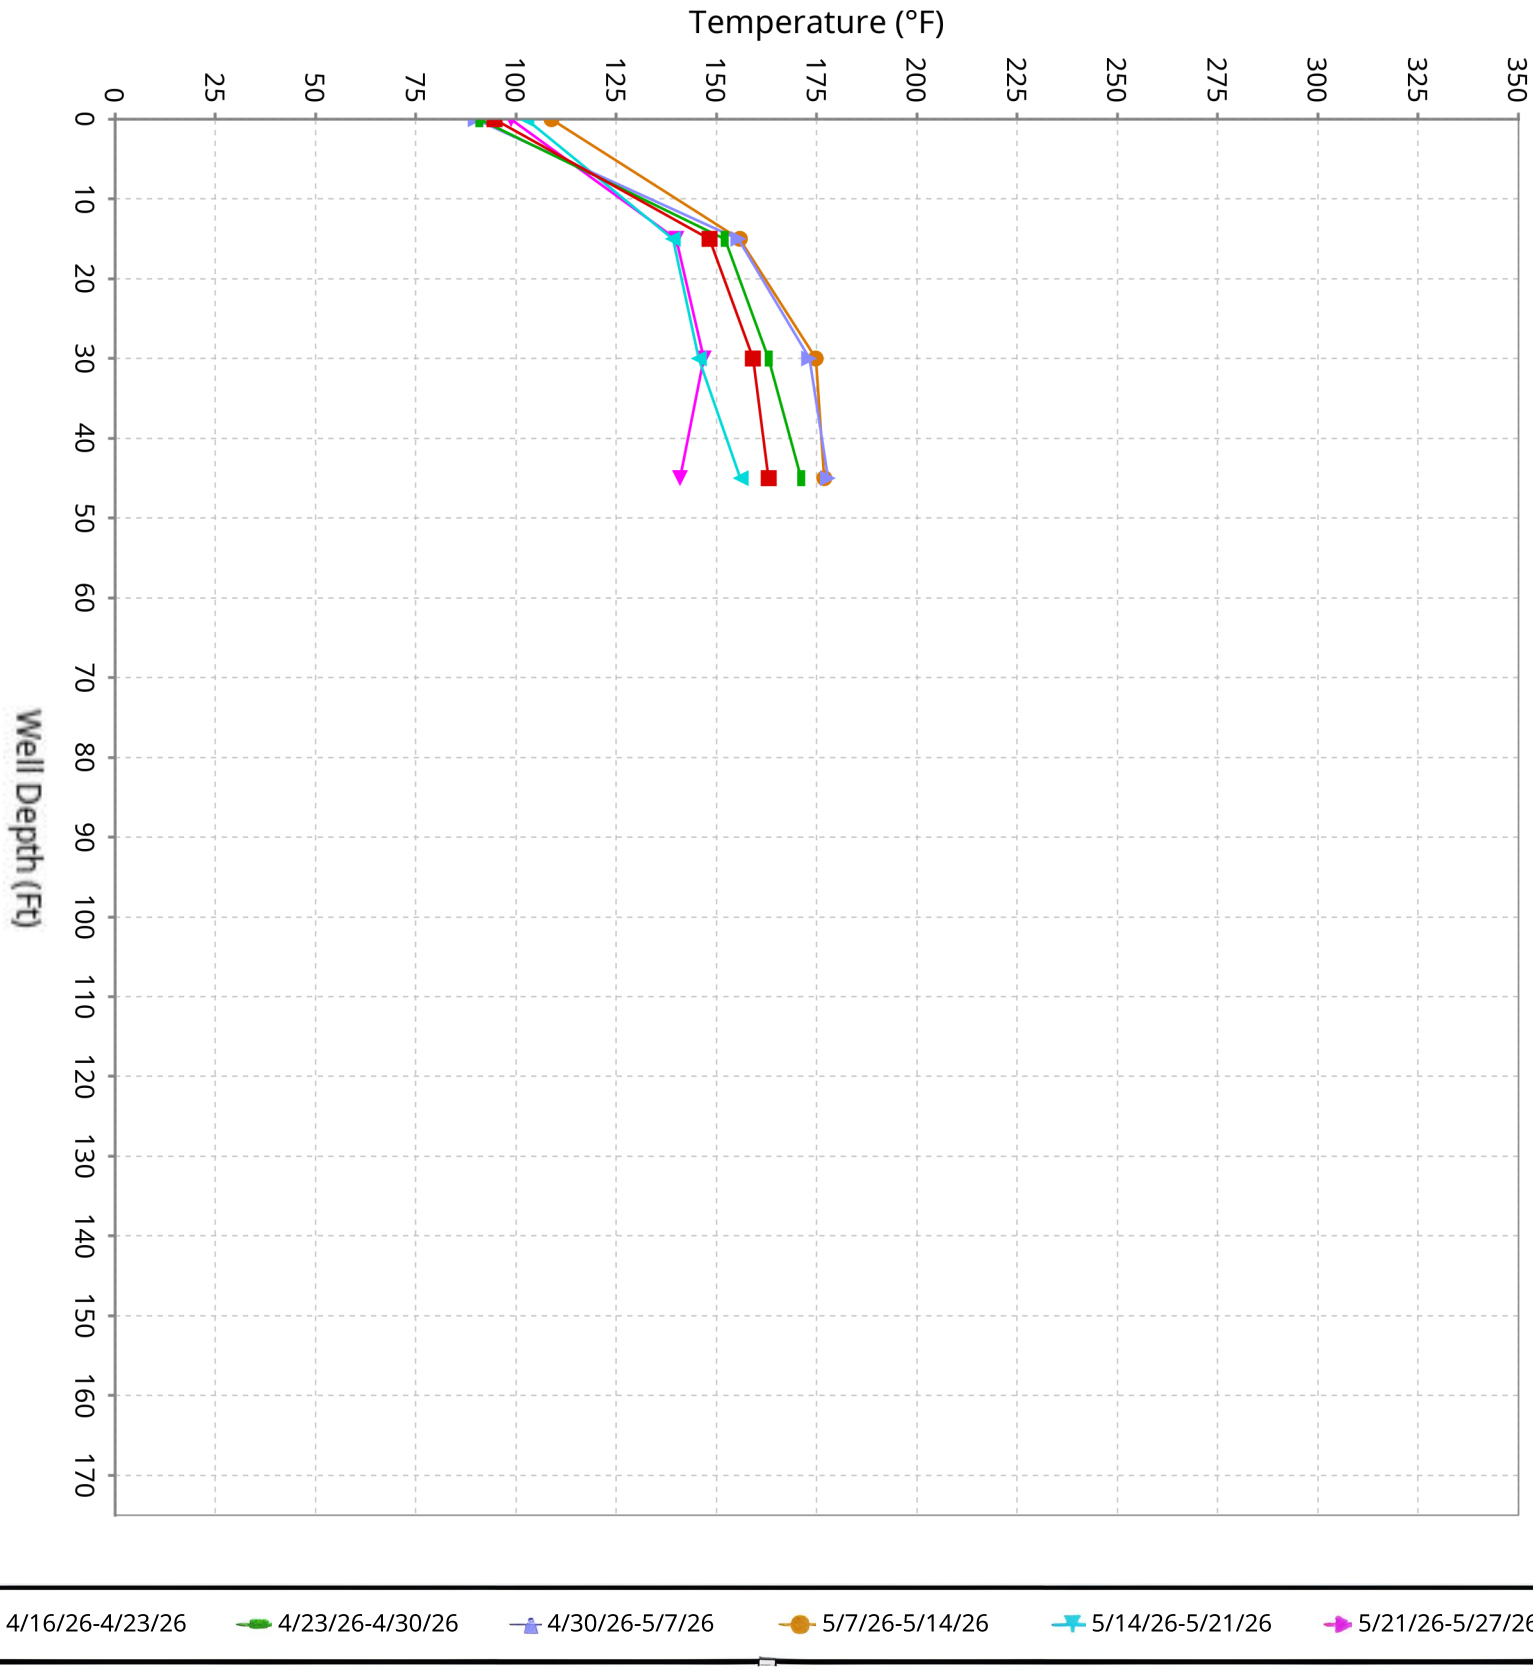
# Vertical Temperature Profiles from Temperature Probes at Chiquita Landfill for TP-8

- TP-08
  - The 125-foot thermocouple went offline on March 3rd and TP-8 was offline between March 6th and March 9th for evaluation and maintenance. Upon removing the thermocouples, the casing for TP-08 was found to be damaged due to differential settlement beyond 45-feet, thus preventing the installation of the 100-foot, 125-foot, and 150-foot thermocouples. The 15-foot, 30-foot, and 45-foot thermocouples are active and reporting data.

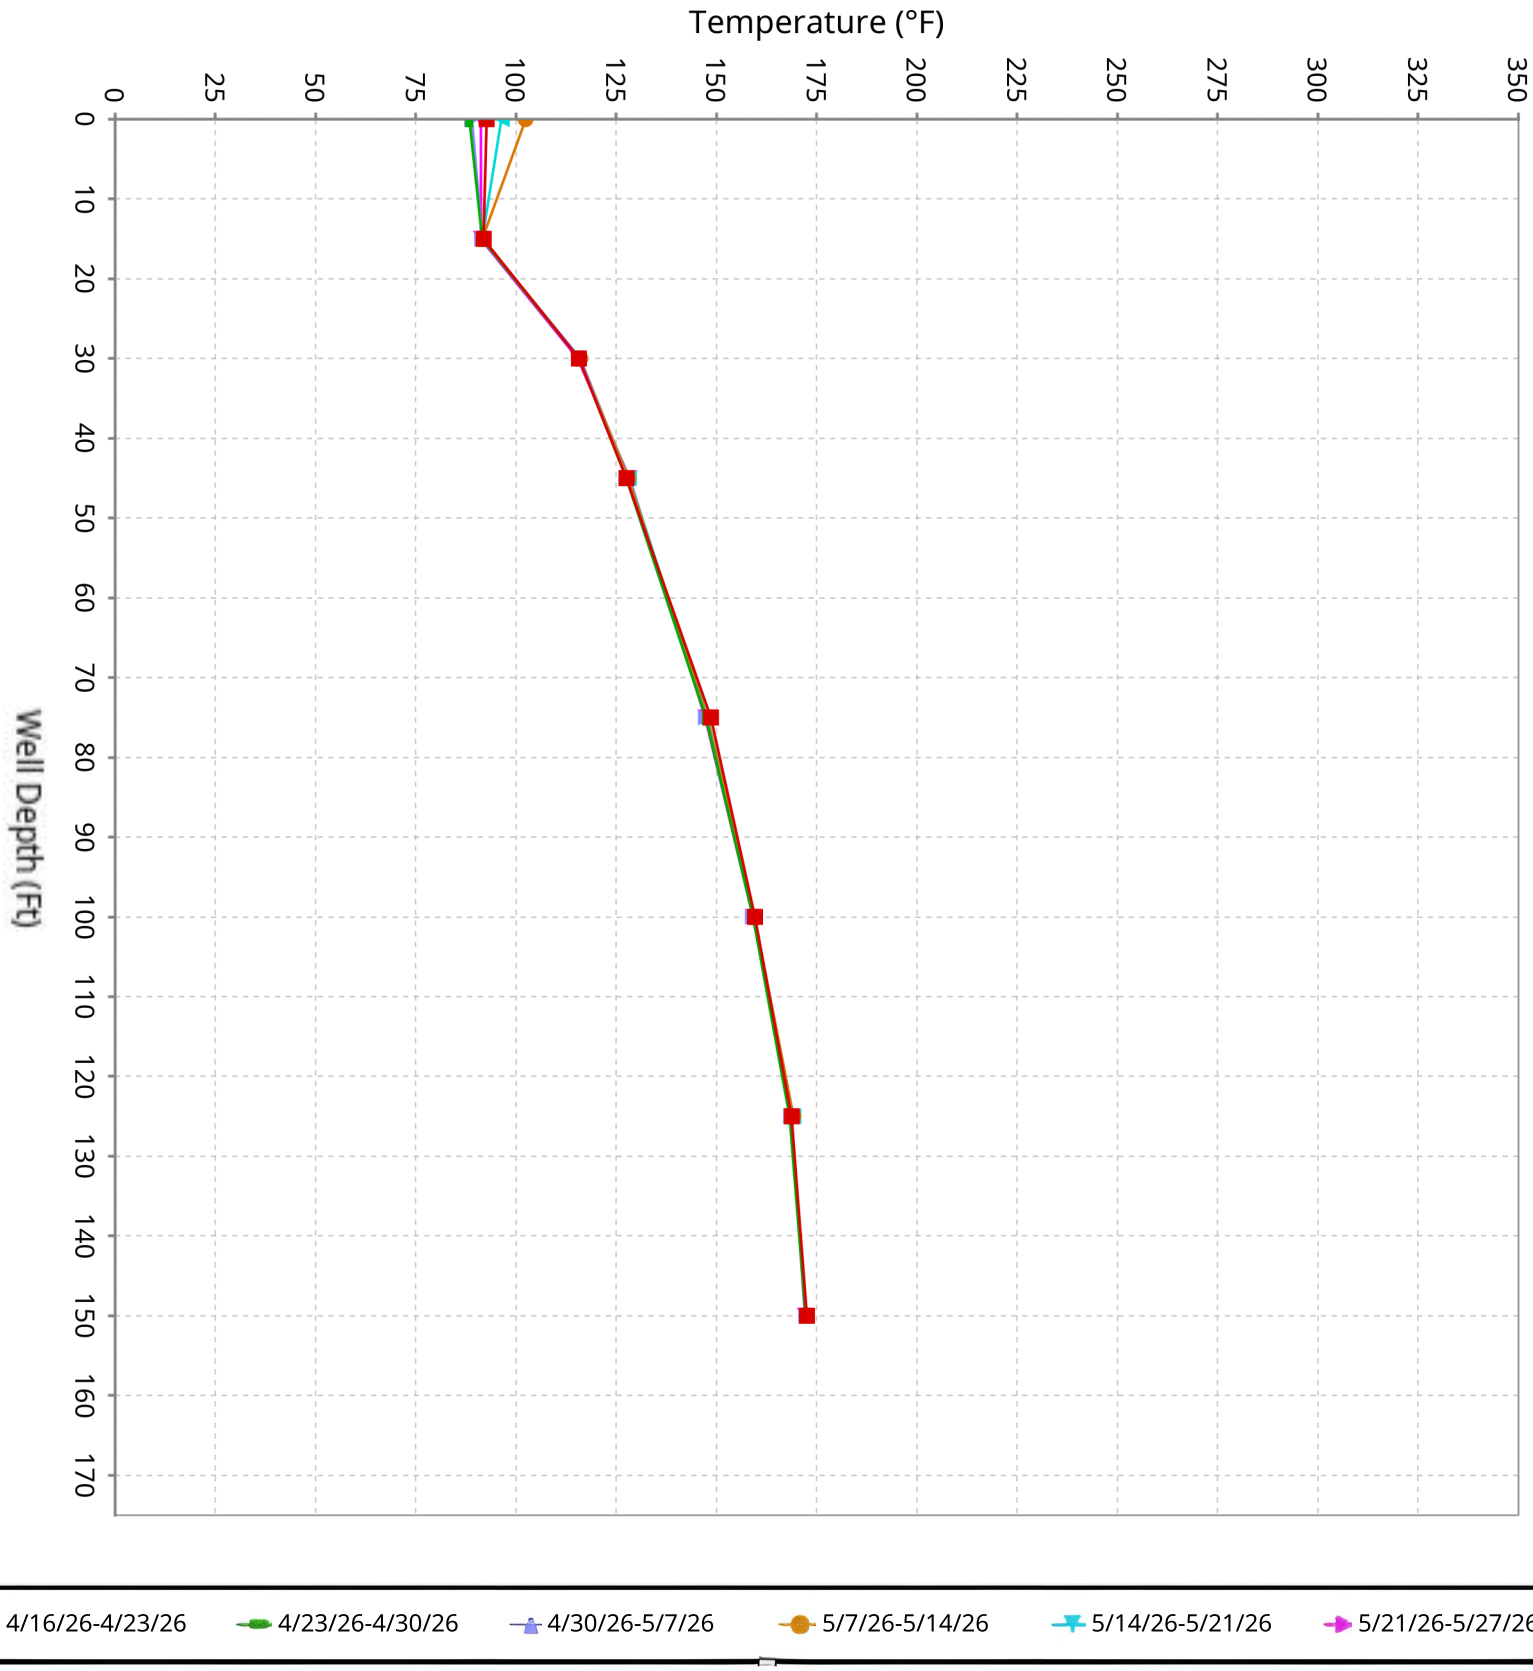
# Vertical Temperature Profiles from Temperature Probes at Chiquita Landfill for TP-14

- TP-14
  - The 150-foot thermocouple reported a maximum temperature of 249°F on May 10th, which was anomalous and likely associated with a potential thermocouple sensor malfunction. As a result, the reported temperatures of 0°F from May 11th to May 15th are also considered anomalous. The 150-foot thermocouple was replaced on May 16th and temperatures were consistent with previous recorded values.
