SCS ENGINEERS

June 15, 2026

**Subject:** **May 2026 Monthly Report Pursuant to Milestones 1A-3 and 5 of the LEA June 6, 2024 Compliance Order and July 30, 2024 Letter, Chiquita Canyon Landfill, Castaic, California**

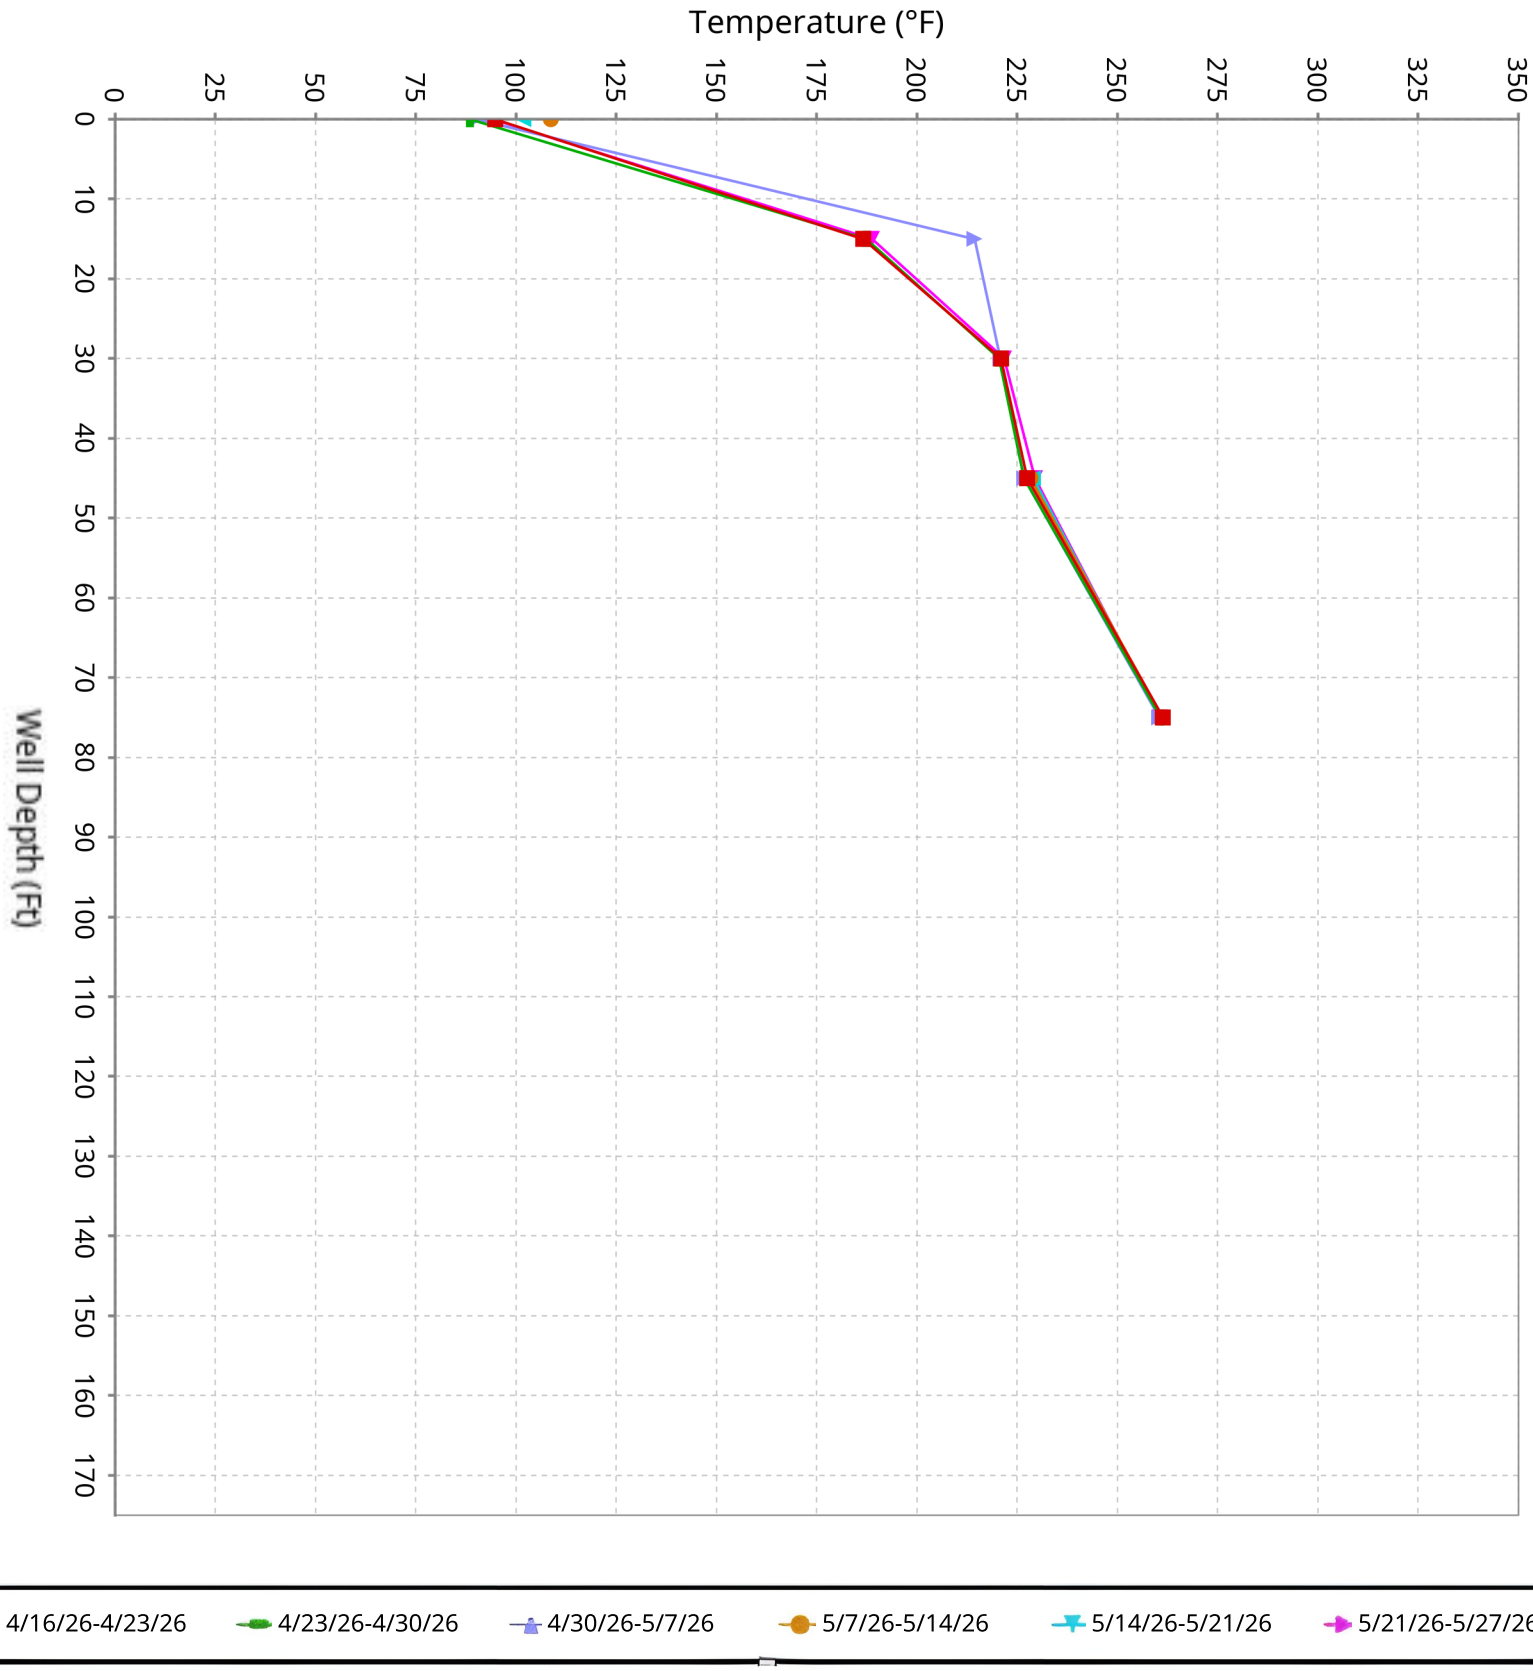
# Vertical Temperature Profiles from Temperature Probes at Chiquita Landfill for TP-23

- TP-23
  - The 15-foot thermocouple reported temperatures of 0°F from May 13th to May 18th, which were anomalous and likely associated with a potential thermocouple sensor malfunction. On May 19th, a temperature of 189°F was reported, with temperatures remaining consistent with previous recorded values through May 27th with the thermocouple functioning as normal.

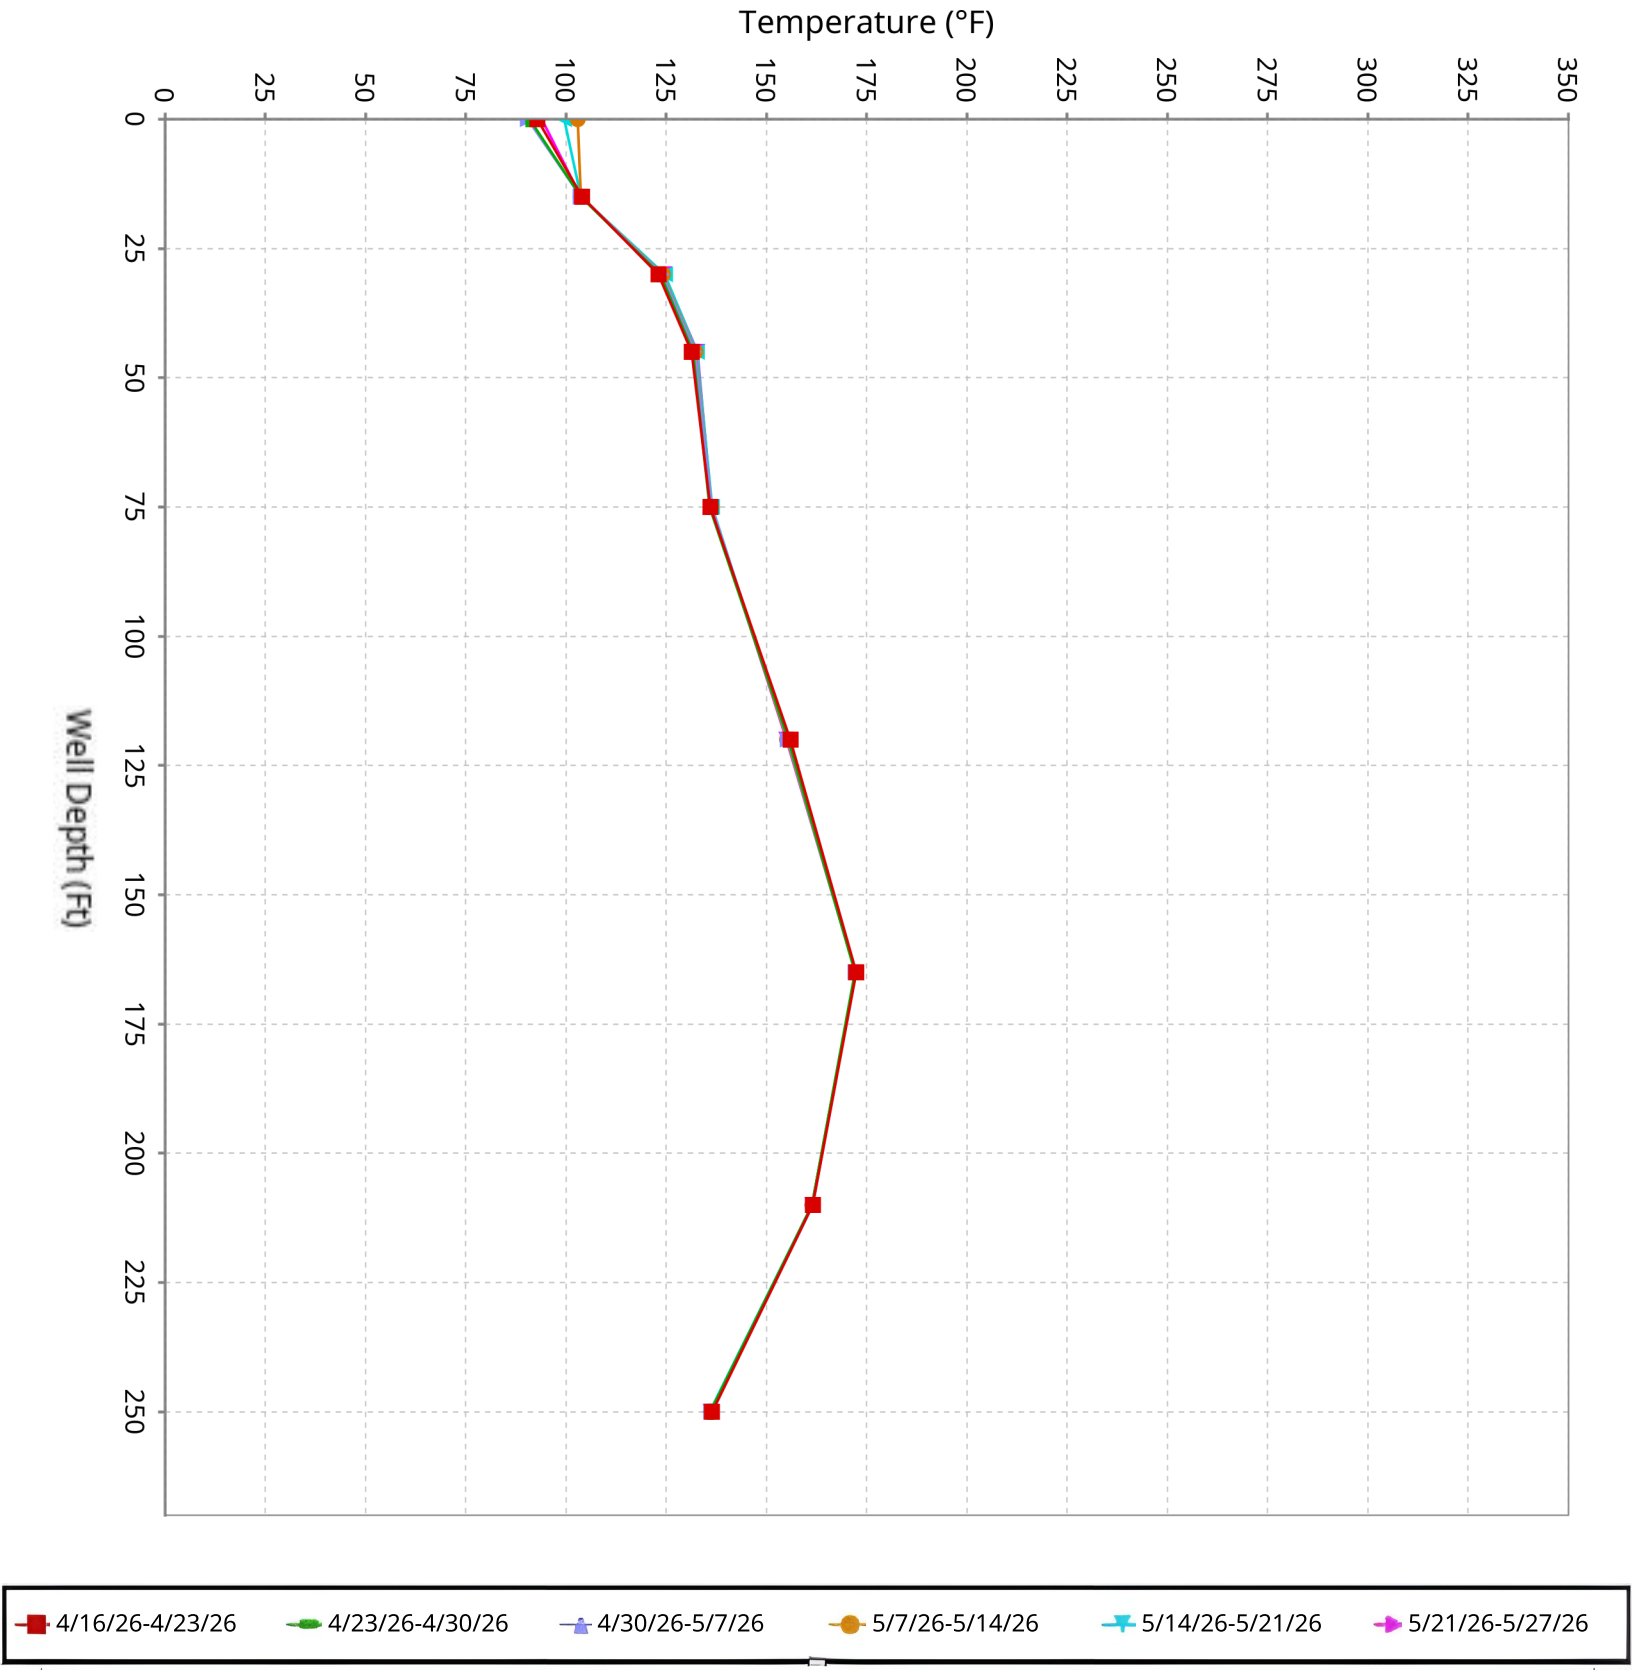
# Vertical Temperature Profiles from Temperature Probes at Chiquita Landfill for TP-36

- TP-36
  - The 250-foot thermocouple was evaluated due to low temperatures on April 6th and wiring that had come loose was corrected. After fixing the wiring issues temperatures returned to 136°F as previously recorded prior to March 21st.

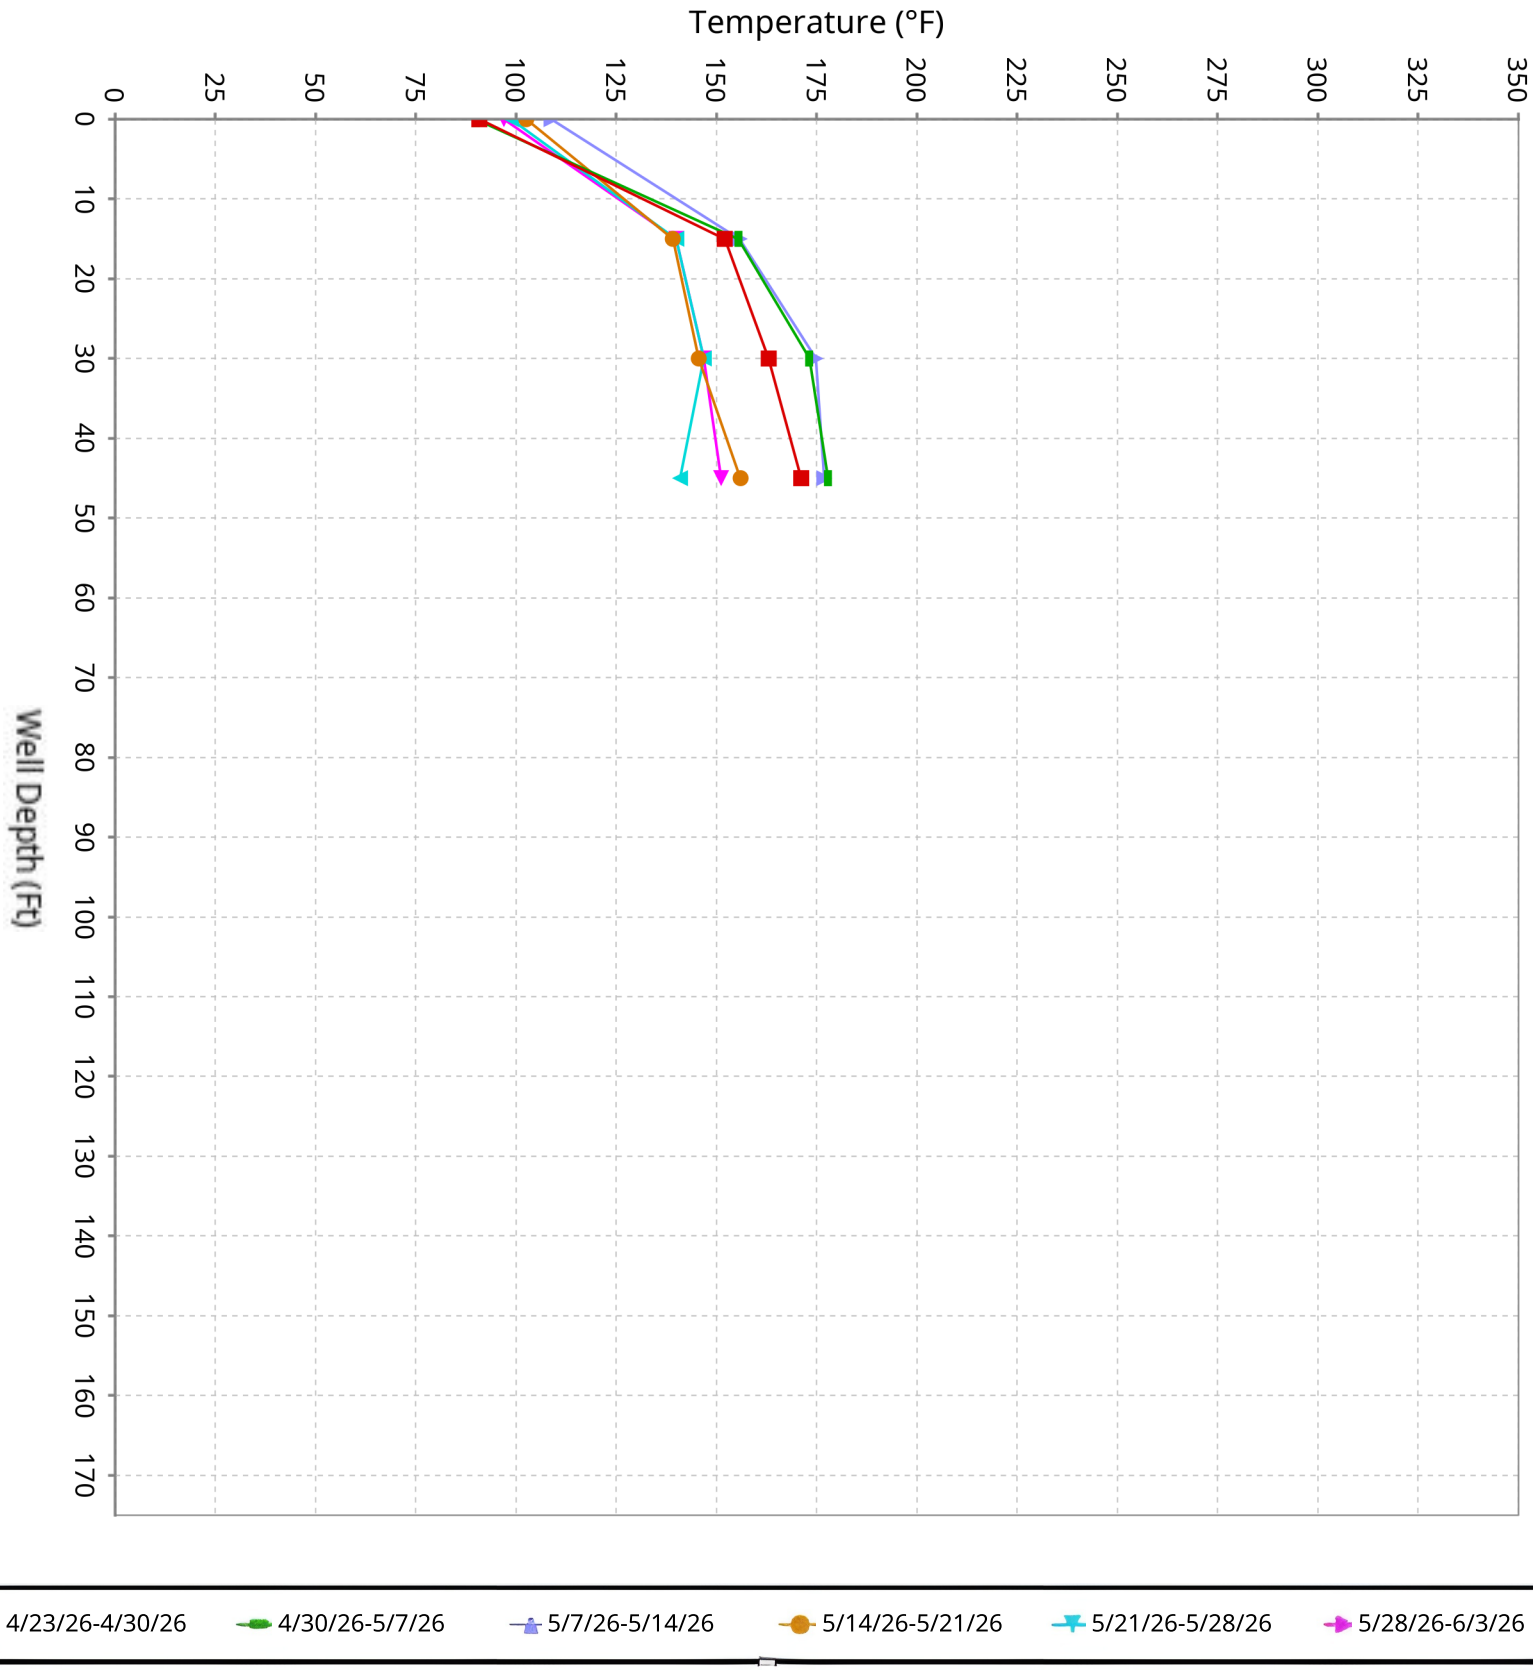
# Vertical Temperature Profiles from Temperature Probes at Chiquita Landfill for TP-8

- TP-08
  - The 125-foot thermocouple went offline on March 3rd and TP-8 was offline between March 6th and March 9th for evaluation and maintenance. Upon removing the thermocouples, the casing for TP-08 was found to be damaged due to differential settlement beyond 45-feet, thus preventing the installation of the 100-foot, 125-foot, and 150-foot thermocouples. The 15-foot, 30-foot, and 45-foot thermocouples are active and reporting data.
  - The 45-foot thermocouple showed an increasein maximum temperature of 18°F from 139°F to 157°F from May 31st to June 3rd.

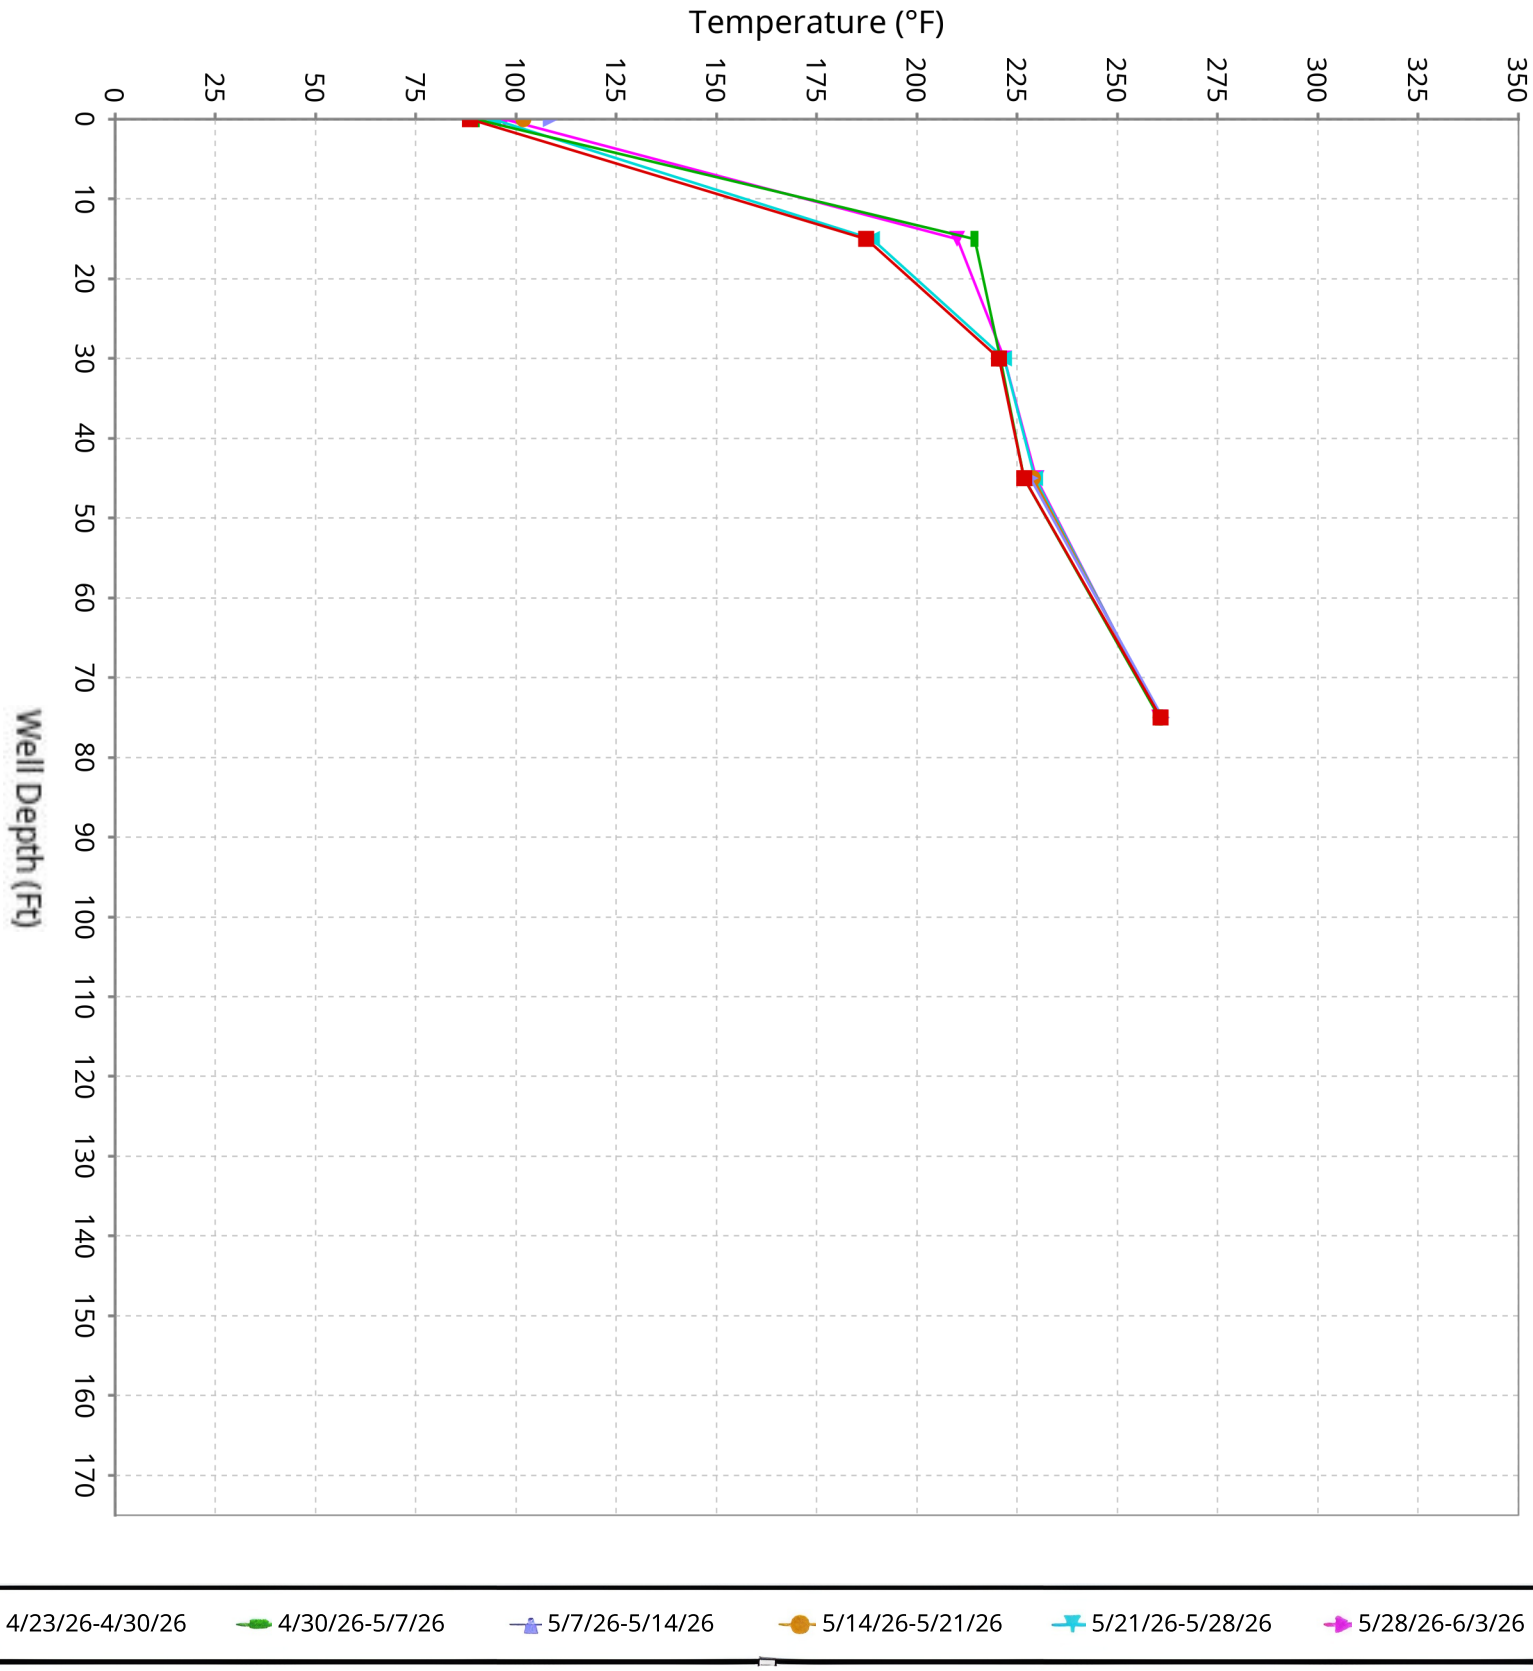
# Vertical Temperature Profiles from Temperature Probes at Chiquita Landfill for TP-23

- TP-23
  - The 15-foot thermocouple remained consistent with previous recorded temperatures.
  - The reported maximum temperature reading of 2508°F is considered anomalous and is believed to be associated with a potential thermocouple sensor malfunction. The sensor remains under evaluation and investigation.
- TP-36
  - The 250-foot thermocouple was evaluated due to low temperatures on April 6th and wiring that had come loose was corrected. After fixing the wiring issues, temperatures returned to 136°F as previously recorded prior to March 21st.

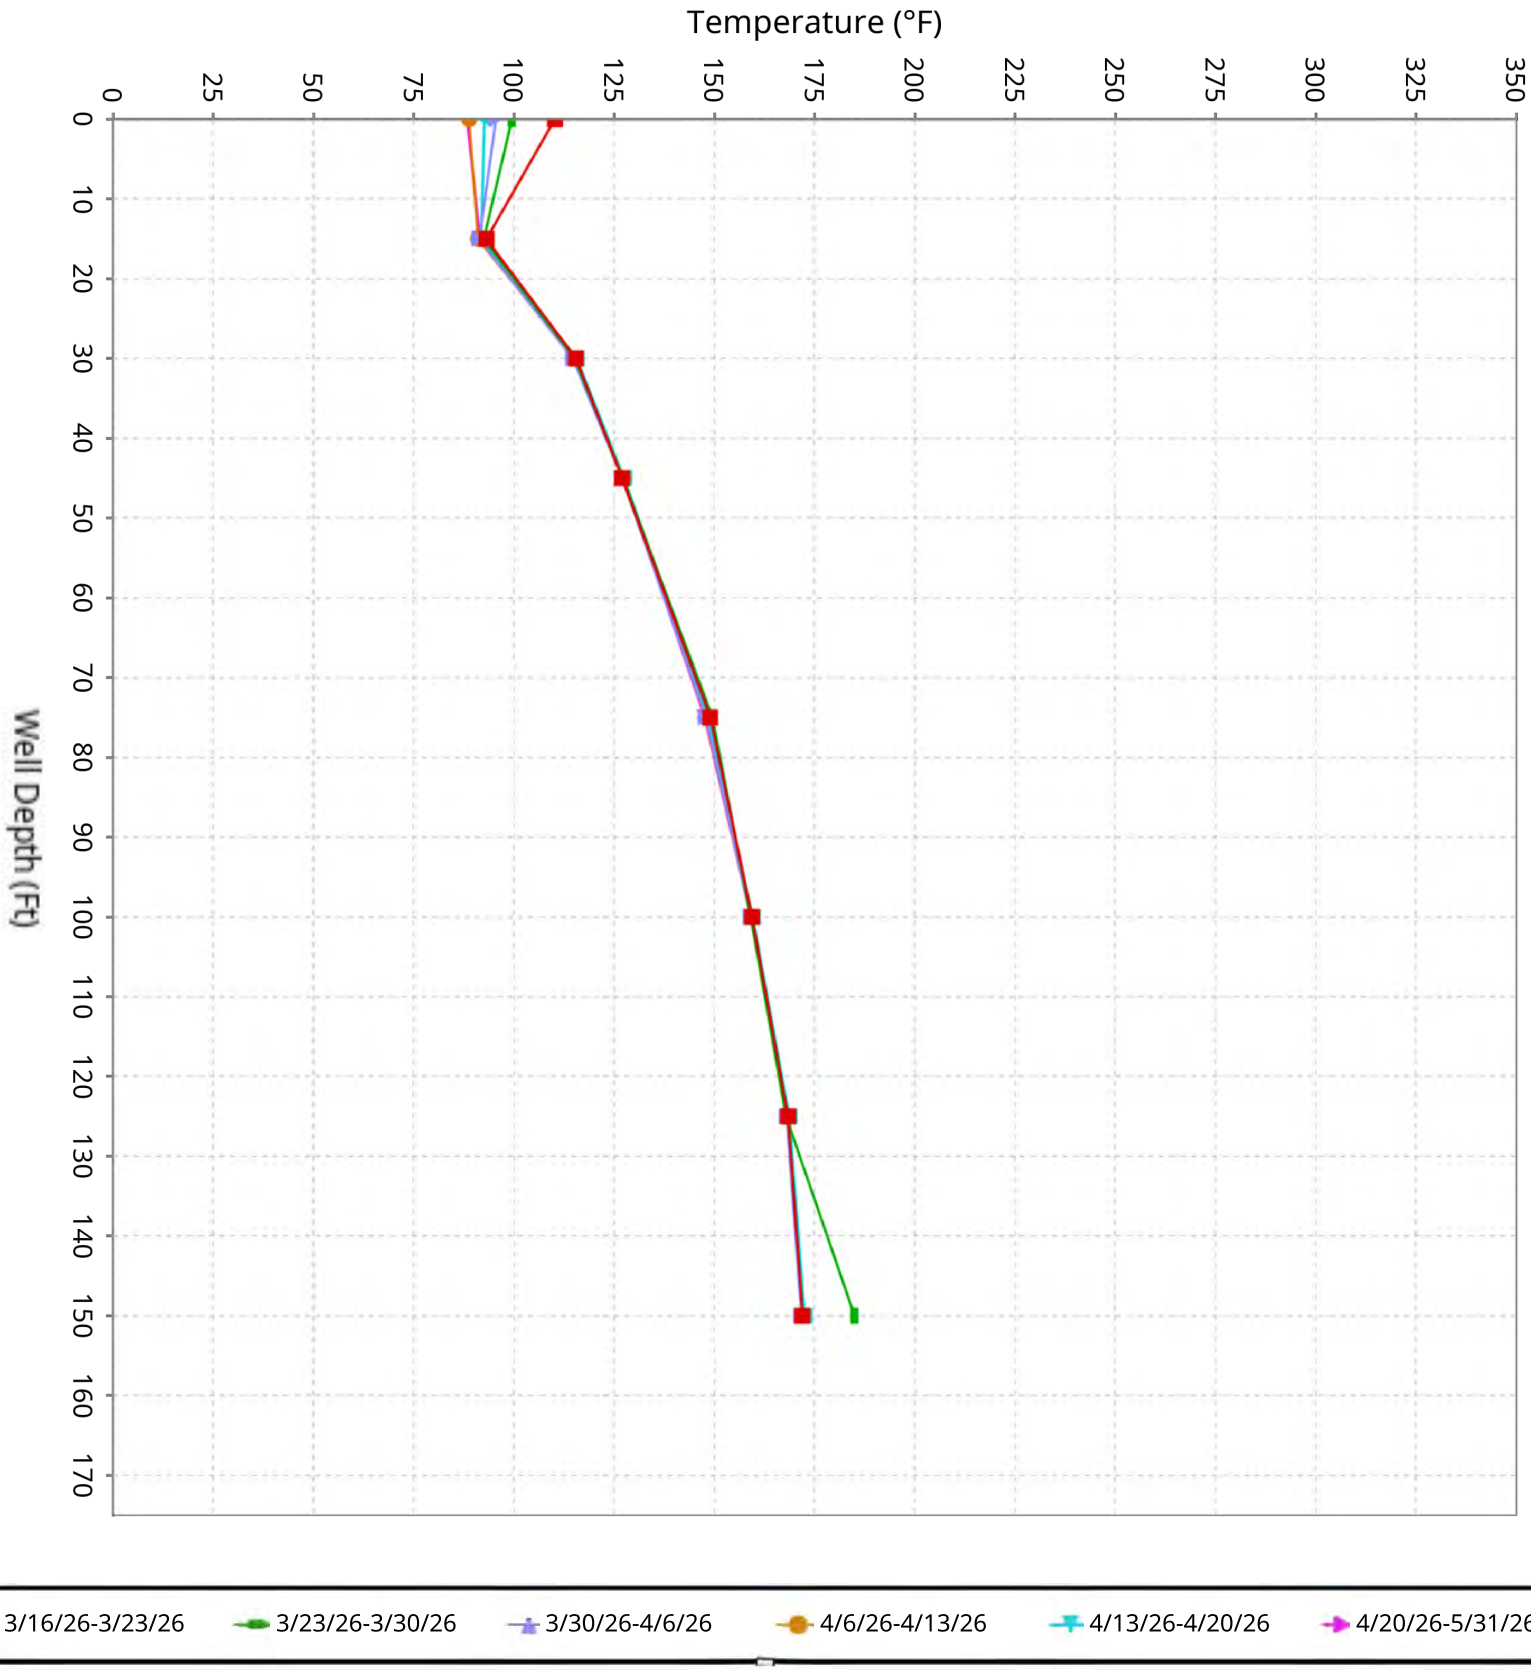
# Vertical Temperature Profiles from Temperature Probes at Chiquita Landfill for TP-14

- The 45-foot thermocouple remained consistent with previous recoded temperatures.
- TP-14
  - The 150-foot thermocouple reported a maximum temperature of 249°F on May 10th, which was anomalous and likely associated with a potential thermocouple sensor malfunction. As a result, the reported temperatures of 0°F from May 11th to May 15th are also considered anomalous. The 150-foot thermocouple was replaced on May 16th and temperatures were consistent with previous recorded values.

- TP-14
  - The 150-foot thermocouple reported a maximum temperature of 249°F on May 10th, which was anomalous and likely associated with a potential thermocouple sensor malfunction. As a result, the reported temperatures of 0°F from May 11th to May 15th are also considered anomalous. The 150-foot thermocouple was replaced on May 16th and temperatures were consistent with previous recorded values.
