SCS ENGINEERS

July 15, 2026

Subject: **June 2026 Monthly Report Pursuant to Milestones 1A-3 and 5 of the LEA June 6, 2024 Compliance Order and July 30, 2024 Letter, Chiquita Canyon Landfill, Castaic, California**

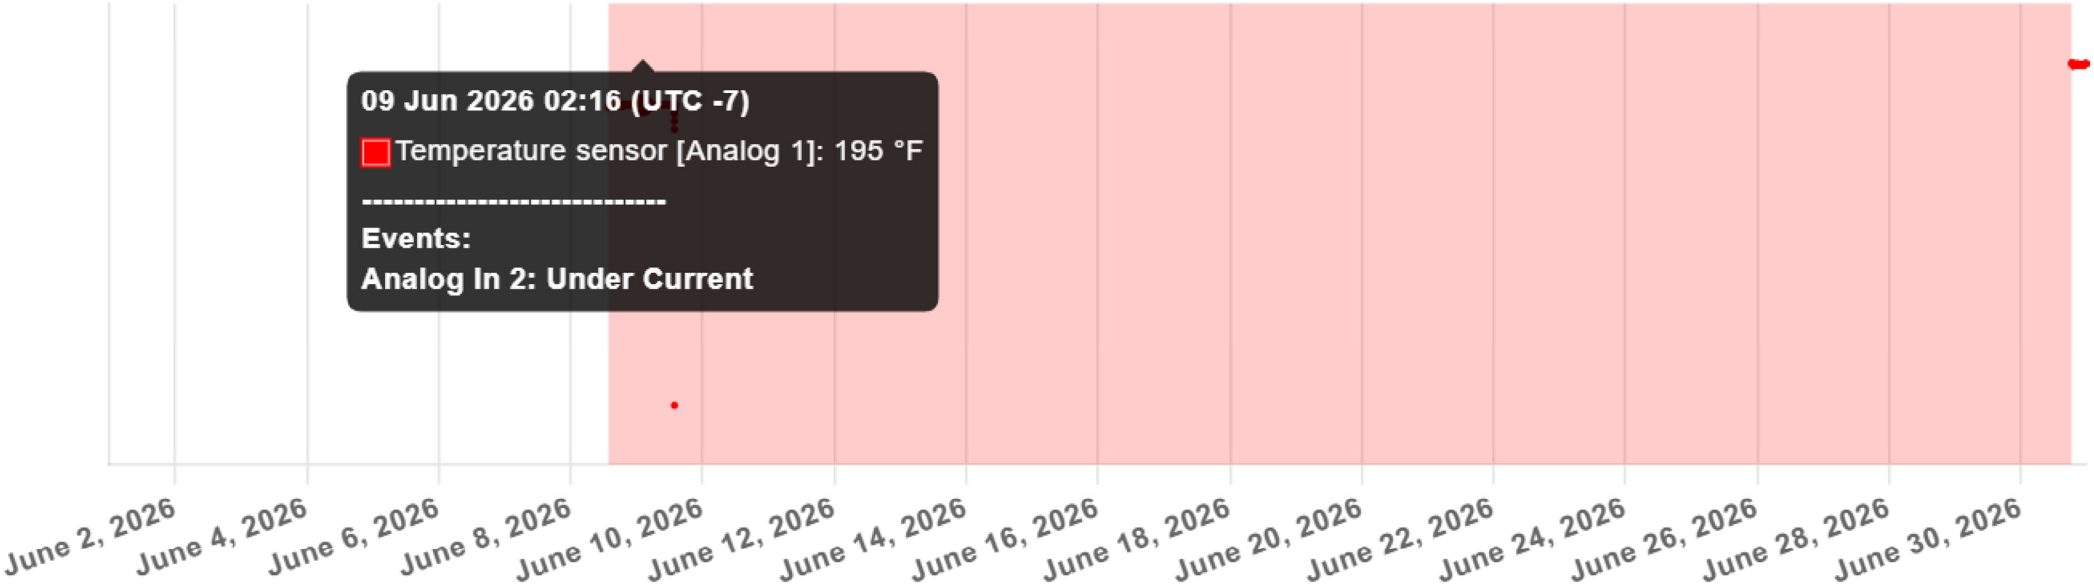
CV-24017

Note that sensor was not working properly for most of June, but has been repaired

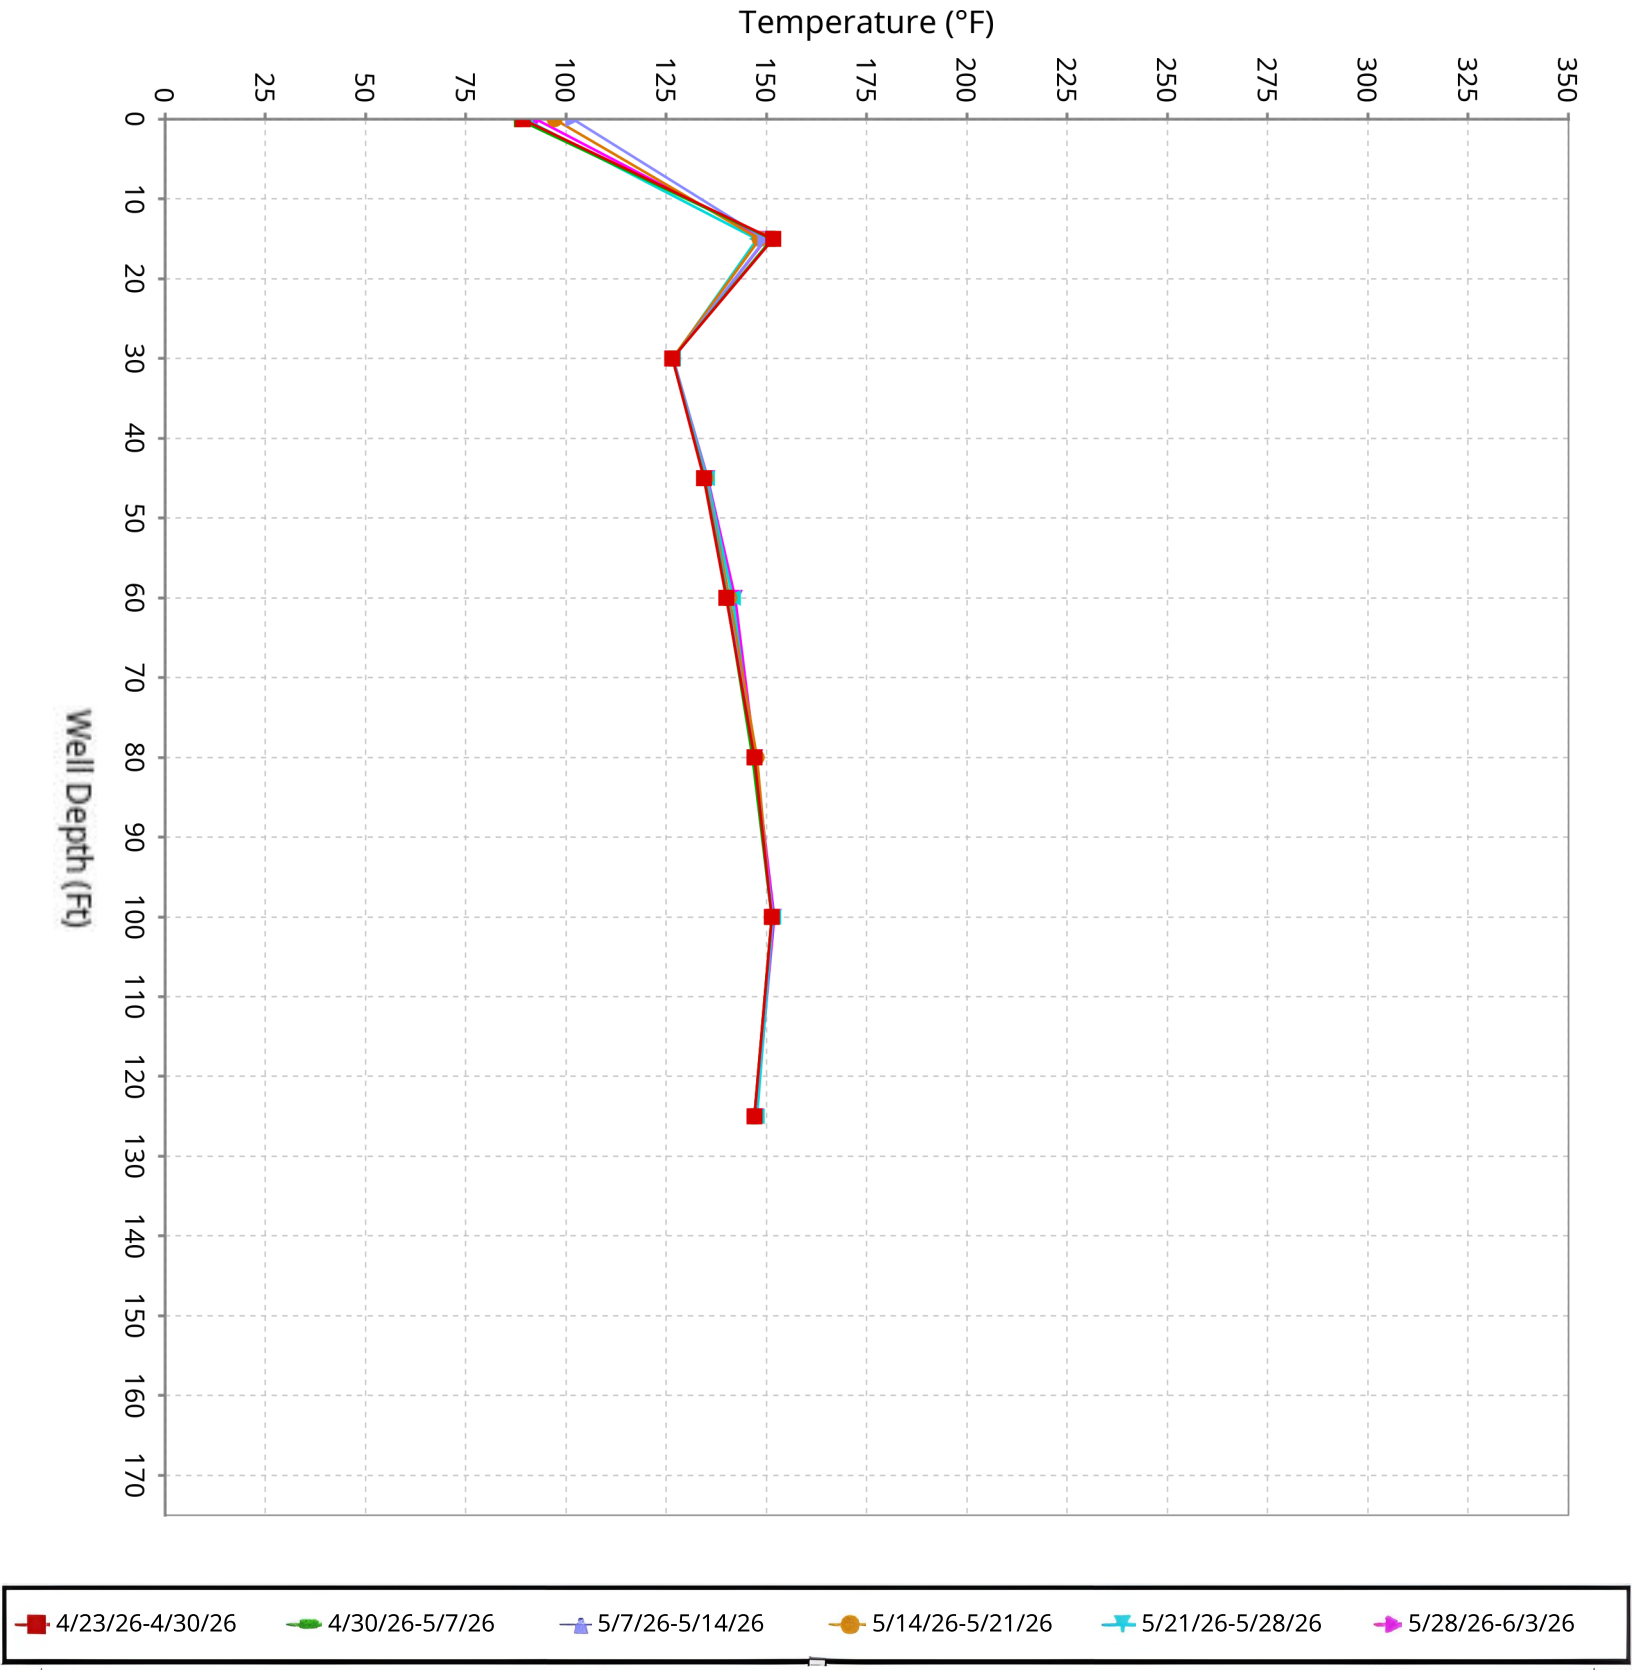
- TP-08
  - The 125-foot thermocouple went offline on March 3rd and TP-8 was offline between March 6th and March 9th for evaluation and maintenance. Upon removing the thermocouples, the casing for TP-08 was found to be damaged due to differential settlement beyond 45-feet, thus preventing the installation of the 100-foot, 125-foot, and 150-foot thermocouples. The 15-foot, 30-foot, and 45-foot thermocouples are active and reporting data.
  - The 45-foot thermocouple showed an increasein maximum temperature of 18°F from 139°F to 157°F from May 31st to June 3rd.

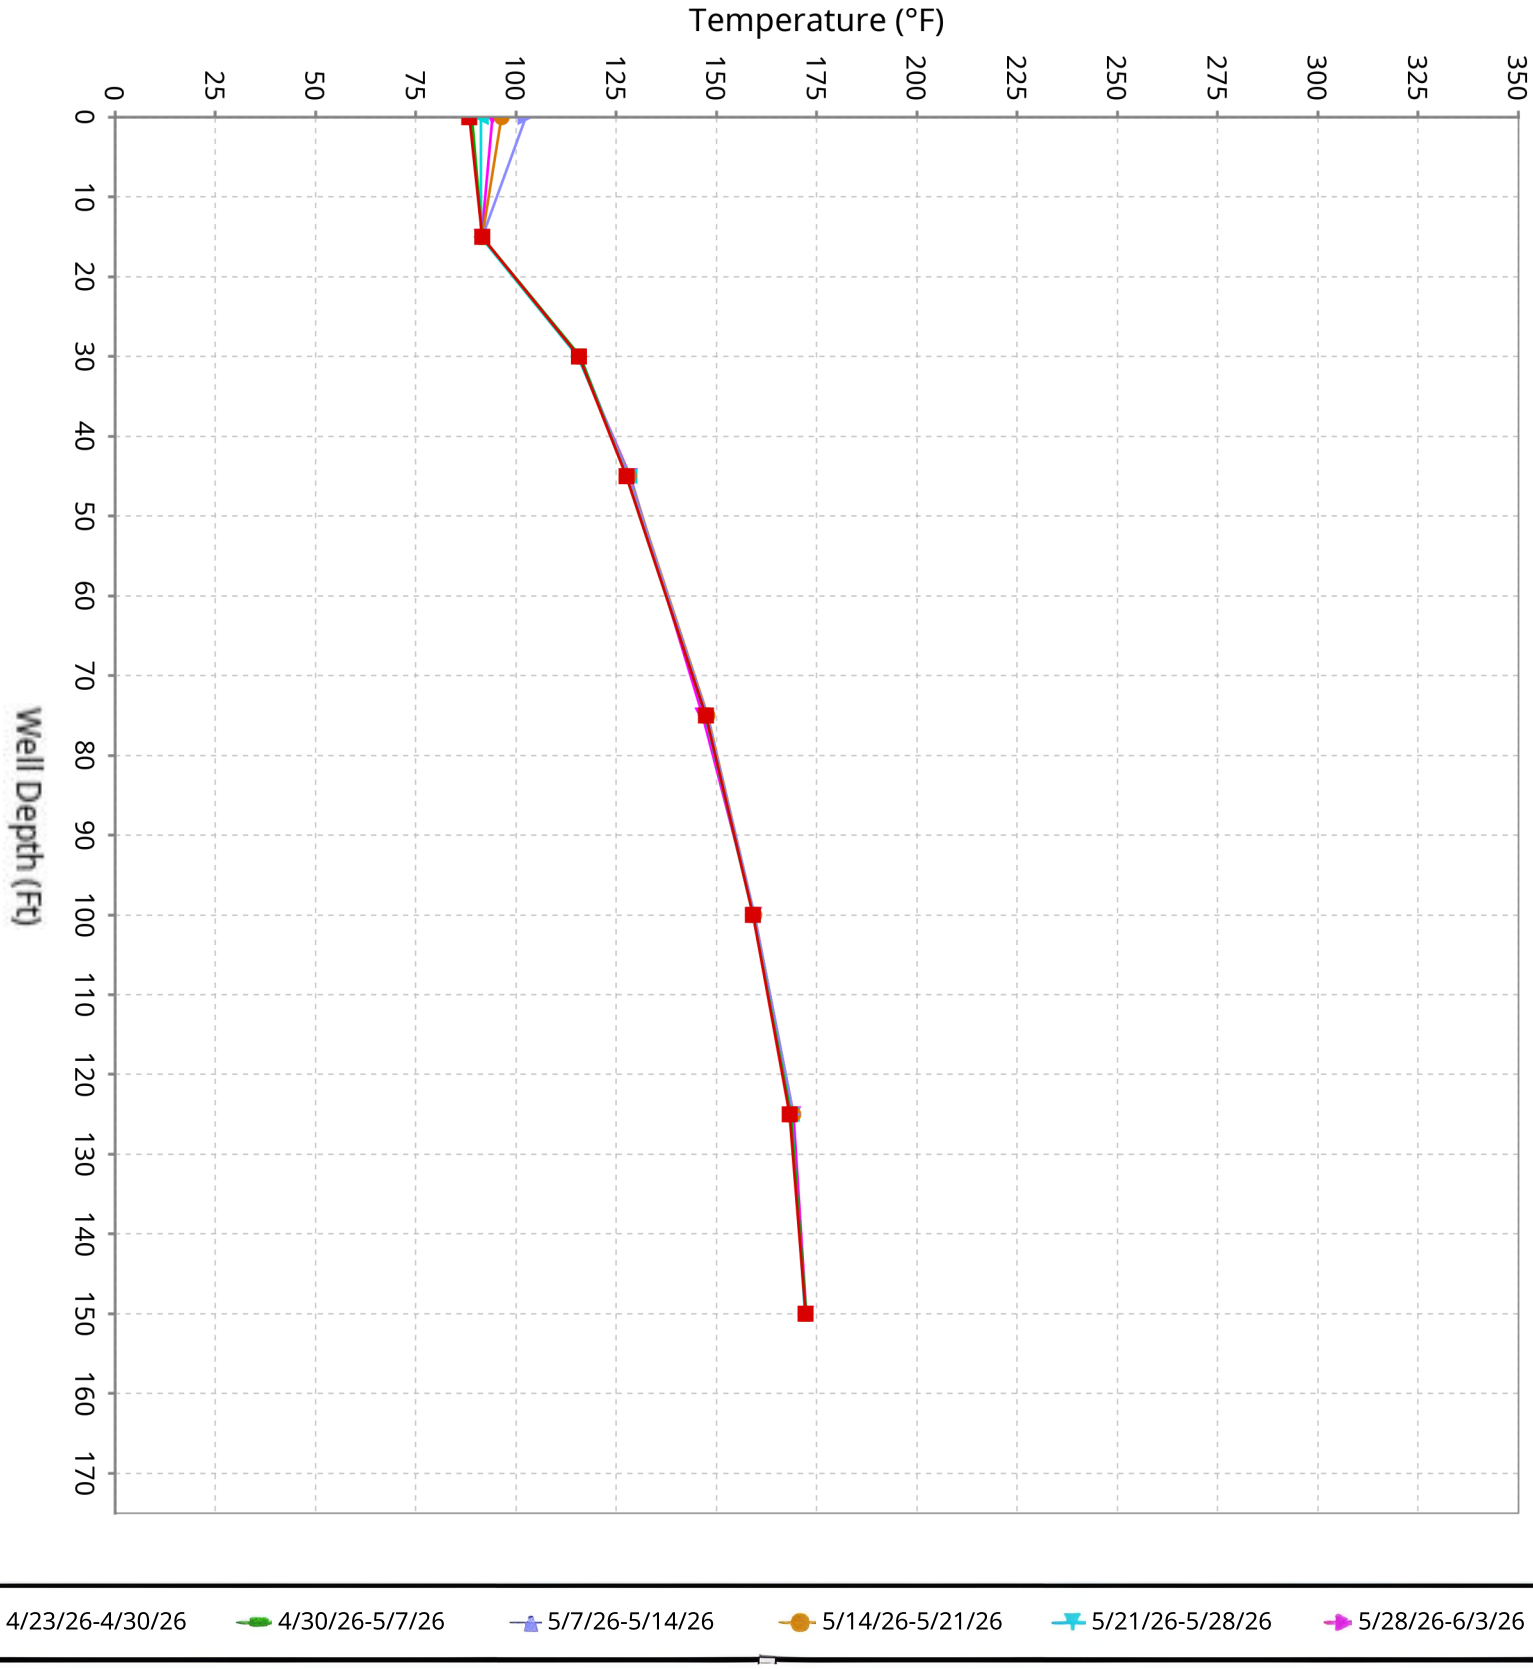
Vertical Temperature Profiles from Temperature Probes at Chiquita Landfill for TP-14

- TP-14
  - The 150-foot thermocouple reported a maximum temperature of 249°F on May 10th, which was anomalous and likely associated with a potential thermocouple sensor malfunction. As a result, the reported temperatures of 0°F from May 11th to May 15th are also considered anomalous. The 150-foot thermocouple was replaced on May 16th and temperatures were consistent with previous recorded values.

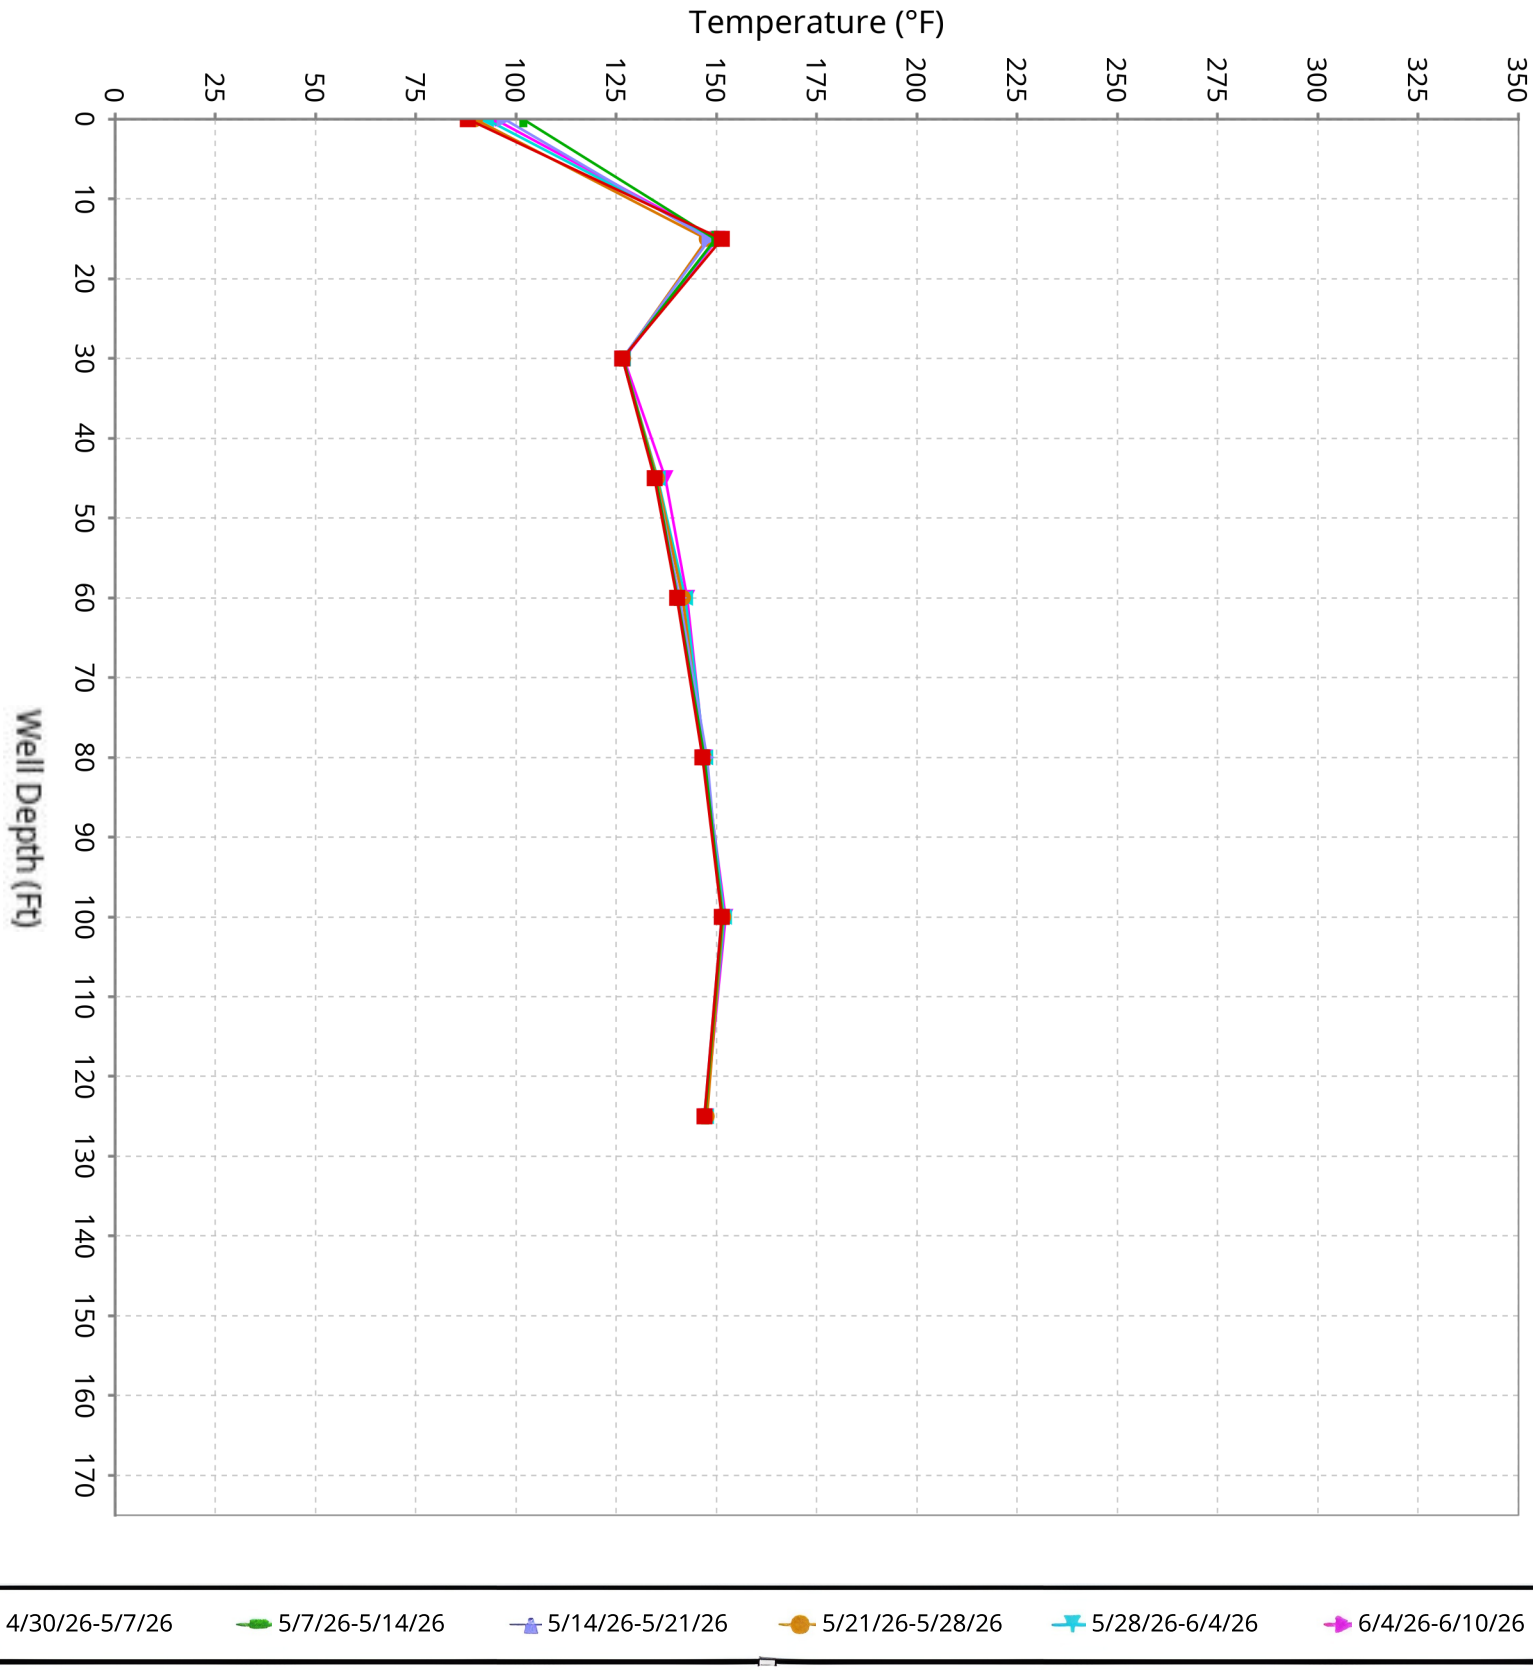
- TP-08
  - The 45-foot thermocouple showed a decrease in maximum temperature of 19°F from 157°F to 138°F from June 4th to June 10th.

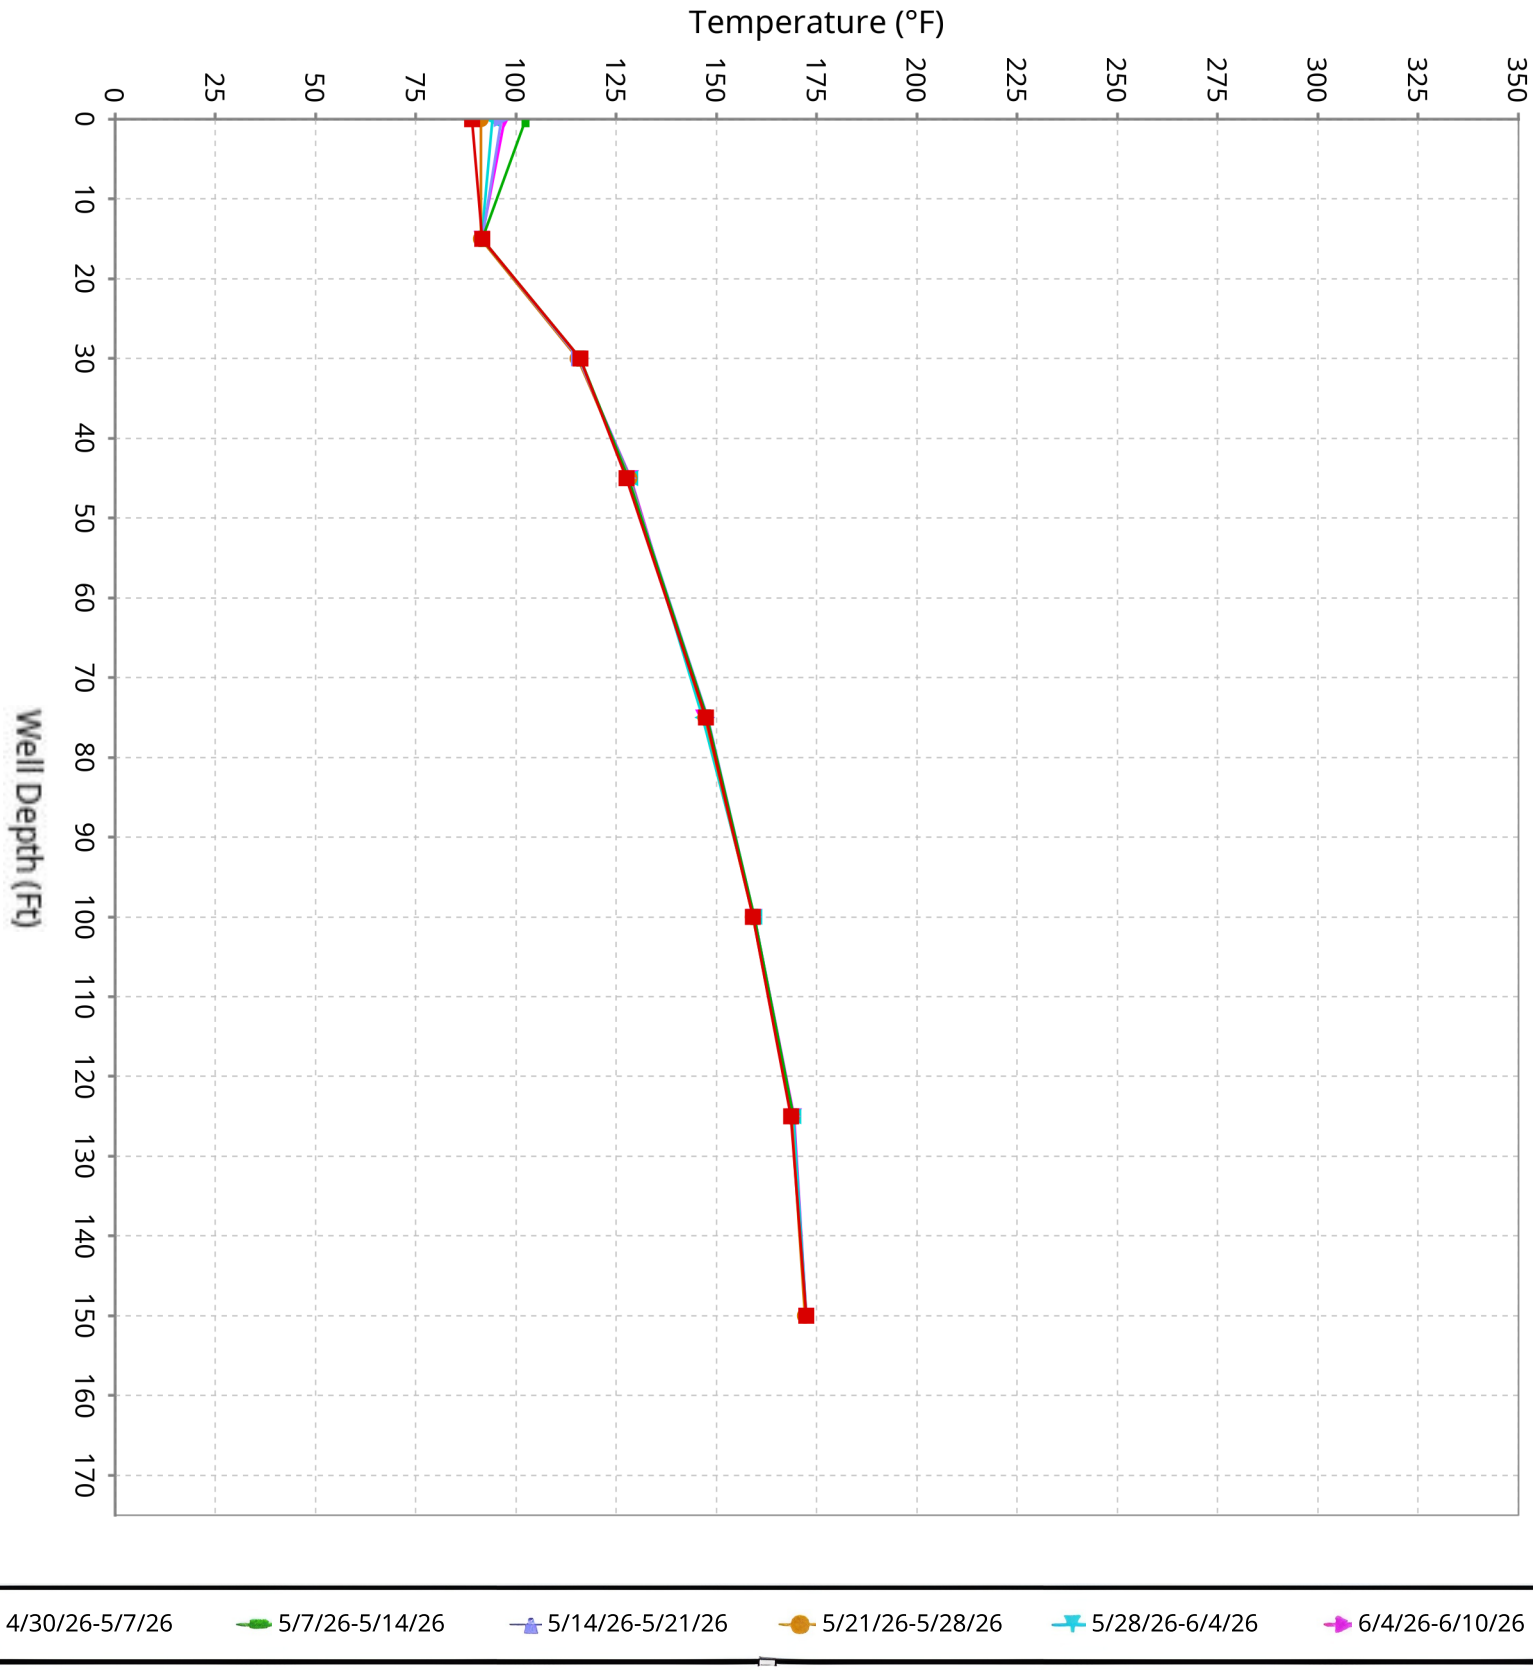
Vertical Temperature Profiles from Temperature Probes at Chiquita Landfill for TP-14

- TP-14
  - The 150-foot thermocouple reported a maximum temperature of 249°F on May 10th, which was anomalous and likely associated with a potential thermocouple sensor malfunction. As a result, the reported temperatures of 0°F from May 11th to May 15th are also considered anomalous. The 150-foot thermocouple was replaced on May 16th and temperatures were consistent with previous recorded values.

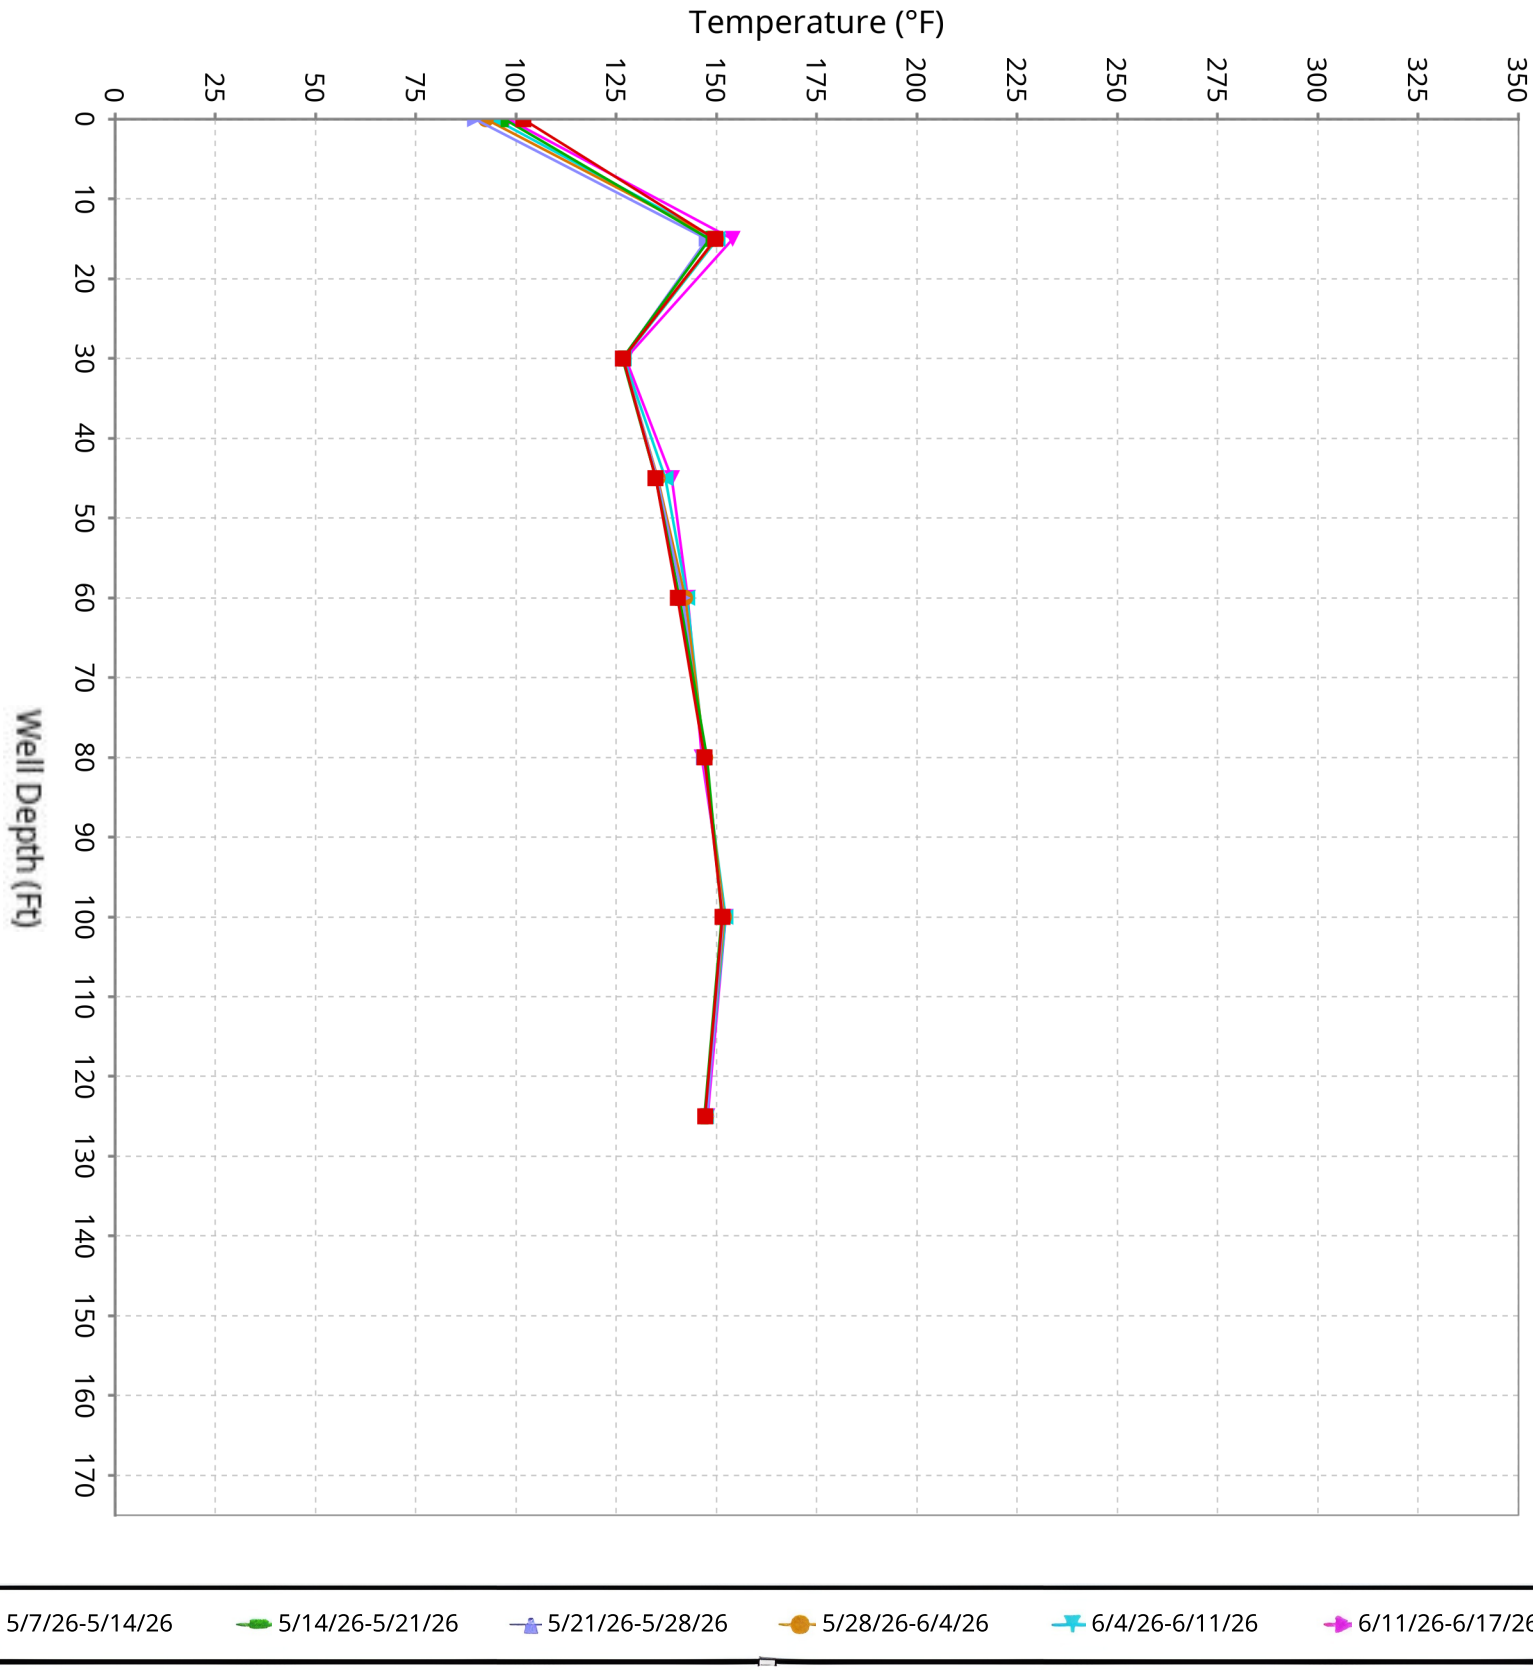
- TP-13
  - The 45-foot thermocouple showed a decrease in maximum temperature of 15°F from 161°F to 146°F from June 11th to June 13th and then an increase in maximum temperature of 19°F from 144°F to 163°F from June 16th to June 17th.

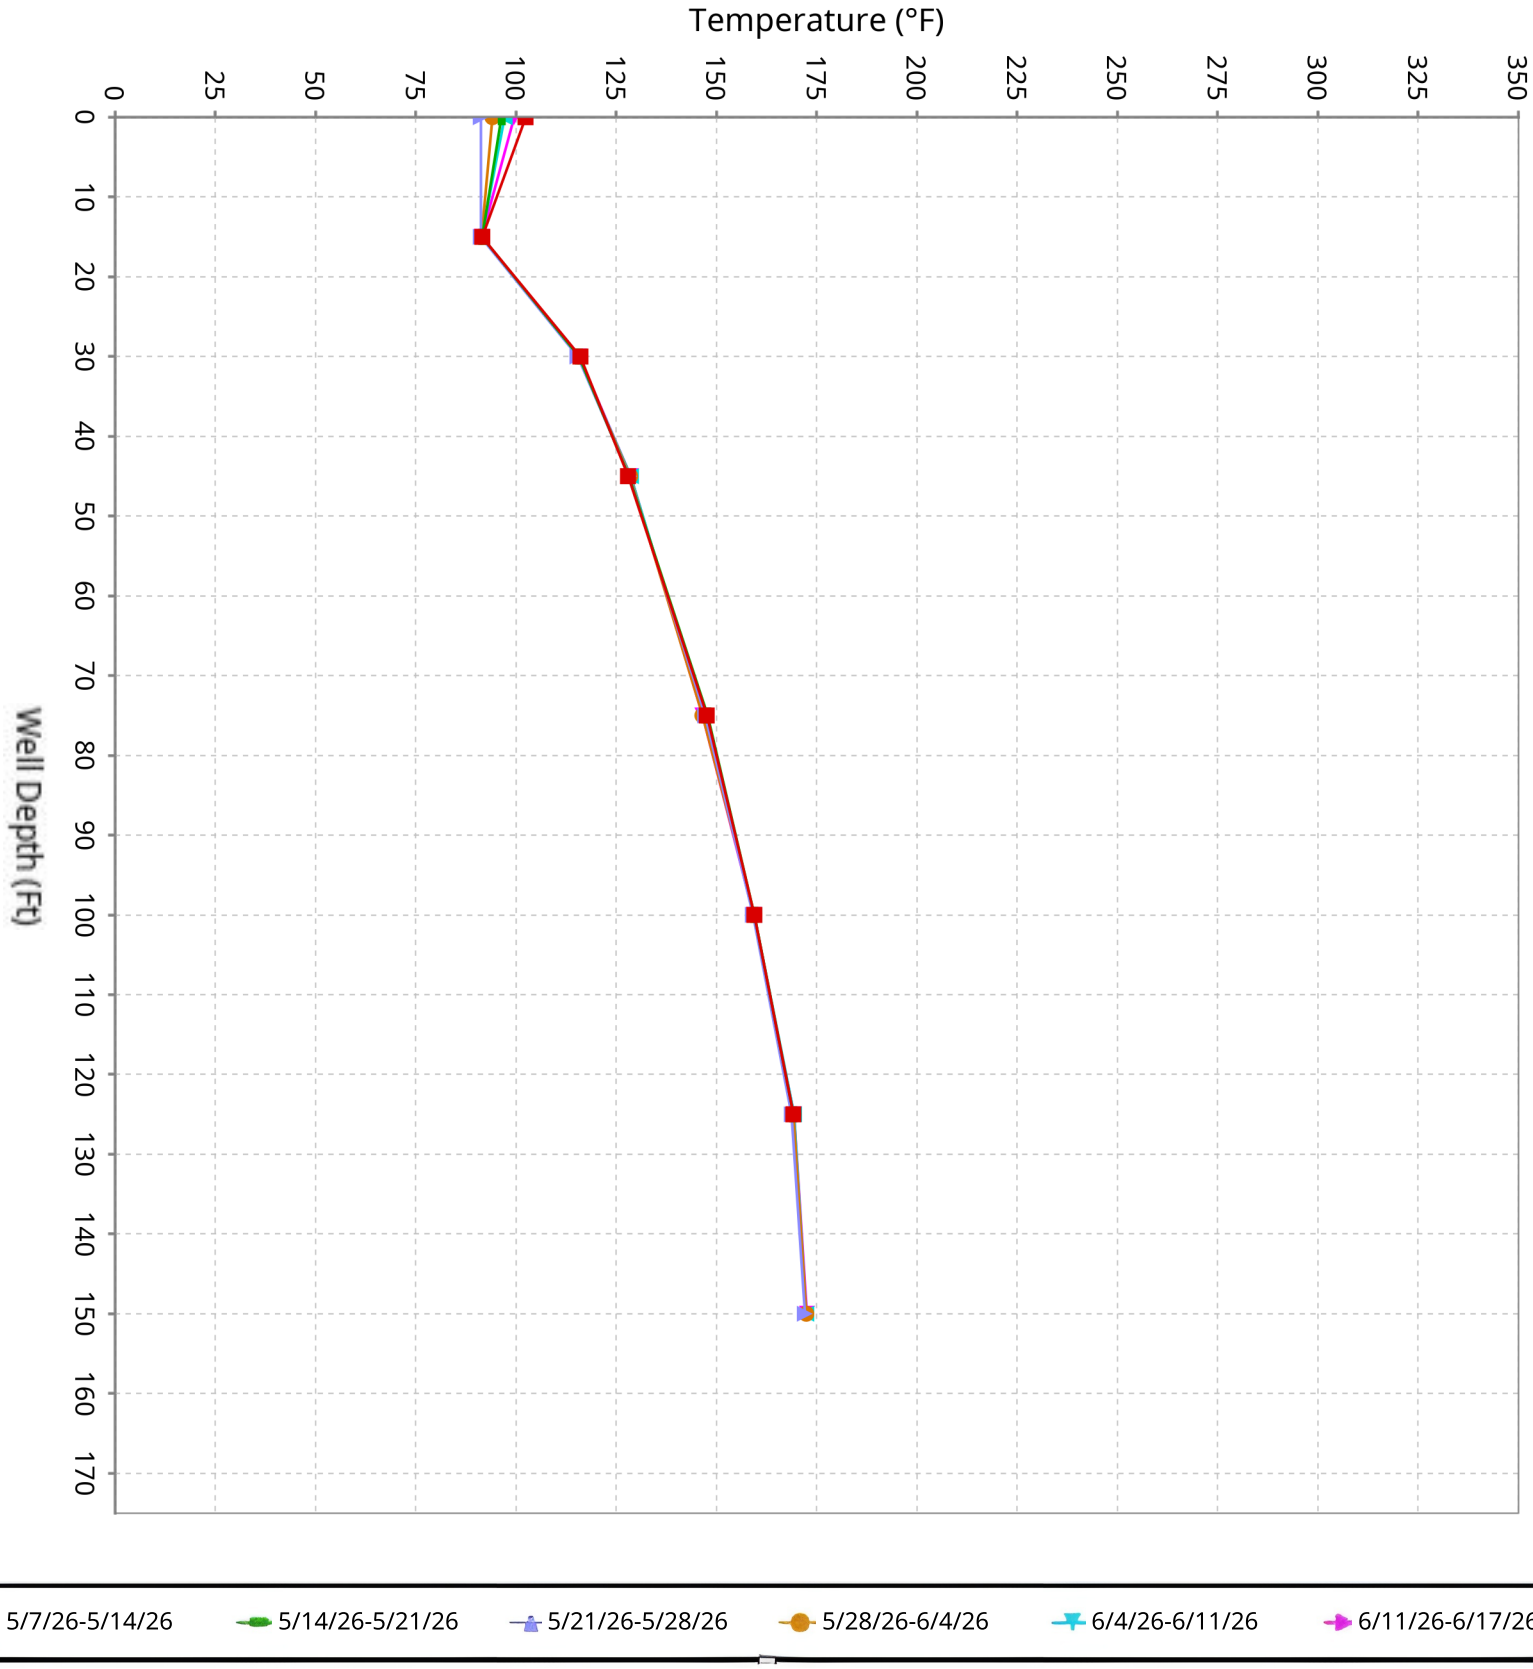
Vertical Temperature Profiles from Temperature Probes at Chiquita Landfill for TP-14

- TP-14
  - The 150-foot thermocouple reported a maximum temperature of 249°F on May 10th, which was anomalous and likely associated with a potential thermocouple sensor malfunction. As a result, the reported temperatures of 0°F from May 11th to May 15th are also considered anomalous. The 150-foot thermocouple was replaced on May 16th and temperatures were consistent with previous recorded values.

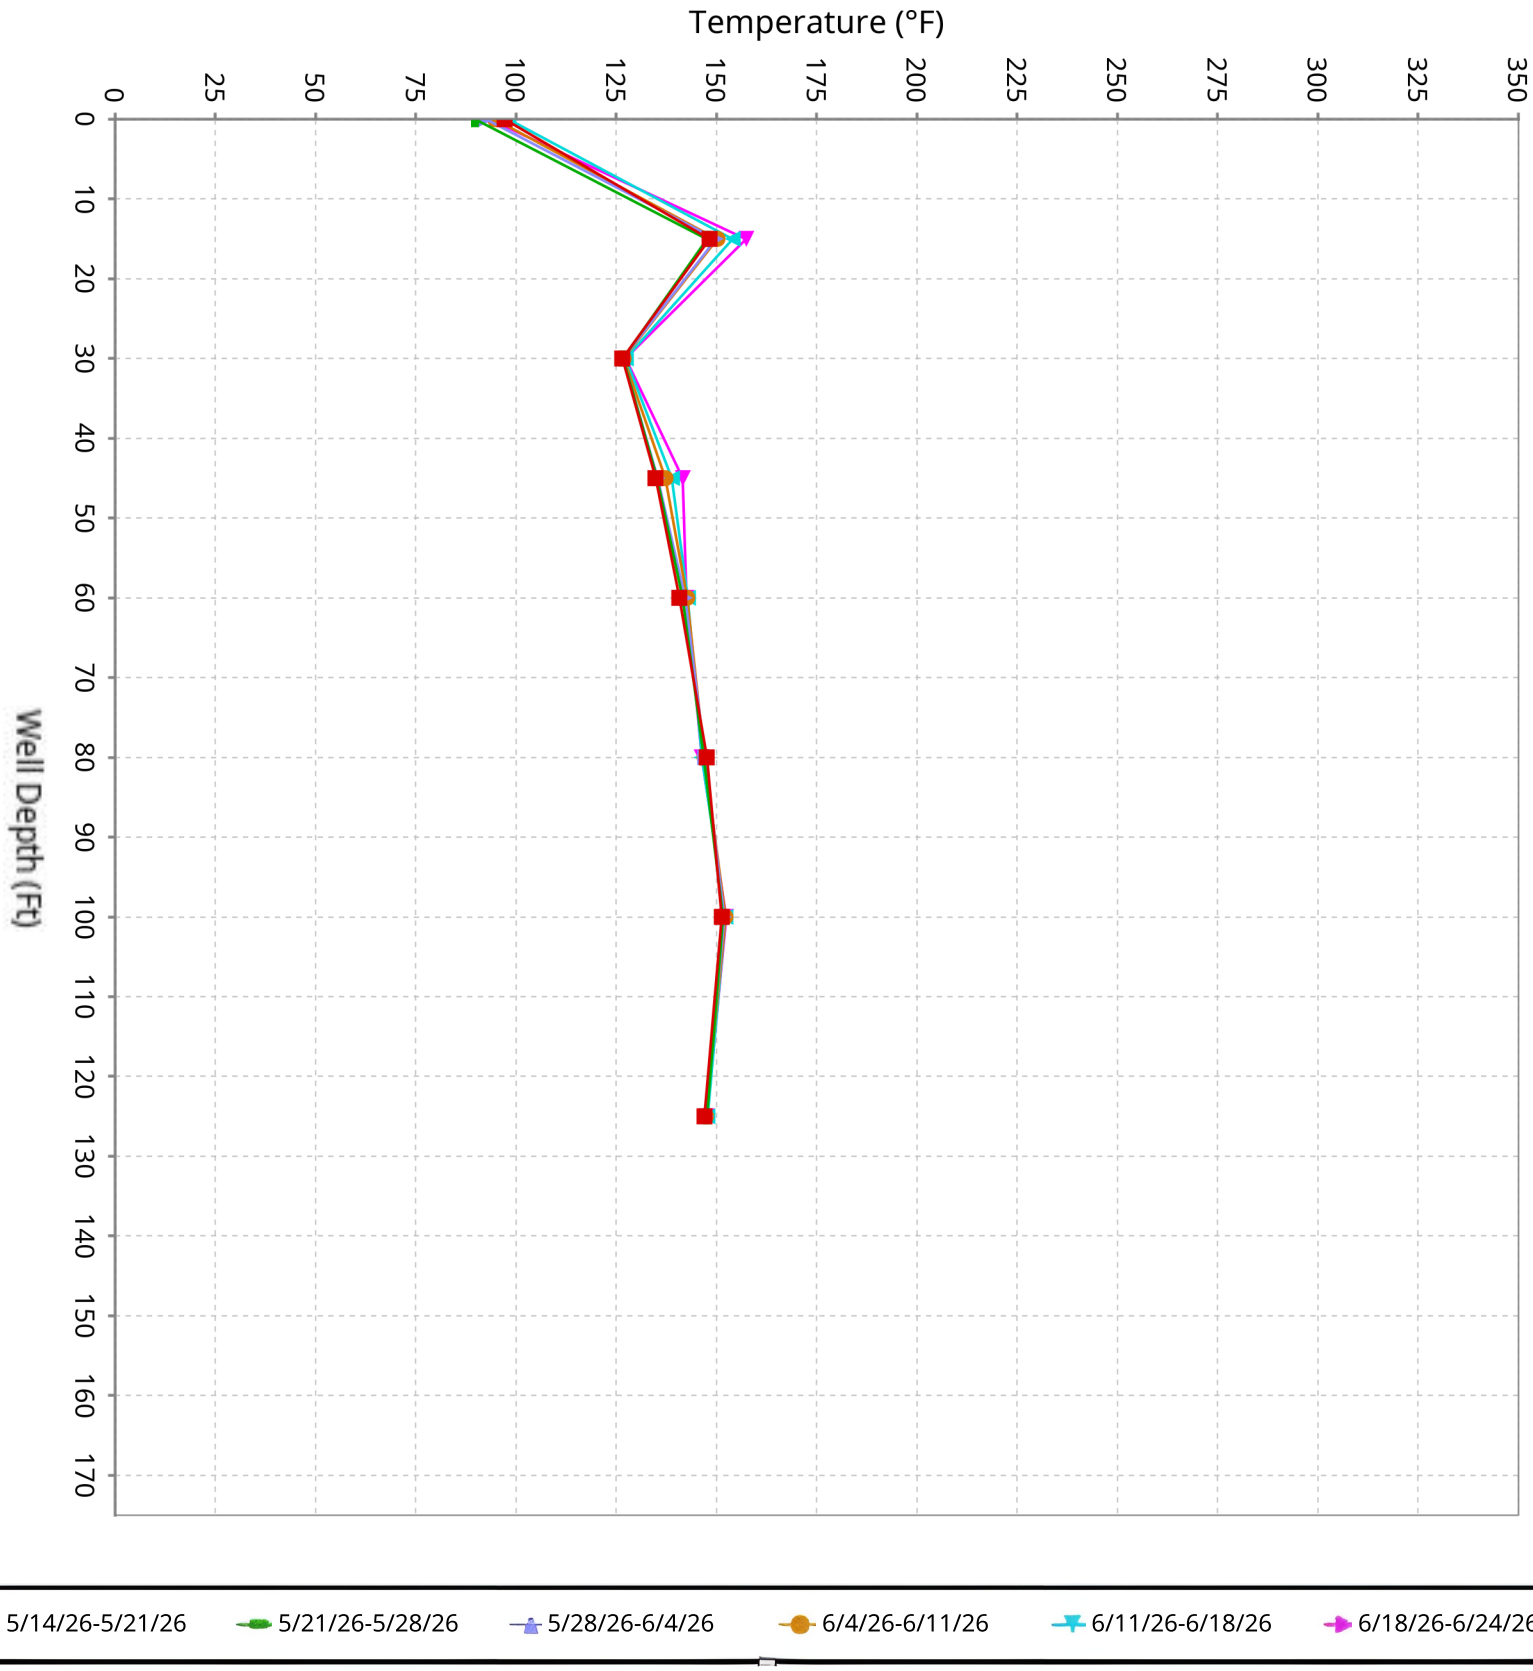
- TP-23
  - The 15-foot thermocouple reported temperatures of 0°F from May 13th to May 18th, which were anomalous and likely associated with a potential thermocouple sensor malfunction. On May 19th, a temperature of 189°F was reported, with temperatures remaining consistent with previous recorded values through May 27th with the thermocouple functioning as normal. The 15-foot thermocouple wiring

was repaired and temperatures were consistent with previous recorded values.
    - The 30-foot thermocouple reported temperatures of 0°F from May 13th to May 18th, which were anomalous and likely associated with a potential thermocouple sensor malfunction. On May 19th, a temperature of 221°F was reported, with temperatures remaining consistent with previously recorded values through May 27th with the thermocouple functioning as normal.

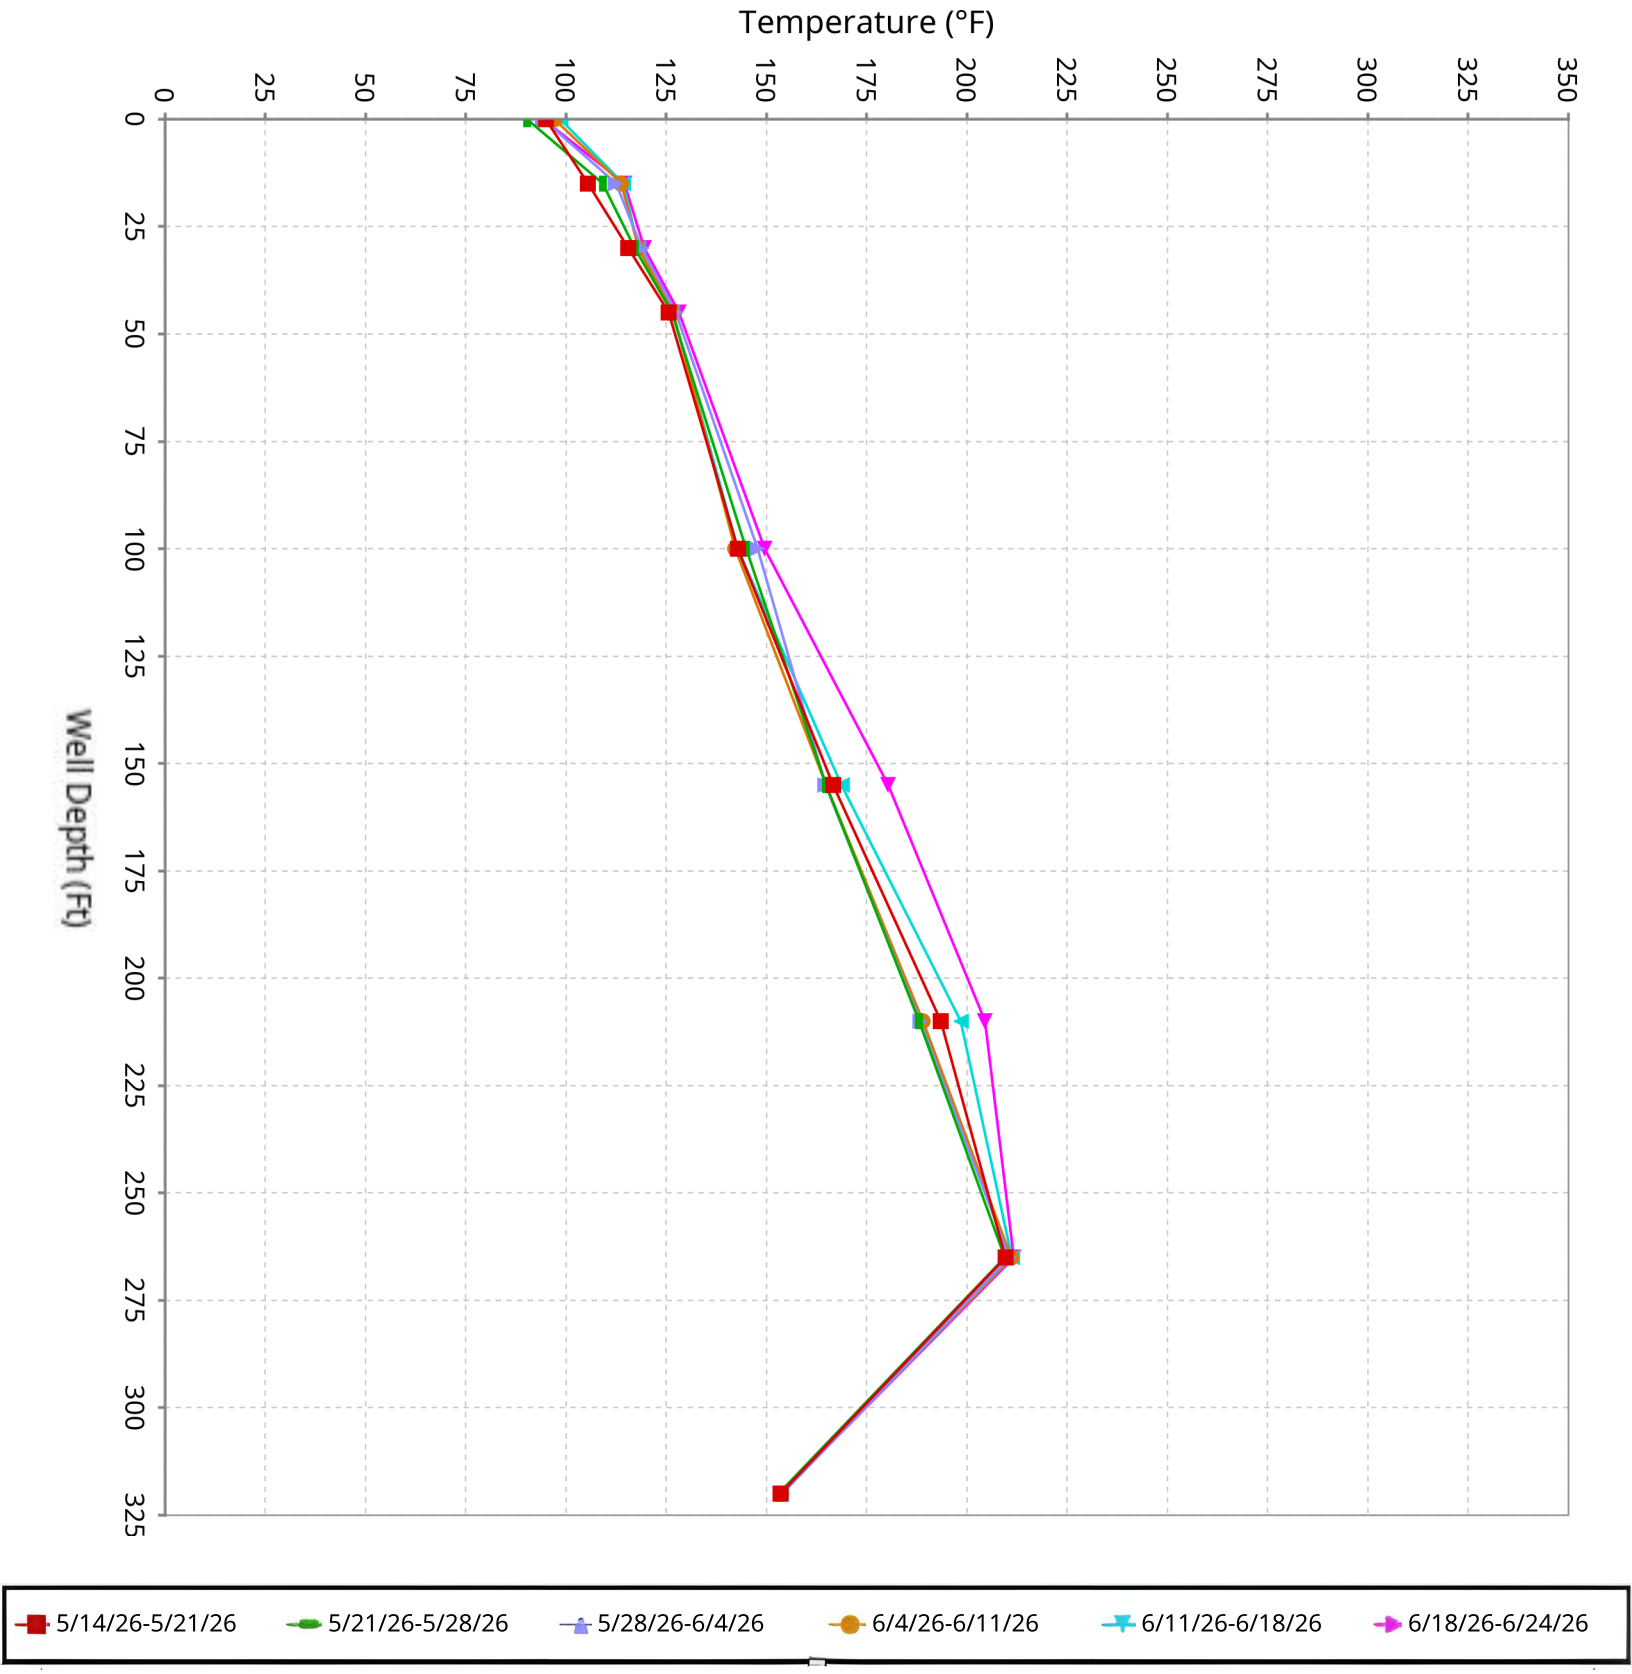
Vertical Temperature Profiles from Temperature Probes at Chiquita Landfill for TP-24

- TP-24
  - The 155-foot thermocouple showed a decrease in maximum temperature of 15°F from 183°F to 168°F from June 27th to June 28th, and then an increase in maximum temperature of 9°F from 168°F to 177°F from June 28th to June 29th.
  - The 210-foot thermocouple showed a decrease in maximum temperature of 13°F from 204°F to 191°F from June 27th to June 28th, then an increase in maximum temperature of 12°F from 191°F to 203°F from June 28th to June 29th, and then a decrease in maximum temperature of 10°F from 200°F to 190°F from June 30th to July 1st.
