SCS ENGINEERS

July 15, 2026

Subject: **June 2026 Monthly Report Pursuant to Milestones 1A-3 and 5 of the LEA June 6, 2024 Compliance Order and July 30, 2024 Letter, Chiquita Canyon Landfill, Castaic, California**

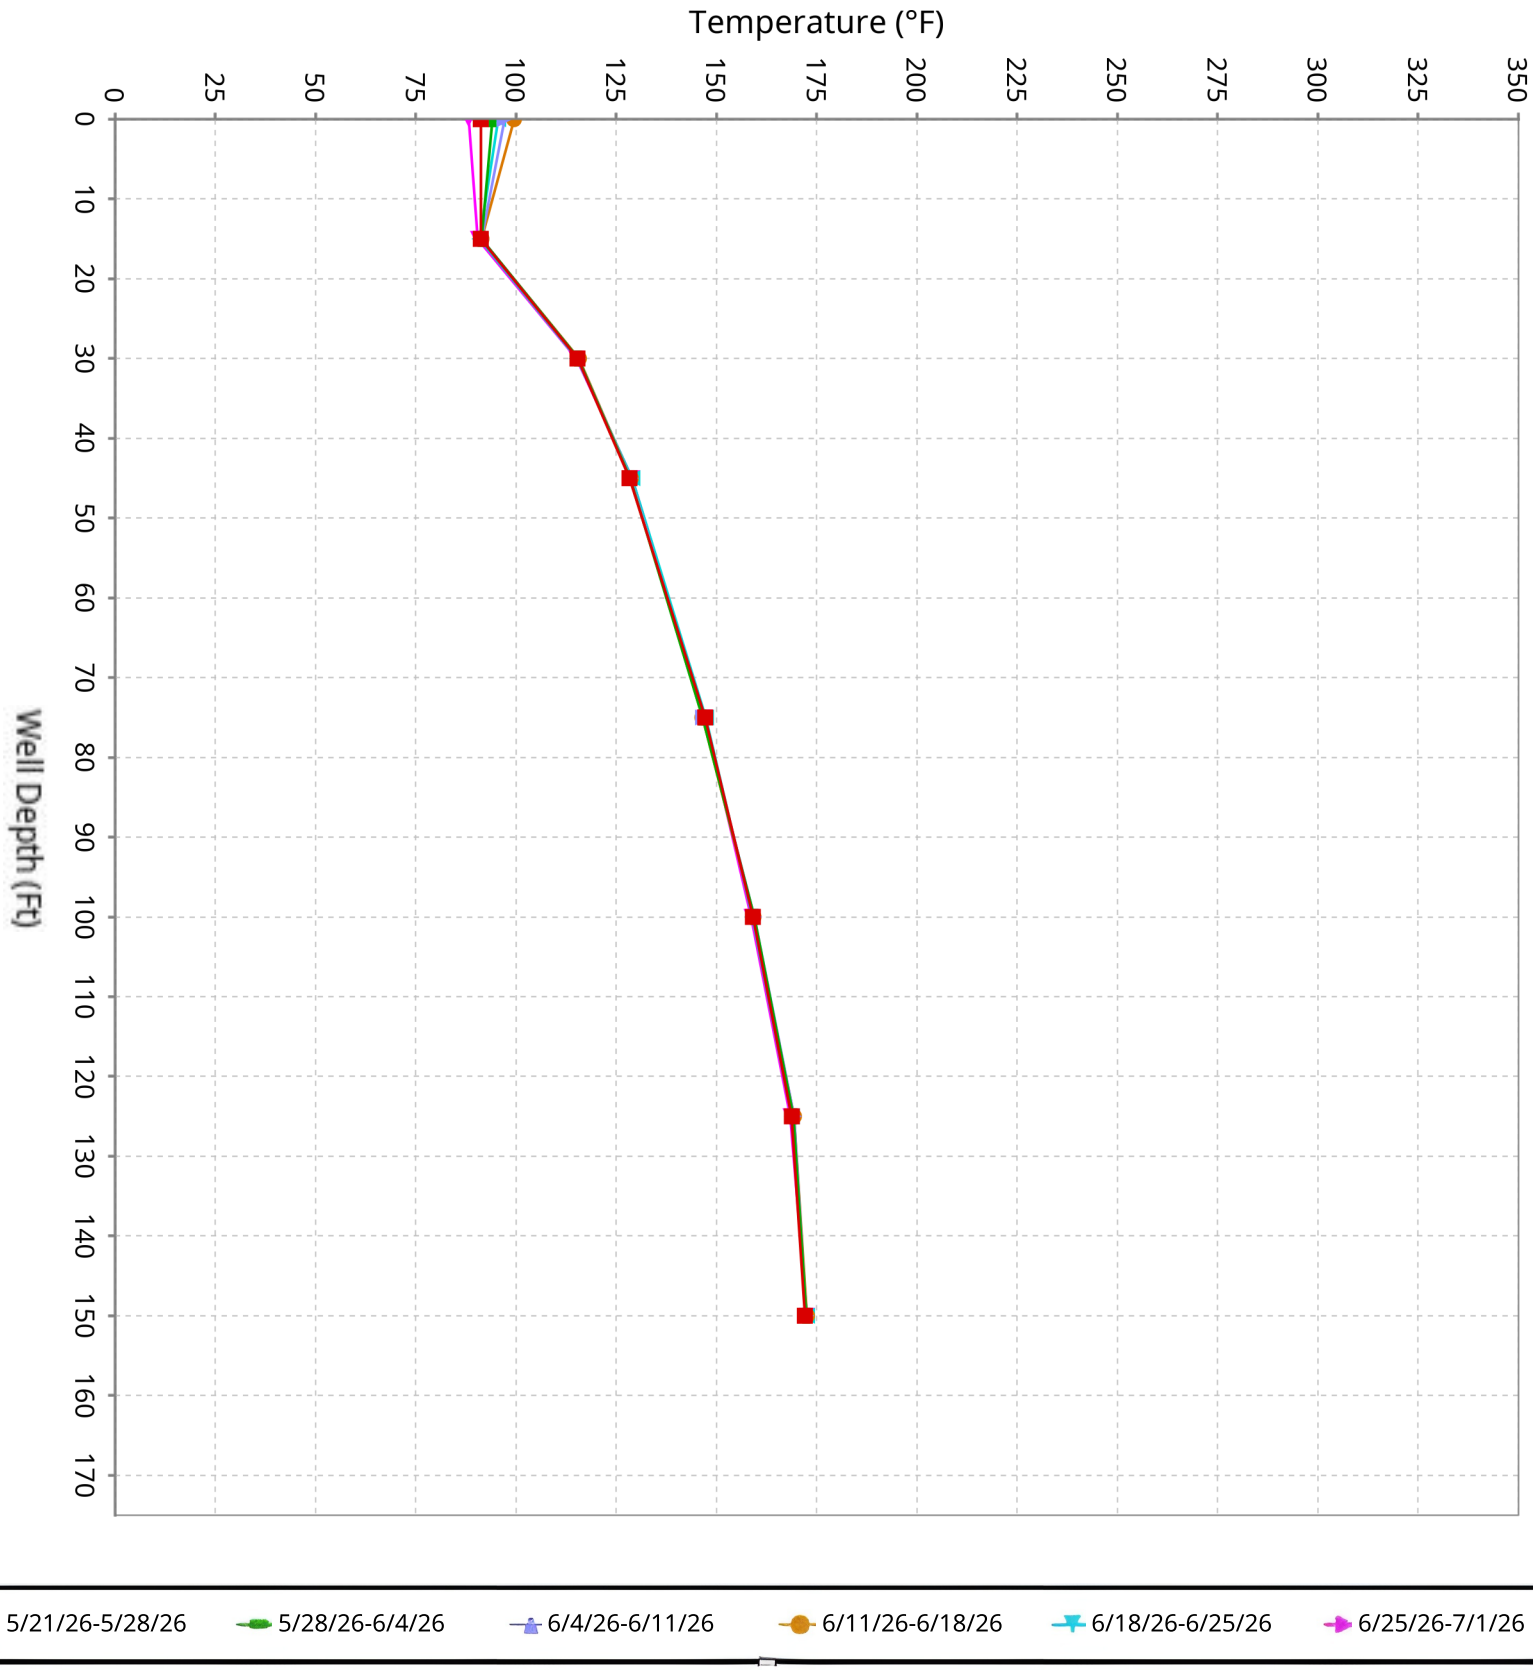
Vertical Temperature Profiles from Temperature Probes at Chiquita Landfill for TP-14

- TP-14
  - The 150-foot thermocouple reported a maximum temperature of 249°F on May 10th, which was anomalous and likely associated with a potential thermocouple sensor malfunction. As a result, the reported temperatures of 0°F from May 11th to May 15th are also considered anomalous. The 150-foot thermocouple was replaced on May 16th and temperatures were consistent with previous recorded values.

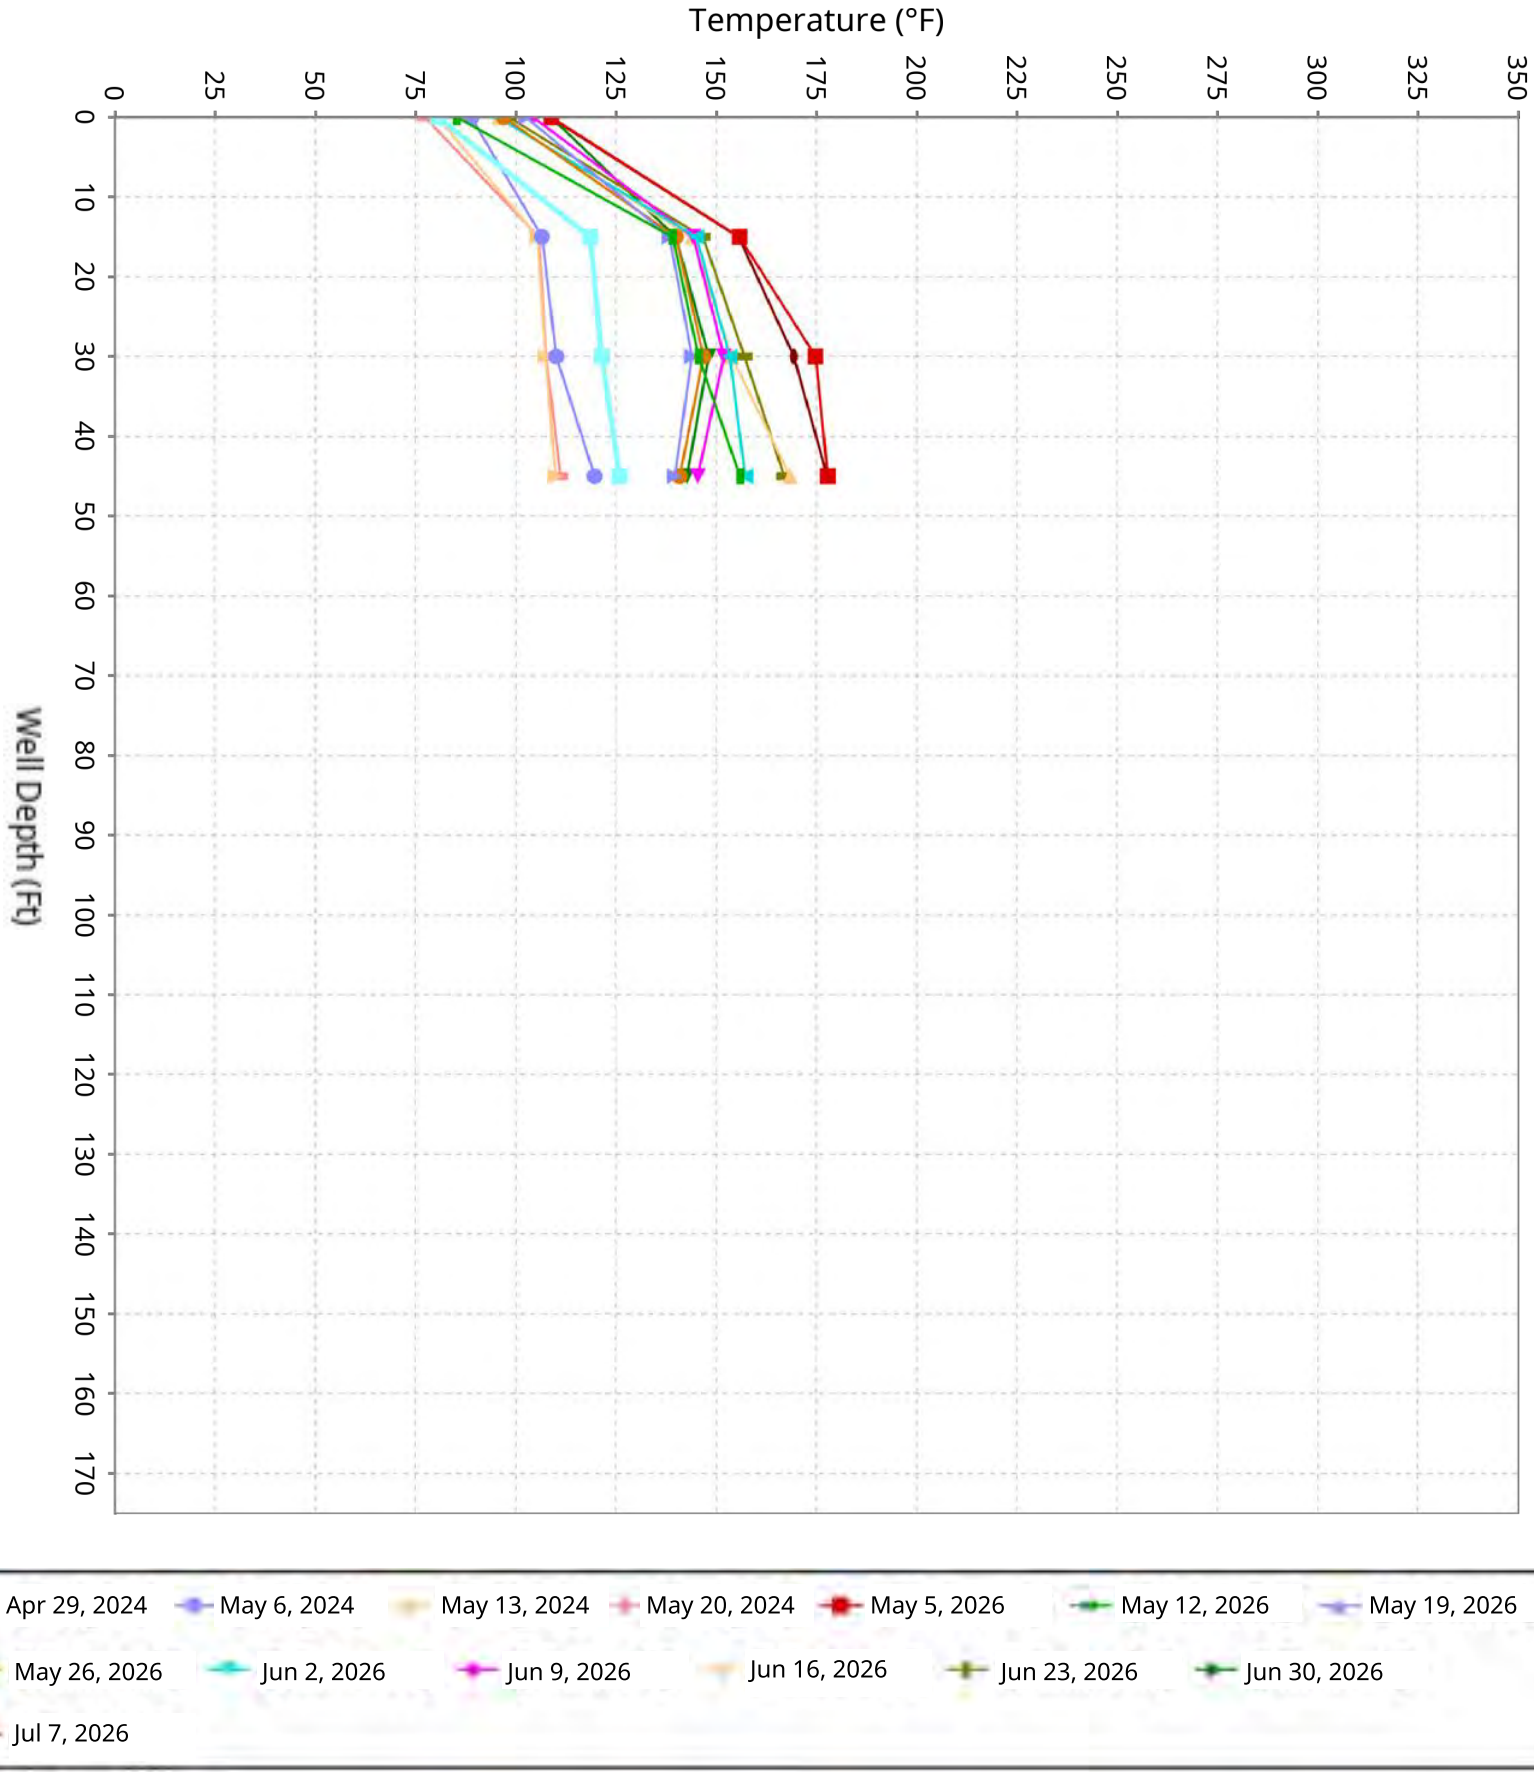
Vertical Temperature Profiles from Temperature Probes at Chiquita Landfill for TP-8

- TP-08
  - The 125-foot thermocouple went offline on March 3rd and TP-8 was offline between March 6th and March 9th for evaluation and maintenance. Upon removing the thermocouples, the casing for TP-08 was found to be damaged due to differential settlement beyond 45-feet, thus preventing the installation of the 100-foot, 125-foot, and 150-foot thermocouples. The 15-foot, 30-foot, and 45-foot thermocouples are active and reporting data.
  - The 45-foot thermocouple showed an increasein maximum temperature of 18°F from 139°F to 157°F from May 31st to June 3rd.

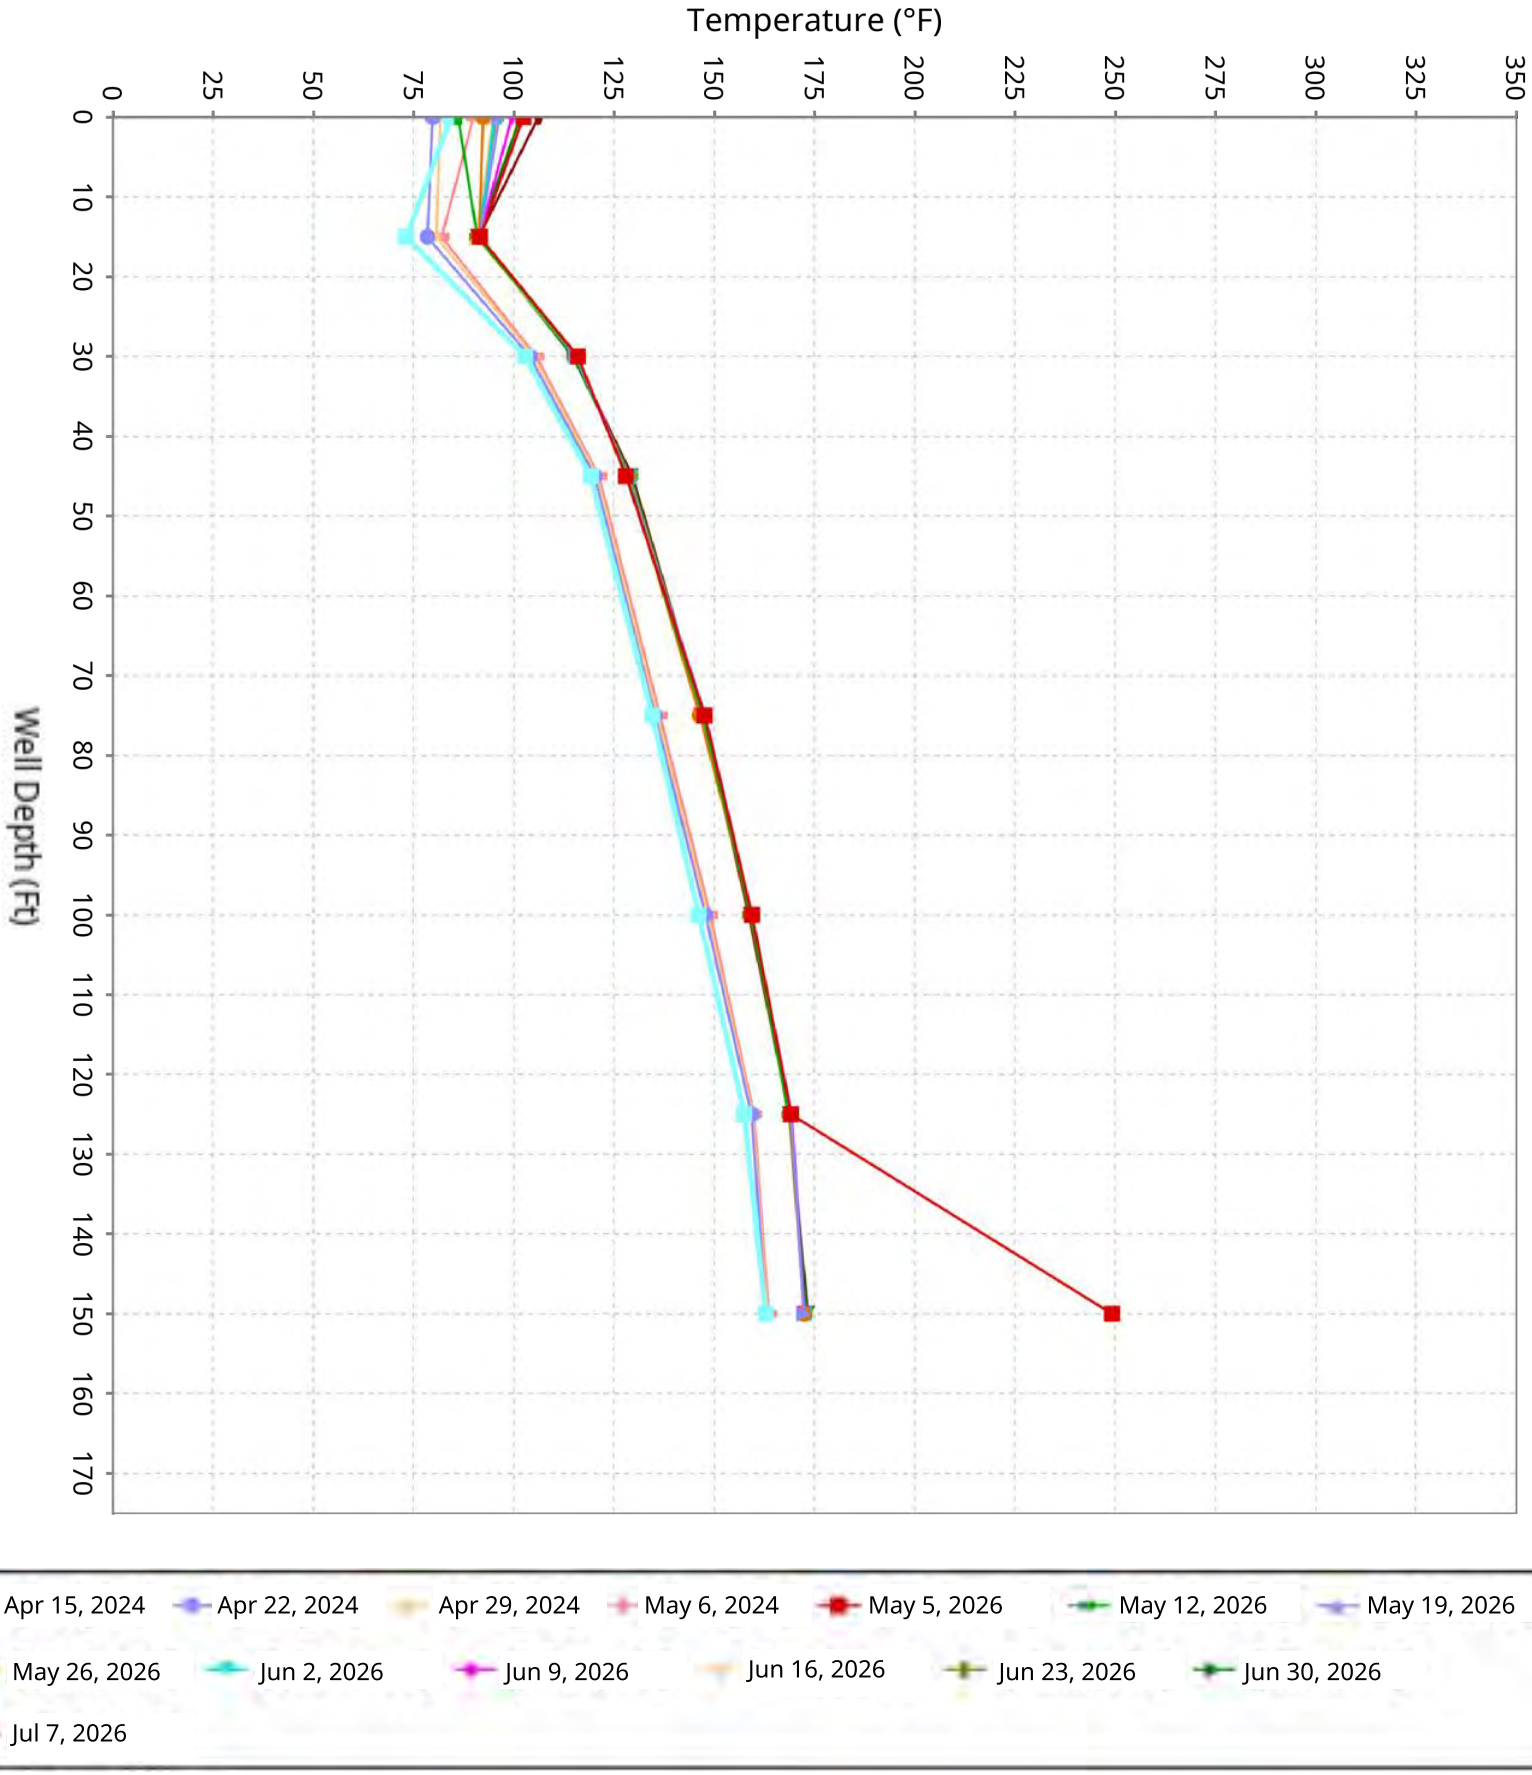
Vertical Temperature Profiles from Temperature Probes at Chiquita Landfill for TP-14

- TP-14
  - The 150-foot thermocouple reported a maximum temperature of 249°F on May 10th, which was anomalous and likely associated with a potential thermocouple sensor malfunction. As a result, the reported temperatures of 0°F from May 11th to May 15th are also considered anomalous. The 150-foot thermocouple was replaced on May 16th and temperatures were consistent with previous recorded values.
