SCS ENGINEERS

14 de agosto de 2026

Asunto: **Informe Mensual de julio de 2026 Conforme a los Objetivos 1A-3 y 5 de la Orden de Cumplimiento de la LEA del 6 de junio de 2024 y a la Carta del 30 de julio de 2024, Vertedero de Chiquita Canyon, Castaic, California**

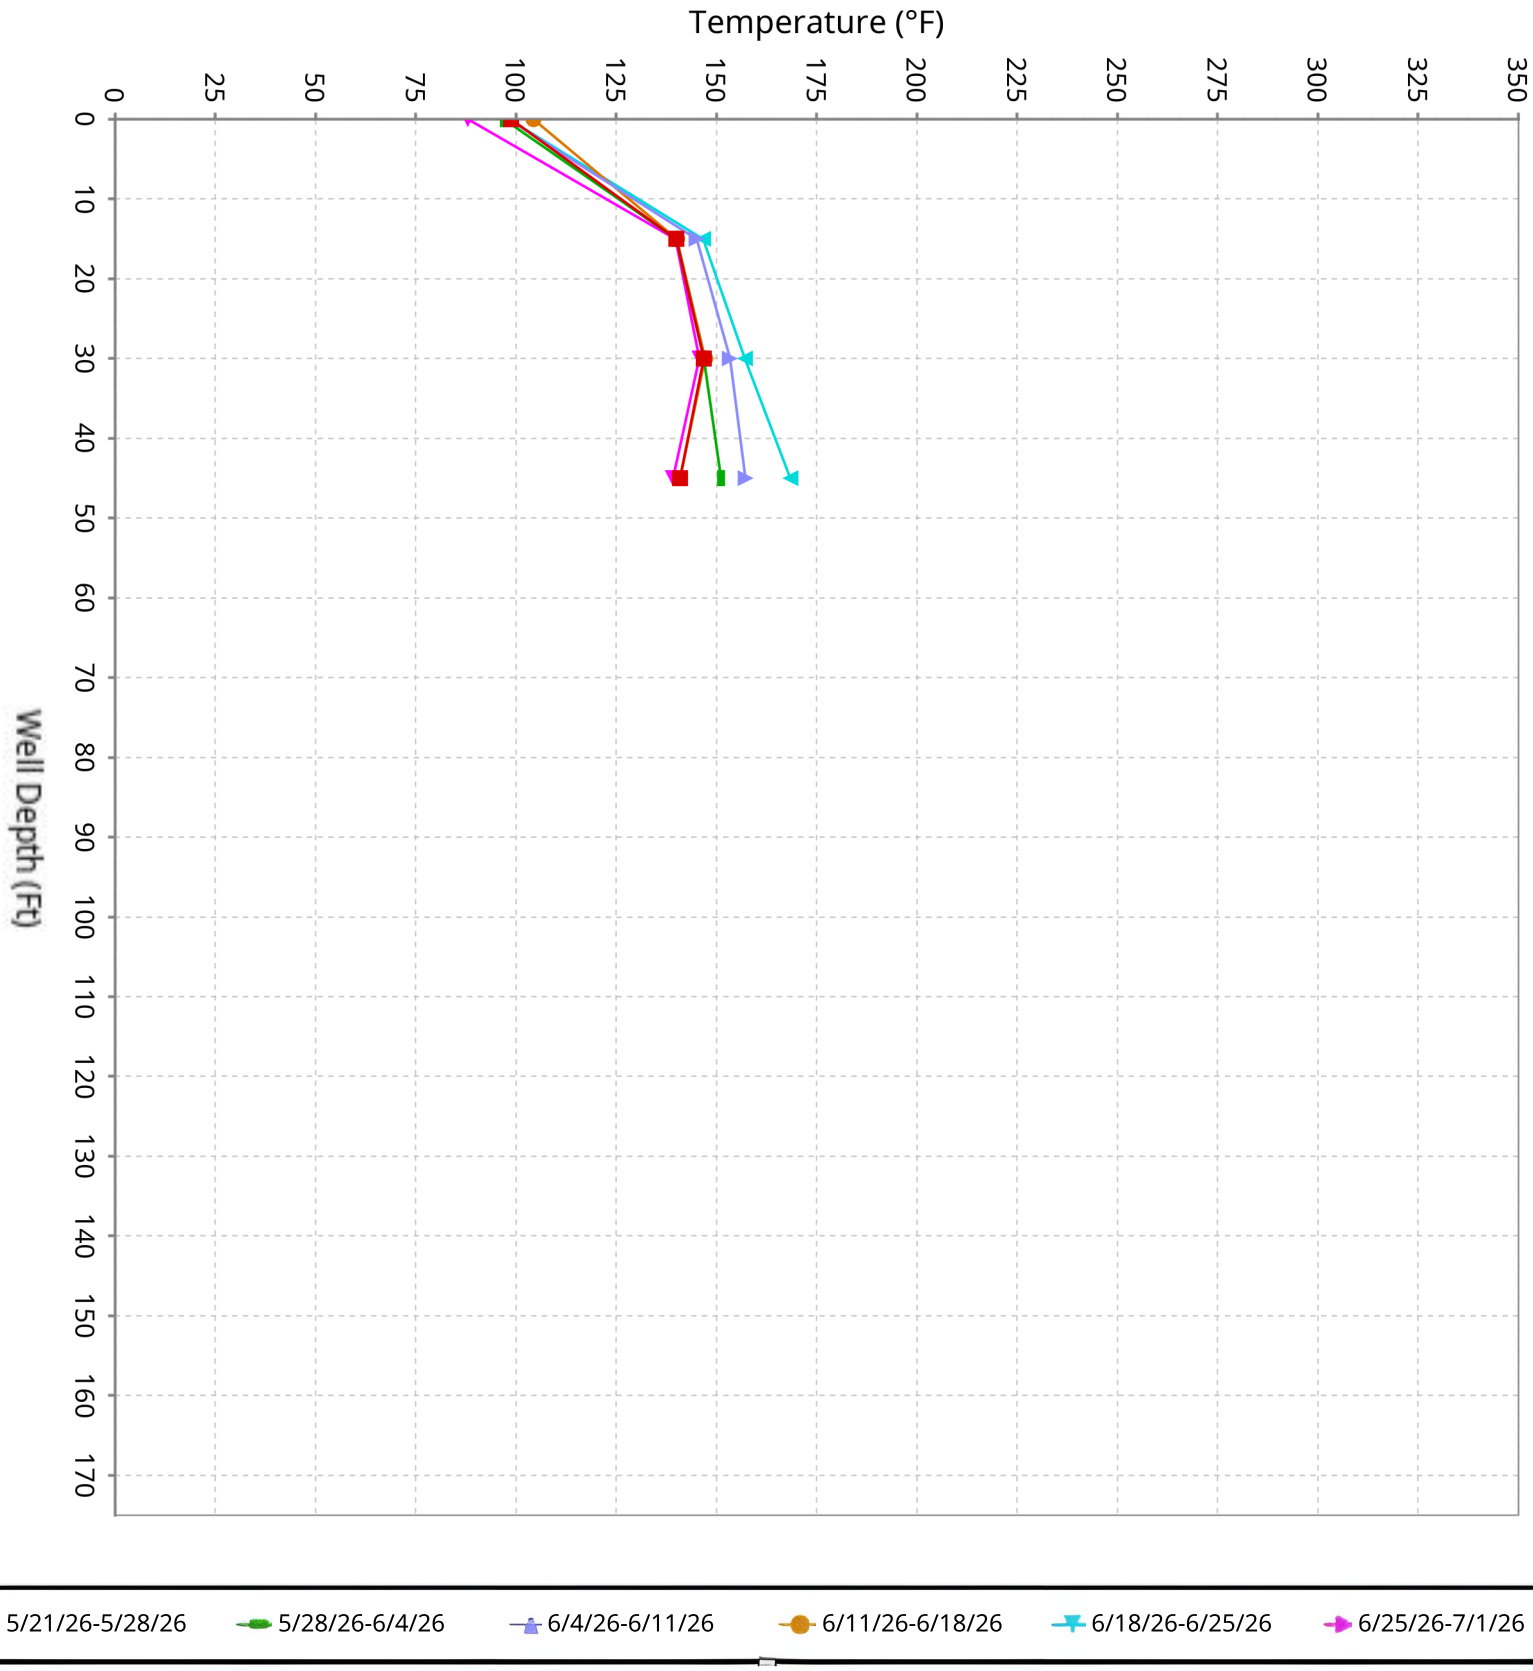
Vertical Temperature Profiles from Temperature Probes at Chiquita Landfill for TP-8

- TP-08
  - The 30-foot thermocouple showed a decrease in maximum temperature of 12°F from 157°F to 145°F from June 23rd to June 25th.
  - The 45-foot thermocouple showed a decrease in maximum temperature of 30°F from 167°F to 137°F from June 23rd to July 1st.

- TP-08
  - The 30-foot and 45-foot thermocouples exhibited temperature increases of 27°F and 29°F, respectively, between July 12, 2026, and July 22, 2026. The Site observed these temperature changes and conducted an investigation between July 23, 2026, and July 29, 2026. TP-08 is installed within extraction well CV-24079, which is equipped with a liquid extraction pump. The investigation determined that recent pump operations removed liquids from the well over the preceding several weeks, influencing the temperature fluctuations observed within TP-08. As liquid levels declined, temperatures measured at the associated thermocouple depths increased. The subsequent decrease in temperature may be attributable to the removal of heat from the landfill mass as liquids were extracted from the well.

- TP-08
  - The 30-foot and 45-foot thermocouples exhibited temperature increases of 27°F and 29°F, respectively, between July 12, 2026, and July 22, 2026. In response, Site personnel observed the temperature changes and conducted an investigation from July 23, 2026, through July 29, 2026. Following the investigation, temperatures continued to decline from July 30, 2026, through August 5, 2026.

- TP-08 is installed within extraction well CV-24079, which is equipped with a liquid extraction pump. The investigation determined that the existing pump is experiencing a power-related issue and requires removal. Site personnel have identified the need for a replacement pump and plan to complete the replacement next week.

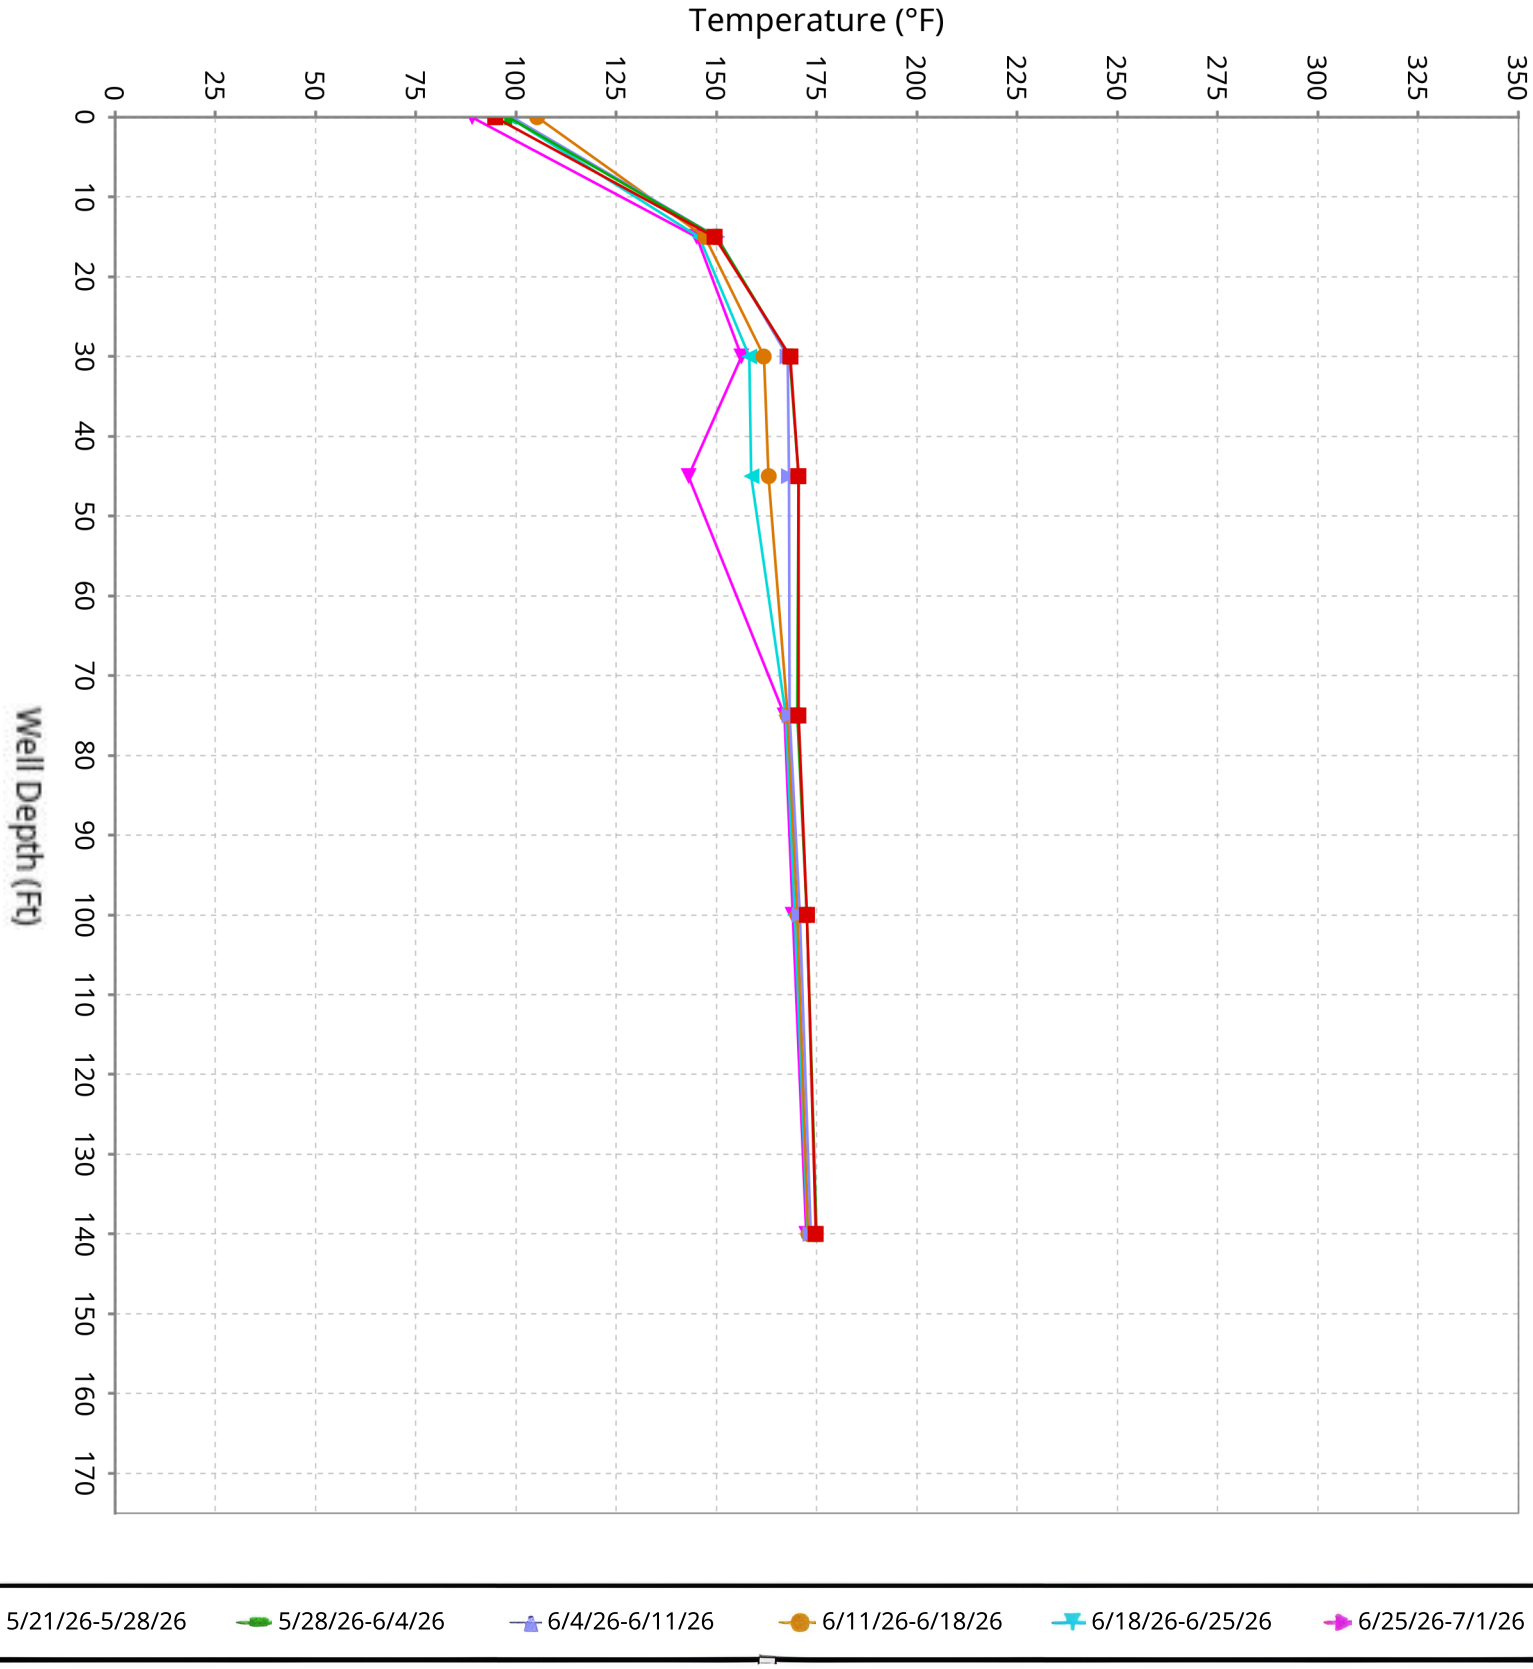
Vertical Temperature Profiles from Temperature Probes at Chiquita Landfill for TP-13

- TP-13
  - The 45-foot thermocouple remained consistent with previous recorded temperatures.

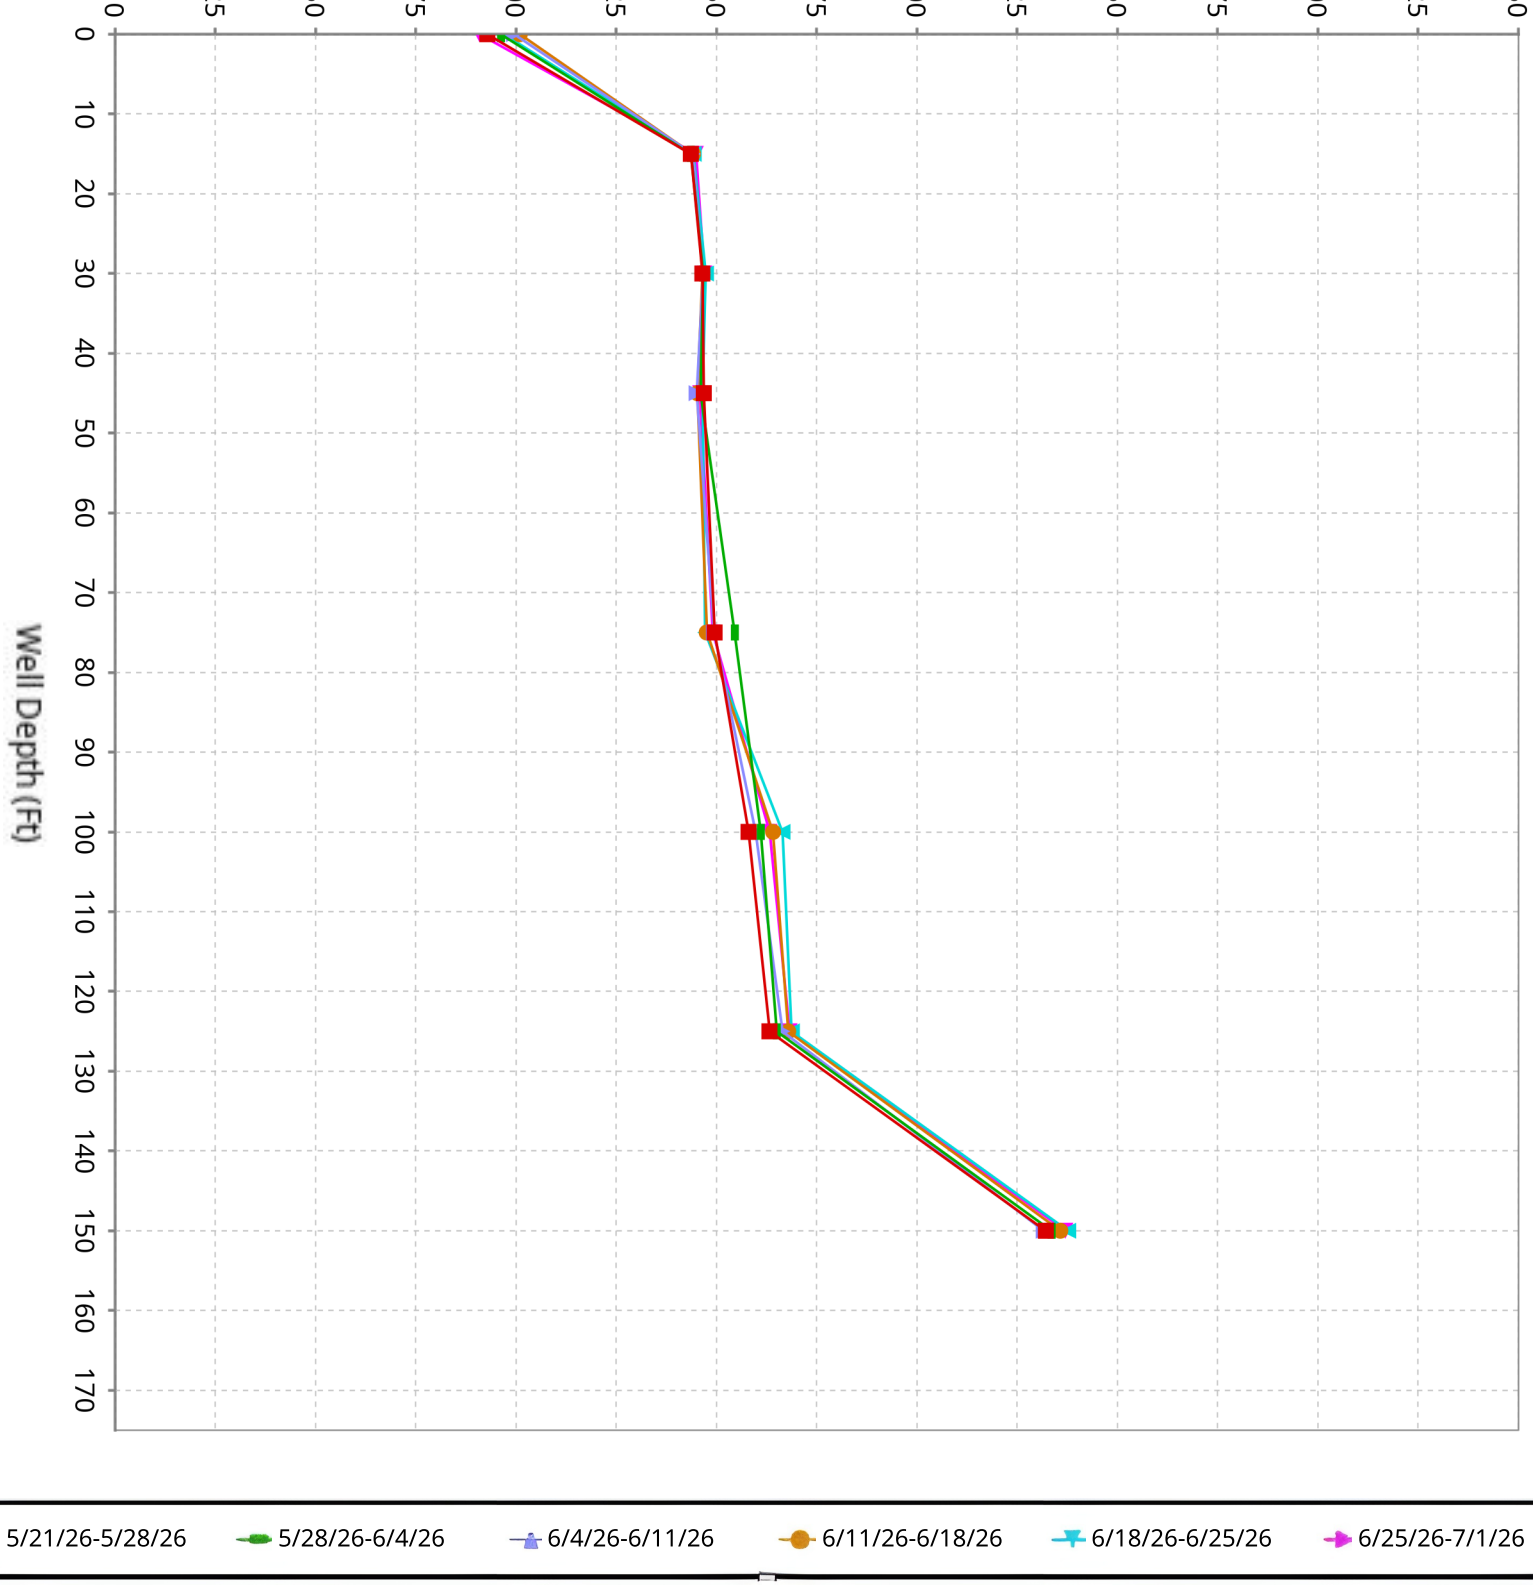
Vertical Temperature Profiles from Temperature Probes at Chiquita Landfill for TP-19

- TP-19
  - A discrepancy was identified during the review of the weekly data. Upon investigation, the Site determined that the associated battery had failed and subsequently replaced it. During this inspection, the temperature reading from the 125-foot thermocouple was observed to be anomalously low. Further evaluation indicated that the 125-foot thermocouple required replacement. As an interim measure, the Site installed a 120-foot thermocouple that was available onsite and ordered a replacement 125-foot thermocouple. The replacement 125-foot thermocouple will be installed upon receipt.
  - The 45-foot thermocouple showed an increase in maximum temperature of 15°F from 146°F to 161°F from July 23rd to July 24th.

TP-19: A discrepancy was identified during the review of the weekly data. Upon investigation, the Site determined that the associated battery had failed and subsequently replaced it. During this inspection, the temperature reading from the 125-foot thermocouple was observed to be anomalously low. Further evaluation indicated that the 125-foot thermocouple required replacement. As an interim measure, the Site installed a 120-foot thermocouple that was available on-site and ordered a replacement 125-foot thermocouple. The replacement 125-foot thermocouple will be installed upon receipt.

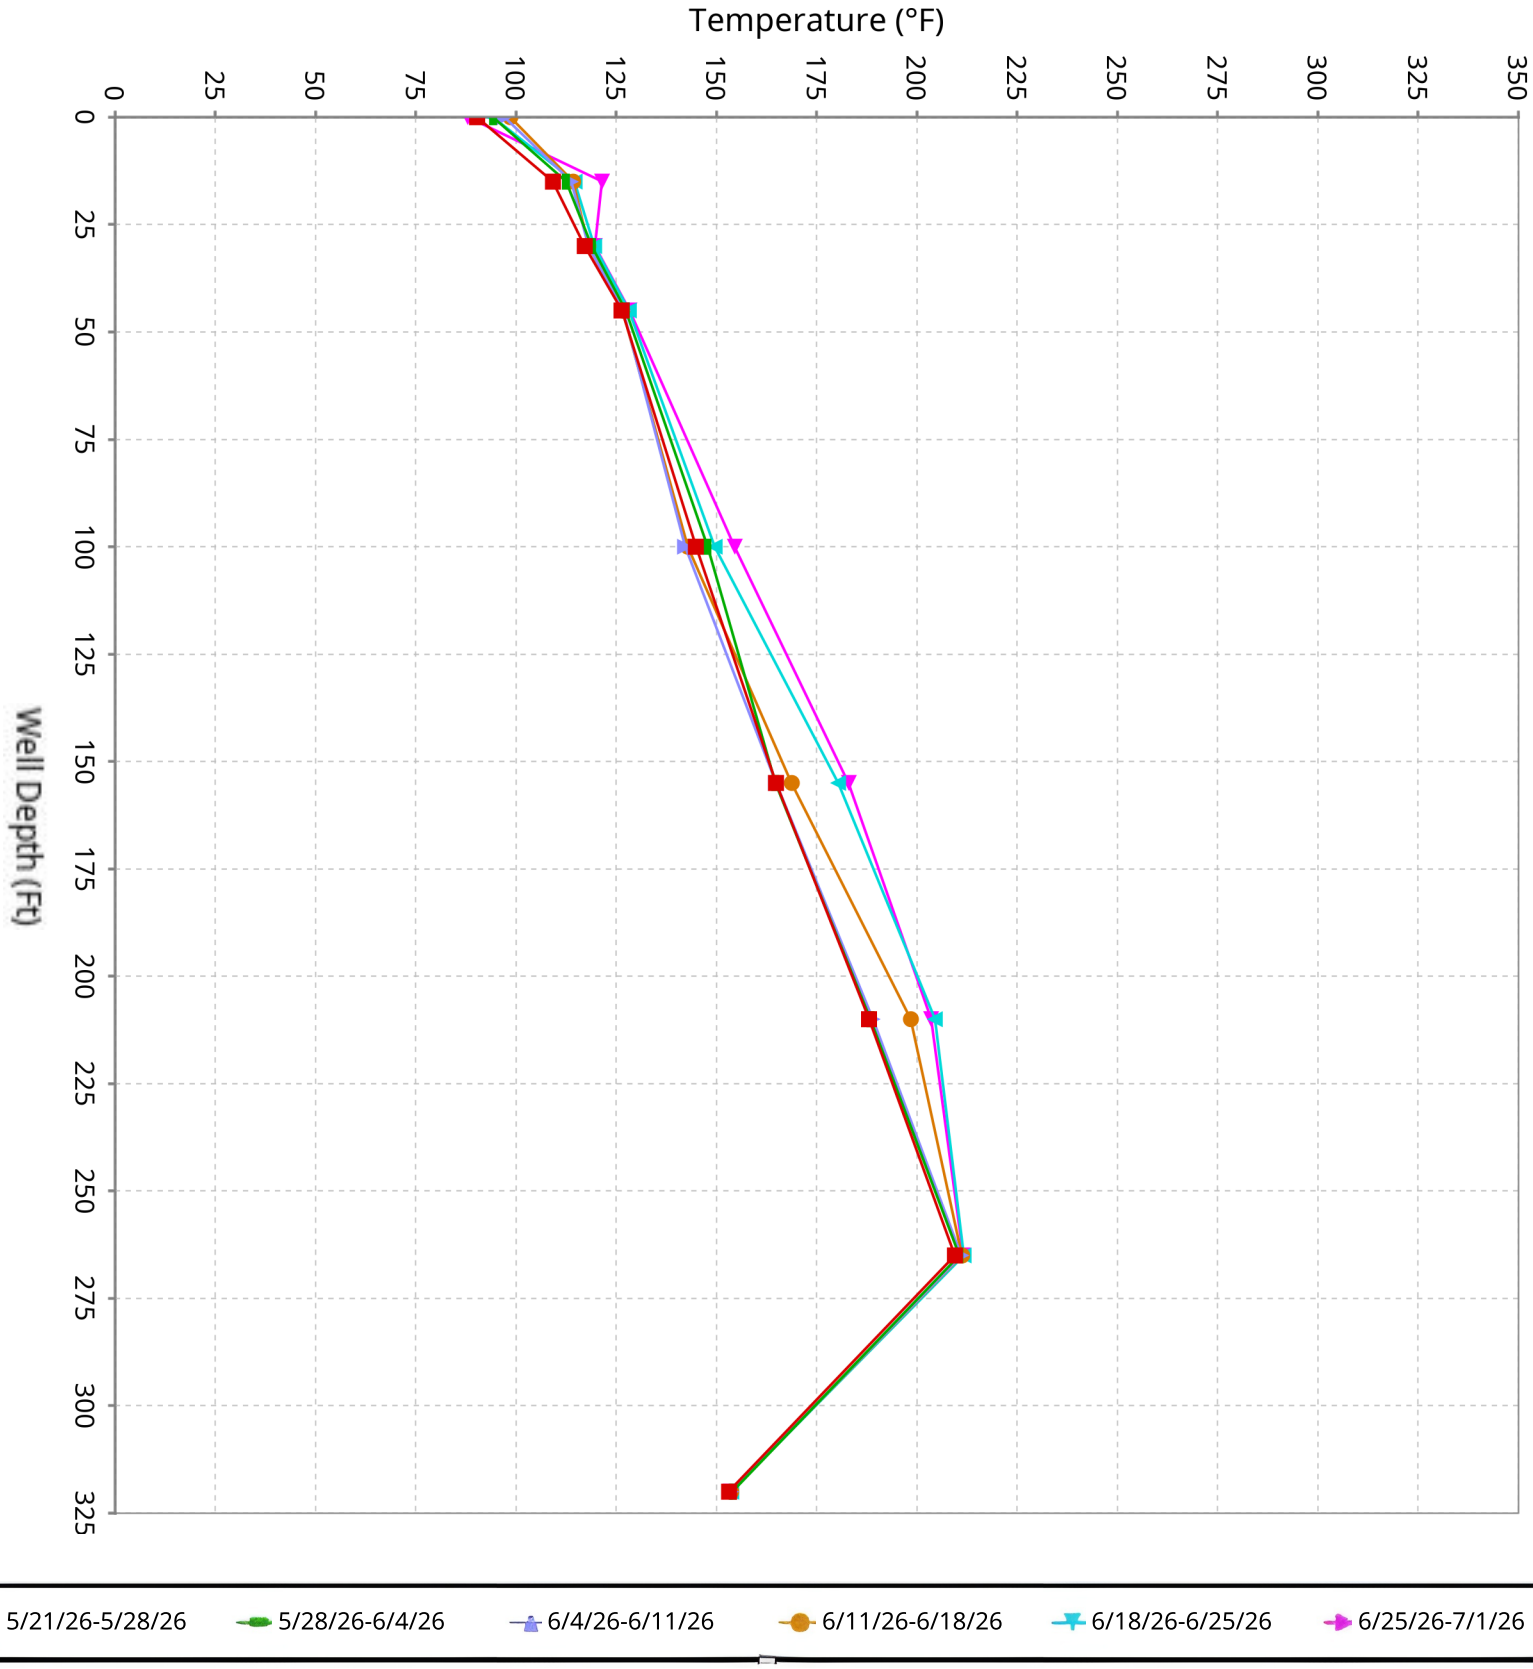
Vertical Temperature Profiles from Temperature Probes at Chiquita Landfill for TP-24

- TP-24
  - The 155-foot thermocouple remained consistent with previous recorded temperatures.
  - The 210-foot thermocouple showed an increase in maximum temperature of 12°F from 190°F to 202°F from July 7th to July 8th.

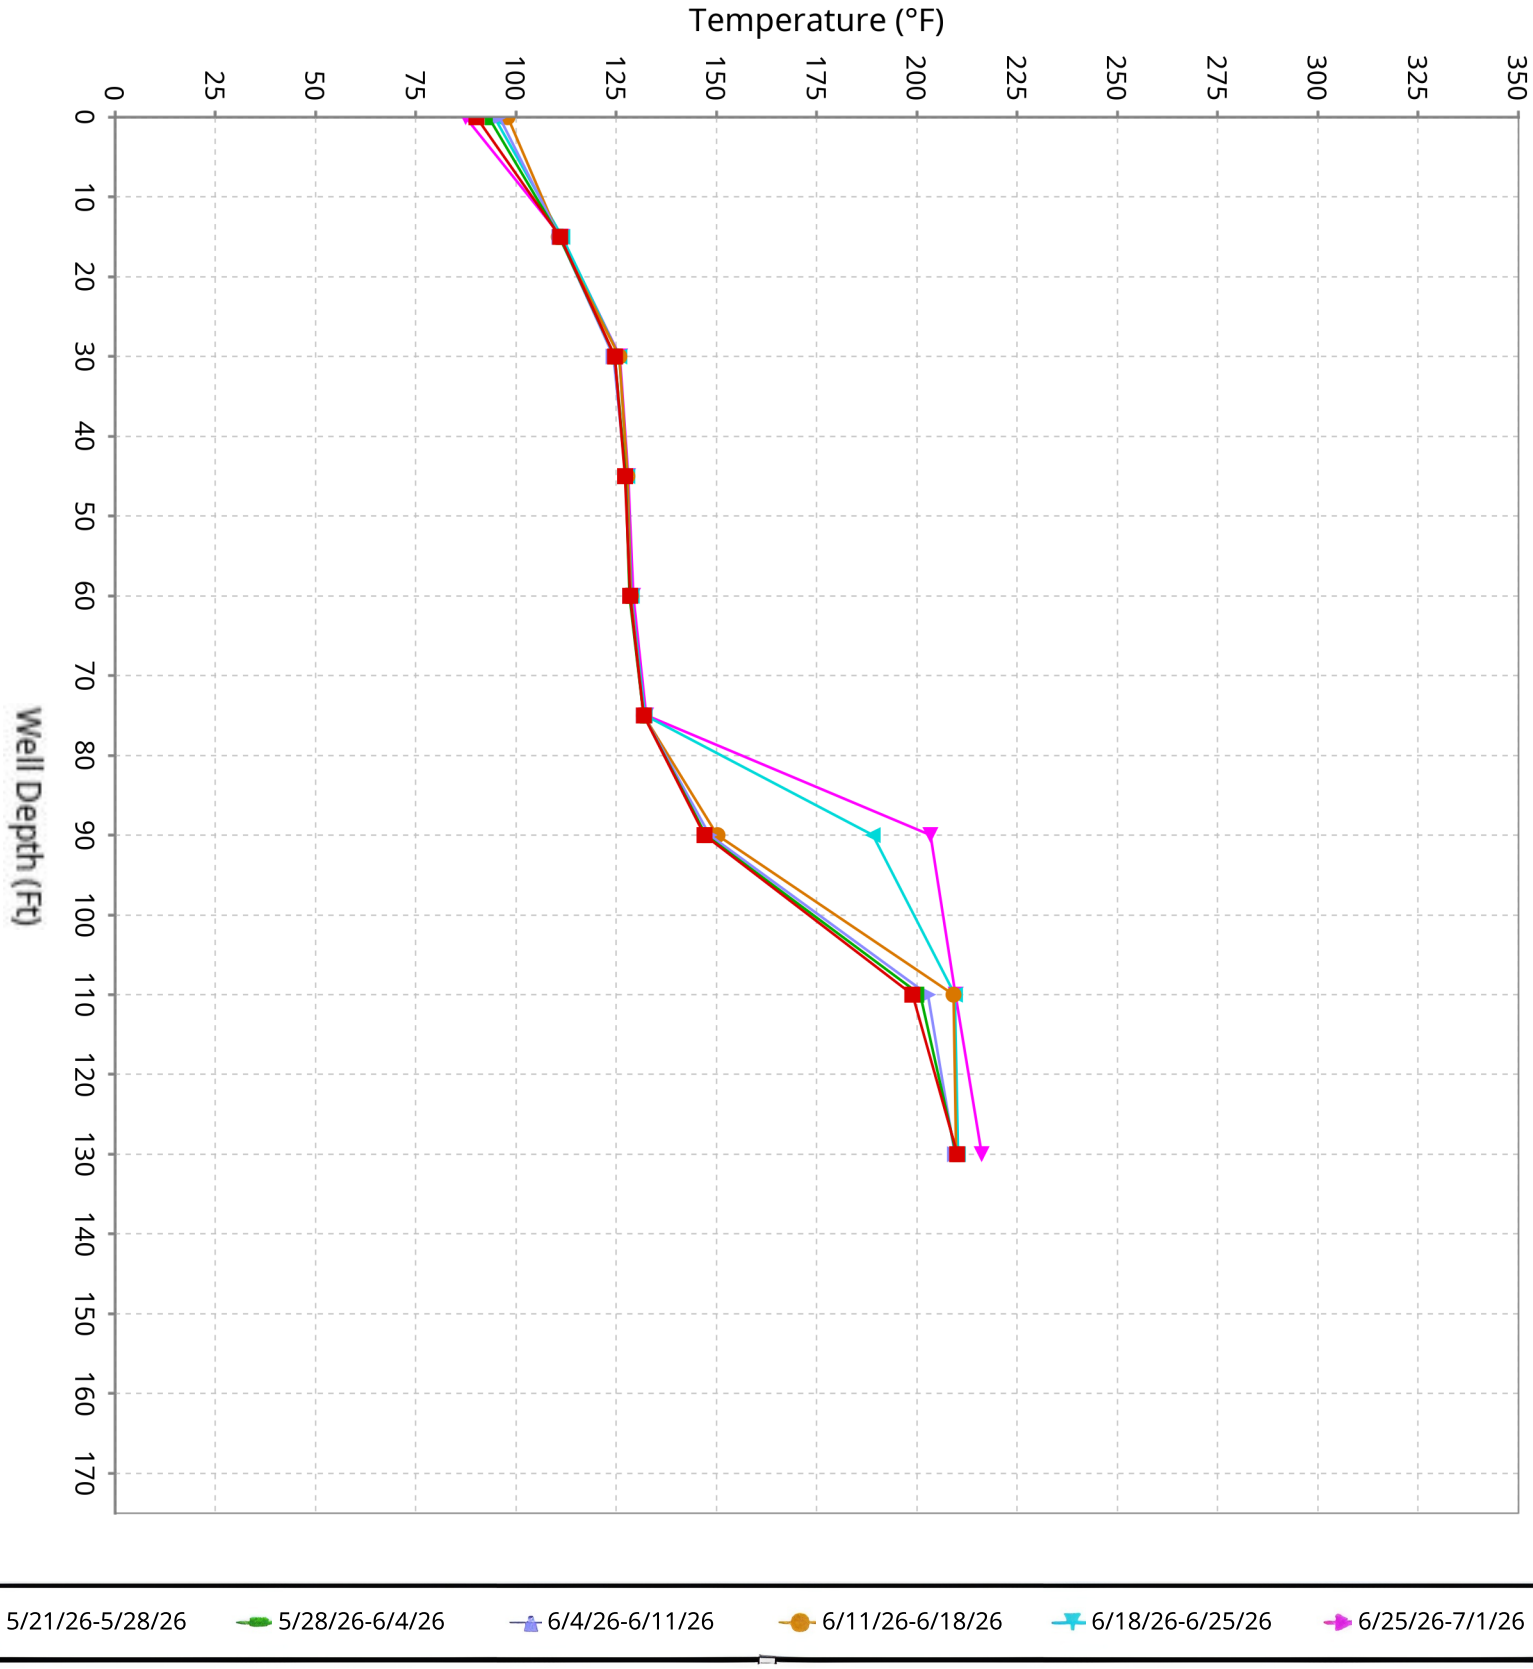
Vertical Temperature Profiles from Temperature Probes at Chiquita Landfill for TP-25

- TP-25
  - The 30-foot thermocouple showed an increase in maximum temperature of 78°F from 127°F to 205°F from July 7th to July 8th. This temperature increase is likely a result of additional pumping in nearby wells resulting in increased gas movement and extraction in the area.

The atypical temperature profiles observed at each thermocouple for TP-25 were investigated. The exterior temperature of the well casing was measured at 181°F. The area surrounding the temperature probe casing has settled approximately 3 to 4 feet since it was installed, and the inspection confirmed that the probe wiring remained intact. No visible signs of aboveground liquid accumulation were observed.

- TP-25
    - The Site evacuated liquid from the TP-25 probe casing and has been routinely monitoring temperature readings. The Site plans to conduct a follow-up camera inspection of the probe casing to determine whether additional liquid infiltration has occurred within the TP-25 well casing and to assess the condition of the casing interior.
    - The 110-foot thermocouple showed a decrease in maximum temperature of 27°F from 238°F to 210°F from July 20th to July 29th.
    - The 130-foot thermocouple showed an increase in maximum temperature of 36°F from 212°F to 248°F from July 22nd to July 27th.

increase may have resulted from additional pumping at nearby wells, which increased gas movement and extraction in the area. The probe will be removed and evaluated to determine whether any failure or other issue with the probe may have contributed to the elevated reading.

During thermocouple removal, the first casing section was unthreaded and conditions were allowed to stabilize before work continued. A downhole camera inspection identified approximately 2 to 3 feet of liquid within the temperature probe casing and moisture at several connection points. Following liquid removal by vacuum extraction, observations suggested that the well seals had failed, allowing communication with the casing annulus. The temperature probe is being evaluated to see if it can be repaired or if it needs to be replaced.

TP-25: The Site evacuated liquid from the TP-25 probe casing and has been routinely monitoring temperature readings. The Site plans to conduct a follow-up camera inspection of the probe casing to determine whether additional liquid infiltration has occurred within the TP-25 well casing and to assess the condition of the casing interior.

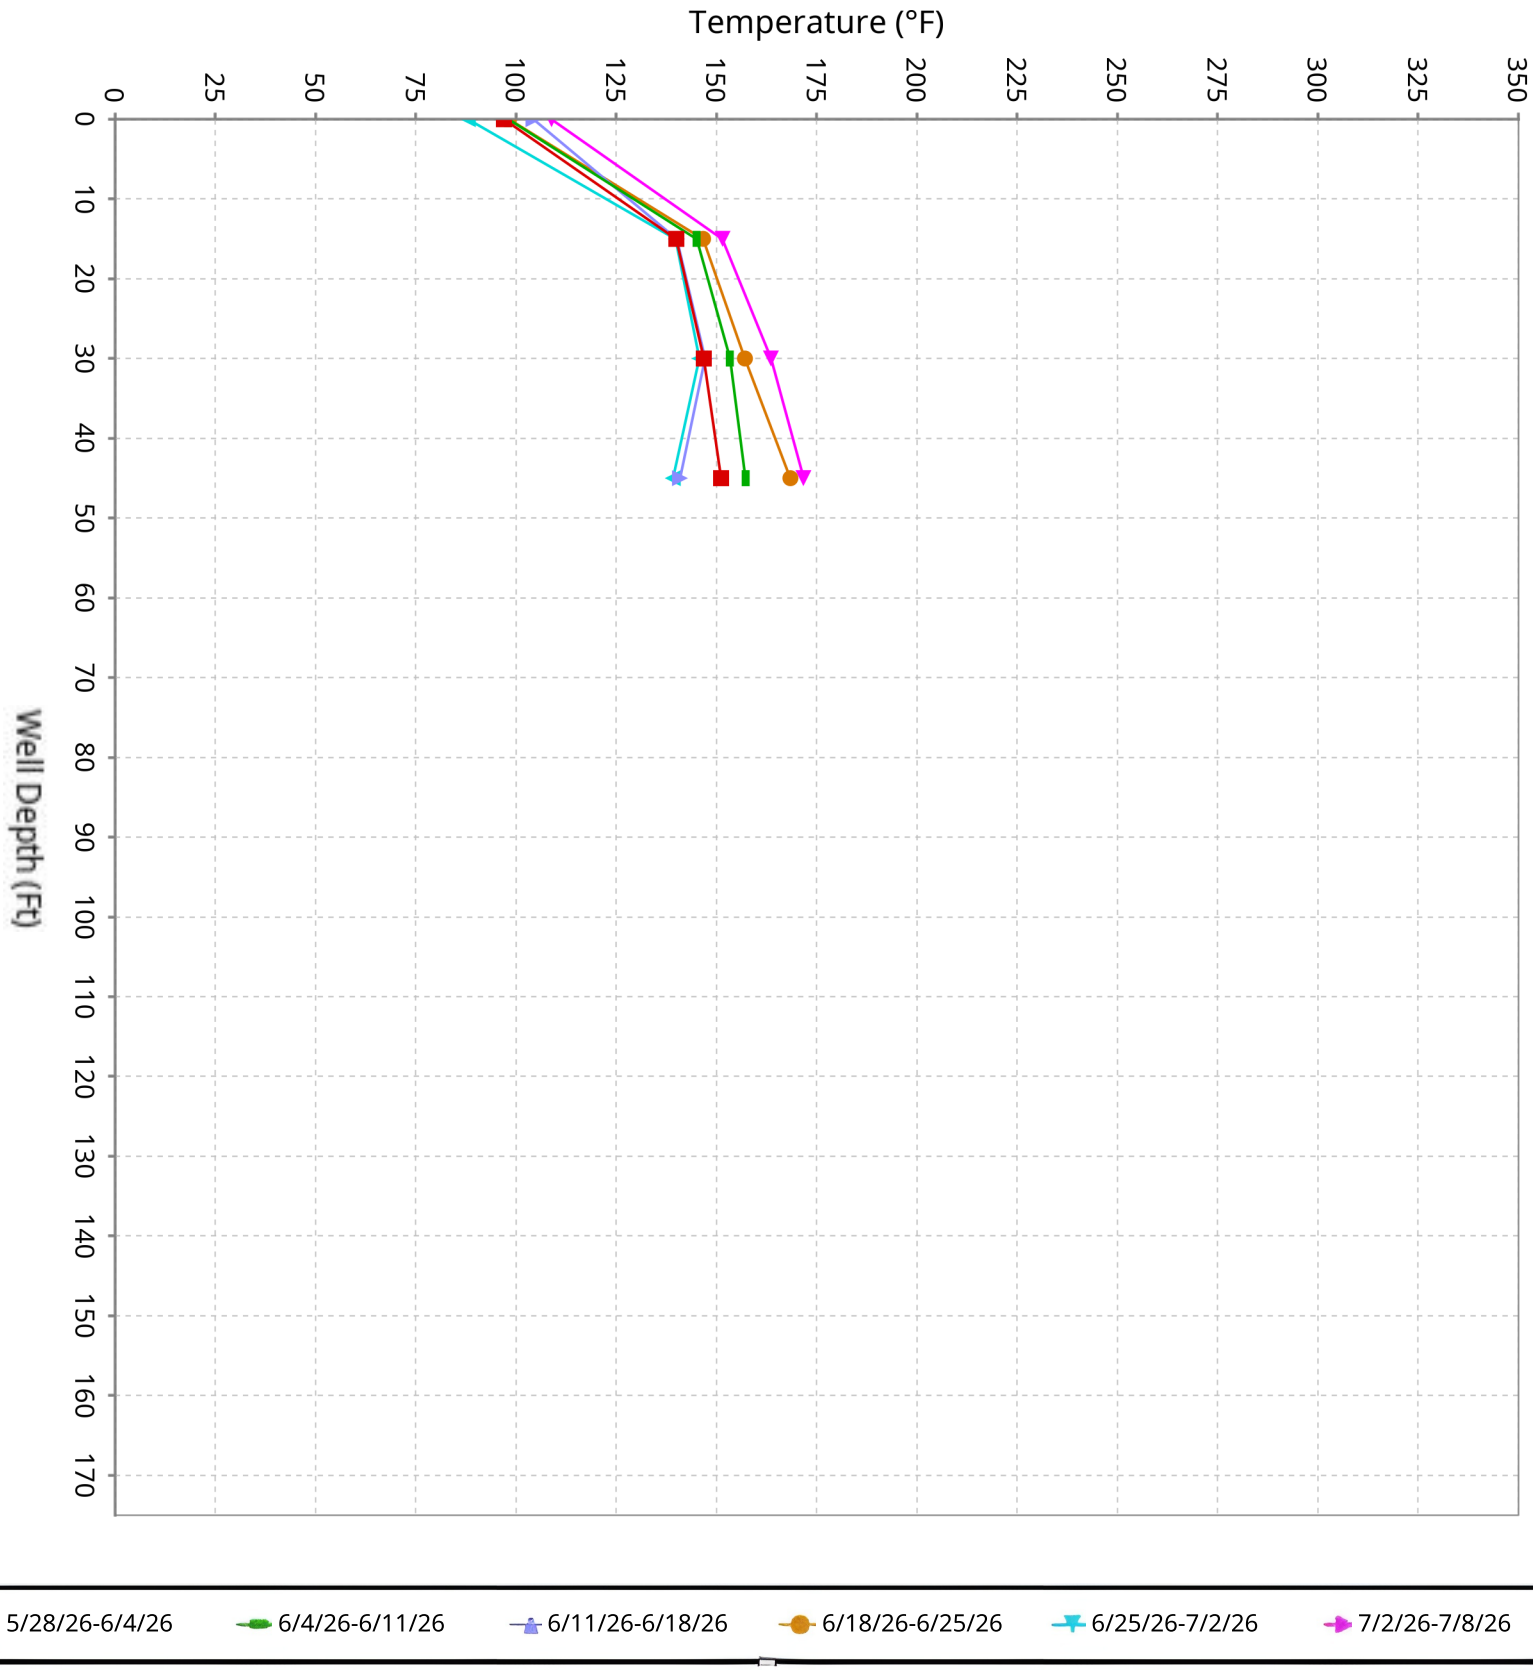
Vertical Temperature Profiles from Temperature Probes at Chiquita Landfill for TP-8

- TP-08
  - The 15-foot thermocouple showed an increase in maximum temperature of 10°F from 138°F to 148°F from July 6th to July 7th.
  - The 30-foot thermocouple showed an increase in maximum temperature of 16°F from 144°F to 160°F from July 6th to July 7th.
  - The 45-foot thermocouple showed an increase in maximum temperature of 34°F from 138°F to 172°F from July 6th to July 7th.

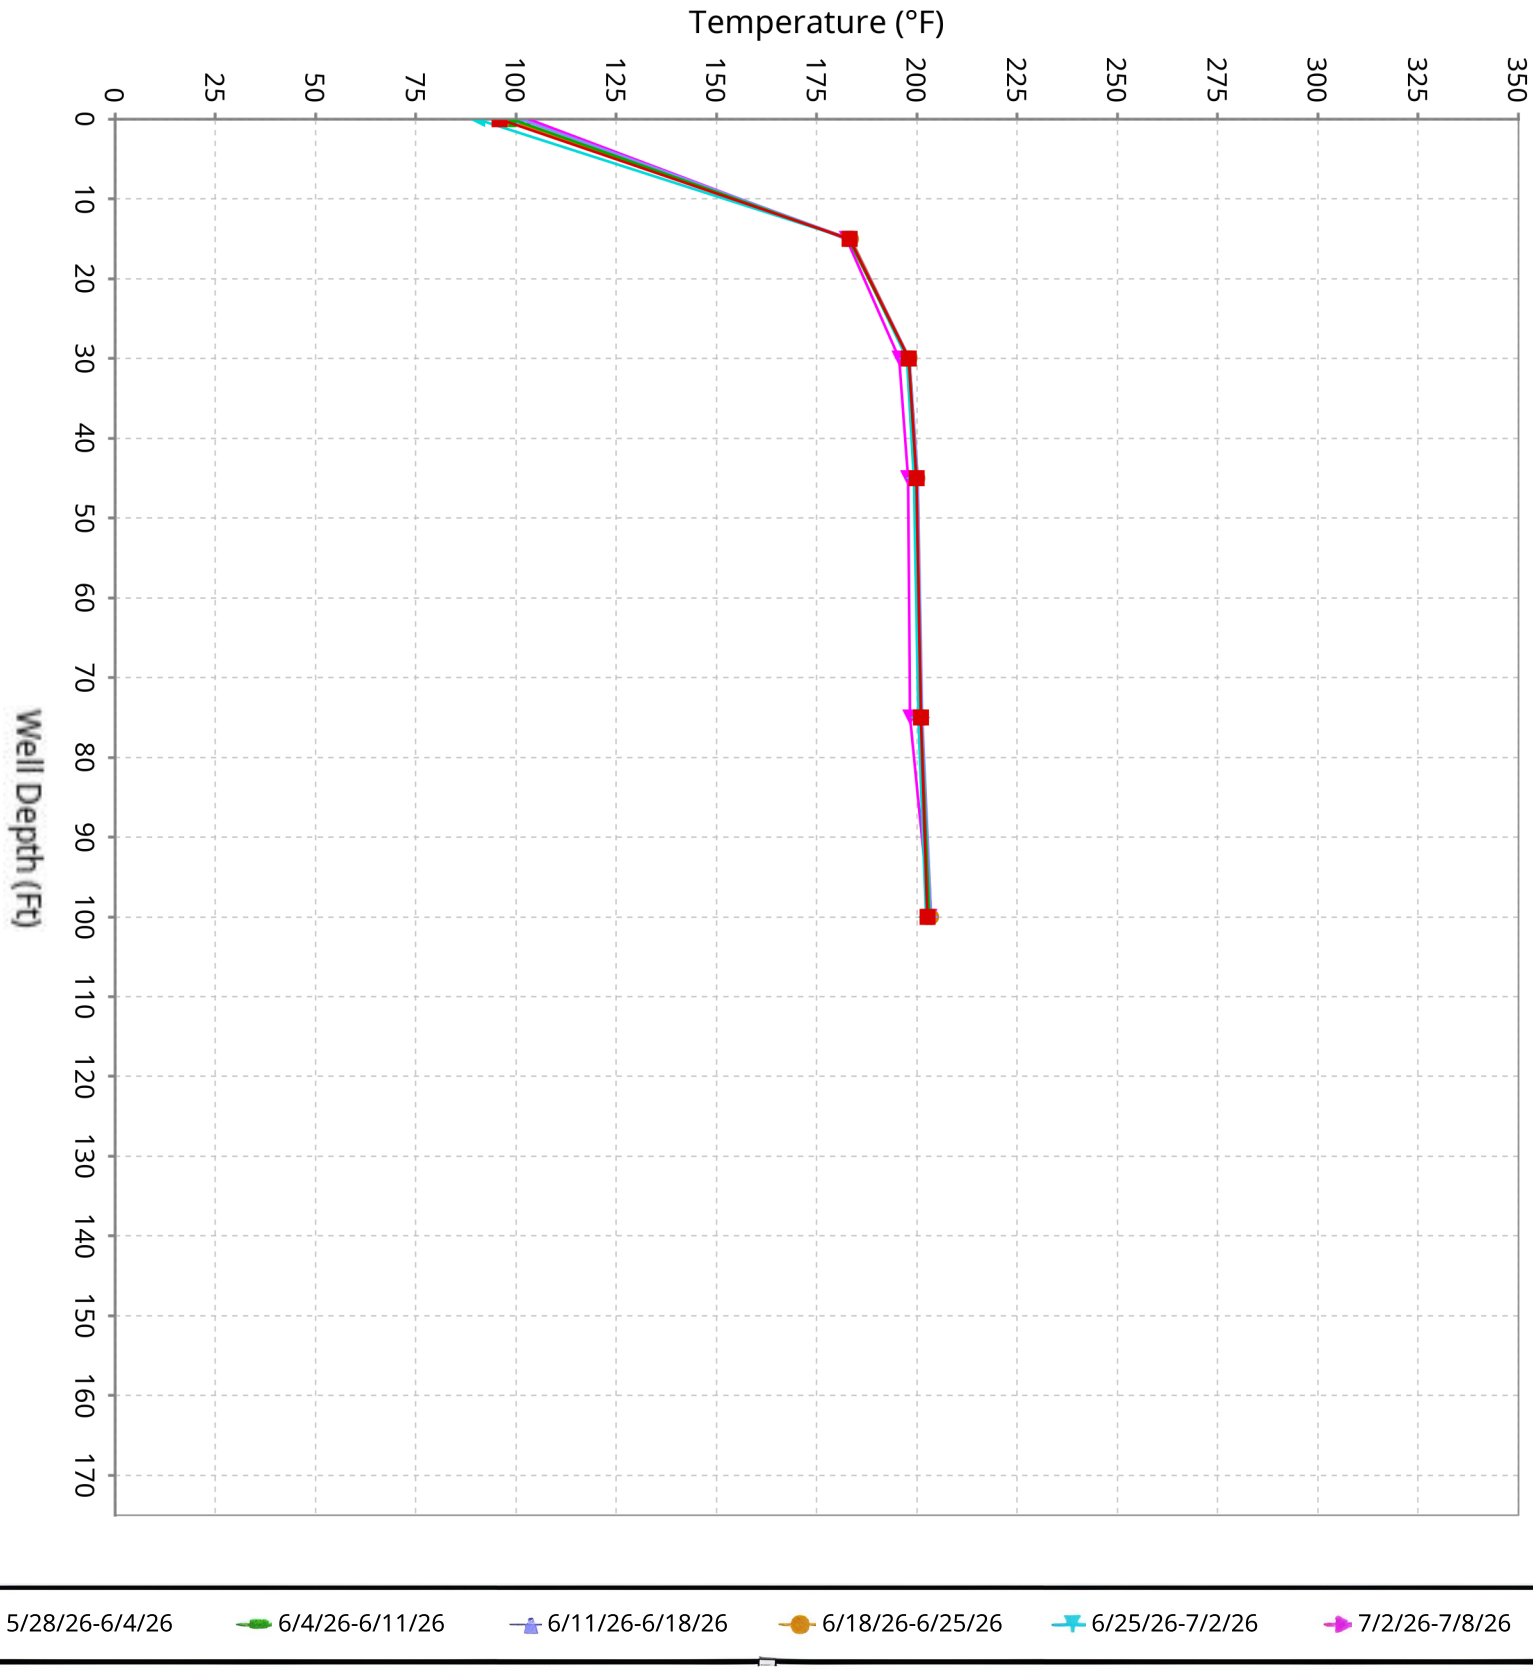
Vertical Temperature Profiles from Temperature Probes at Chiquita Landfill for TP-15

- TP-15
  - The 30-foot thermocouple showed a decrease in maximum temperature of 11°F from 196°F to 185°F from July 2nd to July 4th.

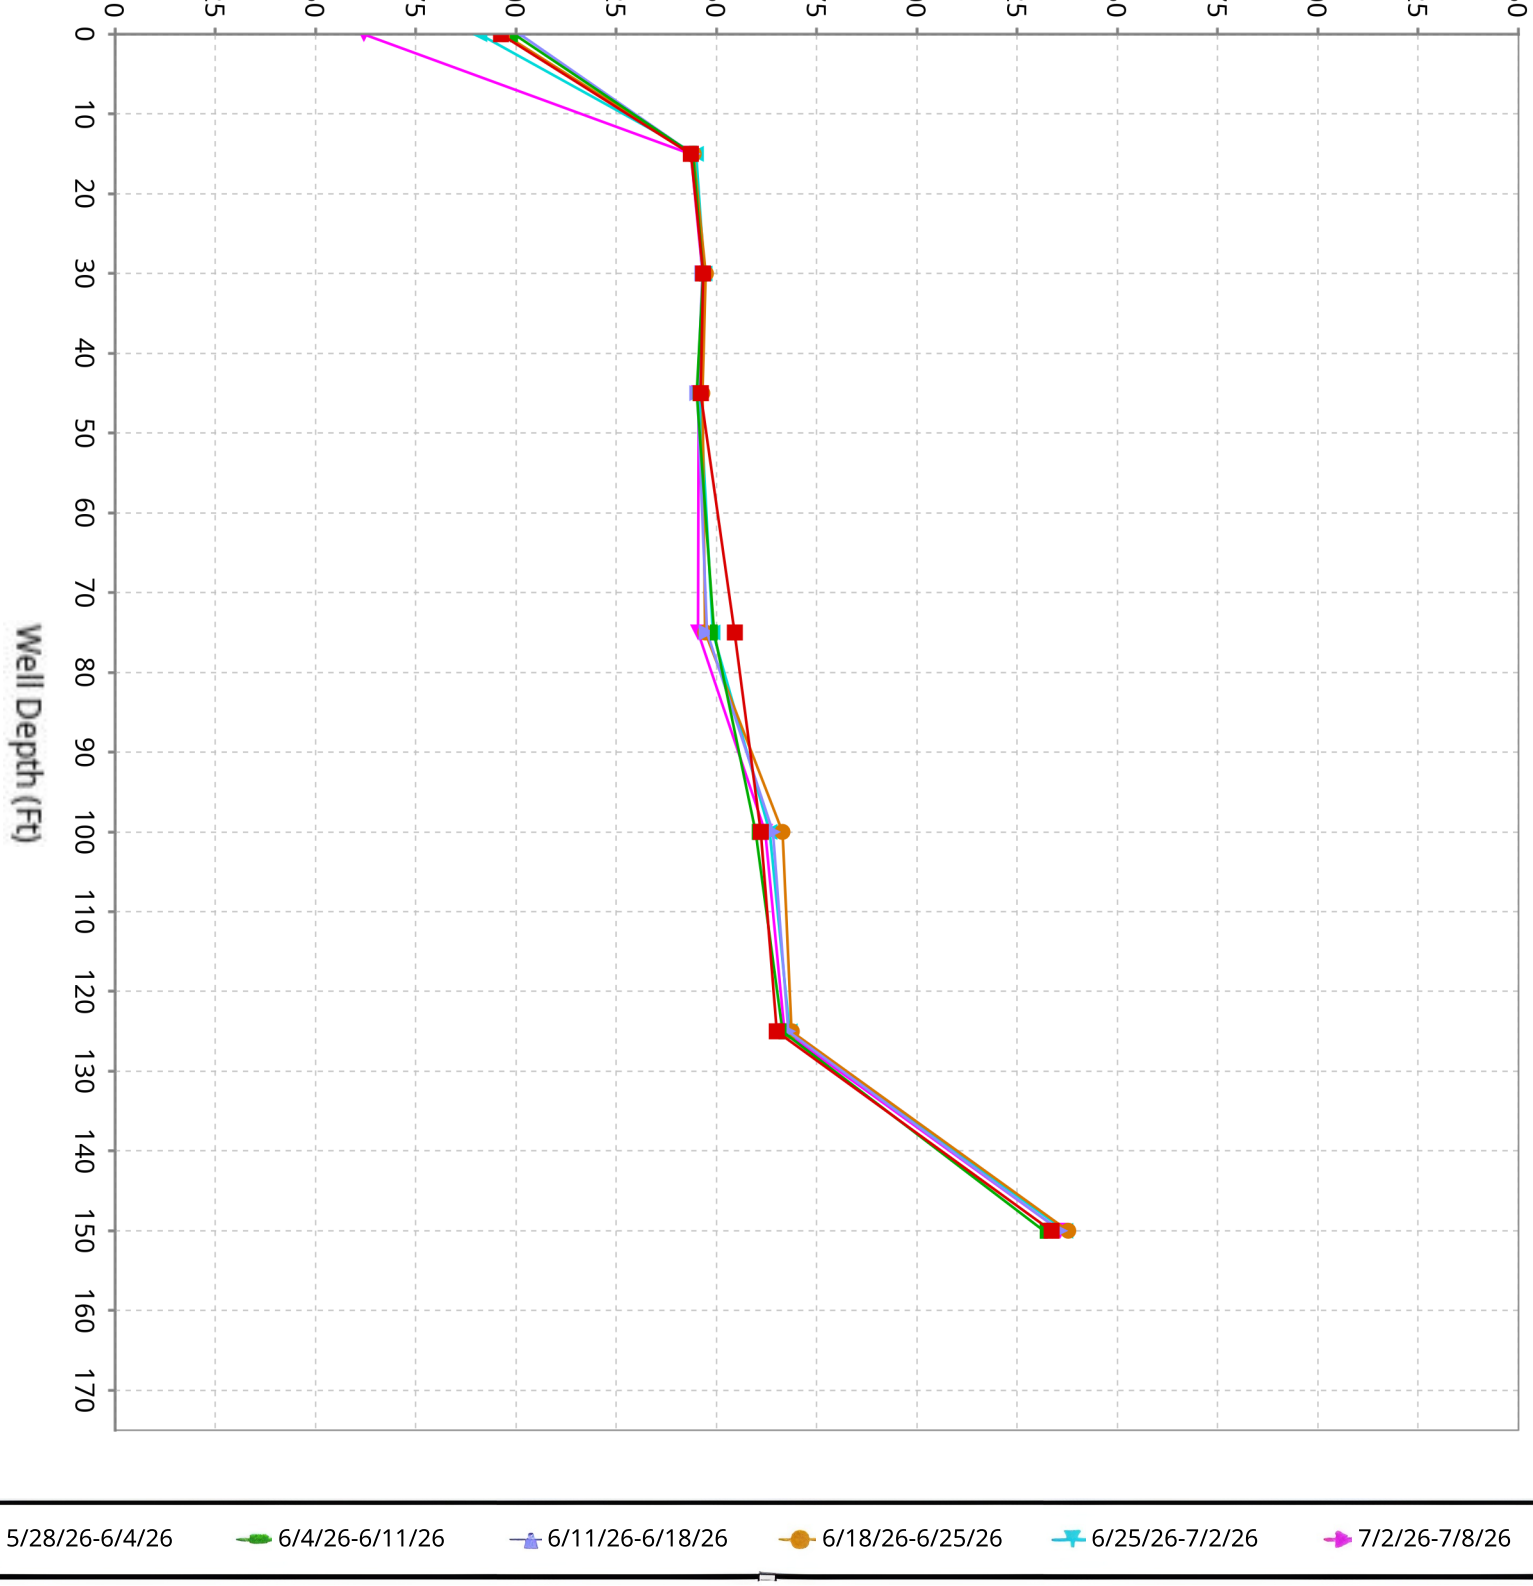
Vertical Temperature Profiles from Temperature Probes at Chiquita Landfill for TP-19

- TP-19
  - A discrepancy was identified during the review of last week's data. Upon investigation, the Site determined that the associated battery had failed and subsequently replaced it. During this inspection, the temperature reading from the 125-foot thermocouple was observed to be anomalously low. Further evaluation indicated that the 125-foot thermocouple required replacement. As an interim measure, the Site installed a 120-foot thermocouple that was available onsite and ordered a replacement 125-foot thermocouple. The replacement 125-foot thermocouple will be installed upon receipt.
  - The 45-foot thermocouple remained consistent with previously recorded temperatures.
  - The 75-foot thermocouple remained consistent with previously recorded temperatures.
