SCS ENGINEERS

14 de agosto de 2026

Asunto: **Informe Mensual de julio de 2026 Conforme a los Objetivos 1A-3 y 5 de la Orden de Cumplimiento de la LEA del 6 de junio de 2024 y a la Carta del 30 de julio de 2024, Vertedero de Chiquita Canyon, Castaic, California**

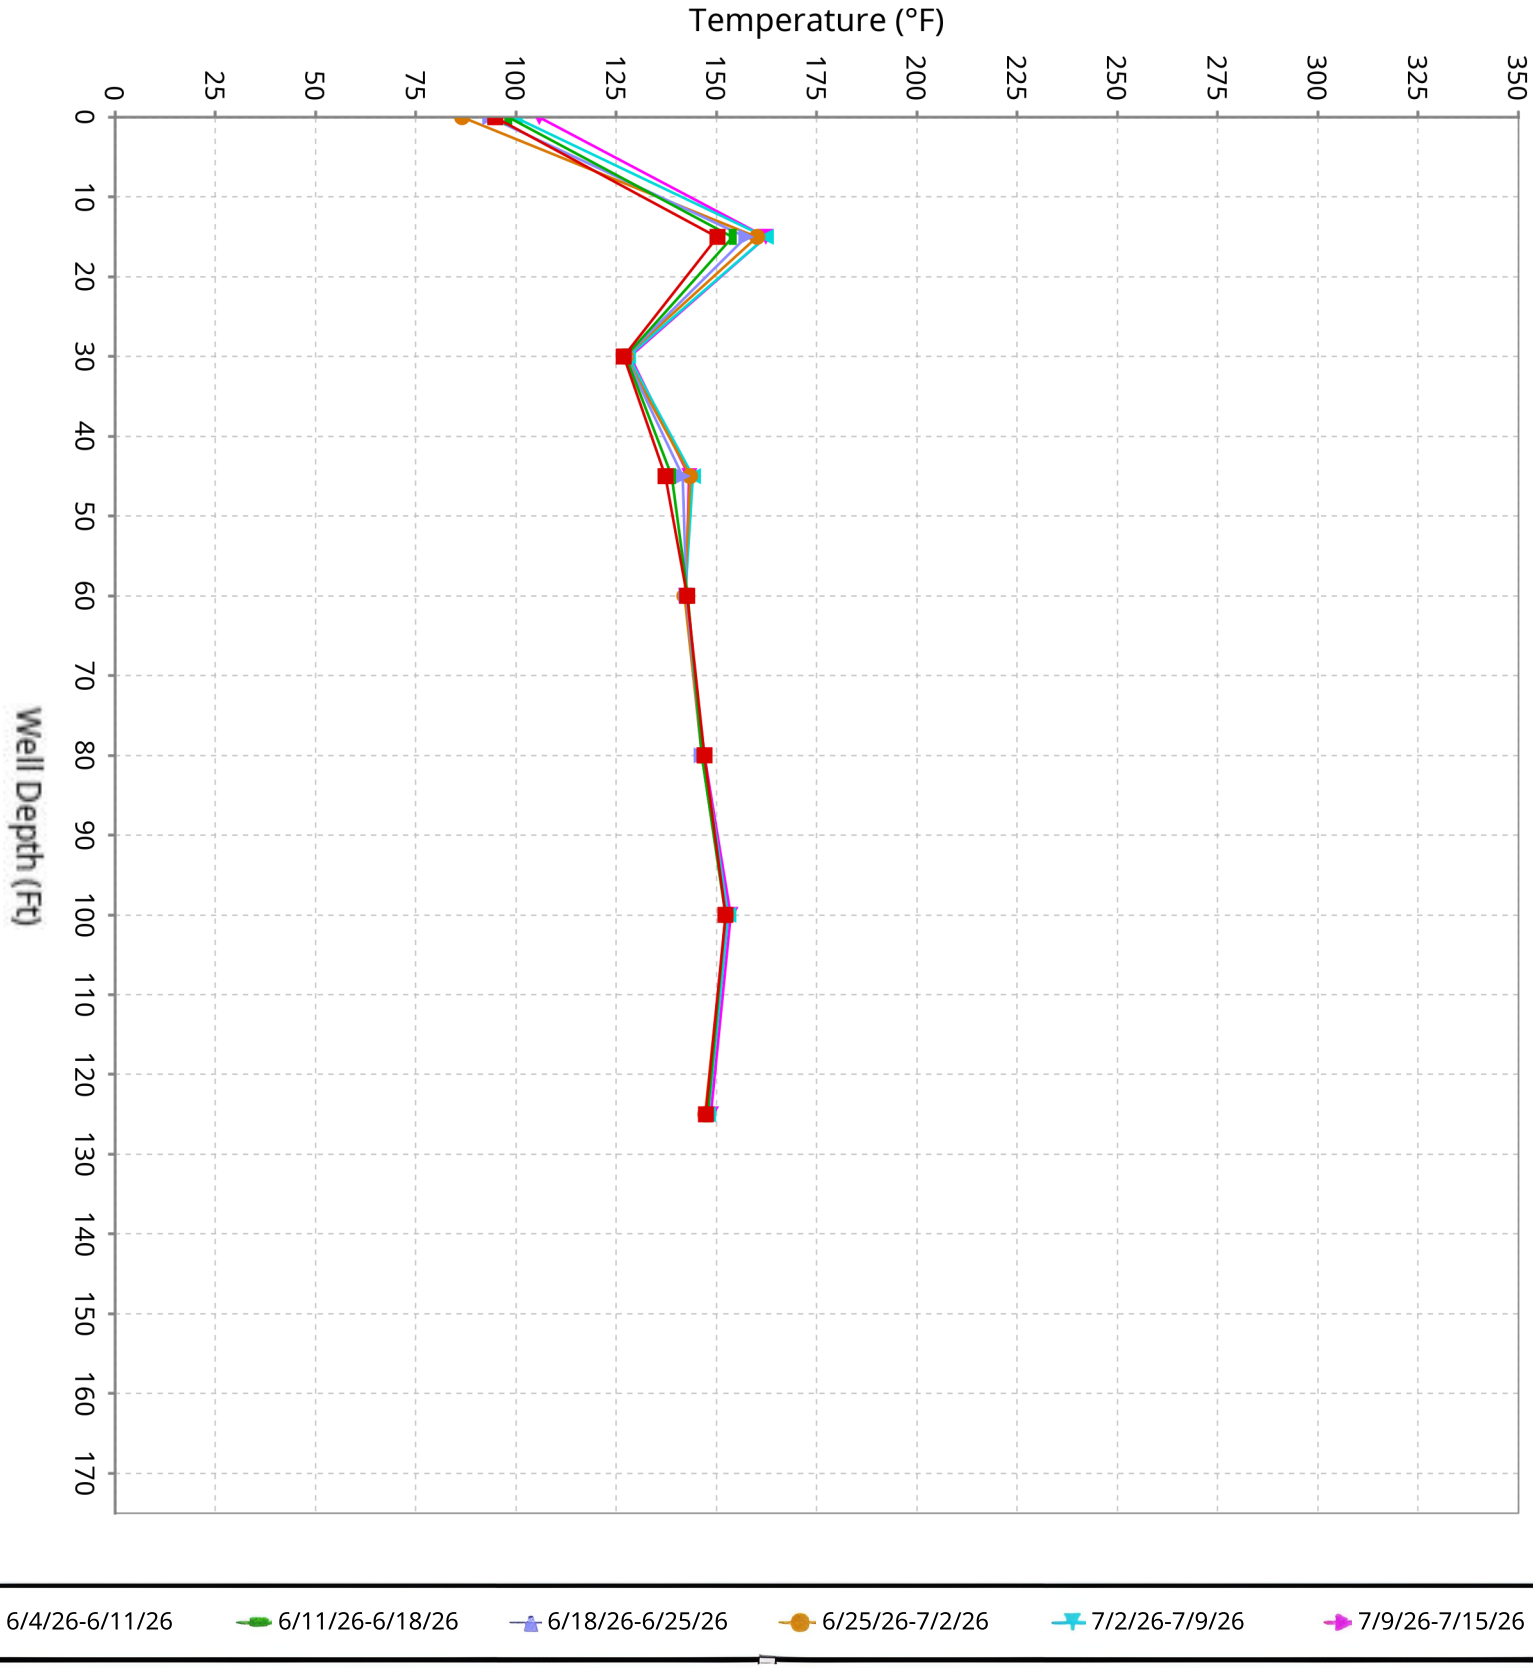
increase may have resulted from additional pumping at nearby wells, which increased gas movement and extraction in the area. The probe will be removed and evaluated to determine whether any failure or other issue with the probe may have contributed to the elevated reading.

- The 30-foot thermocouple remained consistent with previous recorded temperatures.
- The 45-foot thermocouple remained consistent with previous recorded temperatures.
- The 60-foot thermocouple remained consistent with previous recorded temperatures.
- The 75-foot thermocouple remained consistent with previous recorded temperatures.
- The 90-foot thermocouple remained consistent with previous recorded temperatures.
- The 110-foot thermocouple showed a decrease in maximum temperature of 10°F from 220°F to 210°F from July 14th to July 15th.
- The 130-foot thermocouple showed an increase in maximum temperature of 21°F from 217°F to 238°F from July 2nd to July 14th, then a decrease in maximum temperature of 20°F from 238°F to 218°F from July 14th to July 15th.

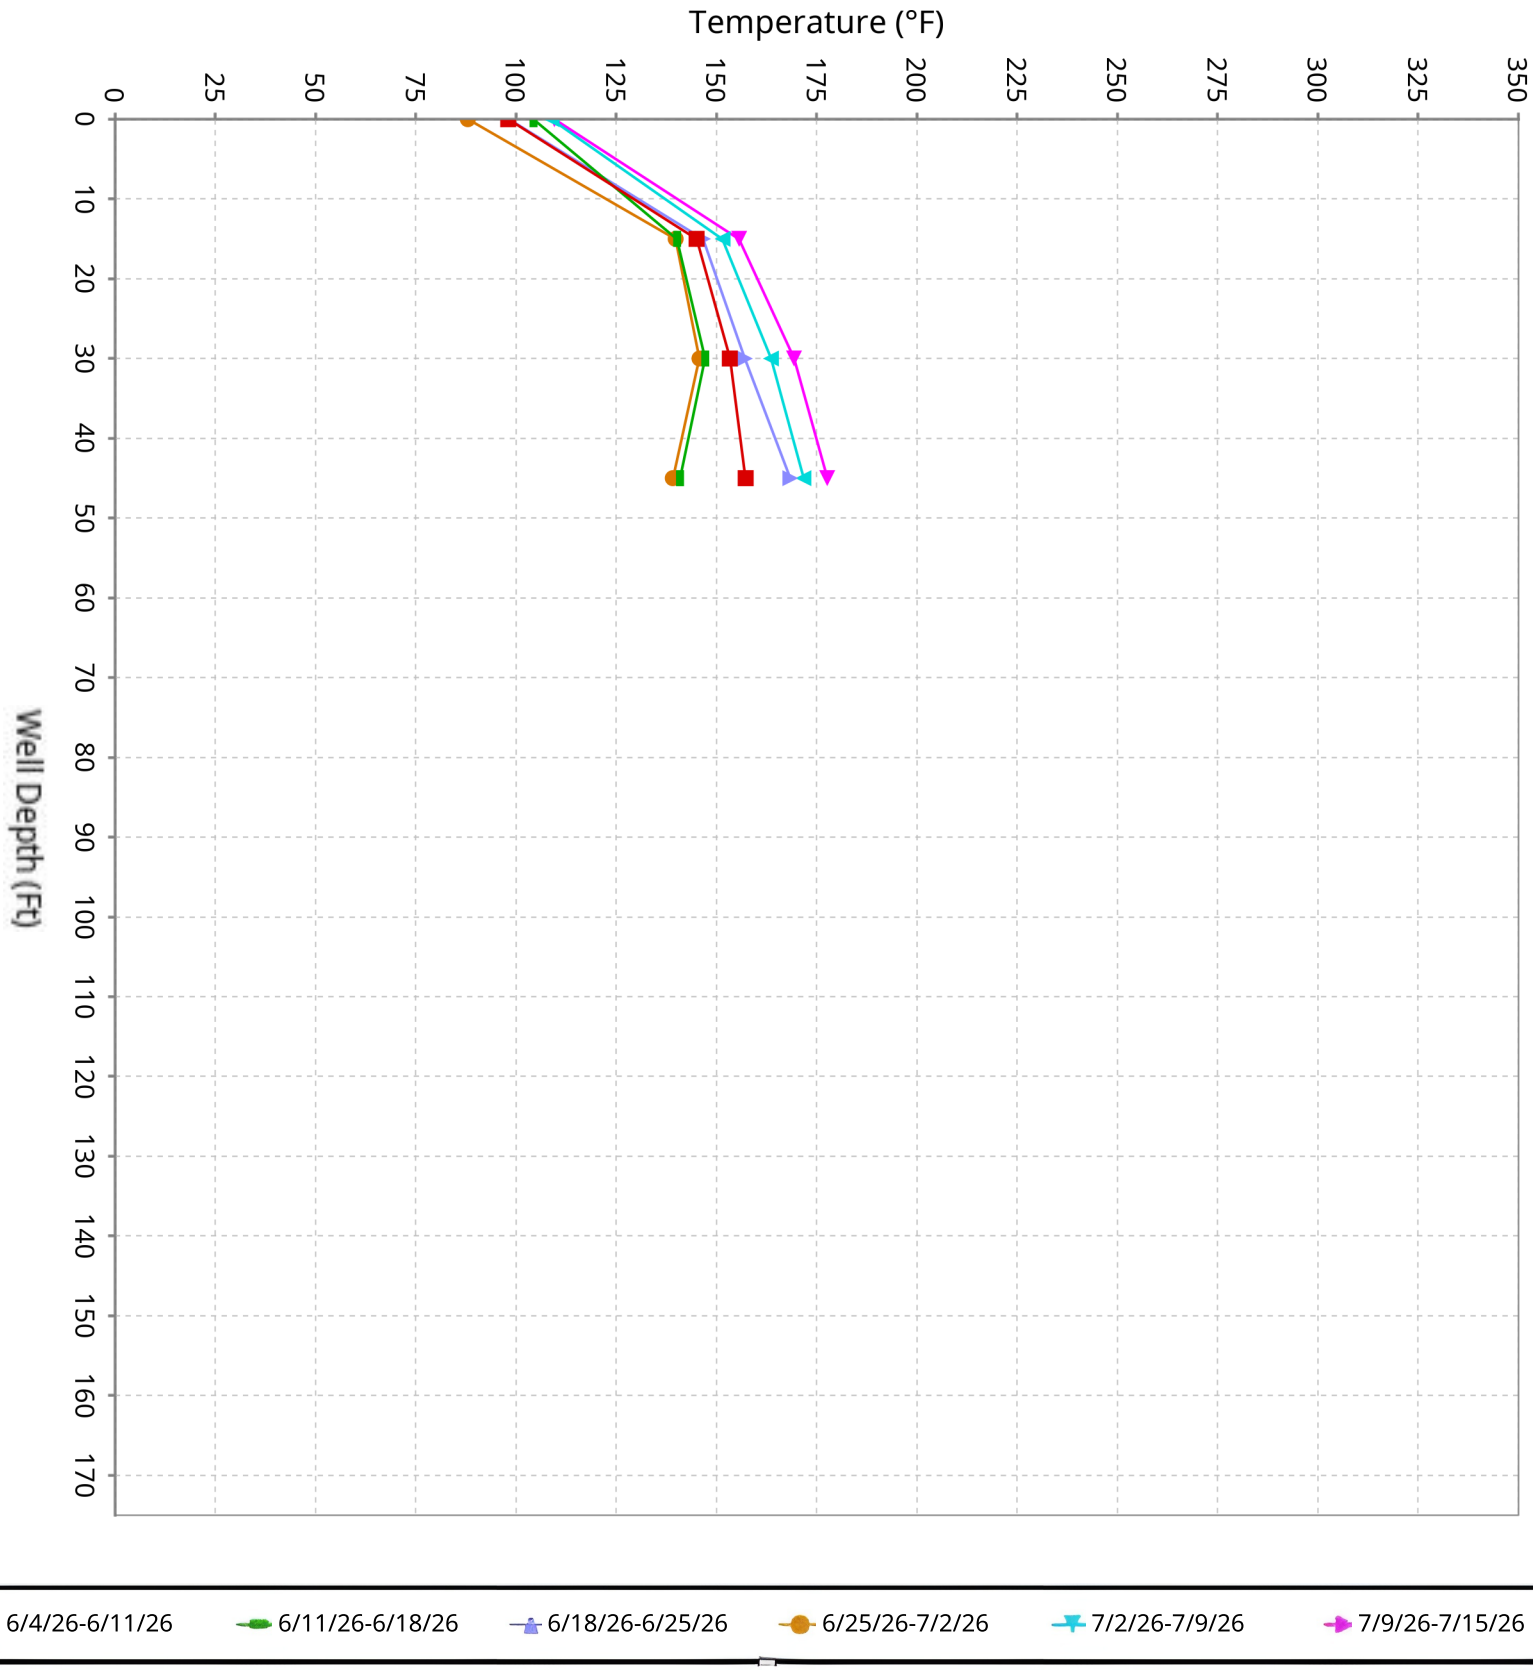
Vertical Temperature Profiles from Temperature Probes at Chiquita Landfill for TP-8

- TP-08
  - The 30-foot and 45-foot thermocouples exhibited temperature increases of 27°F and 29°F, respectively, between July 12, 2026, and July 22, 2026. The Site observed these temperature changes and conducted an investigation between July 23, 2026, and July 29, 2026. TP-08 is installed within extraction well CV-24079, which is equipped with a liquid extraction pump. The investigation determined that recent pump operations removed liquids from the well over the preceding several weeks, influencing the temperature fluctuations observed within TP-08. As liquid levels declined, temperatures measured at the associated thermocouple depths increased. The subsequent decrease in temperature may be attributable to the removal of heat from the landfill mass as liquids were extracted from the well.

TP-08: The 30-foot and 45-foot thermocouples exhibited temperature increases of 27°F and 29°F, respectively, between July 12, 2026, and July 22, 2026. The Site observed these temperature changes and conducted an investigation between July 23, 2026, and July 29, 2026. TP-08 is installed within extraction well CV-24079, which is equipped with a liquid extraction pump. The investigation determined that recent pump operation removed liquids from the well over the preceding several weeks, influencing the temperature fluctuations observed within TP-08. As liquid levels declined, temperatures measured at the associated thermocouple depths increased. The subsequent decrease in temperature may be attributable to the removal of heat from the landfill mass as liquids were extracted from the well.

- TP-08
  - The 30-foot and 45-foot thermocouples exhibited temperature increases of 27°F and 29°F, respectively, between July 12, 2026, and July 22, 2026. In response, Site personnel observed the temperature changes and conducted an investigation from July 23, 2026, through July 29, 2026. Following the investigation, temperatures continued to decline from July 30, 2026, through August 5, 2026.

- TP-08 is installed within extraction well CV-24079, which is equipped with a liquid extraction pump. The investigation determined that the existing pump is experiencing a power-related issue and requires removal. Site personnel have identified the need for a replacement pump and plan to complete the replacement next week.

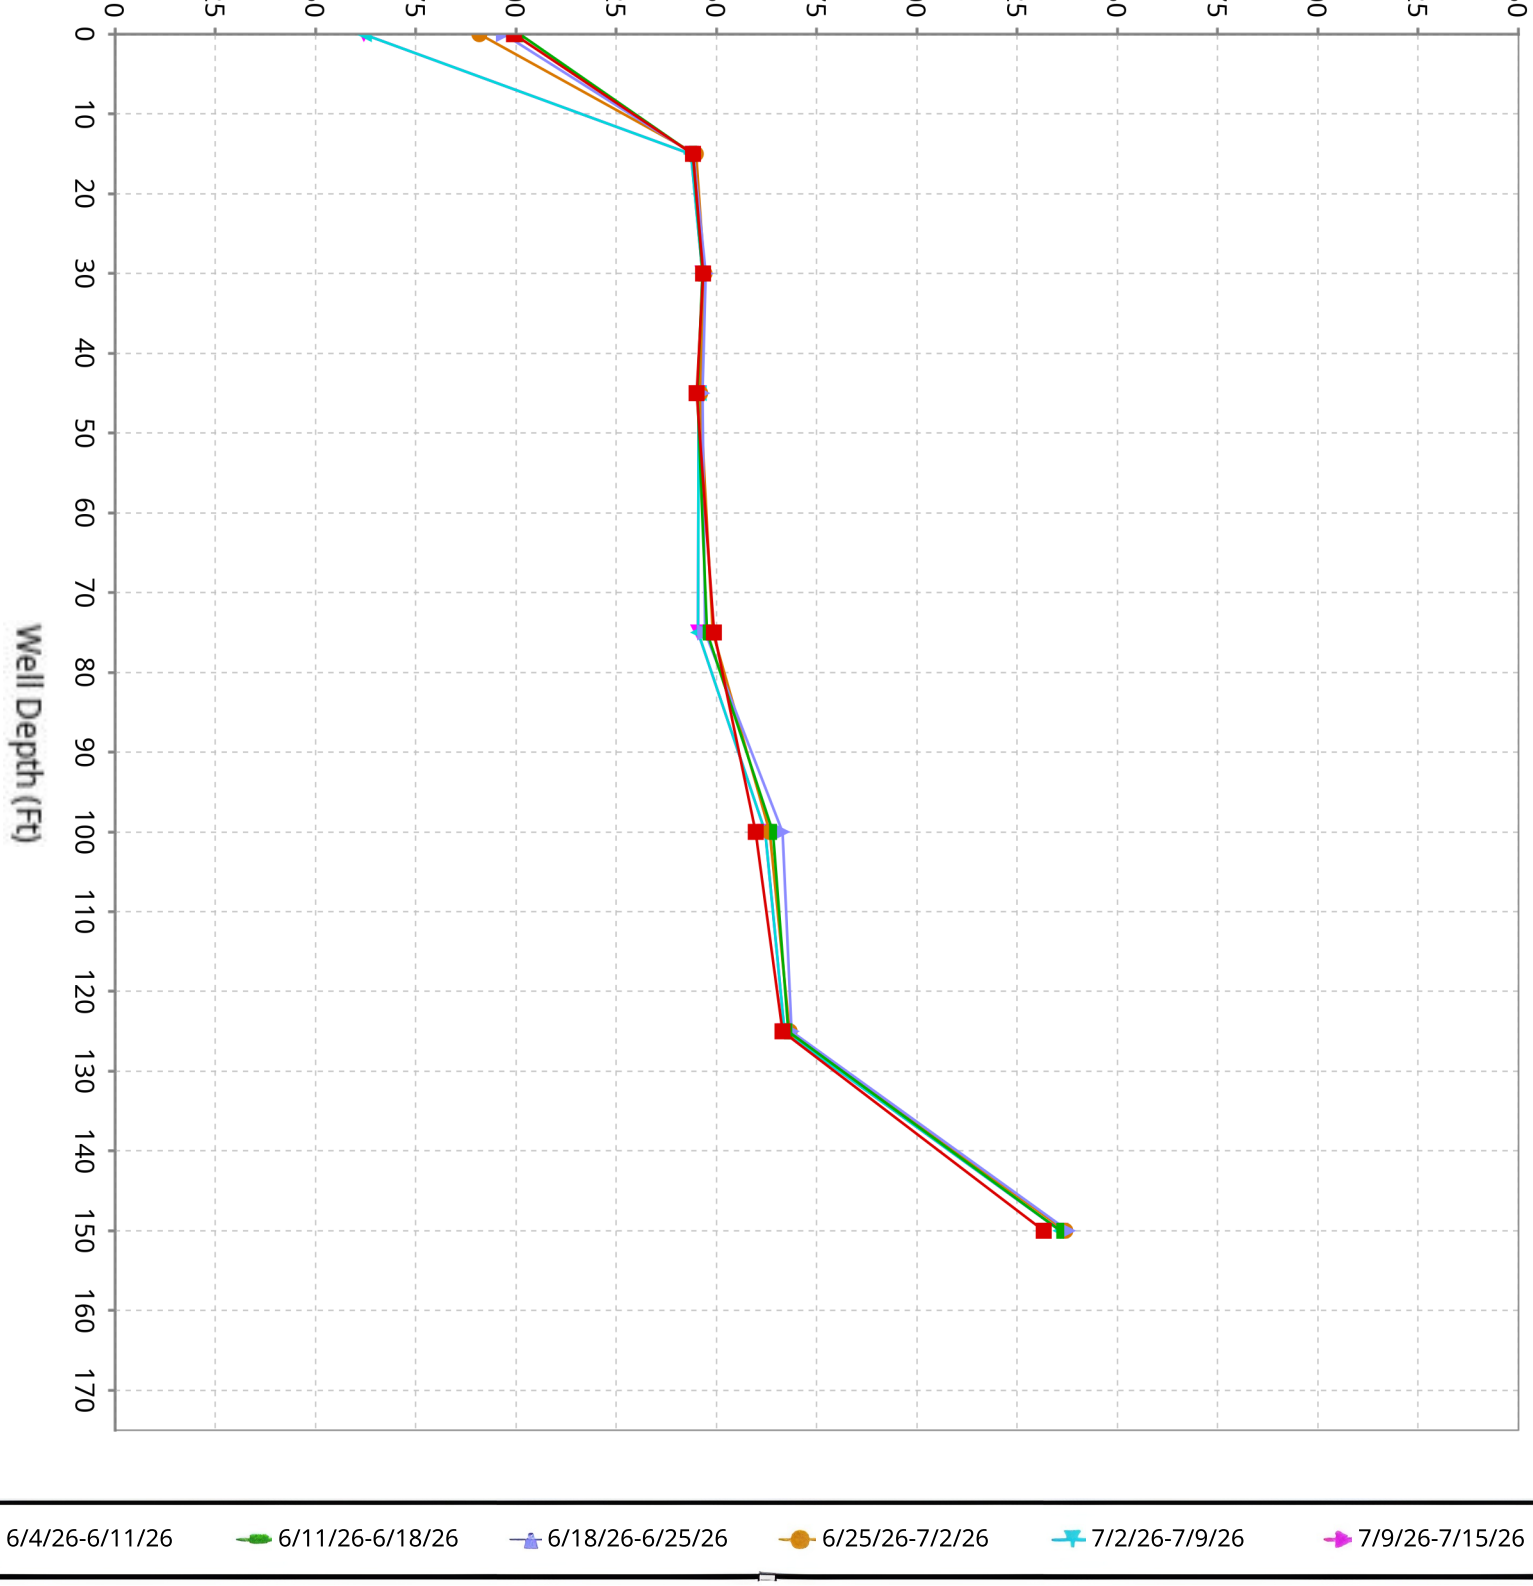
Vertical Temperature Profiles from Temperature Probes at Chiquita Landfill for TP-19

- TP-19
  - A discrepancy was identified during the review of the weekly data. Upon investigation, the Site determined that the associated battery had failed and subsequently replaced it. During this inspection, the temperature reading from the 125-foot thermocouple was observed to be anomalously low. Further evaluation indicated that the 125-foot thermocouple required replacement. As an interim measure, the Site installed a 120-foot thermocouple that was available onsite and ordered a replacement 125-foot thermocouple. The replacement 125-foot thermocouple will be installed upon receipt.
  - The 45-foot thermocouple showed an increase in maximum temperature of 15°F from 146°F to 161°F from July 23rd to July 24th.

TP-19: A discrepancy was identified during the review of the weekly data. Upon investigation, the Site determined that the associated battery had failed and subsequently replaced it. During this inspection, the temperature reading from the 125-foot thermocouple was observed to be anomalously low. Further evaluation indicated that the 125-foot thermocouple required replacement. As an interim measure, the Site installed a 120-foot thermocouple that was available on-site and ordered a replacement 125-foot thermocouple. The replacement 125-foot thermocouple will be installed upon receipt.

- TP-19
  - A discrepancy was identified during the review of last week's data. Upon investigation, the Site determined that the associated battery had failed and subsequently replaced it. During this inspection, the temperature reading from the 125-foot thermocouple was observed to be anomalously low. Further evaluation indicated that the 125-foot thermocouple required replacement. As an interim measure, the Site installed a 120-foot thermocouple that was available onsite and ordered a replacement 125-foot thermocouple. The replacement 125-foot thermocouple will be installed upon receipt.
  - The 45-foot thermocouple remained consistent with previously recorded temperatures.
  - The 75-foot thermocouple remained consistent with previously recorded temperatures.
