SCS ENGINEERS

September 15, 2026

Subject: **August 2026 Monthly Report Pursuant to Milestones 1A-3 and 5 of the LEA June 6, 2024 Compliance Order and July 30, 2024 Letter, Chiquita Canyon Landfill, Castaic, California**

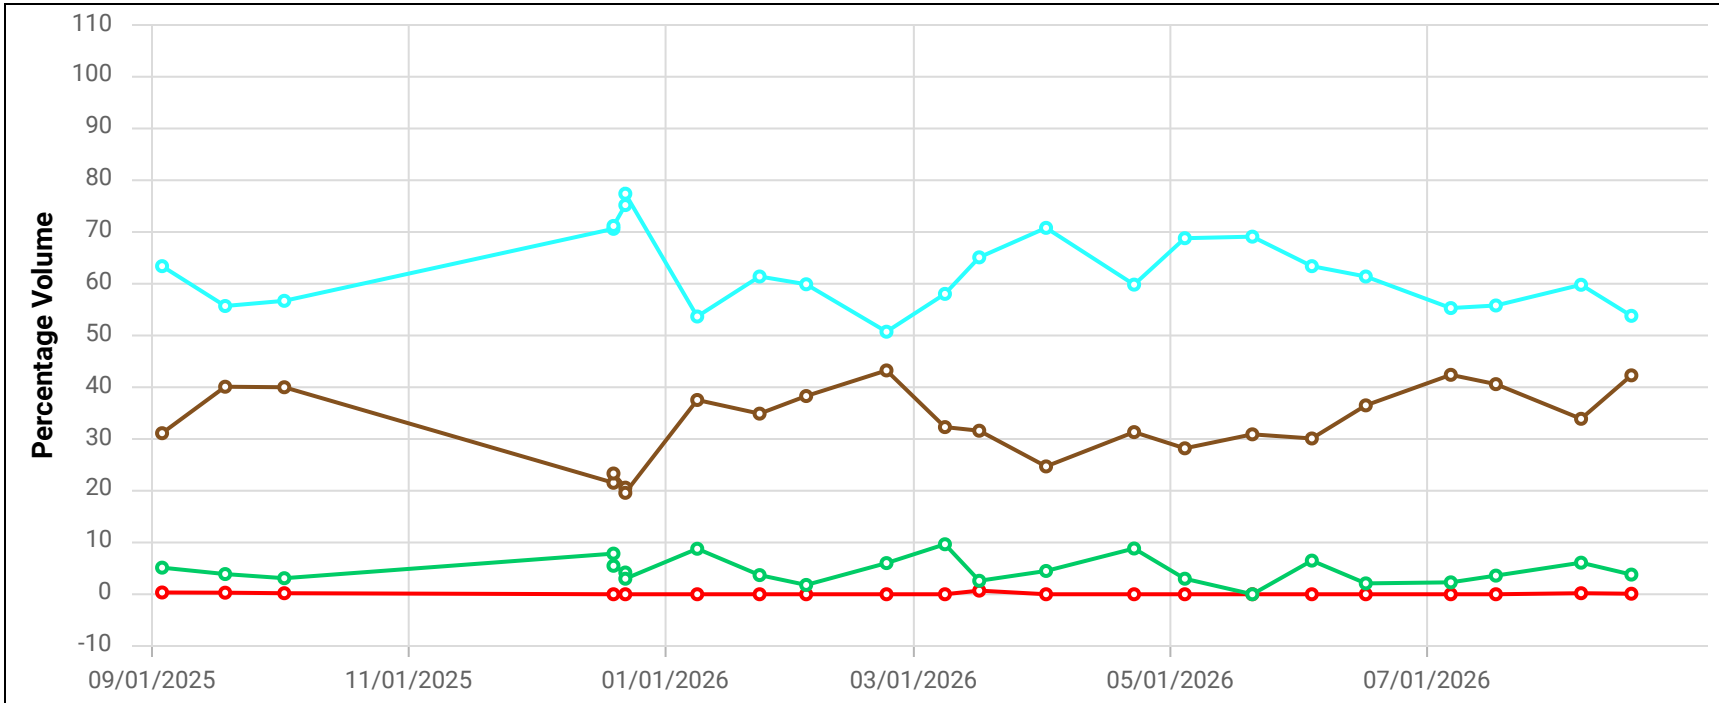
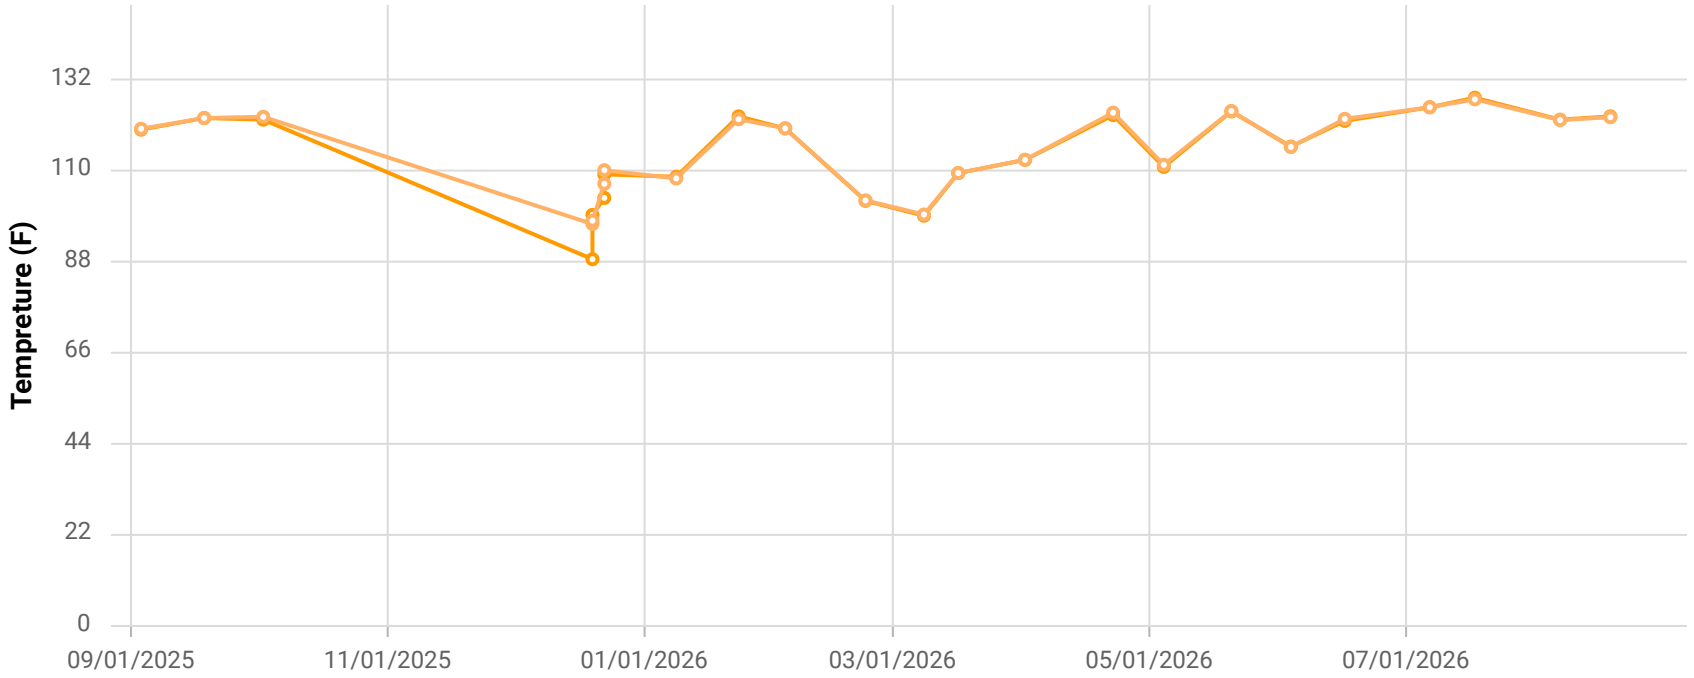
CCV24079 / CV-24079-TP8

- TP-08
  - The 30-foot and 45-foot thermocouples exhibited temperature increases of 27°F and 29°F, respectively, between July 12, 2026, and July 22, 2026. In response, Site personnel observed the temperature changes and conducted an investigation from July 23, 2026, through July 29, 2026. Following the investigation, temperatures continued to decline from July 30, 2026, through August 5, 2026.

- TP-08 is installed within extraction well CV-24079, which is equipped with a liquid extraction pump. The investigation determined that the existing pump is experiencing a power-related issue and requires removal. Site personnel have identified the need for a replacement pump and plan to complete the replacement next week.

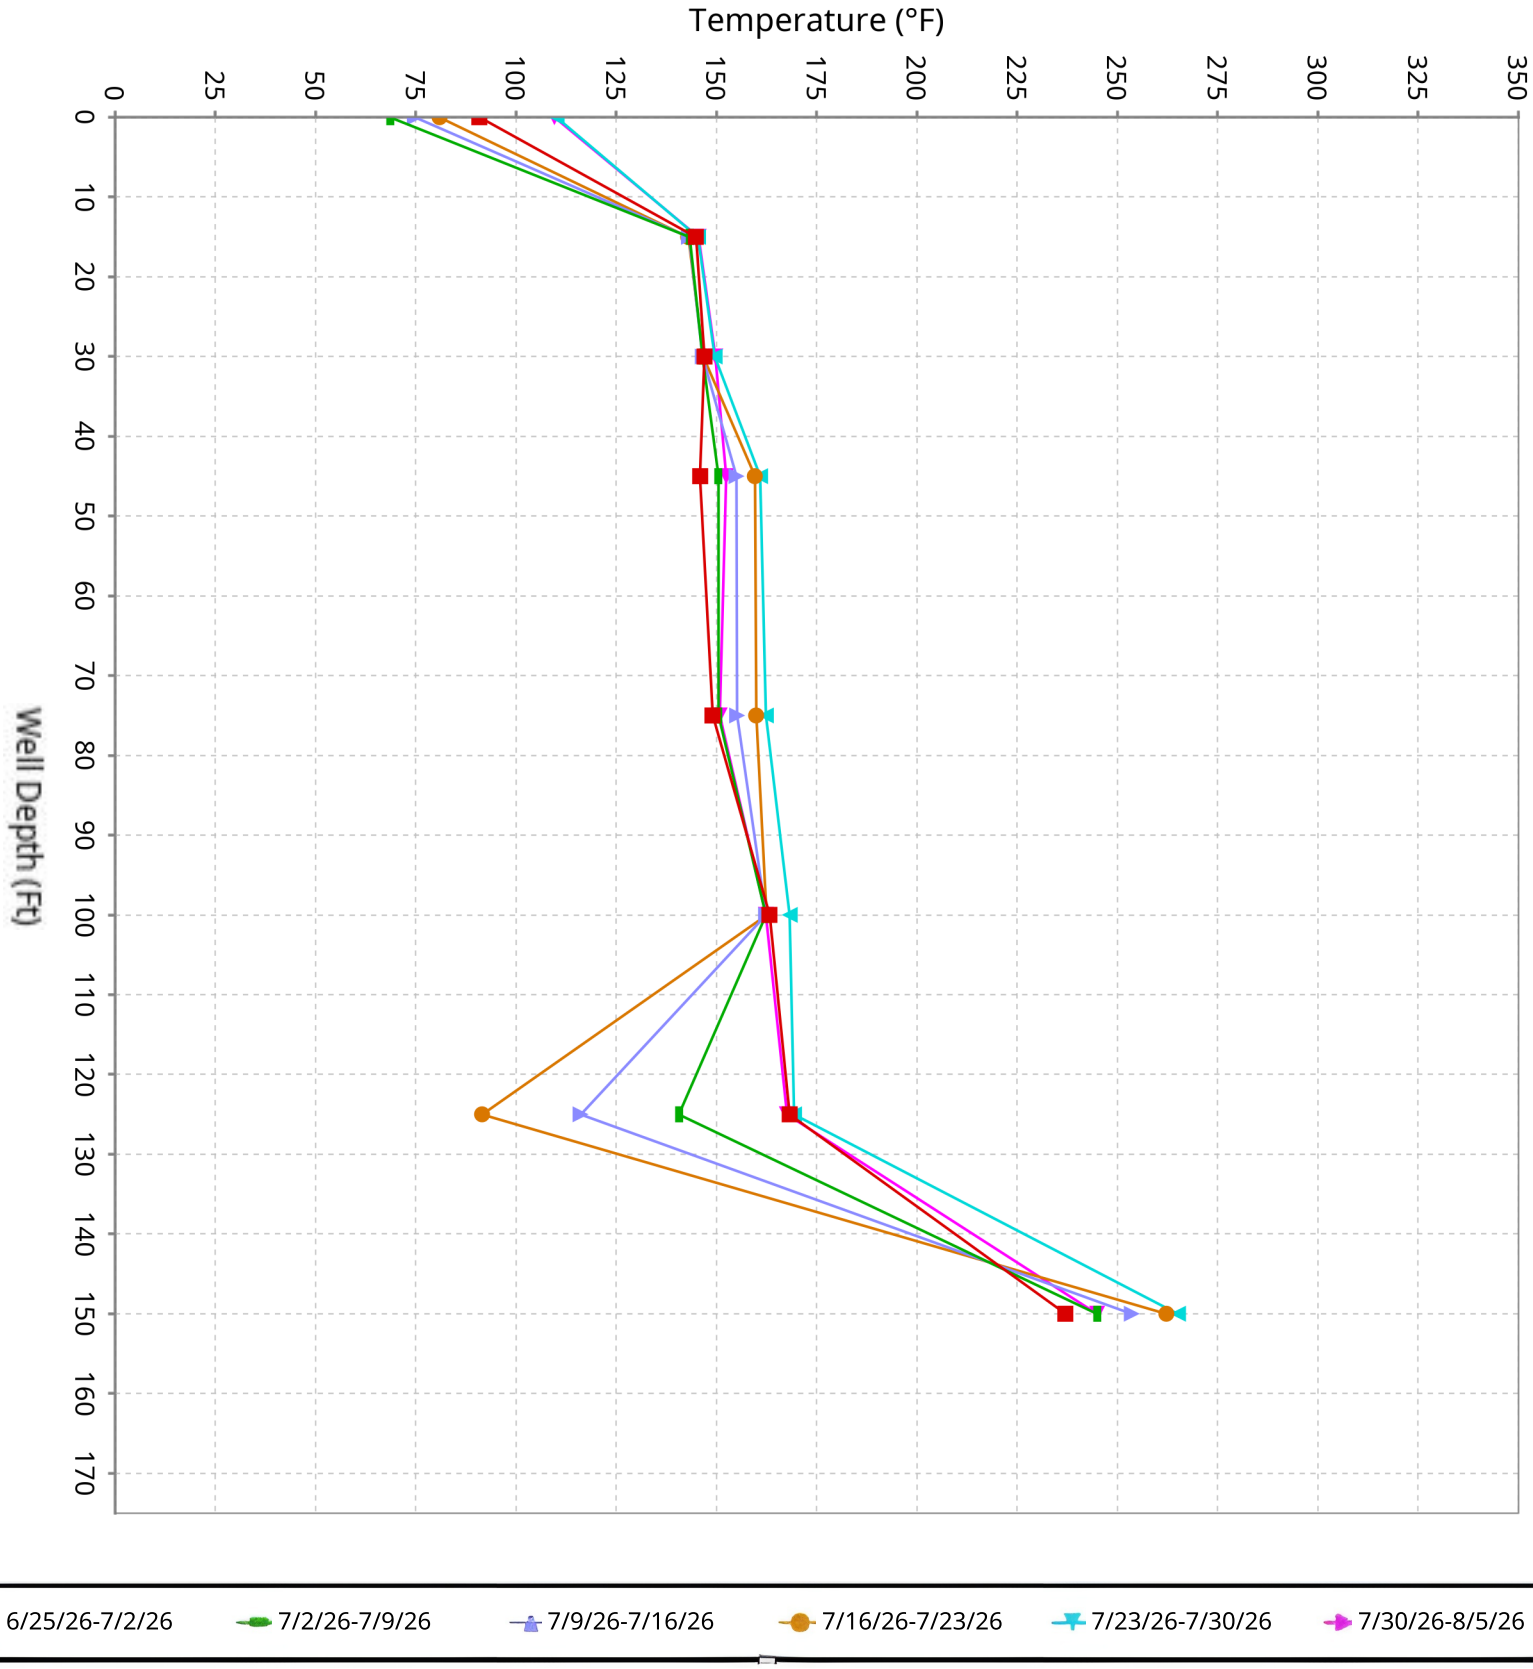
Vertical Temperature Profiles from Temperature Probes at Chiquita Landfill for TP-19

- TP-19
  - A discrepancy was identified during the review of last week's data. Upon investigation, the Site determined that the associated battery had failed and subsequently replaced it. During this inspection, the temperature reading from the 125-foot thermocouple was observed to be anomalously low. Further evaluation indicated that the 125-foot thermocouple required replacement. As an interim measure, the Site installed a 120-foot thermocouple that was available onsite and ordered a replacement 125-foot thermocouple. The replacement 125-foot thermocouple will be installed upon receipt.
  - The 45-foot thermocouple remained consistent with previously recorded temperatures.
  - The 75-foot thermocouple remained consistent with previously recorded temperatures.

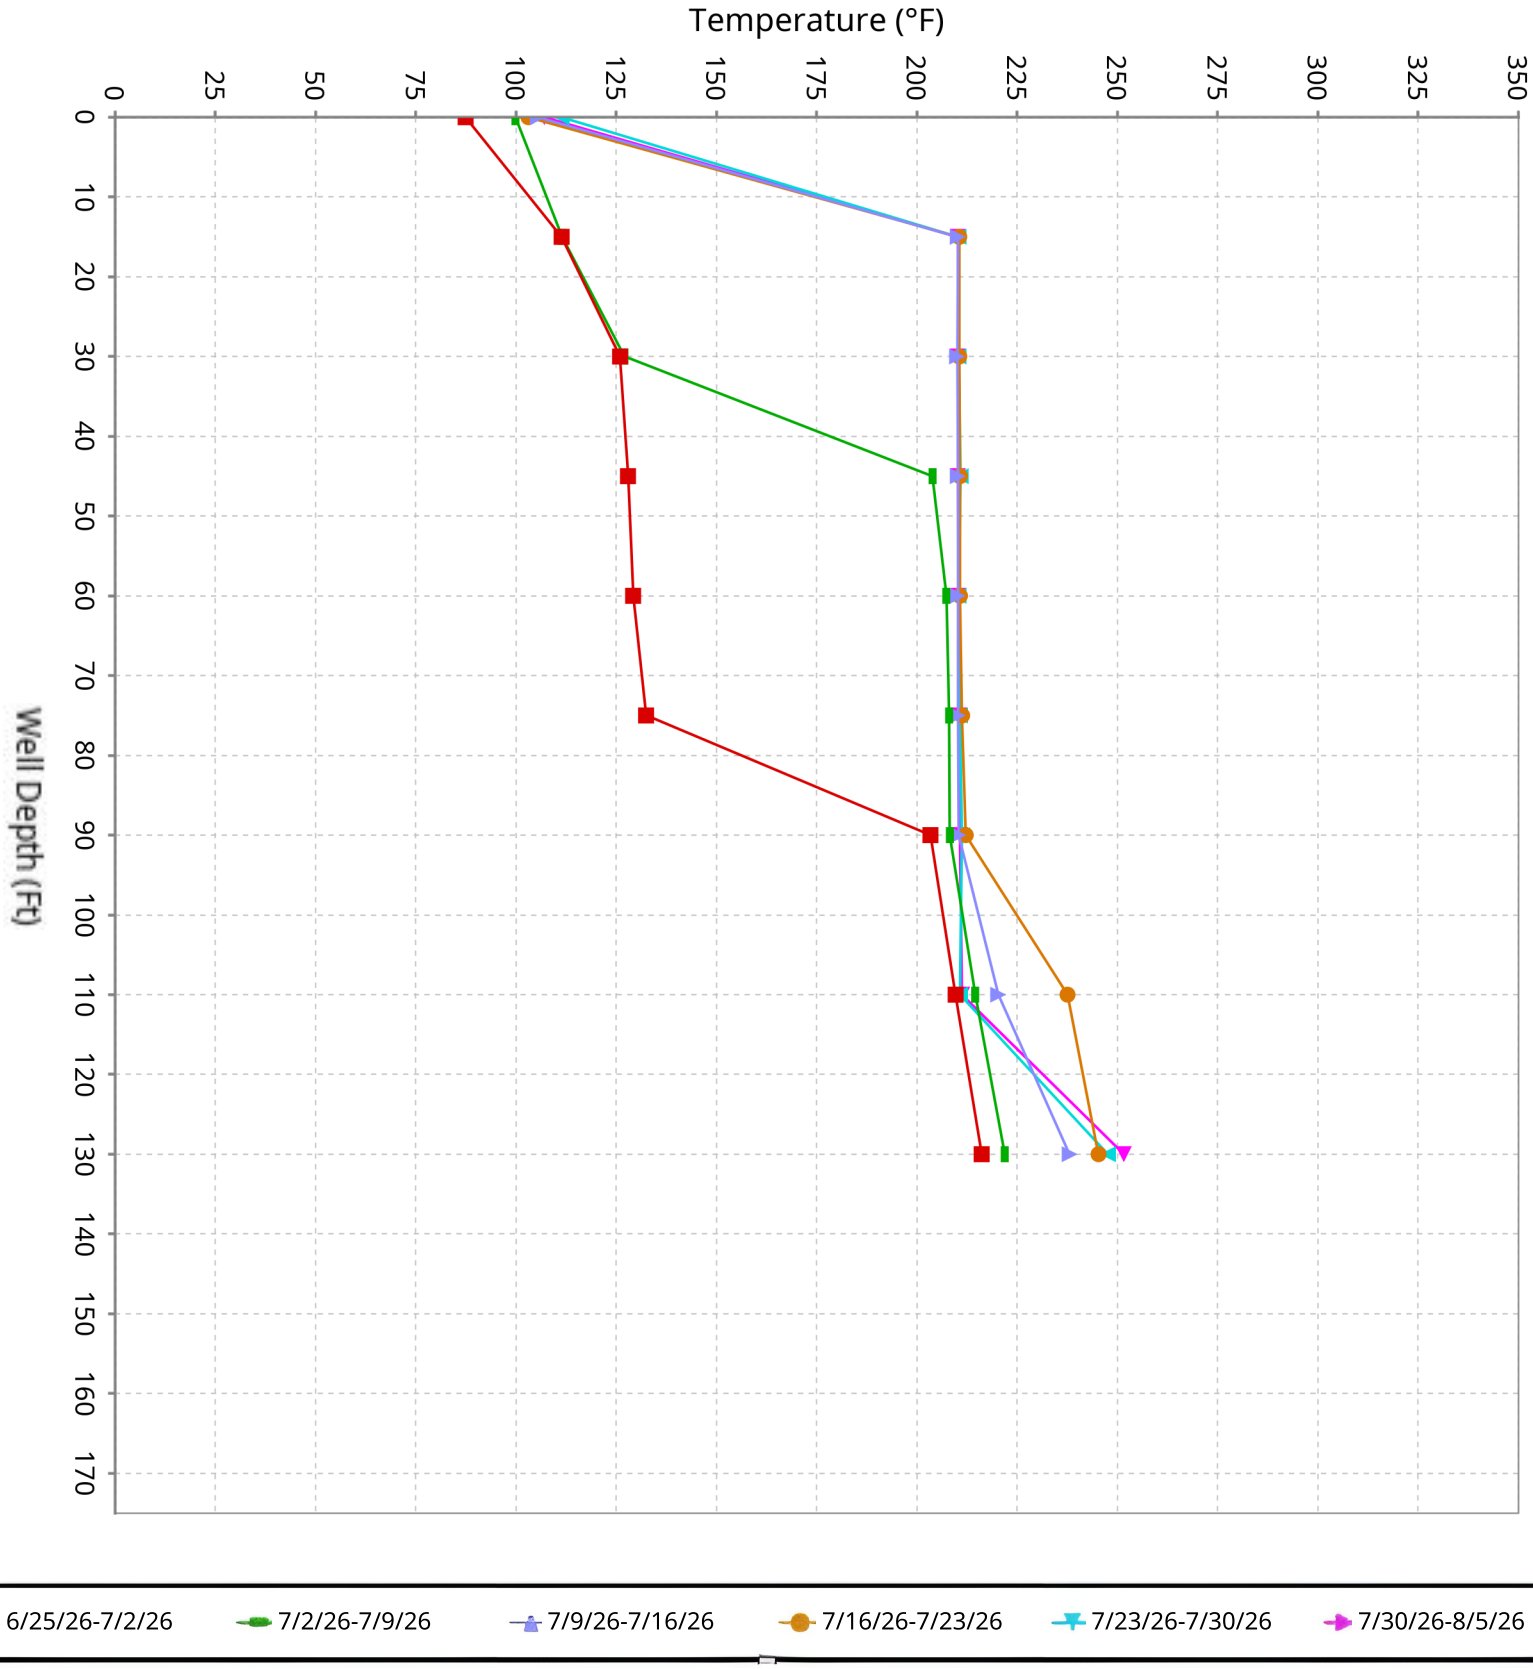
Vertical Temperature Profiles from Temperature Probes at Chiquita Landfill for TP-25

- TP-25
    - The Site plans to conduct a follow-up camera inspection next week of the probe casing to determine whether additional liquid infiltration has occurred within the TP-25 well casing and to assess the condition of the casing interior.
    - The 110-foot thermocouple remained consistent with previously recorded temperatures.
    - The 130-foot thermocouple showed an increase in maximum temperature of 40°F from 212°F to 252°F from July 22nd to August 4th. As described above, the Site is continuing to assess the condition of this probe equipment.

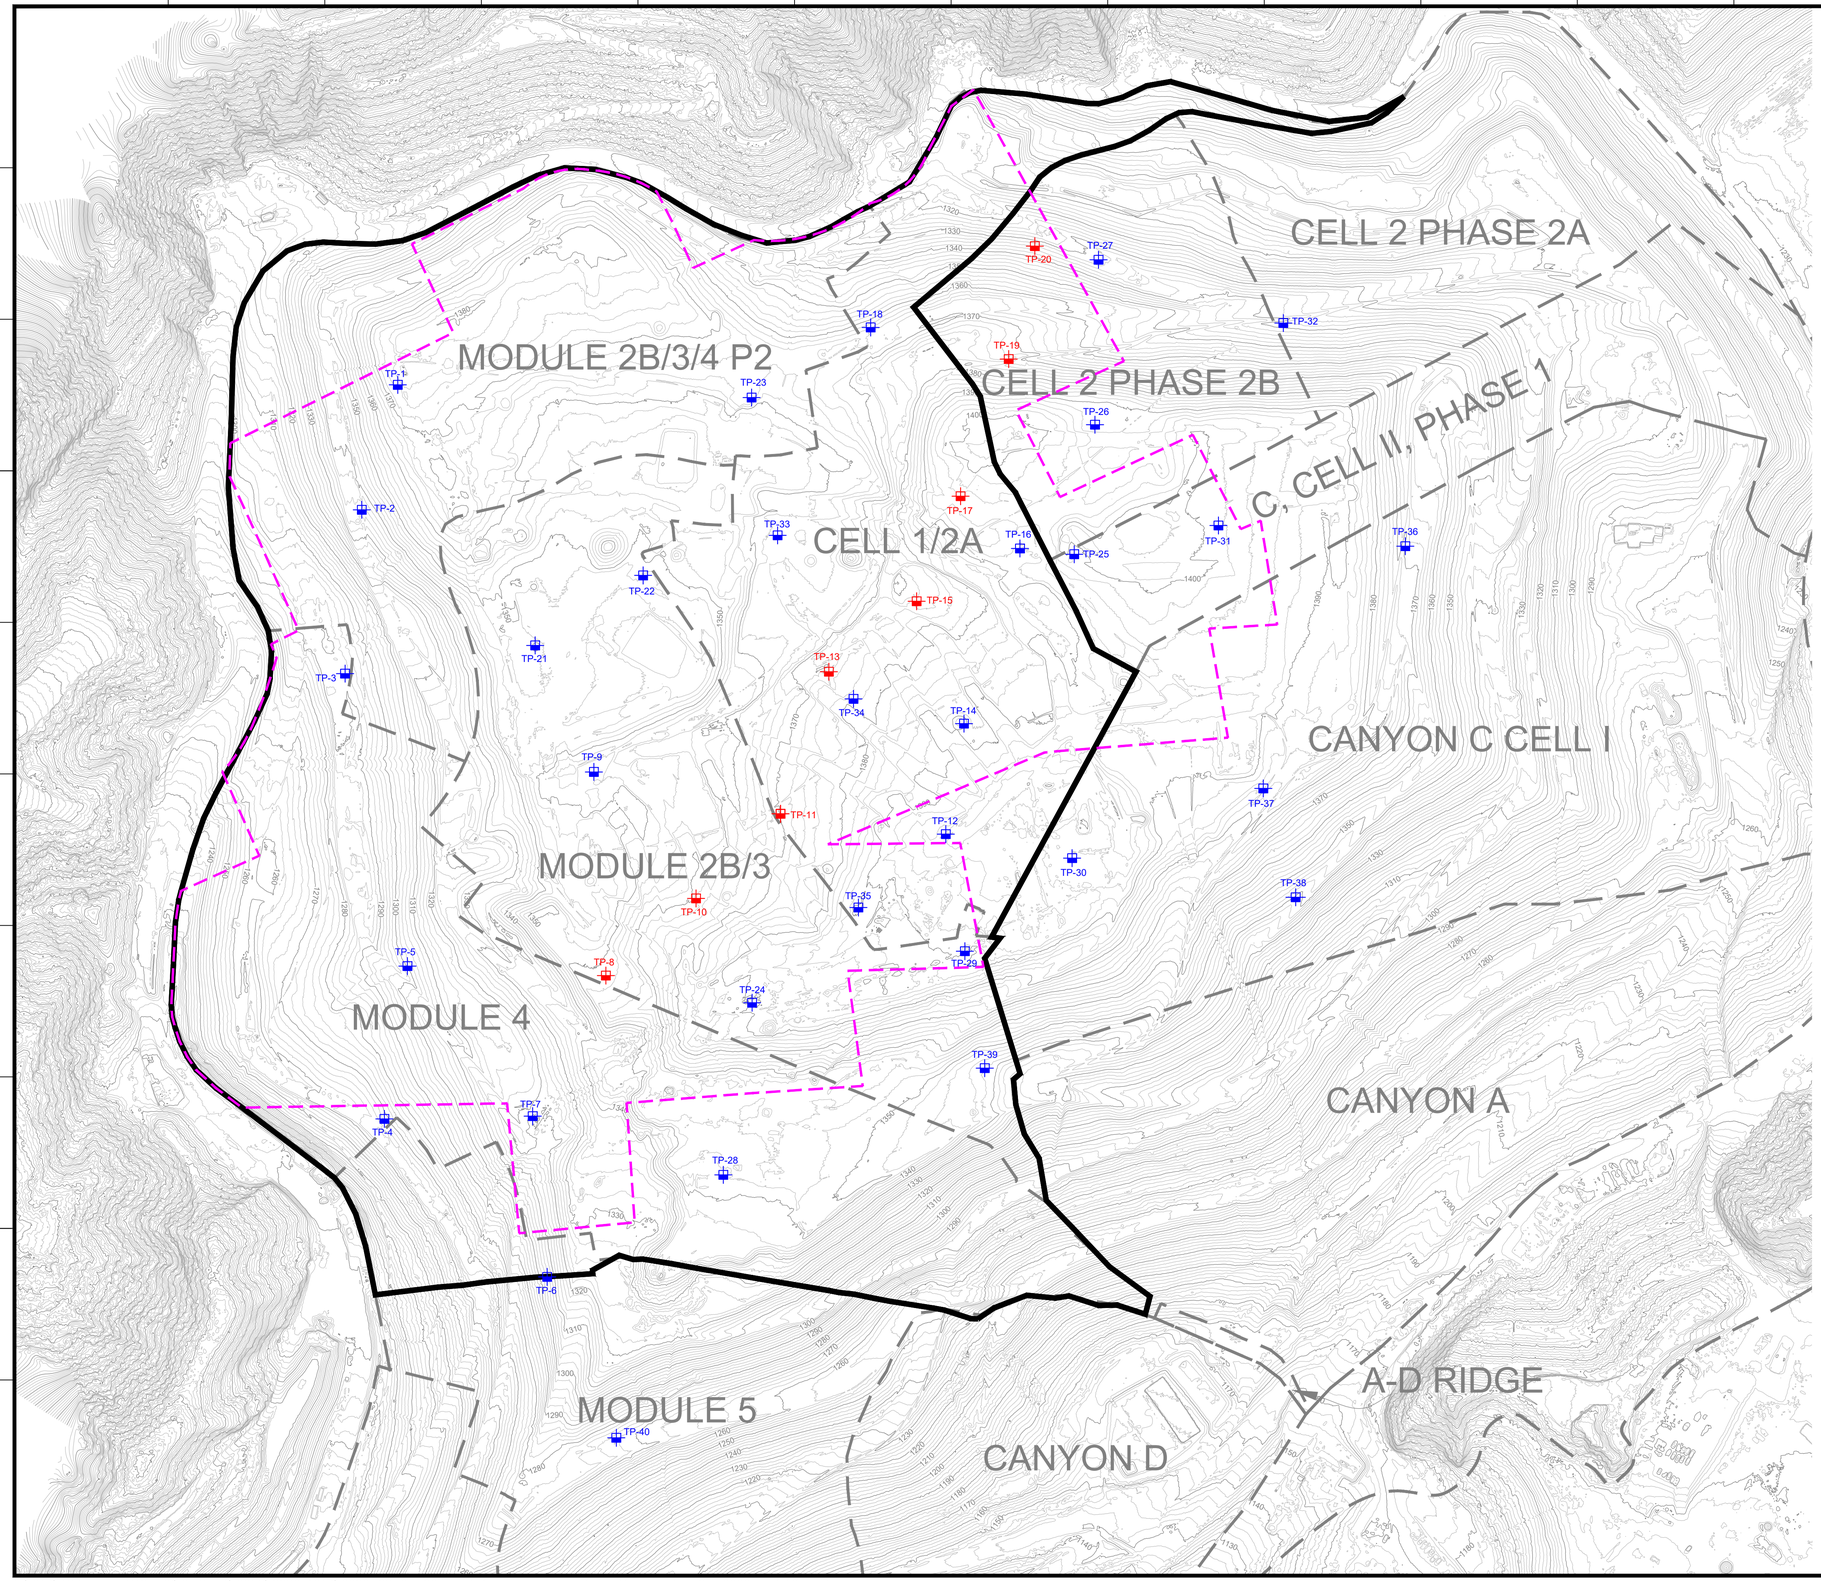
TP-08: The 30-foot and 45-foot thermocouples exhibited temperature increases of 27°F and 29°F, respectively, between July 12, 2026, and July 22, 2026. In response, Site personnel observed the temperature changes and conducted an investigation from July 23, 2026, through July 29, 2026. Following the investigation, temperatures continued to decline from July 30, 2026, through August 5, 2026.
oTP-08 is installed within extraction well CV-24079, which is equipped with a liquid extraction pump. The investigation determined that the existing pump is experiencing a power-related issue and requires removal. Site personnel have identified the need for a replacement pump and plan to complete the replacement next week.
TP-19: A discrepancy was identified during the review of the weekly data. Upon [RH2.1]investigation, the Site determined that the associated battery had failed and subsequently replaced it. During this inspection, the temperature reading from the 125-foot thermocouple was observed to be anomalously low. Further evaluation indicated that the 125-foot thermocouple required replacement. As an interim measure, the Site installed a 120-foot thermocouple that was available onsite and ordered a replacement 125-foot thermocouple. The replacement 125-foot thermocouple will be installed upon receipt.

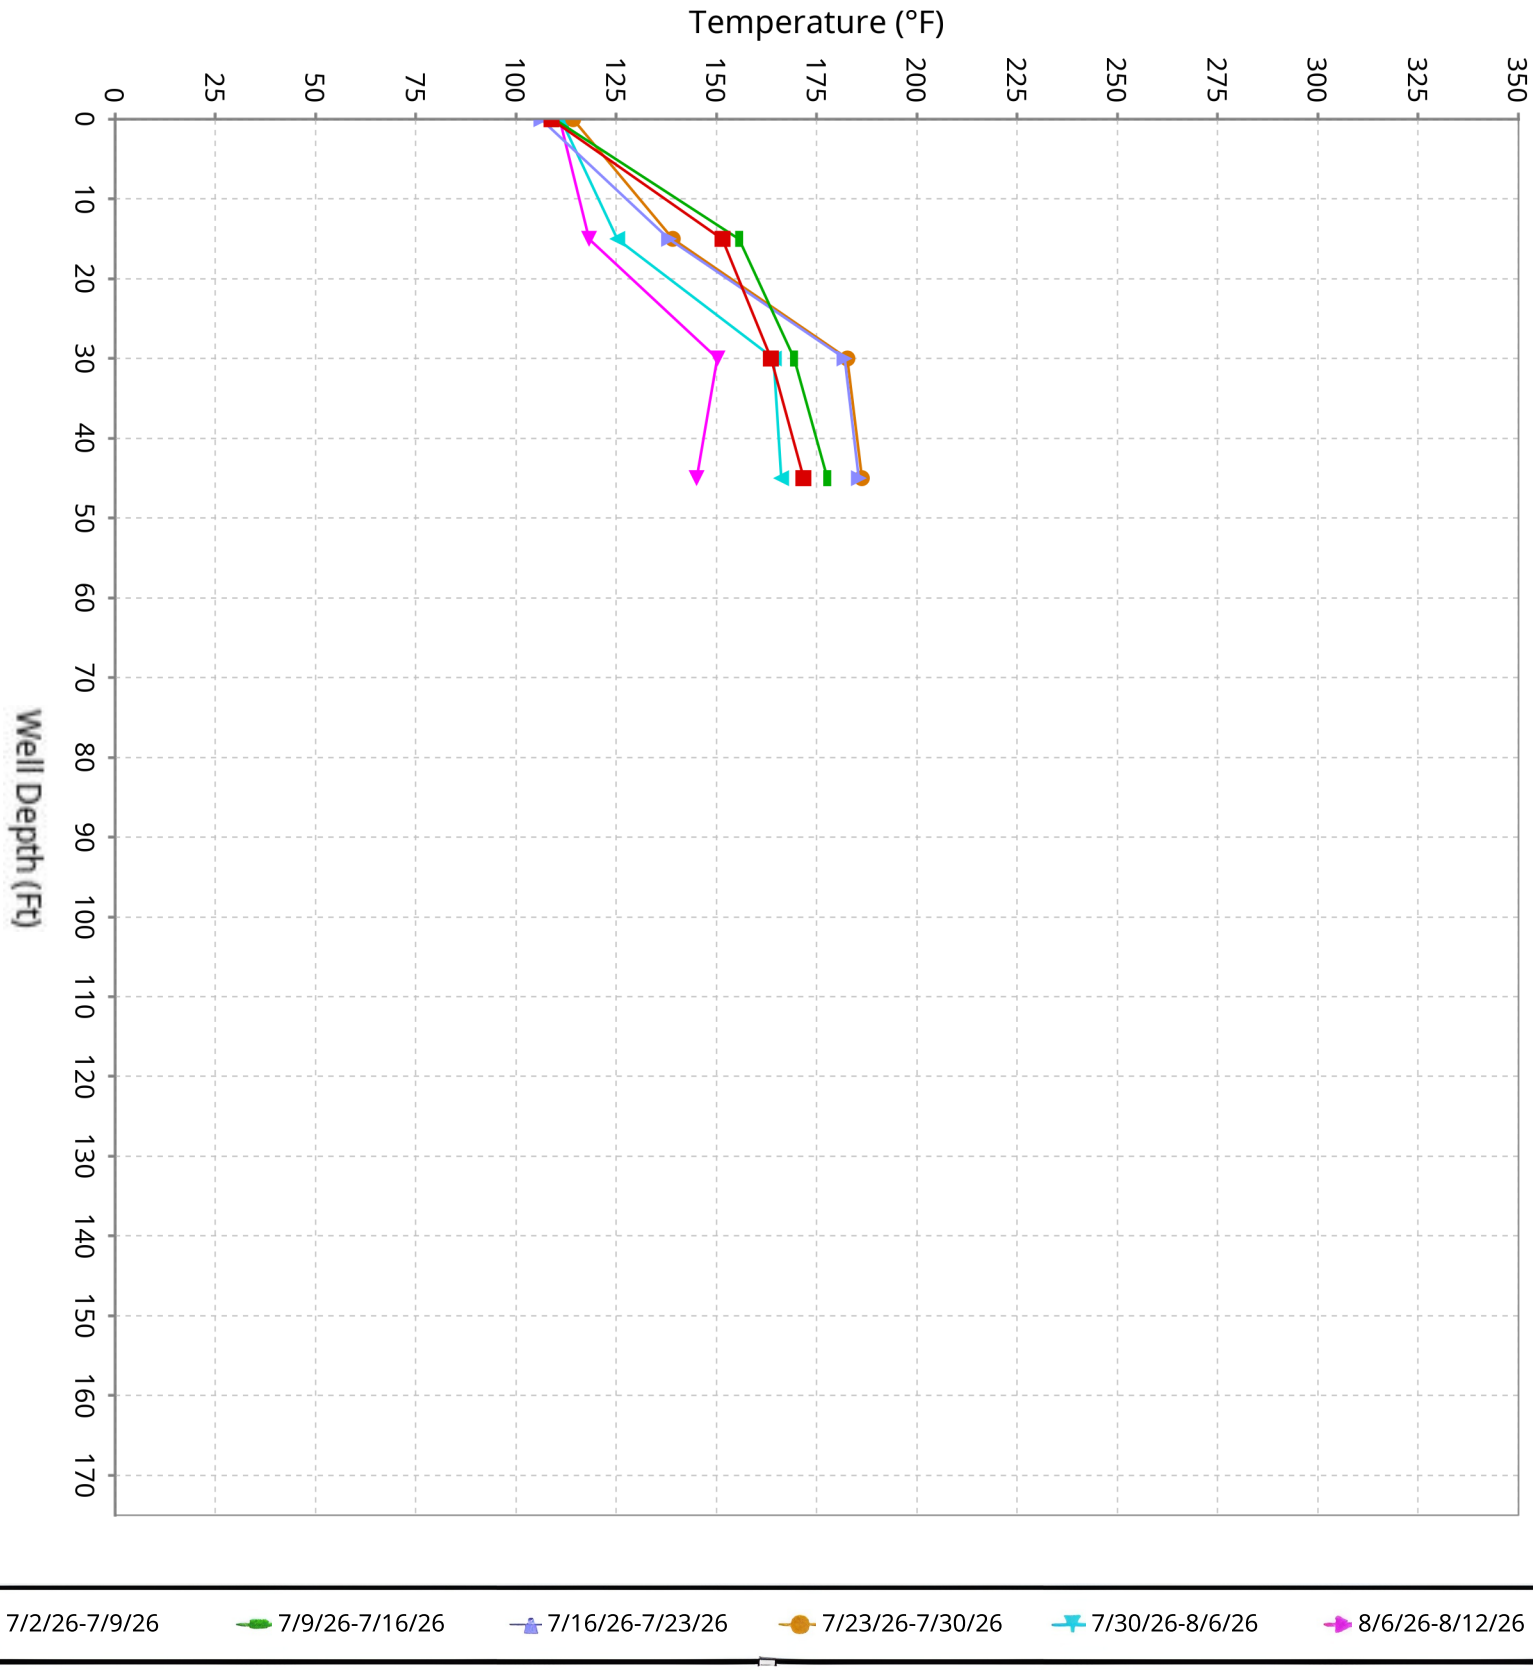
Vertical Temperature Profiles from Temperature Probes at Chiquita Landfill for TP-8

- TP-08
    - The 30-foot and 45-foot thermocouples exhibited temperature increases of 27°F and 29°F, respectively, between July 12, 2026, and July 22, 2026. In response, Site personnel observed the temperature changes and conducted an investigation from July 23, 2026, through July 29, 2026. Following the investigation, temperatures continued to decline from July 30th, 2026, through August 12, 2026.

- TP-08 is installed within extraction well CV-24079, which is equipped with a liquid extraction pump. The investigation determined that the existing pump is experiencing a power-related issue and requires removal. Site personnel have identified the need for a replacement pump and plan to complete the replacement when the road to the well is completed.

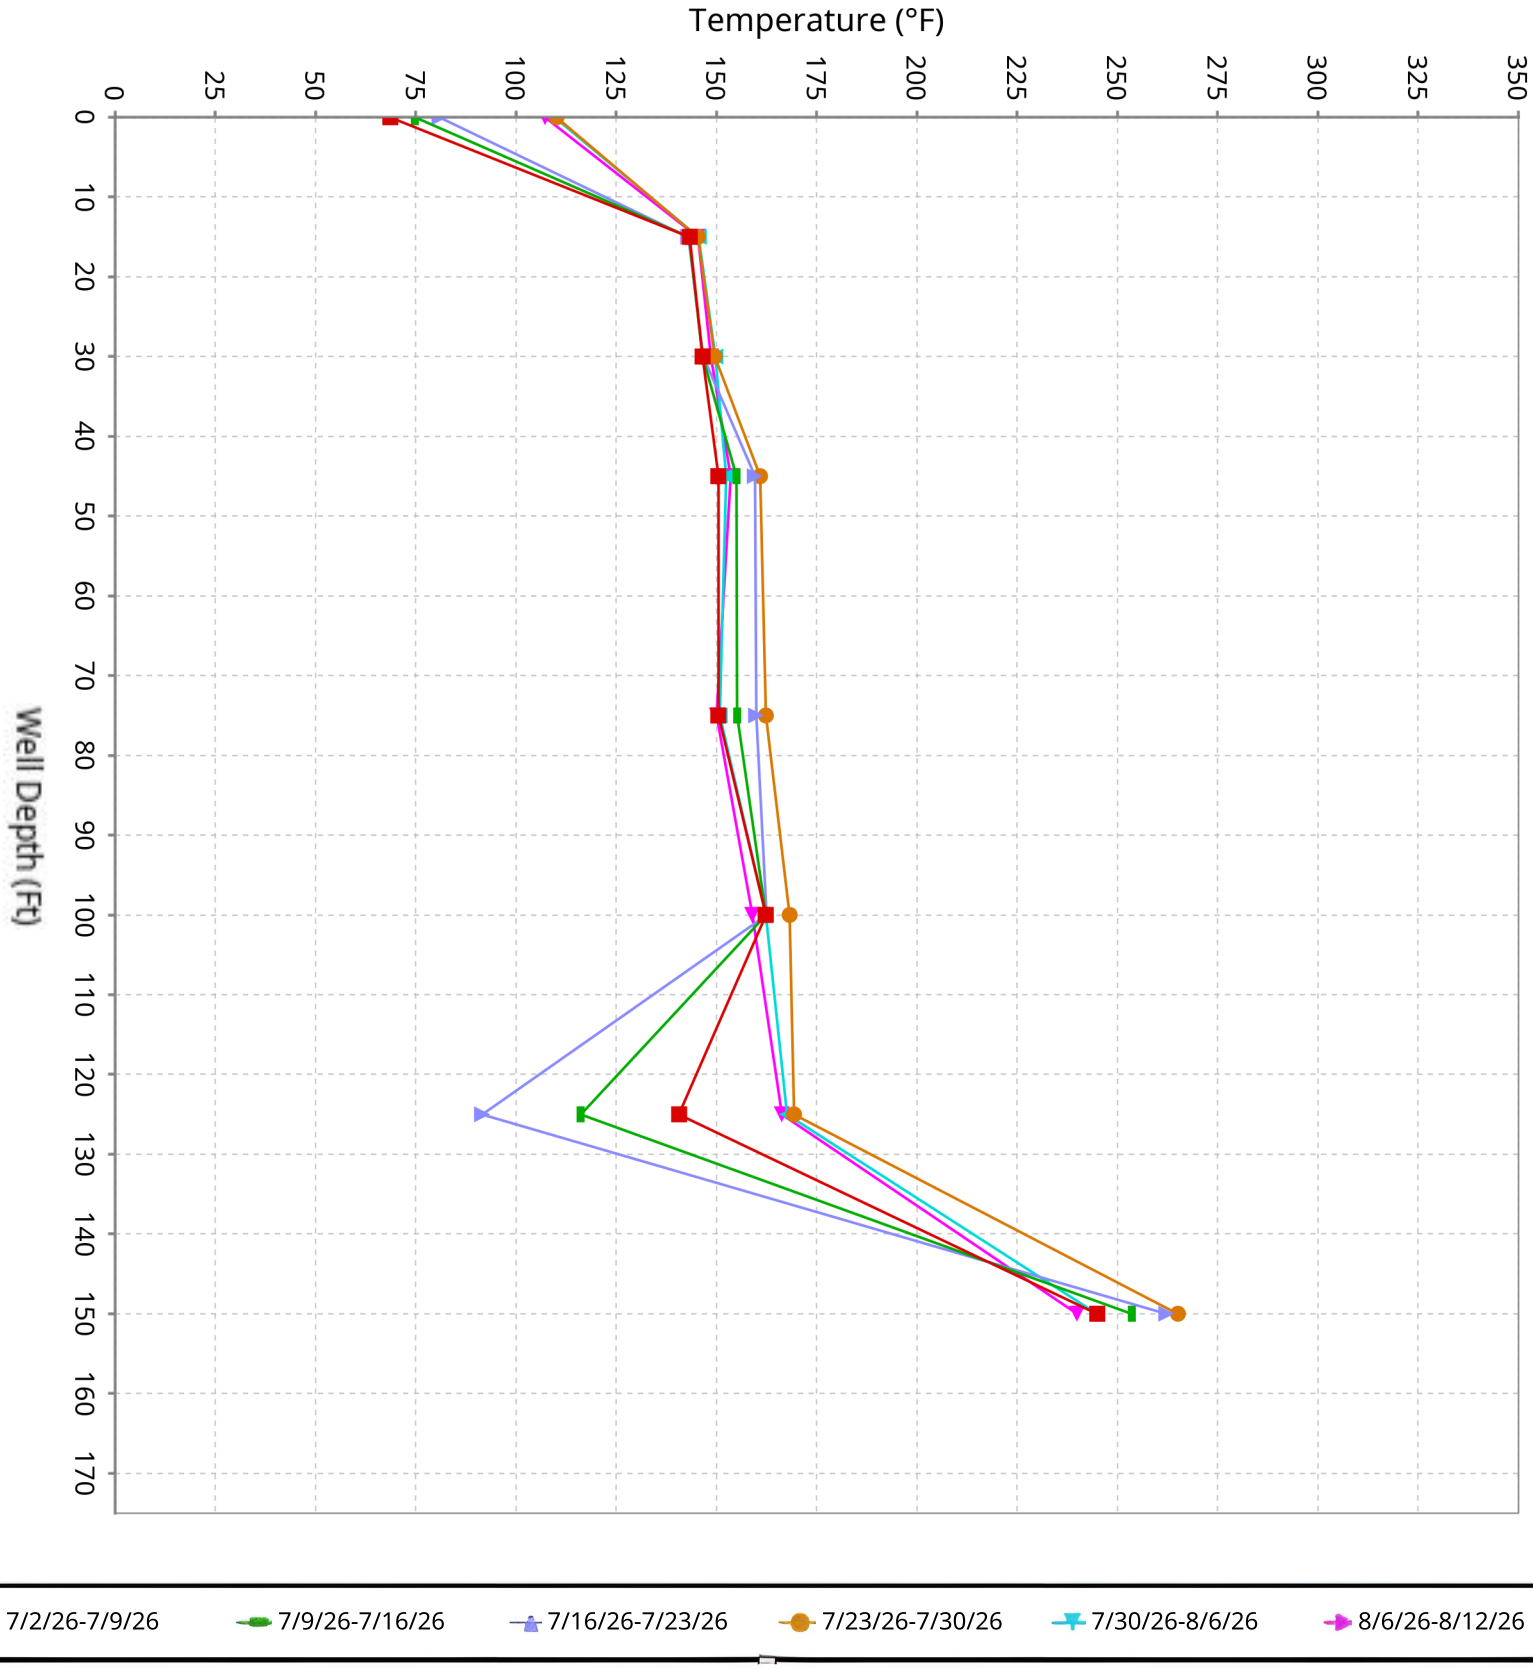
Vertical Temperature Profiles from Temperature Probes at Chiquita Landfill for TP-19

- TP-19
    - A discrepancy was identified during the review of data from two weeks prior. Upon investigation, the Site determined that the associated battery had failed and subsequently replaced it. During this inspection, the temperature reading from the 125-foot thermocouple was observed to be anomalously low. Further evaluation indicated that the 125-foot thermocouple required replacement. As an interim measure, the Site installed a 120-foot thermocouple that was available onsite and ordered a replacement 125-foot thermocouple. The replacement 125-foot thermocouple will be installed upon receipt.
    - The 150-foot thermocouple remained consistent with previously recorded temperatures.

TP19:
A discrepancy was identified during the review of data from two weeks prior. Upon investigation, the Site determined that the associated battery had failed and subsequently replaced it. During this inspection, the temperature reading from the 125-foot thermocouple was observed to be anomalously low. Further evaluation indicated that the 125-foot thermocouple required replacement. As an interim measure, the Site installed a 120-foot thermocouple that was available onsite and ordered a replacement 125-foot thermocouple. The replacement 125-foot thermocouple will be installed upon receipt.

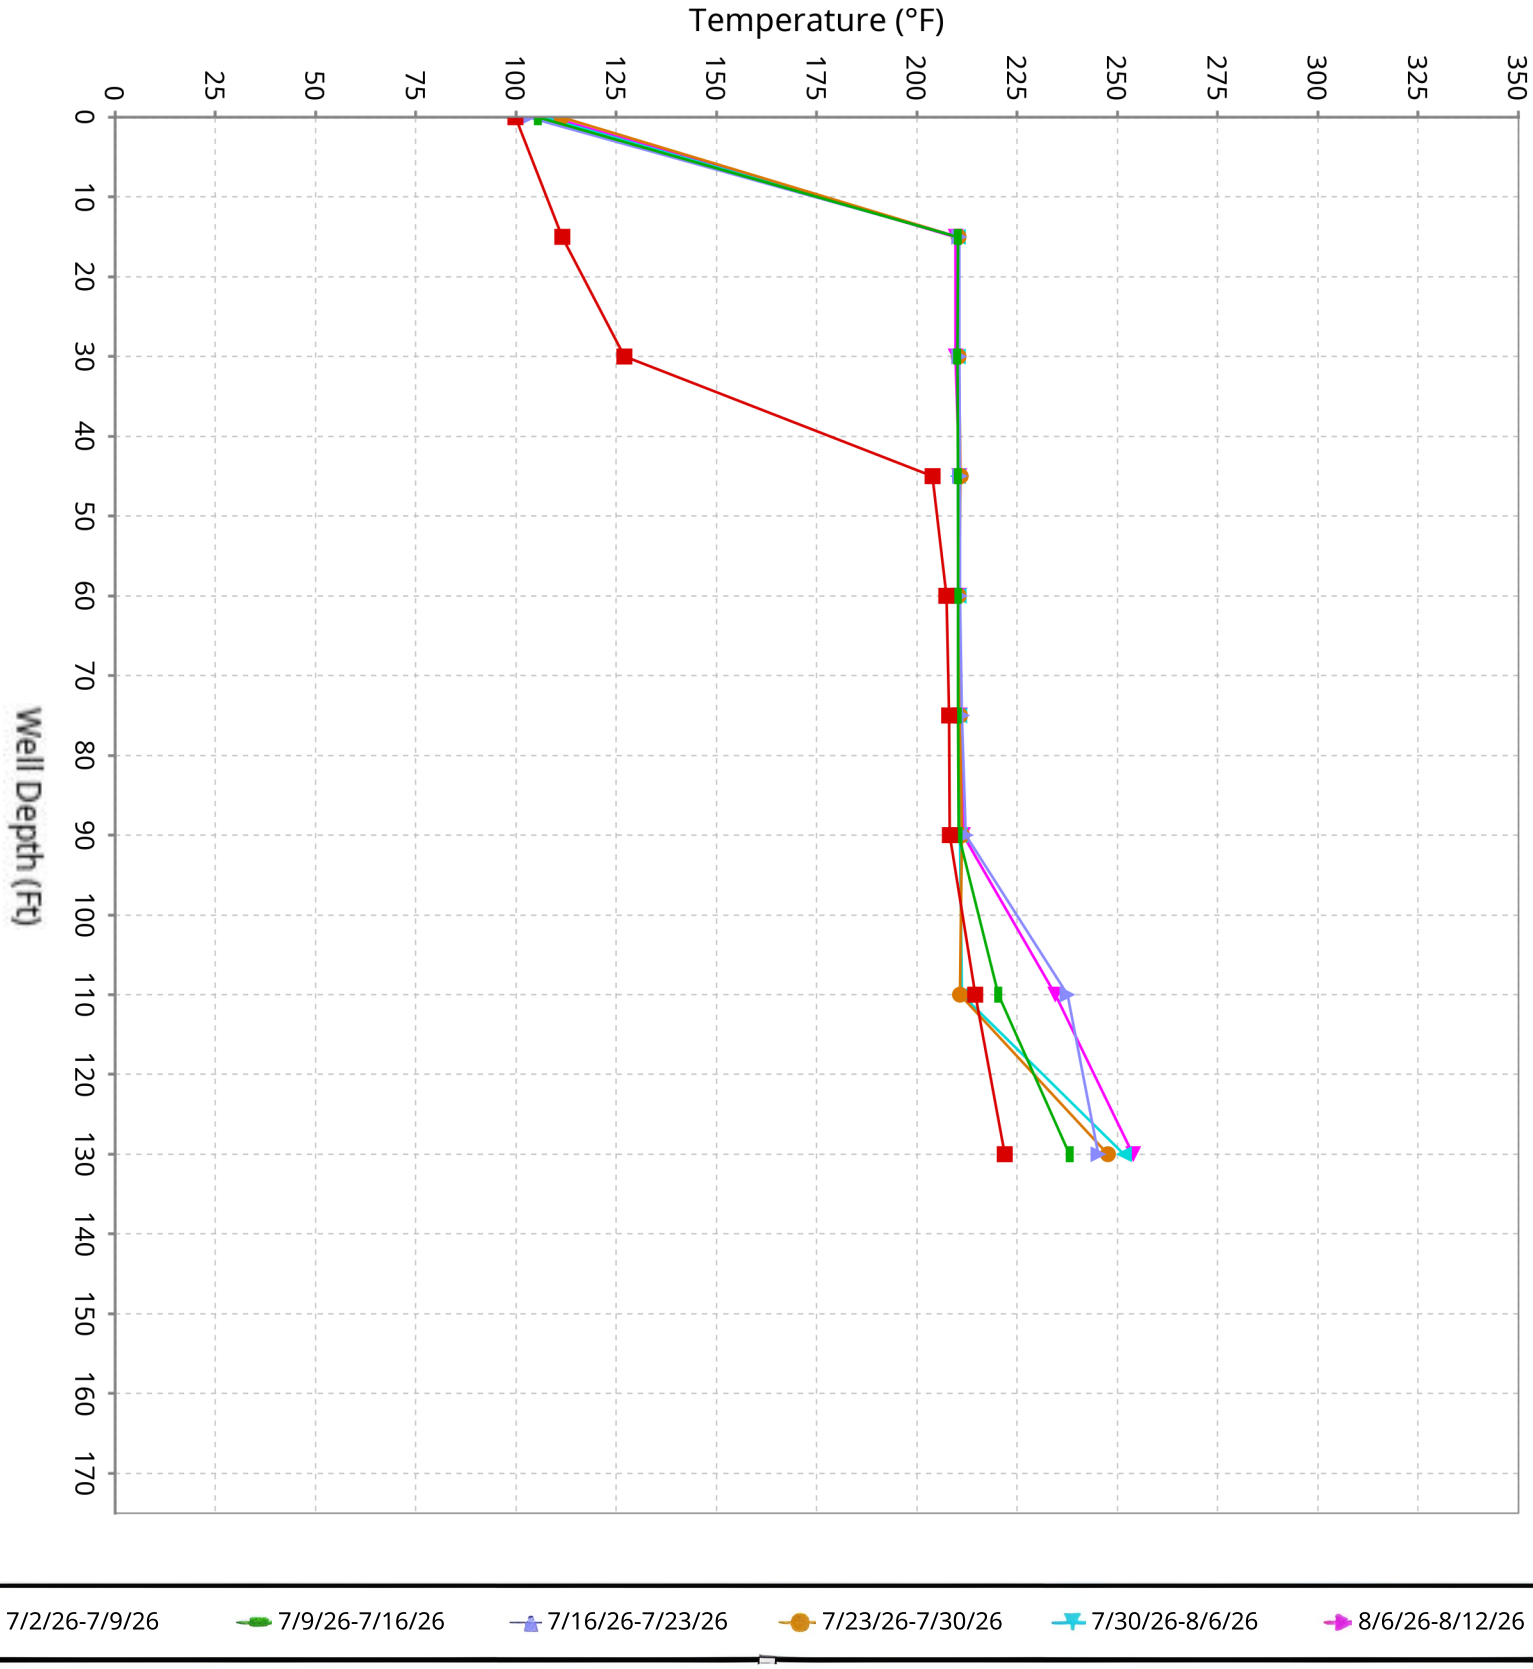
Vertical Temperature Profiles from Temperature Probes at Chiquita Landfill for TP-25

- TP-25
    - The Site conducted a follow-up camera inspection of the TP-25 temperature probe casing this week to evaluate potential liquid infiltration and assess the condition of the casing interior. The inspection indicated that no liquid was present at the bottom of the casing. Instead, pressurized gas was observed upon opening the probe casing. The temperatures inside TP-25 are thus no longer correctly reporting in-situ waste temperatures and are instead reporting gas temperatures traveling to and up the TMP casing. The Site will continue to monitor TP-25.

- The 110-foot thermocouple showed an increase in maximum temperature of 25°F from 210°F to 235°F from August 6th to August 8th, and then a decrease in maximum temperature of 22°F from 235°F to 213°F from August 8th to August 11th. As described above, the Site is continuing to assess the condition of this probe equipment and will continue to monitor the temperature on the thermocouples.

- The 130-foot thermocouple showed an increase in maximum temperature of 42°F from 212°F to 254°F from July 22nd to August 10th. As described above, the Site is continuing to assess the condition of this probe equipment and will continue to monitor the temperature on the thermocouples.

TP25:
The Site conducted a follow-up camera inspection of the TP-25 temperature probe casing this week to evaluate potential liquid infiltration and assess the condition of the casing interior. The inspection indicated that no liquid was present at the bottom of the casing. Instead, pressurized gas was observed upon opening the probe casing. The temperatures inside TP-25 are thus no longer correctly reporting in-situ waste temperatures and are instead reporting gas temperatures traveling to and up the TMP casing. The Site will continue to monitor TP-25.

TP-25: The Site plans to conduct a follow-up camera inspection next week of the probe casing to determine whether additional liquid infiltration has occurred within the TP-25 well casing and to assess the condition of the casing interior.

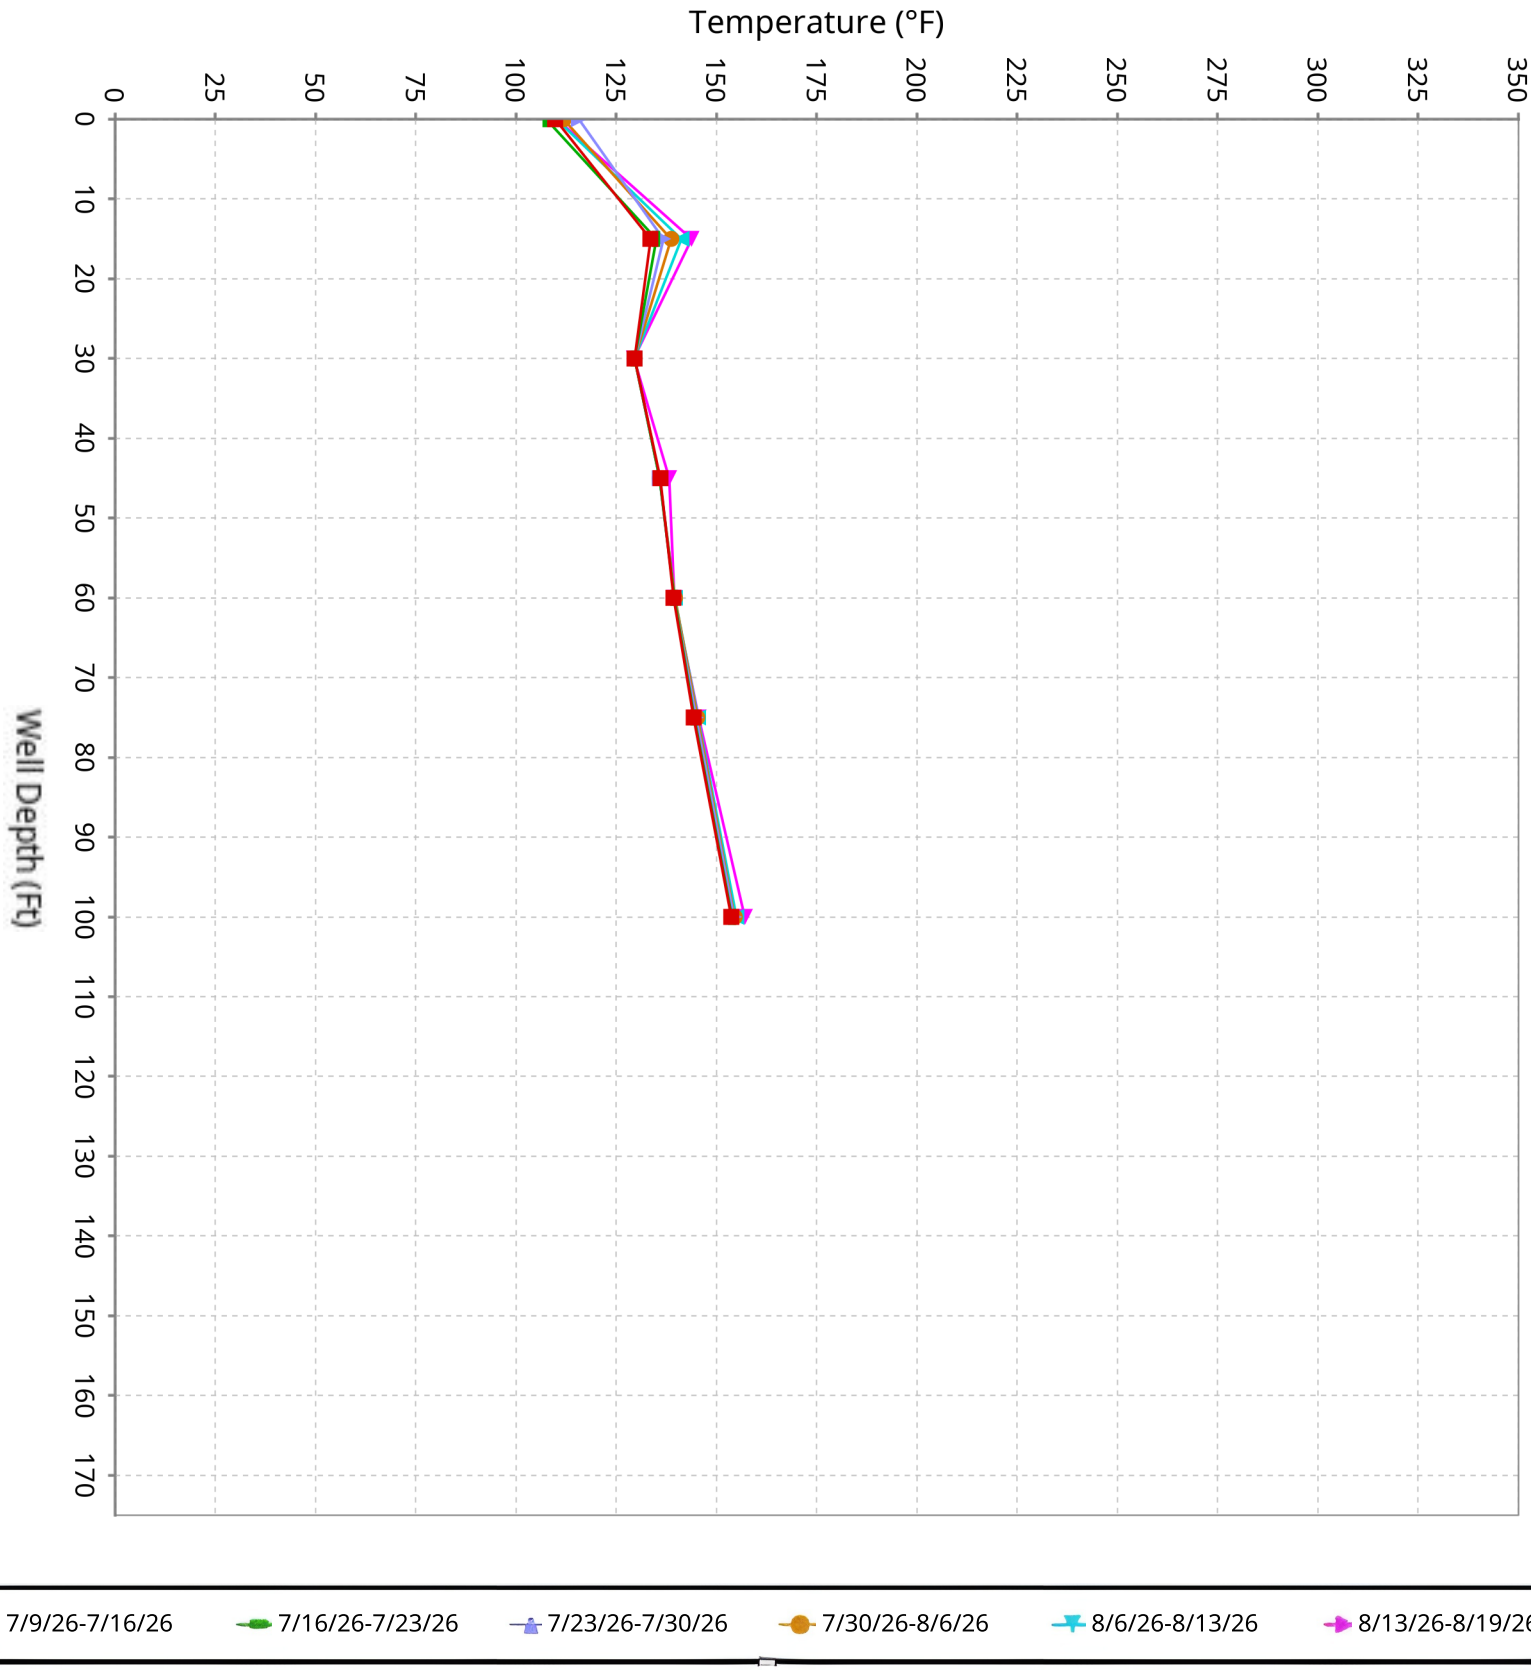
Vertical Temperature Profiles from Temperature Probes at Chiquita Landfill for TP-7

TP-07
One potential factor contributing to the observed temperature increase is the removal of liquids from wells near TP-07.
