SCS ENGINEERS

September 15, 2026

Subject: **August 2026 Monthly Report Pursuant to Milestones 1A-3 and 5 of the LEA June 6, 2024 Compliance Order and July 30, 2024 Letter, Chiquita Canyon Landfill, Castaic, California**

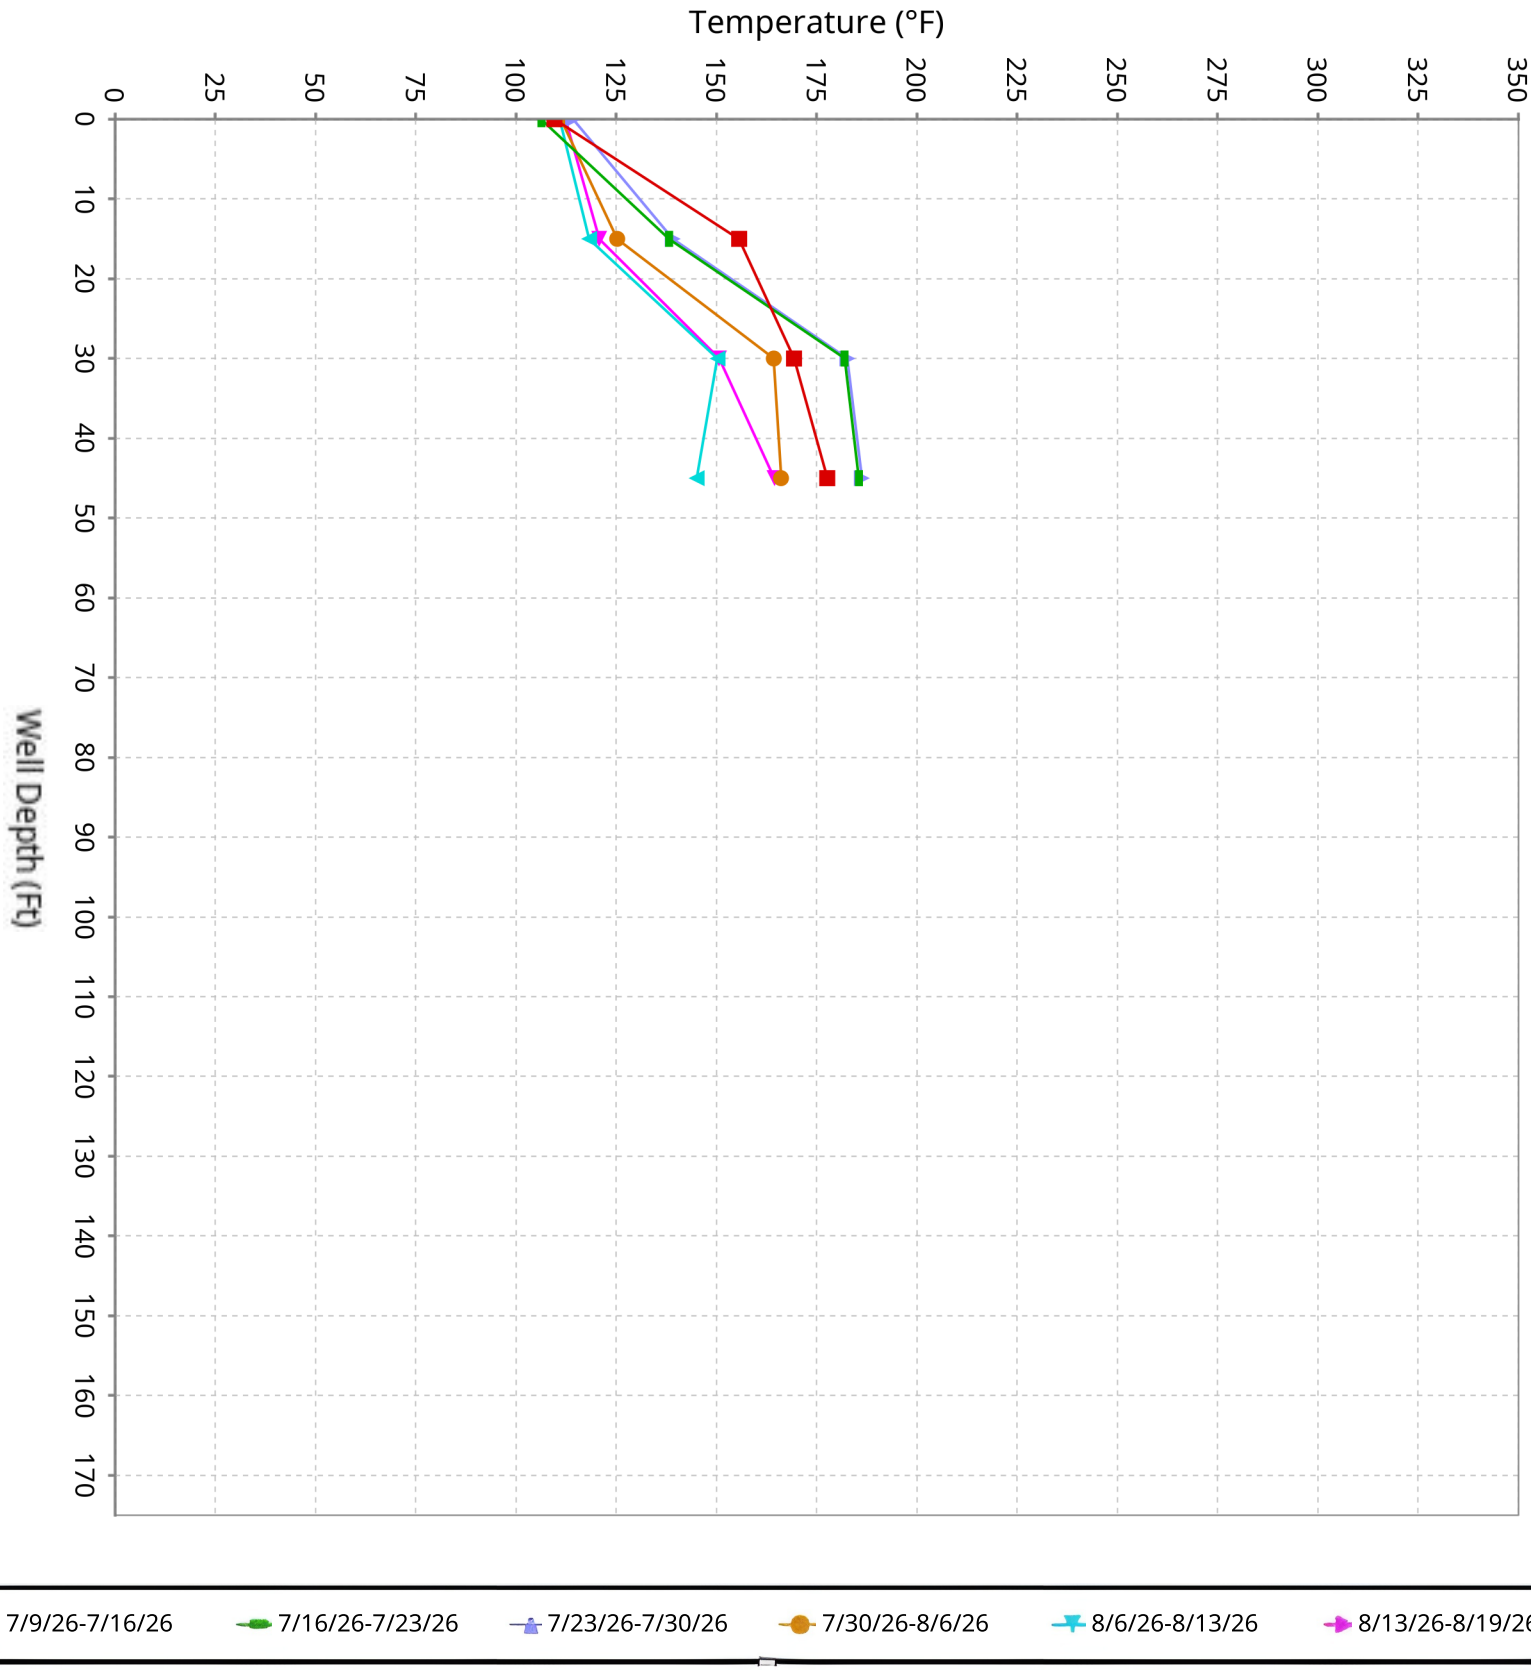
Vertical Temperature Profiles from Temperature Probes at Chiquita Landfill for TP-8

- TP-08
    - The 30-foot and 45-foot thermocouples exhibited temperature increases of 27°F and 29°F, respectively, between July 12, 2026, and July 22, 2026. In response, Site personnel observed the temperature changes and conducted an investigation from July 23, 2026, through July 29, 2026. Following the investigation, temperatures continued to decline at the 30-foot thermocouple from July 30th, 2026, through August 19, 2026, and temperatures started to increase at the 45-foot thermocouple from August 13, 2026, through August 19, 2026.

- TP-08 is installed within extraction well CV-24079, which is equipped with a liquid extraction pump. The investigation determined that the existing pump is experiencing a power-related issue and requires removal. Site personnel have identified the need for a replacement pump and plan to complete the replacement when the road to the well is completed.

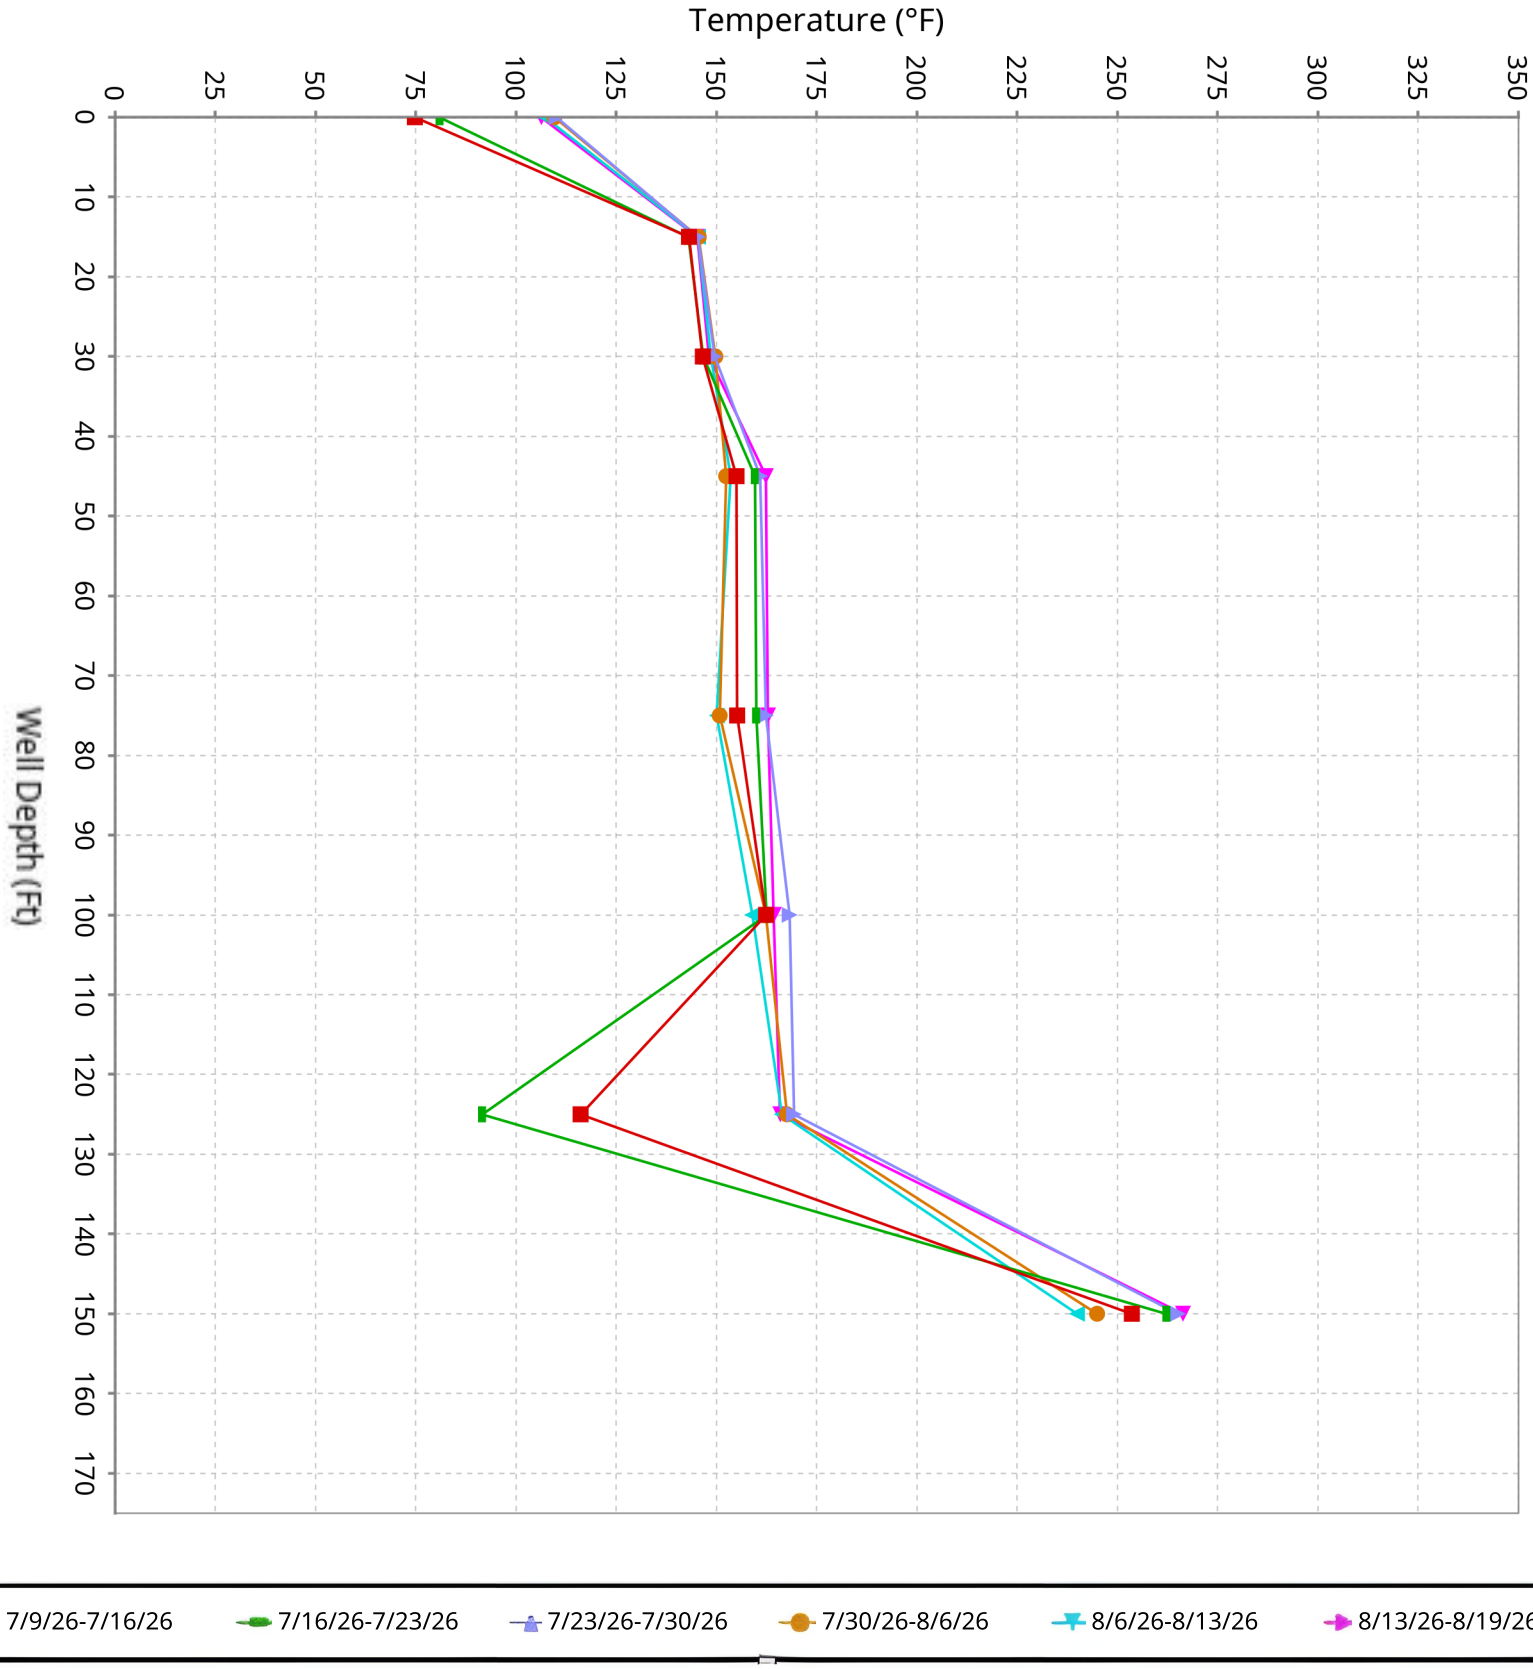
Vertical Temperature Profiles from Temperature Probes at Chiquita Landfill for TP-19

- TP-19
    - A discrepancy was identified during the review of data from three weeks prior. Upon investigation, the Site determined that the associated battery had failed and subsequently replaced it. During this inspection, the temperature reading from the 125-foot thermocouple was observed to be anomalously low. Further evaluation indicated that the 125-foot thermocouple required replacement. As an interim measure, the Site installed a 120-foot thermocouple that was available onsite and ordered a replacement 125-foot thermocouple. The replacement 125-foot thermocouple will be installed upon receipt.
    - The 75-foot thermocouple showed an increase in maximum temperature of 14°F from 149°F to 163°F from August 14th to August 19th.

TP-19: A discrepancy was identified during the review of data from three weeks prior. Upon investigation, the Site determined that the associated battery had failed and subsequently replaced it. During this inspection, the temperature reading from the 125-foot thermocouple was observed to be anomalously low. Further evaluation indicated that the 125-foot thermocouple required replacement. As an interim measure, the Site installed a 120-foot thermocouple that was available onsite and ordered a replacement 125-foot thermocouple. The replacement 125-foot thermocouple will be installed upon receipt.

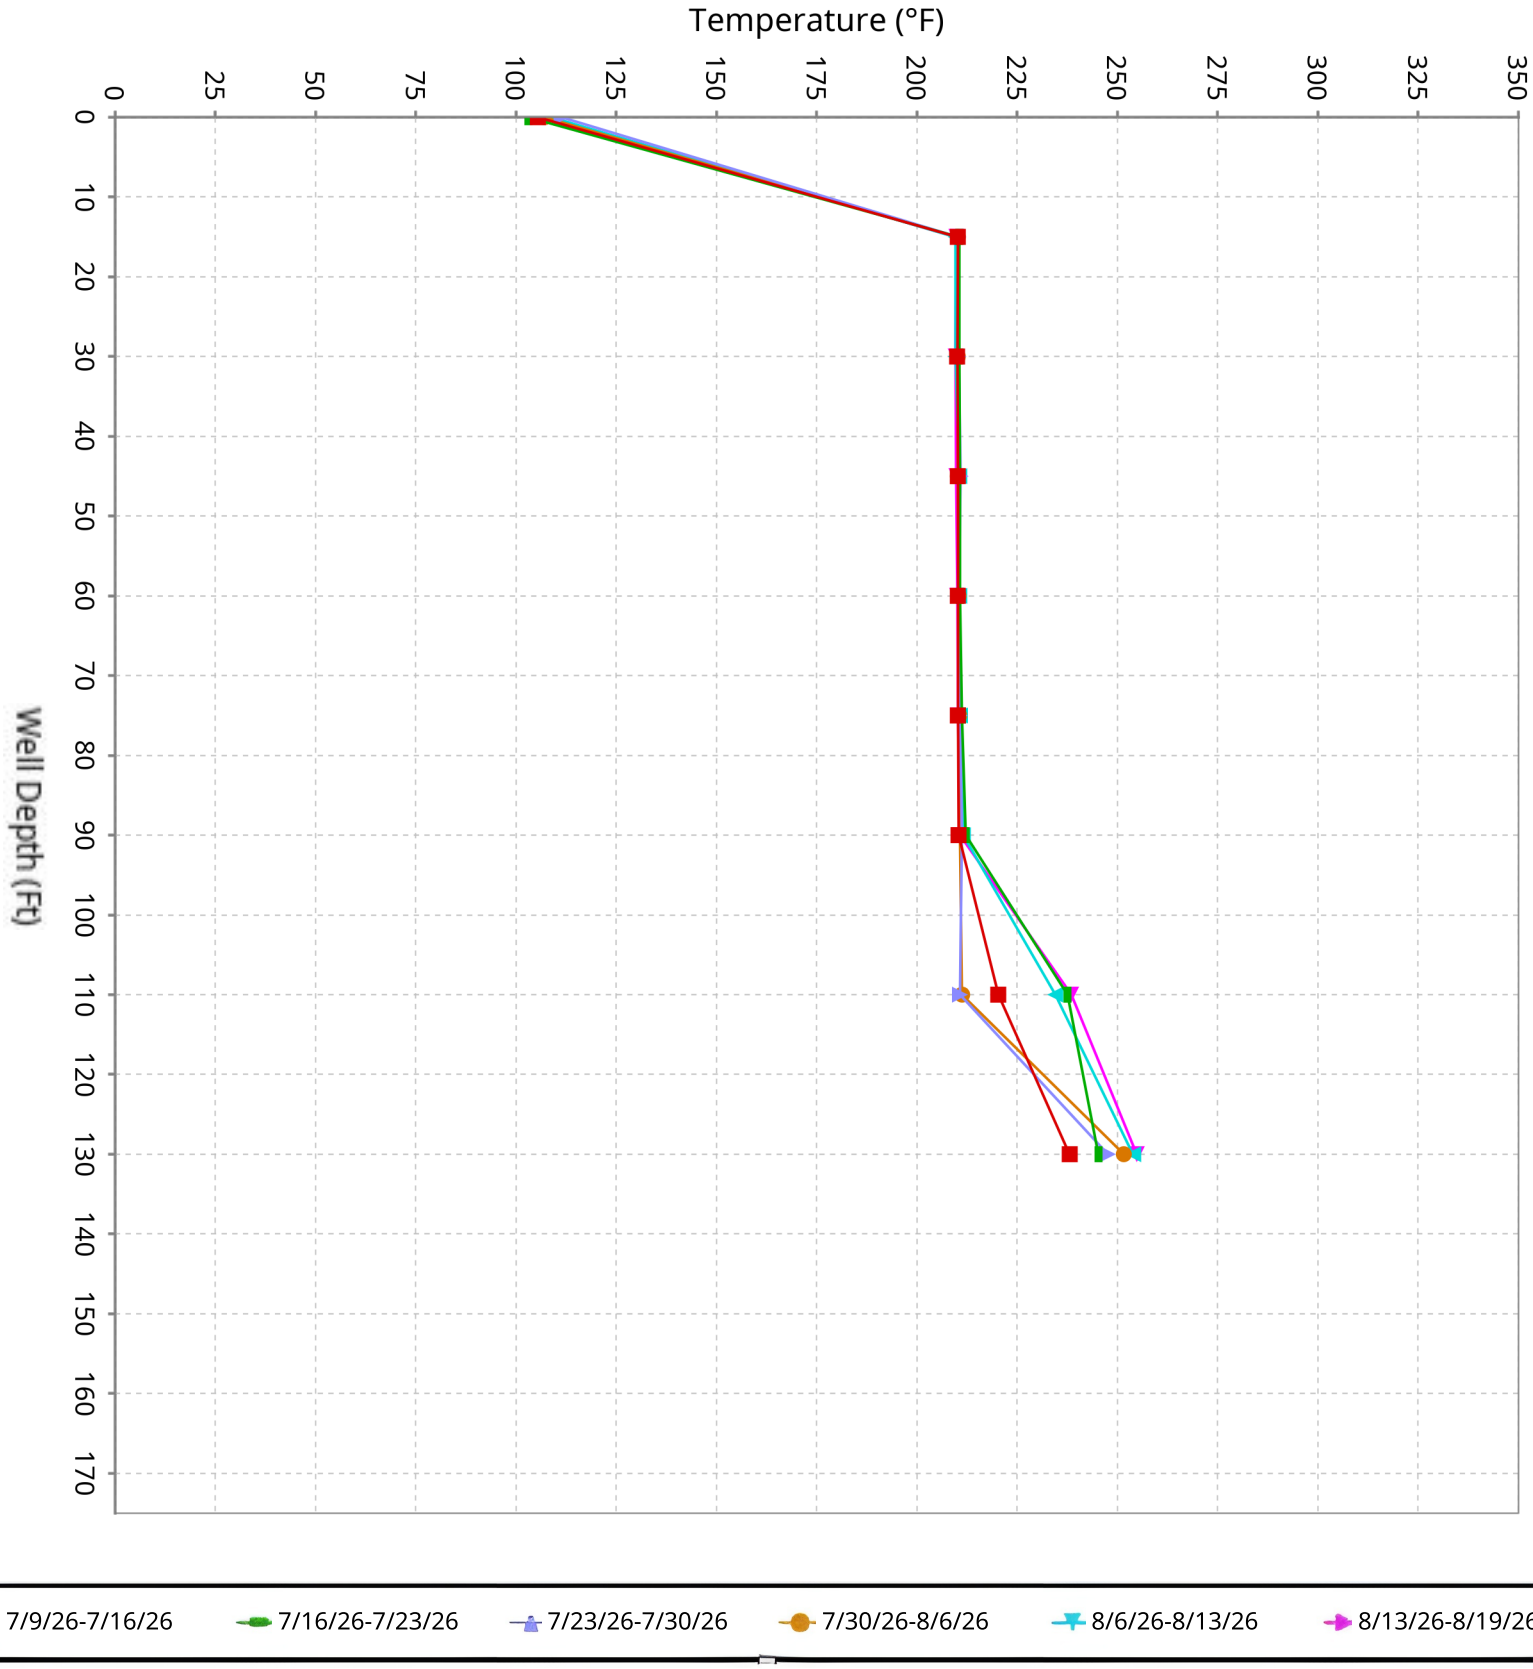
Vertical Temperature Profiles from Temperature Probes at Chiquita Landfill for TP-25

- TP-25
    - The Site conducted a follow-up camera inspection of the TP-25 temperature probe casing last week to evaluate potential liquid infiltration and assess the condition of the casing interior. The inspection indicated that no liquid was present at the bottom of the casing. Instead, pressurized gas was observed upon opening the probe casing. The temperature probes inside TP-25 are thus no longer correctly reporting in-situ waste temperatures and are instead reporting gas temperatures traveling to and up the temperature probe casing. The Site will continue to monitor TP-25.

- The 110-foot thermocouple showed an increase in maximum temperature of 25°F from 213°F to 238°F from August 11th to August 18th. As described above, the Site is continuing to assess the condition of this probe equipment and will continue to monitor the temperature on the thermocouples.

- The 130-foot thermocouple showed an increase in maximum temperature of 42°F from 212°F to 254°F from July 22nd to August 10th. As described above, the Site is continuing to assess the condition of this probe equipment and will continue to monitor the temperature on the thermocouples.

TP-25: The Site conducted a follow-up camera inspection of the TP-25 temperature probe casing last week to evaluate potential liquid infiltration and assess the condition of the casing interior. The inspection indicated that no liquid was present at the bottom of the casing. Instead, pressurized gas was observed upon opening the probe casing. The temperature probes inside TP-25 are thus no longer correctly reporting in-situ waste temperatures and are instead reporting gas temperatures traveling to and up the temperature probe casing. The Site will continue to monitor TP-25.

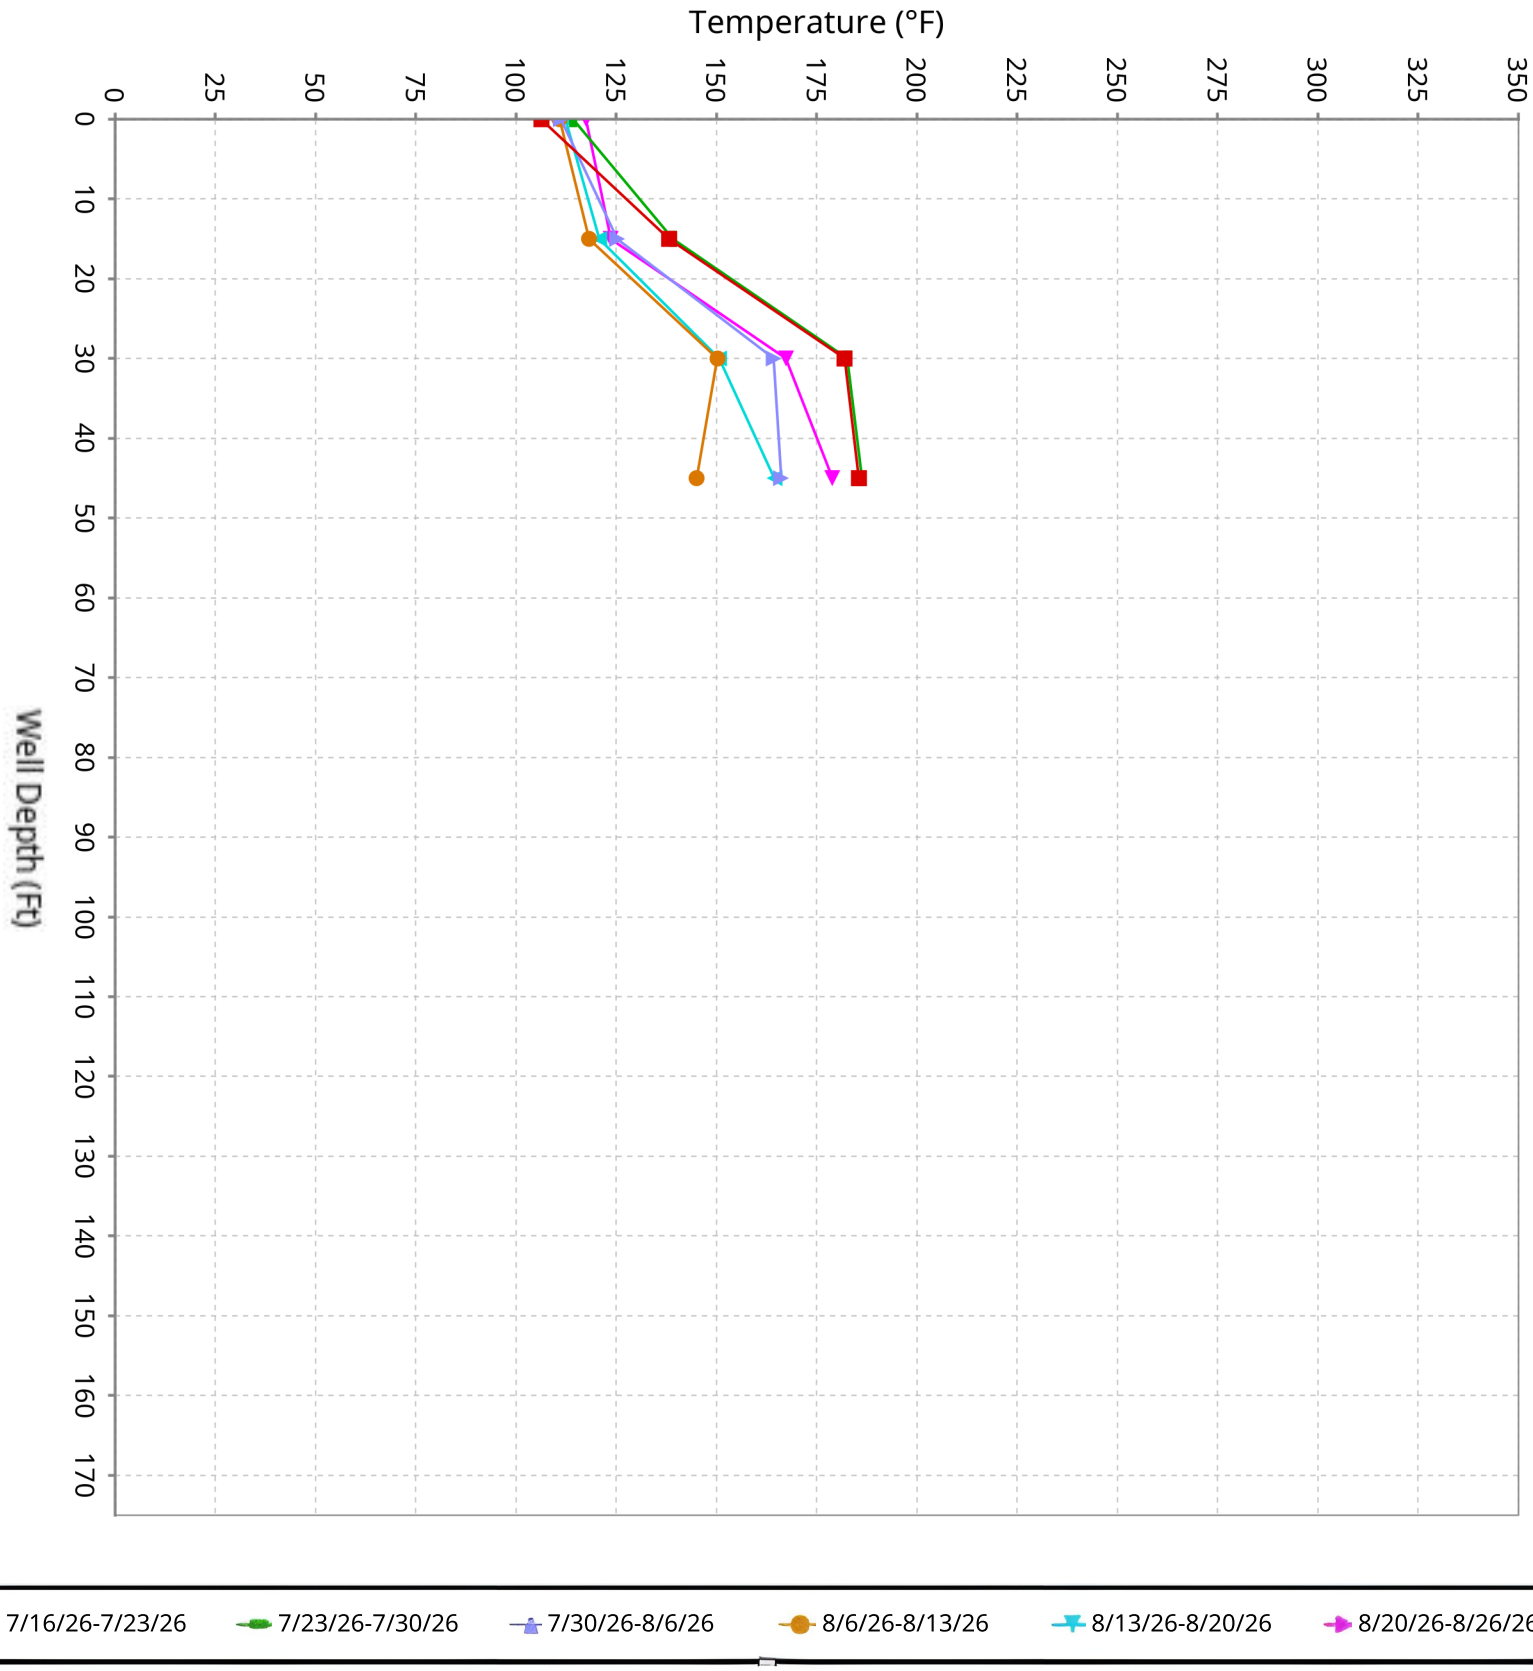
Vertical Temperature Profiles from Temperature Probes at Chiquita Landfill for TP-8

- TP-08
    - The 30-foot and 45-foot thermocouples exhibited temperature increases of 27°F and 29°F, respectively, between July 12, 2026, and July 22, 2026. In response, Site personnel observed the temperature changes and conducted an investigation from July 23, 2026, through July 29, 2026. Following the investigation, temperatures continued to decline at the 30-foot thermocouple from July 30th, 2026, through August 19, 2026, and then temperatures started to increase at the 15, 30, and 45-foot thermocouples from August 20, 2026, through August 26, 2026.

- TP-08 is installed within extraction well CV-24079, which is equipped with a liquid extraction pump. The investigation determined that the existing pump is experiencing a power-related issue and requires removal. Site personnel have identified the need for a replacement pump and plan to complete the replacement when the road to the well is completed.

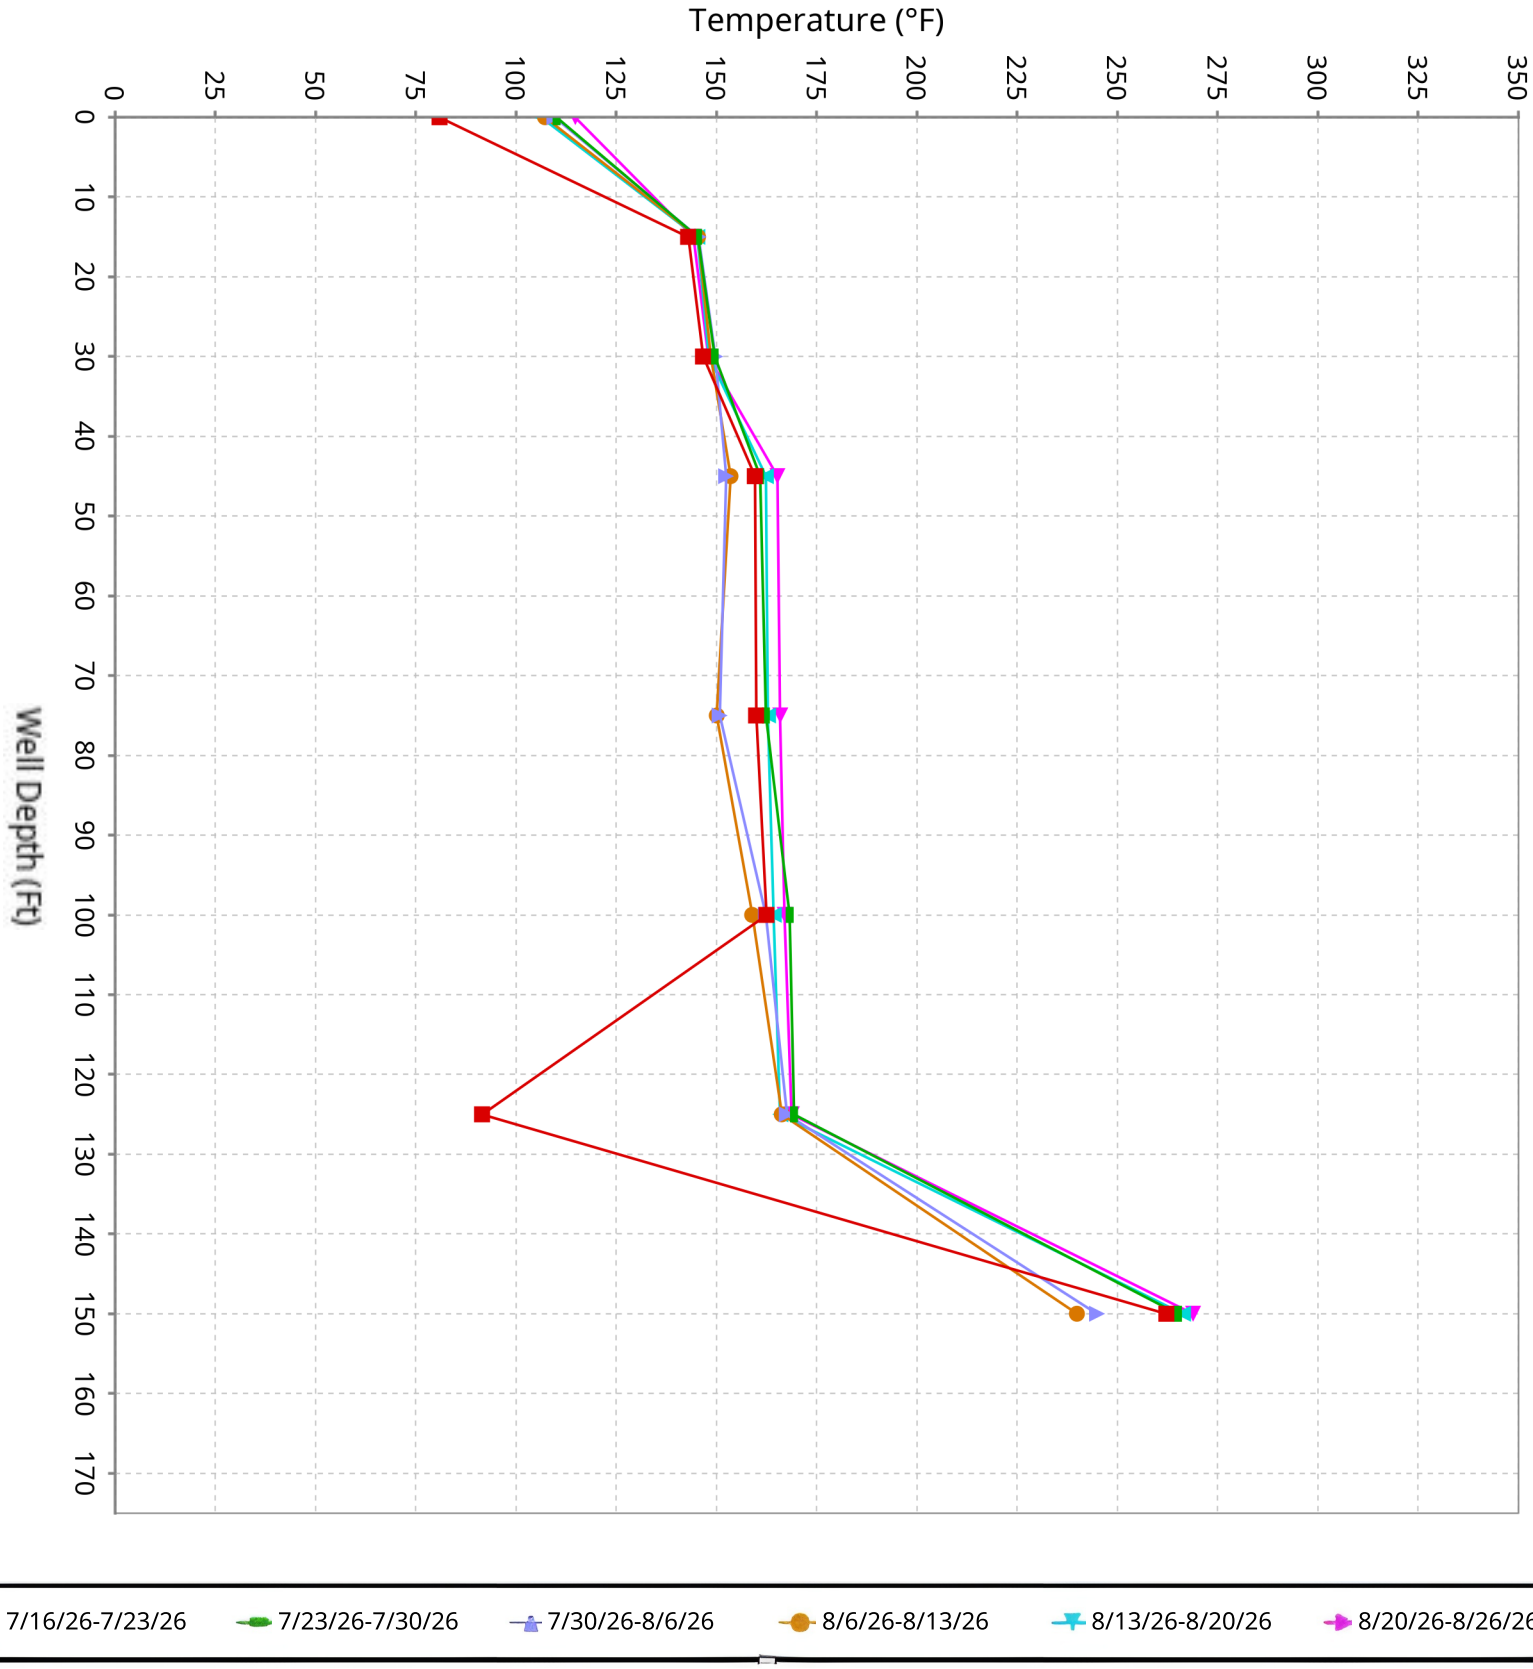
Vertical Temperature Profiles from Temperature Probes at Chiquita Landfill for TP-19

- TP-19
    - A discrepancy was identified during the review of data from four weeks prior. Upon investigation, the Site determined that the associated battery had failed and subsequently replaced it. During this inspection, the temperature reading from the 125-foot thermocouple was observed to be anomalously low. Further evaluation indicated that the 125-foot thermocouple required replacement. As an interim measure, the Site installed a 120-foot thermocouple that was available onsite and ordered a replacement 125-foot

thermocouple. The replacement 125-foot thermocouple is anticipated to be installed upon receipt in October 2026.
    - The 75-foot thermocouple remained consistent with previously recorded temperatures.
    - The 150-foot thermocouple showed an increase in maximum temperature of 30°F from 239°F to 269°F from August 11th to August 26th.

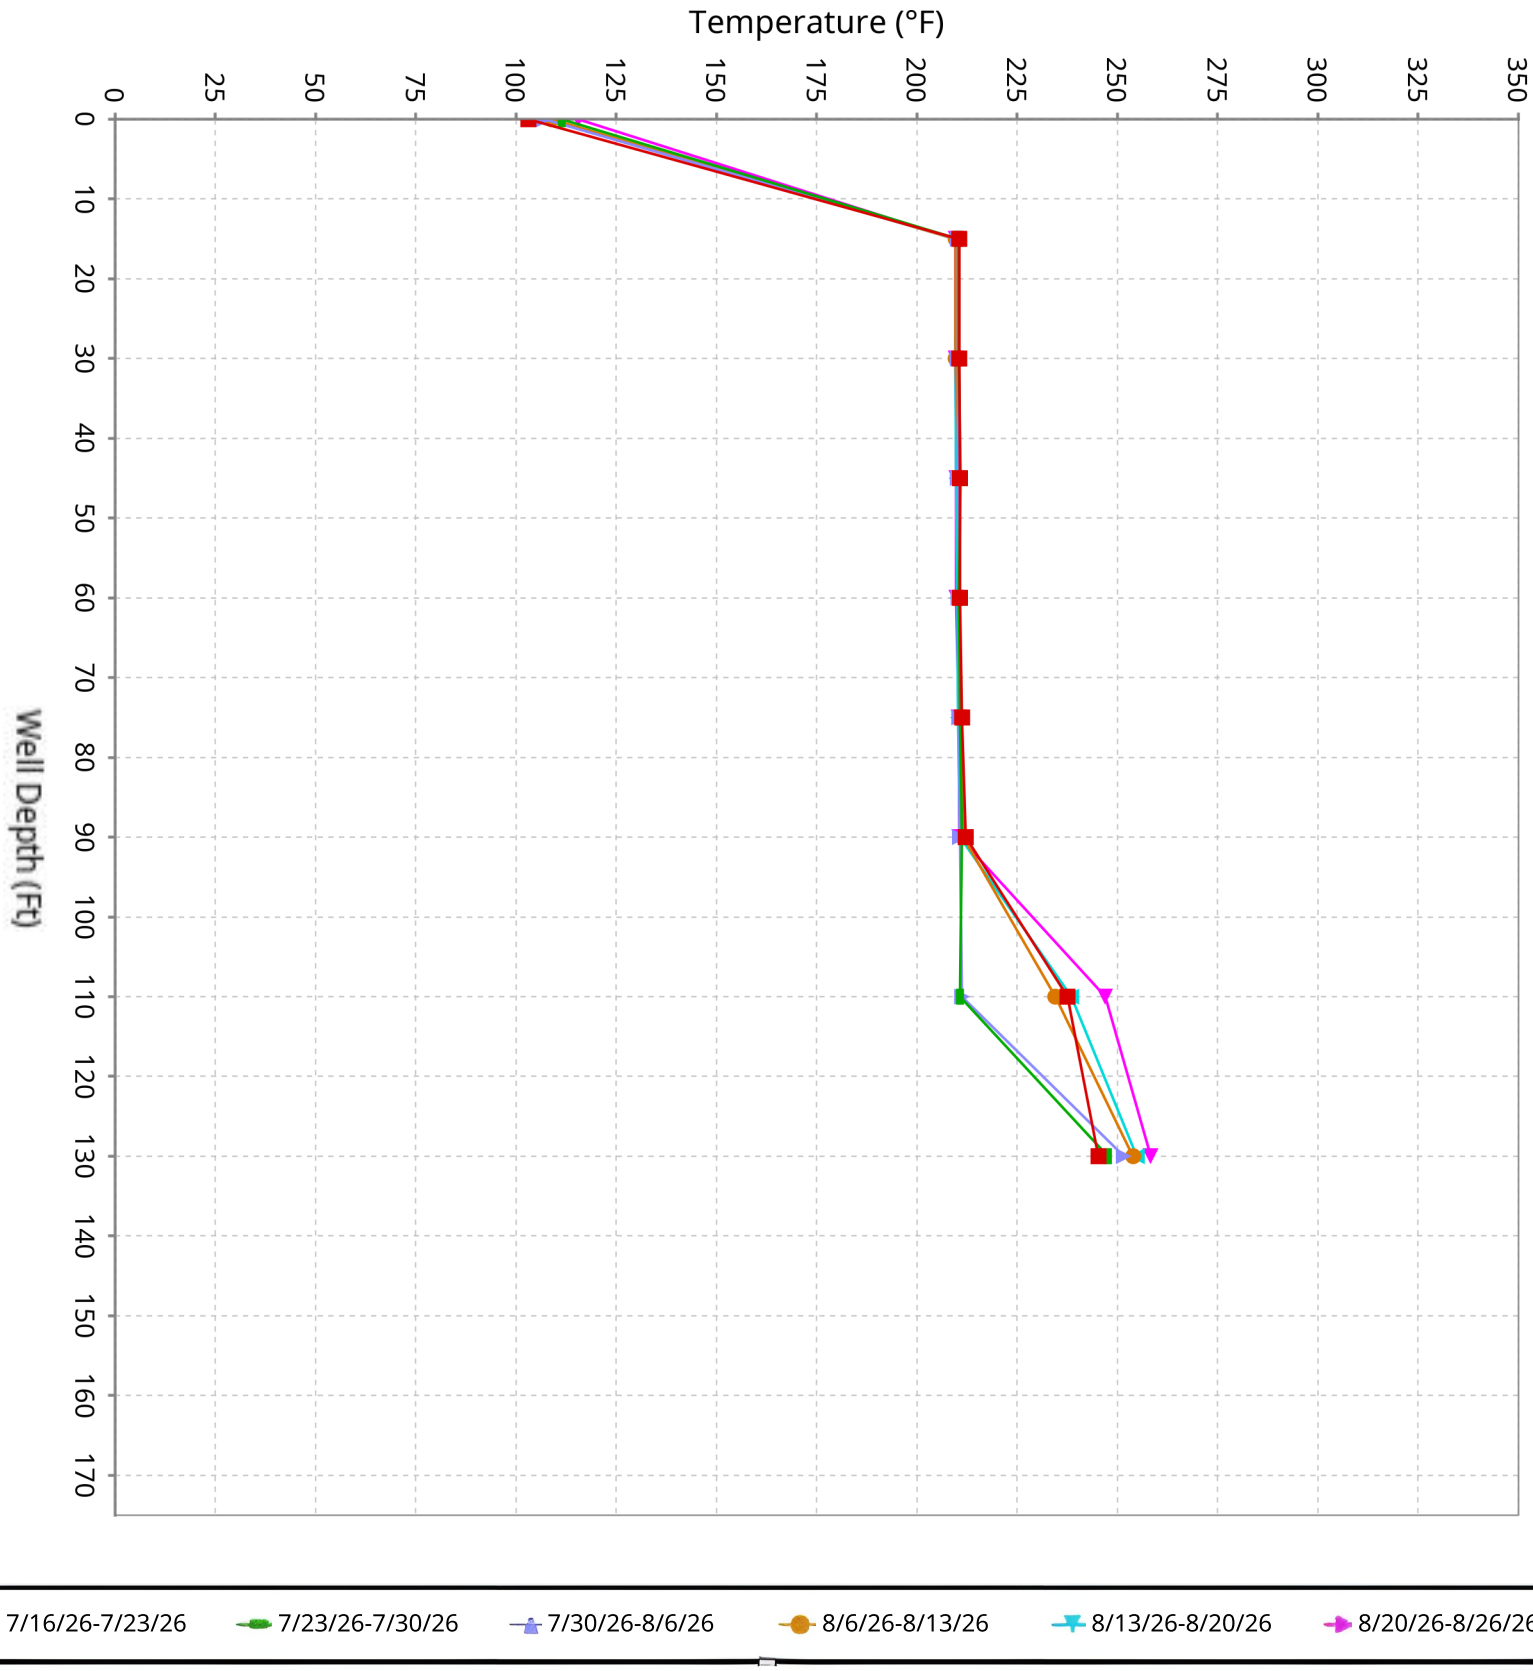
Vertical Temperature Profiles from Temperature Probes at Chiquita Landfill for TP-25

- TP-25
    - The Site conducted a follow-up camera inspection of the TP-25 temperature probe casing last week to evaluate potential liquid infiltration and assess the condition of the casing interior. The inspection indicated that no liquid was present at the bottom of the casing. Instead, pressurized gas was observed upon opening the probe casing. The temperature probes inside TP-25 are thus no longer correctly reporting in-situ waste temperatures and are instead reporting gas temperatures traveling to and up the temperature probe casing. The Site will continue to monitor TP-25.

- The 110-foot thermocouple showed an increase in maximum temperature of 34°F from 213°F to 247°F from August 11th to August 26th. As described above, the Site is continuing to assess the condition of this probe equipment and will continue to monitor the temperature on the thermocouples.

- The 130-foot thermocouple remained consistent with previously recorded temperatures. As described above, the Site is continuing to assess the condition of this probe equipment and will continue to monitor the temperature on the thermocouples.

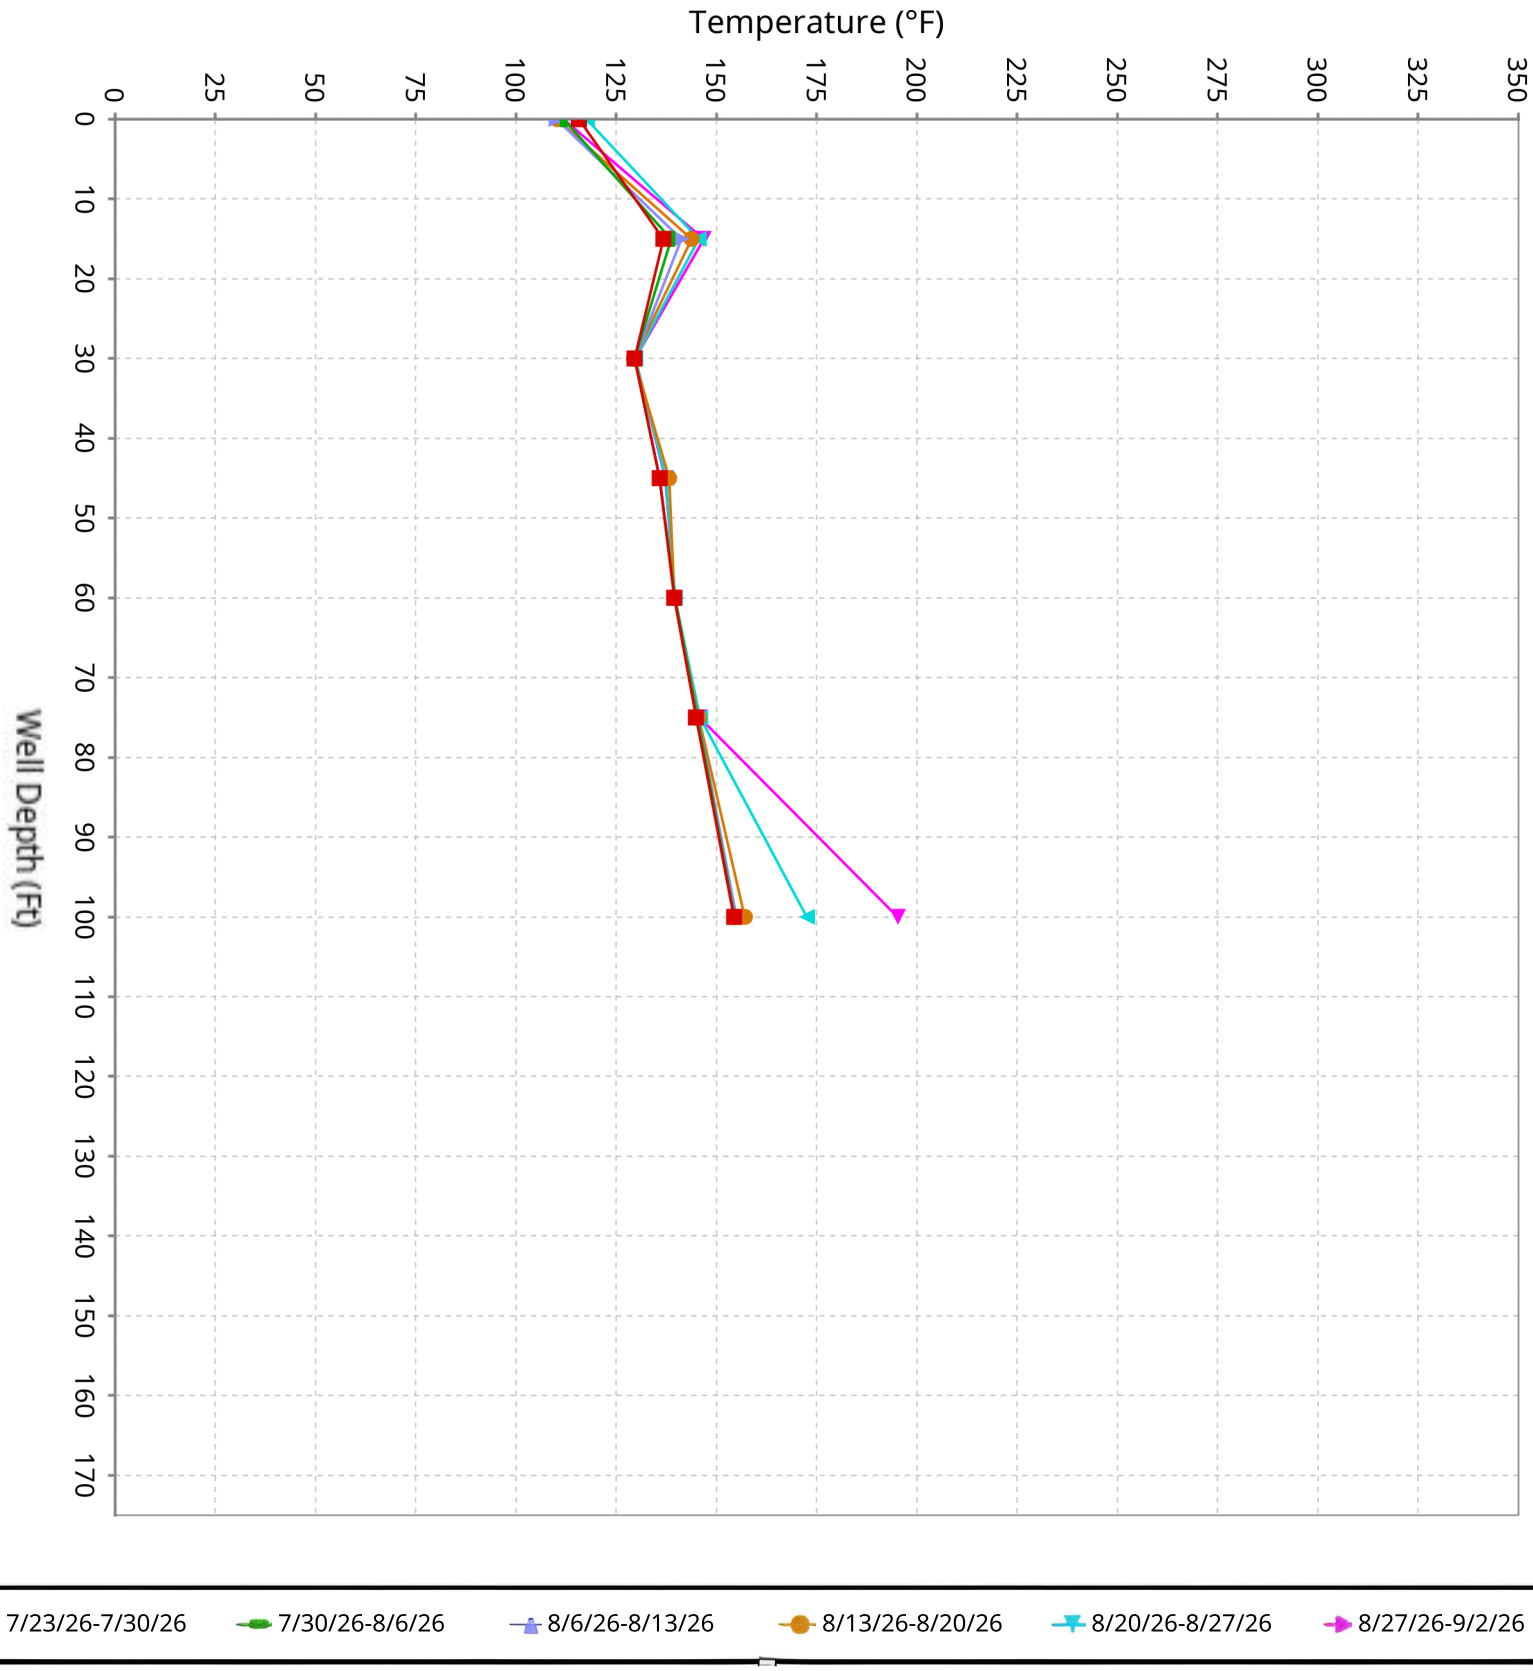
Vertical Temperature Profiles from Temperature Probes at Chiquita Landfill for TP-7

- TP-07
    - The 100-foot thermocouple showed an increase in maximum temperature of 40°F from 155°F to 195°F from August 16th to September 2nd. One potential factor contributing to the observed temperature increase is the removal of liquids from wells near TP-07.

TP-07
One potential factor contributing to the observed temperature increase is the removal of liquids from wells near TP-07.
