SCS ENGINEERS

September 15, 2026

Subject: **August 2026 Monthly Report Pursuant to Milestones 1A-3 and 5 of the LEA June 6, 2024 Compliance Order and July 30, 2024 Letter, Chiquita Canyon Landfill, Castaic, California**

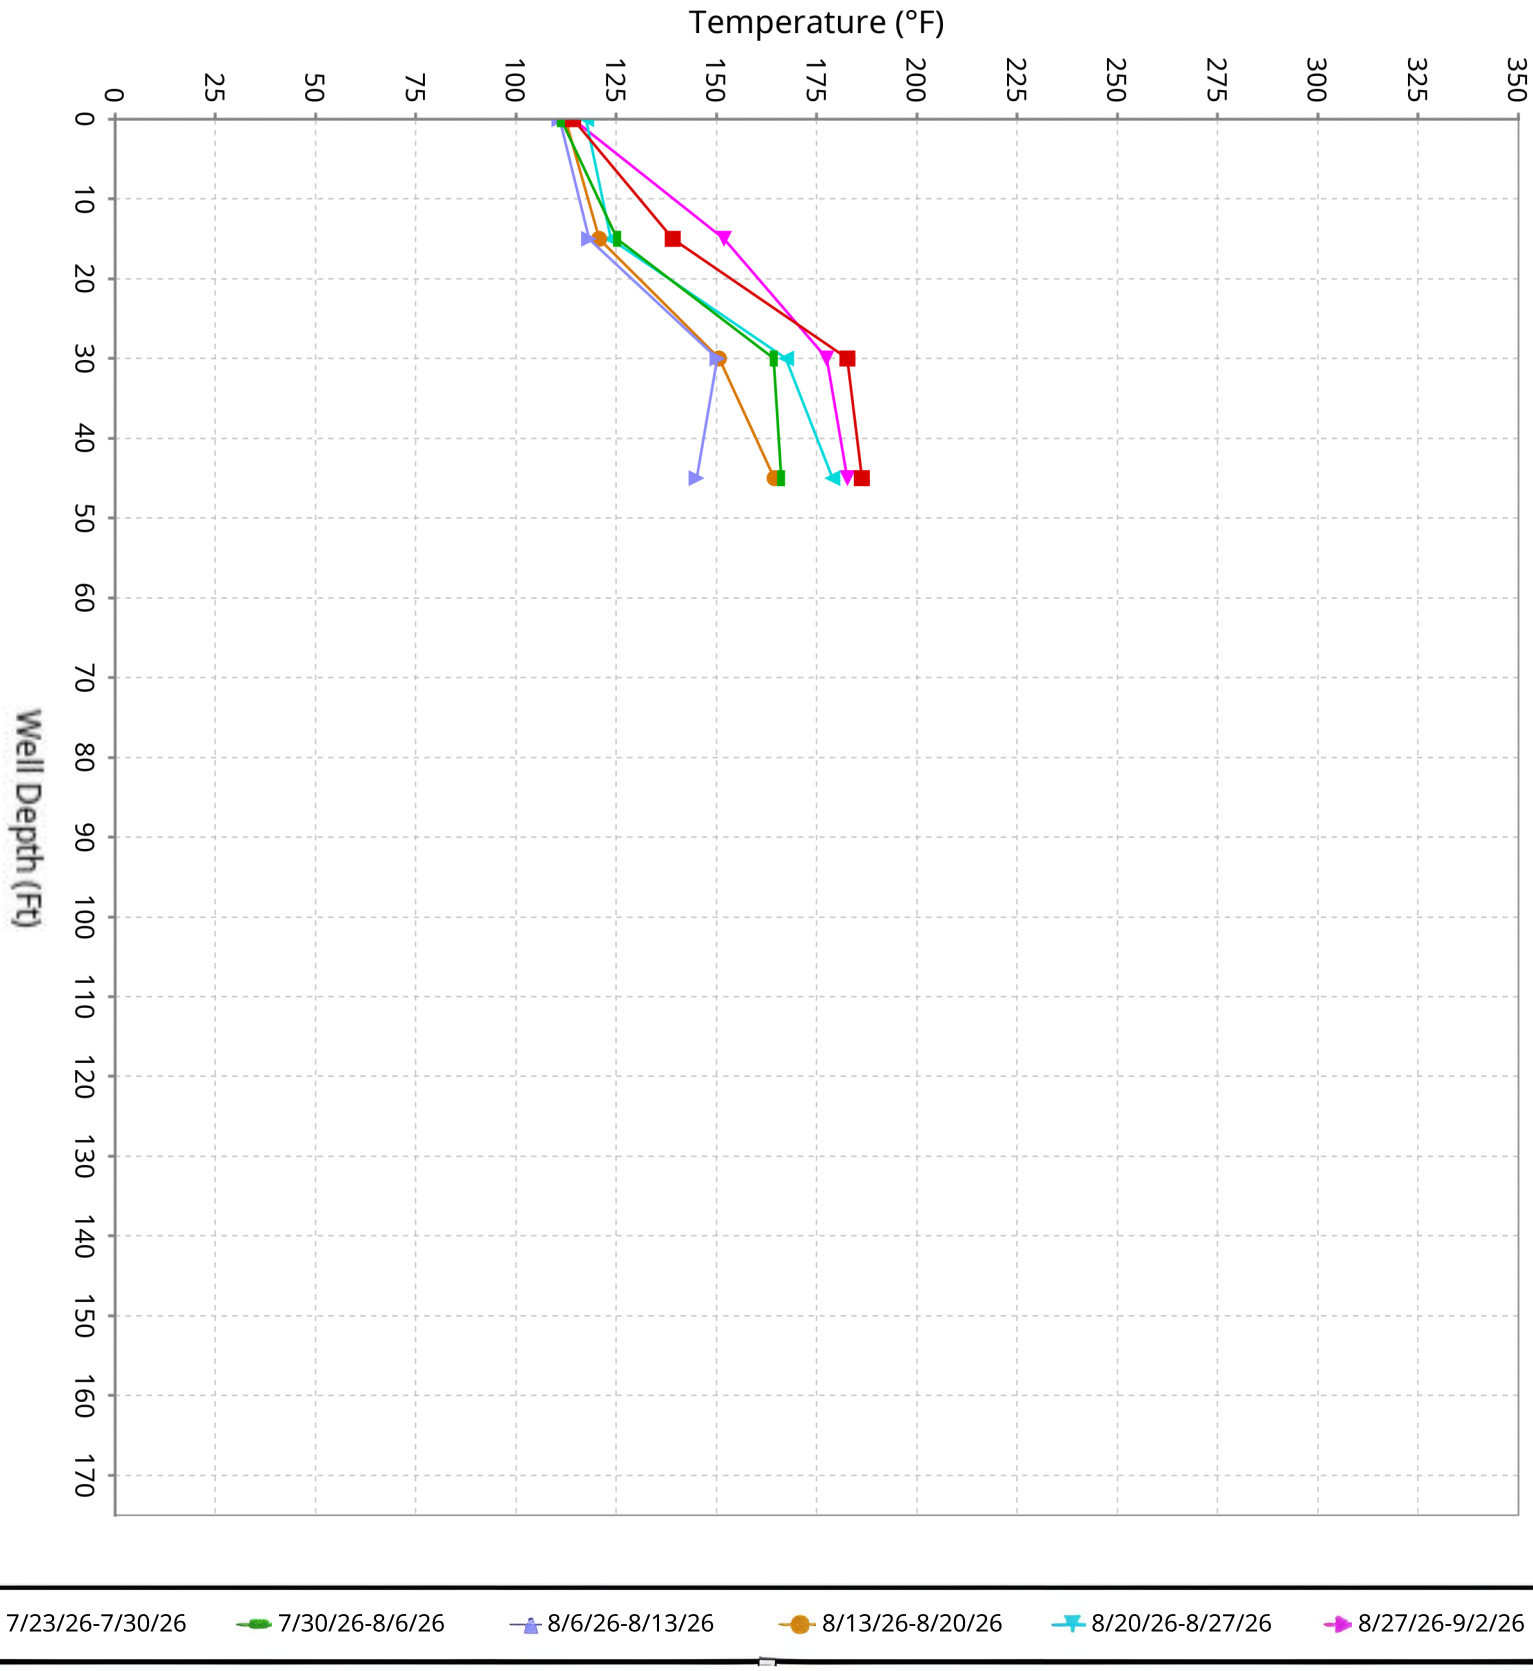
Vertical Temperature Profiles from Temperature Probes at Chiquita Landfill for TP-8

- TP-08
    - The 30-foot and 45-foot thermocouples exhibited temperature increases of 27°F and 29°F, respectively, between July 12, 2026, and July 22, 2026. In response, Site personnel observed the temperature changes and conducted an investigation from July 23, 2026, through July 29, 2026. Following the investigation, temperatures continued to decline at the 30-foot thermocouple from July 30th, 2026, through August 19, 2026, and then temperatures started to increase at the 15, 30, and 45-foot thermocouples from August 20, 2026, through September 2, 2026.

- TP-08 is installed within extraction well CV-24079, which is equipped with a liquid extraction pump. The investigation determined that the existing pump is experiencing a power-related issue and requires removal. Site personnel have identified the need for a replacement pump and plan to complete the replacement when the road to the well is completed. One potential factor contributing to the observed temperature increase is the removal of liquids from wells near TP-08.

- The 15-foot thermocouple showed an increase in maximum temperature of 39°F from 113°F to 152°F from August 22nd to September 2nd.
    - The 30-foot thermocouple showed an increase in maximum temperature of 33°F from 144°F to 177°F from August 21st to September 2nd.

- The 45-foot thermocouple showed an increase in maximum temperature of 21°F from 162°F to 183°F from August 21st to September 2nd.

TP-08
The 30-foot and 45-foot thermocouples exhibited temperature increases of 27°F and 29°F, respectively, between July 12, 2026, and July 22, 2026. In response, Site personnel observed the temperature changes and conducted an investigation from July 23, 2026, through July 29, 2026. Following the investigation, temperatures continued to decline at the 30-foot thermocouple from July 30th, 2026, through August 19, 2026, and then temperatures started to increase at the 15, 30, and 45-foot thermocouples from August 20, 2026, through September 2, 2026.
TP-08 is installed within extraction well CV-24079, which is equipped with a liquid extraction pump. The investigation determined that the existing pump is experiencing a power-related issue and requires removal. Site personnel have identified the need for a replacement pump and plan to complete the replacement when the road to the well is completed. One potential factor contributing to the observed temperature increase is the removal of liquids from wells near TP-08.

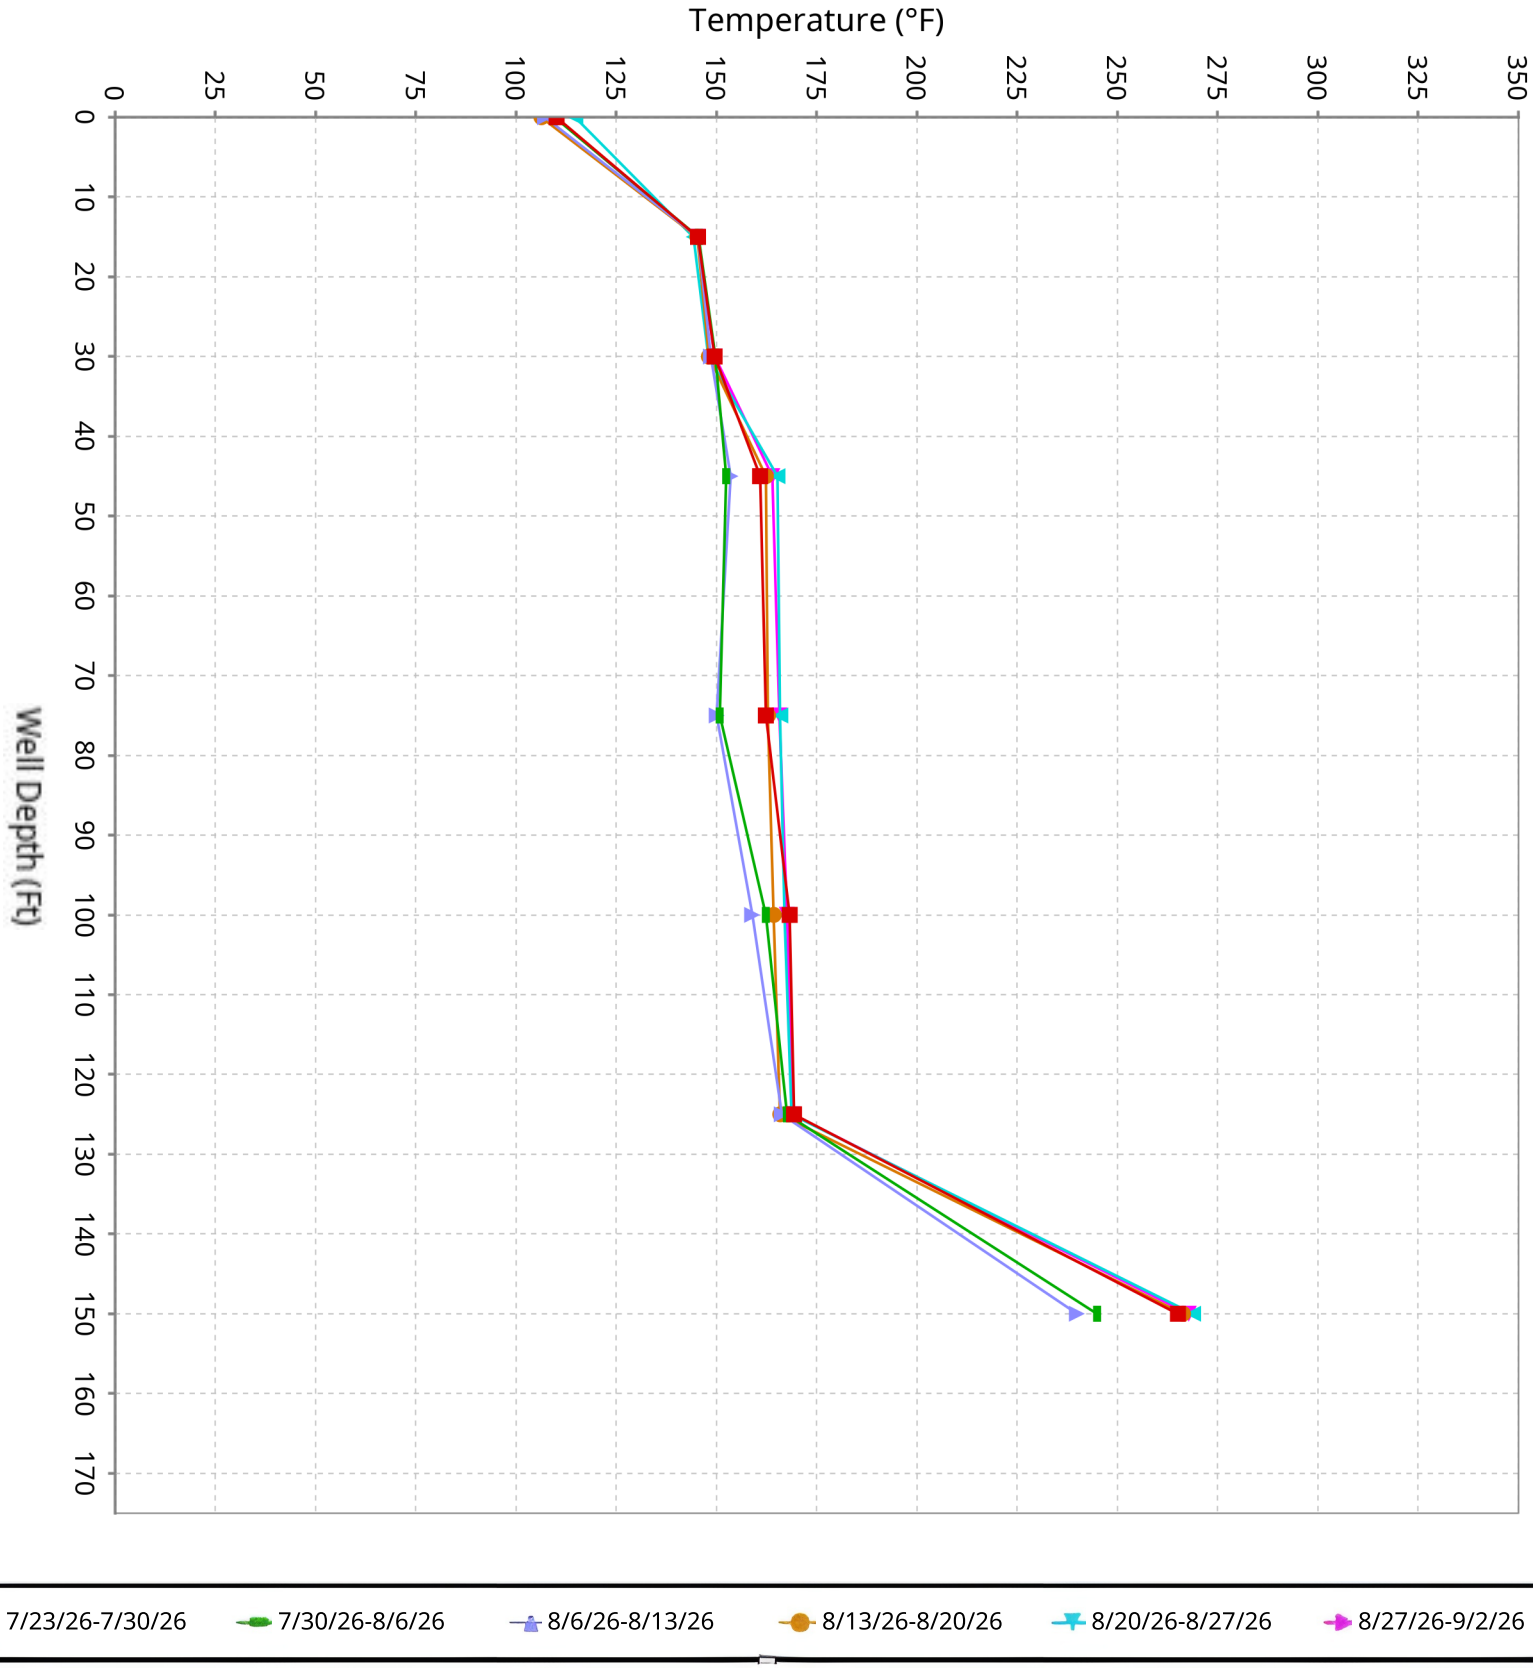
Vertical Temperature Profiles from Temperature Probes at Chiquita Landfill for TP-19

- TP-19
    - A discrepancy was identified during the review of data from five weeks prior. Upon investigation, the Site determined that the associated battery had failed and subsequently replaced it. During this inspection, the temperature reading from the 125-foot thermocouple was observed to be anomalously low. Further evaluation indicated that the 125-foot thermocouple required replacement. As an interim measure, the Site installed a 120-foot

thermocouple that was available onsite and ordered a replacement 125-foot thermocouple. The replacement 125-foot thermocouple is anticipated to be installed upon receipt in October 2026.
    - The 75-foot thermocouple showed a decrease in maximum temperature of 13°F from 166°F to 153°F from August 27th to September 2nd.
    - The 150-foot thermocouple showed a decrease in maximum temperature of 31°F from 269°F to 238°F from August 26th to September 2nd.

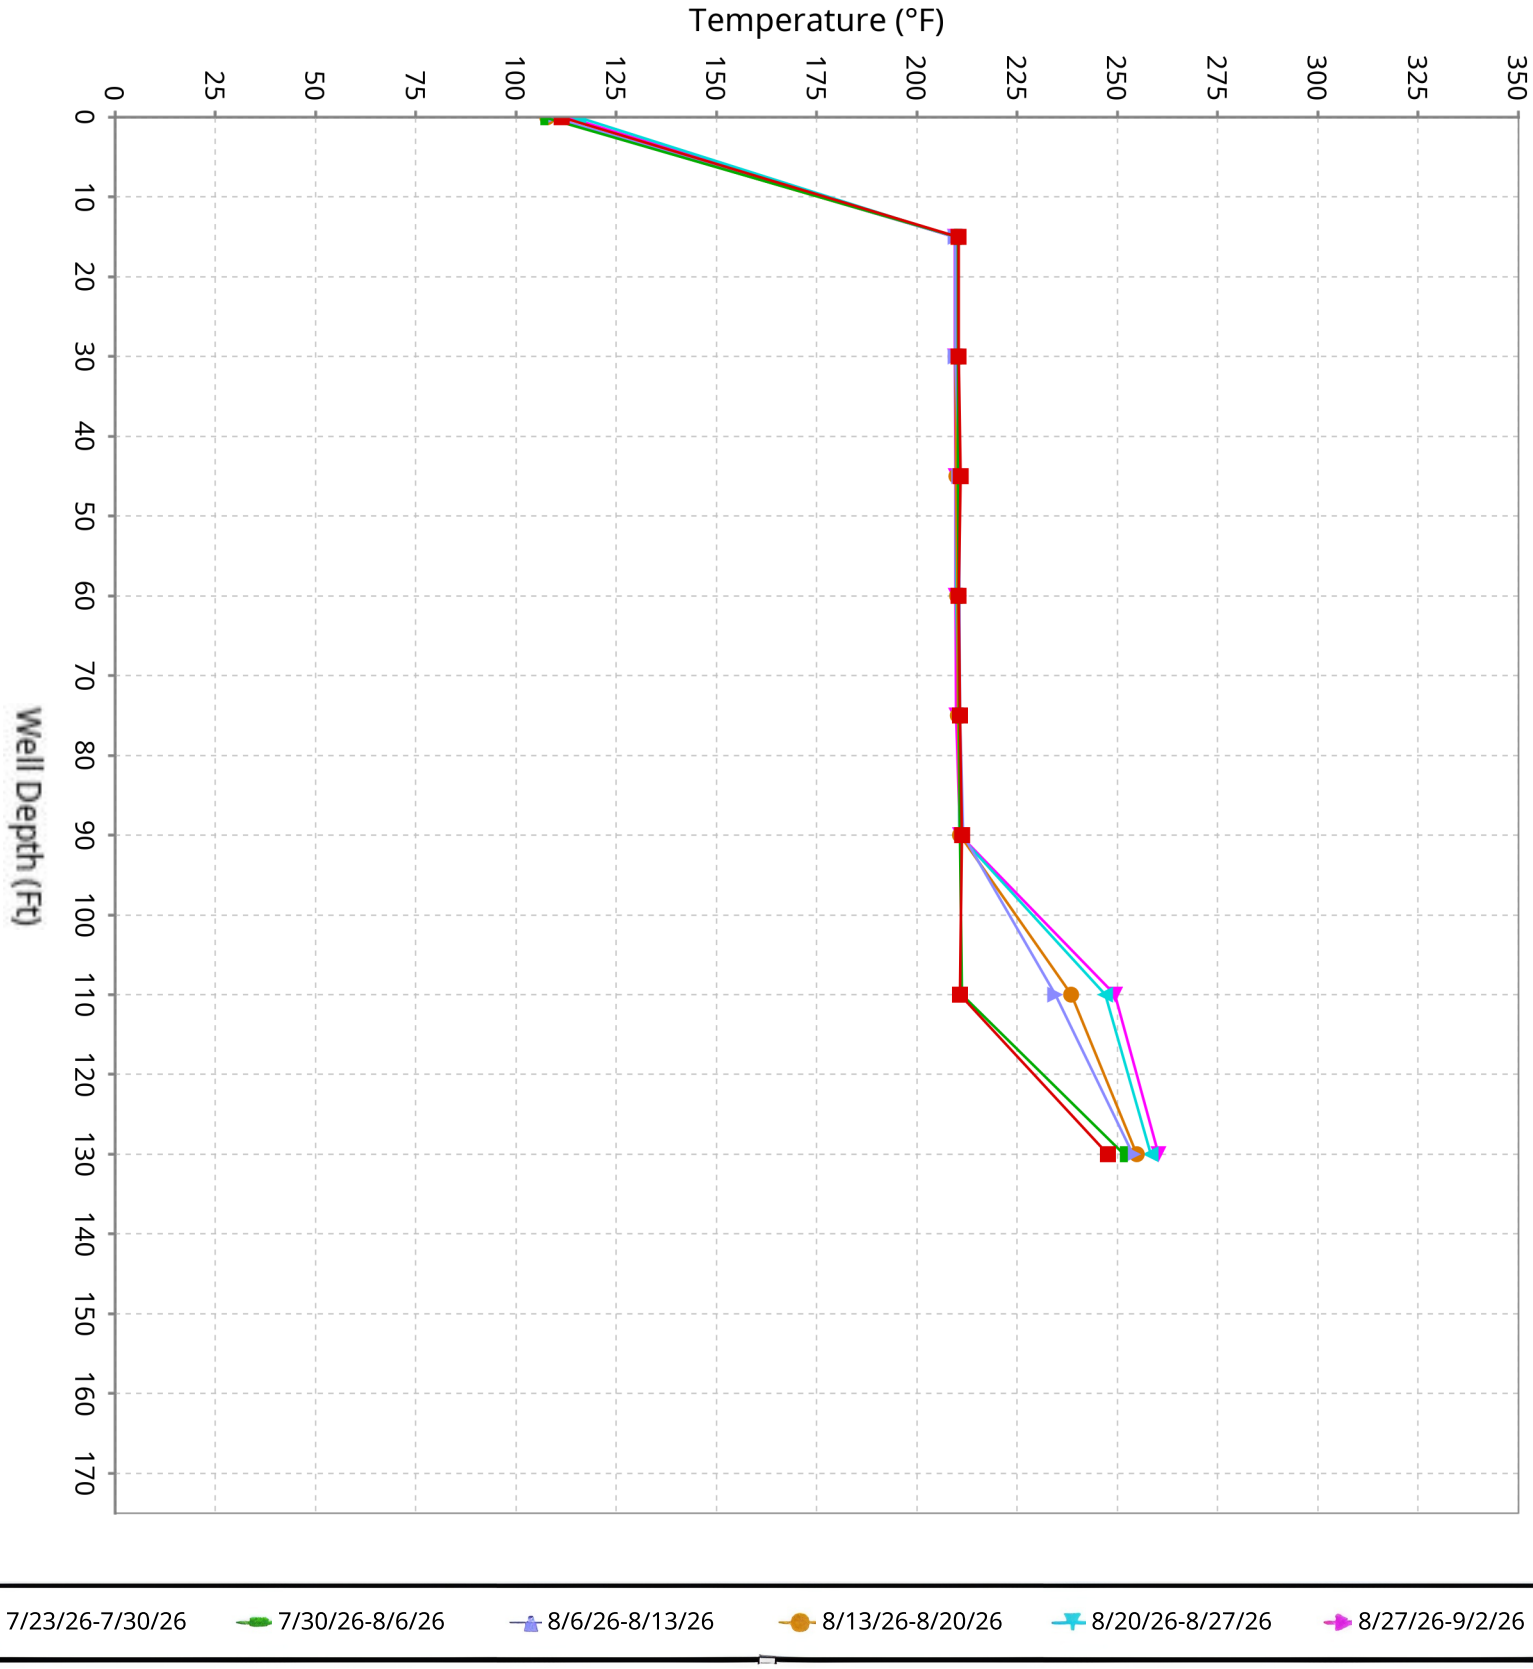
Vertical Temperature Profiles from Temperature Probes at Chiquita Landfill for TP-25

- TP-25
    - The Site conducted a follow-up camera inspection of the TP-25 temperature probe casing last week to evaluate potential liquid infiltration and assess the condition of the casing interior. The inspection indicated that no liquid was present at the bottom of the casing. Instead, pressurized gas was observed upon opening the probe casing. The temperature probes inside TP-25 are thus no longer correctly reporting in-situ waste temperatures and are instead reporting gas temperatures traveling to and up the temperature probe casing. The Site will continue to monitor TP-25.
    - The 110-foot thermocouple remained consistent with previously recorded temperatures. As described above, the Site is continuing to assess the condition of this probe equipment and will continue to monitor the temperature on the thermocouples.

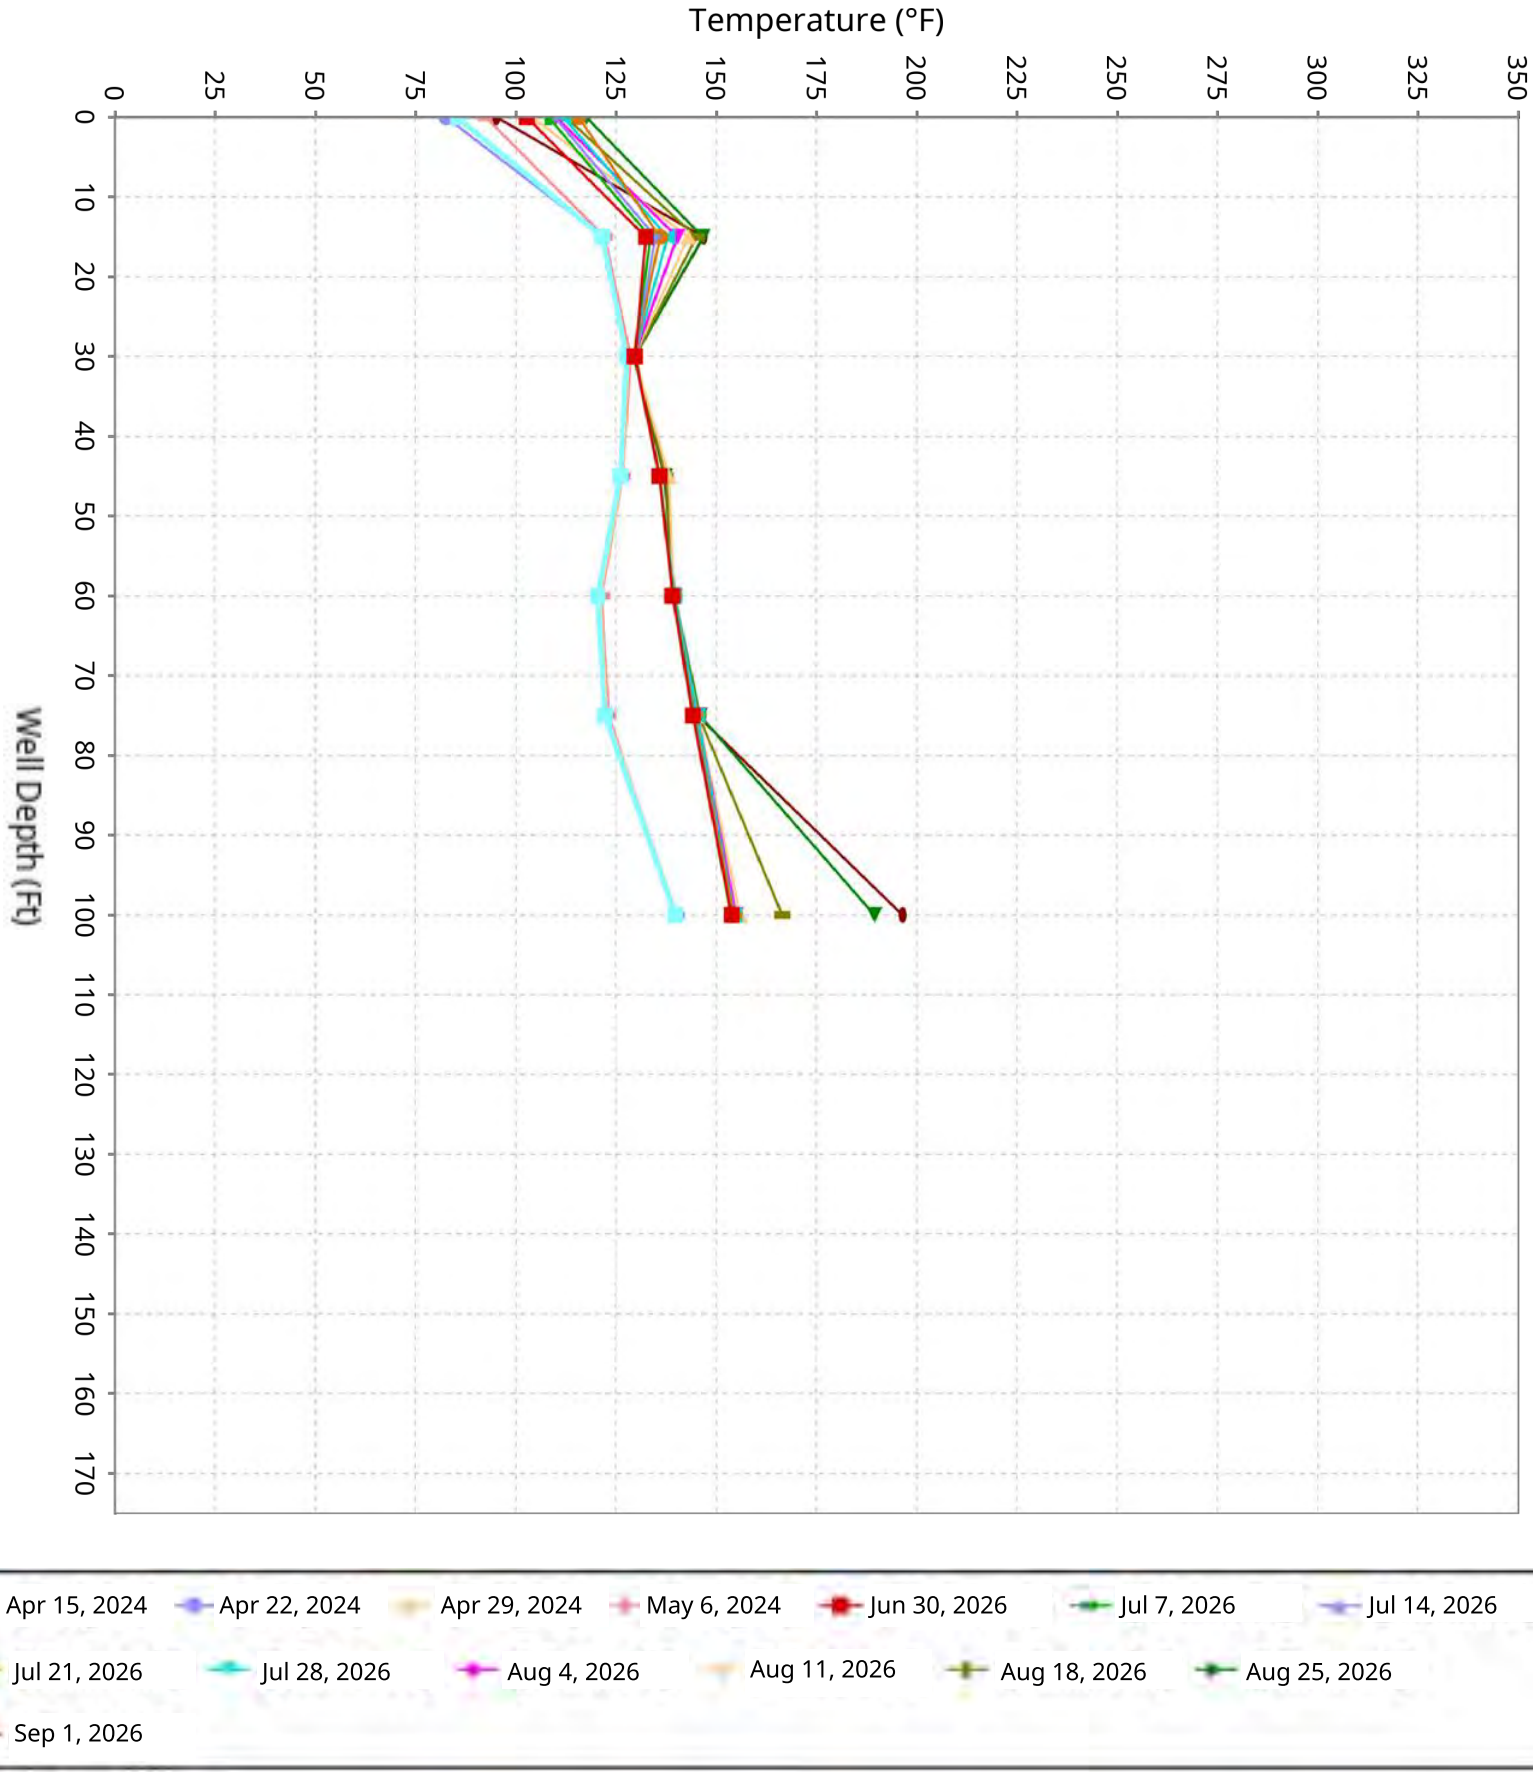
Vertical Temperature Profiles from Temperature Probes at Chiquita Landfill for TP-7

- TP-07
    - The 100-foot thermocouple showed an increase in maximum temperature of 40°F from 155°F to 195°F from August 16th to September 2nd. One potential factor contributing to the observed temperature increase is the removal of liquids from wells near TP-07.

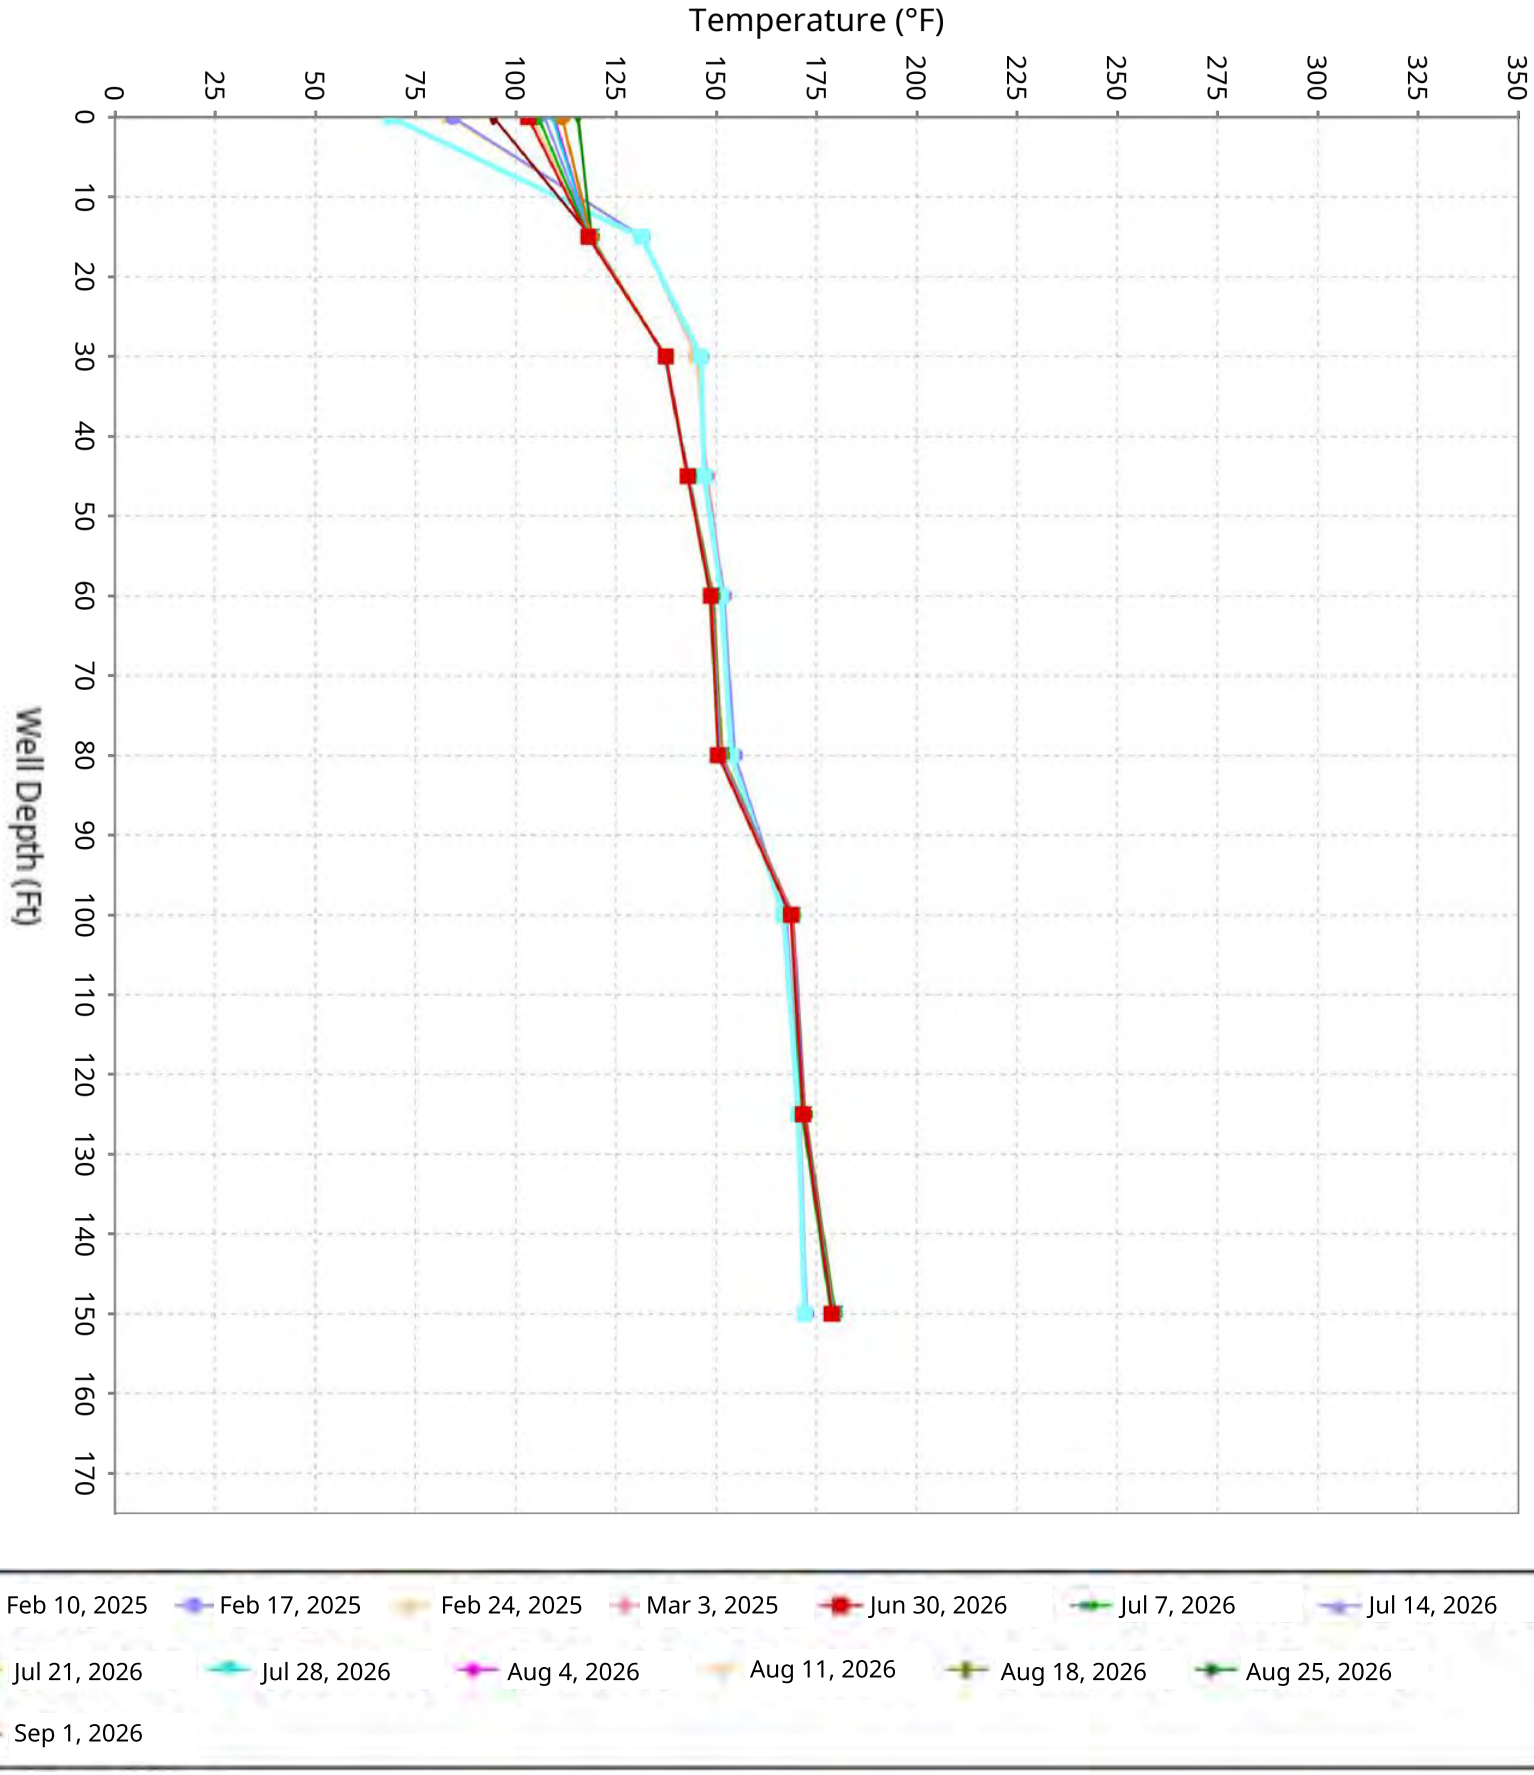
Vertical Temperature Profiles from Temperature Probes at Chiquita Landfill for TP-25

- TP-25
    - The Site conducted a follow-up camera inspection of the TP-25 temperature probe casing last week to evaluate potential liquid infiltration and assess the condition of the casing interior. The inspection indicated that no liquid was present at the bottom of the casing. Instead, pressurized gas was observed upon opening the probe casing. The temperature probes inside TP-25 are thus no longer correctly reporting in-situ waste temperatures and are instead reporting gas temperatures traveling to and up the temperature probe casing. The Site will continue to monitor TP-25.

- The 110-foot thermocouple showed an increase in maximum temperature of 34°F from 213°F to 247°F from August 11th to August 26th. As described above, the Site is continuing to assess the condition of this probe equipment and will continue to monitor the temperature on the thermocouples.

- The 130-foot thermocouple remained consistent with previously recorded temperatures. As described above, the Site is continuing to assess the condition of this probe equipment and will continue to monitor the temperature on the thermocouples.
