SCS ENGINEERS

15 de septiembre de 2026

Asunto: Informe Mensual de Agosto de 2026 Conforme a los Objetivos 1A-3 y 5 de la Orden de Cumplimiento de la LEA del 6 de junio de 2024 y a la Carta del 30 de julio de 2024, Vertedero de Chiquita Canyon, Castaic, California

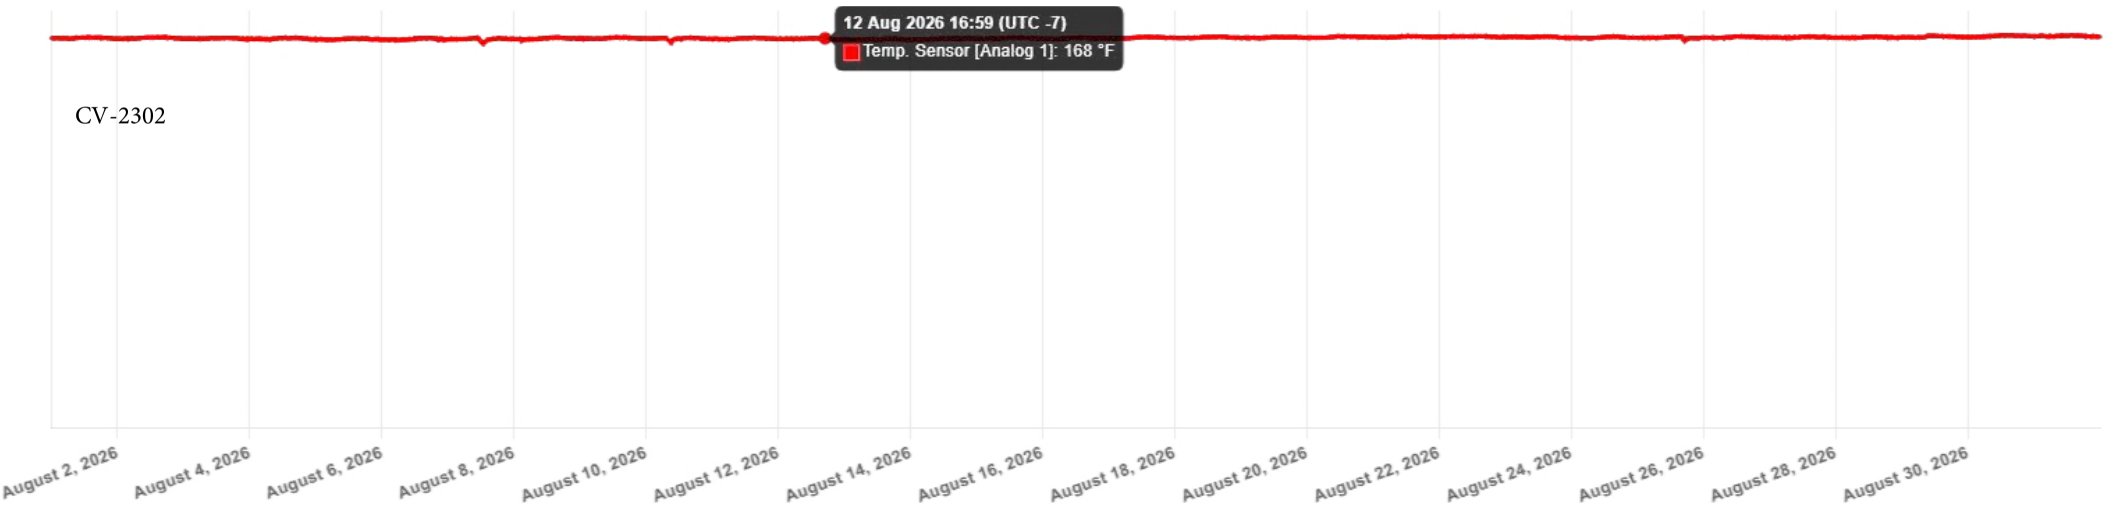
LEA Selected Wells for Down Hole Temperature Monitoring
August 2026

Well Number	Down Well Temp Monitoring Monthly	Last Date Monitored for Downwell Temperatures - 2025	2026 Downwell Temperature Monitoring Date	Comments
CV-2350	Yes	3/12/2025	TBD - Pump Installed	Lorentz pump is damaged and unable to be removed for repairs, no graphing possible.
CV-2351	Yes	3/12/2025	3/10/2026	
CV-2352	Yes	3/12/2025	4/24/2026 and 4/30/2026	Lorentz pump removed, no graph possible
CV-2353	Yes	5/30/2025	3/10/2026, 4/30/2026 and 6/12/2026	
CV-24007	Yes	3/6/2025	3/10/2026 and 6/12/2026	
CV-24017	Yes	3/6/2025	7/21/2026	Graph Attached 8-1 to 8-31-2026
CV-24053	Yes	3/6/2025	TBD - Pump Installed	
CV-24065	Yes	3/6/2025	7/16/2026	Graph Attached 8-1 to 8-31-2026
CV-24095	Yes	3/7/2025	TBD - Pump Installed	Graph Attached 8-1 to 8-31-2026
CV-24101	Yes	3/7/2025	7/1/2026	
CV-24122	Yes	3/7/2025	3/10/2026	
CV-24127	Yes	3/7/2025	3/10/2026	
CV-24138	Yes	4/1/2025	8/6/2026	
CV-24139	Yes	8/18/2025	8/6/2026	
CV-24143	Yes	3/10/2025	6/12/2026

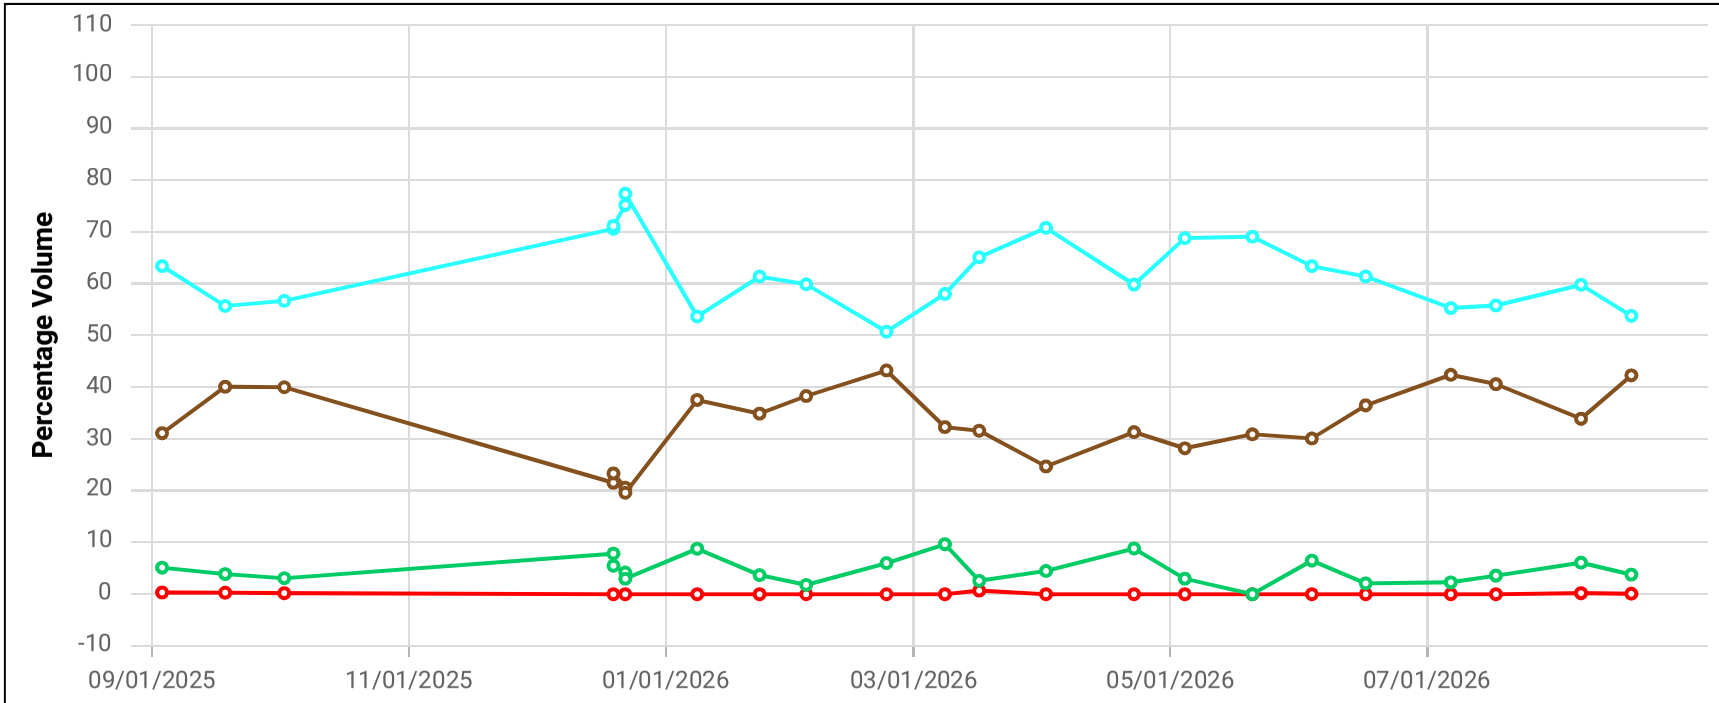
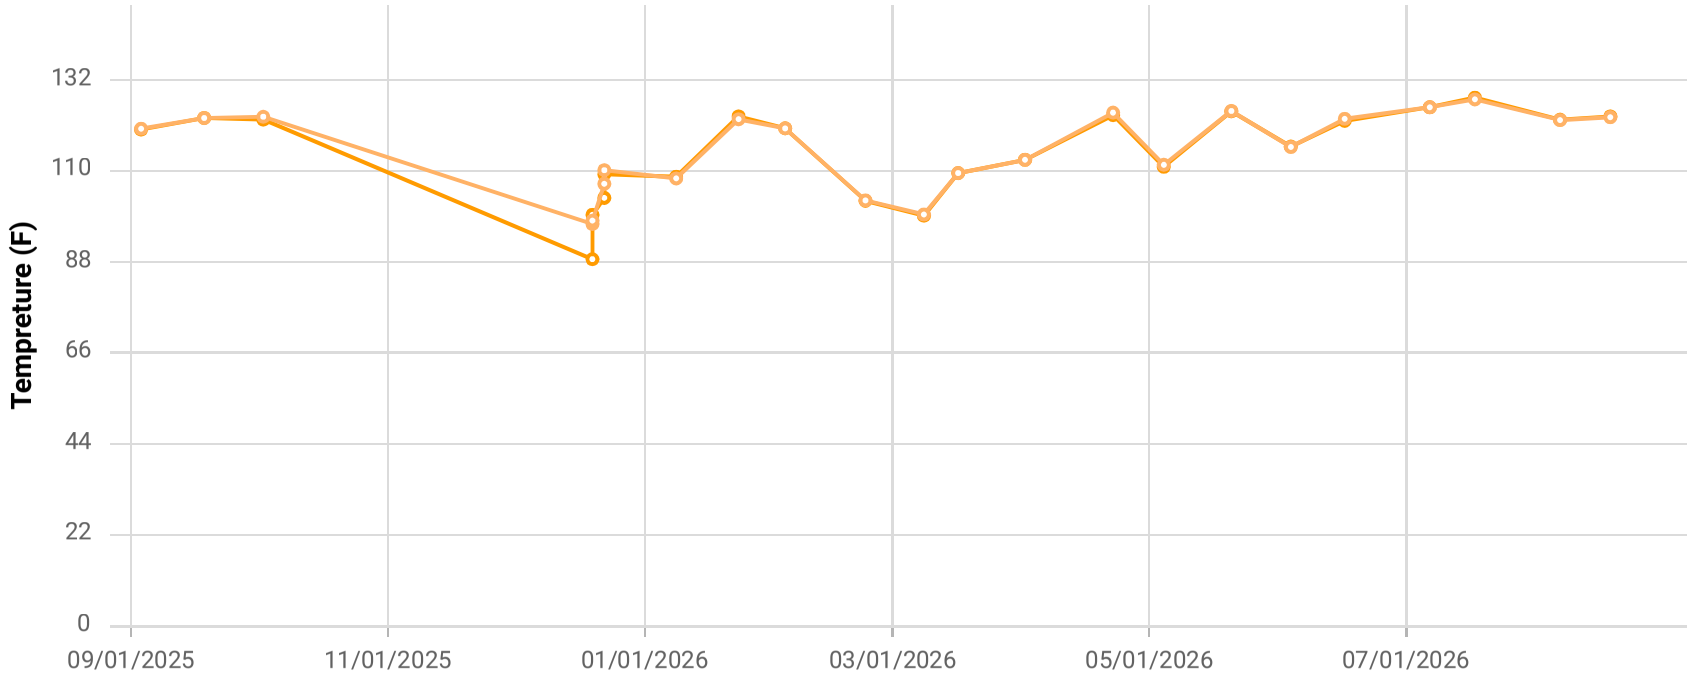
CCV24079 / CV-24079-TP8

- TP-08
  - The 30-foot and 45-foot thermocouples exhibited temperature increases of 27°F and 29°F, respectively, between July 12, 2026, and July 22, 2026. In response, Site personnel observed the temperature changes and conducted an investigation from July 23, 2026, through July 29, 2026. Following the investigation, temperatures continued to decline from July 30, 2026, through August 5, 2026.

- TP-08 is installed within extraction well CV-24079, which is equipped with a liquid extraction pump. The investigation determined that the existing pump is experiencing a power-related issue and requires removal. Site personnel have identified the need for a replacement pump and plan to complete the replacement next week.

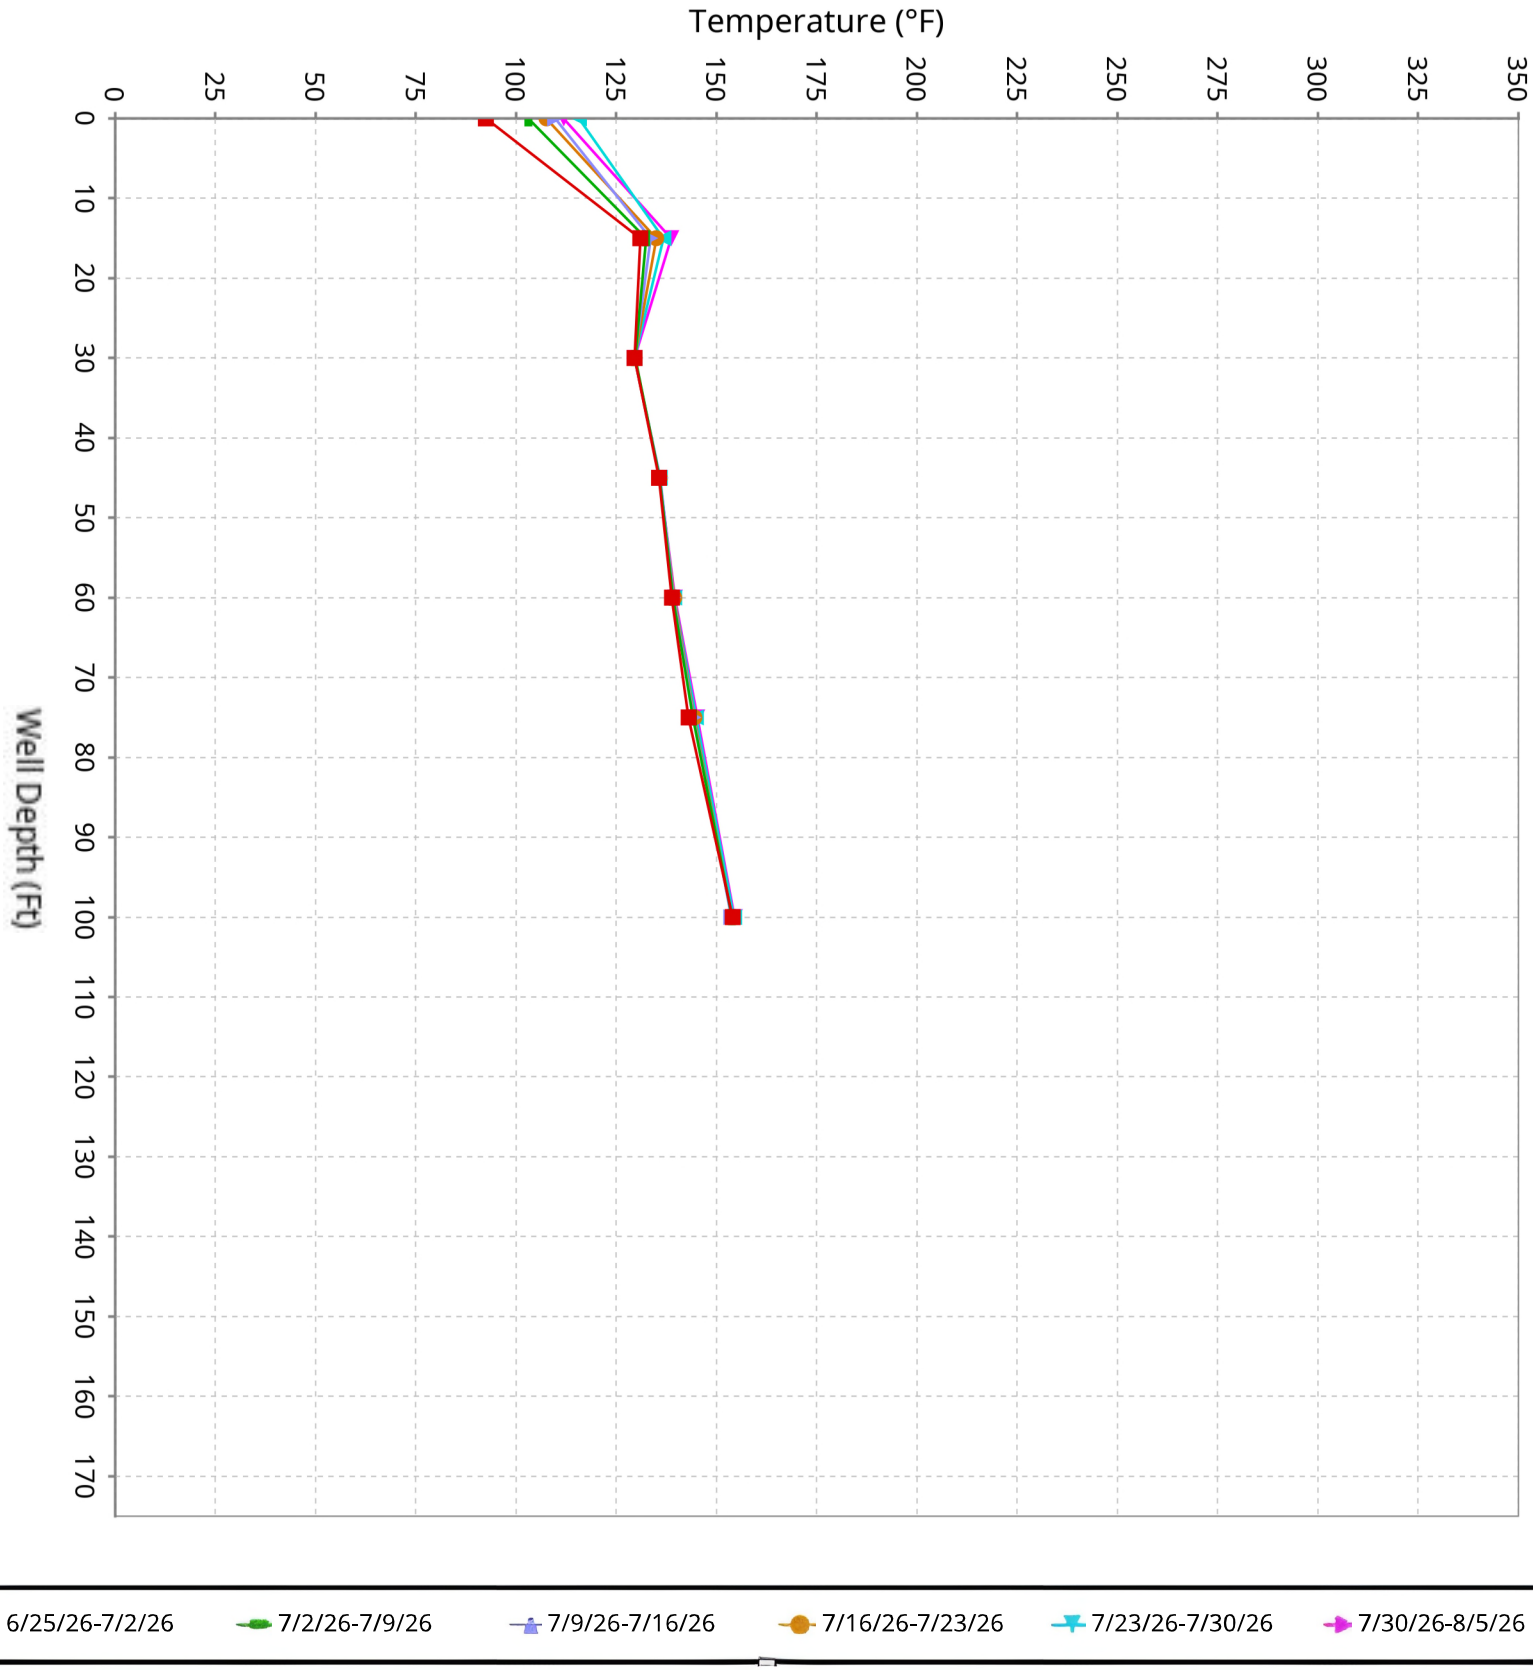
Vertical Temperature Profiles from Temperature Probes atChiquita Landfill for TP-7

TP-07
One potential factor contributing to the observed temperature increase is the removal of liquids from wells near TP-07.

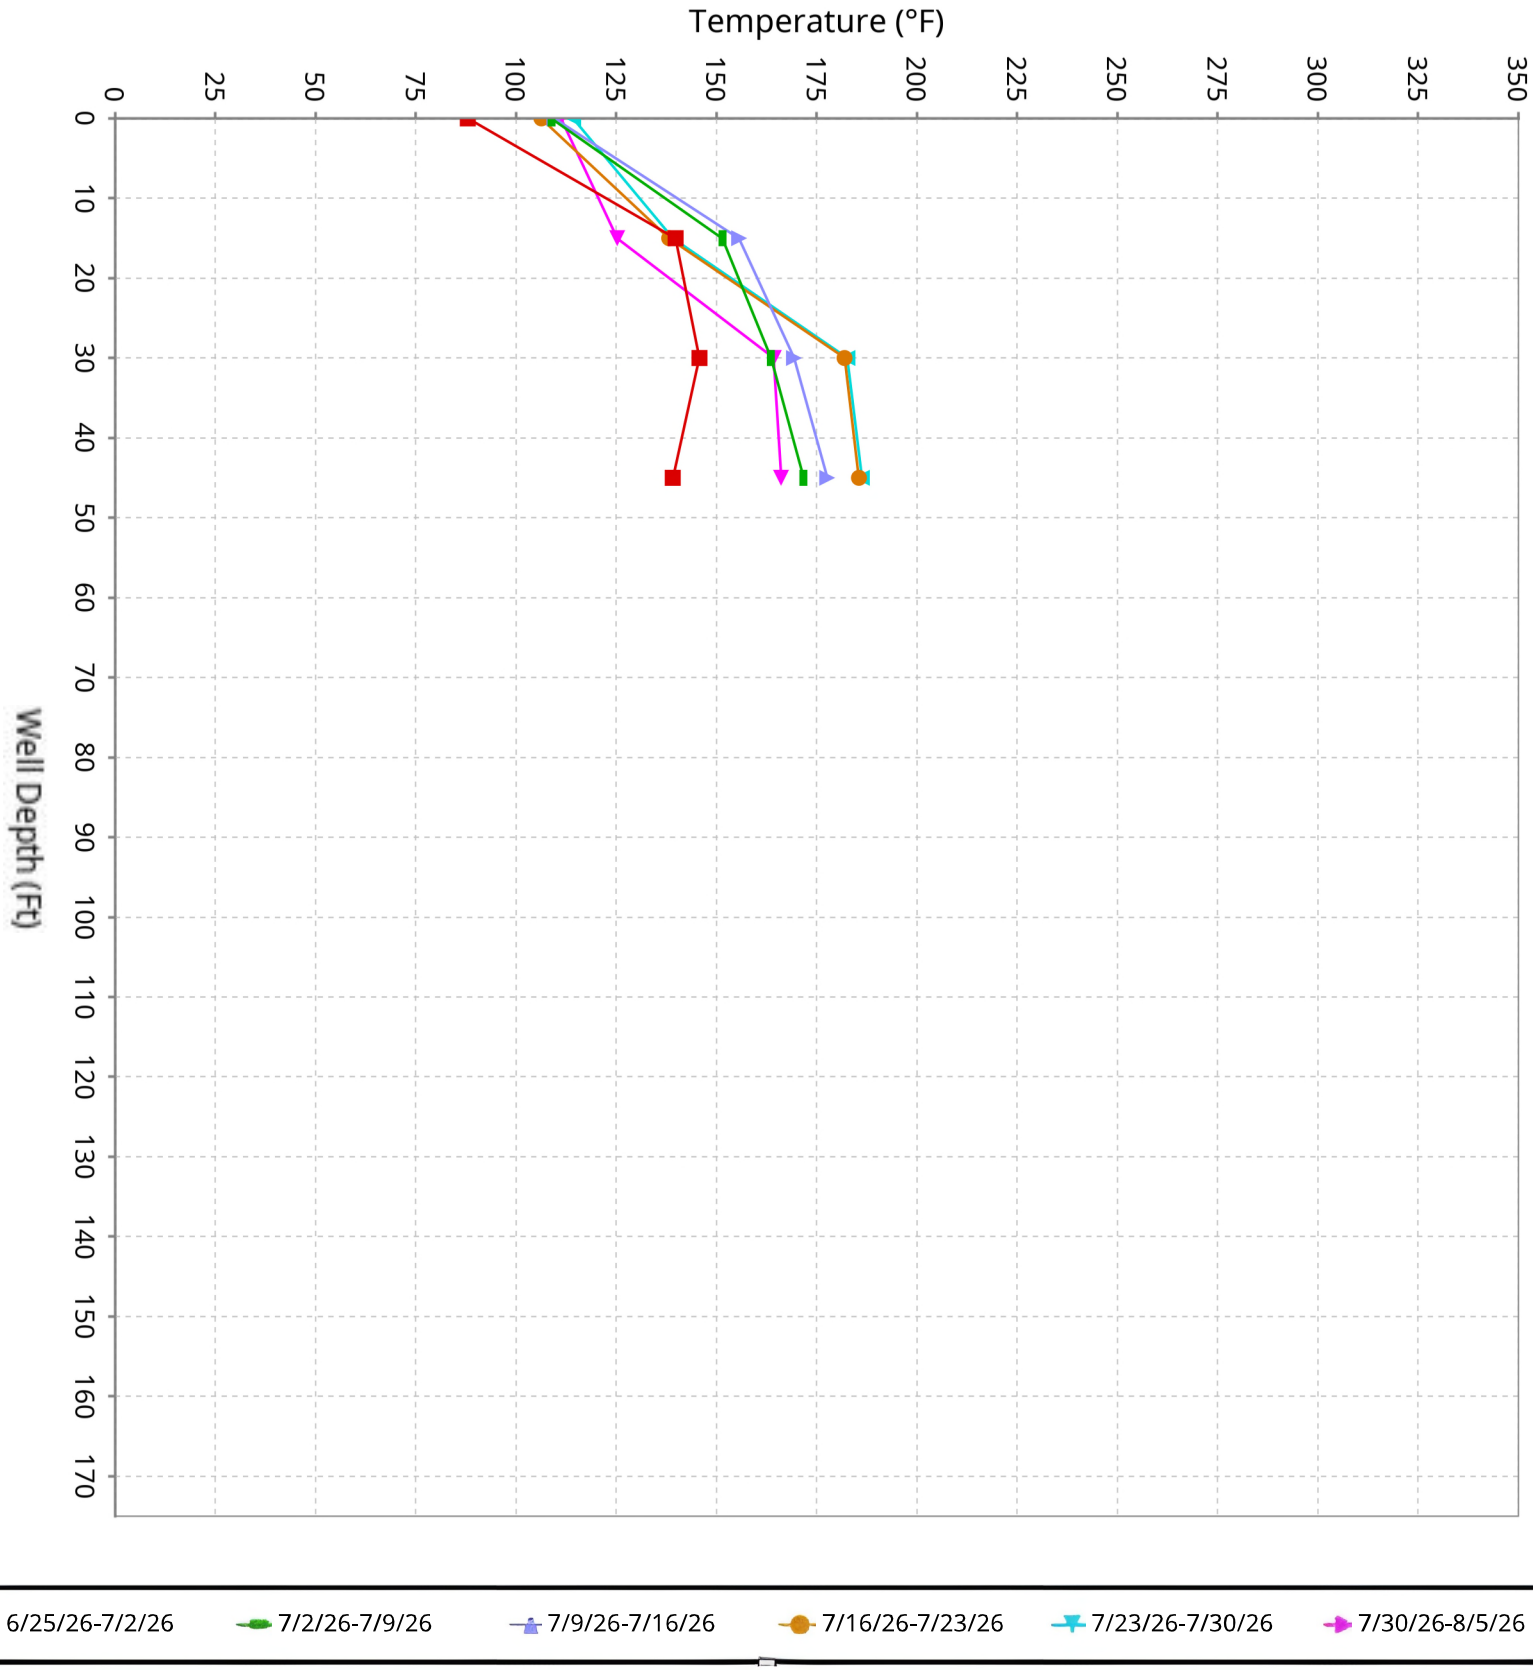
Vertical Temperature Profiles from Temperature Probes atChiquita Landfill for TP-8

TP-08: The 30-foot and 45-foot thermocouples exhibited temperature increases of 27°F and 29°F, respectively, between July 12, 2026, and July 22, 2026. In response, Site personnel observed the temperature changes and conducted an investigation from July 23, 2026, through July 29, 2026. Following the investigation, temperatures continued to decline from July 30, 2026, through August 5, 2026.
oTP-08 is installed within extraction well CV-24079, which is equipped with a liquid extraction pump. The investigation determined that the existing pump is experiencing a power-related issue and requires removal. Site personnel have identified the need for a replacement pump and plan to complete the replacement next week.
TP-19: A discrepancy was identified during the review of the weekly data. Upon [RH2.1]investigation, the Site determined that the associated battery had failed and subsequently replaced it. During this inspection, the temperature reading from the 125-foot thermocouple was observed to be anomalously low. Further evaluation indicated that the 125-foot thermocouple required replacement. As an interim measure, the Site installed a 120-foot thermocouple that was available onsite and ordered a replacement 125-foot thermocouple. The replacement 125-foot thermocouple will be installed upon receipt.

- TP-08
    - The 30-foot and 45-foot thermocouples exhibited temperature increases of 27°F and 29°F, respectively, between July 12, 2026, and July 22, 2026. In response, Site personnel observed the temperature changes and conducted an investigation from July 23, 2026, through July 29, 2026. Following the investigation, temperatures continued to decline from July 30th, 2026, through August 12, 2026.

- TP-08 is installed within extraction well CV-24079, which is equipped with a liquid extraction pump. The investigation determined that the existing pump is experiencing a power-related issue and requires removal. Site personnel have identified the need for a replacement pump and plan to complete the replacement when the road to the well is completed.

- TP-08
    - The 30-foot and 45-foot thermocouples exhibited temperature increases of 27°F and 29°F, respectively, between July 12, 2026, and July 22, 2026. In response, Site personnel observed the temperature changes and conducted an investigation from July 23, 2026, through July 29, 2026. Following the investigation, temperatures continued to decline at the 30-foot thermocouple from July 30th, 2026, through August 19, 2026, and temperatures started to increase at the 45-foot thermocouple from August 13, 2026, through August 19, 2026.

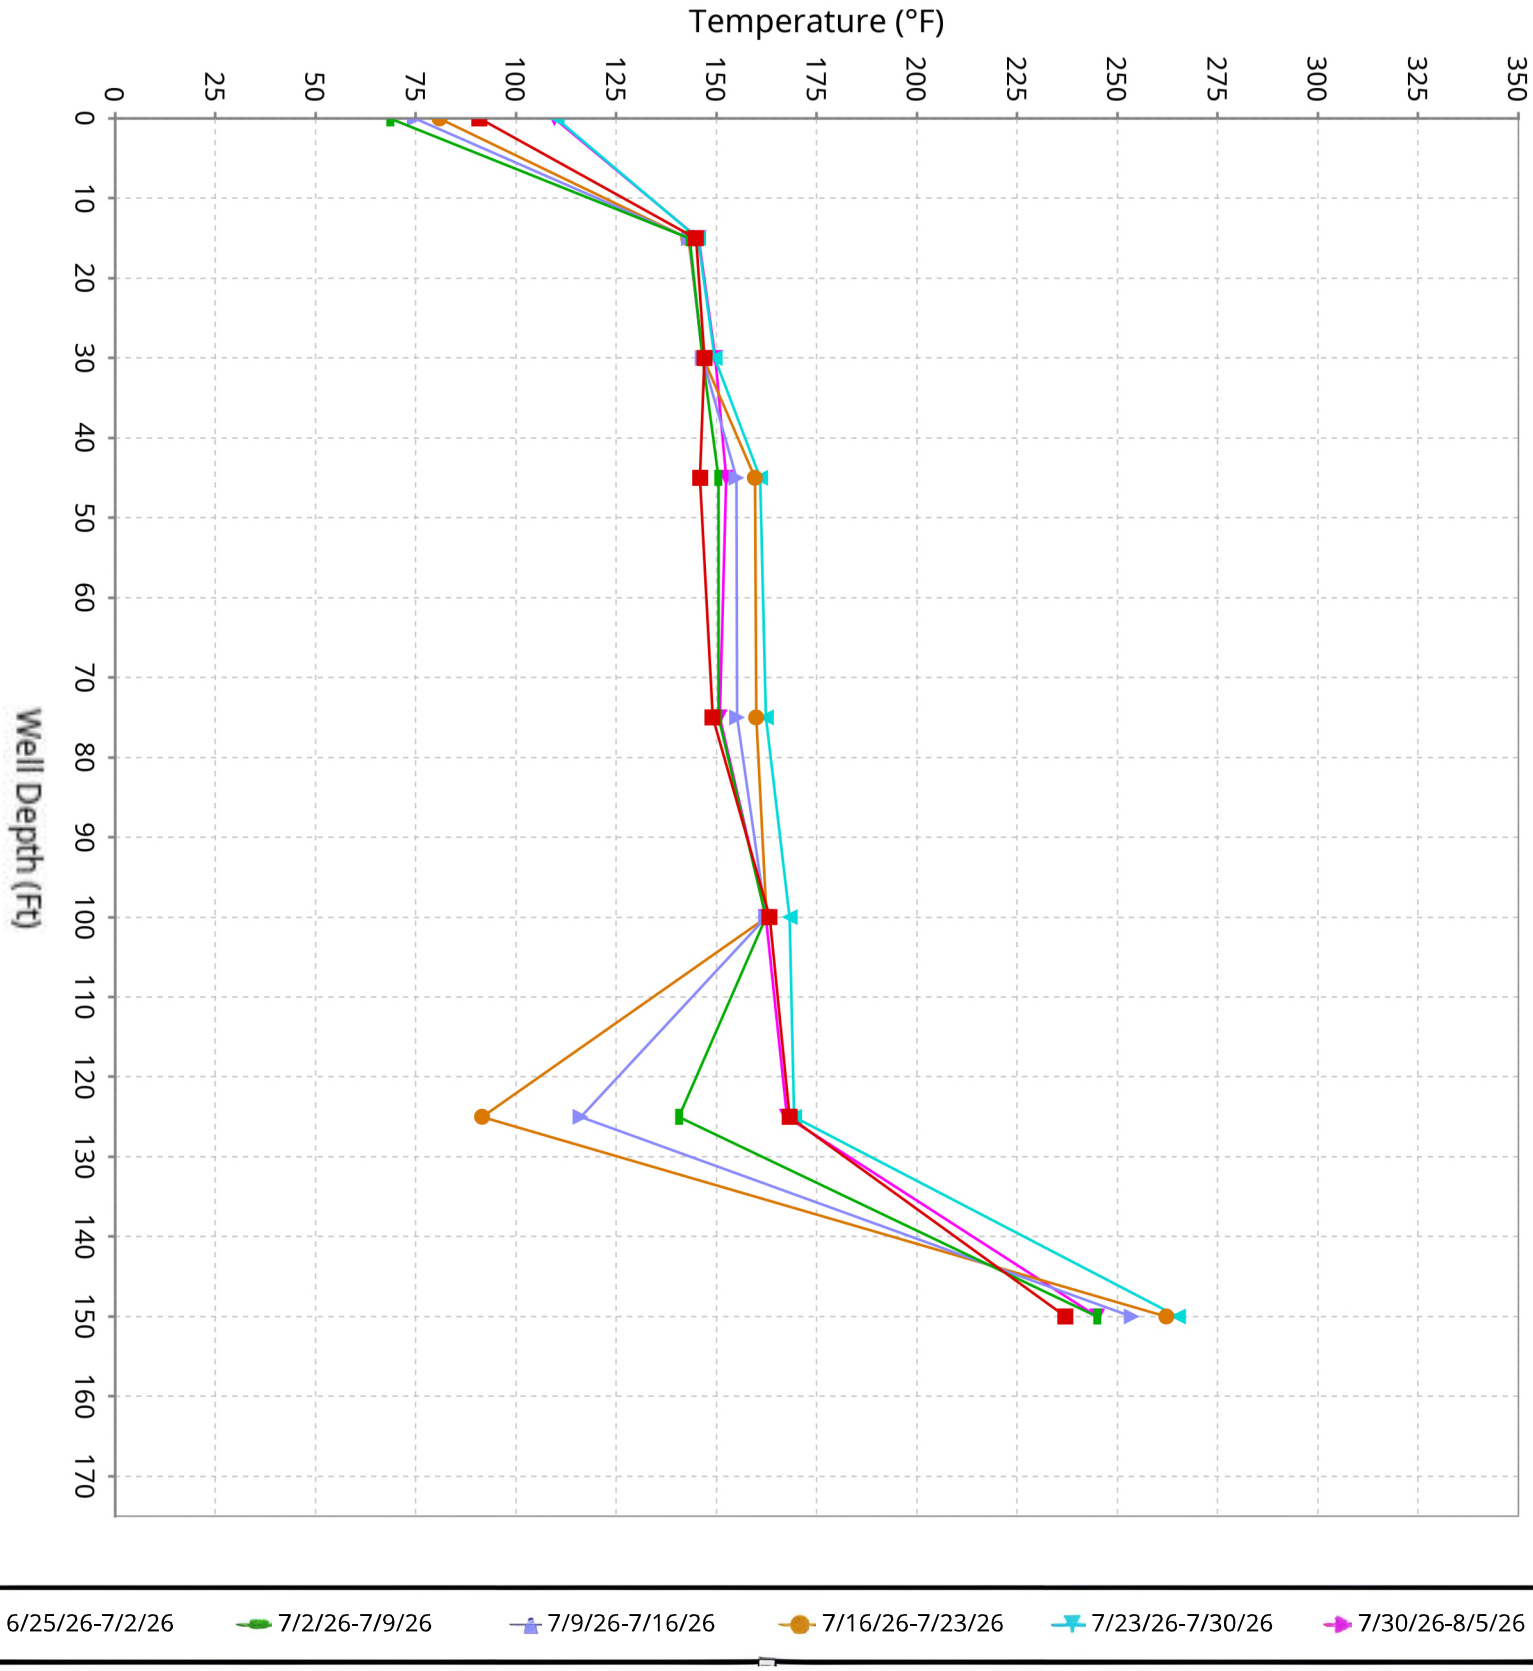
Vertical Temperature Profiles from Temperature Probes atChiquita Landfill for TP-19

- TP-19
  - A discrepancy was identified during the review of last week's data. Upon investigation, the Site determined that the associated battery had failed and subsequently replaced it. During this inspection, the temperature reading from the 125-foot thermocouple was observed to be anomalously low. Further evaluation indicated that the 125-foot thermocouple required replacement. As an interim measure, the Site installed a 120-foot thermocouple that was available onsite and ordered a replacement 125-foot thermocouple. The replacement 125-foot thermocouple will be installed upon receipt.
  - The 45-foot thermocouple remained consistent with previously recorded temperatures.
  - The 75-foot thermocouple remained consistent with previously recorded temperatures.

- TP-19
    - A discrepancy was identified during the review of data from two weeks prior. Upon investigation, the Site determined that the associated battery had failed and subsequently replaced it. During this inspection, the temperature reading from the 125-foot thermocouple was observed to be anomalously low. Further evaluation indicated that the 125-foot thermocouple required replacement. As an interim measure, the Site installed a 120-foot thermocouple that was available onsite and ordered a replacement 125-foot thermocouple. The replacement 125-foot thermocouple will be installed upon receipt.
    - The 150-foot thermocouple remained consistent with previously recorded temperatures.

- TP-19
    - A discrepancy was identified during the review of data from three weeks prior. Upon investigation, the Site determined that the associated battery had failed and subsequently replaced it. During this inspection, the temperature reading from the 125-foot thermocouple was observed to be anomalously low. Further evaluation indicated that the 125-foot thermocouple required replacement. As an interim measure, the Site installed a 120-foot thermocouple that was available onsite and ordered a replacement 125-foot thermocouple. The replacement 125-foot thermocouple will be installed upon receipt.
    - The 75-foot thermocouple showed an increase in maximum temperature of 14°F from 149°F to 163°F from August 14th to August 19th.

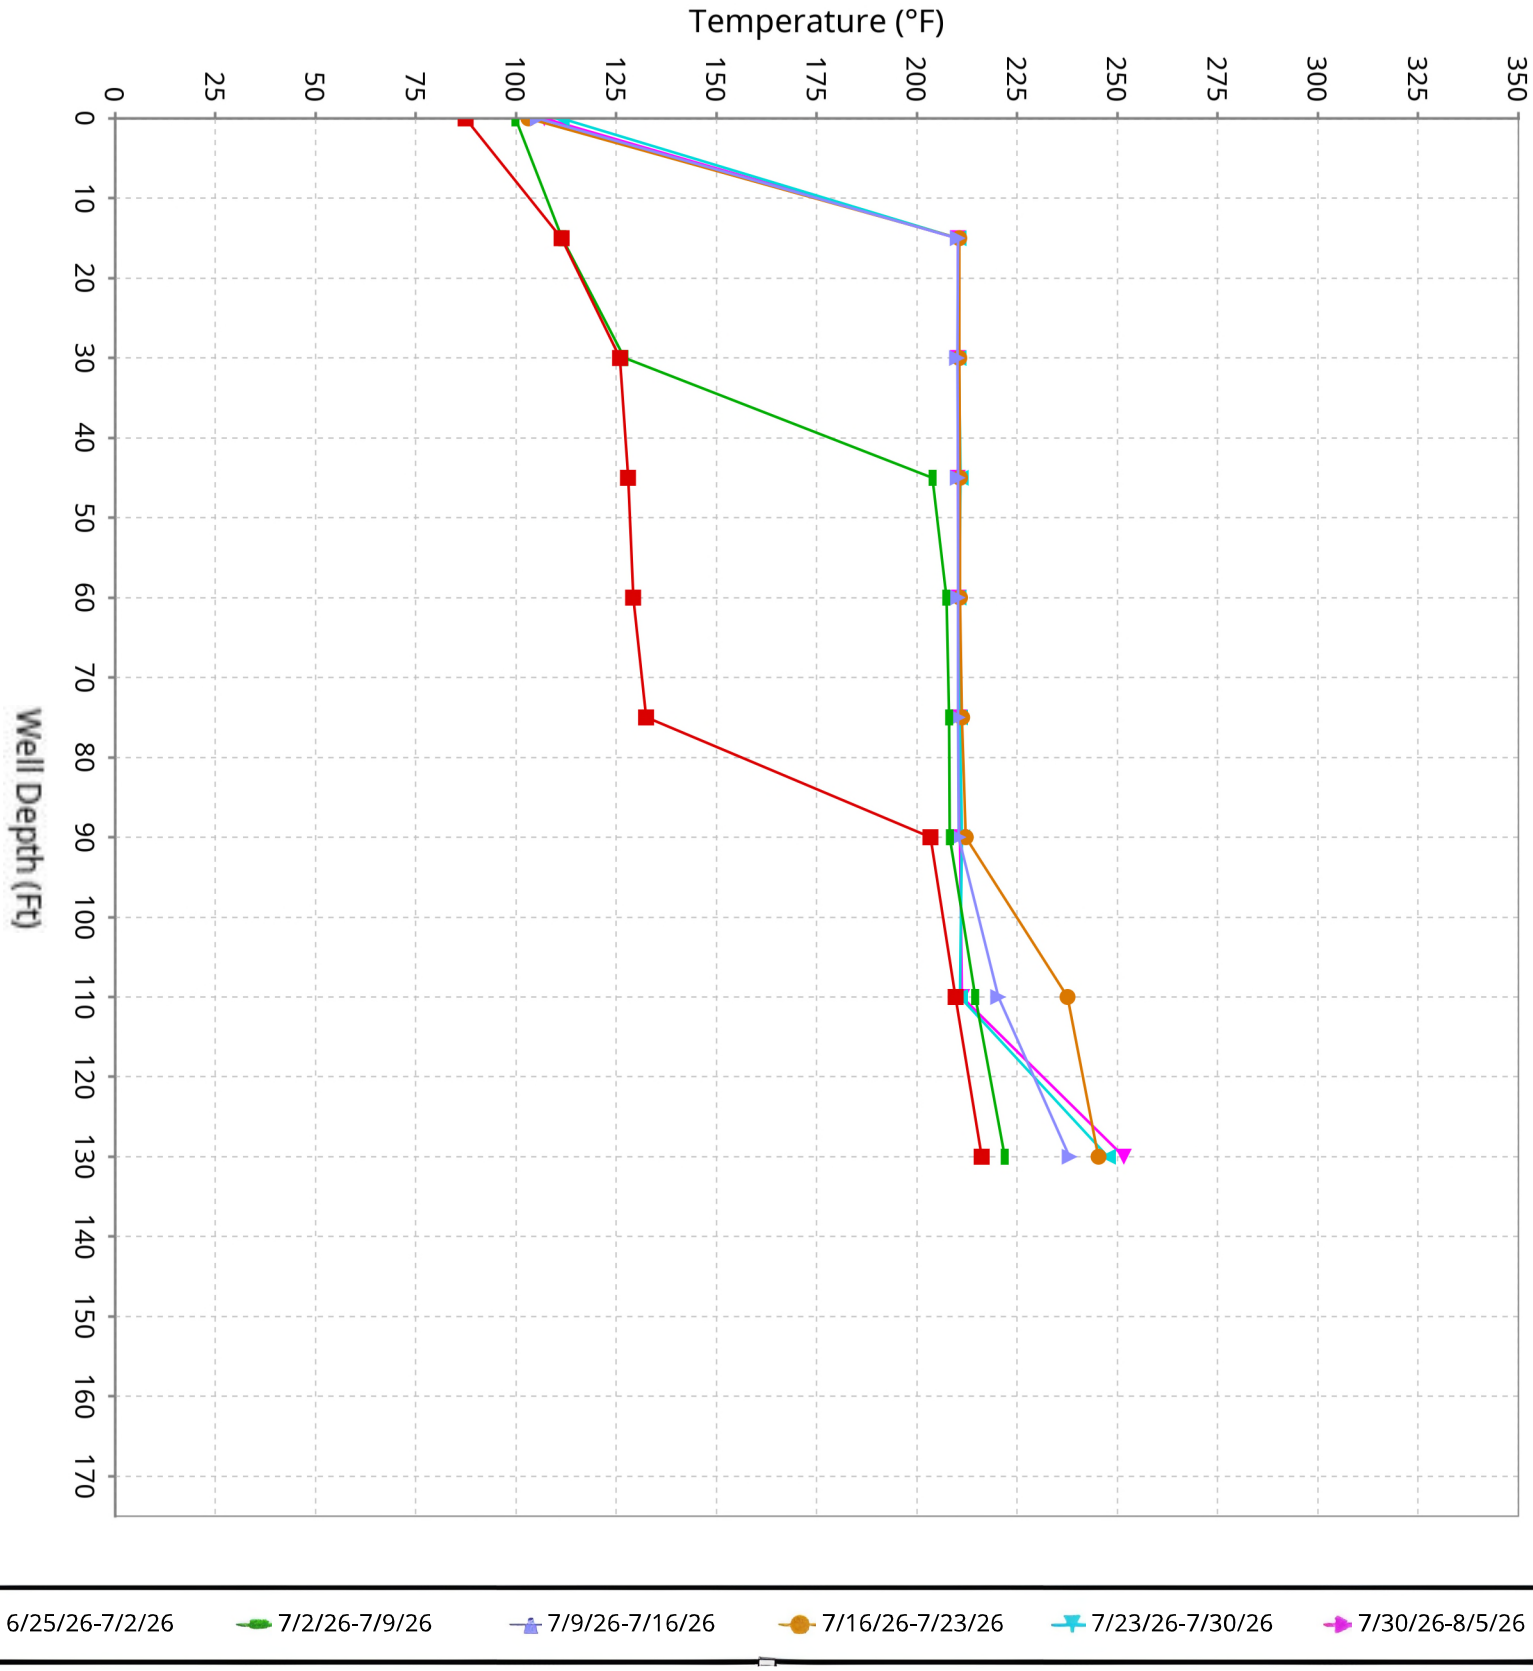
Vertical Temperature Profiles from Temperature Probes atChiquita Landfill for TP-25

- TP-25
    - The Site plans to conduct a follow-up camera inspection next week of the probe casing to determine whether additional liquid infiltration has occurred within the TP-25 well casing and to assess the condition of the casing interior.
    - The 110-foot thermocouple remained consistent with previously recorded temperatures.
    - The 130-foot thermocouple showed an increase in maximum temperature of 40°F from 212°F to 252°F from July 22nd to August 4th. As described above, the Site is continuing to assess the condition of this probe equipment.

- TP-25
    - The Site conducted a follow-up camera inspection of the TP-25 temperature probe casing this week to evaluate potential liquid infiltration and assess the condition of the casing interior. The inspection indicated that no liquid was present at the bottom of the casing. Instead, pressurized gas was observed upon opening the probe casing. The temperatures inside TP-25 are thus no longer correctly reporting in-situ waste temperatures and are instead reporting gas temperatures traveling to and up the TMP casing. The Site will continue to monitor TP-25.

- The 110-foot thermocouple showed an increase in maximum temperature of 25°F from 210°F to 235°F from August 6th to August 8th, and then a decrease in maximum temperature of 22°F from 235°F to 213°F from August 8th to August 11th. As described above, the Site is continuing to assess the condition of this probe equipment and will continue to monitor the temperature on the thermocouples.

- The 130-foot thermocouple showed an increase in maximum temperature of 42°F from 212°F to 254°F from July 22nd to August 10th. As described above, the Site is continuing to assess the condition of this probe equipment and will continue to monitor the temperature on the thermocouples.

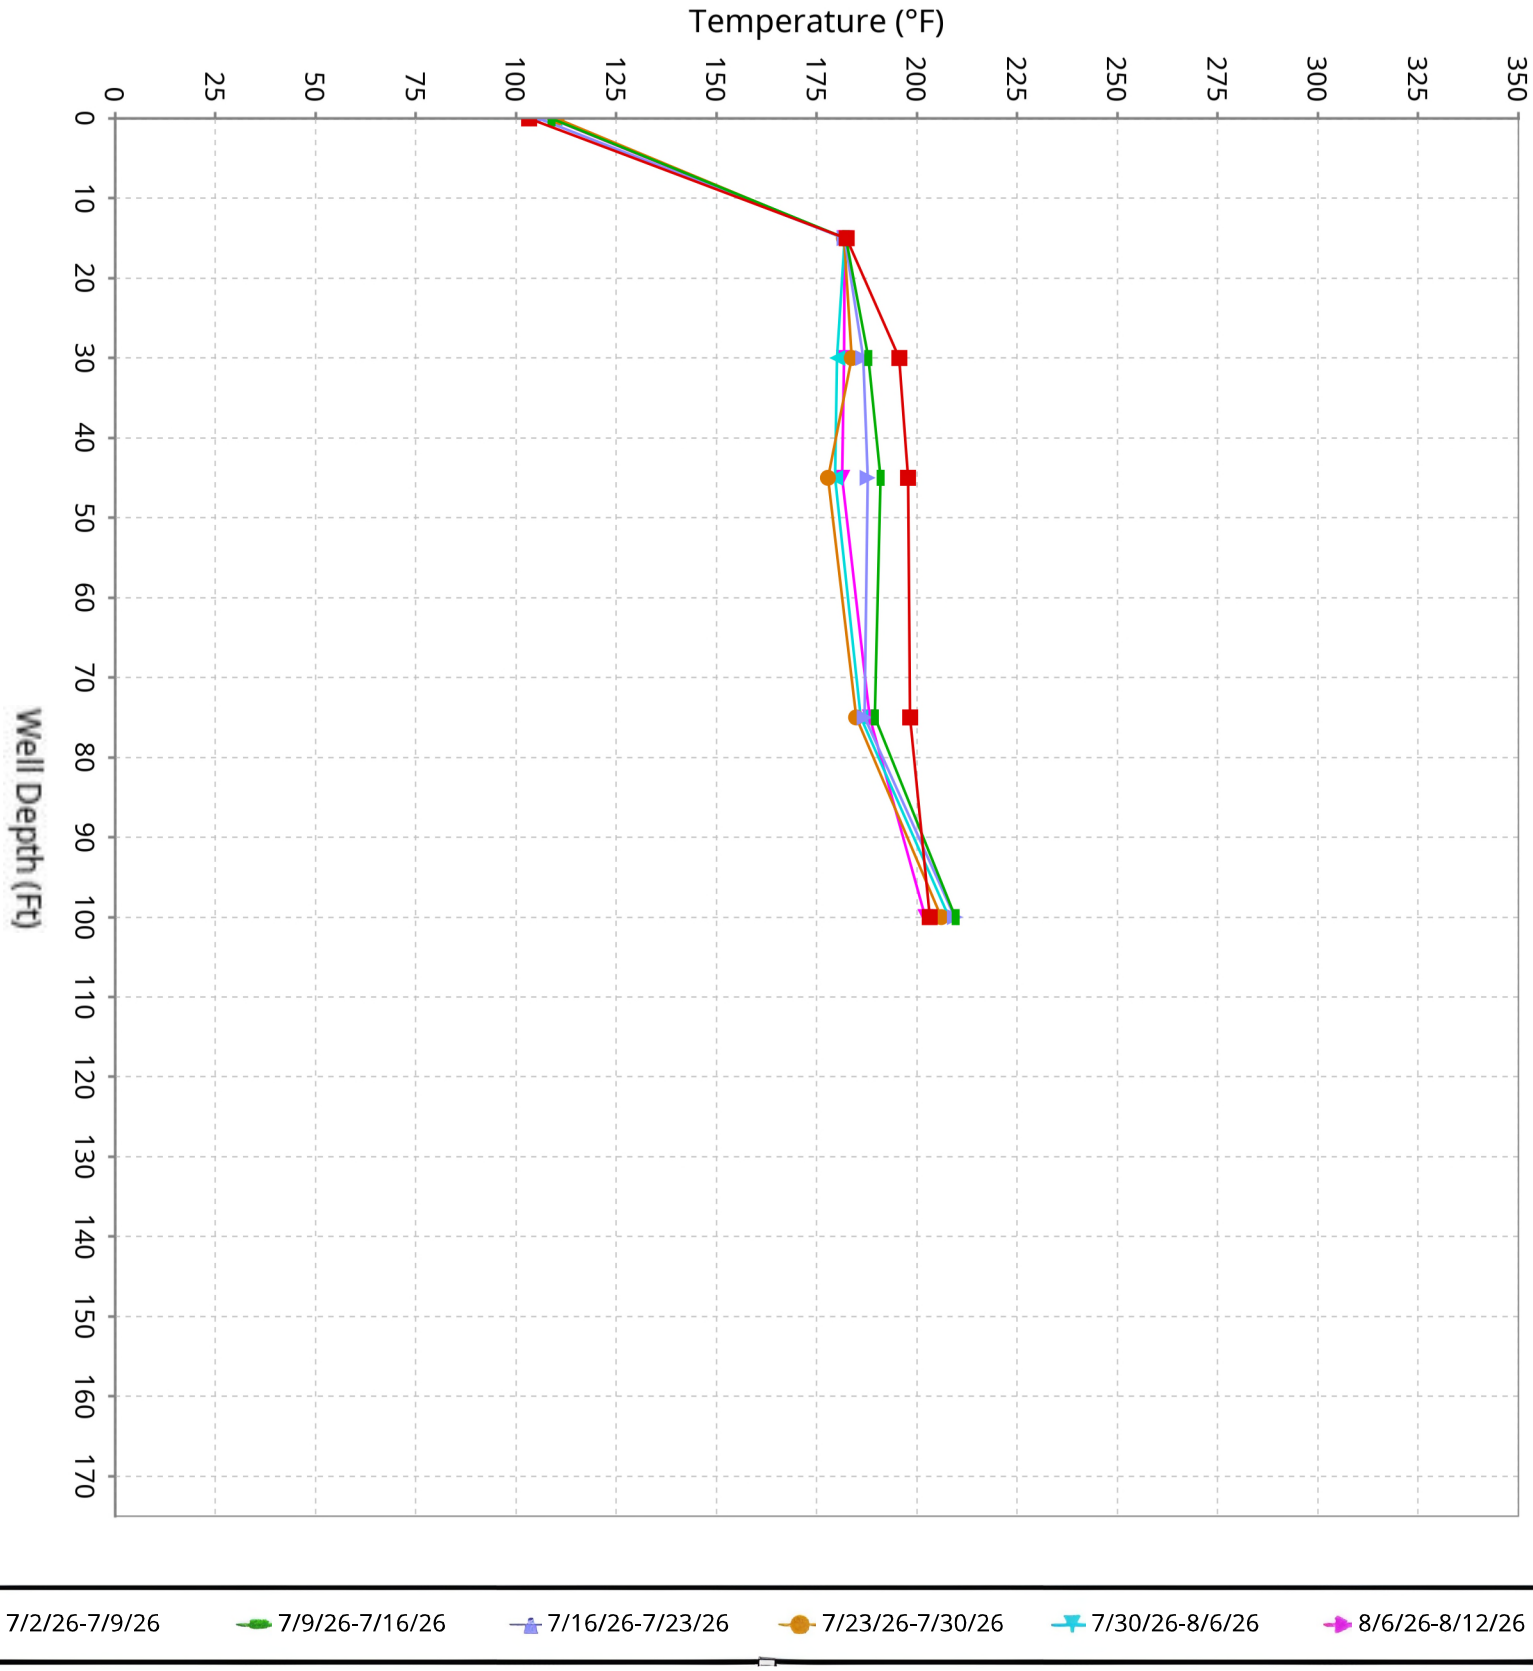
Vertical Temperature Profiles from Temperature Probes atChiquita Landfill for TP-15

- TP-15
    - The 100-foot thermocouple remained consistent with previously recorded temperatures.

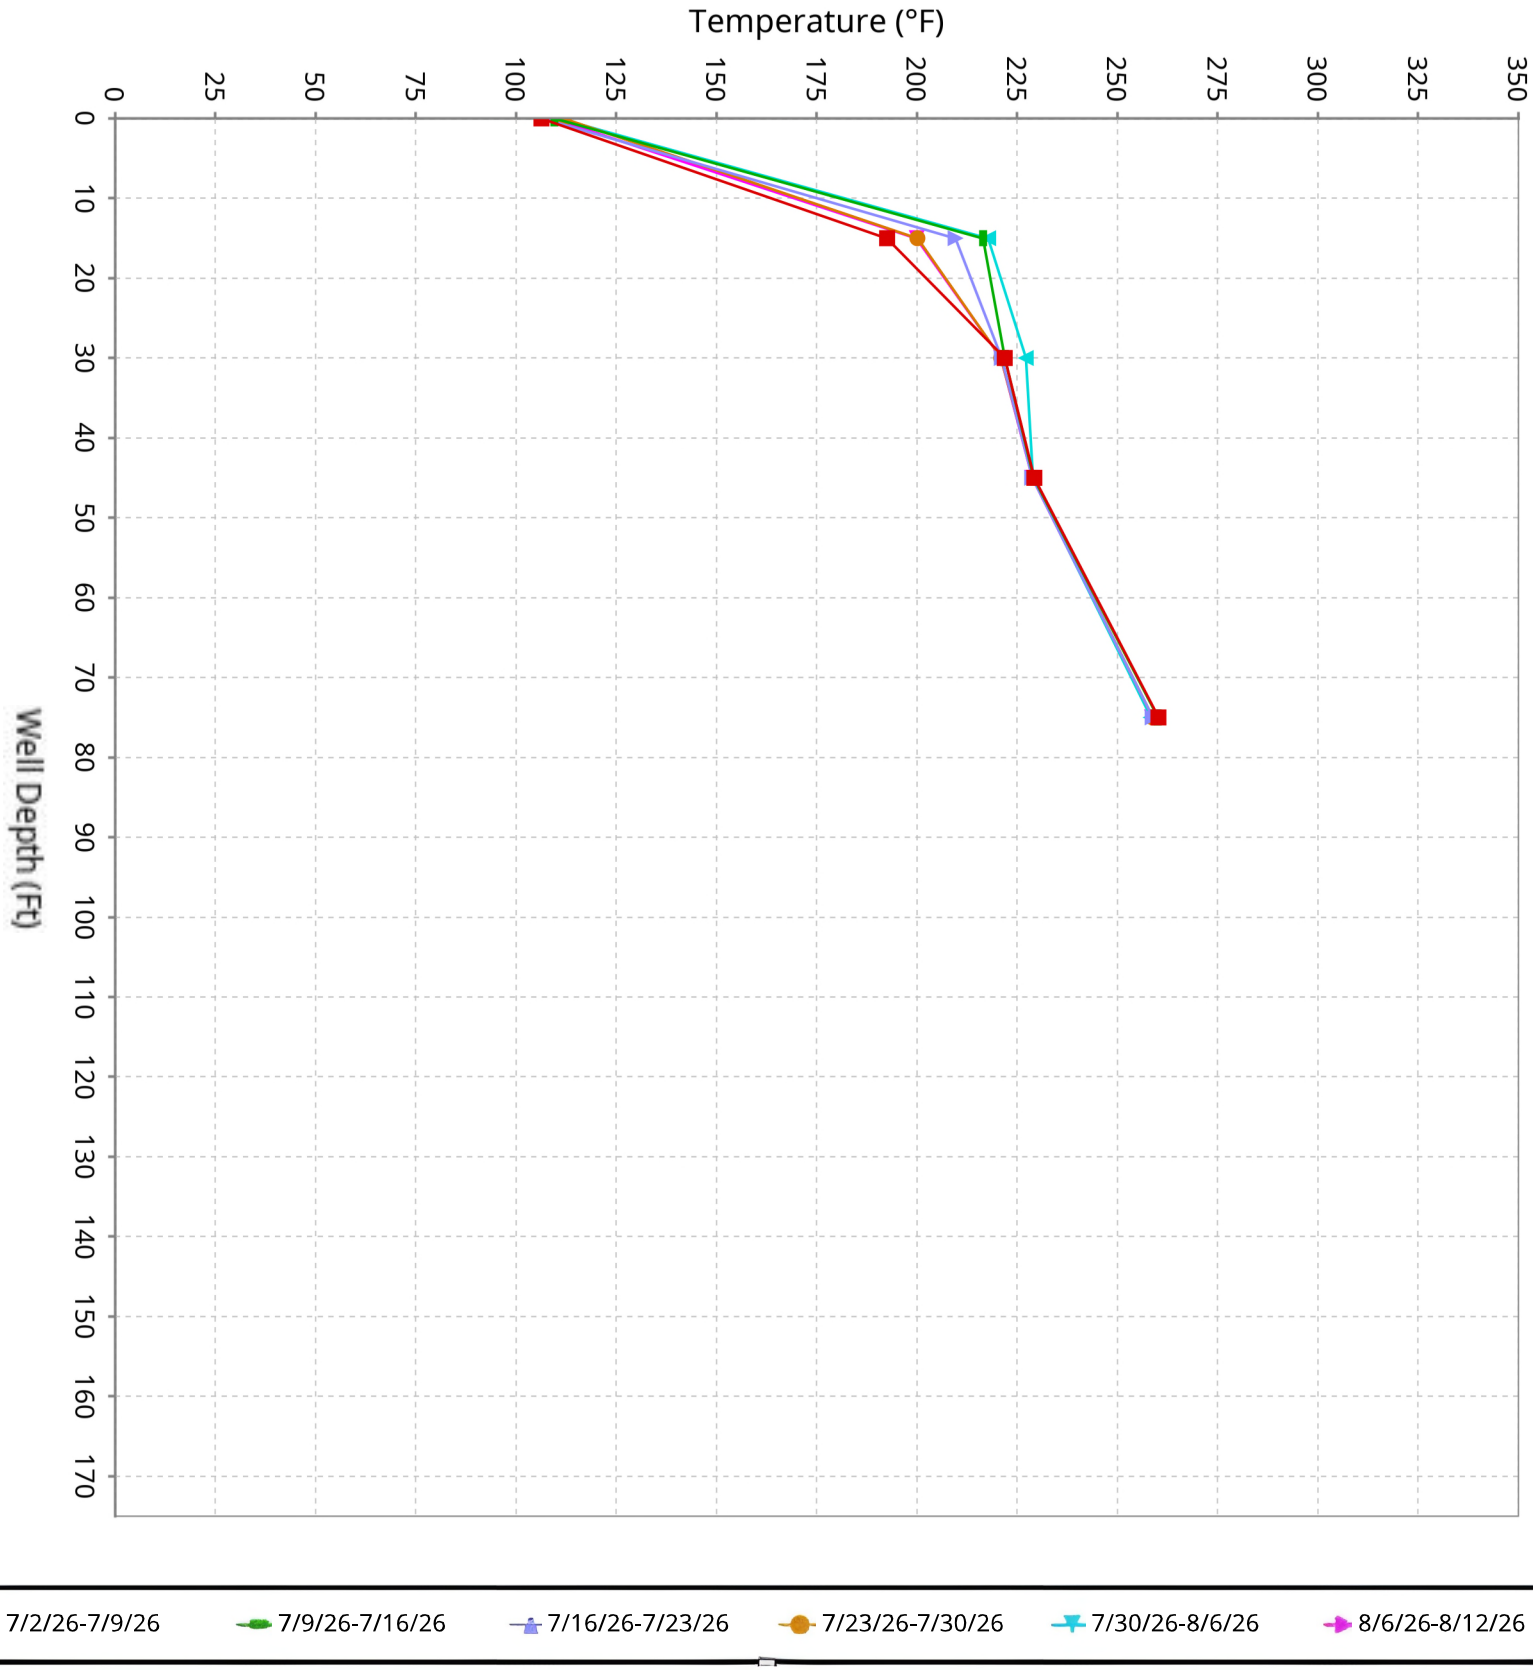
Vertical Temperature Profiles from Temperature Probes atChiquita Landfill for TP-23

- TP-23
    - The 15-foot thermocouple remained consistent with previously recorded temperatures.
