SCS ENGINEERS

15 de septiembre de 2026

Asunto: Informe Mensual de Agosto de 2026 Conforme a los Objetivos 1A-3 y 5 de la Orden de Cumplimiento de la LEA del 6 de junio de 2024 y a la Carta del 30 de julio de 2024, Vertedero de Chiquita Canyon, Castaic, California

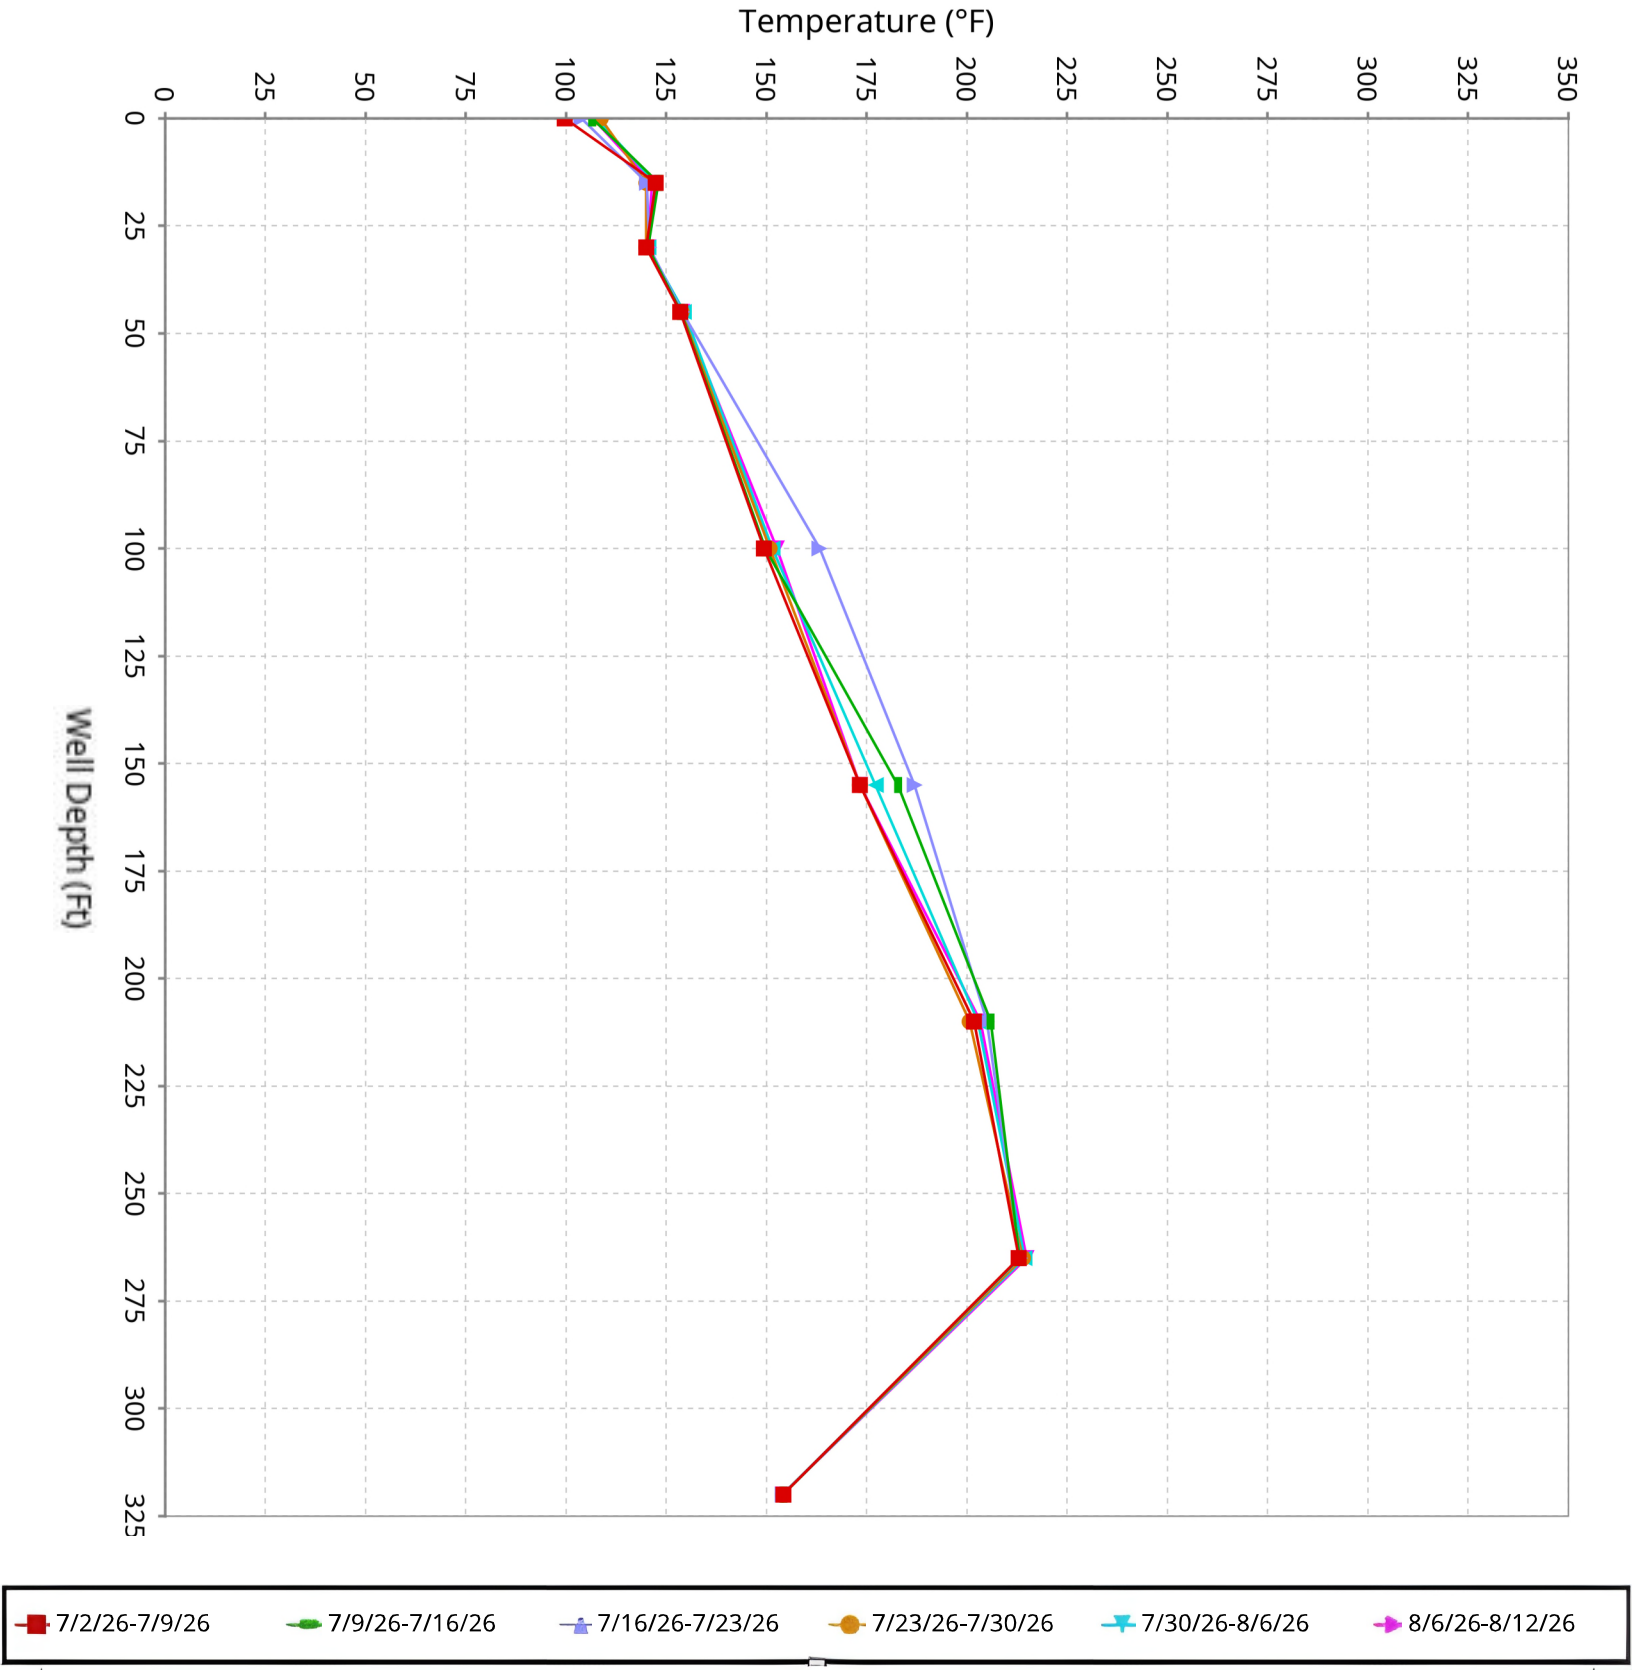
Vertical Temperature Profiles from Temperature Probes atChiquita Landfill for TP-24

- TP-24
    - The 155-foot thermocouple remained consistent with previously recorded temperatures.
    - The 210-foot thermocouple showed an increase in maximum temperature of 10°F from 193°F to 203°F from August 9th to August 11th.

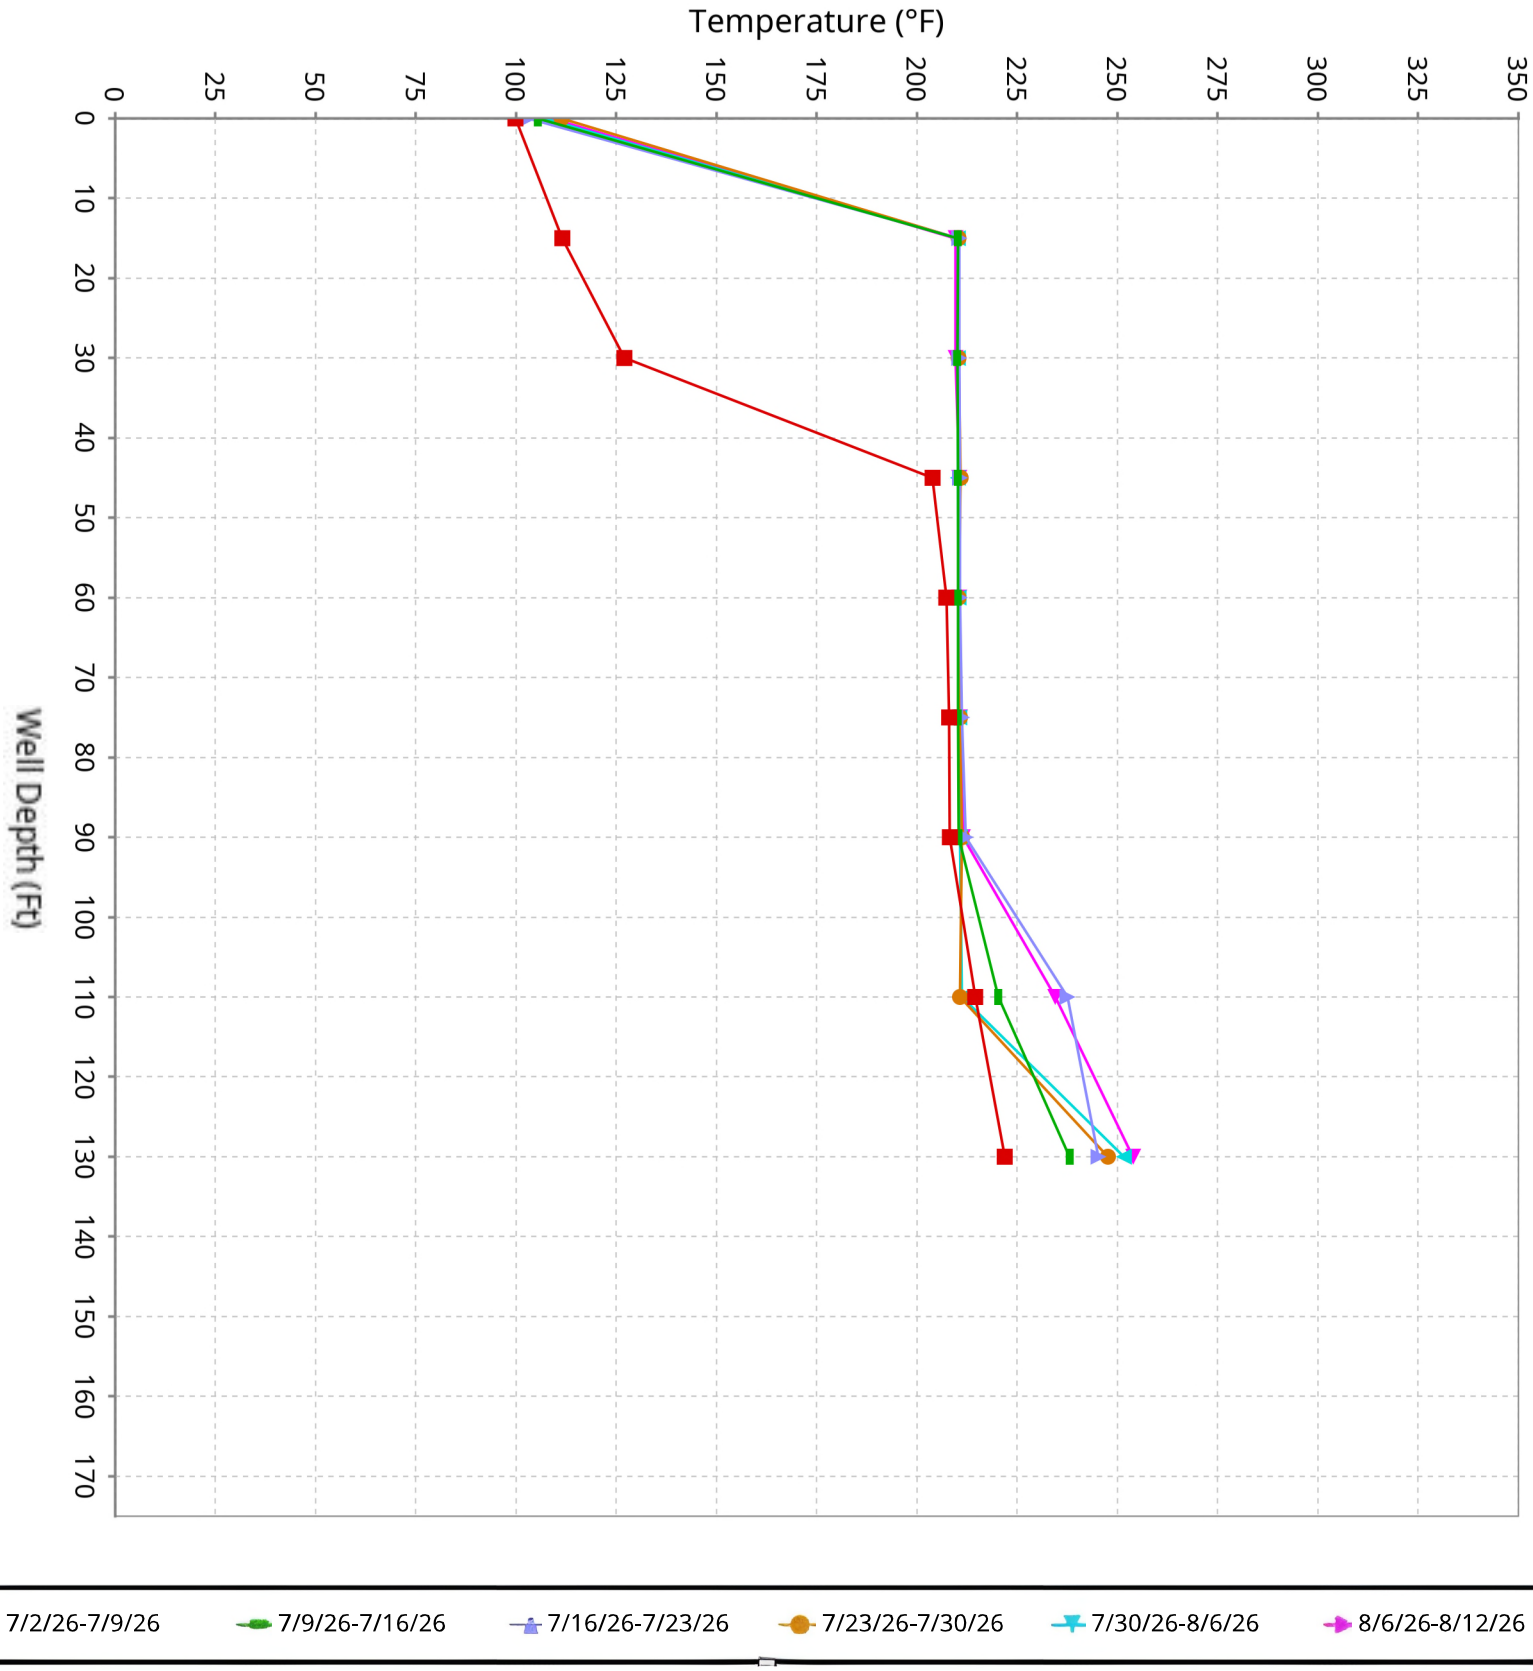
Vertical Temperature Profiles from Temperature Probes atChiquita Landfill for TP-25

- TP-25
    - The Site conducted a follow-up camera inspection of the TP-25 temperature probe casing this week to evaluate potential liquid infiltration and assess the condition of the casing interior. The inspection indicated that no liquid was present at the bottom of the casing. Instead, pressurized gas was observed upon opening the probe casing. The temperatures inside TP-25 are thus no longer correctly reporting in-situ waste temperatures and are instead reporting gas temperatures traveling to and up the TMP casing. The Site will continue to monitor TP-25.

- The 110-foot thermocouple showed an increase in maximum temperature of 25°F from 210°F to 235°F from August 6th to August 8th, and then a decrease in maximum temperature of 22°F from 235°F to 213°F from August 8th to August 11th. As described above, the Site is continuing to assess the condition of this probe equipment and will continue to monitor the temperature on the thermocouples.

- The 130-foot thermocouple showed an increase in maximum temperature of 42°F from 212°F to 254°F from July 22nd to August 10th. As described above, the Site is continuing to assess the condition of this probe equipment and will continue to monitor the temperature on the thermocouples.

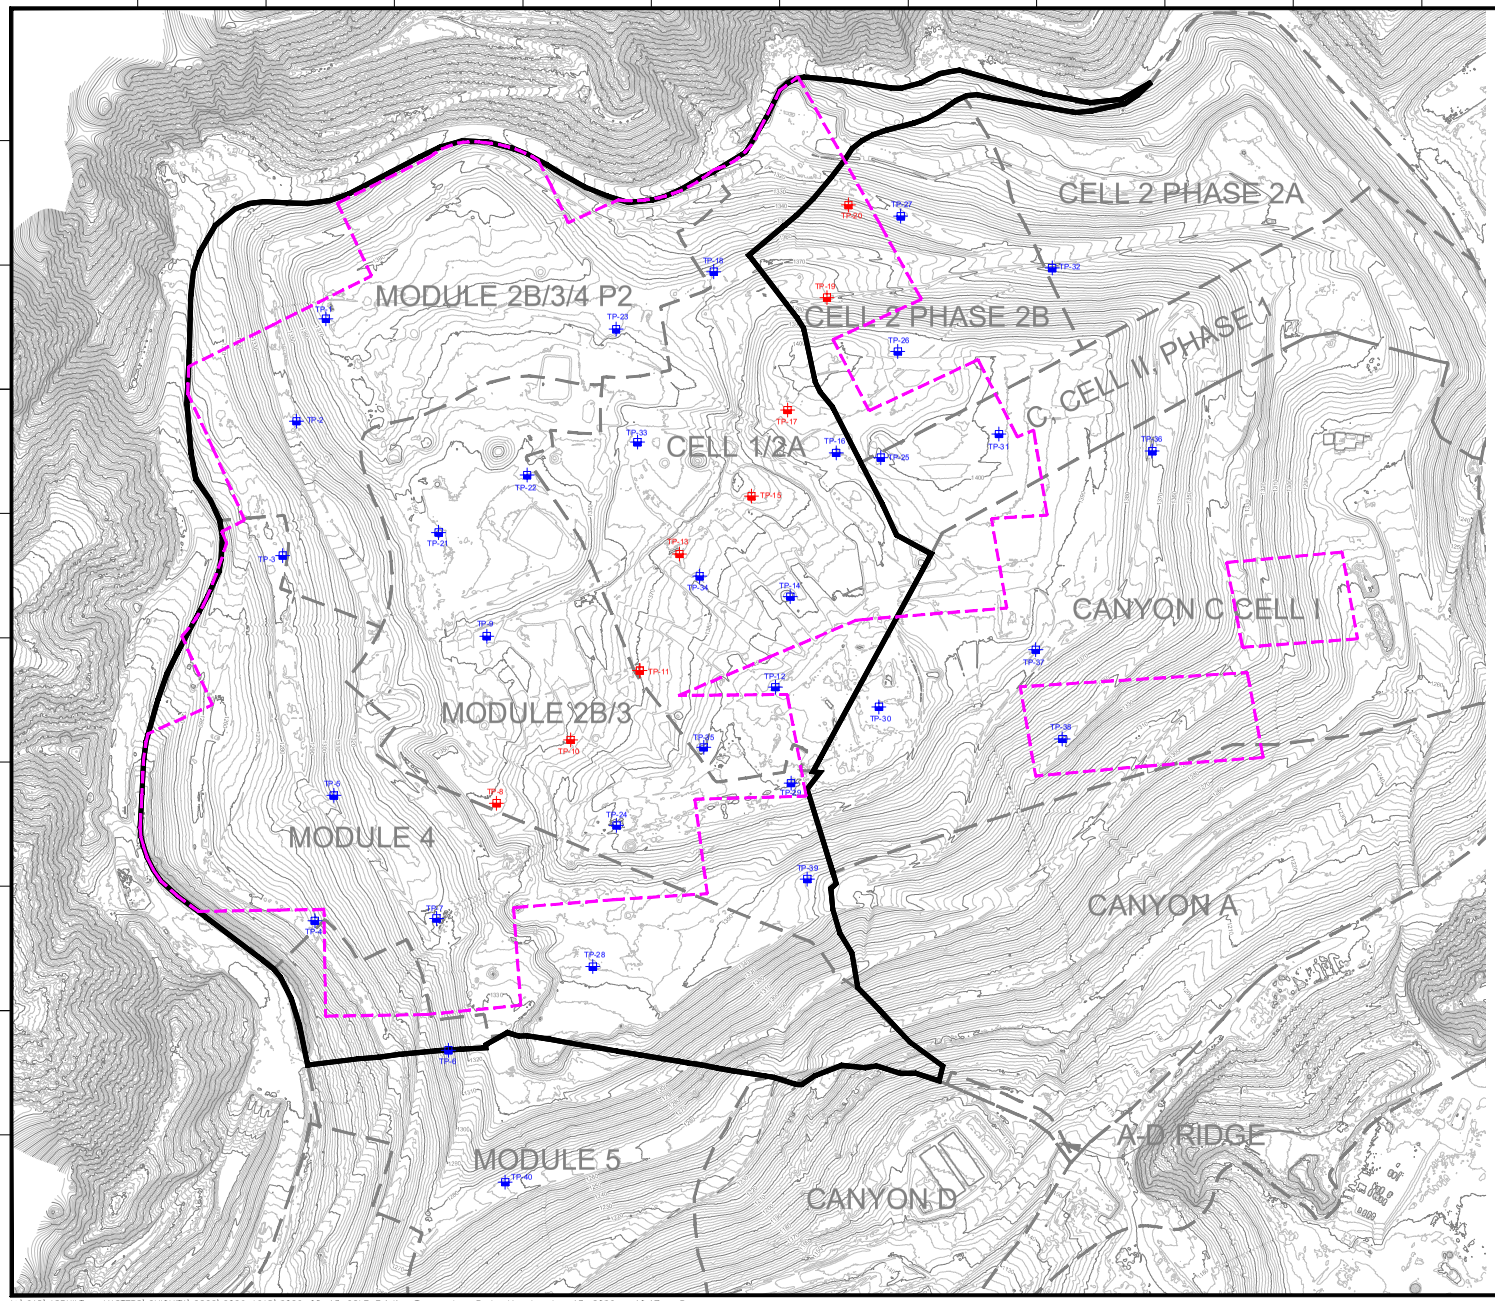
TP19:
A discrepancy was identified during the review of data from two weeks prior. Upon investigation, the Site determined that the associated battery had failed and subsequently replaced it. During this inspection, the temperature reading from the 125-foot thermocouple was observed to be anomalously low. Further evaluation indicated that the 125-foot thermocouple required replacement. As an interim measure, the Site installed a 120-foot thermocouple that was available onsite and ordered a replacement 125-foot thermocouple. The replacement 125-foot thermocouple will be installed upon receipt.

TP25:
The Site conducted a follow-up camera inspection of the TP-25 temperature probe casing this week to evaluate potential liquid infiltration and assess the condition of the casing interior. The inspection indicated that no liquid was present at the bottom of the casing. Instead, pressurized gas was observed upon opening the probe casing. The temperatures inside TP-25 are thus no longer correctly reporting in-situ waste temperatures and are instead reporting gas temperatures traveling to and up the TMP casing. The Site will continue to monitor TP-25.

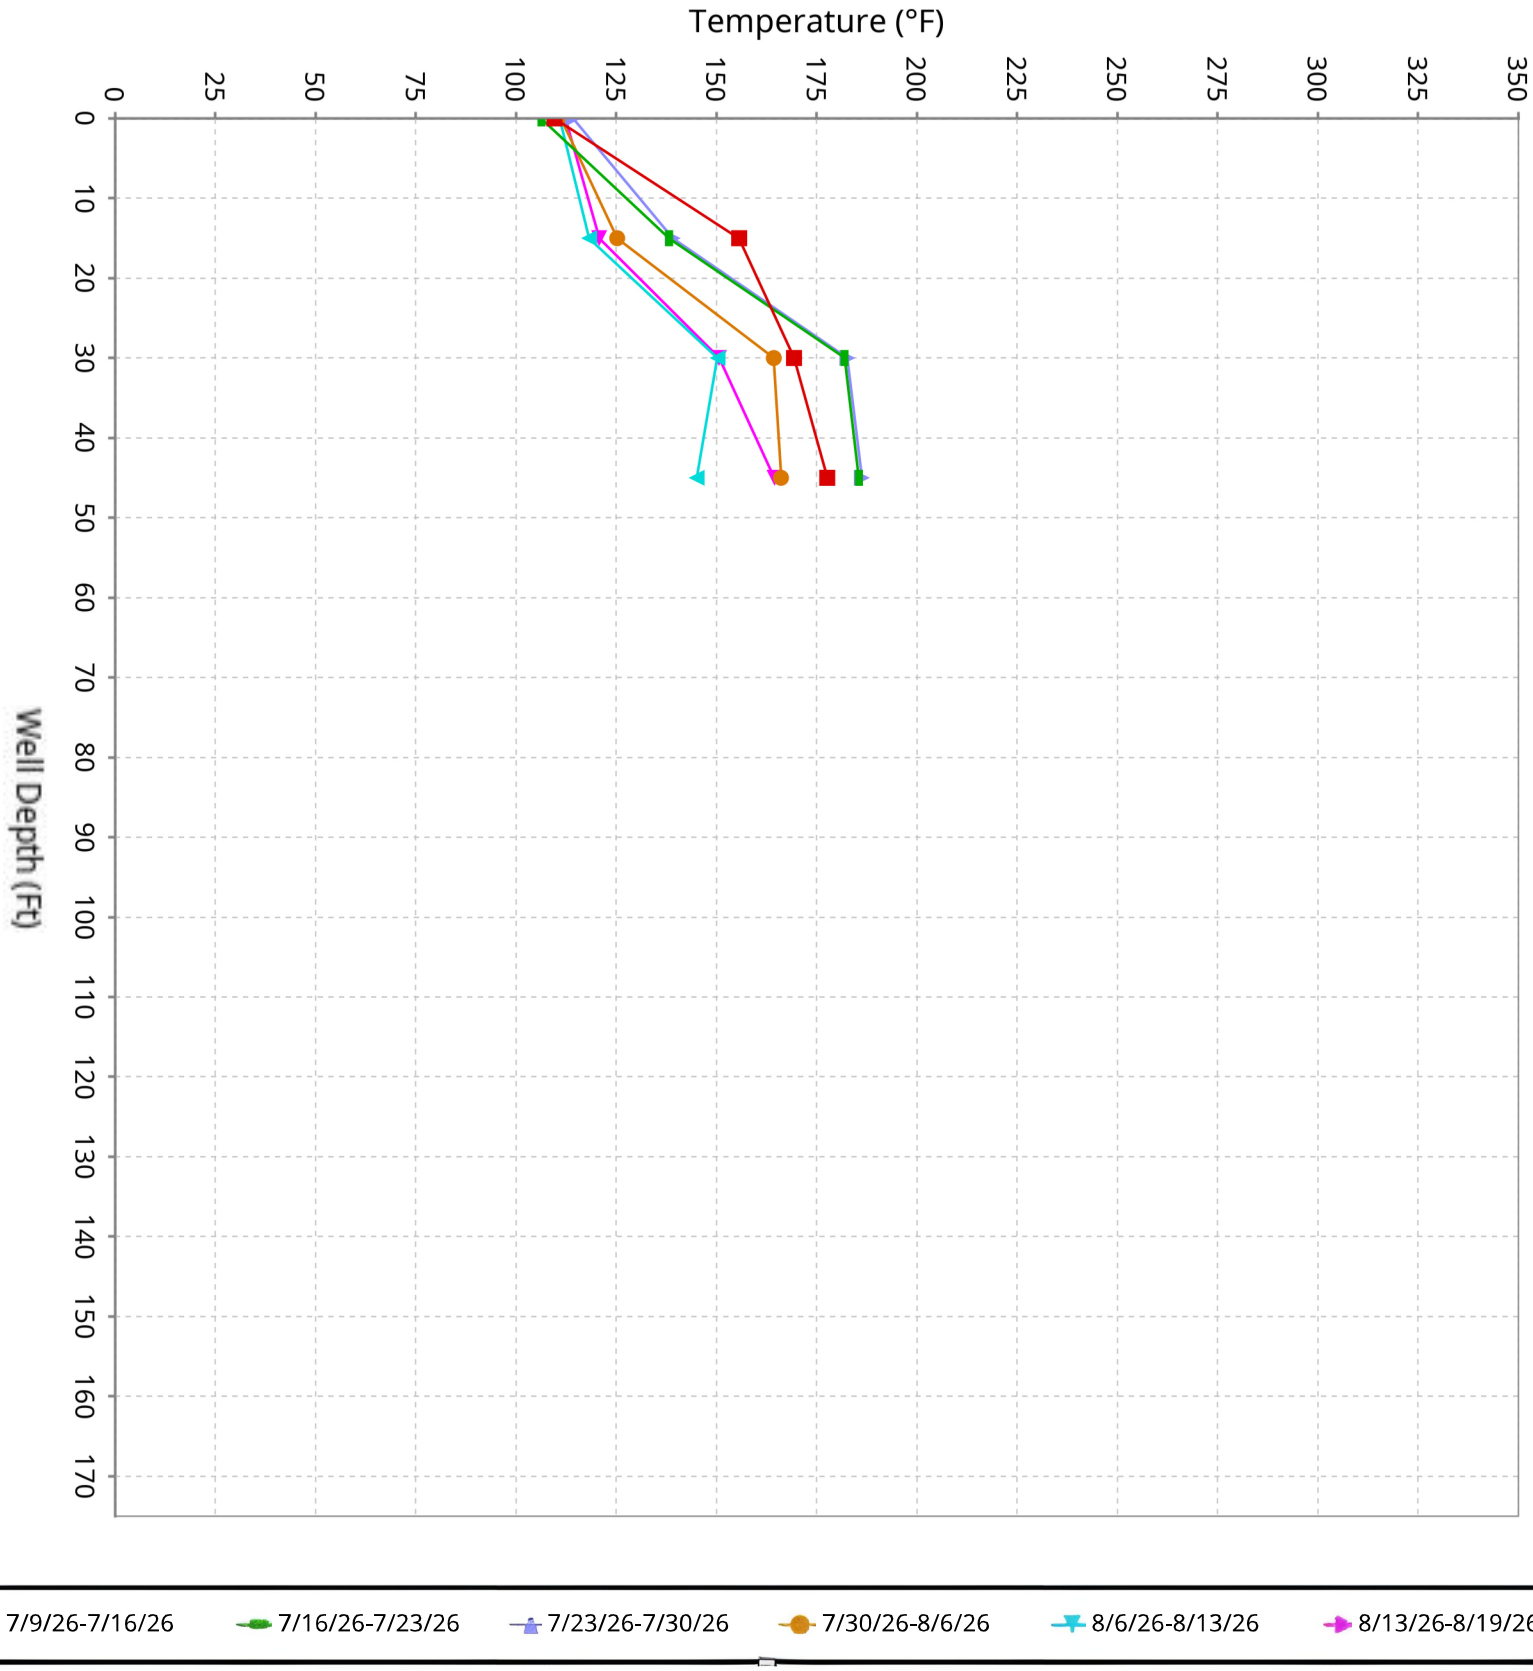
Vertical Temperature Profiles from Temperature Probes atChiquita Landfill for TP-8

- TP-08
    - The 30-foot and 45-foot thermocouples exhibited temperature increases of 27°F and 29°F, respectively, between July 12, 2026, and July 22, 2026. In response, Site personnel observed the temperature changes and conducted an investigation from July 23, 2026, through July 29, 2026. Following the investigation, temperatures continued to decline at the 30-foot thermocouple from July 30th, 2026, through August 19, 2026, and temperatures started to increase at the 45-foot thermocouple from August 13, 2026, through August 19, 2026.

- TP-08 is installed within extraction well CV-24079, which is equipped with a liquid extraction pump. The investigation determined that the existing pump is experiencing a power-related issue and requires removal. Site personnel have identified the need for a replacement pump and plan to complete the replacement when the road to the well is completed.

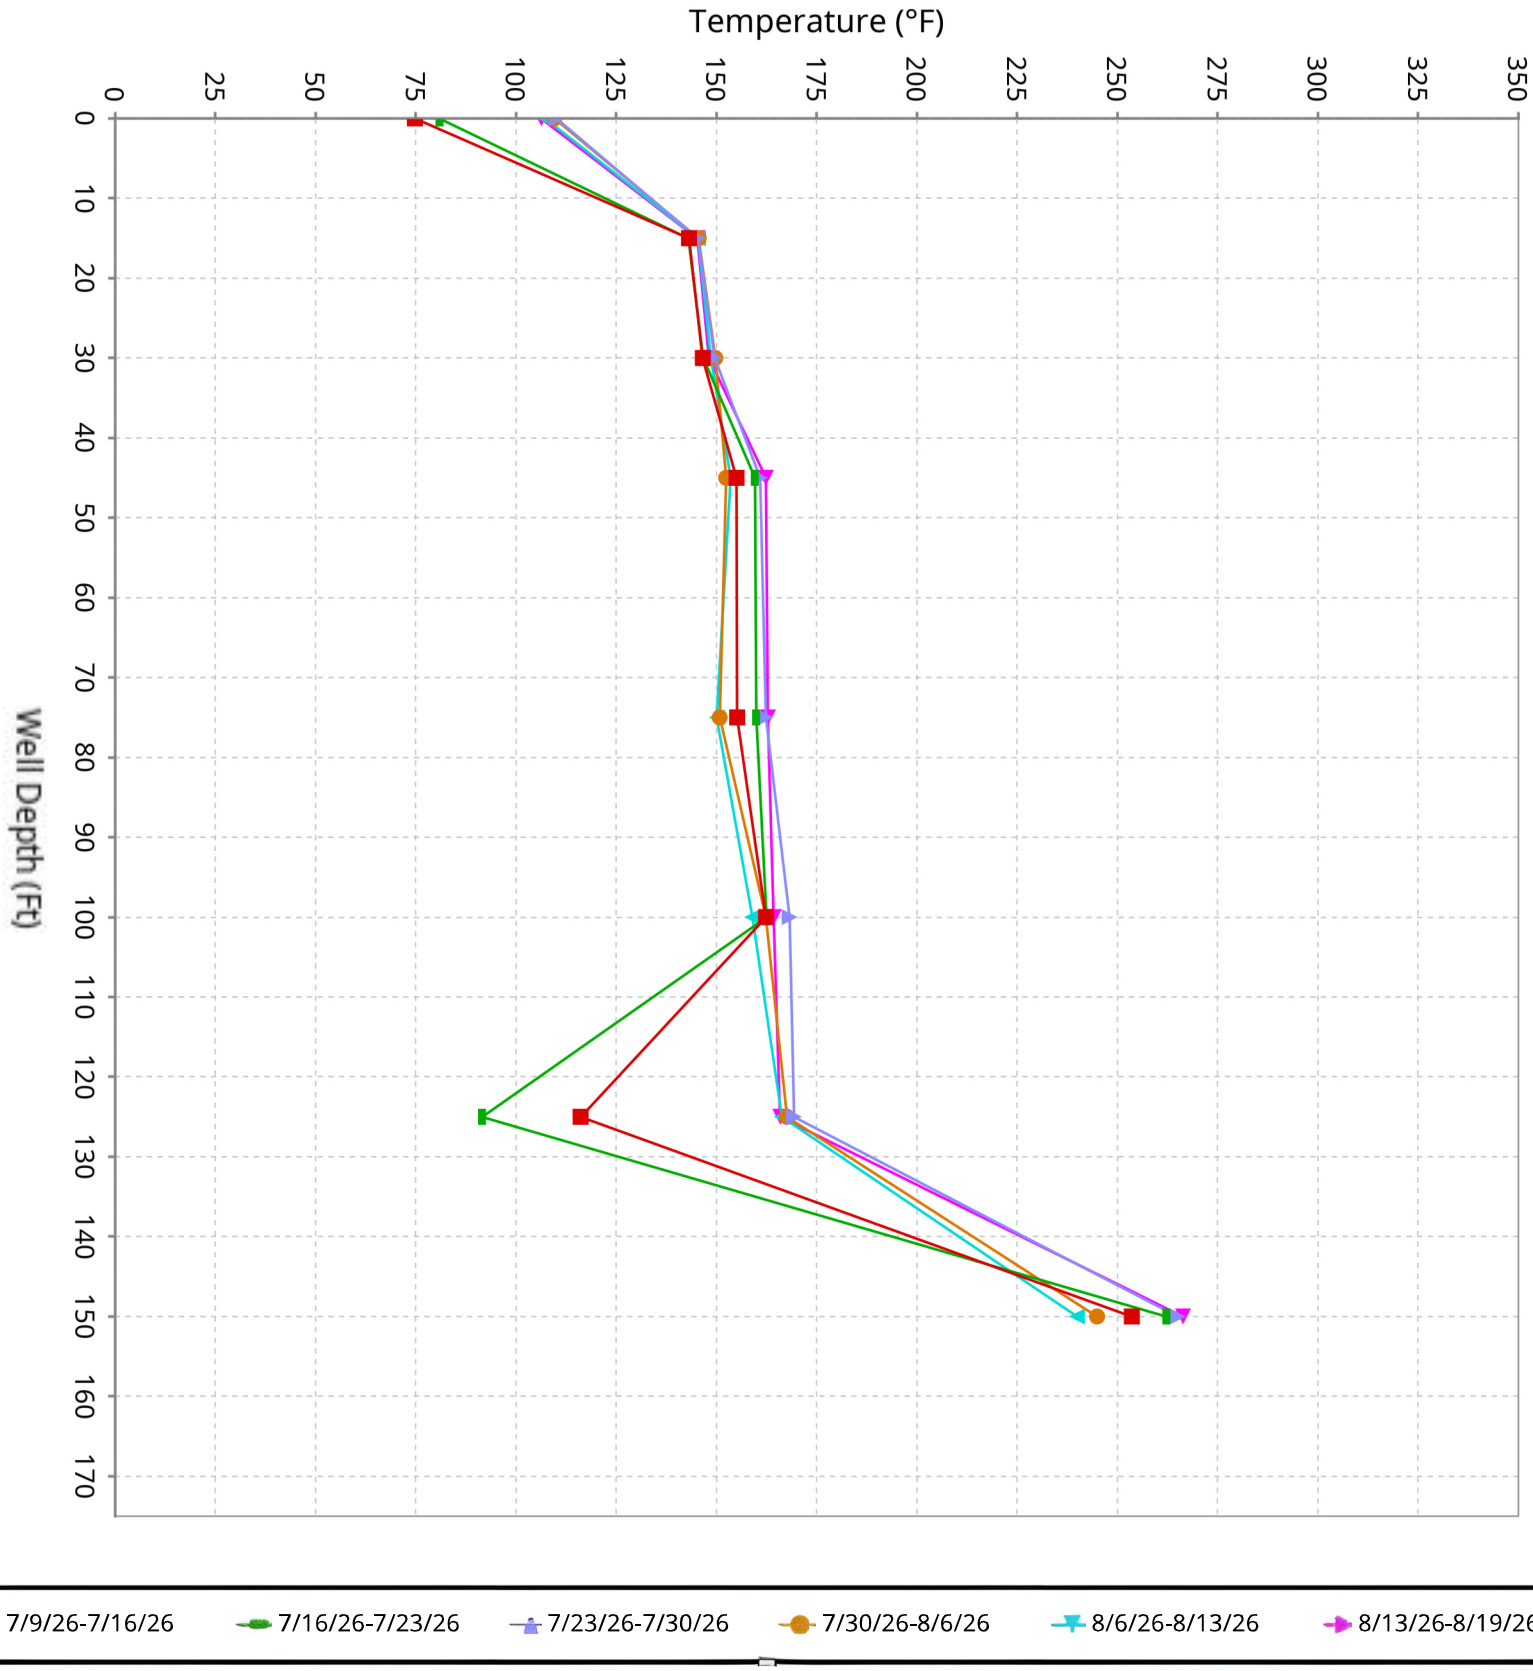
Vertical Temperature Profiles from Temperature Probes atChiquita Landfill for TP-19

- TP-19
    - A discrepancy was identified during the review of data from three weeks prior. Upon investigation, the Site determined that the associated battery had failed and subsequently replaced it. During this inspection, the temperature reading from the 125-foot thermocouple was observed to be anomalously low. Further evaluation indicated that the 125-foot thermocouple required replacement. As an interim measure, the Site installed a 120-foot thermocouple that was available onsite and ordered a replacement 125-foot thermocouple. The replacement 125-foot thermocouple will be installed upon receipt.
    - The 75-foot thermocouple showed an increase in maximum temperature of 14°F from 149°F to 163°F from August 14th to August 19th.

- The 150-foot thermocouple showed an increase in maximum temperature of 27°F from 239°F to 266°F from August 11th to August 16th.

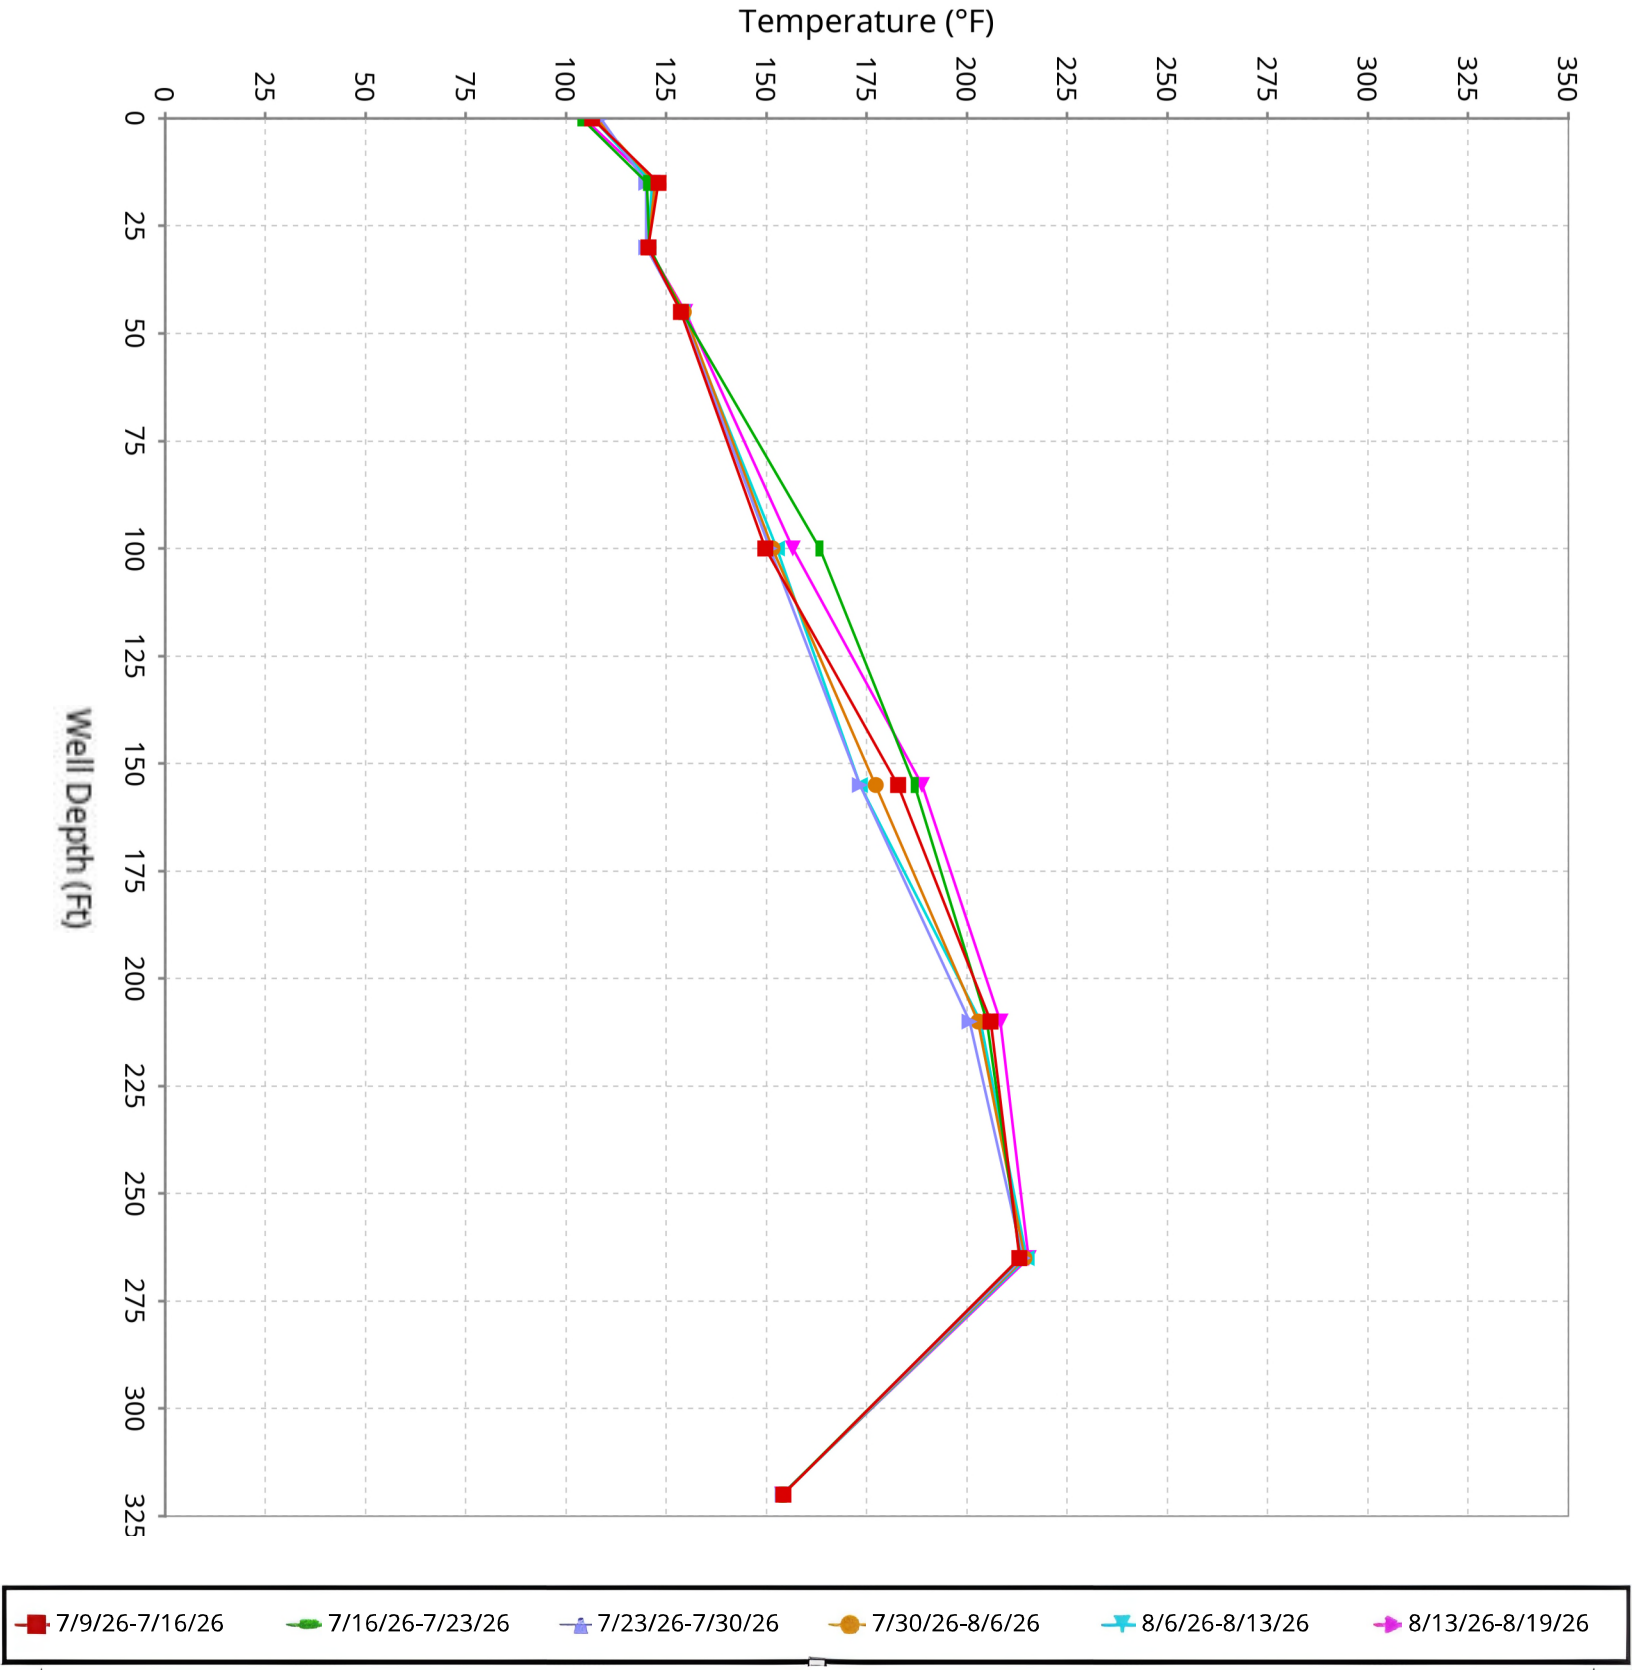
Vertical Temperature Profiles from Temperature Probes atChiquita Landfill for TP-24

- TP-24
    - The 155-foot thermocouple showed an increase in maximum temperature of 20°F from 169°F to 189°F from August 14th to August 16th.
    - The 210-foot thermocouple showed an increase in maximum temperature of 11°F from 197°F to 208°F from August 13th to August 16th.

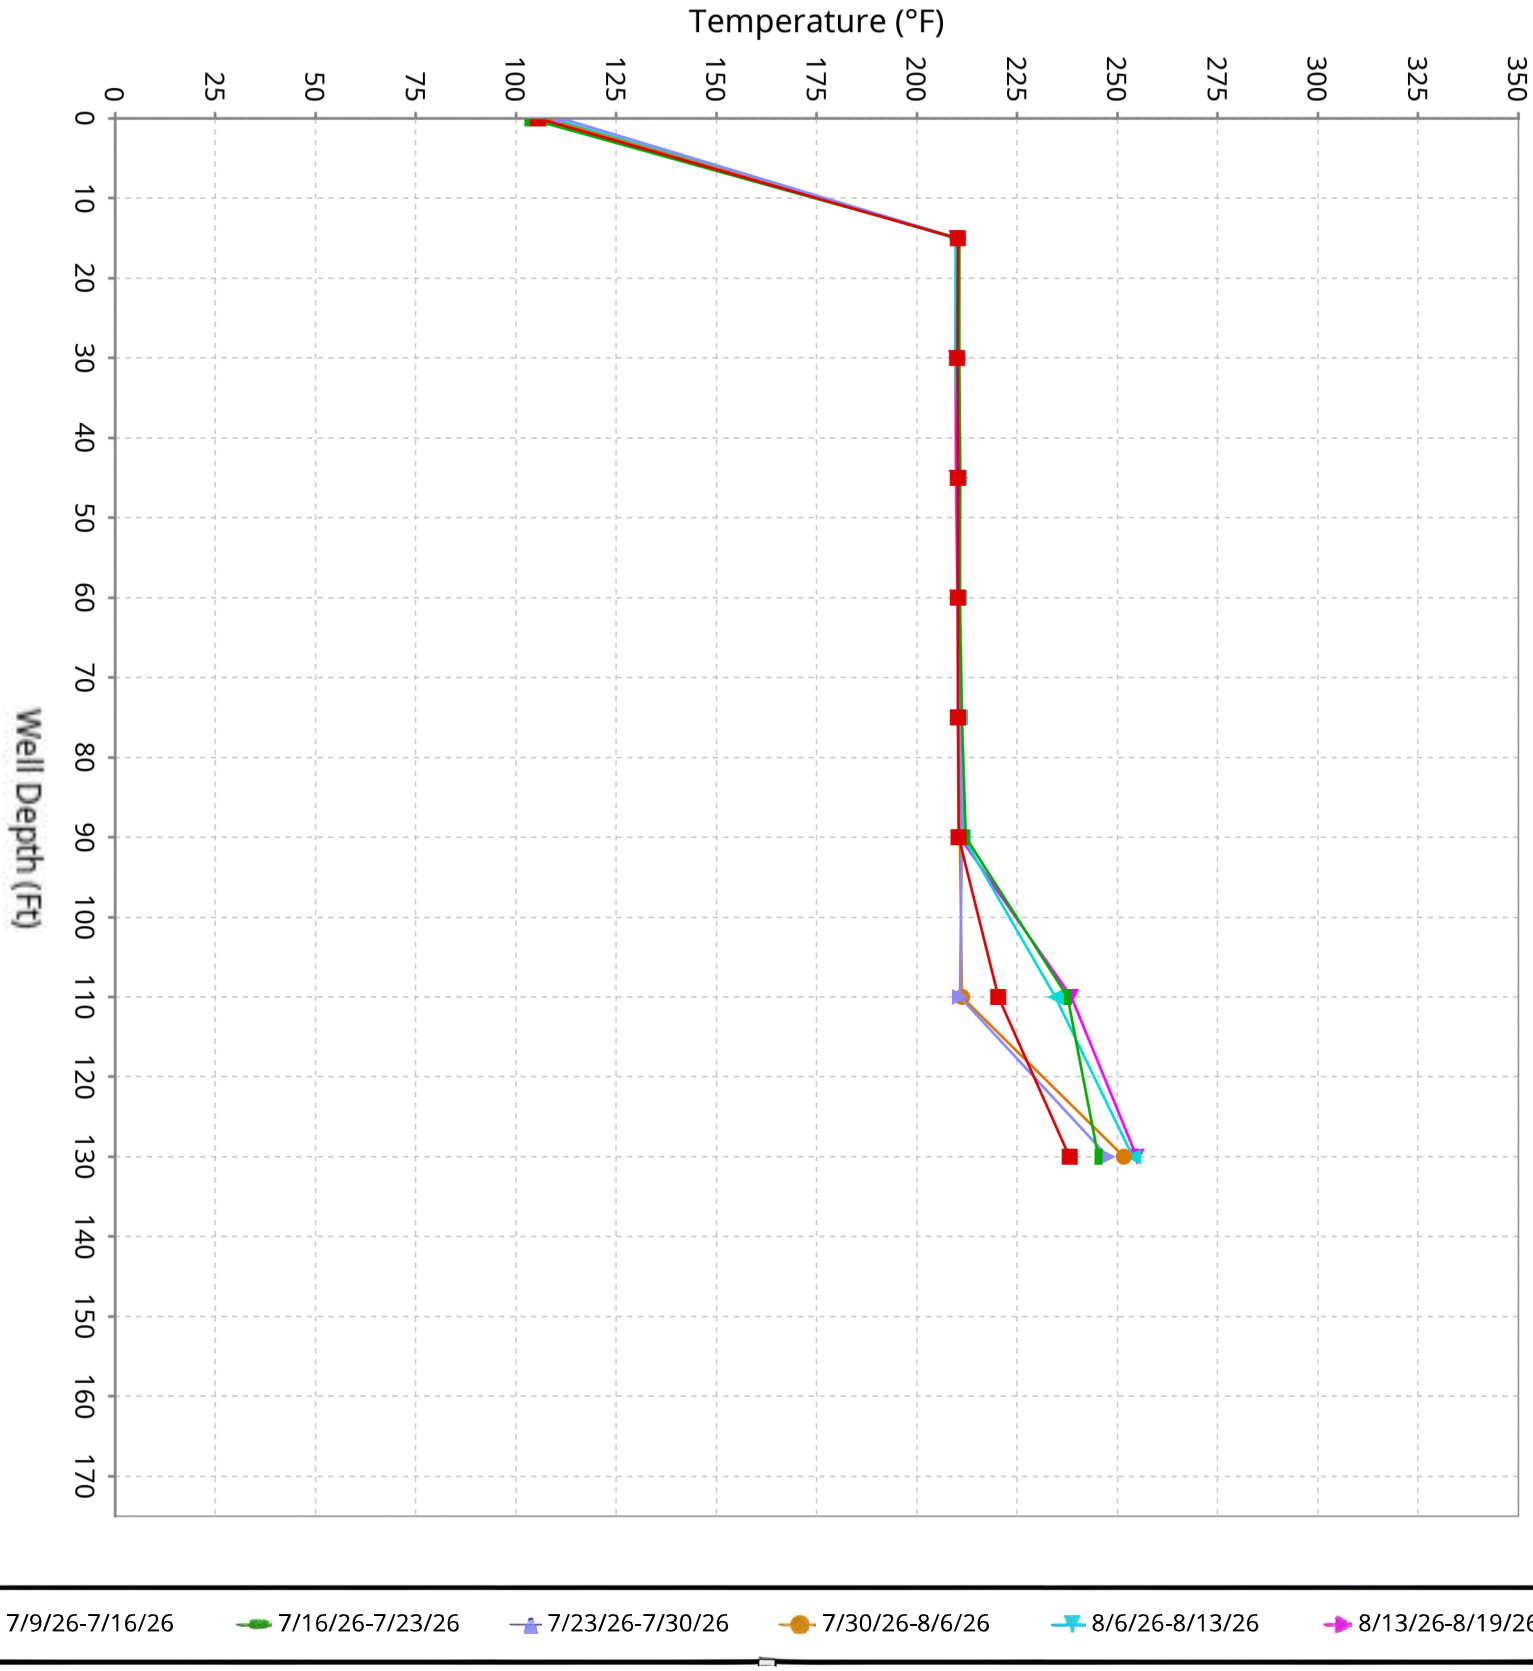
Vertical Temperature Profiles from Temperature Probes atChiquita Landfill for TP-25

- TP-25
    - The Site conducted a follow-up camera inspection of the TP-25 temperature probe casing last week to evaluate potential liquid infiltration and assess the condition of the casing interior. The inspection indicated that no liquid was present at the bottom of the casing. Instead, pressurized gas was observed upon opening the probe casing. The temperature probes inside TP-25 are thus no longer correctly reporting in-situ waste temperatures and are instead reporting gas temperatures traveling to and up the temperature probe casing. The Site will continue to monitor TP-25.

- The 110-foot thermocouple showed an increase in maximum temperature of 25°F from 213°F to 238°F from August 11th to August 18th. As described above, the Site is continuing to assess the condition of this probe equipment and will continue to monitor the temperature on the thermocouples.

- The 130-foot thermocouple showed an increase in maximum temperature of 42°F from 212°F to 254°F from July 22nd to August 10th. As described above, the Site is continuing to assess the condition of this probe equipment and will continue to monitor the temperature on the thermocouples.

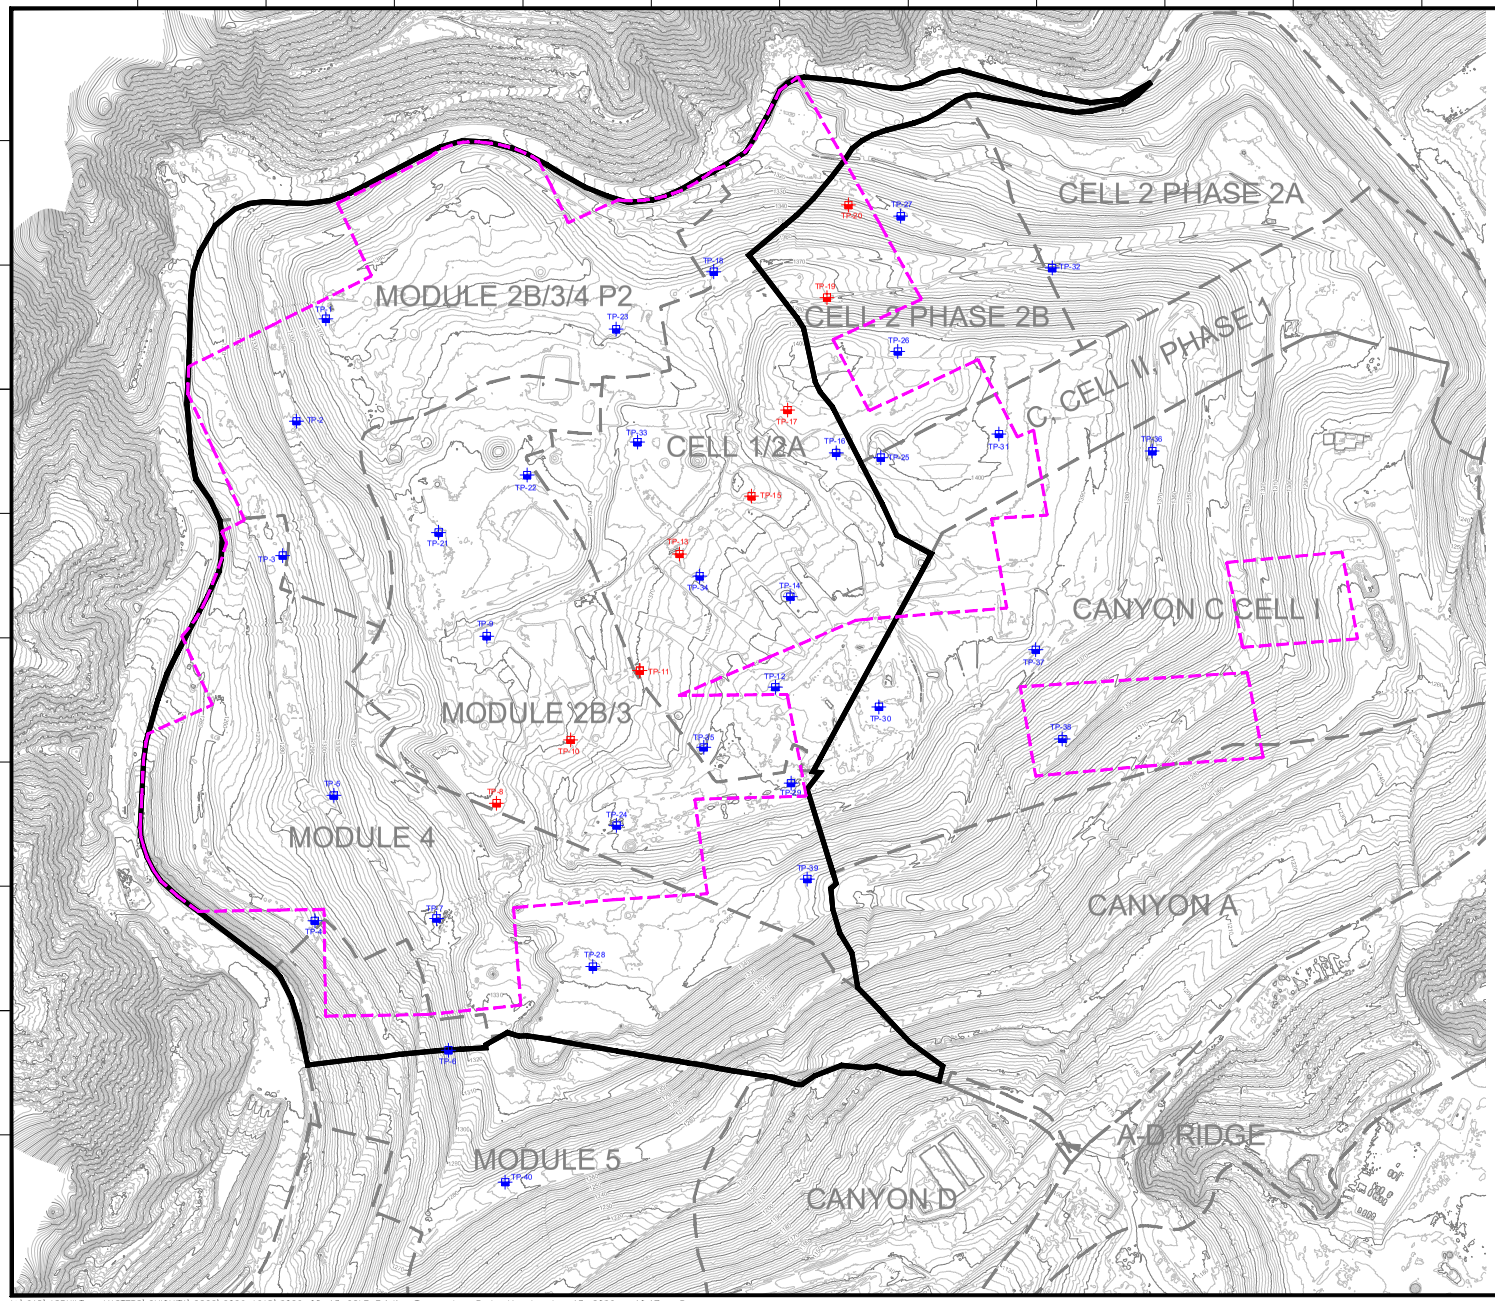
TP-19: A discrepancy was identified during the review of data from three weeks prior. Upon investigation, the Site determined that the associated battery had failed and subsequently replaced it. During this inspection, the temperature reading from the 125-foot thermocouple was observed to be anomalously low. Further evaluation indicated that the 125-foot thermocouple required replacement. As an interim measure, the Site installed a 120-foot thermocouple that was available onsite and ordered a replacement 125-foot thermocouple. The replacement 125-foot thermocouple will be installed upon receipt.

TP-25: The Site conducted a follow-up camera inspection of the TP-25 temperature probe casing last week to evaluate potential liquid infiltration and assess the condition of the casing interior. The inspection indicated that no liquid was present at the bottom of the casing. Instead, pressurized gas was observed upon opening the probe casing. The temperature probes inside TP-25 are thus no longer correctly reporting in-situ waste temperatures and are instead reporting gas temperatures traveling to and up the temperature probe casing. The Site will continue to monitor TP-25.
