SCS ENGINEERS

15 de septiembre de 2026

Asunto: Informe Mensual de Agosto de 2026 Conforme a los Objetivos 1A-3 y 5 de la Orden de Cumplimiento de la LEA del 6 de junio de 2024 y a la Carta del 30 de julio de 2024, Vertedero de Chiquita Canyon, Castaic, California

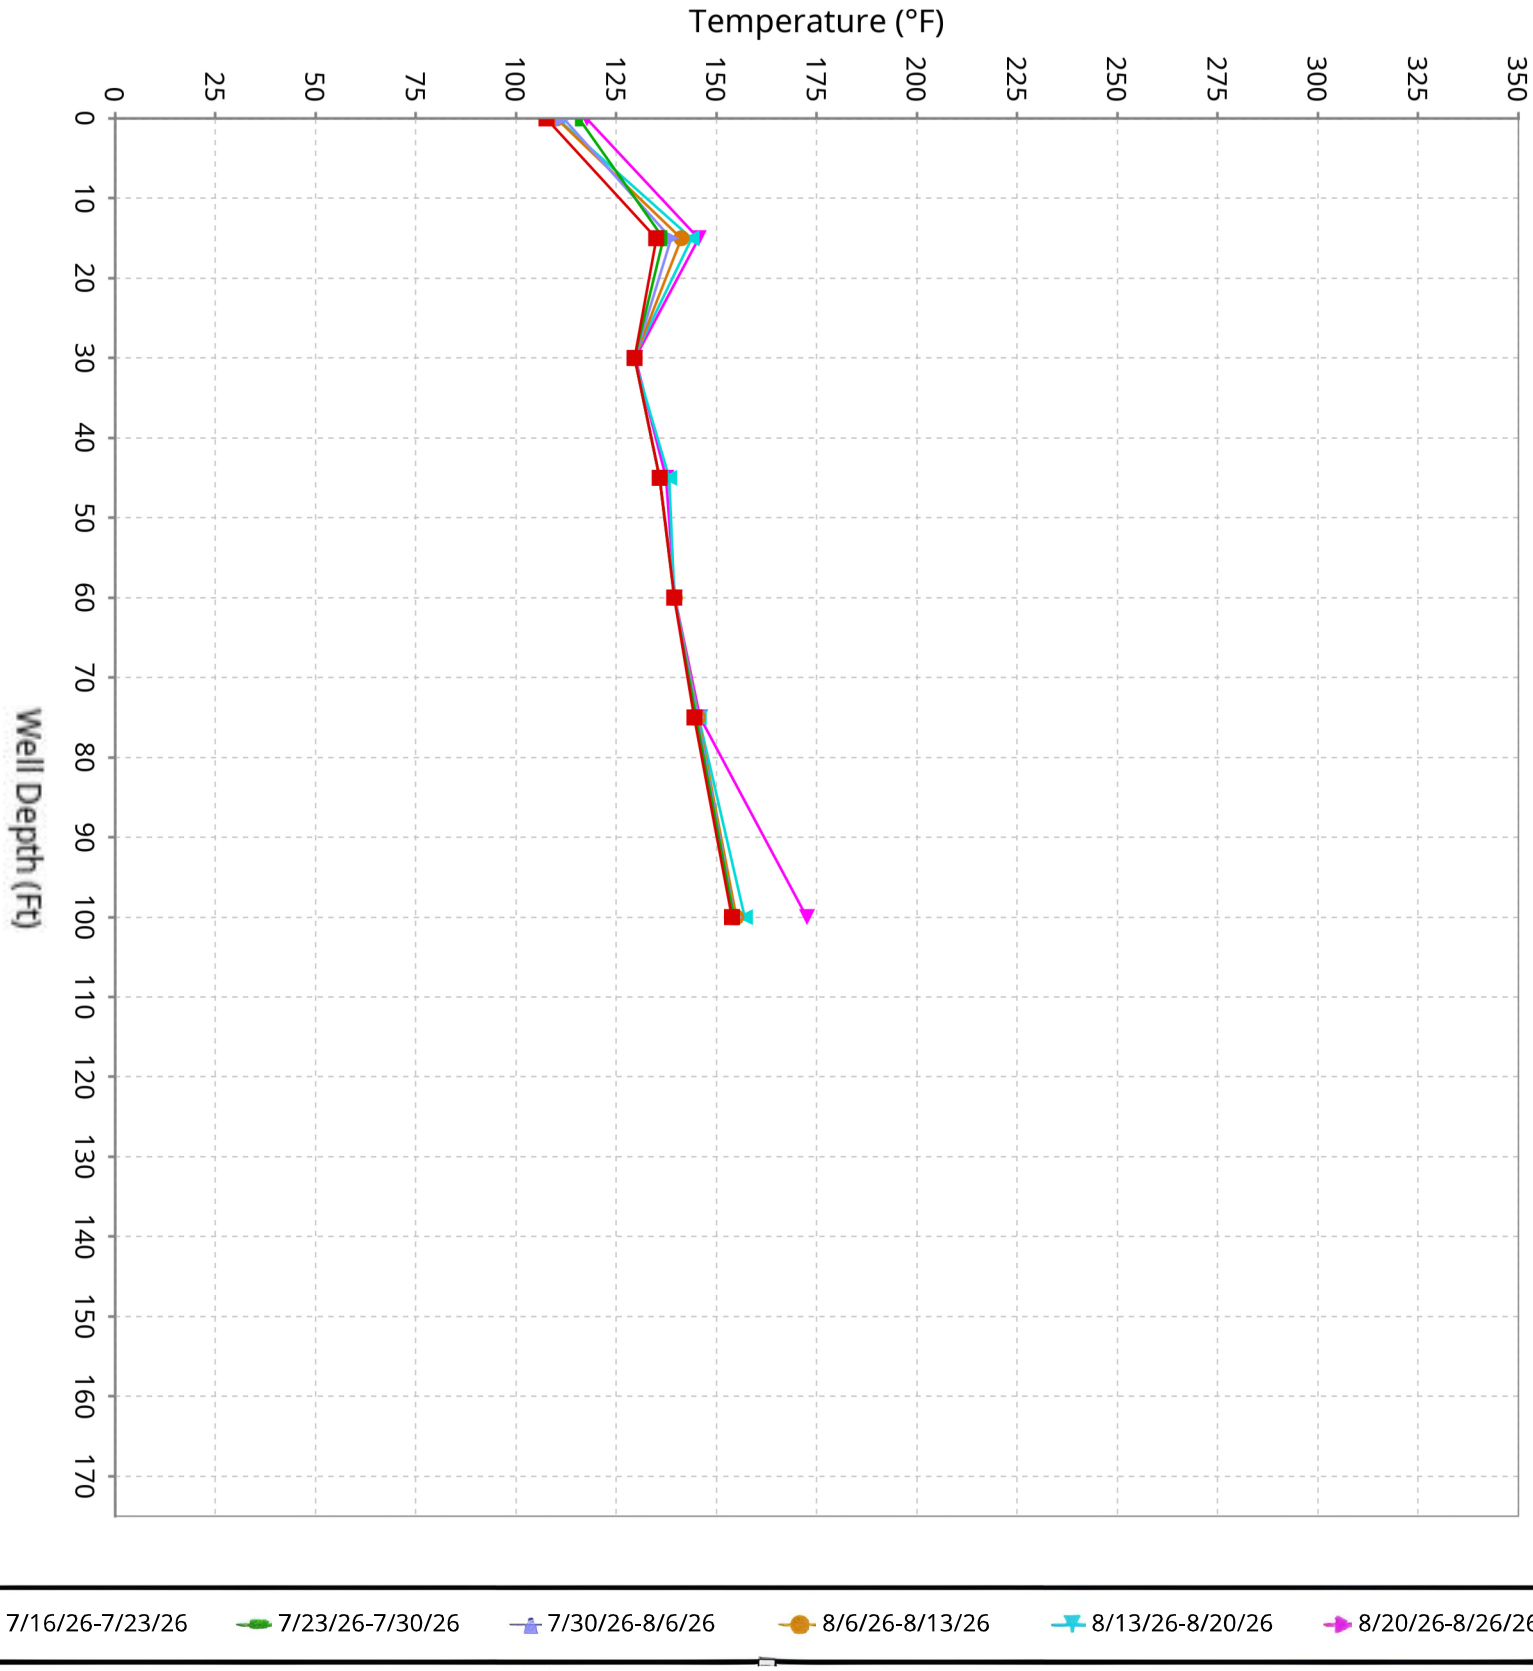
Vertical Temperature Profiles from Temperature Probes atChiquita Landfill for TP-7

- TP-07
    - The 100-foot thermocouple showed an increase in maximum temperature of 40°F from 155°F to 195°F from August 16th to September 2nd. One potential factor contributing to the observed temperature increase is the removal of liquids from wells near TP-07.

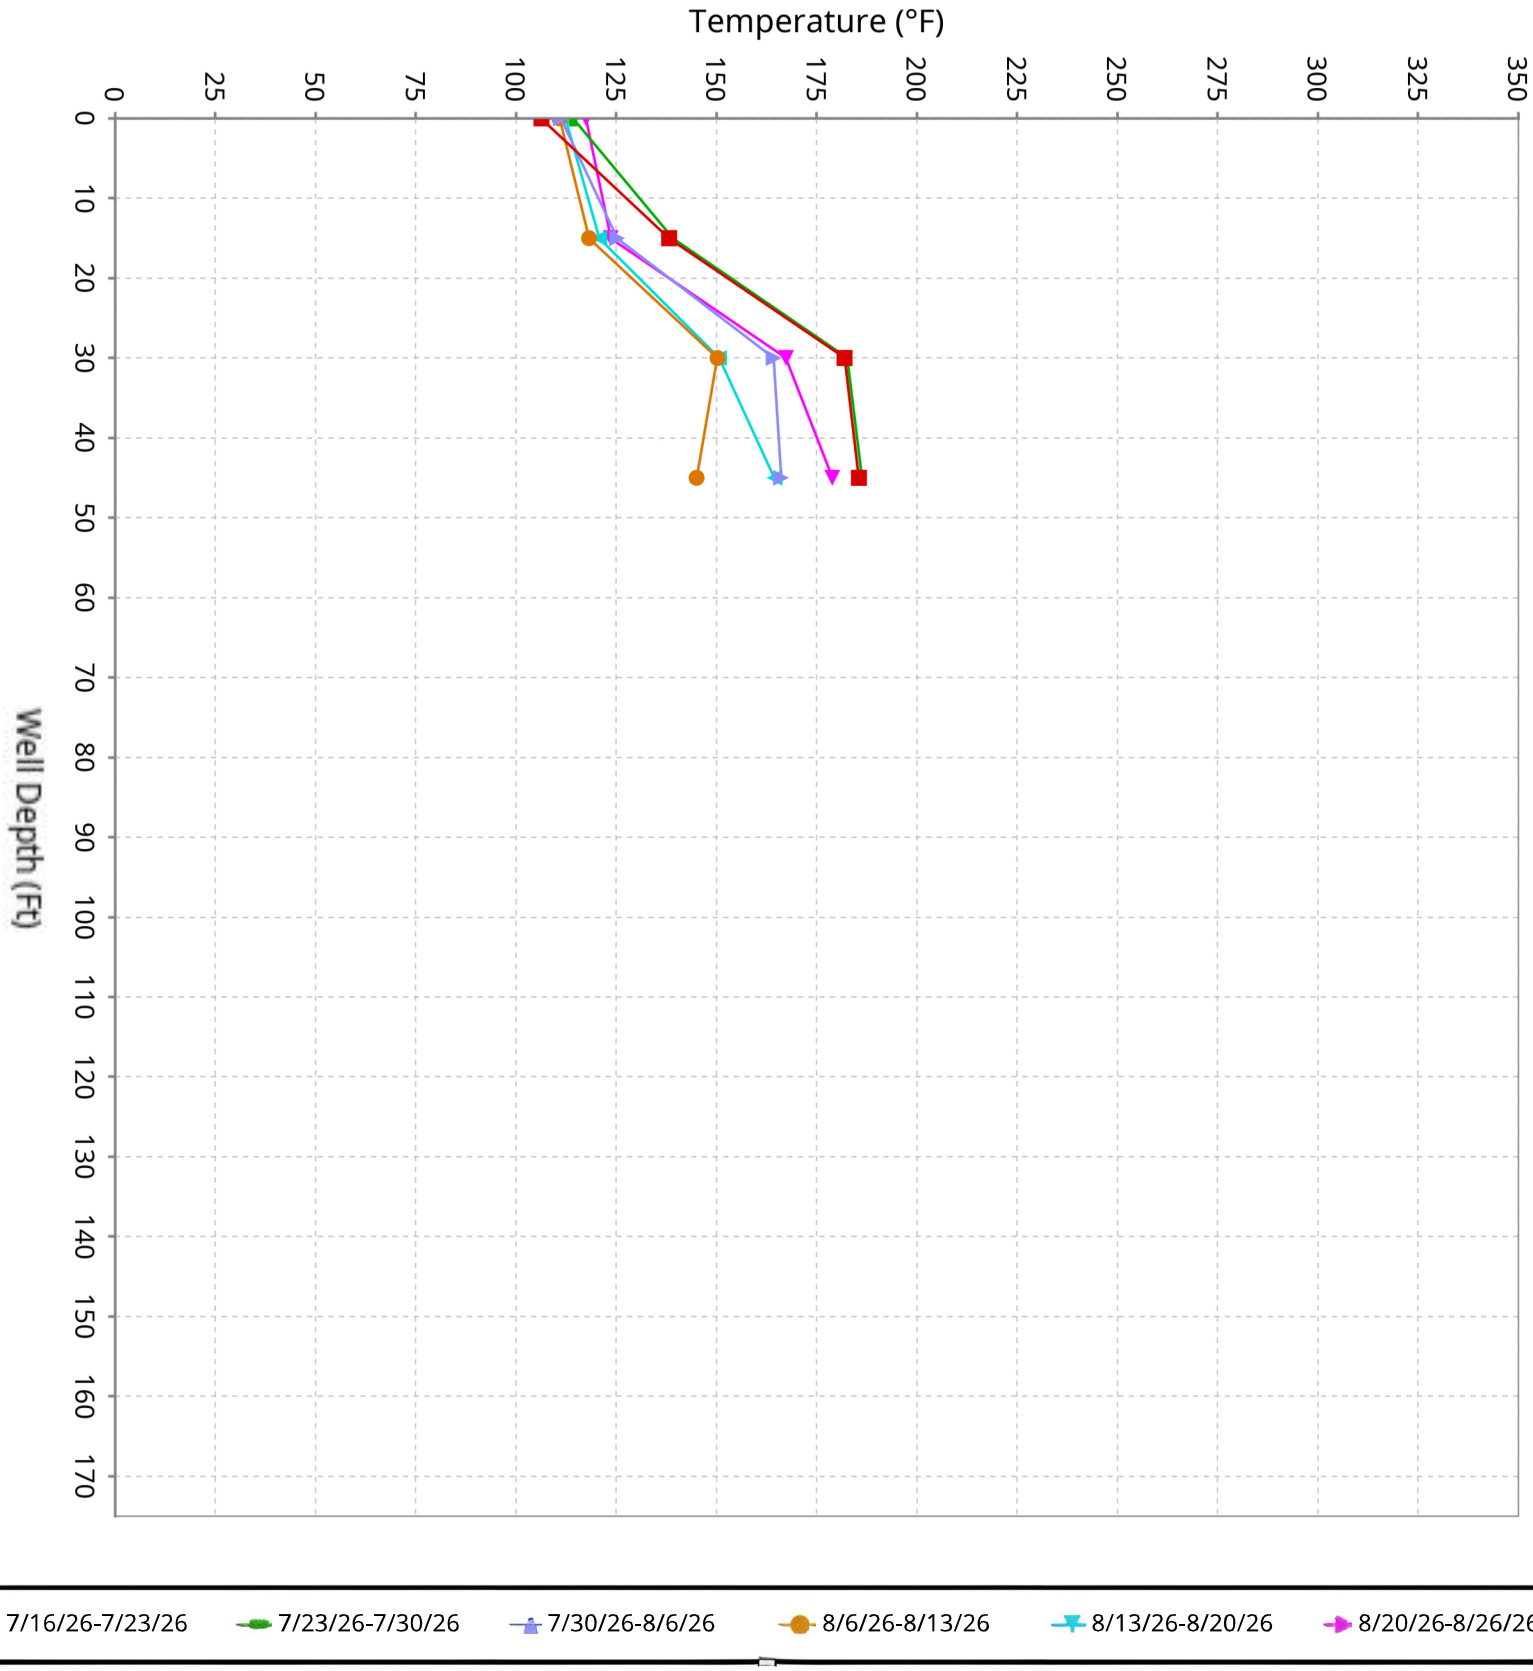
Vertical Temperature Profiles from Temperature Probes atChiquita Landfill for TP-8

- TP-08
    - The 30-foot and 45-foot thermocouples exhibited temperature increases of 27°F and 29°F, respectively, between July 12, 2026, and July 22, 2026. In response, Site personnel observed the temperature changes and conducted an investigation from July 23, 2026, through July 29, 2026. Following the investigation, temperatures continued to decline at the 30-foot thermocouple from July 30th, 2026, through August 19, 2026, and then temperatures started to increase at the 15, 30, and 45-foot thermocouples from August 20, 2026, through August 26, 2026.

- TP-08 is installed within extraction well CV-24079, which is equipped with a liquid extraction pump. The investigation determined that the existing pump is experiencing a power-related issue and requires removal. Site personnel have identified the need for a replacement pump and plan to complete the replacement when the road to the well is completed.

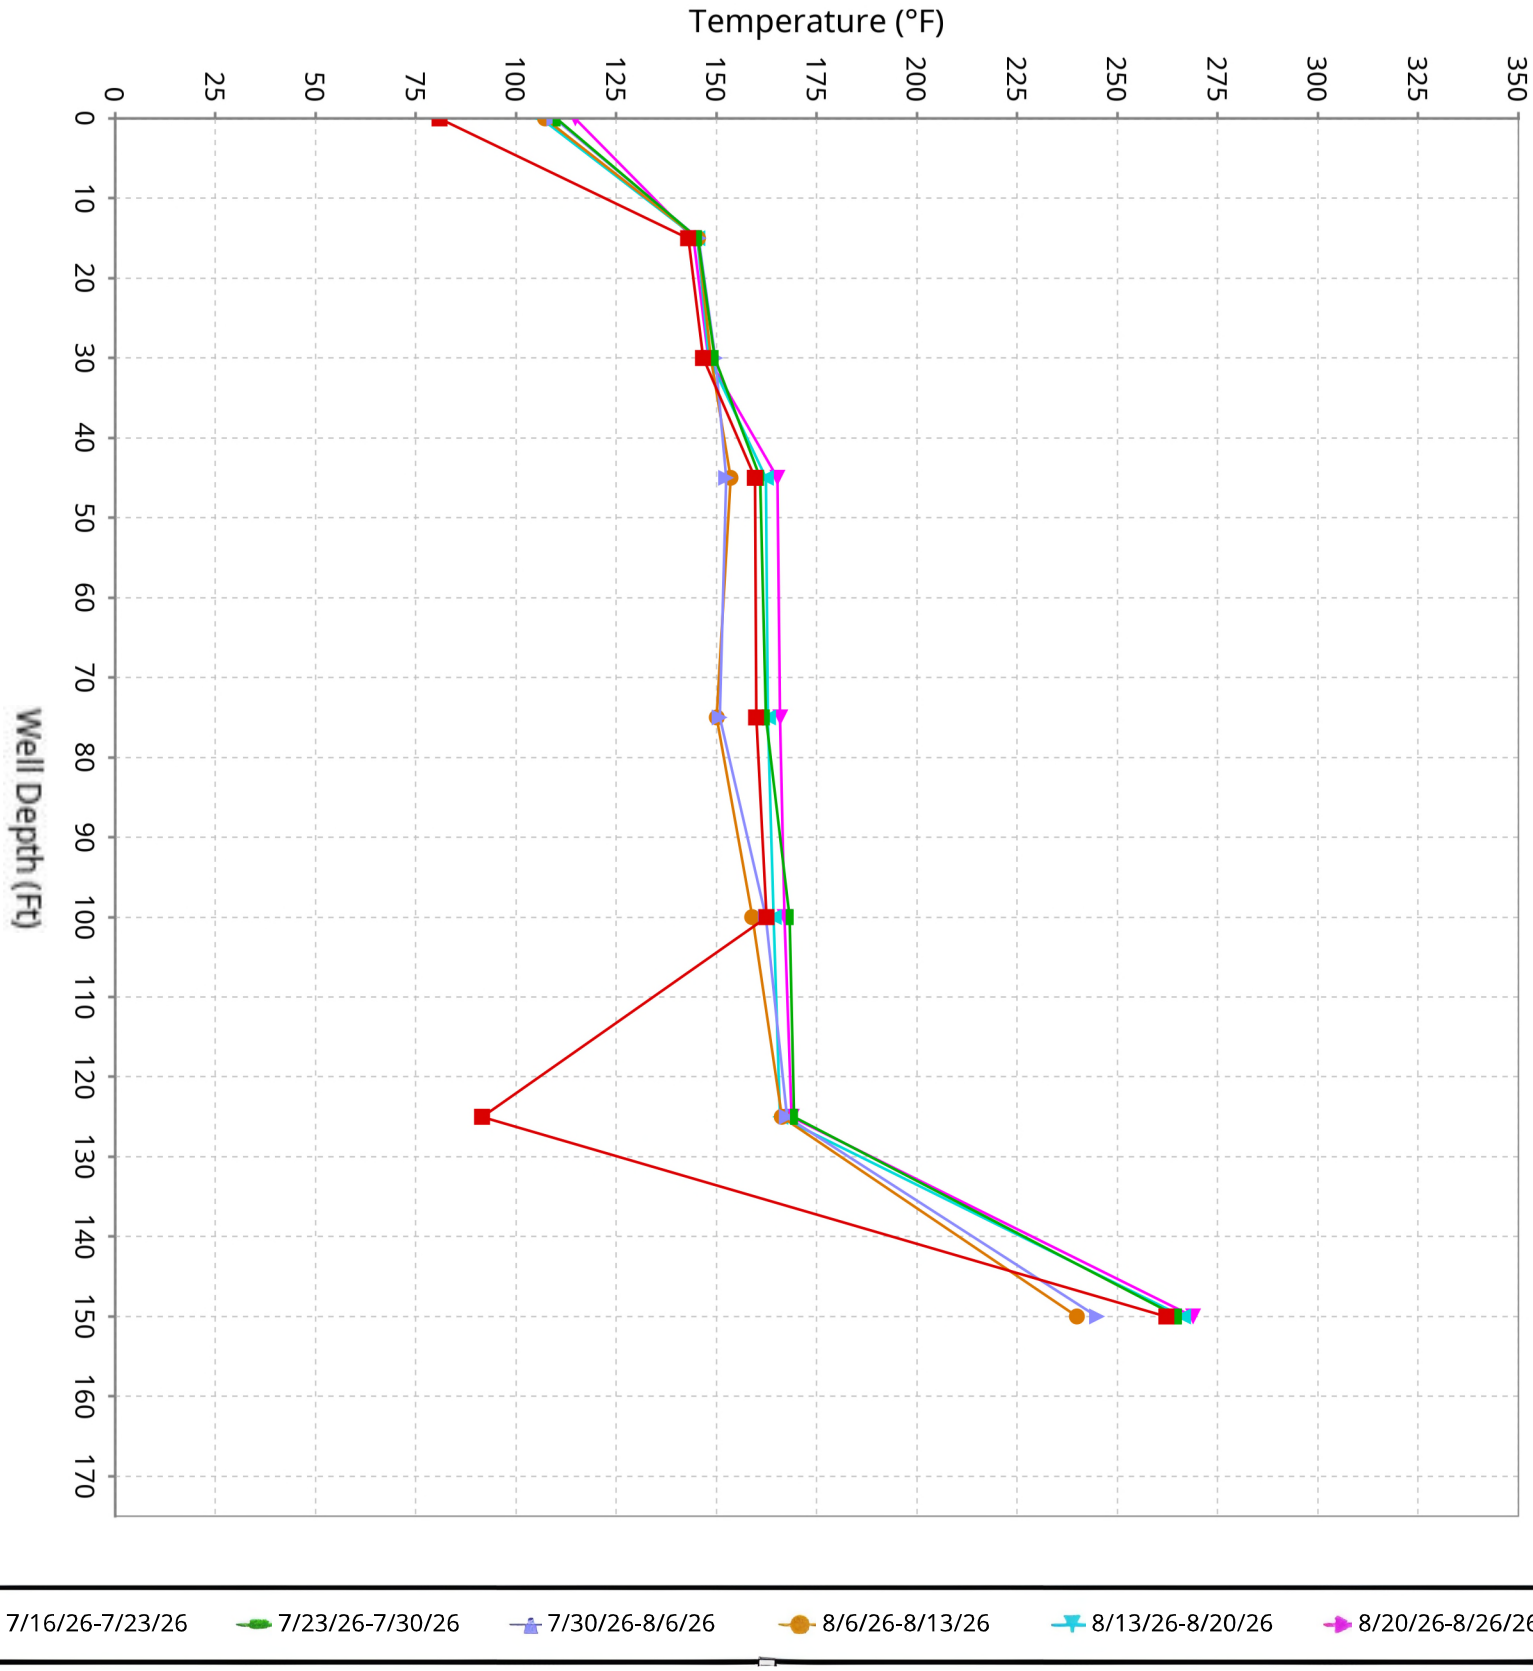
Vertical Temperature Profiles from Temperature Probes atChiquita Landfill for TP-19

- TP-19
    - A discrepancy was identified during the review of data from four weeks prior. Upon investigation, the Site determined that the associated battery had failed and subsequently replaced it. During this inspection, the temperature reading from the 125-foot thermocouple was observed to be anomalously low. Further evaluation indicated that the 125-foot thermocouple required replacement. As an interim measure, the Site installed a 120-foot thermocouple that was available onsite and ordered a replacement 125-foot

thermocouple. The replacement 125-foot thermocouple is anticipated to be installed upon receipt in October 2026.
    - The 75-foot thermocouple remained consistent with previously recorded temperatures.
    - The 150-foot thermocouple showed an increase in maximum temperature of 30°F from 239°F to 269°F from August 11th to August 26th.

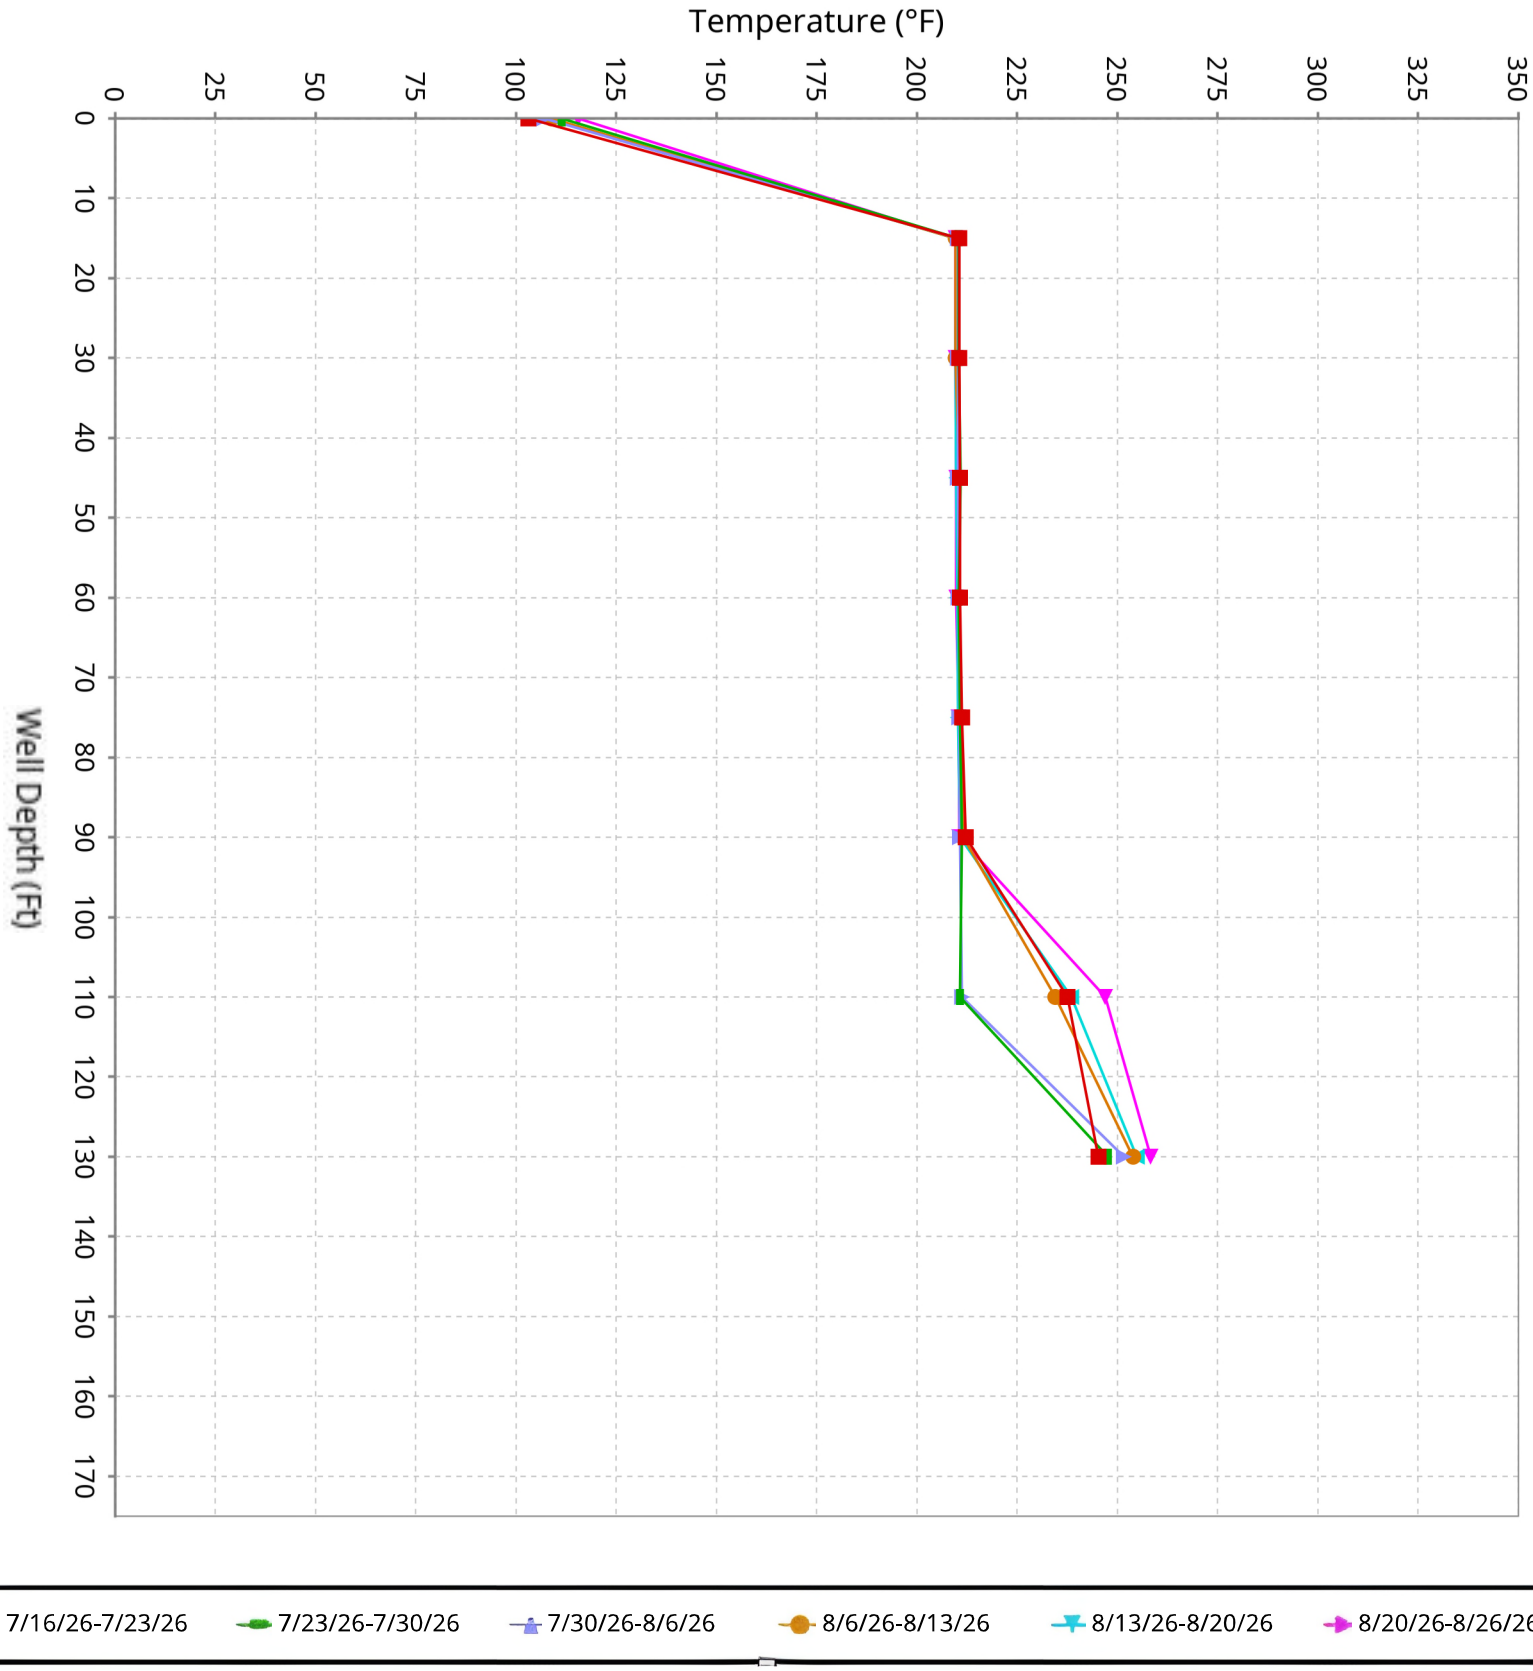
Vertical Temperature Profiles from Temperature Probes atChiquita Landfill for TP-25

- TP-25
    - The Site conducted a follow-up camera inspection of the TP-25 temperature probe casing last week to evaluate potential liquid infiltration and assess the condition of the casing interior. The inspection indicated that no liquid was present at the bottom of the casing. Instead, pressurized gas was observed upon opening the probe casing. The temperature probes inside TP-25 are thus no longer correctly reporting in-situ waste temperatures and are instead reporting gas temperatures traveling to and up the temperature probe casing. The Site will continue to monitor TP-25.

- The 110-foot thermocouple showed an increase in maximum temperature of 34°F from 213°F to 247°F from August 11th to August 26th. As described above, the Site is continuing to assess the condition of this probe equipment and will continue to monitor the temperature on the thermocouples.

- The 130-foot thermocouple remained consistent with previously recorded temperatures. As described above, the Site is continuing to assess the condition of this probe equipment and will continue to monitor the temperature on the thermocouples.

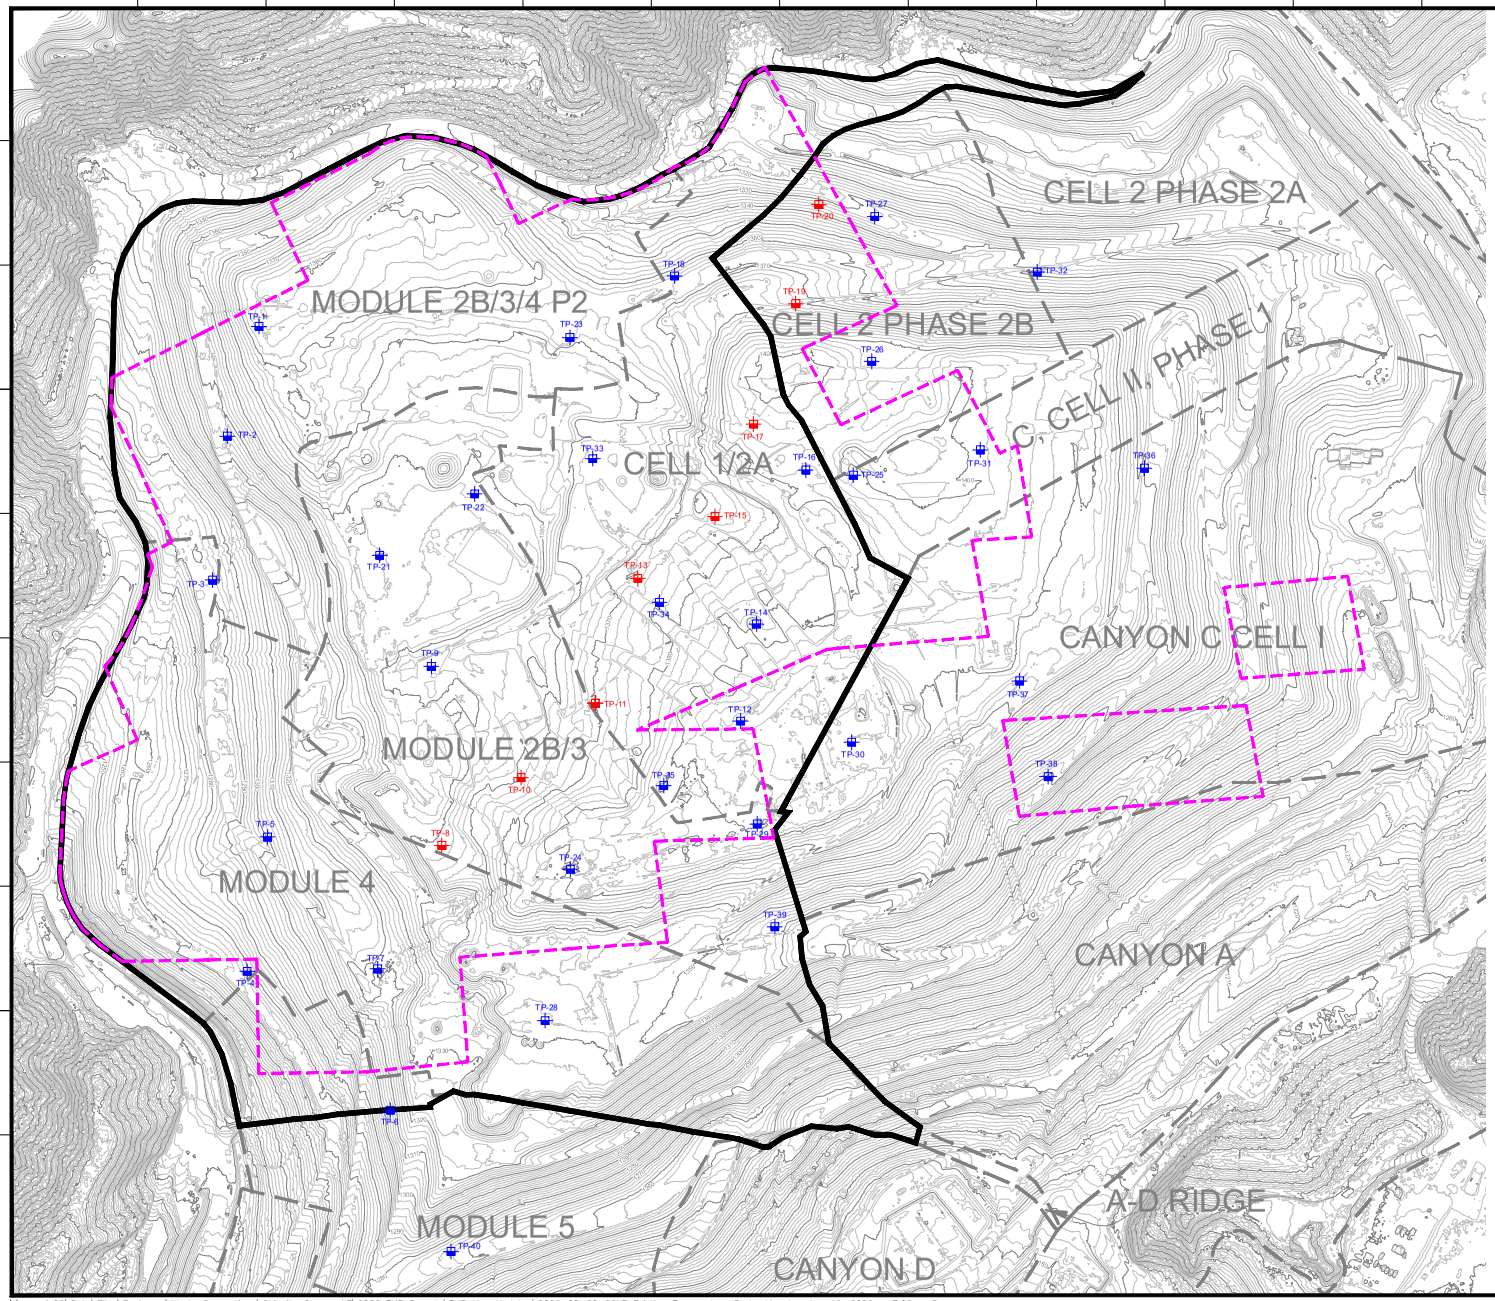
TP-08: The 30-foot and 45-foot thermocouples exhibited temperature increases of 27°F and 29°F, respectively, between July 12, 2026, and July 22, 2026. In response, Site personnel observed the temperature changes and conducted an investigation from July 23, 2026, through July 29, 2026. Following the investigation, temperatures continued to decline at the 30-foot thermocouple from July 30th, 2026, through August 19, 2026, and then temperatures started to increase at the 15, 30, and 45-foot thermocouples from August 20, 2026, through August 26, 2026.
TP-08 is installed within extraction well CV-24079, which is equipped with a liquid extraction pump. The investigation determined that the existing pump is experiencing a power-related issue and requires removal. Site personnel have identified the need for a replacement pump and plan to complete the replacement when the road to the well is completed.

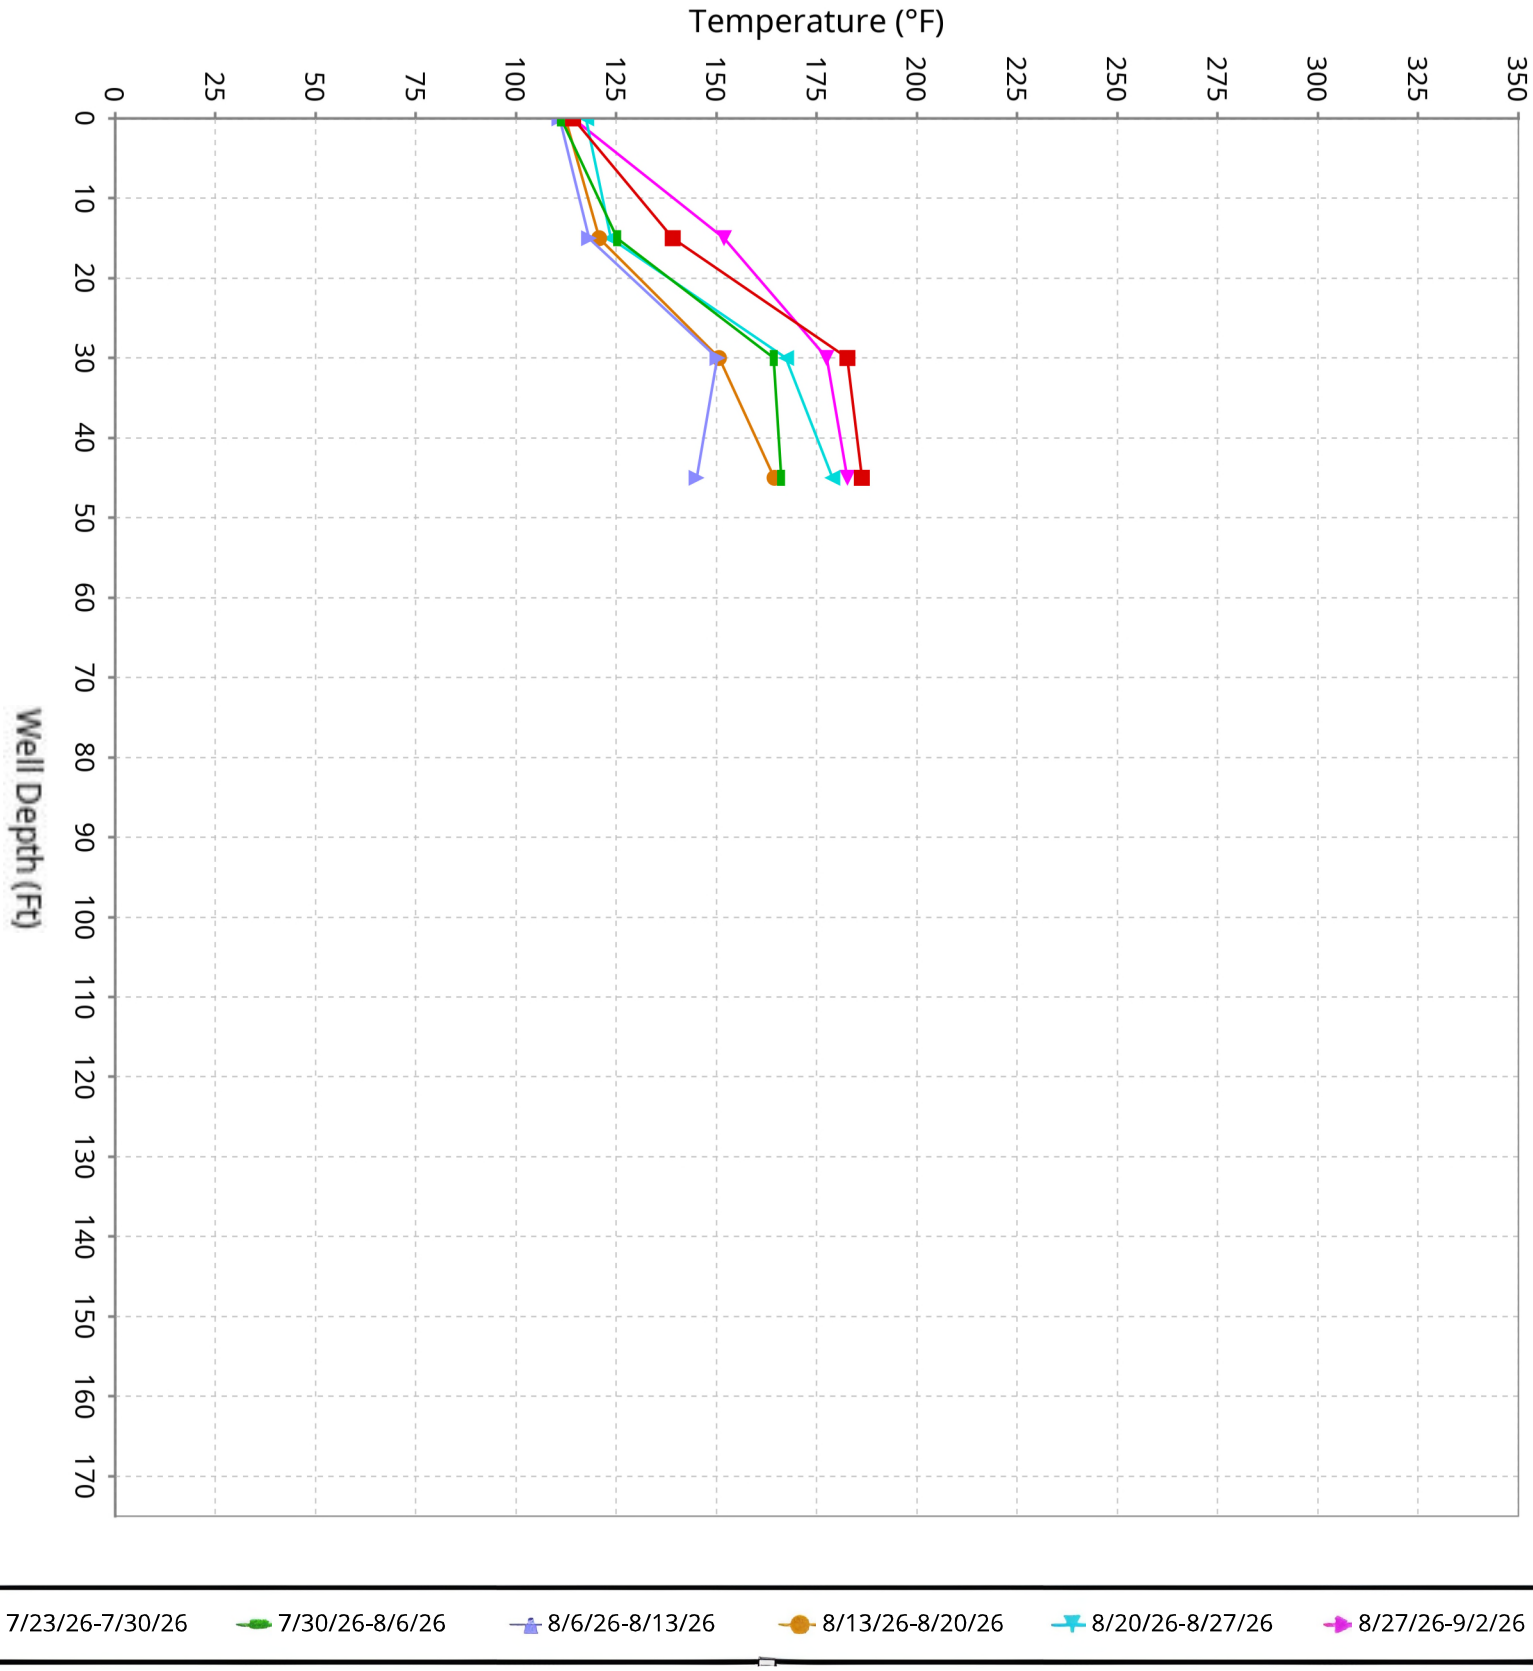
Vertical Temperature Profiles from Temperature Probes atChiquita Landfill for TP-8

- TP-08
    - The 30-foot and 45-foot thermocouples exhibited temperature increases of 27°F and 29°F, respectively, between July 12, 2026, and July 22, 2026. In response, Site personnel observed the temperature changes and conducted an investigation from July 23, 2026, through July 29, 2026. Following the investigation, temperatures continued to decline at the 30-foot thermocouple from July 30th, 2026, through August 19, 2026, and then temperatures started to increase at the 15, 30, and 45-foot thermocouples from August 20, 2026, through September 2, 2026.

- TP-08 is installed within extraction well CV-24079, which is equipped with a liquid extraction pump. The investigation determined that the existing pump is experiencing a power-related issue and requires removal. Site personnel have identified the need for a replacement pump and plan to complete the replacement when the road to the well is completed. One potential factor contributing to the observed temperature increase is the removal of liquids from wells near TP-08.

- The 15-foot thermocouple showed an increase in maximum temperature of 39°F from 113°F to 152°F from August 22nd to September 2nd.
    - The 30-foot thermocouple showed an increase in maximum temperature of 33°F from 144°F to 177°F from August 21st to September 2nd.

- The 45-foot thermocouple showed an increase in maximum temperature of 21°F from 162°F to 183°F from August 21st to September 2nd.

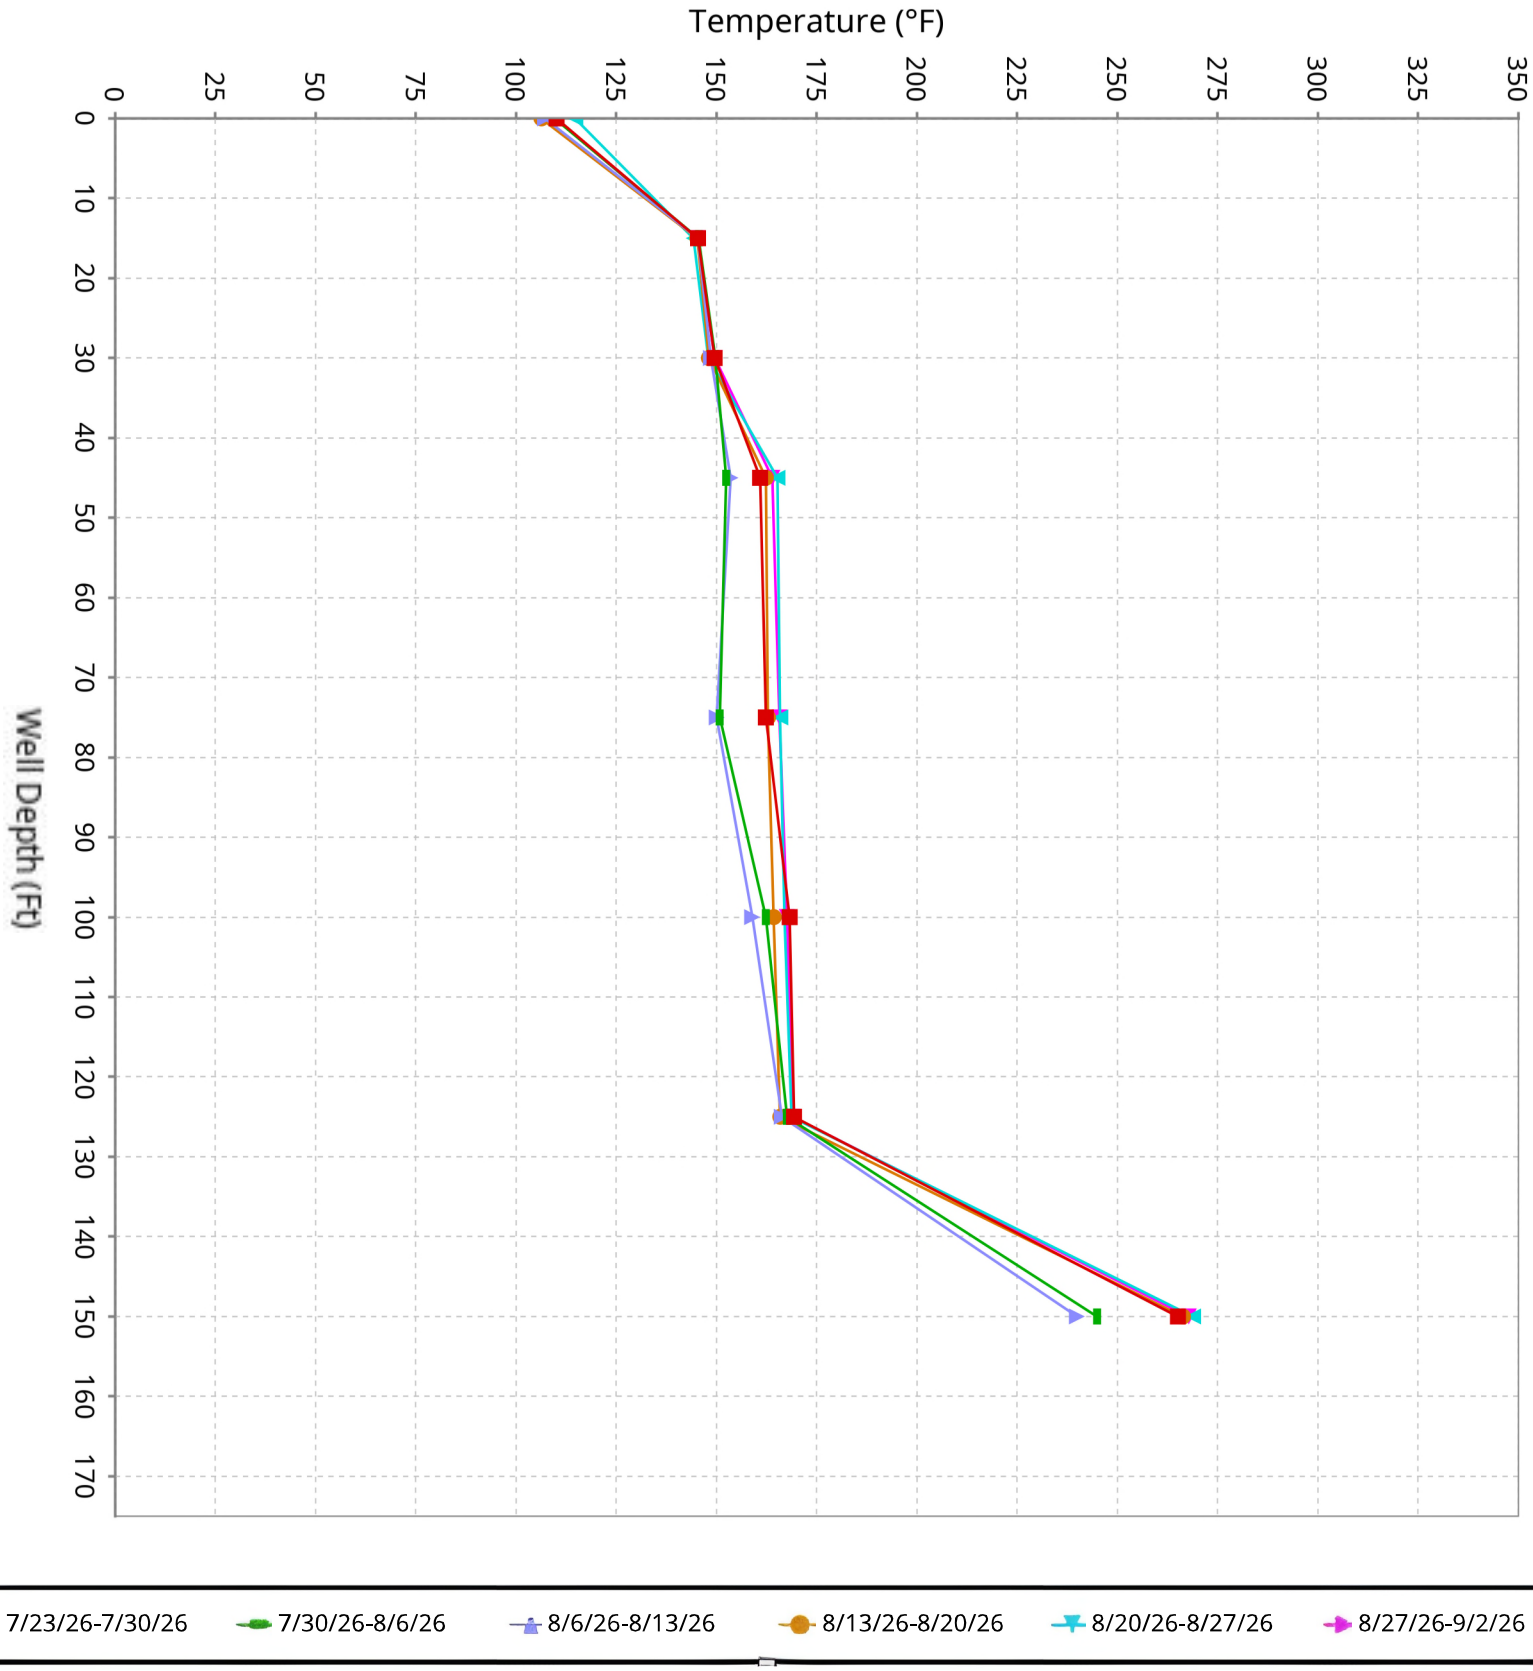
Vertical Temperature Profiles from Temperature Probes atChiquita Landfill for TP-19

- TP-19
    - A discrepancy was identified during the review of data from five weeks prior. Upon investigation, the Site determined that the associated battery had failed and subsequently replaced it. During this inspection, the temperature reading from the 125-foot thermocouple was observed to be anomalously low. Further evaluation indicated that the 125-foot thermocouple required replacement. As an interim measure, the Site installed a 120-foot

thermocouple that was available onsite and ordered a replacement 125-foot thermocouple. The replacement 125-foot thermocouple is anticipated to be installed upon receipt in October 2026.
    - The 75-foot thermocouple showed a decrease in maximum temperature of 13°F from 166°F to 153°F from August 27th to September 2nd.
    - The 150-foot thermocouple showed a decrease in maximum temperature of 31°F from 269°F to 238°F from August 26th to September 2nd.

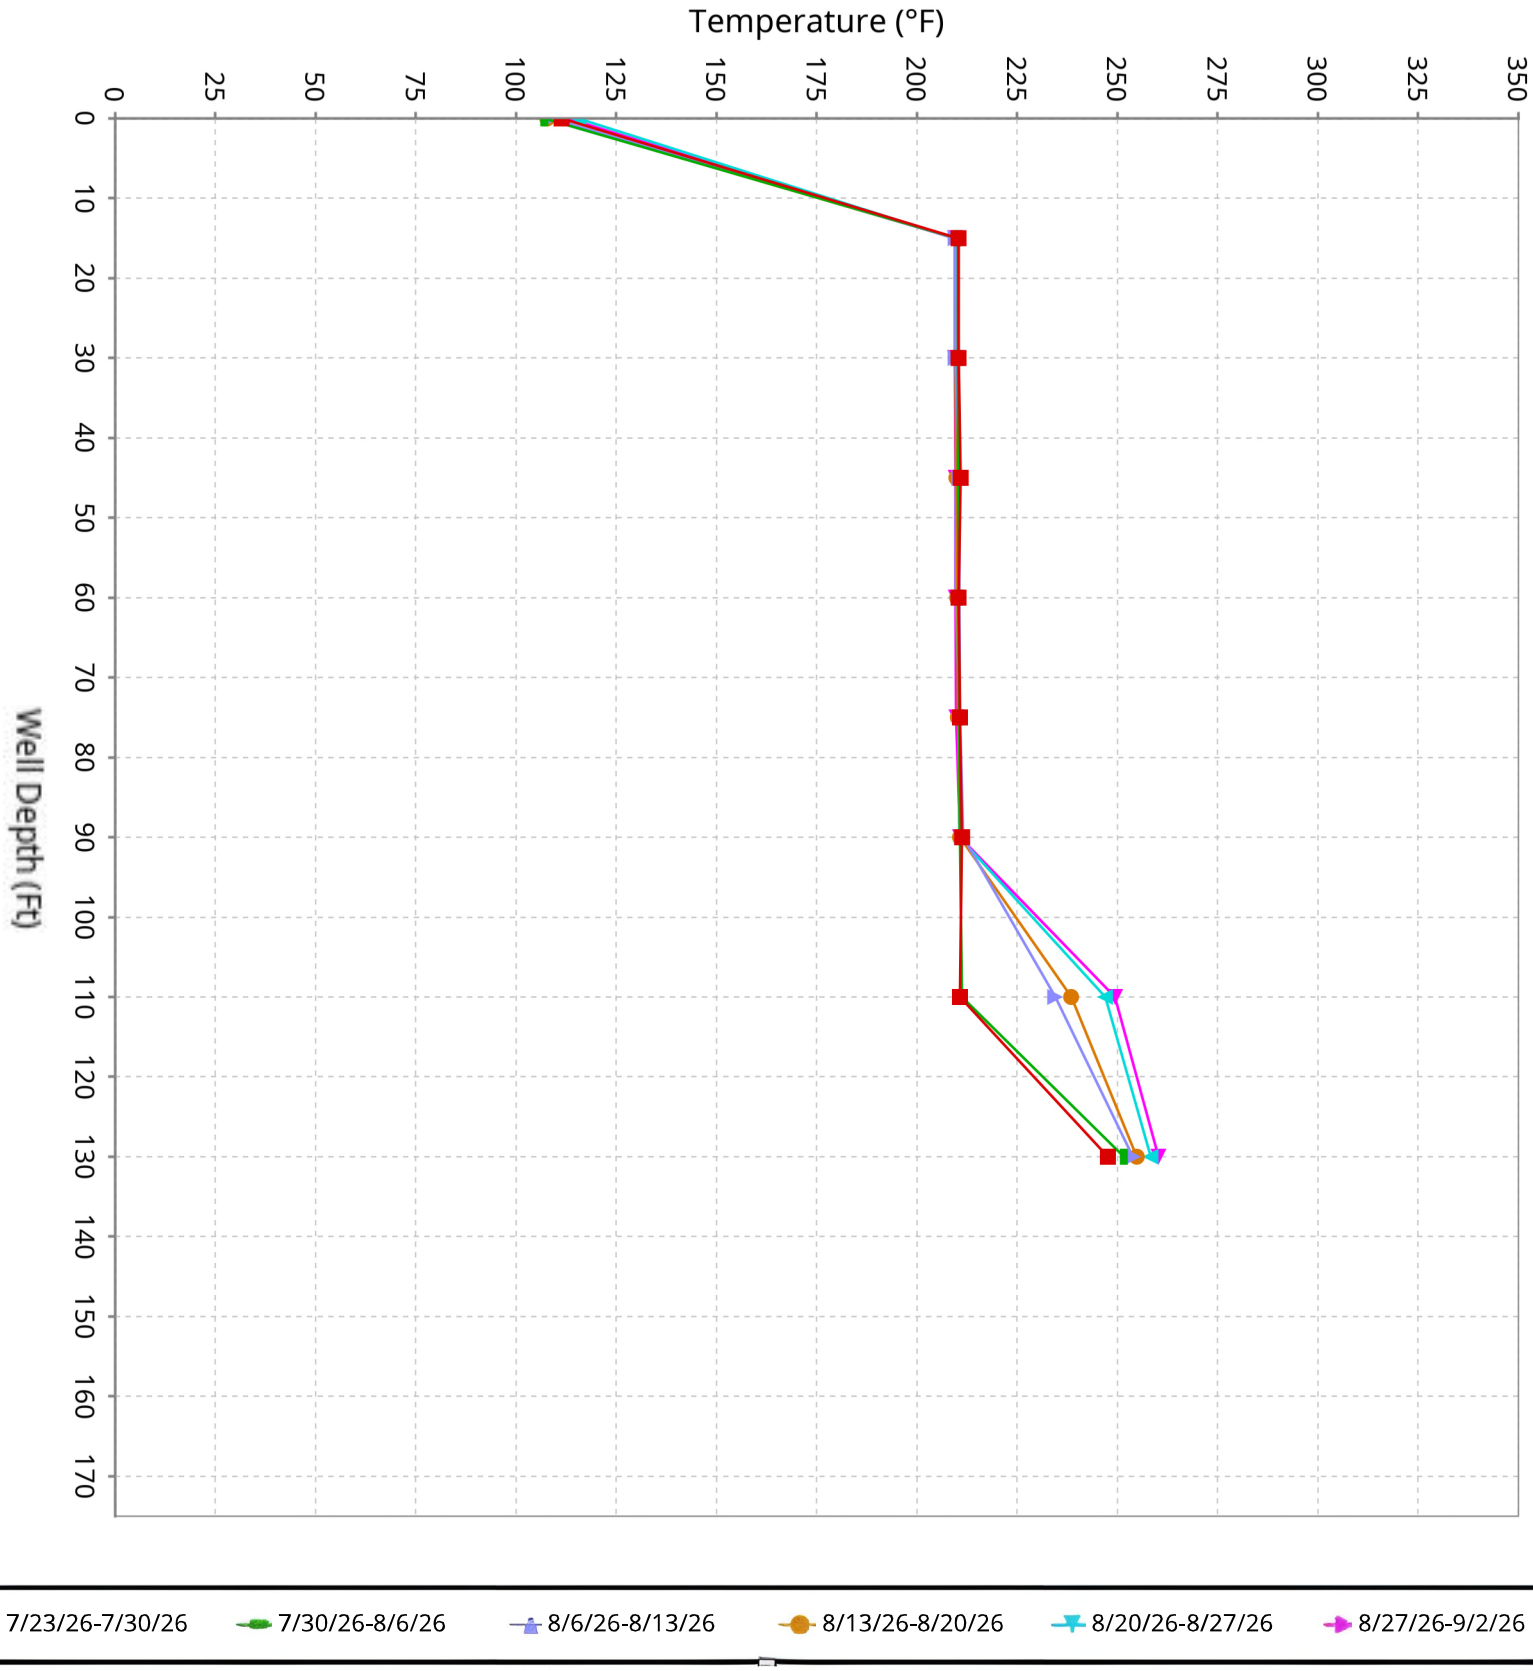
Vertical Temperature Profiles from Temperature Probes atChiquita Landfill for TP-25

TP-25
The Site conducted a follow-up camera inspection of the TP-25 temperature probe casing last week to evaluate potential liquid infiltration and assess the condition of the casing interior. The inspection indicated that no liquid was present at the bottom of the casing. Instead, pressurized gas was observed upon opening the probe casing. The temperature probes inside TP-25 are thus no longer correctly reporting in-situ waste temperatures and are instead reporting gas temperatures traveling to and up the temperature probe casing. The Site will continue to monitor TP-25.
