SCS ENGINEERS

15 de septiembre de 2026

Asunto: Informe Mensual de Agosto de 2026 Conforme a los Objetivos 1A-3 y 5 de la Orden de Cumplimiento de la LEA del 6 de junio de 2024 y a la Carta del 30 de julio de 2024, Vertedero de Chiquita Canyon, Castaic, California

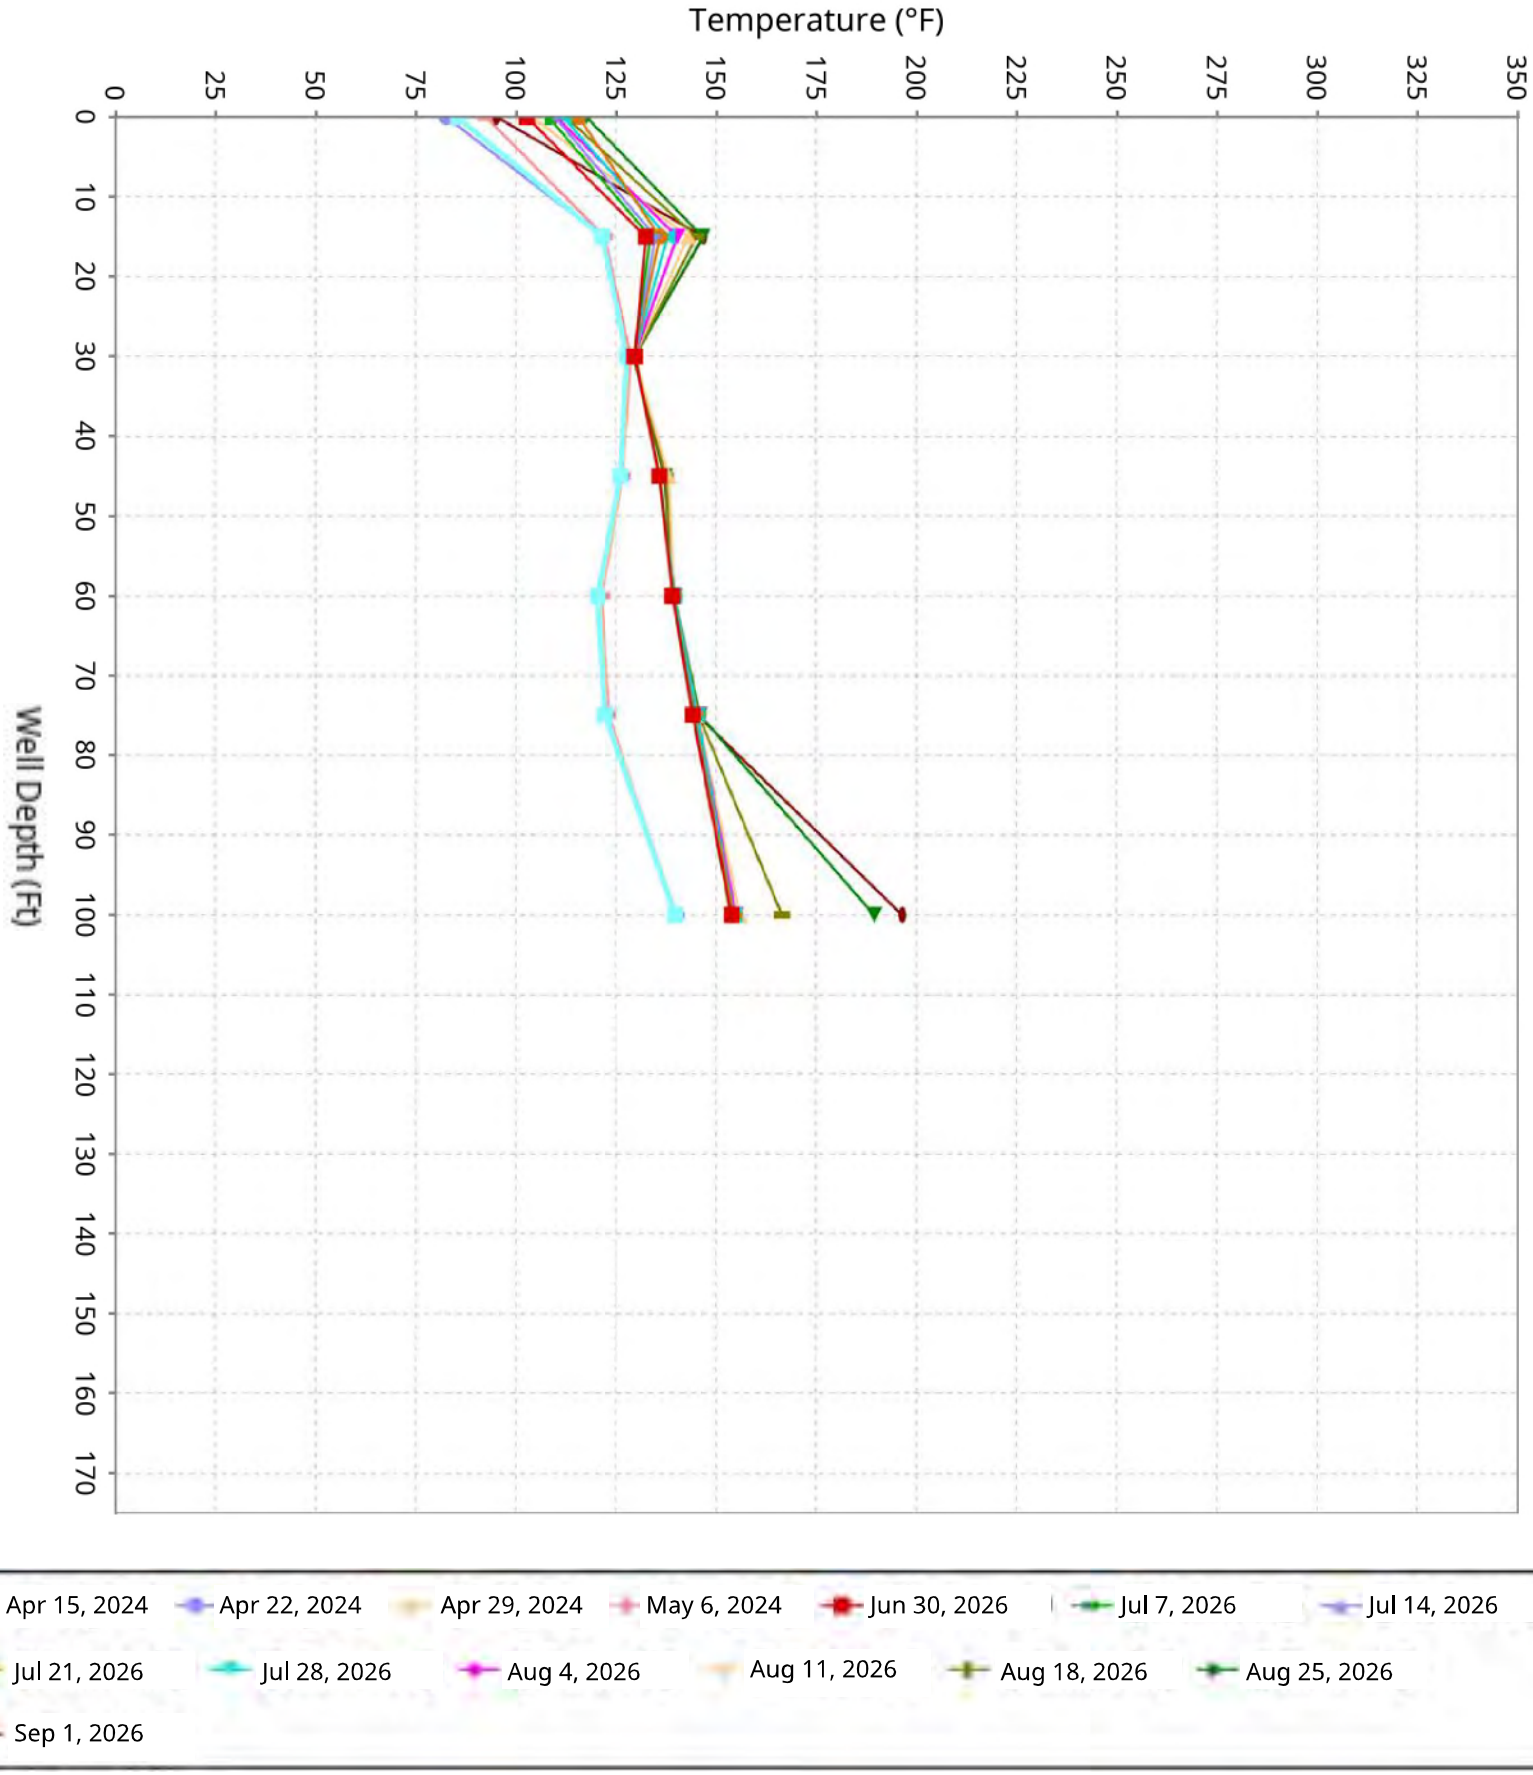
Vertical Temperature Profiles from Temperature Probes at Chiquita Landfill for TP-7

- TP-07
    - The 100-foot thermocouple showed an increase in maximum temperature of 40°F from 155°F to 195°F from August 16th to September 2nd. One potential factor contributing to the observed temperature increase is the removal of liquids from wells near TP-07.

TP-07
One potential factor contributing to the observed temperature increase is the removal of liquids from wells near TP-07.

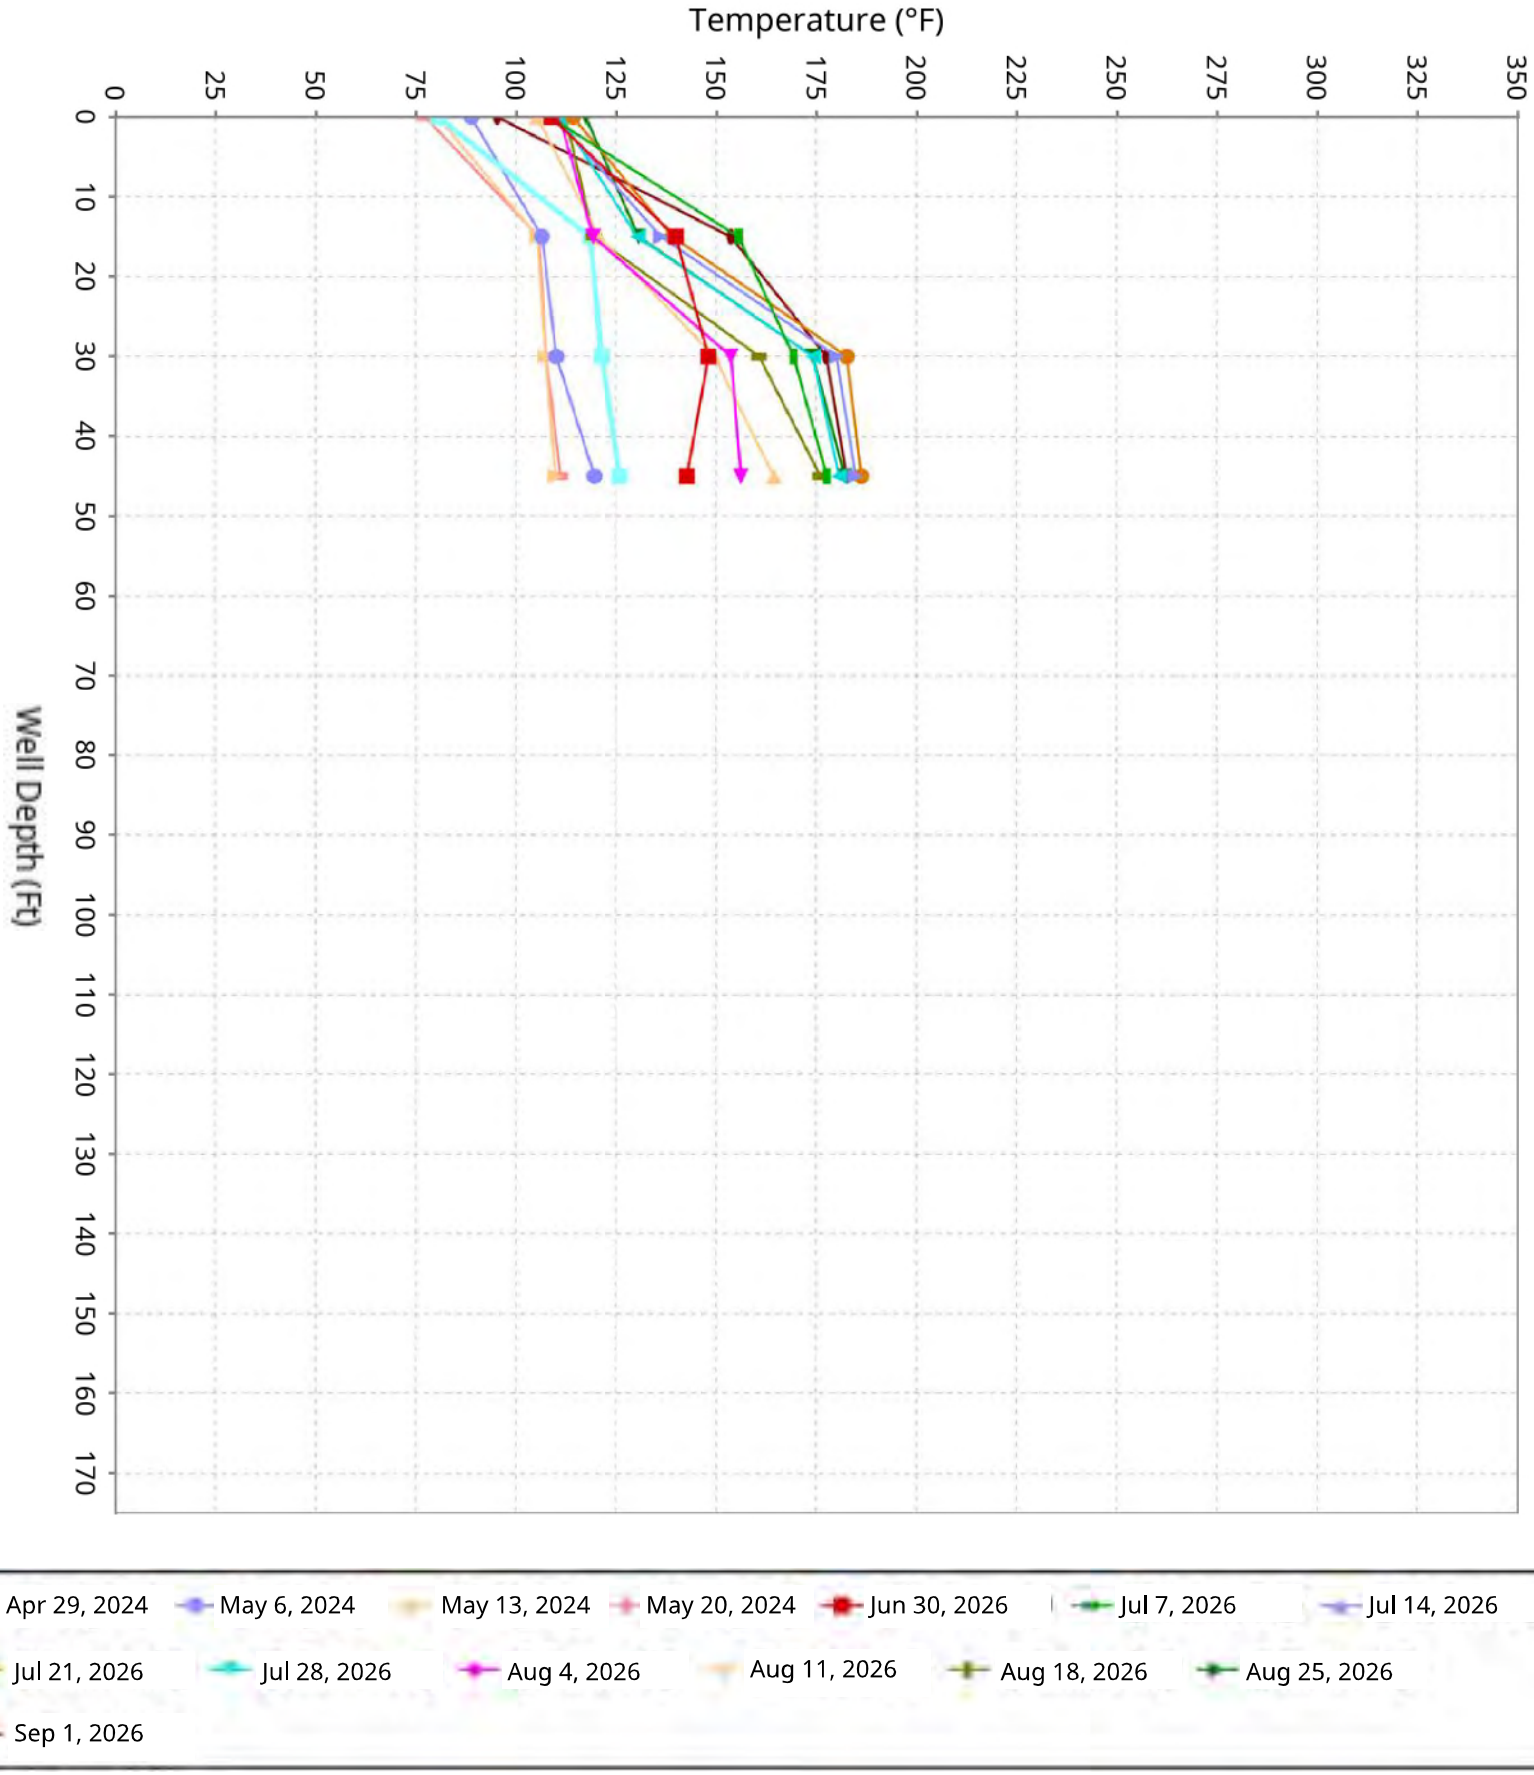
Vertical Temperature Profiles from Temperature Probes at Chiquita Landfill for TP-8

- TP-08
    - The 30-foot and 45-foot thermocouples exhibited temperature increases of 27°F and 29°F, respectively, between July 12, 2026, and July 22, 2026. In response, Site personnel observed the temperature changes and conducted an investigation from July 23, 2026, through July 29, 2026. Following the investigation, temperatures continued to decline at the 30-foot thermocouple from July 30th, 2026, through August 19, 2026, and then temperatures started to increase at the 15, 30, and 45-foot thermocouples from August 20, 2026, through September 2, 2026.

- TP-08 is installed within extraction well CV-24079, which is equipped with a liquid extraction pump. The investigation determined that the existing pump is experiencing a power-related issue and requires removal. Site personnel have identified the need for a replacement pump and plan to complete the replacement when the road to the well is completed. One potential factor contributing to the observed temperature increase is the removal of liquids from wells near TP-08.

TP-08
The 30-foot and 45-foot thermocouples exhibited temperature increases of 27°F and 29°F, respectively, between July 12, 2026, and July 22, 2026. In response, Site personnel observed the temperature changes and conducted an investigation from July 23, 2026, through July 29, 2026. Following the investigation, temperatures continued to decline at the 30-foot thermocouple from July 30th, 2026, through August 19, 2026, and then temperatures started to increase at the 15, 30, and 45-foot thermocouples from August 20, 2026, through September 2, 2026.
TP-08 is installed within extraction well CV-24079, which is equipped with a liquid extraction pump. The investigation determined that the existing pump is experiencing a power-related issue and requires removal. Site personnel have identified the need for a replacement pump and plan to complete the replacement when the road to the well is completed. One potential factor contributing to the observed temperature increase is the removal of liquids from wells near TP-08.

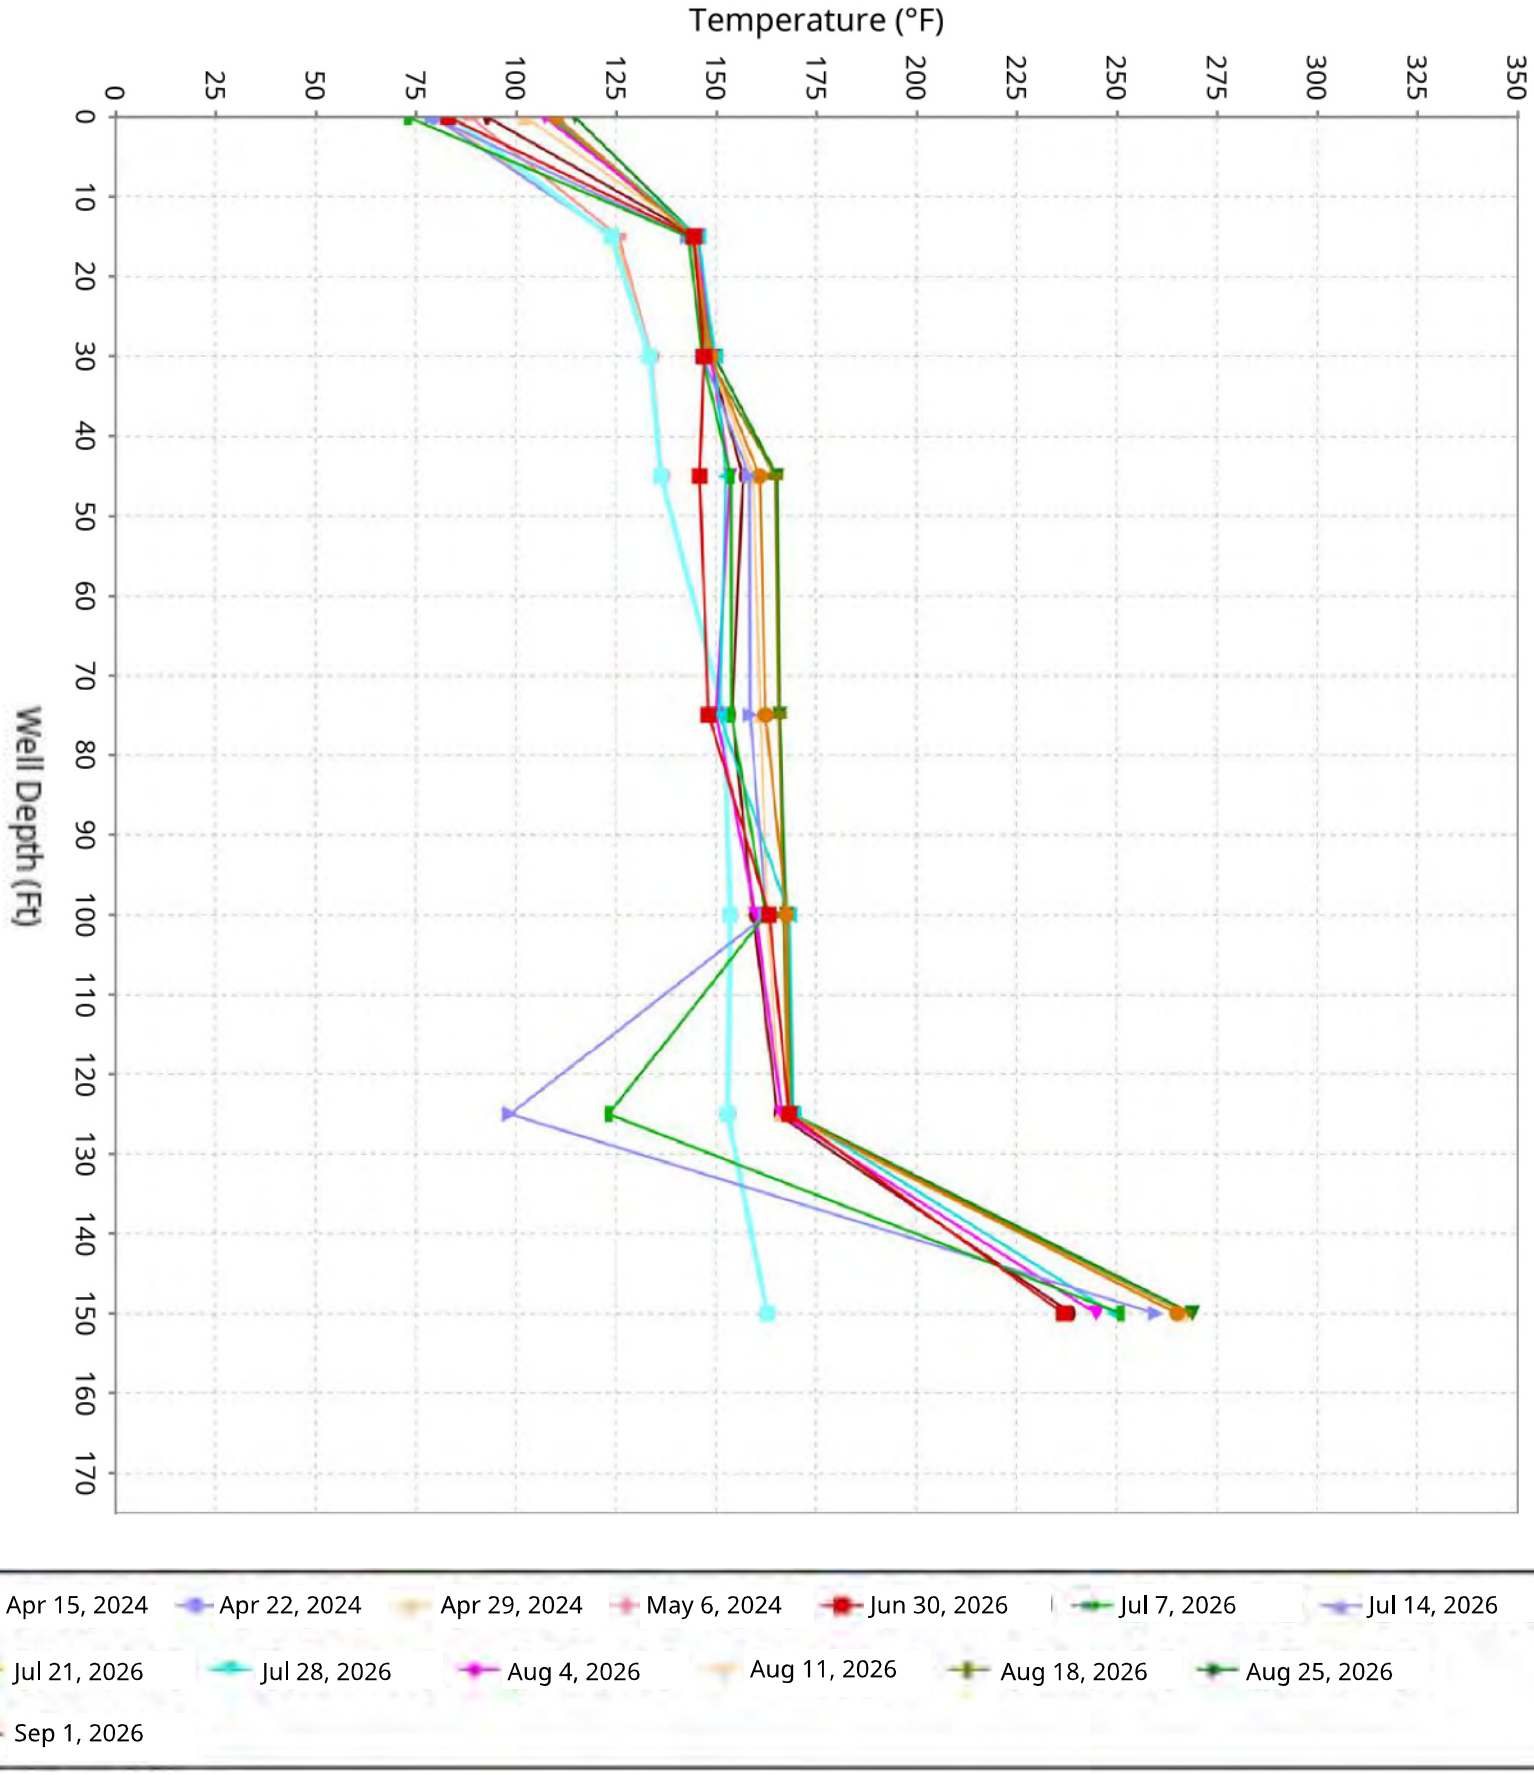
Vertical Temperature Profiles from Temperature Probes at Chiquita Landfill for TP-19

- TP-19
    - A discrepancy was identified during the review of data from five weeks prior. Upon investigation, the Site determined that the associated battery had failed and subsequently replaced it. During this inspection, the temperature reading from the 125-foot thermocouple was observed to be anomalously low. Further evaluation indicated that the 125-foot thermocouple required replacement. As an interim measure, the Site installed a 120-foot

thermocouple that was available onsite and ordered a replacement 125-foot thermocouple. The replacement 125-foot thermocouple is anticipated to be installed upon receipt in October 2026.
    - The 75-foot thermocouple showed a decrease in maximum temperature of 13°F from 166°F to 153°F from August 27th to September 2nd.
    - The 150-foot thermocouple showed a decrease in maximum temperature of 31°F from 269°F to 238°F from August 26th to September 2nd.

TP-19
A discrepancy was identified during the review of data from five weeks prior. Upon investigation, the Site determined that the associated battery had failed and subsequently replaced it. During this inspection, the temperature reading from the 125-foot thermocouple was observed to be anomalously low. Further evaluation indicated that the 125-foot thermocouple required replacement. As an interim measure, the Site installed a 120-foot thermocouple that was available onsite and ordered a replacement 125-foot thermocouple. The replacement 125-foot thermocouple is anticipated to be installed upon receipt in October 2026.

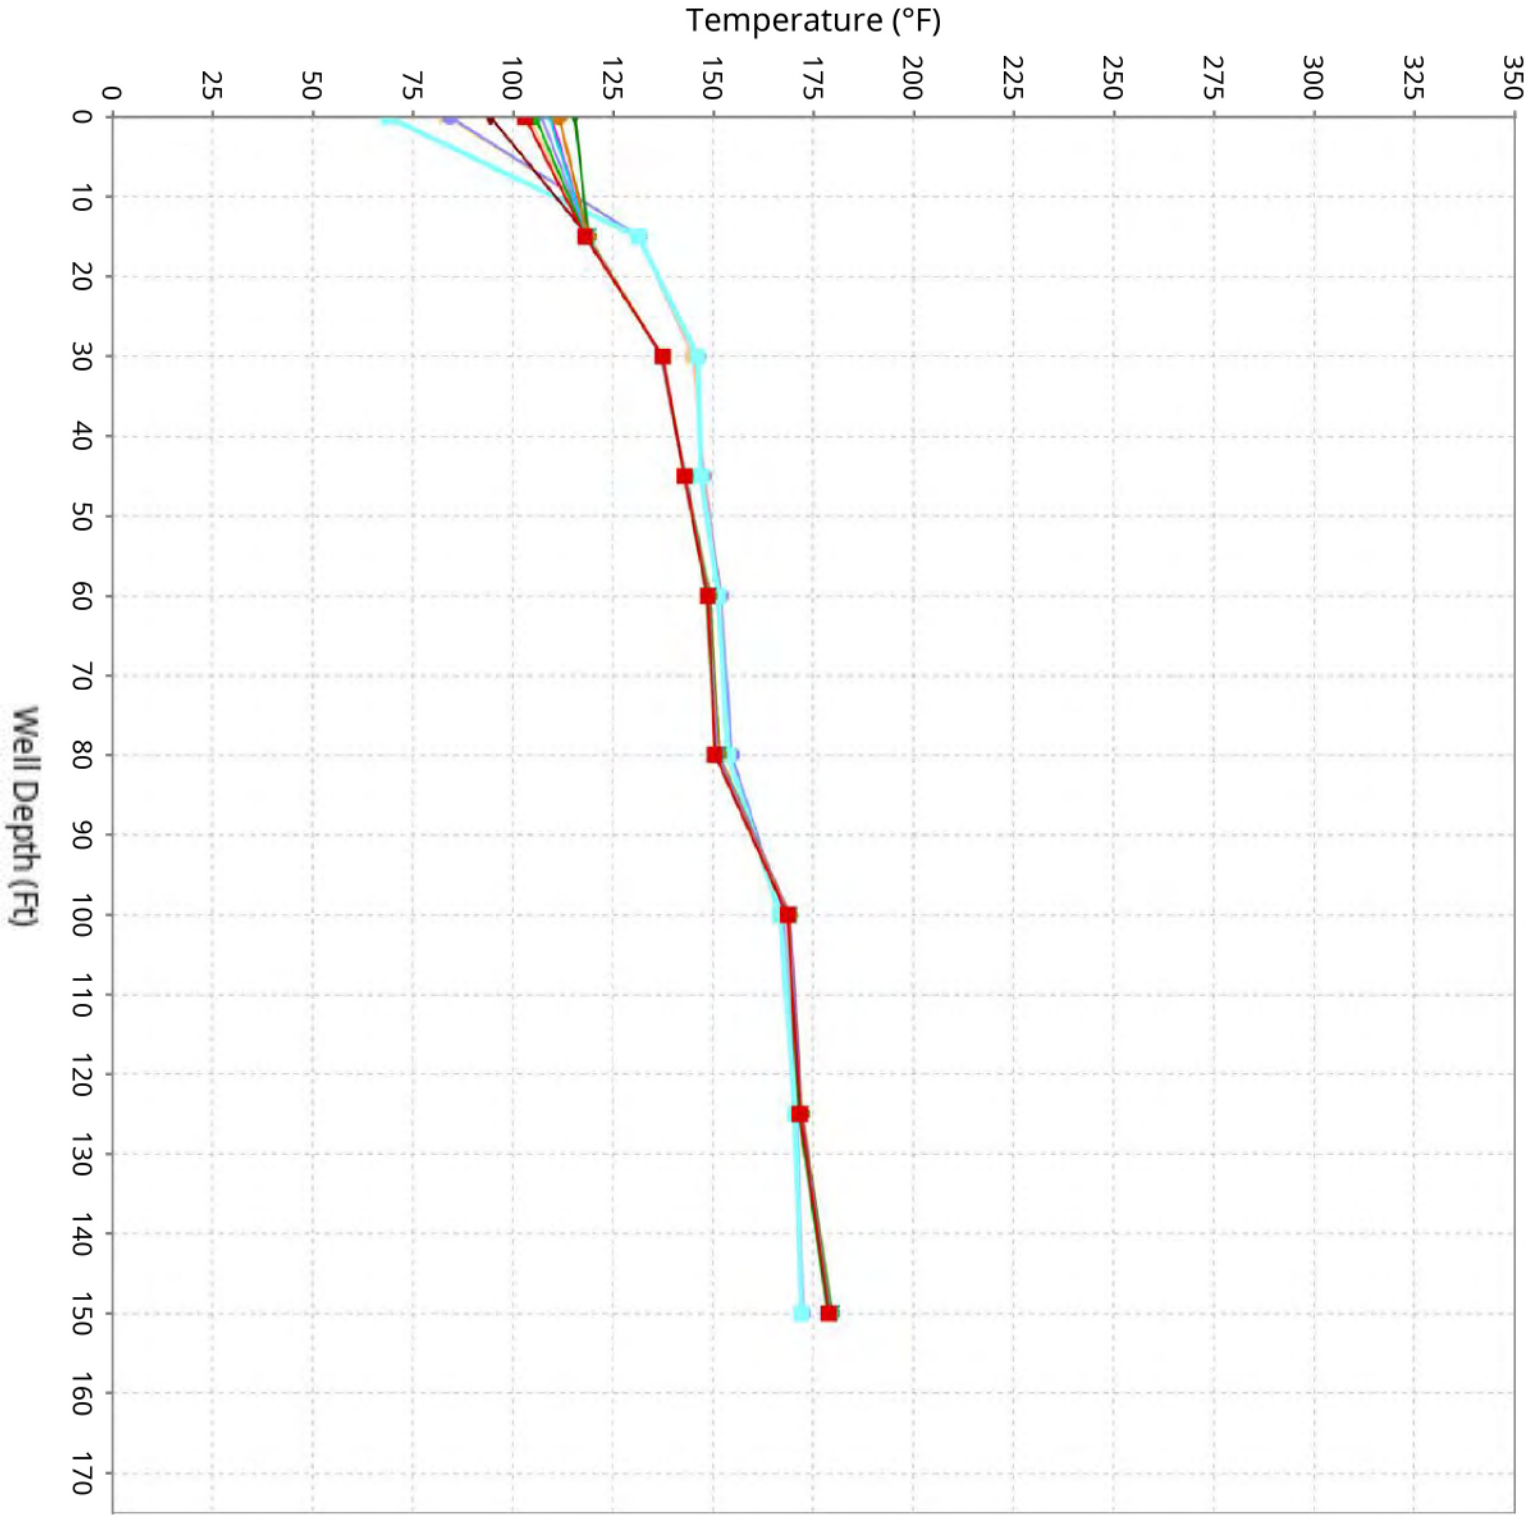
Vertical Temperature Profiles from Temperature Probes at Chiquita Landfill for TP-25

- TP-25
    - The Site conducted a follow-up camera inspection of the TP-25 temperature probe casing last week to evaluate potential liquid infiltration and assess the condition of the casing interior. The inspection indicated that no liquid was present at the bottom of the casing. Instead, pressurized gas was observed upon opening the probe casing. The temperature probes inside TP-25 are thus no longer correctly reporting in-situ waste temperatures and are instead reporting gas temperatures traveling to and up the temperature probe casing. The Site will continue to monitor TP-25.
    - The 110-foot thermocouple remained consistent with previously recorded temperatures. As described above, the Site is continuing to assess the condition of this probe equipment and will continue to monitor the temperature on the thermocouples.

TP-25
The Site conducted a follow-up camera inspection of the TP-25 temperature probe casing last week to evaluate potential liquid infiltration and assess the condition of the casing interior. The inspection indicated that no liquid was present at the bottom of the casing. Instead, pressurized gas was observed upon opening the probe casing. The temperature probes inside TP-25 are thus no longer correctly reporting in-situ waste temperatures and are instead reporting gas temperatures traveling to and up the temperature probe casing. The Site will continue to monitor TP-25.
