SCS ENGINEERS

15 de octubre de 2026

Asunto: **Informe Mensual de Septiembre de 2026 Conforme a los Objetivos 1A-3 y 5 de la Orden de Cumplimiento de la LEA del 6 de junio de 2024 y a la Carta del 30 de julio de 2024, Vertedero de Chiquita Canyon, Castaic, California**

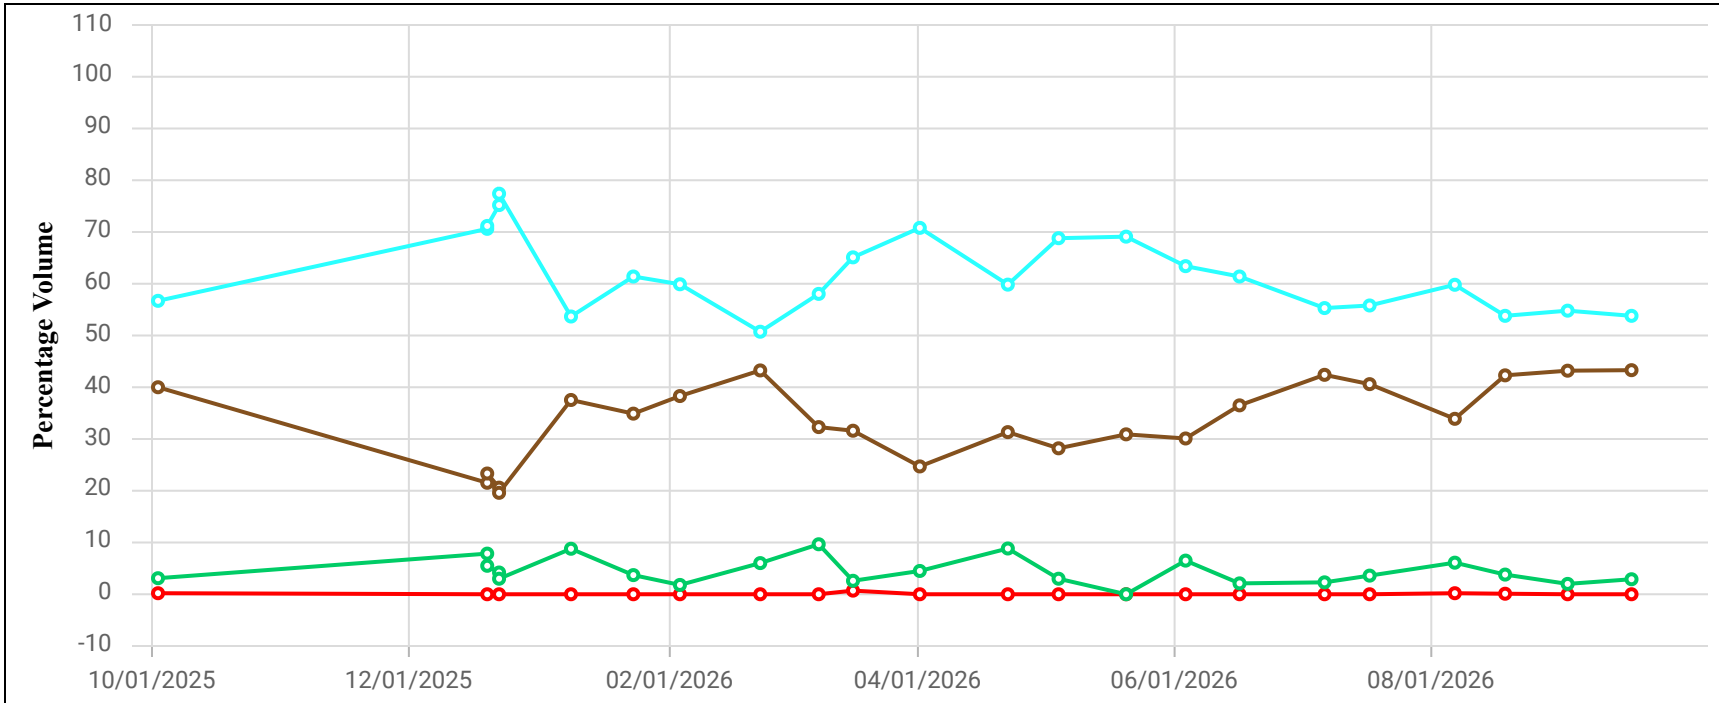
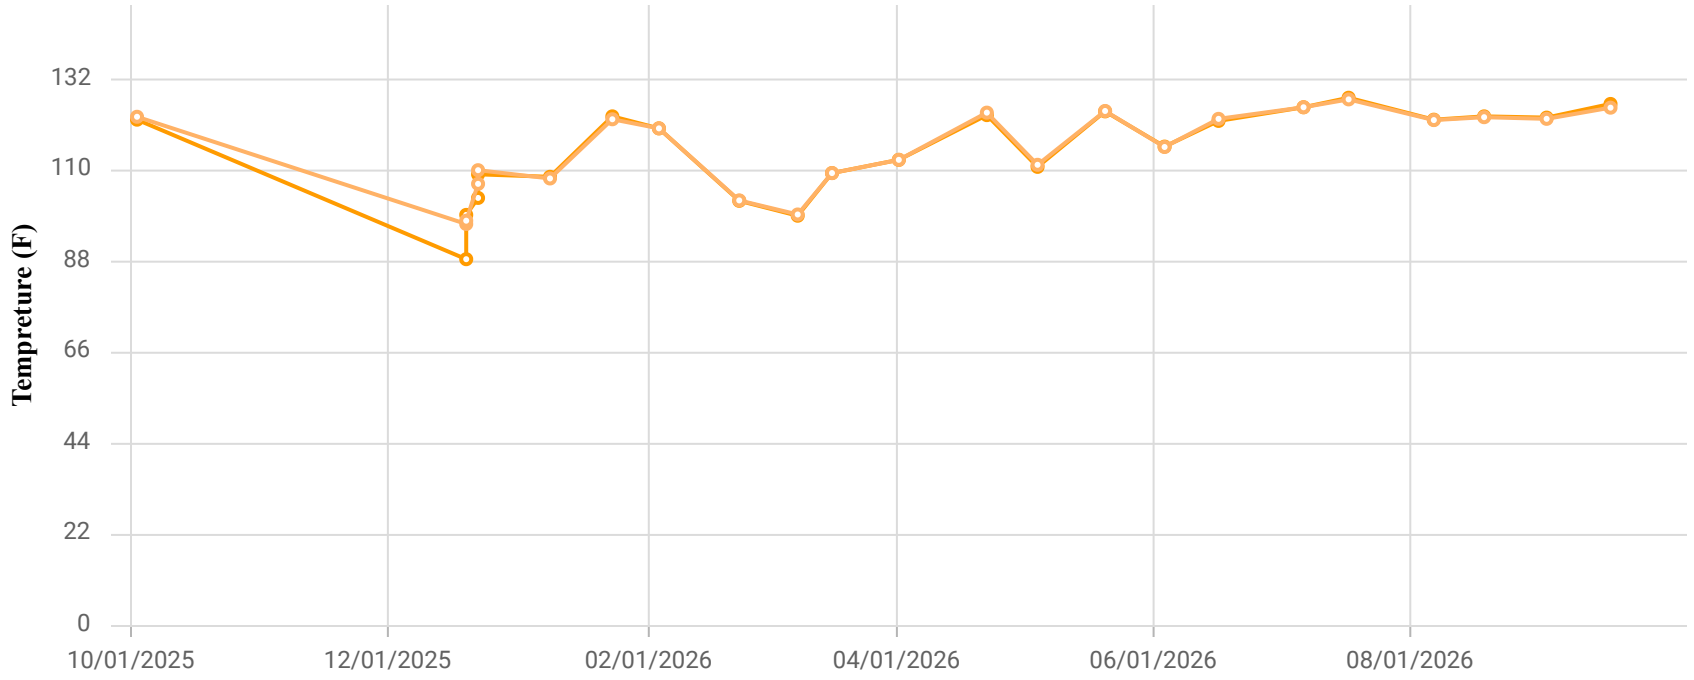
CCV24079 / CV-24079-TP8

- TP-08 is installed within extraction well CV-24079, which is equipped with a liquid extraction pump. The investigation determined that the existing pump is experiencing a power-related issue and requires removal. Site personnel have identified the need for a replacement pump and plan to complete the replacement when the road to the well is completed. One potential factor contributing to the observed temperature increase is the removal of liquids from wells near TP-08.

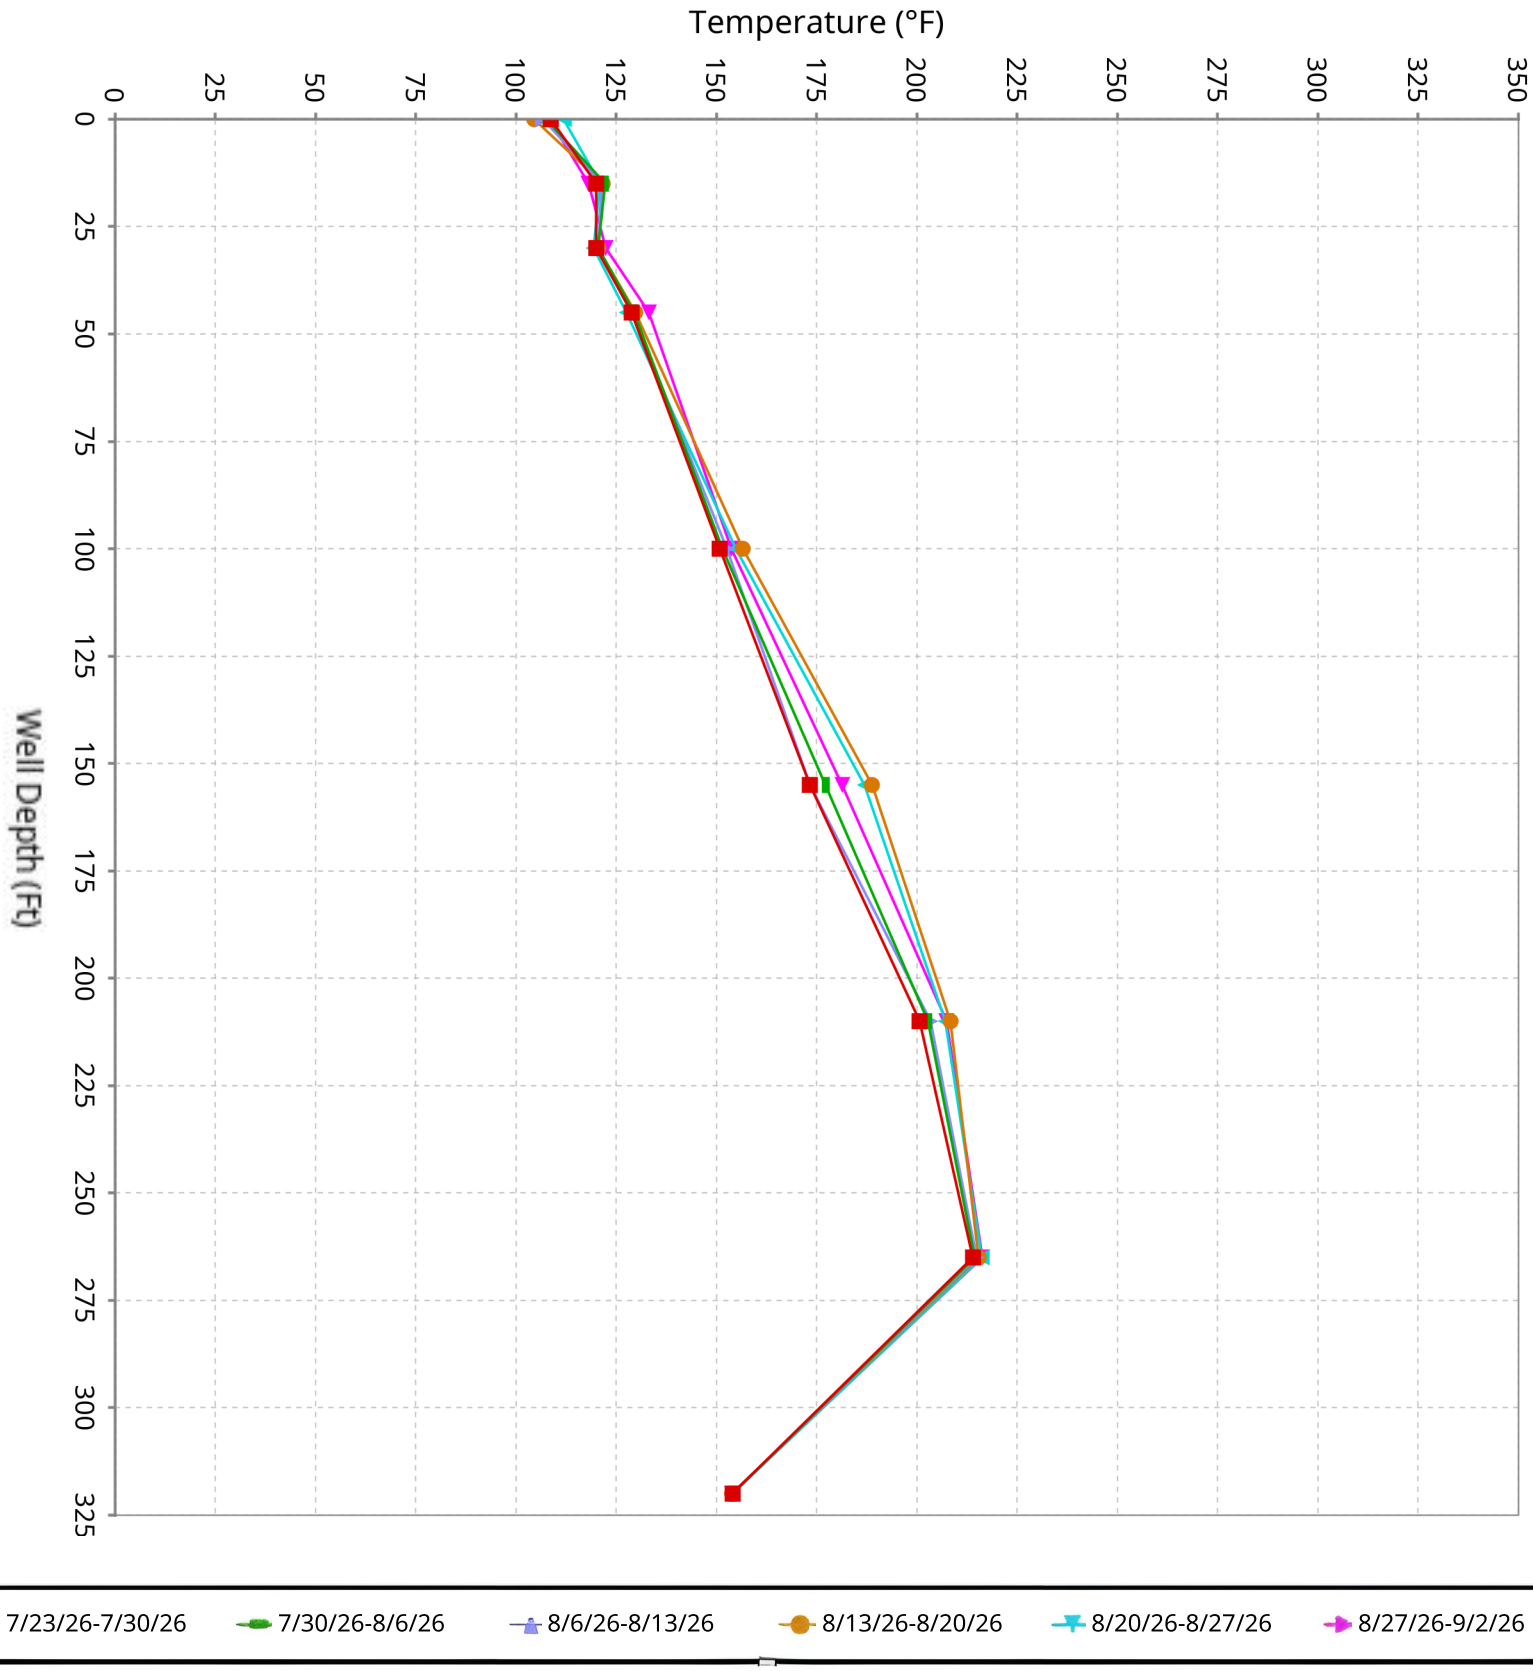
Vertical Temperature Profiles from Temperature Probes at Chiquita Landfill for TP-24

- TP-24
    - The 265-foot thermocouple showed an increase in maximum temperature of 34°F from 217°F to 251°F from September 6th to September 7th, and then a decrease in maximum temperature of 34°F from 251°F to 217°F from September 7th to September 8th. Potential factors contributing to the observed temperature increase are the flow changes in the wellfield and removal of liquids from wells near TP-24.

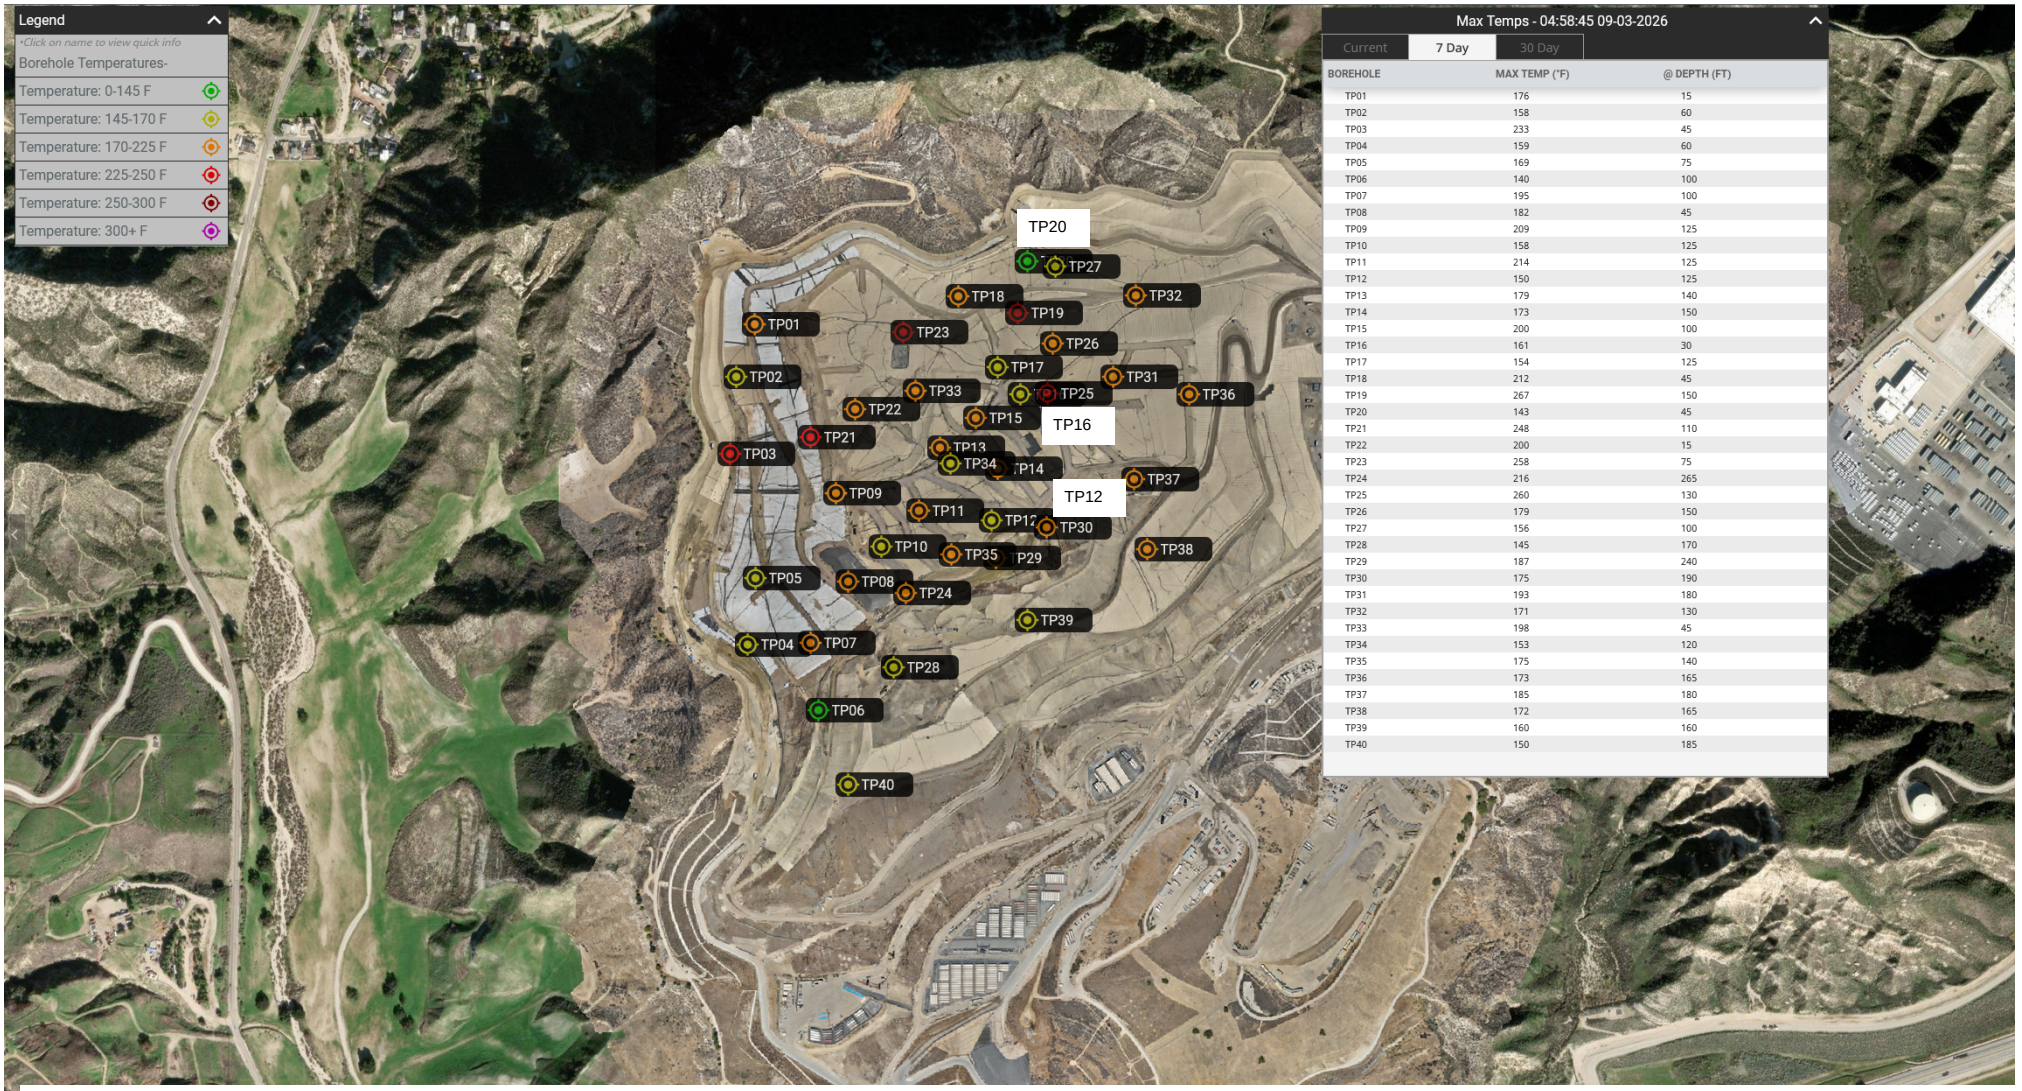
Maximum Vertical Temperature Map from Temperature Probes at Chiquita Landfill

TP-07
One potential factor contributing to the observed temperature increase is the removal of liquids from wells near TP-07.

TP-08
The 30-foot and 45-foot thermocouples exhibited temperature increases of 27°F and 29°F, respectively, between July 12, 2026, and July 22, 2026. In response, Site personnel observed the temperature changes and conducted an investigation from July 23, 2026, through July 29, 2026. Following the investigation, temperatures continued to decline at the 30-foot thermocouple from July 30th, 2026, through August 19, 2026, and then temperatures started to increase at the 15, 30, and 45-foot thermocouples from August 20, 2026, through September 2, 2026.
TP-08 is installed within extraction well CV-24079, which is equipped with a liquid extraction pump. The investigation determined that the existing pump is experiencing a power-related issue and requires removal. Site personnel have identified the need for a replacement pump and plan to complete the replacement when the road to the well is completed. One potential factor contributing to the observed temperature increase is the removal of liquids from wells near TP-08.

TP-19
A discrepancy was identified during the review of data from five weeks prior. Upon investigation, the Site determined that the associated battery had failed and subsequently replaced it. During this inspection, the temperature reading from the 125-foot thermocouple was observed to be anomalously low. Further evaluation indicated that the 125-foot thermocouple required replacement. As an interim measure, the Site installed a 120-foot thermocouple that was available onsite and ordered a replacement 125-foot thermocouple. The replacement 125-foot thermocouple is anticipated to be installed upon receipt in October 2026.

TP-25
The Site conducted a follow-up camera inspection of the TP-25 temperature probe casing last week to evaluate potential liquid infiltration and assess the condition of the casing interior. The inspection indicated that no liquid was present at the bottom of the casing. Instead, pressurized gas was observed upon opening the probe casing. The temperature probes inside TP-25 are thus no longer correctly reporting in-situ waste temperatures and are instead reporting gas temperatures traveling to and up the temperature probe casing. The Site will continue to monitor TP-25.

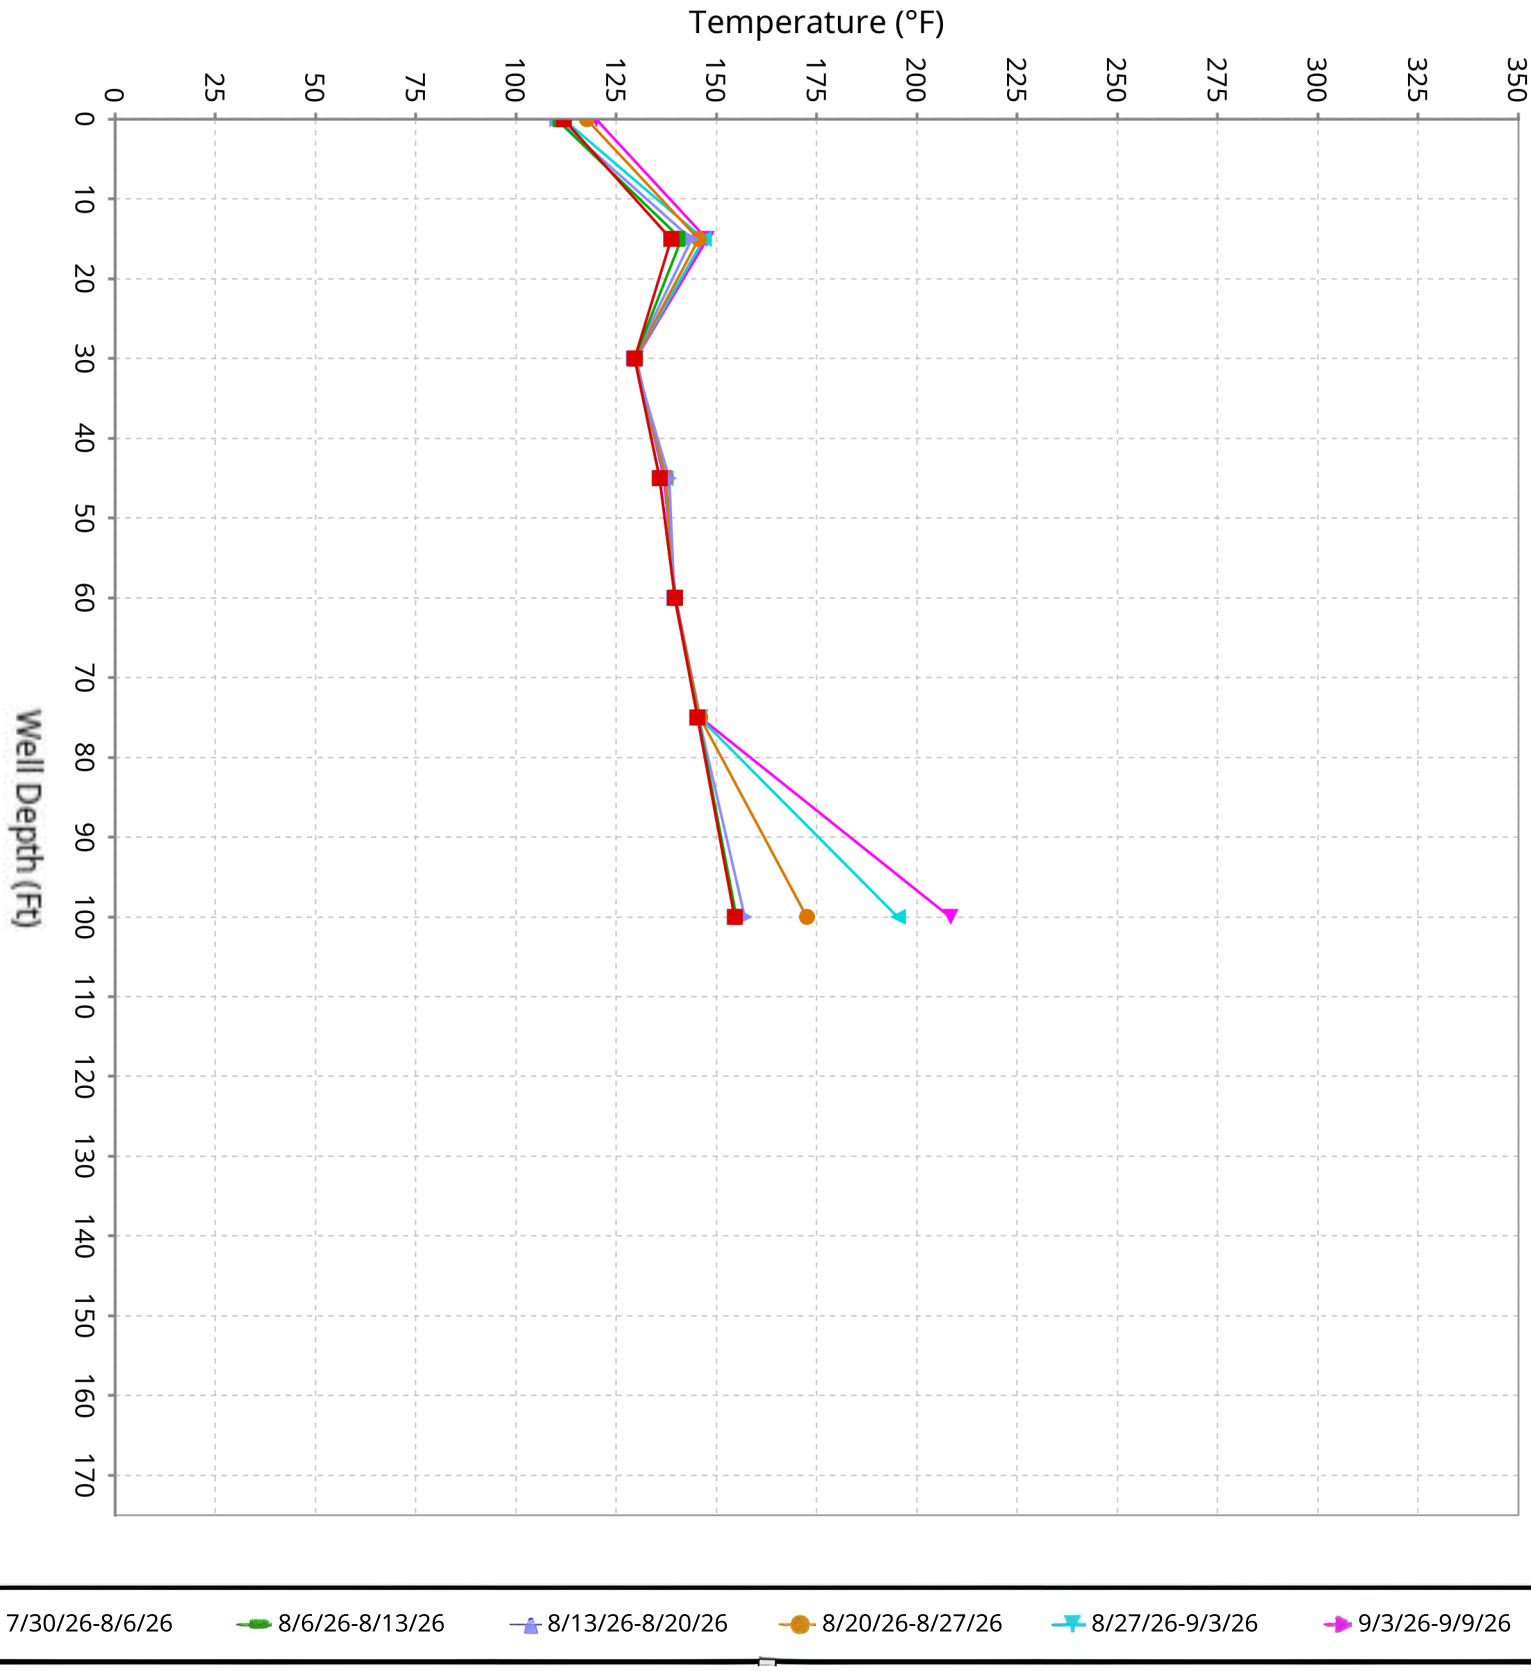
Vertical Temperature Profiles from Temperature Probes at Chiquita Landfill for TP-7

- TP-07
    - The 100-foot thermocouple showed an increase in maximum temperature of 48°F from 160°F to 208°F from August 21st to September 9th. One potential factor contributing to the observed temperature increase is the removal of liquids from wells near TP-07.

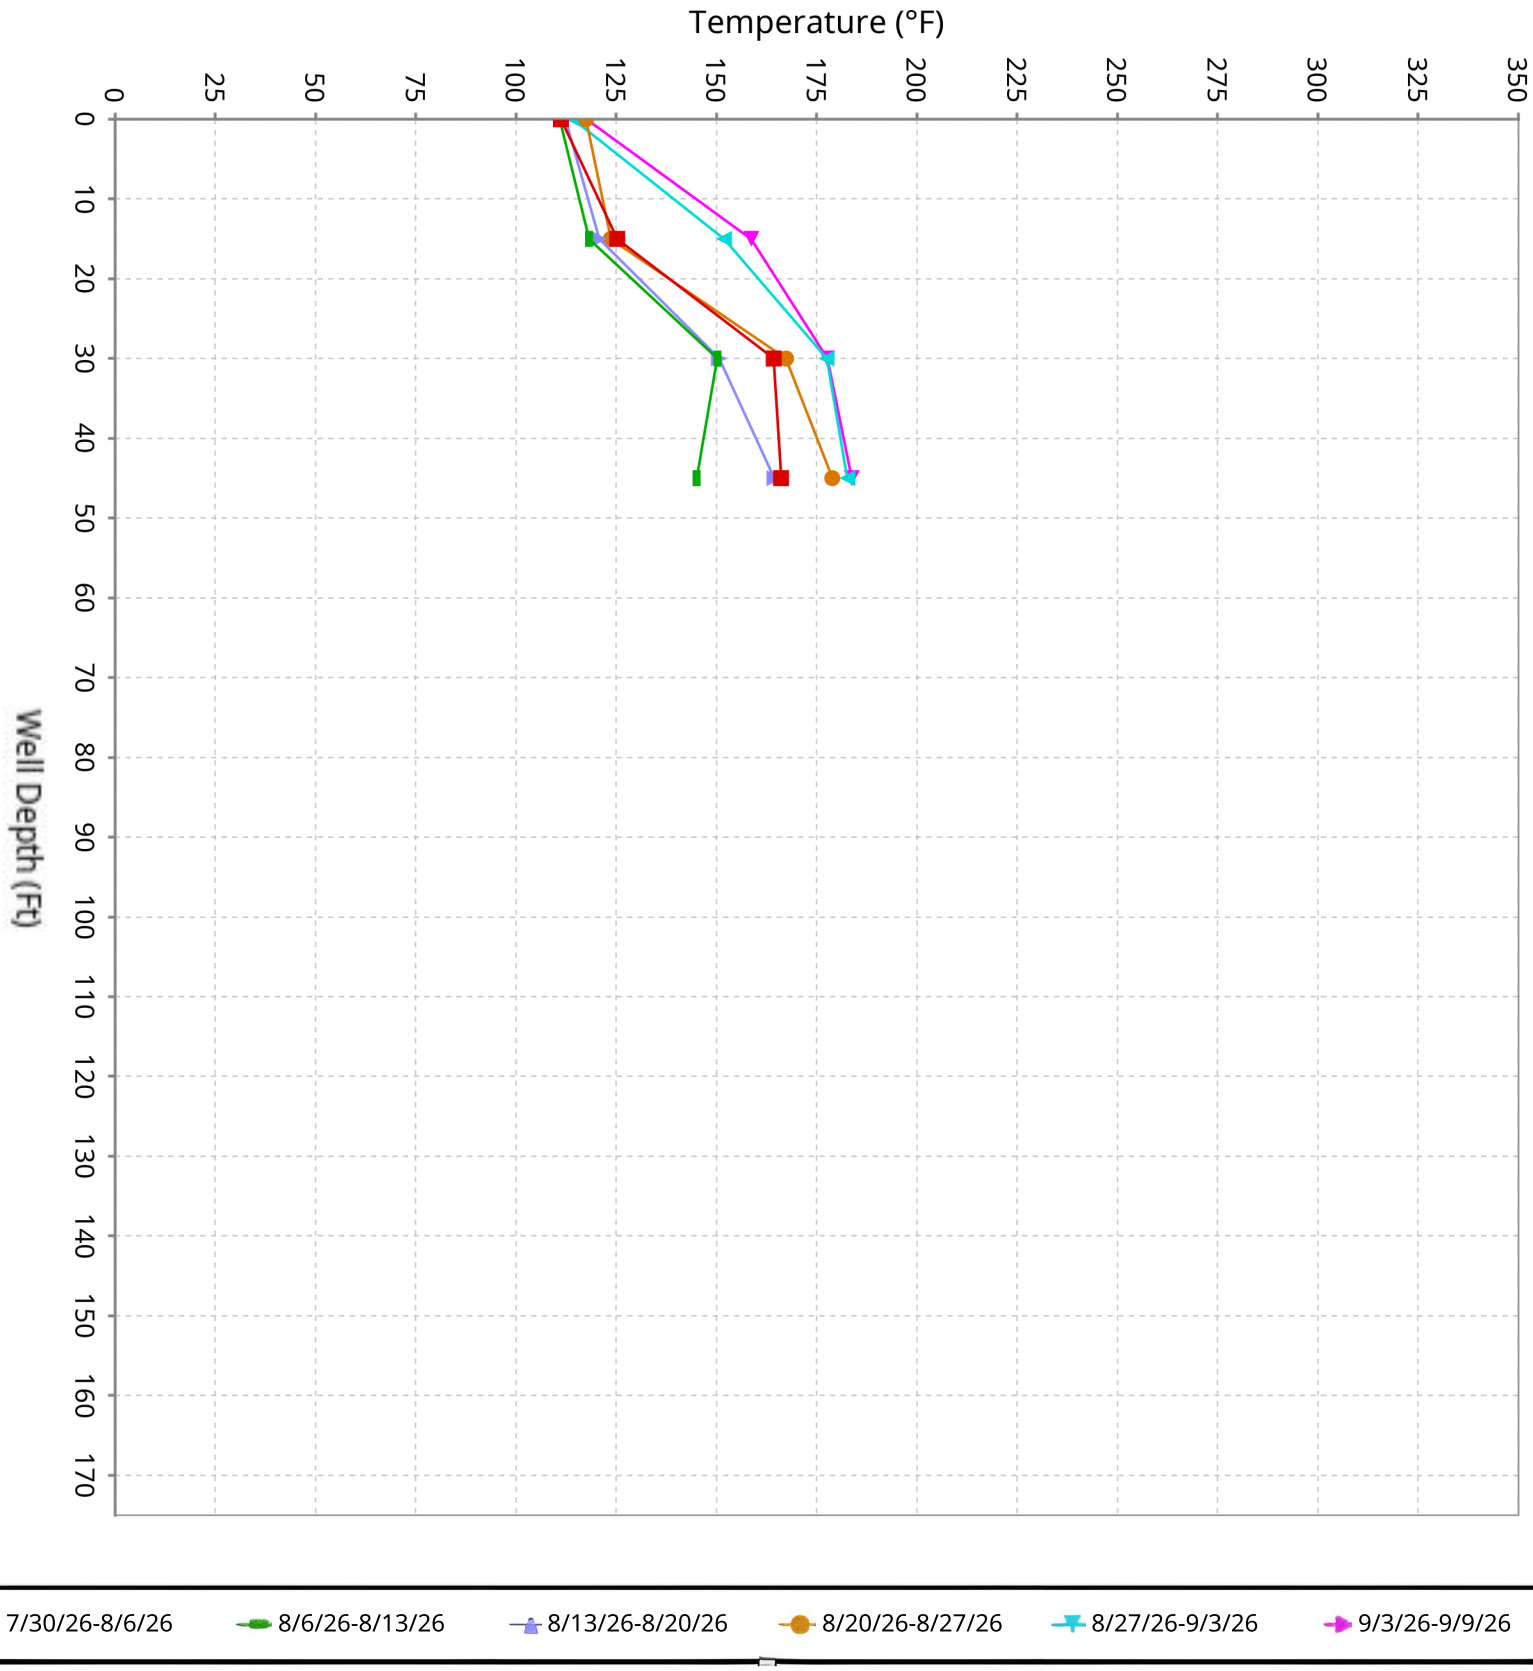
Vertical Temperature Profiles from Temperature Probes at Chiquita Landfill for TP-8

- TP-08
    - The 30-foot and 45-foot thermocouples exhibited temperature increases of 27°F and 29°F, respectively, between July 12, 2026, and July 22, 2026. In response, Site personnel observed the temperature changes and conducted an investigation from July 23, 2026, through July 29, 2026. Following the investigation, temperatures continued to decline at the 30-foot thermocouple from July 30th, 2026, through August 19, 2026, and then temperatures started to increase at the 15, 30, and 45-foot thermocouples from August 20, 2026, through September 2, 2026.

- TP-08 is installed within extraction well CV-24079, which is equipped with a liquid extraction pump. The investigation determined that the existing pump is experiencing a power-related issue and requires removal. Site personnel have constructed the road to TP-08 this week and the pump is on the schedule for maintenance this week. One potential factor contributing to the observed temperature increase is the removal of liquids from wells near TP-08.

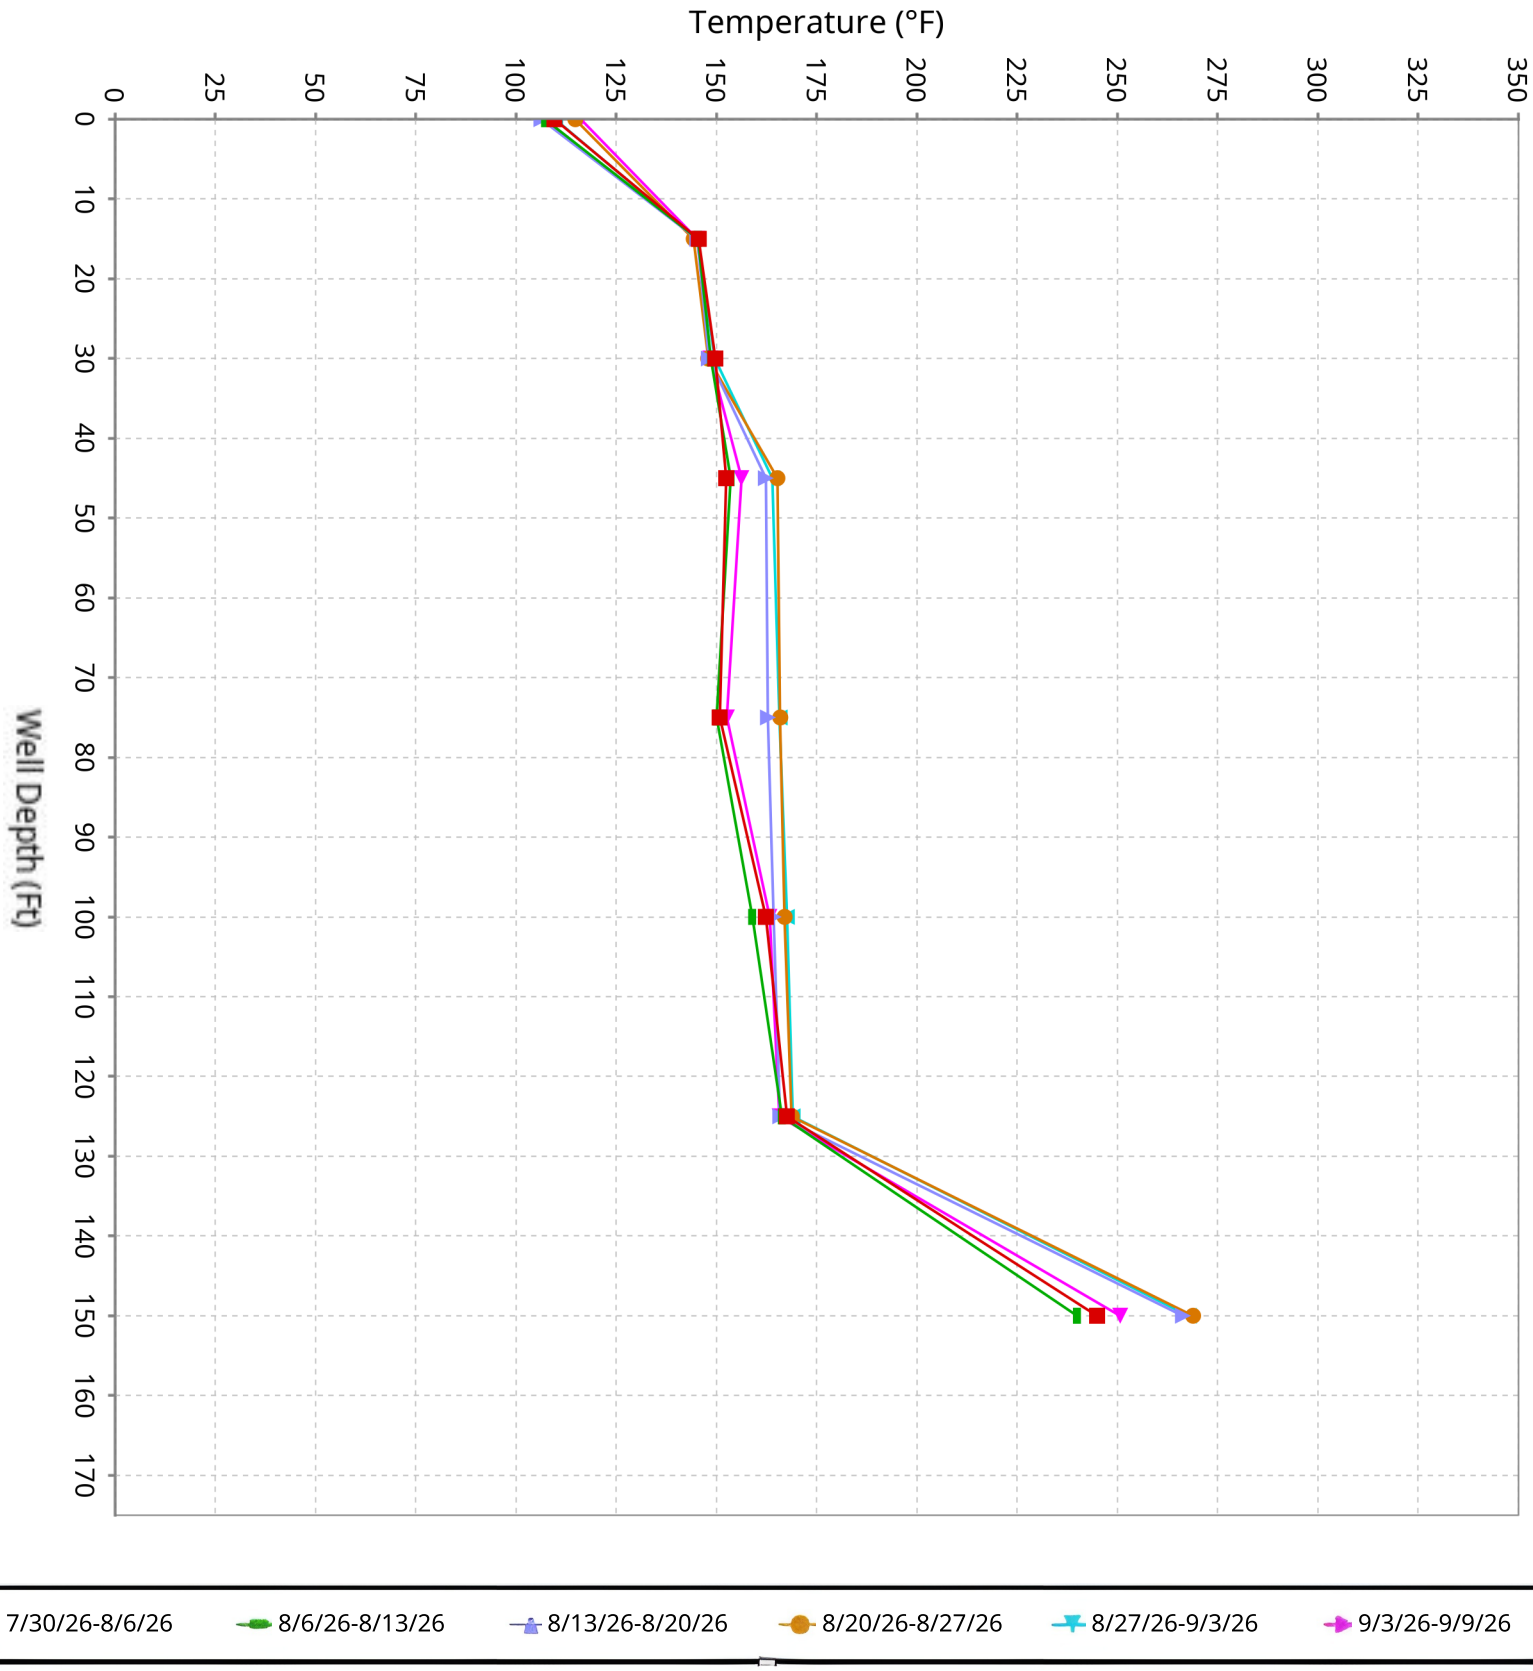
Vertical Temperature Profiles from Temperature Probes at Chiquita Landfill for TP-19

- TP-19
    - A discrepancy was identified during the review of data from six weeks prior. Upon investigation, the Site determined that the associated battery had failed and subsequently replaced it. During this inspection, the temperature

reading from the 125-foot thermocouple was observed to be anomalously low. Further evaluation indicated that the 125-foot thermocouple required replacement. As an interim measure, the Site installed a 120-foot thermocouple that was available onsite and ordered a replacement 125-foot thermocouple. The replacement 125-foot thermocouple is anticipated to be installed upon receipt in October 2026.
    - The 75-foot thermocouple remained consistent with previously recorded temperatures.
    - The 150-foot thermocouple showed an increase in maximum temperature of 13°F from 238°F to 251°F from September 3rd to September 9th.

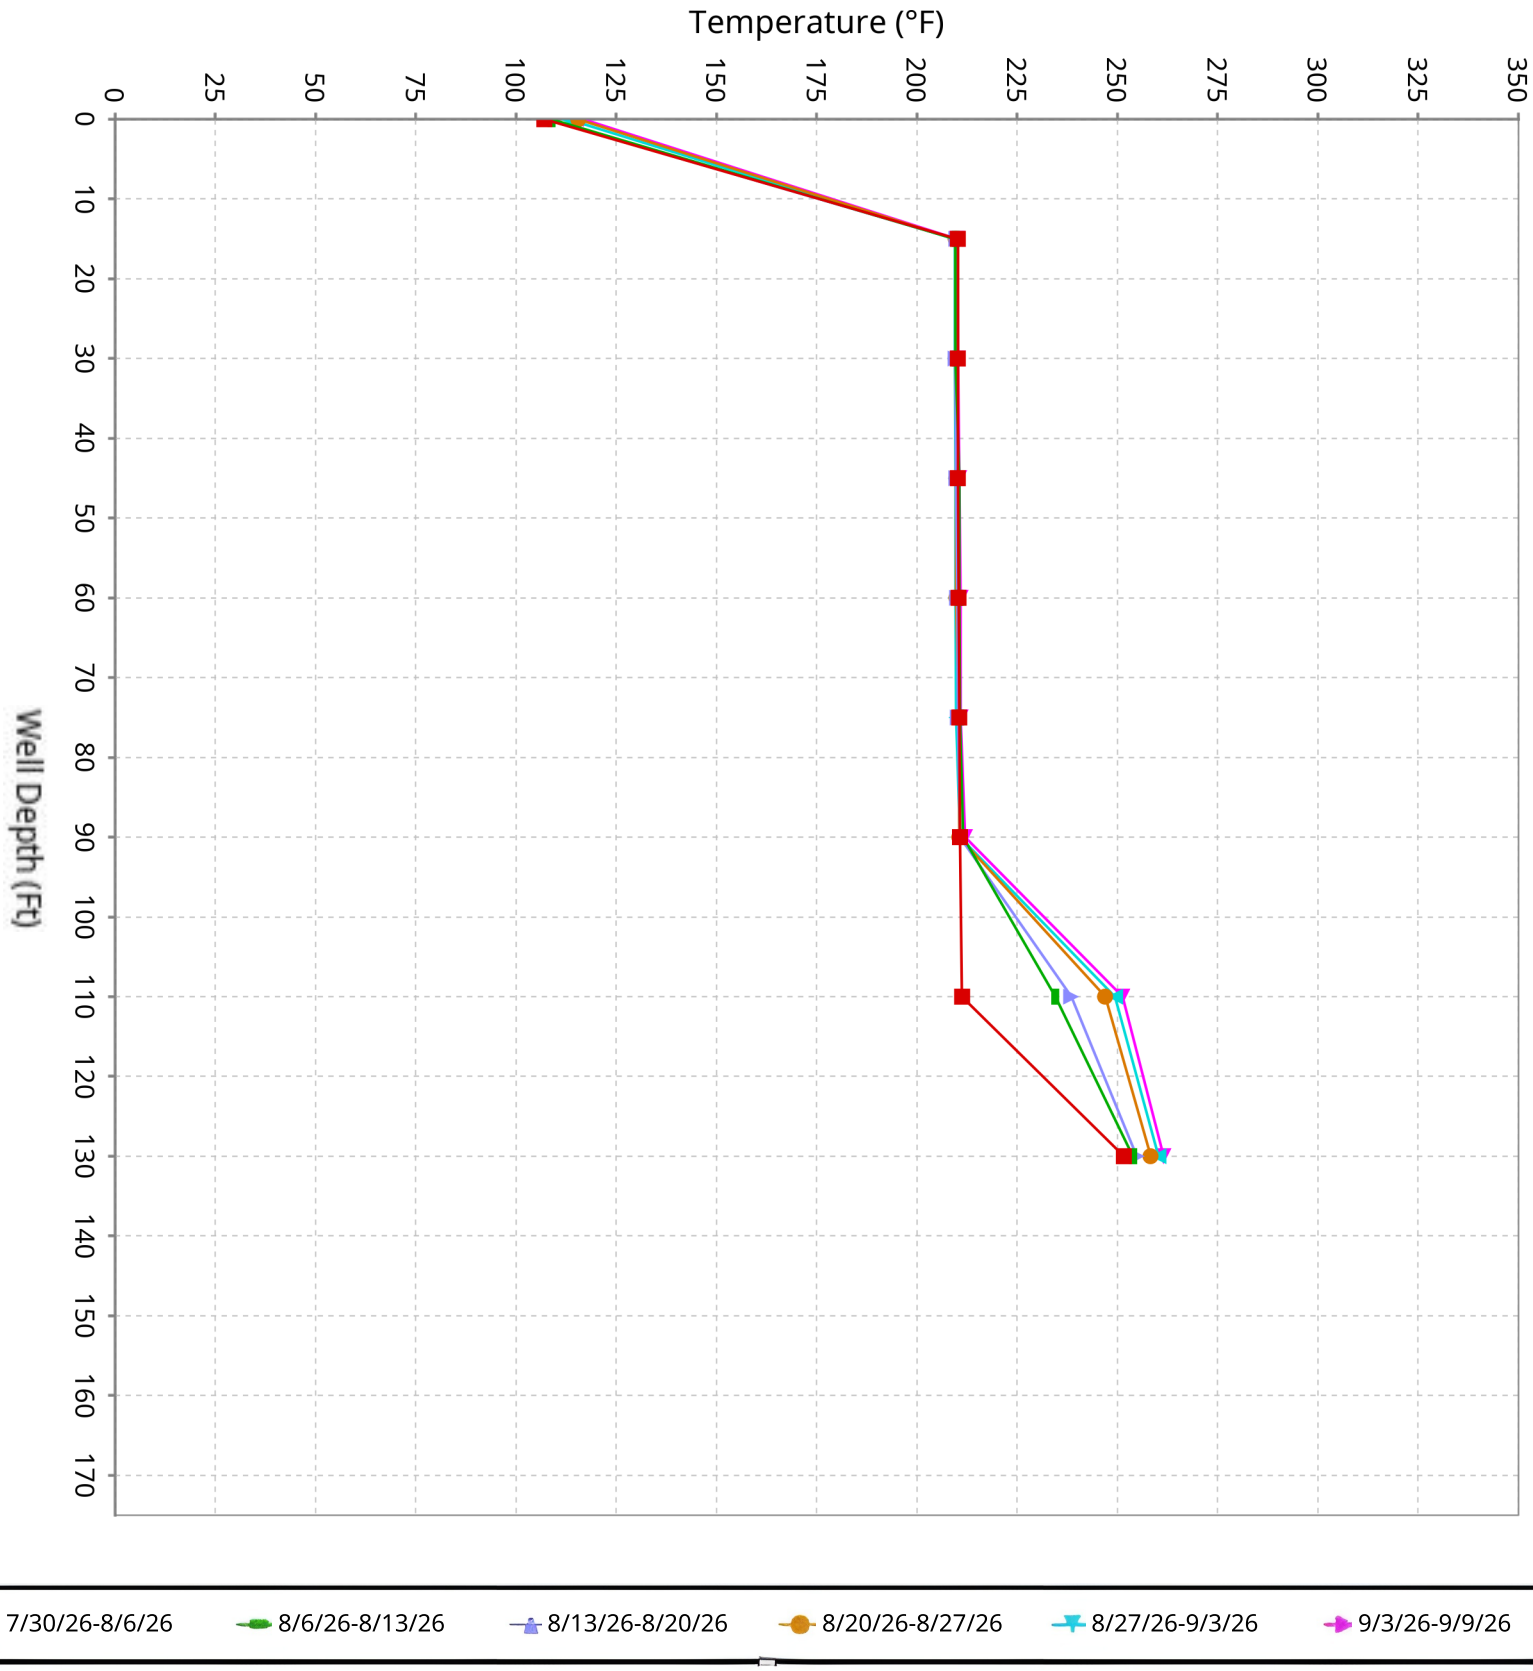
Vertical Temperature Profiles from Temperature Probes at Chiquita Landfill for TP-25

- TP-25
    - The Site recently conducted a follow-up camera inspection of the TP-25 temperature probe casing to evaluate potential liquid infiltration and assess the condition of the casing interior. The inspection confirmed that no liquid was present at the bottom of the casing. Pressurized landfill gas (LFG) was observed, however, when the probe casing was opened. Based on these observations, the Site believes that the temperature readings at TP-25 may be influenced by LFG entering and moving within the casing and, therefore, may not be representative of in-situ waste temperatures. The elevated temperatures recorded at TP-25 are most likely attributable, at least in part, to LFG intrusion associated with a compromised casing seal. The Site is continuing to monitor TP-25 and evaluate the condition of the probe casing and is assessing appropriate next steps to address the observed conditions and obtain reliable in-situ waste temperature measurements.

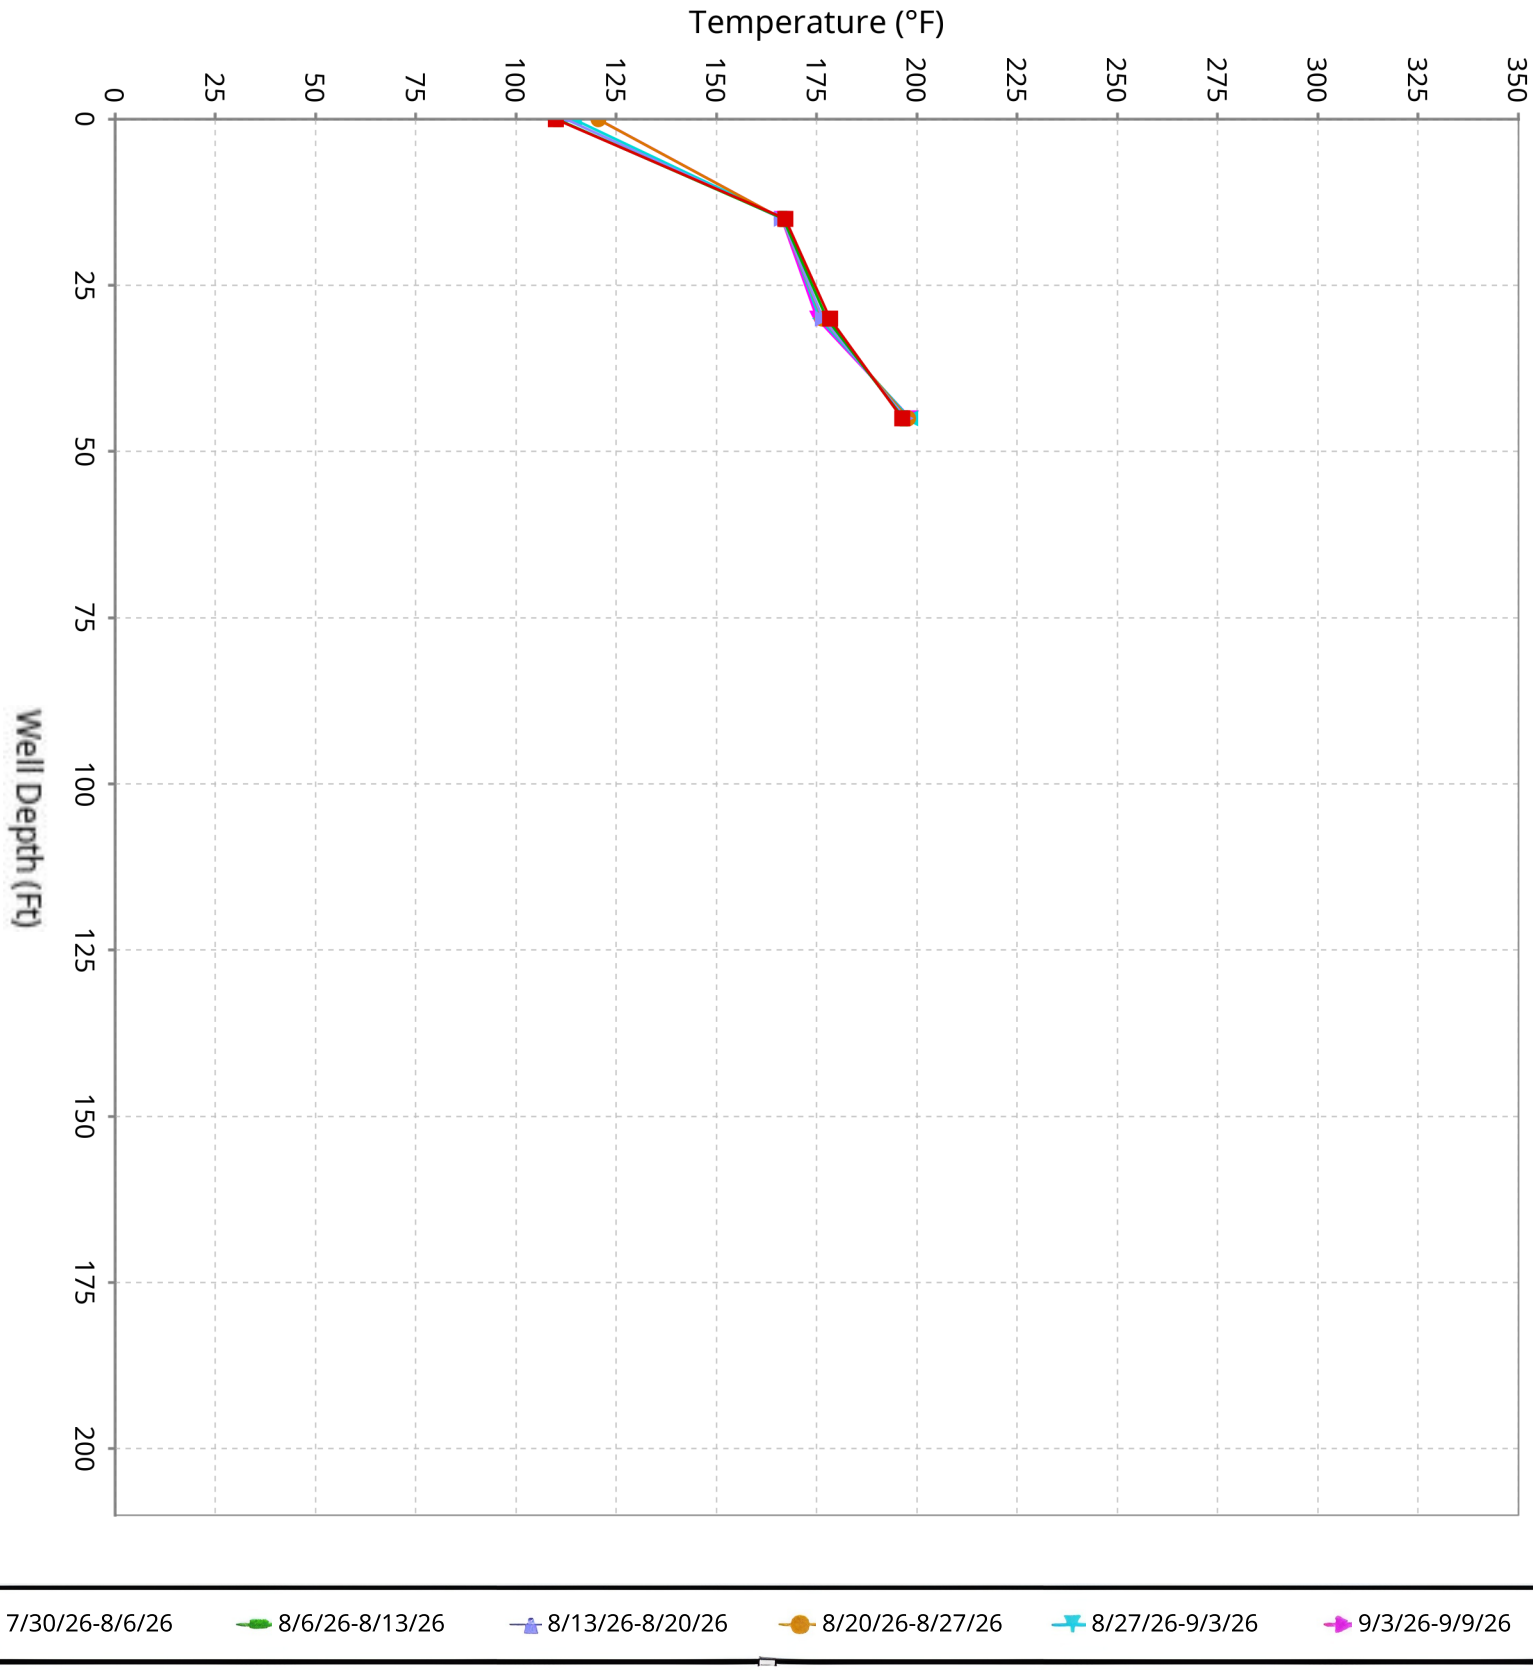
Vertical Temperature Profiles from Temperature Probes at Chiquita Landfill for TP-33

- TP-33
    - The 30-foot thermocouple remained consistent with previously recorded temperatures.
