SCS ENGINEERS

15 de octubre de 2026

Asunto: **Informe Mensual de Septiembre de 2026 Conforme a los Objetivos 1A-3 y 5 de la Orden de Cumplimiento de la LEA del 6 de junio de 2024 y a la Carta del 30 de julio de 2024, Vertedero de Chiquita Canyon, Castaic, California**

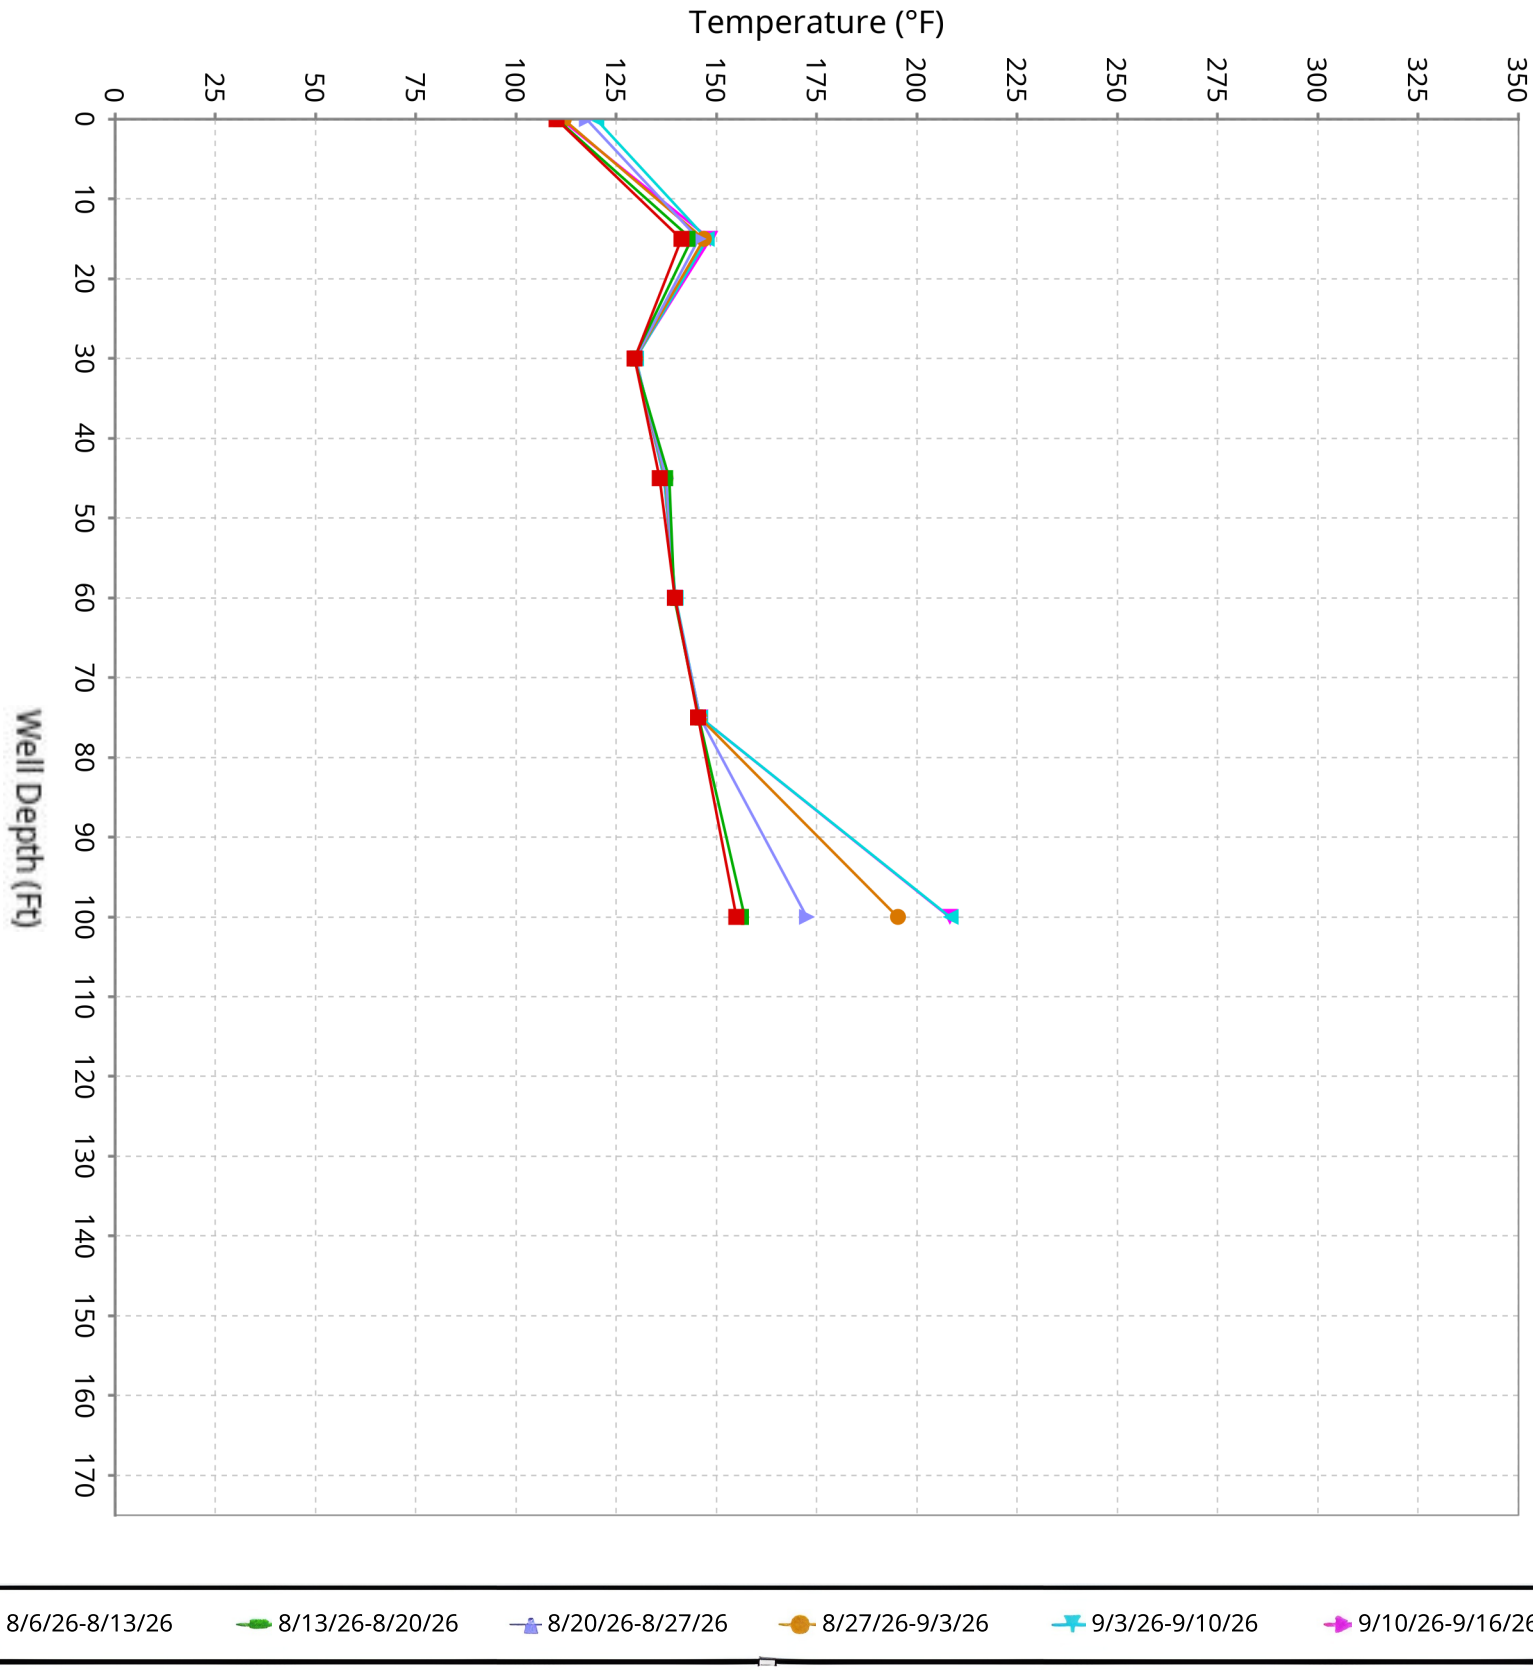
Vertical Temperature Profiles from Temperature Probes at Chiquita Landfill for TP-7

- TP-07
    - The 100-foot thermocouple showed an increase in maximum temperature of 48°F from 160°F to 208°F from August 21st to September 9th. One potential factor contributing to the observed temperature increase is the removal of liquids from wells near TP-07.

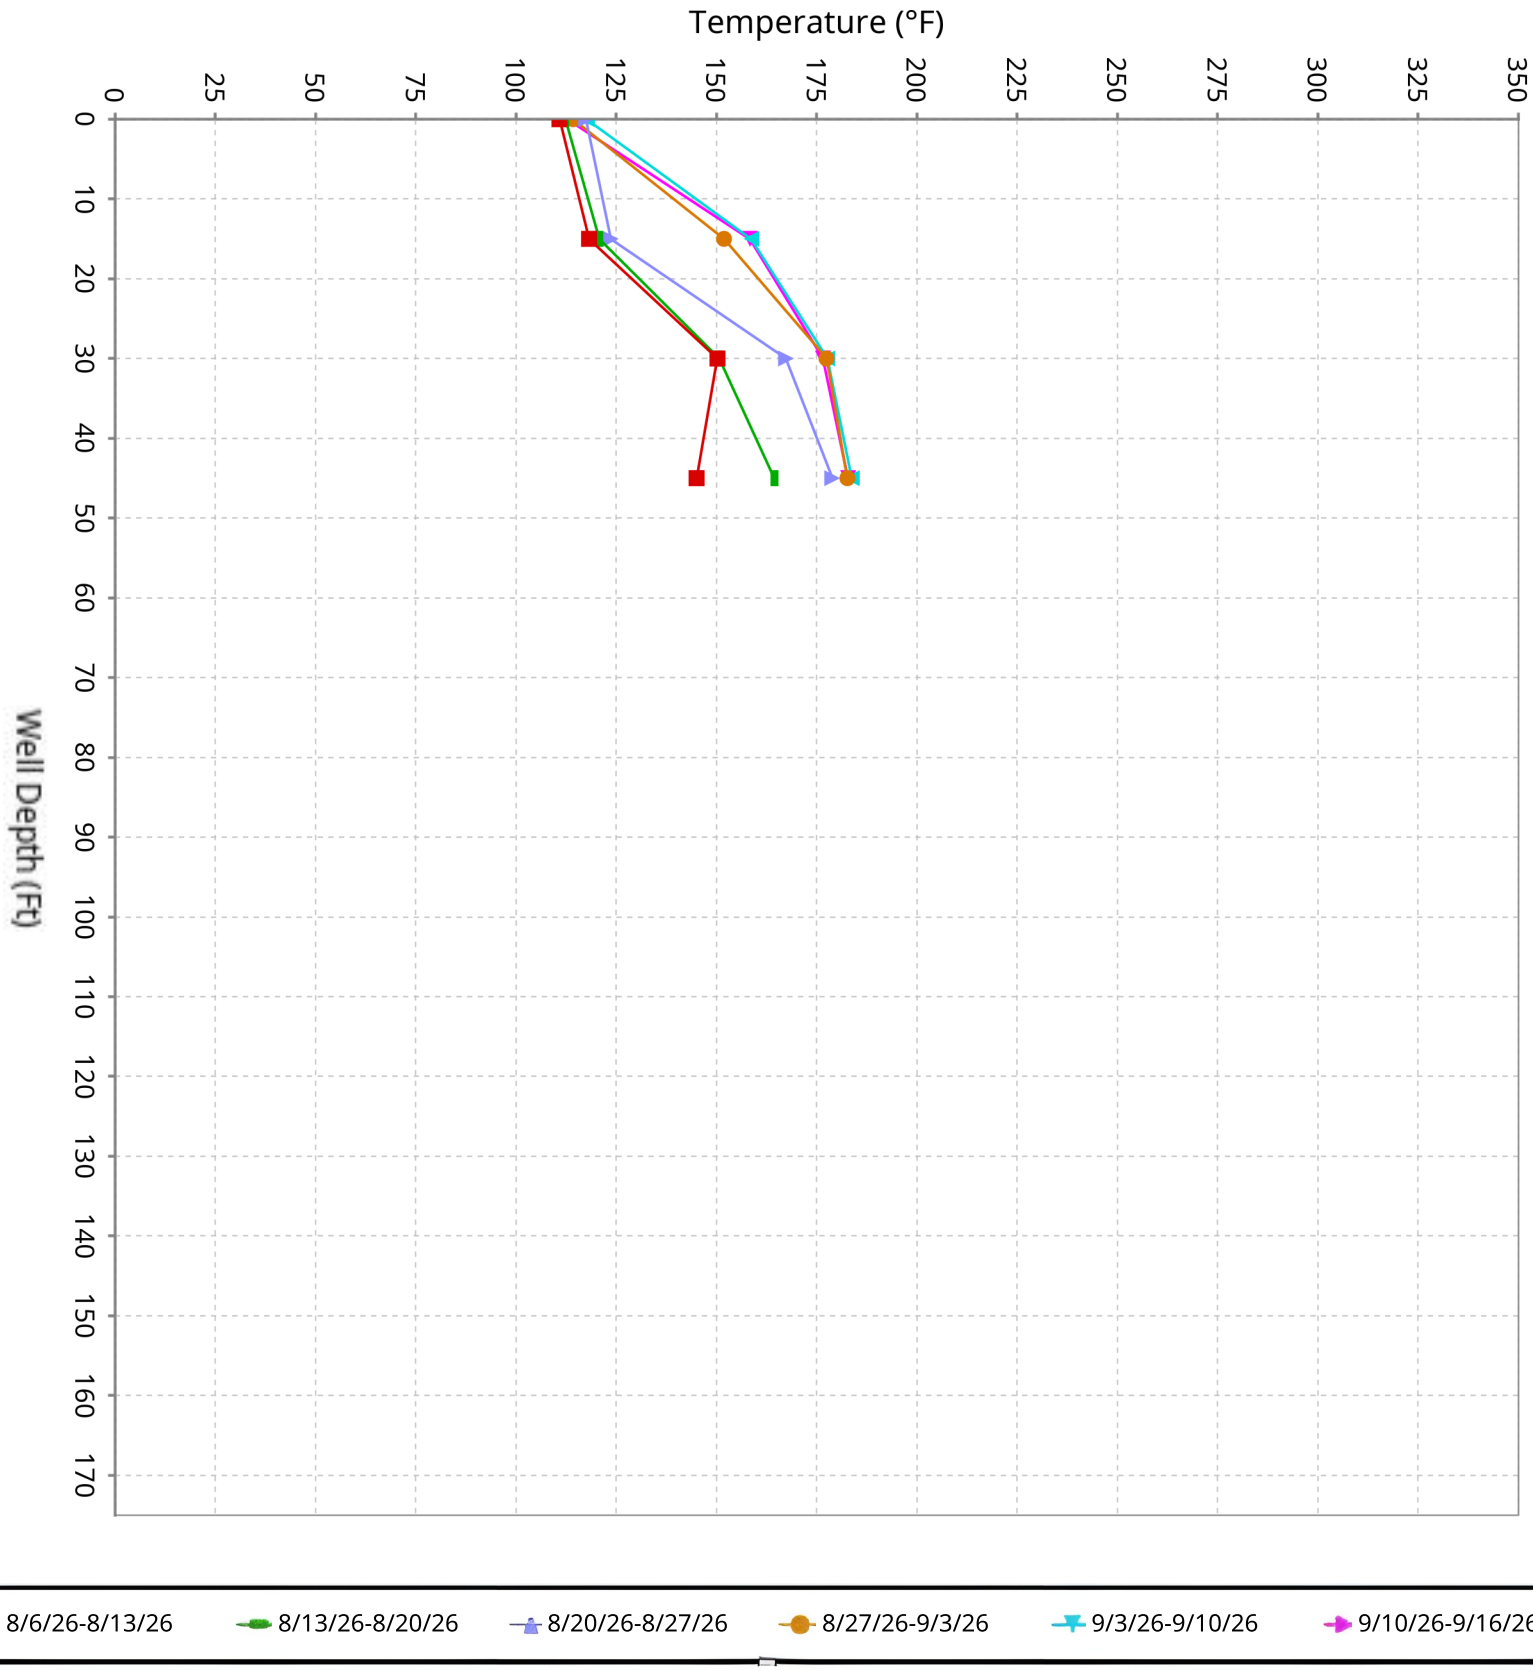
Vertical Temperature Profiles from Temperature Probes at Chiquita Landfill for TP-8

- TP-08
    - The 30-foot and 45-foot thermocouples exhibited temperature increases of 27°F and 29°F, respectively, between July 12, 2026, and July 22, 2026. In response, Site personnel observed the temperature changes and conducted an investigation from July 23, 2026, through July 29, 2026. Following the investigation, temperatures continued to decline at the 30-foot thermocouple from July 30th, 2026, through August 19, 2026, and then temperatures started to increase at the 15, 30, and 45-foot thermocouples from August 20, 2026, through September 12, 2026, then a decrease was observed in the 30 and 45-foot thermocouples from September 12, 2026, through September 16,2026.

- TP-08 is installed within extraction well CV-24079, which is equipped with a liquid extraction pump. The investigation determined that the existing pump is experiencing a power-related issue and requires removal. Site personnel removed the existing pump this week, and cleaned, repaired, reset, and reinstalled it. One potential factor contributing to the observed temperature increase and subsequent decrease is the removal of liquids from wells near TP-08 and in well CV-24079.

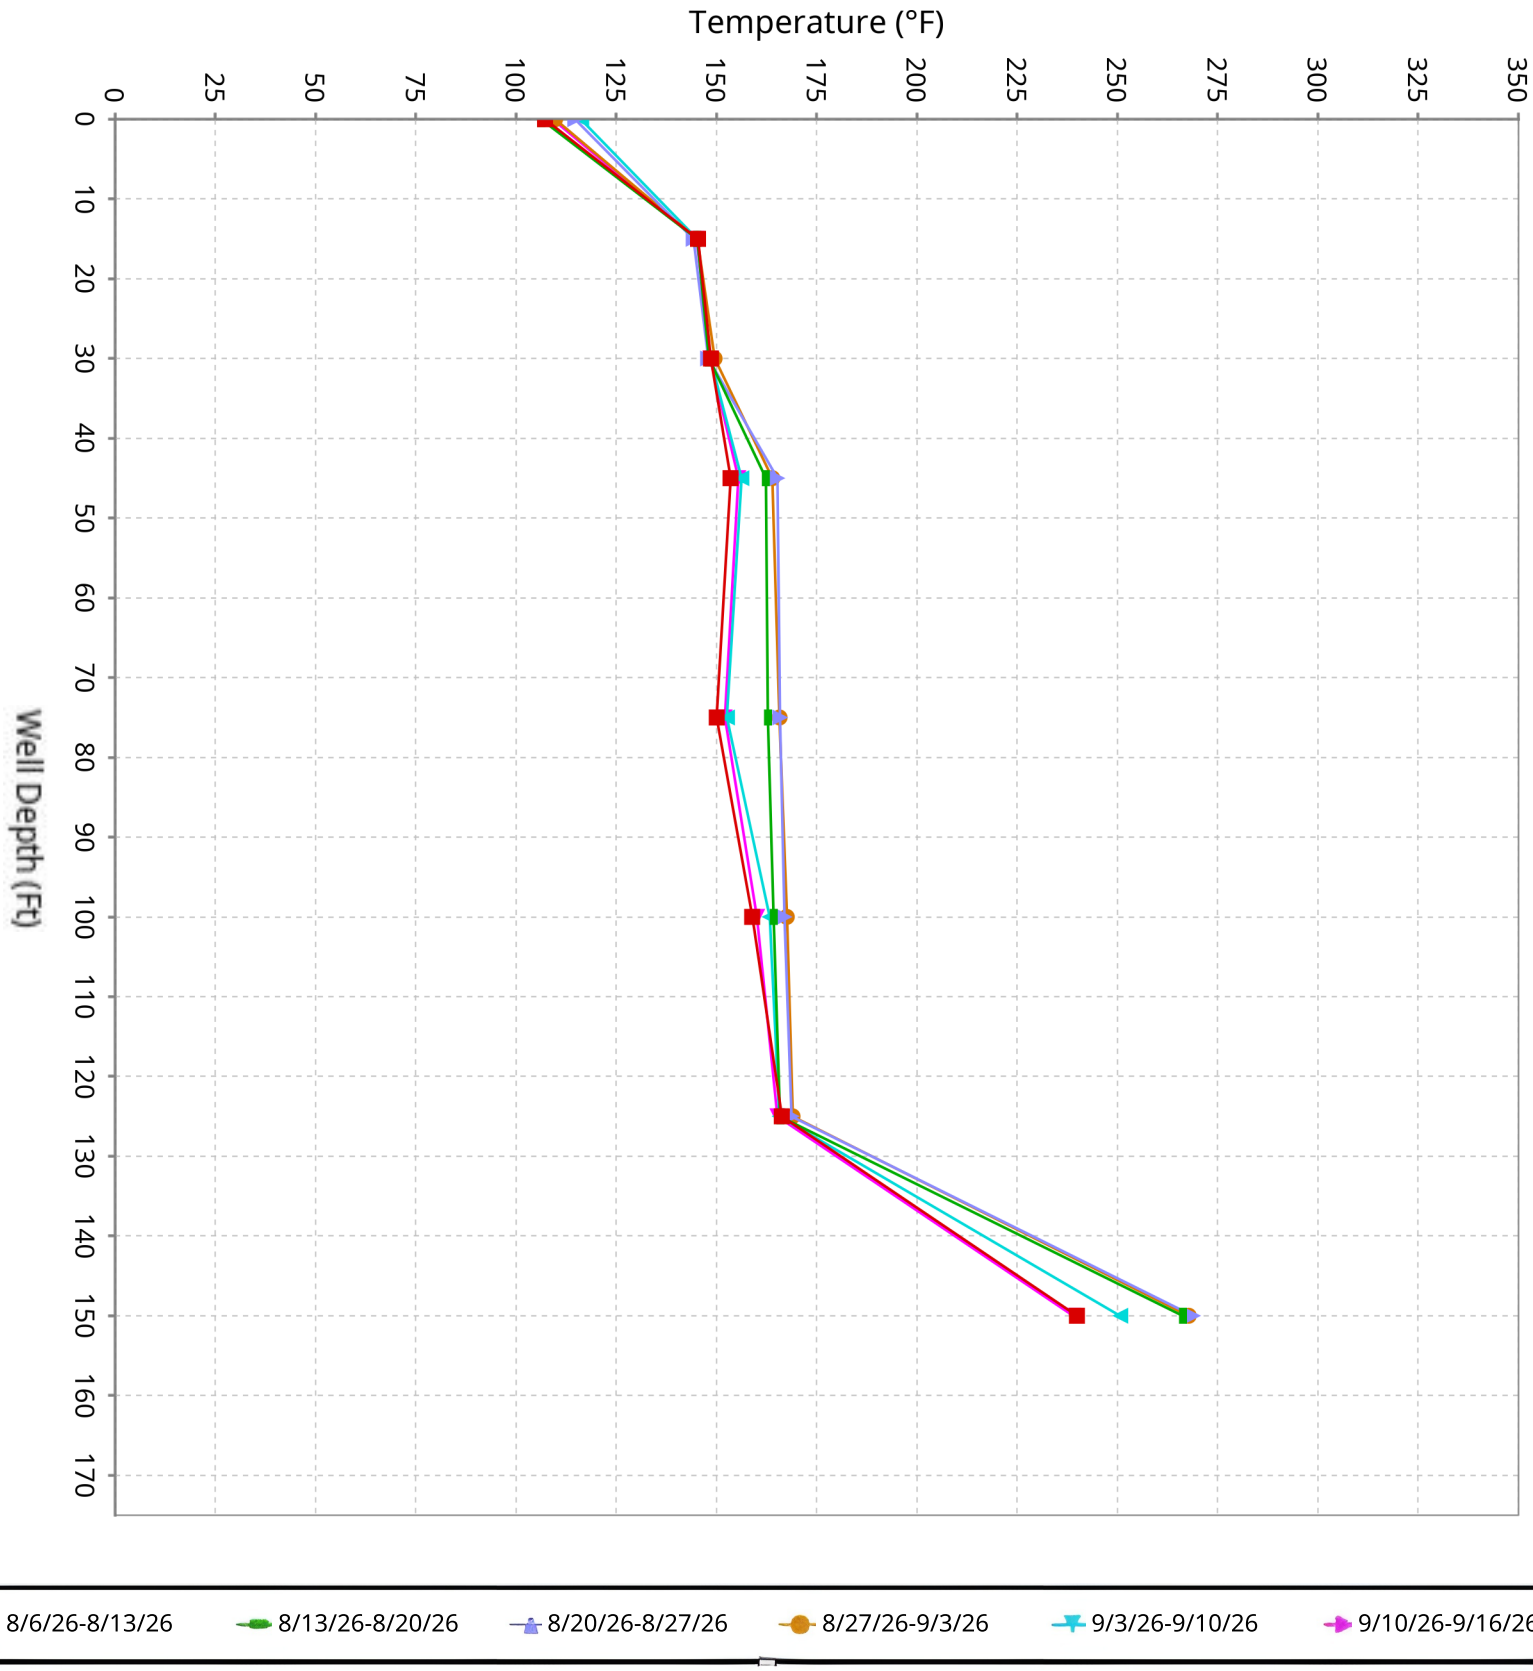
Vertical Temperature Profiles from Temperature Probes at Chiquita Landfill for TP-19

- TP-19
    - A discrepancy was identified during the review of data from six weeks prior. Upon investigation, the Site determined that the associated battery had failed and subsequently replaced it. During this inspection, the temperature reading from the 125-foot thermocouple was observed to be anomalously low. Further evaluation indicated that the 125-foot thermocouple required replacement. As an interim measure, the Site installed a 120-foot thermocouple that was available onsite and ordered a replacement 125-foot thermocouple. The replacement 125-foot thermocouple is anticipated to be installed upon receipt in October 2026.
    - The 150-foot thermocouple showed a decrease in maximum temperature of 15°F from 251°F to 236°F from September 9th to September 14th.

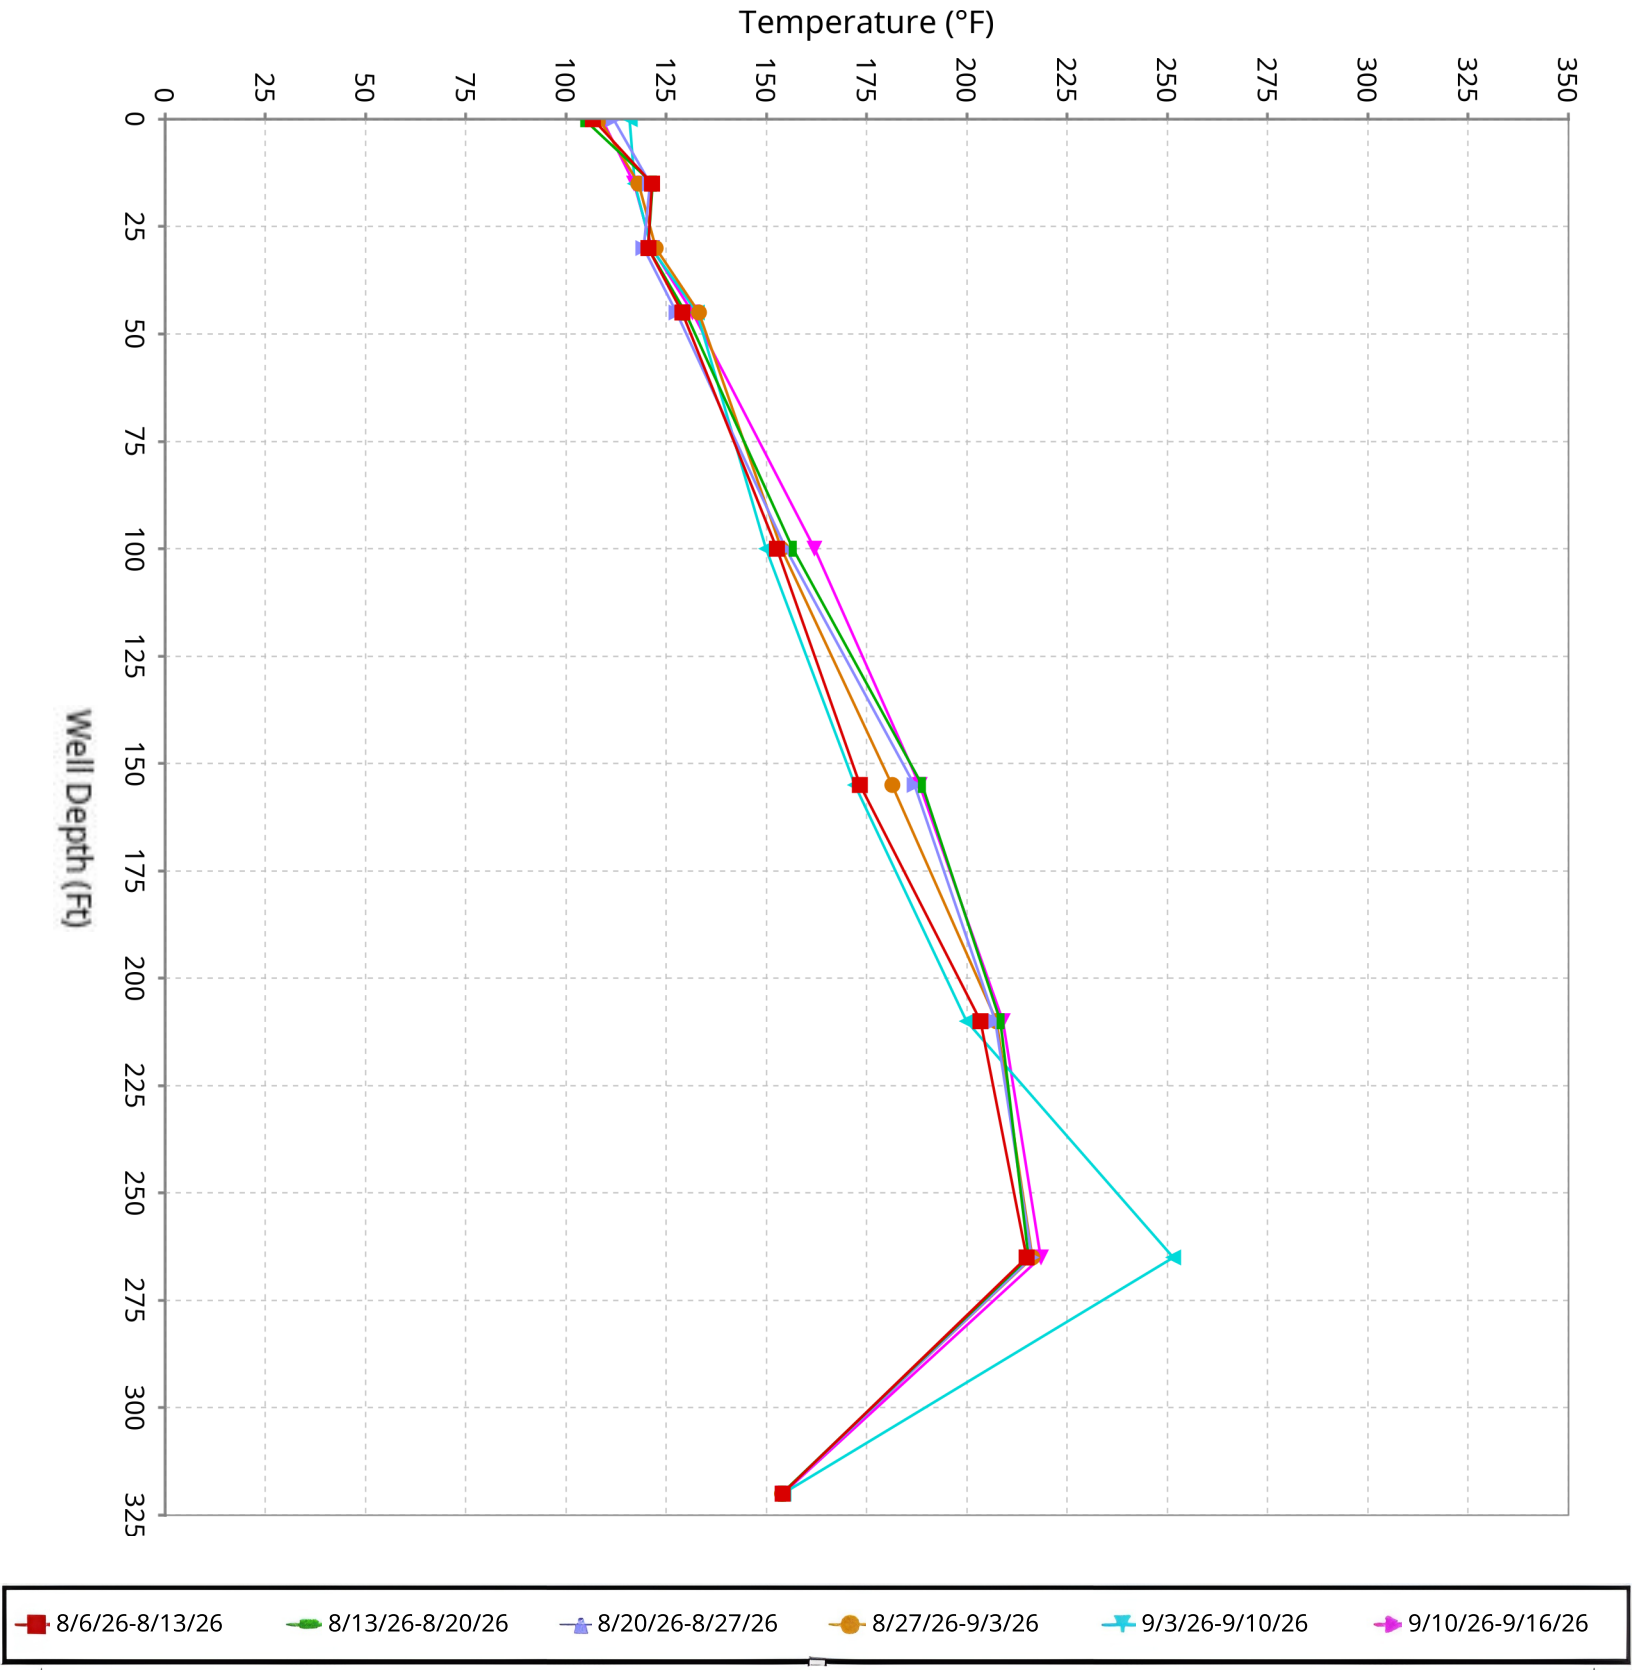
Vertical Temperature Profiles from Temperature Probes at Chiquita Landfill for TP-24

TP-24
Potential factors contributing to the observed temperature increase is the flow changes in the wellfield and removal of liquids from wells near TP-24.

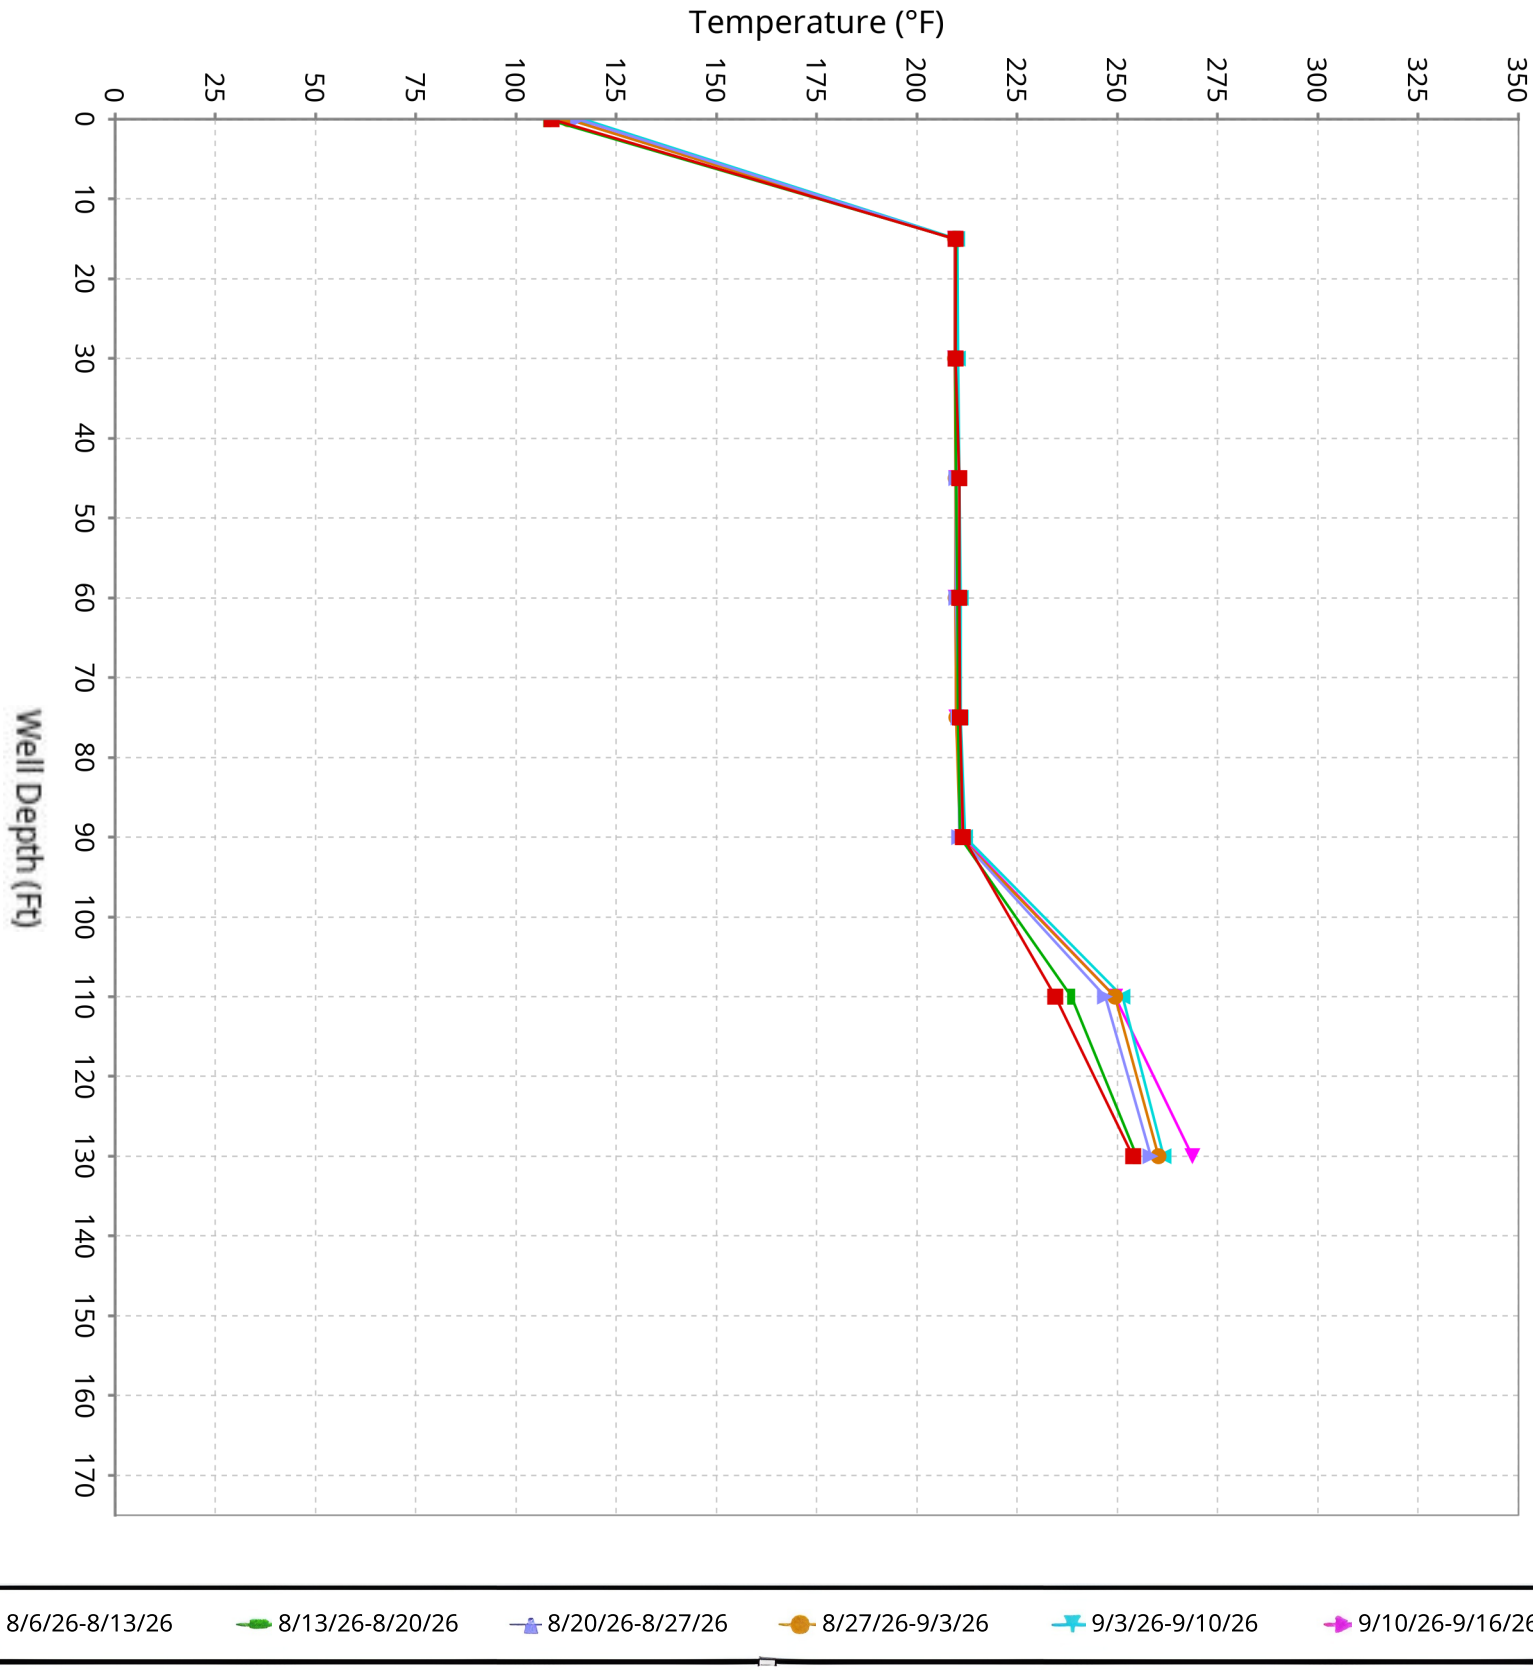
Vertical Temperature Profiles from Temperature Probes at Chiquita Landfill for TP-25

- TP-25
    - The Site recently conducted a follow-up camera inspection of the TP-25 temperature probe casing to evaluate potential liquid infiltration and assess the condition of the casing interior. The inspection confirmed that no liquid was present at the bottom of the casing. Pressurized landfill gas (LFG) was observed, however, when the probe casing was opened. Based on these observations, the Site believes that the temperature readings at TP-25 may be influenced by LFG entering and moving within the casing and, therefore, may not be representative of in-situ waste temperatures. The elevated temperatures recorded at TP-25 are most likely attributable, at least in part, to LFG intrusion associated with a compromised casing seal. The Site is continuing to monitor TP-25. Temperatures remained consistent with previously recorded temperatures.

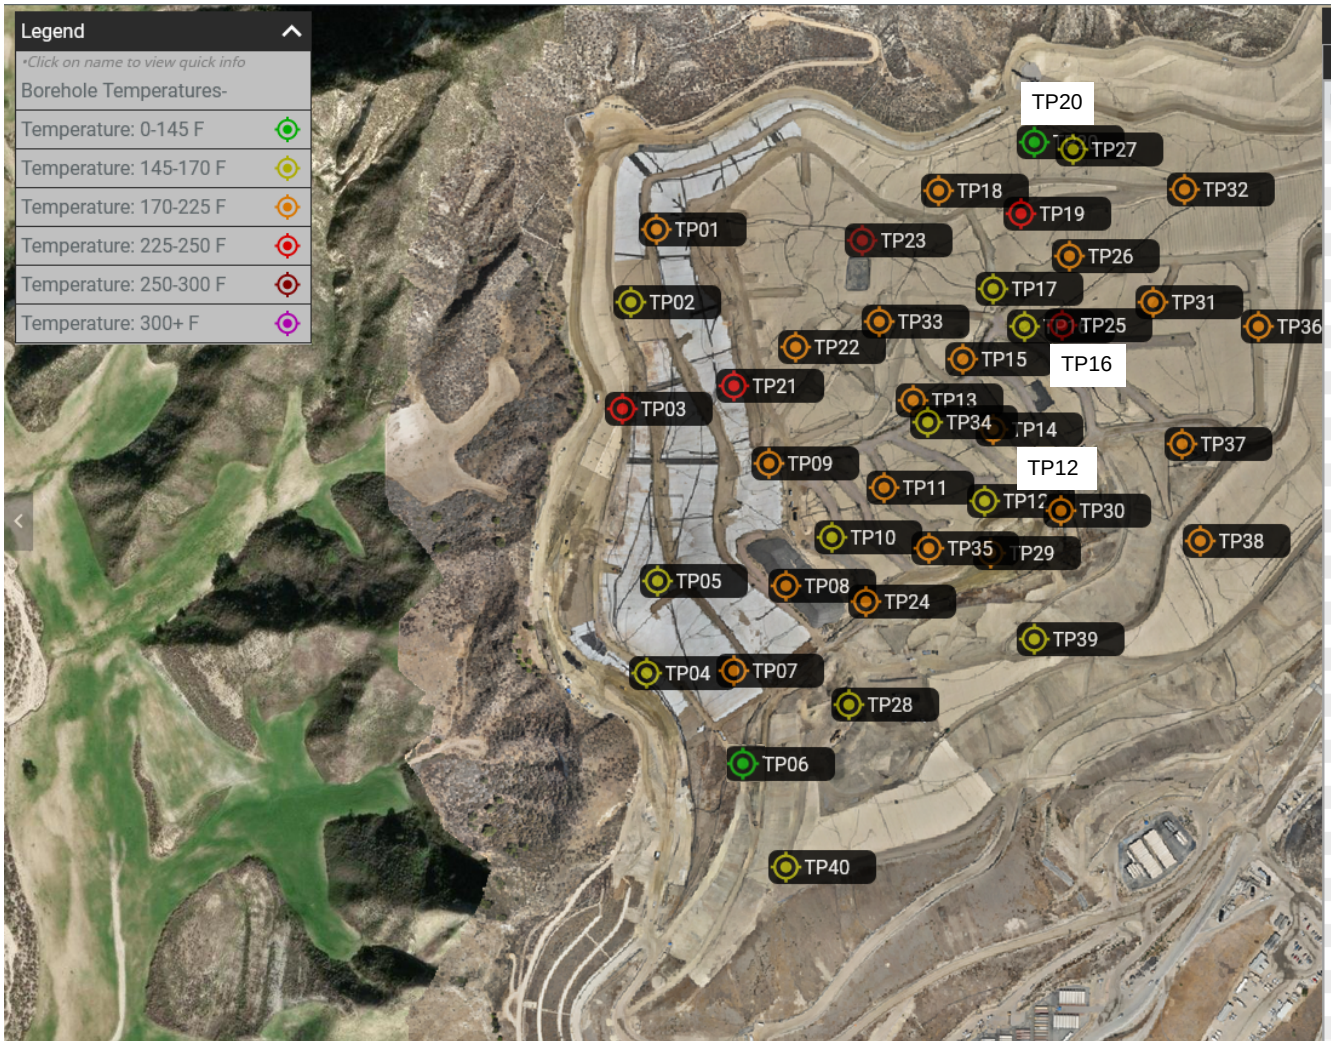
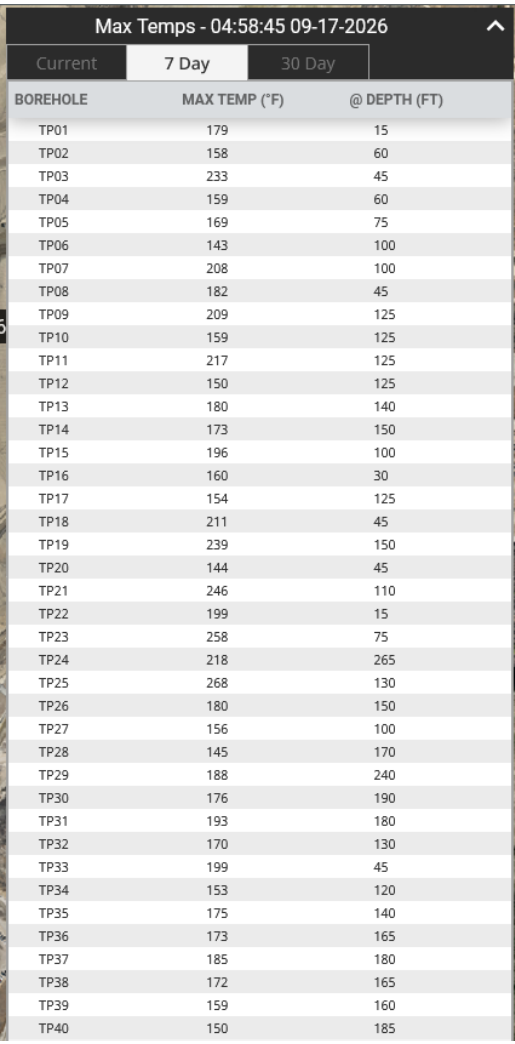
Maximum Vertical Temperature Map from Temperature Probes at Chiquita Landfill

BOREHOLE	MAX TEMP (°F)	@ DEPTH (FT)
TP01	179	15
TP02	158	60
TP03	233	45
TP04	159	60
TP05	169	75
TP06	143	100
TP07	208	100
TP08	182	45
TP09	209	125
TP10	159	125
TP11	217	125
TP12	150	125
TP13	180	140
TP14	173	150
TP15	196	100
TP16	160	30
TP17	154	125
TP18	211	45
TP19	239	150
TP20	144	45
TP21	246	110
TP22	199	15
TP23	258	75
TP24	218	265
TP25	268	130
TP26	180	150
TP27	156	100
TP28	145	170
TP29	188	240
TP30	176	190
TP31	193	180
TP32	170	130
TP33	199	45
TP34	153	120
TP35	175	140
TP36	173	165
TP37	185	180
TP38	172	165
TP39	159	160
TP40	150	185

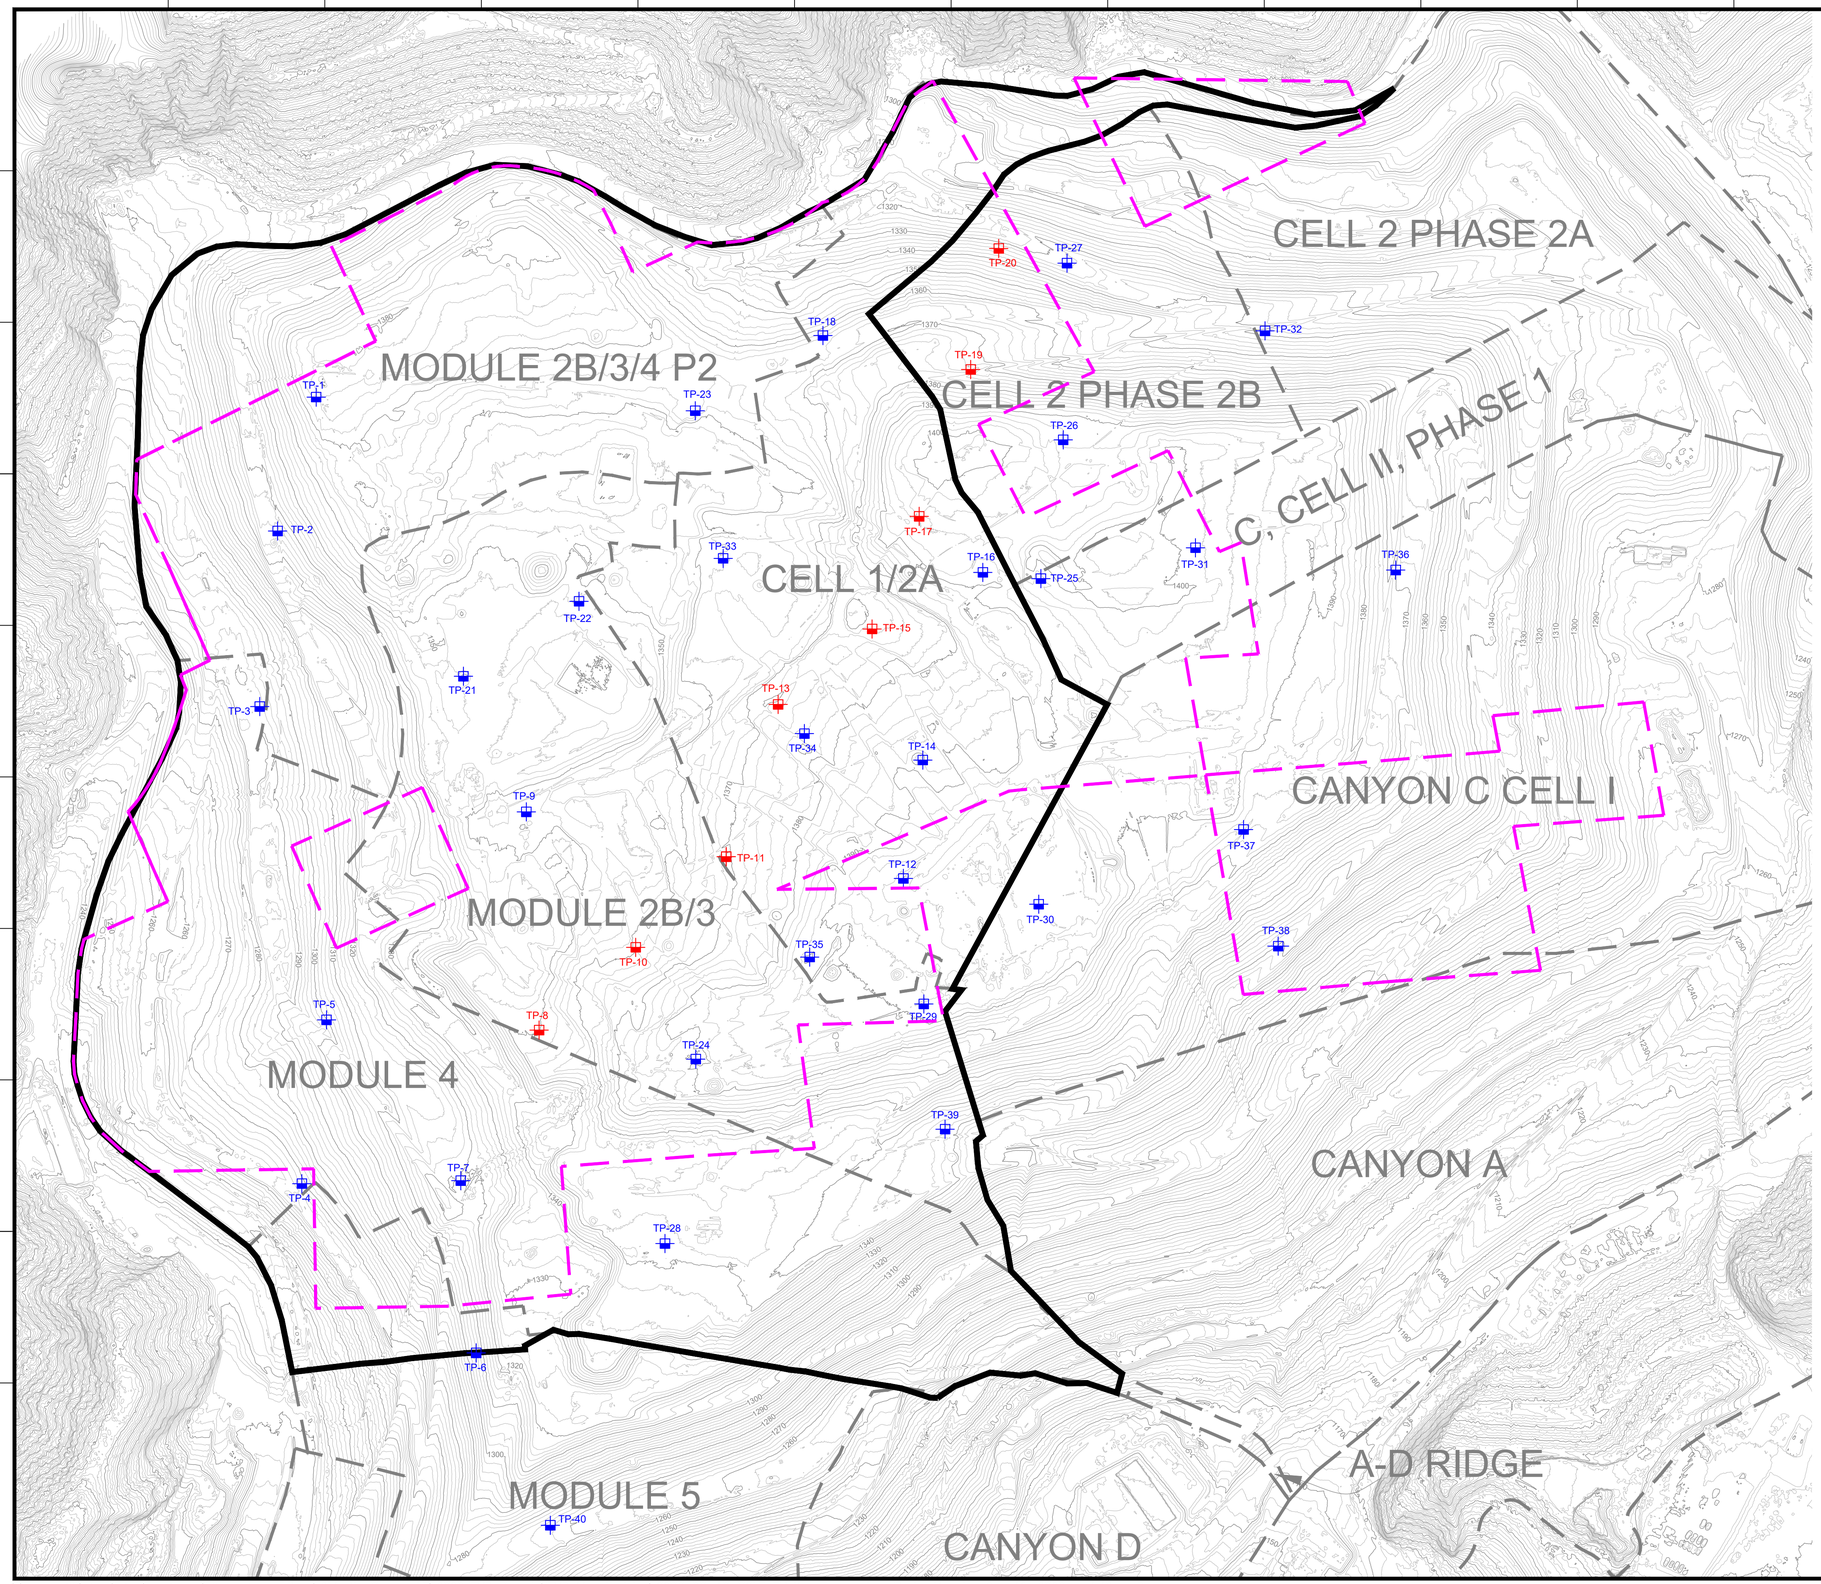
TP-19
A discrepancy was identified during the review of data from six weeks prior. Upon investigation, the Site determined that the associated battery had failed and subsequently replaced it. During this inspection, the temperature reading from the 125-foot thermocouple was observed to be anomalously low. Further evaluation indicated that the 125-foot thermocouple required replacement. As an interim measure, the Site installed a 120-foot thermocouple that was available onsite and ordered a replacement 125-foot thermocouple. The replacement 125-foot thermocouple is anticipated to be installed upon receipt in October 2026.

TP-25
The Site recently conducted a follow-up camera inspection of the TP-25 temperature probe casing to evaluate potential liquid infiltration and assess the condition of the casing interior. The inspection confirmed that no liquid was present at the bottom of the casing. Pressurized landfill gas (LFG) was observed, however, when the probe casing was opened. Based on these observations, the Site believes that the temperature readings at TP-25 may be influenced by LFG entering and moving within the casing and, therefore, may not be representative of in-situ waste temperatures. The elevated temperatures recorded at TP-25 are most likely attributable, at least in part, to LFG intrusion associated with a compromised casing seal. The Site is continuing to monitor TP-25. Temperatures remained consistent with previously recorded temperatures.

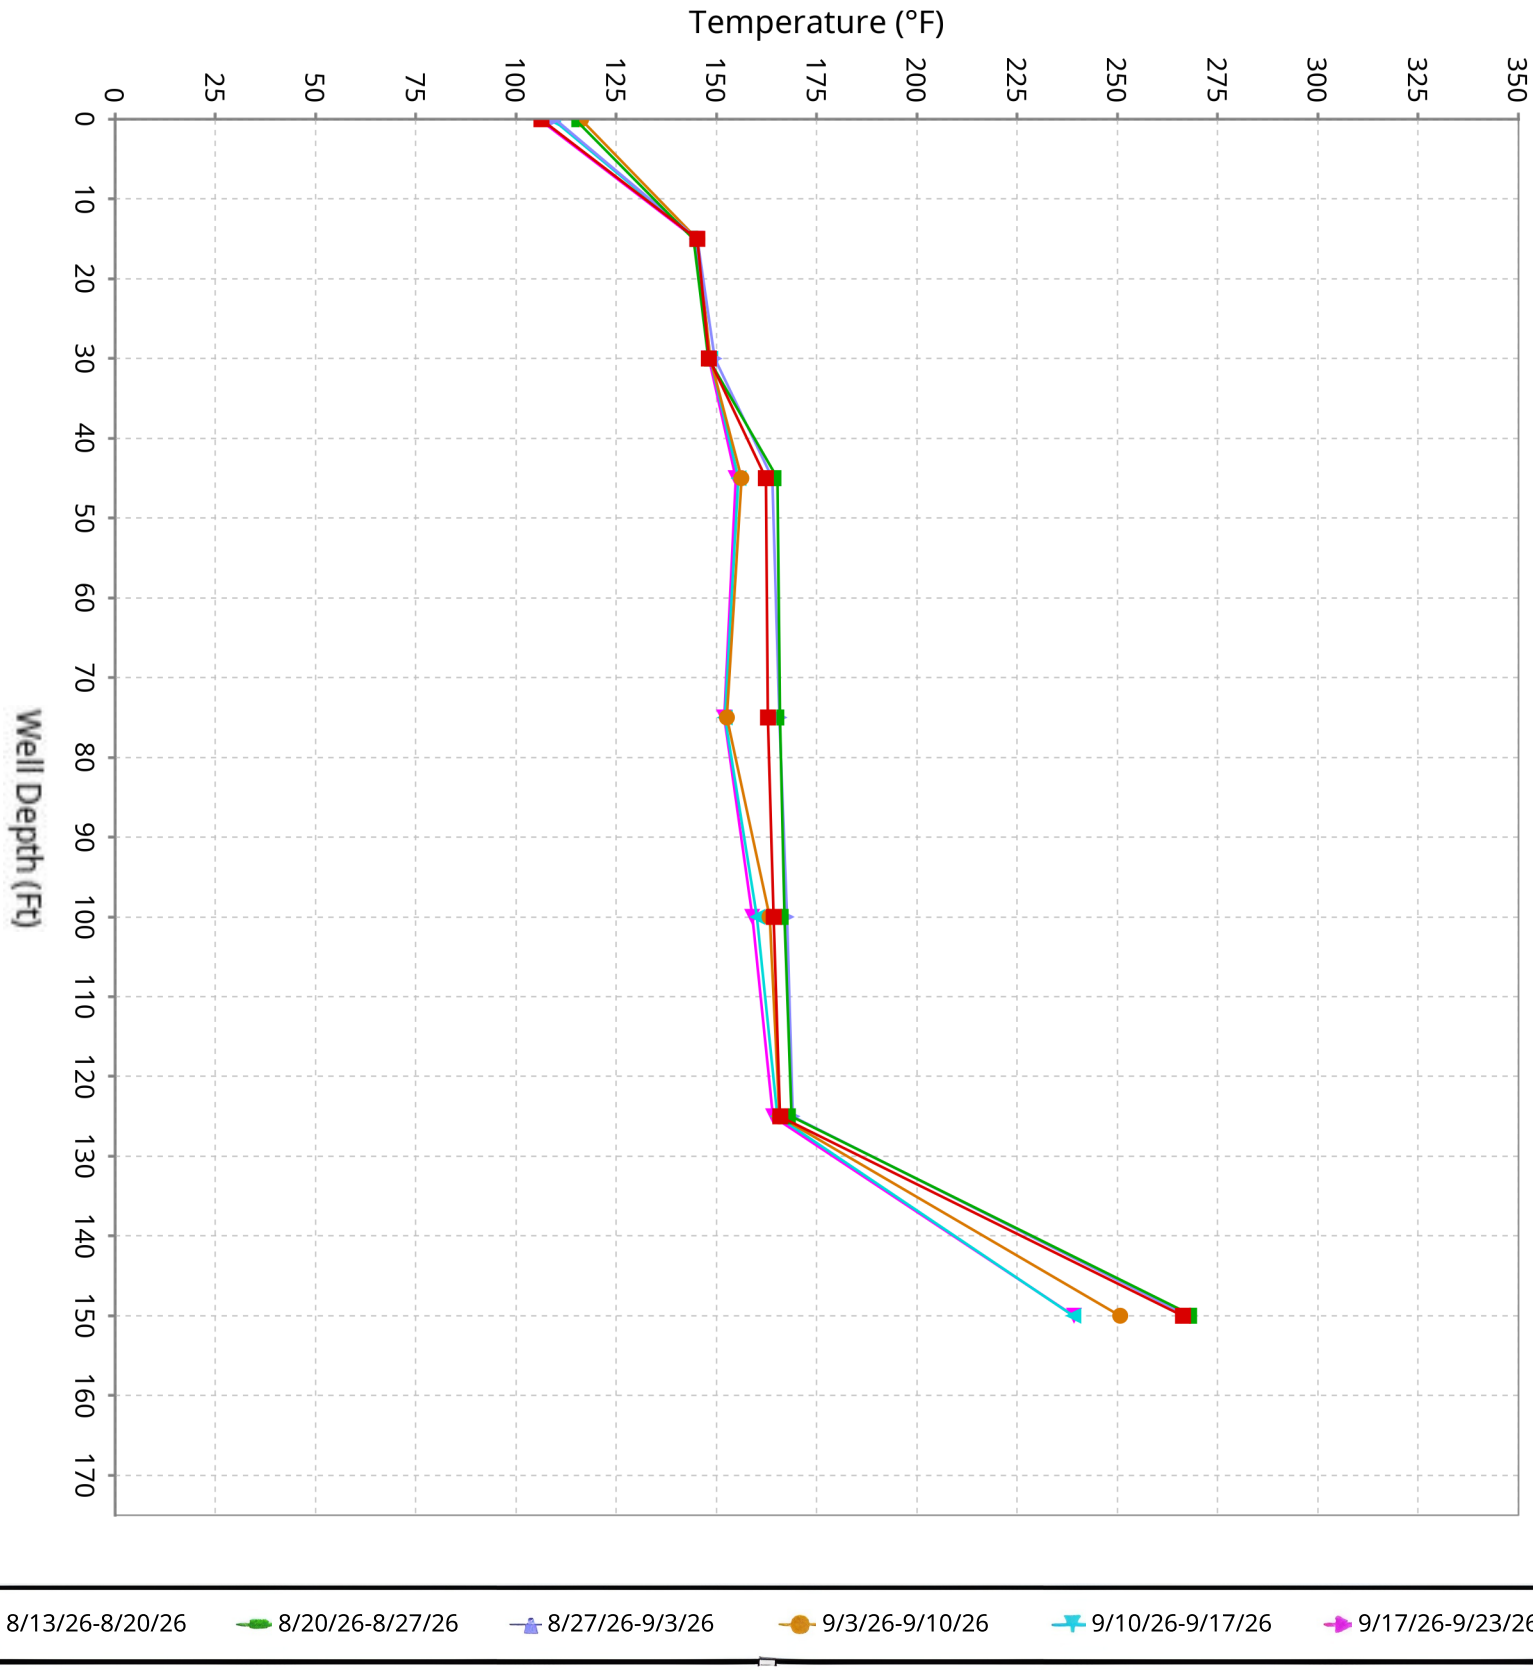
Vertical Temperature Profiles from Temperature Probes at Chiquita Landfill for TP-19

- TP-19
  - A discrepancy was identified during the review of data from seven weeks prior. Upon investigation, the Site determined that the associated battery had failed and subsequently replaced it. During this inspection, the temperature reading from the 125-foot thermocouple was observed to be anomalously low. Further evaluation indicated that the 125-foot thermocouple required replacement. As an interim measure, the Site installed a 120-foot thermocouple that was available onsite and ordered a replacement 125-foot thermocouple. The replacement 125-foot thermocouple is anticipated to be installed upon receipt in October 2026.
  - The 150-foot thermocouple remained consistent with previously recorded temperatures.

- TP-19
  - A discrepancy was identified during the review of data from seven weeks prior. Upon investigation, the Site determined that the associated battery had failed and subsequently replaced it. During this inspection, the temperature reading from the 125-foot thermocouple was observed to be anomalously low. Further evaluation indicated that the 125-foot thermocouple required replacement. As an interim measure, the Site installed a 120-foot thermocouple that was available onsite and ordered a replacement 125-foot thermocouple. The replacement 125-foot thermocouple is anticipated to be installed upon receipt in October 2026.
