SCS ENGINEERS

15 de octubre de 2026

Asunto: **Informe Mensual de Septiembre de 2026 Conforme a los Objetivos 1A-3 y 5 de la Orden de Cumplimiento de la LEA del 6 de junio de 2024 y a la Carta del 30 de julio de 2024, Vertedero de Chiquita Canyon, Castaic, California**

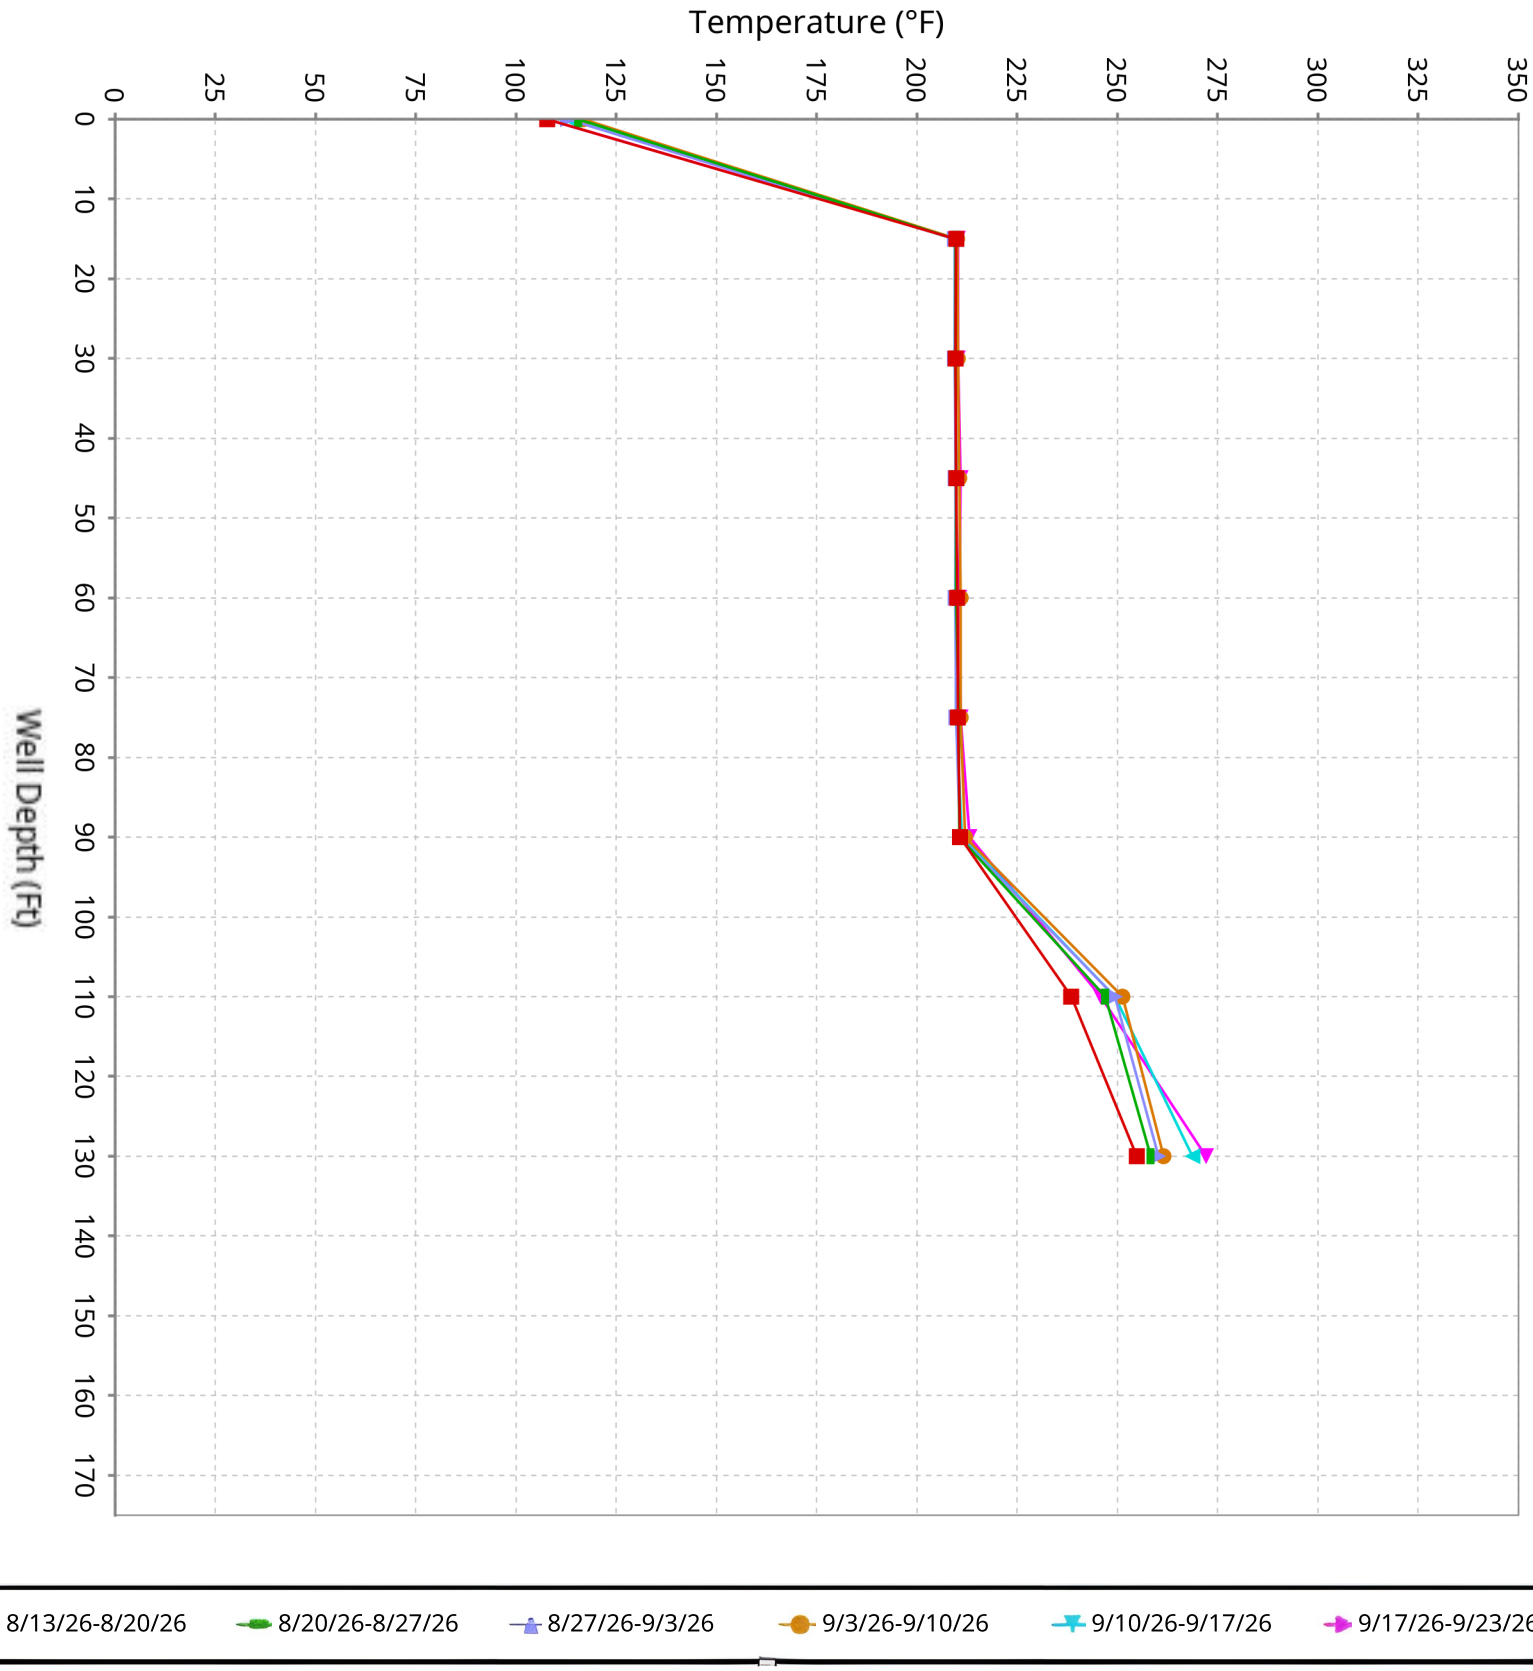
Vertical Temperature Profiles from Temperature Probes at Chiquita Landfill for TP-25

- TP-25
    - The Site recently conducted a follow-up camera inspection of the TP-25 temperature probe casing to evaluate potential liquid infiltration and assess the condition of the casing interior. The inspection confirmed that no liquid was present at the bottom of the casing. Pressurized landfill gas (LFG) was observed, however, when the probe casing was opened. Based on these observations, the Site believes that the temperature readings at TP-25 may be influenced by LFG entering and moving within the casing and, therefore, may not be representative of in-situ waste temperatures. The elevated temperatures recorded at TP-25 are most likely attributable, at least in part, to LFG intrusion associated with a compromised casing seal. The Site is continuing to monitor TP-25. Temperatures remained consistent with previously recorded temperatures.

TP-25
The Site recently conducted a follow-up camera inspection of the TP-25 temperature probe casing to evaluate potential liquid infiltration and assess the condition of the casing interior. The inspection confirmed that no liquid was present at the bottom of the casing. Pressurized landfill gas (LFG) was observed, however, when the probe casing was opened. Based on these observations, the Site believes that the temperature readings at TP-25 may be influenced by LFG entering and moving within the casing and, therefore, may not be representative of in-situ waste temperatures. The elevated temperatures recorded at TP-25 are most likely attributable, at least in part, to LFG intrusion associated with a compromised casing seal. The Site is continuing to monitor TP-25. Temperatures remained consistent with previously recorded temperatures.

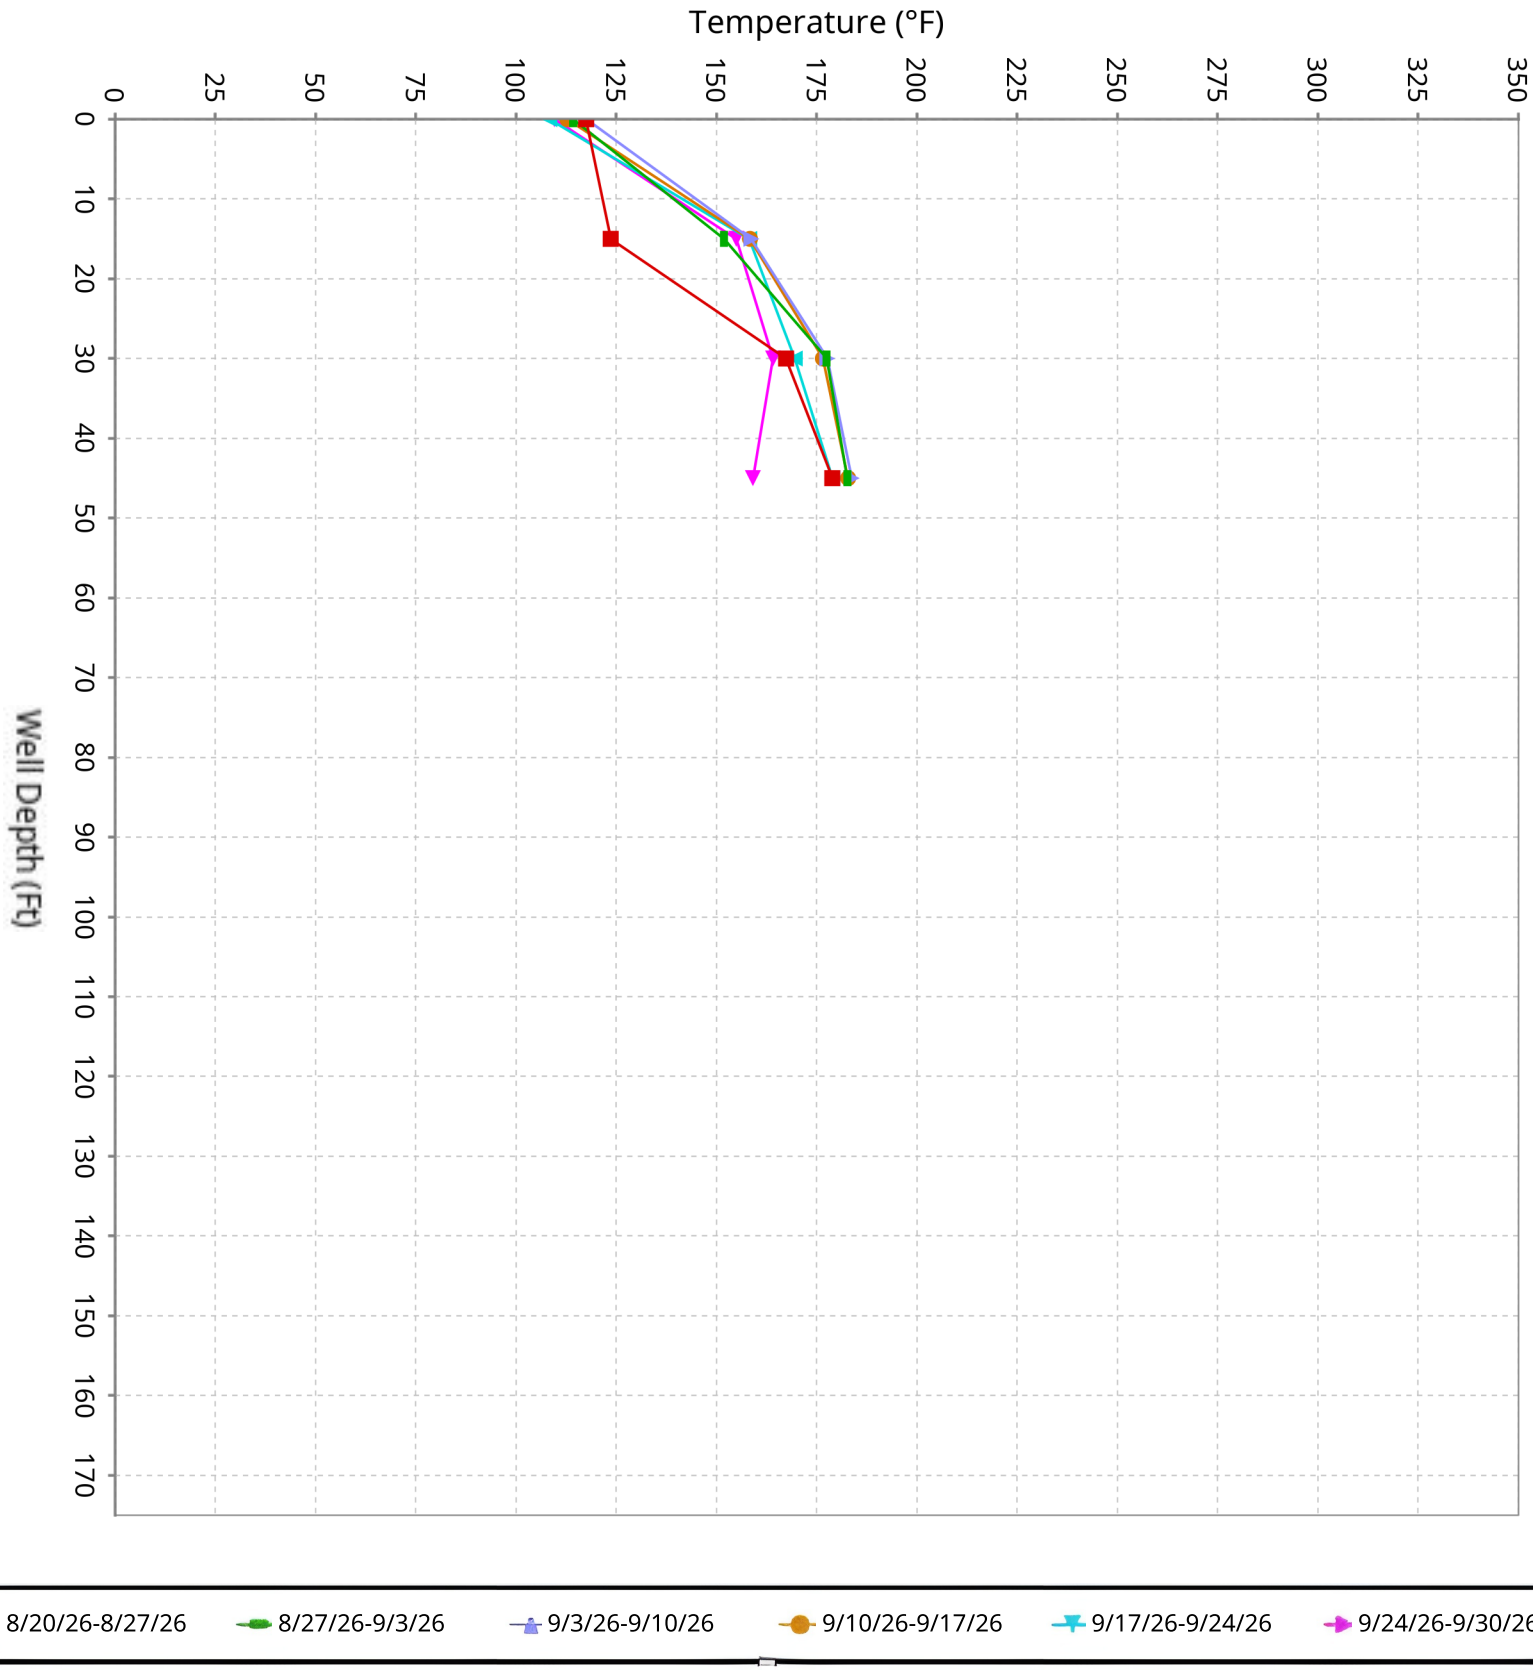
Vertical Temperature Profiles from Temperature Probes at Chiquita Landfill for TP-8

- TP-08
    - The 30-foot and 45-foot thermocouples exhibited temperature increases of 27°F and 29°F, respectively, between July 12, 2026, and July 22, 2026. In response, Site personnel observed the temperature changes and conducted an investigation from July 23, 2026, through July 29, 2026. Following the investigation, temperatures continued to decline at the 30-foot thermocouple from July 30th, 2026, through August 19, 2026, and then temperatures started to increase at the 15, 30, and 45-foot thermocouples from August 20, 2026, through September 12, 2026, then a decrease was observed in the 30 and 45-foot thermocouples from September 12, 2026, through September 16,2026.

- TP-08 is installed within extraction well CV-24079, which is equipped with a liquid extraction pump. The investigation determined that the existing pump is experiencing a power-related issue and requires removal. Site personnel removed the existing pump this week, and cleaned, repaired, reset, and reinstalled it. One potential factor contributing to the observed temperature increase and subsequent decrease is the removal of liquids from wells near TP-08 and in well CV-24079.

TP-08
The 30-foot and 45-foot thermocouples exhibited temperature increases of 27°F and 29°F, respectively, between July 12, 2026, and July 22, 2026. In response, Site personnel observed the temperature changes and conducted an investigation from July 23, 2026, through July 29, 2026. Following the investigation, temperatures continued to decline at the 30-foot thermocouple from July 30th, 2026, through August 19, 2026, and then temperatures started to increase at the 15, 30, and 45-foot thermocouples from August 20, 2026, through September 12, 2026, then a decrease was observed in the 30 and 45-foot thermocouples from September 12, 2026, through September 16,2026.
TP-08 is installed within extraction well CV-24079, which is equipped with a liquid extraction pump. The investigation determined that the existing pump is experiencing a power-related issue and requires removal. Site personnel were able to remove the pump this week, and cleaned, repaired, reset, and reinstalled it. One potential factor contributing to the observed temperature increase and subsequent decrease is the removal of liquids from wells near TP-08 and in well CV-24079.

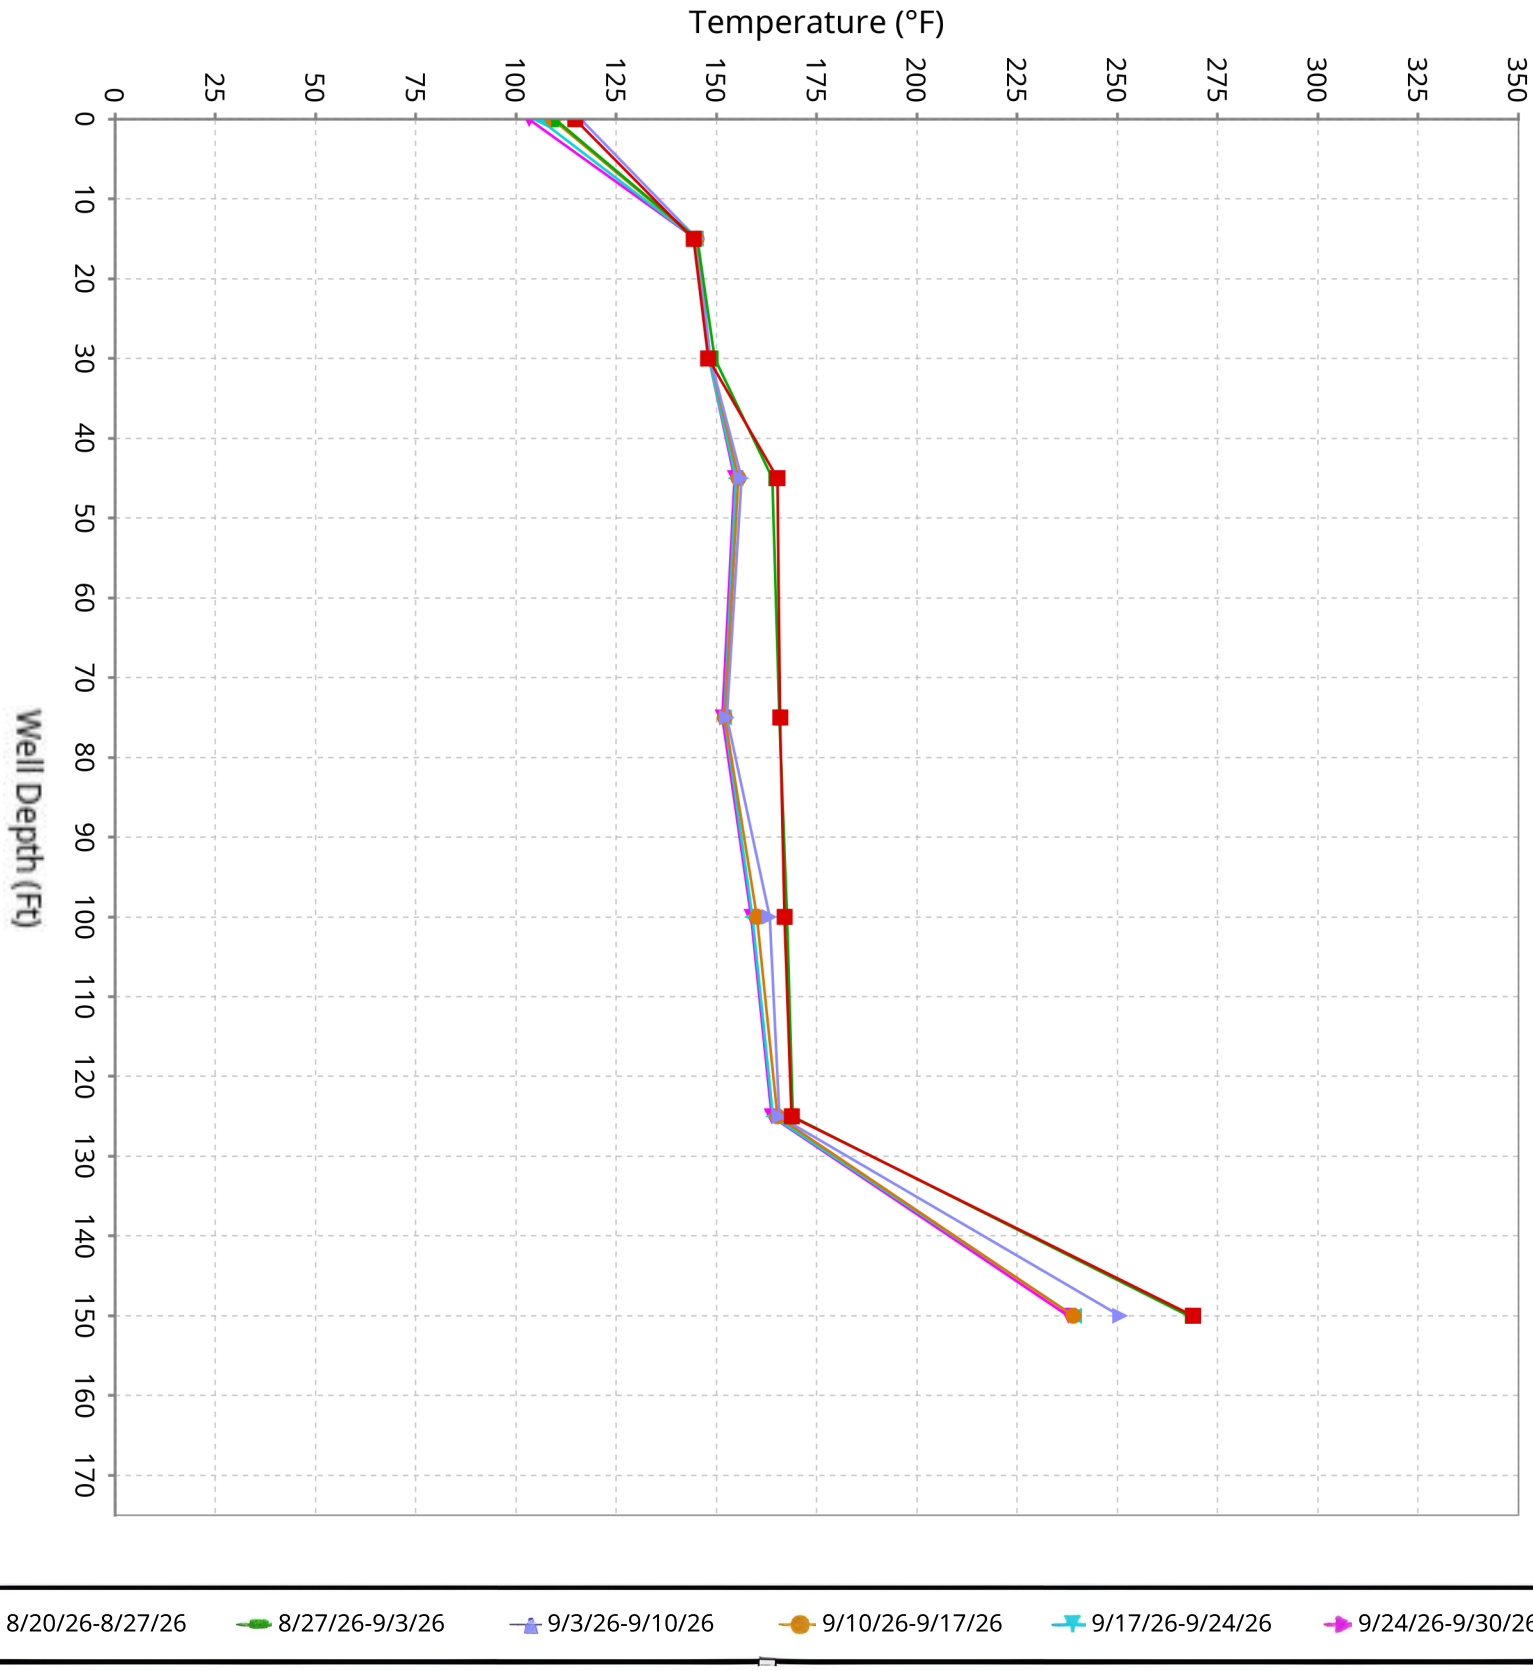
Vertical Temperature Profiles from Temperature Probes at Chiquita Landfill for TP-19

- TP-19
    - A discrepancy was identified during the review of data from six weeks prior. Upon investigation, the Site determined that the associated battery had failed and subsequently replaced it. During this inspection, the temperature reading from the 125-foot thermocouple was observed to be anomalously low. Further evaluation indicated that the 125-foot thermocouple required replacement. As an interim measure, the Site installed a 120-foot thermocouple that was available onsite and ordered a replacement 125-foot thermocouple. The replacement 125-foot thermocouple is anticipated to be installed upon receipt in October 2026.
    - The 150-foot thermocouple showed a decrease in maximum temperature of 15°F from 251°F to 236°F from September 9th to September 14th.

TP-19
A discrepancy was identified during the review of data from six weeks prior. Upon investigation, the Site determined that the associated battery had failed and subsequently replaced it. During this inspection, the temperature reading from the 125-foot thermocouple was observed to be anomalously low. Further evaluation indicated that the 125-foot thermocouple required replacement. As an interim measure, the Site installed a 120-foot thermocouple that was available onsite and ordered a replacement 125-foot thermocouple. The replacement 125-foot thermocouple is anticipated to be installed upon receipt in October 2026.

- TP-19
  - A discrepancy was identified during the review of data from seven weeks prior. Upon investigation, the Site determined that the associated battery had failed and subsequently replaced it. During this inspection, the temperature reading from the 125-foot thermocouple was observed to be anomalously low. Further evaluation indicated that the 125-foot thermocouple required replacement. As an interim measure, the Site installed a 120-foot thermocouple that was available onsite and ordered a replacement 125-foot thermocouple. The replacement 125-foot thermocouple is anticipated to be installed upon receipt in October 2026.
  - The 150-foot thermocouple remained consistent with previously recorded temperatures.

TP-19
A discrepancy was identified during the review of data from seven weeks prior. Upon investigation, the Site determined that the associated battery had failed and subsequently replaced it. During this inspection, the temperature reading from the 125-foot thermocouple was observed to be anomalously low. Further evaluation indicated that the 125-foot thermocouple required replacement. As an interim measure, the Site installed a 120-foot thermocouple that was available onsite and ordered a replacement 125-foot thermocouple. The replacement 125-foot thermocouple is anticipated to be installed upon receipt in October 2026.

- TP-19
  - A discrepancy was identified during the review of data from seven weeks prior. Upon investigation, the Site determined that the associated battery had failed and subsequently replaced it. During this inspection, the temperature reading from the 125-foot thermocouple was observed to be anomalously low. Further evaluation indicated that the 125-foot thermocouple required replacement. As an interim measure, the Site installed a 120-foot thermocouple that was available onsite and ordered a replacement 125-foot thermocouple. The replacement 125-foot thermocouple is anticipated to be installed upon receipt in October 2026.

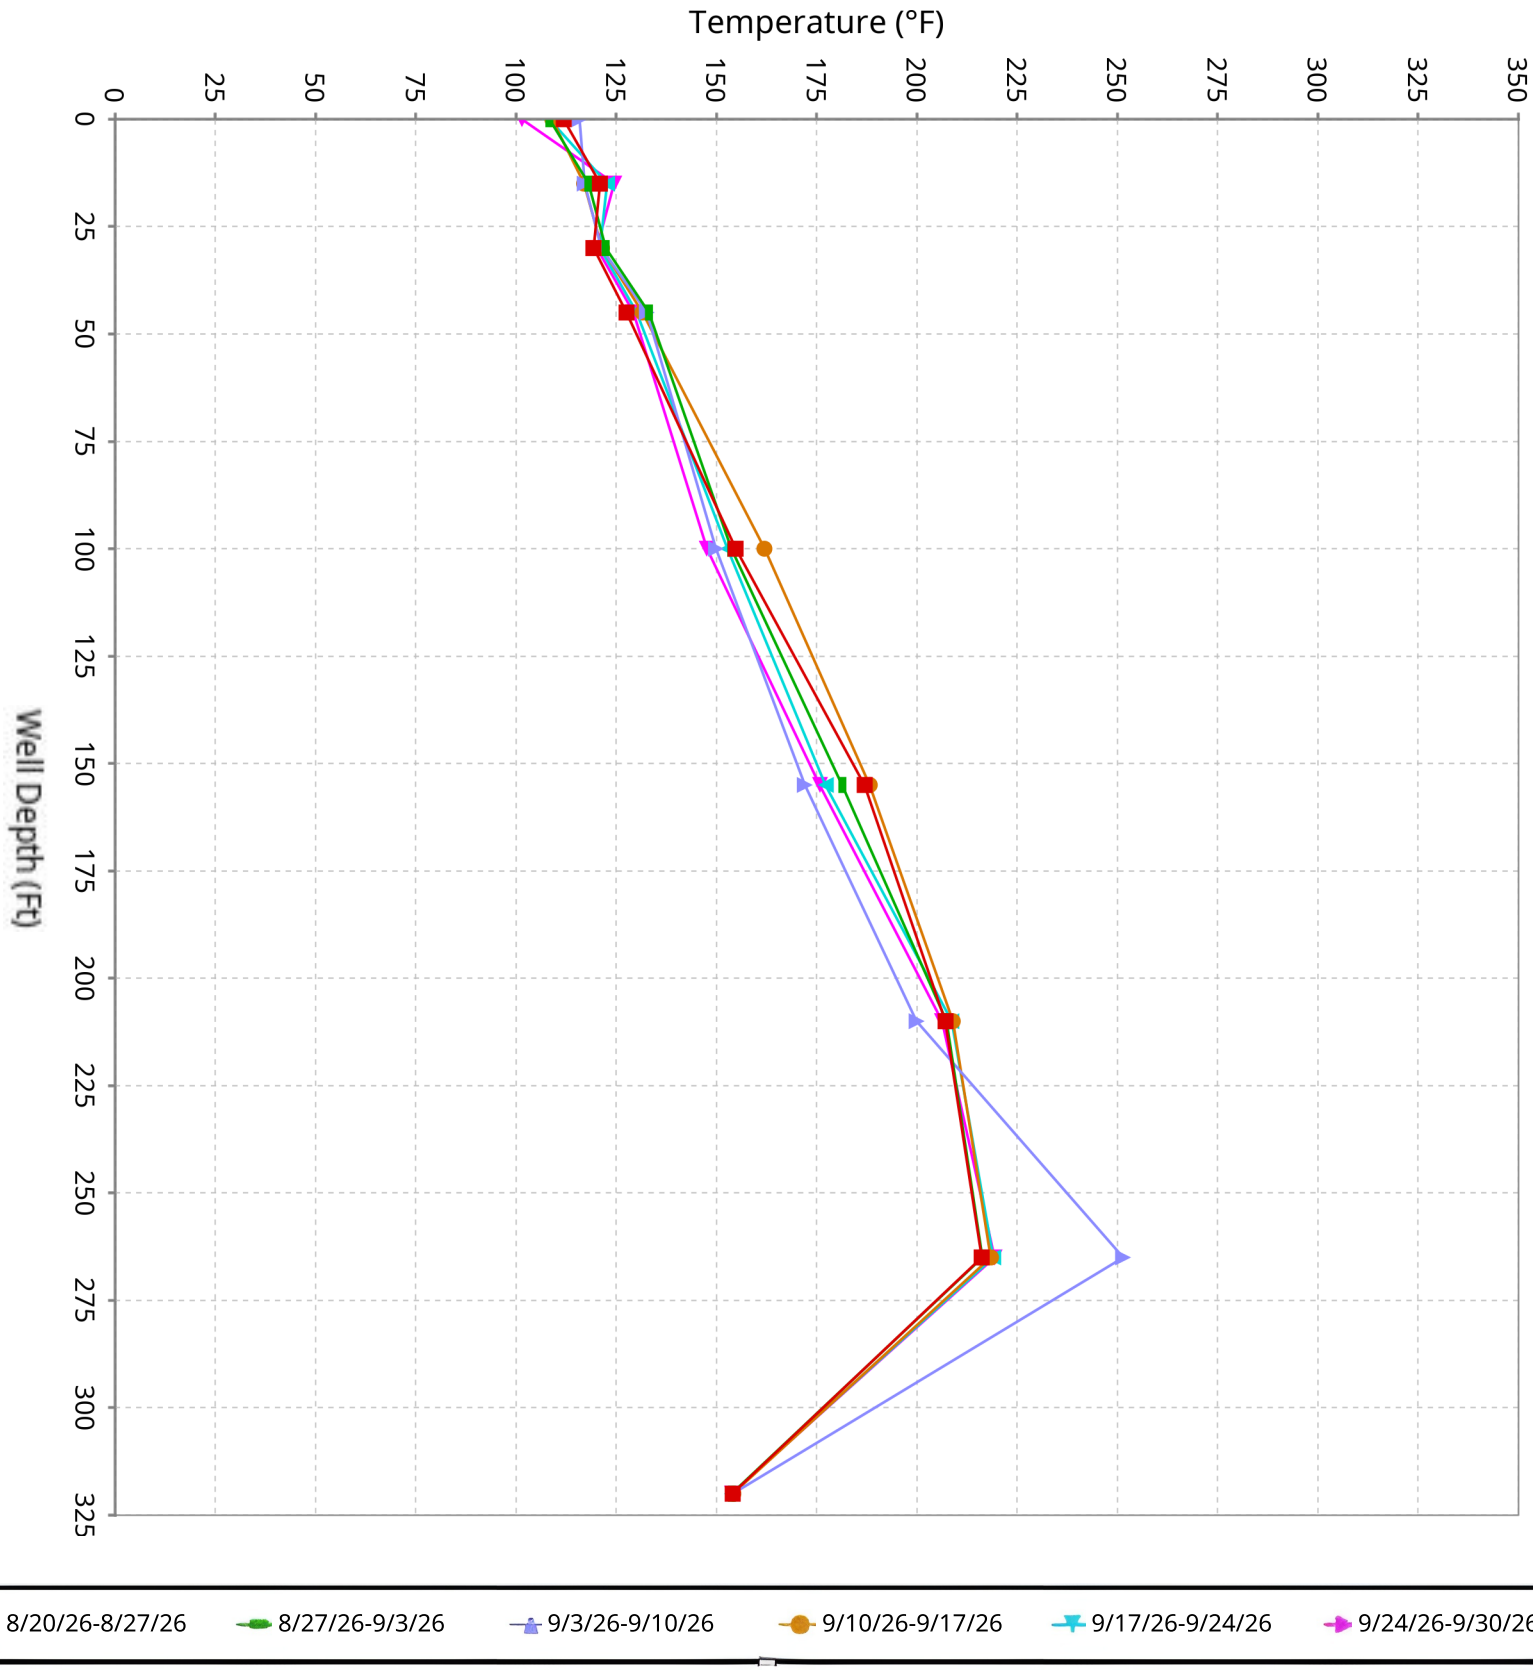
Vertical Temperature Profiles from Temperature Probes at Chiquita Landfill for TP-24

TP-24
Potential factors contributing to the observed temperature increase is the flow changes in the wellfield and removal of liquids from wells near TP-24.

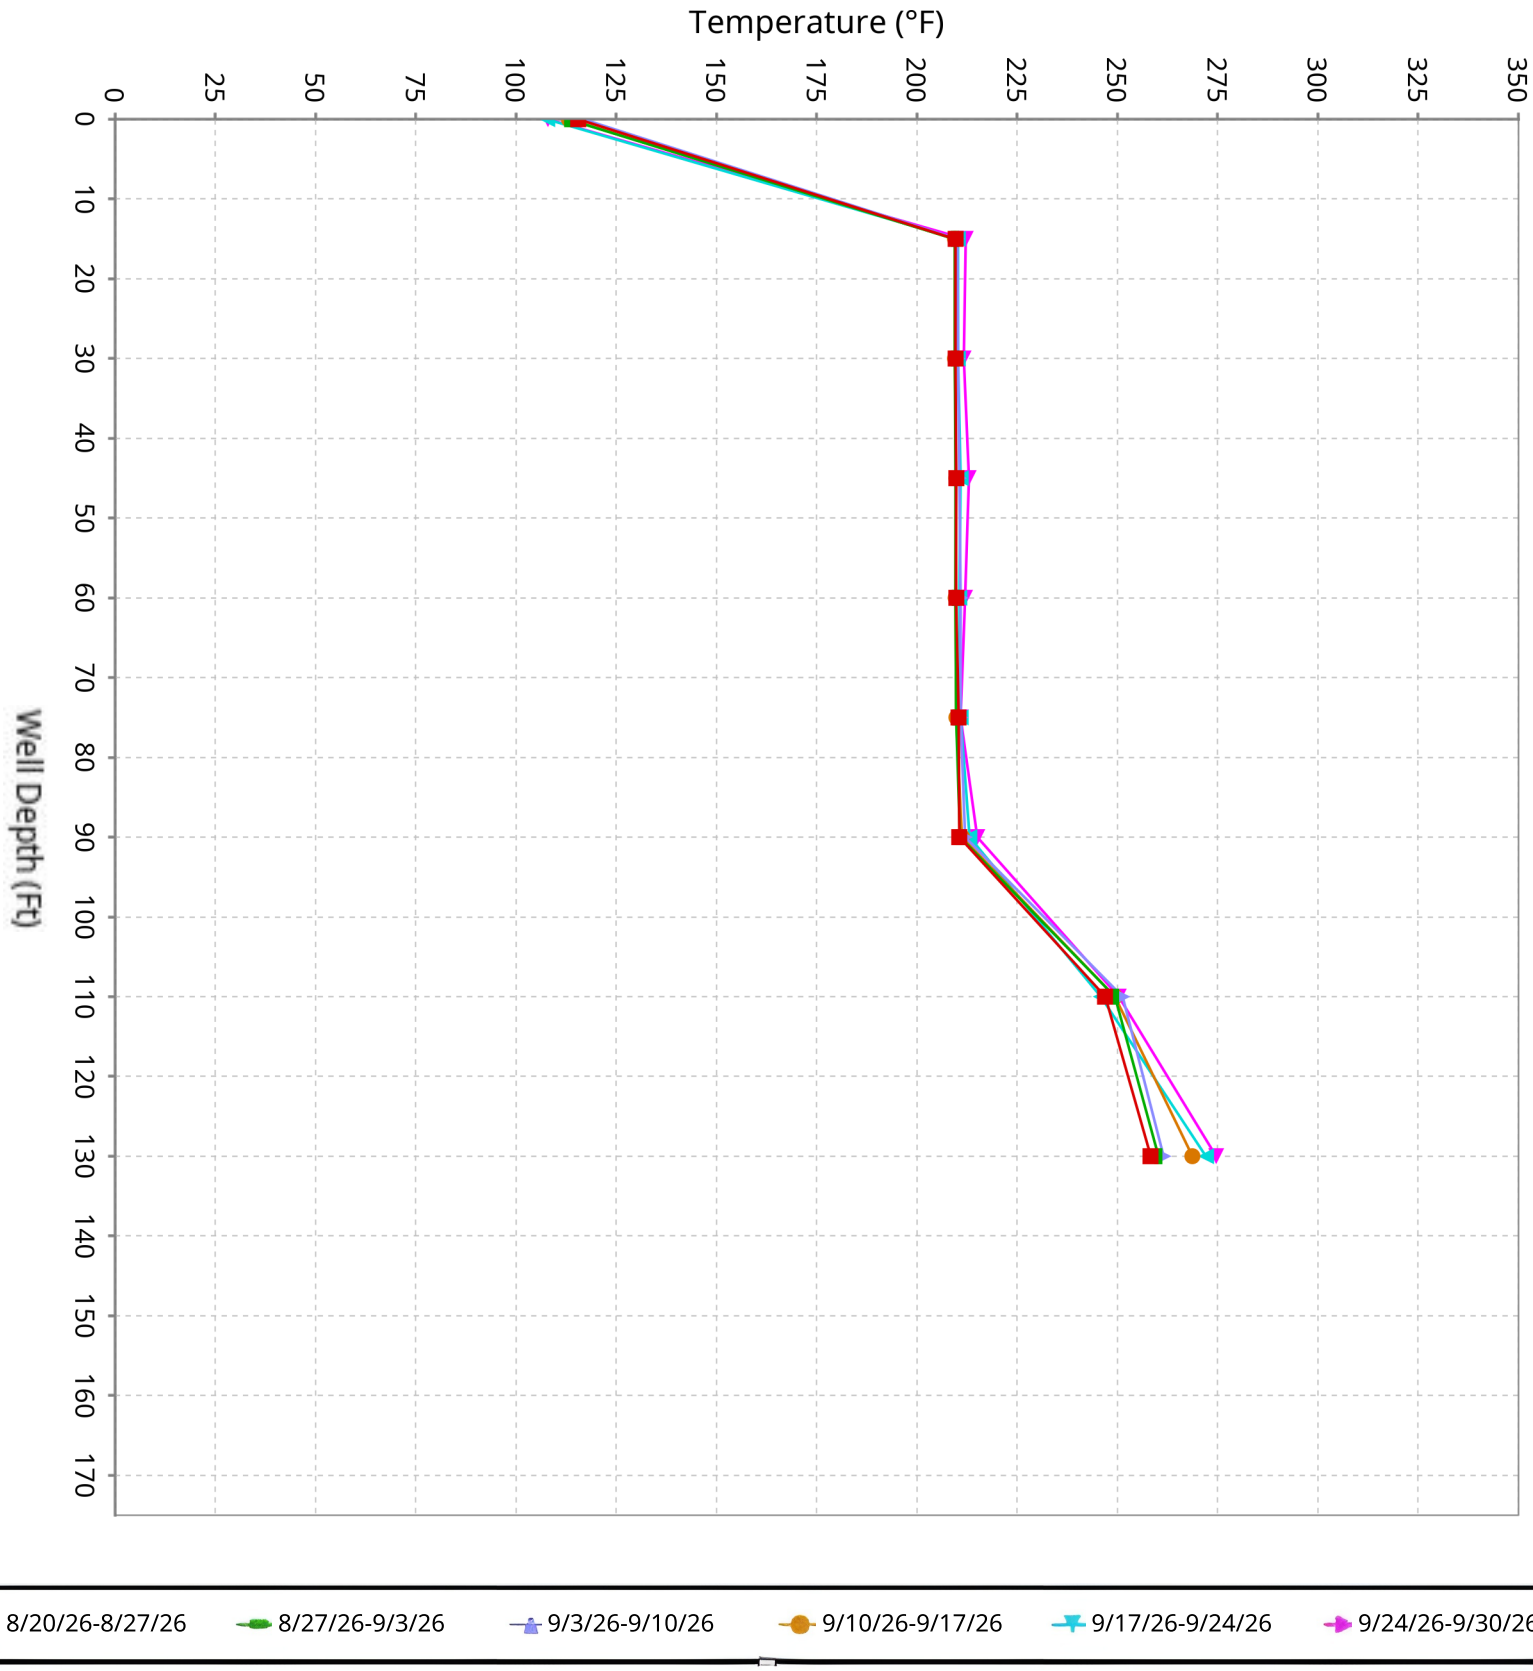
Vertical Temperature Profiles from Temperature Probes at Chiquita Landfill for TP-25

TP-25
The Site recently conducted a follow-up camera inspection of the TP-25 temperature probe casing to evaluate potential liquid infiltration and assess the condition of the casing interior. The inspection confirmed that no liquid was present at the bottom of the casing. Pressurized landfill gas (LFG) was observed, however, when the probe casing was opened. Based on these observations, the Site believes that the temperature readings at TP-25 may be influenced by LFG entering and moving within the casing and, therefore, may not be representative of in-situ waste temperatures. The elevated temperatures recorded at TP-25 are most likely attributable, at least in part, to LFG intrusion associated with a compromised casing seal. The Site is continuing to monitor TP-25 and evaluate the condition of the probe casing and is assessing appropriate next steps to address the observed conditions and obtain reliable in-situ waste temperature measurements.

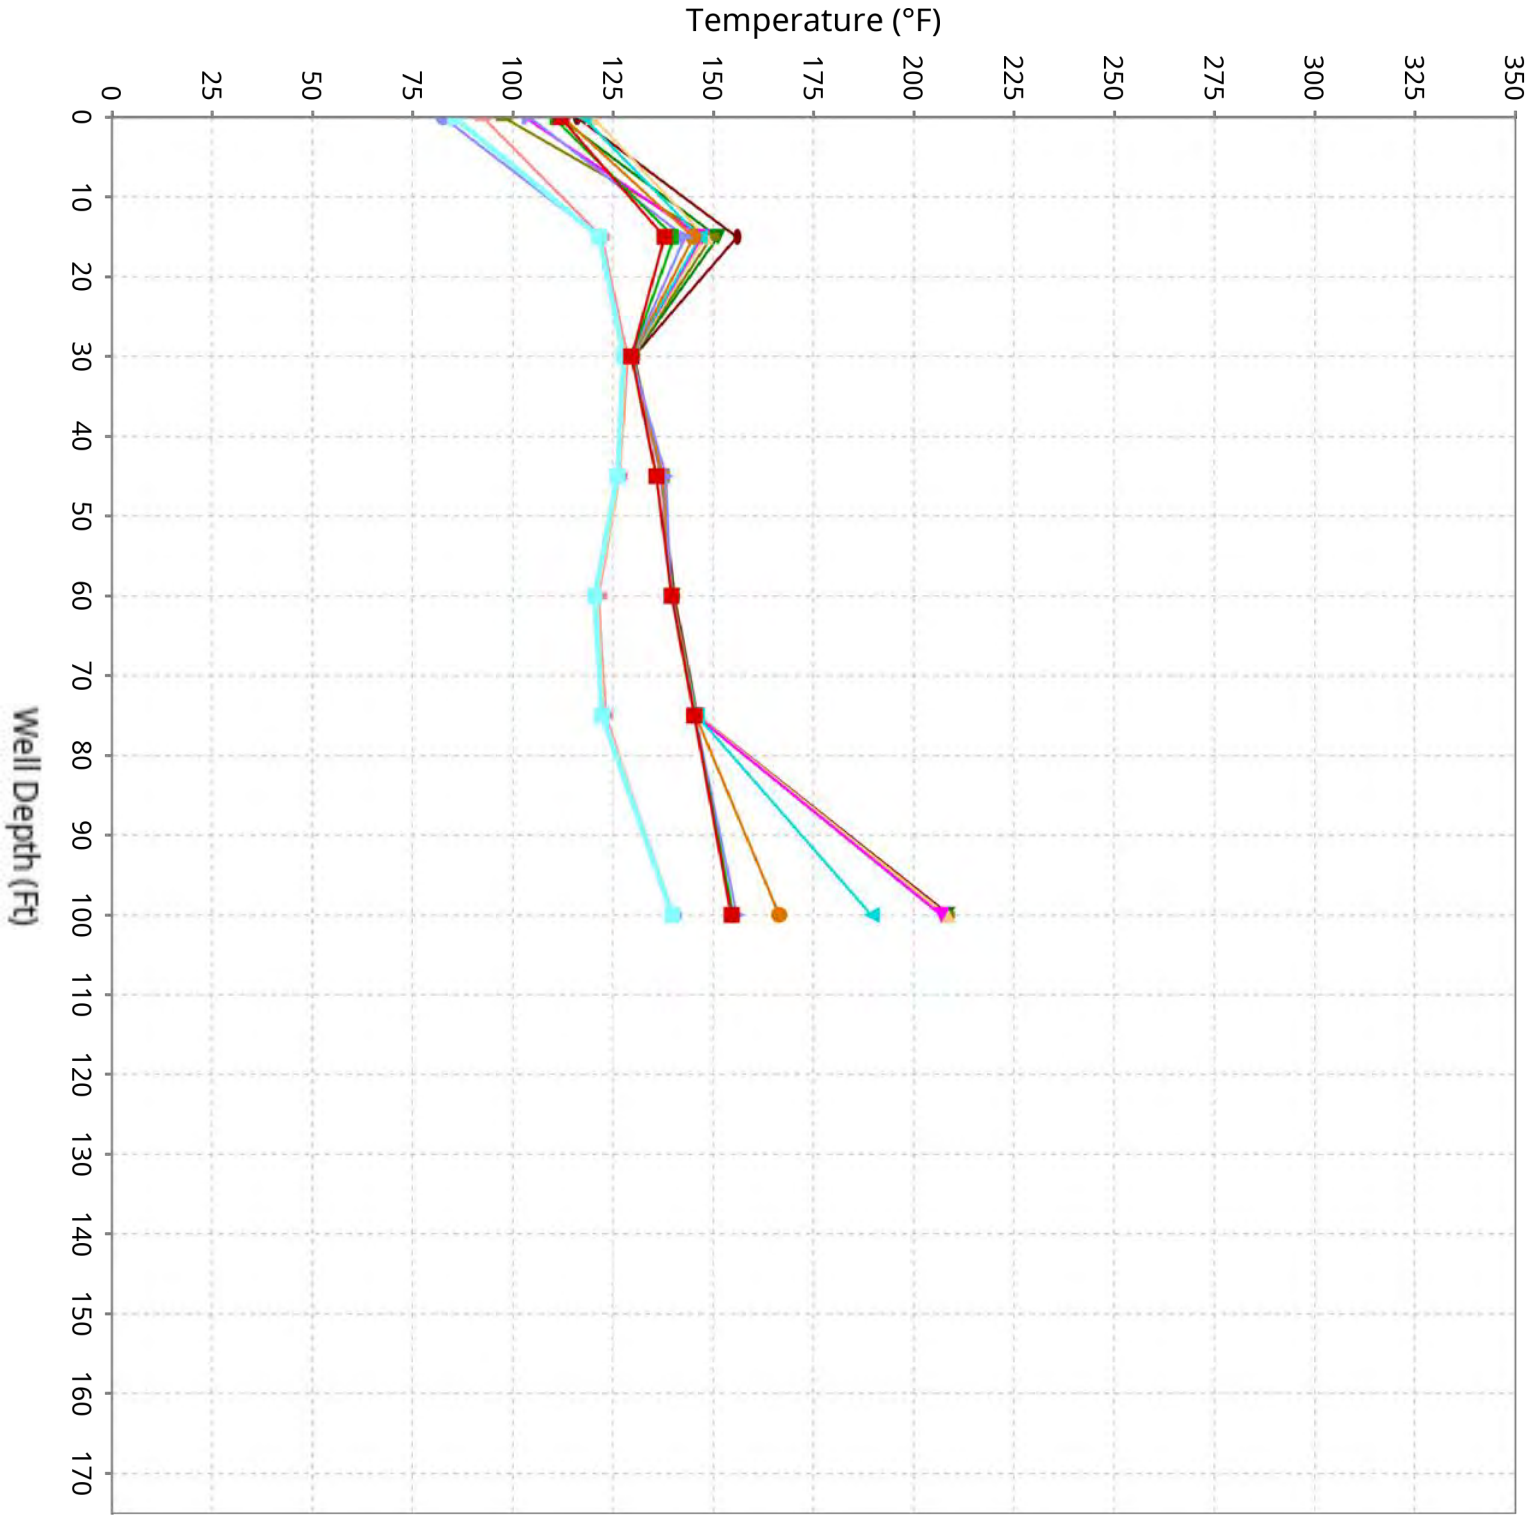
Vertical Temperature Profiles from Temperature Probes at Chiquita Landfill for TP-7

TP-07
One potential factor contributing to the observed temperature increase is the removal of liquids from wells near TP-07.
