SCS ENGINEERS

October 15, 2026

Subject: **September 2026 Monthly Report Pursuant to Milestones 1A-3 and 5 of the LEA June 6, 2024 Compliance Order and July 30, 2024 Letter, Chiquita Canyon Landfill, Castaic, California**

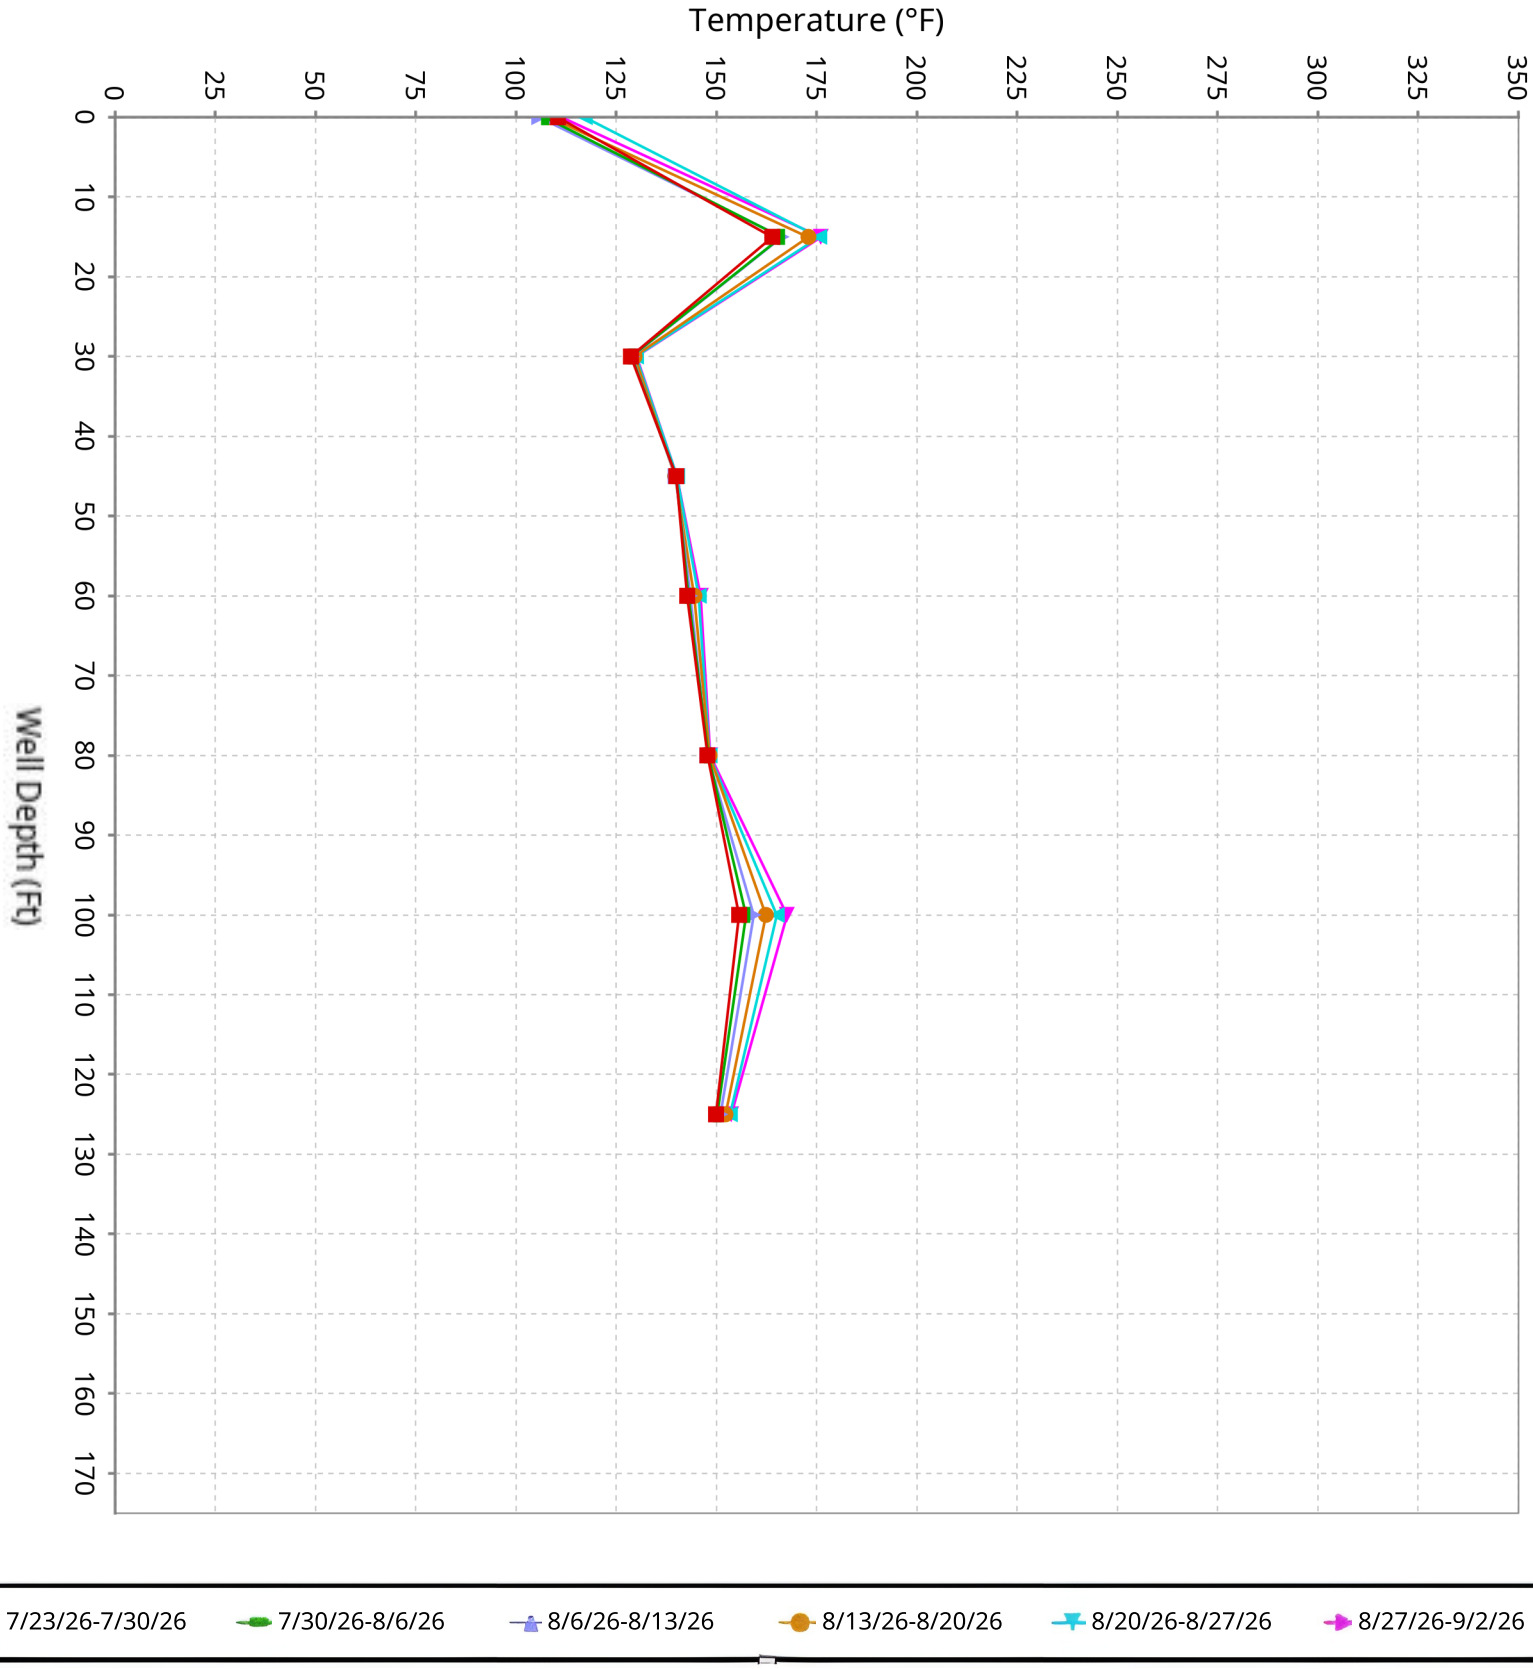
- The 45-foot thermocouple showed an increase in maximum temperature of 21°F from 162°F to 183°F from August 21st to September 2nd.

- TP-19
    - A discrepancy was identified during the review of data from five weeks prior. Upon investigation, the Site determined that the associated battery had failed and subsequently replaced it. During this inspection, the temperature reading from the 125-foot thermocouple was observed to be anomalously low. Further evaluation indicated that the 125-foot thermocouple required replacement. As an interim measure, the Site installed a 120-foot

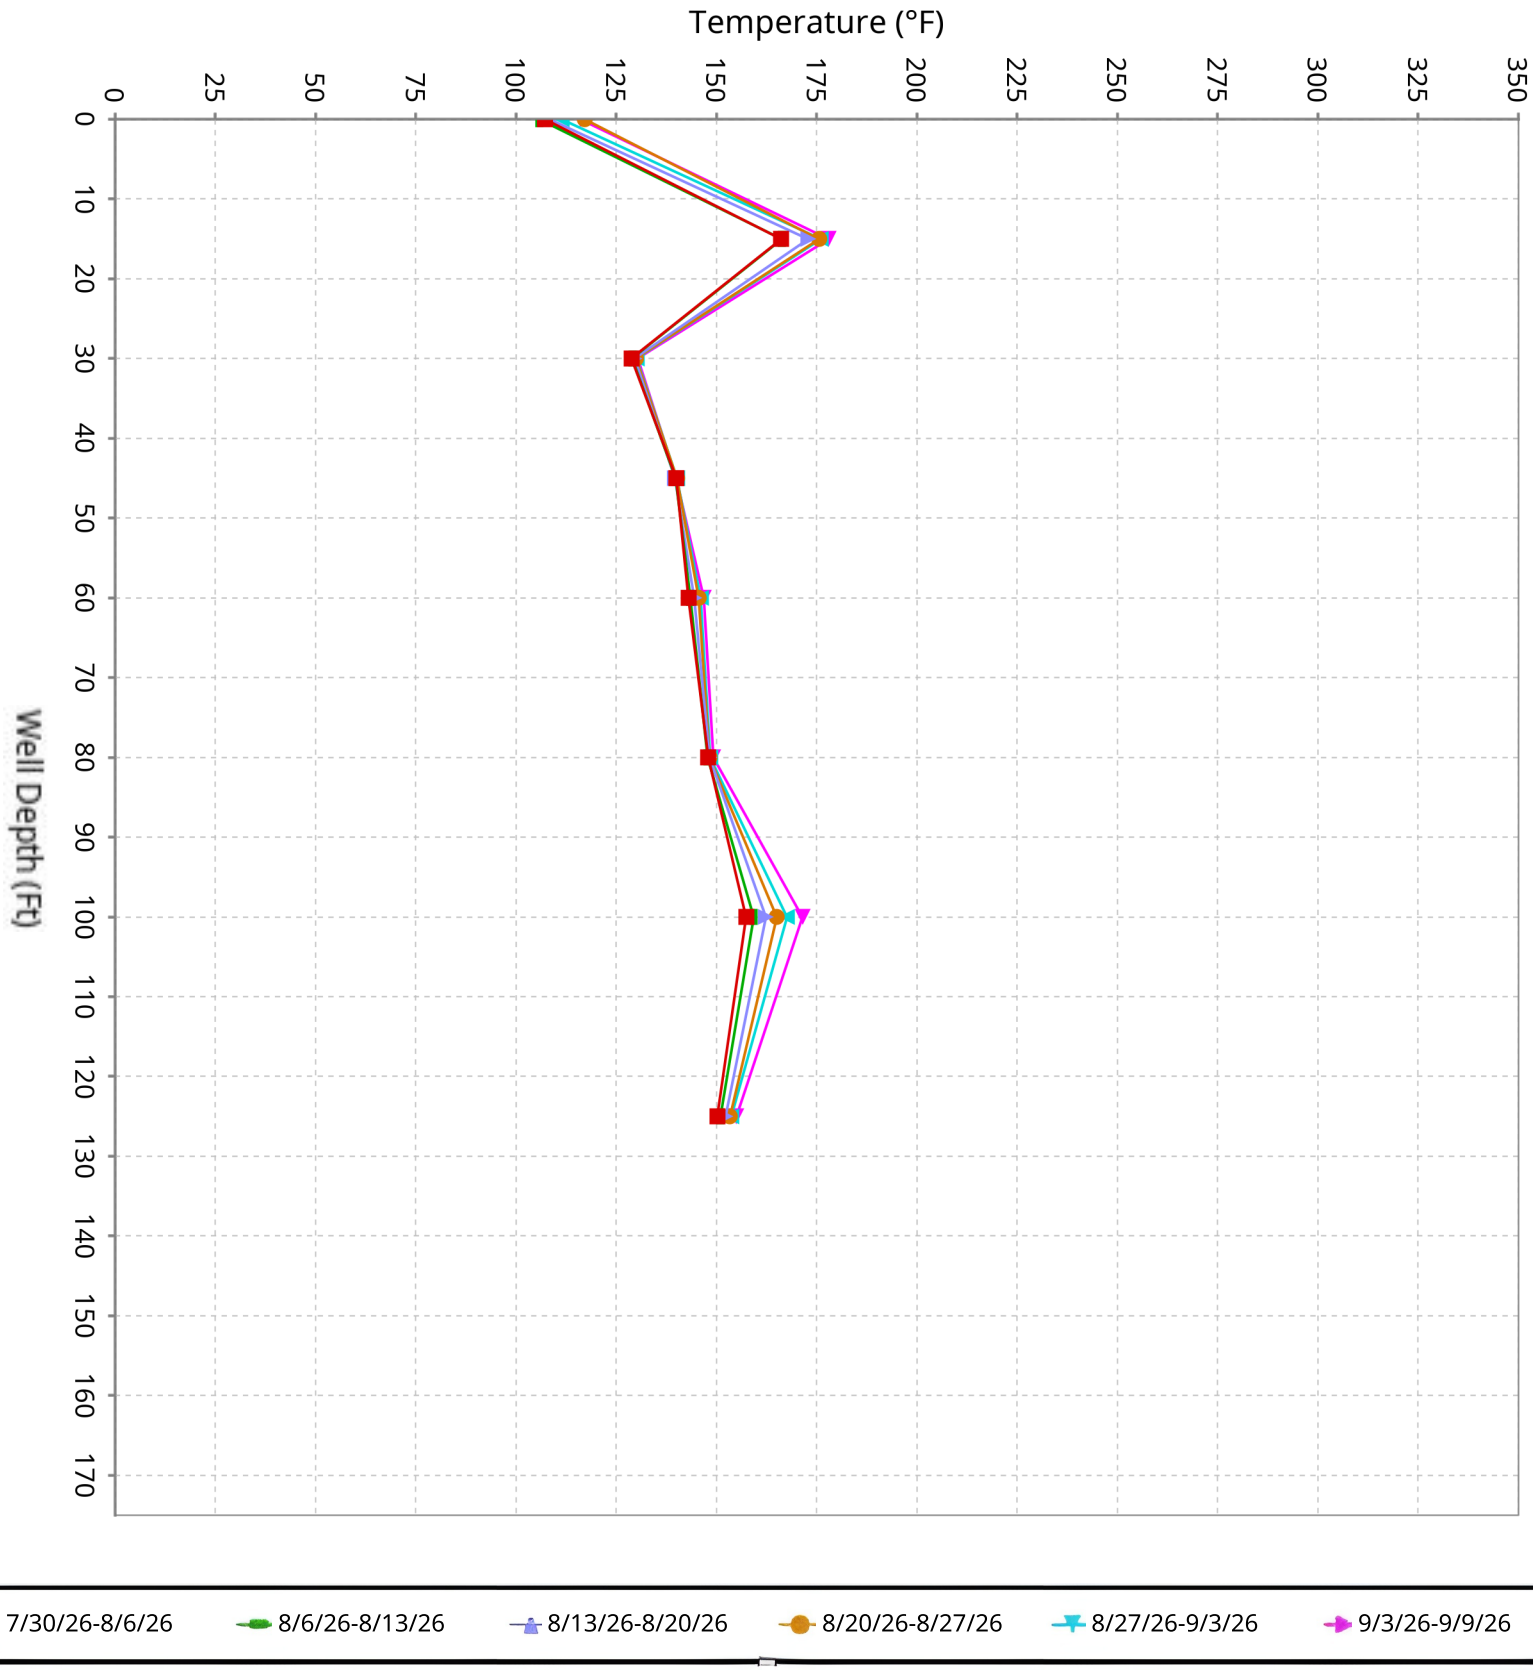
reading from the 125-foot thermocouple was observed to be anomalously low. Further evaluation indicated that the 125-foot thermocouple required replacement. As an interim measure, the Site installed a 120-foot thermocouple that was available onsite and ordered a replacement 125-foot thermocouple. The replacement 125-foot thermocouple is anticipated to be installed upon receipt in October 2026.
    - The 75-foot thermocouple remained consistent with previously recorded temperatures.
    - The 150-foot thermocouple showed an increase in maximum temperature of 13°F from 238°F to 251°F from September 3rd to September 9th.

- TP-24
    - The 265-foot thermocouple showed an increase in maximum temperature of 34°F from 217°F to 251°F from September 6th to September 7th, and then a decrease in maximum temperature of 34°F from 251°F to 217°F from September 7th to September 8th. Potential factors contributing to the observed temperature increase are the flow changes in the wellfield and removal of liquids from wells near TP-24.

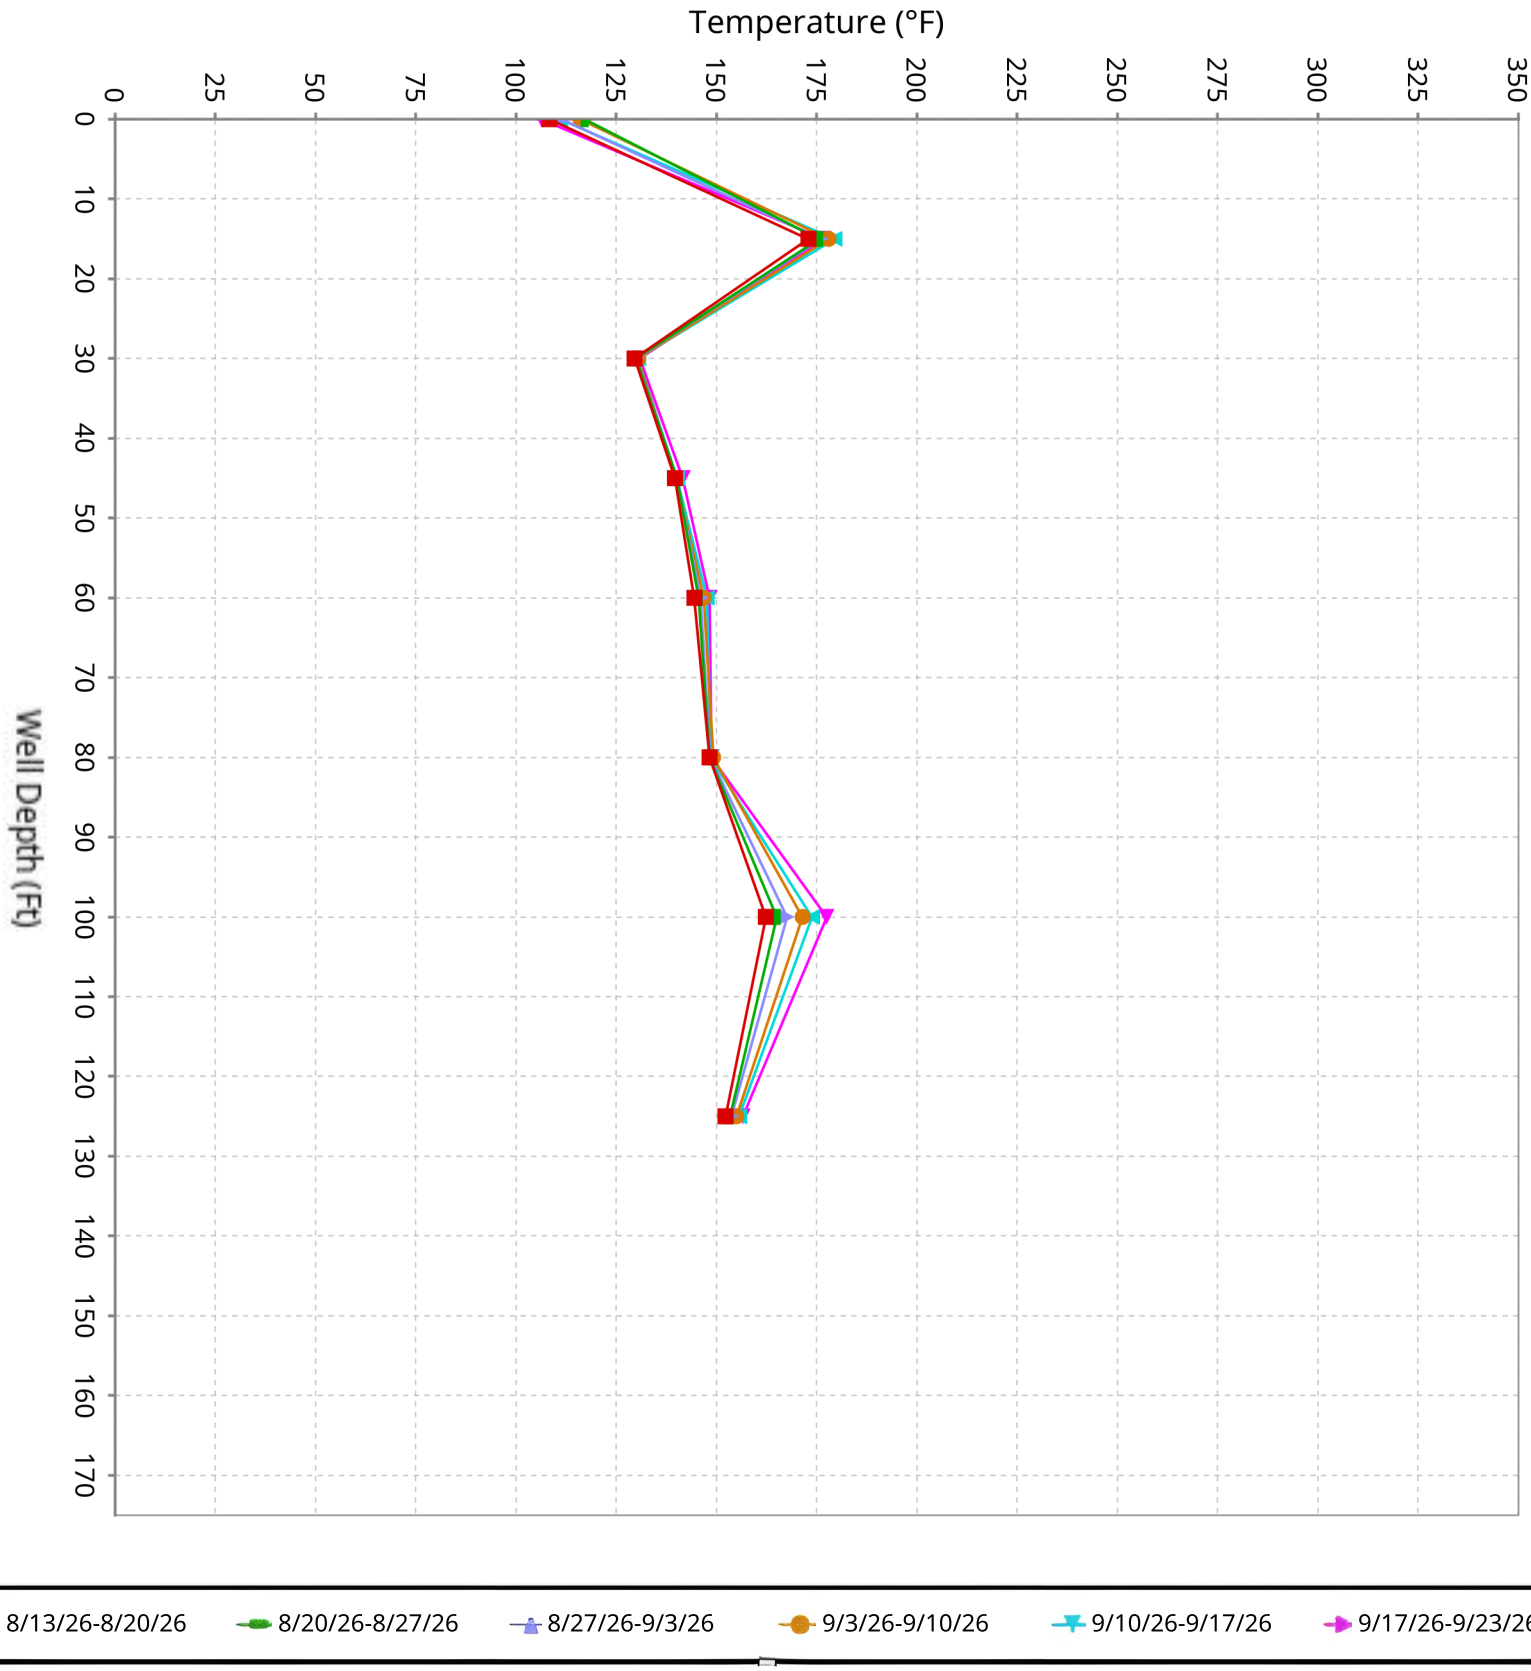
- TP-13
  - The 100-foot thermocouple showed an increase in maximum temperature of 12°F from 161°F to 173°F from September 18th to September 23rd.

- TP-19
  - A discrepancy was identified during the review of data from seven weeks prior. Upon investigation, the Site determined that the associated battery had failed and subsequently replaced it. During this inspection, the temperature reading from the 125-foot thermocouple was observed to be anomalously low. Further evaluation indicated that the 125-foot thermocouple required replacement. As an interim measure, the Site installed a 120-foot thermocouple that was available onsite and ordered a replacement 125-foot thermocouple. The replacement 125-foot thermocouple is anticipated to be installed upon receipt in October 2026.
  - The 150-foot thermocouple remained consistent with previously recorded temperatures.

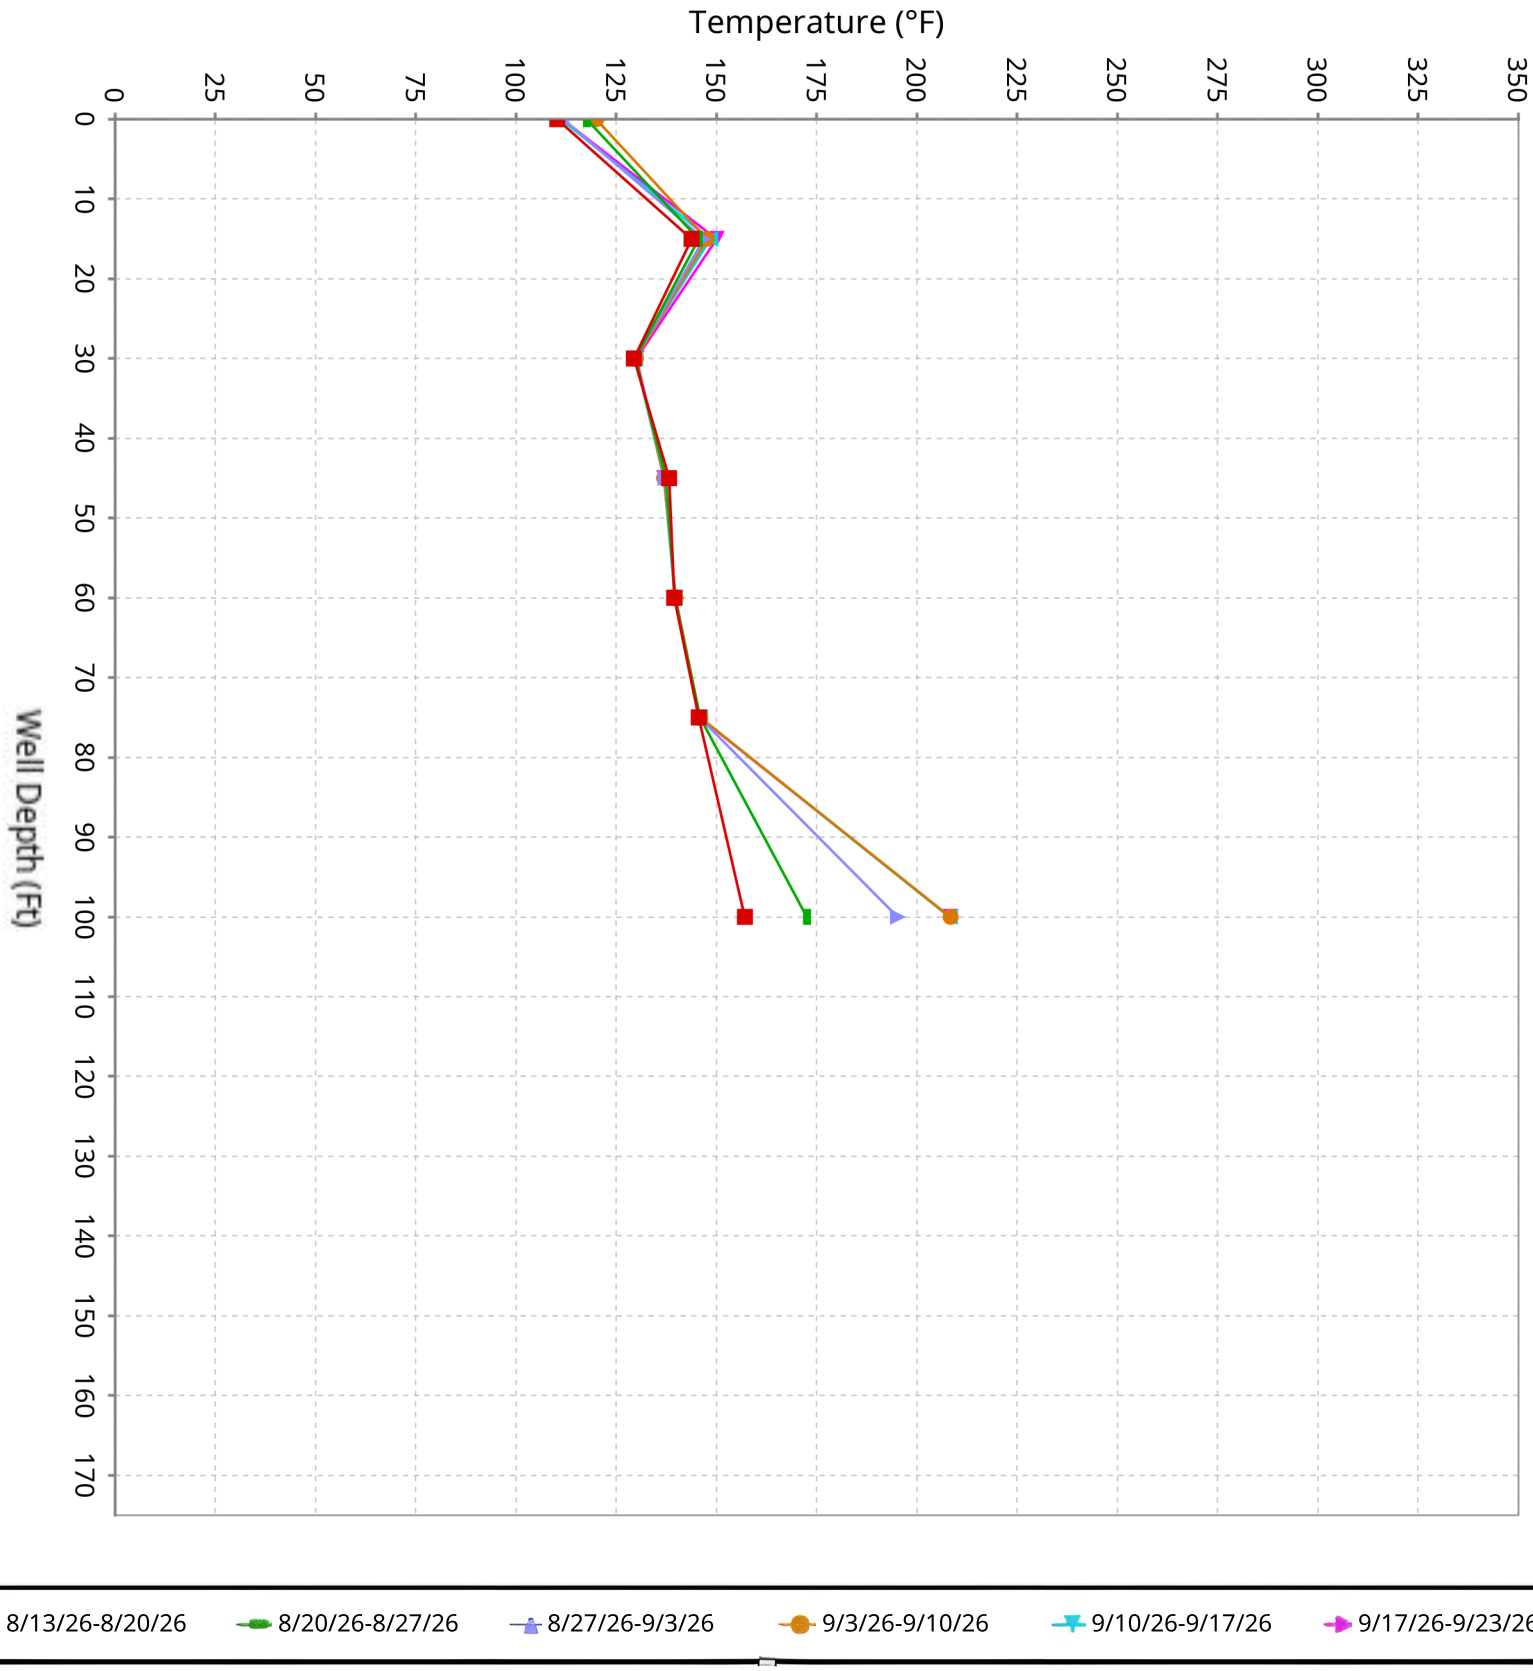
Vertical Temperature Profiles from Temperature Probes at Chiquita Landfill for TP-7

- TP-07
    - The 100-foot thermocouple showed an increase in maximum temperature of 48°F from 160°F to 208°F from August 21st to September 9th. One potential factor contributing to the observed temperature increase is the removal of liquids from wells near TP-07.

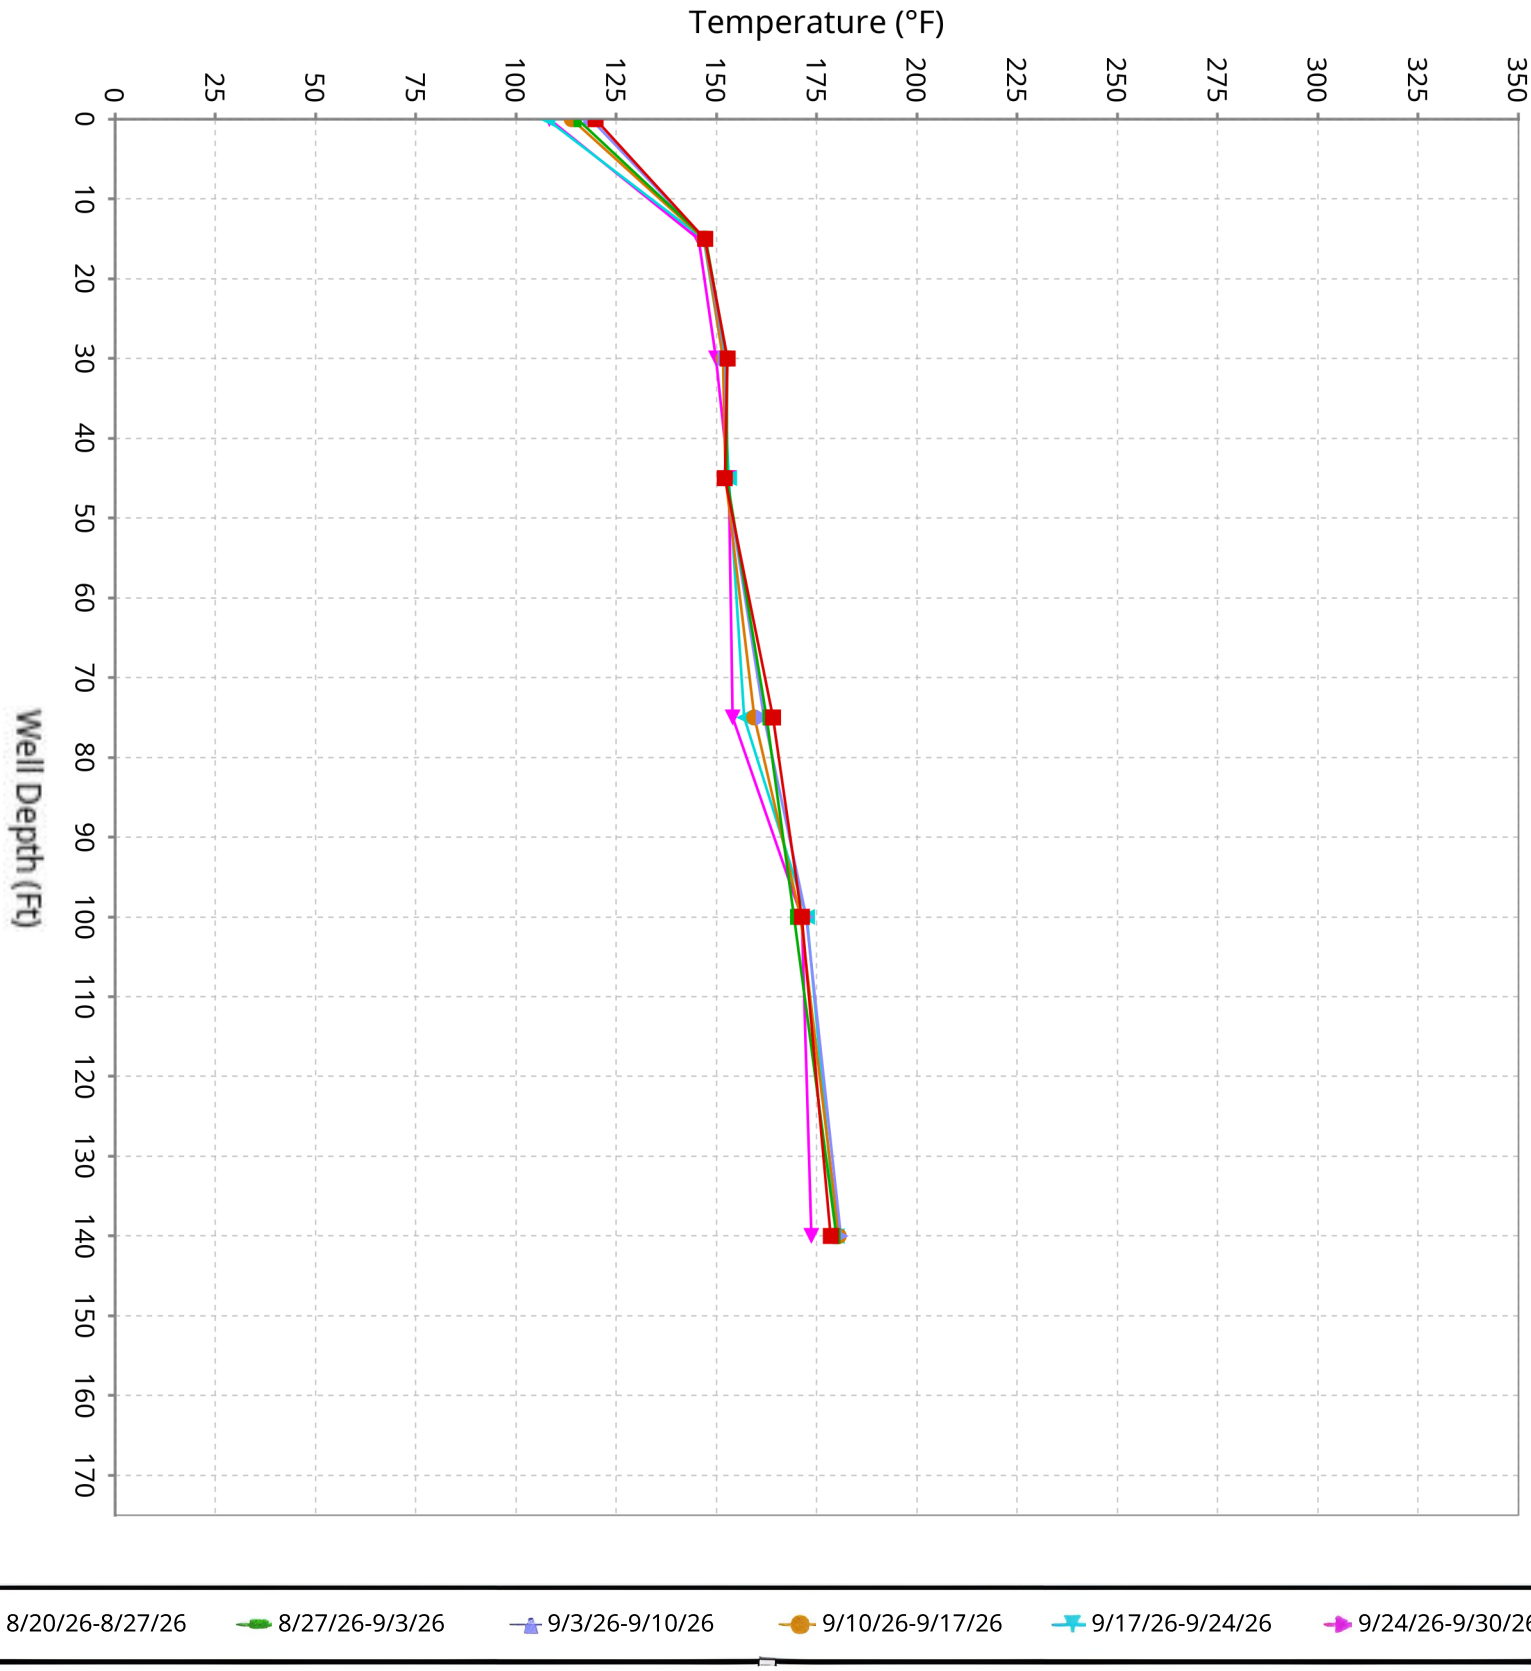
Vertical Temperature Profiles from Temperature Probes at Chiquita Landfill for TP-13

- TP-13
  - The 100-foot thermocouple remained consistent with previously recorded temperatures.
