October 20, 2026
File No. 01204123.42, Task 10

Subject: September 2026 Monthly Report for Modified Stipulated Order for Abatement (Case No. 6177-4), Chiquita Canyon Landfill (Facility ID 119219), Castaic, California

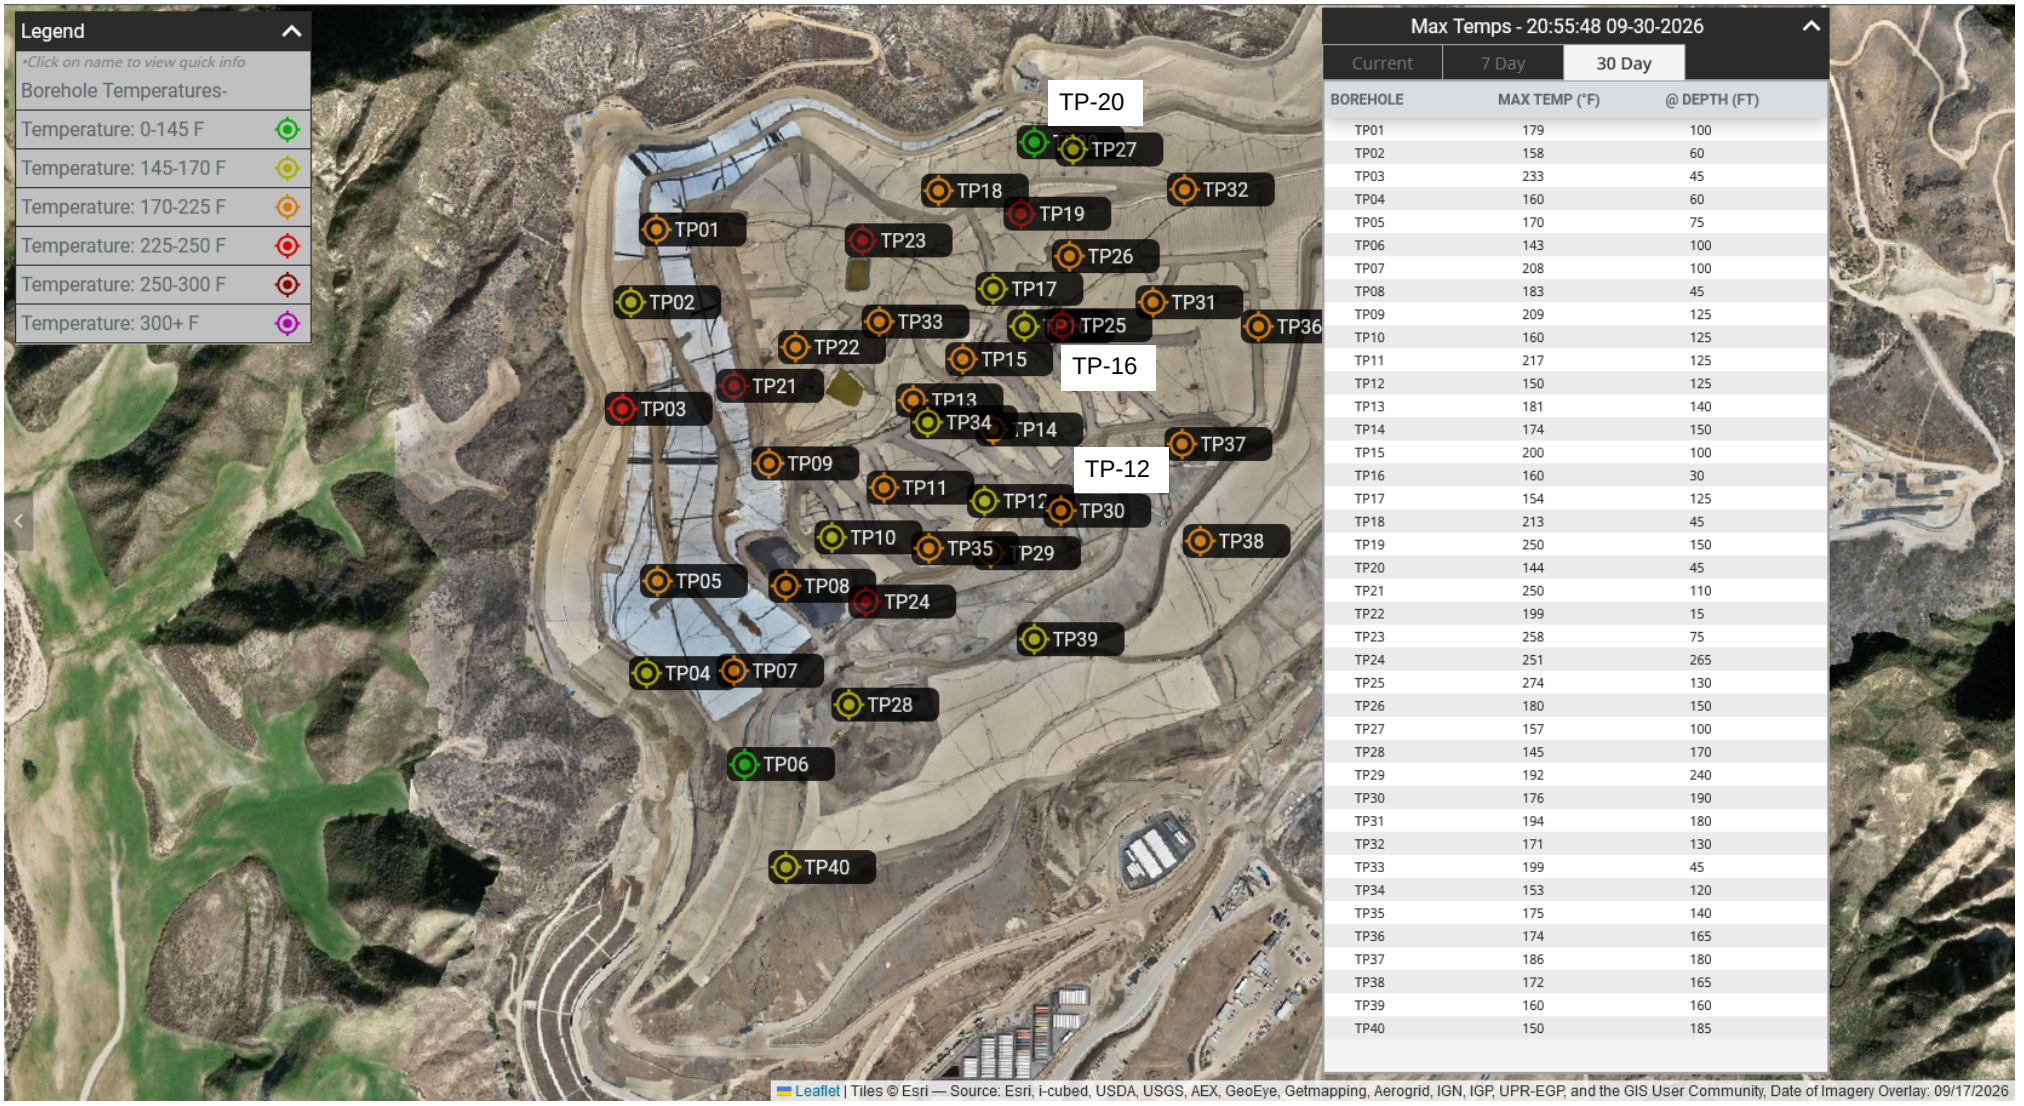
Thirty Day Maximum Vertical Temperature Map from Temperature Probes at Chiquita Landfill

Max Temps - 20:55:48 09-30-2026

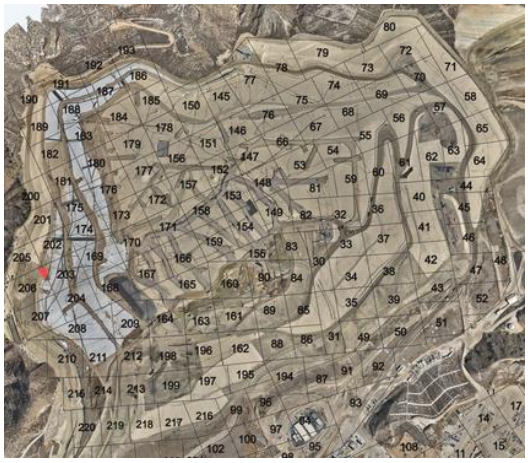
Photo 2

Leachate seep/pooling Inspection 2

Dirt added and a piece of liner put in place to contain seep.
