20 de octubre de 2026
Archivo No. 01204123.42, Tarea 10

Asunto: Informe Mensual de Septiembre de 2026 de la Orden de Depuración Estipulada Modificada (Caso No. 6177-4), Vertedero de Chiquita Canyon (Código de Centro 119219), Castaic, California

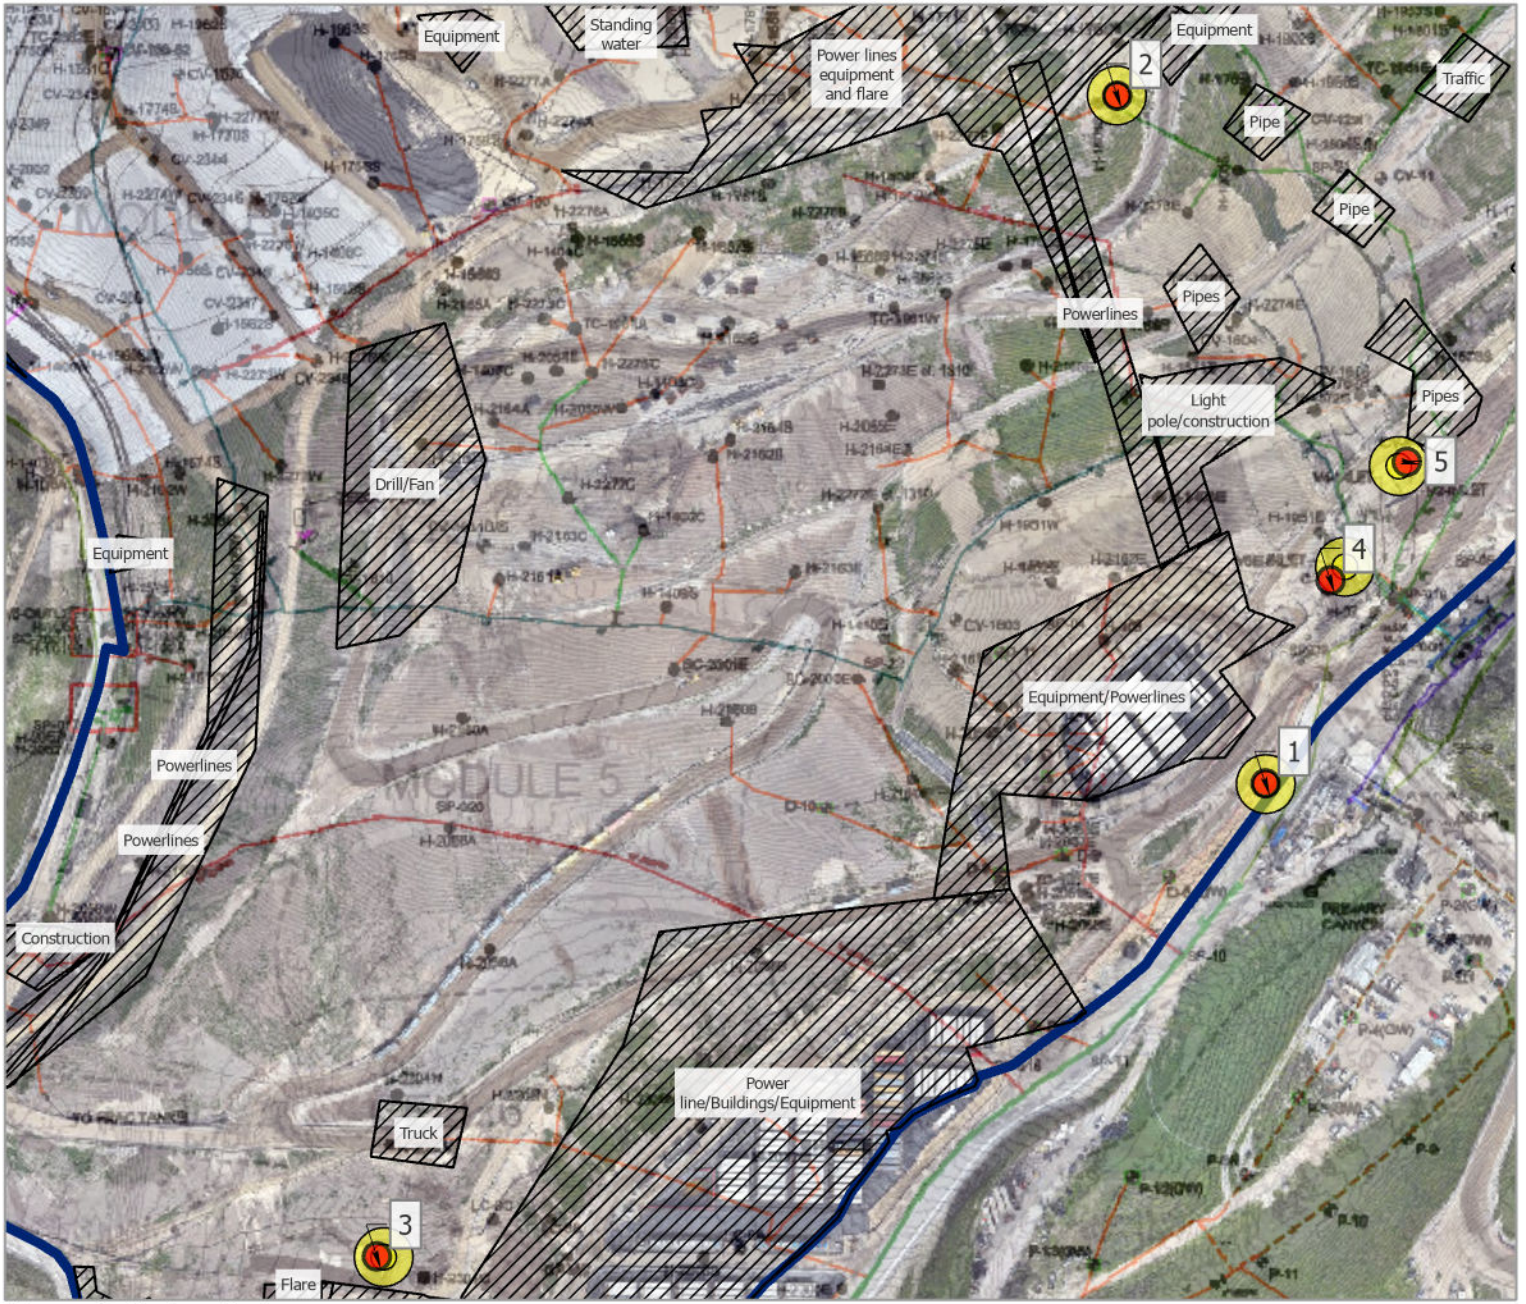
This map provides an overview of all increased meter readings of methane, or "Drone Flight Peaks", over the course of the inspection and the manual verification measurements taken at each peak.

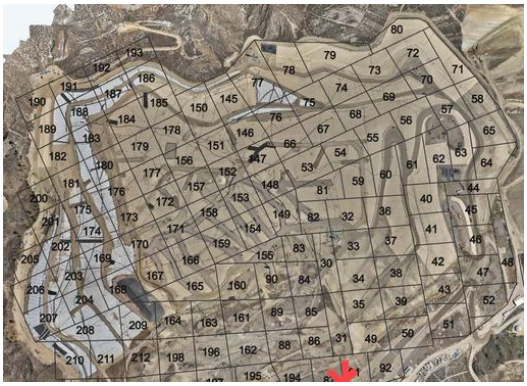
Brian W. Fung
Laboratory Director

Leachate Seep Inspection	
Leachate seep/pooling Inspection	
Leachate seep/pooling Inspection 1	
Has a leachate seep/pooling been located?	Yes
Which grid is the leachate seep/pooling located?	94

Drop Pin to record lat/long of seep/pooling location.	Castaic CA 91384 United States (34.43103202156213, -118.64536455843471)
Time seep/pooling was discovered	31 Aug 2026 7:53 AM PDT
Estimated duration of presence of leachate at such location	8 hours
Estimated quantity of leachate	1-5 gallons
Extent of area impacted (approximate sq ft impacted)	12 sq ft
Odor type	Leachate

Odor intensity	1 - Very Light Odor Detected
Surrounding soil saturation level	Saturated

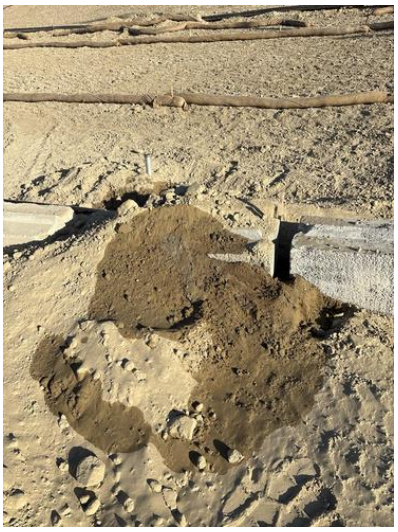
Photo 2

Did the seep/pooling travel into the stormwater channel?	No

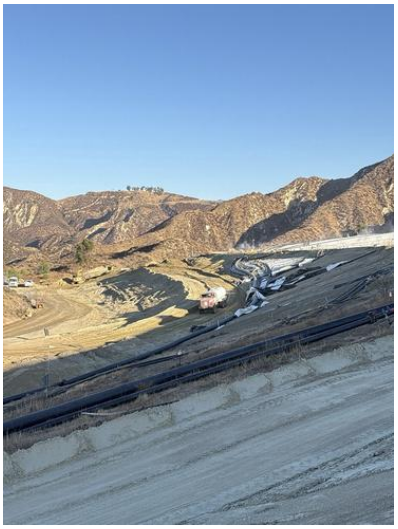
Photo 1

Description of area in photo where there is no leachate seepage or pooling.	Westside perimeter road. None of the seepage previously observed in this area were observed at the time of this inspection. Permanent repairs are being conducted to contain seepage in this area as well.

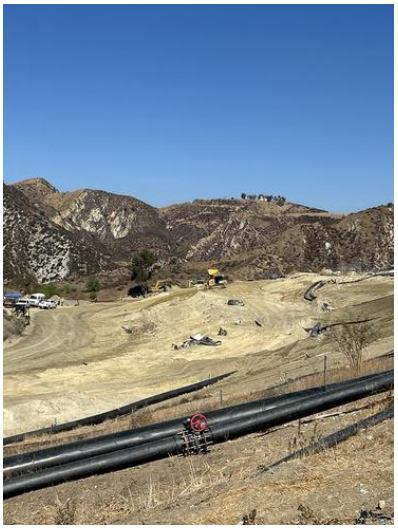
Photo 1

Description of area in photo where there is no leachate seepage or pooling.	Westside perimeter road. None of the seepage previously observed in this area were observed at the time of this inspection. Permanent repairs are being conducted to contain seepage in this area as well.

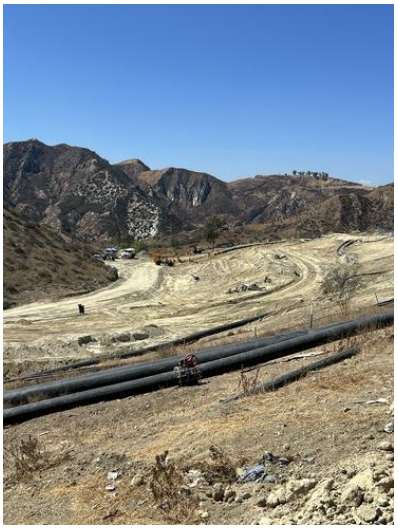
Photo 1

Description of area in photo where there is no leachate seepage or pooling.	Westside perimeter road. None of the seepage previously observed in this area were observed at the time of this inspection. Permanent repairs are being conducted to contain seepage in this area as well.

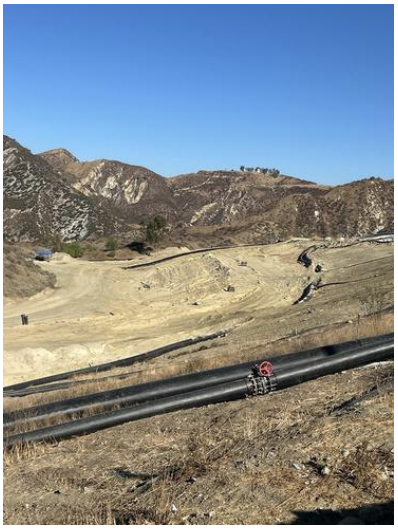
Photo 1

Description of area in photo where there is no leachate seepage or pooling.	Westside perimeter road. None of the seepage previously observed in this area were observed at the time of this inspection. Permanent repairs are being conducted to contain seepage in this area as well.

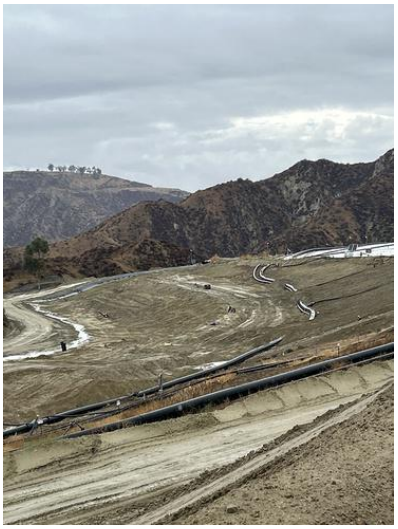
Photo 1

Description of area in photo where there is no leachate seepage or pooling.	Westside perimeter road. None of the seepage previously observed in this area were observed at the time of this inspection. Permanent repairs are being conducted to contain seepage in this area as well.

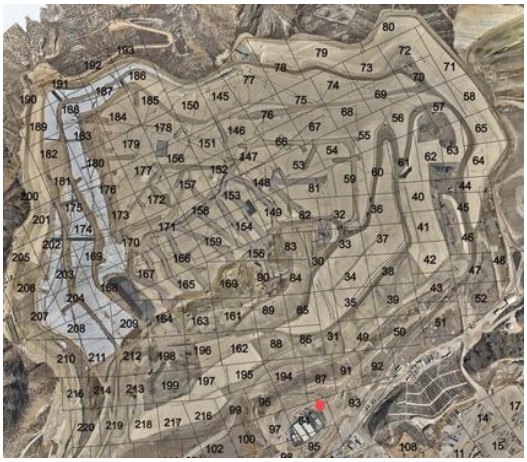
Leachate Seep Inspection	
Leachate seep/pooling Inspection	
Leachate seep/pooling Inspection 1	
Has a leachate seep/pooling been located?	Yes
Which grid is the leachate seep/pooling located?	94

Drop Pin to record lat/long of seep/pooling location.	Castaic CA 91384 United States (34.43109548536677, -118.64515220812355)
Time seep/pooling was discovered	8 Sep 2026 8:05 AM PDT
Estimated duration of presence of leachate at such location	5 hours
Estimated quantity of leachate	1-5 gallons
Extent of area impacted (approximate sq ft impacted)	16 sq ft
Odor type	Leachate
Odor intensity	1 - Very Light Odor Detected
Surrounding soil saturation level	Standing free liquid

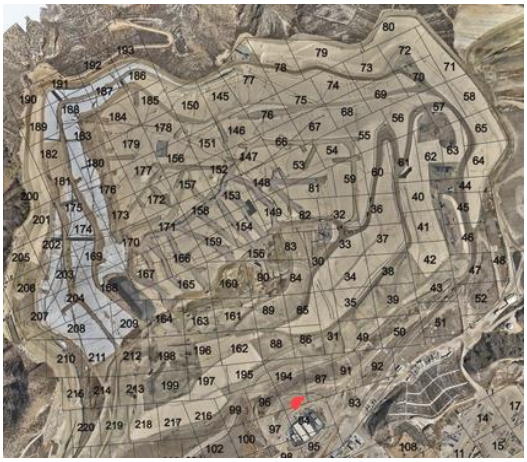
Leachate Seep Inspection	
Leachate seep/pooling Inspection	
Leachate seep/pooling Inspection 1	
Has a leachate seep/pooling been located?	Yes
Which grid is the leachate seep/pooling located?	194

Drop Pin to record lat/long of seep/pooling location.	Castaic CA 91384 United States (34.429721642482185, -118.64545066355299)
Time seep/pooling was discovered	9 Sep 2026 1:06 PM PDT
Estimated duration of presence of leachate at such location	5 hours
Estimated quantity of leachate	11-20 gallons
Extent of area impacted (approximate sq ft impacted)	35 sq ft
Odor type	Leachate
Odor intensity	2 - Light Odor Detected
Surrounding soil saturation level	Standing free liquid

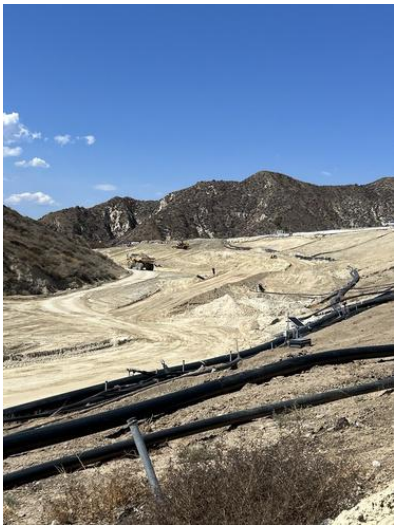
Photo 1

Description of area in photo where there is no leachate seepage or pooling.	Westside perimeter road. None of the seepage previously observed in this area were observed at the time of this inspection. Permanent repairs are being conducted to contain seepage in this area as well.

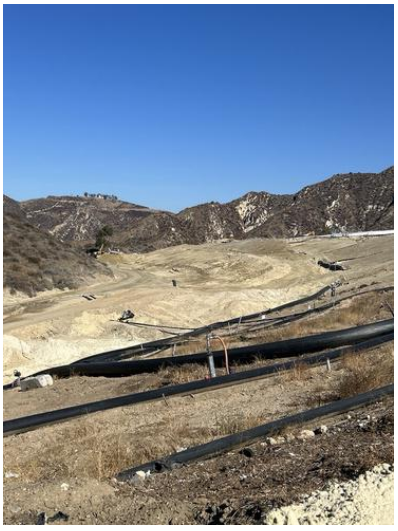
Photo 1

Description of area in photo where there is no leachate seepage or pooling.	Westside perimeter road. None of the seepage previously observed in this area were observed at the time of this inspection. Permanent repairs are being conducted to contain seepage in this area as well.

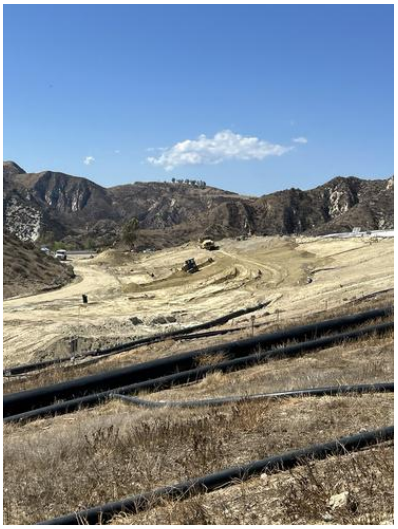
Photo 1

Description of area in photo where there is no leachate seepage or pooling.	Westside perimeter road. None of the seepage previously observed in this area were observed at the time of this inspection. Permanent repairs are being conducted to contain seepage in this area as well.

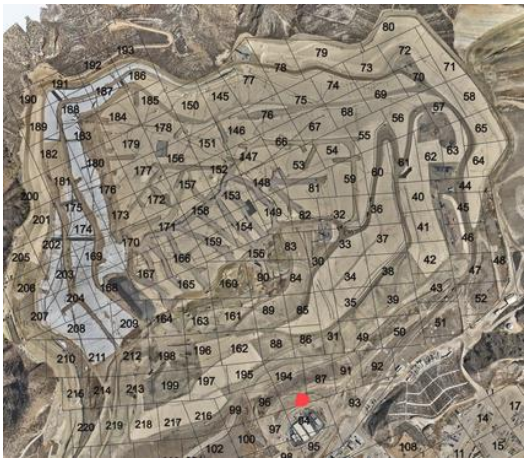
Leachate Seep Inspection	
Leachate seep/pooling Inspection	
Leachate seep/pooling Inspection 1	
Has a leachate seep/pooling been located?	Yes
Which grid is the leachate seep/pooling located?	194

Drop Pin to record lat/long of seep/pooling location.	Castaic CA 91384 United States (34.43099405154067, -118.6455685739579)
Time seep/pooling was discovered	13 Sep 2026 7:27 AM PDT
Estimated duration of presence of leachate at such location	4 hours
Estimated quantity of leachate	6-10 gallons
Extent of area impacted (approximate sq ft impacted)	16 sqft
Odor type	Leachate
Odor intensity	2 - Light Odor Detected
Surrounding soil saturation level	Standing free liquid

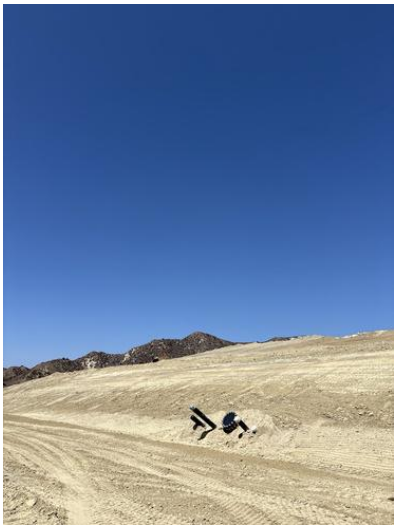
Photo 1

Description of area in photo where there is no leachate seepage or pooling.	Westside perimeter road. None of the seepage previously observed in this area were observed at the time of this inspection. Permanent repairs are being conducted to contain seepage in this area as well. The seep observed this morning in grid 194 was not observed during this inspection.

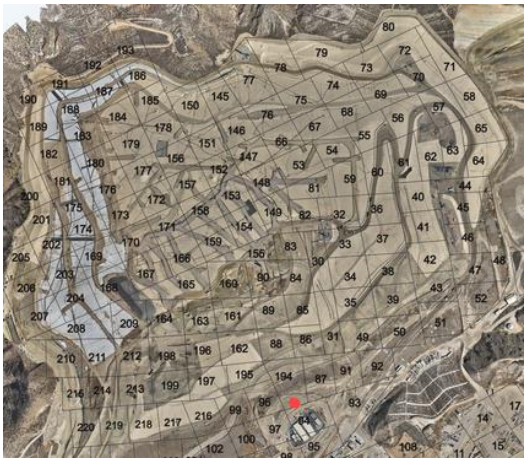
Leachate Seep Inspection	
Leachate seep/pooling Inspection	
Leachate seep/pooling Inspection 1	
Has a leachate seep/pooling been located?	Yes
Which grid is the leachate seep/pooling located?	194

Drop Pin to record lat/long of seep/pooling location.	Castaic CA 91384 United States (34.43042935465008, -118.64554660034025)
Time seep/pooling was discovered	14 Sep 2026 7:11 AM PDT
Estimated duration of presence of leachate at such location	3 hours
Estimated quantity of leachate	1-5 gallons
Extent of area impacted (approximate sq ft impacted)	16 sq ft
Odor type	Leachate
Odor intensity	1 - Very Light Odor Detected
Surrounding soil saturation level	Saturated

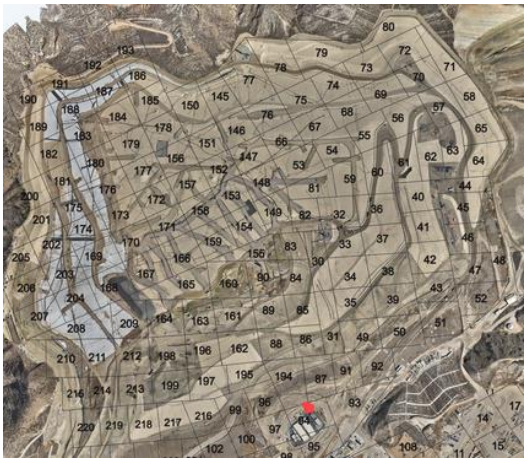
Leachate Seep Inspection	
Leachate seep/pooling Inspection	
Leachate seep/pooling Inspection 1	
Has a leachate seep/pooling been located?	Yes
Which grid is the leachate seep/pooling located?	94

Drop Pin to record lat/long of seep/pooling location.	Castaic CA 91384 United States (34.430730928586094, -118.64528325173862)
Time seep/pooling was discovered	15 Sep 2026 9:24 AM PDT
Estimated duration of presence of leachate at such location	6 hours
Estimated quantity of leachate	11-20 gallons
Extent of area impacted (approximate sq ft impacted)	100 sq ft
Odor type	Leachate
Odor intensity	0 - No Odor Detected
Surrounding soil saturation level	Standing free liquid

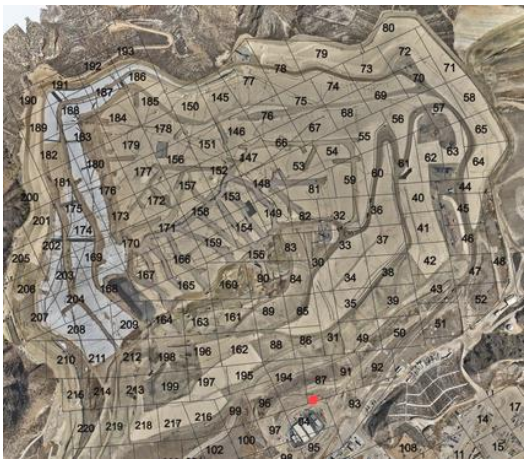
Leachate seep/pooling Inspection 2

Soil added to contain seep

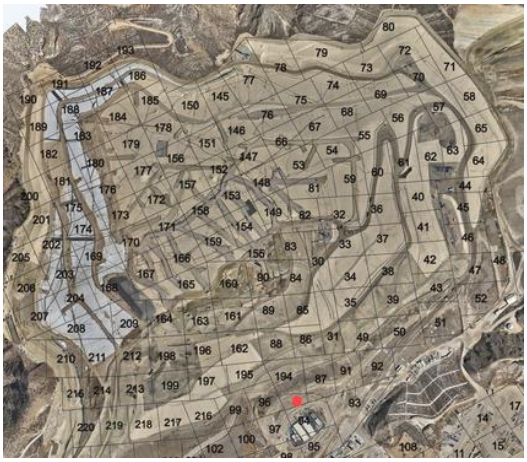
Leachate Seep Inspection	
Leachate seep/pooling Inspection	
Leachate seep/pooling Inspection 1	
Has a leachate seep/pooling been located?	Yes
Which grid is the leachate seep/pooling located?	194

Drop Pin to record lat/long of seep/pooling location.	Castaic CA 91384 United States (34.42984709505895, -118.64531673763602)
Time seep/pooling was discovered	16 Sep 2026 7:49 AM PDT
Estimated duration of presence of leachate at such location	4 hours
Estimated quantity of leachate	1-5 gallons
Extent of area impacted (approximate sq ft impacted)	8sq ft
Odor type	Leachate
Odor intensity	1 - Very Light Odor Detected
Surrounding soil saturation level	Standing free liquid

Dirt added and a piece of liner put in place to contain seep.

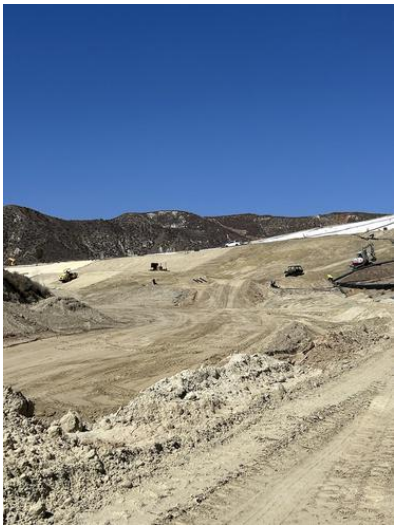
Photo 1

Description of area in photo where there is no leachate seepage or pooling.	Westside perimeter road. None of the seepage previously observed in this area were observed at the time of this inspection. Permanent repairs are being conducted to contain seepage in this area as well.

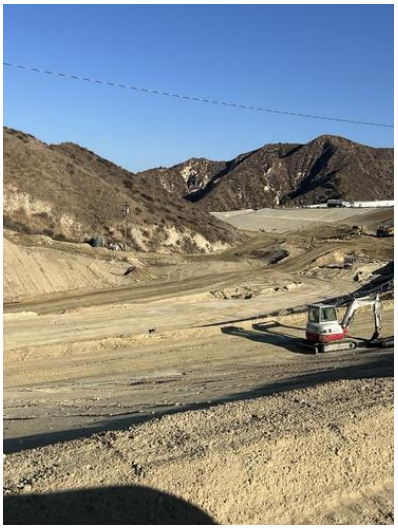
Photo 1

Description of area in photo where there is no leachate seepage or pooling.	Westside perimeter road. None of the seepage previously observed in this area were observed at the time of this inspection. Permanent repairs are being conducted to contain seepage in this area as well.

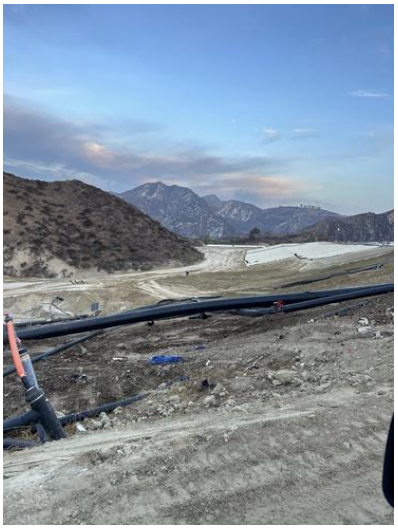
Photo 1

Description of area in photo where there is no leachate seepage or pooling.	Westside perimeter road. None of the seepage previously observed in this area were observed at the time of this inspection. Permanent repairs are being conducted to contain seepage in this area as well.

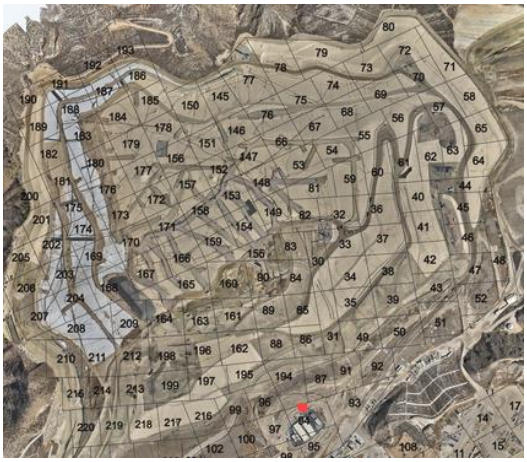
For the week of September 21 through September 27, 2026, leachate seepage was initially observed on September 21, 2026, in Grid 94 at the Chiquita Canyon Landfill (the "Landfill"), at approximately 9:27 a.m. The specific location of this seep is shown on the maps included in the attachment. Upon discovery of the seep, Chiquita promptly initiated response and mitigation measures, including adding fresh soil to the affected area. This initial response work was completed by approximately 11:00 a.m. on September 21, 2026. The seepage is estimated to have been present for approximately six hours. The total volume of leachate associated with this seepage is estimated to have been between one and five gallons. The observed area impacted by the seepage was approximately 12 square feet. The saturation of the soil was characterized as "Standing free liquid." The odor intensity was characterized as "Very Light." This seepage is related to the previously reported seepage that occurred in Grid 94 and Grid 194. Chiquita is currently installing a seep collector, similar to a leachate toe drain, in the area to minimize the potential for future recurrence.

Leachate Seep Inspection	
Leachate seep/pooling Inspection	
Leachate seep/pooling Inspection 1	
Has a leachate seep/pooling been located?	Yes
Which grid is the leachate seep/pooling located?	94

Drop Pin to record lat/long of seep/pooling location.	Castaic CA 91384 United States (34.429568314455985, -118.64553770982519)
Time seep/pooling was discovered	21 Sep 2026 9:27 AM PDT
Estimated duration of presence of leachate at such location	6 hours
Estimated quantity of leachate	1-5 gallons
Extent of area impacted (approximate sq ft impacted)	12 sq ft
Odor type	Leachate
Odor intensity	1 - Very Light Odor Detected
Surrounding soil saturation level	Standing free liquid

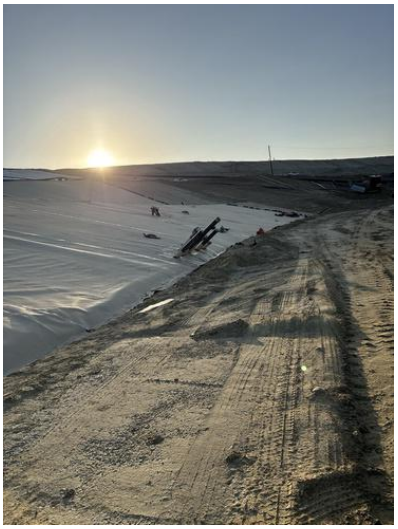
Photo 1

Description of area in photo where there is no leachate seepage or pooling.	Westside perimeter road. None of the seepage previously observed in this area were observed at the time of this inspection. Permanent repairs are being conducted to contain seepage in this area as well.

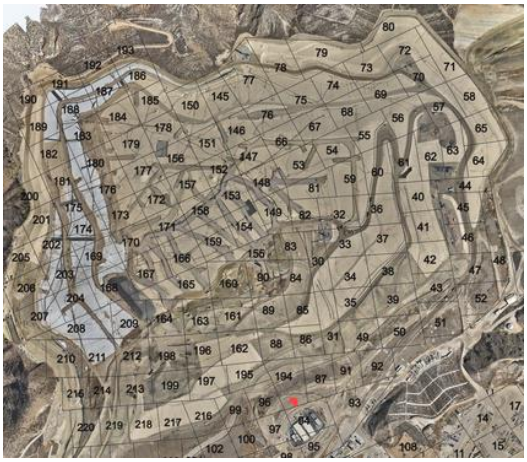
On September 22, 2026, seepage was also observed in Grid 194, at approximately 3:03 p.m. The specific location of this seep is shown on the maps included in the attachment. Upon discovery of the seep, Chiquita promptly initiated response and mitigation measures, including adding fresh soil to the affected area. This initial response work was completed by approximately 3:30 p.m. on September 22, 2026. The seepage is estimated to have been present for approximately three hours. The total volume of leachate associated with this seepage during that period is estimated to have been between one and five gallons. The observed area impacted by the seepage was approximately six square feet. The saturation of the soil was characterized as "Saturated." The odor intensity was characterized as "Very Light." This seepage was not observed again during the twice daily inspections conducted that week.

Leachate Seep Inspection	
Leachate seep/pooling Inspection	
Leachate seep/pooling Inspection 1	
Has a leachate seep/pooling been located?	Yes
Which grid is the leachate seep/pooling located?	194

Drop Pin to record lat/long of seep/pooling location.	Castaic CA 91384 United States (34.42927249578992, -118.64584659211286)
Time seep/pooling was discovered	22 Sep 2026 3:03 PM PDT
Estimated duration of presence of leachate at such location	3 hours
Estimated quantity of leachate	1-5 gallons
Extent of area impacted (approximate sq ft impacted)	6 sq ft
Odor type	Leachate
Odor intensity	1 - Very Light Odor Detected
Surrounding soil saturation level	Saturated

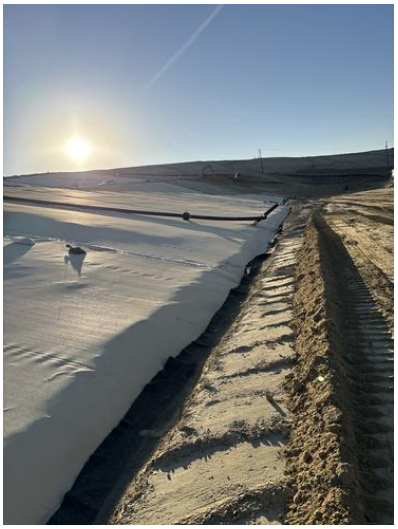
Photo 1

Description of area in photo where there is no leachate seepage or pooling.	Westside perimeter road. None of the seepage previously observed in this area were observed at the time of this inspection. Permanent repairs are being conducted to contain seepage in this area as well.

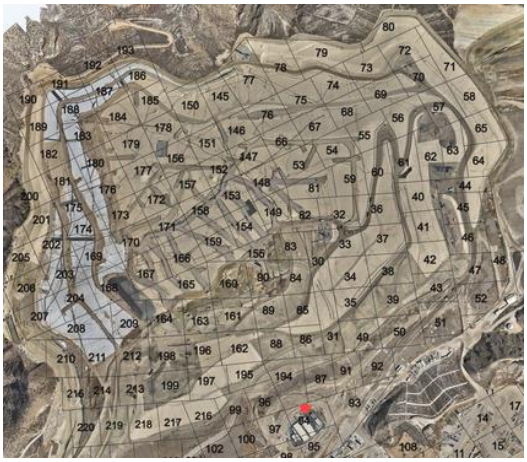
Seepage was again observed at the same location during the afternoon inspection conducted on September 23, 2026. Chiquita continued to implement response measures, including adding fresh soil to the affected area. Seepage observed in Grid 94 was estimated to have been present for approximately two hours on September 23. The estimated quantity of leachate was between one and five gallons during that period. The observed area impacted was approximately seven square feet. The saturation of the soil was characterized as "Standing free liquid." No odor associated with this seepage was detected. The seepage was not observed during subsequent inspections conducted that week.

Leachate Seep Inspection	
Leachate seep/pooling Inspection	
Leachate seep/pooling Inspection 1	
Has a leachate seep/pooling been located?	Yes
Which grid is the leachate seep/pooling located?	94

Drop Pin to record lat/long of seep/pooling location.	Castaic CA 91384 United States (34.42969961471349, -118.64579633425224)
Time seep/pooling was discovered	23 Sep 2026 2:44 PM PDT
Estimated duration of presence of leachate at such location	2 hours
Estimated quantity of leachate	1-5 gallons
Extent of area impacted (approximate sq ft impacted)	7sq ft
Odor type	Leachate
Odor intensity	0 - No Odor Detected
Surrounding soil saturation level	Standing free liquid

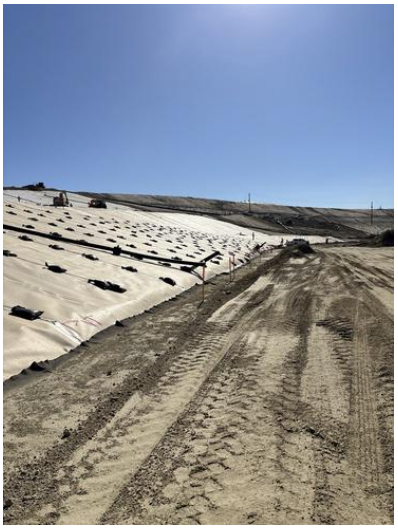
Photo 1

Description of area in photo where there is no leachate seepage or pooling.	Westside perimeter road. None of the seepage previously observed in this area were observed at the time of this inspection, permanent repairs are being conducted to contain the seepage in this area.

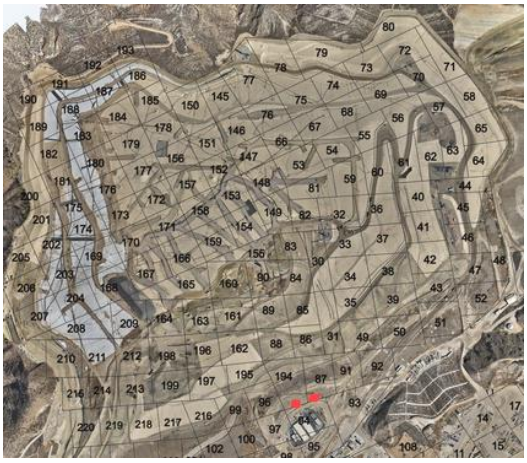
For the week of September 28, 2026 through October 4, 2026, multiple related seeps were observed on September 30, 2026, in Grid 87 and Grid 194 at the Landfill, at approximately 6:30 a.m. The specific location of the seepage is shown on the maps included in the attachment. Upon discovery of the seepage, Chiquita promptly initiated response and mitigation measures, including adding fresh soil to the affected areas. This initial response work was completed by approximately 8:15 a.m. on September 30, 2026. The seepage is estimated to have been present for approximately four hours. The total volume of leachate from the seepage is estimated to have been between six and ten gallons. The combined area impacted by the seepage was approximately 25 square feet. The saturation of the soil was characterized as "Standing free liquid." The odor intensity was characterized as "Light." This seepage was not observed again during the twice daily inspections during the week. This seepage is related to the previously reported seepage that occurred in Grid 94 and Grid 194. On October 2, 2026, Chiquita completed the installation of a seep collector, similar to a leachate toe drain, in the area to further minimize the potential for recurrence.

Has a leachate seep/pooling been located?	Yes
Which grid is the leachate seep/pooling located?	194,87

Seeping from multiple locations, all related.

Drop Pin to record lat/long of seep/pooling location.	Castaic CA 91384 United States (34.43111202925636, -118.64528987991329)
Time seep/pooling was discovered	30 Sep 2026 6:30 AM PDT
Estimated duration of presence of leachate at such location	4 hours
Estimated quantity of leachate	6-10 gallons

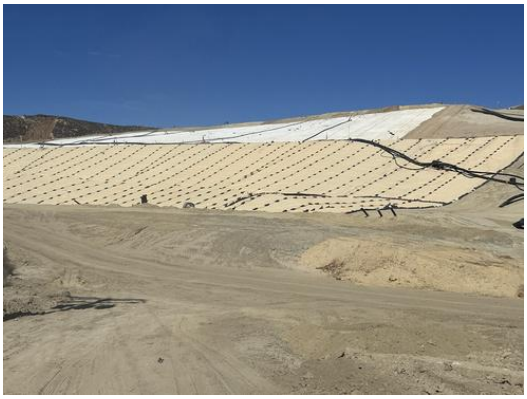
Photo 1

Description of area in photo where there is no leachate seepage or pooling.	Westside perimeter road. None of the seepage previously observed in this area were observed at the time of this inspection. Permanent repairs are being conducted to contain seepage in this area as well.

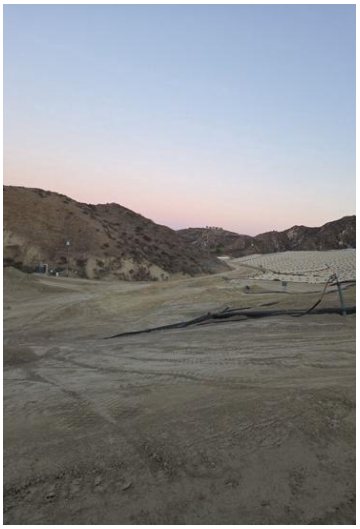
Photo 1

Description of area in photo where there is no leachate seepage or pooling.	Westside perimeter road. None of the seepage previously observed in this area were observed at the time of this inspection. Permanent repairs are being conducted to contain seepage in this area as well.

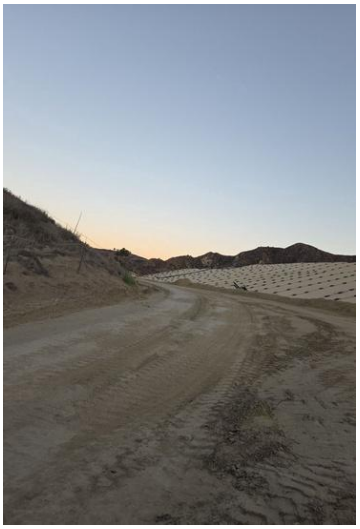
Photo 1

Description of area in photo where there is no leachate seepage or pooling.	Westside perimeter road. None of the seepage previously observed in this area were observed at the time of this inspection. Permanent repairs are being conducted to contain seepage in this area as well.

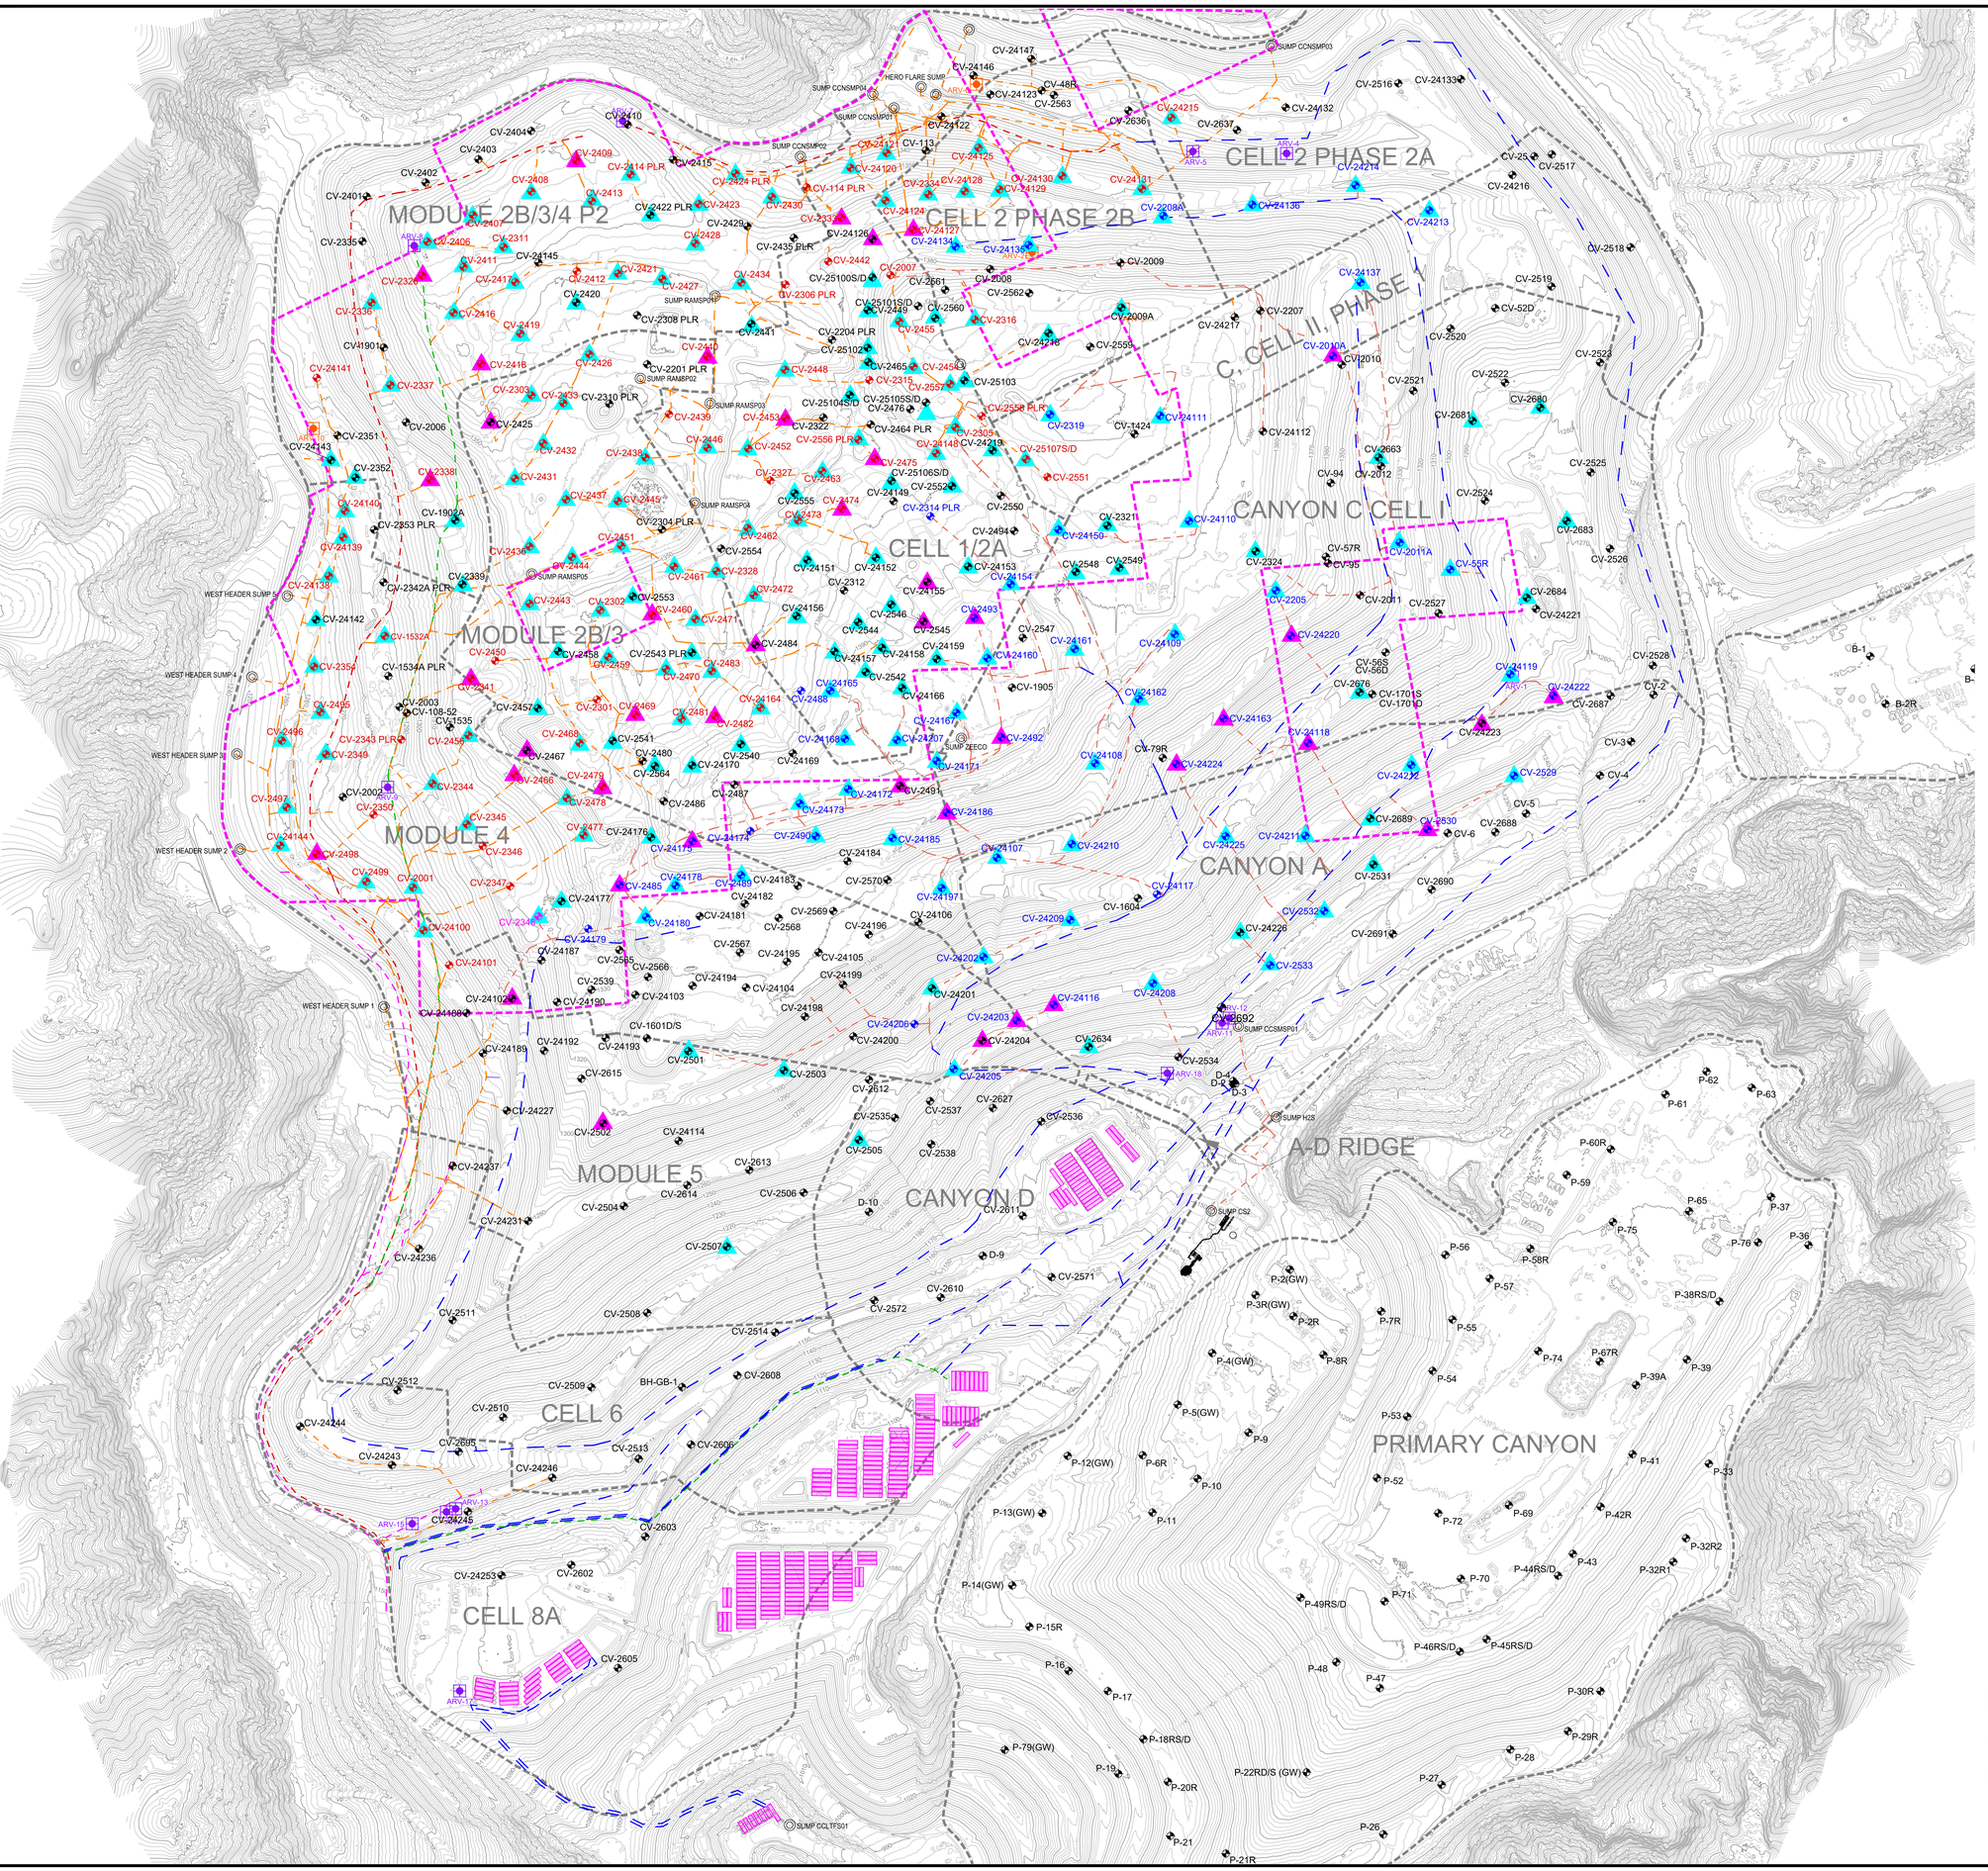
Photo 1

Description of area in photo where there is no leachate seepage or pooling.	Westside perimeter road. None of the seepage previously observed in this area were observed at the time of this inspection. Permanent repairs are being conducted to contain seepage in this area as well.

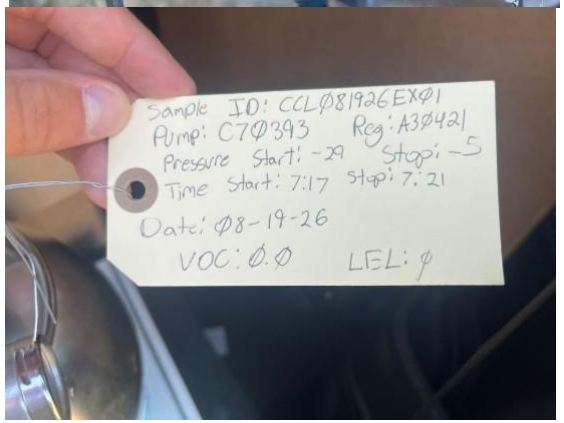
West Slope Toe Improvement Condition 42 Sampling | **CCL081926EX01**
3-in From Exposed Waste - Sample-Pickup

Sample Type: Summa Canister
Sample Date: 8/19/2026 1:48 PM
Location: 3-inches from exposed waste layer
Location Category: Site Characterization
GPS: 34.432128, -118.651456

Comments: Prevailing winds from the N
Ground winds from the S to the N
Used MR M01EA17450 for readings.
VOC:0.0
LEL: 0

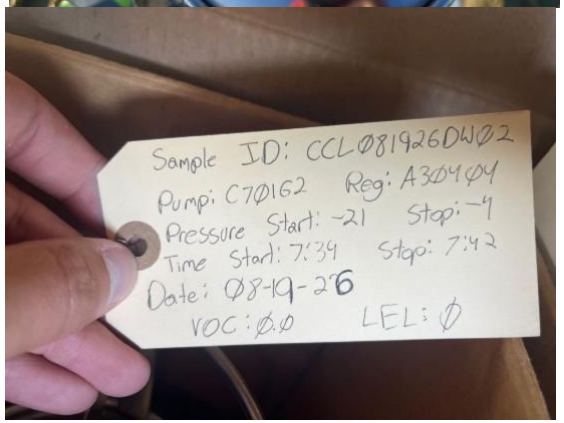
West Slope Toe Improvement Condition 42 Sampling | **CCL081926DW02**

Sample Type: Summa Canister
Sample Date: 8/19/2026 1:59 PM
Location: Immediately downwind of excavation.
Location Category: Site Characterization
GPS: 34.432287, -118.651714

Comments: Prevailing winds from the N
Ground winds from the S to the N
Used MR M01EA17450 for readings.
VOC: 0.0
LEL: 0

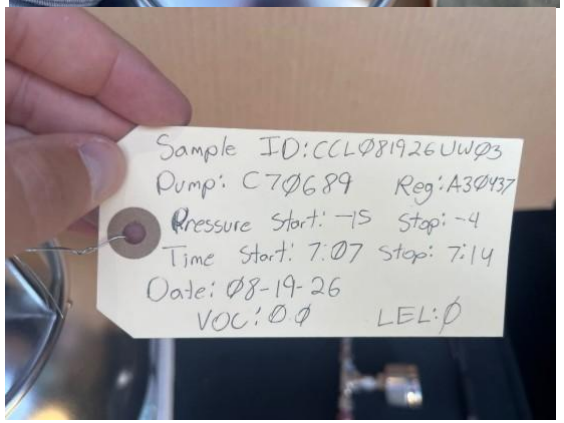
West Slope Toe Improvement Condition 42 Sampling | **CCL081926UW03**

Sample Type: Summa Canister
Sample Date: 8/19/2026 2:01 PM
Location: Immediately upwind of excavation.
Location Category: Site Characterization
GPS: 34.431892, -118.650925

Comments: Prevailing winds from the N
Ground winds from the S to the N
Used MR M01EA17450 for readings.
VOC: 0.0
LEL: 0

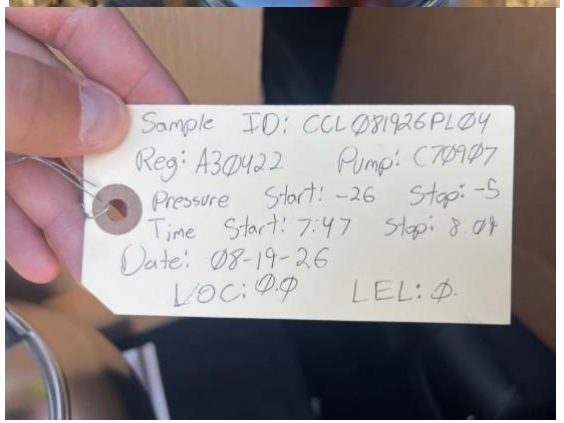
West Slope Toe Improvement Condition 42 Sampling | **CCL081926PL04**

Sample Type: Summa Canister
Sample Date: 8/19/2026 2:02 PM
Location: Downwind as close to the property line that can be accessed by road or path.
Location Category: Site Characterization
GPS: 34.432668, -118.652201

Comments: Prevailing winds from the N
Ground winds from the S to the N
Used MR M01EA17450 for readings.
VOC: 0.0
LEL: 0

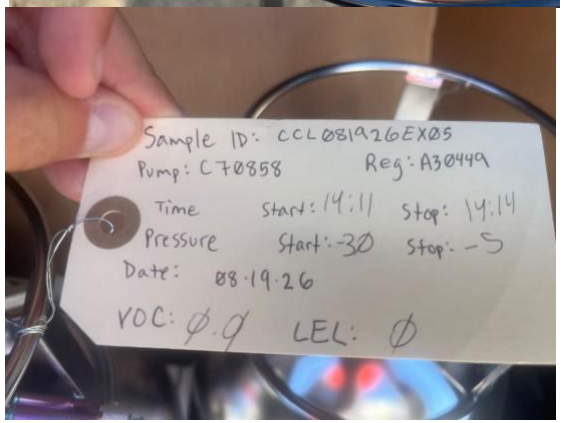
West Slope Toe Improvement Condition 42 Sampling | **CCL081926EX05**
3-in From Exposed Waste - Sample-Pickup

Sample Type: Summa Canister
Sample Date: 8/19/2026 8:15 PM
Location: 3-inches from exposed waste layer
Location Category: Site Characterization
GPS: 34.432025, -118.651177

Comments: Prevailing winds from the N
Ground winds from the S to the N
Used MR M01EA17450 for readings.
VOC: 0.0
LEL: 0

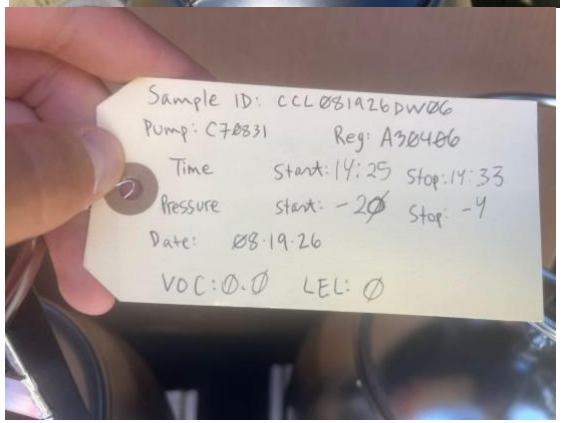
West Slope Toe Improvement Condition 42 Sampling | **CCL081926DW06**
Immediately Downwind - Sample-Pickup

Sample Type: Summa Canister
Sample Date: 8/19/2026 8:18 PM
Location: Immediately downwind of excavation.
Location Category: Site Characterization
GPS: 34.43222, -118.651697

Comments: Prevailing winds from the N
Ground winds from the S to the N
Used MR M01EA17450 for readings.
VOC: 0.0
LEL: 0

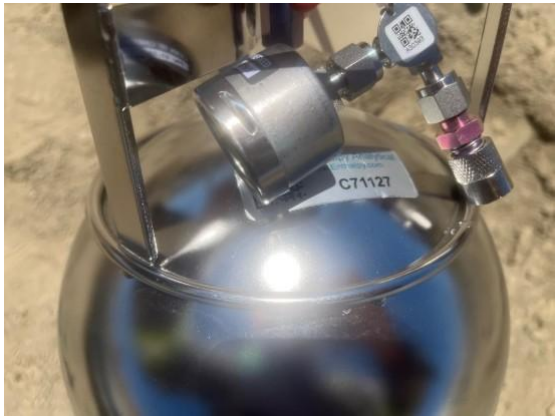
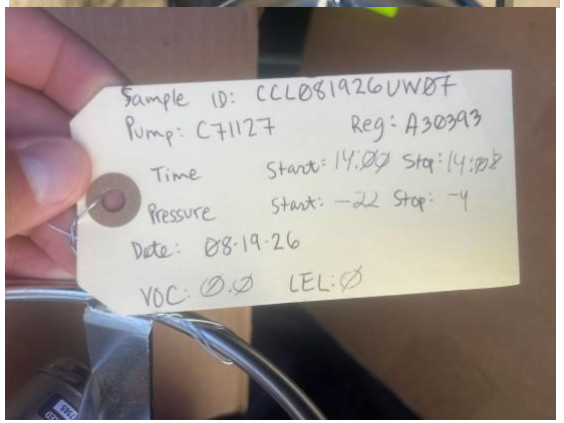
West Slope Toe Improvement Condition 42 Sampling | **CCL081926UW07**
Immediately Upwind - Sample-Pickup

Sample Type: Summa Canister
Sample Date: 8/19/2026 8:19 PM
Location: Immediately upwind of excavation.
Location Category: Site Characterization
GPS: 34.431821, -118.650914

Comments: Prevailing winds from the N
Ground winds from the S to the N
Used MR M01EA17450 for readings.
VOC: 0.0
LEL: 0

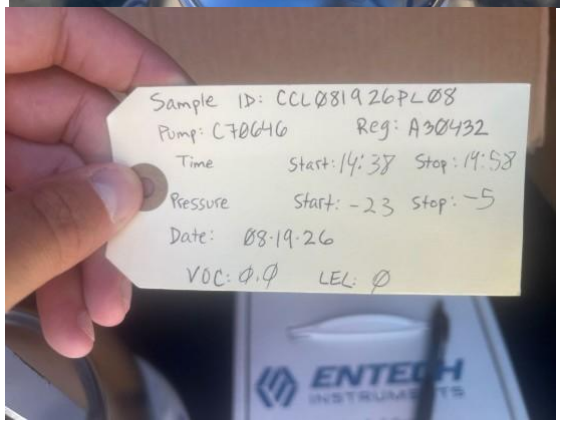
West Slope Toe Improvement Condition 42 Sampling | **CCL081926PL08**

Sample Type: Summa Canister
Sample Date: 8/19/2026 8:20 PM
Location: Downwind as close to the property line that can be accessed by road or path.
Location Category: Site Characterization
GPS: 34.432666, -118.652204

Comments: Prevailing winds from the N
Ground winds from the S to the N
Used MR M01EA17450 for readings.
VOC: 0.0
LEL: 0
