CHIQUITA CANYON
A Waste Connections Company

Re: Chiquita Canyon, LLC's Weekly Report on the Documentation and Tracking of Cover Issues

4050 - Geosynthetic Cover Inspection

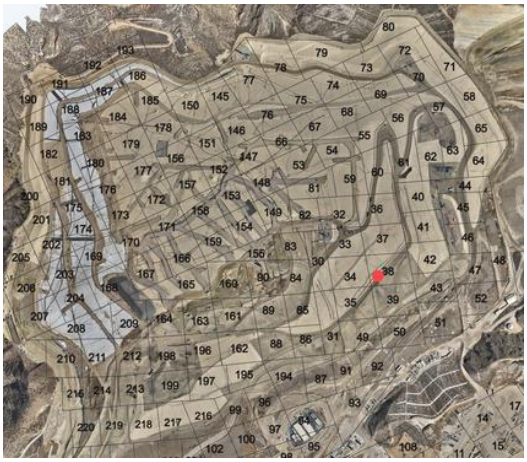
Identification of Issues	
Identified Issue	
Identified Issue 1	
Are there any issues with the geosynthetic cover?	Yes
Date and Time Issue Found	26 Oct 2026 1:53 PM PDT

Notate what the issue is and what needs to be repaired	Tear in liner needs to be patched/extrusion welded.

Description of repair work	Tear taped upon discovery then patched and extrusion welded
Date and time of repair (within 2 hours)	26 Oct 2026 1:56 PM PDT
Are further permanent repairs required?	No
Date and Time of final repair (if necessary)	30 Oct 2026 3:02 PM PDT

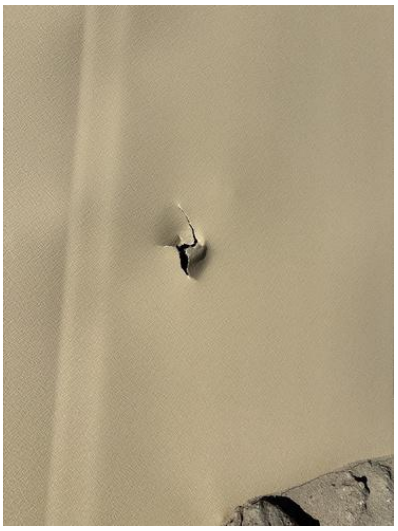
Photo 1

Grid Number	38

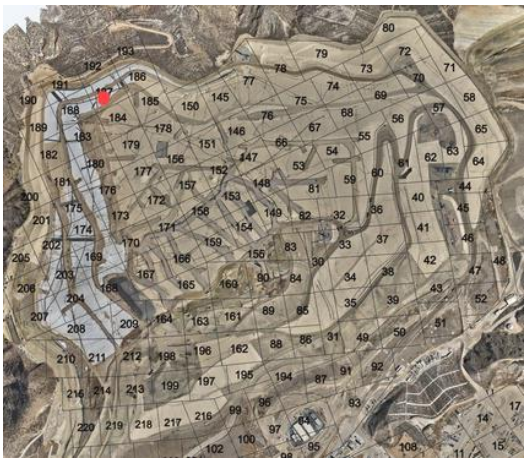
Grid Number	187

Are there any issues with the geosynthetic cover?	Yes
Date and Time Issue Found	26 Oct 2026 3:07 PM PDT

Description of repair work	Taped upon discovery then patched and extrusion welded
Date and time of repair (within 2 hours)	26 Oct 2026 3:38 PM PDT
Are further permanent repairs required?	No
Date and Time of final repair (if necessary)	30 Oct 2026 3:05 PM PDT
Instability under the cover	
Are there any anomalous (unusual or unexpected) areas of cover damage or deformation that may indicate underlying instability?	No
Are there any signs of a downslope tension crack at the top of the slope or bulging at or near the toe of the slope?	No
Is there any movement of the equipment that vertically penetrates the cover (e.g., tilting)?	No

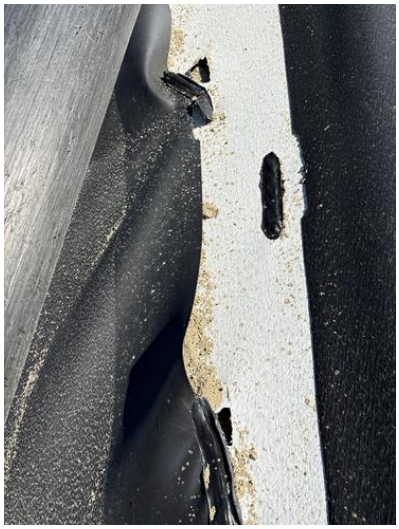
Photo 5

Liner torn. Needs to be patched and extrusion welded

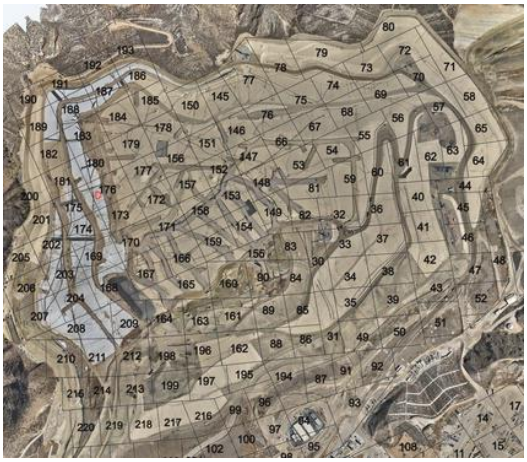
Grid Number	176

Identification of Issues	
Identified Issue	
Identified Issue 1	
Are there any issues with the geosynthetic cover?	Yes
Date and Time Issue Found	27 Oct 2026 2:16 PM PDT

Notate what the issue is and what needs to be repaired	Two small tears in liner. Needs to be patched and extrusion welded

Description of repair work	Taped and sandbagged upon discovery
Date and time of repair (within 2 hours)	27 Oct 2026 2:44 PM PDT
Are further permanent repairs required?	Yes

Permanent repair scheduled for 11/4/26

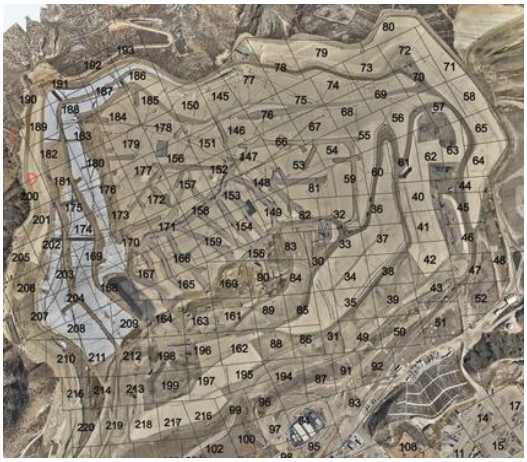
Grid Number	200

Identification of Issues	
Identified Issue	
Identified Issue 1	
Are there any issues with the geosynthetic cover?	Yes
Date and Time Issue Found	28 Oct 2026 11:06 AM PDT

Notate what the issue is and what needs to be repaired	Liner torn. Needs to be patched and extrusion welded

Description of repair work	Taped and sandbagged upon discovery then patched and extrusion welded
Date and time of repair (within 2 hours)	28 Oct 2026 11:19 AM PDT
Are further permanent repairs required?	No
Date and Time of final repair (if necessary)	2 Nov 2026 8:37 AM PST

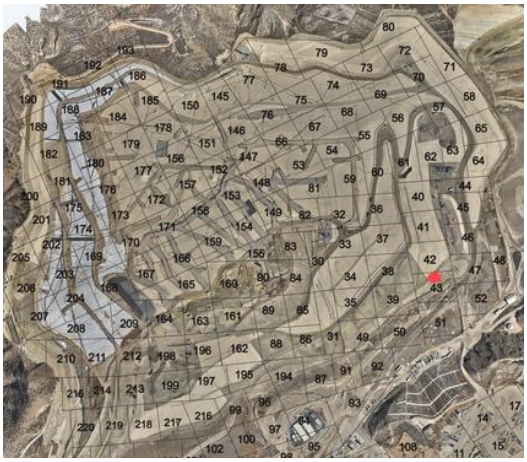
Grid Number	43

Identification of Issues	
Identified Issue	
Identified Issue 1	
Are there any issues with the geosynthetic cover?	Yes
Date and Time Issue Found	30 Oct 2026 10:57 AM PDT

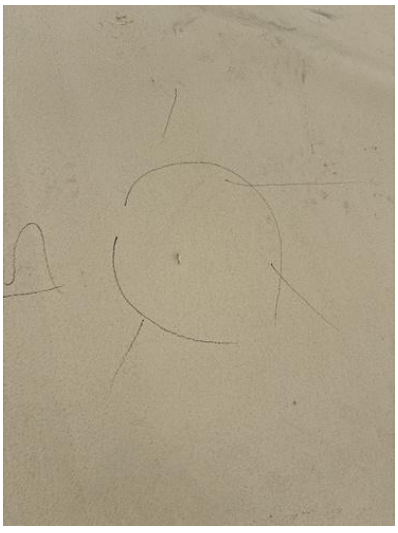
Photo 2

Notate what the issue is and what needs to be repaired	Two small holes need to be extrusion welded.

Description of repair work	Tears sandbagged upon discovery.
Date and time of repair (within 2 hours)	30 Oct 2026 11:00 AM PDT
Are further permanent repairs required?	Yes

Permanent repair scheduled for 11/4/26
