CHIQUITA CANYON
A Waste Connections Company

Re: Chiquita Canyon, LLC's Weekly Report on the Documentation and Tracking of Cover Issues

Attachment: November 17, 2026 Weekly Cover Issues Report
cc: Bahha Abuelsaad, Department of Public Health
Beverly Tway, Department of Public Health
Eric Morofuji, Department of Public Health

4050 - Geosynthetic Cover Inspection

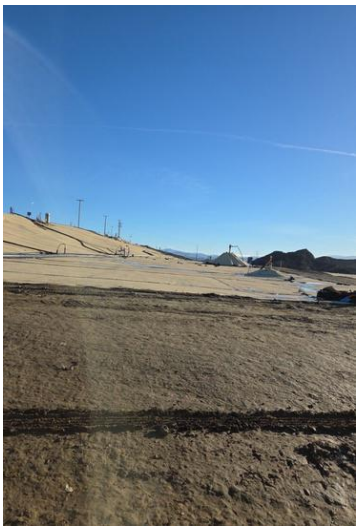
Photo 1

Grid number of area in photo where there is no fissure or tension crack	164
Instability	
Are there any indications of slope stability concerns?	No

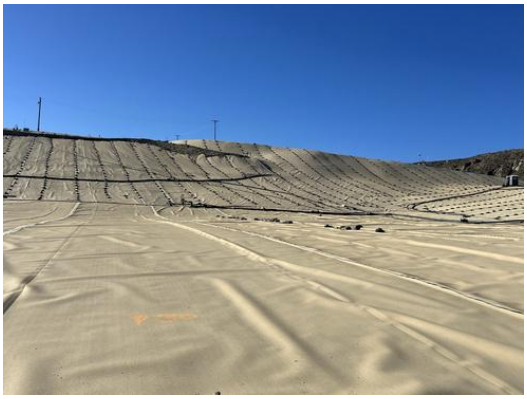
Photo 3

Instability under the cover	
Are there any anomalous (unusual or unexpected) areas of cover damage or deformation that may indicate underlying instability?	No
Are there any signs of a downslope tension crack at the top of the slope or bulging at or near the toe of the slope?	No
Is there any movement of the equipment that vertically penetrates the cover (e.g., tilting)?	No

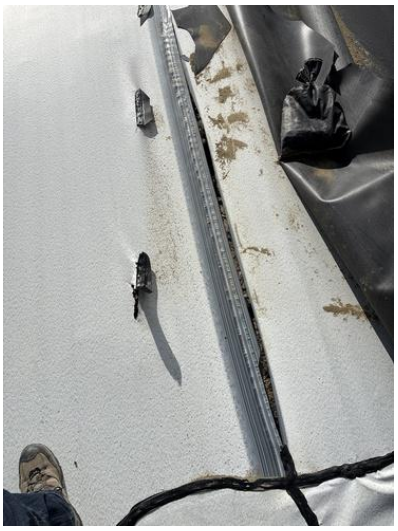
Photo 1

Grid Number	188

Notate what the issue is and what needs to be repaired	Tears in liner and separation at seam need to be patched/extrusion welded.

Description of repair work	Tears taped upon discovery and later patched/extrusion welded.
Date and time of repair (within 2 hours)	13 Nov 2026 10:40 AM PST
Are further permanent repairs required?	No
Date and Time of final repair (if necessary)	16 Nov 2026 10:00 AM PST

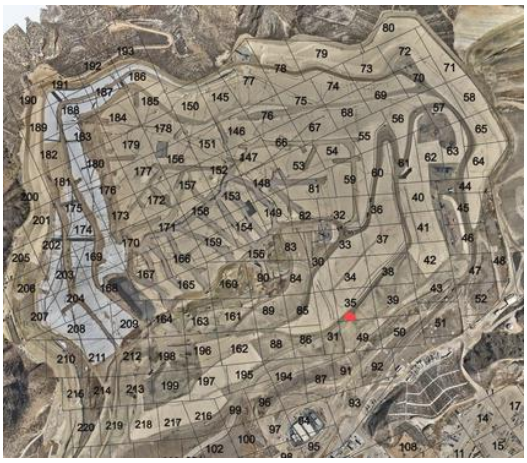
Photo 4

Grid Number	35

Notate what the issue is and what needs to be repaired	Tear in liner needs to be patched/extrusion welded.

Description of repair work	Tear taped upon discovery and later extrusion welded.
Date and time of repair (within 2 hours)	13 Nov 2026 2:39 PM PST
Are further permanent repairs required?	No
Date and Time of final repair (if necessary)	16 Nov 2026 11:00 AM PST

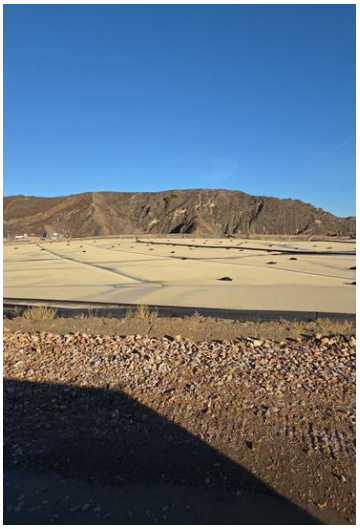
Photo 2

Instability under the cover	
Are there any anomalous (unusual or unexpected) areas of cover damage or deformation that may indicate underlying instability?	No
Are there any signs of a downslope tension crack at the top of the slope or bulging at or near the toe of the slope?	No
Is there any movement of the equipment that vertically penetrates the cover (e.g., tilting)?	No
