EMS STATION RENOVATIONS

ADDENDUM NO. 4

REPORT OF LIMITED FACILITY SURVEY TO IDENTIFY ASBESTOS-CONTAINING MATERIALS

WAKE COUNTY EMS STATIONS 7, 8, & 10
INTERIOR RENOVATIONS
337 SOUTH SALISBURY STREET
RALEIGH, NORTH CAROLINA
EEC JOB NO.: N-26-21

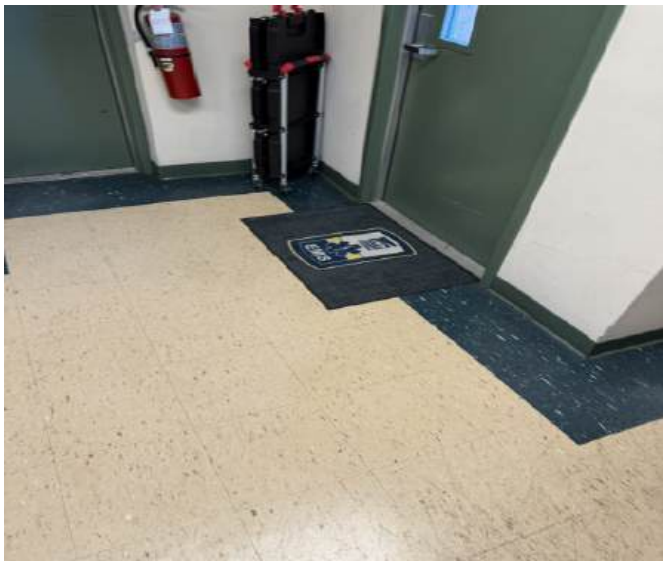
PHOTO No. 1
EMS Station #8 - 2'x2'Ceiling Panels and Wallboard & Joint Compound. (Non-ACM)
