**Re: Chiquita Canyon, LLC's Weekly Leachate Inspection Report for Stipulated Order for Abatement (Case No. 6177-4), Condition 27(c)**

Attachment: Leachate Inspection Logs from February 3 – February 9, 2025

# 4050 - Chiquita Leachate Seep/Pooling Inspection

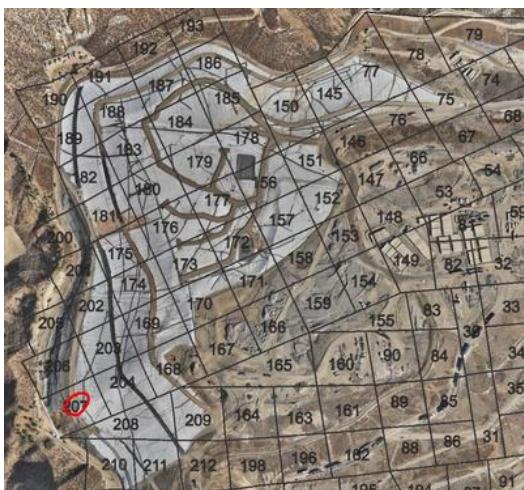
### Indicate on the map the location

Castaic CA 91384  
United States  
(34.43722746338188,  
-118.64507714297497)

Standing liquid vacuumed. Seam was temporarily sealed. Permanent repair was completed on 2/10/25

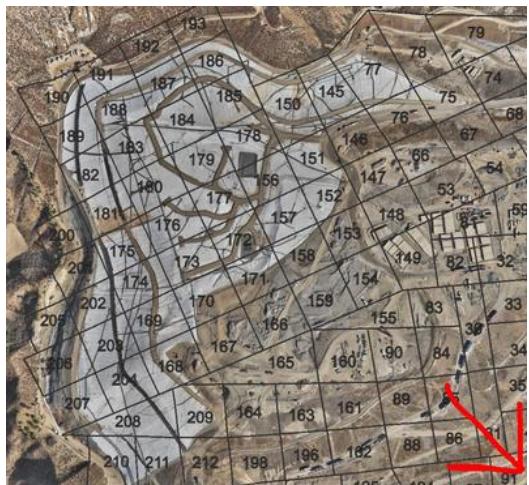
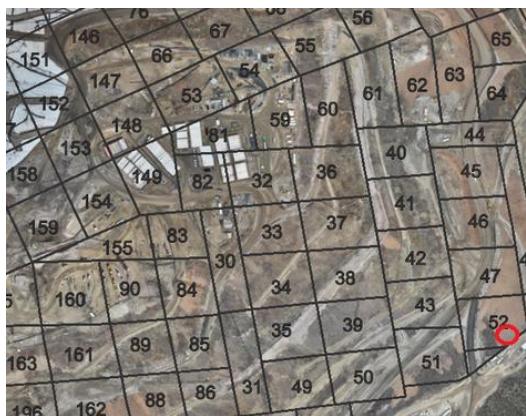
**Indicate on the map the location**

Castaic CA 91384

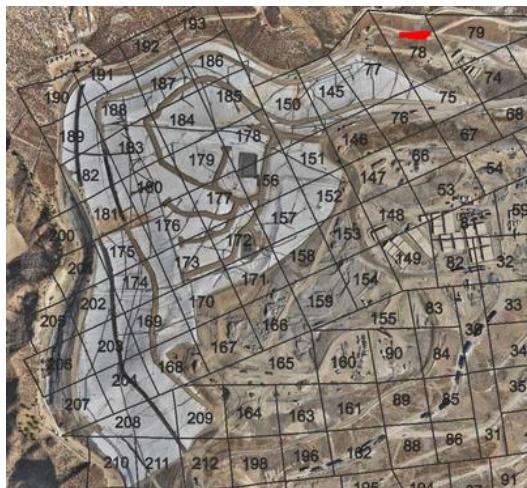
Indicate on the map the location

28724 Castaic Canyon Rd  
Valencia CA 91355  
United States  
(34.437823304624935,  
-118.60150541113175)
