CHIQUITA CANYON
A Waste Connections Company

Re: Chiquita Canyon, LLC's Weekly Report on the Documentation and Tracking of Cover Issues

4050 - Chiquita Reaction Area Tracking of Fissures and Tension Cracks

4050 - Geosynthetic Cover Inspection

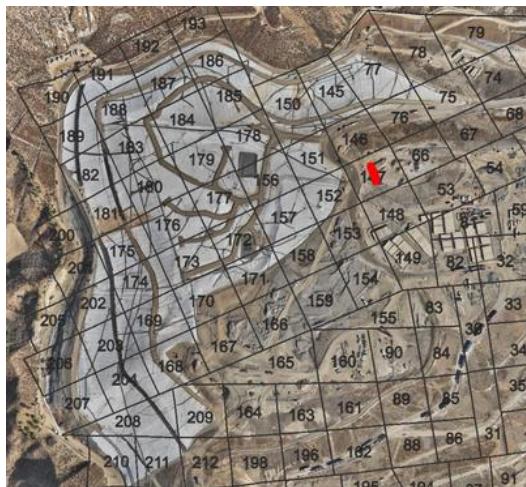
147

Using the attached image, annotate all areas where inspectors identified a fissure or tension crack.

Cracks were track walked.

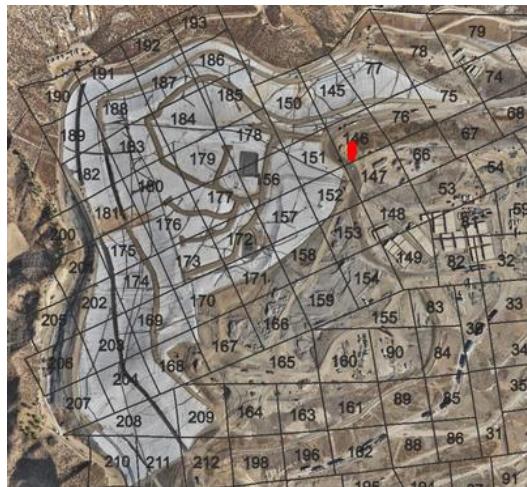
146

Using the attached image, annotate all areas where inspectors identified a fissure or tension crack.

Cracks were track walked.

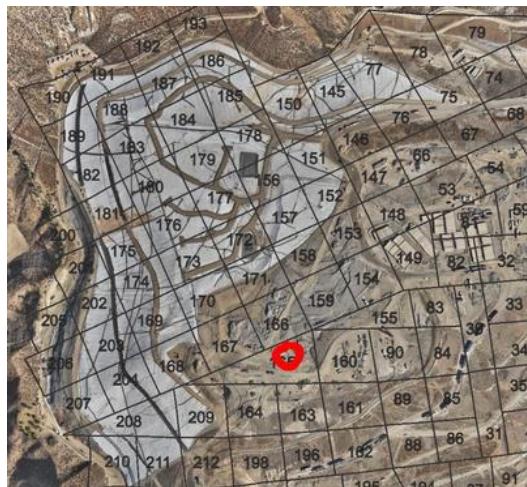
165

Using the attached image, annotate all areas where inspectors identified a fissure or tension crack.

Cracks were track walked.

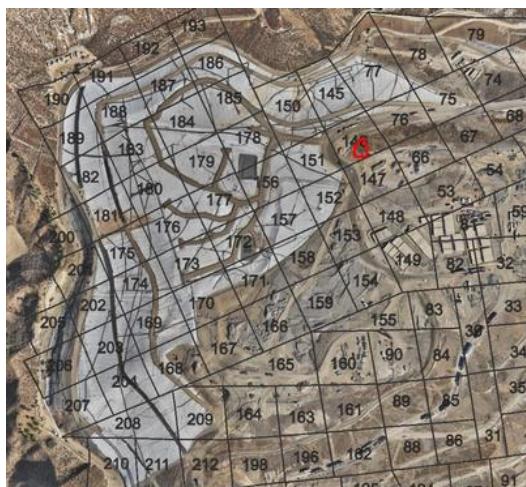
146

Using the attached image, annotate all areas where inspectors identified a fissure or tension crack.

Description of repairs	Cracks were track walked.
Chiquita Reaction Area Tracking of Fissures and Tension Cracks 2

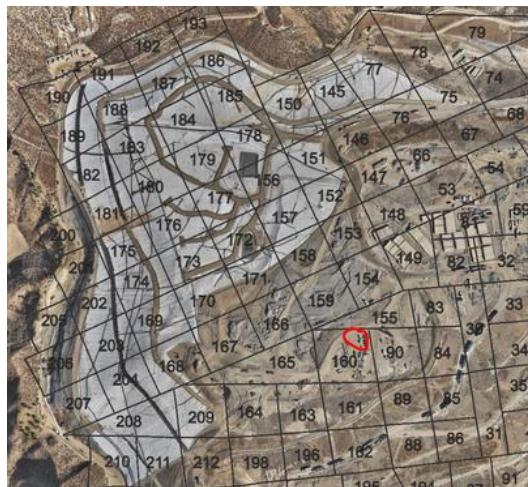
160

Using the attached image, annotate all areas where inspectors identified a fissure or tension crack.

Cracks were removed and compacted with scraper

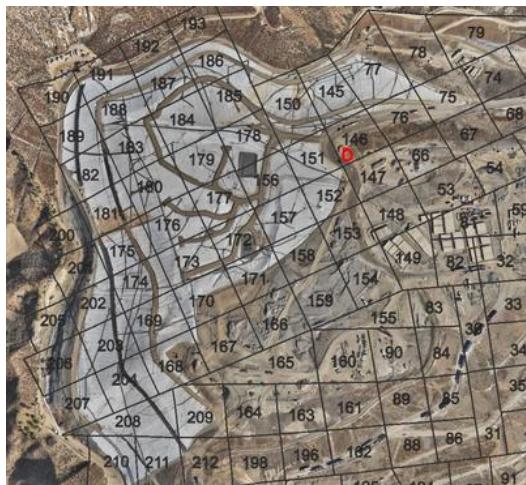
146

Using the attached image, annotate all areas where inspectors identified a fissure or tension crack.

Cracks were track walked.

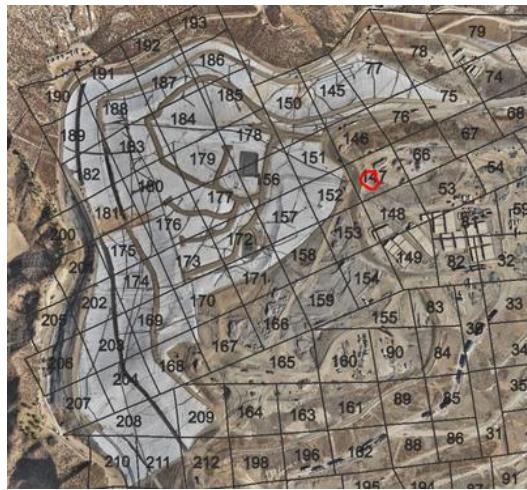
147

Using the attached image, annotate all areas where inspectors identified a fissure or tension crack.

Cracks were track walked.

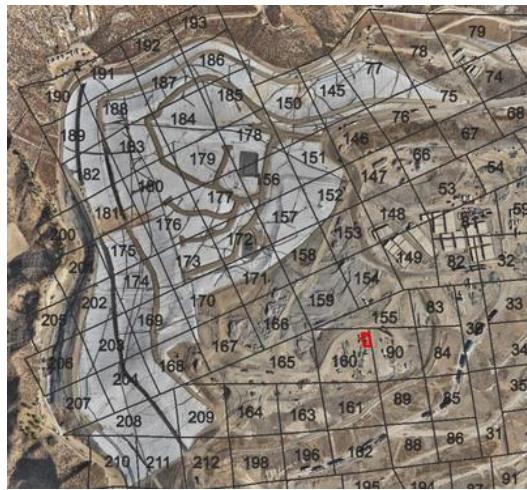
160

Using the attached image, annotate all areas where inspectors identified a fissure or tension crack.

Cracks were track walked.

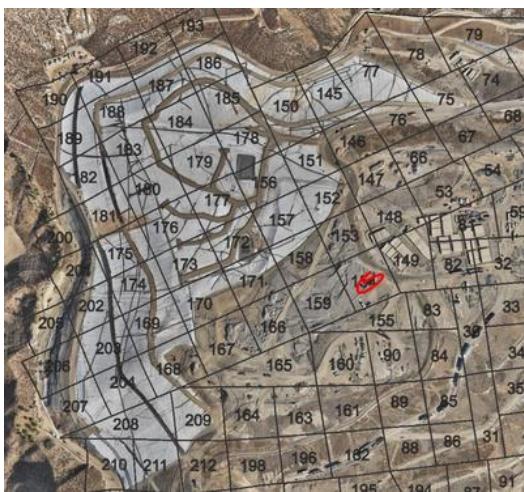
154

Using the attached image, annotate all areas where inspectors identified a fissure or tension crack.

Cracks were track walked.

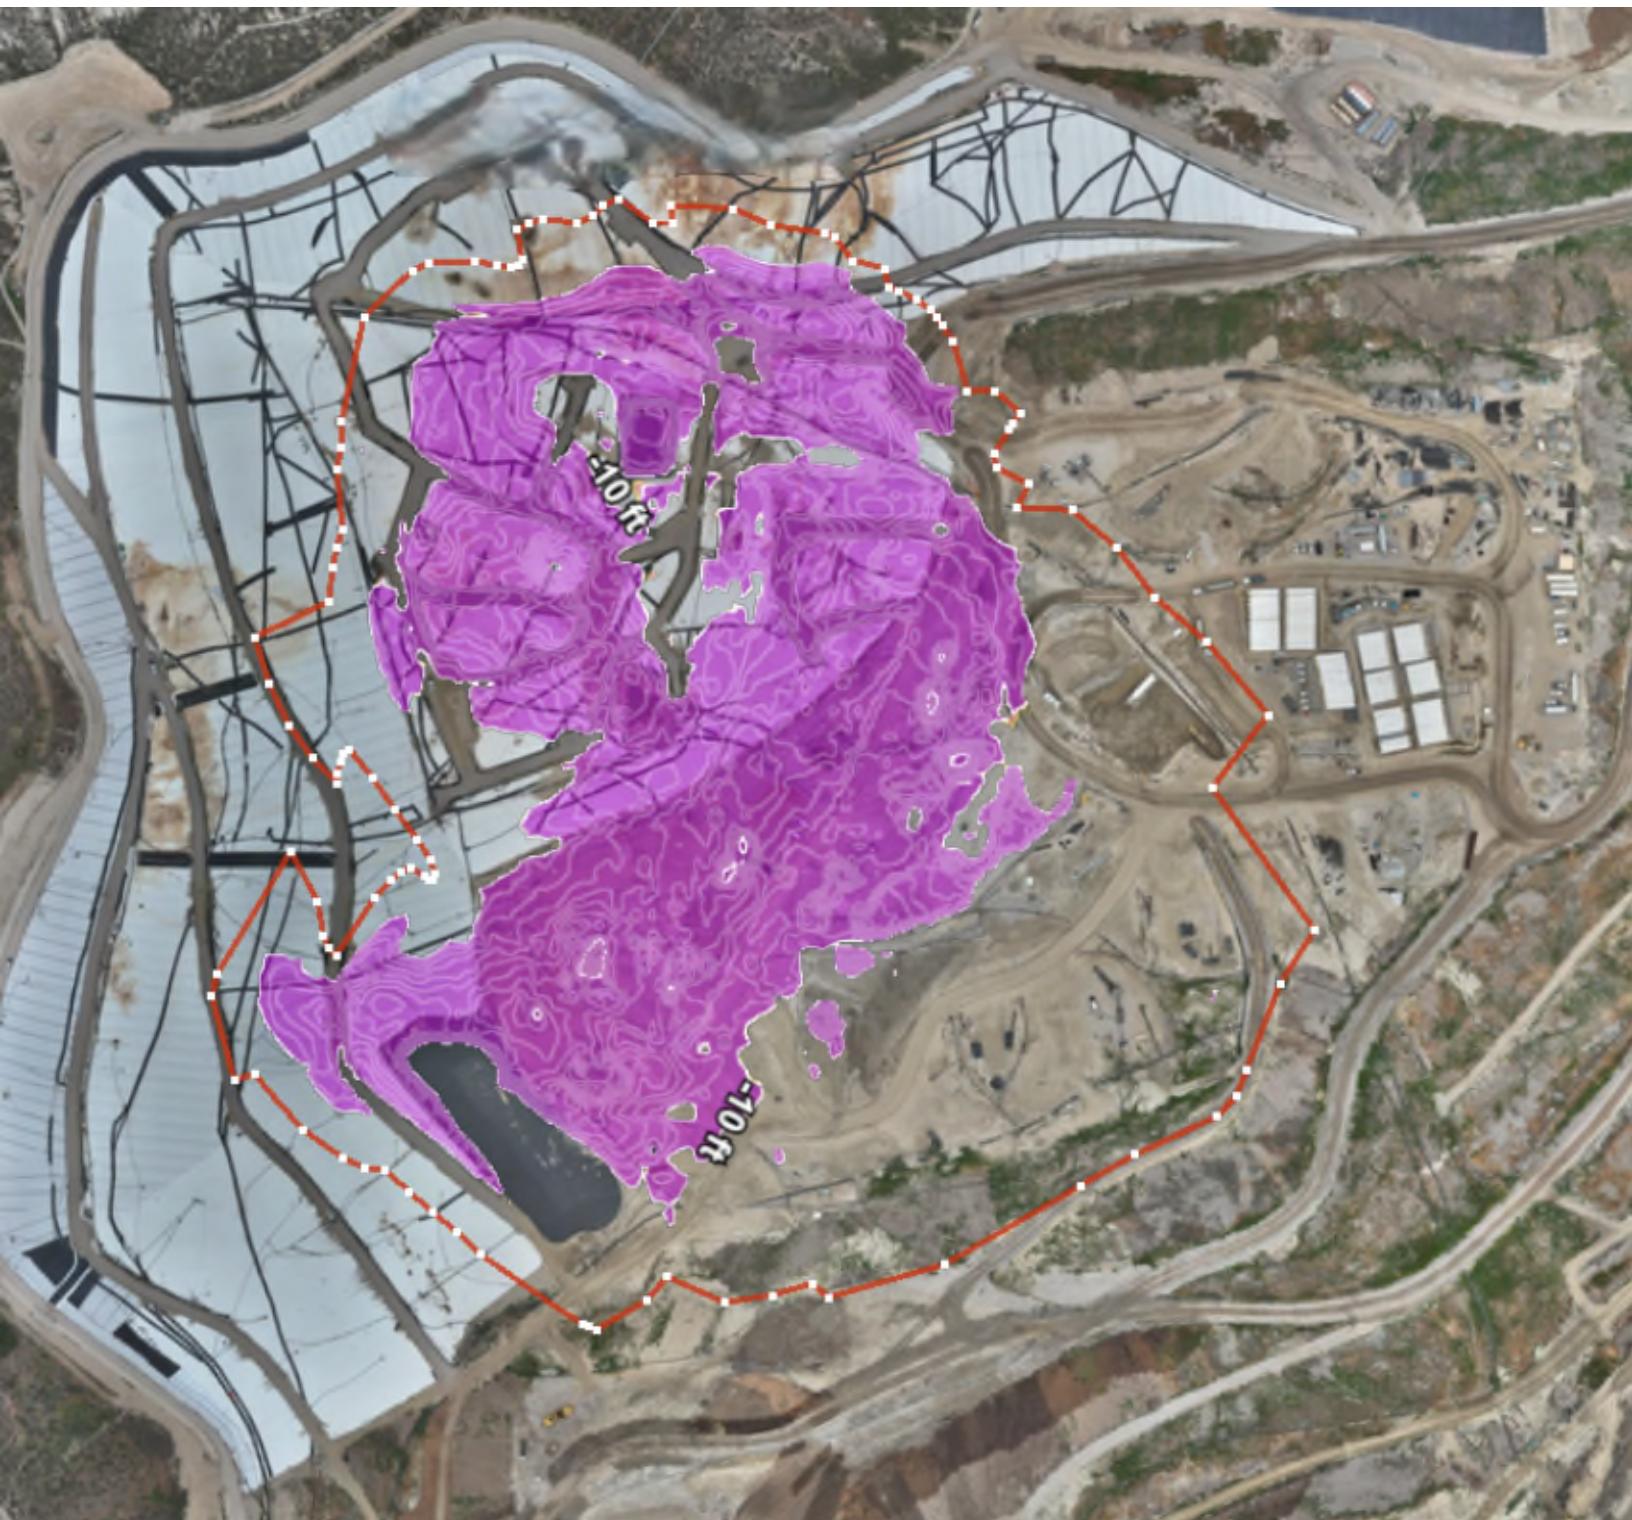
Settlement area between 4/10/2024 and 4/9/2025, submitted on 4/15/2025, and provided again herein for comparison
