CHIQUITA CANYON

Re: Chiquita Canyon, LLC's Weekly Report on the Documentation and Tracking of Cover Issues and Monthly Summary

4050 - Chiquita Reaction Area Tracking of Fissures and Tension Cracks

**APRIL 2025 FISSURE AND TENSION CRACK MONITORING SUMMARY
CHIQUITA CANYON LANDFILL
CASTAIC, CALIFORNIA**

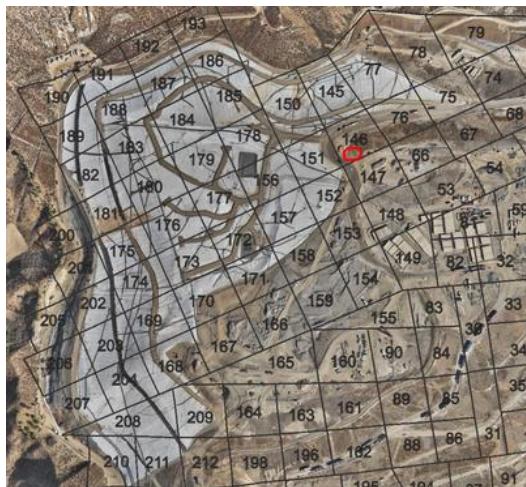
Grid Location

146

Description of repairs**Other (please describe)**

Cracks were tracked further to make sure it didn't open wider and then dirt was added to fill cracks and track walked.

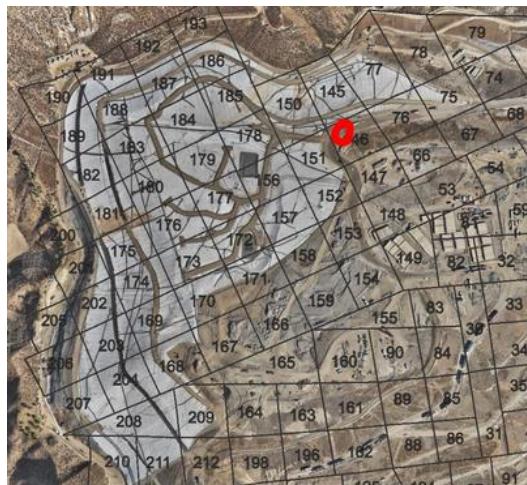
Grid Location

146

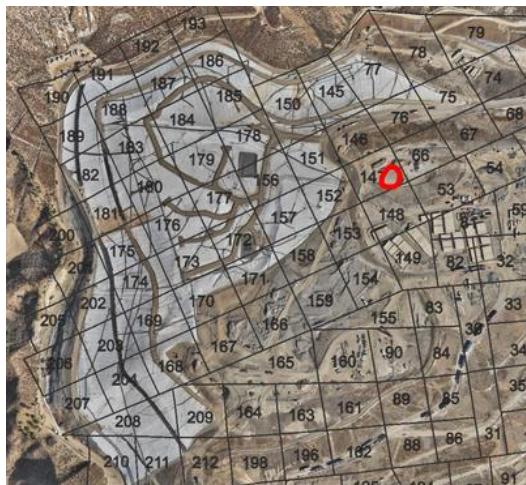
Grid Location

147

Description of repairs

Dirt was added and compacted to part of the crack and the other sections was track walked.

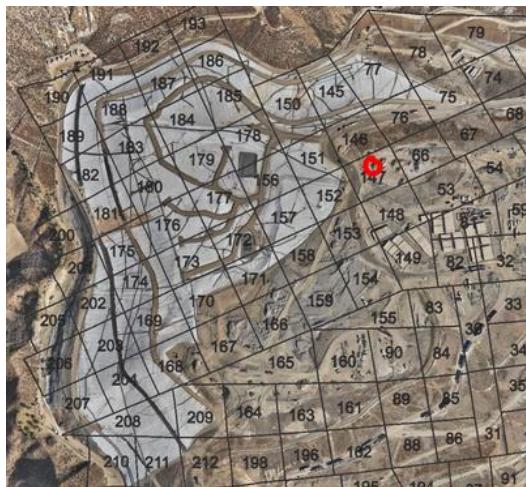
Grid Location

147

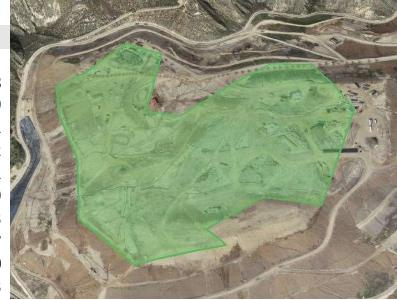
5/8/2024	7	4,000	494,000	571
5/15/2024	7	3,000	505,000	429
5/22/2024	7	3,000	511,000	429
5/29/2024	7	2,000	524,000	286
6/5/2024	7	2,000	532,000	286
6/12/2024	7	6,000	542,853	857
6/19/2024	7	2,000	540,000	286
6/26/2024	7	2,000	545,000	286
7/3/2024	7	4,000	555,000	571
7/10/2024	7	3,000	563,000	429
7/17/2024	7	3,000	573,000	429
7/24/2024	7	4,000	590,000	571
7/31/2024	7	3,000	597,000	429
8/8/2024	8	4,000	609,000	500
8/14/2024	6	2,000	619,000	333
8/21/2024	7	3,000	631,000	429
8/28/2024	7	4,000	649,000	571
9/4/2024	7	1,000	654,000	143
9/11/2024	7	4,000	665,000	571
9/18/2024	7	2,000	673,000	286
9/25/2024	7	2,000	679,000	286
10/2/2024	7	5,000	696,000	714
10/9/2024	7	3,000	689,000	429
10/16/2024	7	4,000	706,000	571
10/23/2024	7	2,000	712,000	286
10/30/2024	7	2,000	719,000	286
11/8/2024	9	9,000	739,000	1,000
11/13/2024	5	1,000	739,000	200
11/20/2024	7	4,000	753,000	571
11/27/2024	7	5,000	768,000	714
12/4/2024	7	7,000	788,000	1,000

12/11/2024	7	5,000	794,000	714
12/18/2024	7	4,000	807,000	571
12/26/2024	8	2,000	816,000	250
1/3/2025	8	1,000	821,000	125
1/10/2025	7	2,000	835,000	286
1/17/2025	7	5,000	843,000	714
1/22/2025	5	3,000	856,000	600
1/29/2025	7	4,000	868,000	571
2/6/2025	8	3,000	880,000	375
2/14/2025	8	6,000	894,000	750
2/19/2025	5	3,000	903,000	600
2/26/2025	7	4,000	915,000	571
3/7/2025	9	2,000	925,000	222
3/11/2025	4	2,000	930,000	500
3/19/2025	8	3,000	945,000	375
3/26/2025	7	2,000	956,000	286
4/2/2025	7	2,000	964,000	286
4/9/2025	7	4,000	985,000	571
4/16/2025	7	600	990,000	86
4/23/2025	7	400	991,000	57
4/30/2025	7	2,000	1,009,000	286
5/7/2025	7	400	1,020,000	57

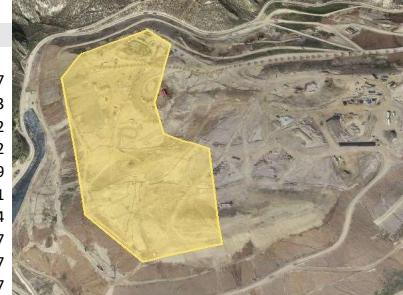
Location 2

Flyover Date	Days Between Flights	Volume Change	Cumulative Volume Change	Volume Change Per Day
5/31/2023	0	-	-	-
6/19/2023	19	18,000	18,000	947
7/21/2023	32	34,000	54,000	1,063
8/11/2023	21	20,000	75,000	952
8/28/2023	17	15,000	93,000	882
9/25/2023	28	26,000	121,000	929
10/9/2023	14	8,000	134,000	571
10/23/2023	14	10,000	149,000	714
11/7/2023	15	7,000	161,000	467
11/22/2023	15	13,000	178,000	867
12/4/2023	12	5,000	190,000	417
12/13/2023	9	1,000	197,000	111
1/2/2024	20	16,000	199,000	800
1/15/2024	13	10,000	208,000	769
1/29/2024	14	11,000	220,000	786
2/12/2024	14	12,000	233,000	857
2/28/2024	16	9,000	241,000	563
3/5/2024	6	8,000	254,000	1,333
3/20/2024	15	6,000	254,000	400
3/27/2024	7	2,000	260,000	286
4/3/2024	7	1,000	267,000	143
4/10/2024	7	1,000	269,000	143
4/17/2024	7	1,000	274,000	143
4/24/2024	7	2,000	281,000	286
5/1/2024	7	2,000	284,000	286
5/8/2024	7	2,000	289,000	286
5/15/2024	7	1,000	296,000	143
5/22/2024	7	1,000	300,000	143

5/29/2024	7	1,000	308,000	143
6/5/2024	7	1,000	312,000	143
6/12/2024	7	3,000	316,000	429
6/19/2024	7	1,000	315,000	143
6/26/2024	7	1,000	320,000	143
7/3/2024	7	2,000	330,000	286
7/10/2024	7	1,000	334,000	143
7/17/2024	7	1,000	339,000	143
7/24/2024	7	1,000	350,000	143
7/31/2024	7	1,000	354,000	143
8/8/2024	8	1,000	361,000	125
8/14/2024	6	1,000	366,000	167
8/21/2024	7	2,000	375,000	286
8/28/2024	7	2,000	385,000	286
9/4/2024	7	300	387,000	43
9/11/2024	7	1,000	393,000	143
9/18/2024	7	400	396,000	57
9/25/2024	7	400	397,000	57
10/2/2024	7	4,000	407,000	571
10/9/2024	7	2,000	406,000	286
10/16/2024	7	1,000	412,000	143
10/23/2024	7	500	415,000	71
10/30/2024	7	500	419,000	71
11/8/2024	9	4,000	431,000	444
11/13/2024	5	500	432,000	100
11/20/2024	7	2,000	441,000	286
11/27/2024	7	1,000	448,000	143
12/4/2024	7	4,000	461,000	571
12/11/2024	7	1,000	461,000	143
12/18/2024	7	3,000	471,000	429
12/26/2024	8	1,000	473,000	125
1/3/2025	8	1,000	478,000	125

1/10/2025	7	300	485,000	43
1/17/2025	7	1,000	490,000	143
1/22/2025	5	1,000	498,000	200
1/29/2025	7	1,000	503,000	143
2/6/2025	8	1,000	511,000	125
2/14/2025	8	2,000	518,000	250
2/19/2025	5	1,000	523,000	200
2/26/2025	7	1,000	531,000	143
3/7/2025	9	400	536,000	44
3/11/2025	4	700	537,000	175
3/19/2025	8	2,000	547,000	250
3/26/2025	7	300	551,000	43
4/2/2025	7	400	558,000	57
4/9/2025	7	2,000	569,000	286
4/16/2025	7	200	573,000	29
4/23/2025	7	60	572,000	9

4/30/2025	7	1,000	585,000	143
5/7/2025	7	200	591,000	29

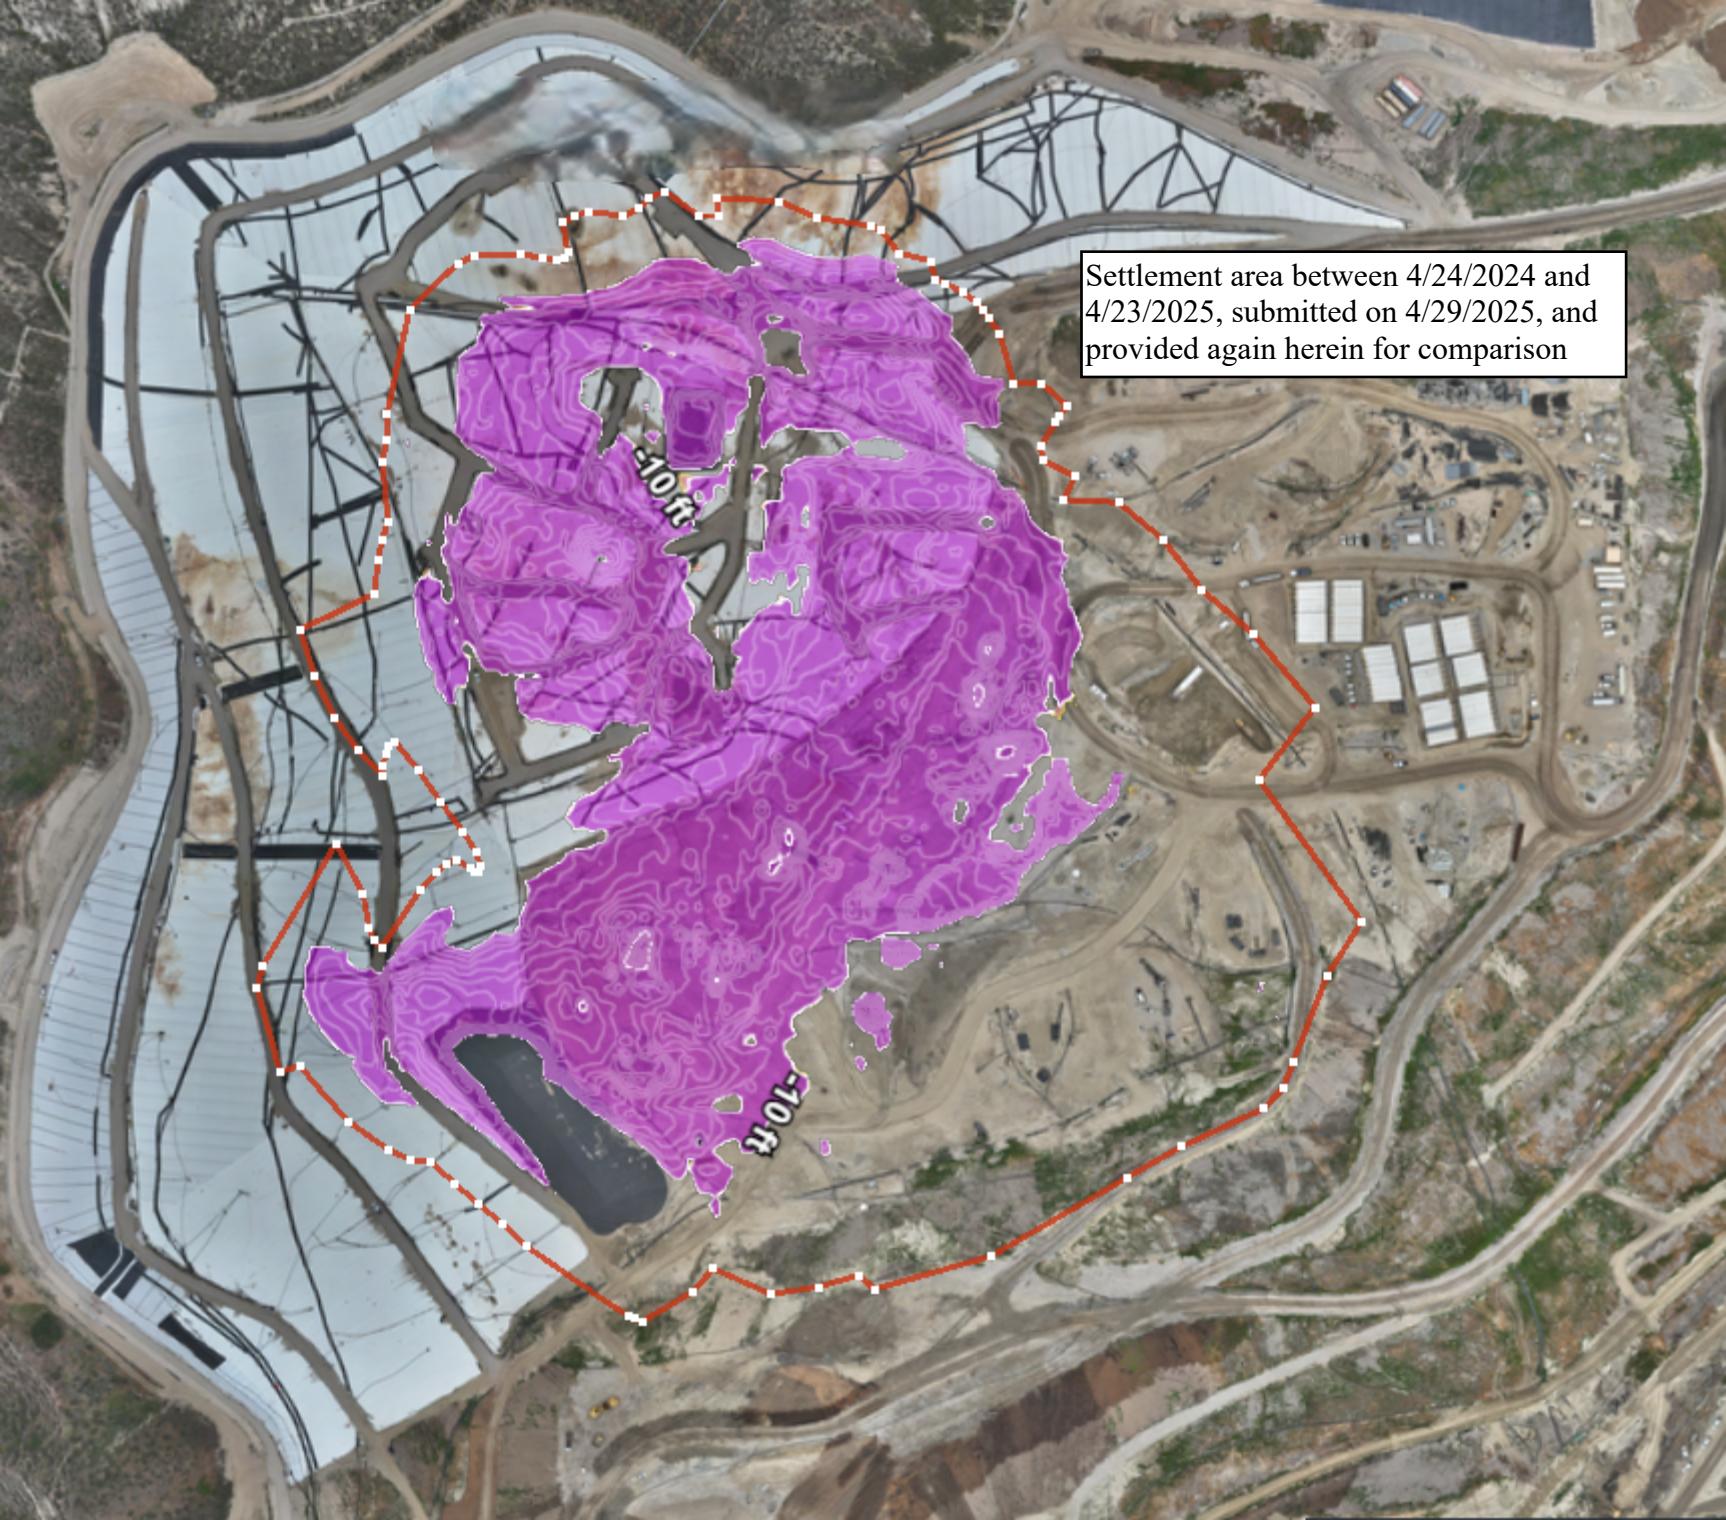
Settlement area between 4/24/2024 and 4/23/2025, submitted on 4/29/2025, and provided again herein for comparison

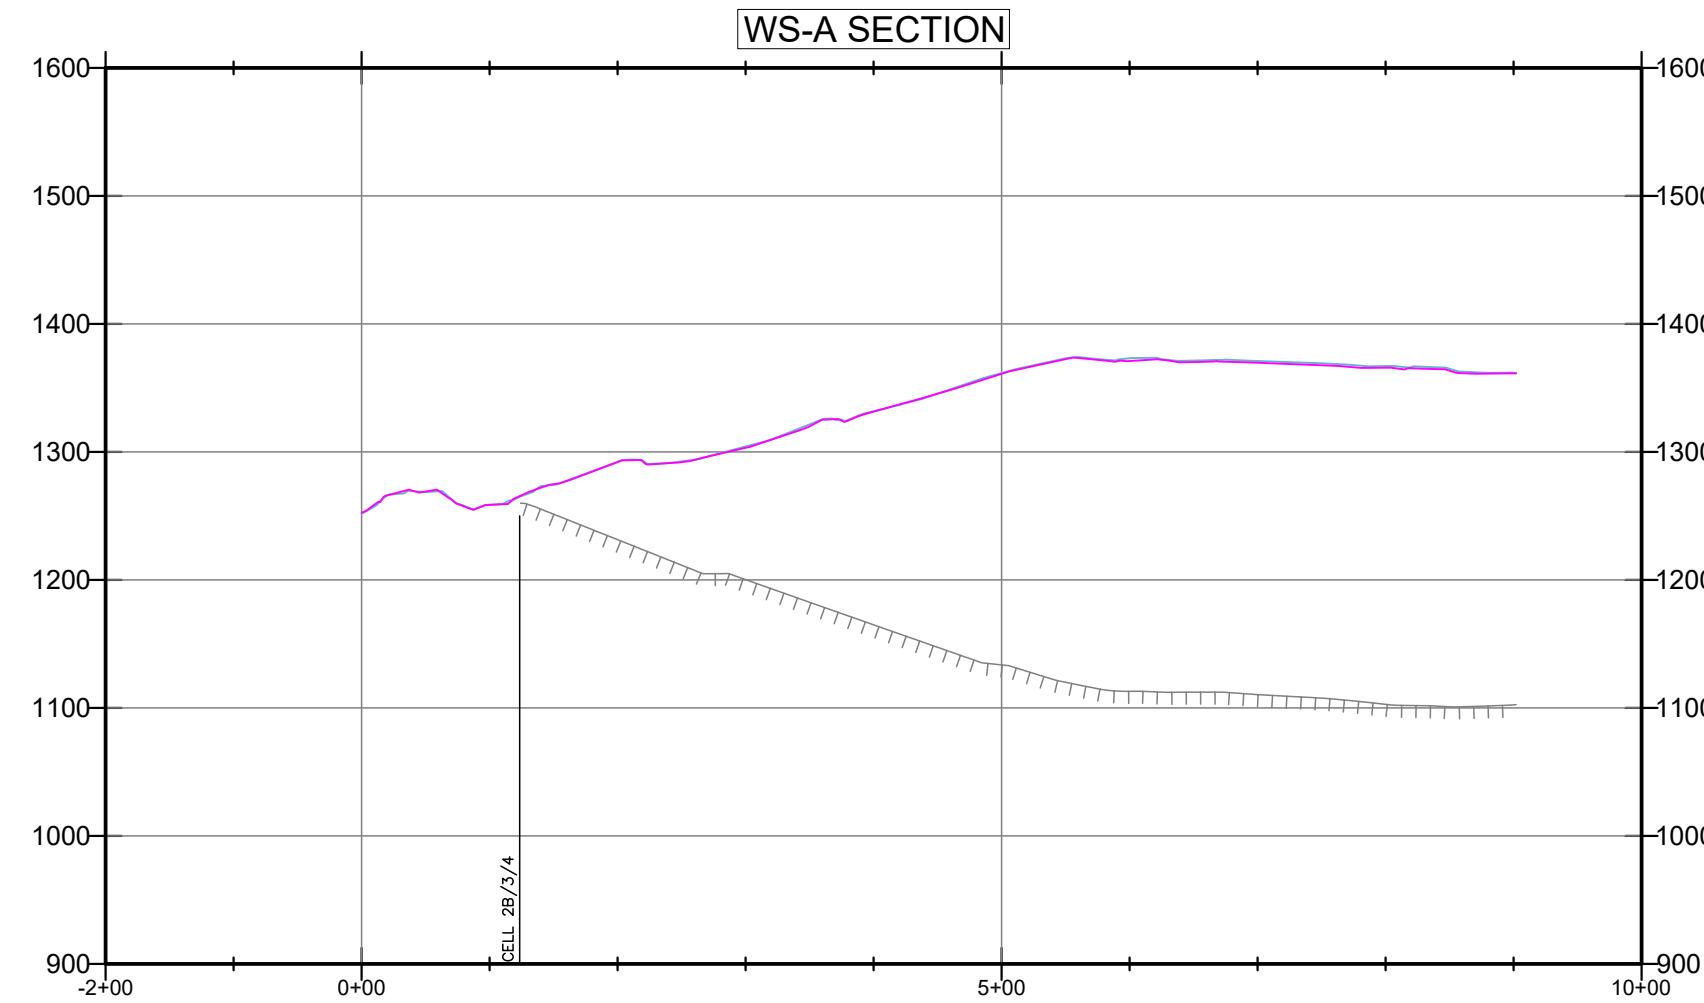
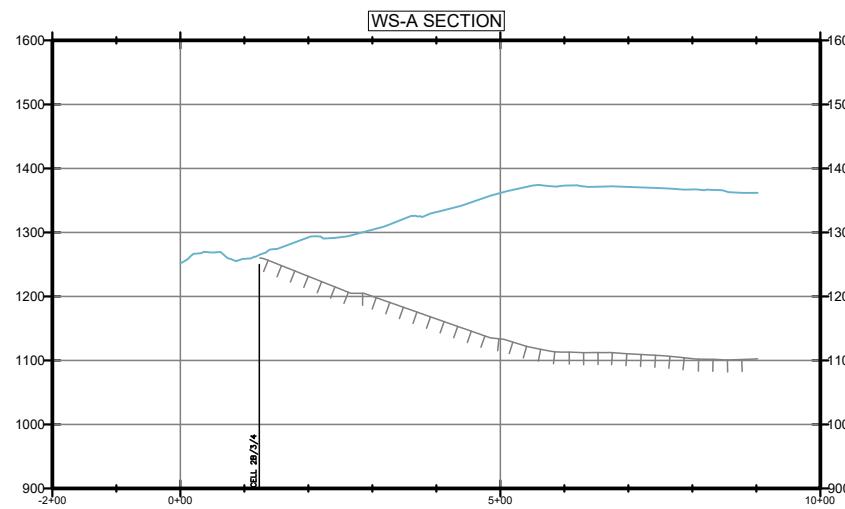
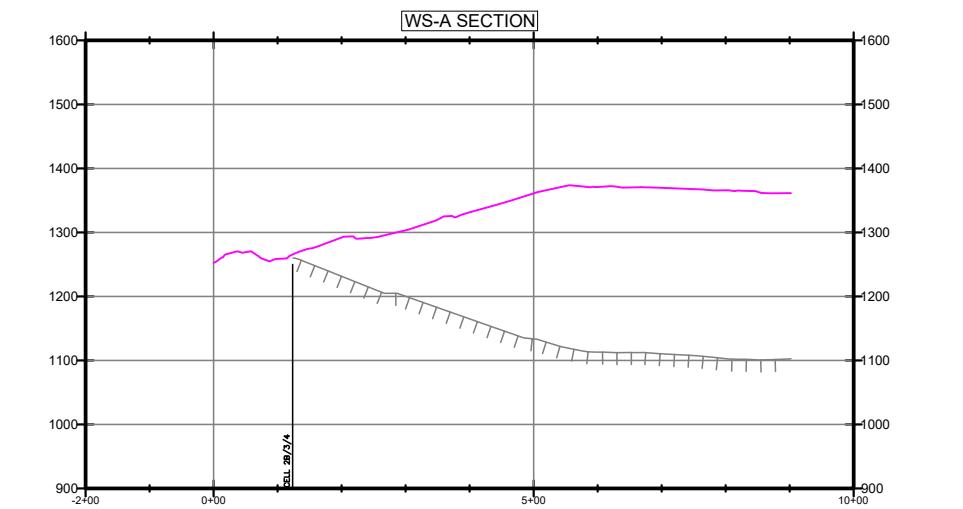
FIGURE 2A

WESTERN SLOPE CROSS SECTION A
APRIL 2025 MONITORING SUMMARY
CHIQUITA CANYON LANDFILL
COUNTY OF LOS ANGELES, CA

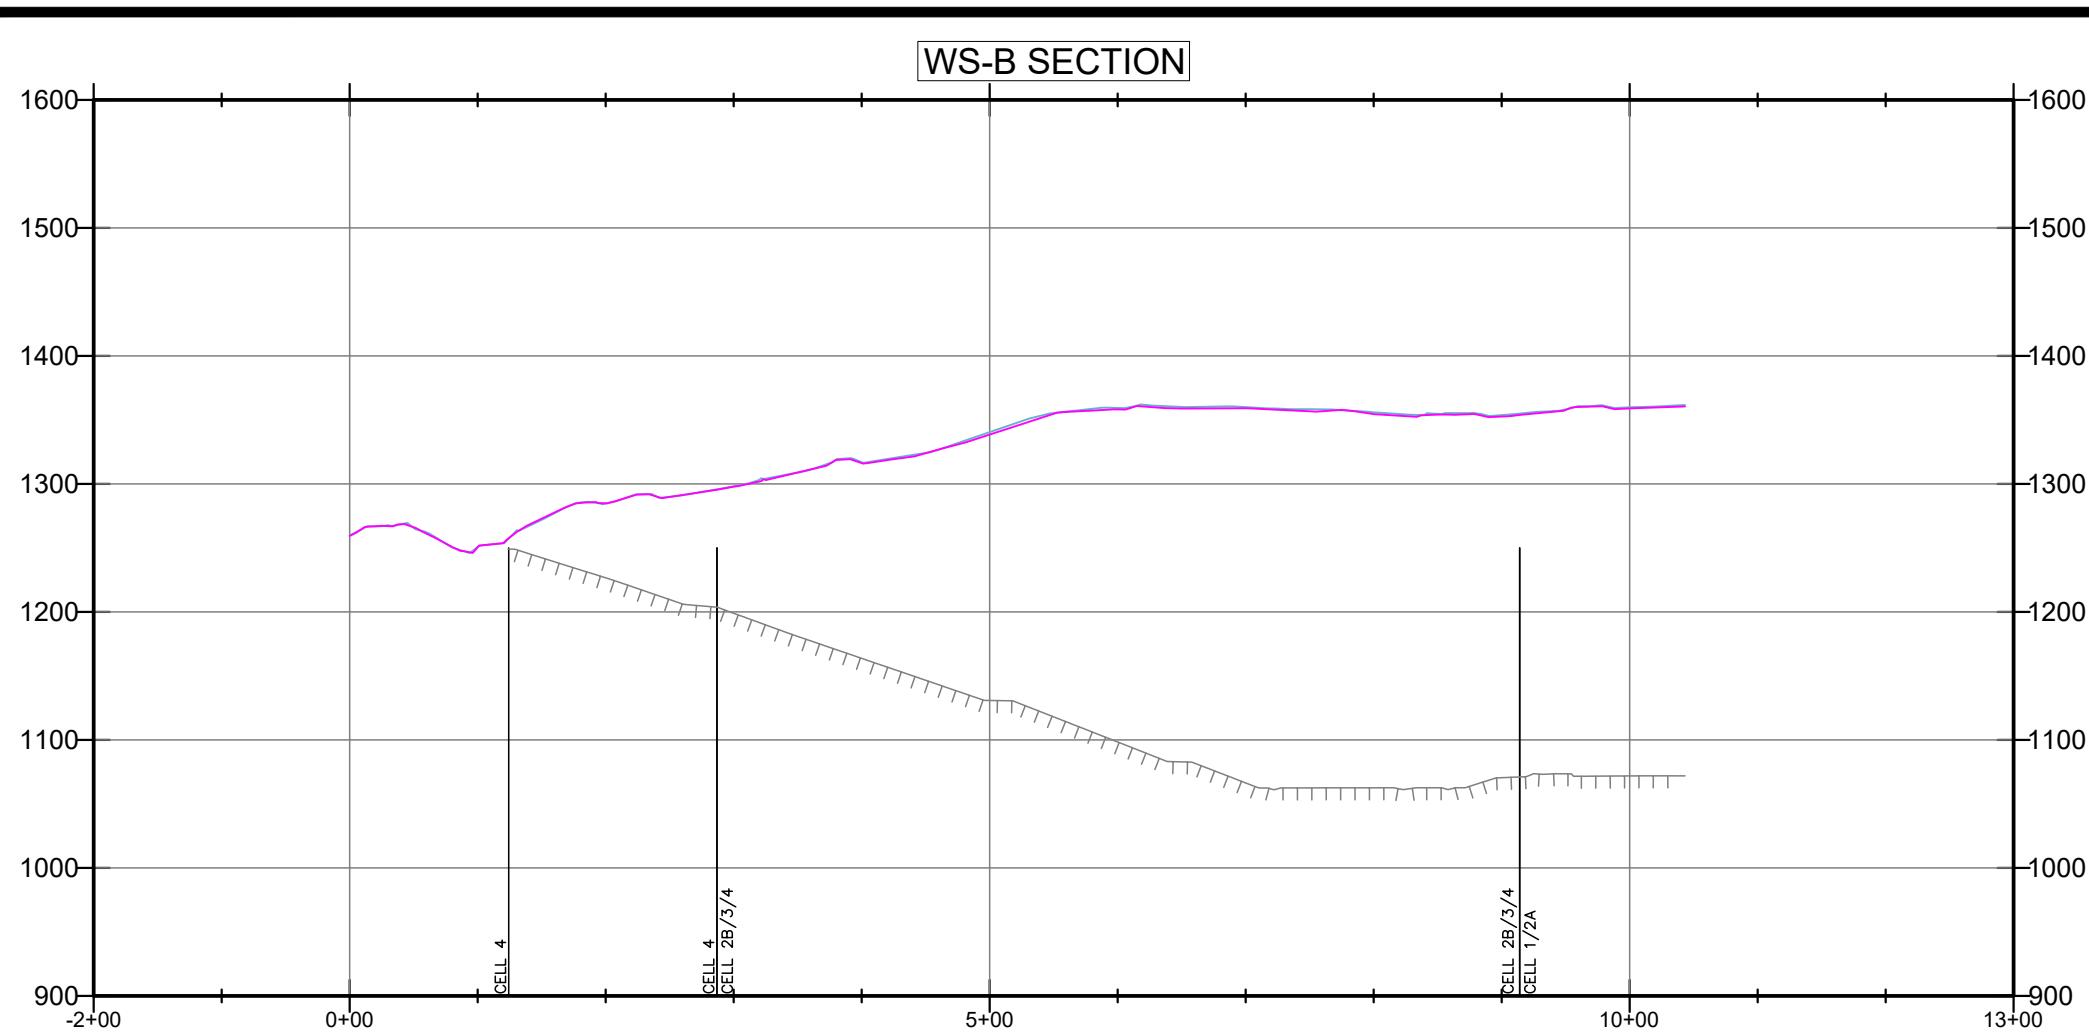
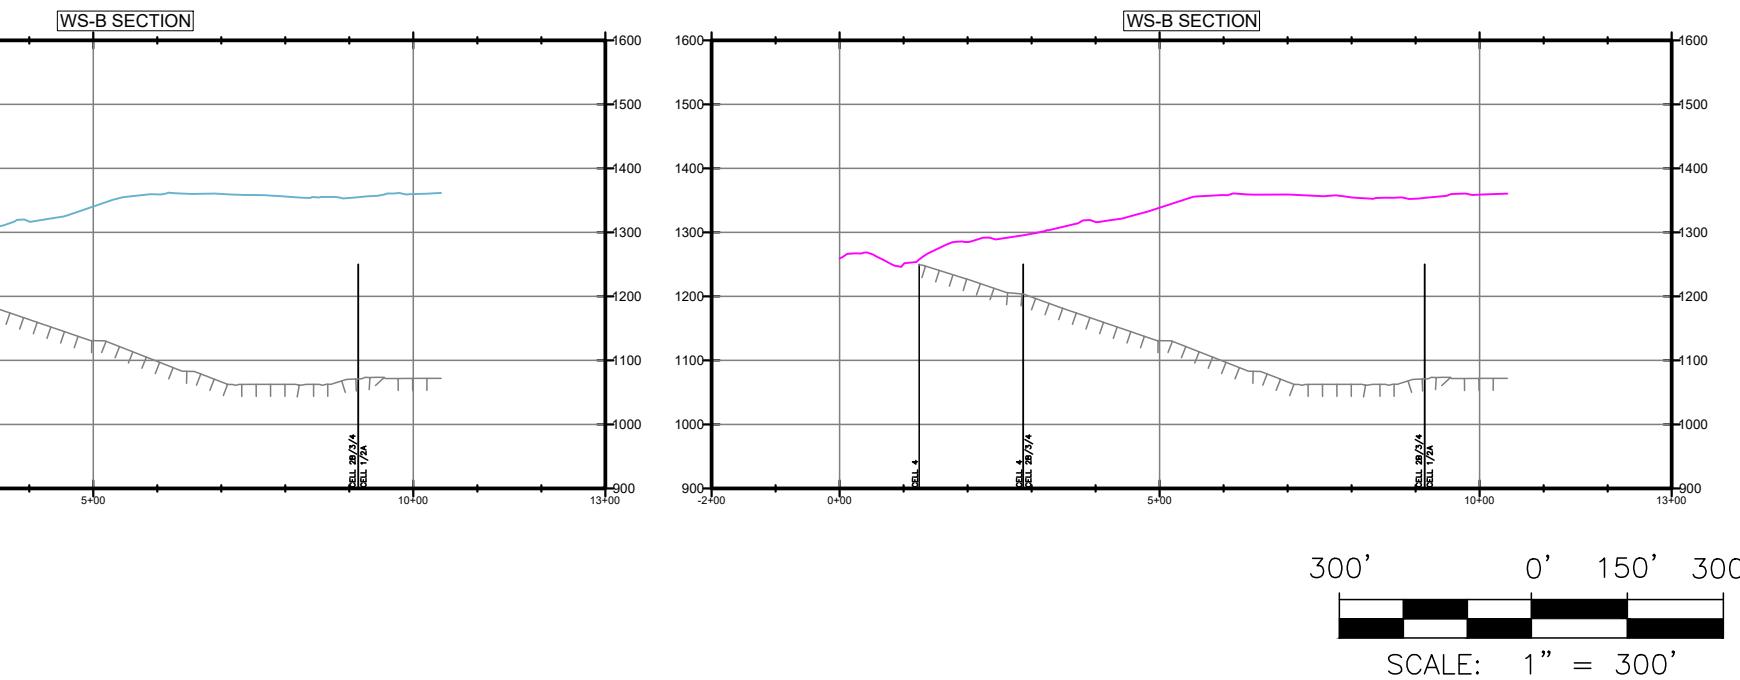
FIGURE 2B
WESTERN SLOPE CROSS SECTION B
APRIL 2025 MONITORING SUMMARY
CHIQUITA CANYON LANDFILL
COUNTY OF LOS ANGELES, CA
