# CHIQUITA CANYON

**Re: Chiquita Canyon, LLC's Weekly Report on the Documentation and Tracking of Cover Issues and Monthly Summary**

# **Fissures and Tension Cracks**

**MAY 2025 FISSURE AND TENSION CRACK MONITORING SUMMARY**  
**CHIQUITA CANYON LANDFILL**  
**CASTAIC, CALIFORNIA**

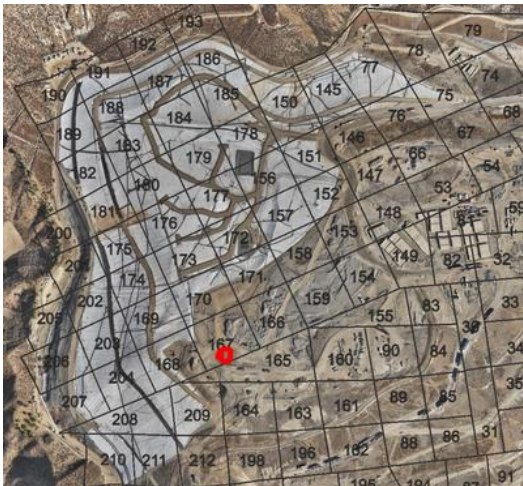
167

**Length of crack (ft) or area containing multiple cracks (ft x ft)** 20ft x 30ft

**Description of repairs** Cracks were track walked.

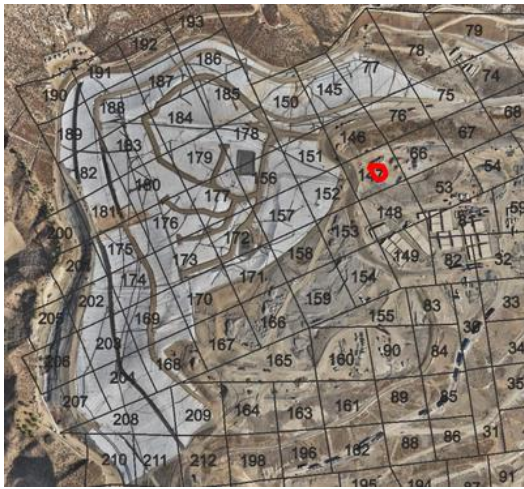
147

**Length of crack (ft) or area containing multiple cracks (ft x ft)** 25ft x 45ft

Dirt was added and cracks were track walked.

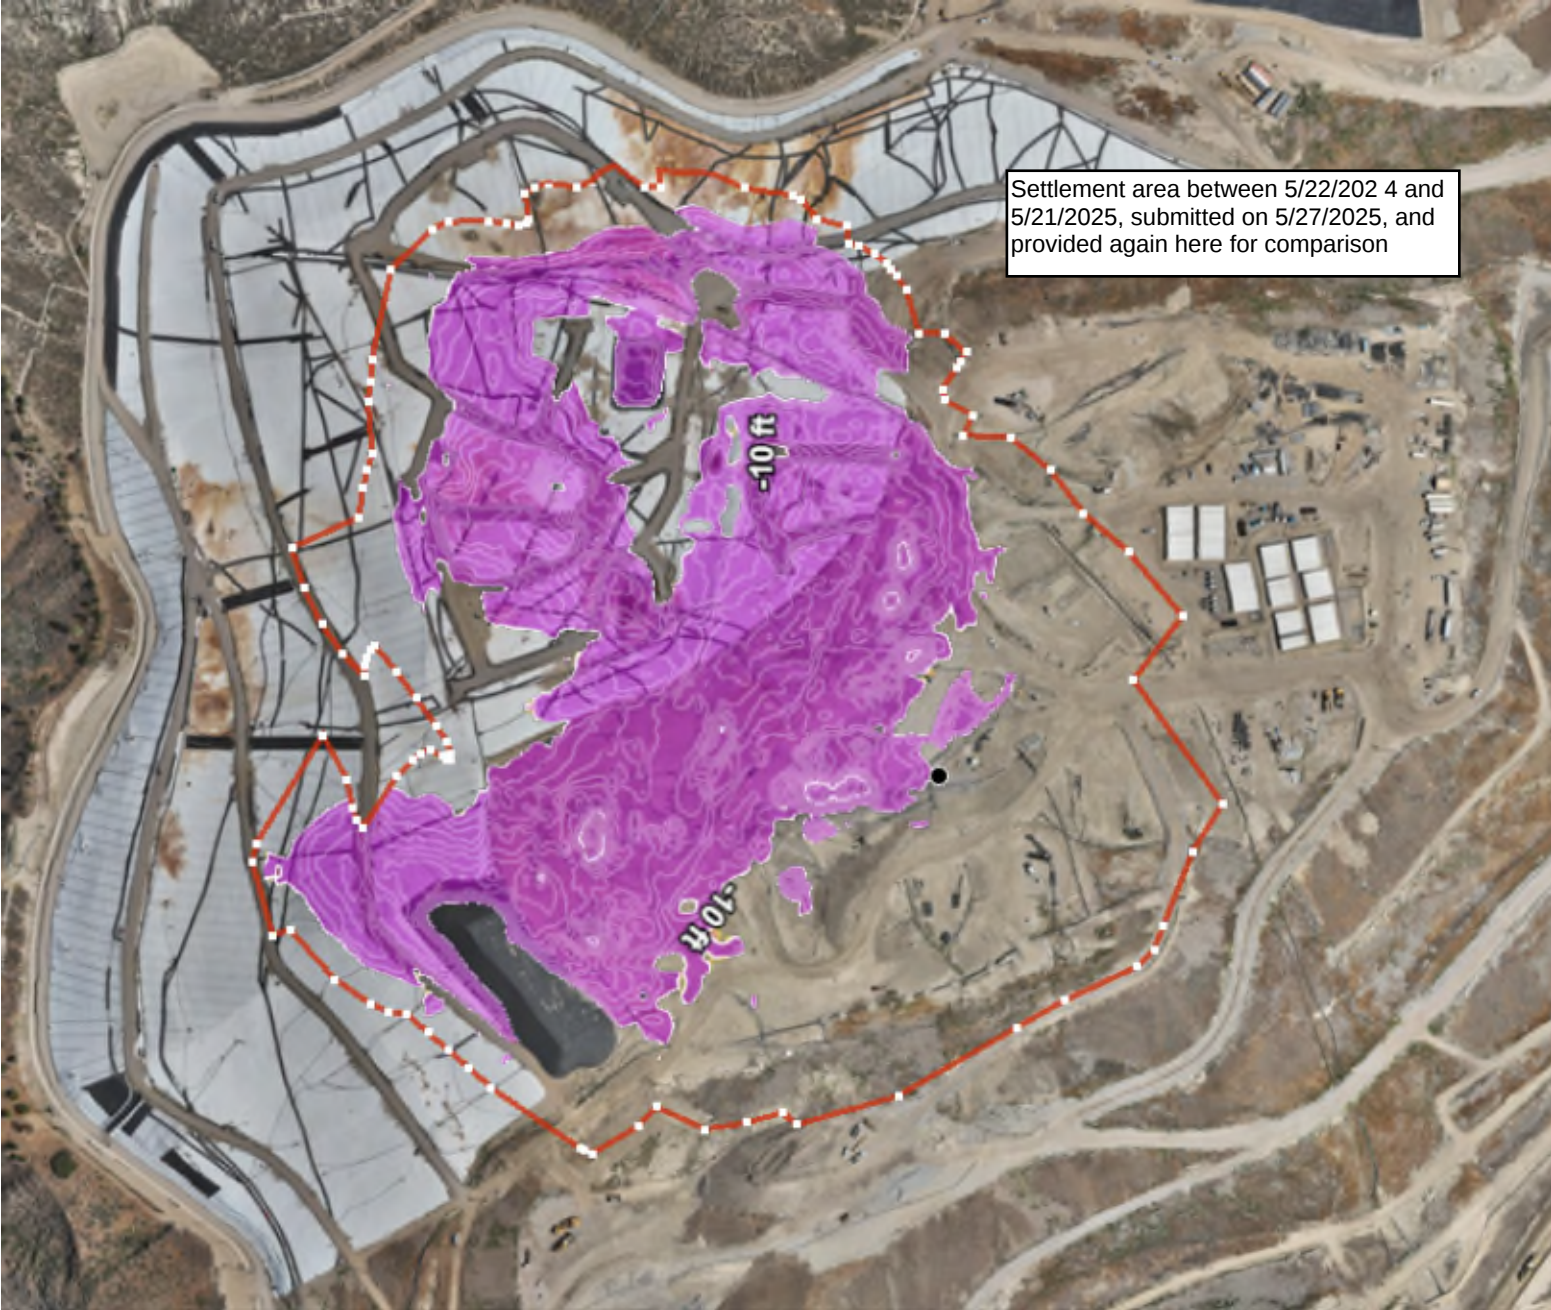
Settlement area between 5/22/202 4 and 5/21/2025, submitted on 5/27/2025, and provided again here for comparison

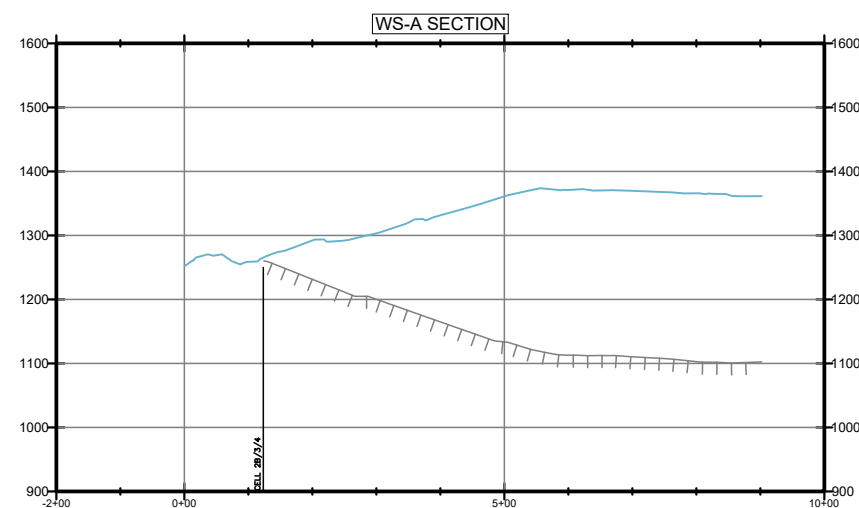
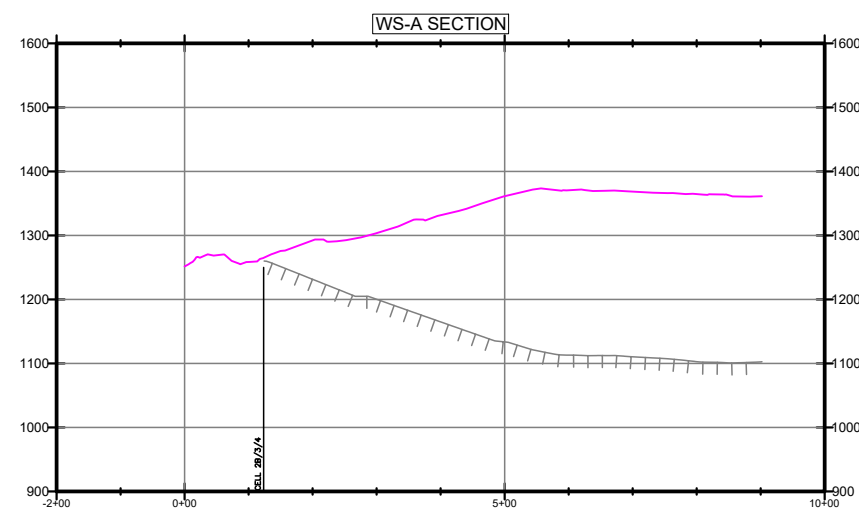
FIGURE 2A

WESTERN SLOPE CROSS SECTION A  
MAY 2025 MONITORING SUMMARY  
CHIQUITA CANYON LANDFILL  
COUNTY OF LOS ANGELES, CA

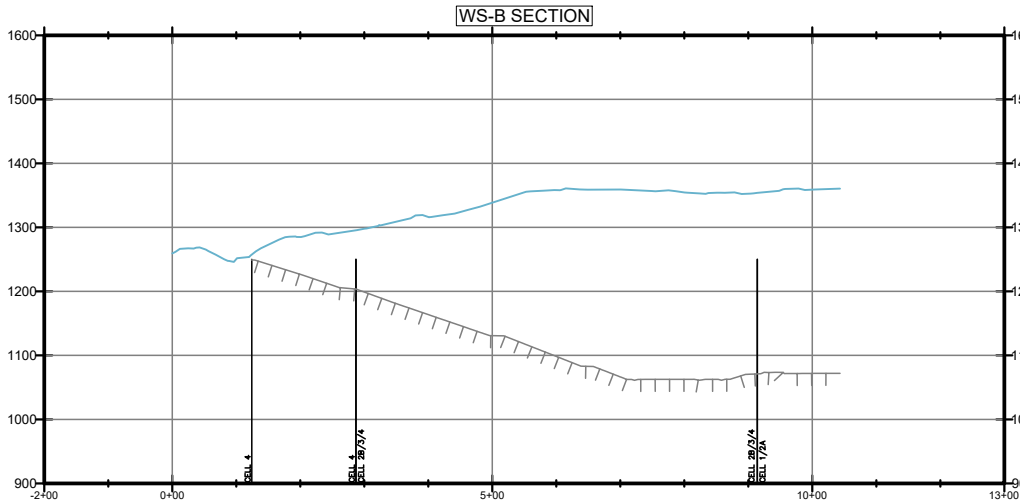
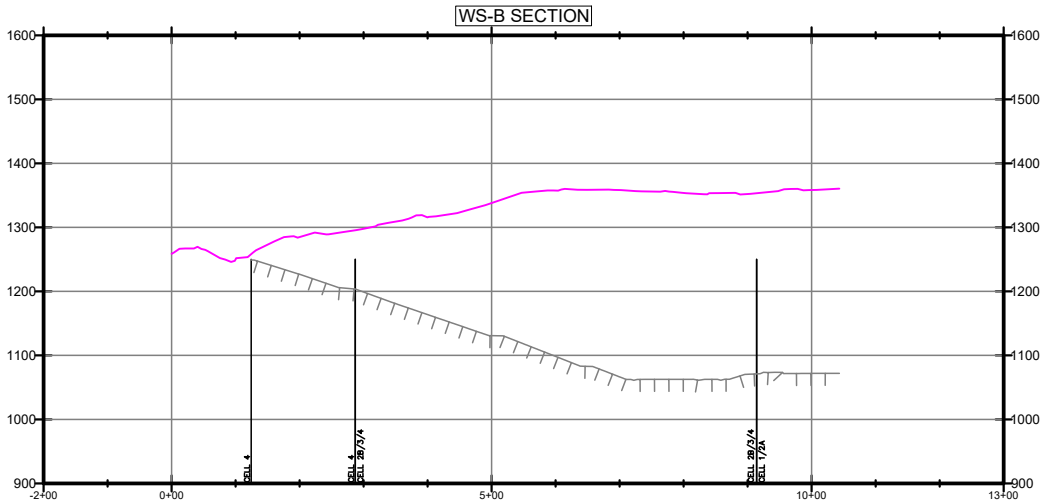
FIGURE 2B

WESTERN SLOPE CROSS SECTION B  
MAY 2025 MONITORING SUMMARY  
CHIQUITA CANYON LANDFILL  
COUNTY OF LOS ANGELES, CA

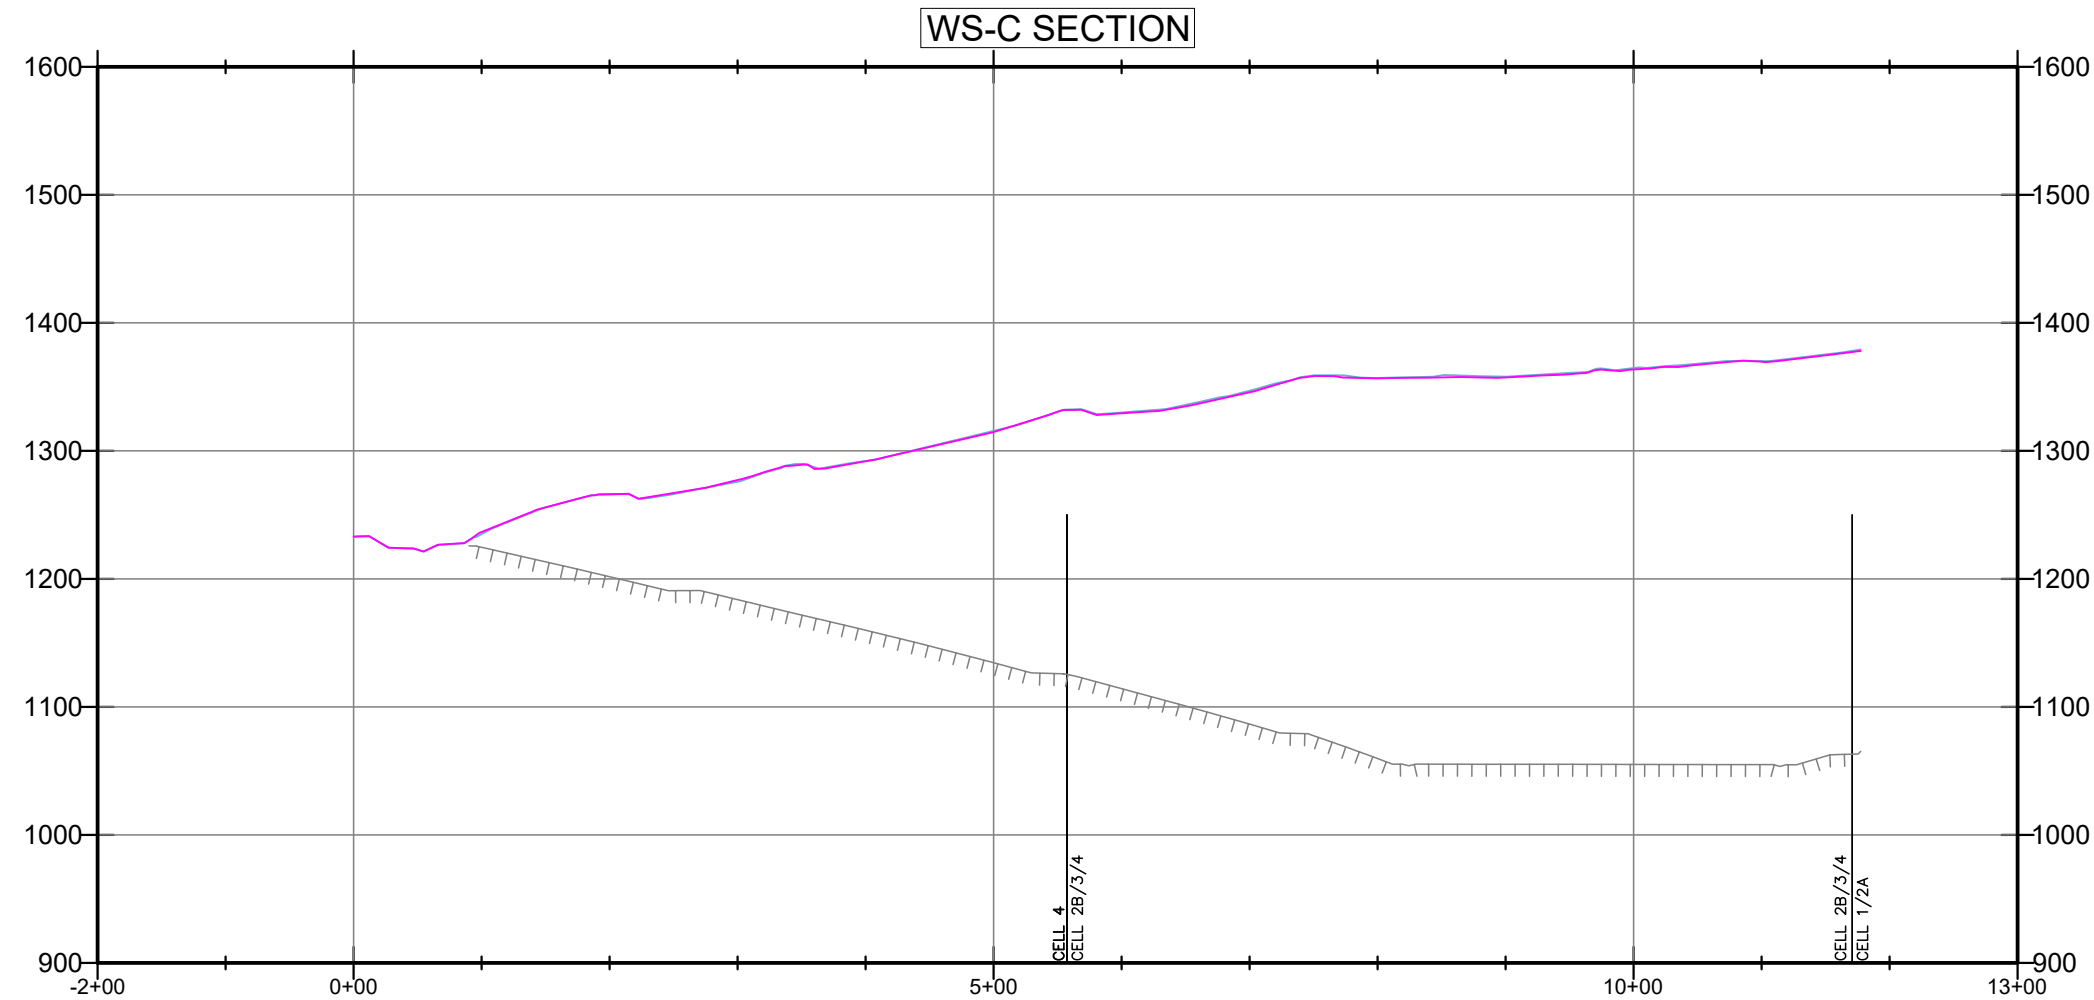
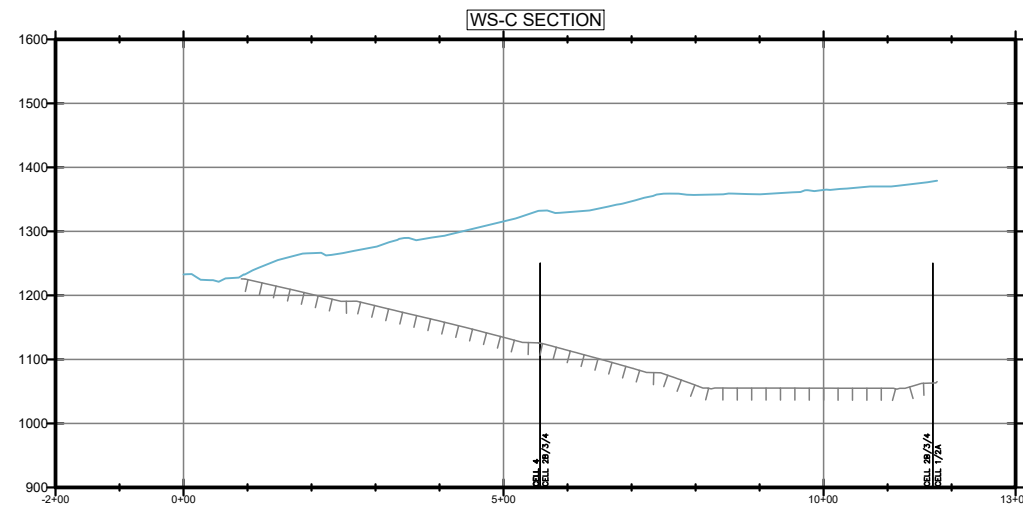
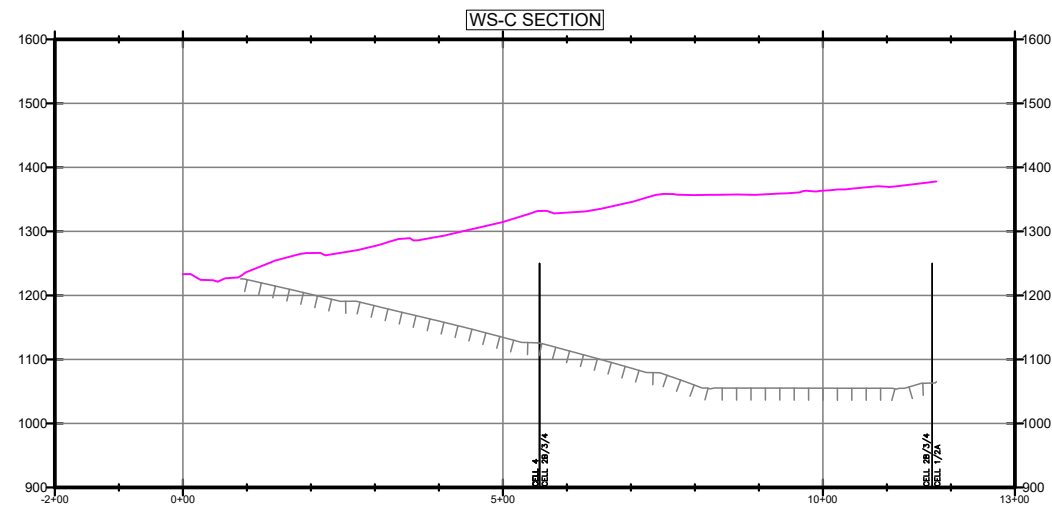
FIGURE 2C

WESTERN SLOPE CROSS SECTION C

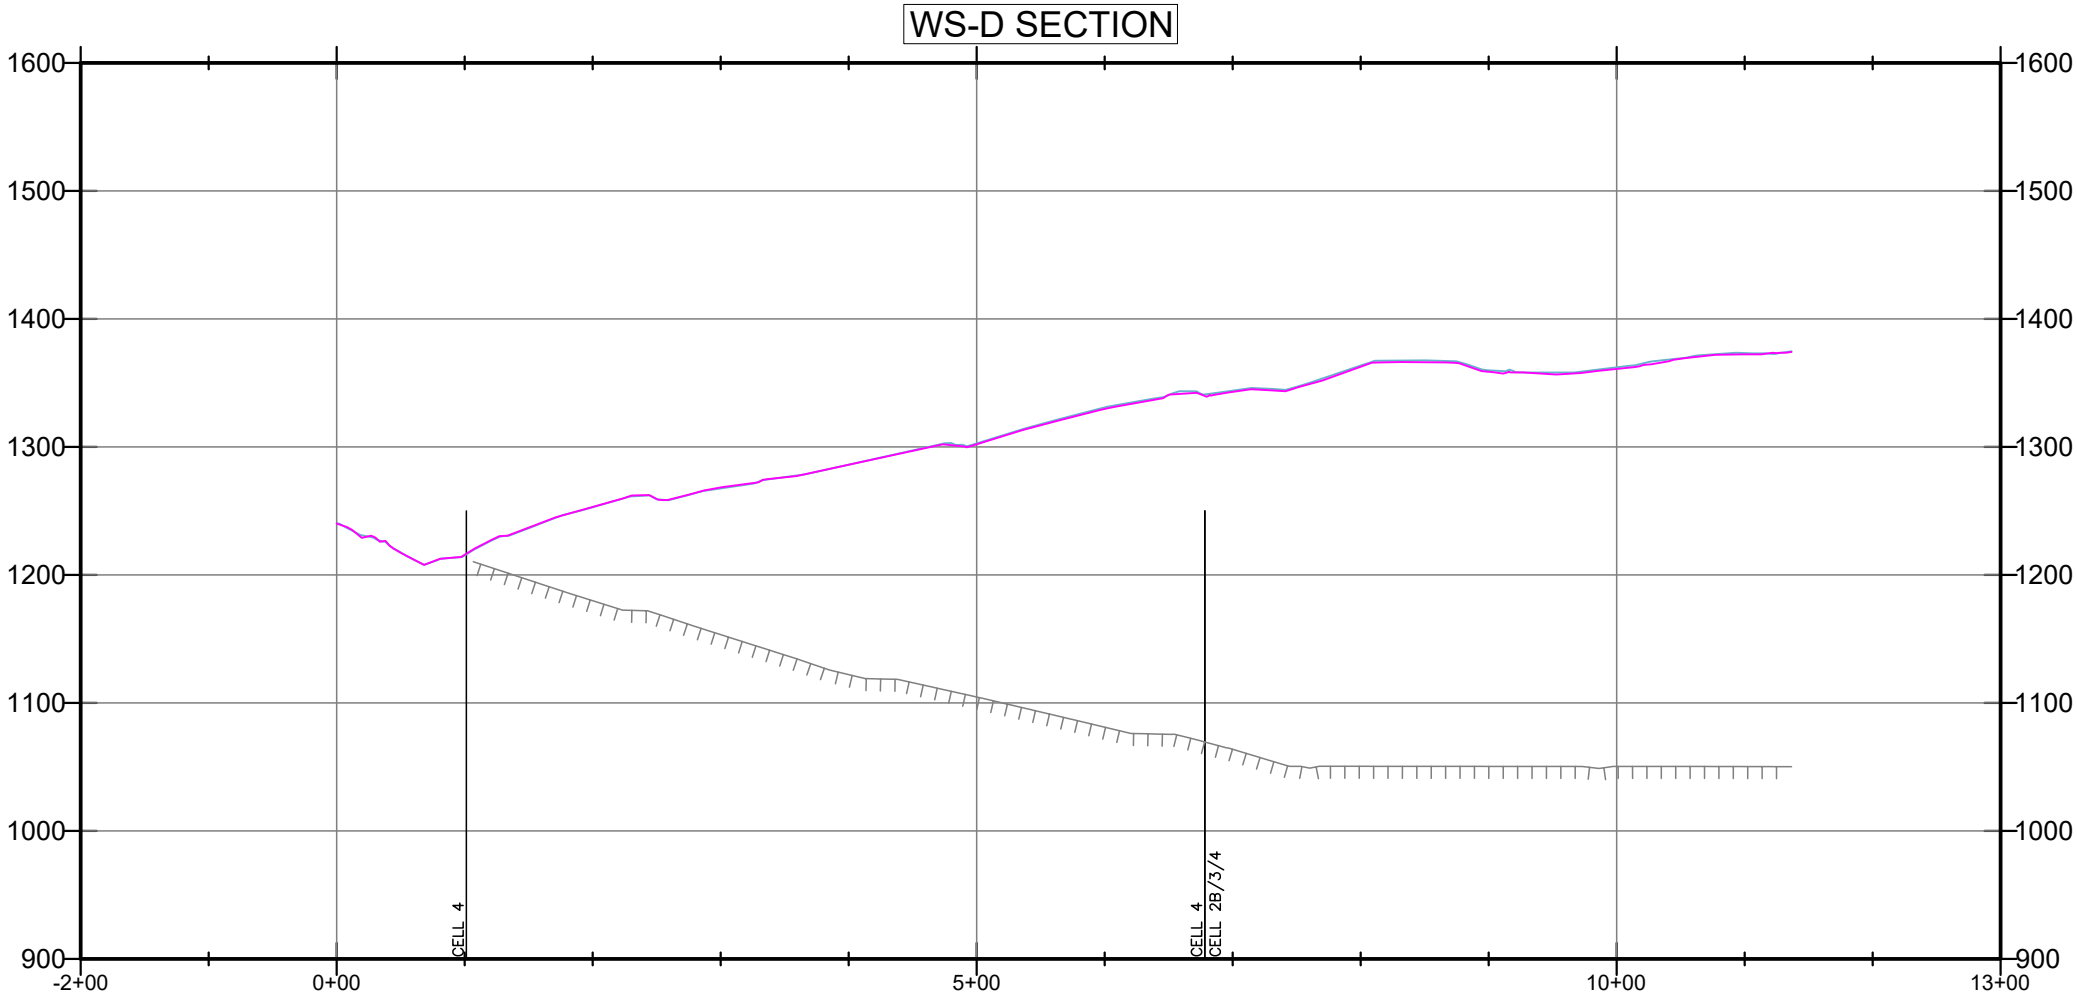
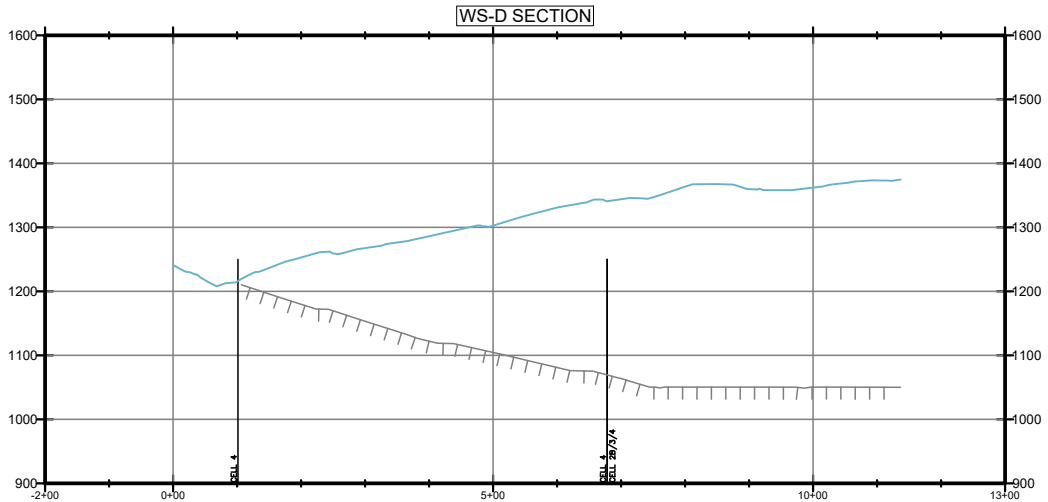
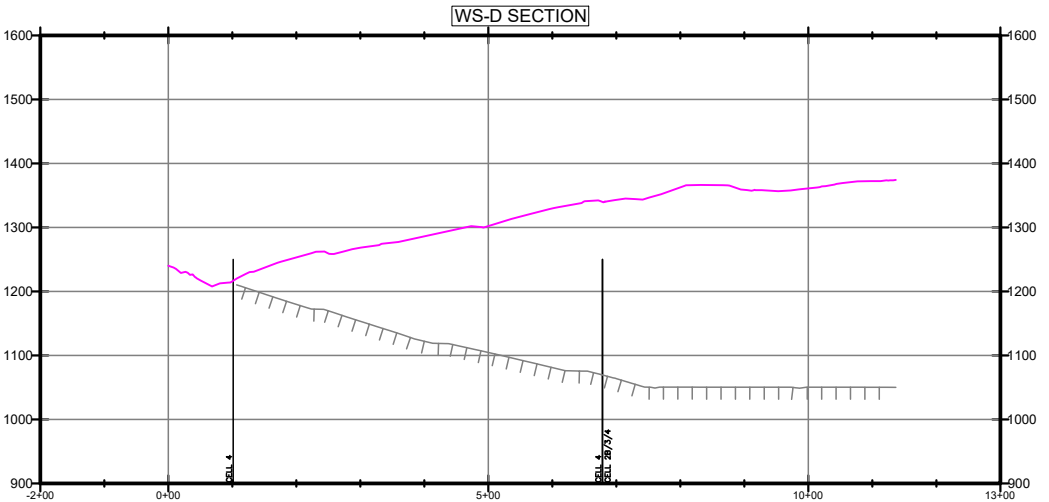
FIGURE 2D  
WESTERN SLOPE CROSS SECTION D  
MAY 2025 MONITORING SUMMARY  
CHIQUITA CANYON LANDFILL  
COUNTY OF LOS ANGELES, CA

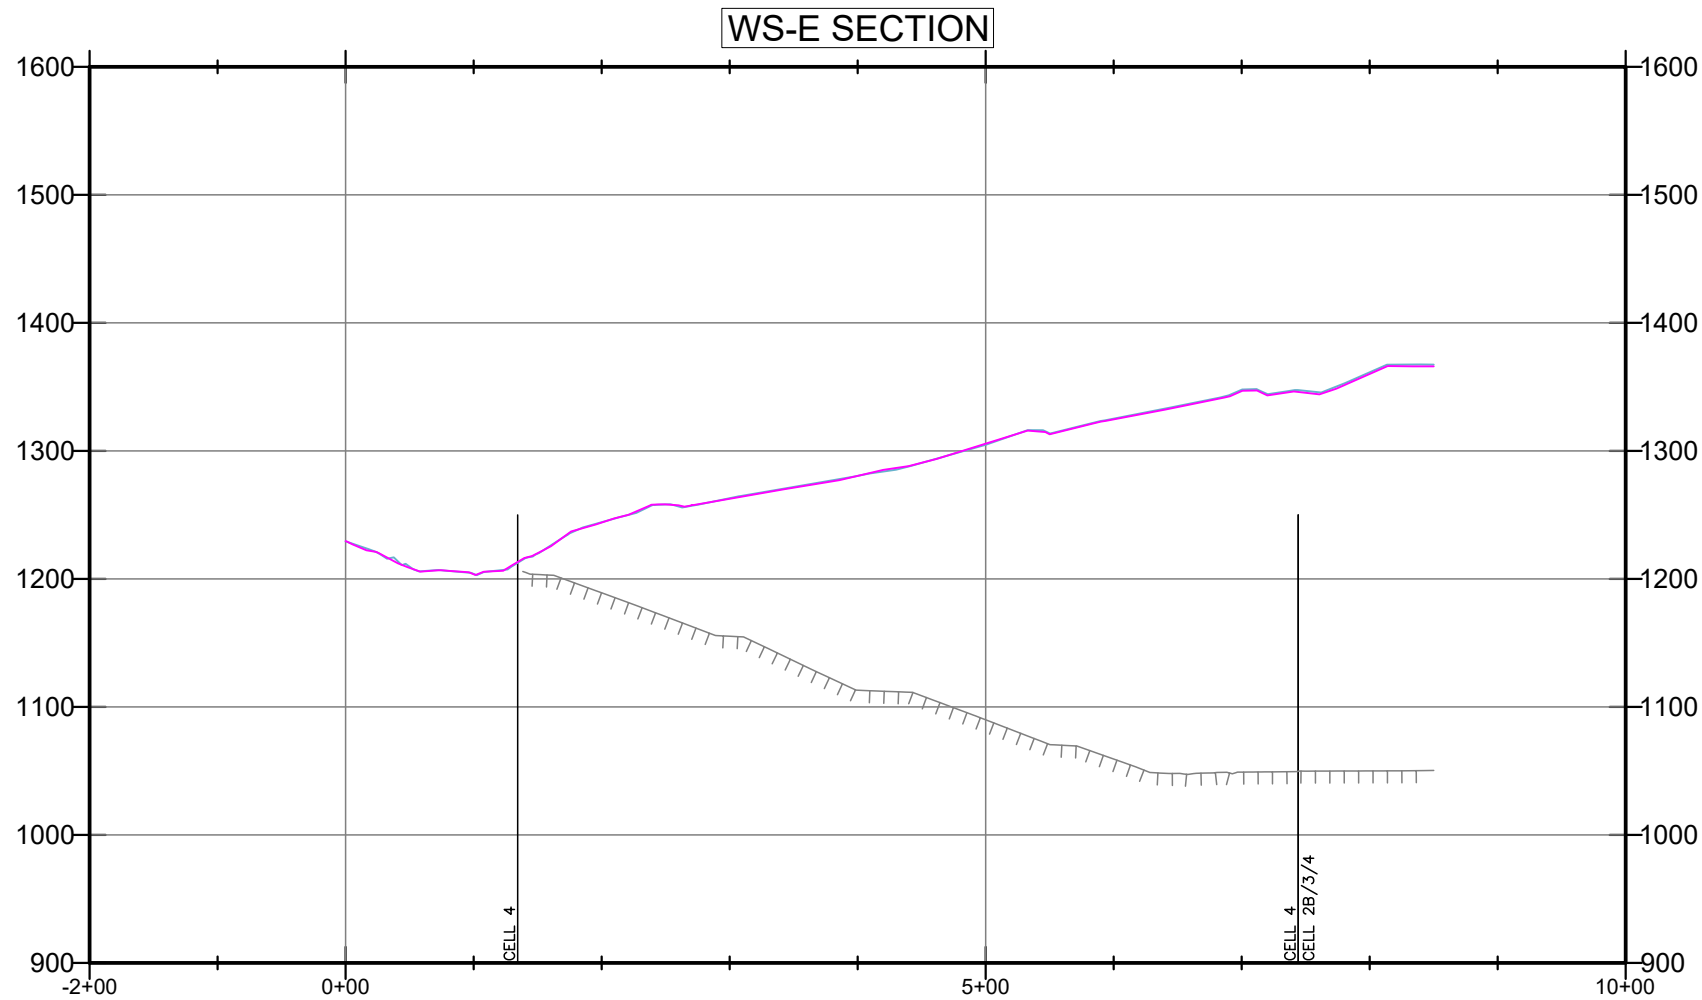
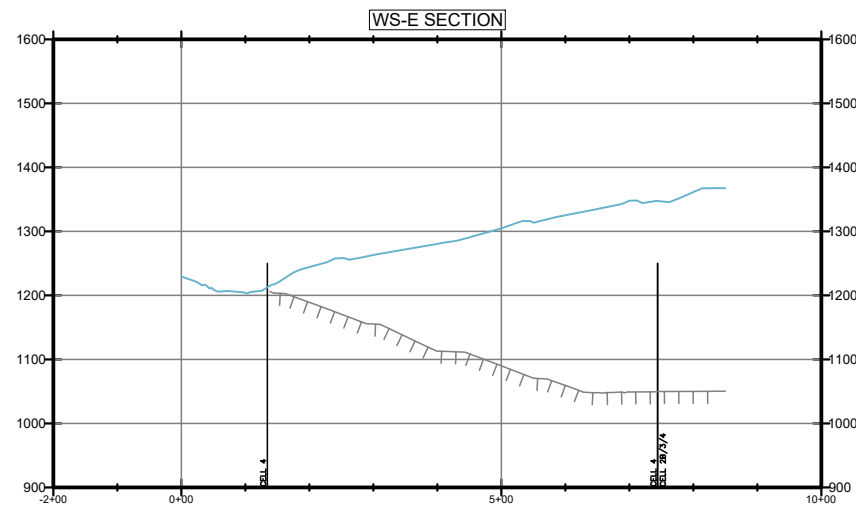
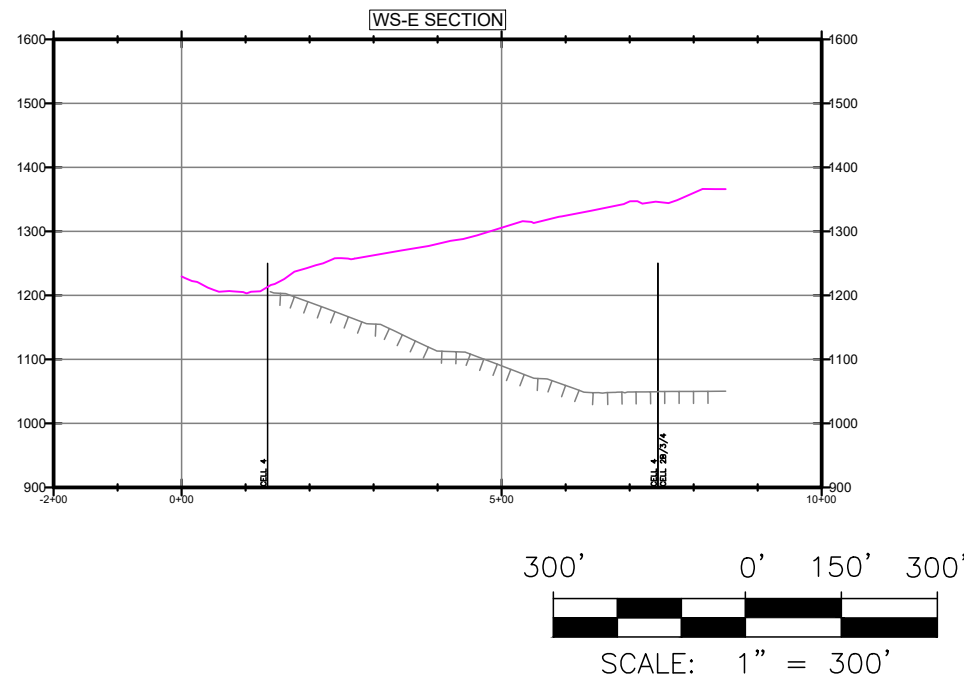
FIGURE 2E  
WESTERN SLOPE CROSS SECTION E  
MAY 2025 MONITORING SUMMARY  
CHIQUITA CANYON LANDFILL  
COUNTY OF LOS ANGELES, CA

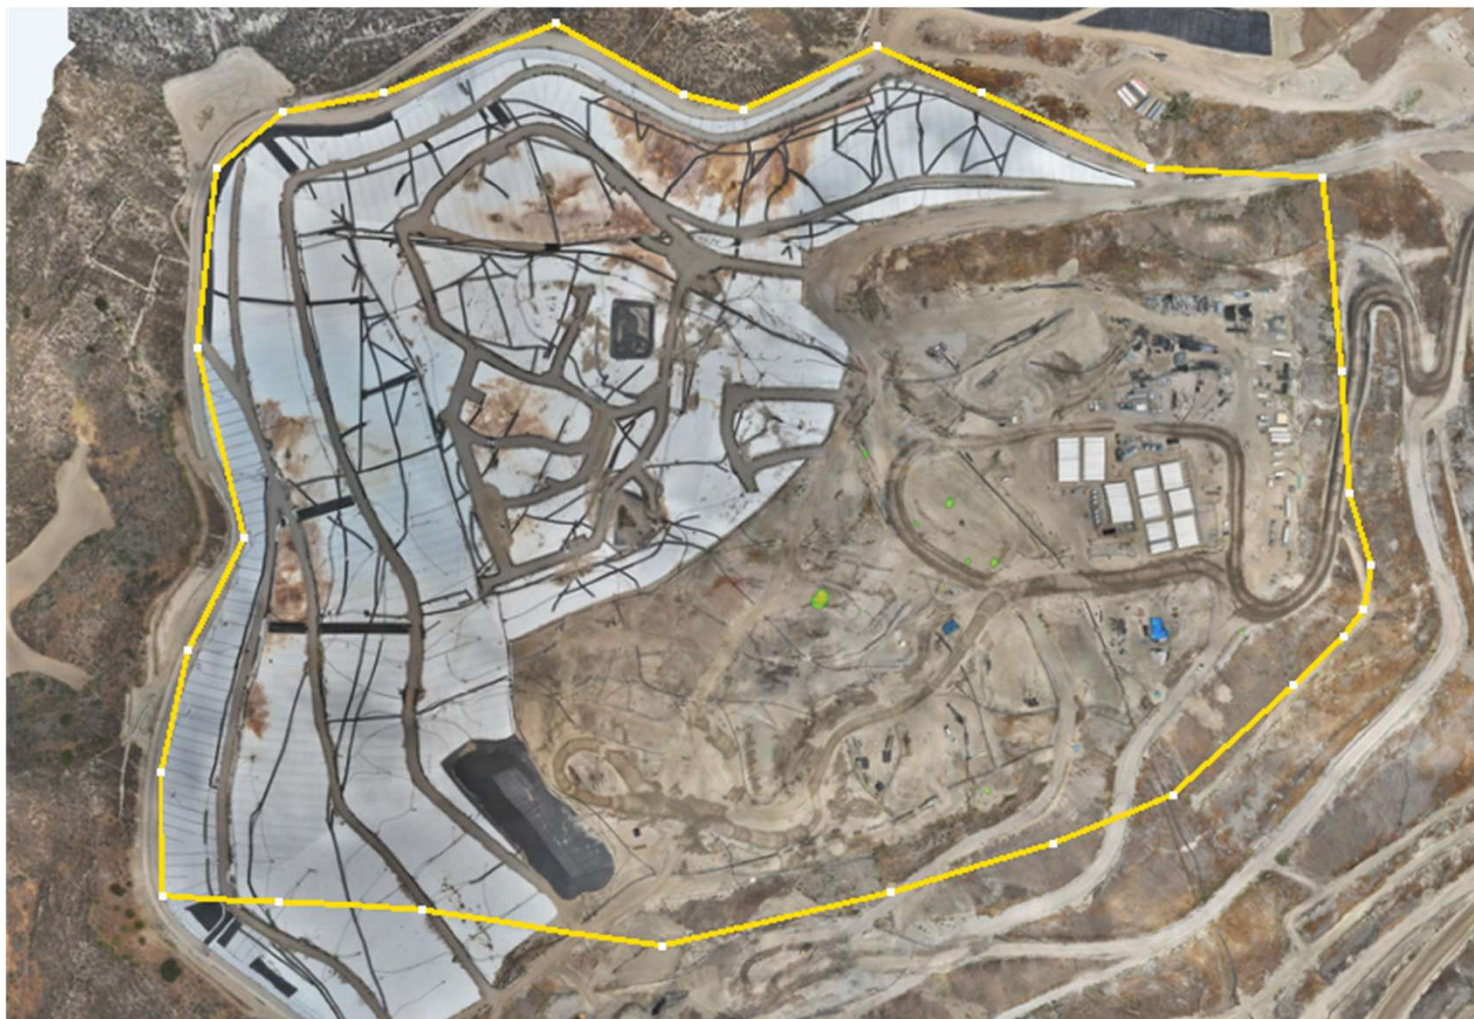
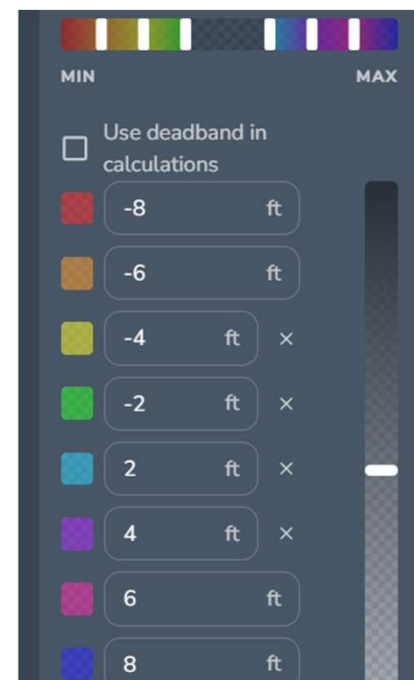
# Chiquita Canyon Landfill - Isopach

April 2, 2025 Survey Image. April 30, 2025 vs May 28, 2025
