CHIQUITA CANYON
A Waste Connections Company

Re: Chiquita Canyon, LLC's Weekly Report on the Documentation and Tracking of Cover Issues

Attachment: July 1, 2025 Weekly Cover Issues Report

4050 - Chiquita Reaction Area Tracking of Fissures and Tension Cracks

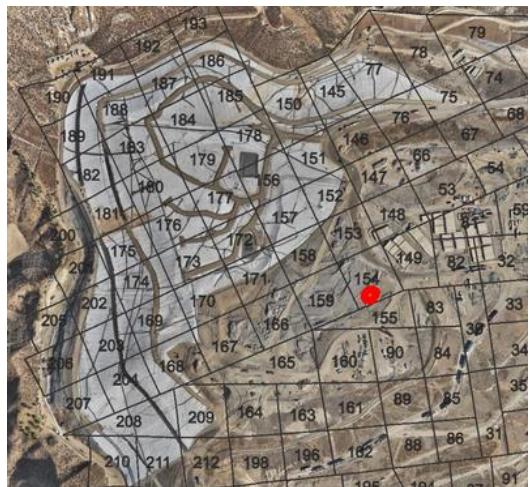
154

Length of crack (ft) or area containing multiple cracks (ft x ft)	15ft x 25ft
Horizontal Offset (width)	Small 0.5-2" in width
Vertical Offset (height)	Extra small <0.5" in height
Orientation (direction)	NE to SW
